St Cybi's Church, Holyhead Internal west wall of nave

Archaeological Watching Brief and Survey

Project No. G2343

Report No. 1357

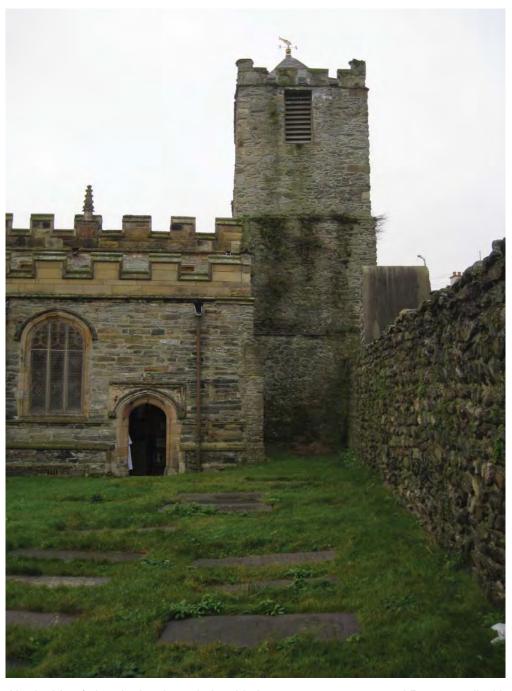
North side of church showing relationship between nave, tower and Roman wall with north aisle in foreground

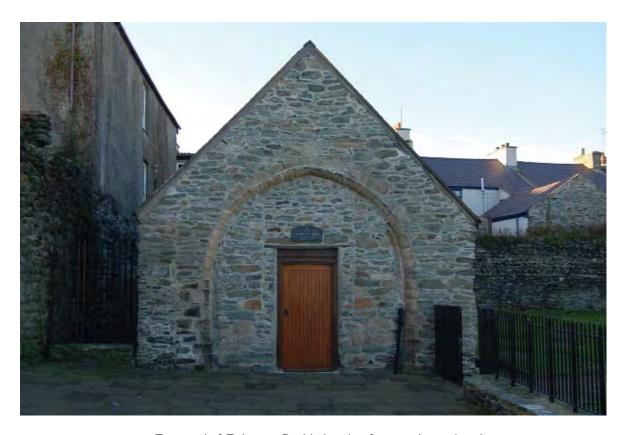
East end of Eglwys y Bedd showing former chancel arch

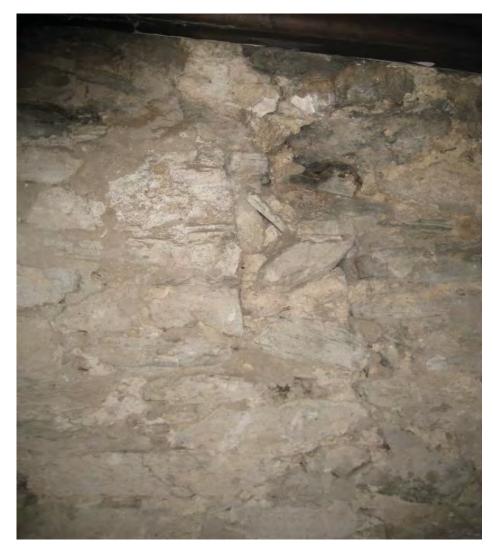
(i) North opening

The dimensions of this opening are approximately 0.28m wide by 0.56m high. There is no obvious lintel or sill, though the jambs are recessed at the base where a timber lintel may have fitted. There is a straight joint on the south side, and another, slightly less clear one, on the north. The blocking contains an angled stone in the centre, with fairly loose creamy pale mortar around. The mortar appears weaker in the blocking

The north opening appears to lie on the former north roof-line.

than in the wall either side. The jambs on the north are of relatively large slabs laid horizontally. Their positioning would suggest the opening was made at the time the roof line was extended.

The small north opening is likely, from the positioning of the jambs, to date from this late-medieval rebuilding. Its purpose is unknown, though if there was no west tower at this time, it must have opened out. It is similar to small rectangular loops which typically light stairs, and it may suggest the presence of a former stair either inside or outside the west wall.

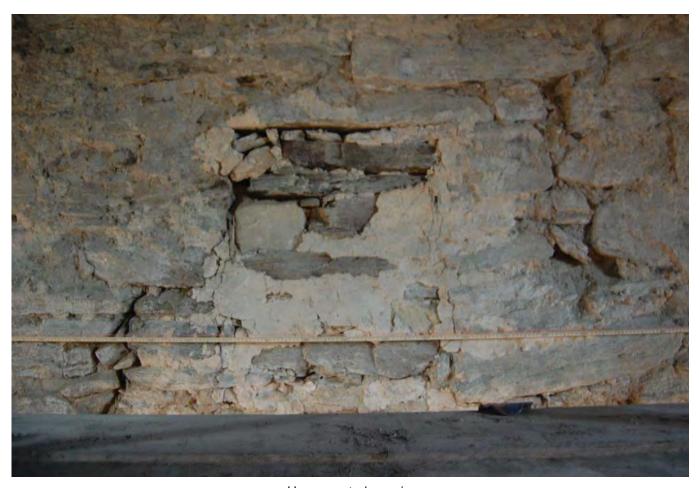
Upper central opening

This blocked opening is 0.58m wide. There is a stone lintel across the top, with loose blocking stones and a slightly harder, whiter mortar poorly plastered over some of the stones. The lower part of the opening is difficult to interpret because of the second opening below, however it would appear to be marked by a line of three blocking stones 0.58m below the lintel. There is no obvious sill.

The two larger openings appear, from the style of construction, to be later in date, and to post-date the construction of the tower. The upper opening appears to be the earlier, and may date from the occupation of the church by the military during the civil war. Either might be associated with a west gallery, a feature of many Anglesey churches in the 18th century.

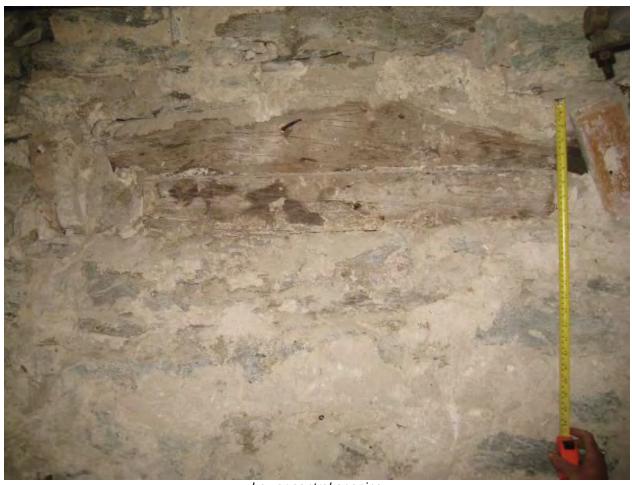
Lower central opening

The lower central opening has two timber lintels in place, with a brick laid at an angle on the north side. The opening measures approximately 0.8m high by 1.2m wide. There is no obvious sill. A slightly darker mortar obscures the jambs, though a straight joint is indicated within the mortar.

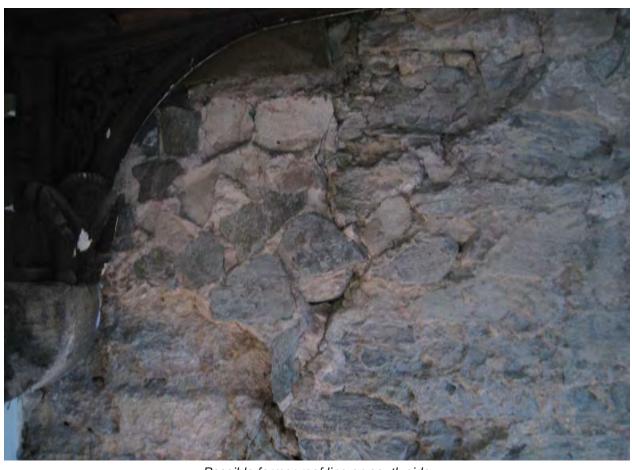
These are visible on the north and south sides. They are not easy to follow accurately and are best appreciated from the illustration. The apex was above the level of the ceiling, and is not visible. The roofline starts approximately 1.4m below the present ceiling.

Possible former roof line on south side

The two diagonal lines are best interpreted as marking a former pitched roof-line, and quite possibly the same as those visible on the west side from within the tower, as recorded by Hughes, and still visible (though additional survey work is required to confirm this). These must pre-date the 16th century roof, and quite possibly belong to the earlier 12th century church. This masonry, as Hughes suggests, is likely to

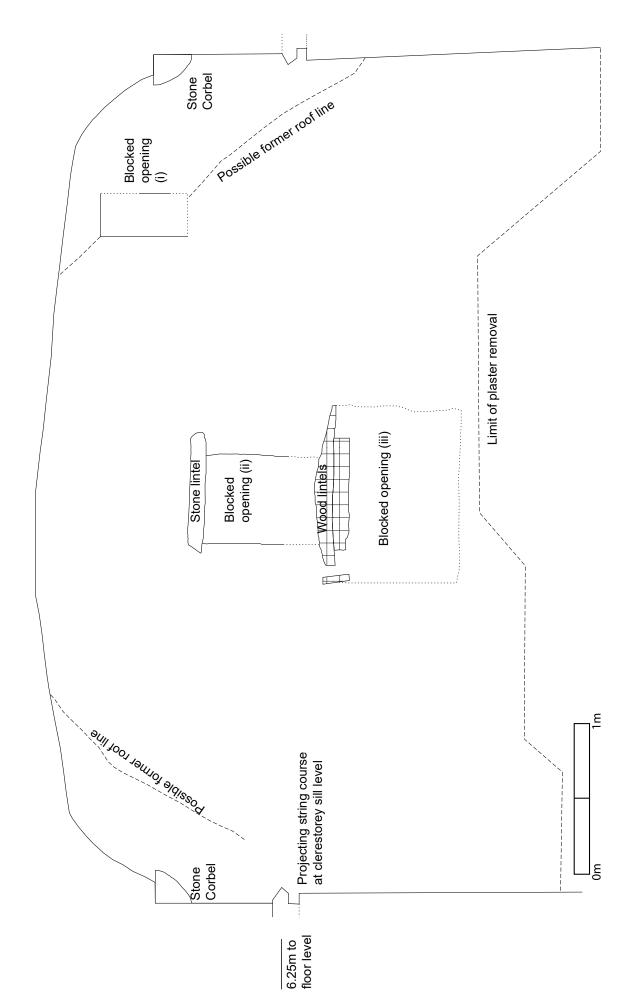
Changes visible within the masonry included evidence of three former openings, and two diagonal lines thought to represent an earlier roof-line. The three openings consist of (i) a small rectangular loop on the north side, which cuts the northern diagonal roofline; (ii) an upper square central opening with lintel; and (iii) immediately below (ii) a larger opening with lintel. Each of these would have opened into the present tower.

Location of principal features on east facing wall of nave following plaster removal

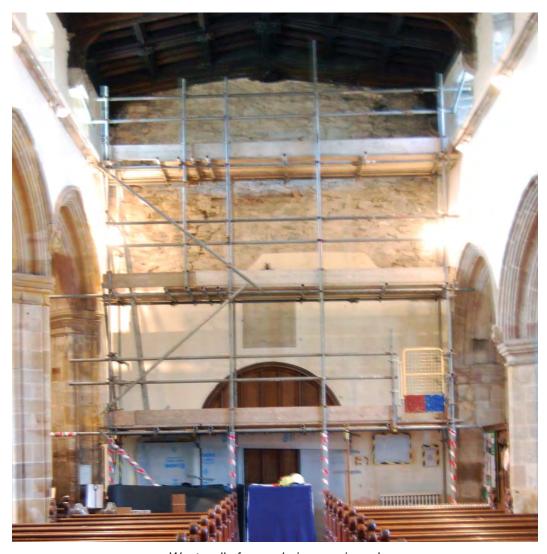
West wall of nave during repair work

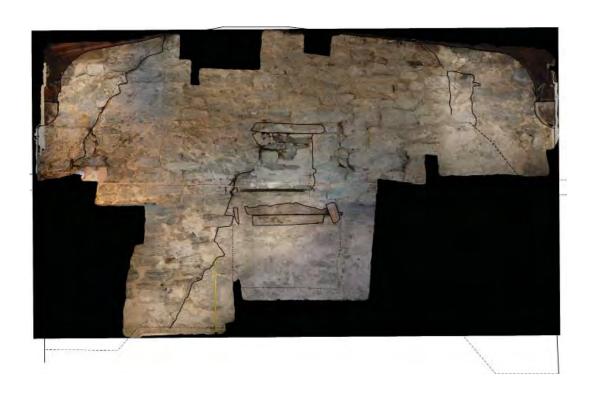
West wall of nave showing changes in masonry
