St. Cybi's Church, Holyhead, Anglesey

Recording of the Southern Clerestory Windows

Project No. G2478

Report No. 1358

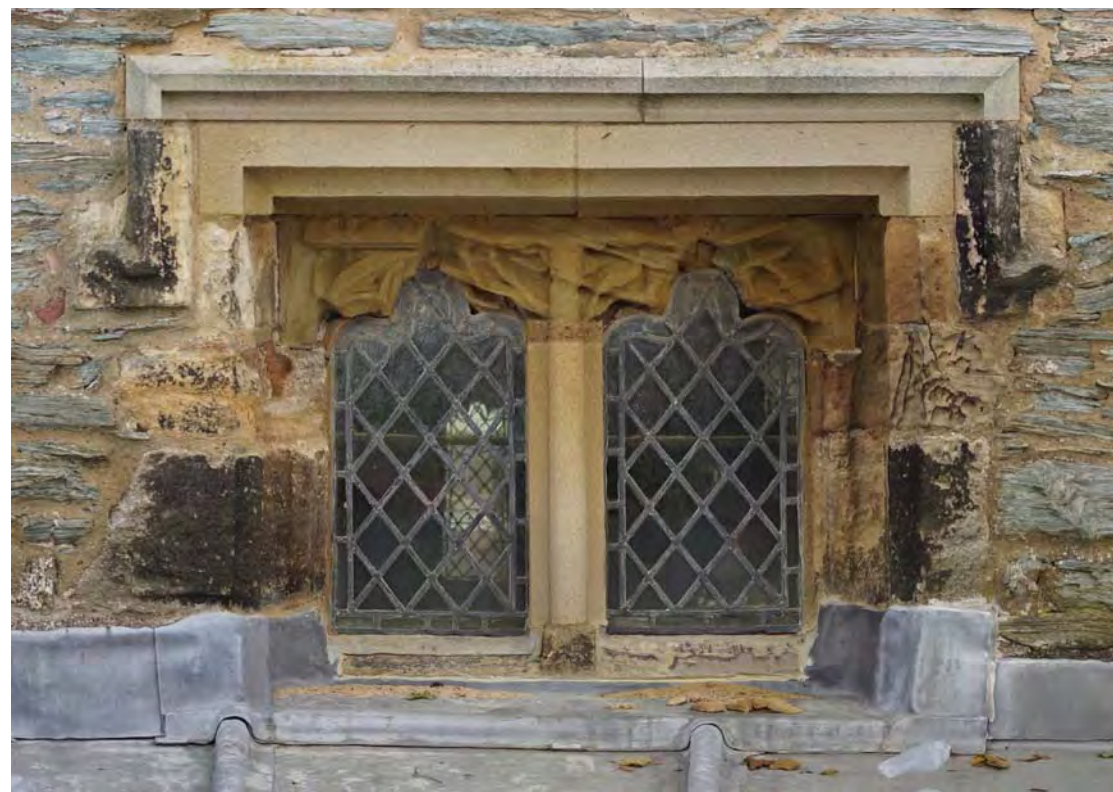
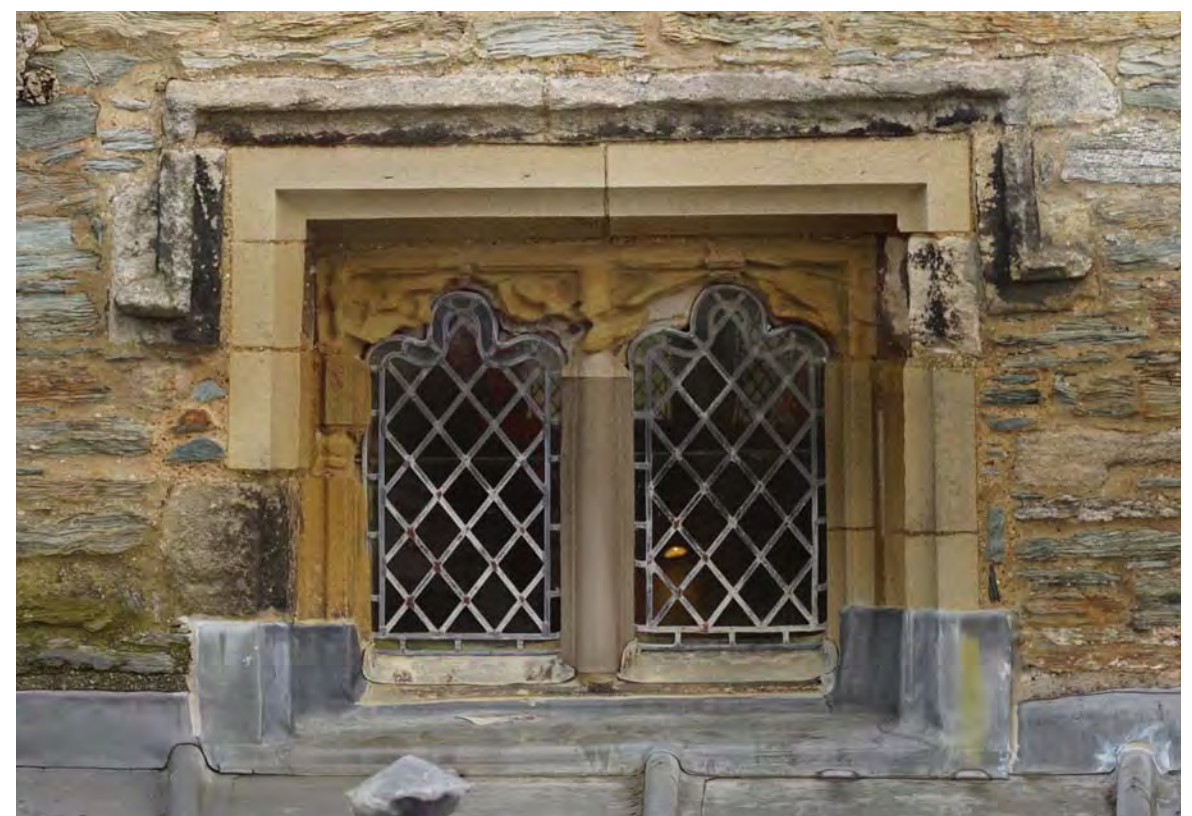
Detail of southern clerestory windows: first two windows from west

The southern clerestory windows have undergone many phases of repair, much of it during the 20th century. The eastern two windows above the crossing, both with three lights, were inserted by Gilbert Scott during the restoration works of 1877-79 (Hughes 1930, 357). Despite this late date there is some erosion on these windows and one mullion has been replaced. The other windows are originally of late medieval date and although there has been much replacement of stones all the windows are thought to have some surviving elements of the original jambs and labels. The window heads of the three western most windows are so eroded that they could be original with yellow sandstone being used to enable fine carving. The head on the third window from the west is of a different pattern to the other two and may have been partly recut, possibly to take a central bar which reached into the square frame, though vertical tool marks visible on this and not others may suggest a later replacement.

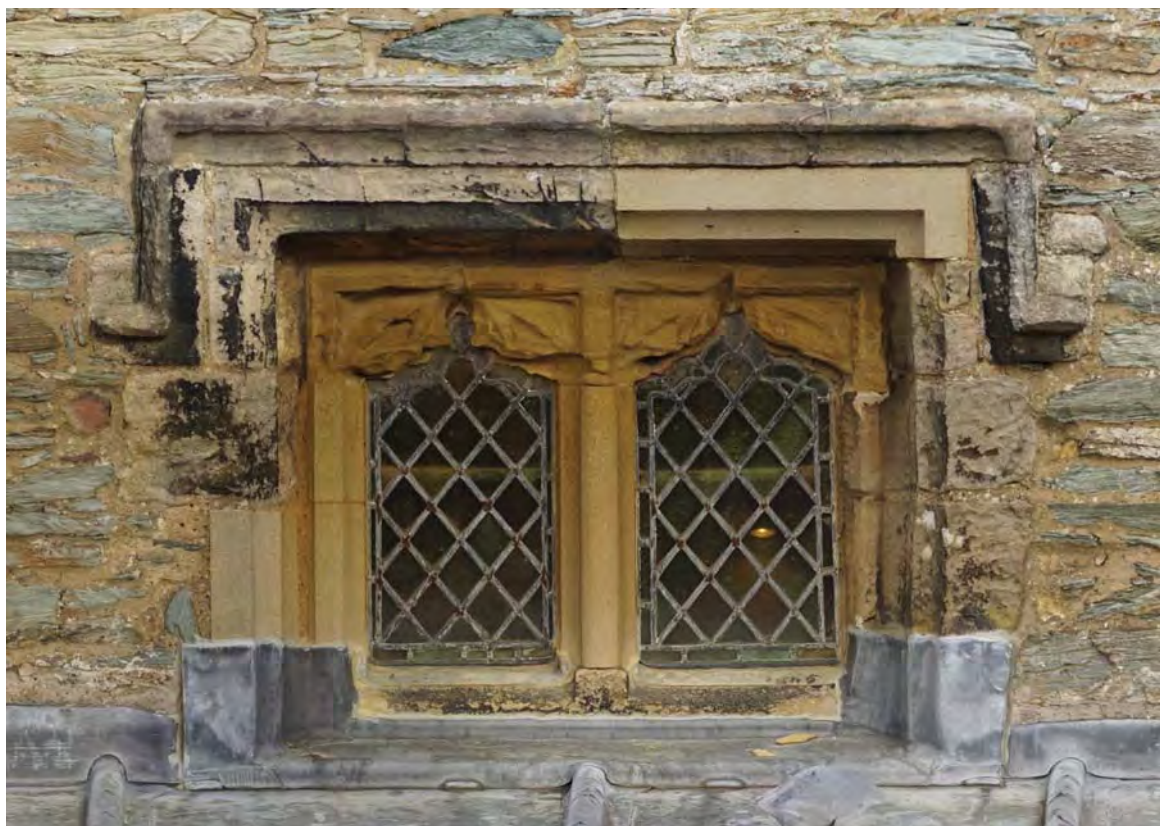
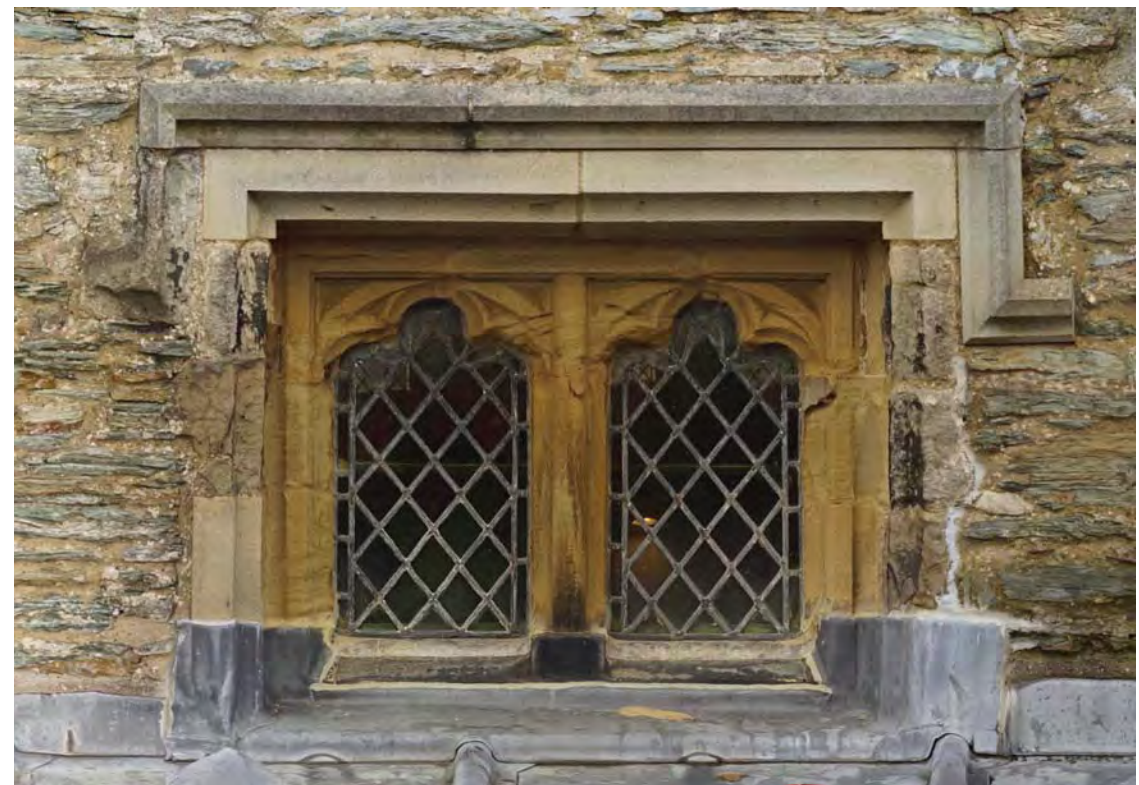
Detail of southern clerestory windows: third and four windows from west

The fourth window from the west is the best preserved, and has probably been renewed. It appears to have been used as the basis for the design copied by Scott. The condition of the stonework in this window and the different colour of the stone suggests that it is not part of Scott's restoration but probably an eighteenth or early 19th century restoration.

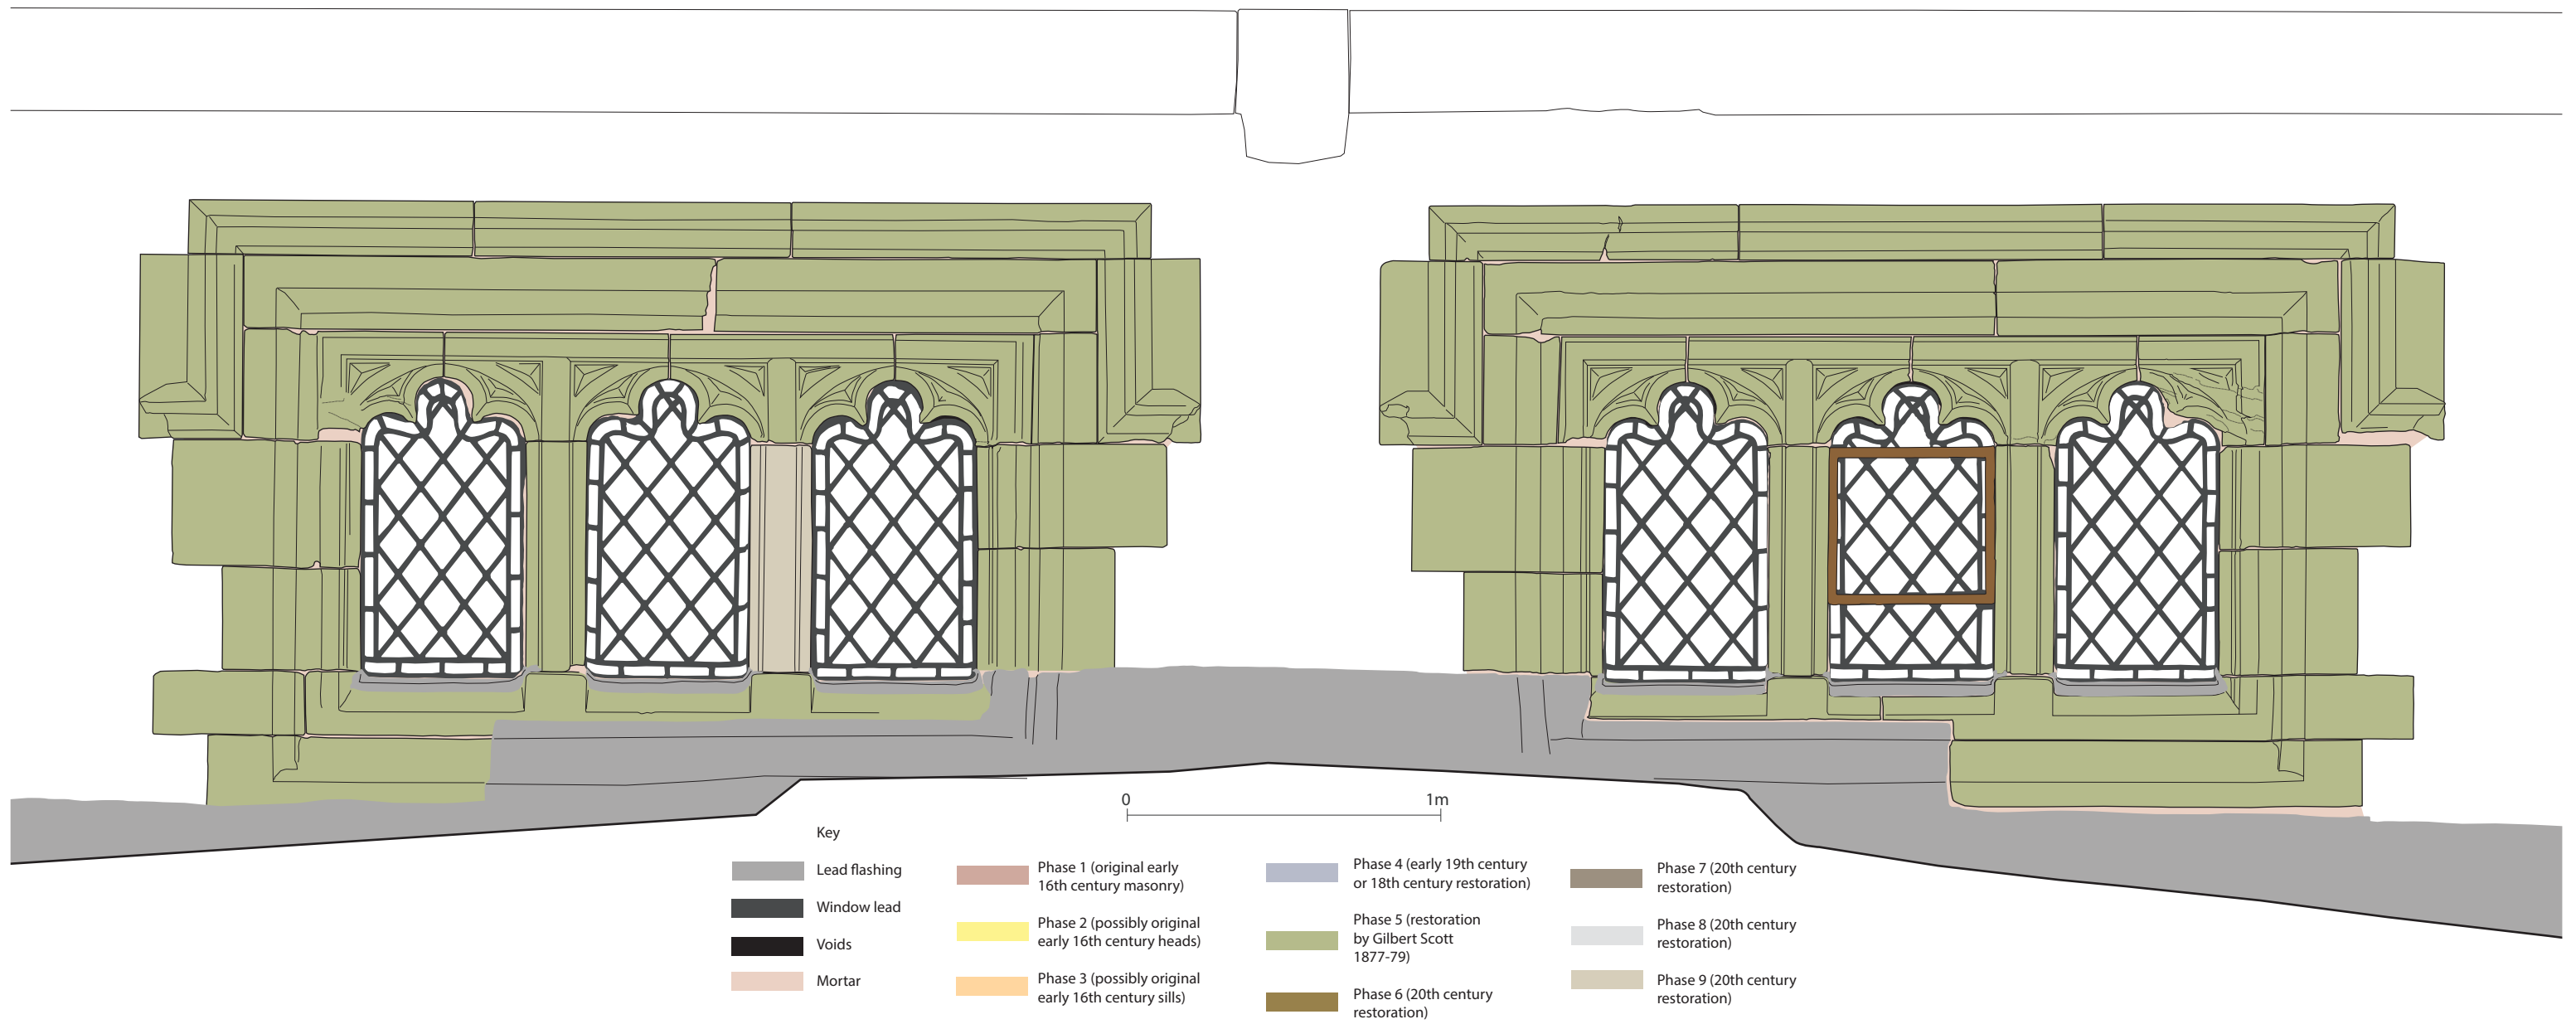
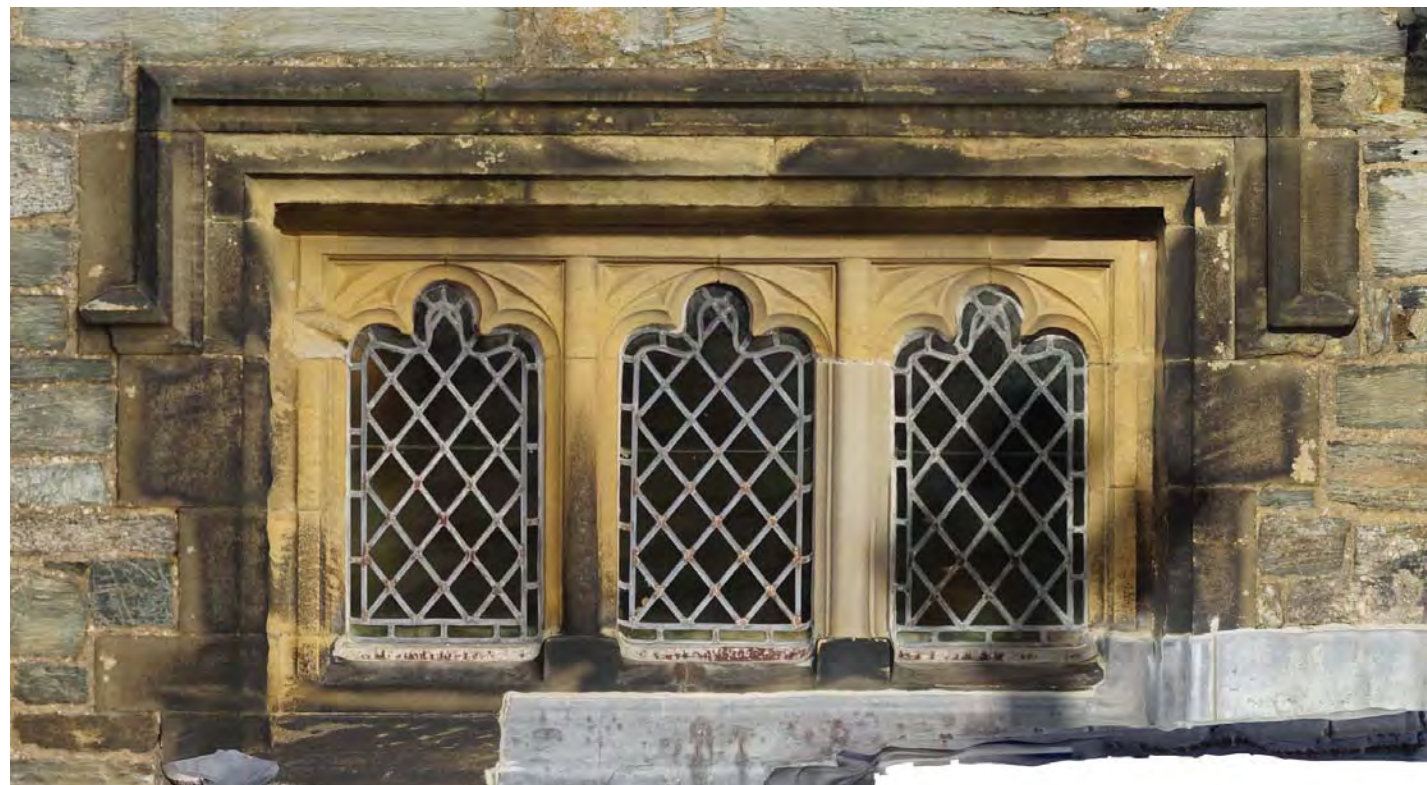
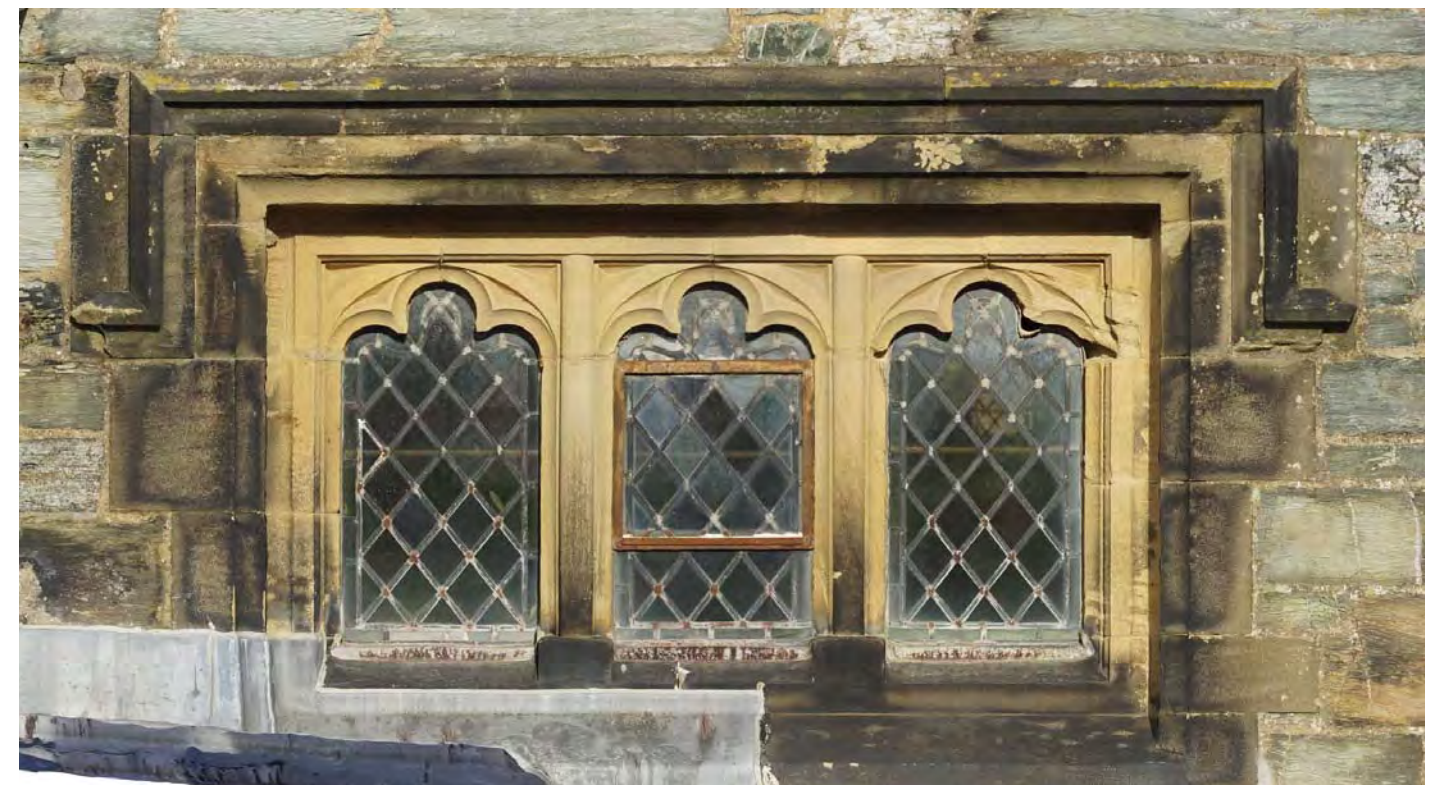
Detail of southern clerestory windows: fifth and sixth windows from west
