New Ysgol Bro Aberffraw Primary School, Newborough, Anglesey

Archaeological Mitigation: Field Boundary Basic Record

Project No. G2467

Report No. 1367

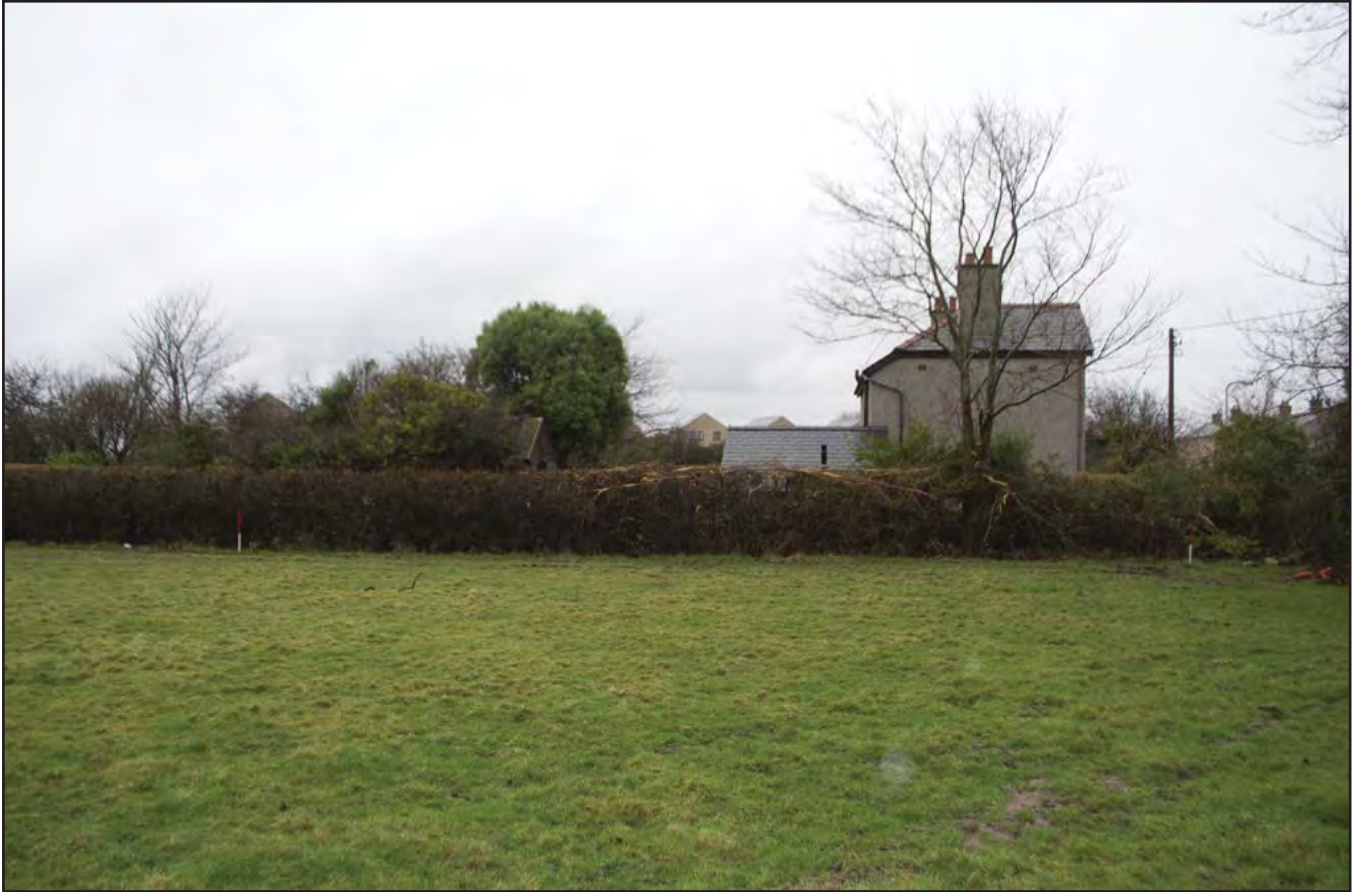
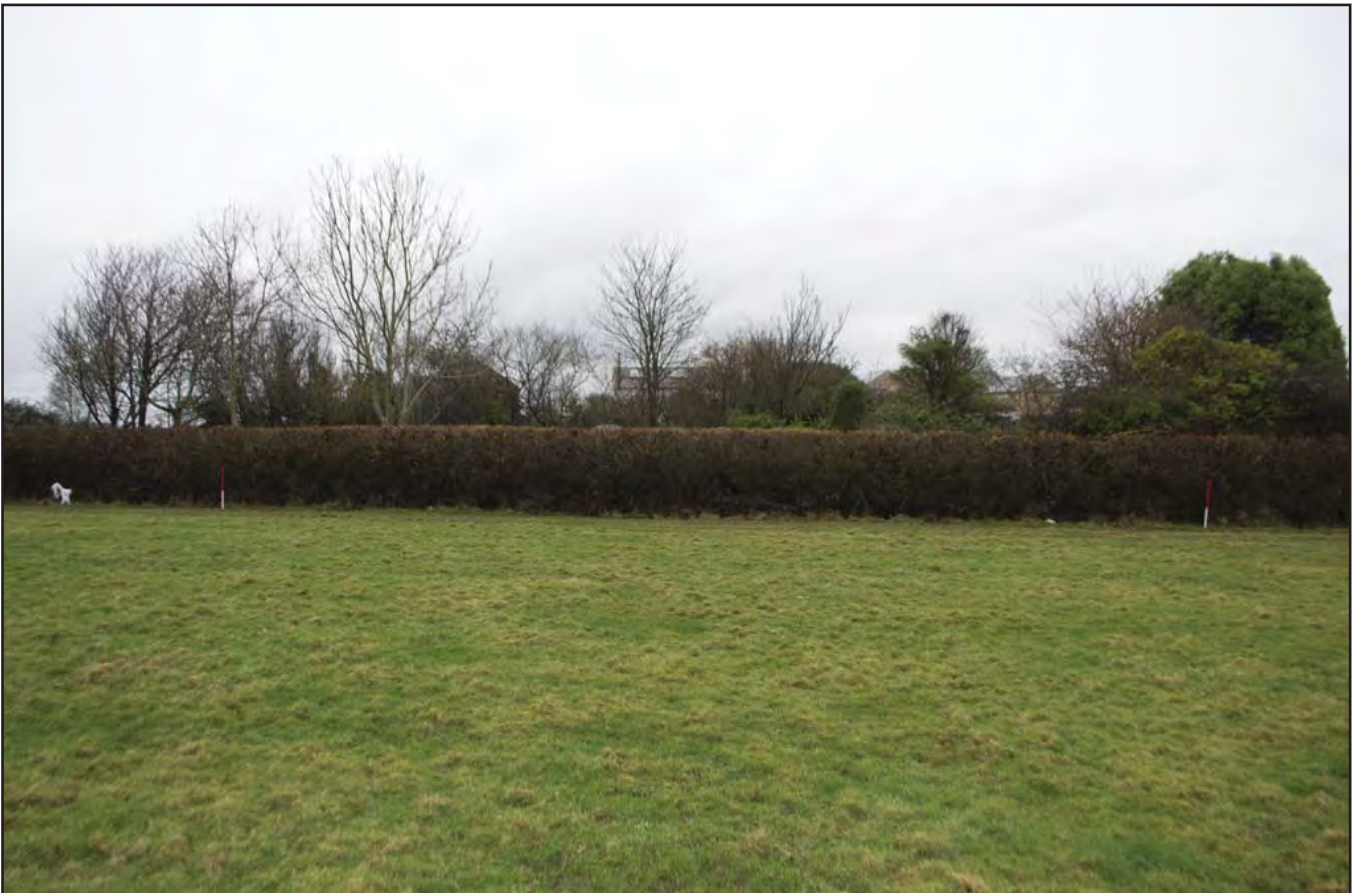
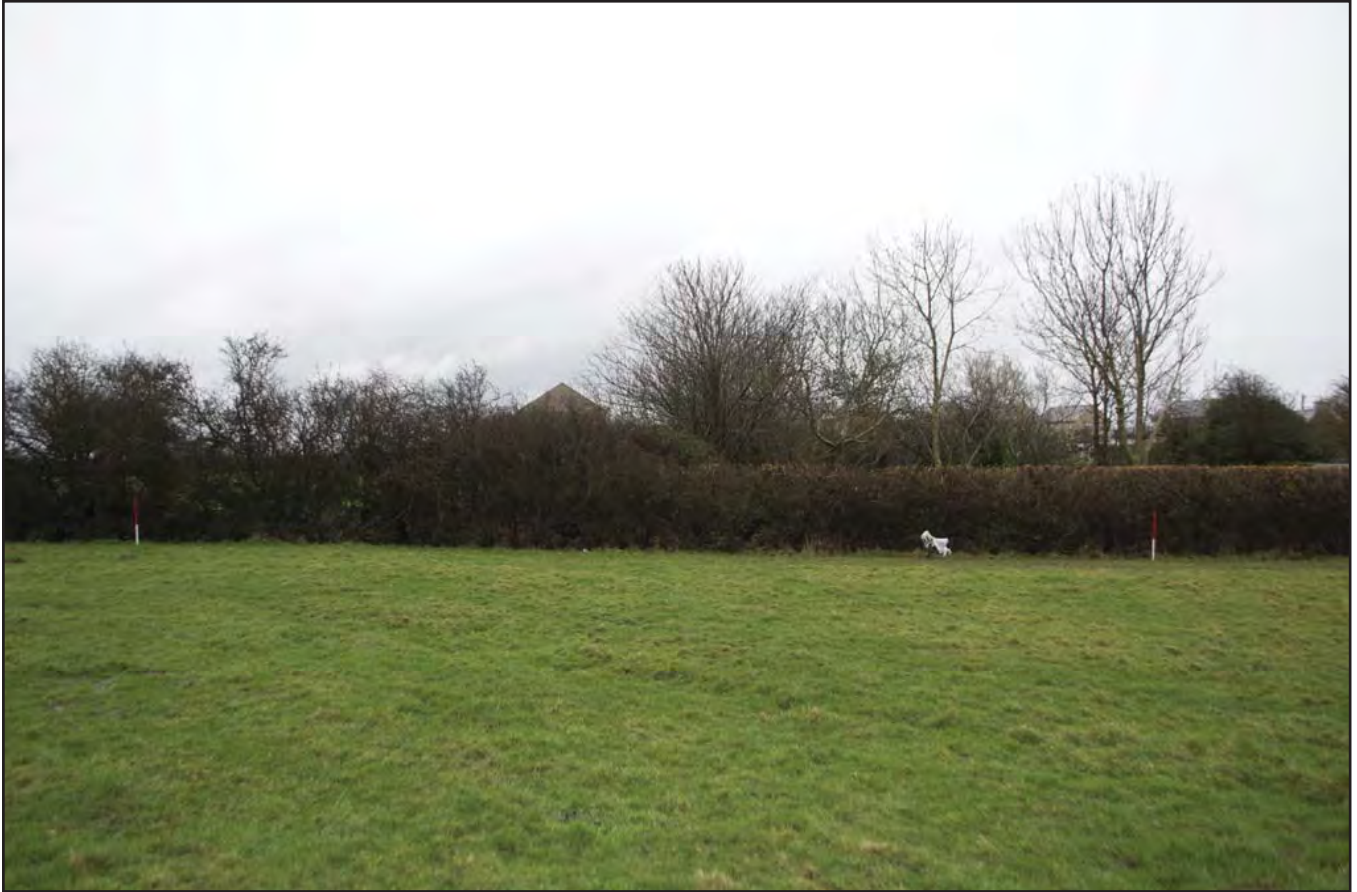
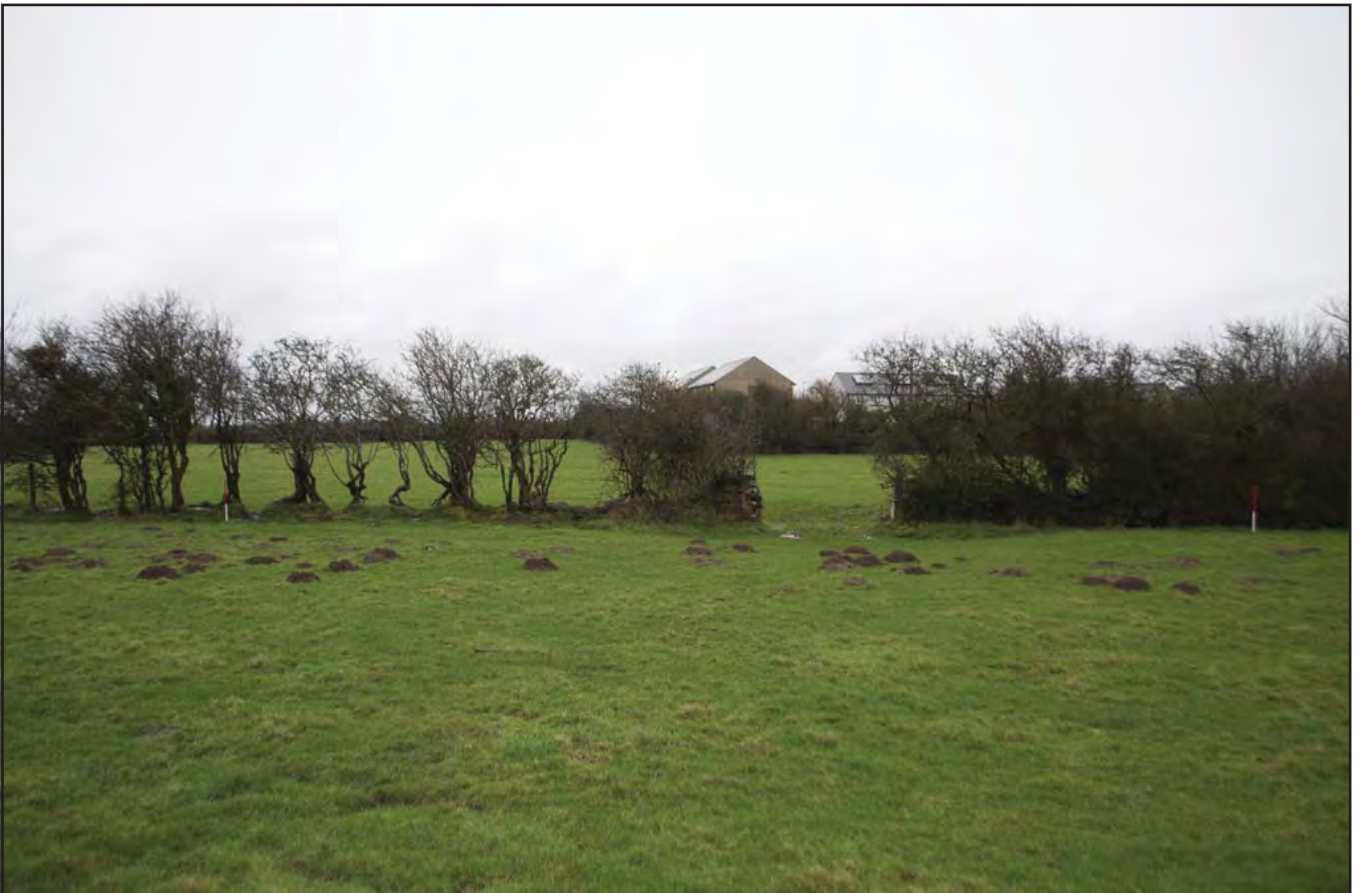
The main drystone wall section measured 69m in length and was screened by a hedgerow for the majority of its length (Plates 01 to 04). The wall was built from irregular sized sub-rectangular and measured an average 0.4m in height and 0.5m in width, with upright stone capping. There was evidence of disrepair. This section was separated from the rest of the boundary by a 3.0m wide gateway (Plate 04 and Plate 09). The gateway comprised a 1.5m high and 0.5m wide stone carved gatepost on the southern side (Plate 10) and a drystone built, conical shaped gatepost on the northern side, 1.3m high and 1.4m wide (Plate 11). The drystone built gatepost included evidence of cement patch repair. The gate had been removed, with metal hinge supports still visible in the stone carved gatepost and a small hole visible in the cement render on the opposite gatepost, for receiving a sprung gate bolt. An additional 4m length of drystone wall continued north from the gateway, built in a similar style to the rest of the drystone wall, but in a more dilapidated state; the remainder of the boundary comprised a clawdd.

Plate 01: Boundary 1 west facing side: first 20m length detailing drystone wall section, hidden by hedgerow; scale: 2x1m (archive image: G2467_214)

Plate 02: Boundary 1 west facing side: second 20m length detailing drystone wall section, hidden by hedgerow; scale: 2x1m (archive image: G2467_215)

Plate 03: Boundary 1 west facing side: third 20m length detailing drystone wall section, hidden by hedgerow; scale: 2x1m (archive image: G2467_216)

Plate 04: Boundary 1 west facing side: fourth 20m length detailing drystone wall section, gateway and start of clawdd section; scale: 2x1m (archive image: G2467_217)

It is recommended that additional basic recording is completed for both boundaries during any breaching or removal as this would provide further opportunities to record any phasing and construction, including the profiles of the banks. It would be particularly useful to record the bank section of Boundary 2, as this is so heavily obscured by vegetation; attendance during removal of vegetation would allow opportunity to complete a record of the boundary.

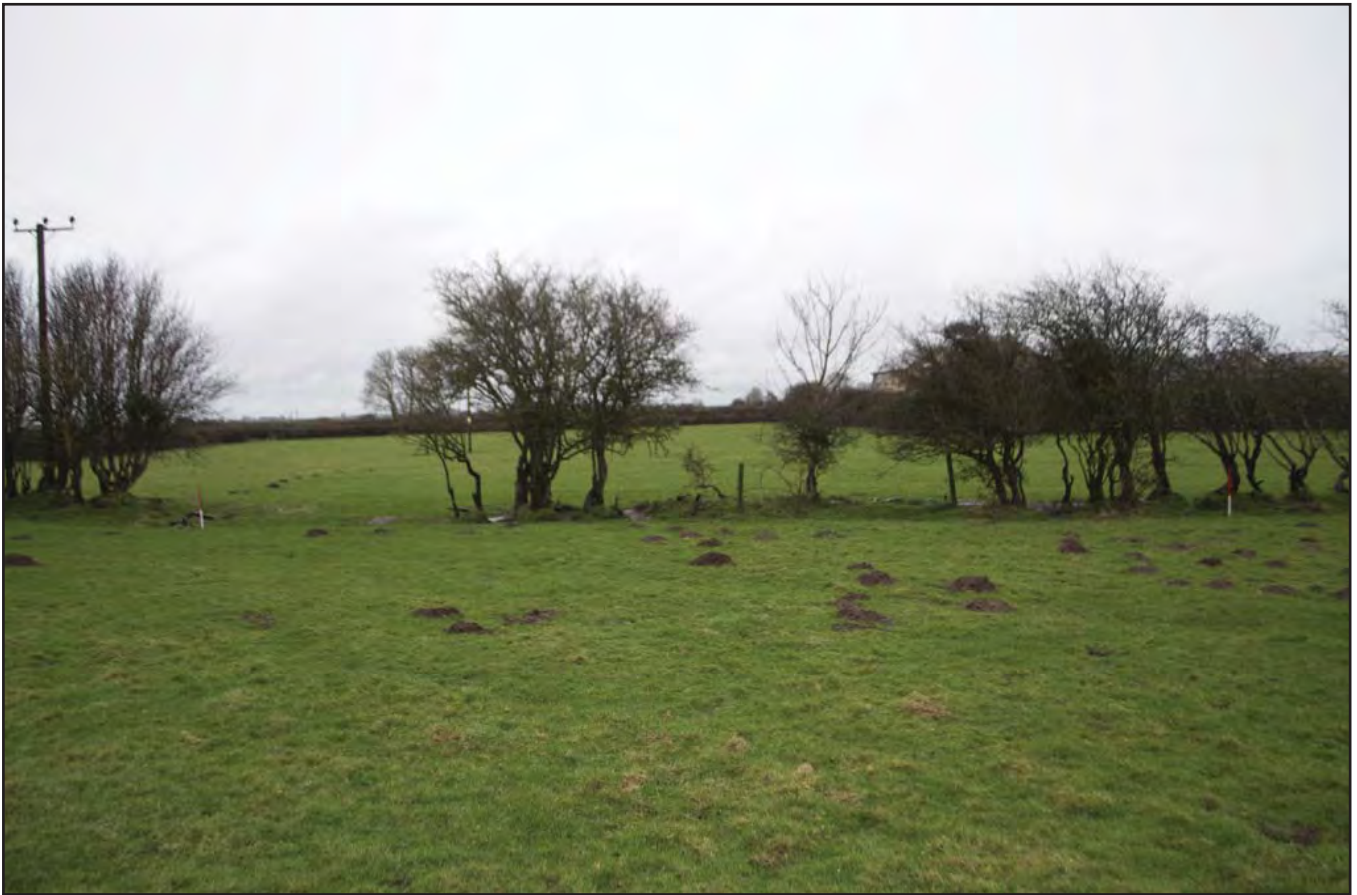
Plate 05: Boundary 1 west facing side: fifth 20m length detailing denuded clawdd section; scale: 2x1m (archive image: G2467_218)

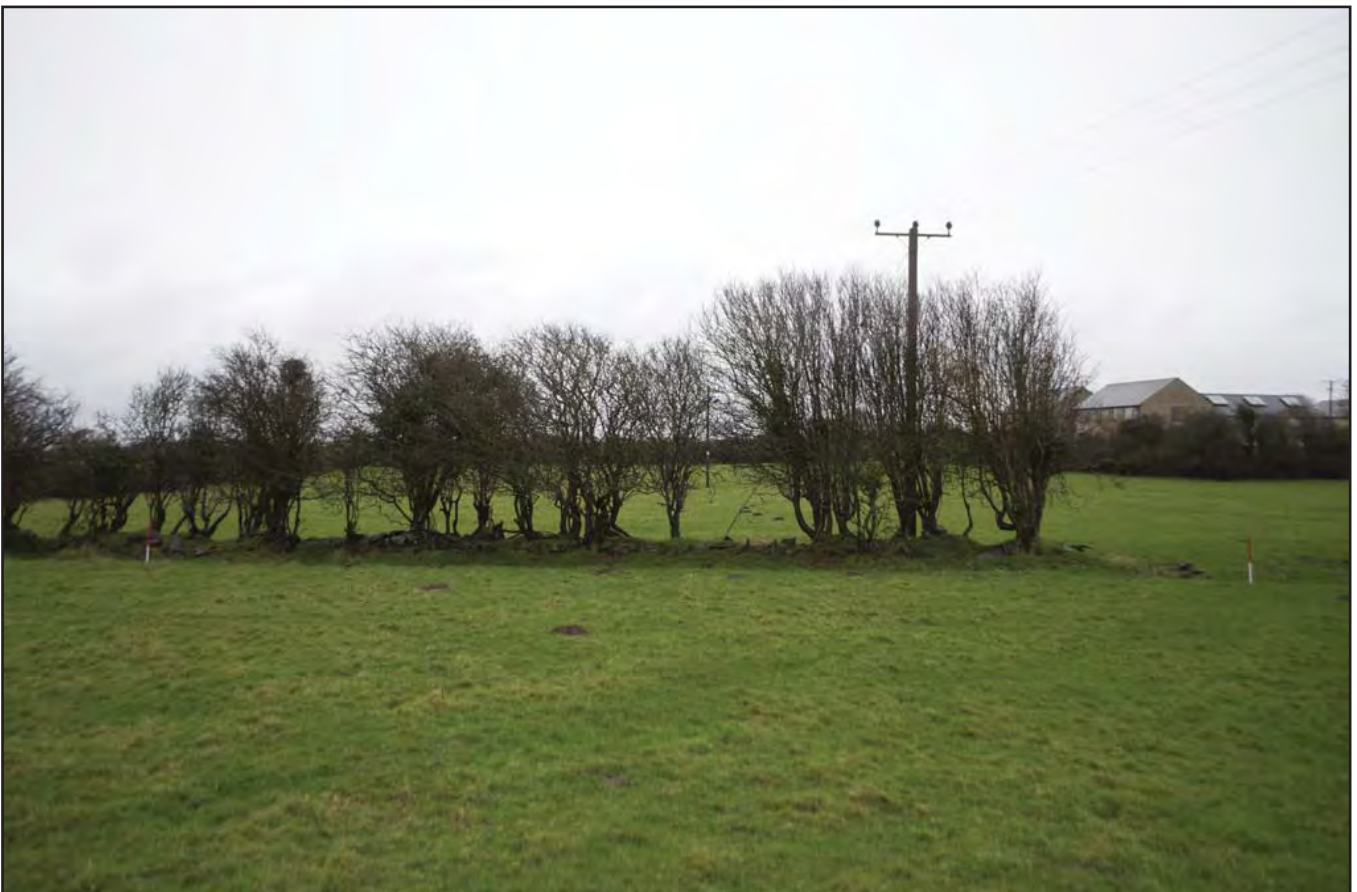
Plate 06: Boundary 1 west facing side: sixth 20m length detailing clawdd section; scale: 2x1m (archive image: G2467_219)

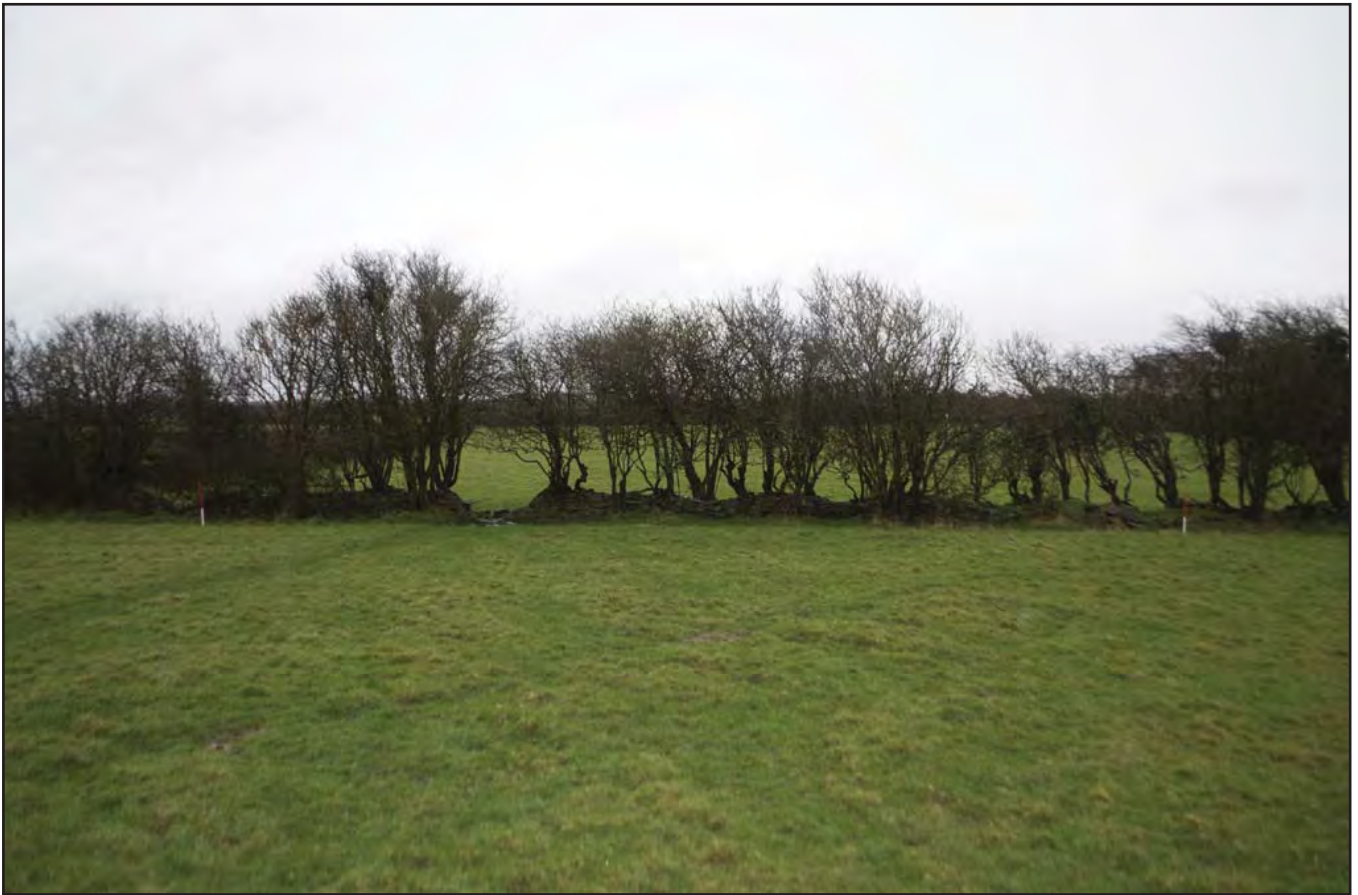
Plate 07: Boundary 1 west facing side: seventh 20m length detailing clawdd section; scale: 2x1m (archive image: G2467_220)

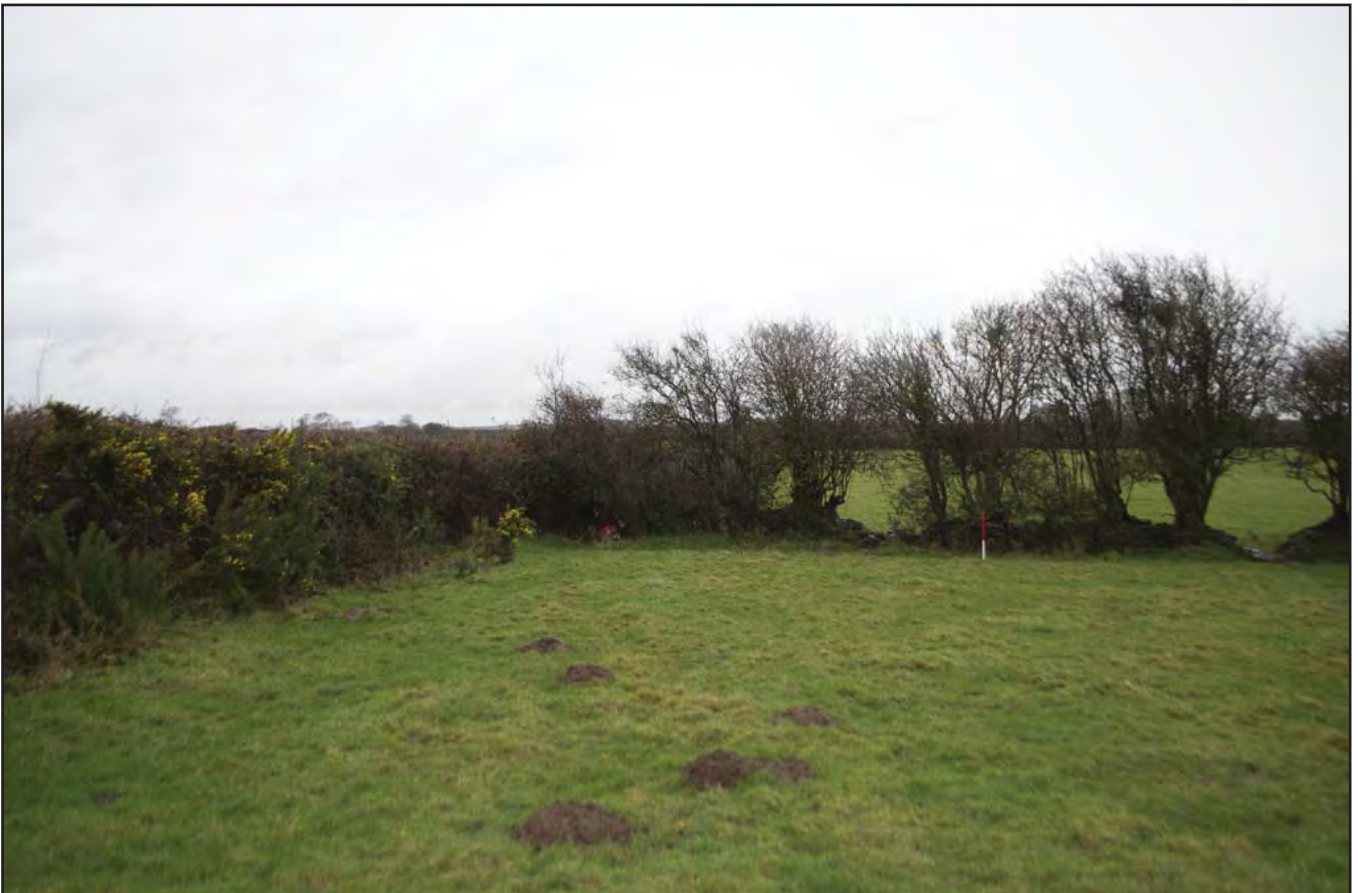
Plate 08: Boundary 1 west facing side: final 20m length detailing clawdd section, where it connects with another boundary; scale: 2x1m (archive image: G2467_221)

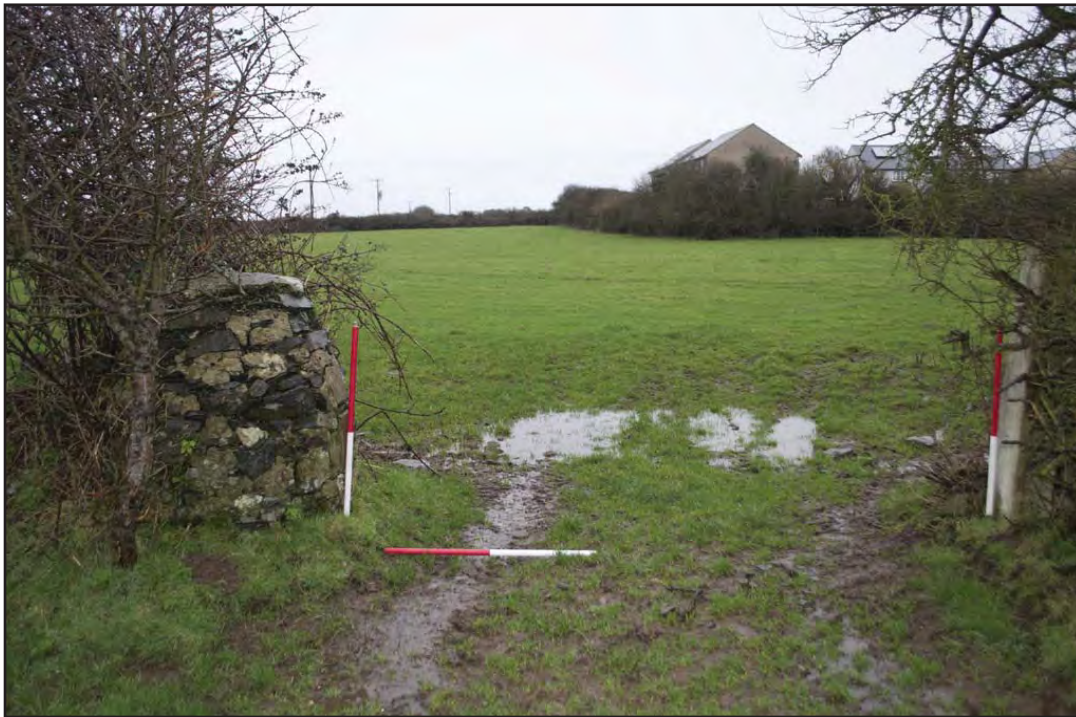
**Plate 09: Boundary 1 view from west of gateway through boundary; scale: 3x1m
(archive image: G2467_222)**

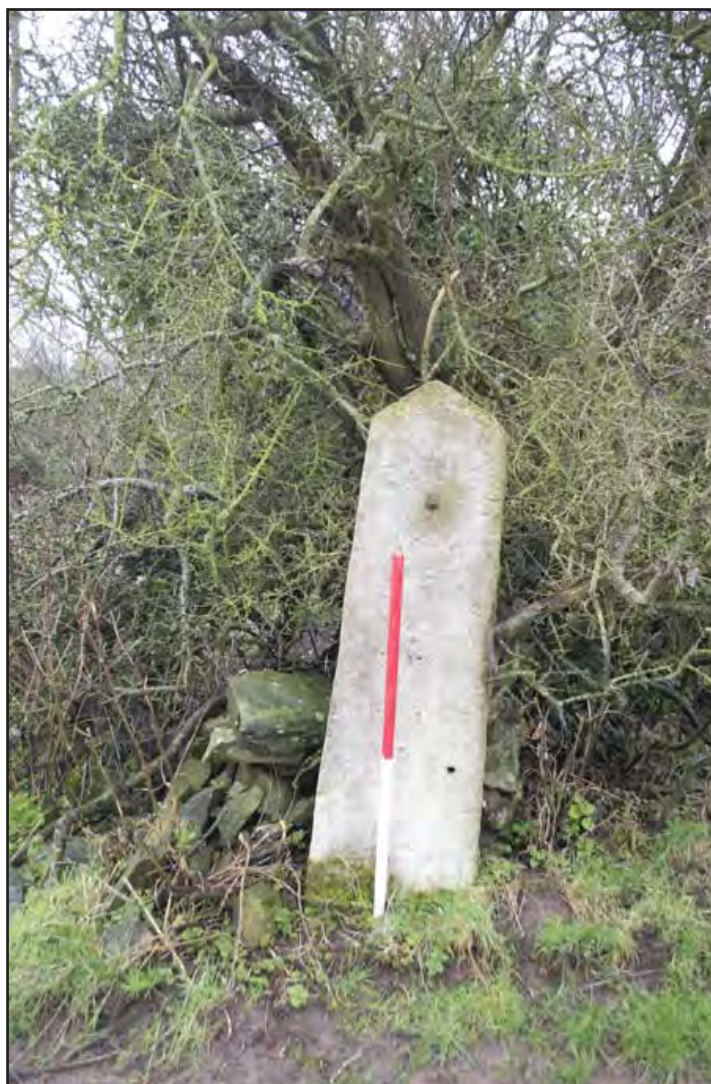
**Plate 10: Boundary 1 view from north detailing stone gatepost
on southern side of gateway; scale: 3x1m
(archive image: G2467_223)**

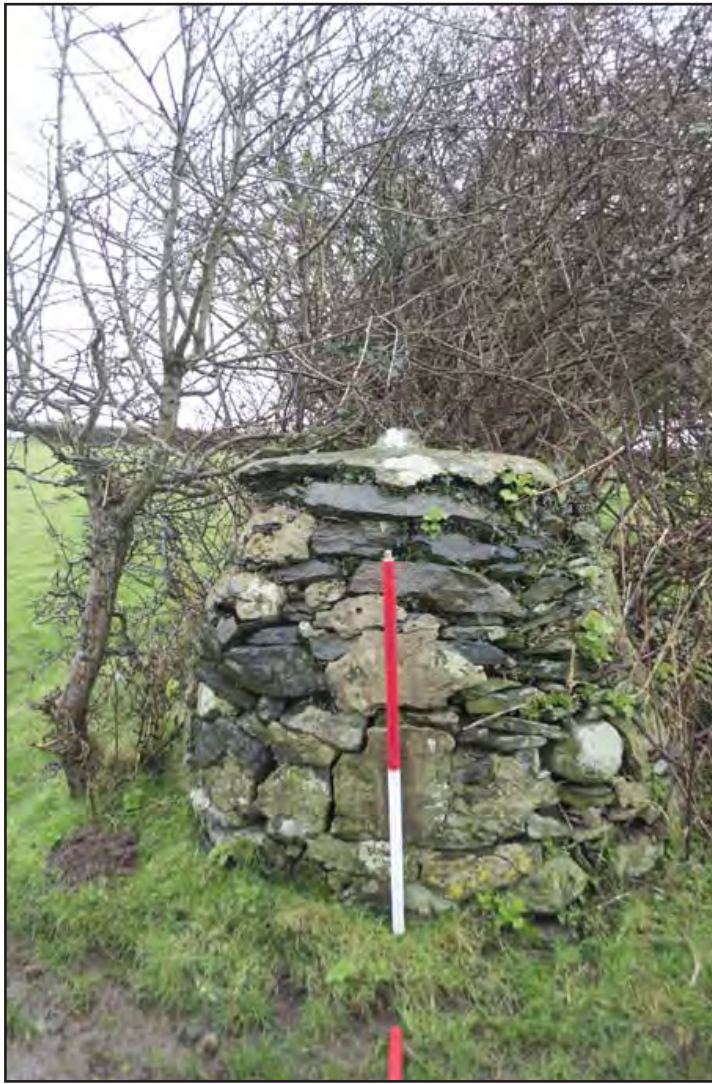
**Plate 11: Boundary 1 view from south of stone-built gatepost; scale: 1m
(archive image: G2467_224)**

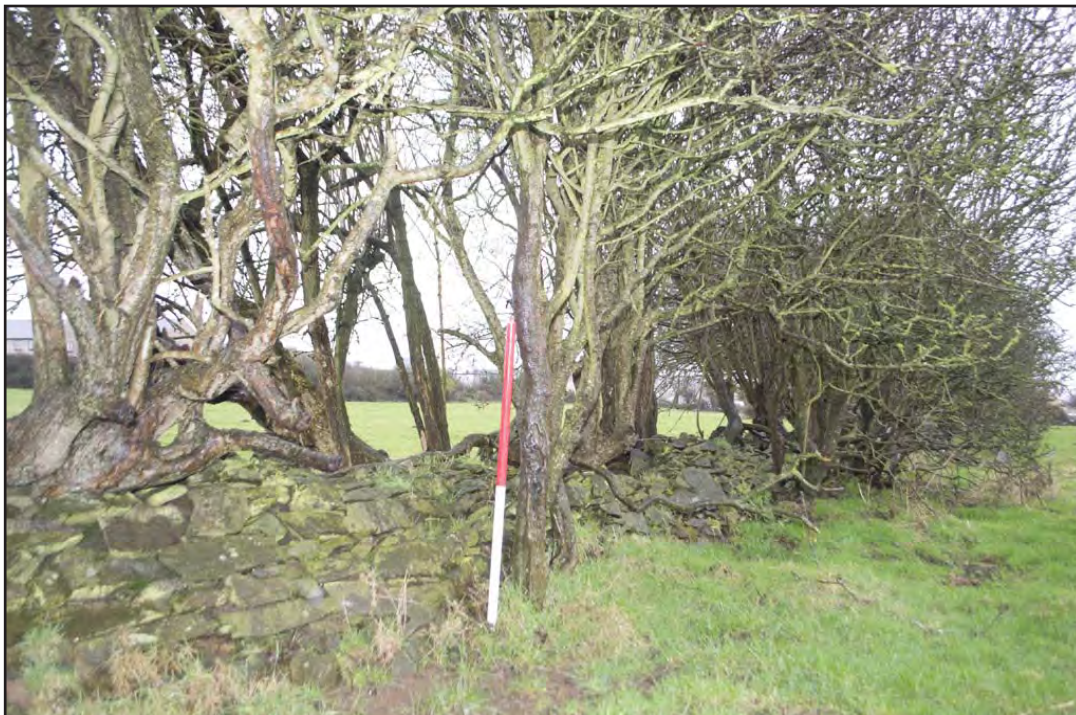
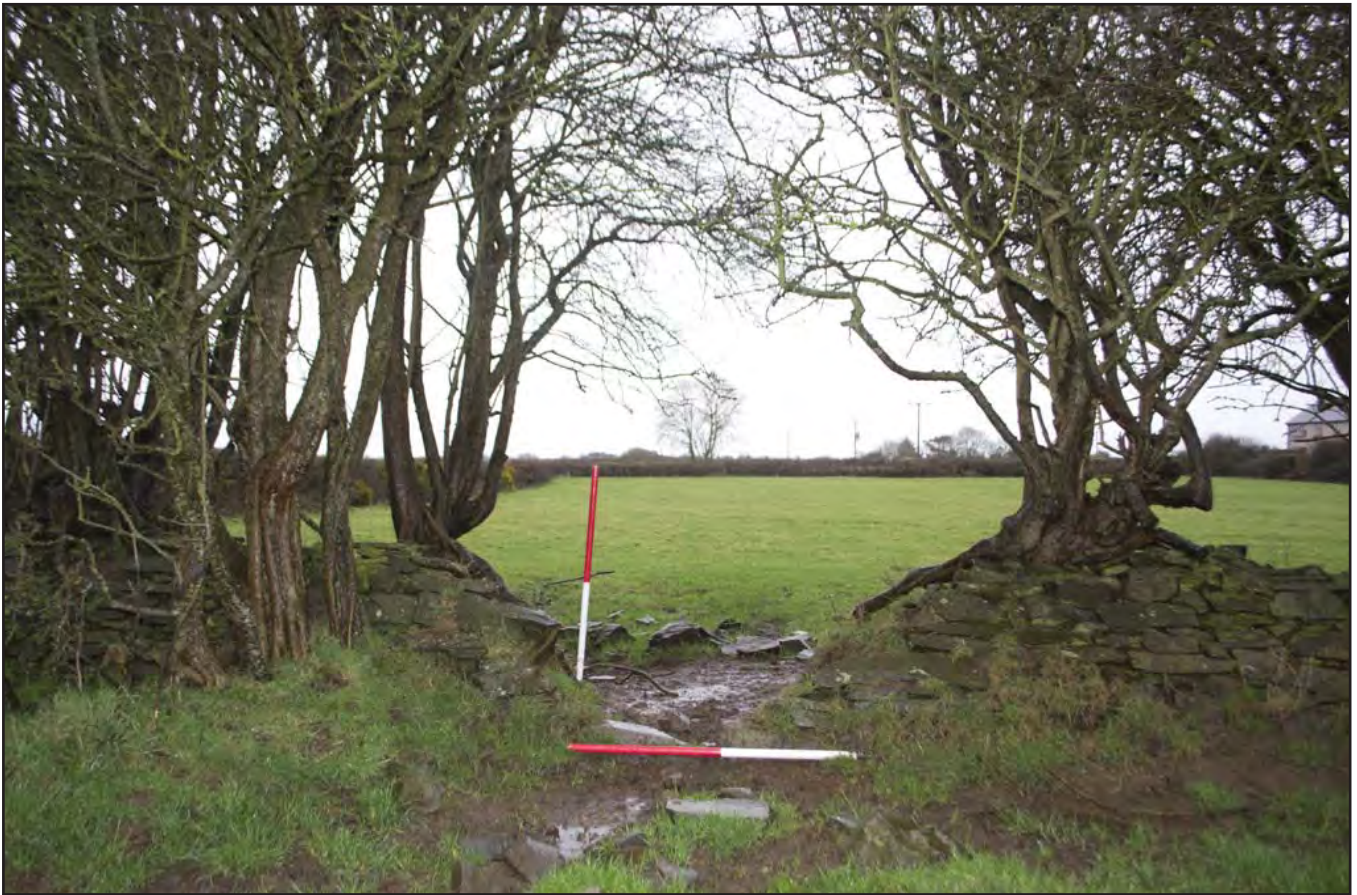
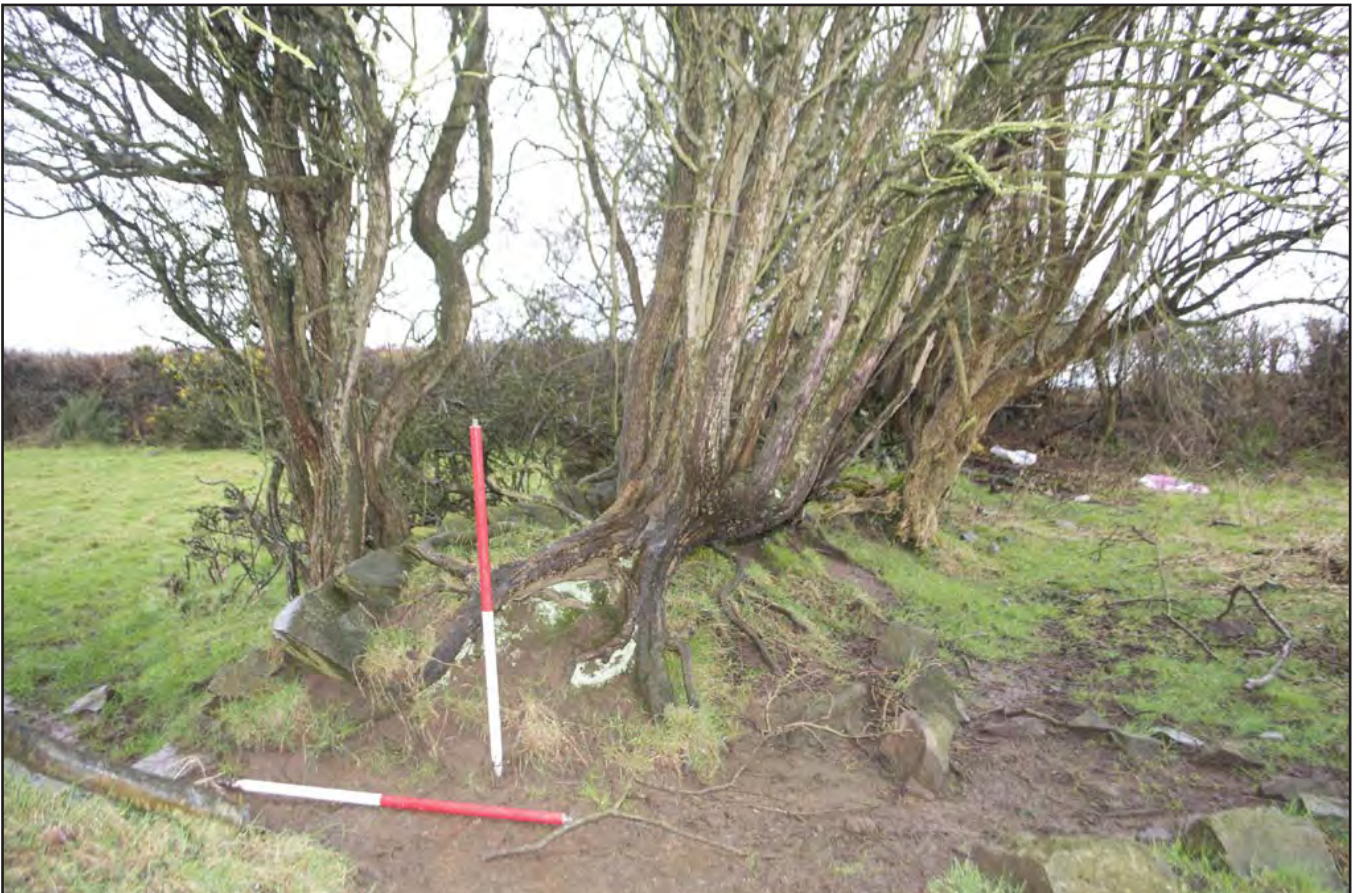
The clawdd comprised three sections of varied construction and condition: a 36m long, 2.5m wide and 0.35m high denuded earth bank limited stonework (Plates 12 to 14); a 23m long, 2m wide and 0.7m high earth and stone bank, with the stone covering both sides and the top of the bank (Plates 15 to 16), and a final length of 22m long, 2m wide and 0.6m high earth bank (Plates 17 and 18). All three sections were surmounted by unpruned hawthorn and trees. Both sections incorporating the earth and stone bank used closely packed sub-rectangular and sub-angular stones of varying size, with the 23m long section more dilapidated, in part from root action.

**Plate 12: Boundary 1 oblique view from north at northern end of boundary
detailing clawdd construction; scale: 1m (archive image: G2467_237)**

Plate 13: Boundary 1 view from west of breach in clawdd towards northern end of boundary; scale: 2x1m (archive image: G2467_236)

Plate 14: Boundary 1 oblique view from south of breach in clawdd towards northern end of boundary; on this section, the stone facing is only present on the western side; scale: 2x1m (archive image: G2467_235)

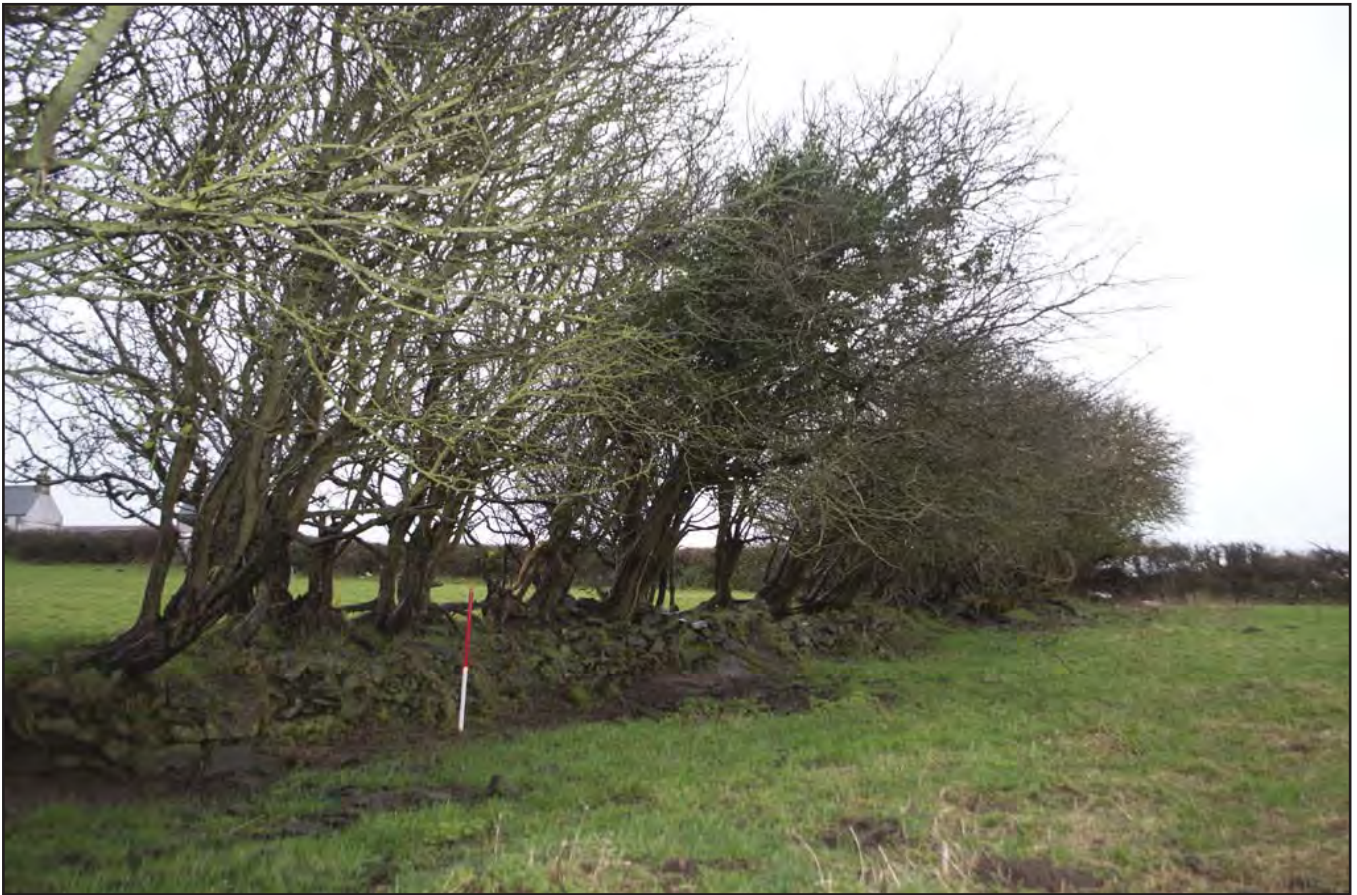
Plate 15: Boundary 1 oblique view from southeast along eastern side of boundary; scale: 1m
(archive image: G2467_233)

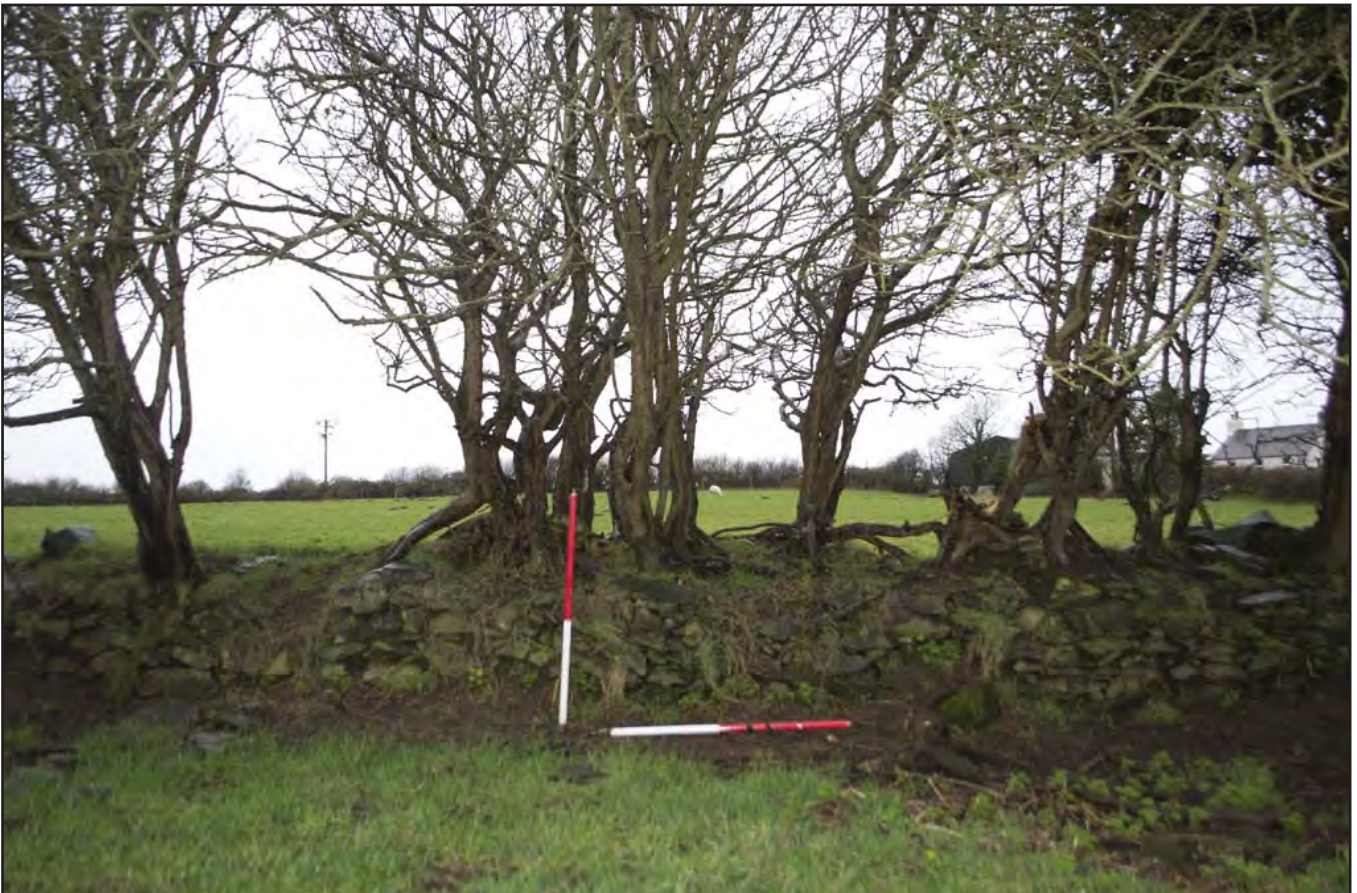
Plate 16: Boundary 1 view west of clawdd construction detailing stone; scale: 2x1m
(archive image: G2467_232)

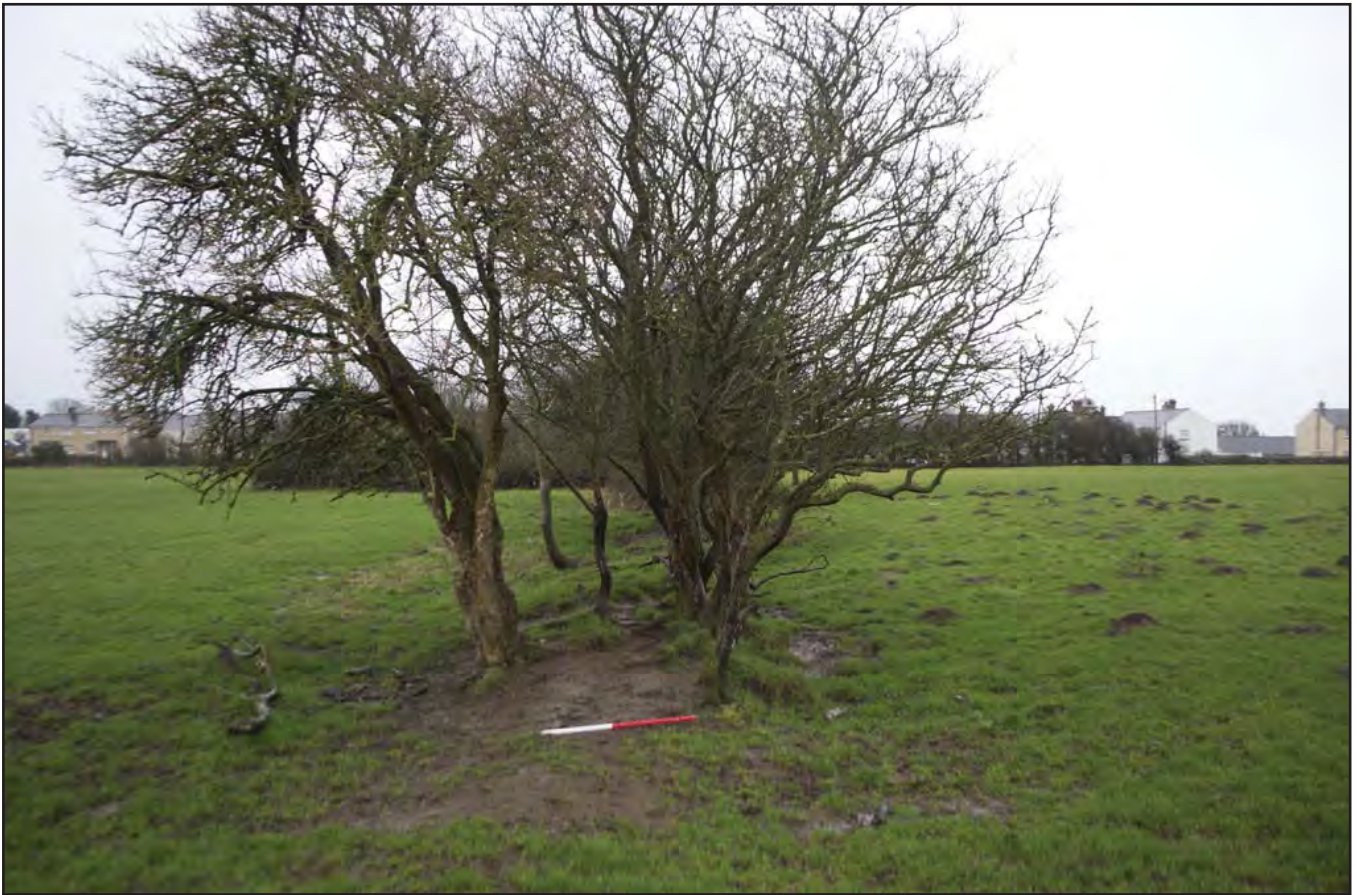
Plate 17: Boundary 1 view from north of breach in clawdd and denuded clawdd bank; scale: 1m
(archive image: G2473_239)

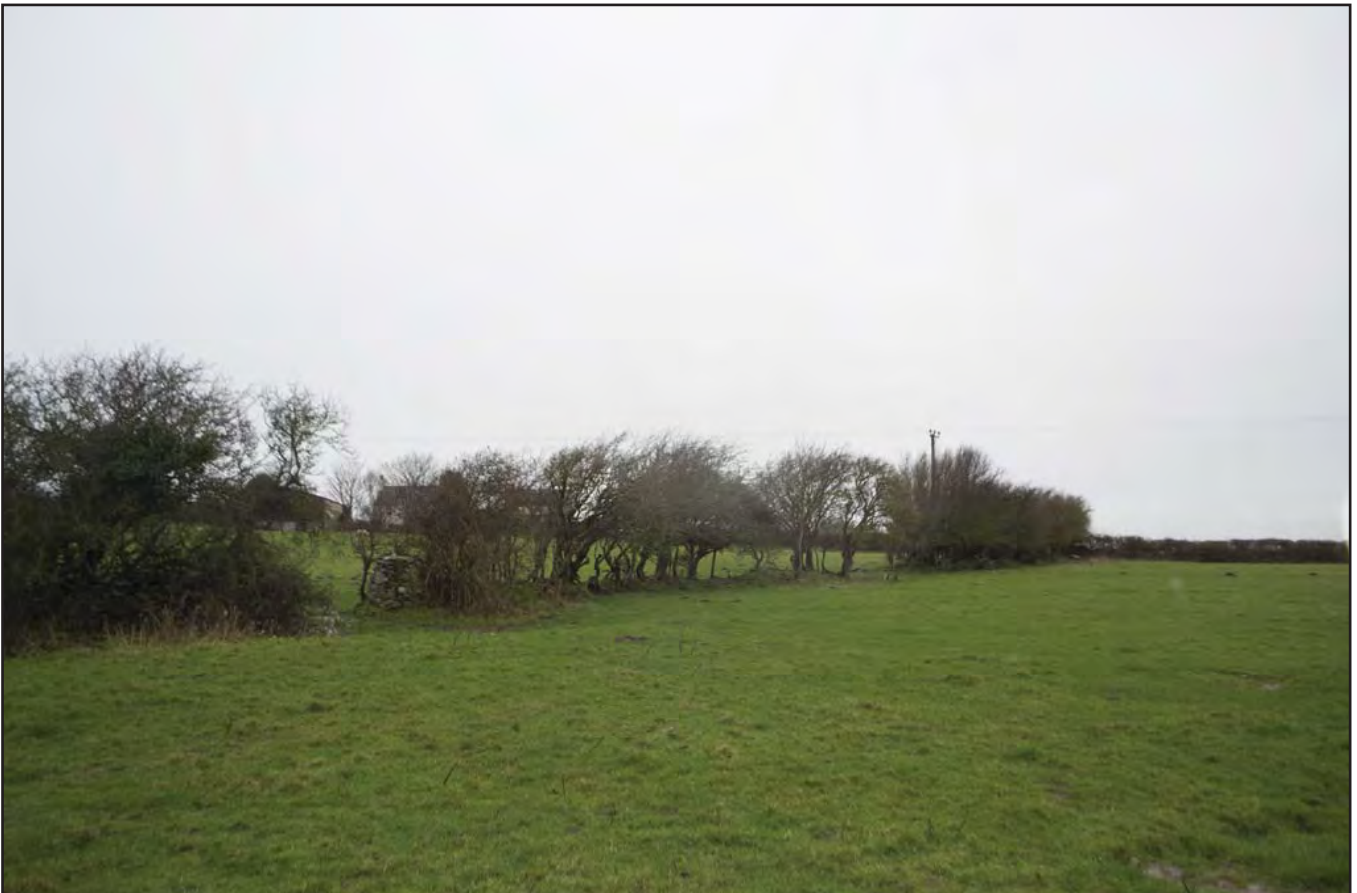
Plate 18: Boundary 1 oblique view from the south of eastern side of boundary
(archive image: G2473_244)

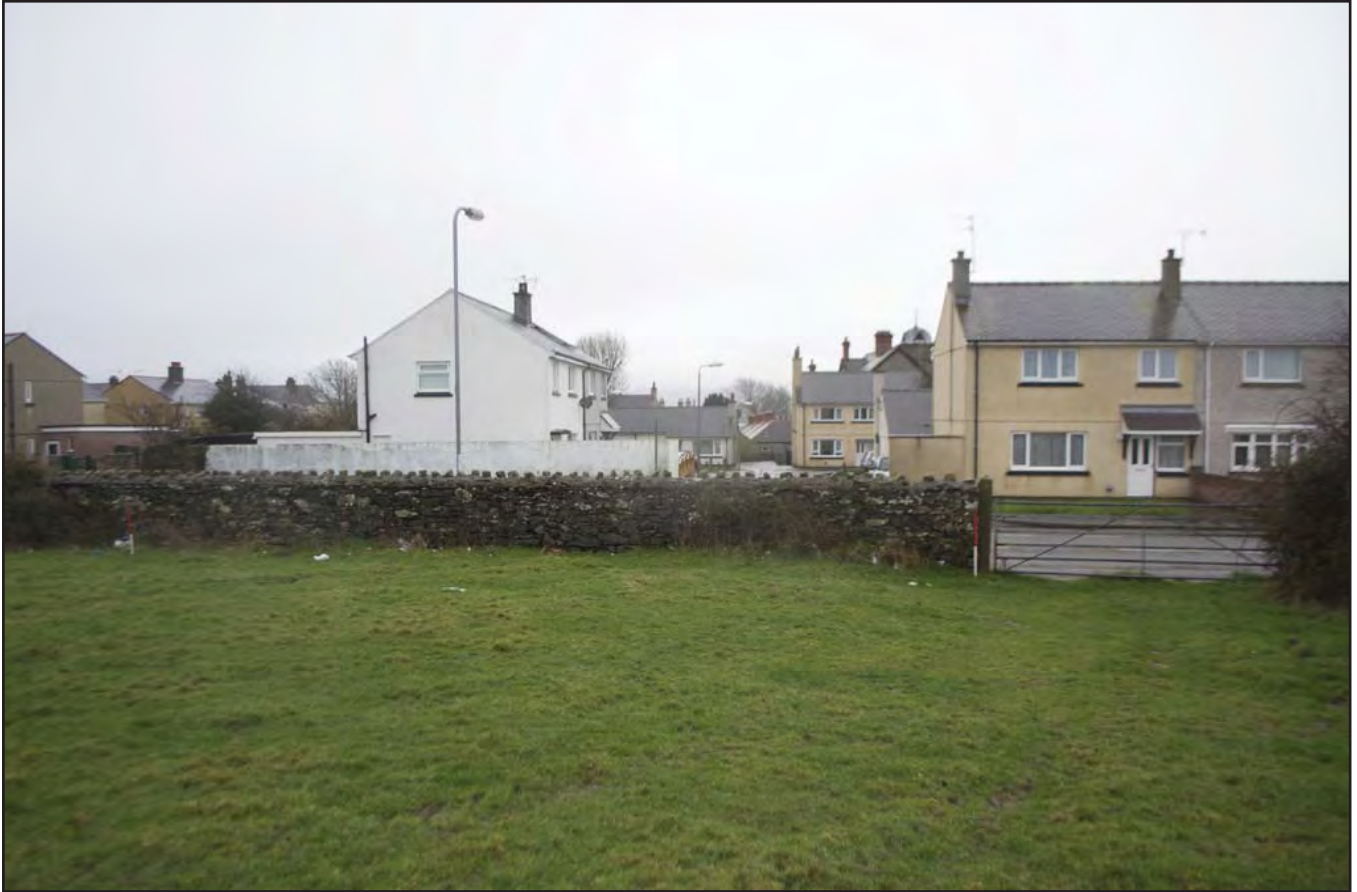
Plate 19: Boundary 2: first 20m length with view from north of boundary detailing gate and stone wall construction; scale: 2x1m (archive image: G2467_246)
