New Ysgol Bro Aberffraw Primary School, Newborough, Anglesey

Archaeological Mitigation: Field Boundary Basic Record

Project No. G2467

Report No. 1367

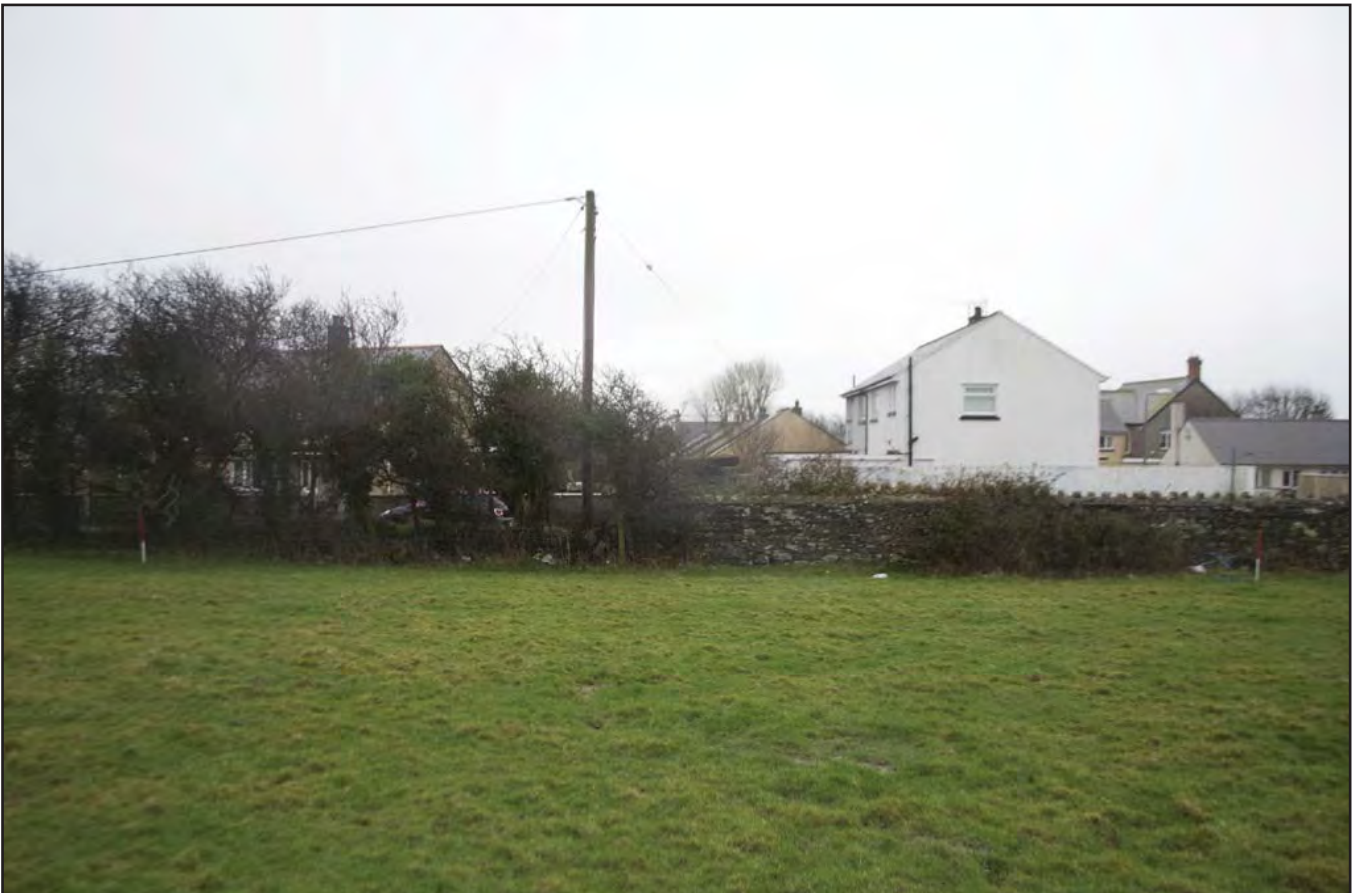
Plate 20: Boundary 2: second 20m length with view from north of boundary detailing transition from stone wall to earth bank; scalew: 2x1m (archive image: G2467_247)

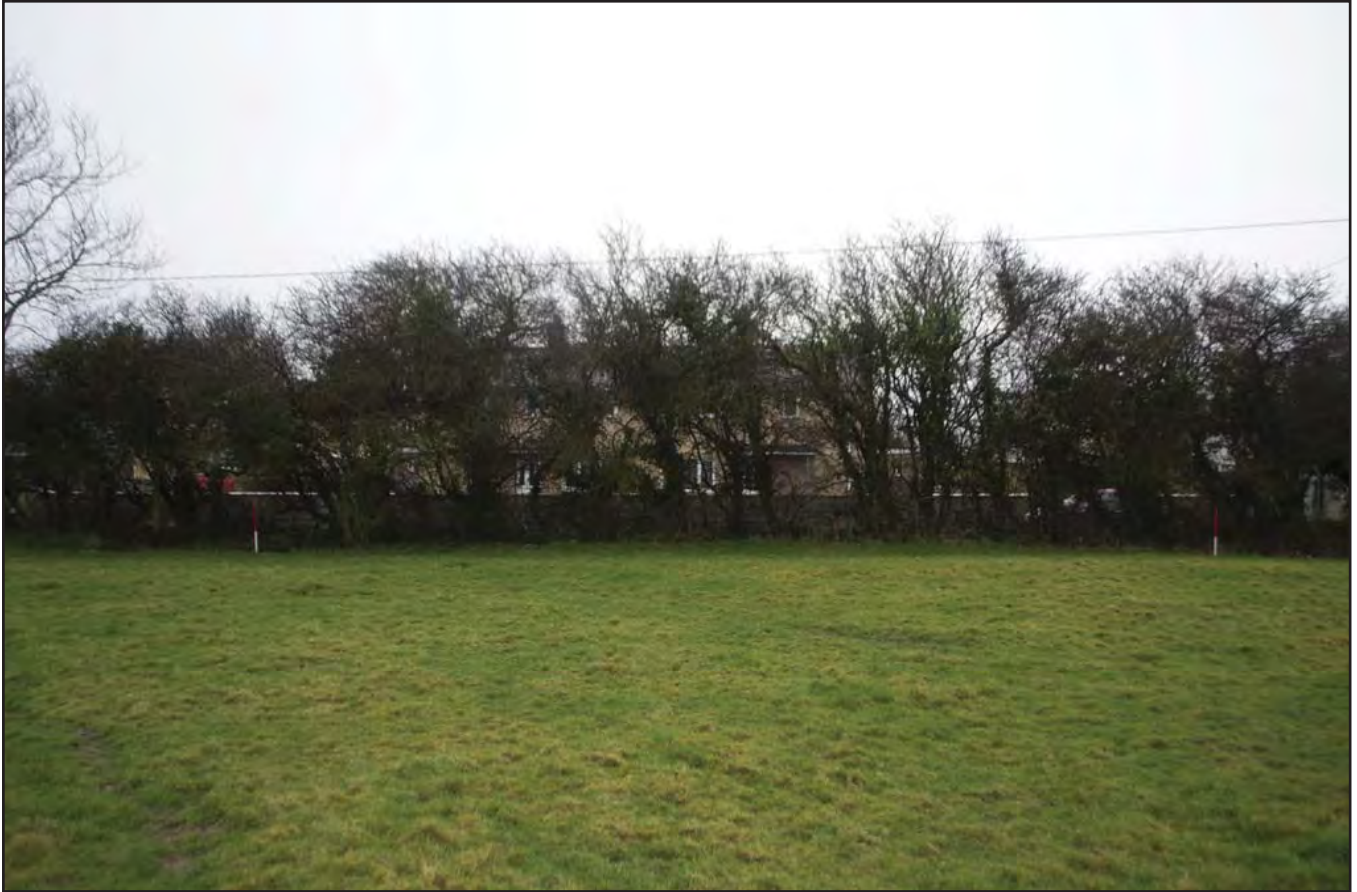
**Plate 21: Boundary 2: third 20m length with view from north detailing earth bank section;
scale: 2x1m (archive image: G2467_249)**

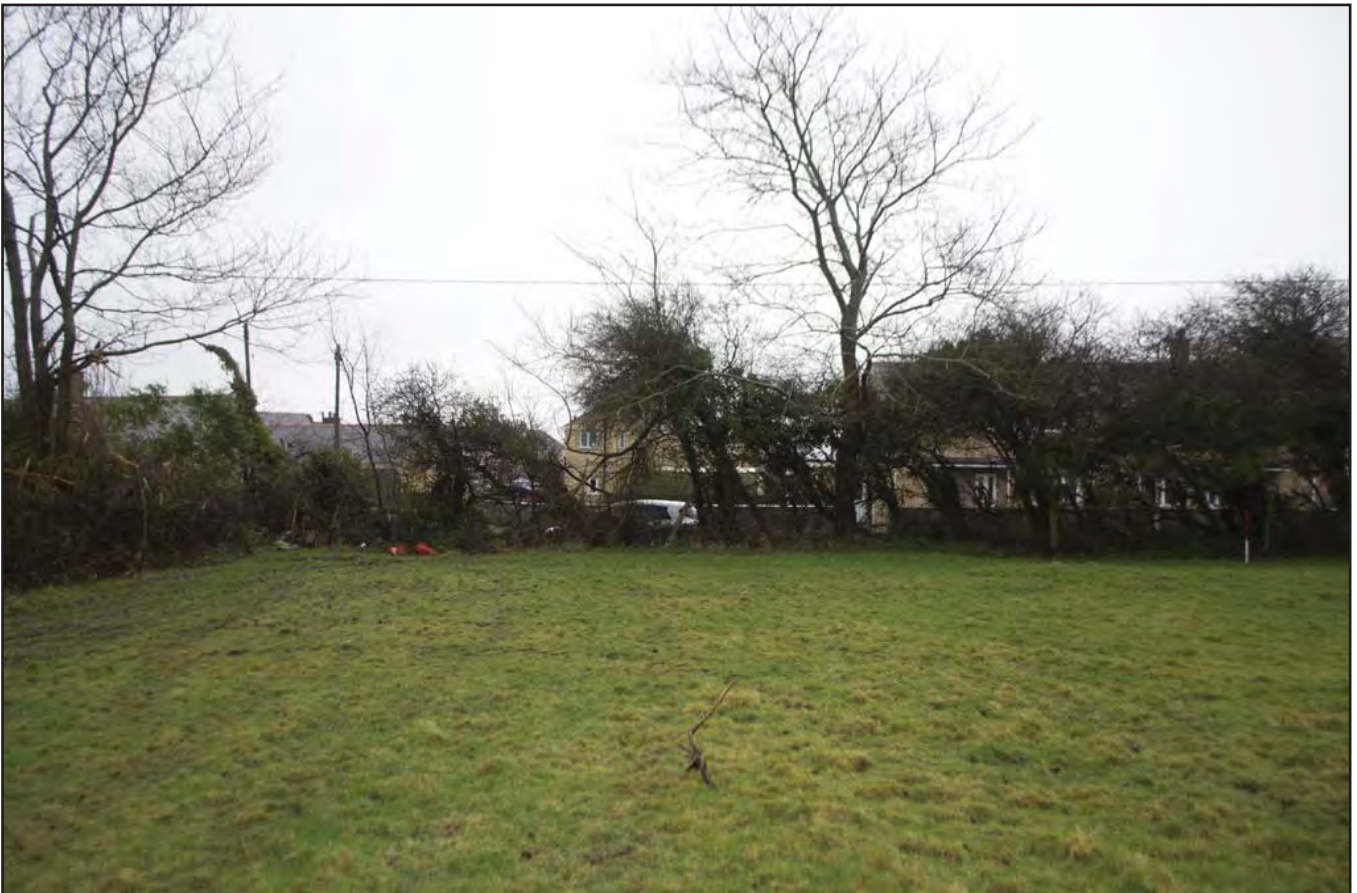
**Plate 22: fourth 20m length with view from north of boundary detailing earth bank section and
intersection with Boundary 1; scale: 2x1m (archive image: G2467_250)**

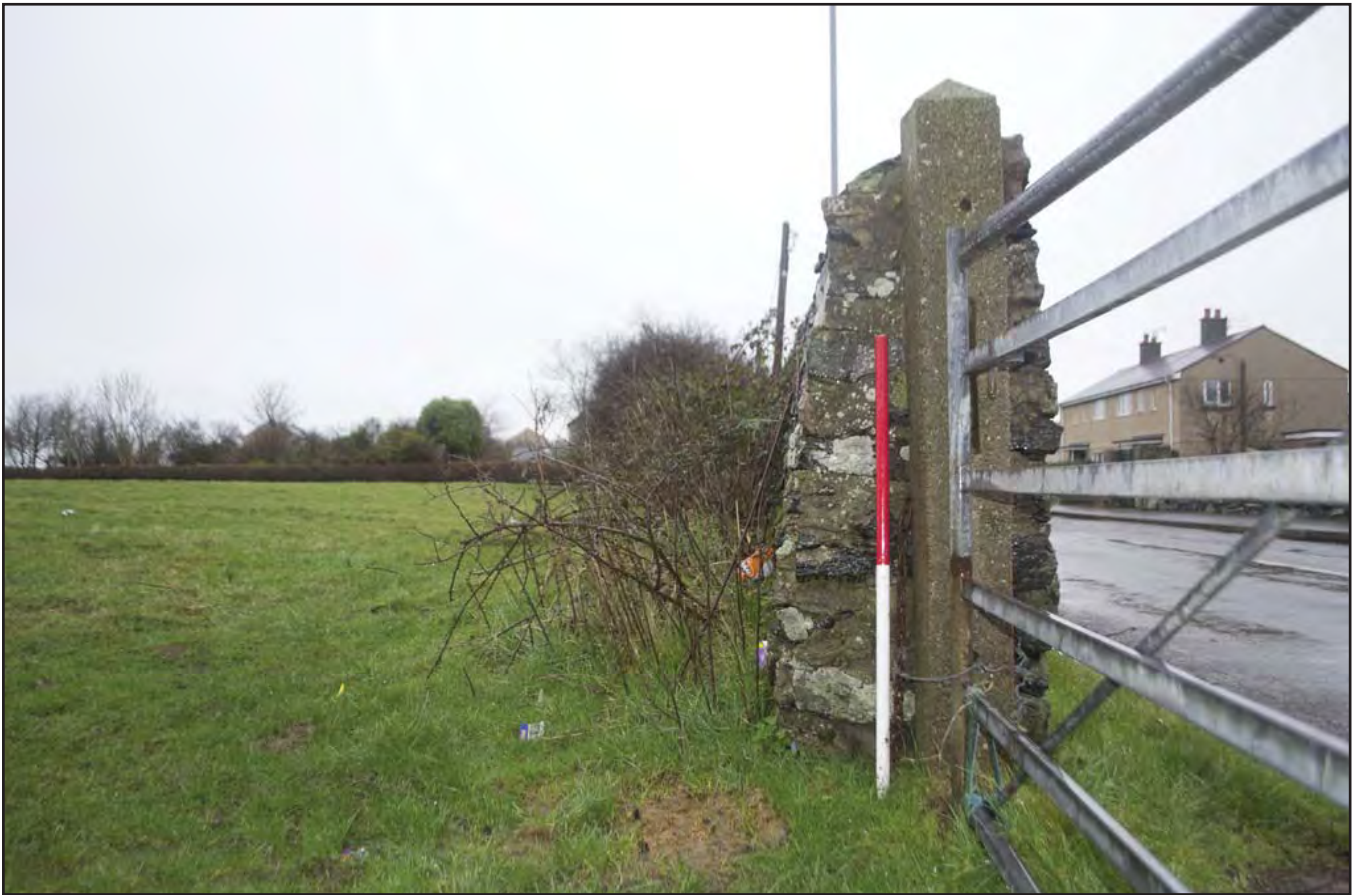
Plate 23: Boundary 2 side on view from west of gate detailing construction; scale: 1m
(archive image: G2467_254)

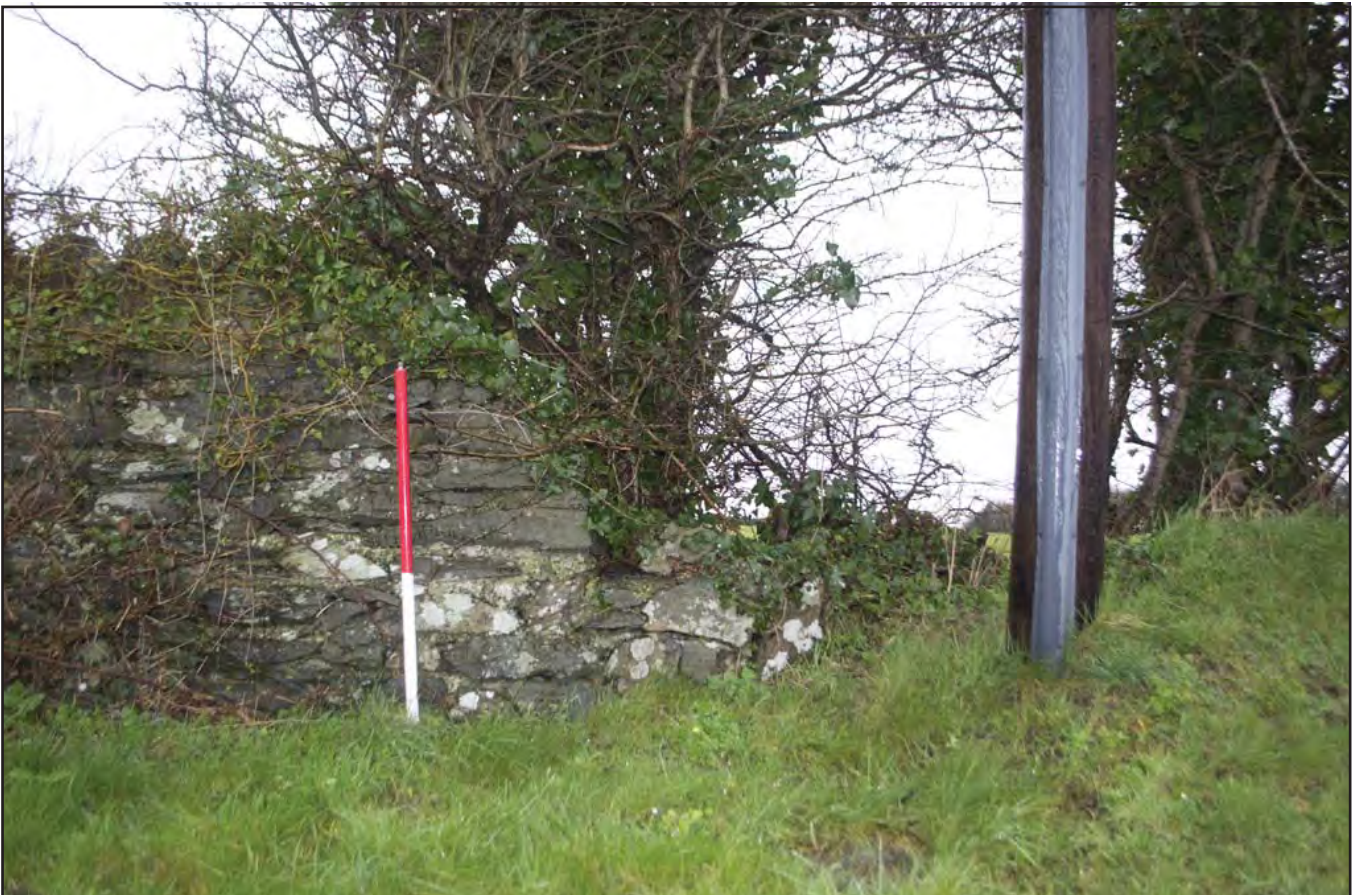
Plate 24: Boundary 2 view from south of transition from stone wall to earth bank; scale: 1m
(archive image: G2467_256)

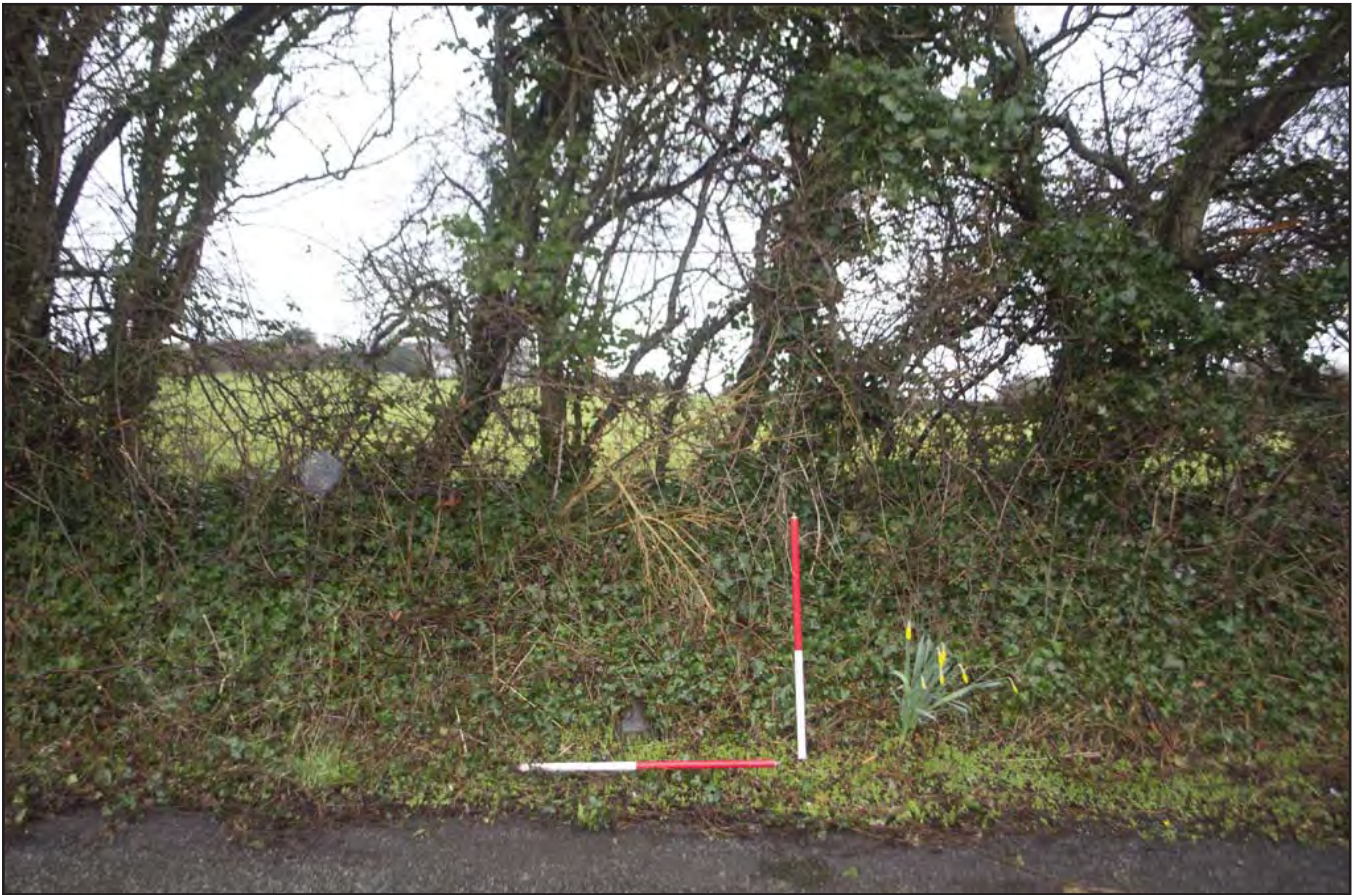
Plate 25: Boundary 2 view from south of earth bank; scale: 1m
(archive image: G2467_258)

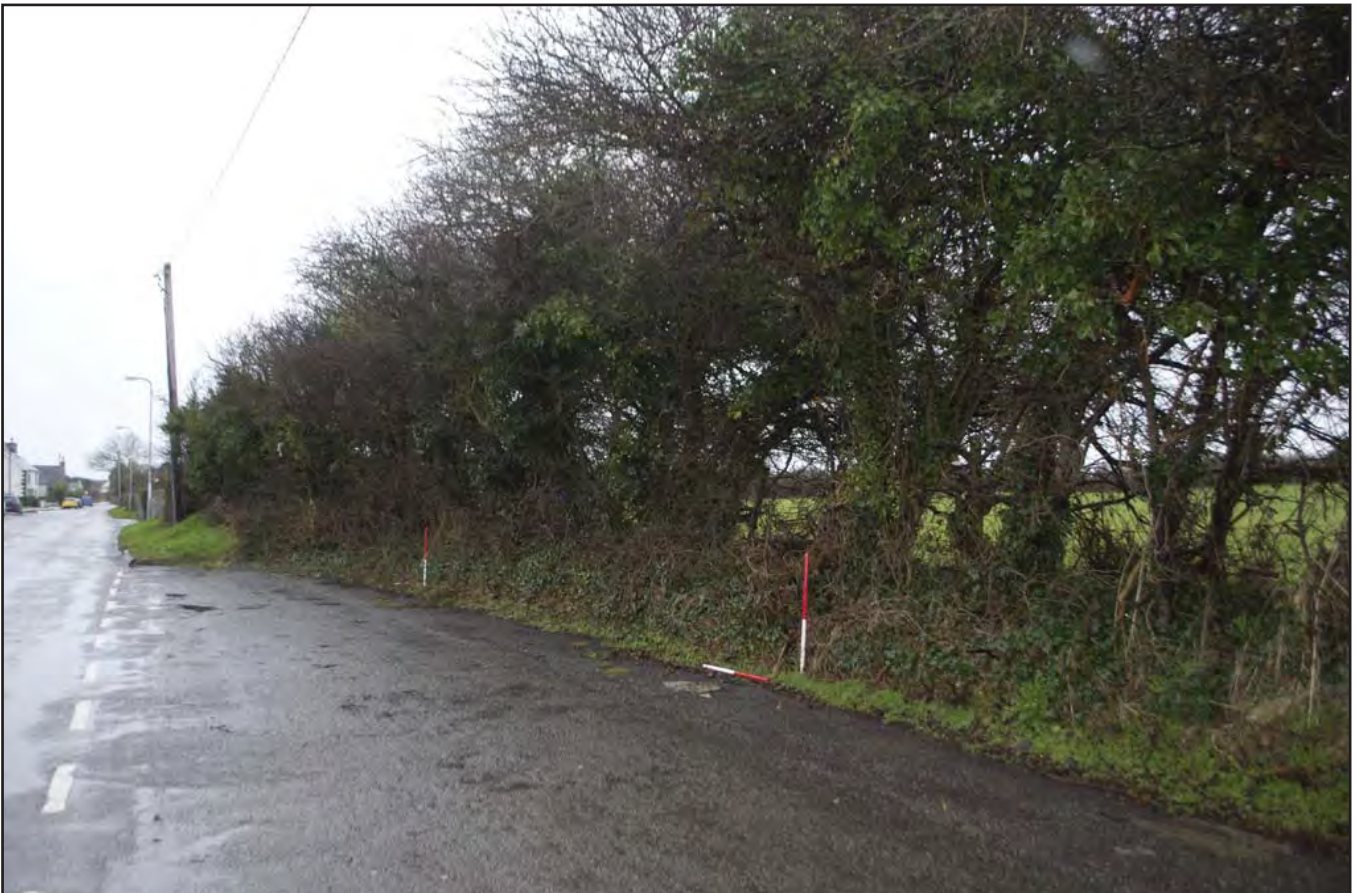
Boundary 2 comprised an east to west orientated field boundary centred on NGR SH42506591 and running alongside a lay-by attached to the B4421 road (north side). The field boundary formed the southern end of Field 1 and incorporated an earth bank and stone wall. Total length recorded was 77m, with 45m comprising the earth bank and the remaining length a stone wall (Plates 19 to 22). The earth bank was heavily obscured on both sides by vegetation overgrowth and could not be accessed to measure the height or width of construction. No stone work was visible. The stone wall measured 1.4m in height and 0.5m in width and was built from mortar bonded irregular sized sub-angular and sub-rectangular stone, with crenelated capping of roughly square shaped stone. The stones used appeared similar to those used for the drystone wall and clawdd sections of Boundary 1. The field entrance was incorporated into the boundary and included a precast concrete pillar supporting the gate hinges (Plate 23). The roadside portion of the stone wall was partly obscured by a grassed embank and vegetation overgrowth (Plates 26 and 26).

Plate 26: Boundary 2 oblique view from east of earth bank on south side of boundary; scale: 1m
(archive image: G2467_261)
