Dinas, Allt Wen, Dwygyfylchi, Conwy

Topographic and Condition Survey

Project No. G2490

Report No. 1368

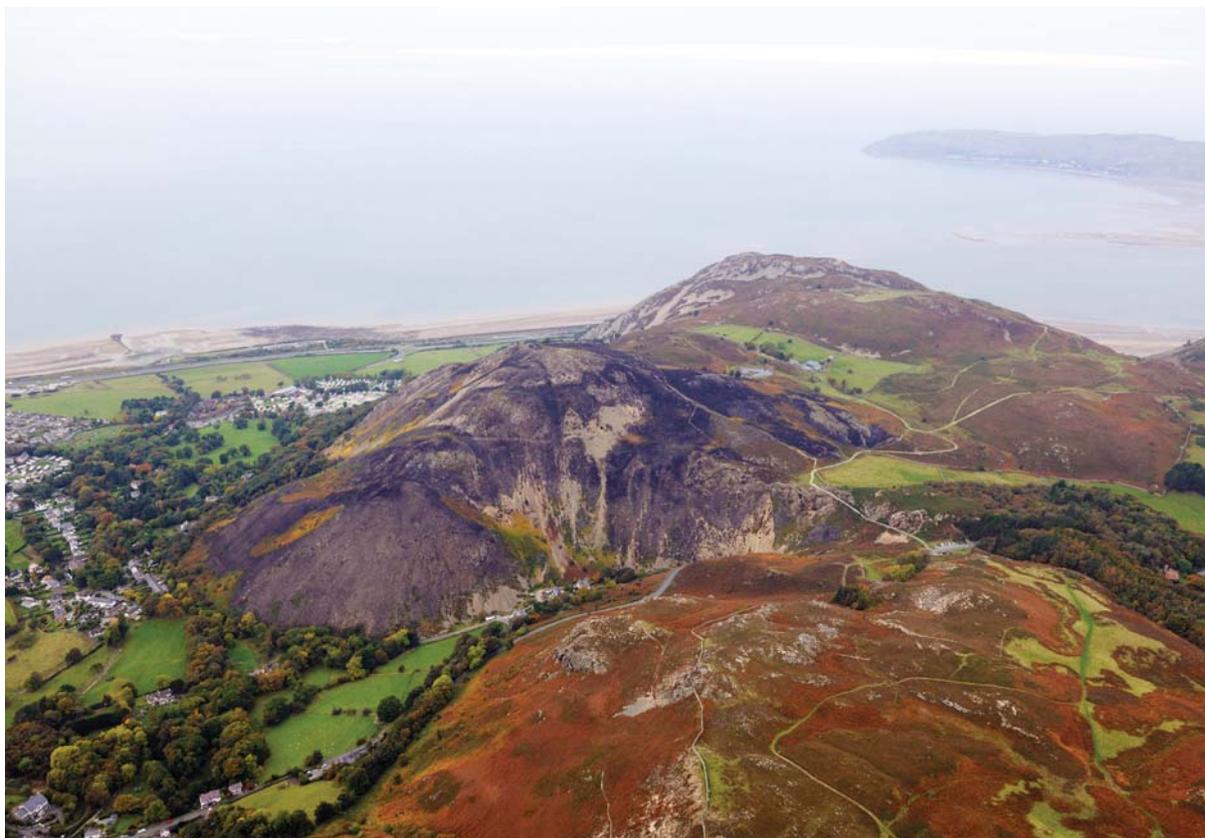
Plate 2. Allt Wen showing the extent of the burning. Maen Escob is in the foreground with Penmaen Bach behind Allt Wen and the Great Orme in the far distance.
(© Crown Copyright: RCAHMW; © Hawlfraint y Goron: CBHC)

On the evening of 4th June 2016 a fire started on the slopes of Allt Wen and continued to burn for more than 36 hours and extended over much of the hill (plate 2, figure 3). It threatened houses at the base of the hill as well as causing problems with smoke across neighbouring roads (Daily Post 5th June 2016³). The North Wales Fire Service believed that the fire was caused deliberately (Daily Post 10th June 2016⁴).

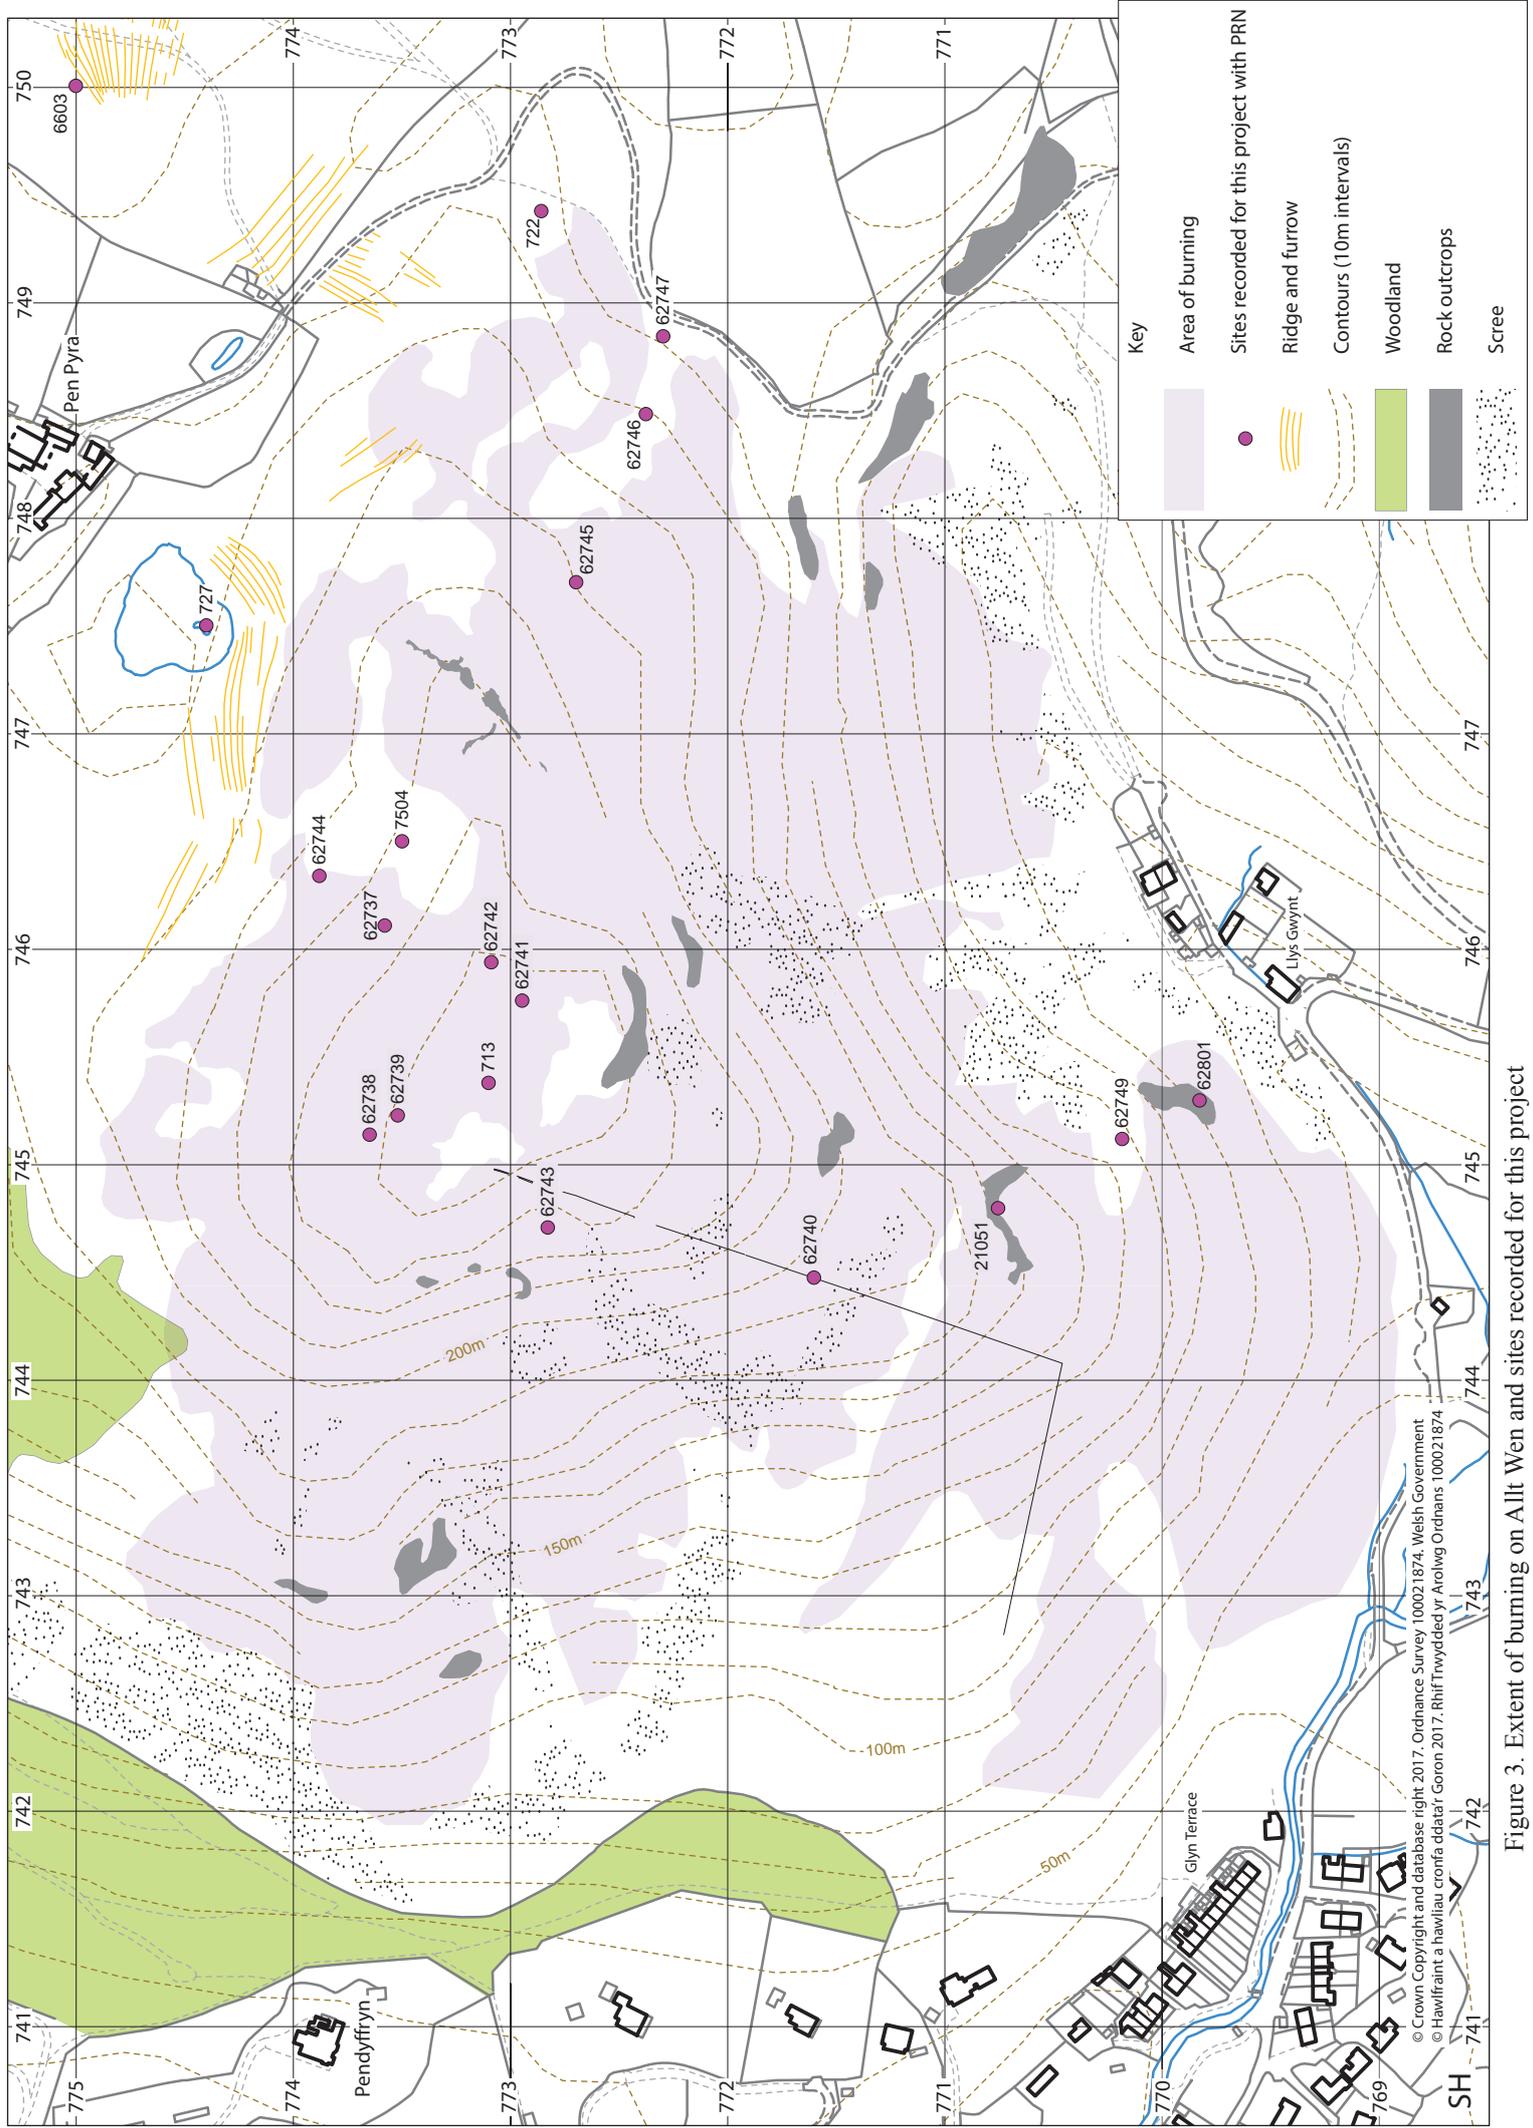
Figure 3. Extent of burning on Allt Wen and sites recorded for this project

Figure 3 shows the general location of sites described below and the full extent of the burnt area. Figure 4 shows the area of most detailed survey and how figures 5 and 6 (detailed survey plans) related together.

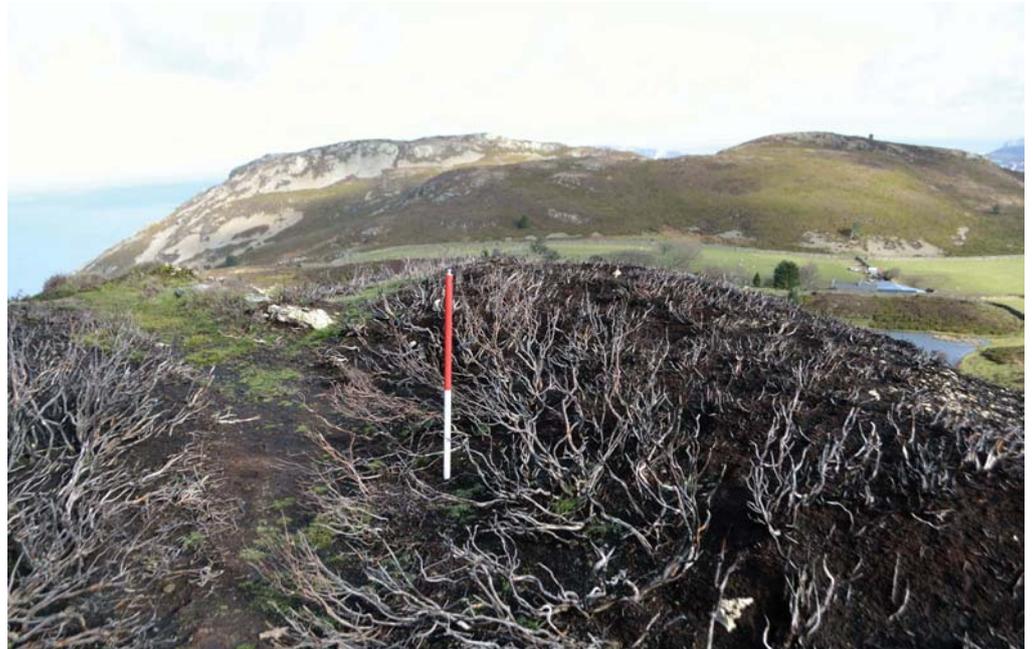
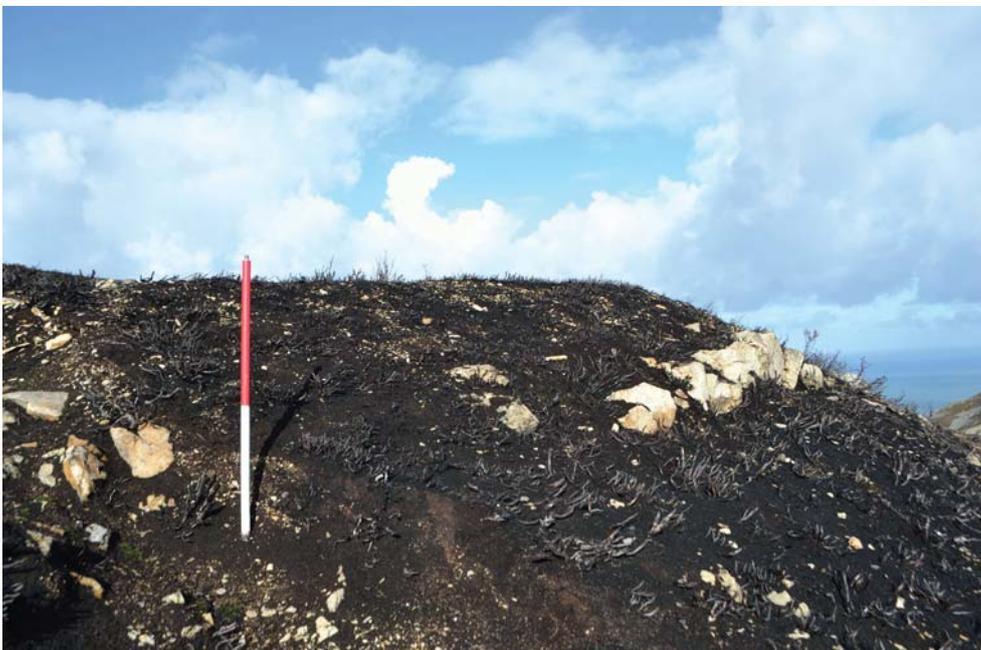
Plate 8. Eastern rampart showing outer facing stones and height of surviving rampart, from south-east

It is clear that the rampart was not just a bank of earth but was stone-faced on both the interior and exterior. The facing stones survive in places all round the circuit but in most places only the lowest course survives (plates 9 and 10). More of these facing stones were found than expected as some can be seen even on the southern and western sides where the rampart has almost entirely eroded away (plate 11). On the northern side there is a short section where two or possibly three rough courses survive, but these are rather haphazardly placed and it is possible that these have been rebuilt at some time (plate 12).

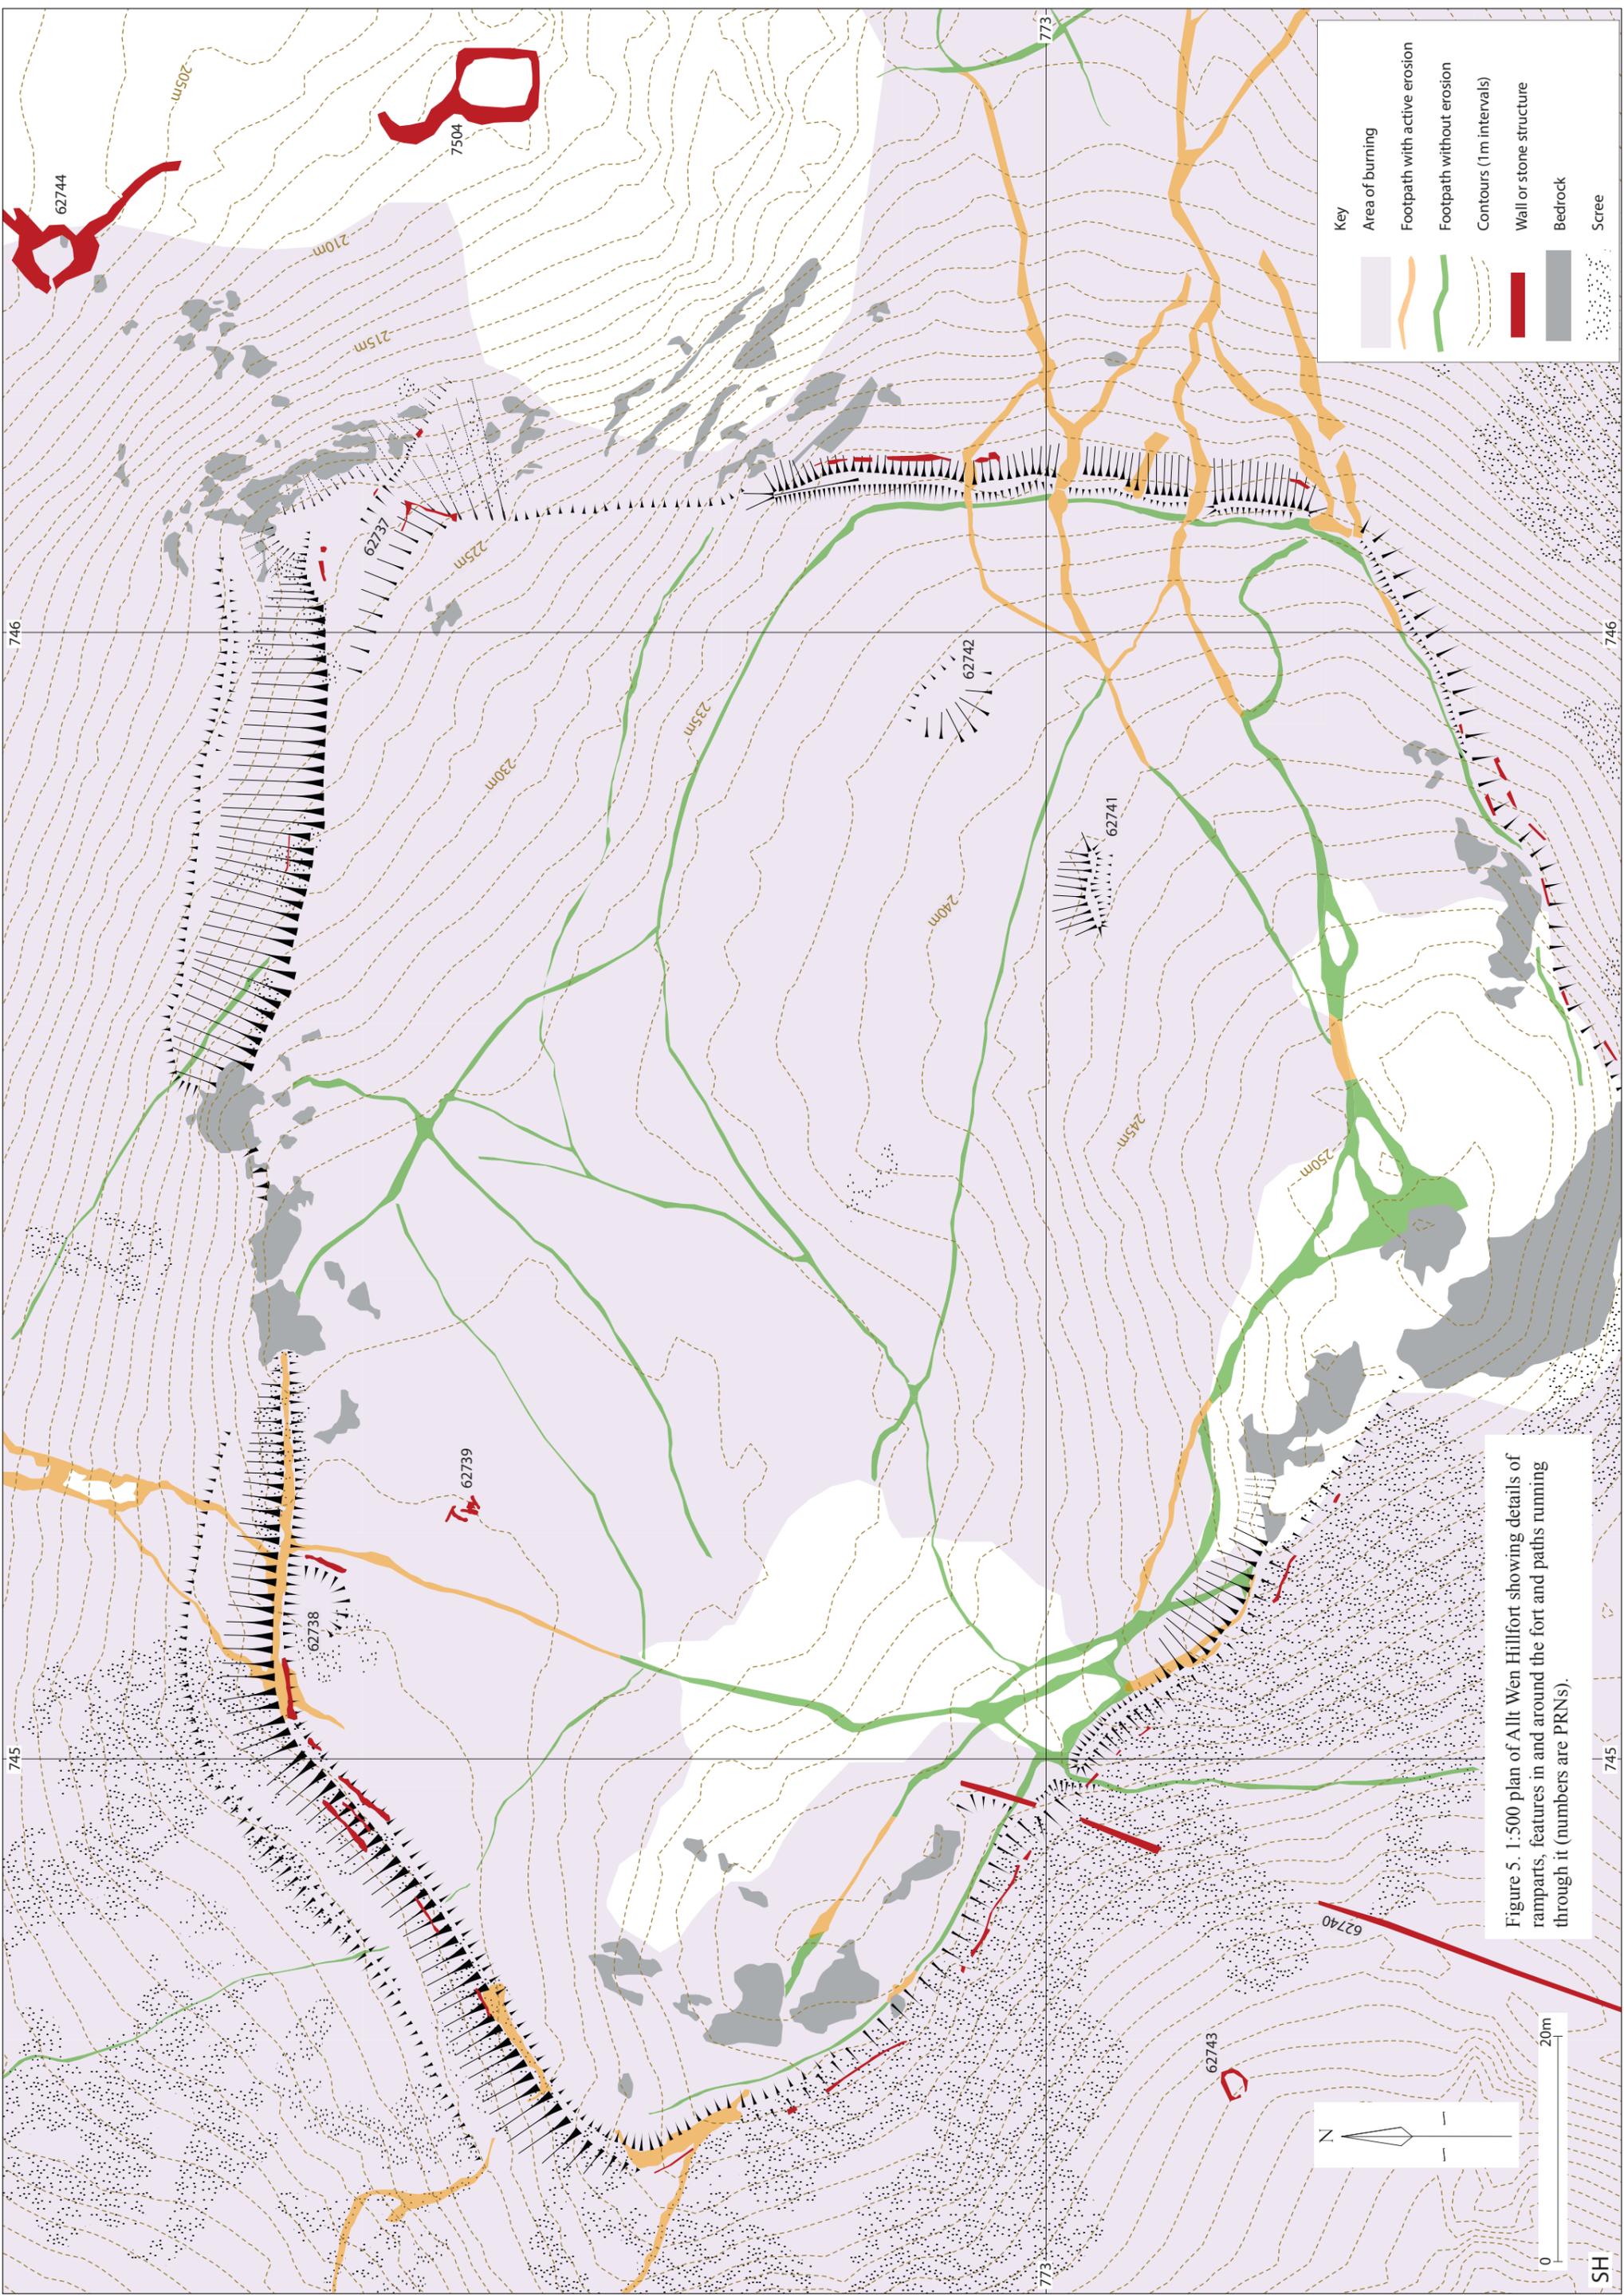
Figure 5. 1:500 plan of Allt Wen Hillfort showing details of ramparts, features in and around the fort and paths running through it (numbers are PRNs).

The vegetation has been burnt off almost the entire area of the hillfort, with just small patches of grass left (figure 5). This is particularly significant on the rampart where the stones forming the rampart are covered by barely 2cm of charred soil at best, with many areas entirely exposed. There is no significant evidence of water erosion in these exposed areas but if they remain exposed it seems highly likely that heavy rains would create gullies through the surviving material. Especially on the steeper slopes (plate 14) facing stones are likely to become loose and be lost, meaning that the slight hints of the location of the rampart that survive today will have gone. However there is hope that vegetation will return fairly rapidly. On the lower, warmer slopes, even at the start of March, new gorse shoots could be seen emerging. It seems likely that the heather inside the fort will return, although it has been quite intensely burnt. Where soil is particularly thin or almost non-existent on parts of the rampart there must be some question of roots of existing plants surviving but eventually seeds may blow in and cause recolonization. On some of the steeper natural scree slopes there must be some significant doubt about the previous heather cover returning, although this may give opportunities to some rarer species, but natural re-vegetation across the hillfort seems likely.

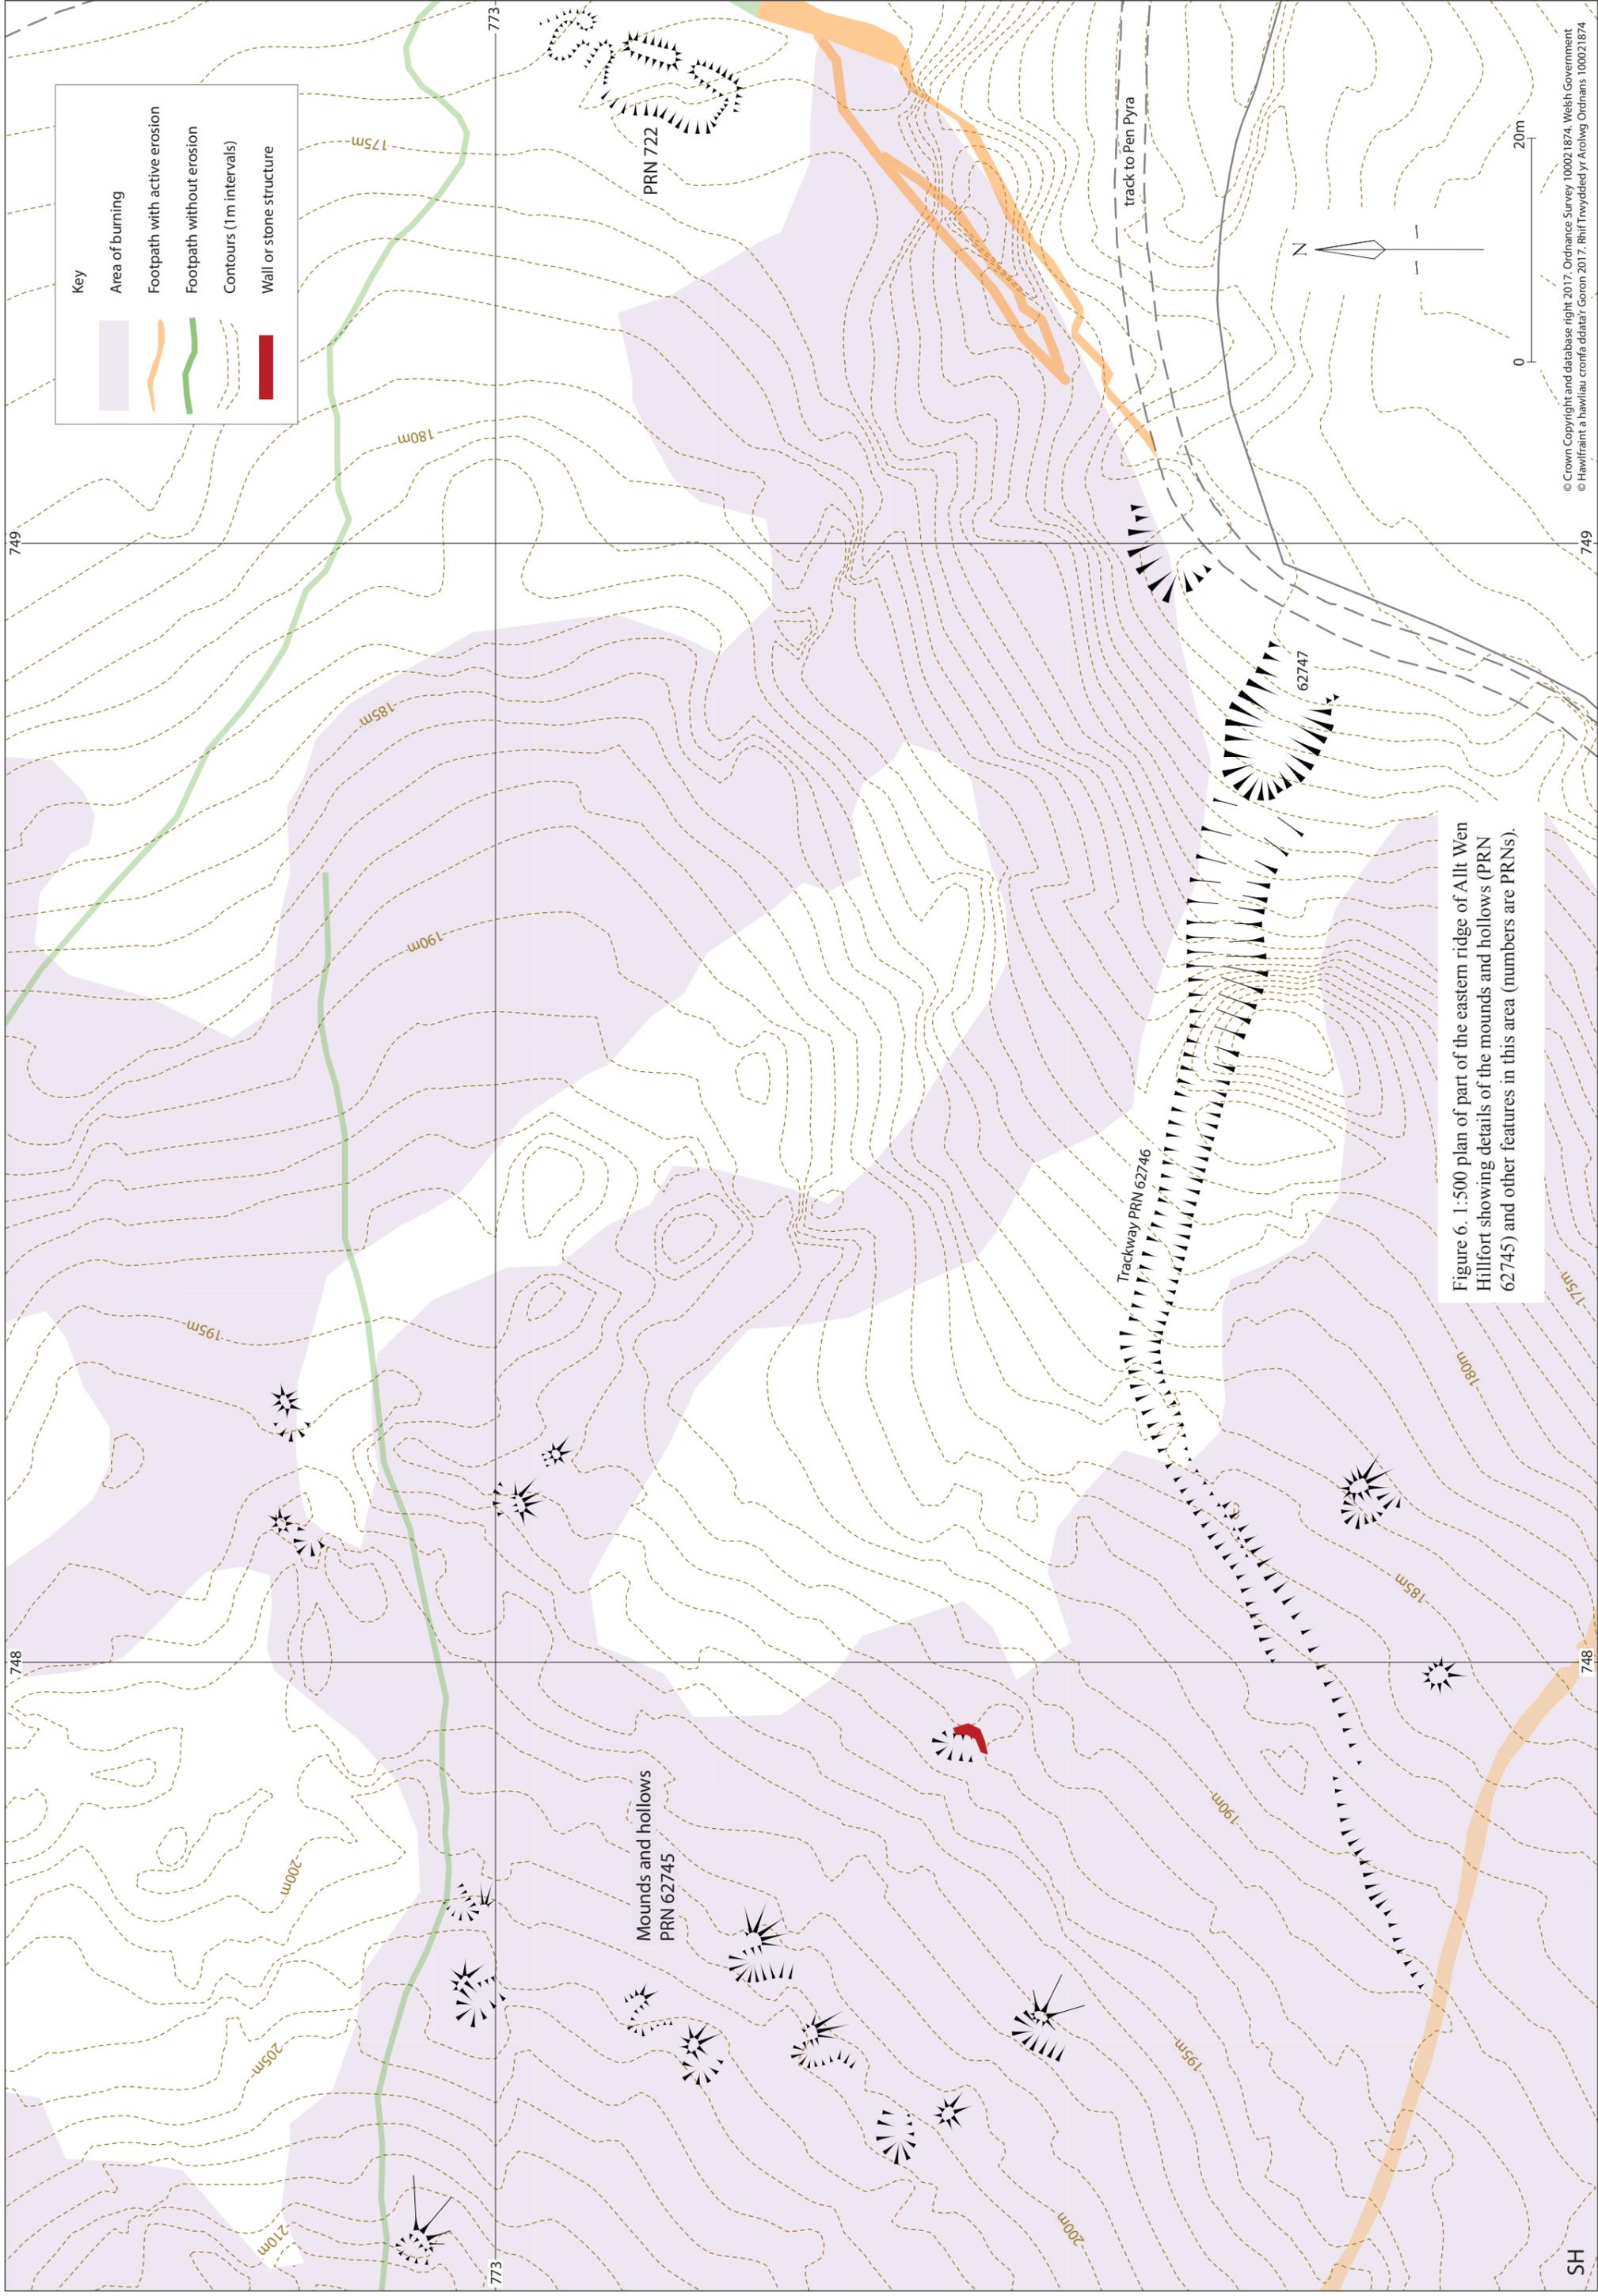
Figure 6. 1:500 plan of part of the eastern ridge of Allt Wen Hillfort showing details of the mounds and hollows (PRN 62745) and other features in this area (numbers are PRNs).

A group of at least 15 small mounds next to slight hollows are scattered over the lower part of the eastern slope of Allt Wen. The mounds measure no more than about 6m by 3m and are rarely over 0.3m high (although one is about 0.7m high). The hollows are a similar size and about 0.3m deep. The mounds are formed of small loose stones and occasional larger stones clearly dug from the hollows and cast over the downhill side. The hollows open out to the downhill side. In one case a mound was found without an obvious adjacent hollow and in another the hollow and the mound were about 2m apart, when in the other cases they are immediately adjacent. One mound has a rough wall constructed on top (plate 35), little more than a linear heap of stones from the hollow. This may have been to convert the hollow into a rough shelter or it may just be that more larger stones than usual were extracted from this hollow and placed on top of the mound.

Most of the mounds are scattered over the south facing slope of the ridge but a few were found on the top of the ridge and some could be under vegetation on the northern side of the ridge. There are other very slight hollows and scatters of stone that may be other more eroded mounds and hollows but these were not surveyed as they were

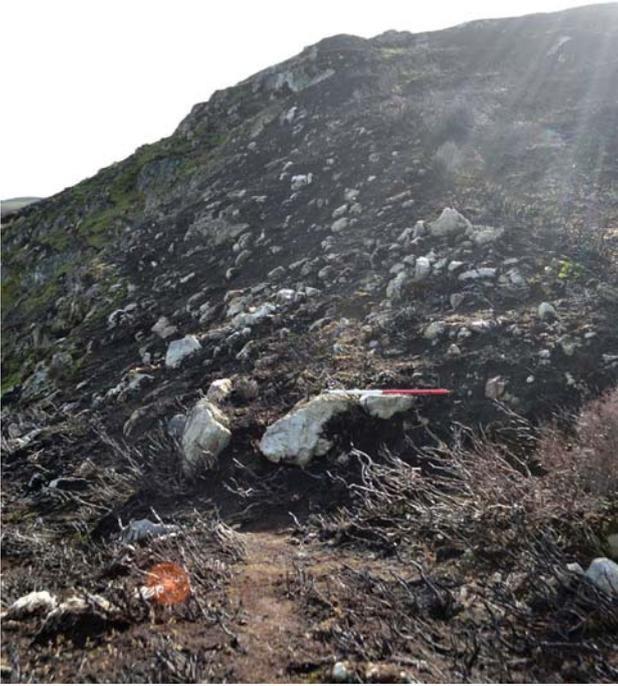
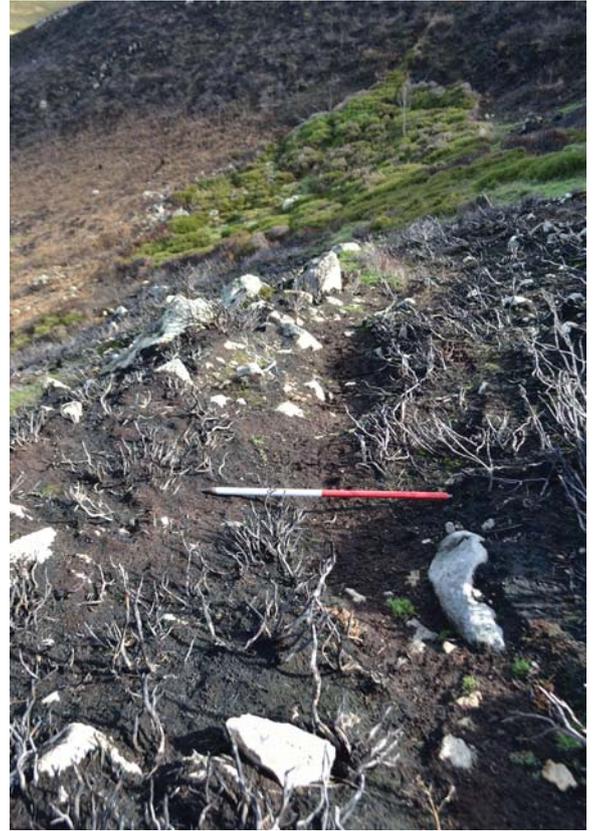
Plate 16. Probable trackway to the entrance of the hillfort, view from the north-west

The only possible entrance to the hillfort is in the north-eastern corner (PRN 62737). This was noted in the Inventory (RCAHMW 1956, 86), where the entrance is described as being 10ft wide. While it is likely that this is the entrance, it is far from a well-defined feature. Where the eastern rampart descends the slope towards this point it has almost entirely been eroded away and is little more than a sharp change of slope at the top of the natural hillside. However at the very northern end some rampart material does seem to survive. This appears as an area of small stones apparently faced on the eastern side by medium sized stones (plate 15). This facing is not very clear but the line of stones is consistent enough to be convincing. At the northern end two large stones and some smaller ones seem to form a facing at right angles, creating a squared-off end to the rampart. There is a linear hollow about 2.5m wide between this possible facing and the rocky outcrop that forms the north-eastern corner of the fort. The linear hollow runs from the north-west down towards the south-east and becomes a slight benched trackway no more than 1.3m wide, marked on its northern side by a steep natural slope and outcrops of rock (plate 16). There

is also a single rock that seems to have been deliberately set on edge marking the side of the track. At its base this track leads to a somewhat more level area and fairly gentle slopes lead either down to where there is currently a small pond or up slightly to the eastern ridge. However there is no sign of a continuation of the track in either of these directions, although this area had avoided the burning and was still heavily vegetated.

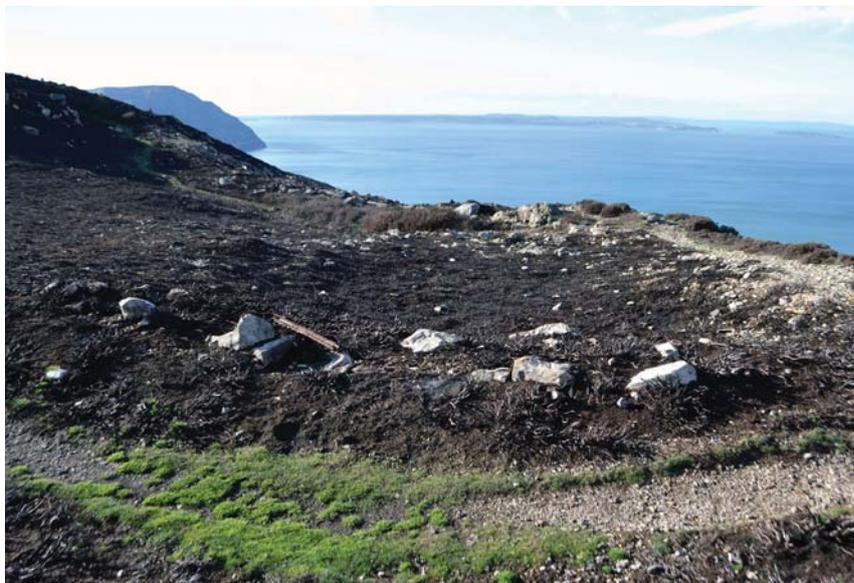
Plate 19. Hollow within hillfort suggested as being a hut circle (PRN 62738) but this seems unlikely. Stones of boundary PRN 62740 on the foreground with fence post. View from E

There were a small number of features identified inside the hillfort, the descriptions of which are included below. This includes one possible hut circle (PRN 62738), which now fully exposed looks less convincing and is probably a natural hollow or perhaps the end of a quarry hollow for the rampart. There is also a slight platform (PRN 62742) that could have supported a small structure but this is rectangular rather than circular and there is no evidence that it is directly related to the hillfort. It would therefore appear that there were no huts or roundhouses within the area of the fort.

A semi-circular hollow measuring 6.2m by 4.5m located up against the inside of the northern rampart of Allt Wen hillfort. The hollow is up to 0.3m deep and opens towards the west. There is no trace of a stone wall associated with this hollow. The soil is very thin here so it is very unlikely that the foundations of a wall are buried, giving very little evidence to demonstrate that this is the remains of a roundhouse. There is a short section of walling on the lip of the hollow but this is straight and is on exactly the same alignment as the wall/fence (PRN 62740) that cut right across the hill. This piece of walling is therefore not part of a roundhouse wall. It seems probable that the hollow is of natural origin, made to appear more artificial by the presence of the rampart and late wall, or that it is the end of a quarry hollow for the rampart.

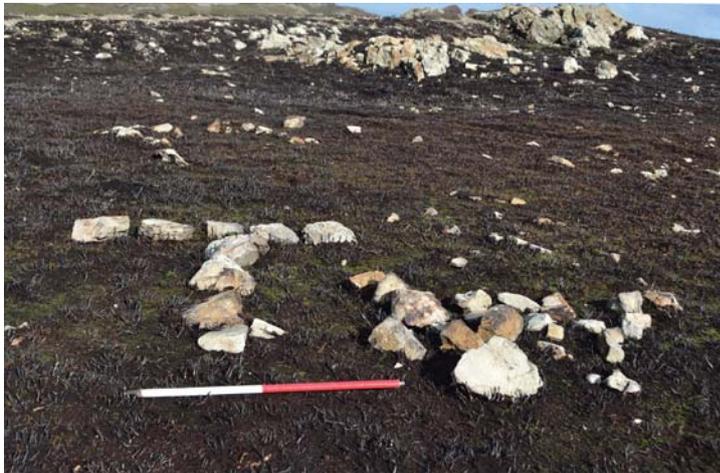
Plate 20. Initials (PRN 62739) marked out in stone inside the hillfort, view from SW

Medium sized stones laid out on a flat area inside the Allt Wen hillfort to form two letters, probably "TW". The letters are about 1.5m high. These are someone's initials marked out here when the area was not covered in heather, as it has been for many years. Other scatters and rough lines of stones in the same area suggest that there was a tradition of writing initials in stones here and that there were originally several of these but none of the others are now recognisable. The initials were entirely obscured by heather until a fire in June 2016 burnt off all the vegetation on the hill.

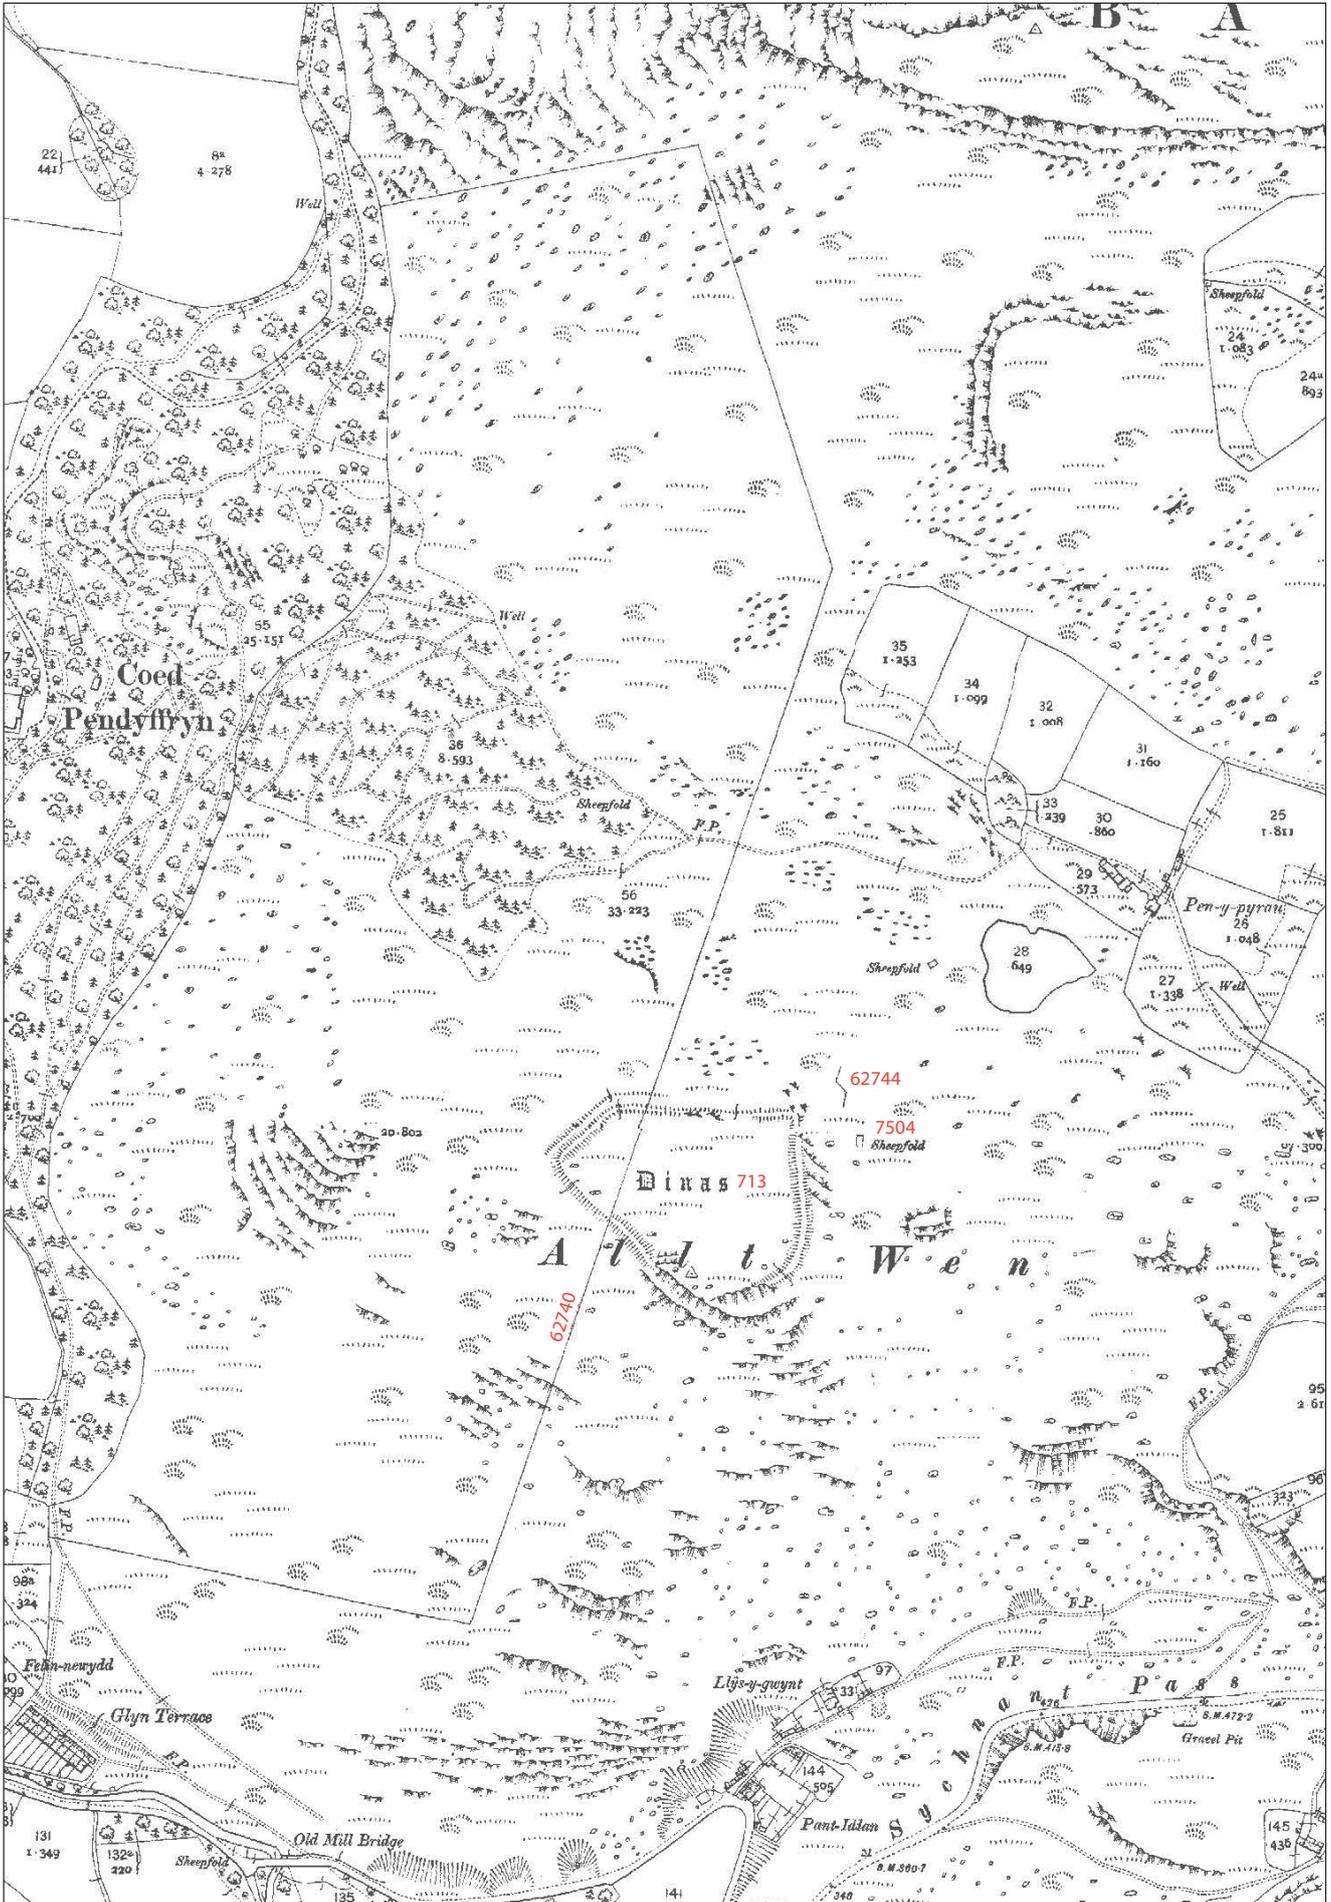
Figure 7. 3rd edition 25 inch County Series Ordnance Survey map, part of Caernarvonshire sheets IV.11 and IV.15 (1913). (PRNs of features shown on the map are marked in red).

The boundary is shown on the 25 inch OS maps (figure 7). It ran from just north of Glyn Terrace east-south-east up the hill to the top of the southern ridge of Allt Wen where it turned north-east and continued in an absolutely straight line for 700m right across Allt Wen and the hillfort. It turned north-west near Pen Pyra then west back down to the foot of the hill. This seems to have enclosed the part of the hill belonging to Pendyffryn.

The 1889 and 1913 25 inch OS maps, but for some reason not the 1900 map, show a short zigzag wall in this location but do not indicate the fold (figure 7). The zigzag wall is almost certainly a shelter wall for sheep and the fold must have been added at some time.

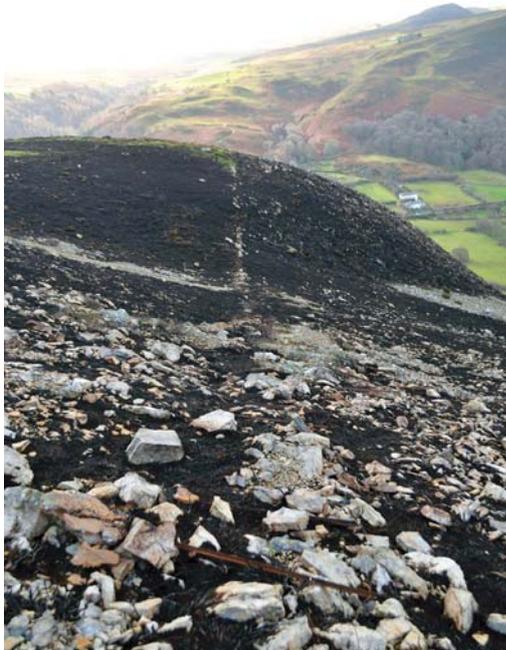
Plate 22. Remains of boundary (PRN 62740) running SW down from hillfort, view from NE

A remarkably straight former boundary running across Allt Wen. It is particularly visible on the south-western side of the hill where remains of iron fence posts can be seen marking the line and towards the top of the hill footings of a wall can be seen. The wall footings are about 0.5m wide and only survive as a single course but it appears that the boundary might originally have been a wall, replaced by a fence. Alternatively it might have been a wall on the more level areas and a fence on the steeper slopes. There is very little trace of the boundary where it crossed the flat plateau just below the summit, except for a footpath largely following the line of the boundary. Also, near the northern side of the fort, adjacent to hollow PRN 62738, are the remains of wall footings surviving for about 4m, with pieces of iron fencing. Nothing of the boundary survives down the northern side of the hill except for very occasional displaced remains of iron fence posts. However the footpath on this side follows the line of the boundary almost exactly.

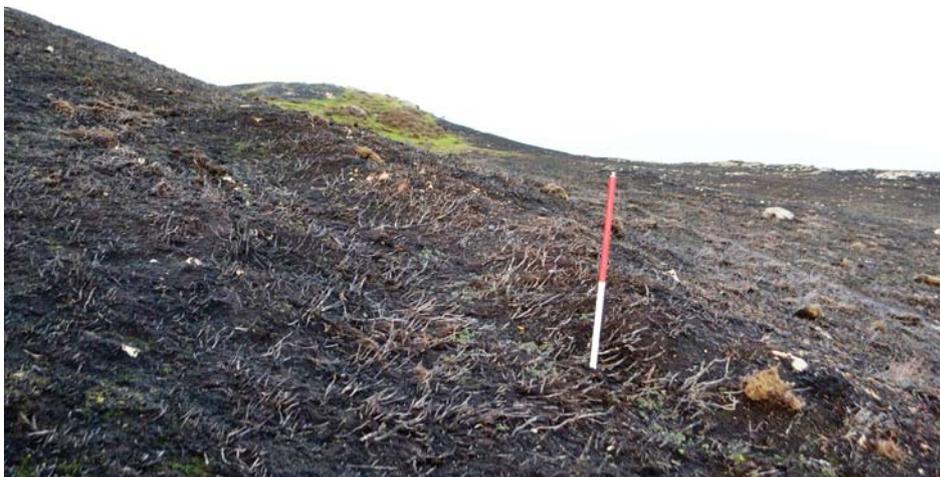
Plate 23. Mound (PRN 62741) inside hillfort, view from E

An elongated, rather irregular oval mound measuring c.10m by 5m and aligned east-west roughly along the contours. The downhill (northern) side of the mound is 1.3m high and the uphill (southern) side is c.0.2m high. Immediately to the south is a very slight hollow running along the base of the mound. This is similar to mounds and hollows found lower down the hill (PRN 62745) but the mound is larger with only a minimal hollow. Its function is unknown.

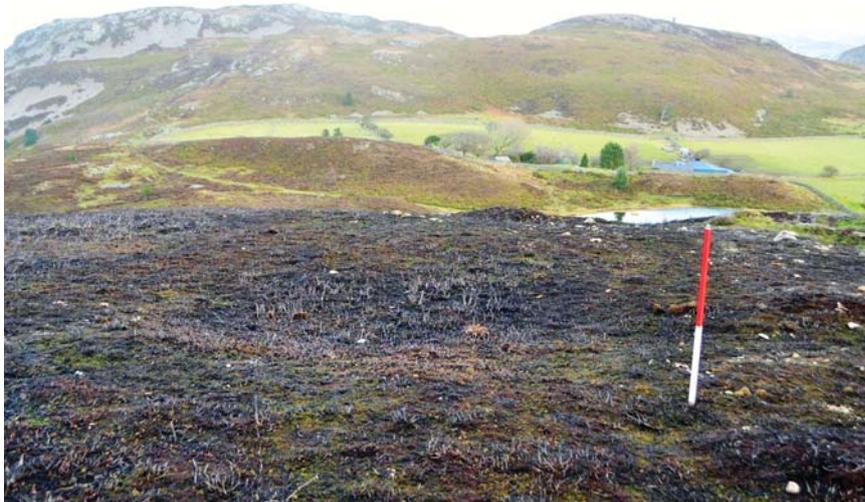
Plate 24. Slight platform (PRN 62742) inside the hillfort, view from the SW

A level, sub-rectangular platform measuring about 6.8m by 3m aligned north-west to south-east running along the contours of the hill slope inside the Allt Wen hillfort. It is terraced into the hill slope so that the upslope side is about 0.8m high, but this slopes fairly gradually and the feature is not well-defined. This is a fairly slight and subtle feature but does provide a level platform within the area of the hillfort that would be just large enough for a small building. The platform can only be seen now (March 2017) because of the heather having been burnt off. When the vegetation grows back this feature will be impossible to find.

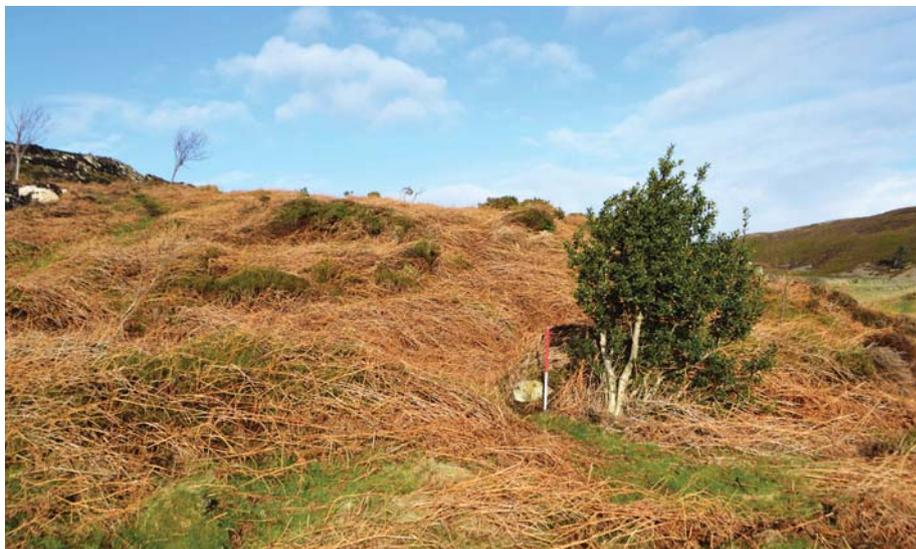
Plate 25. Long hut PRN 722 rom SE with ranging rod next to entrance

This was surveyed with a GPS on 01/02/2017 but the survey is very rough as the site is so overgrown and it avoided the fire that cleared much of the rest of the hill. A holly tree and a small rowan are growing on the long hut walls, which could threaten their stability in the long term.
