Dinas, Allt Wen, Dwygyfylchi, Conwy

Topographic and Condition Survey

Project No. G2490

Report No. 1368

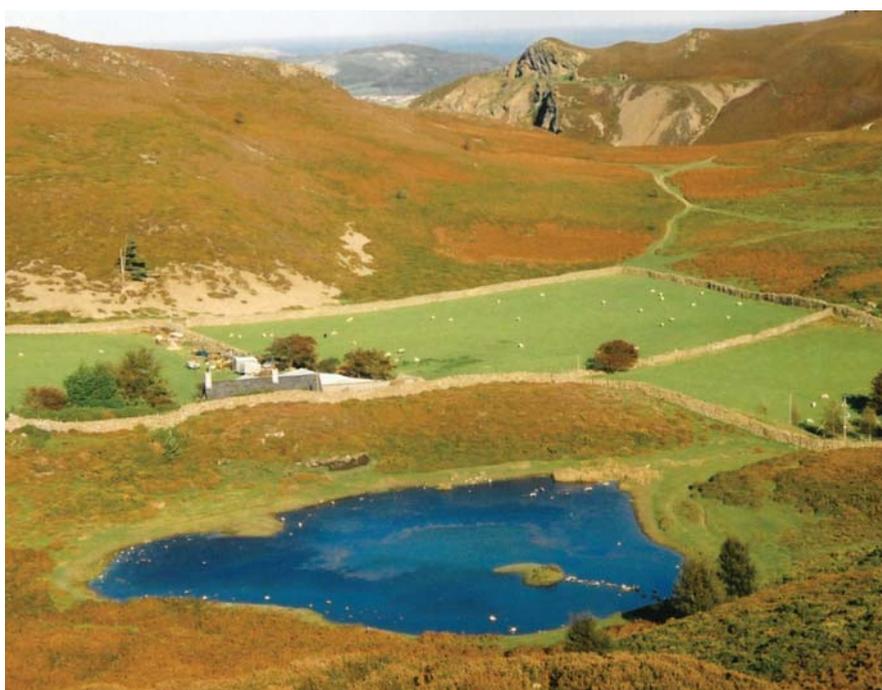
Plate 26. Photograph of burnt mound (PRN 727) in the pond near Pen Pyra Farm taken by George Smith of GAT on 04/10/2004 (from Further Information File)

This crescent-shaped mound of burnt stone is located in a small pond and has a causeway running south from it. The causeway must have been added after the pond had formed to allow access to the mound and is therefore clearly not an original feature and is probably recent. The orthomosaic created from aerial photographs for project G2490 revealed the mound and causeway and allowed them to be added to a plan of the area. However when the site was visited on the ground (01/03/2017) the water level in the pond was so high that only the top of the mound was visible and it could not be inspected on the ground.

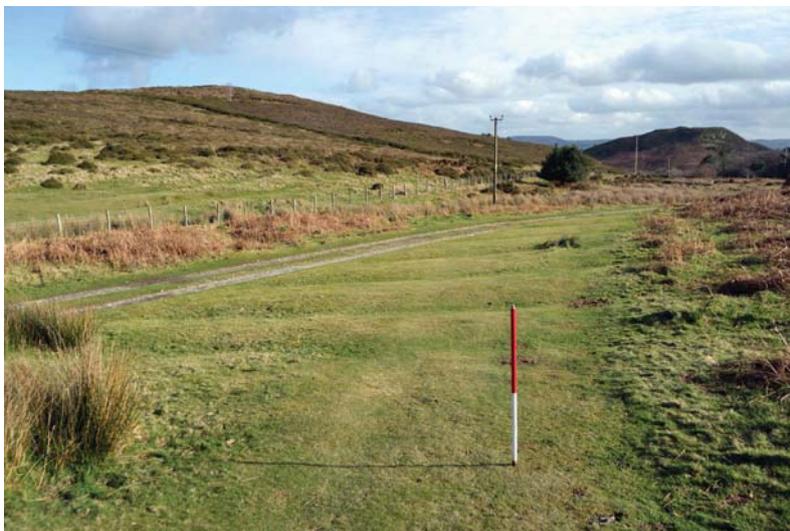
Plate 27. Ridge and furrow next to track to Pen Pyra (part of PRN 6603), view from the NW

The ridge and furrow east of Pen Pyra was reported to the HER by Richard Kelly in August 1996 when it was described as “really well-developed ridge and furrow cultivation around SH750775 SE of Pen-pyra Farm near Sychnant pass” (letter in FI file). No other information was given and it does not seem to have been inspected since. It is assumed that the area was fairly clear in 1996 but most is now overgrown with gorse and heather. However when looking at the area for G2490 it was noticed that some ridge and furrow could be seen on aerial photographs. The opportunity was taken to trace the furrows that could be seen where gorse and heather were sparse when the photographs were taken. Some ridges are also visible in the short grass next to the track to Pen Pyra. This shows small groups of ridge and furrow mainly to the east of Pen Pyra with a few to the south. The ridges run in a variety of different directions and seem to represent very small fields or unenclosed furlongs. This may have been from a recent period of agricultural expansion such as the Napoleonic Wars but the curve of most of the ridges suggests traditional medieval ploughing techniques. The ridges visible near the track are variable in width between 2m and 4m but are no more than 0.1m high.

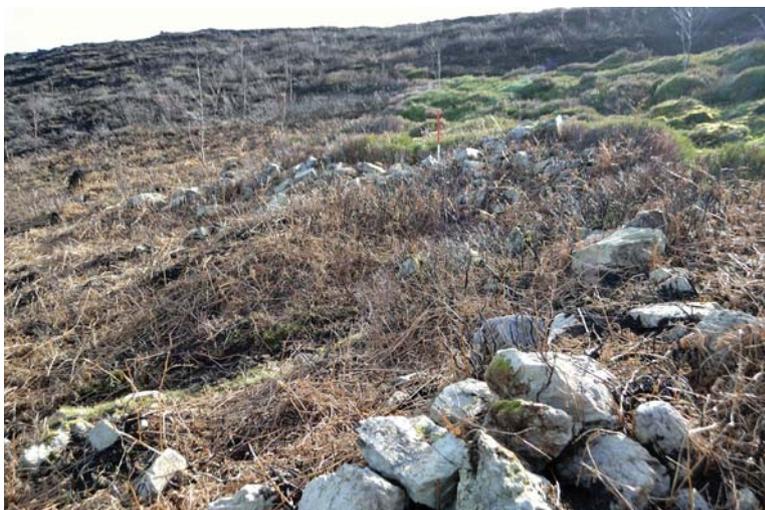
Plate 28. Largely overgrown sheepfold (PRN 7504) with curving wall in foreground, view from N

A rectangular stone-built structure measuring about 6m by 4.3m internally and aligned almost exactly north-south. The walls are well-built and about 0.6m wide and survive to up to 0.5m high. A rough wall runs from the north-west corner to enclose a small area. This wall is very collapsed and confused. The structure is heavily overgrown

with bilberry and details are difficult to identify. Only the curving wall and the northern end of the structure were burnt in the fire, leaving most obscured by vegetation.

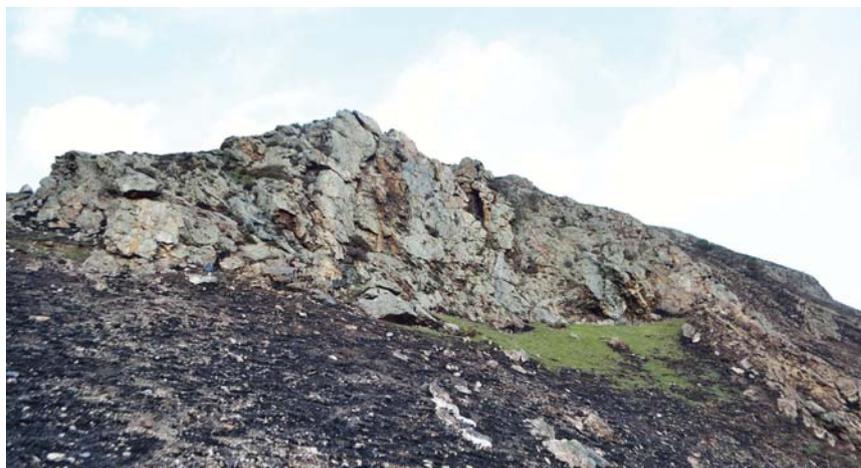
Plate 29. Crag previously suspected of being a quarry (PRN 21051) but appears natural, view from S

The HER has not previously had a description of this site, only a reference to SNP Industrial Record, No.772704. This seems to have been identified from aerial photographs as a quarry. The original grid reference given is SH745771 and this seems most likely to refer to the crags at the current grid reference. Although these crags do curve round to resemble a quarry, close inspection failed to identify any firm evidence that it had been a quarry. Particularly it is in an inaccessible position and no trace of any access routes or inclines were found, so it seems highly unlikely that stone was removed from here. The face of the crags appeared quite natural and no drill holes were visible.

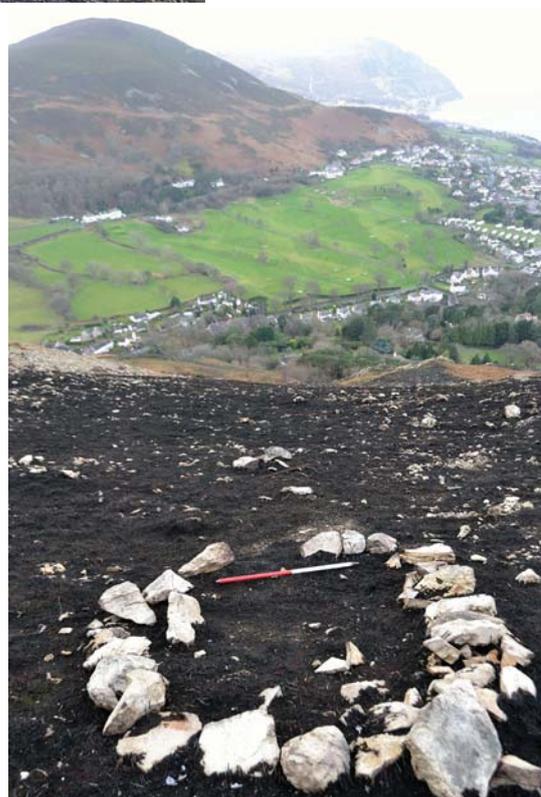
Plate 30. Small shelter or arrangement of stones (PRN 62743) with view over Dwygyfylchi, view from NE

A small roughly oval structure measuring 2.8m by 2.2m. It is formed of a single line of stones that does not seem to have been the base of a wall so it is hard to see this as a shelter or fold. There is a gap in the south-western side and it is aligned north-east to south-west sloping down the hill, not in any way terraced into the slope. This feature is located on a slightly flatter part of the western side of Allt Wen. This would normally have been impossible to see when the area was covered in heather but has been clearly visible since the hill was burnt in June 2016.

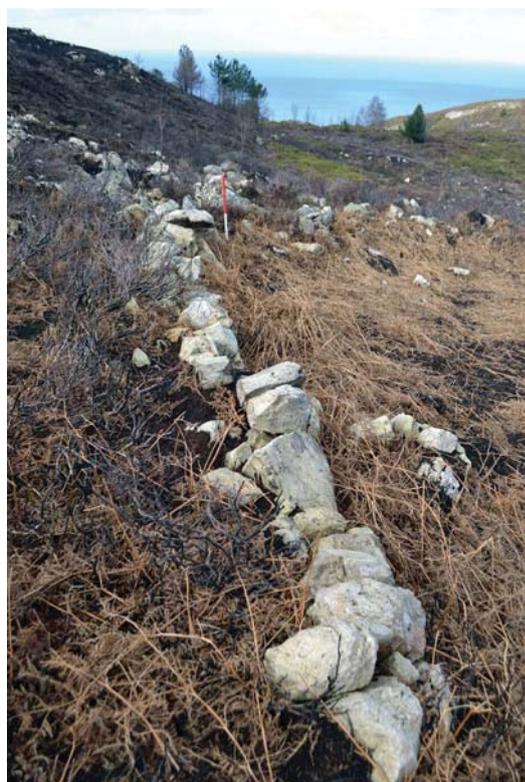
Plate 31. Wall leading from small sheepfold (PRN 62744) with fold in background, view from SE

The 1889 and 1913 25 inch OS maps, but for some reason not the 1900 map, show a short zigzag wall in this location but do not indicate the fold (figure 7). The zigzag wall is almost certainly a shelter wall for sheep and the fold must have been added at some time.

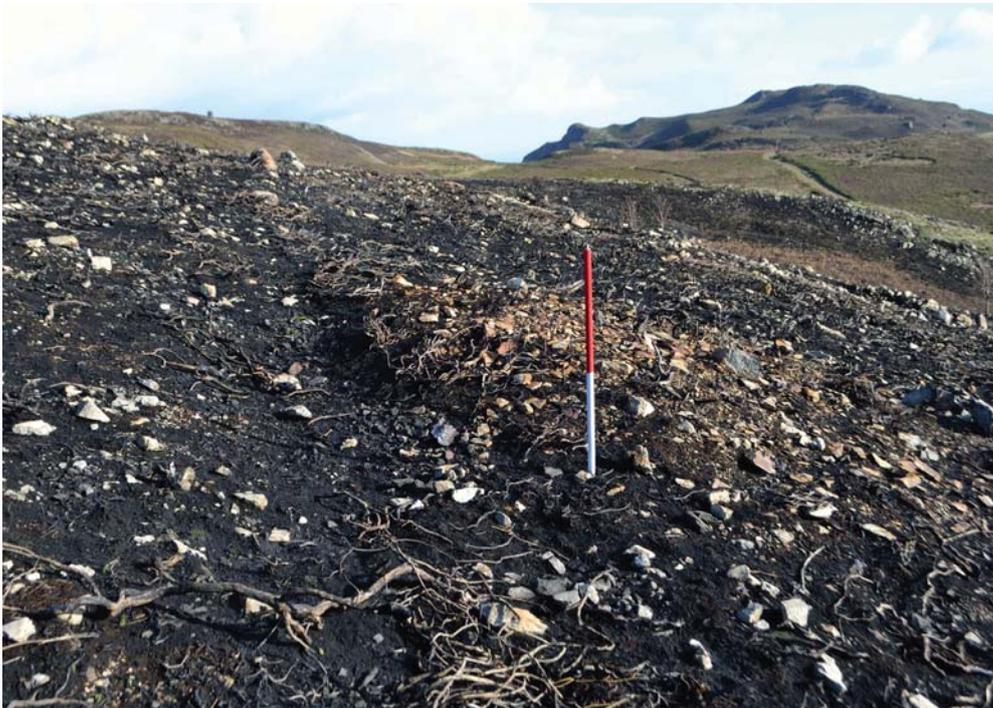
Plate 33. Mound and hollow
(part of PRN 62745) from
c.SH74765 77247, view
from SW

A group of at least 15 small mounds next to slight hollows are scattered over the lower part of the eastern slope of Allt Wen. The mounds measure no more than about 6m by 3m and are rarely over 0.3m high (although one is about 0.7m high). The hollows are a similar size and about 0.3m deep. The mounds are formed of small loose stones and occasional larger stones clearly dug from the hollows and cast over the downhill side. The hollows open out to the downhill side. In one case a mound was found without an obvious adjacent hollow and in another the hollow and the mound were about 2m apart, when in the other cases they are immediately adjacent. One mound has a rough wall constructed on top (plate 35), little more than a linear heap of stones from the hollow. This may have been to convert the hollow into a rough shelter or it may just be that more larger stones than usual were extracted from this hollow and placed on top of the mound.

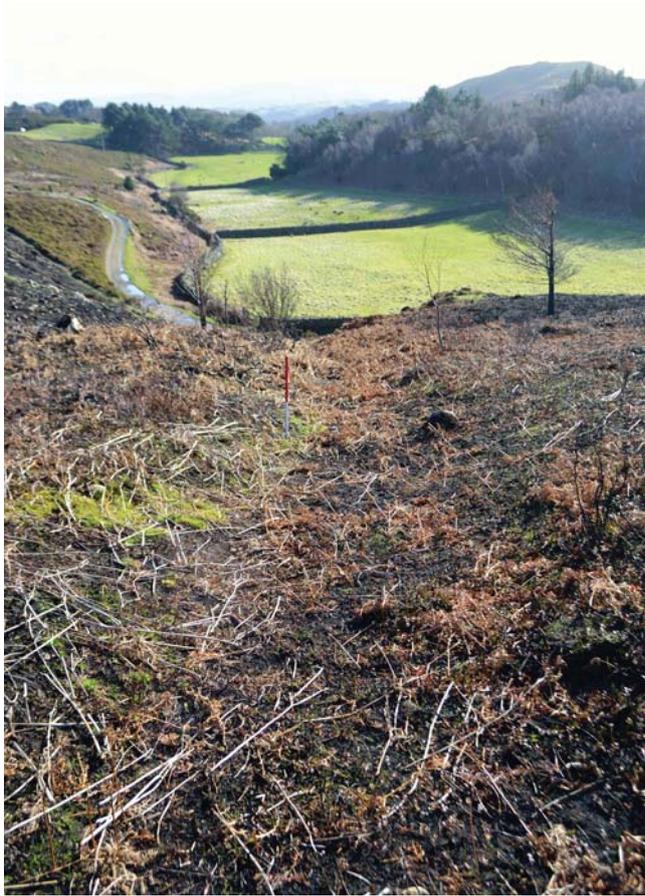
Plate 36. Trackway (PRN 62746) onto eastern slope of Allt Wen, from NW

This might be an earlier footpath up Allt Wen but the lack of zigzagging on the lower steeper section and the fact that it does not seem to be orientated towards the hill top suggests otherwise. The western end is not close to any other feature and there is no evidence of what it might have led from. The lower steep section is so direct that it resembles an incline. If there was any peat on the hill it might be considered to be for removing cut peats but there is no evidence that there was ever any depth of peat anywhere on Allt Wen. There is a group of mounds and hollows (PRN 62745) north-west and uphill from the track, with two downhill. It is possible that the track was related to these but their function is not known.

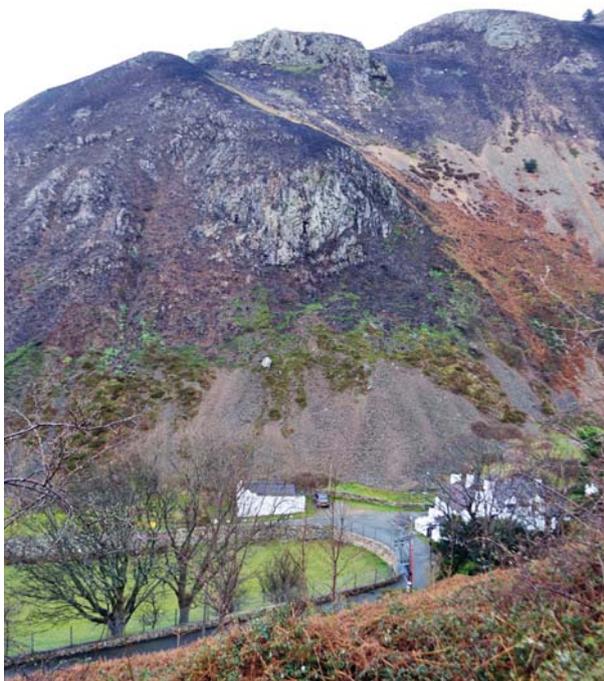
Plate 39. Crag above Llys Gwynt with at least two caves

An opening is visible in the crag above Llys Gwynt. Local tradition related that this was the entrance to a Roman mine but according to a pamphlet printed in 1896 (Paget 1896) local quarrymen visiting the feature in 1893 considered it to be a natural cave. Lady Paget, who wrote the pamphlet, had her friends investigate the cave in October 1896 and they described an extensive cave with three chambers. The first chamber was 76 yards long with a smaller chamber beyond it 44 yards long, 5 ft wide and 7 ft high. Beyond that was a built wall and then another cave measuring 60ft long, 5ft 4 inches wide and 6ft 9 inches high. The walling suggests that the caves were used by people but the investigators were certain that they were natural caves and not mines.

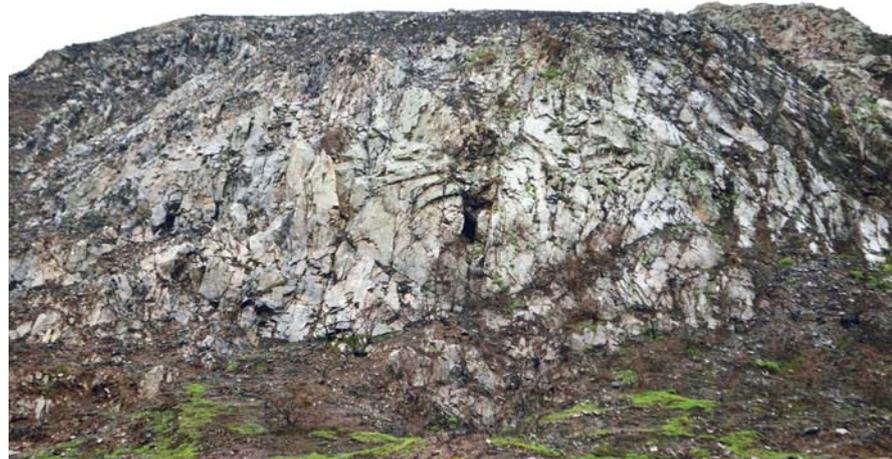
Plate 40. Close-up of crag with both caves visible

Britain Viewer shows a band of mudstone near this location the openings are clearly in the rhyolite crag, and while there may be mine shafts in the mudstone, which were not located, the openings in the crag do not seem to be targeting the mudstone. The inaccessibility of the openings, especially the main one, and the lack of spoil or any traces of access routes, strongly support Lady Paget's contention that these are natural caves. The possibility that they were used by people at an unknown period, possibly of some antiquity, does make them worth investigation if the opportunity arose.

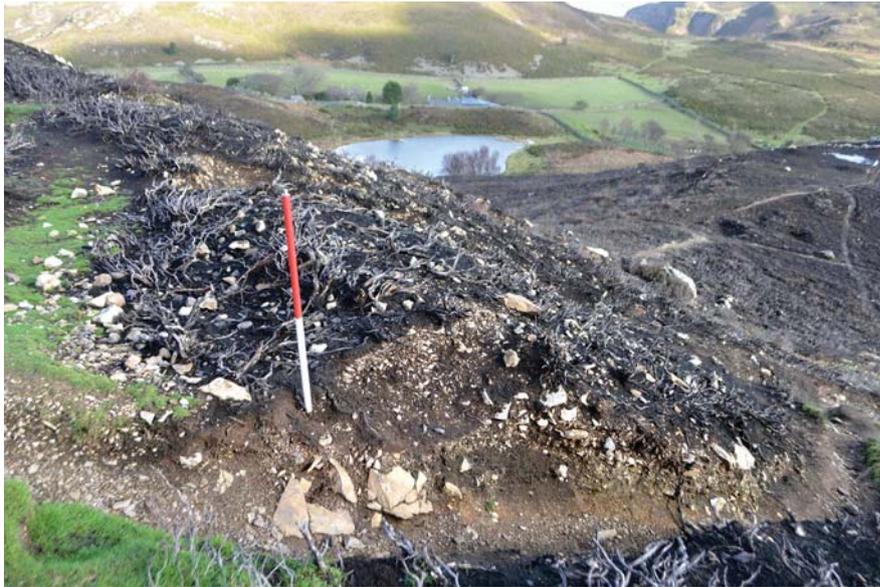
Plate 41. Pathway eroded through eastern rampart

The worst erosion caused by footpaths is on the main access route through the eastern rampart (plates 41 and 42). The route into the fort has braided and there are four active access points into the fort with two older ones that are not currently active. This spreads the extent of the damage. Where the paths cross the rampart they have eroded through the full depth of the rampart and into the natural deposits below. In the long term these paths seem to be a significant threat to the best preserved eastern rampart. It would seem worthwhile carrying out remedial work on this side. If a built path or steps were constructed to one gap, which was reinforced to minimise further erosion, and the other gaps filled in, further erosion might be minimised or even avoided entirely. However this would be an expensive solution and Allt Wen does not receive a very large number of visitors, although it is quite a popular dog walking spot for locals.

It is therefore recommended that reseeded of the ramparts is considered as well as the possibility of creating a built pathway into the hillfort on the eastern side to reduce long term erosion on the paths here. The site should also be monitored to ensure that vegetation is returning and that no significant erosion does develop.
