# DCWW Llanfaethlu Waste Water Treatment Works

## Archaeological Mitigation

Prosiect Rhif / Project No. G2482

Adroddiad Rhif / Report No. 1382

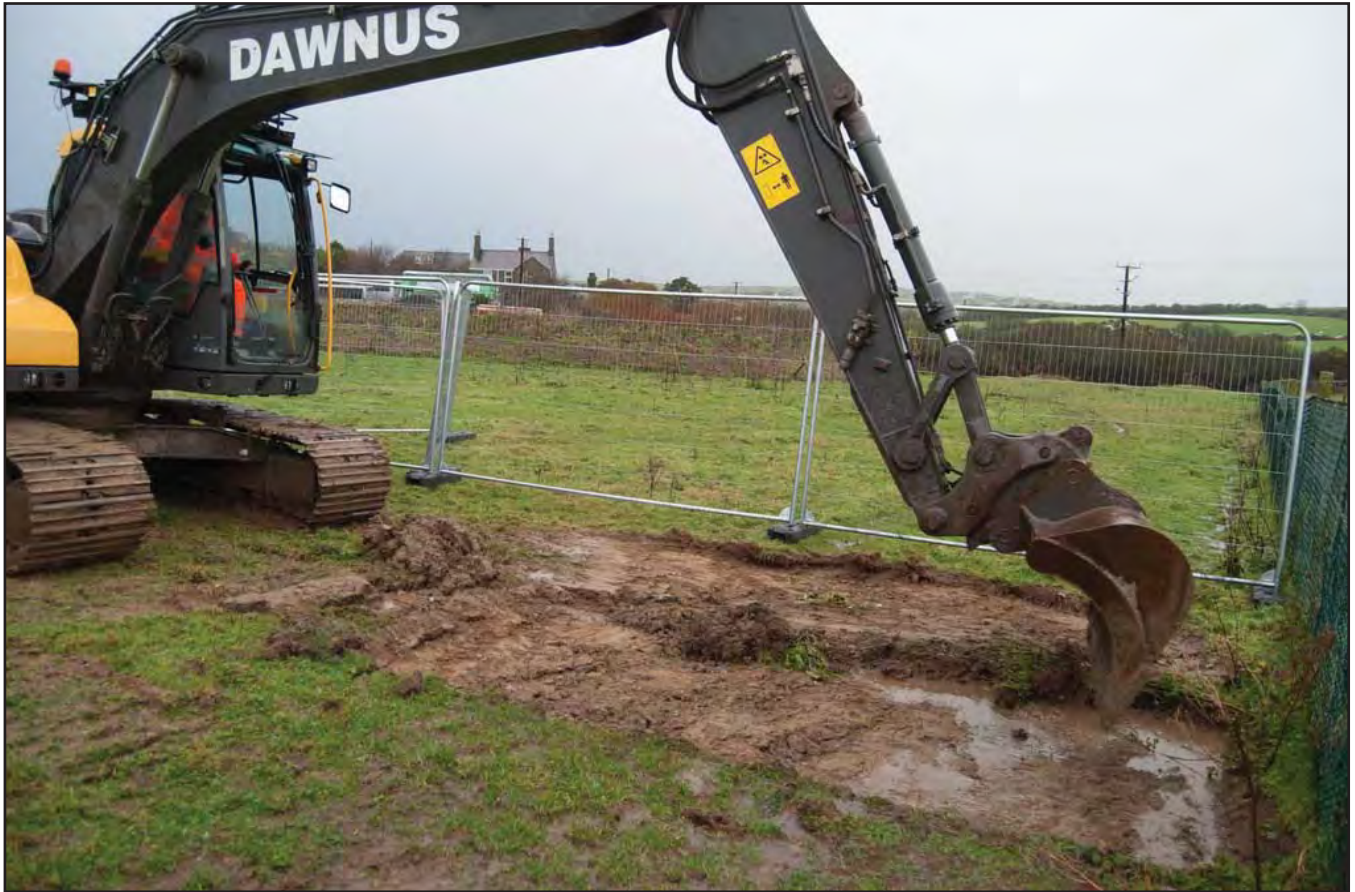
**Plate 01: Commencement of controlled strip. No scale. (Photographic archive ref. G2482\_005)**

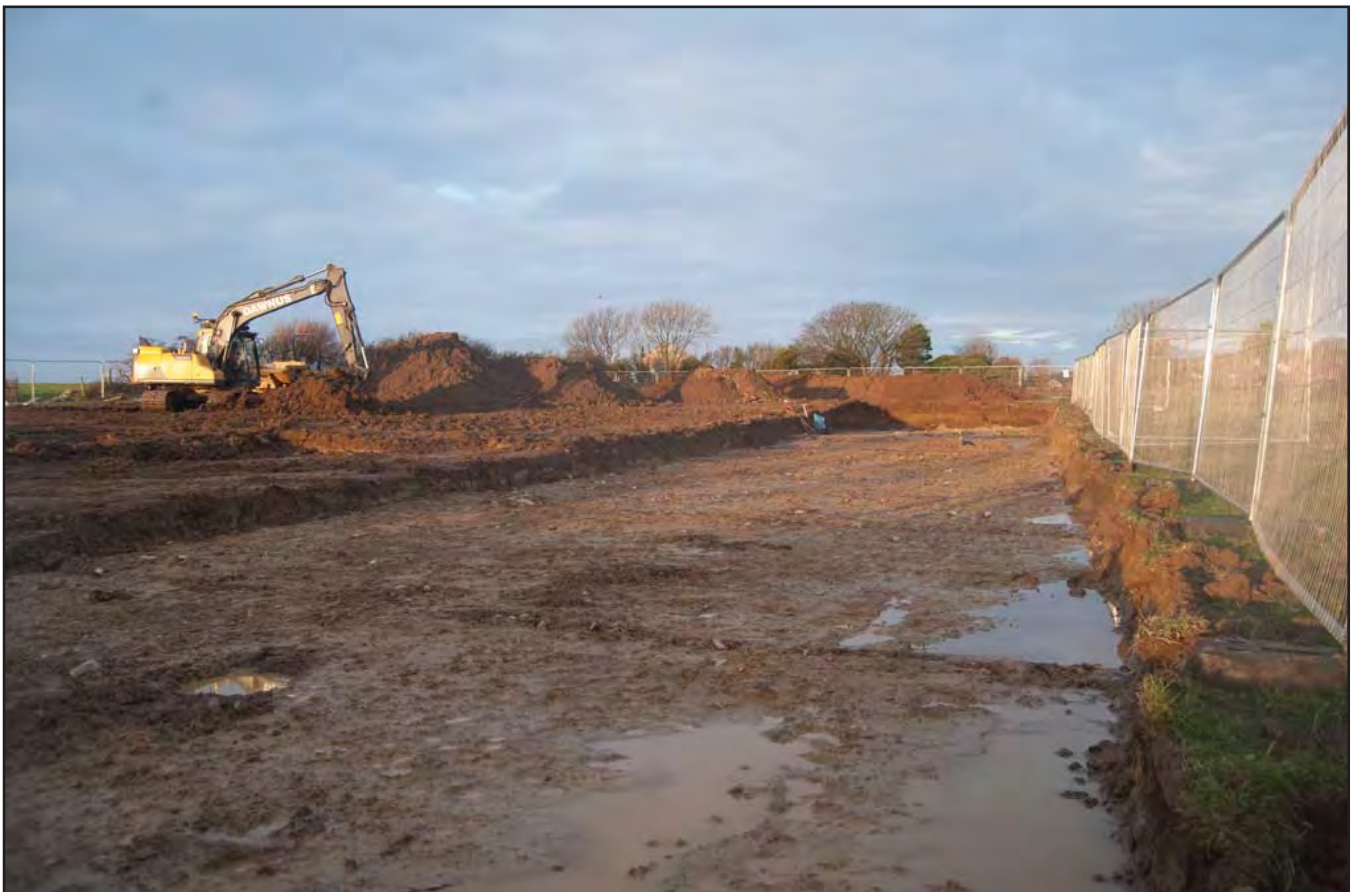
**Plate 02: Topsoil and subsoil bunds at NW edge of controlled strip. No scale. (Photographic archive ref. G2482\_016)**

Plate 02: Topsoil and subsoil bunds at NW edge of controlled strip. No scale. (Photographic archive ref. G2482\_016);

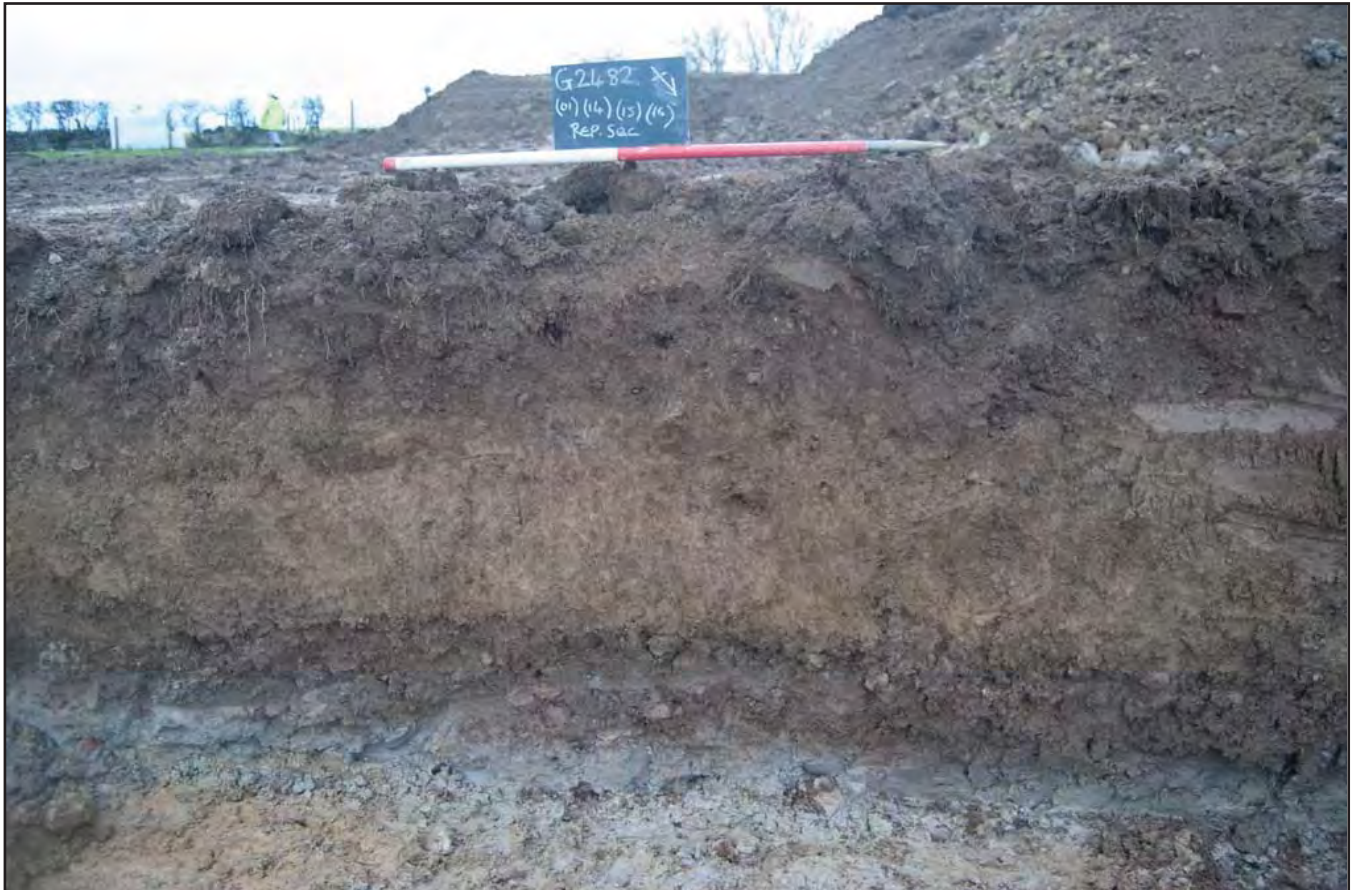
Plate 05: NNE facing section showing layers (01),(14),(15),(16). Scale 1.0m.  
(Photographic archive ref. G2482\_012)

The topsoil covered a wide variety of subsoil and natural deposits that were uncovered during the course of the controlled strip. The subsoil varied in colour and texture in part due to the underlying ground conditions. Along the northeastern edge of the controlled strip, in the lowest lying area of the site three subsoil deposits were identified in section (14), (15) and (16) (Plate 05). The earliest deposit (16) consisted of a thin (0.13m) band of plastic light grey gravelly sandy clay with no inclusions. The colour and texture of (16) reflects the waterlogged nature of this portion of the site. It was sealed beneath (15) a plastic dark brown layer of silty clay mixed with occasional inclusions of gravel and it had a maximum depth of 0.30m. This was covered by the upper most layer of subsoil (14) which consisted of a band of plastic light-mid brown clayey sand with no inclusions and maximum exposed depth of 0.50m. It was sealed beneath the topsoil (01).

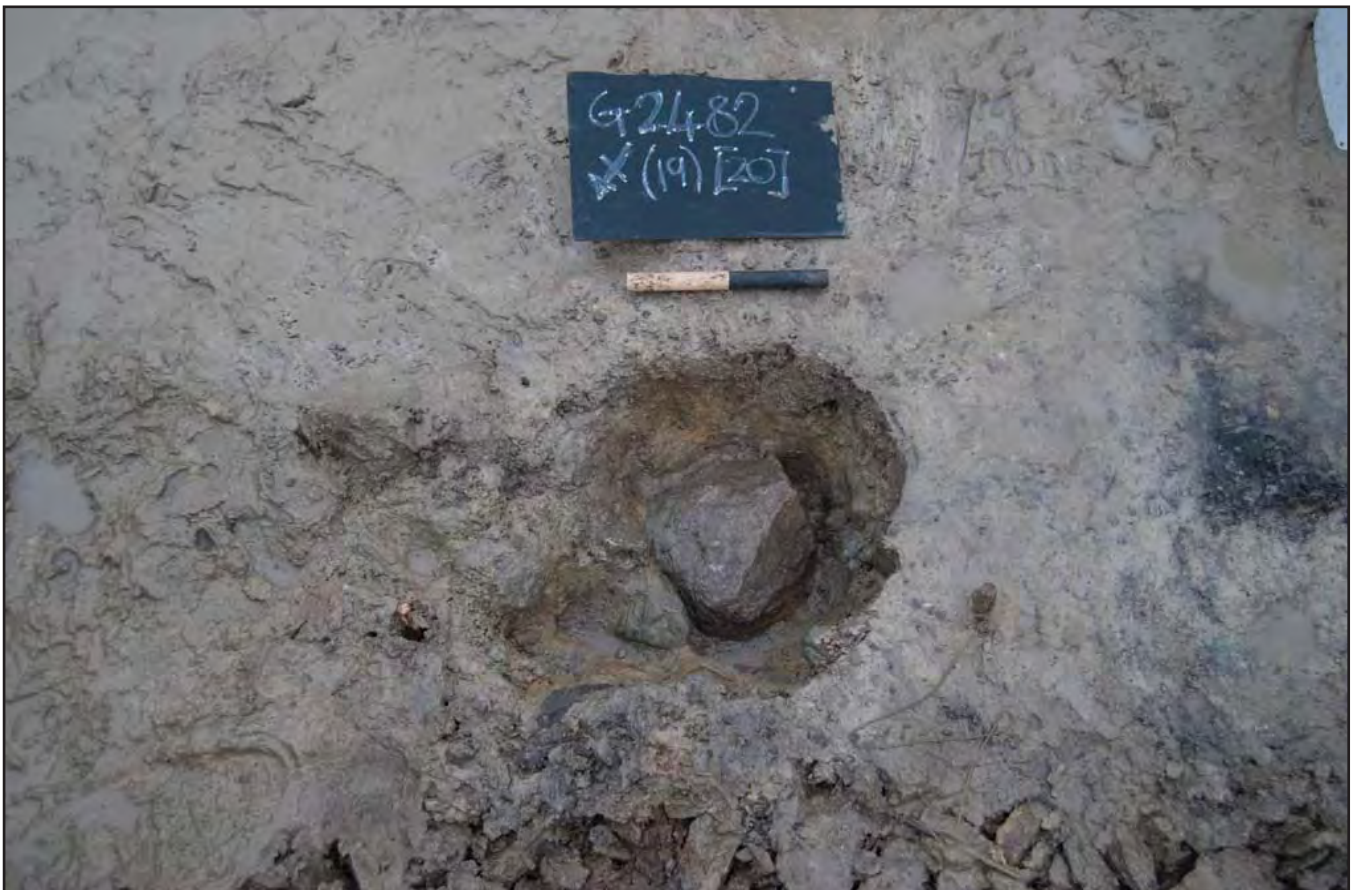
Plate 06: Mid-excavation shot of [19]. Scale 0.30m.(Photographic archive ref. G2482\_036)

The initial strip along the eastern edge of the site uncovered a limited concentration of prehistoric features, two post holes [19] and [24] associated with a burnt spread (08) (Figure 07). Post hole [19] was sub-circular in plan (Plate 06), with a sharp break of slope at the top and base of the cut with steep sides and a flat base. It had a maximum diameter of 0.33m, depth of 0.30m and was filled by (20) which consisted of a plastic dark brownish black sandy clay mixed with moderate flecks of charcoal along with frequent small to medium and occasional large sub-angular stones that were predominantly concentrated along the edge of the cut. The cut for the post hole appears to have been lined by these stones as post packing. The excavation of [19] suggests that the post had been forcibly removed that caused disturbance to the packing stones and the northern side of the cut.

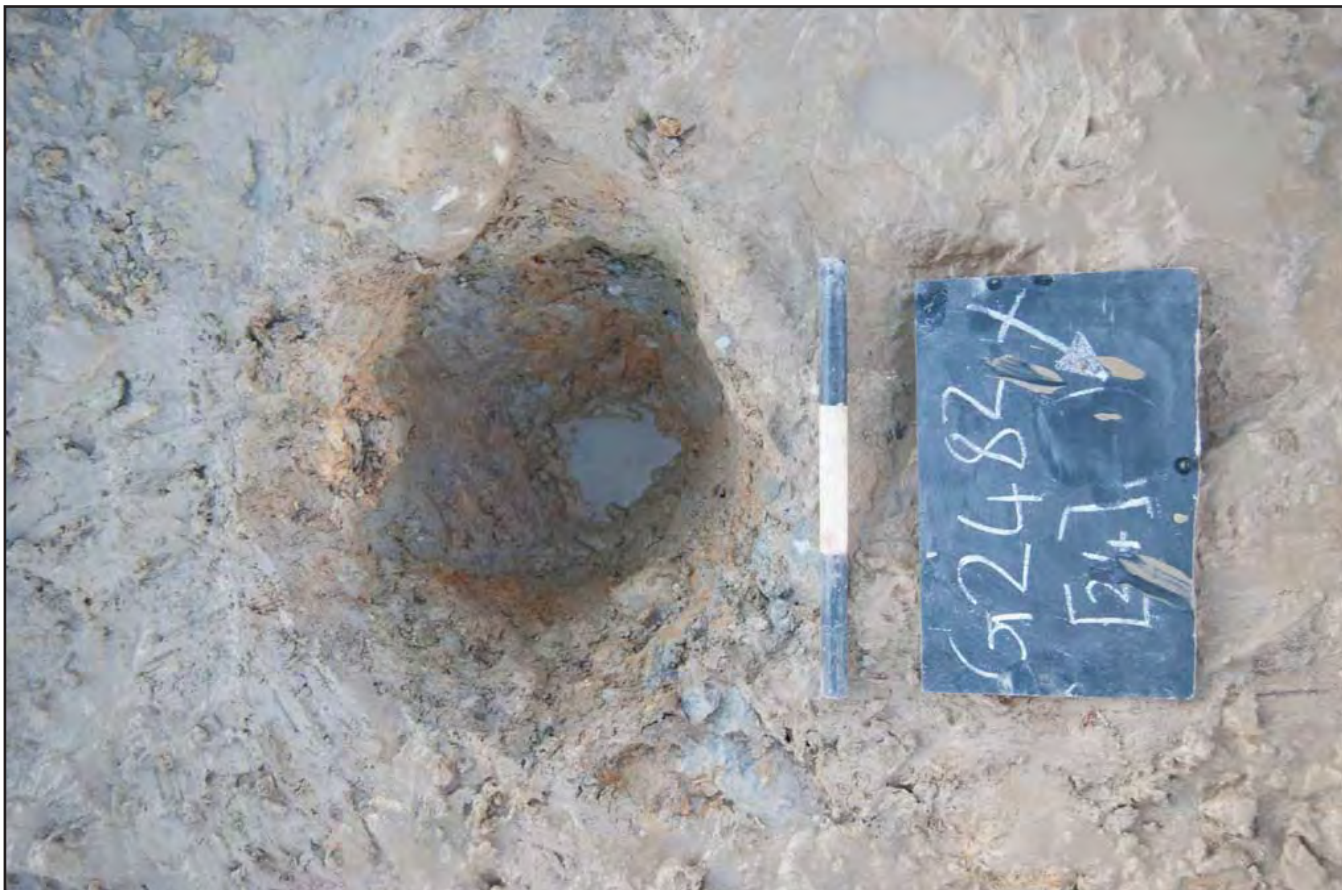
Plate 07: Post-excavation shot of [24]. Scale 0.30m. (Photographic archive ref. G2482\_045)

Plate 07: Post-excavation shot of [24]. Scale 0.30m. (Photographic archive ref. G2482\_045);

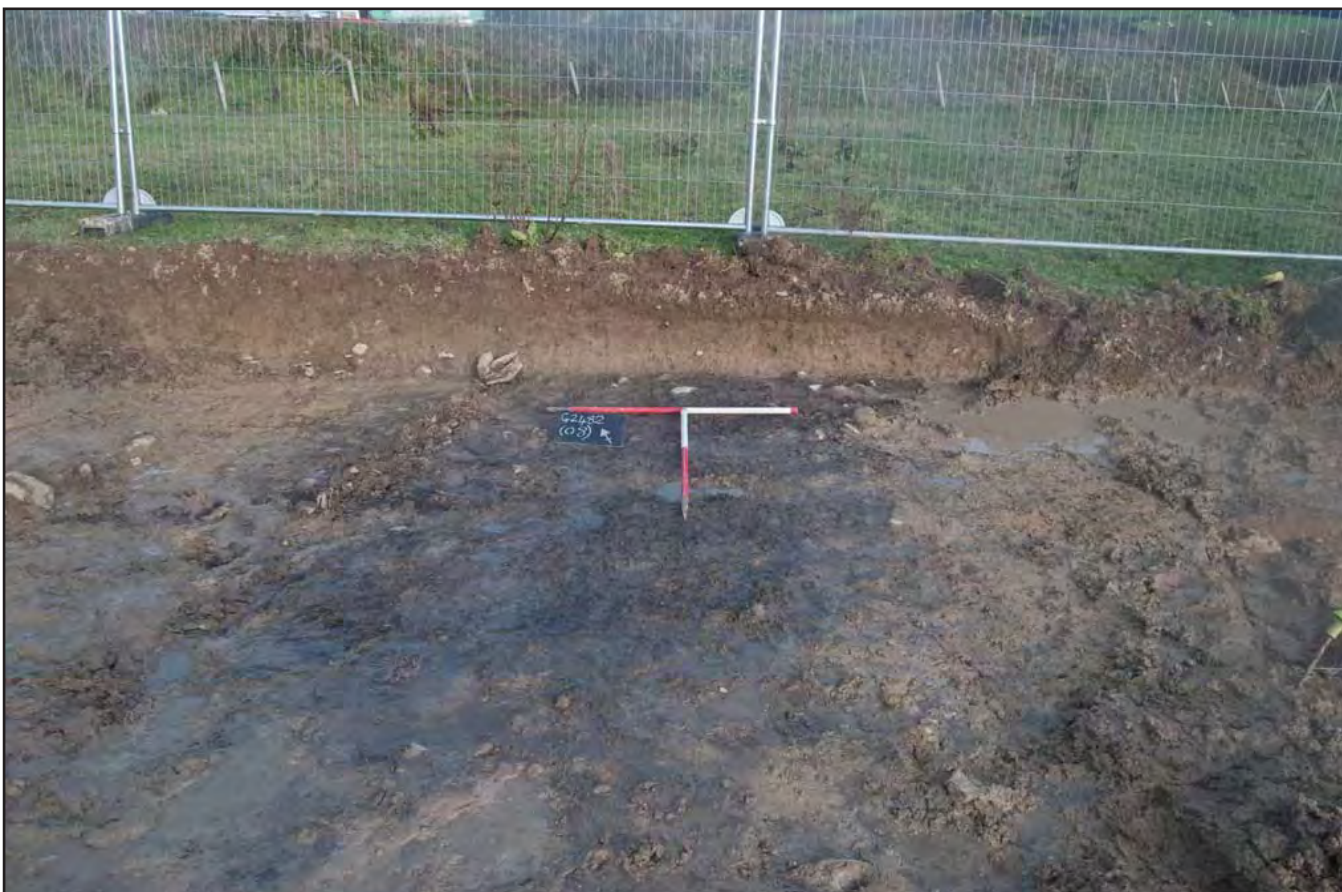
Plate 08: Pre-excavation shot of (08) and [18]. Scale 2 x 1.0m. (Photographic archive ref. G2482\_019)

The post holes were associated with a burnt spread (08) which was irregular in plan that measured 3.65m in length by 3.0m in width (Plate 08), with a maximum depth of 0.12m (Figure 08). The deposit was friable dark greyish brown sandy silt mixed with frequent sub-angular stones, 25% of which were heat fractured and moderate inclusions of charcoal. The spread continued north east beyond the boundary of the controlled strip. The quantity of burnt stone and charcoal became less concentrated toward the south western limit of the spread as it petered out. The western edge of the deposit was truncated by a field drain [18]. It produced several artefacts, including a chert scraper and four small sherds of pottery. The underlying natural did not show signs of burning, this implies that the burnt deposit was not generated in this location and when it was deposited it was not sufficiently hot to mark the underlying natural. This would strongly indicate that the main source of activity which produced (08) occurred further east. The spread is associated with the post holes [19] and

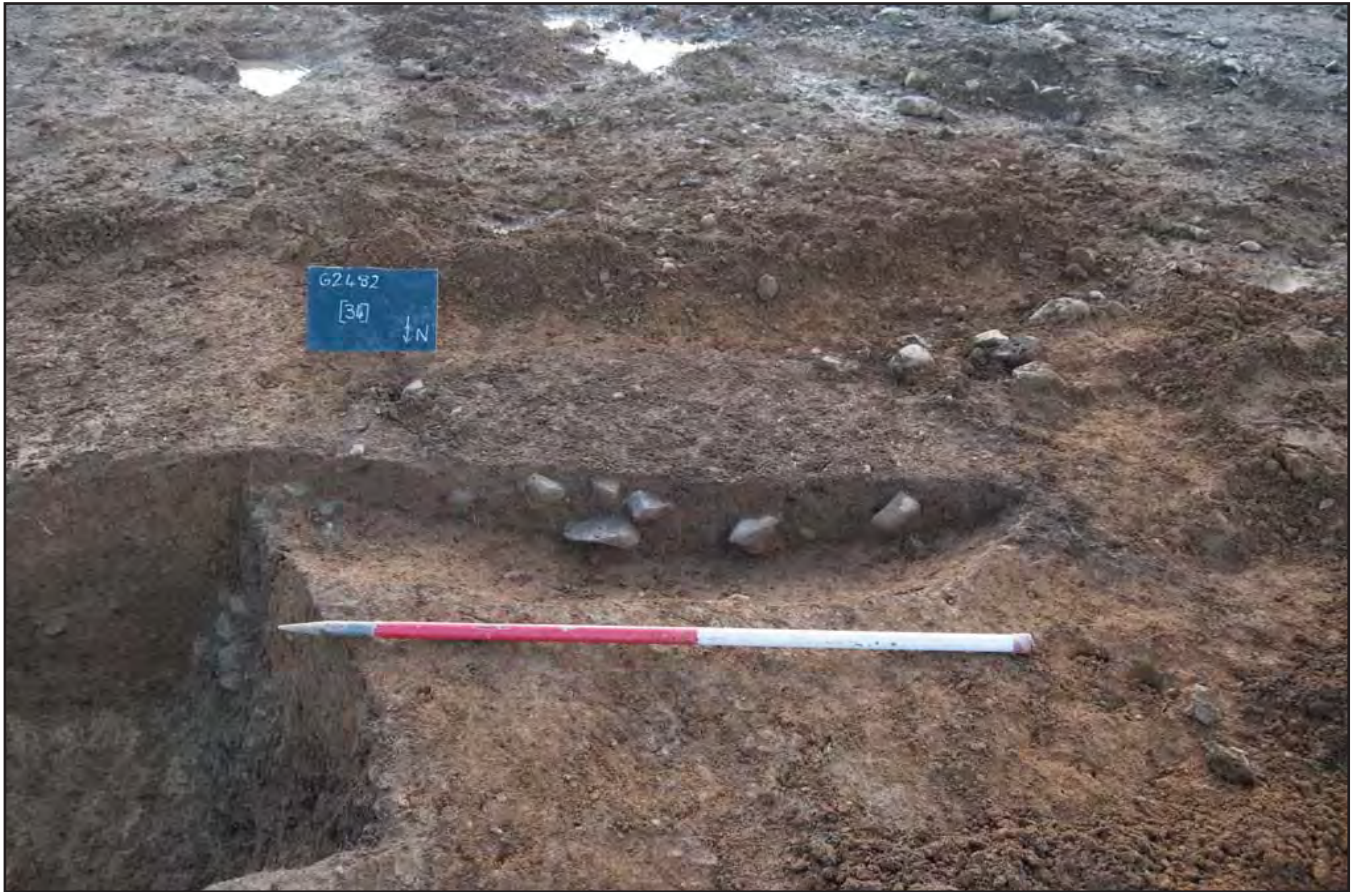
Plate 09: N facing section through [34]. Scale 1.0m. (Photographic archive ref. G2482\_056)

Plate 09: N facing section through [34]. Scale 1.0m. (Photographic archive ref. G2482\_056);

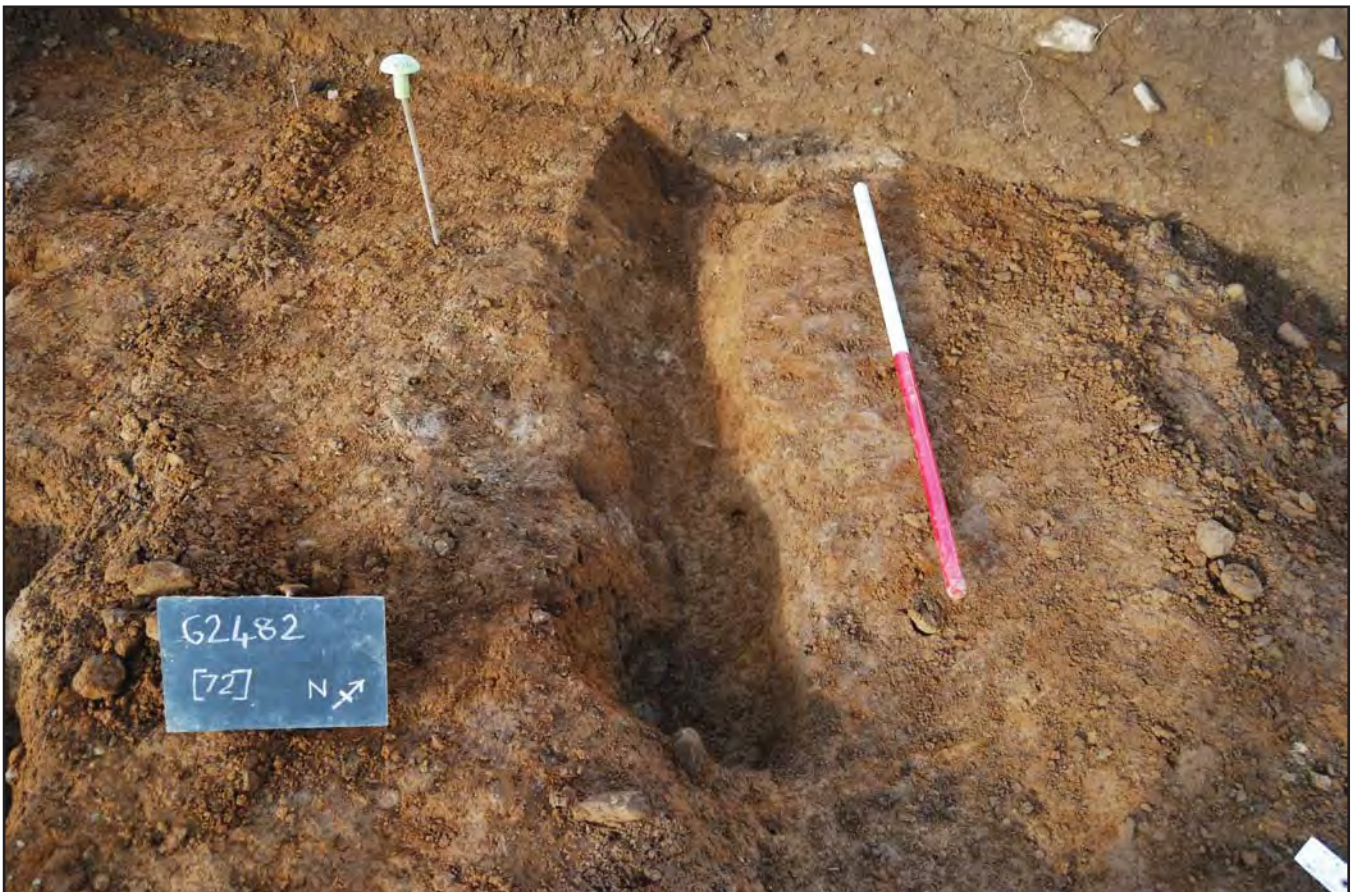
Plate 10: Post-ex shot of gully [72]. Scale 1.0m. (Photographic archive ref. G2482\_133)

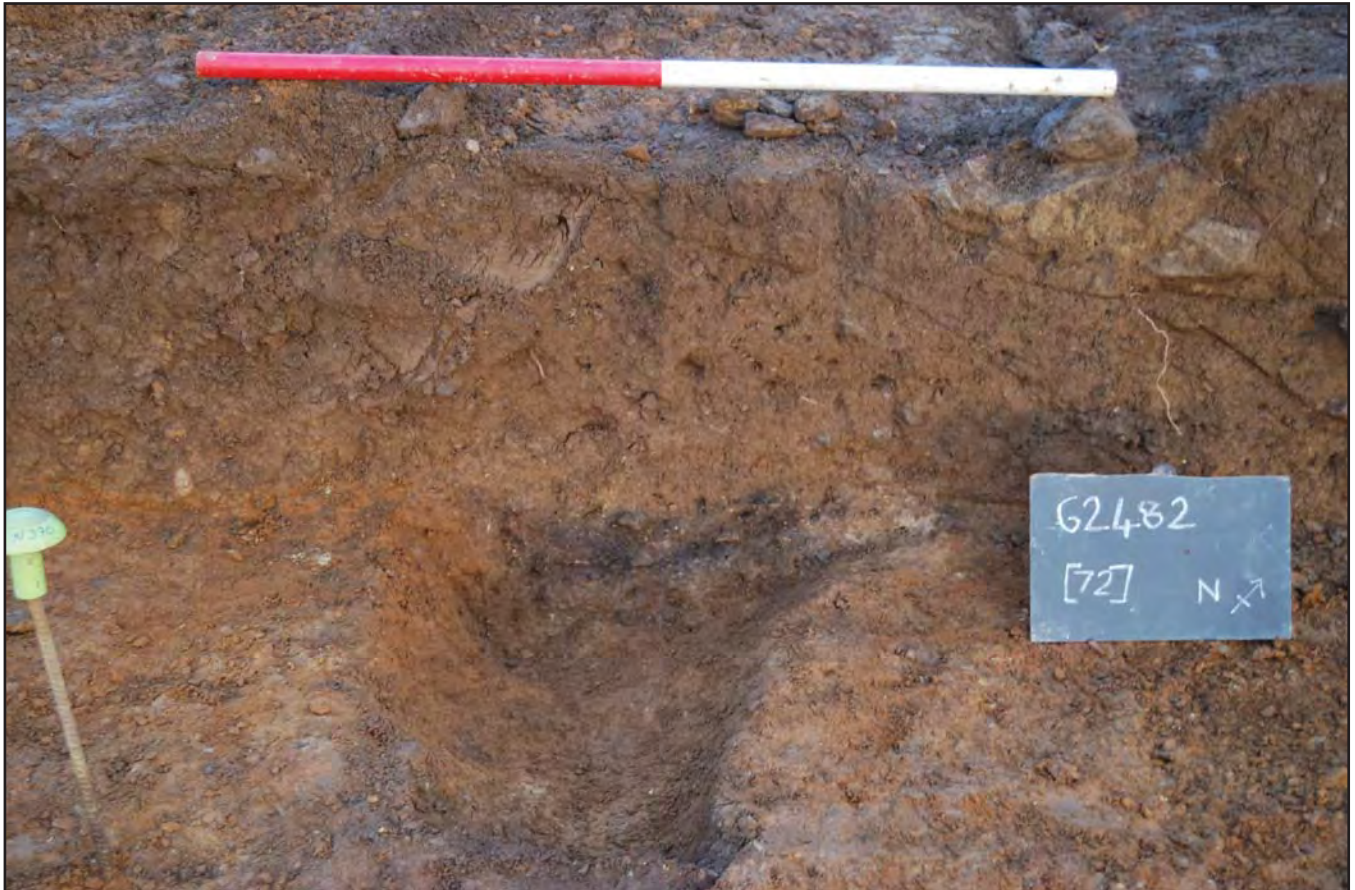
Plate 11: SE facing baulk section through [72]. Scale 1.0m. (Photographic archive ref. G2482\_130)

Plate 11: SE facing baulk section through [72]. Scale 1.0m. (Photographic archive ref. G2482\_130);

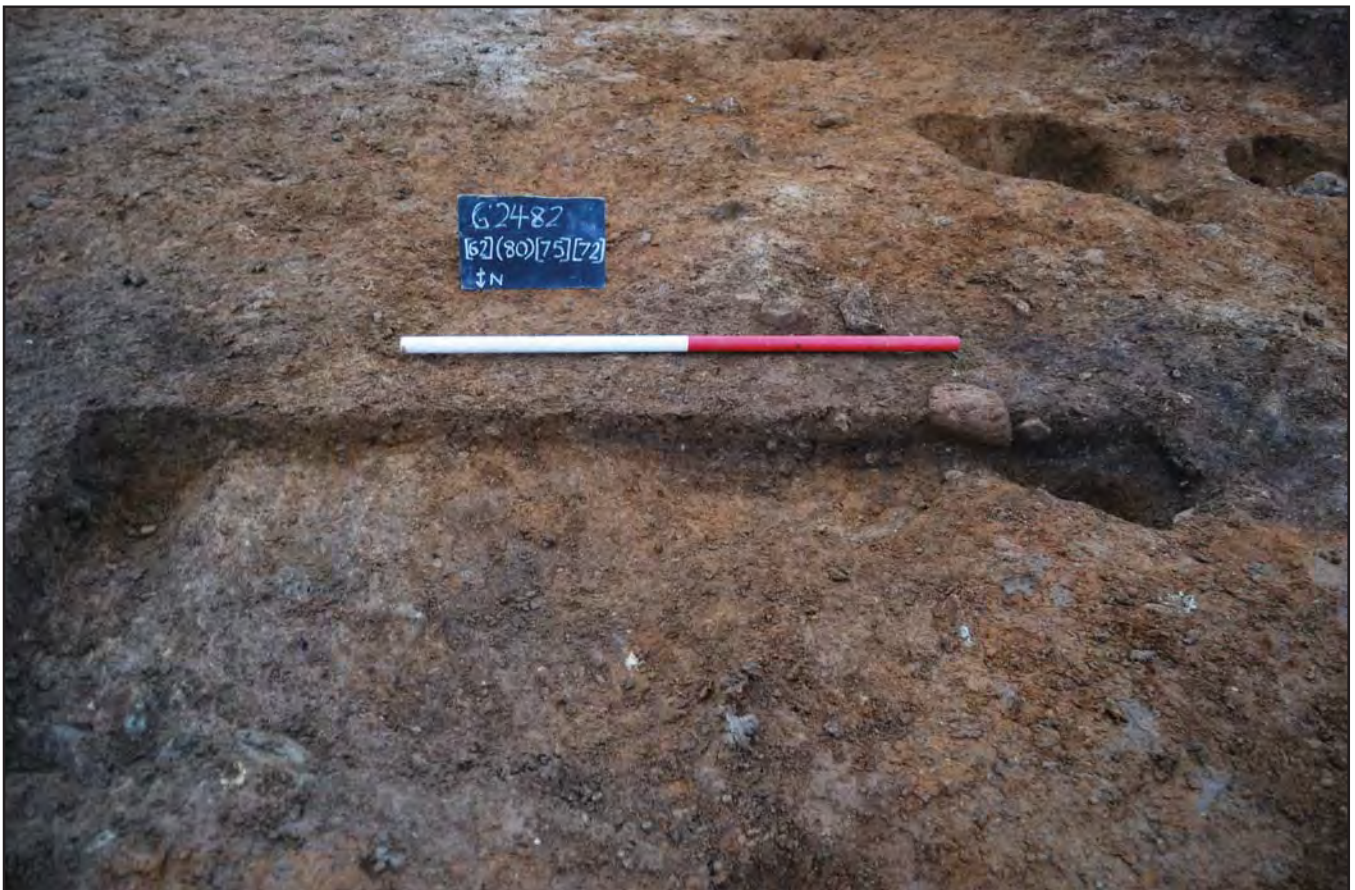
Plate 12: N facing section through [62], (80), [75] and [72]. Scale 1.0m. (Photographic archive ref. G2482\_121)

Plate 12: N facing section through [62], (80), [75] and [72]. Scale 1.0m. (Photographic archive ref. G2482\_121);

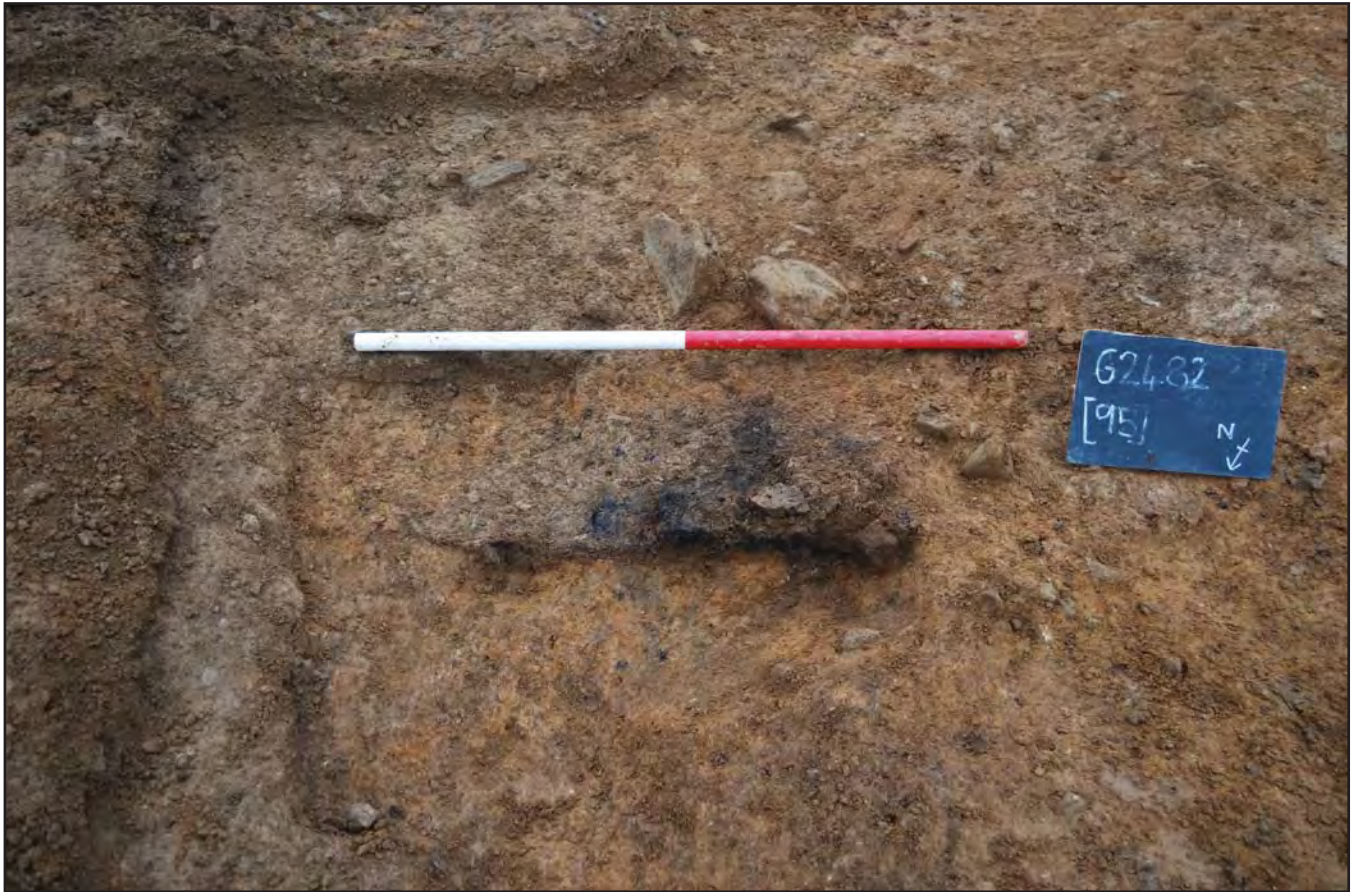
Plate 13: NW facing section through [95]. Scale 1.0m. (Photographic archive ref. G2482\_139)

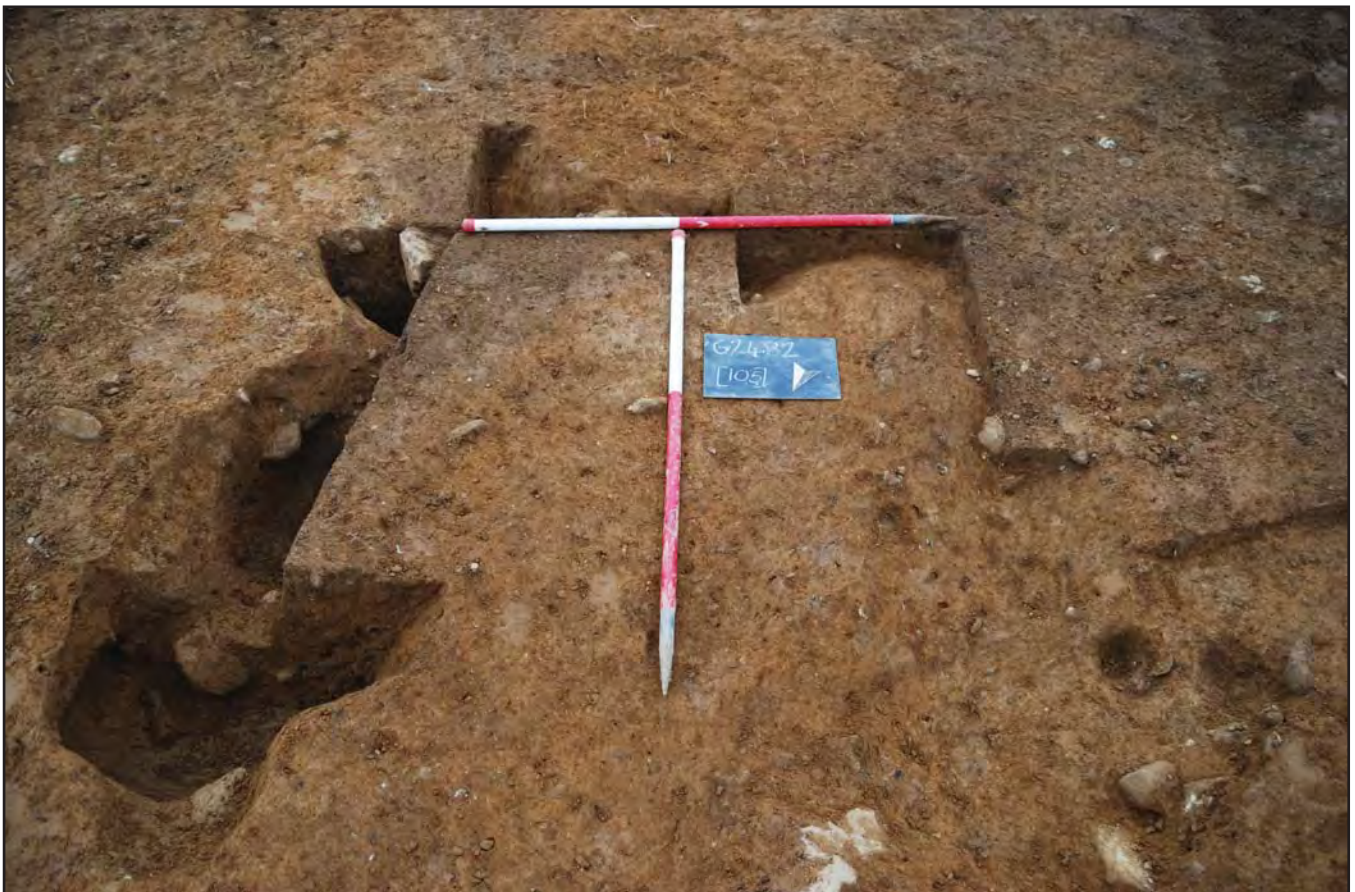
Plate 14: Mid-excavation shot of intercutting features [105] Scale 2 x 1.0m. (Photographic archive ref. G2482\_153)

Plate 14: Mid-excavation shot of intercutting features [105] Scale 2 x 1.0m. (Photographic archive ref. G2482\_153);

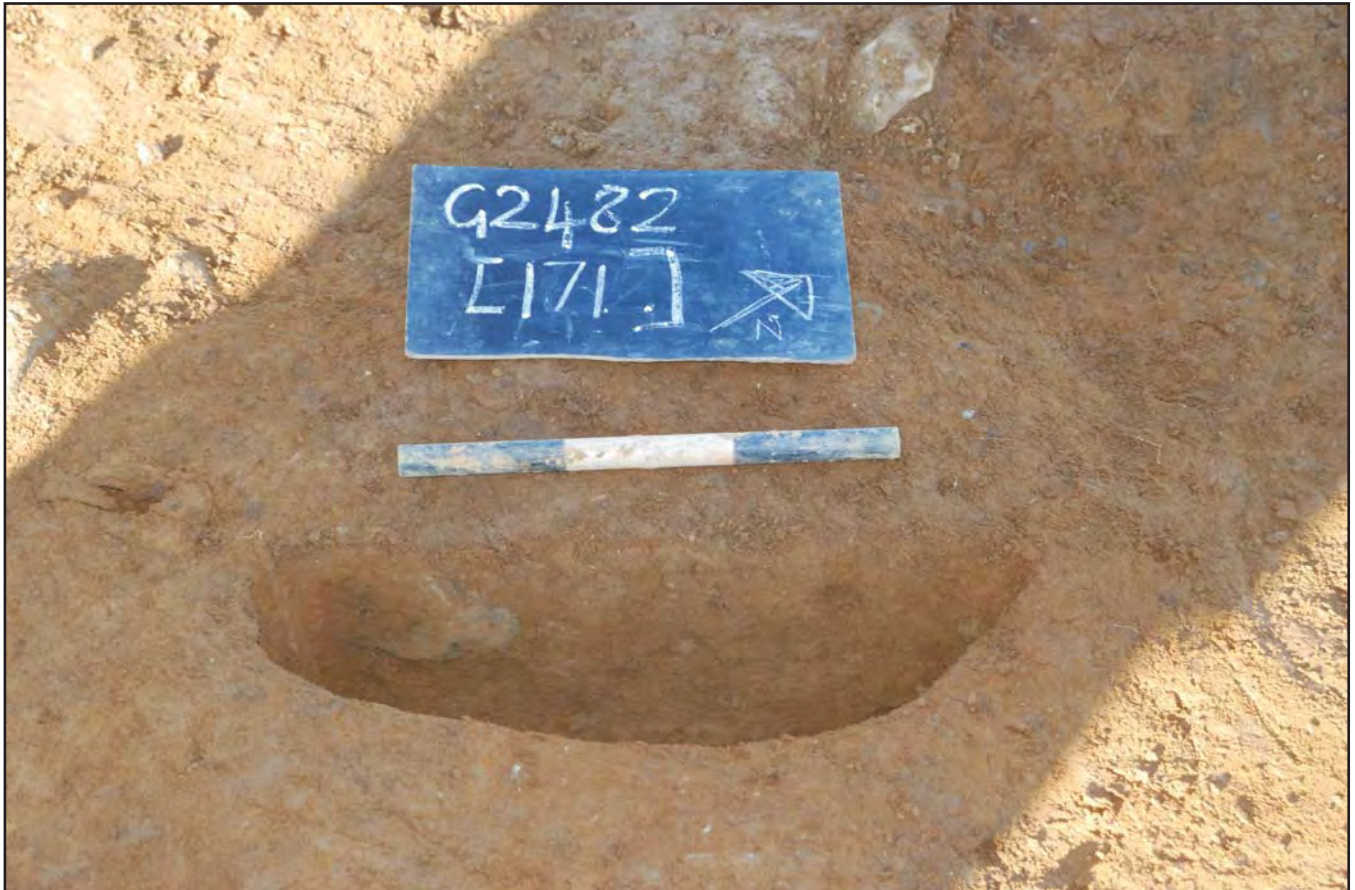
Plate 15: SE facing section through [171]. Scale 0.30m. (Photographic archive ref. G2482\_245)

Plate 15: SE facing section through [171]. Scale 0.30m. (Photographic archive ref. G2482\_245);

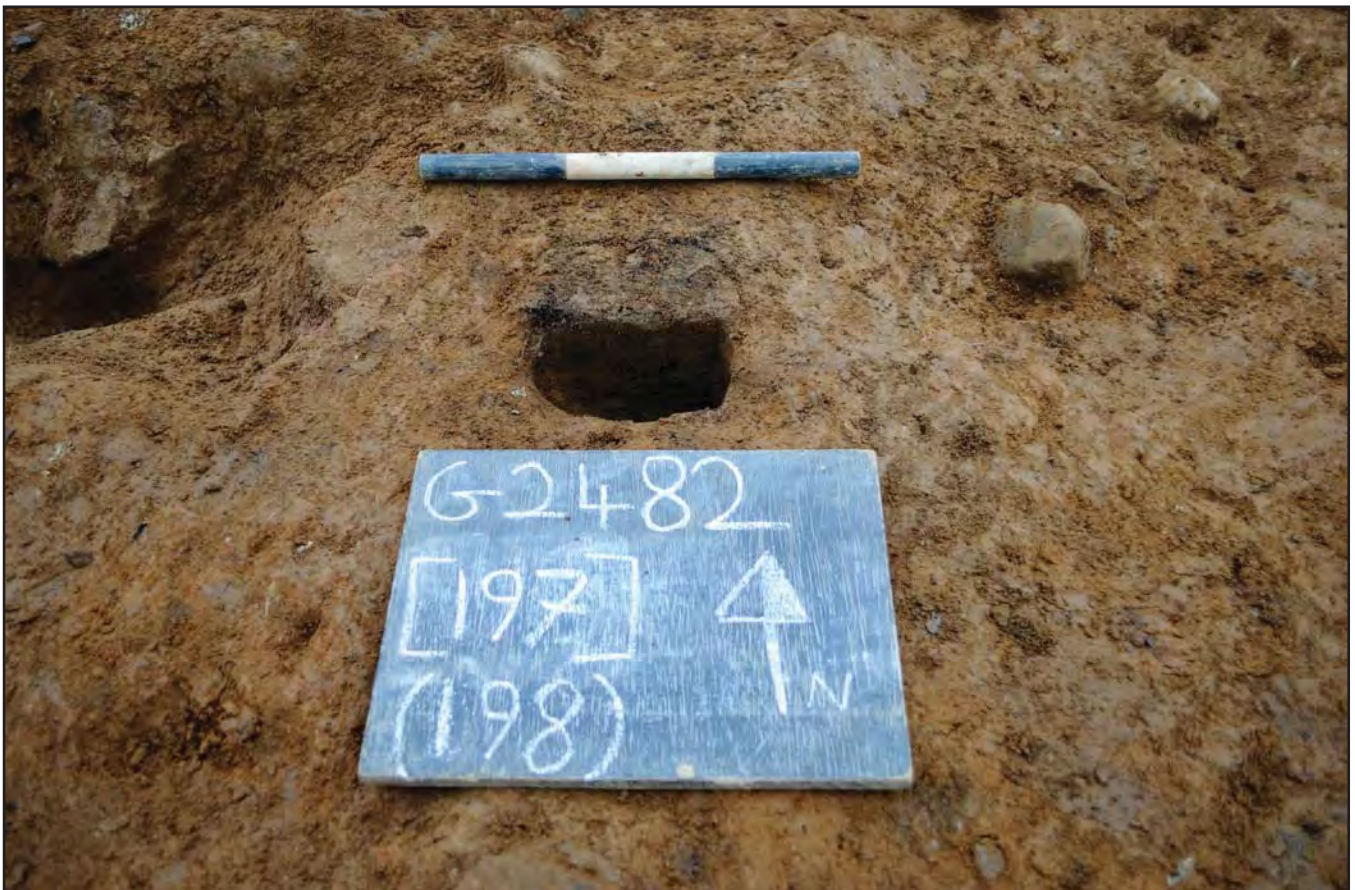
Plate 16: S facing section through [197]. Scale 0.30m. (Photographic archive ref. G2482\_286)

To the north of [171], immediately adjacent to an area of bioturbation, was the small post hole [197] that was sub-circular in plan with a maximum diameter of 0.17m and depth of 0.10m. The cut had an abrupt break of slope at the top with vertical sides and a more moderate break of slope at the base, which was concave. It was filled by (198) a loose, friable dark brown sandy silt mixed with very frequent charcoal flecks (Plate 16).

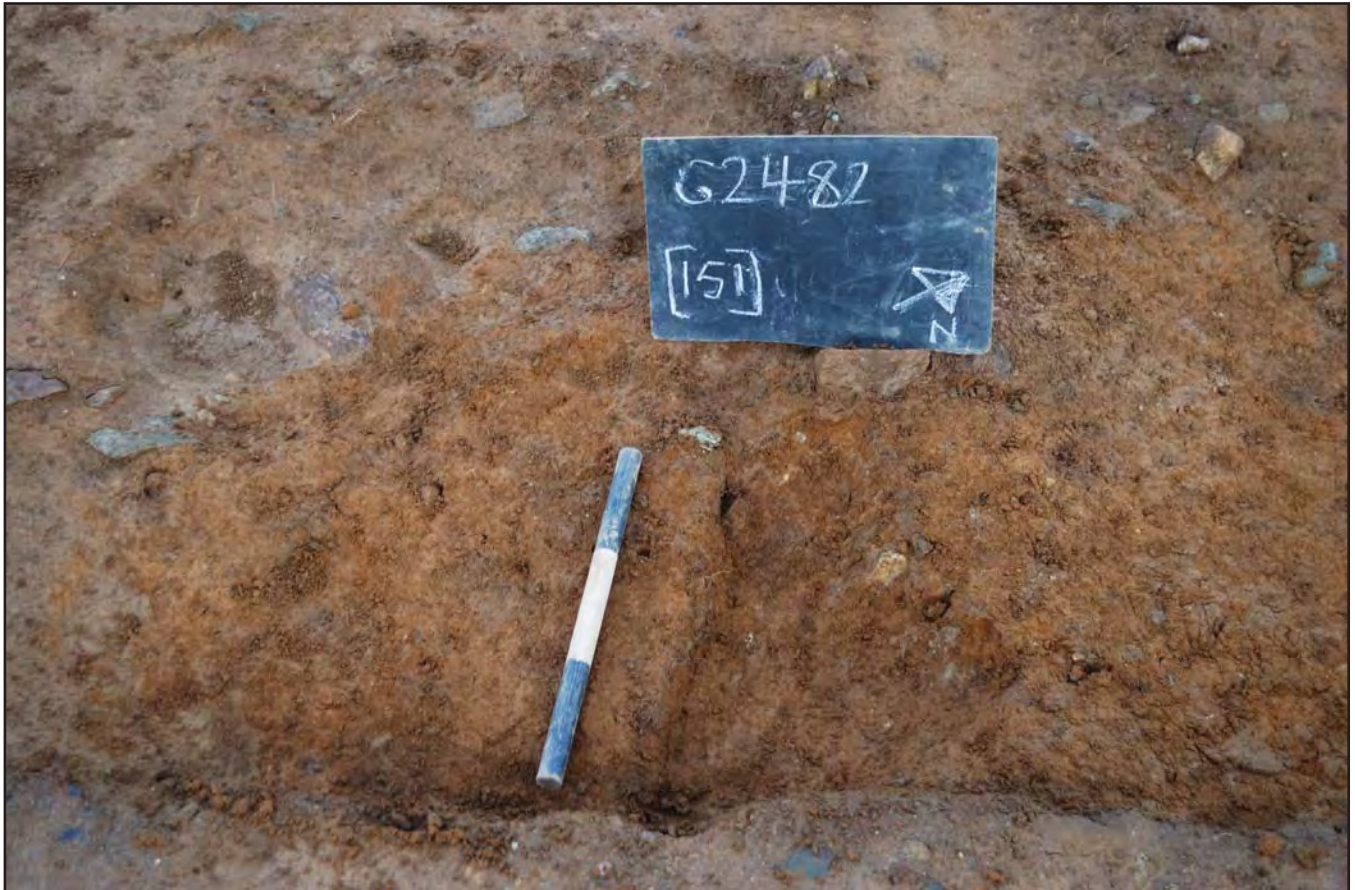
Plate 17: Post-excavation shot of [151]. Scale 0.30m. (Photographic archive ref. G2482\_225)

Plate 17: Post-excavation shot of [151]. Scale 0.30m. (Photographic archive ref. G2482\_225);

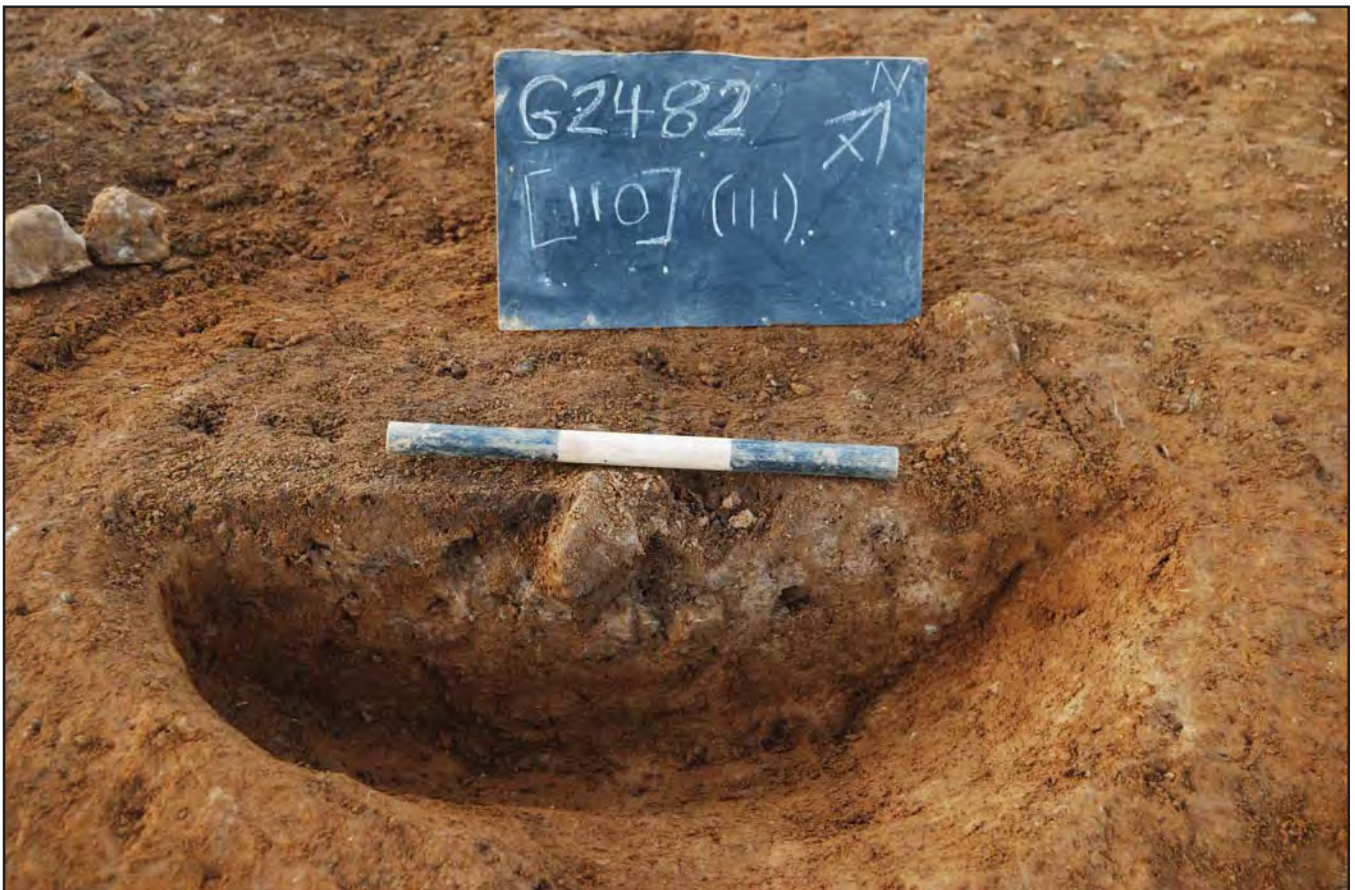
Plate 18: SE facing section through [110]. Scale 0.30m. (Photographic archive ref. G2482\_165)

Plate 18: SE facing section through [110]. Scale 0.30m. (Photographic archive ref. G2482\_165);

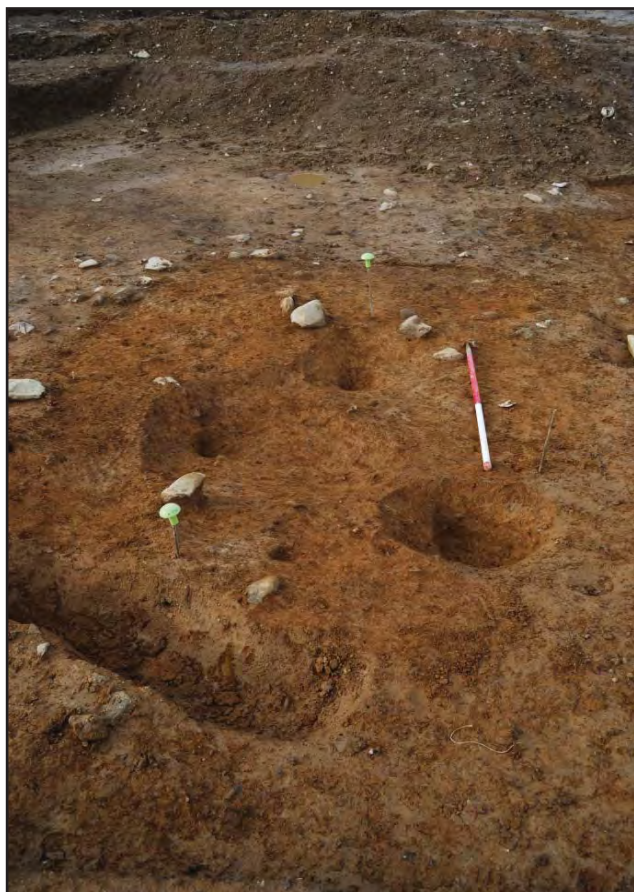
Plate 19: Post-ex shot showing pits [160], [154] and [156]. Scale 1.0m. (Photographic archive ref. G2482\_239)

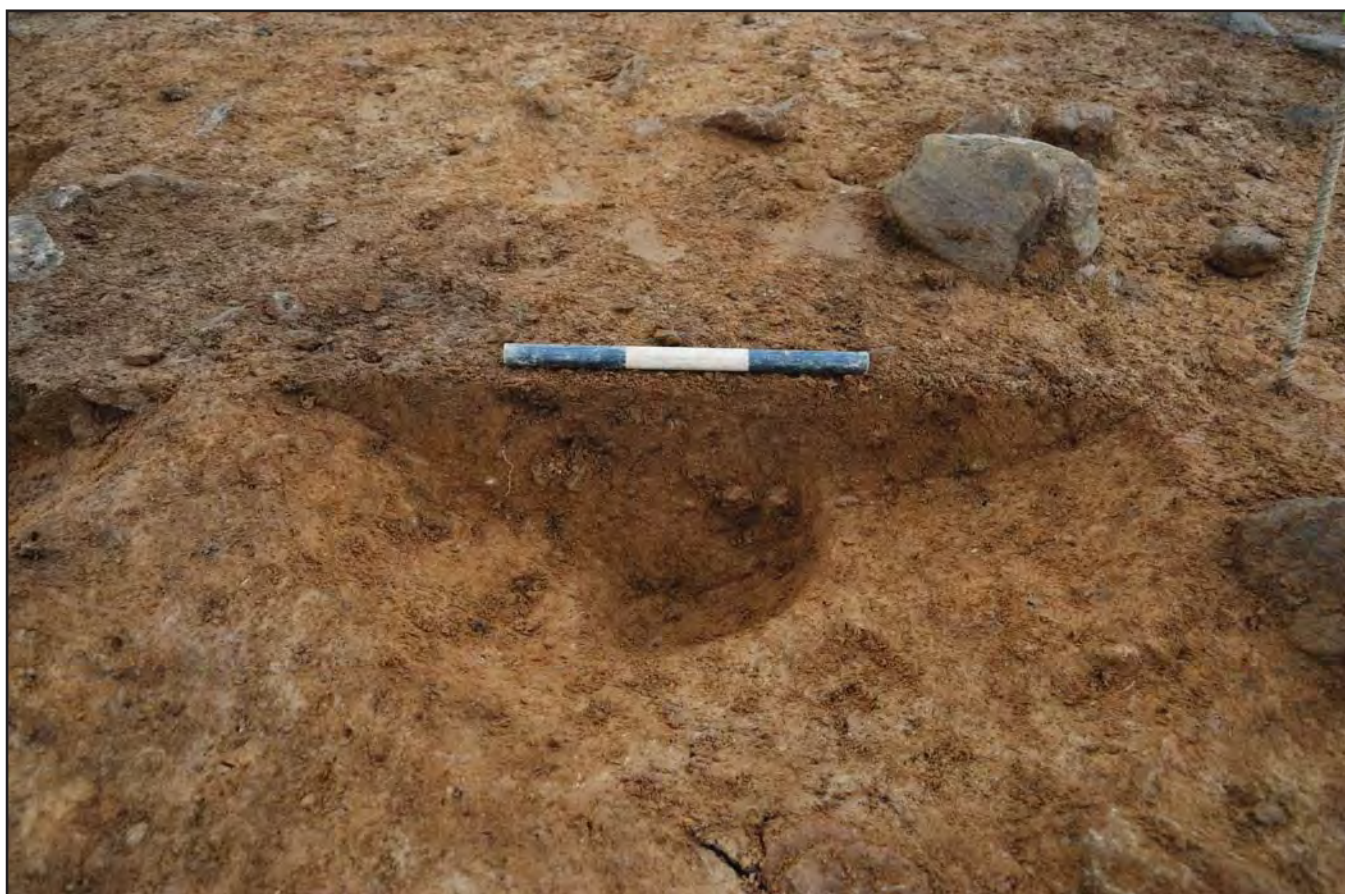
Plate 20: NE facing section through [156]. Scale 0.30m. (Photographic archive ref. G2482\_233)

Plate 20: NE facing section through [156]. Scale 0.30m. (Photographic archive ref. G2482\_233);
