# DCWW Llanfaethlu Waste Water Treatment Works

## Archaeological Mitigation

Prosiect Rhif / Project No. G2482

Adroddiad Rhif / Report No. 1382

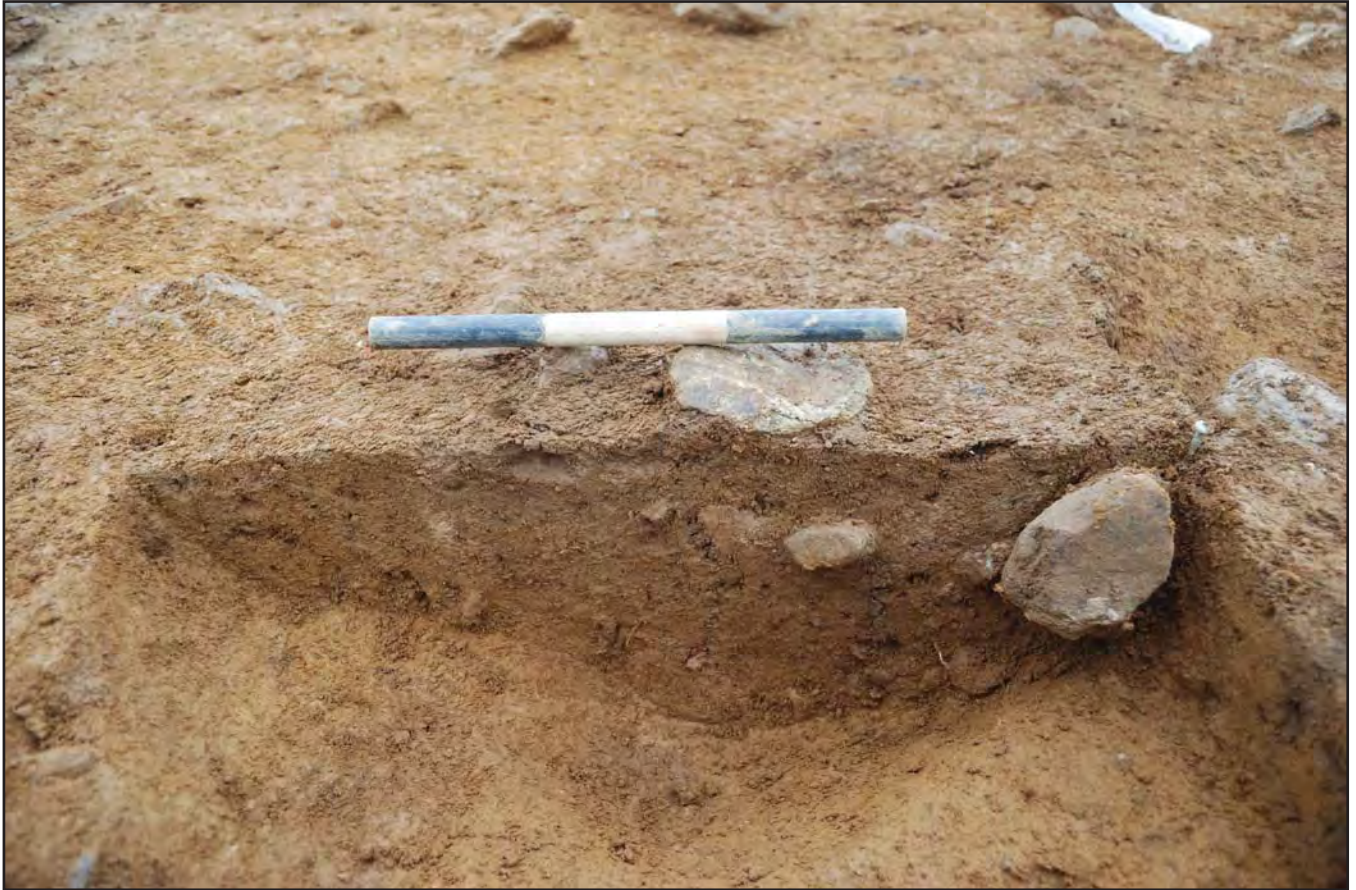
Plate 21: SE facing section through [154]. Scale 0.30m. (Photographic archive ref. G2482\_229)

Plate 21: SE facing section through [154]. Scale 0.30m. (Photographic archive ref. G2482\_229);

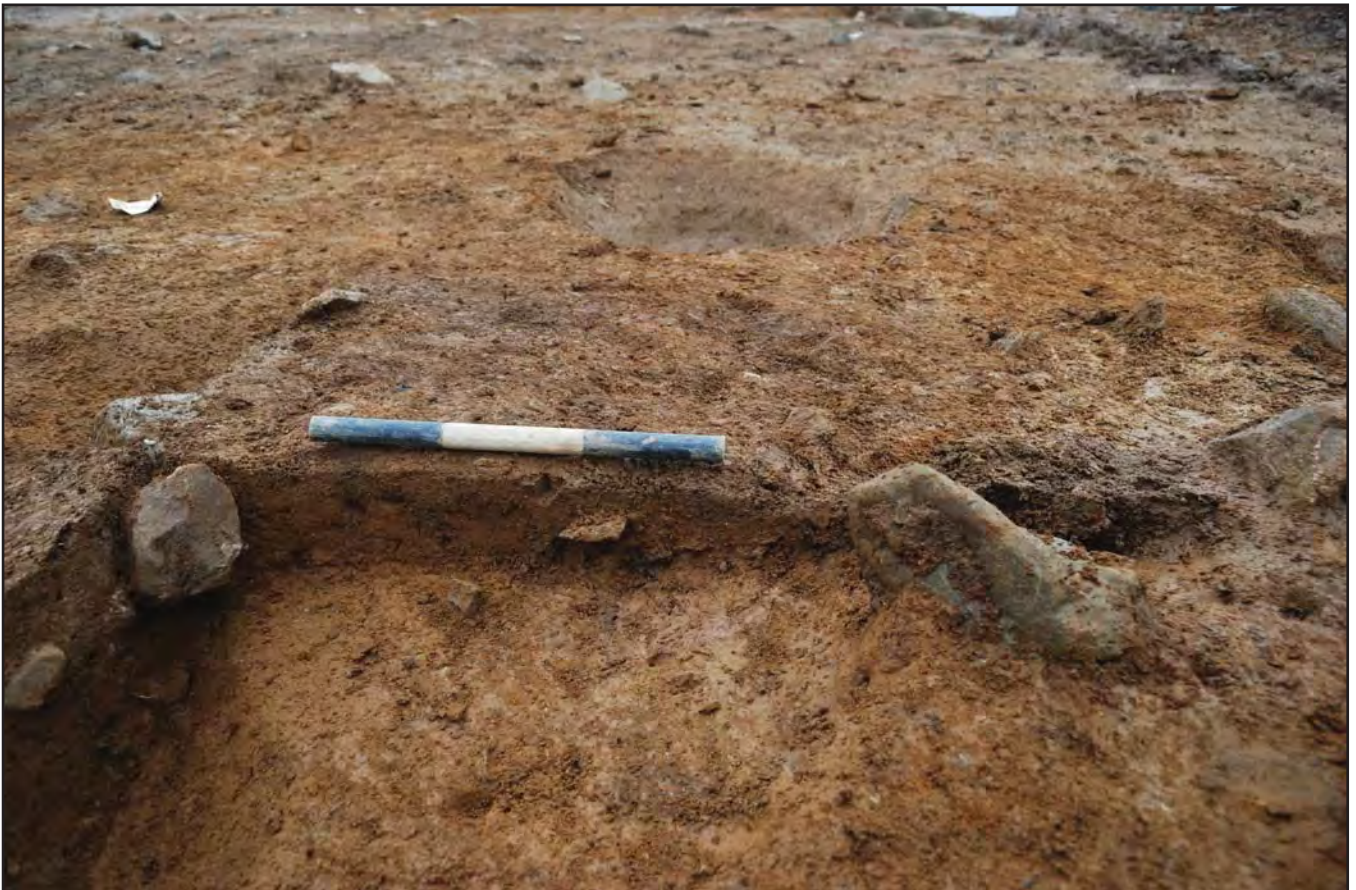
Plate 22: SW facing section through [154] and [160]. Scale 0.30m. (Photographic archive ref. G2482\_230)

Plate 22: SW facing section through [154] and [160]. Scale 0.30m. (Photographic archive ref. G2482\_230);

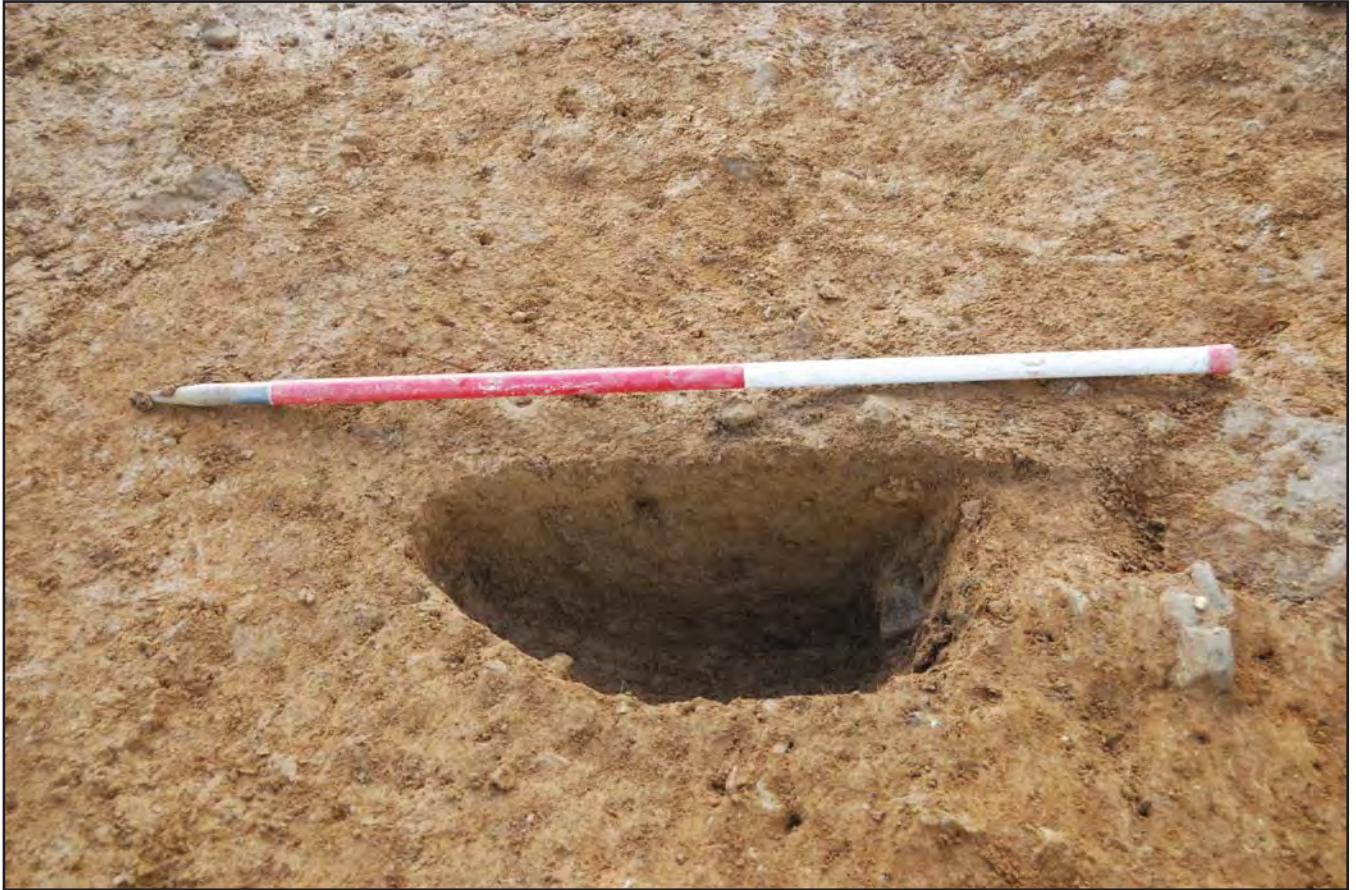
Plate 23: Mid-excavation shot of [162]. Scale 1.0m. (Photographic archive ref. G2482\_238)

Plate 23: Mid-excavation shot of [162]. Scale 1.0m. (Photographic archive ref. G2482\_238);

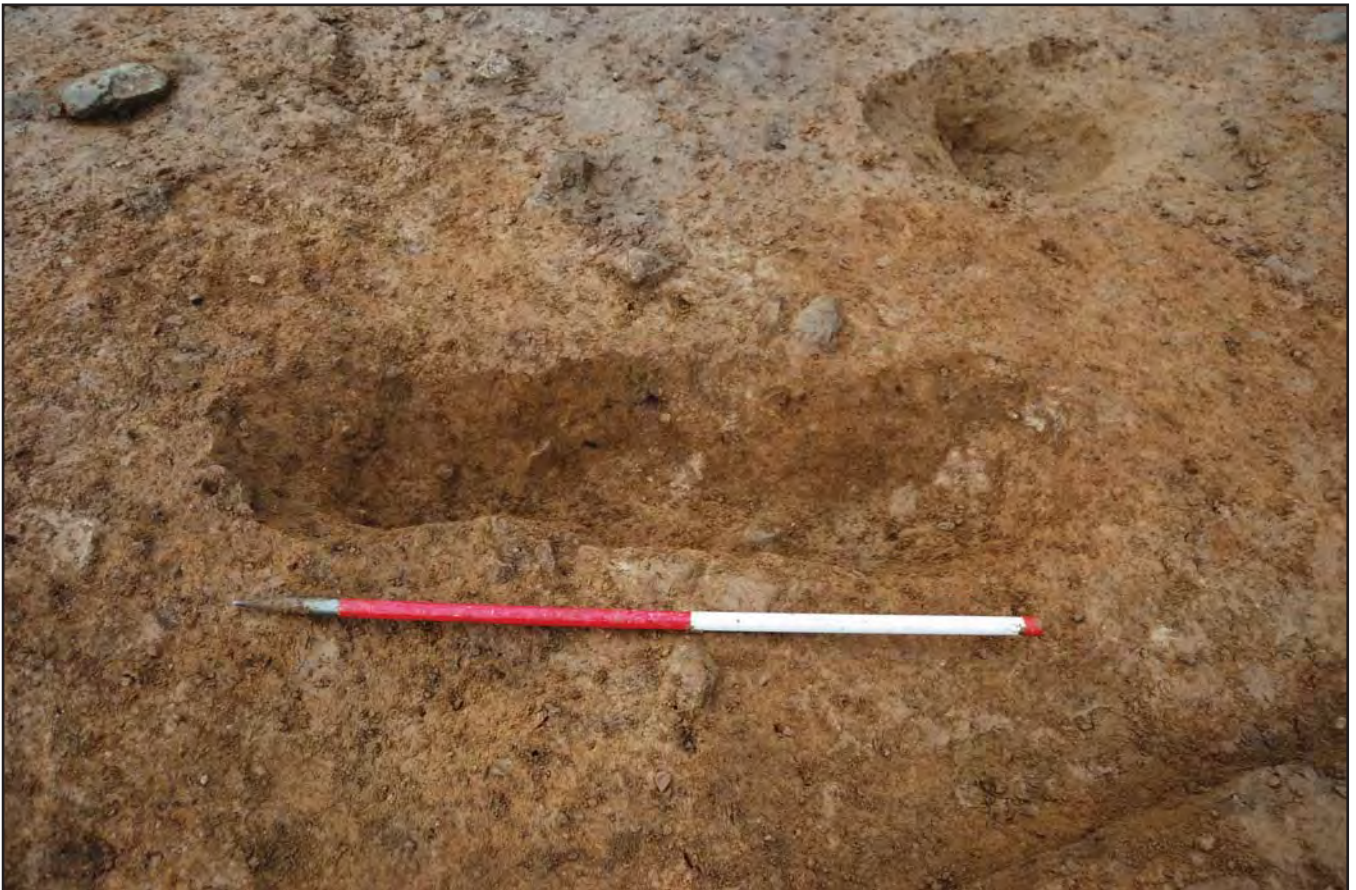
Plate 24: Post-excavation shot of [134]. Scale 1.0m. (Photographic archive ref. G2482\_211)

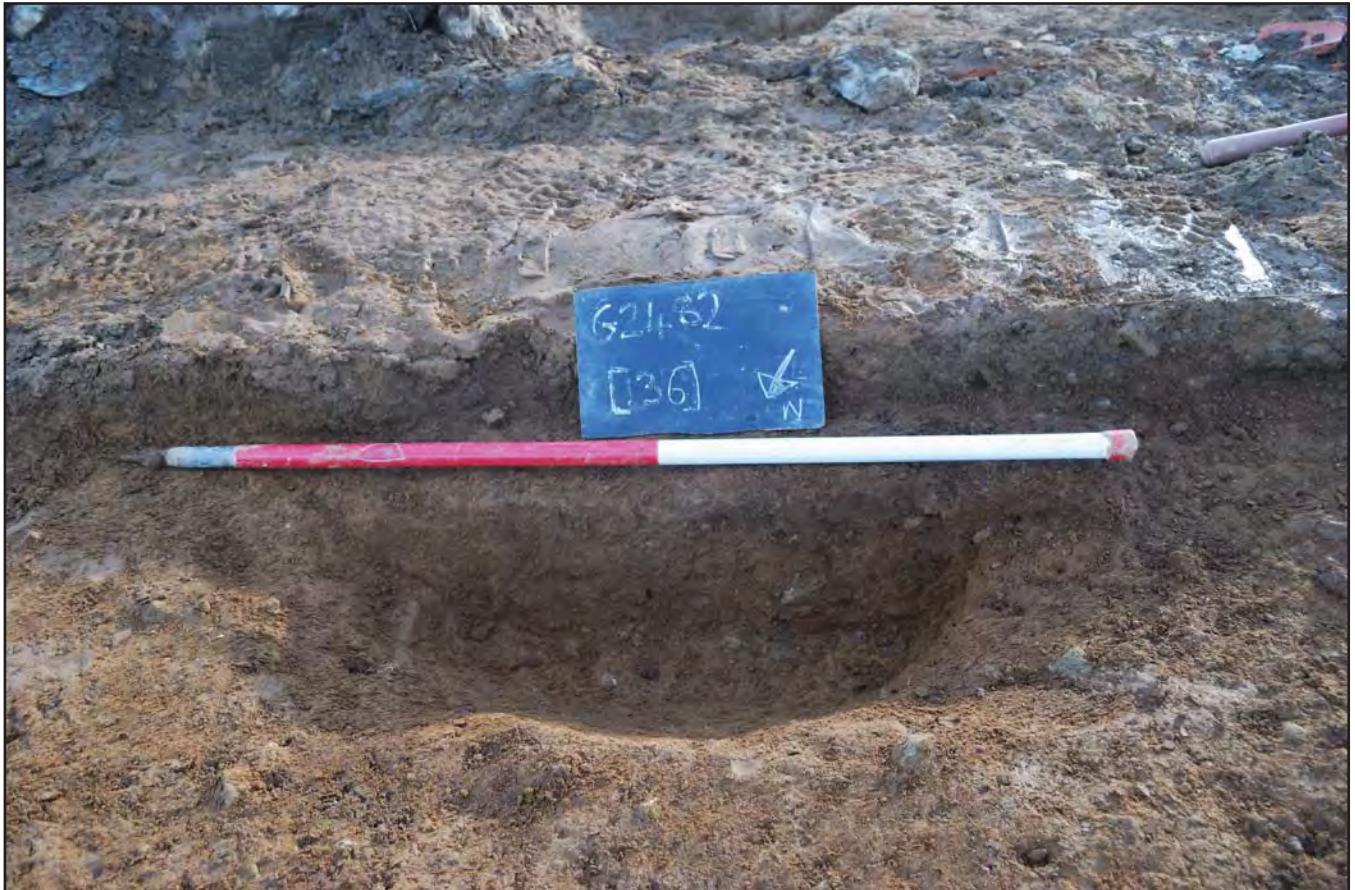
Plate 25: NW facing section through [136]. Scale 1.0m. (Photographic archive ref. G2482\_206)

Plate 25: NW facing section through [136]. Scale 1.0m. (Photographic archive ref. G2482\_206);

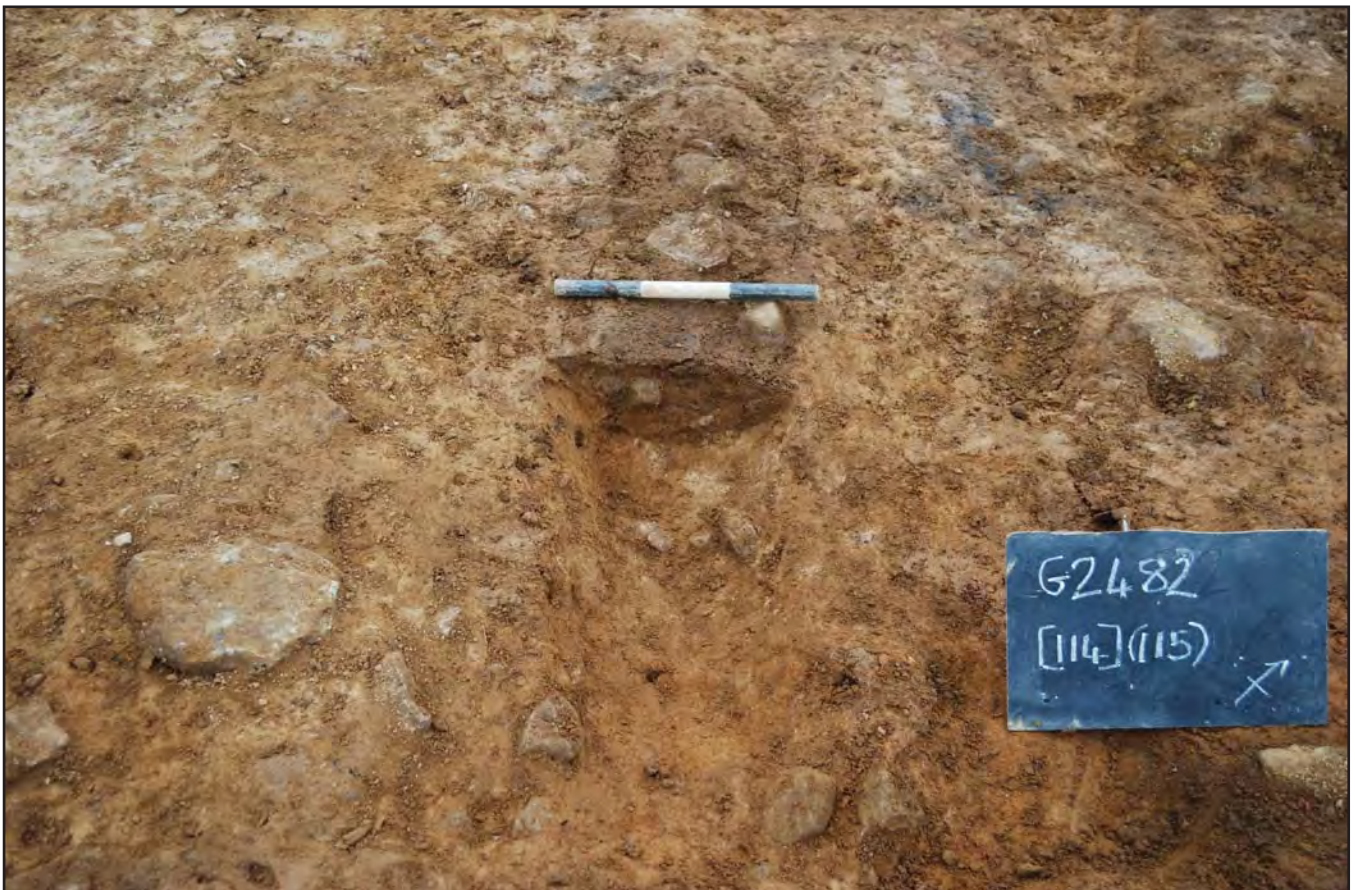
Plate 26: SE facing section through [115]. (ID board incorrect). Scale 0.30m. (Photographic archive ref G2482\_169)

Plate 26: SE facing section through [115]. (ID board incorrect). Scale 0.30m. (Photographic archive ref G2482\_169);

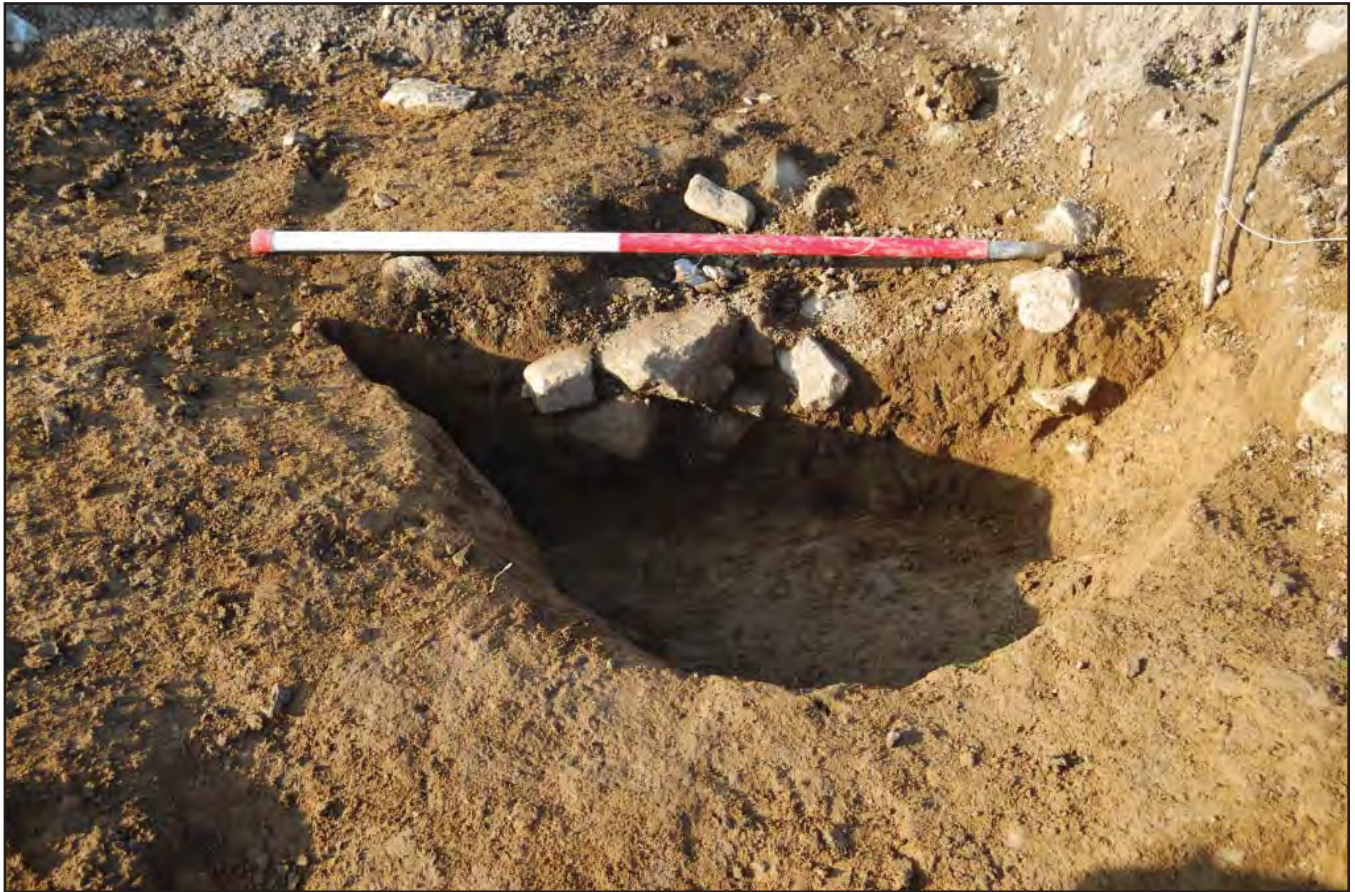
Plate 27: SE facing section through [104]. Scale 1.0m. (Photographic archive ref. G2482\_163)

Plate 27: SE facing section through [104]. Scale 1.0m. (Photographic archive ref. G2482\_163);

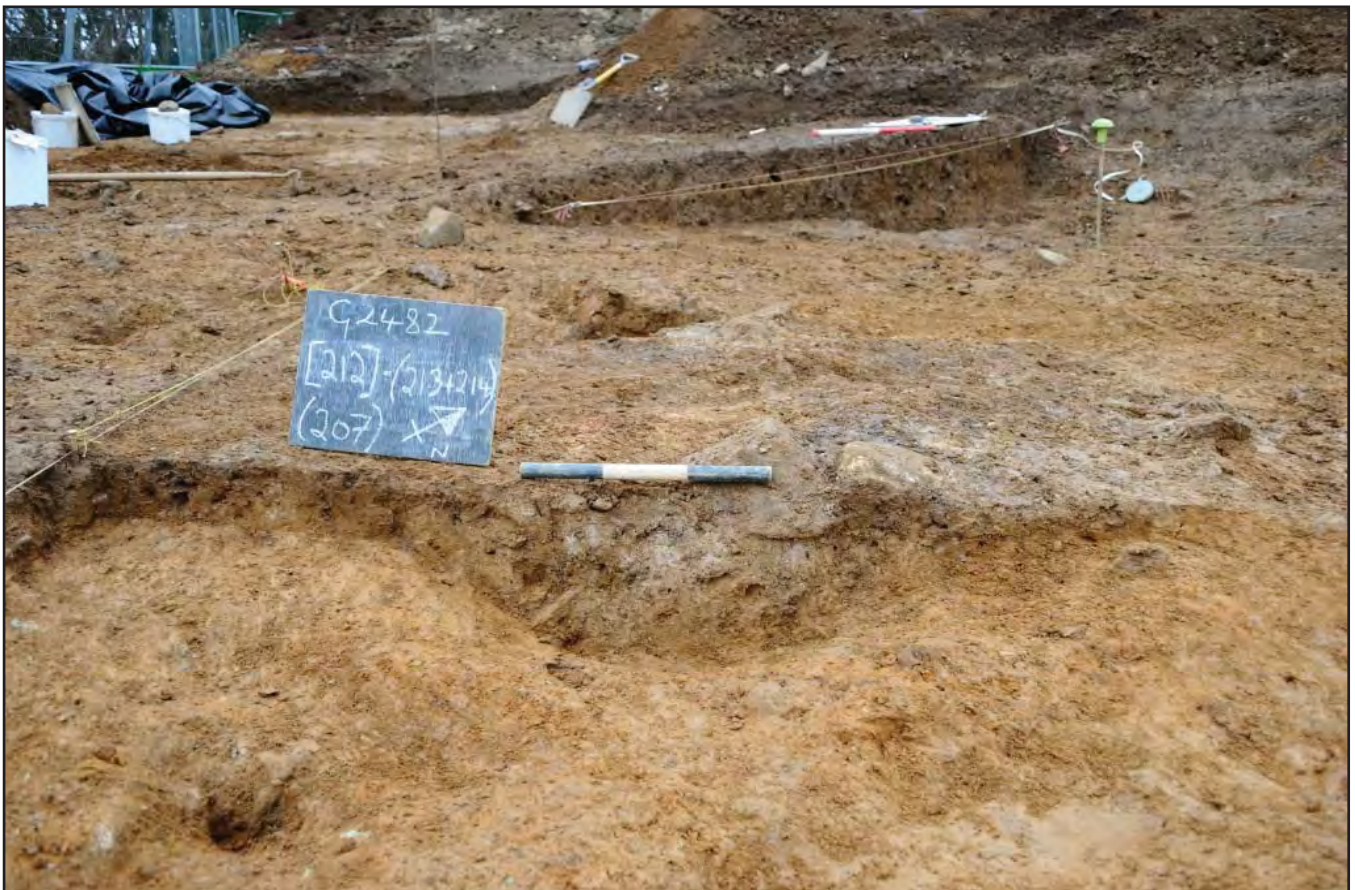
Plate 28: SE facing section through [212]. Scale 0.30m. (Photographic archive ref. G2482\_317)

To the north west of [104] and west of [115] was the oval in plan pit [212] that was 0.90m long, 0.60m wide and was 0.18m deep. The cut had a sharp break of slope at the top with gradually sloping sides that merged with a concave base (Plate 28). It contained two fills (213) and (214). The primary fill (214) consisted of a loose orangey light grey silty clay mixed with the occasional small angular stone with an in section width of 0.20m and depth of 0.10m. It was concentrated along the southwestern edge of [212] and was overlaid by (213)

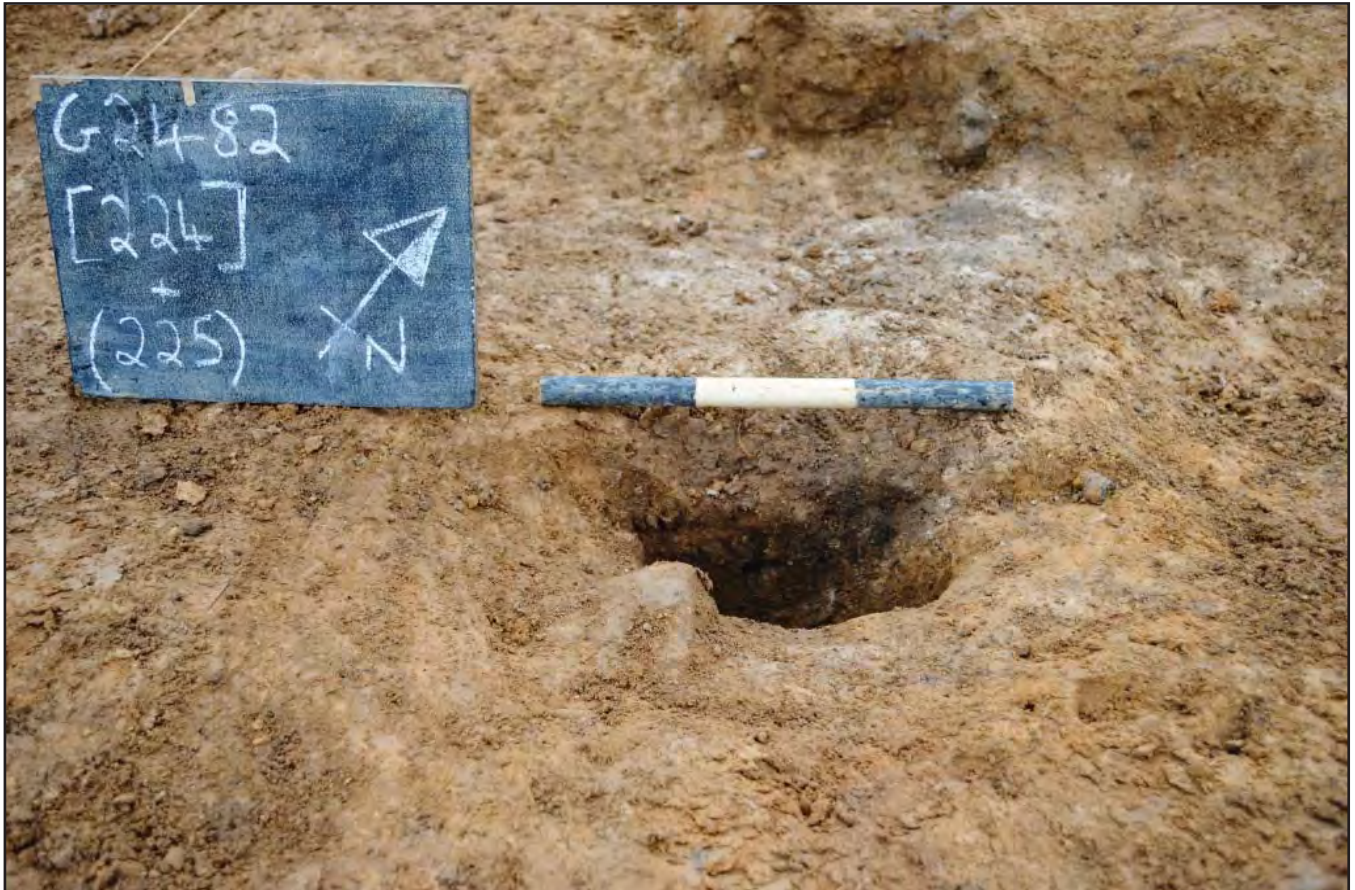
Plate 29: SE facing section through [224]. Scale 0.30m. (Photographic archive ref. G2482\_329)

Plate 29: SE facing section through [224]. Scale 0.30m. (Photographic archive ref. G2482\_329);

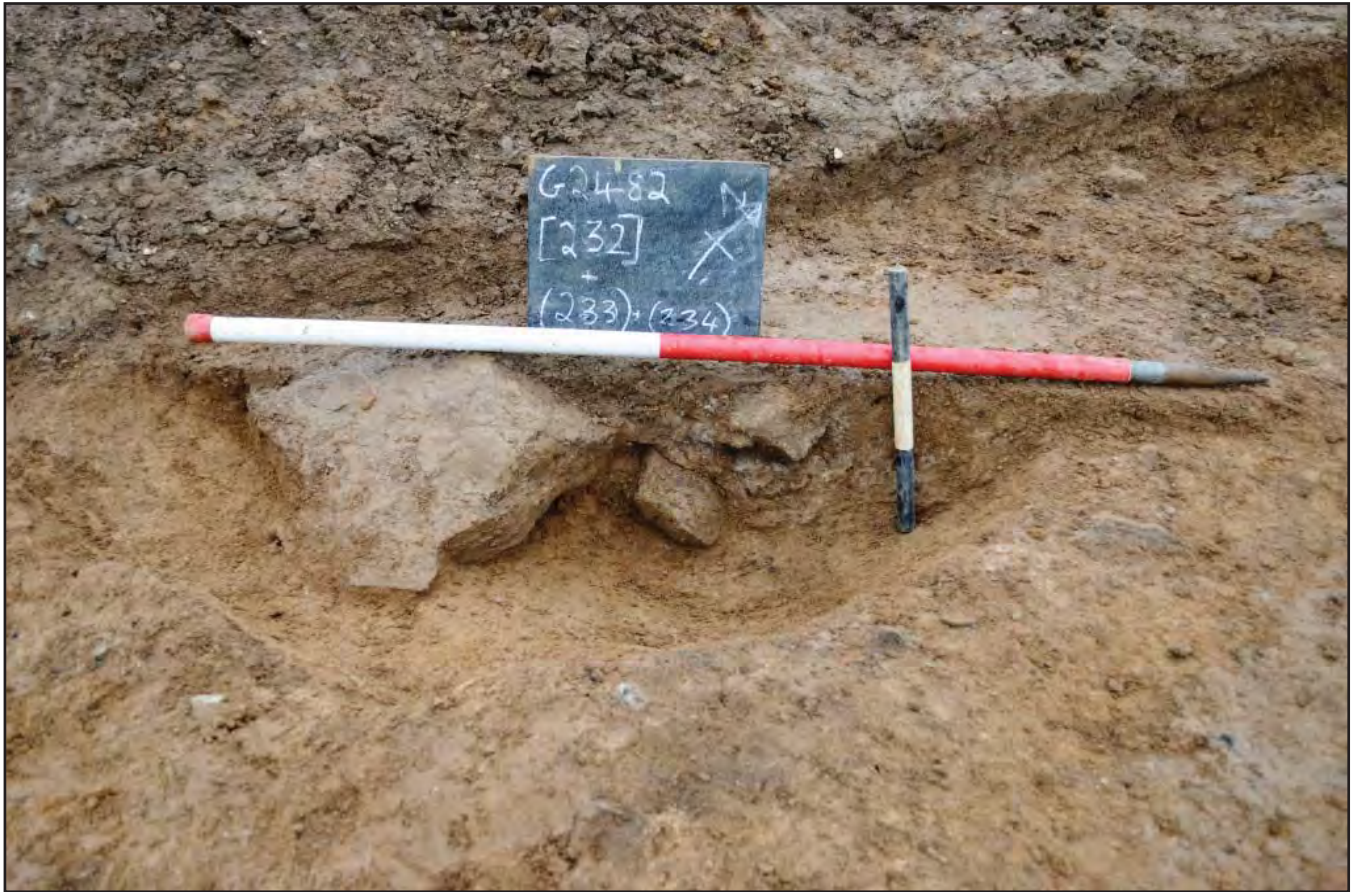
Plate 31: SSE facing section through [232]. Scale 0.30m & 1.0m. (Photographic archive ref. G2482\_331)

Plate 31: SSE facing section through [232]. Scale 0.30m & 1.0m. (Photographic archive ref. G2482\_331);

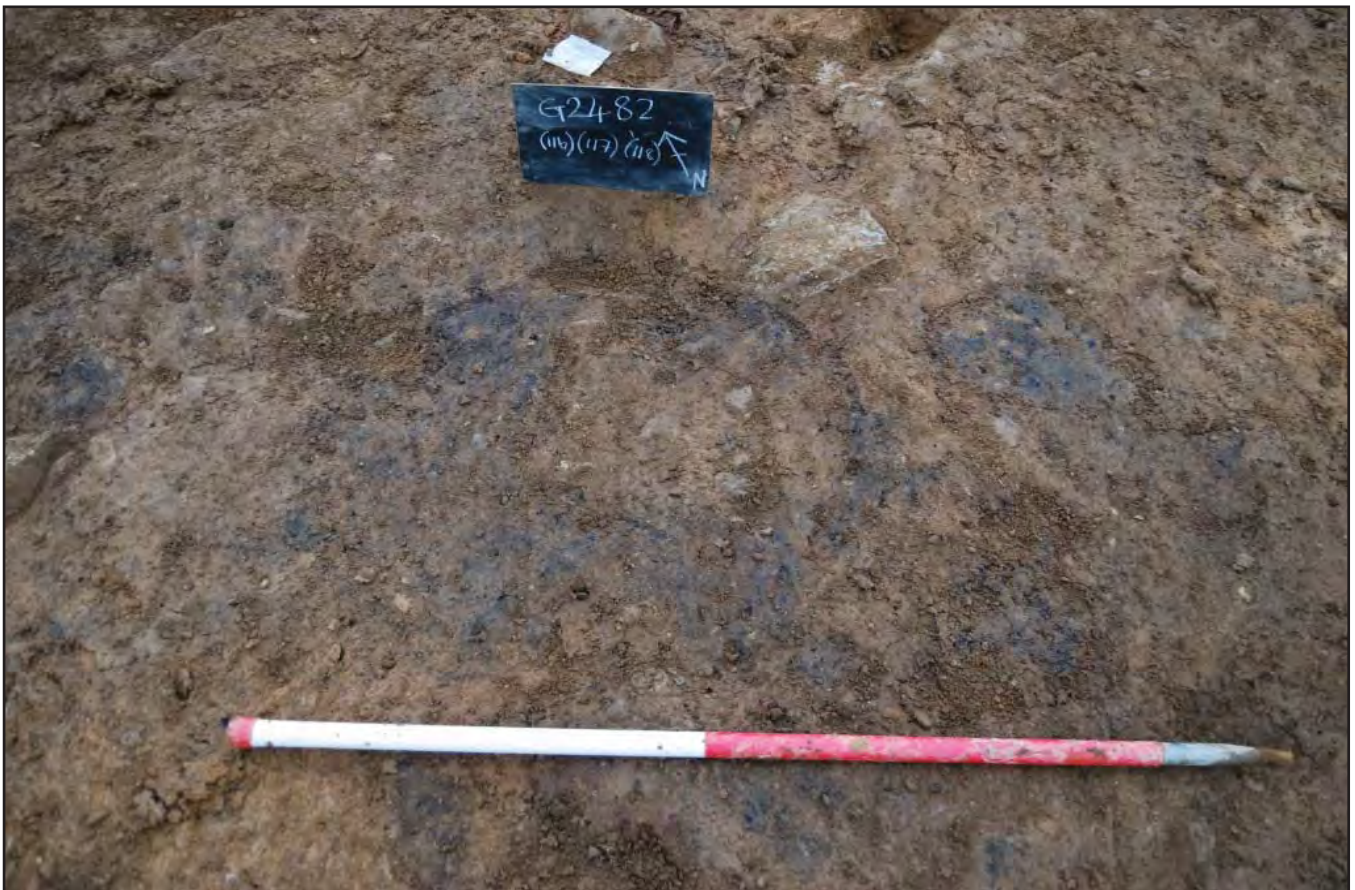
Plate 32: Pre-excavation shot of (116). Scale 1.0m. (Photographic archive ref. G2482\_174)

Plate 32: Pre-excavation shot of (116). Scale 1.0m. (Photographic archive ref. G2482\_174);

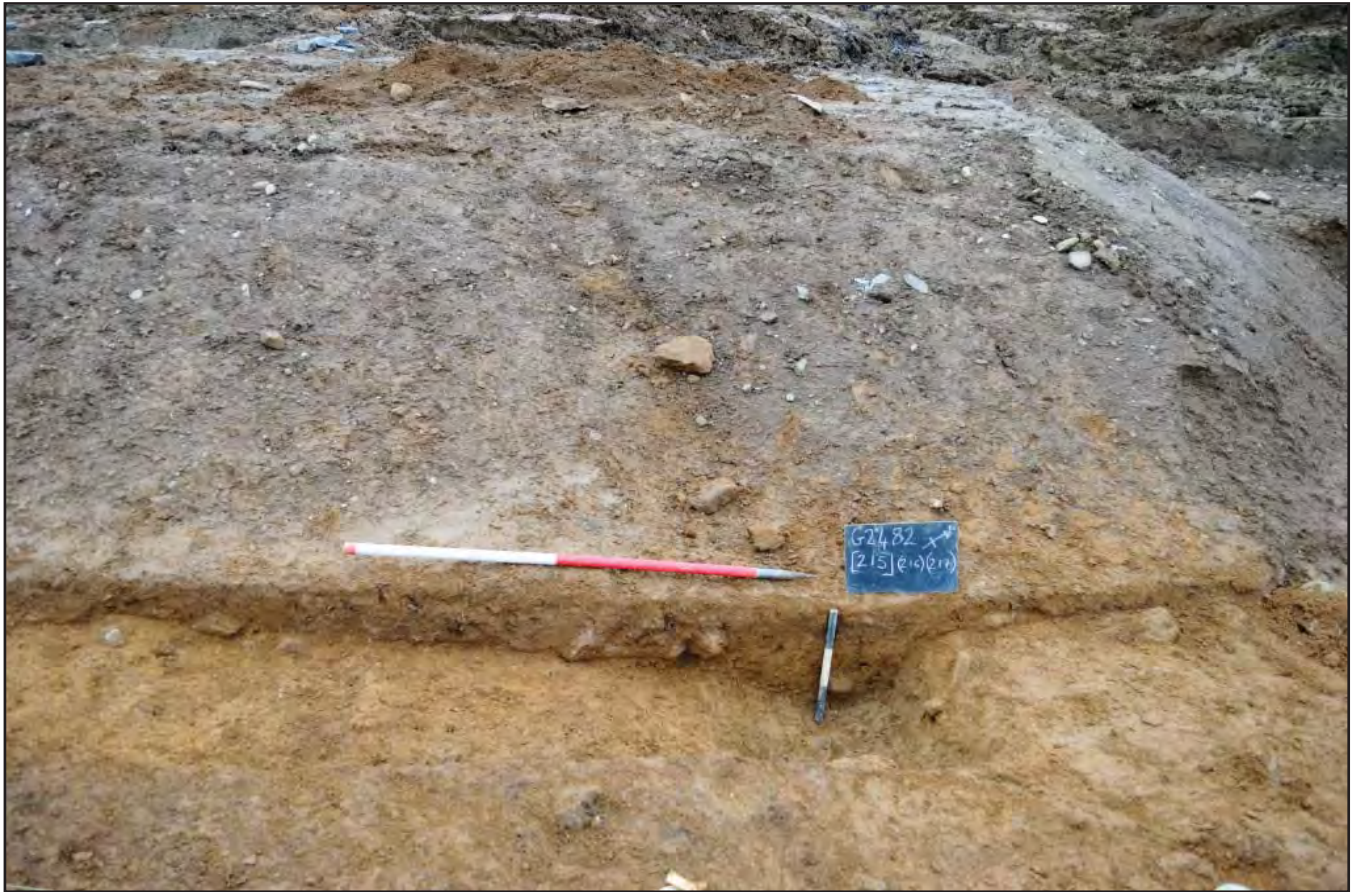
Plate 33: SE facing section through [215]. Scale 0.30m & 1.0m. (Photographic archive ref. G2482\_319)

visible length of 3.50m, width of 0.75m and depth of 0.32m. The cut had an abrupt break of slope at the top with moderately steep sides and moderate break of slope at the base which was slightly convex (Plate 33). The ditch had a rounded terminus at the southwest, at which point the cut had become narrower (0.55m) and more shallow (0.12m) (Figure 08) and continued beyond the limit of excavation to the northwest. The fill of the ditch (216) was a loose mid orangey brown silty sandy clay mixed with moderate small to medium sized rounded and sub-angular stones and infrequent flecks of charcoal. It included a medium sized quartzite angular stone and produced a flint core that was retrieved from the terminus of the ditch.

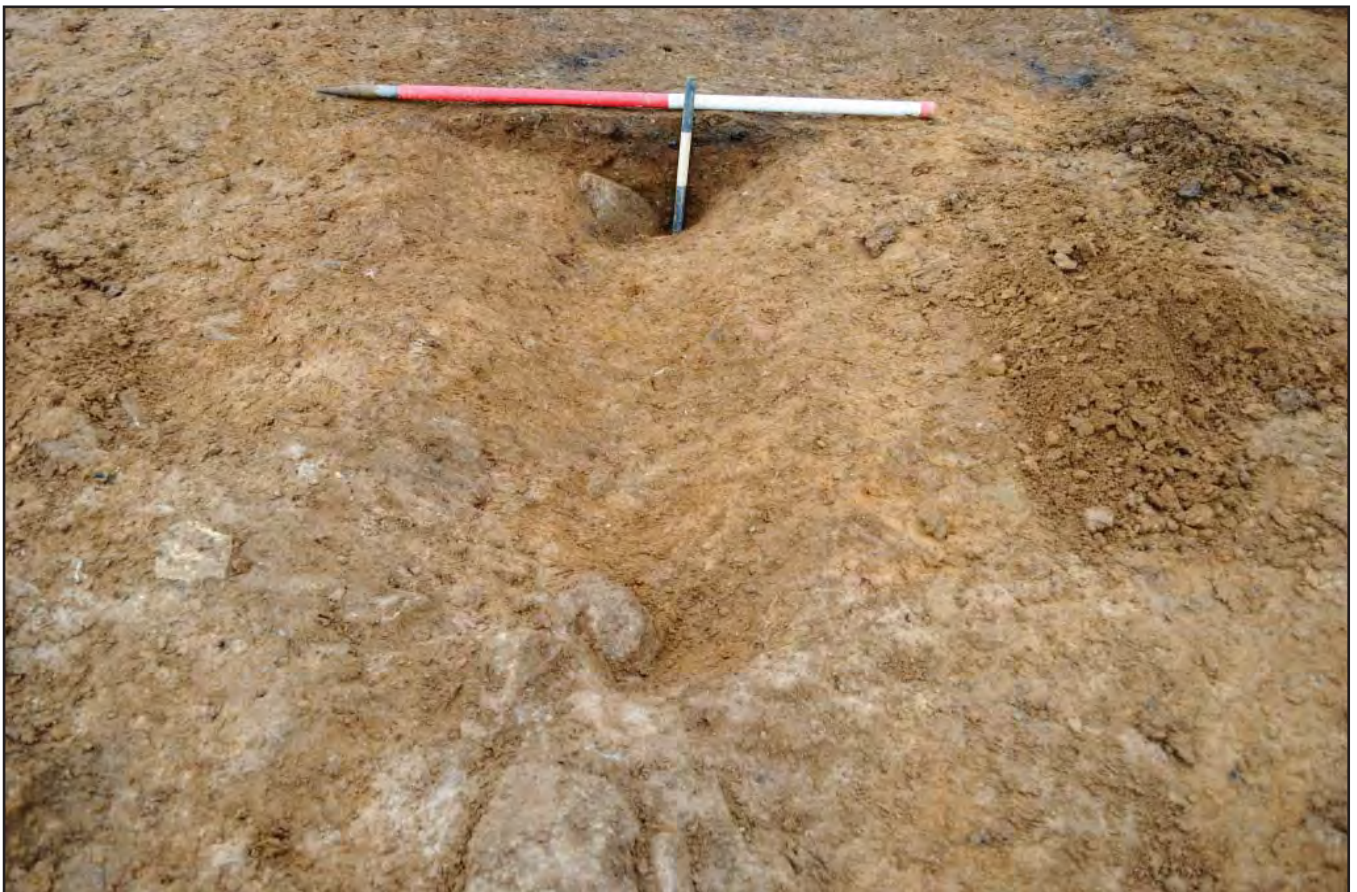
Plate 34: E facing section through [229]. Scale 0.30m & 1.0m. (Photographic archive ref. G2482\_338)

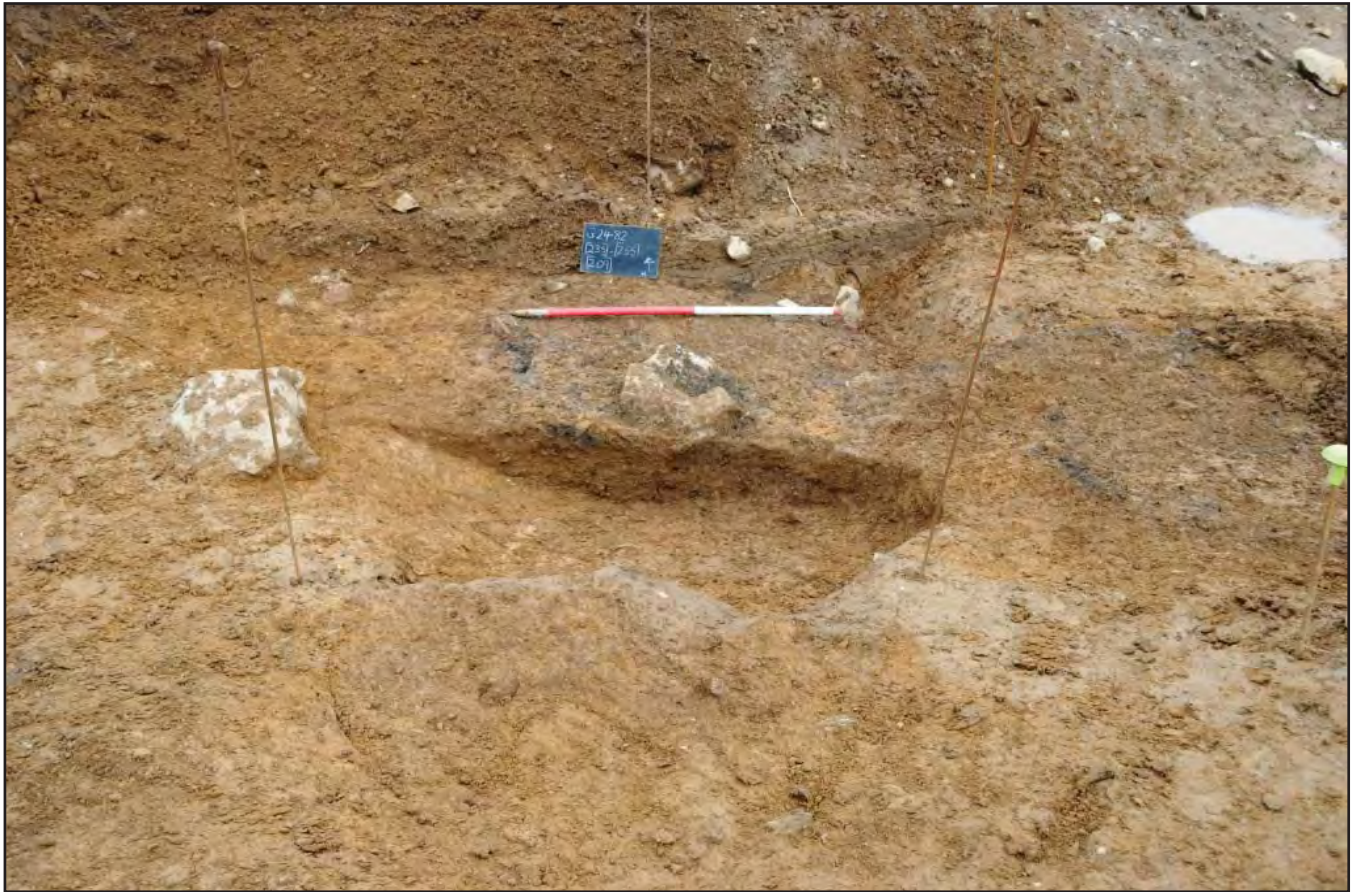
Plate 35: SSW facing section through [235] & [255]. Scale 1.0m. (Photographic archive ref. G2482\_368)

Plate 35: SSW facing section through [235] & [255]. Scale 1.0m. (Photographic archive ref. G2482\_368);

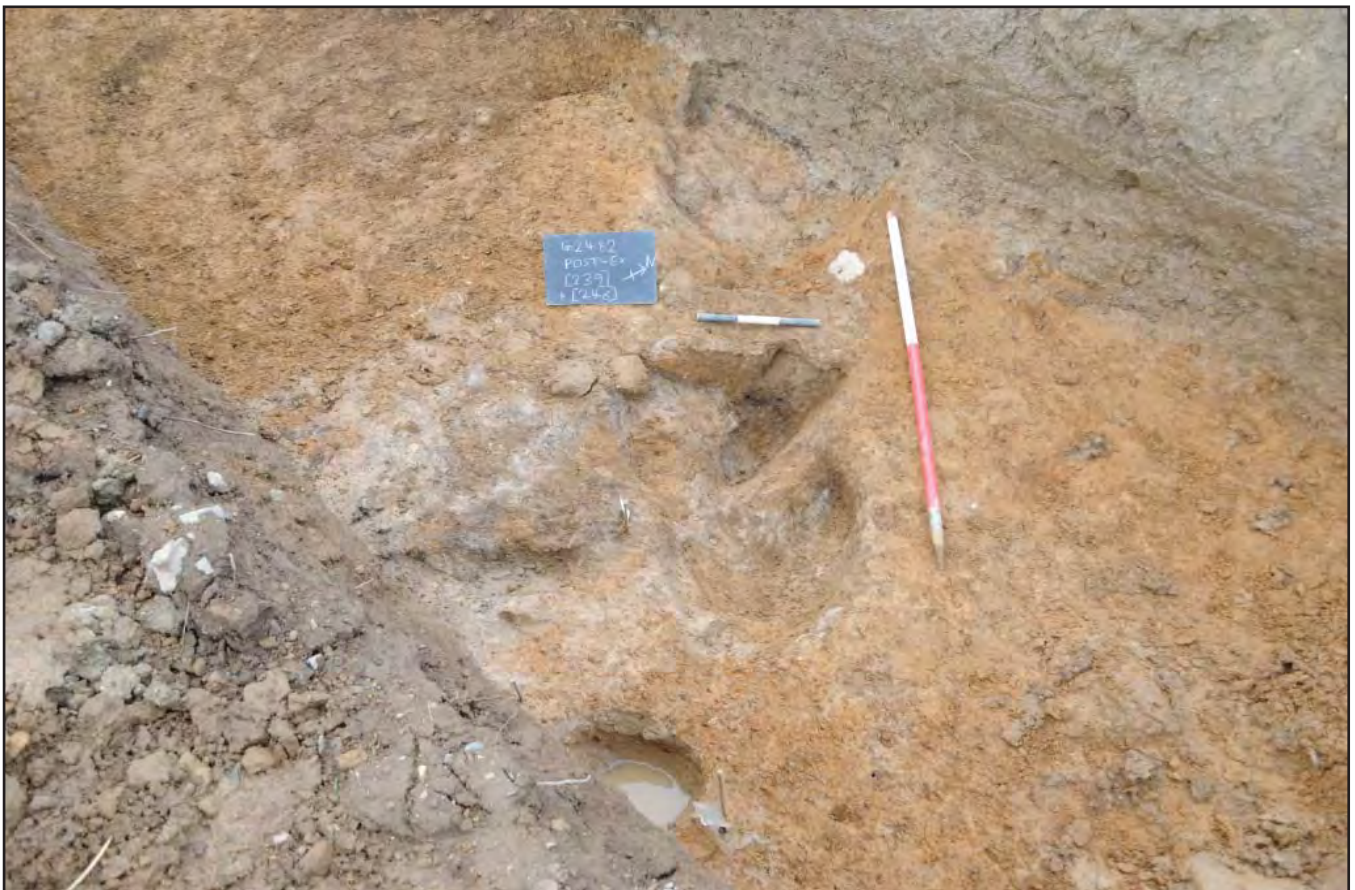
Plate 36: Post-excavation shot of [239] and [247]. Scale 0.30m & 1.0m. (Photographic archive ref. G2482\_366)

To the northwest of [202] by a distance of 4.50m there was a small cluster of features [239], [247] and [252] (Plate 36 & Figure 10). The linear [239] which had a rounded eastern terminus had an exposed length of 1.50m and continued west beyond the limit of excavation, with a maximum width (not in section) of 0.58m and depth of 0.16m (Figure 09). It had an abrupt break of slope at the top of the cut with predominantly steep sides and sharp break of slope at the base which was uneven. There were two fills (240) and (246) (Plate 37). The primary fill (246) was found throughout the feature with a maximum depth of 0.07m. It was a fine, compact dark brownish black silty clay mixed with frequent flecks of charcoal, occasional specks of mid grey silty gravel deposits and the occasional medium to large angular quartzite stone. Given the charcoal rich nature of (246) this is most likely a burnt deposit but it was most likely not burnt in-situ but rather may have been hot when deposited along the base of [239] and scorched the underlying clay natural (41) discolouring it from orange to a mid greyish white clay. It was sealed beneath (240) extended along the length and breadth of the cut with a maximum depth of 0.12m. The fill consisted of a loose, soft, fine mid greyish brown with occasional specks of orange silty clay mixed with moderate small to medium sized sub-angular stones, some of which were quartzite.

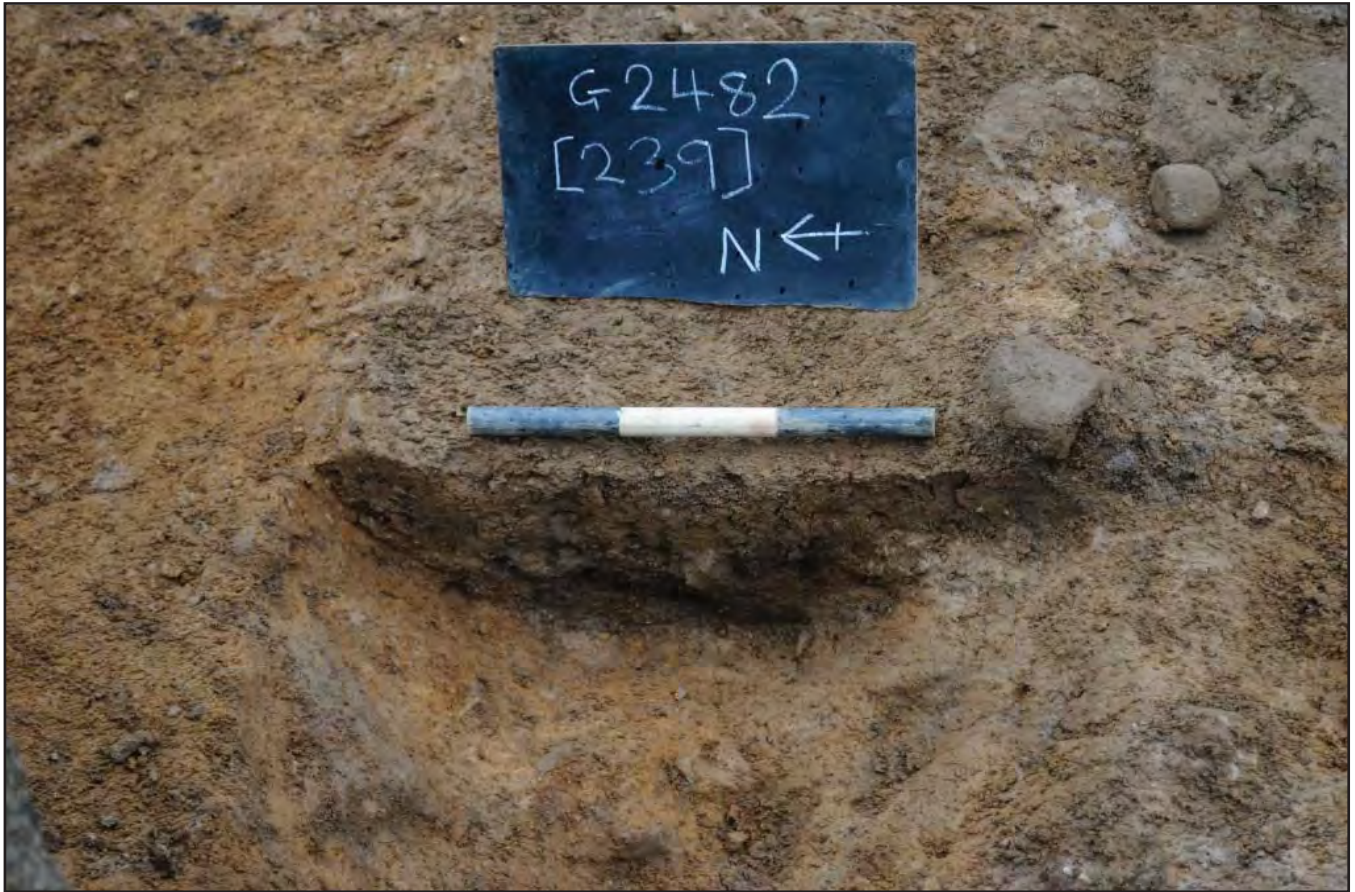
Plate 37: W facing section through [239]. Scale 0.30m. (Photographic archive ref. G2482\_348)

Plate 37: W facing section through [239]. Scale 0.30m. (Photographic archive ref. G2482\_348);

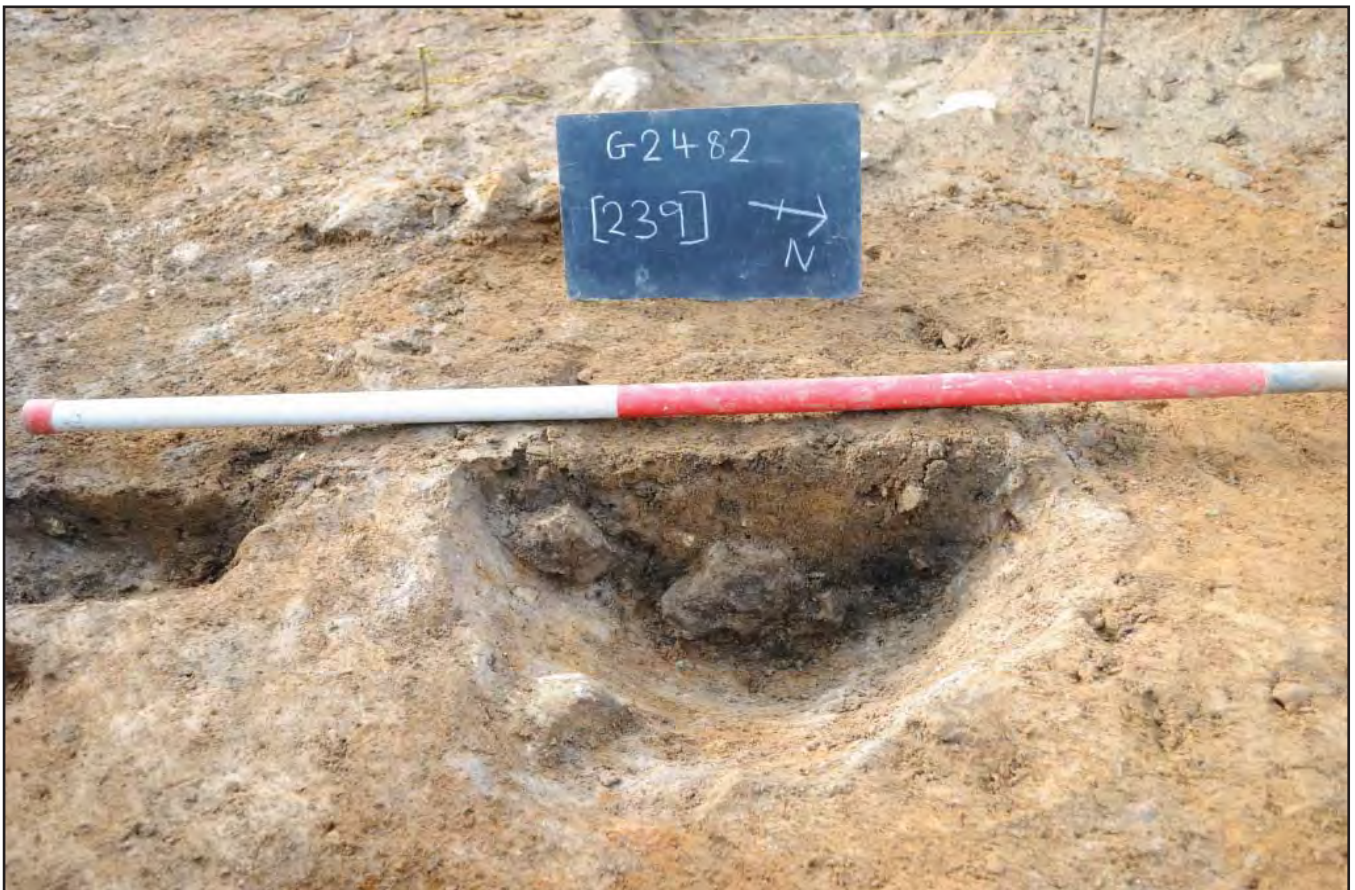
Plate 38: E facing section through [252]. Scale 1.0m. (Photographic archive ref. G2482\_359)

Plate 38: E facing section through [252]. Scale 1.0m. (Photographic archive ref. G2482\_359);
