# DCWW Llanfaethlu Waste Water Treatment Works

## Archaeological Mitigation

Prosiect Rhif / Project No. G2482

Adroddiad Rhif / Report No. 1382

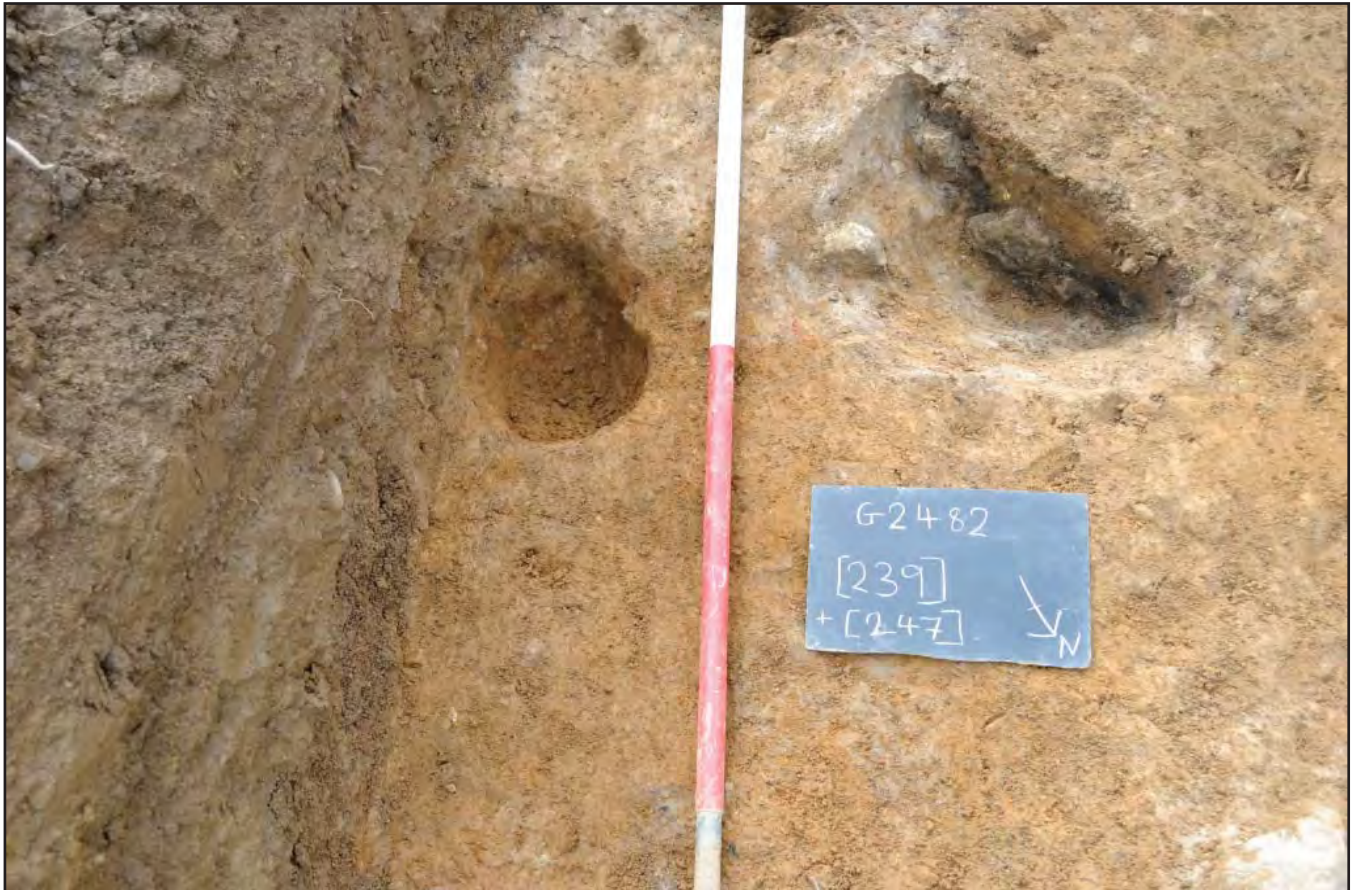
Plate 39: Post-excavation shot of [252] and [247] (ID board incorrect). Scale 1.0m.  
(Photographic archive ref. G2482\_359)

Plate 39: Post-excavation shot of [252] and [247] (ID board incorrect). Scale 1.0m. (Photographic archive ref. G2482\_359);

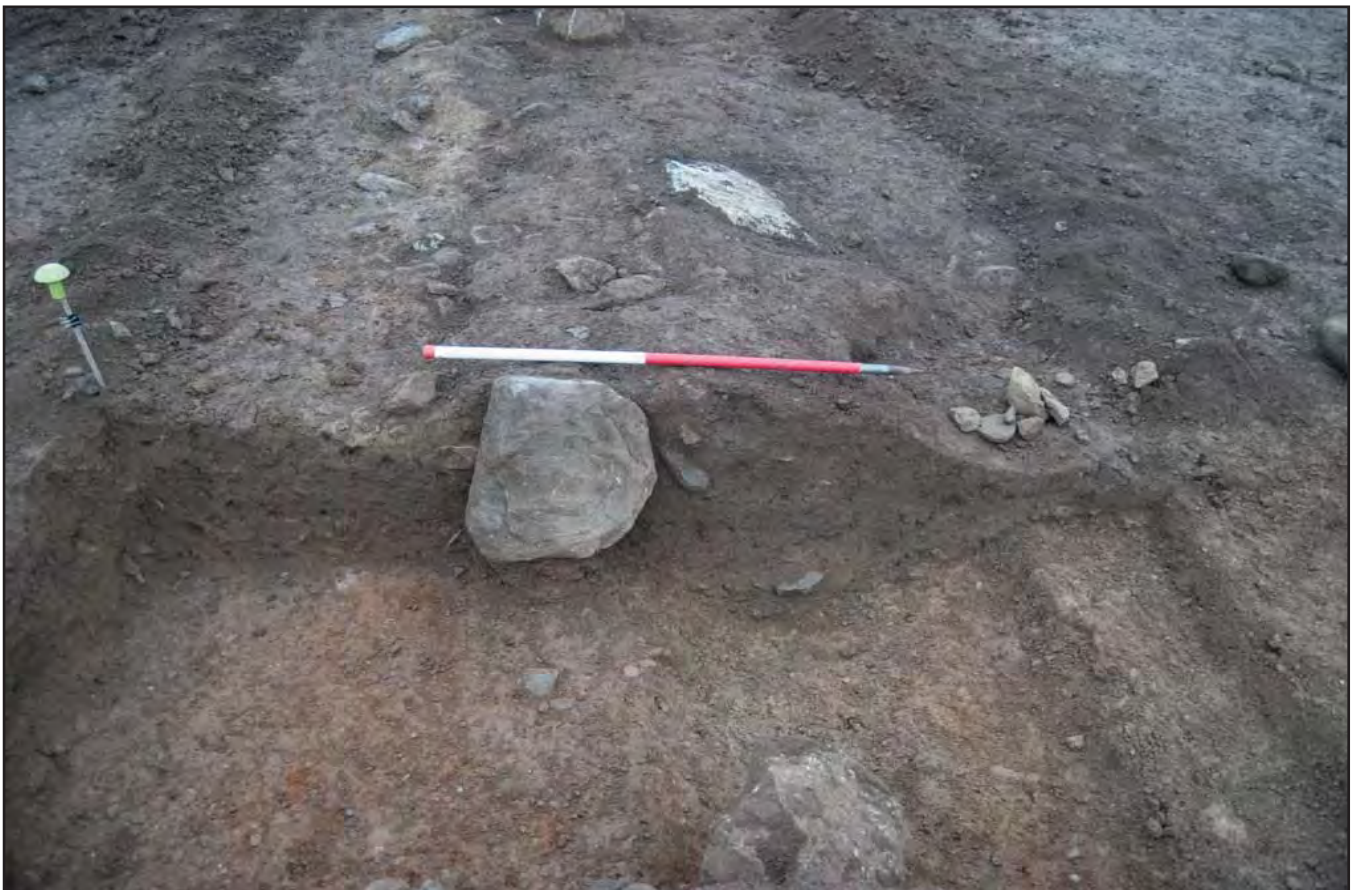
Plate 40: SE facing section across [62]. Scale 1.0m. (Photographic archive ref. G2482\_108)

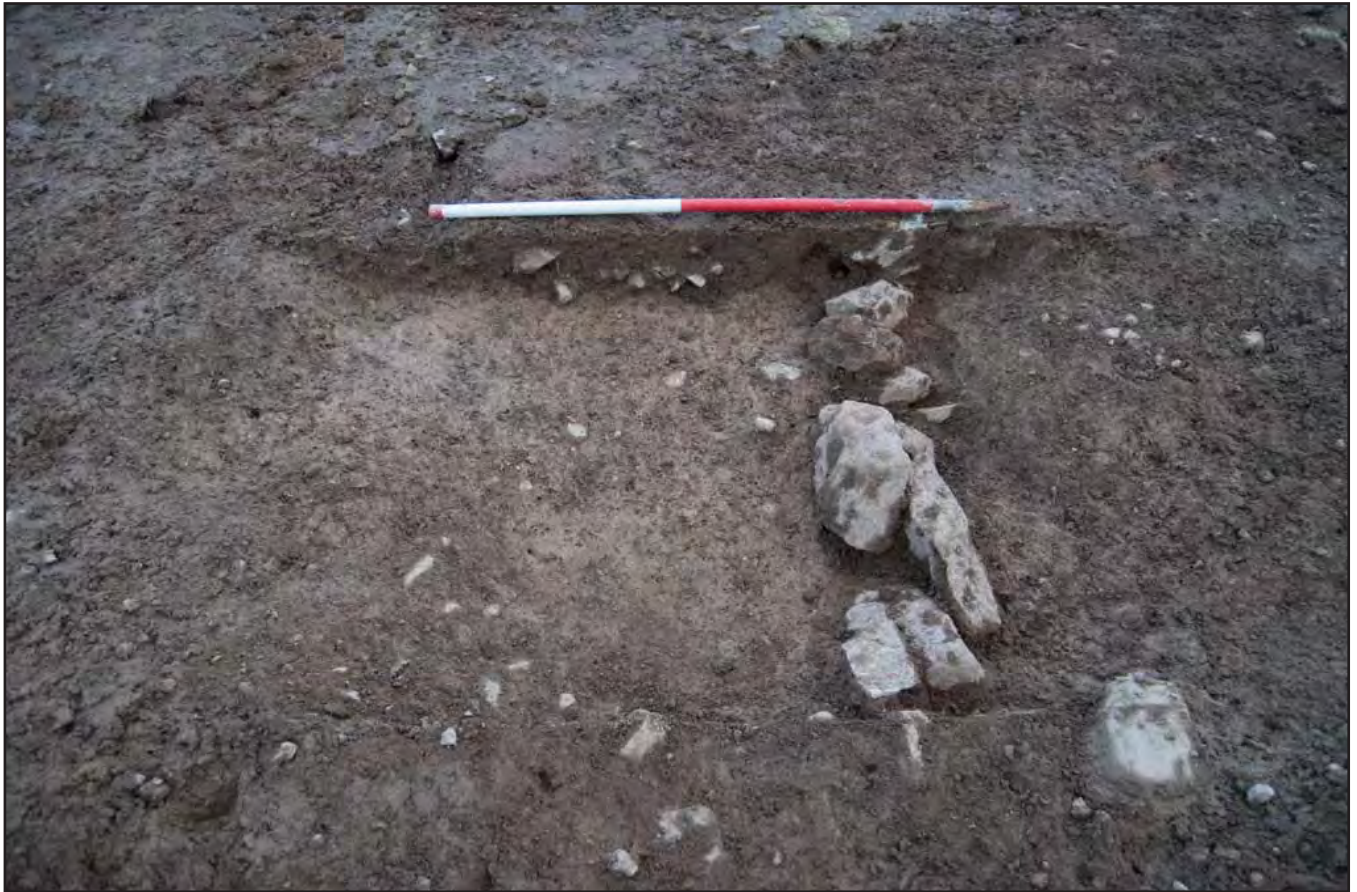
Plate 41: NE facing section through [38]. Scale 1.0m. (Photographic archive ref. G2482\_058)

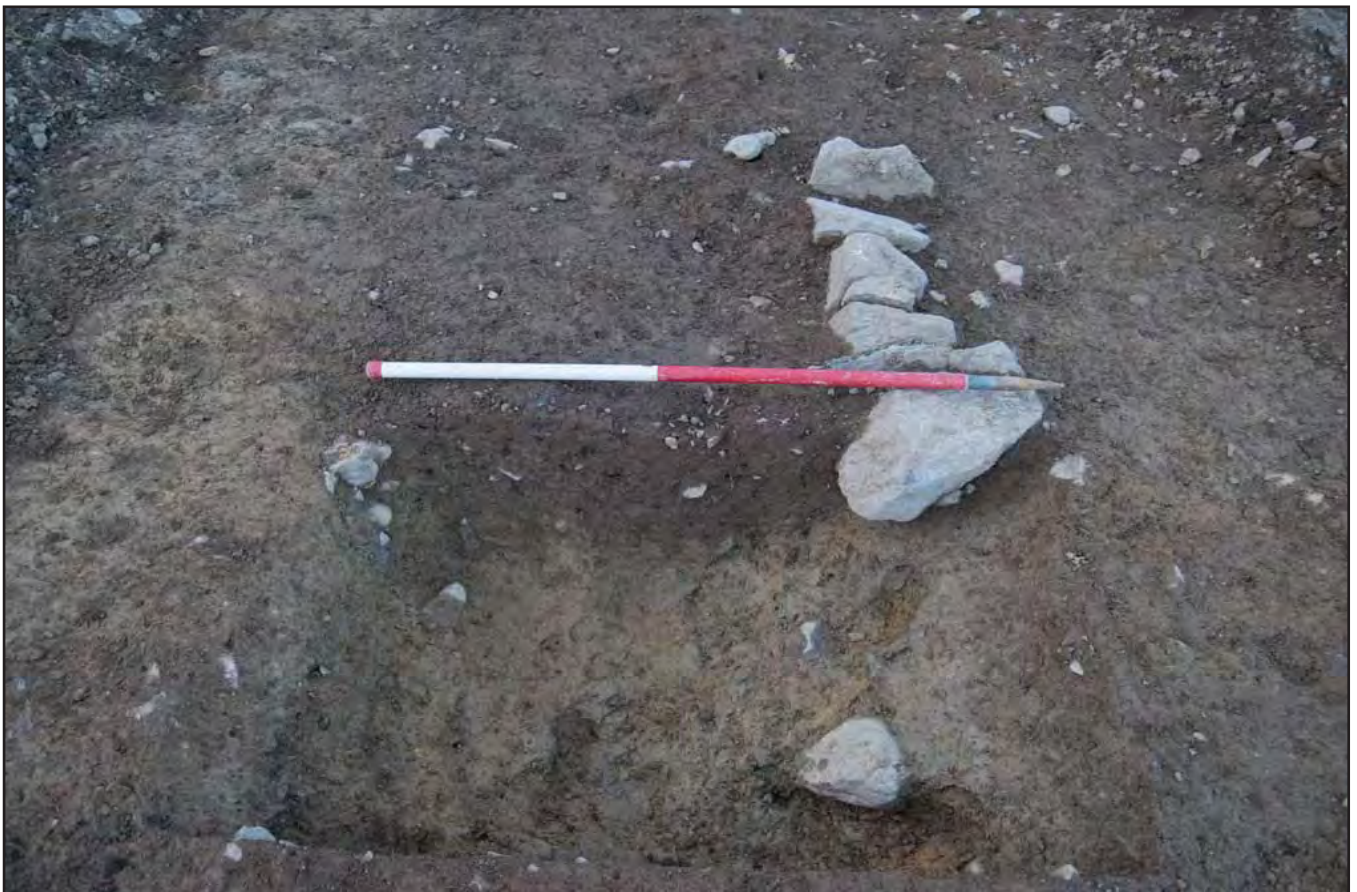
Plate 42: NE facing section through [56] and (40). Scale 1.0m. (Photographic archive ref. G2482\_91)

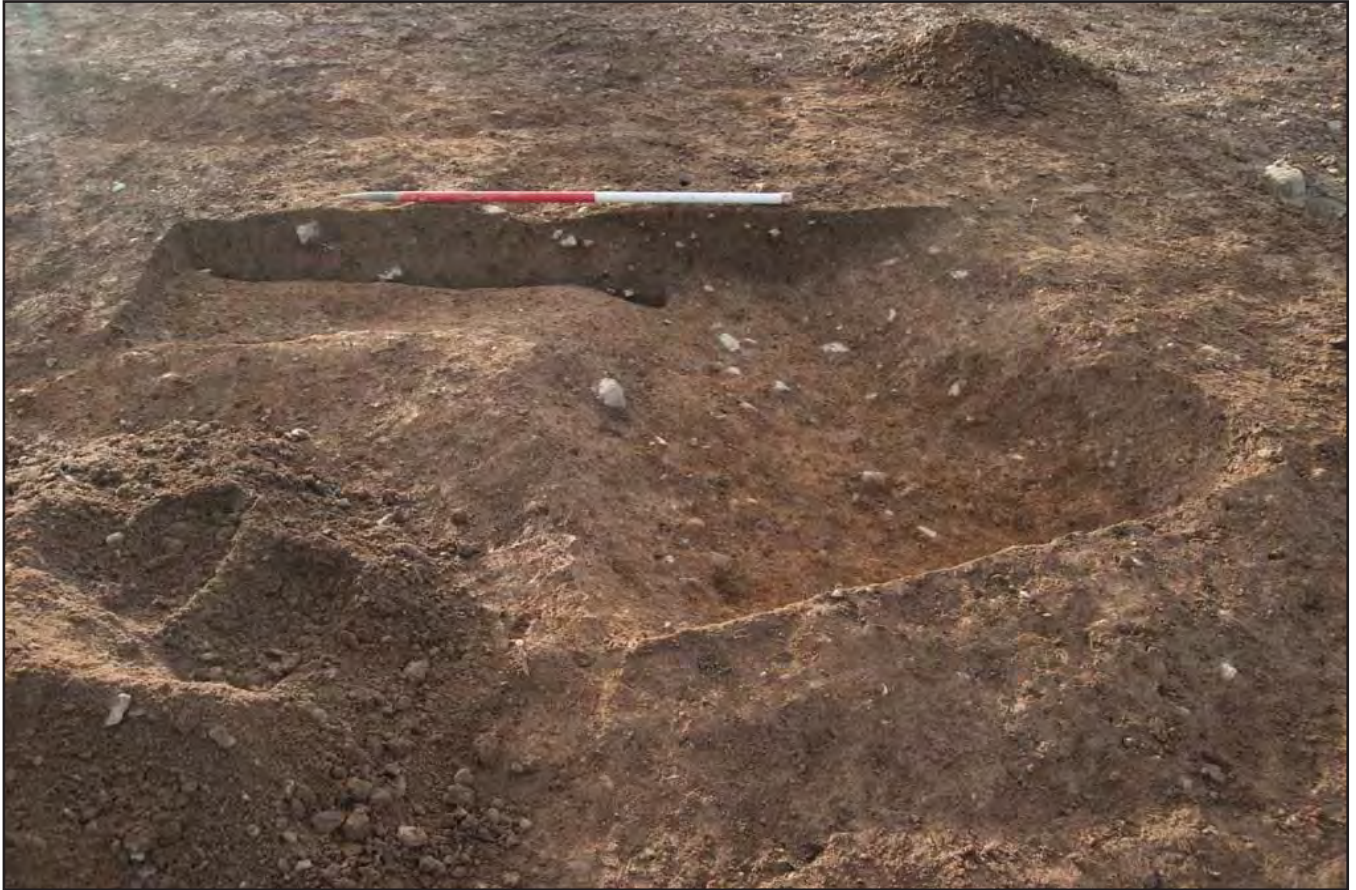
Plate 43: NE facing section through [30] and [260]. Scale 1.0m. (Photographic archive ref. G2482\_075)

A third slot trench excavated 19.5m from the northeast end of the eastern ditch [260] targeted the relationship between this feature and a northwest-southeast orientated linear [30] (Plate 43). The trench demonstrated that [260] truncated, and thus post-dated [30] (Figure 13). The profile of [260] was similar to that observed in slot 1, being shallow and flat

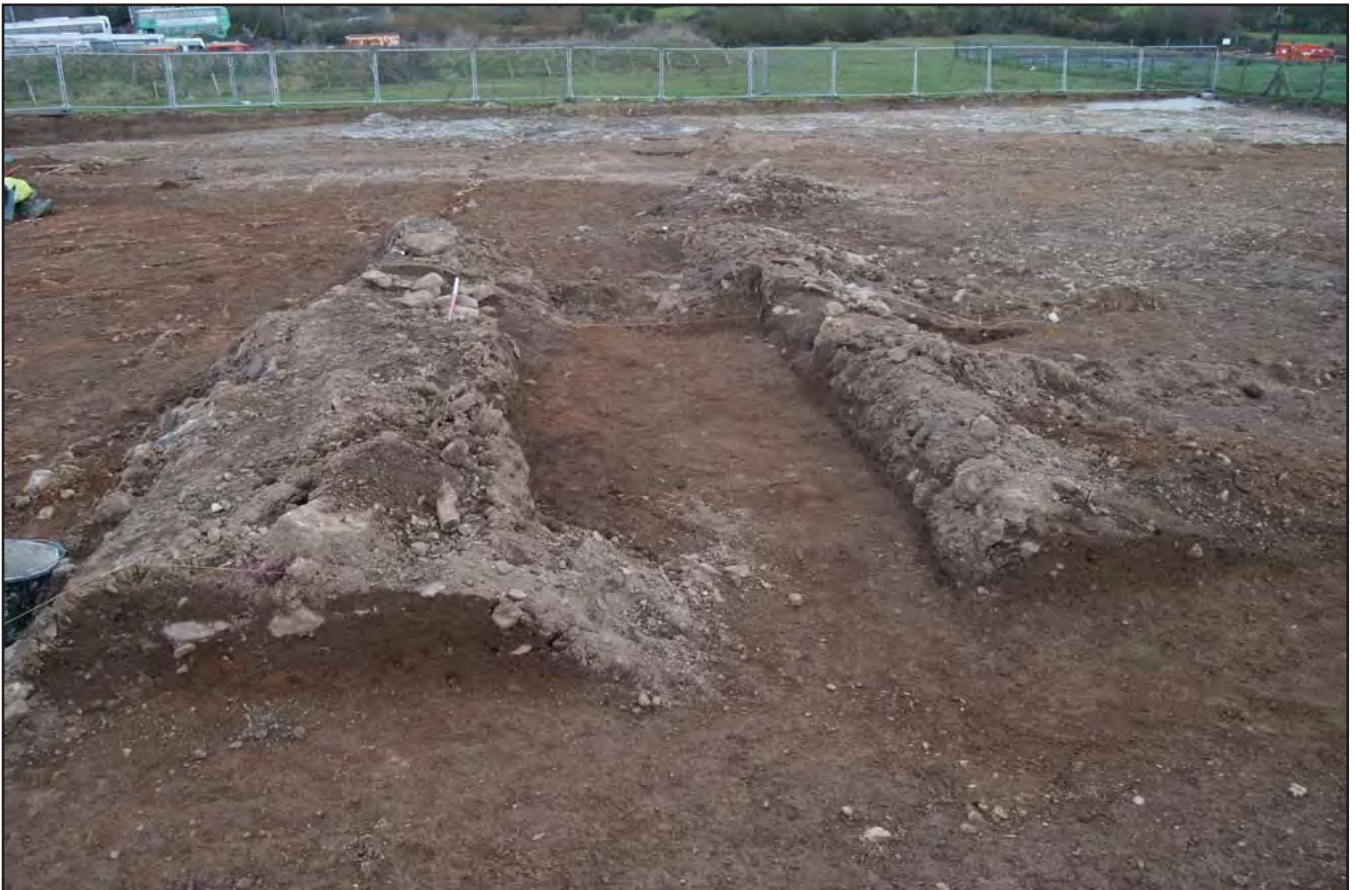
Plate 44: View of [58] and [59]. Scale 1.0m. (Photographic archive ref. G2482\_100)

Towards the middle of the site the ditches were no longer visible within the underlying clay natural. At the southwestern end of the site the ditches were replaced by a pair of low parallel banks (58) and (59) with an exposed length of 11.5m and which continued beyond the limit of excavation (Figure 12). A 2.20m wide slot was excavated through the banks using a 360° excavator under archaeological supervision in order to view the banks in section (Plate 44). In addition a 1.0m wide section of the banks was hand cleaned in order to reveal the stone within their construction (Plate 45). The banks were shown to be predominantly constructed of a mid greyish brown clayey sand, mixed with occasional sub-angular cobbles. Bank (58) had a surviving width of 1.0m and height of 0.60m while (59) had a width of 1.40m and height of 0.40m.

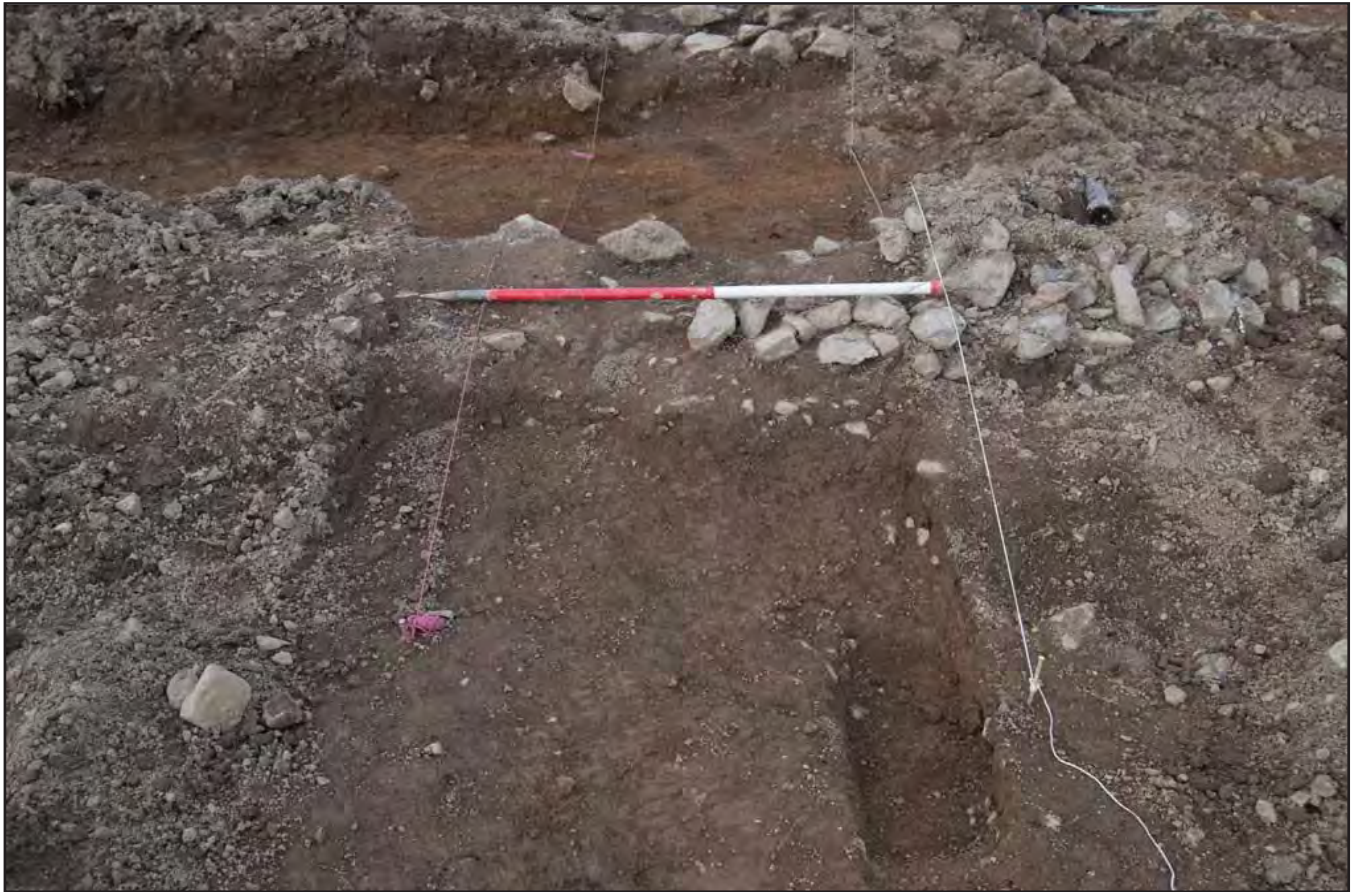
Plate 45: Stones within [58] and [59]. Scale 1.0m. (Photographic archive ref. G2482\_097)

Plate 45: Stones within [58] and [59]. Scale 1.0m. (Photographic archive ref. G2482\_097);

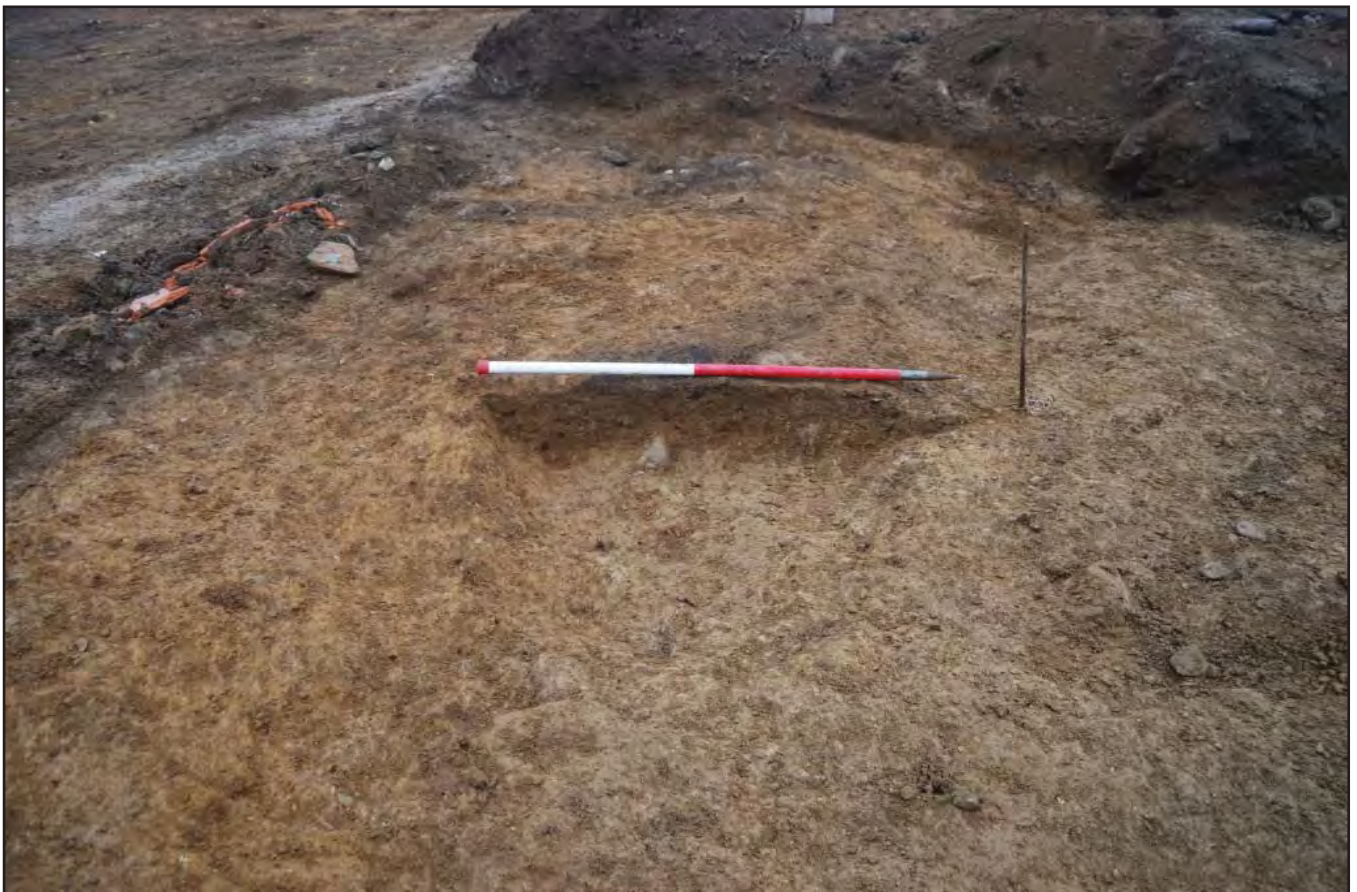
Plate 46: SSW facing section through terminus of [70]. Scale 1.0m. (Photographic archive ref. G2482\_136)

Plate 46: SSW facing section through terminus of [70]. Scale 1.0m. (Photographic archive ref. G2482\_136);

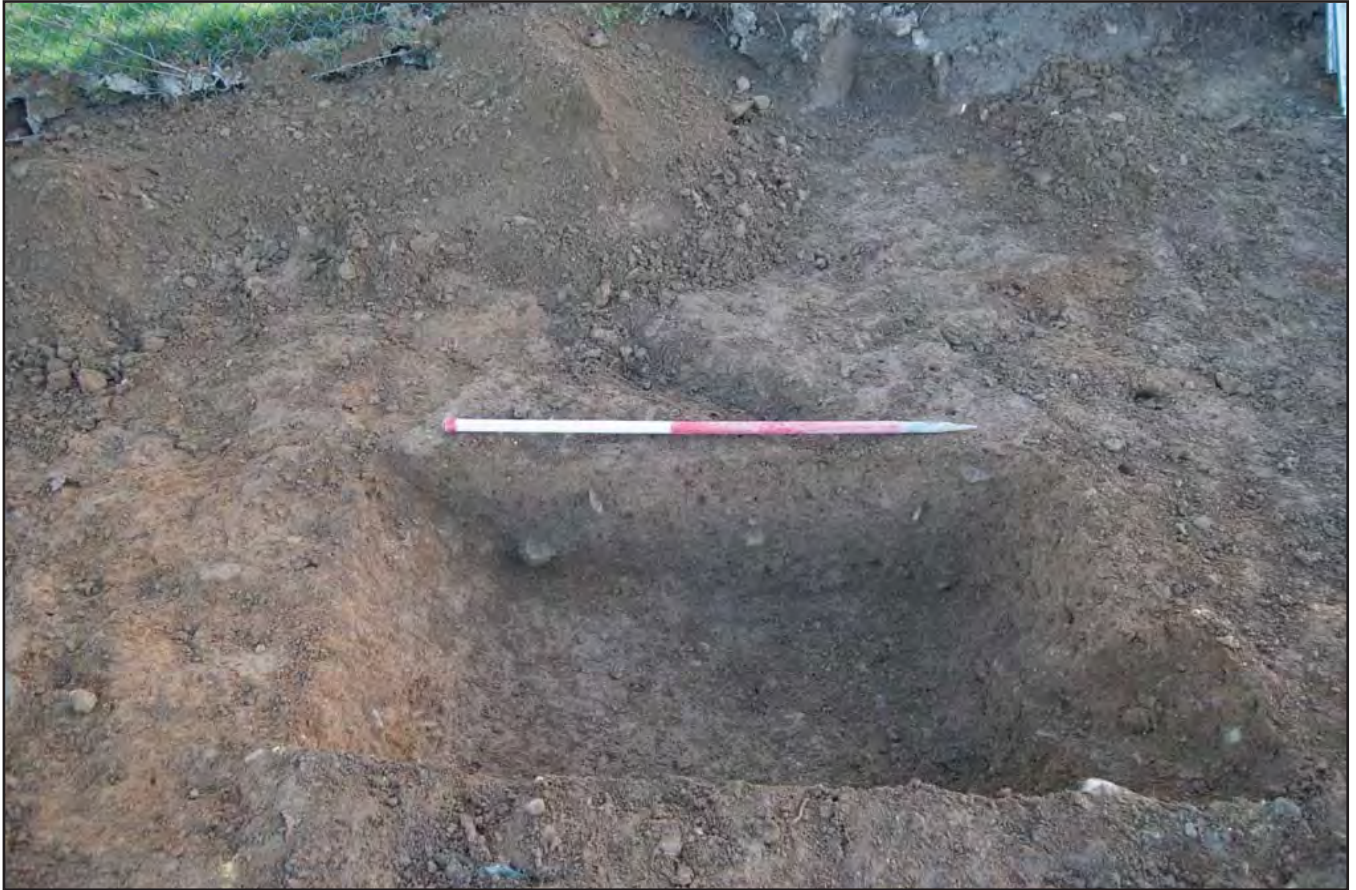
Plate 47: NW facing section through [28]. Scale 1.0m. (Photographic archive ref. G2482\_048)

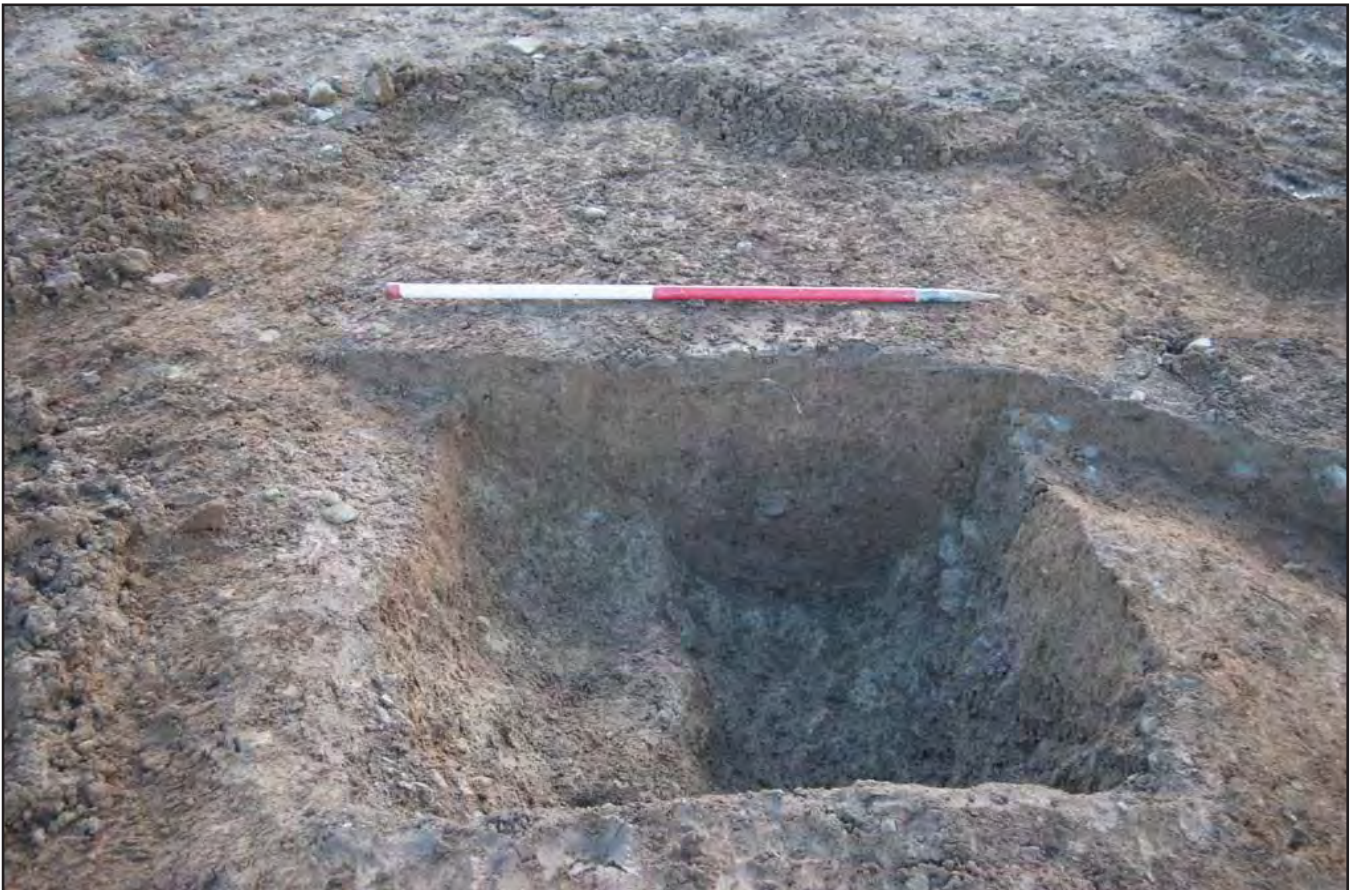
Plate 48: NW facing section through [31]. Scale 1.0m. (Photographic archive ref. G2482\_054)

Plate 48: NW facing section through [31]. Scale 1.0m. (Photographic archive ref. G2482\_054);

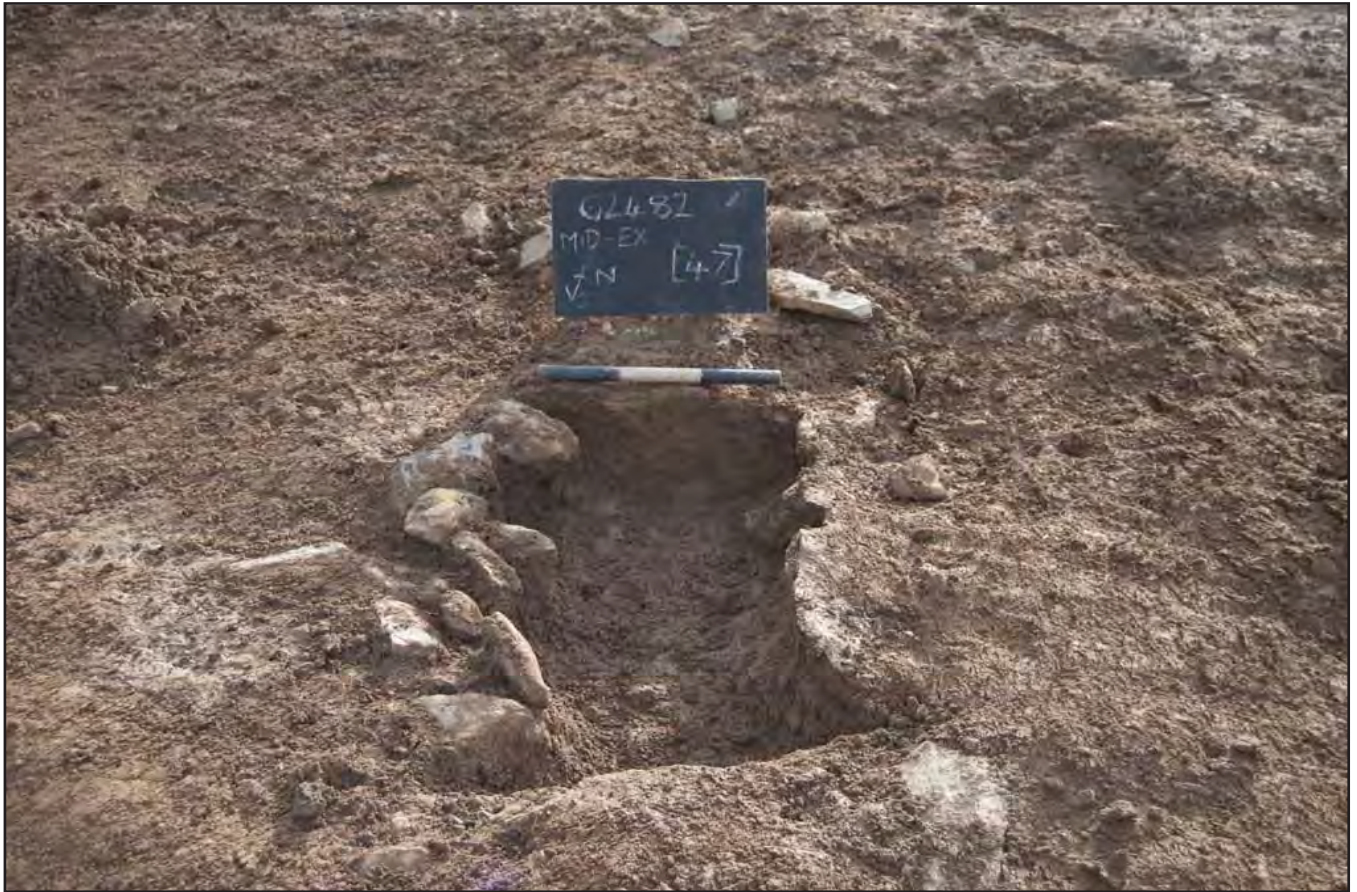
**Plate 49:** Stone lining of NW terminal of [30]. Scale 0.30m. (Photographic archive ref. G2482\_073)
