Dinorwig Power Station, Llanberis

Archaeological Watching Brief

Prosiect Rhif / Project No. G2486

Adroddiad Rhif / Report No. 1388

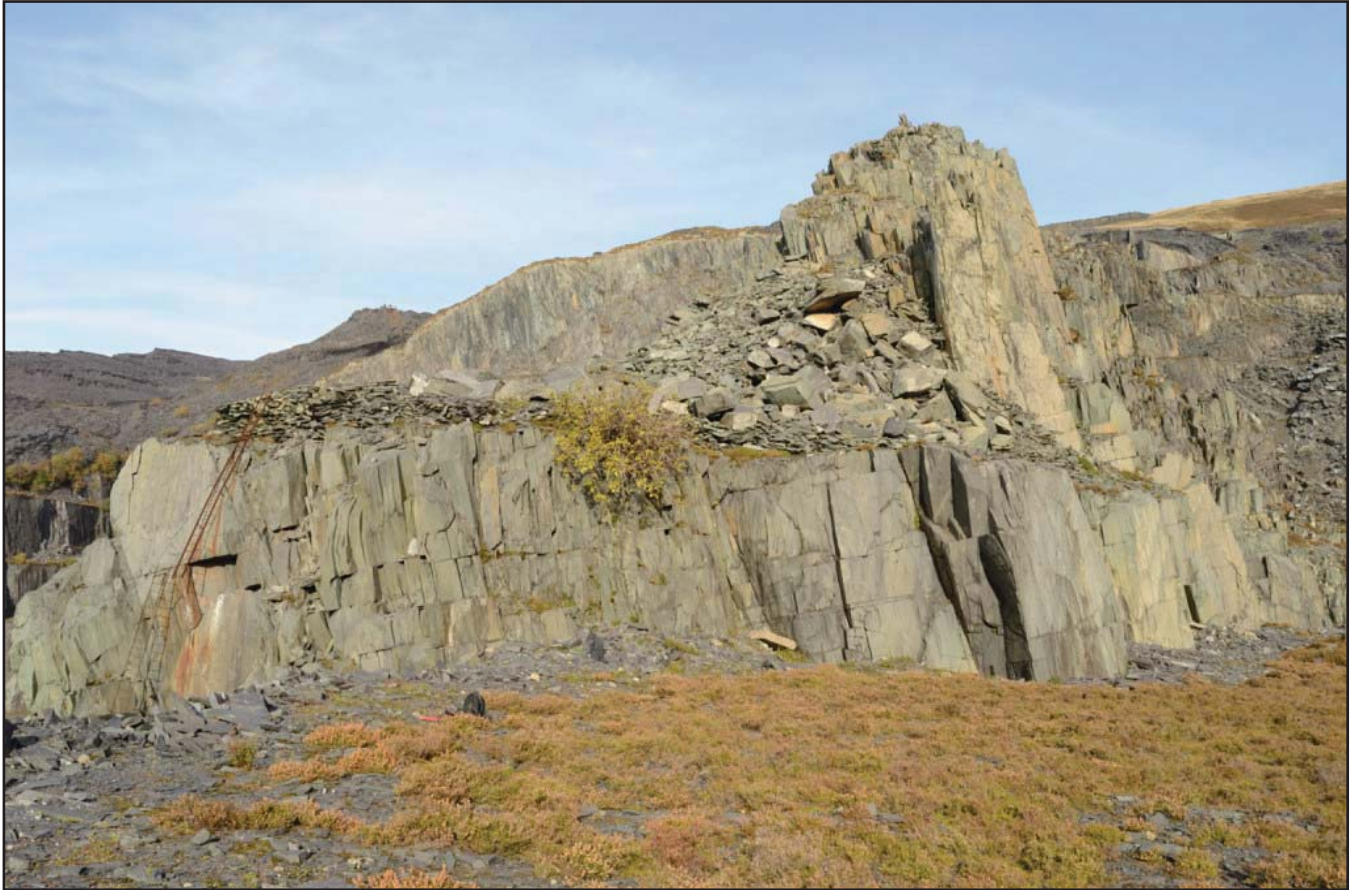
Plate 01: Collapsing section of cliff face at the 'Cockerel', with metal ladders and dry-stone wall. View from the southwest (Photographic archive ref. G2486_025).

First Hydro wanted to undertake urgent safety work within the quarry to remove a section of cliff face at the 'Cockerel' as it was in danger of collapsing (Plate 01) further to rock falls in recent months. The work was undertaken as permitted development but the project was monitored by Gwynedd Archaeological Planning Service (GAPS). A project design, defining the scope and methodology for the archaeological watching brief, was submitted to GAPS by GAT in November 2016 ([Appendix I](#)).

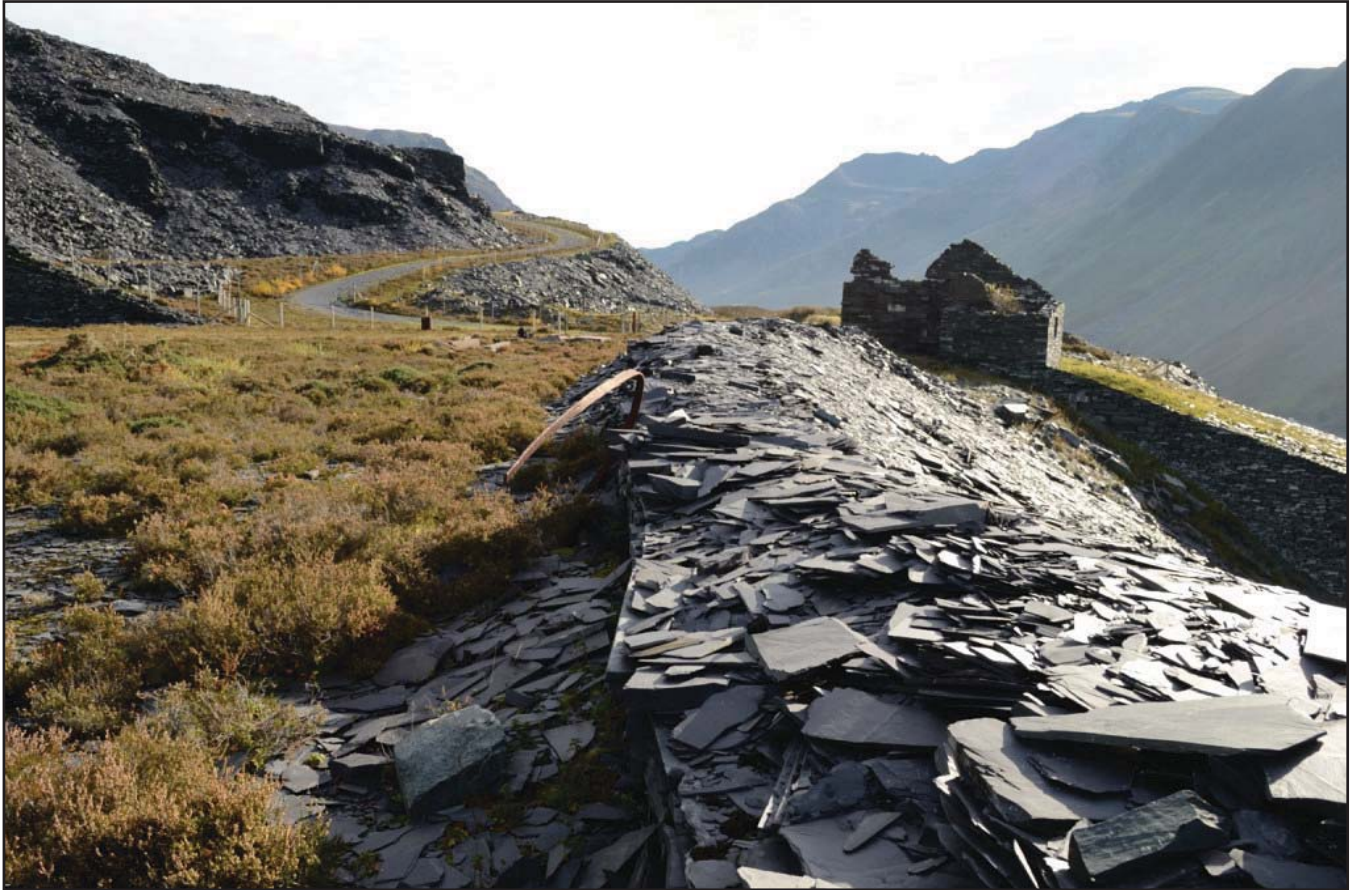
Plate 03: Remnants of slate dry stone wall adjacent to Victoria inclined plane. View from the northwest (Photographic archive ref. G2486_009).

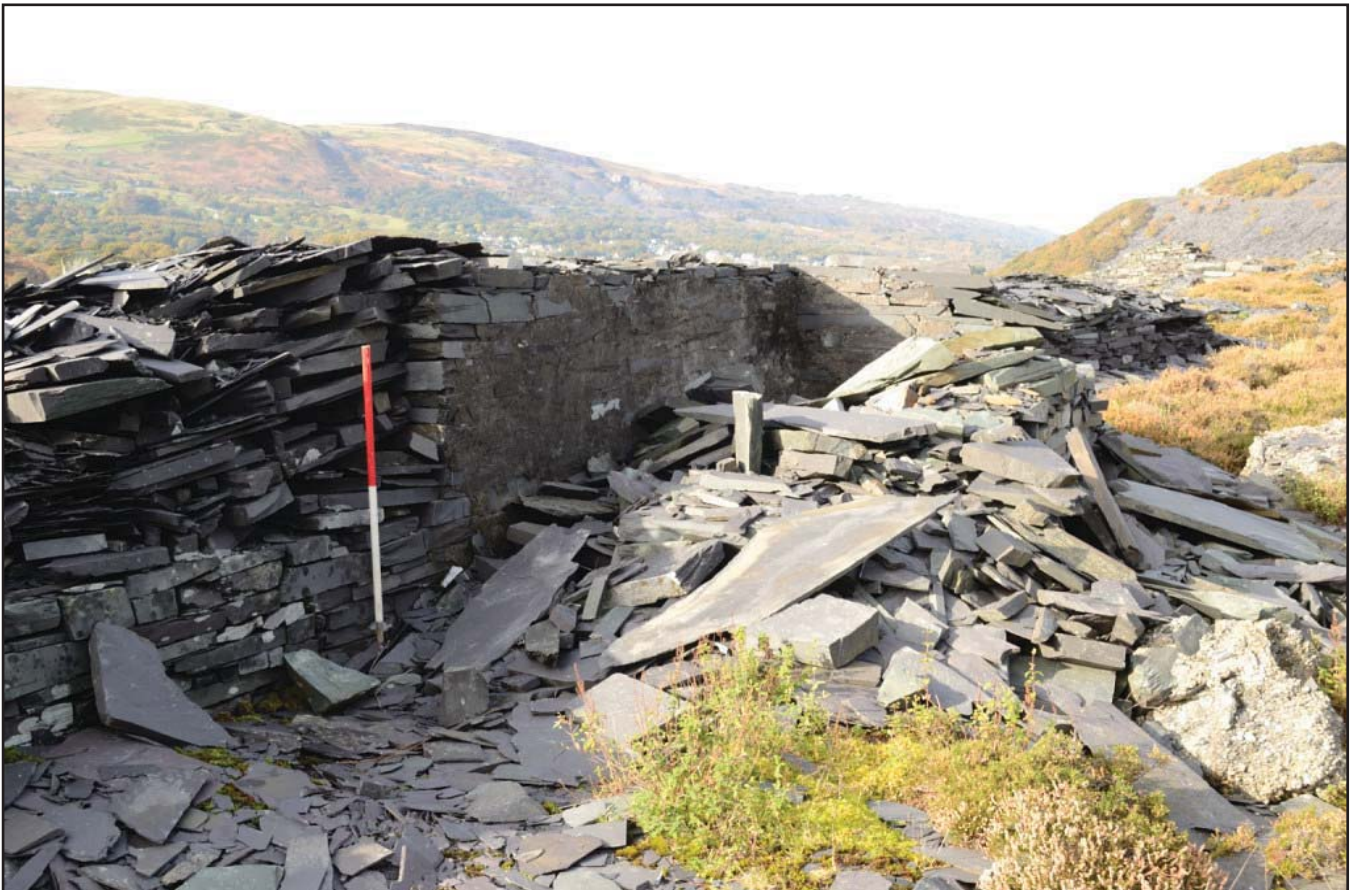
Plate 04: Remnants of mortar and stone building set within wall. Scale 1.0m. View from the southeast (Photographic archive ref. G2486_008).

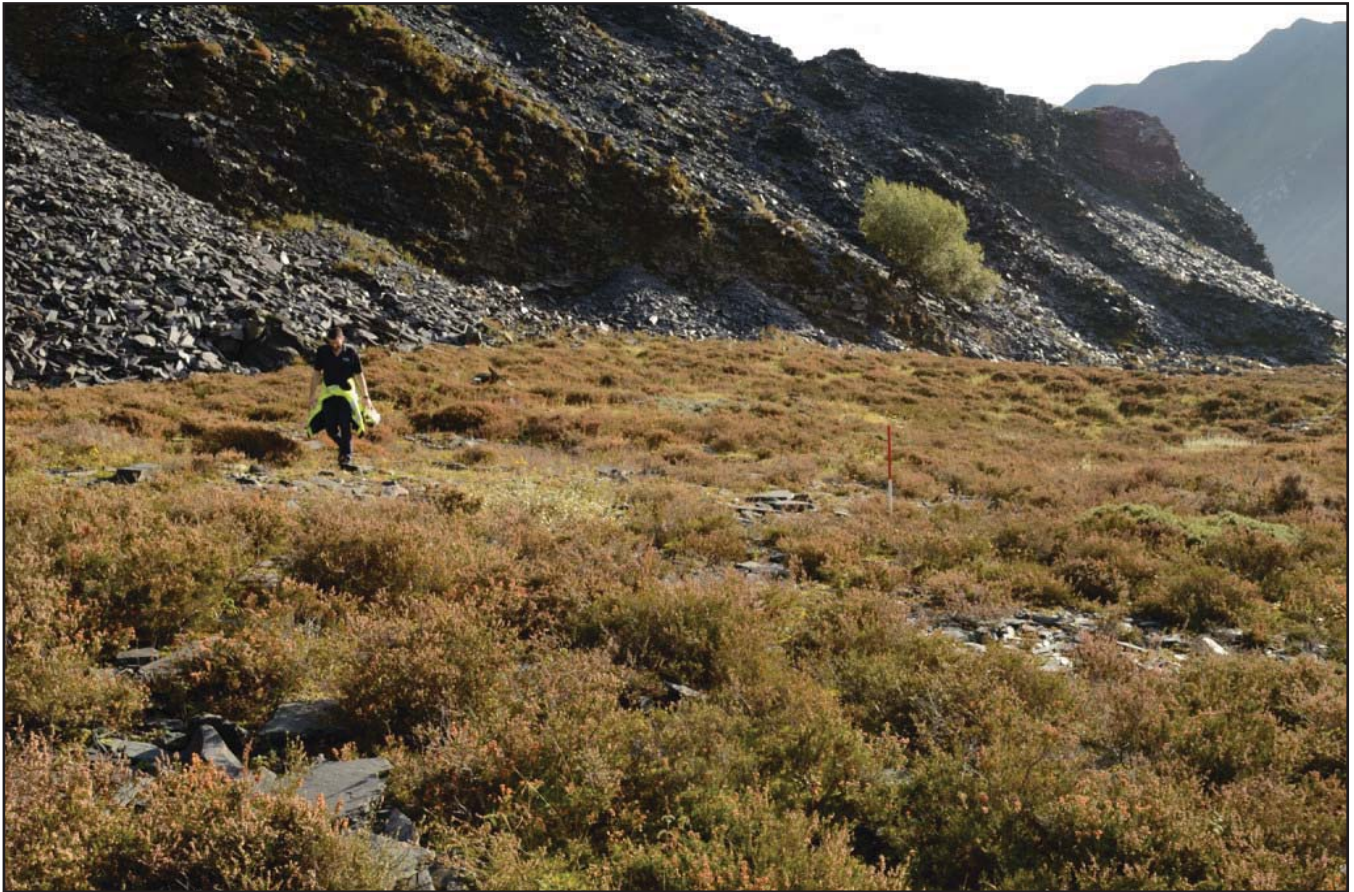
Plate 05: Location of temporary site compound. Scale 1.0m. View from the north (Photographic archive ref. G2486_019).

The temporary compound was located along the southern edge of the site boundary, adjacent to old quarry slate faces (Plate 10), off the track that extended north – south through the work area. The re-fuelling depot was positioned at the southern edge of the compound. A rectangular trench that measured 9.00m long by 3.50m wide was excavated by a 360° excavator fitted with a toothless bucket for the re-fuelling depot (Plate 11). The trench was excavated through quarry slate waste to a depth of 0.40m, lined with heavy sheet plastic and subsequently backfilled.

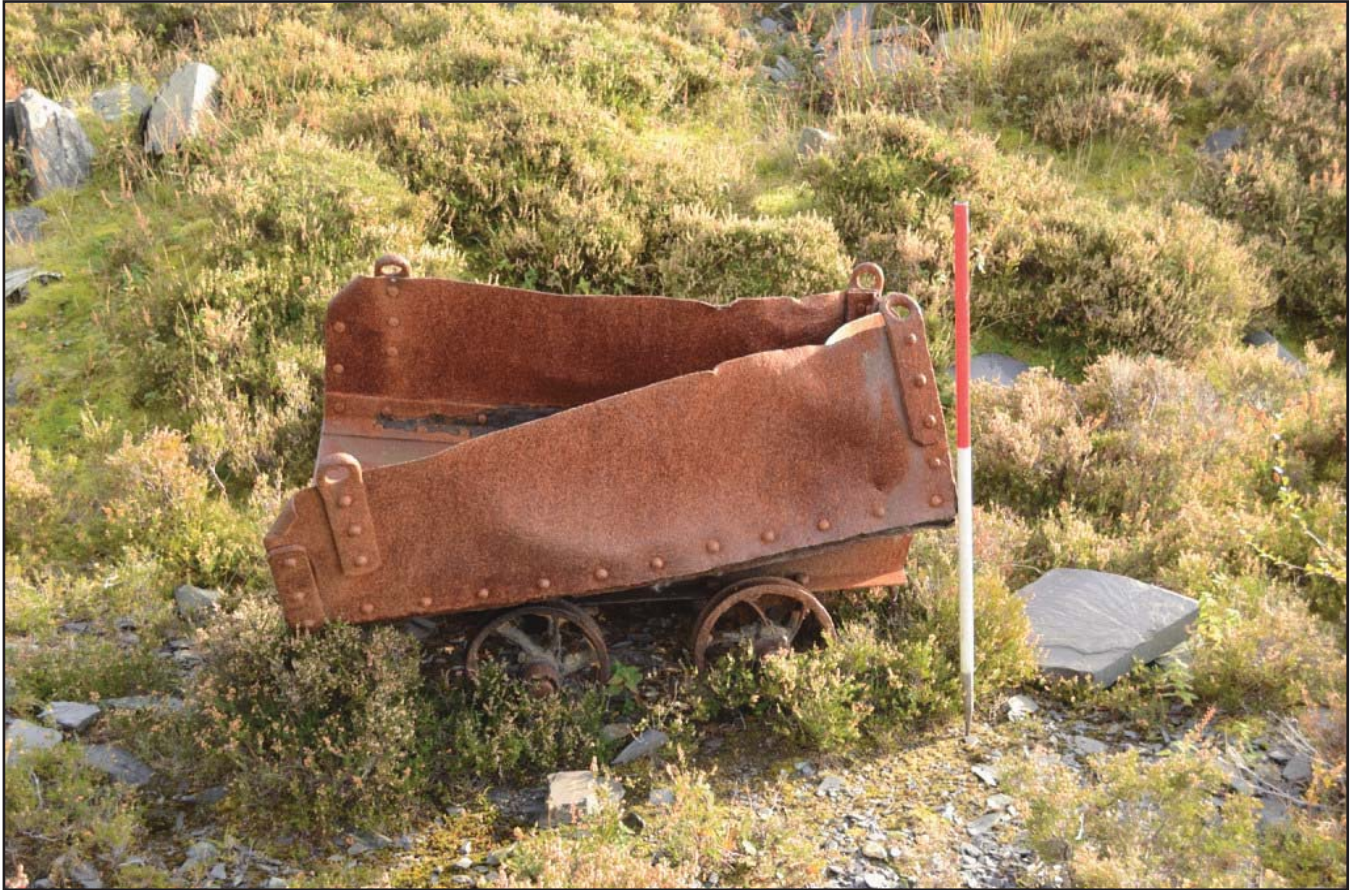
The assessment did not identify any upstanding remains within the temporary compound, (Plate 05) borrow area (Plate 06) or re-fuelling depot. At the base of the southern face of the 'Cockerel' there is the rusted remains of an old cast iron quarry truck (Plate 07) and attached to the south face of unstable rock were two cast iron quarry ladders (Plate 08). The lower of the two ladders was no longer plane to the rock face but was more or less in its original position, while the upper of the two ladders was still fastened in place by a chain that was anchored by the remnants of a dry stone wall. According to Meirion Pritchard, a former Dinorwig quarry worker, he helped to set the ladder in place in January 1946 for the purpose of allowing the engineer responsible for safety to inspect the 'Cockerel' (Bryan Williams, First Hydro engineer, pers. comm.) These quarry features were documented as they were removed during the safety works but due to the rock face being unstable it was not safe to access this part of the 'Cockerel' to take measurements.

Plate 07: Cast iron quarry truck adjacent to south face of the 'Cockerel'. Scale 1.0m. View from the north-northwest (Photographic archive ref. G2486_026).

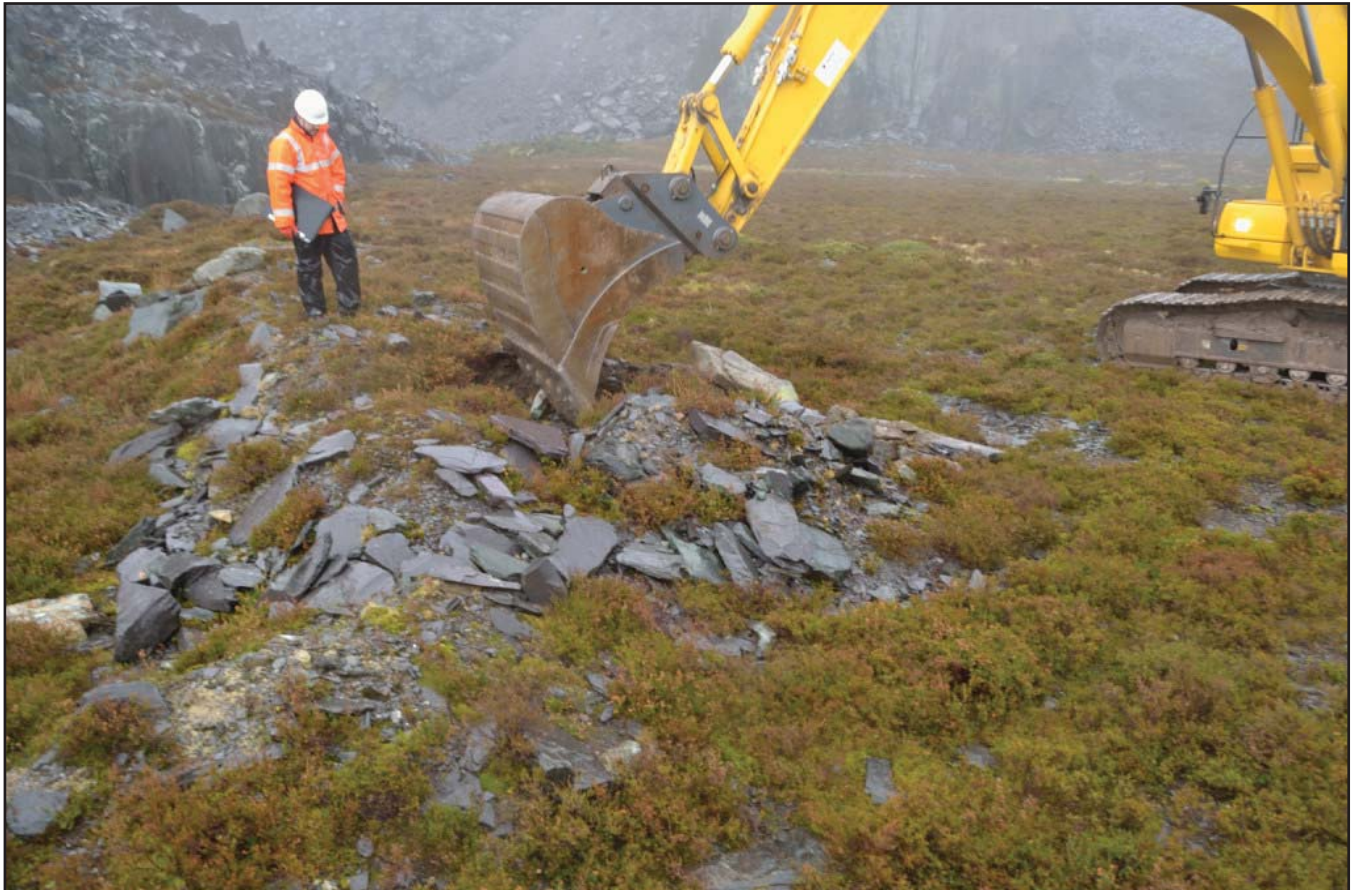
Plate 09: Excavation of ecological trial hole. View from the northwest (Photographic archive ref. G2486_033).

Six trial holes were excavated by a 360° excavator for the project ecologist to check for the presence of slow worms and lizards (Plate 09). The trial holes were concentrated in areas of dense vegetation within the borrow area (the area of the site that was used to create temporary ramps to allow plant access to the 'Cockerel'). The trial holes had an average length of 2.50m and width of 2.00m and cleared the vegetation onto the surface of the underlying quarry slate waste. The area was subsequently inspected by the ecologist. No wildlife or archaeological remains were identified during this work.

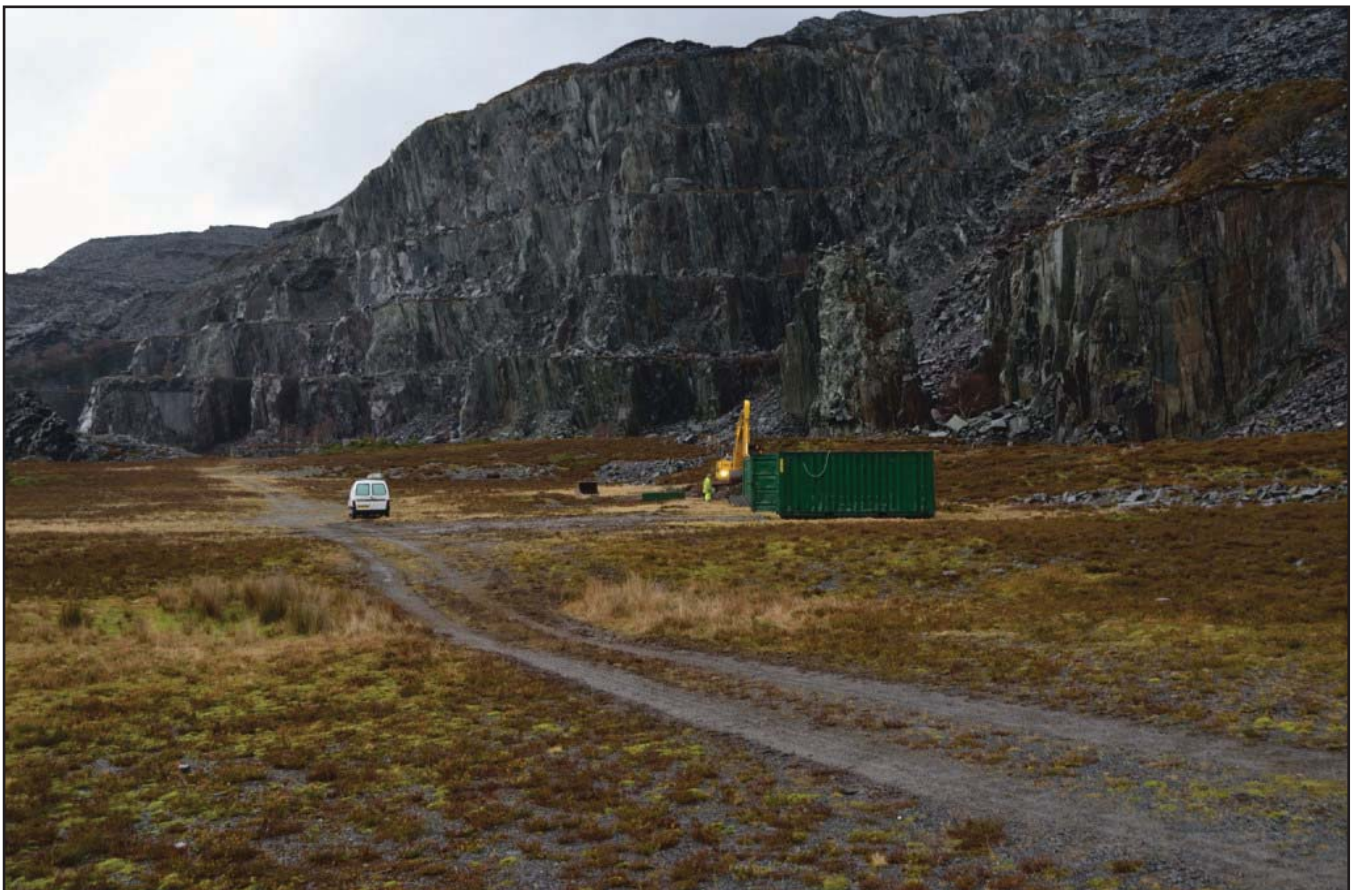
Plate 10: Location of Jones Bros Ltd compound. View from the southeast (Photographic archive ref. G2486_038).

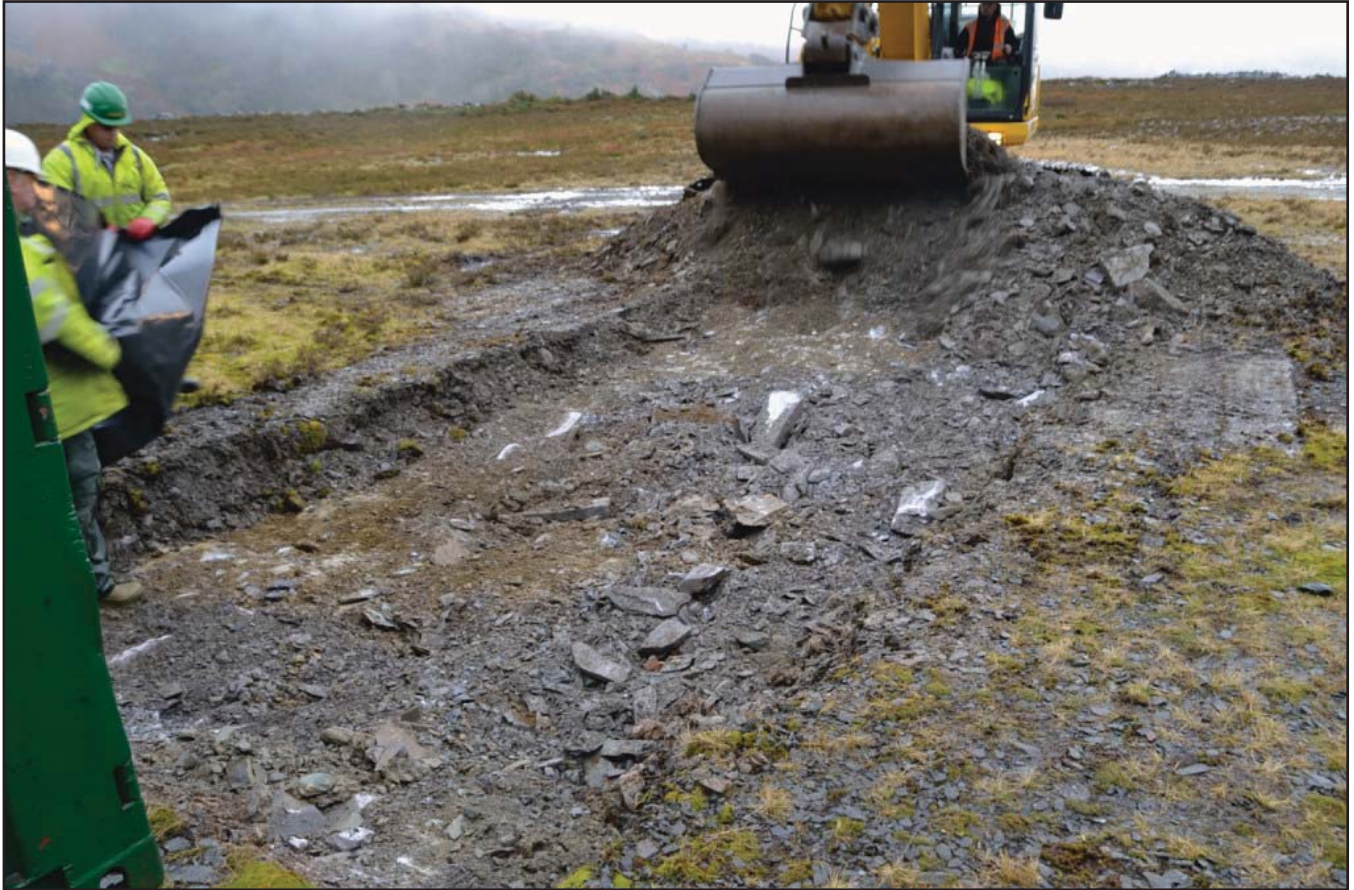
Plate 11: Re-fuelling depot excavated. View from the northeast (Photographic archive ref. G2486_036).

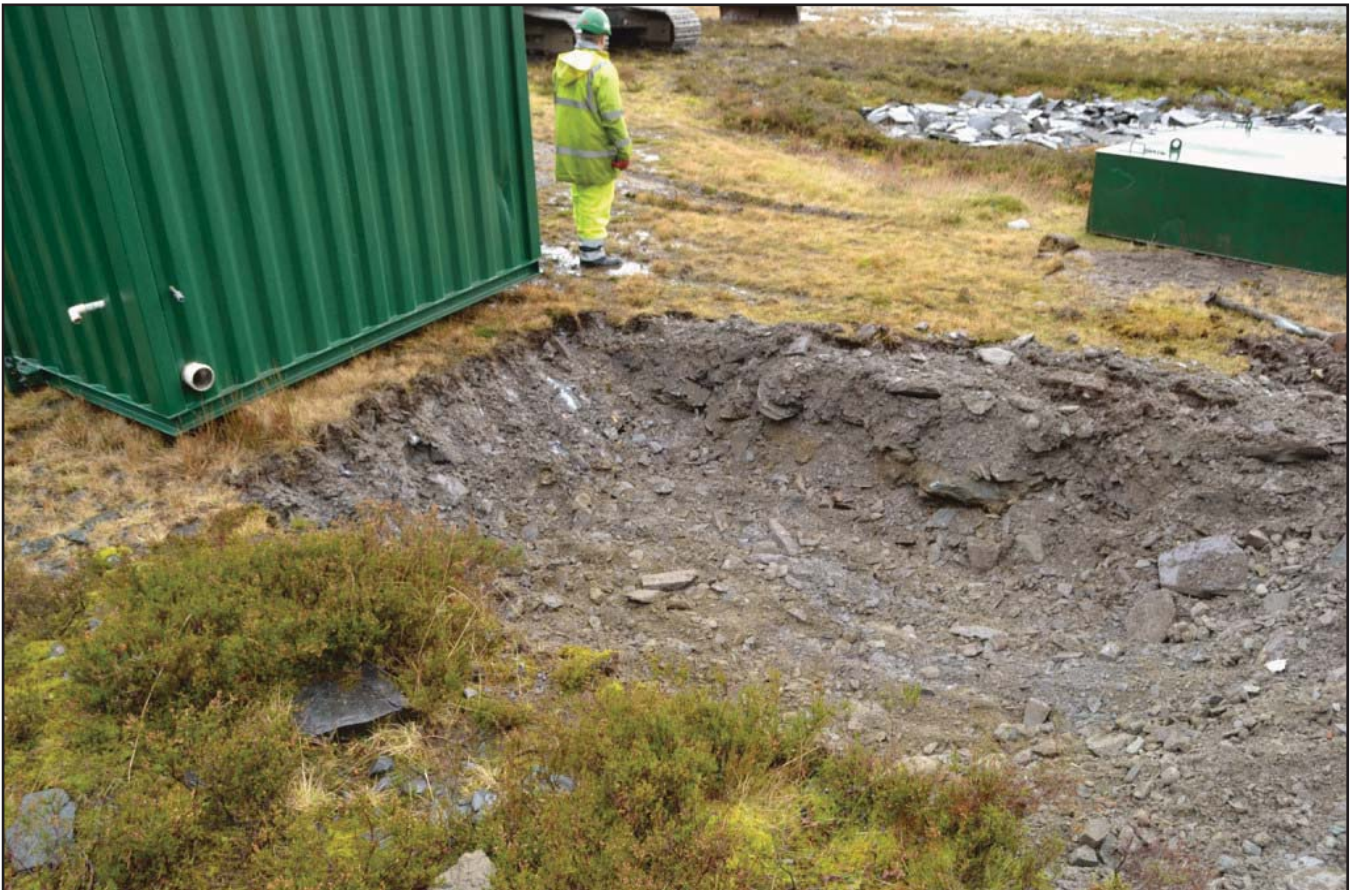
At the northern end of the temporary compound a second trench was excavated with a length of 8.00m, width of 4.00m and depth of 0.50m for the toilet block tank (Plate 12). It was excavated by a 360° excavator fitted with a toothless bucket. The trench was excavated through quarry slate waste that was mixed with the occasional piece of scrap metal, wood and brick. No in situ structures or archaeological remains were noted in either trench.

Plate 12: Trench for toilet block tank excavated. View from the northwest (Photographic archive ref. G2486_037).

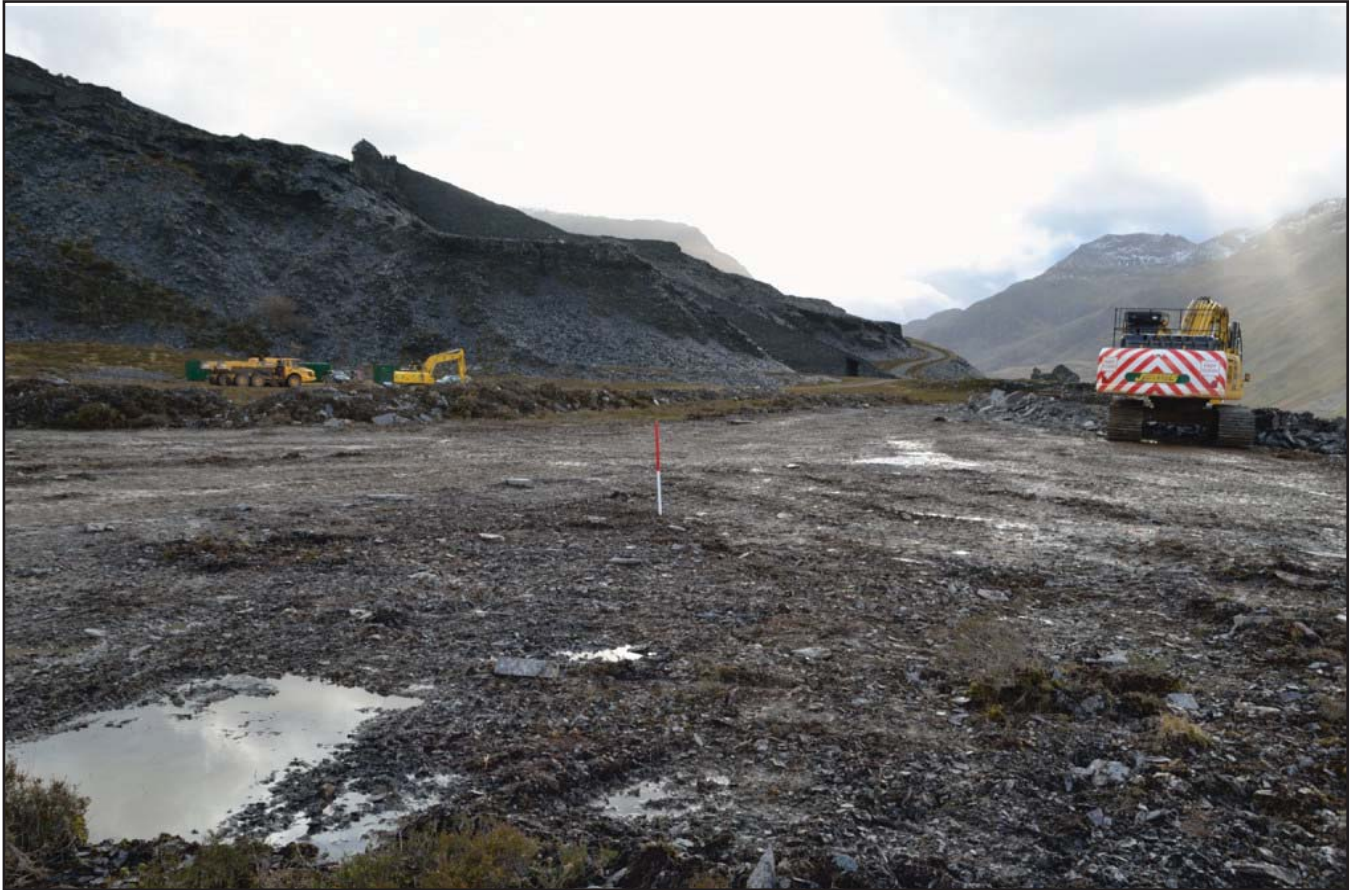
Plate 13: Vegetation cleared off borrow area. Scale 1.0m. View from the northwest (Photographic archive ref. G2486_041).

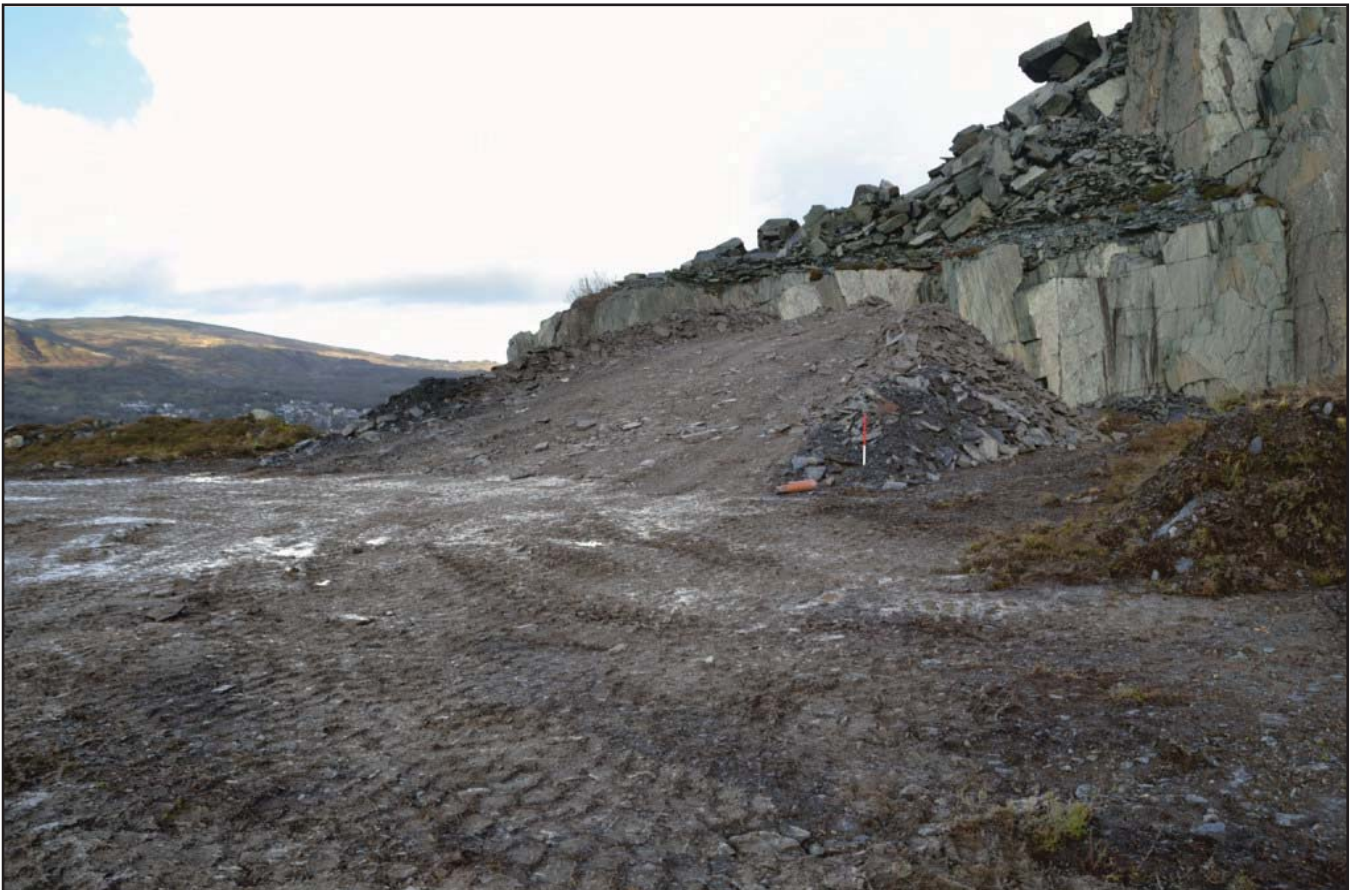
Plate 14: Access incline being constructed beside the 'Cockerel'. Scale 1.0m. View from the southeast (Photographic archive ref. G2486_042).

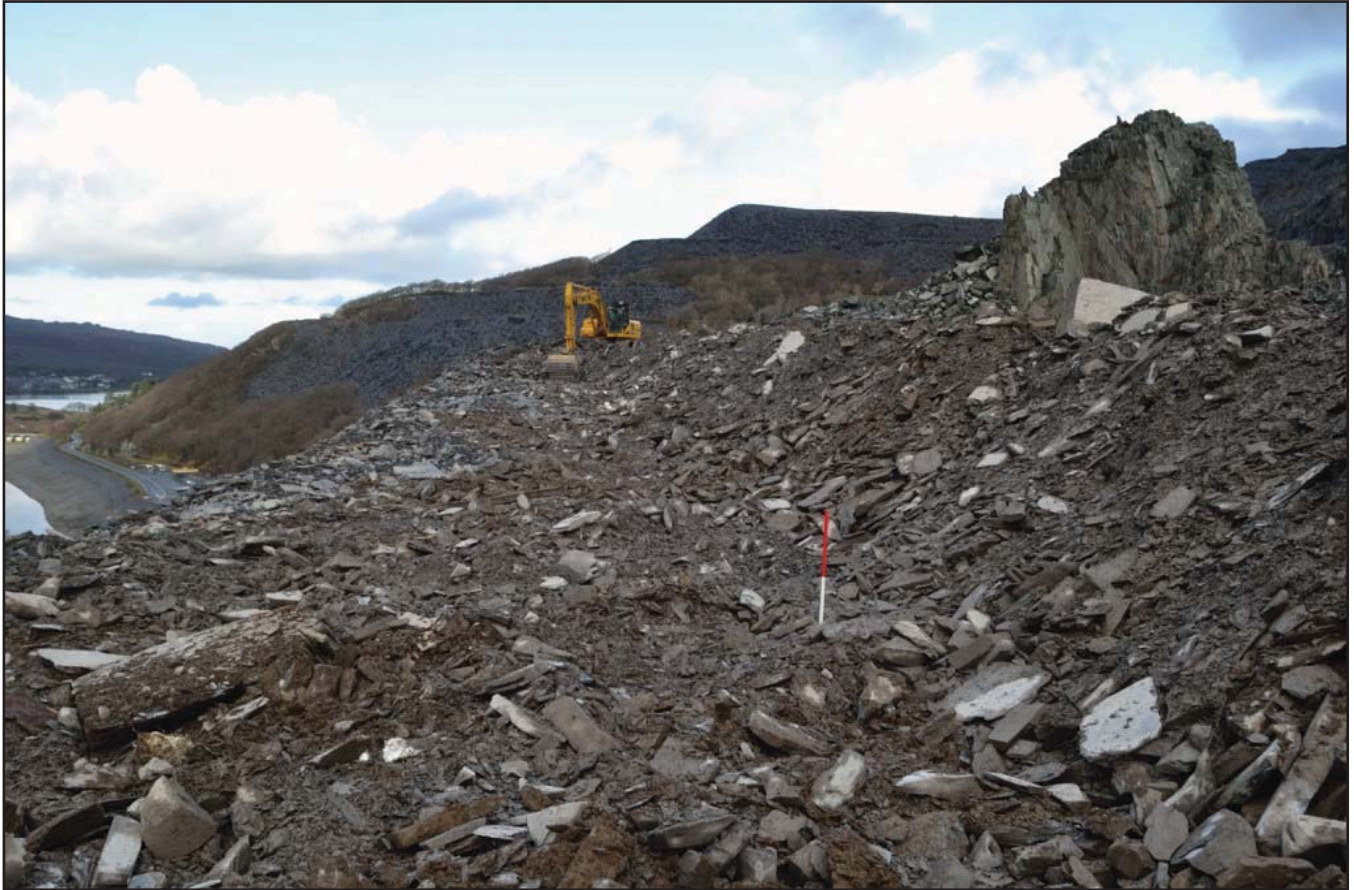
Plate 15: Excavation of the borrow area. Scale 1.0m. View from the southeast (Photographic archive ref. G2486_039).

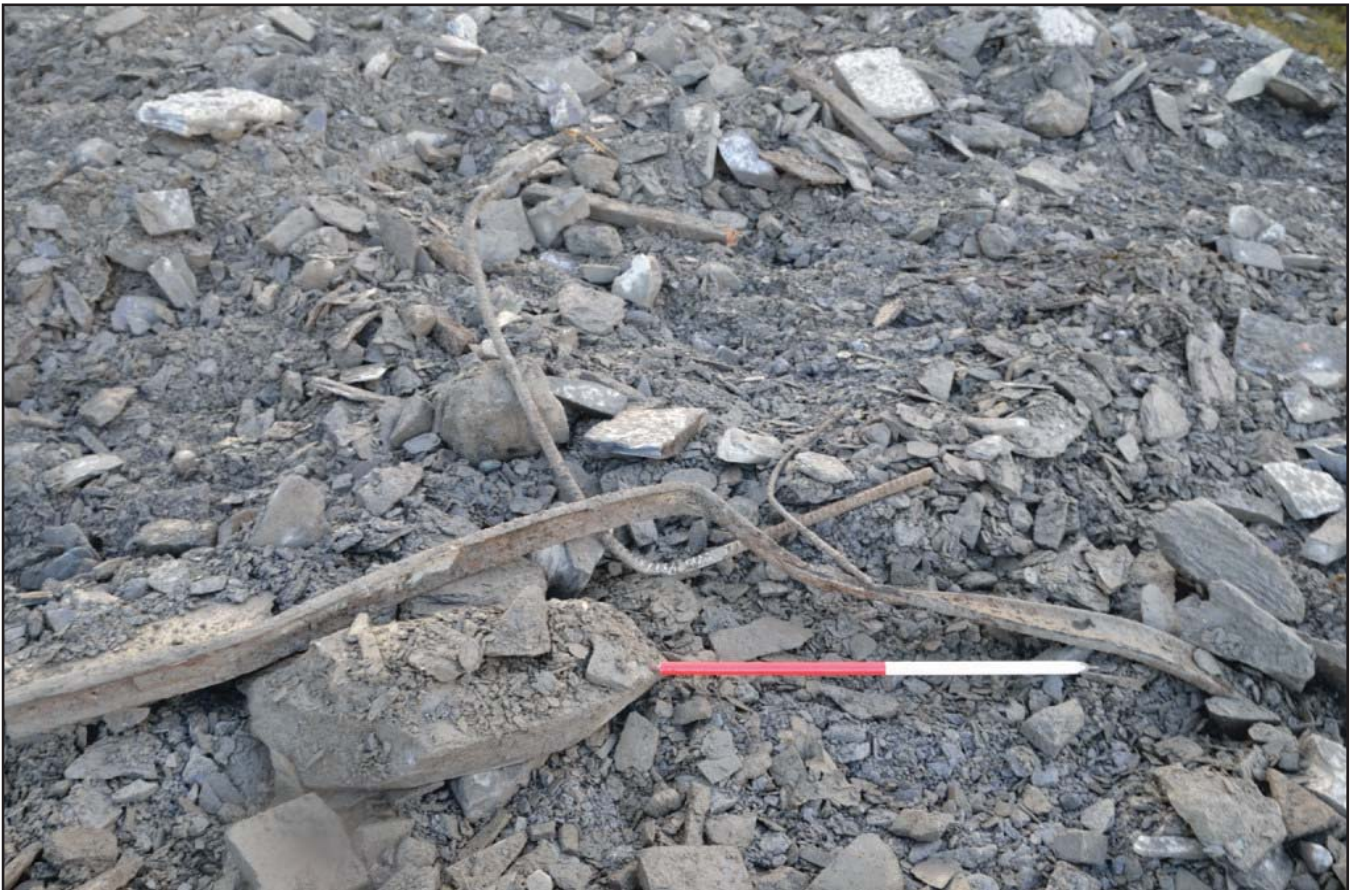
By 7th February Jones Bros Ltd. had cleared the vegetation off the surface of the borrow area (Plate 13) and had commenced removing the quarry slate waste to form the temporary access incline (Plate 14) by the south face of the 'Cockerel'. The excavation of the quarry slate waste was focused along the western edge of the borrow area, alongside a former quarry track, overlooking the Llyn Peris reservoir. The material was excavated by a 360° excavator fitted with a large toothed digging bucket, loaded onto two Volvo dumper trucks and deposited at the base of the south face of the 'Cockerel'. The excavation had an approximate depth of 2.00m (Plate 15). The quarry slate waste within the borrow area was mixed with occasional blocks of reinforced concrete, timber and waste metal (girders and re-bar) (Plate 16). No in situ structures or archaeological remains were noted and the material mixed with the slate waste was indicative of 20th century activity.

Plate 16: Example of material mixed with quarry slate waste. Scale 1.0m. View from the northwest (Photographic archive ref. G2486_040).

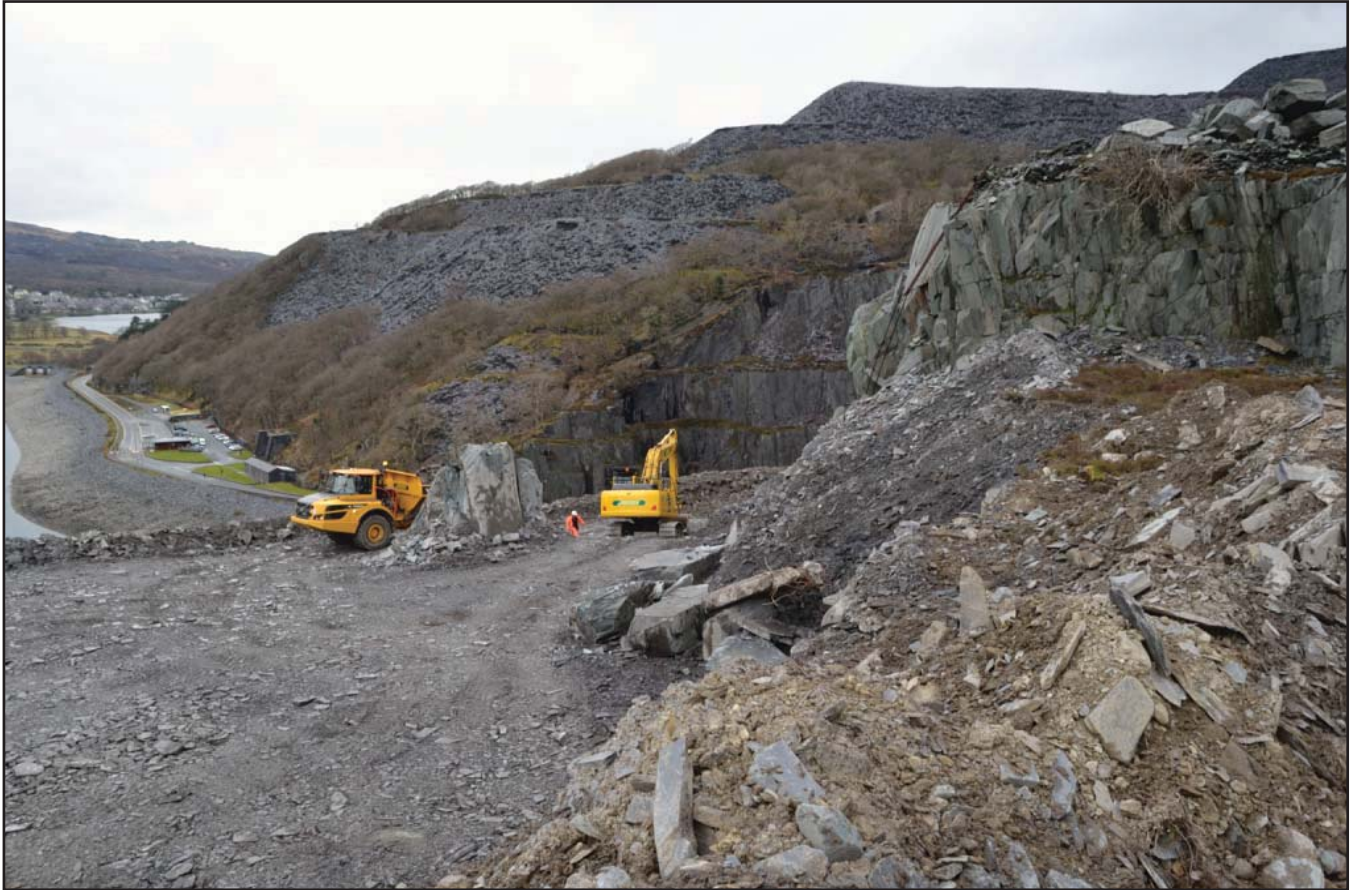
Plate 17: Catchment area and bunds below the 'Cockerel'. View from the southeast (Photographic archive ref. G2486_059).

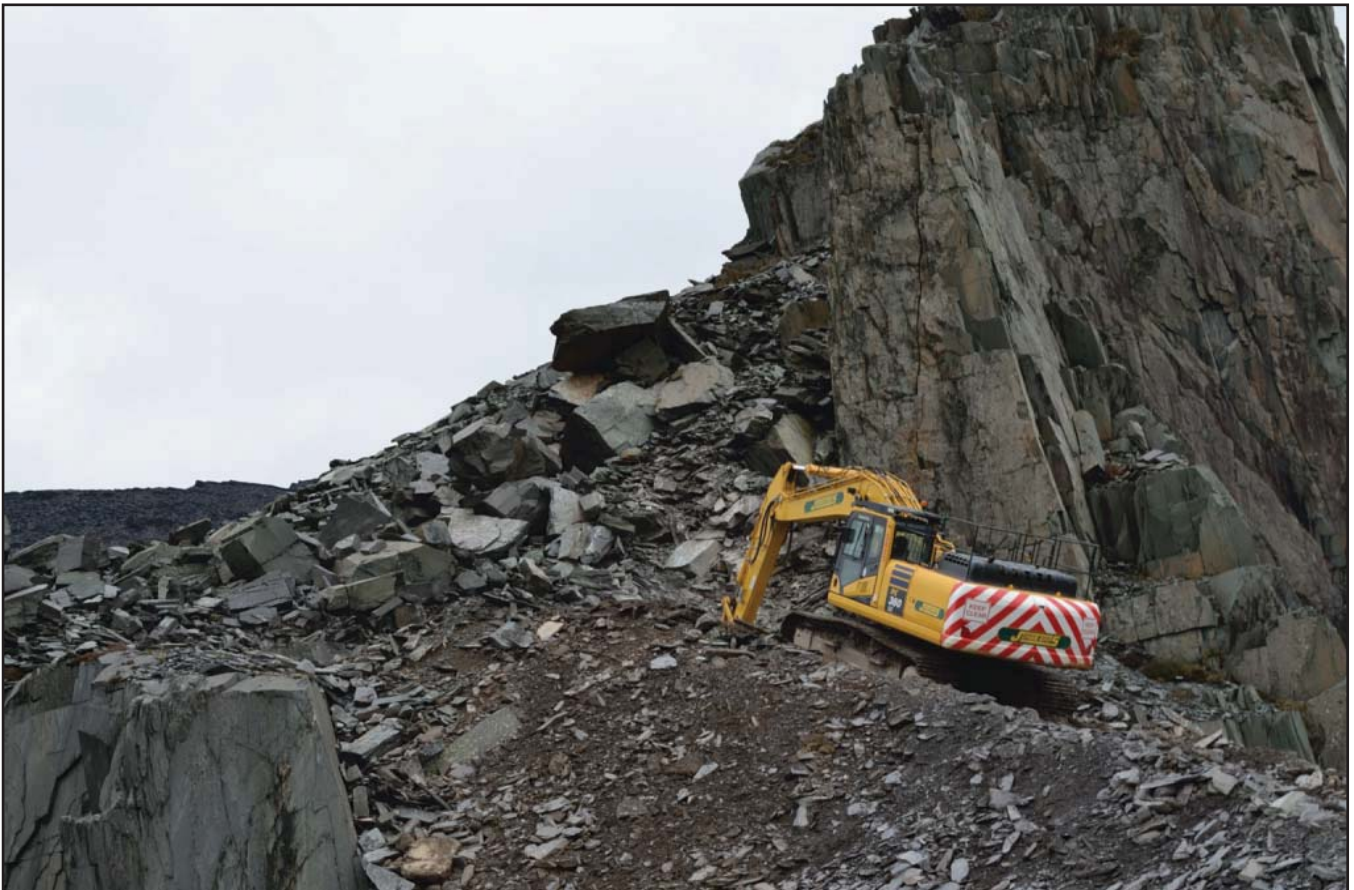
Plate 18: Start of rock fall clearance work. View from the southeast (Photographic archive ref. G2486_060).

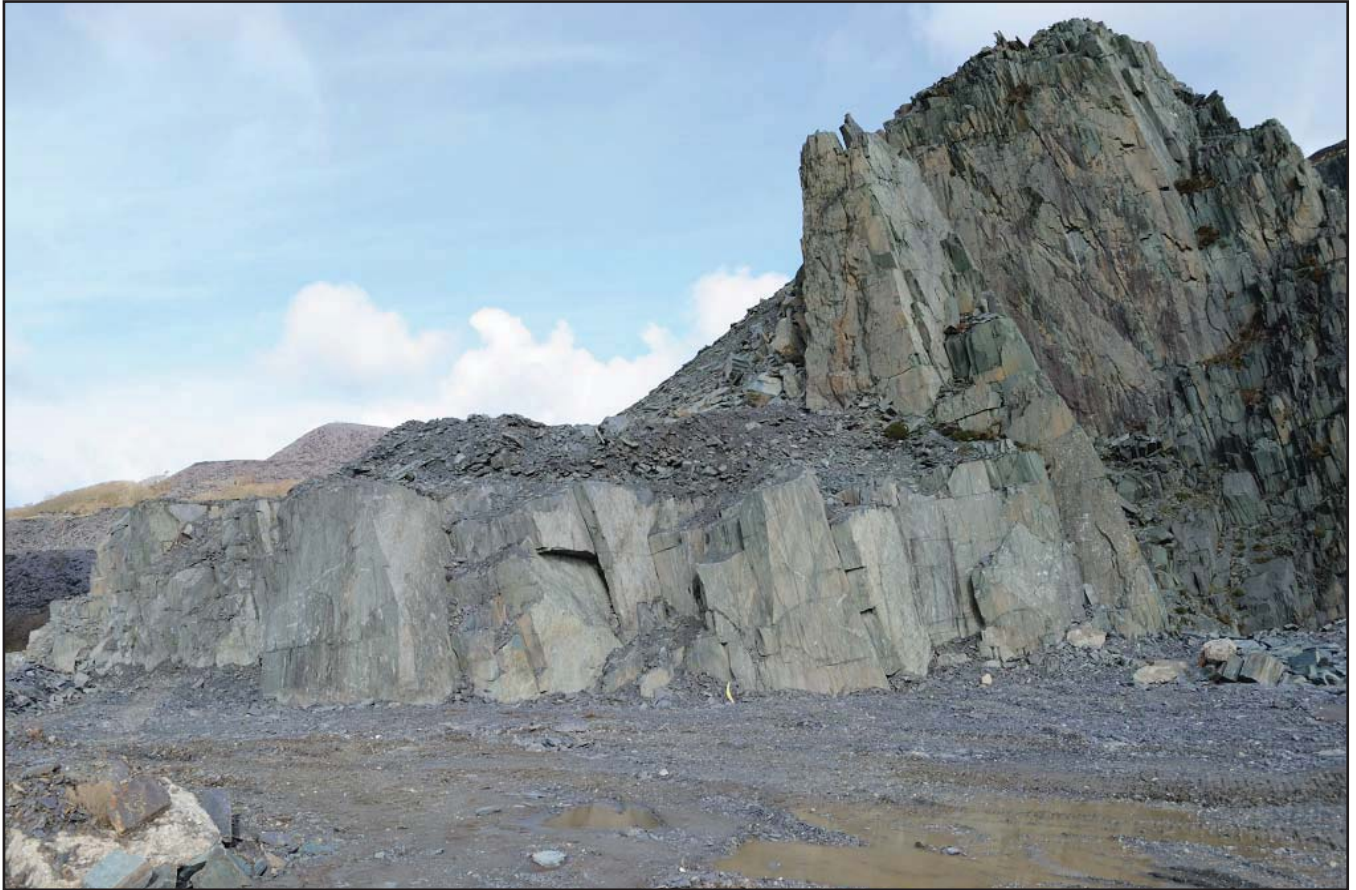
Plate 19: Upper bund along edge of the 'Cockerel'. View from the south (Photographic archive ref. G2486_064).

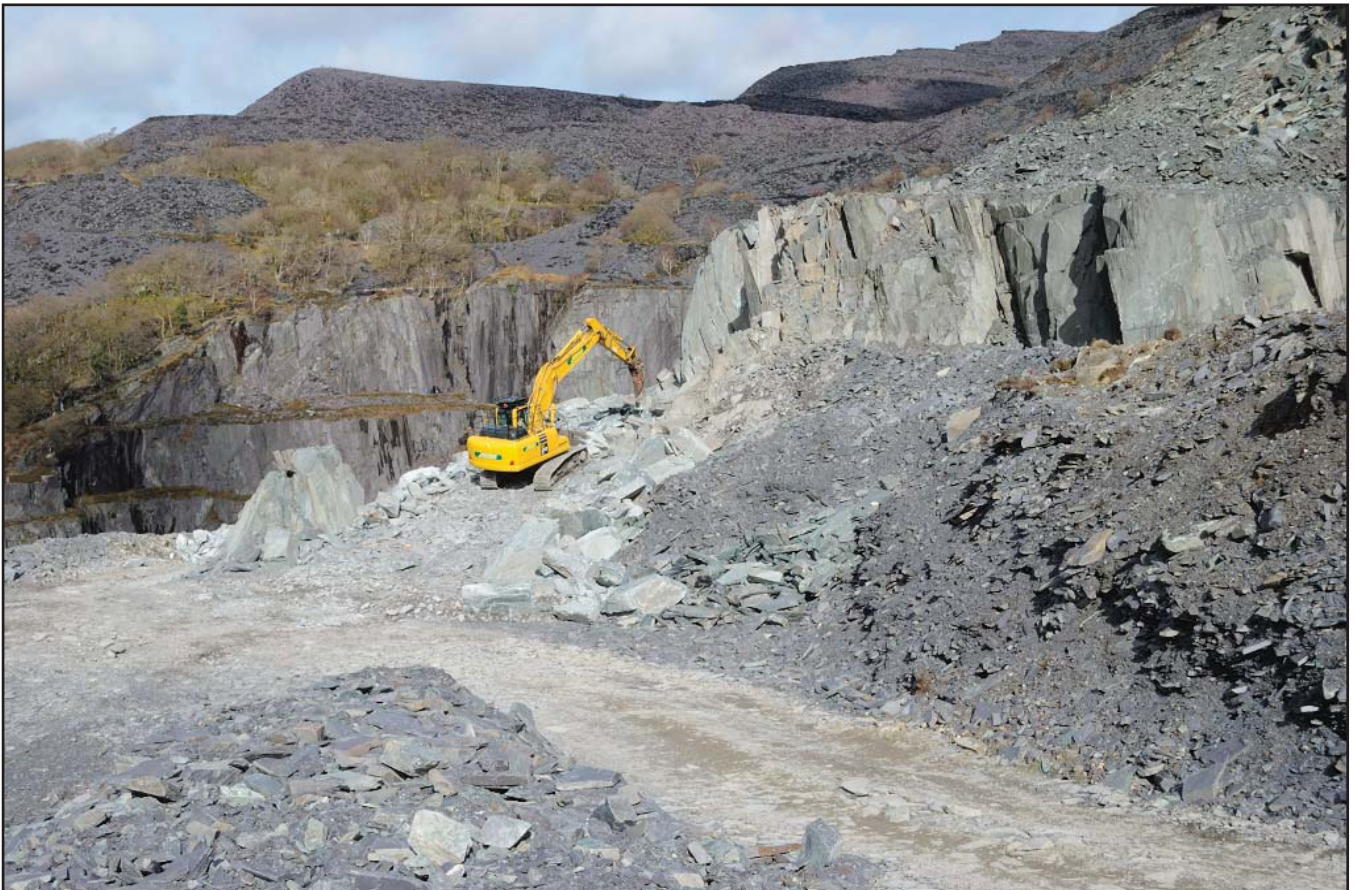
Plate 20: Breaking up boulders from unstable rock face of the 'Cockerel'. View from the south (Photographic archive ref. G2486_065).
