Dinorwig Power Station, Llanberis

Archaeological Watching Brief

Prosiect Rhif / Project No. G2486

Adroddiad Rhif / Report No. 1388

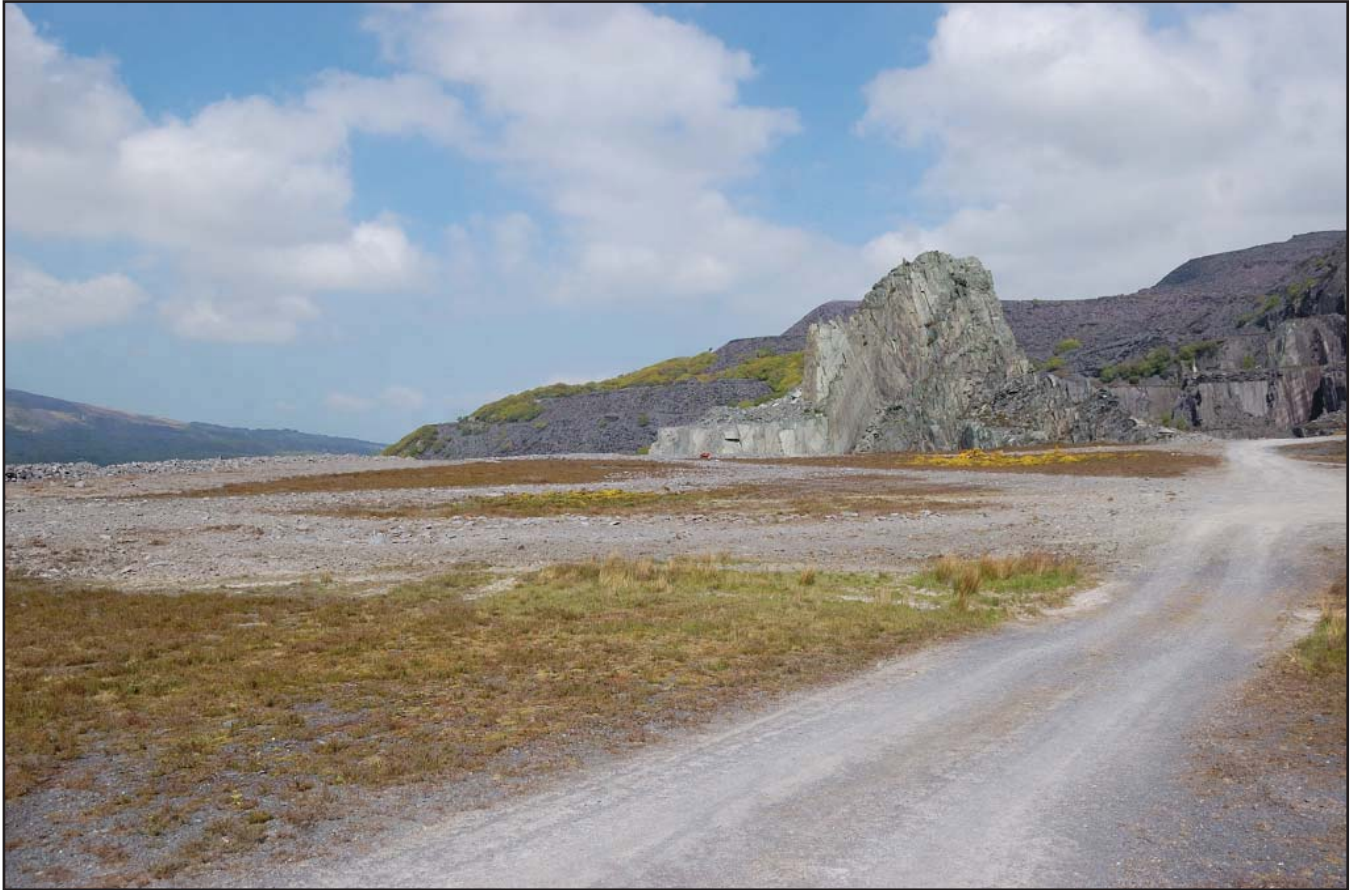
Plate 21: Reinstated borrow area after completion of groundworks. View from the south (Photographic archive ref. G2486_067).

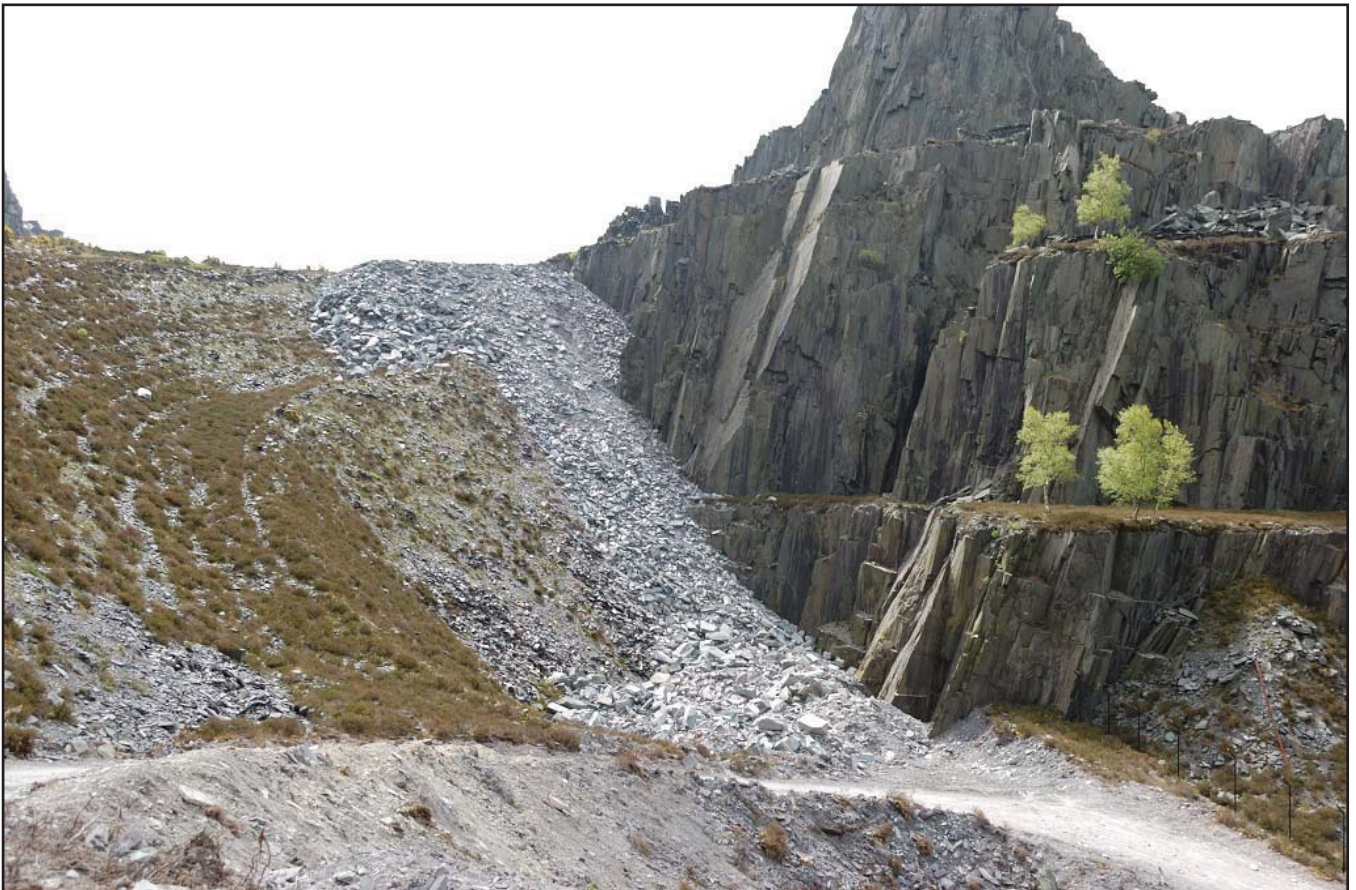
Plate 22: Waste slate dumped into east quarry hole from the 'Cockerel'. View from the north-northeast (Photographic archive ref. G2486_076).

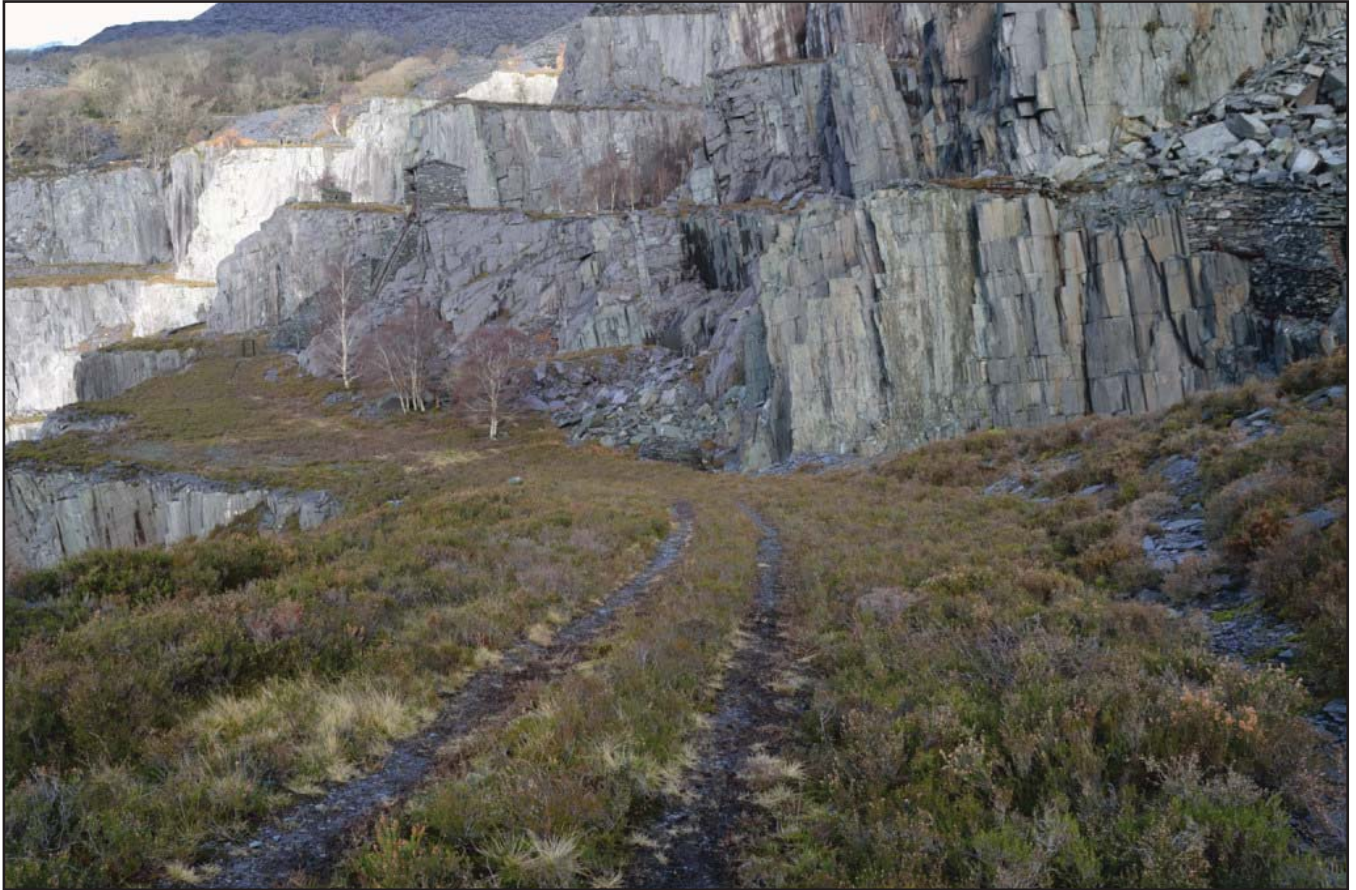
The circular blast shelter is located to the east of the 'Cockerel', at the base of a vertical slate quarry face and immediately adjacent to a quarry track (Plate 23) and the east quarry hole. In advance of the rock fall clearance from the 'Cockerel' and deposition of this material into the east quarry hole the shelter was surveyed in, photographed and recorded on GAT watching brief pro-formas.

Plate 23: Location of circular blast shelter. View from the southeast (Photographic archive ref. G2486_043).

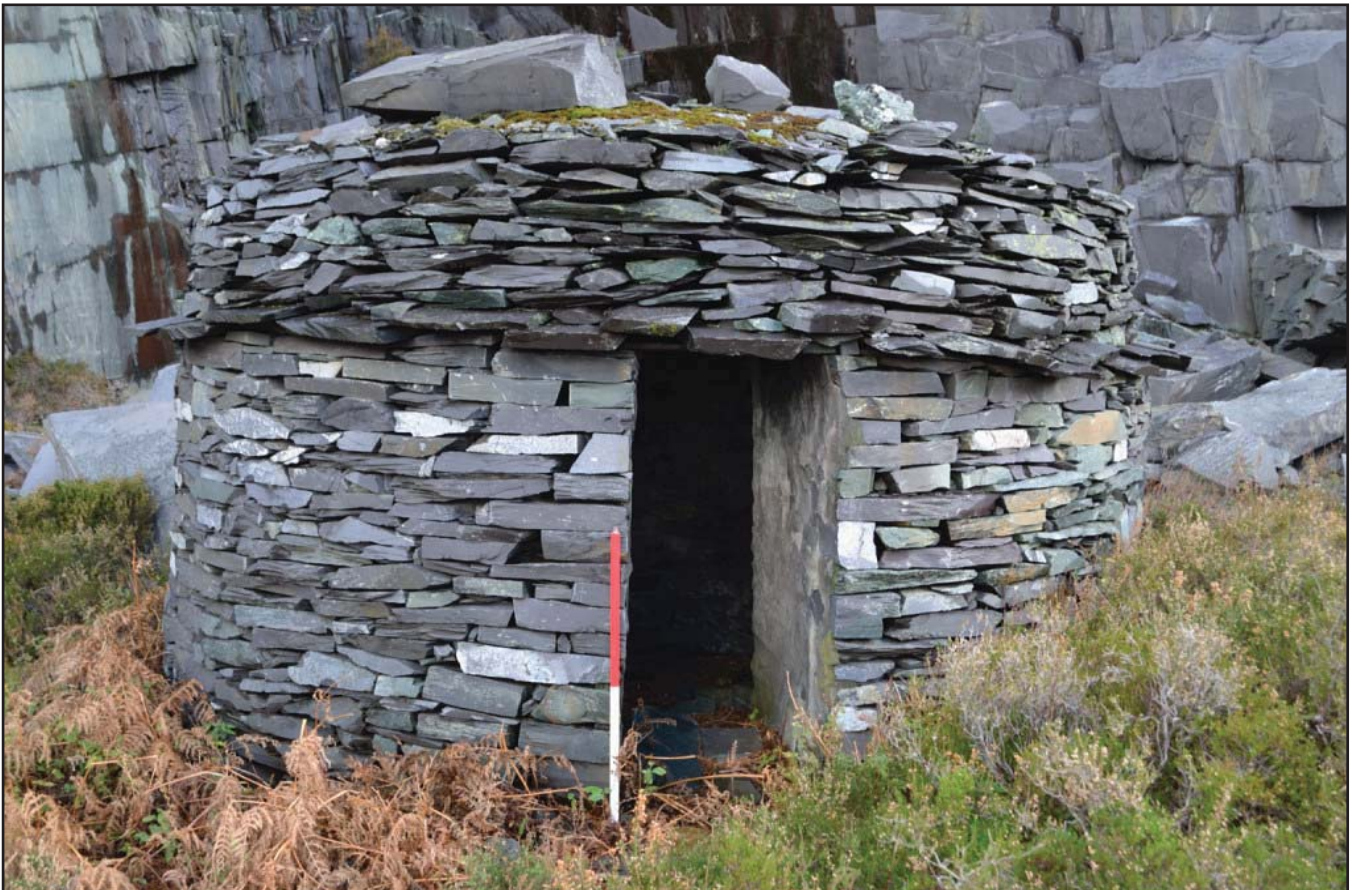
The circular blast shelter is of roughly coursed dry stone build, comprised of roughly dressed angular slate blocks of various lengths, with a corbelled roof (Plate 24). The wall of the shelter had an average height of 1.62m with the corbelled roof being approximately 0.62m high; combined height of 2.24m. It has an internal circumference of 1.85m and approximate external circumference of 3.90m and wall thickness of 1.36m. There is a single narrow (1.00m) entrance on the west face. The interior of the blast shelter, including the entrance, was lined by a fine, coarse light greyish white lime mortar that has an engraved date (*July 1952*) on the eastern wall (Plate 25), opposite the entrance. The ceiling of the shelter consists of seven lengths of timber (Plate 26), most of which still retained bark, whereas the ceiling of the entrance comprises of nine narrow steel bars (Plate 27). This is a well-built structure designed to protect the quarry workers during blasting of quarry faces.

Plate 24: The circular blast shelter. Scale 1.0m. View from the west (Photographic archive ref. G2486_044).

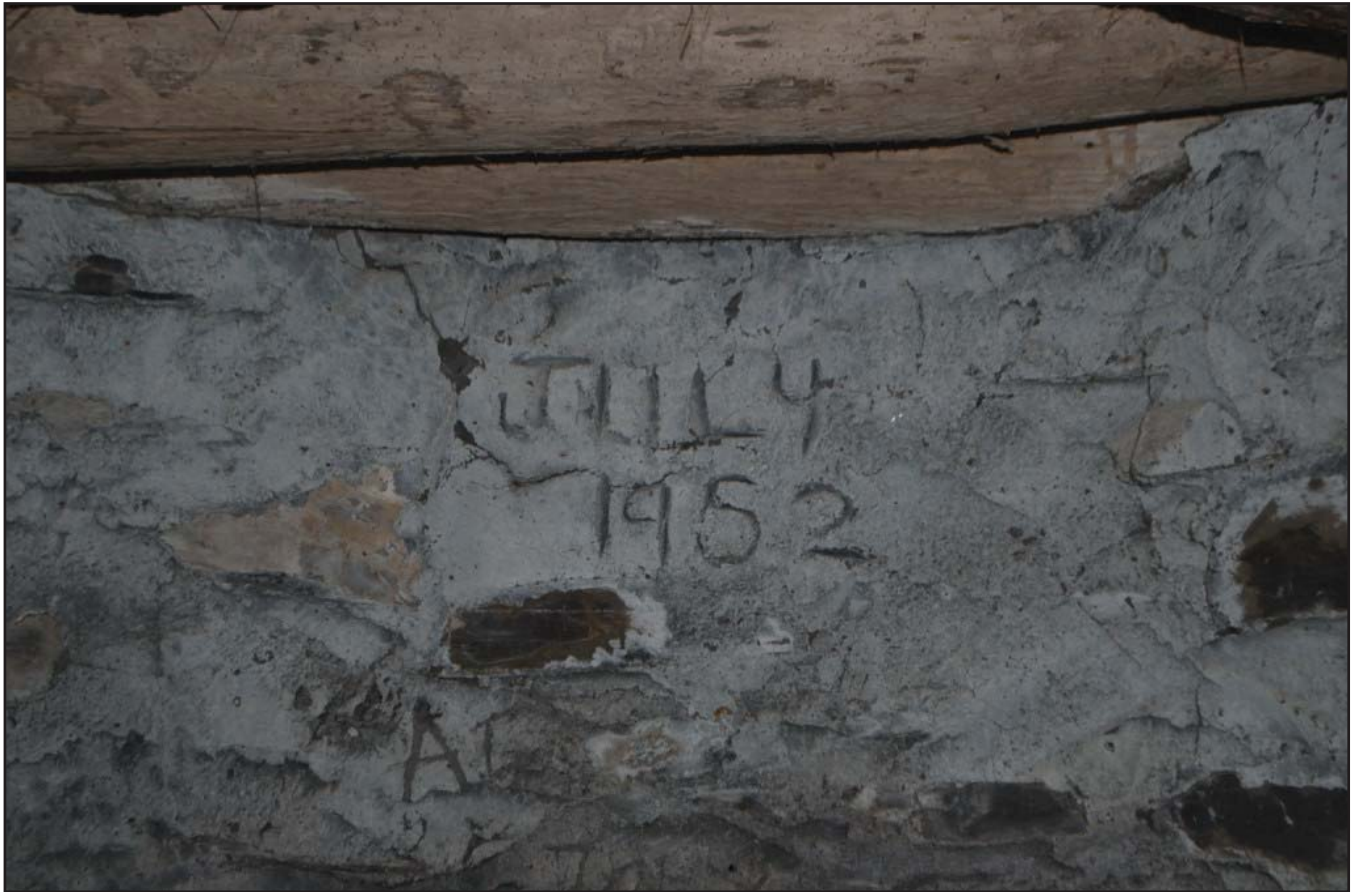
The circular blast shelter does not appear on any of the available OS maps and cannot be dated through map regression but the engraved date within the lime mortar render would place its construction quite succinctly to July 1952. The shelter was not damaged or altered during the safety works but the protective boulders have been left in situ which does alter the immediate setting of the shelter.

Plate 25: Engraved date within lime mortar render of circular blast shelter. View from the west (Photographic archive ref. G2486_051).

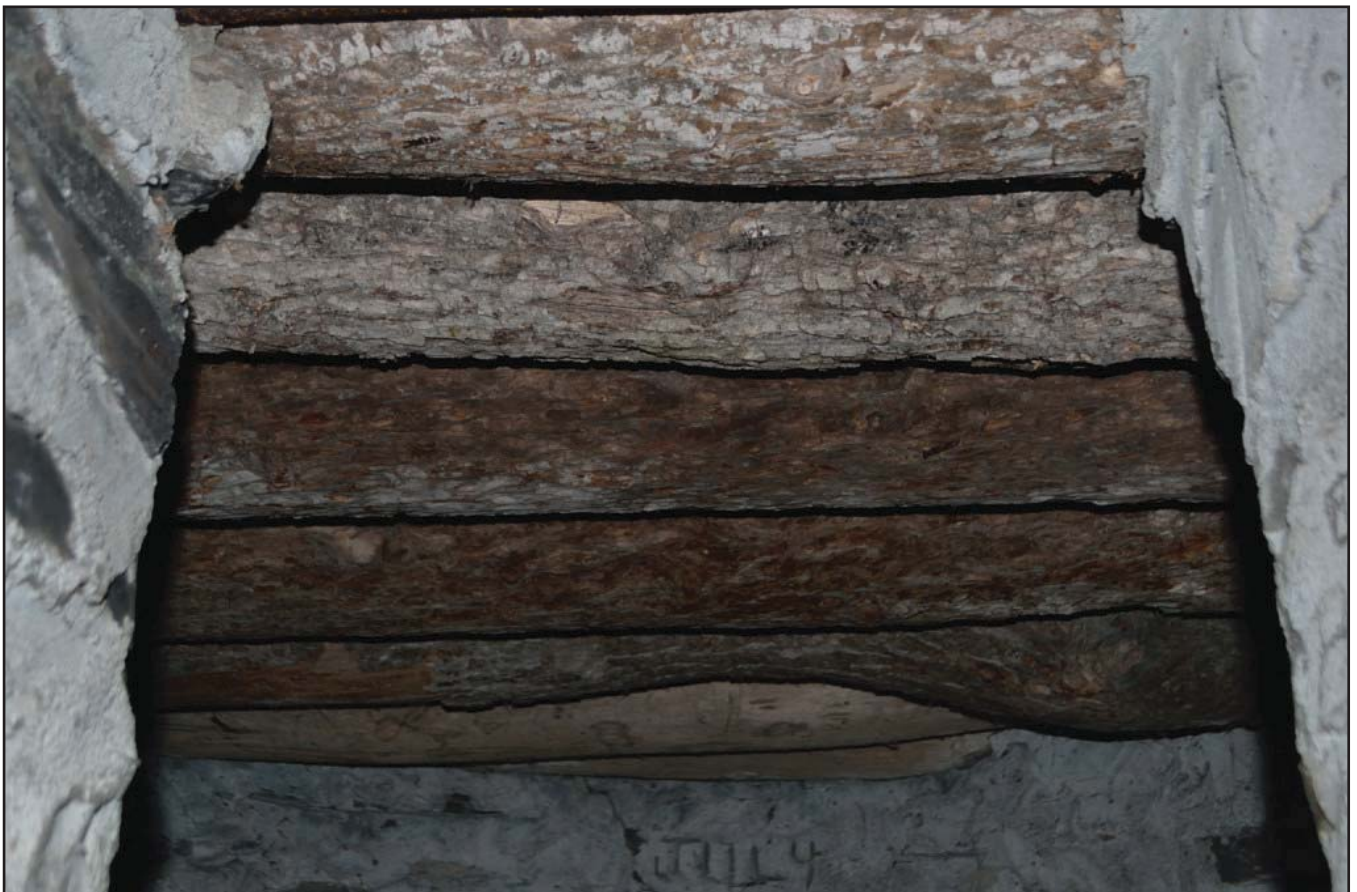
Plate 26: Timber ceiling of circular blast shelter. View from the west (Photographic archive ref. G2486_052).

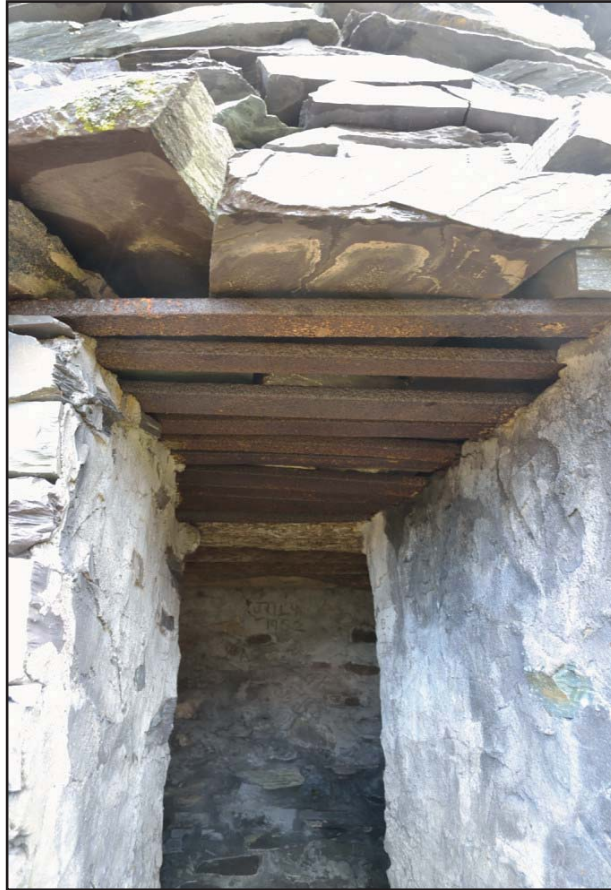
Plate 27: Ceiling of the entrance of the circular blast shelter. View from the west (Photographic archive ref. G2486_050).

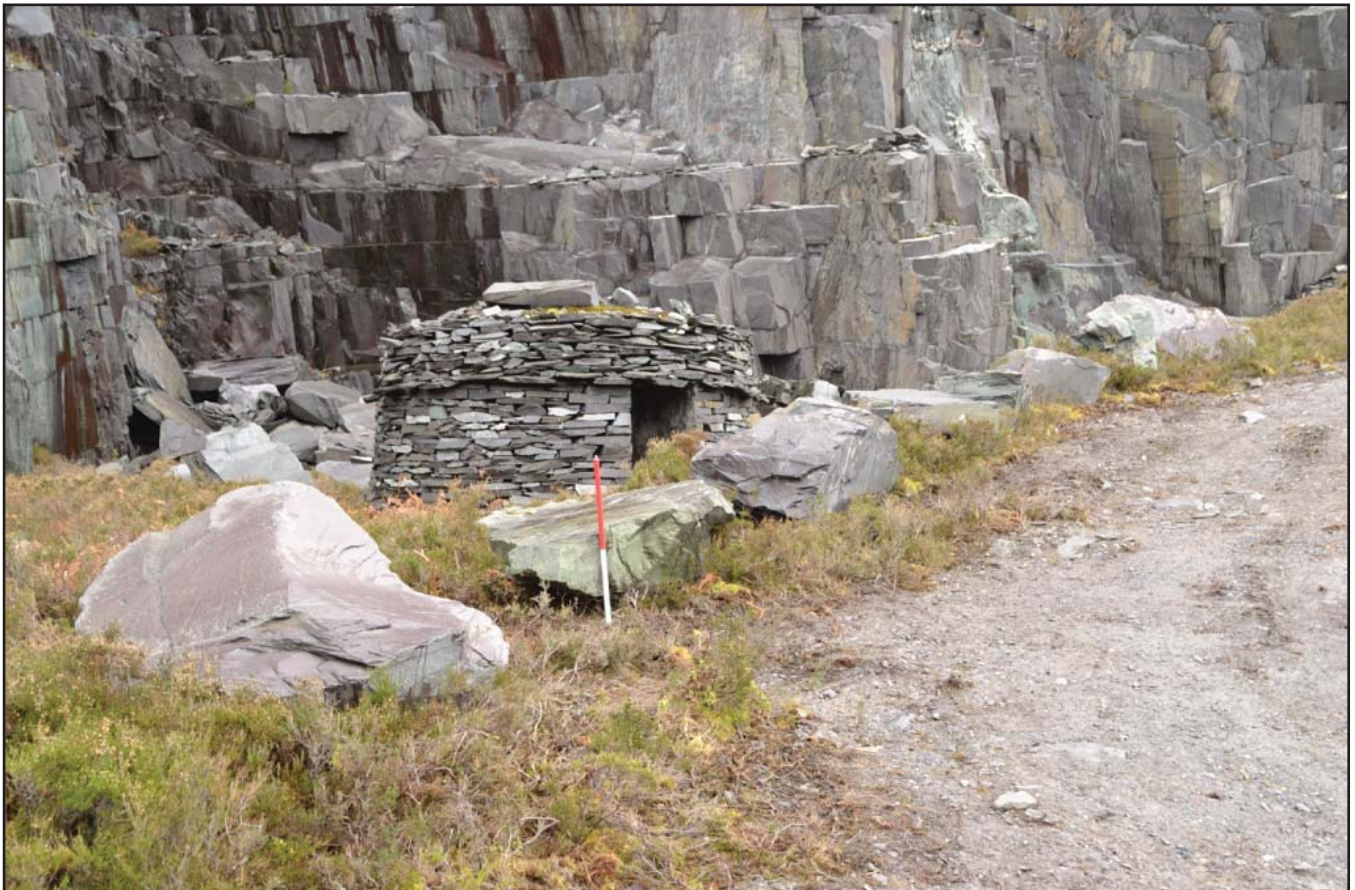
Subsequent to recording the circular blast shelter on 7th February but when the project archaeologist was not on site, Jones Bros Ltd. set eight large angular slate boulders along the eastern edge of the quarry track (Plate 28); the boulders were noted during the third site visit on 20th February. The boulders were set in place instead of a bank to protect the circular blast shelter from the Volvo dumper trucks as the rock fall material was cleared from the 'Cockerel' and deposited in the east quarry hole. The shelter was visited again on 21st March and during the last site visit on 10th May.

Plate 28: Slate boulders to protect the circular blast shelter. Scale 1.0m. View from the west (Photographic archive ref. G2486_057).

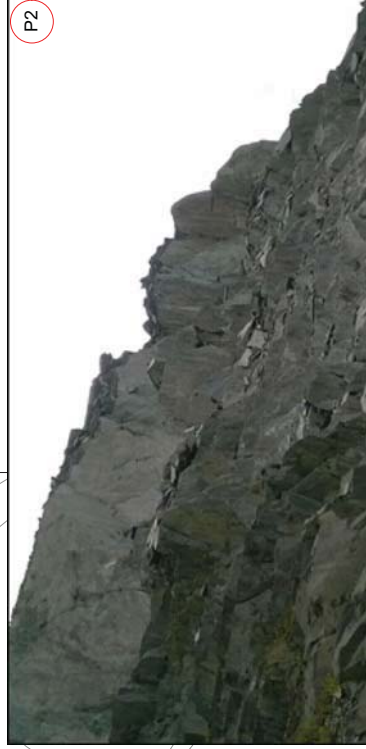
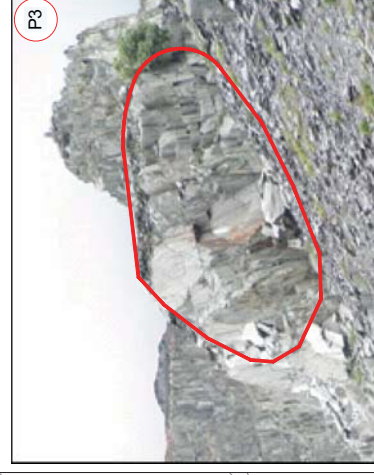
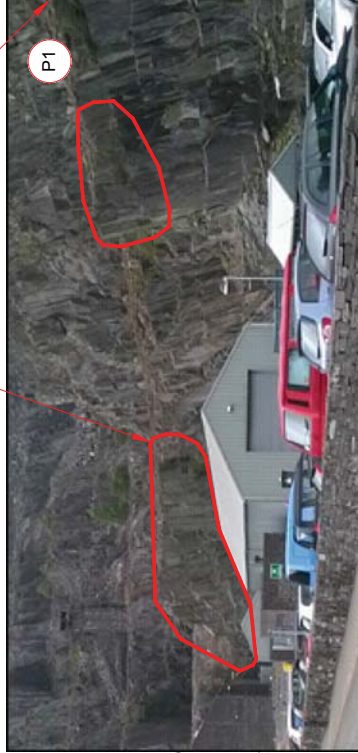
FIGURE 05
Reproduction First Hydro Company Drawing Number Figure 3

Upper Clearance Area

Rockfall Catch Fencing

Rockfall Earthworks - Proposed
Permanent Features - Plan / Photos

A **partial** watching brief is proposed for the safety works after correspondence with GAPS (email 03.11.16). The watching brief will monitor the initial clearance works within the site boundary (Figure 05), in particular:

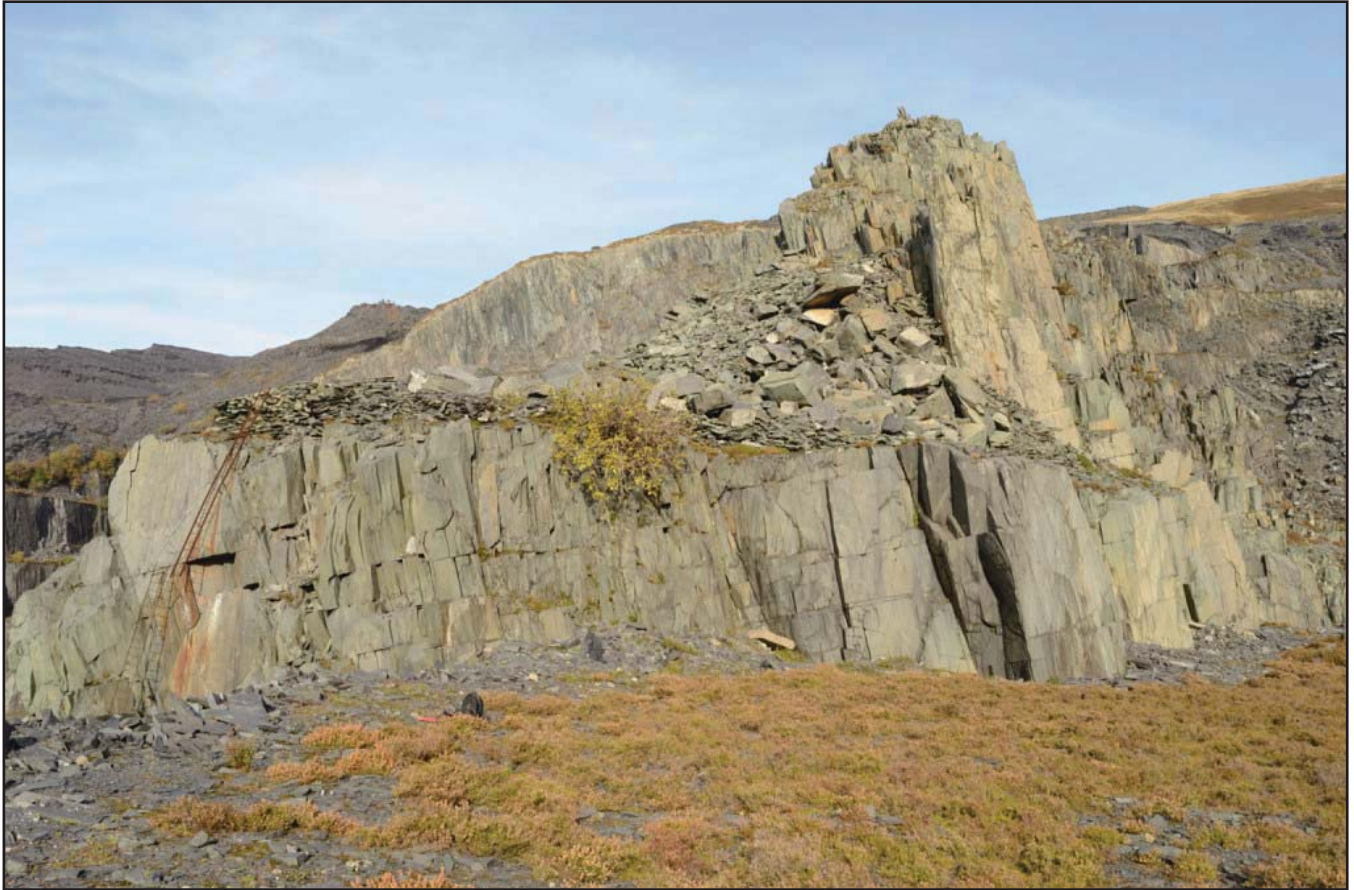
Plate 01: Collapsing section of cliff face at the 'Cockrell', with metal ladders and dry-stone wall. View from the southwest.

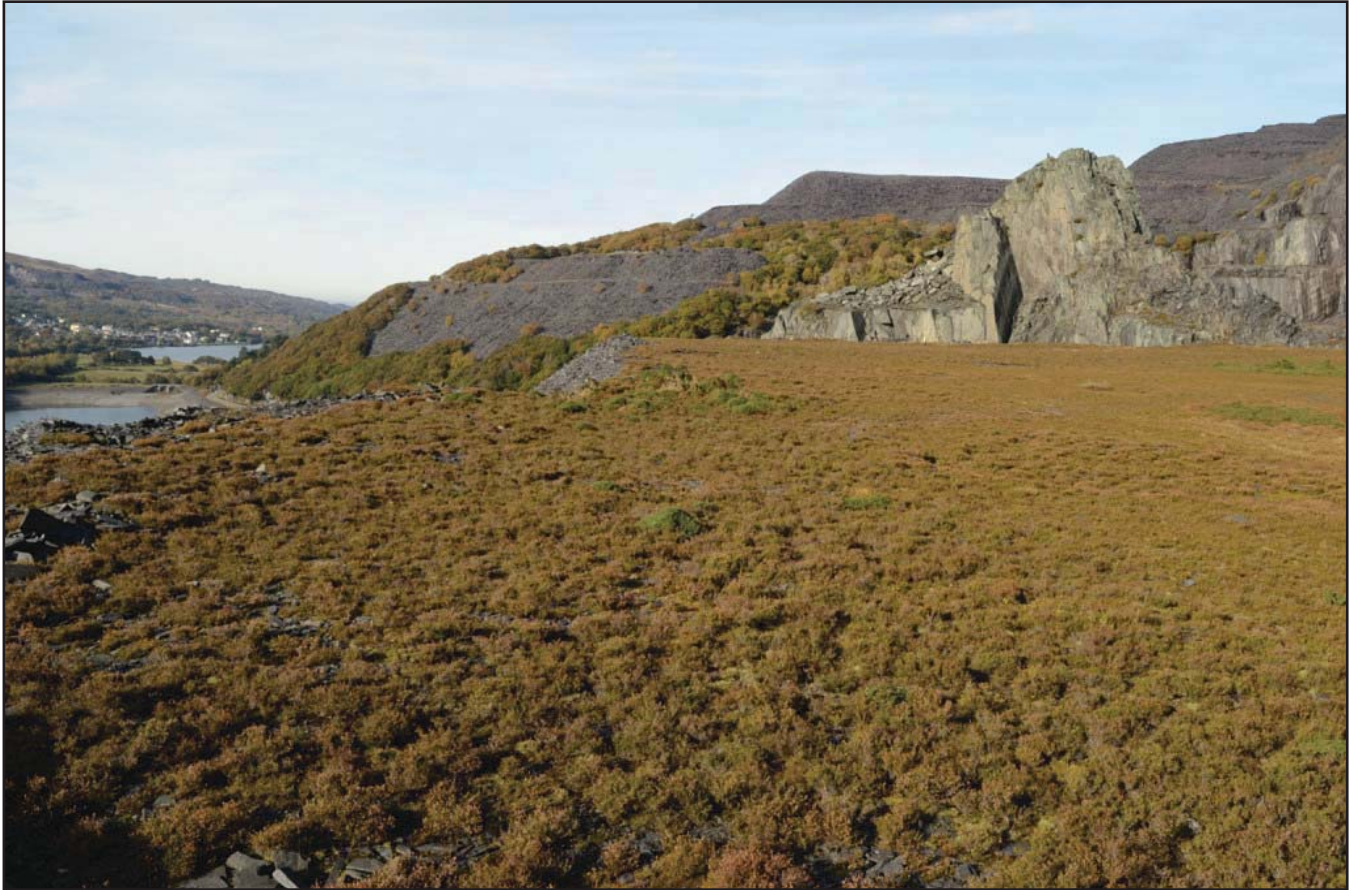
Plate 03: The proposed source of slate waste to be used to creat temporary access inclines. View from the southeast.

- The source of slate waste to be used to create temporary access inclines (Plate 03); and
- The proposed re-fuelling area (Plate 04).

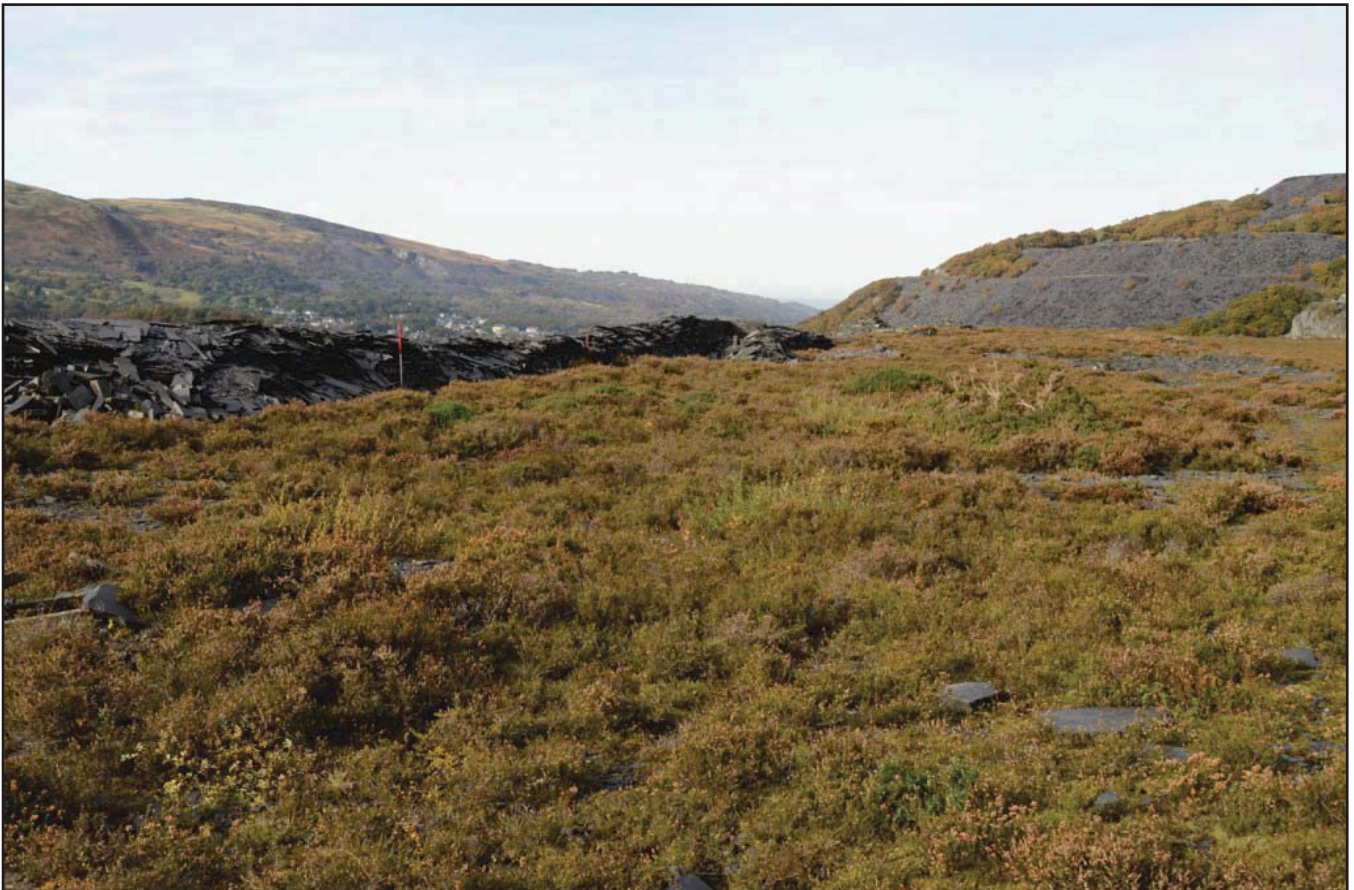
Plate 04: The proposed re-fuelling area, with dry-stone wall in the background. Scale 1x1m. View from the south.
