# A55(T) Abergwyngregyn to Tai'r Meibion Improvement Advance Works

## Archaeological Watching Brief

Project No. G2424

Report No. 1391

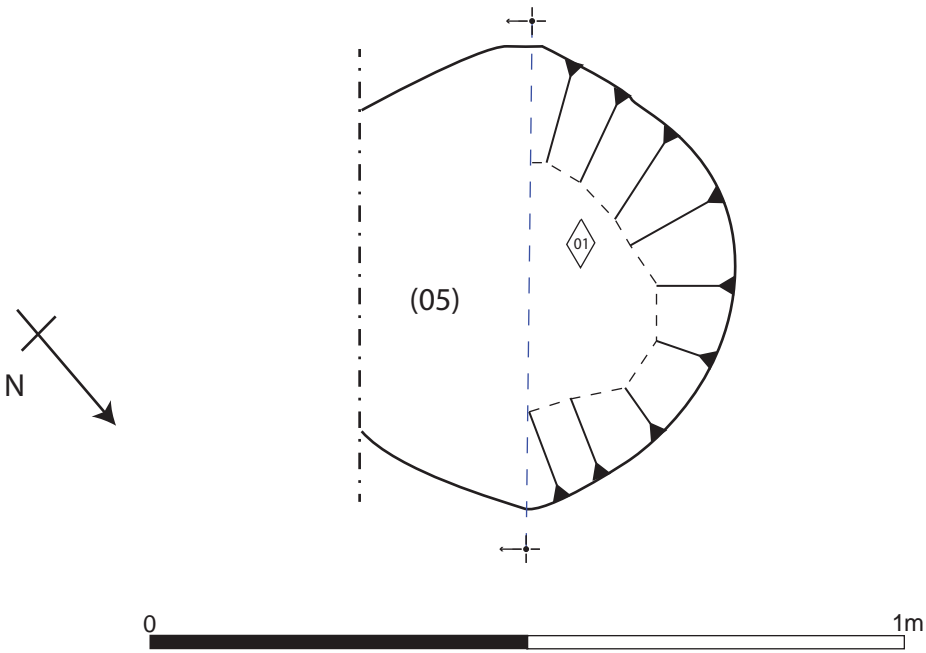
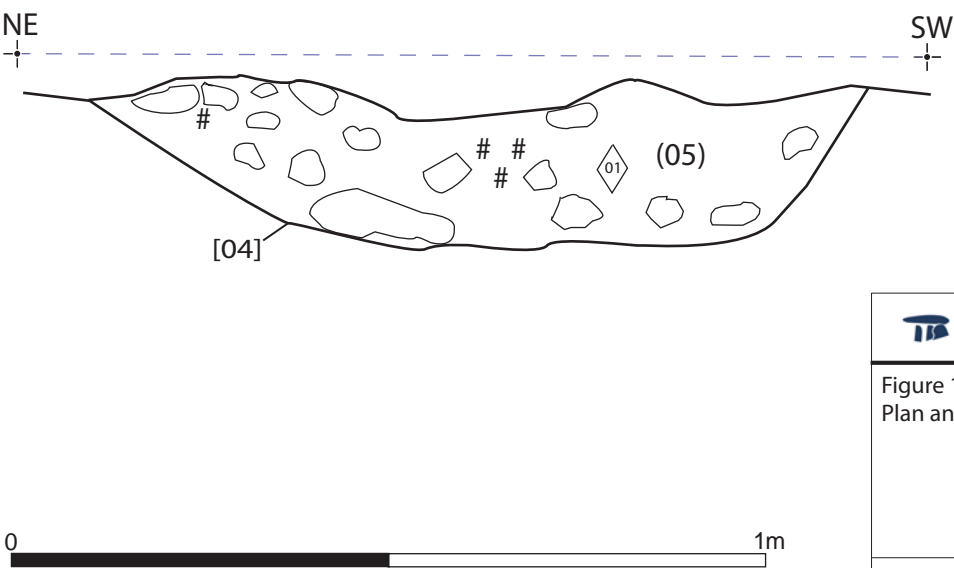
Plan of Pit [04]  
Scale 1:20@A4

Approximately 125m along the trench, from the NE boundary between Fields 4 & 5, a burnt pit [004] was uncovered at NGR SH62287225 (Plate 16; Figure 01 and Figure 10). The pit had a loose charcoal rich fill (005), (sample 01) and was packed with burnt stone that appeared to have shattered due to heat. The complete extent of the pit could not be established on the E side but it appeared to be circular with a diameter of 1.22m. The sides of the pit were steeply sloping with sharp breaks of slope the base of the pit was flat. There was some staining on the natural geology at the base of the pit which would suggest in situ burning (Plate 17).

NW Facing section through Pit [04]  
Scale 1:10@A4

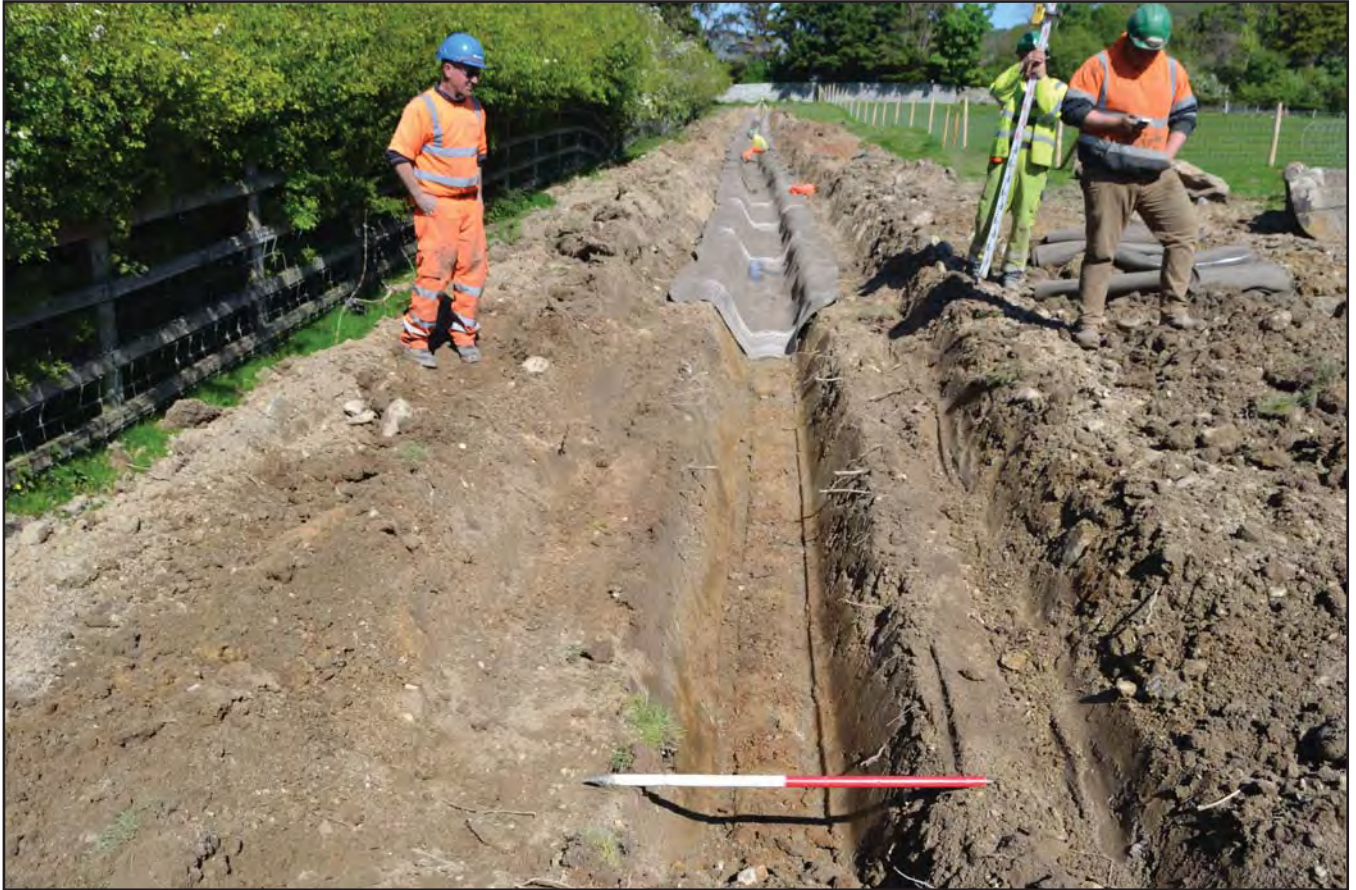
Plate 01: Drainage channel in Field 1. View from SW. Scale 1x1m. (G2424\_WB\_2017\_058).

The drainage channel in this area was 100m in length with a NE/SW orientation. The topsoil here consisted of a mid-brown silty clay with moderate stone inclusions and an average depth of 0.28m. The natural geology in the area was a yellow sandy clay with frequent stone inclusions and patches of gravel. No archaeology found in this area. (Plate 01)

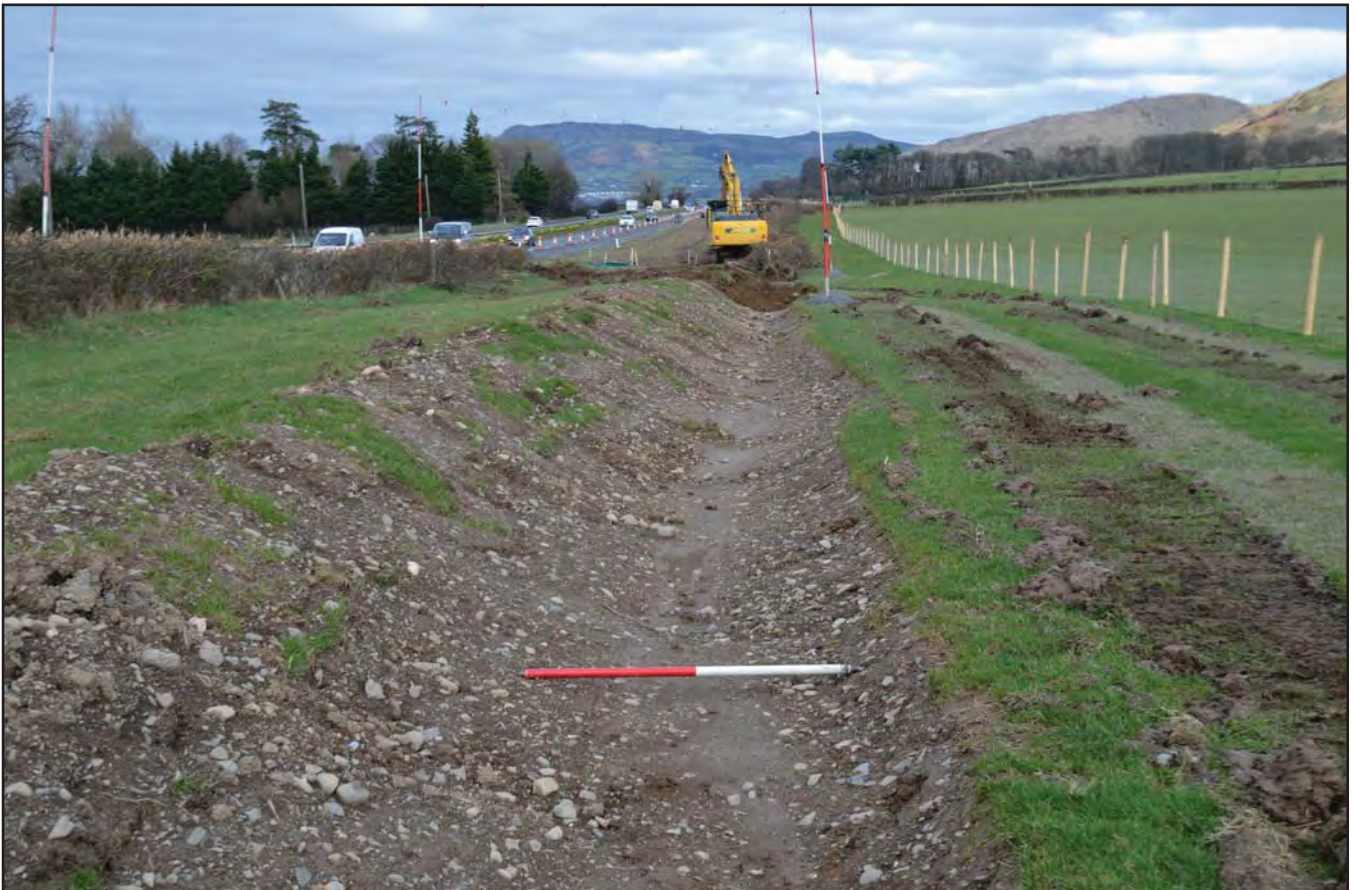
Plate 18: Ditch for translocation of hedge in Field 6. View from SW. Scale 1x1m. (G2424\_WB\_2017\_025).

This field had mid-brown sandy clay topsoil with frequent stone inclusions and an average depth of 0.35m. The natural geology, where reached consisted of a yellow mottled sandy clay with frequent stones, cobbles and boulders. The ditch spanned the length of the field, a distance of approximately 280m. No archaeology was found in this field. (Plate 18).

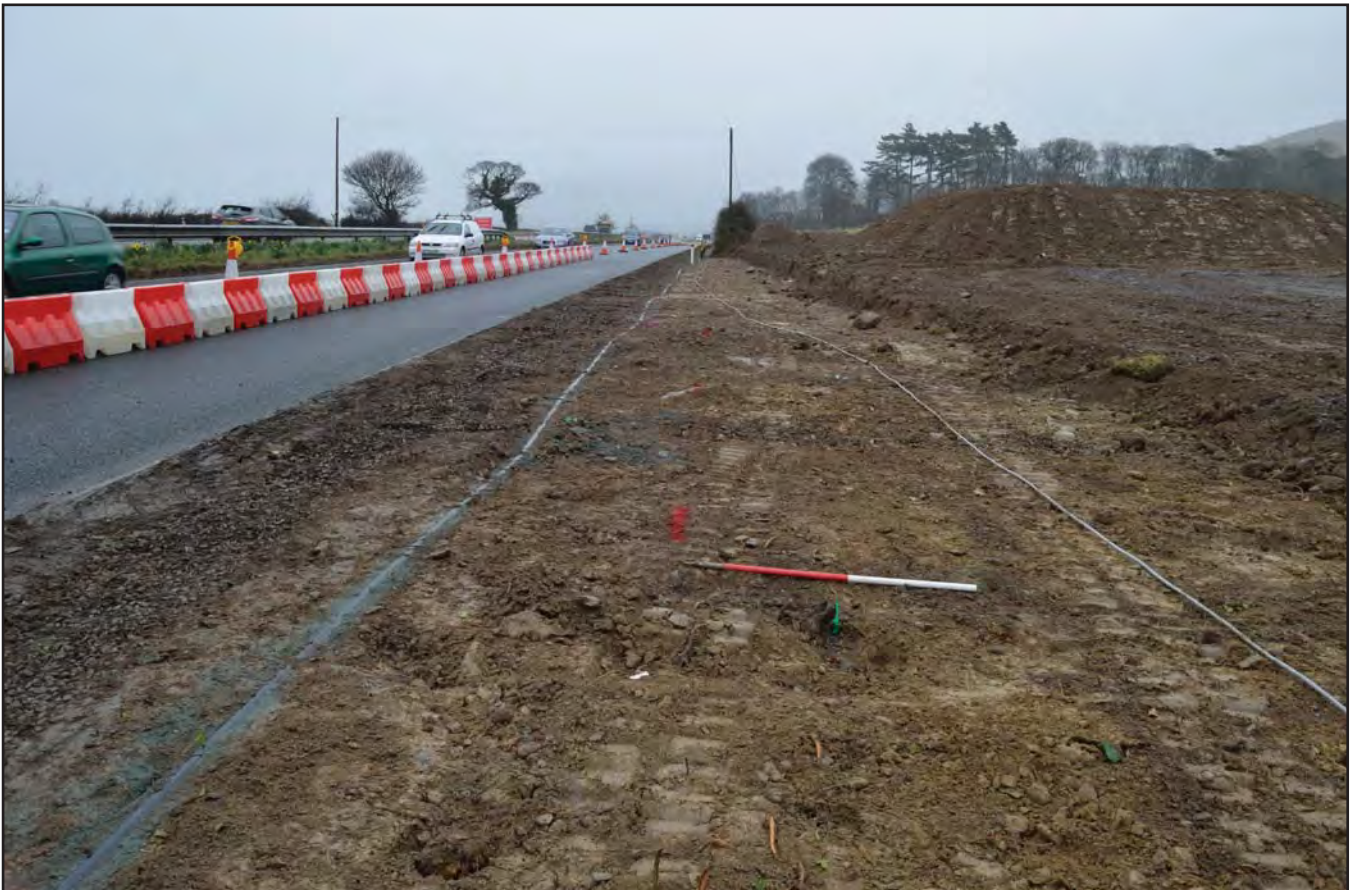
Plate 20: Strip to natural for diverge taper. View from SW. Scale 1x1m. (G2424\_WB\_2017\_018).

In order to construct the diverge taper and area 50x4m (at its widest point) next to the existing carriageway construction was excavated to the natural geology which consisted of an orange sandy clay with gravel patches (Plate 20). No archaeology was found.

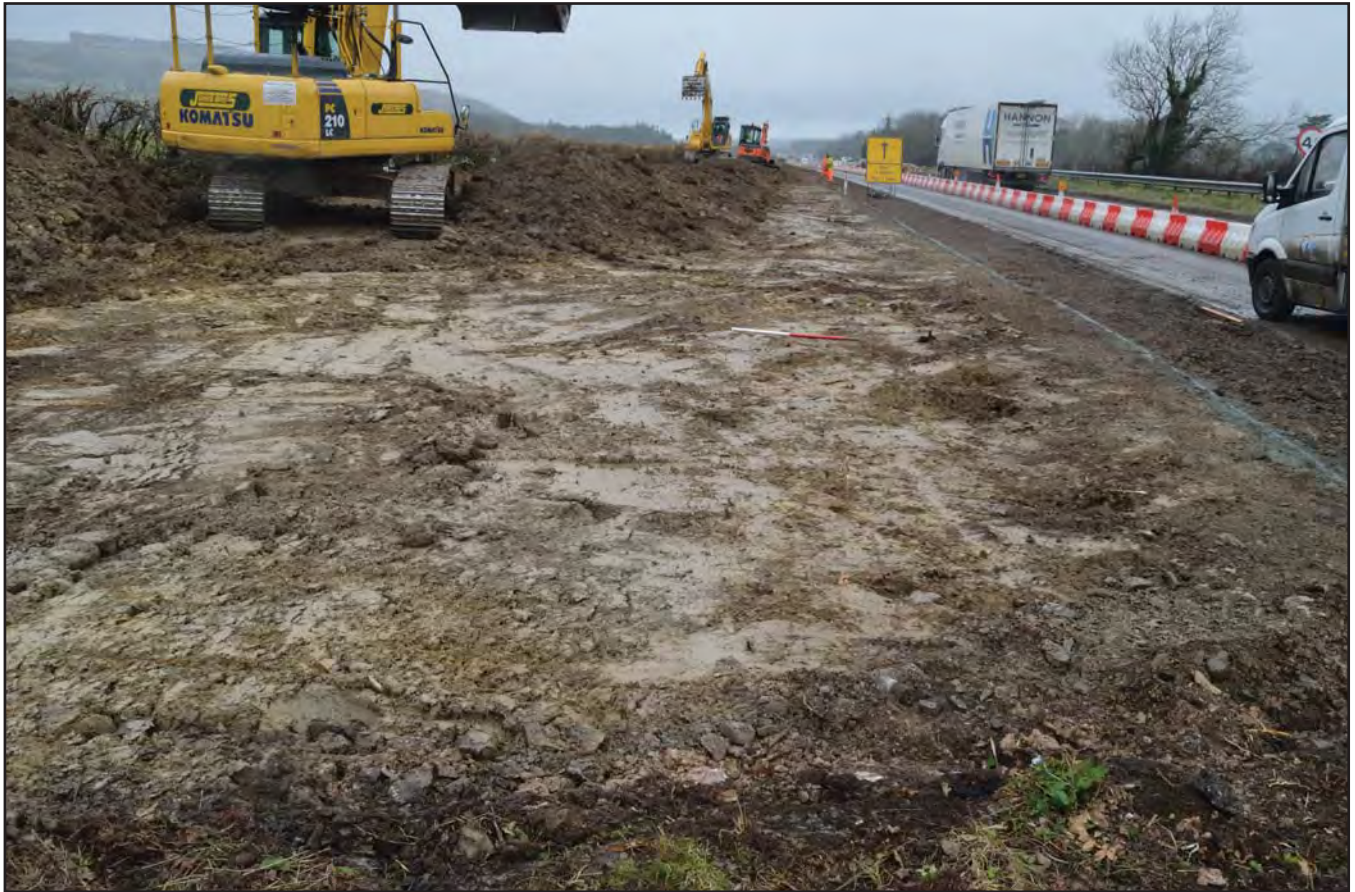
Plate 21: Strip to natural for merge taper. View from NE. Scale 1x1m. (G2424\_WB\_2017\_019).

The merge taper was also reduced to the natural geology which was a yellow sandy clay with moderate stones, cobbles and occasional boulders. No archaeology was found (Plate 21, Plate 22).

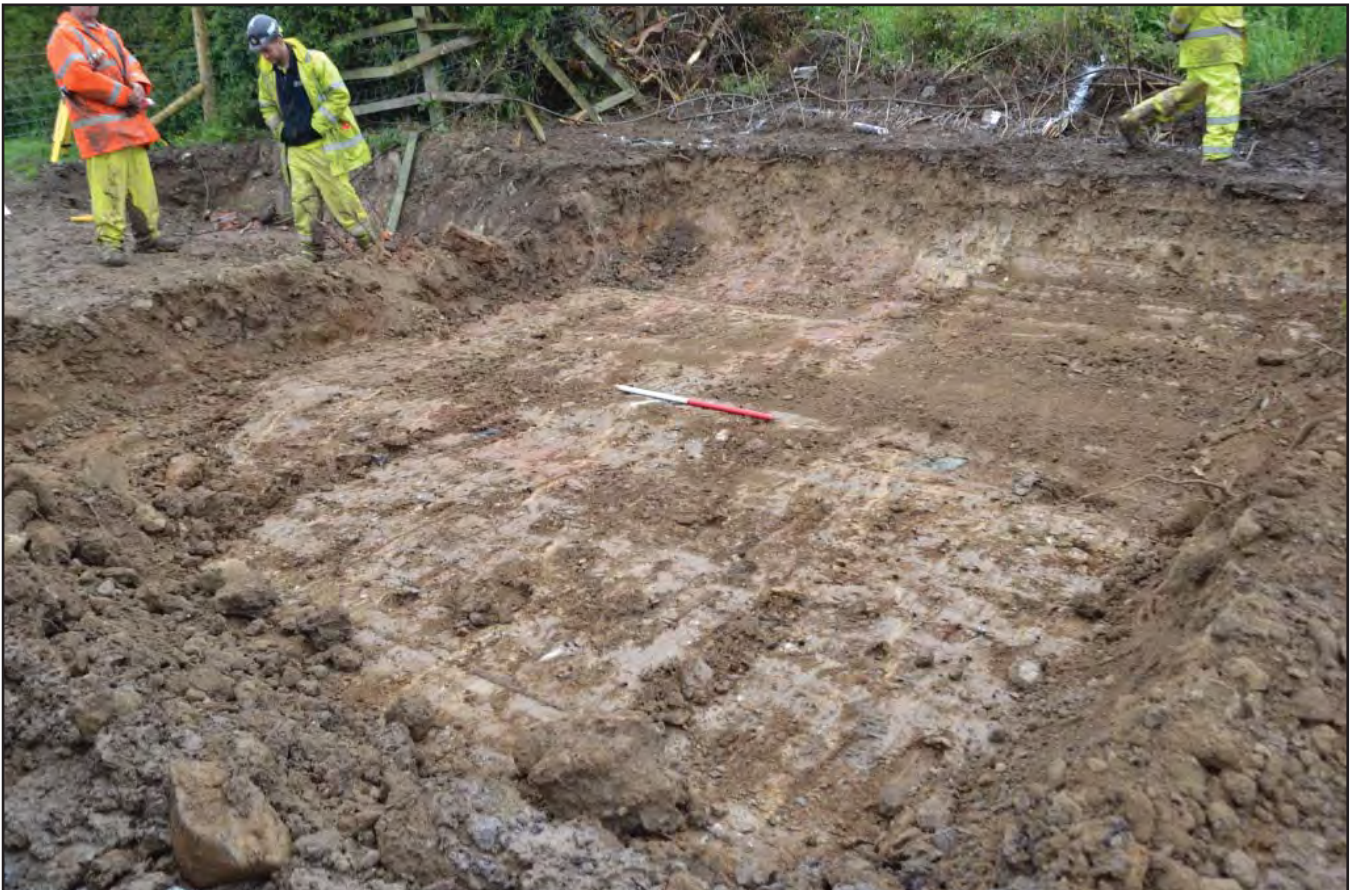
Plate 24: Excavation of reception pit in Field 9. View from the W. Scale 1x1m. (G2424\_WB\_2017\_065).

Another pit measuring 6x4x0.72m was required in this field in order to install the pipe under the A55(T). The topsoil in this area consisted of a mid-brown silty clay with a moderate amount of stone inclusions, average depth 0.24m. This gave way to the natural geology which consisted of a yellow mottled sandy clay with frequent stone and cobble inclusions. No archaeology was found in this area (Plate 24).

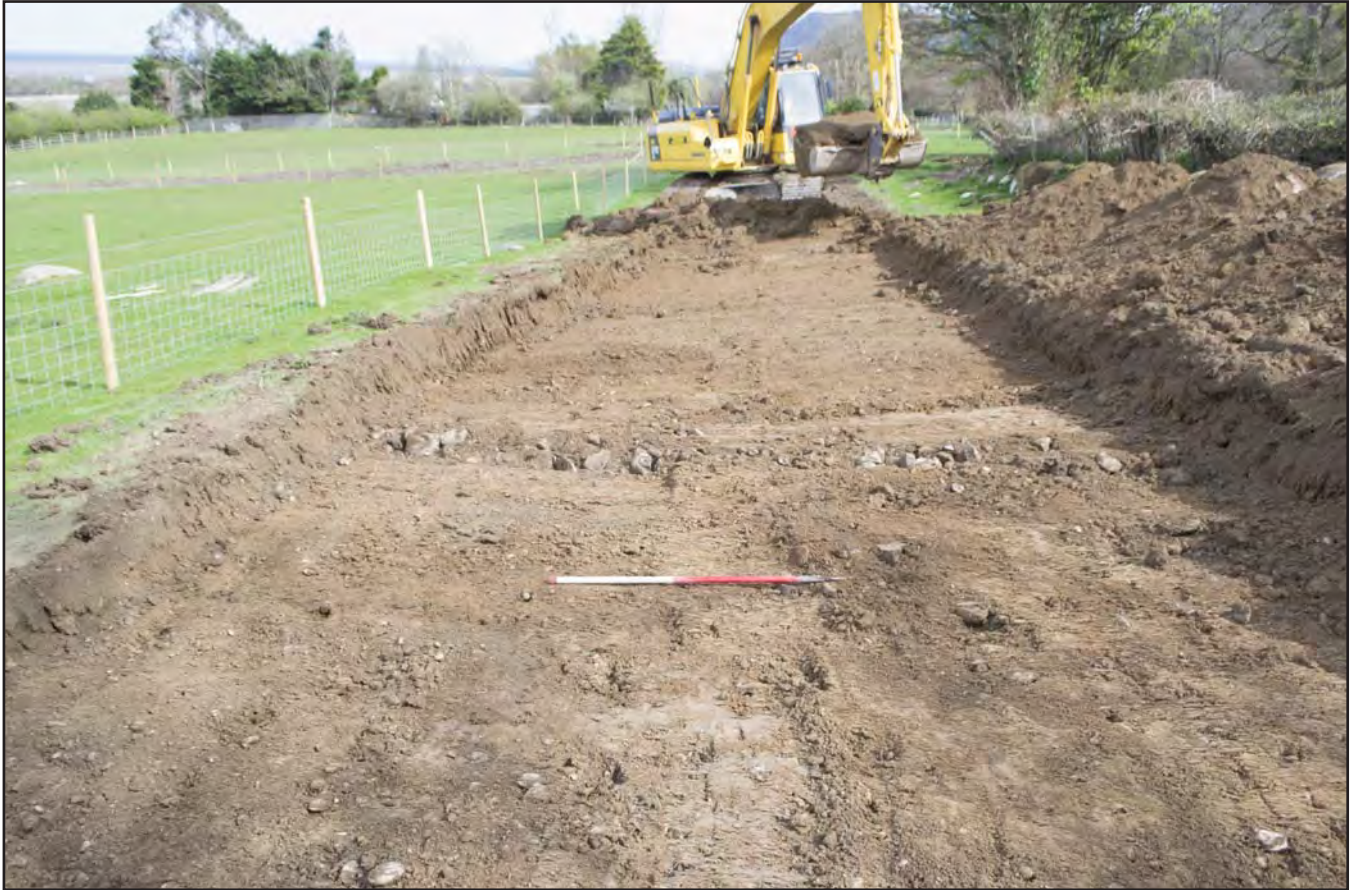
Plate 25: Topsoil strip for access road in Field 1. View from S. Scale 1x1m (G2424\_WB\_2017\_035).

In order to provide access for vehicles a topsoil strip was undertaken in this area and then covered with stone. The strip was approximately 90-100m in length, 3.5m wide and to a depth of 0.4m (Plate 25). No archaeology was noted within the stripped area.

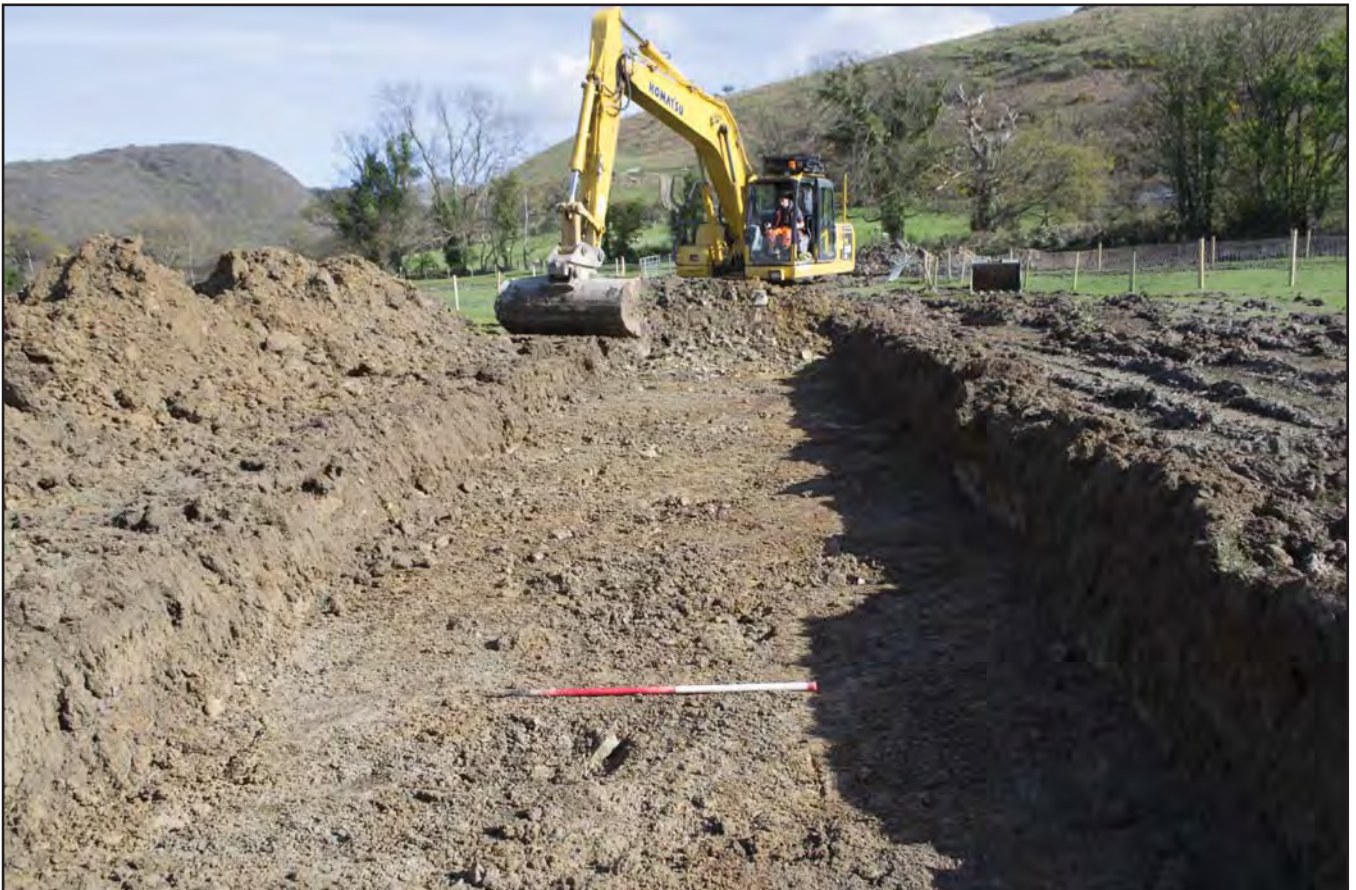
Plate 26: Strip in advance of 450mm pipe in Field 1. View from NW. Scale 1x1m (G2424\_WB\_2017\_044).

A strip to the natural geology was undertaken along the route of the new pipe across this field. The strip was orientated NW-SE and was approximately 125m in length and 4m wide. Topsoil was a mid-brown silty clay with moderate stone and cobble inclusions, average depth 0.33m. The natural geology consisted of a yellow/orange/grey mottled sandy clay with frequent stone, cobbles and occasional boulders. No archaeology found (Plate 26).
