Bishops Palace, Bangor

Archaeological Mitigation: Final Report

Prosiect Rhif / Project No. G2358

Adroddiad Rhif / Report No. 1421

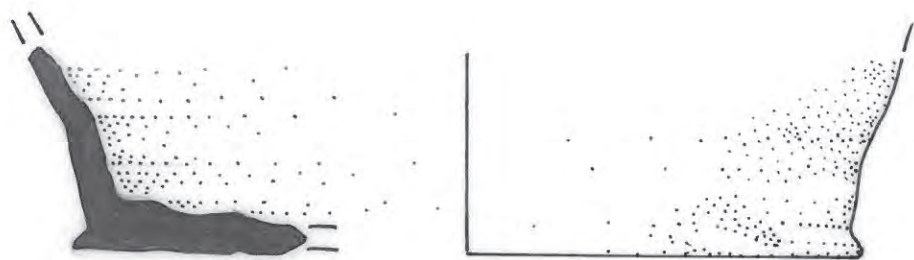
Figure 12: Drawings of Small Find 18 and Unstratified Find from Trench 2 by Timothy Morgan.
Drawn at Actual Size @A4

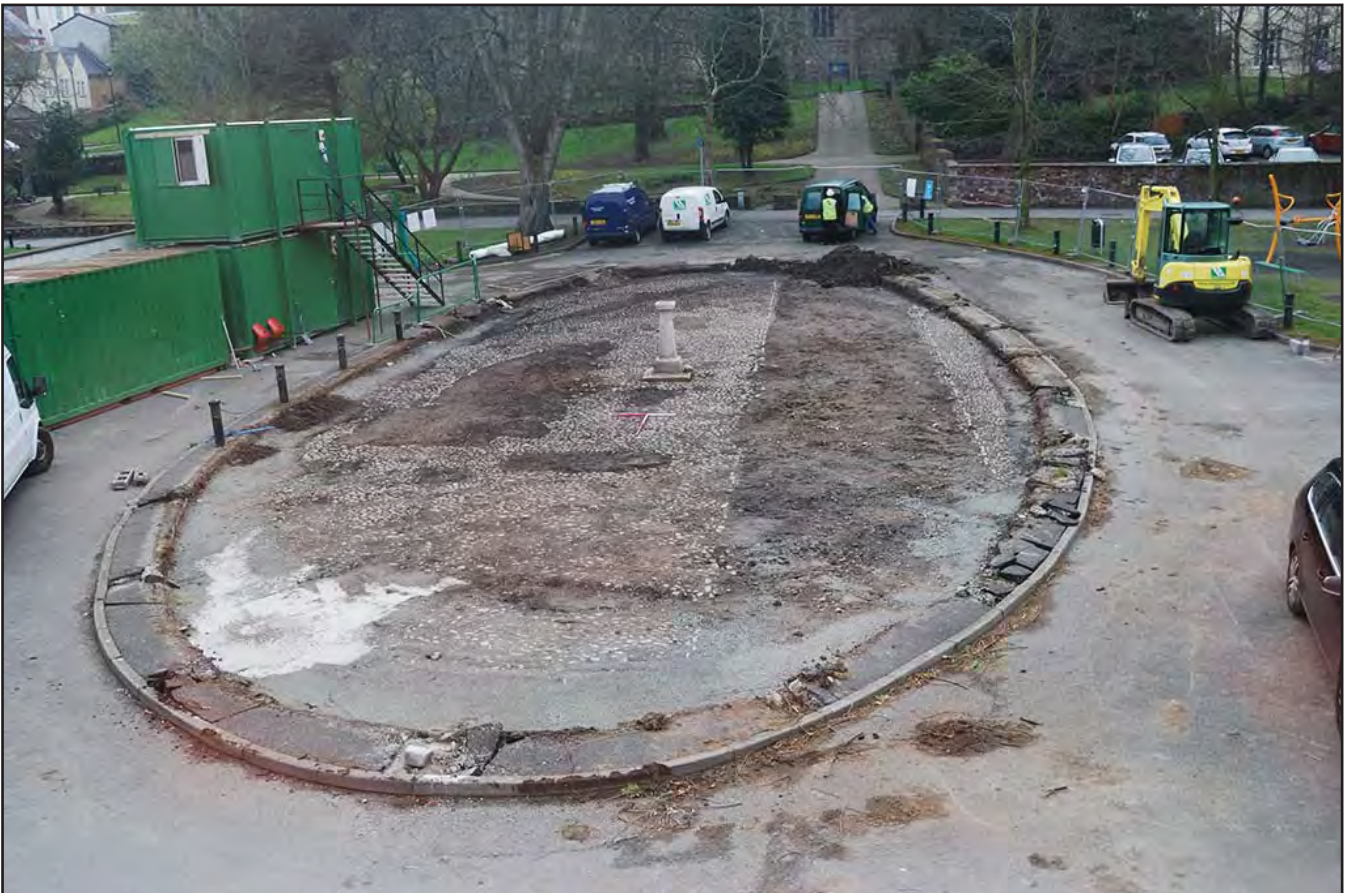
Plate 02: Post-excitation shot of the cobbled surface within the oval planting area. Scale 2x1m; view from the northeast

A cobbled surface [110] was identified across multiple working areas to the south of the Bishop's Palace, primarily within the large central oval area which measured 28m x 15m (Figure 02; Plates 02-03, 12, 16). Recent planting and service trenches had caused localised disturbance but preservation on the whole was remarkable. The full extent of the surface is unknown; no defined edge was identified, though the surface was somewhat disturbed towards the eastern edge of the excavation area, likely associated with the development of the adjacent site in 2004. The surface did not appear in the majority of section A of the lighting trench, or any other work areas to the west of the central area, although some of these excavations were perhaps too shallow. Within Trench 1 (Figure 02) a walkway surface was noted below an area of damaged cobbles (Plate 18). Within Trench 2 the cobbled surface (120) was truncated by a linear [113] which contained disturbed cobbles so is thought to be relatively modern in date (Plate 20).

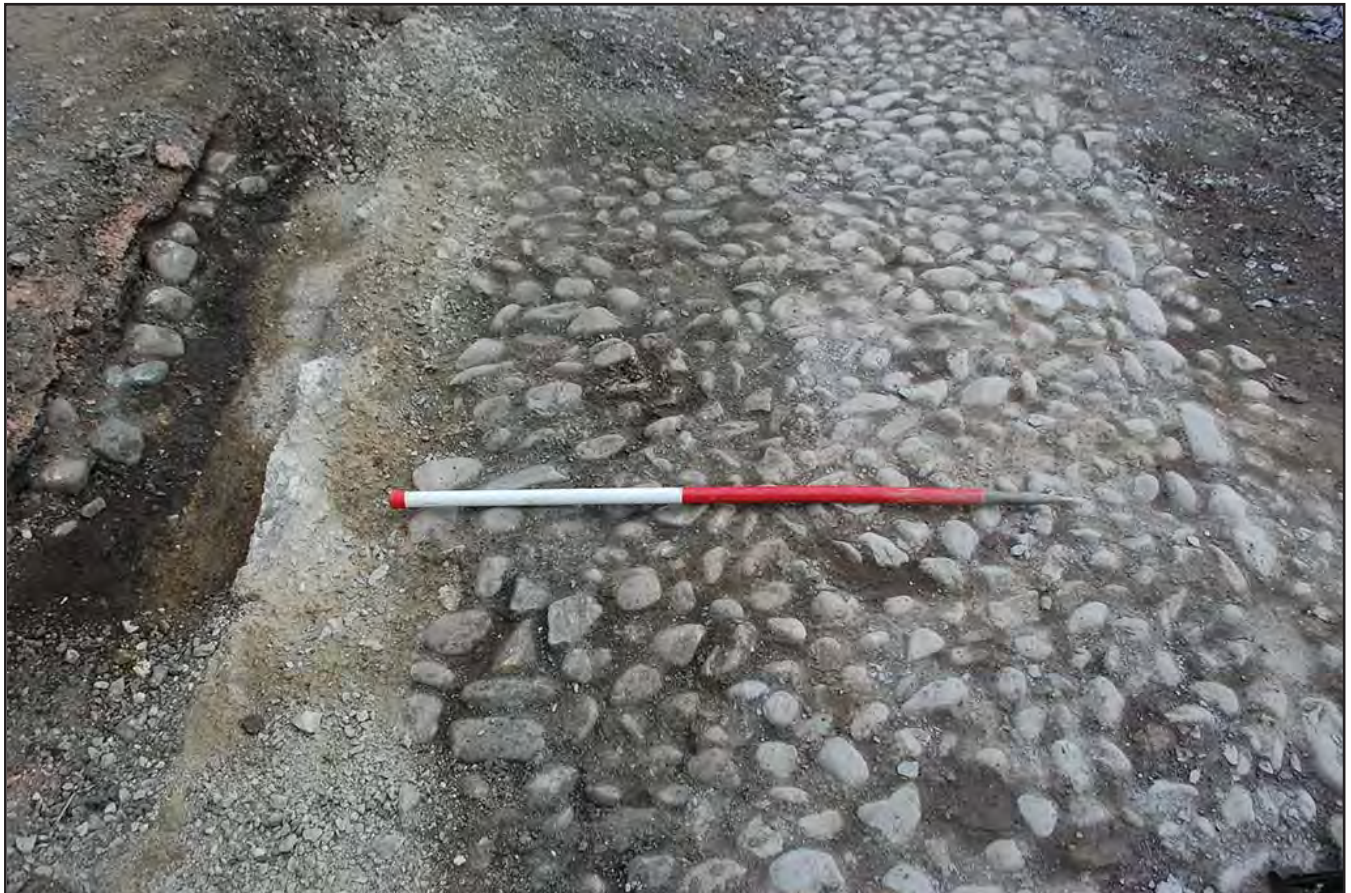
Plate 03: Close up of cobbled surface (009) showing to the right the cobble border (008) west of the walkway [144].
 To the left of the shot the cut for the modern kerb is shown truncating the cobbles.
 Scale 1x1m; view from the southwest

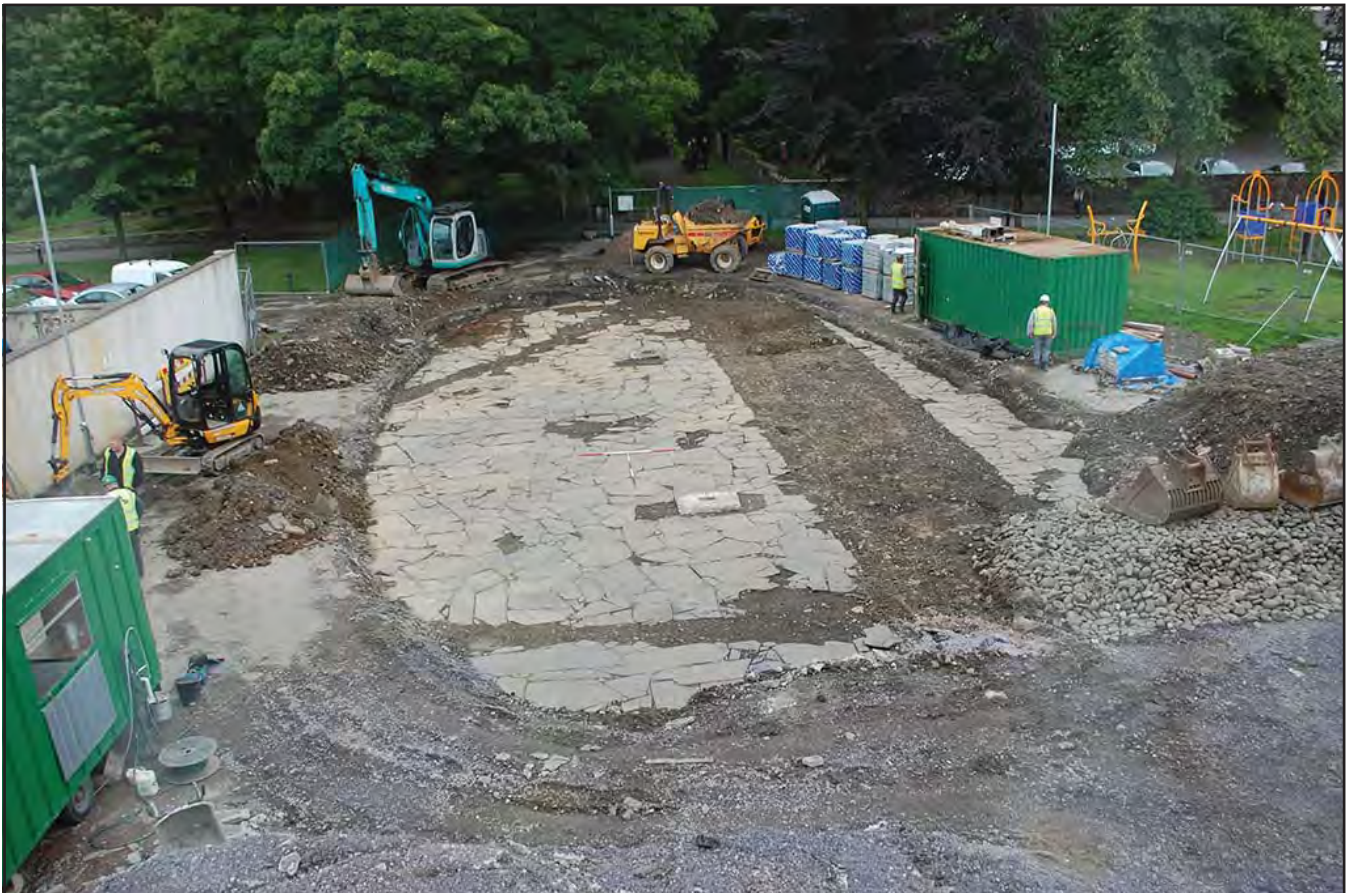
Plate 04: Post-excavation shot of the stone flagged surface within the oval planting area.
 Scale 2x2m; view from the northeast

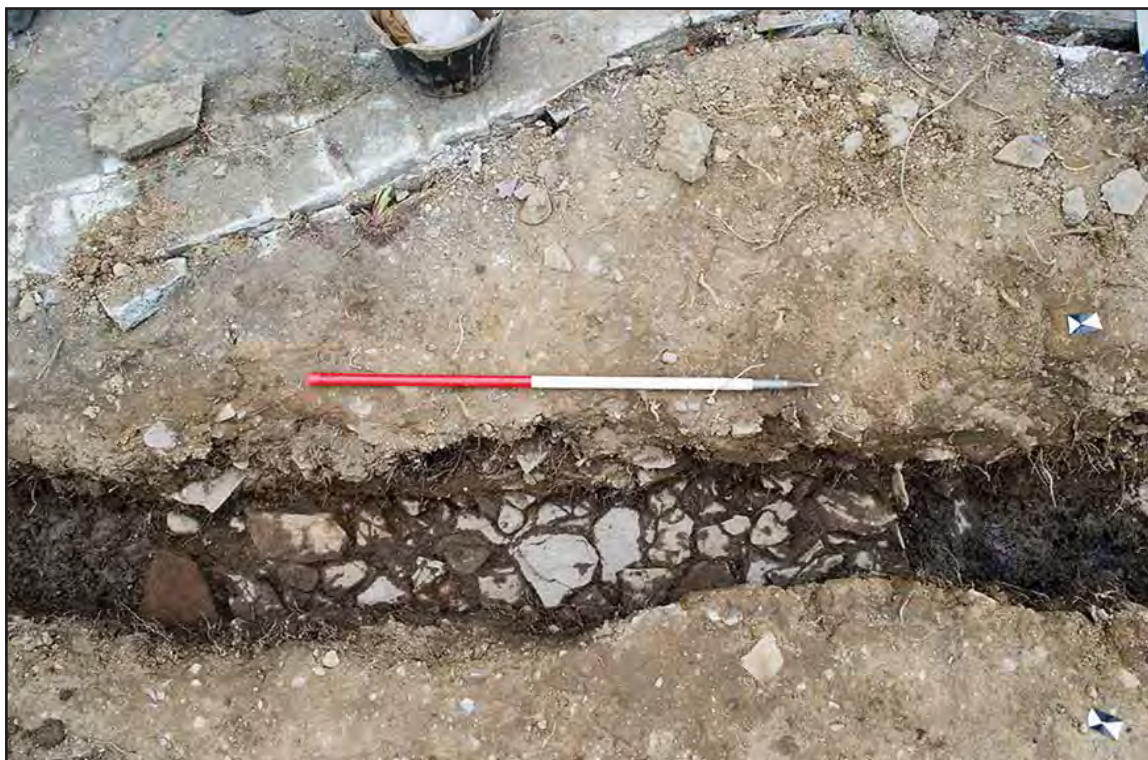
Plate 06: Post-excavation shot of the wall [003] identified in the western portion of the electric cable trench located to the northwest of the Bishop's Palace. Scale 1x1m; view from the southwest

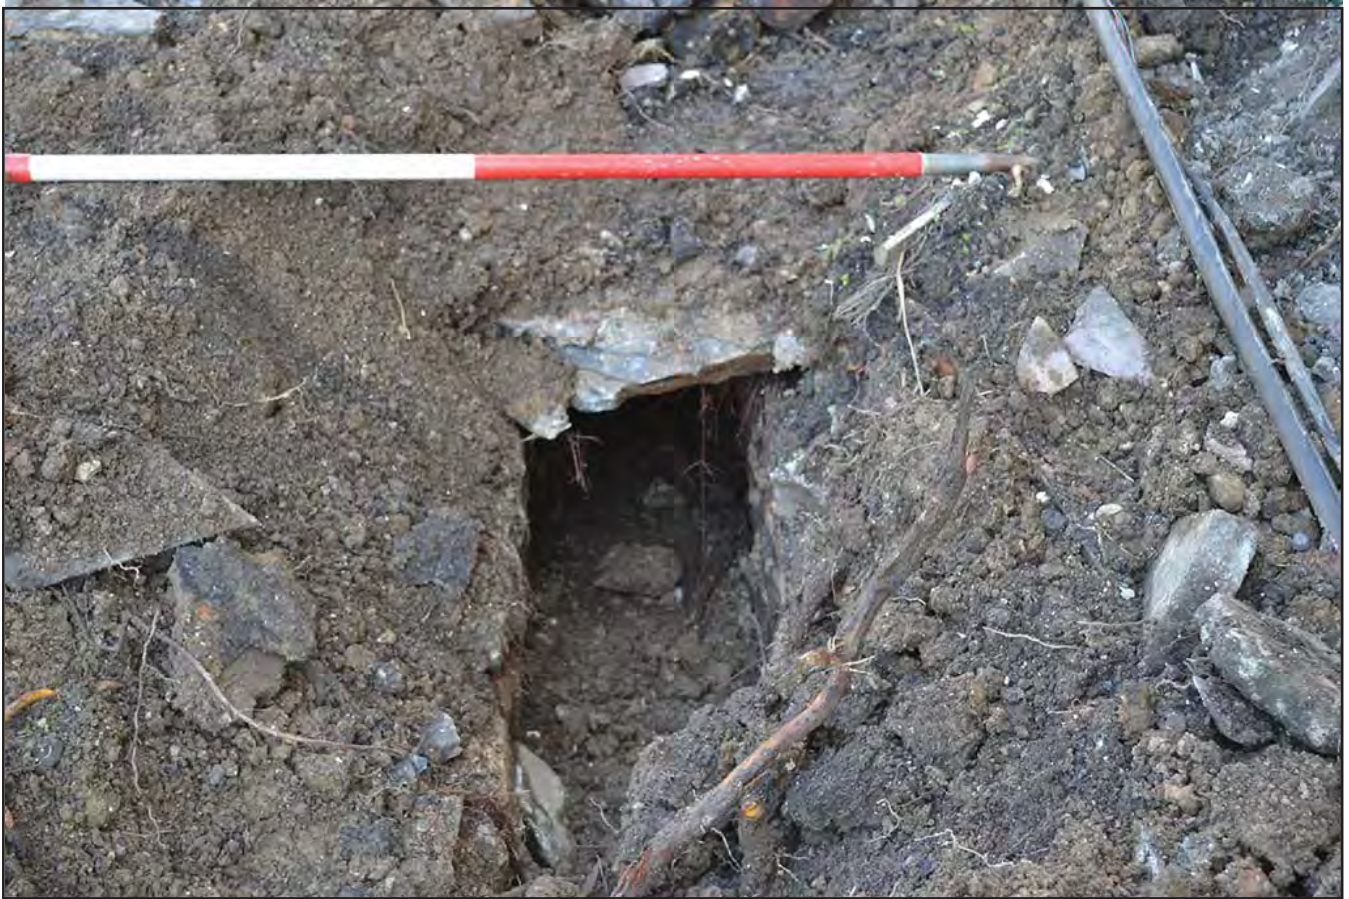
Plate 09: Post-excitation shot of the culvert within the drainage trench located to the west of the Bishop's Palace. Scale 1 x 1m; view from the southwest

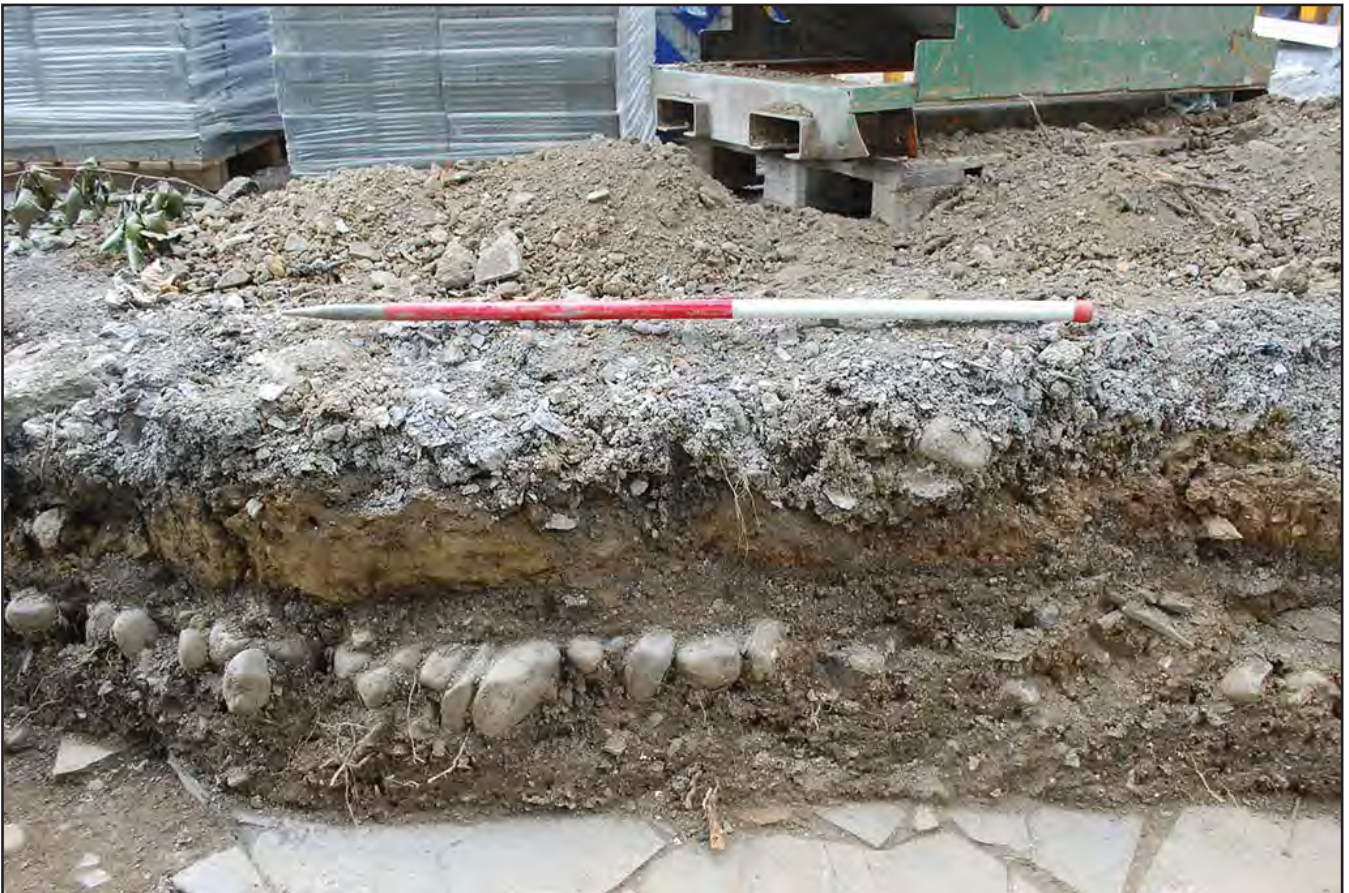
Plate 10: Post-excitation shot of the southeast end of lighting cable trench A, showing the cobbled surface (052) in section and the stone flagged surface (054) in the base of the trench. Scale 1 x 1m; view from the southwest

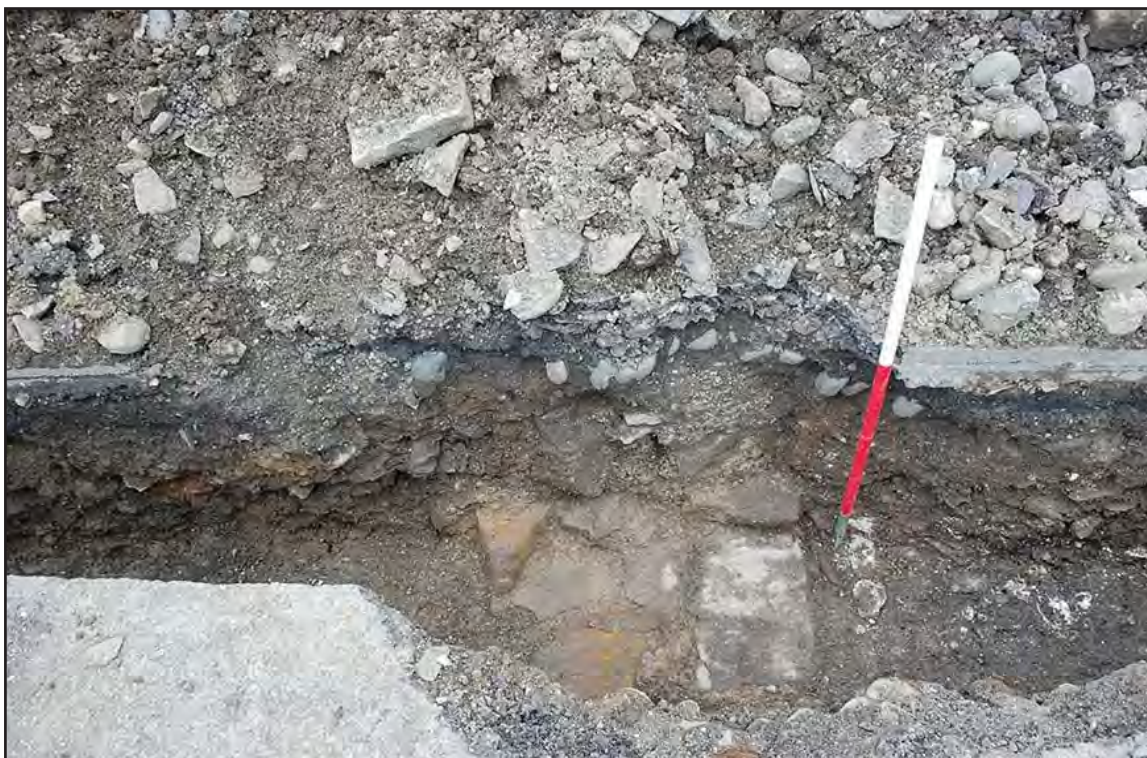
Plate 14: Post-excavation shot of wall [077] within lighting cable trench E. Scale 1 x 1m; view from the northeast

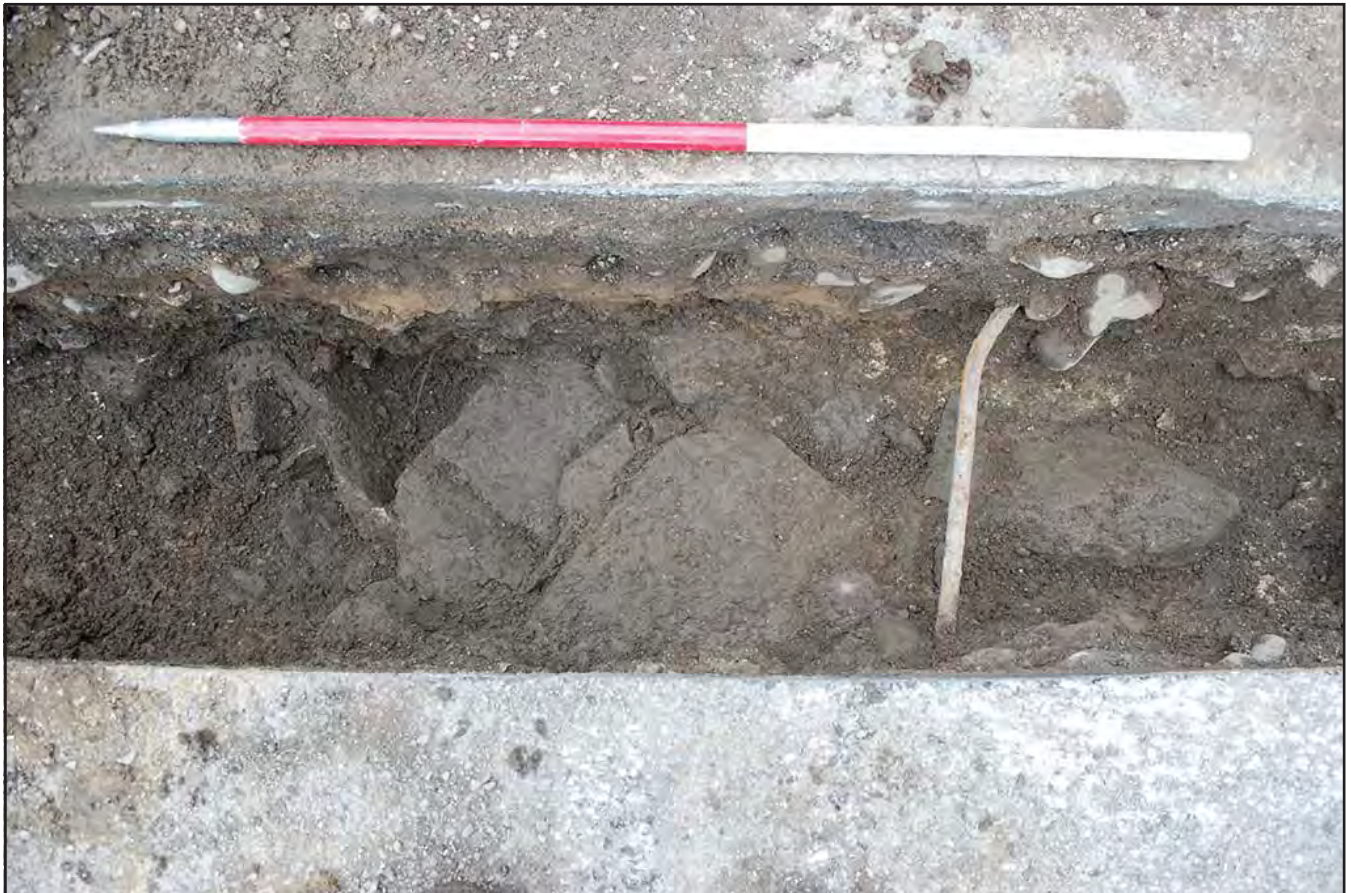
Plate 15: Post-excavation shot of wall [076] within lighting cable trench E. Scale 1 x 1 m; view from the northeast

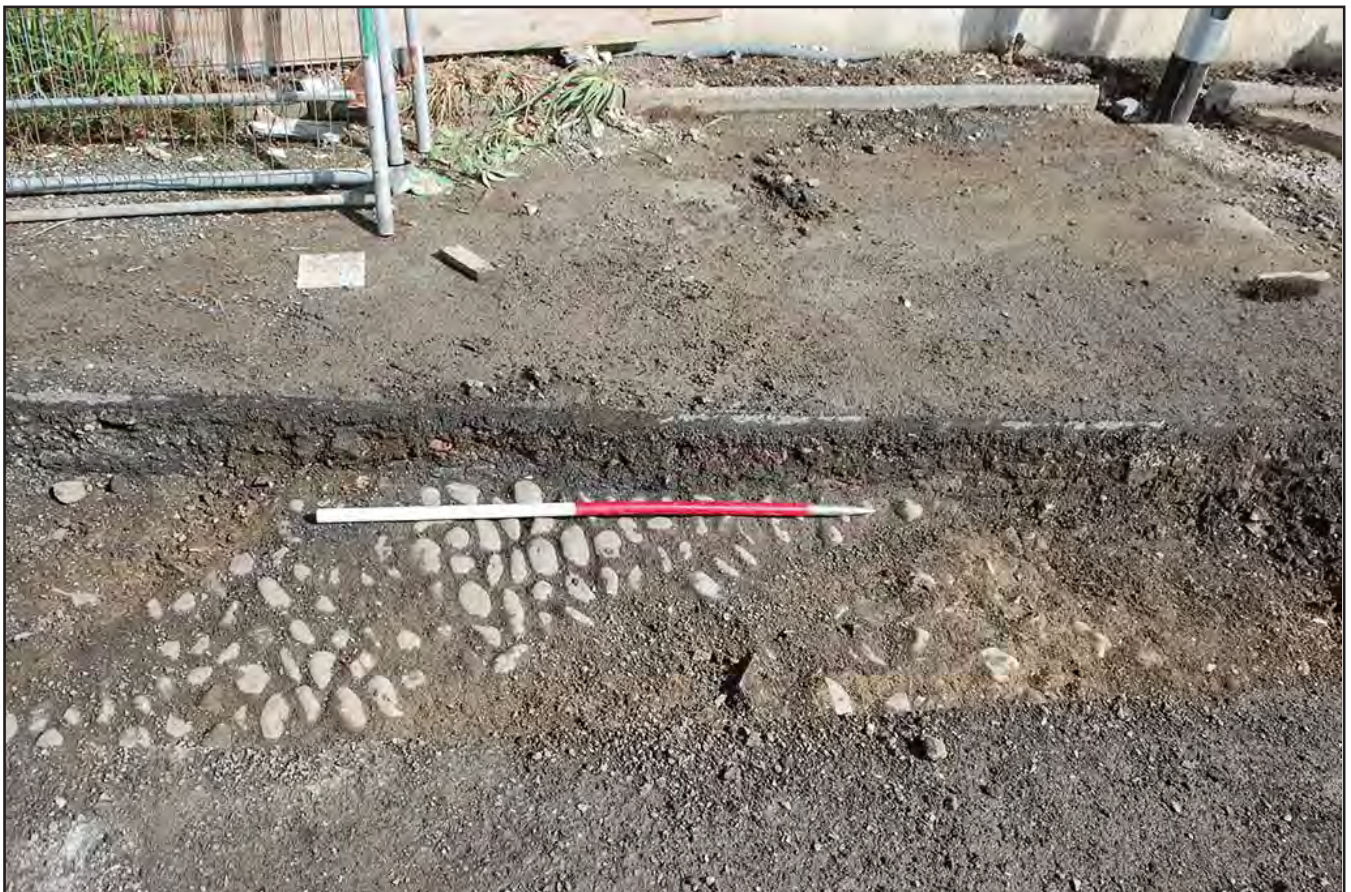
Plate 16: Post-excavation shot of disturbed cobble deposit (106) within the drainage trench excavated to the south of the Bishop's Palace. Scale 1 x 1 m; view from the northeast

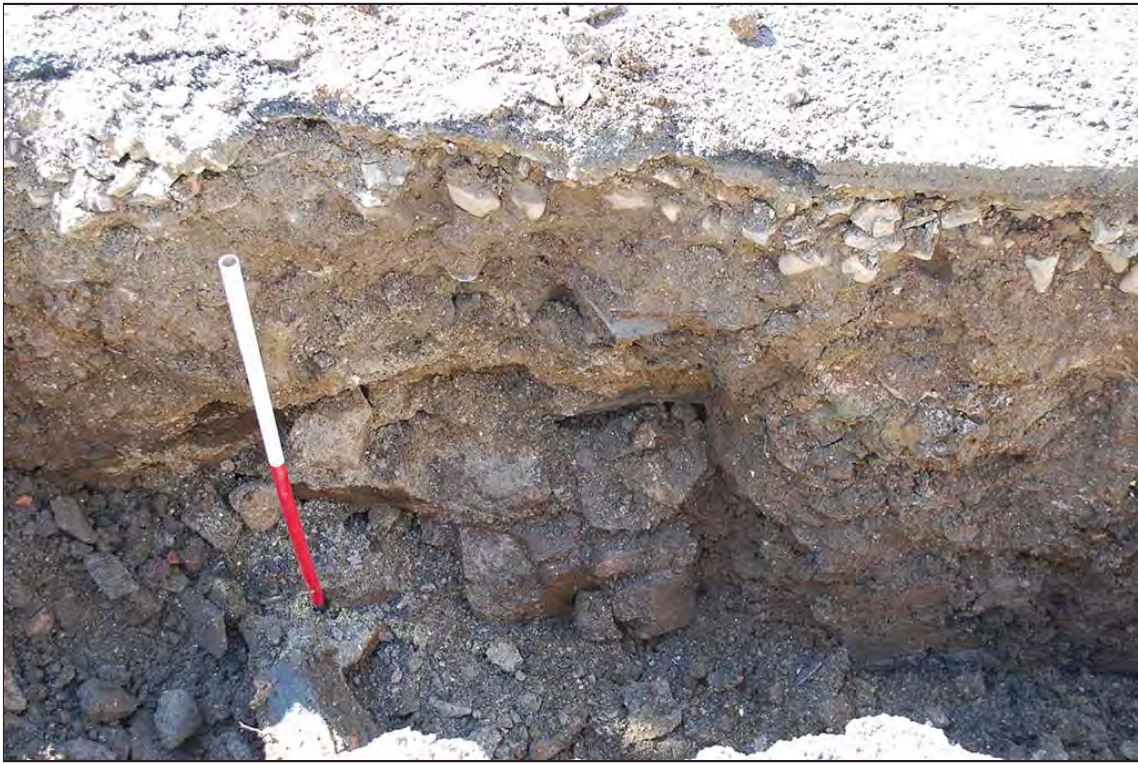
Plate 17: View of wall [151] visible in the section of the drainage trench excavated to the south of the Bishop's Palace. Scale 1 x 1m; view from the northeast

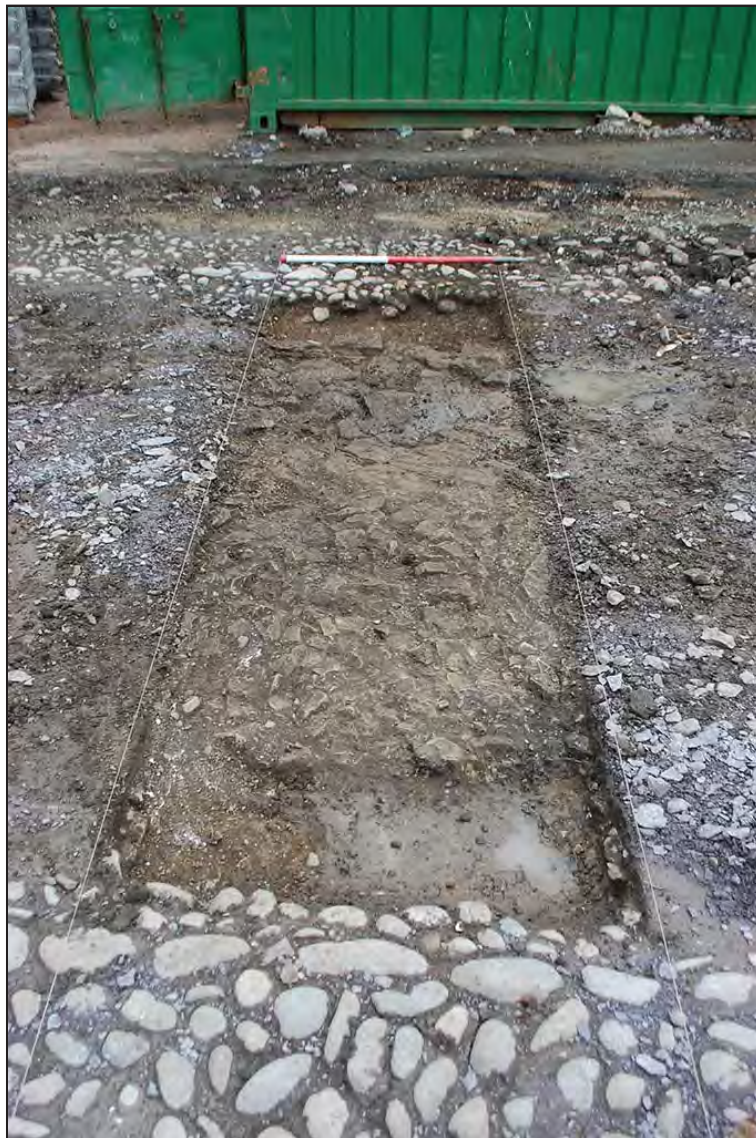
Plate 18: Post-excavation shot of walkway surface (023) within trench 1. Scale 1 x 1m; view from the southeast

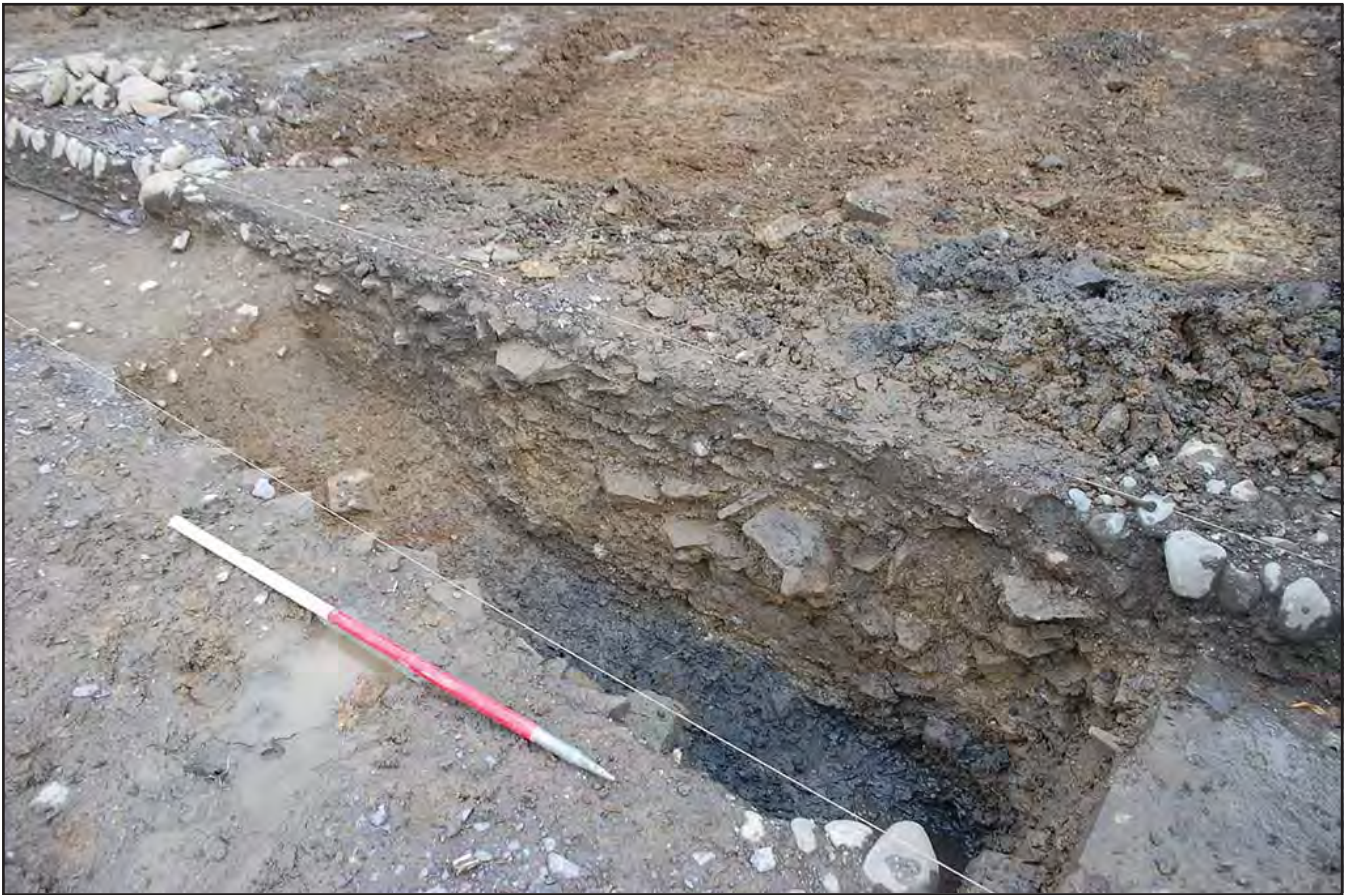
Plate 19: Post-excavation shot of trench 1 showing paleochannel [091]. Scale 1 x 1m; view from the north

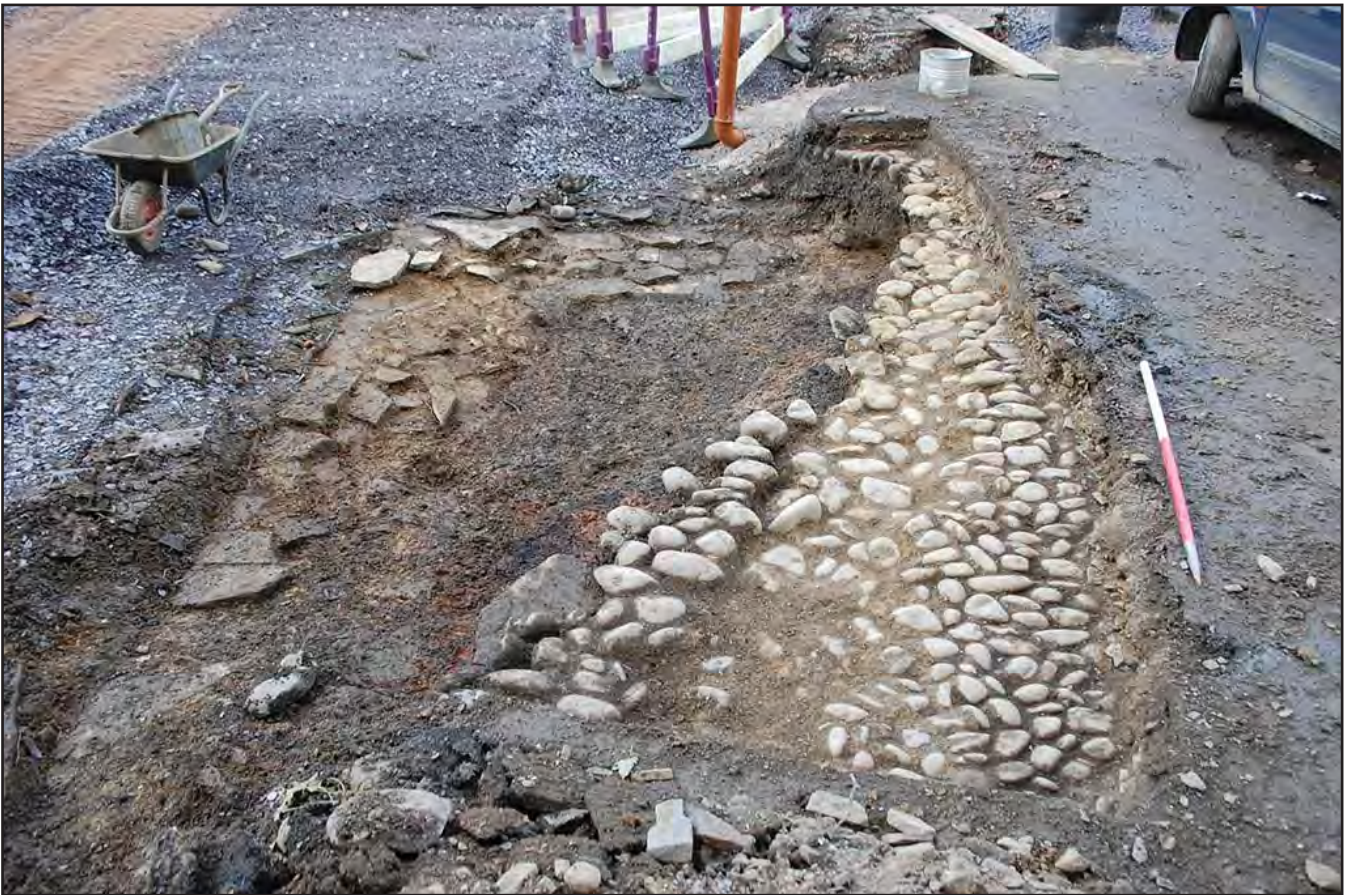
Plate 20: Post-excavation shot of cobbled surface (120) truncated by linear [113] within Trench 2. Scale 1 x 1m; view from the southwest

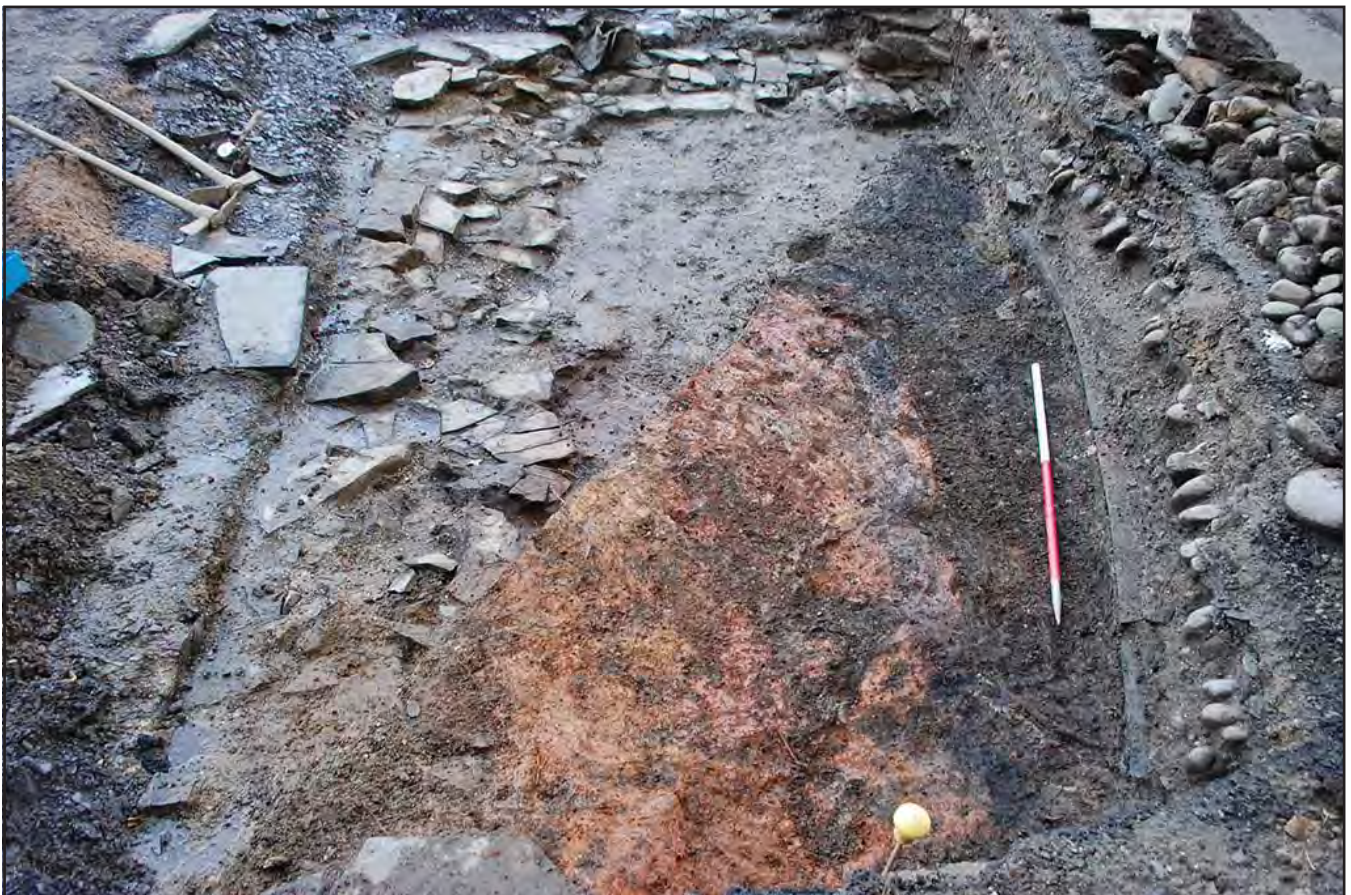
Plate 22: Mid-excavation shot of Trench 2 showing truncated burnt deposit (124). Scale 1 x 1m; view from the north

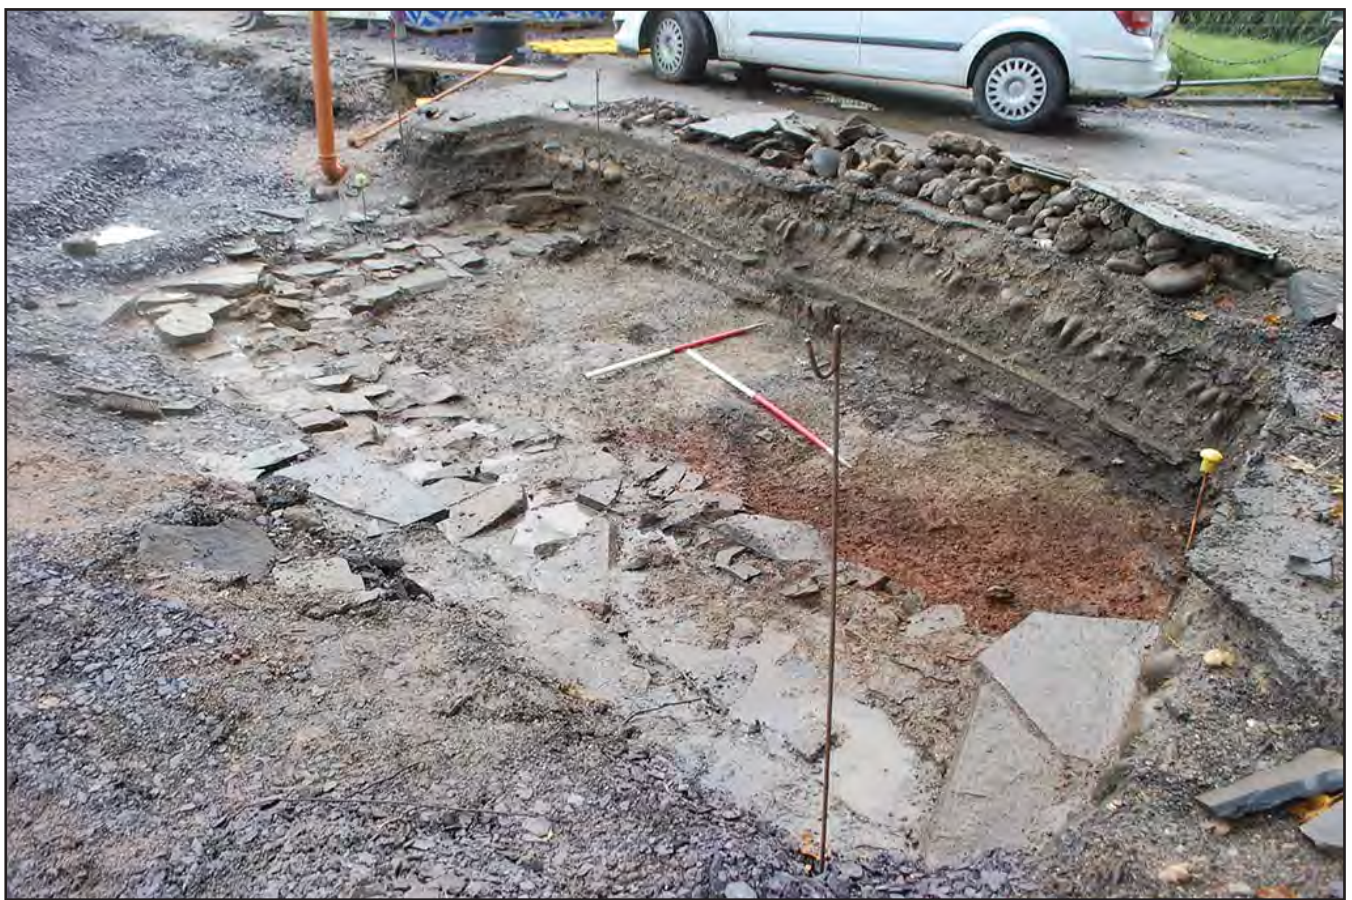
Plate 23: : Post-excavation shot of Trench 2 showing wall [109]. Scale 1 x 1m; view from the north

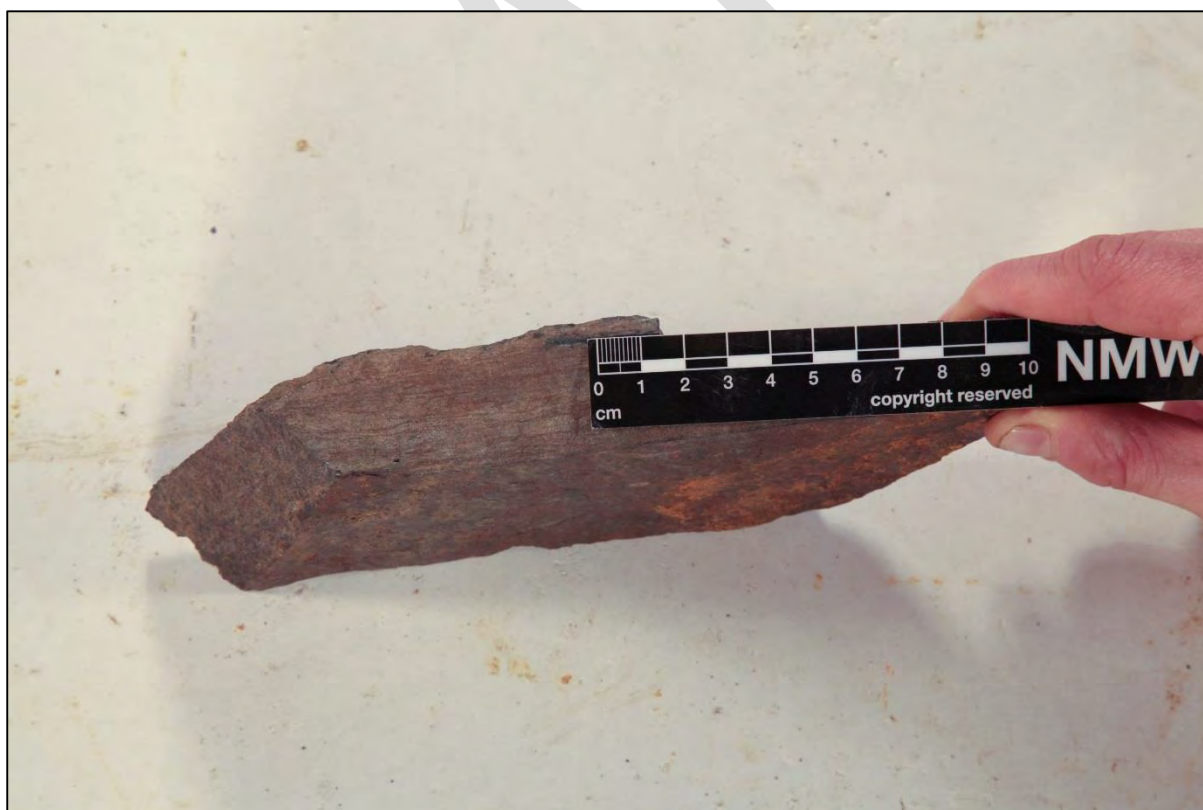
Sample G2358: (UB02) 24

An extremely fine grained, homogeneous, reddish-grey [Munsell 2.5YR 3/1 – 4/1 (dark reddish grey)] laminated mudstone (grains too small to see with the naked eye), showing much iron discolouration. The rock splits readily along laminations and the largest faces of the block are oriented parallel to them, and represent a natural bedding surface. It is not possible to state whether this block has been split by hand or has split naturally along these planes. The sides of the block whilst perpendicular to bedding, appear to have quite a strong, straight and smooth edge. This would suggest fracturing along a natural plane of weakness e.g. jointing. No obvious tool marks were observed.

The nature of the laminations perpendicular to jointing and the rock's ability to be split into large slabs (whether naturally or by hand) would have made it an ideal choice as a flooring slab. The bedrock at the Bishop's Palace site comprises mudstones and silty mudstones of the Ordovician, Nant Ffrancon Subgroup (Arenig to Cadadoc in age) and this matches the lithology of the specimen described here. It is therefore highly likely that these slabs were sourced from the local bedrock.
