Understanding Place: Characterisation and Deposit Modelling for Newborough, Anglesey

Project No. G2404

Report No. 1426

Prepared for: Cadw

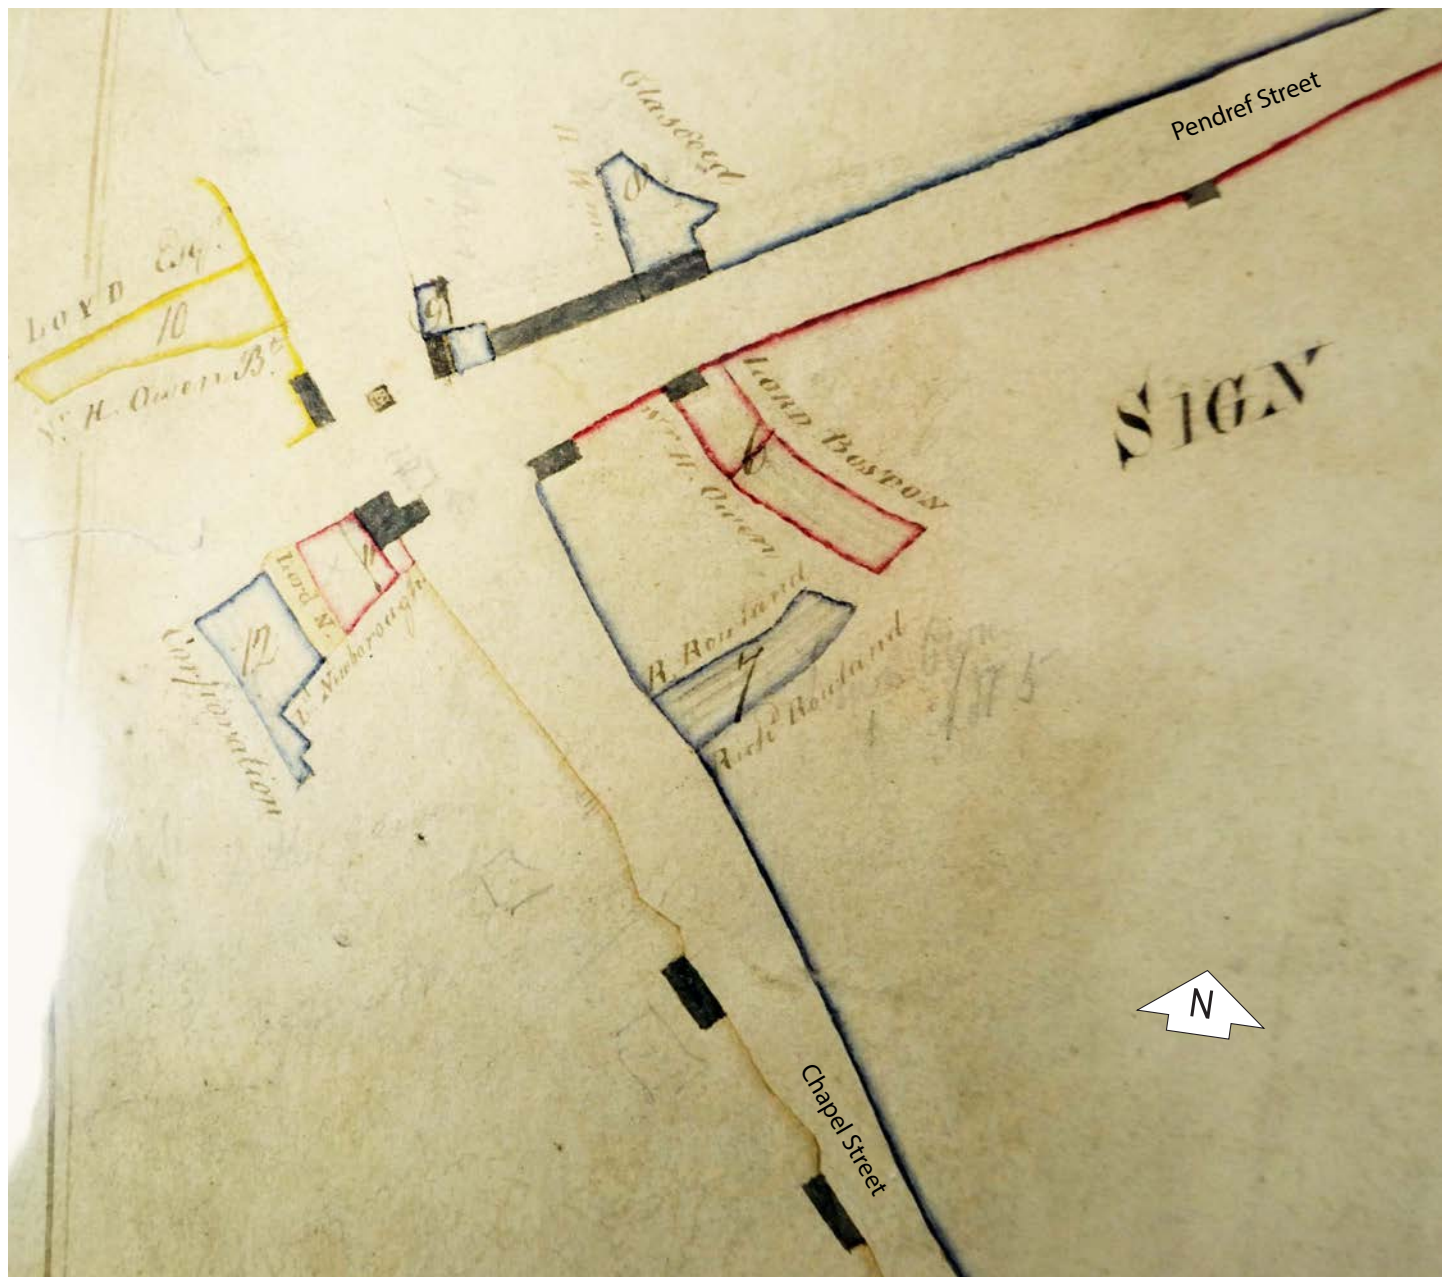
Figure 3. Part of Plan of the Sign and Tyddynpwrpas in the parish of Newborough, date 1799
(Archives and Special Collections, Bangor University, MISC 3/101)

There are two long rows of houses shown on the tithe map on the north-eastern side of Chapel Street, which still exist in an altered form today (PRN 69202 and 69203). However earlier maps suggest that the south-easterly of these two terraces was built in the early 19th century on open plots. Maps of 1799 (figure 3) and 1801 (figure 4) show quilllets (agricultural strips of land) on the north-eastern side of Chapel Street with no houses, and plot 204a was still lacking a house in 1846 (figure 7). A row of houses on the 1827 map (figure 5) shows that houses had been built here by that date. There seem to always have been houses along the upper part of the street but these have been heavily rebuilt. The house called Cae Crwn has a date stone of 1806 (plate 17) and this could indicate a major period of rebuilding for the whole row in the early 19th century. This rebuilding very likely resulted in the demolition of the earlier buildings but a 16th century doorway recorded by RCAHMW (PRN 67574, NPRN 15763) (plate 18) may be located in this row, probably in Carrog House, though it was not located during the current project. This may indicate the survival of earlier fabric, though it is likely that the doorway was reused from elsewhere and could have been built into the property in the early 19th century. The last house in the row, now completely rebuilt, used to be the start of a terrace running perpendicular to Chapel Street (PRN 69204). This terrace was called Rhenc Isaf and was occupied by poorer families (Norman Evans pers. comm.).

It is possible that parts of Malltraeth Street near the cross roads lacked houses in the 18th century. The 1799 map (figure 3) shows a plot without a house, but it is suspected that this map does not always show houses that existed at the time. Certainly there were rows of houses on both sides of the street by 1827 (figure 5).

The south-eastern side of the street was less built-up in the time of the tithe map. There was a short terrace (PRN 69216) running across the Sain Delyn plot. The 1799 map shows a single building on the street front (figure 3) but by 1846 the terrace had been built further back from the street and by 1889 this was rebuilt or reduced to two single storey cottages. The cottages were made into one dwelling about 40 years ago (David Owen pers. comm.). The row of houses towards the street corner were probably built in the 1840s as one of the buildings was a Baptist Chapel (PRN 8111), known as the Seion Chapel, and that was built in 1849, as recorded by a plaque still built into the wall of the house built on its site (plate 20). Llys Gwynedd, next to it, used to be the police station and the small shed at the back of the building was the prison cell (David Owens pers. comm.).

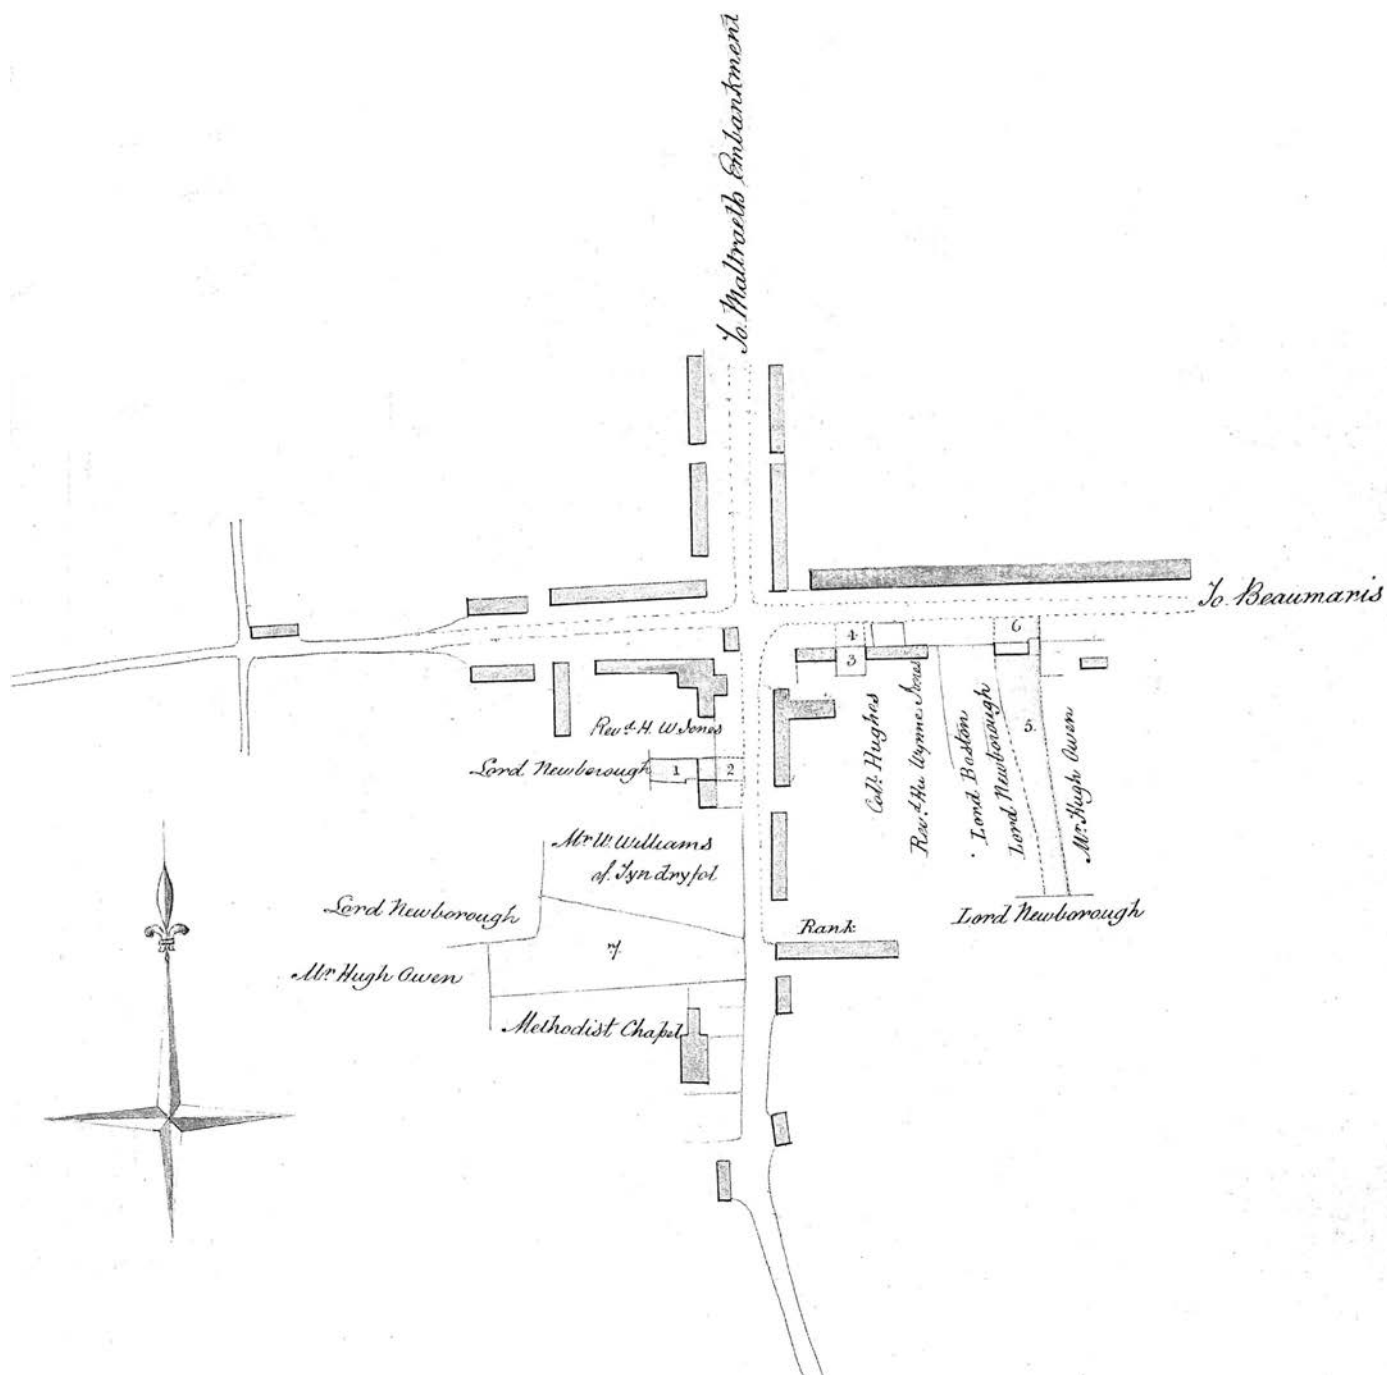
Figure 5. Plan of Mostyn property in Newborough, date 1827
(Archives and Special Collections, Bangor University, Mostyn Mss 8450)

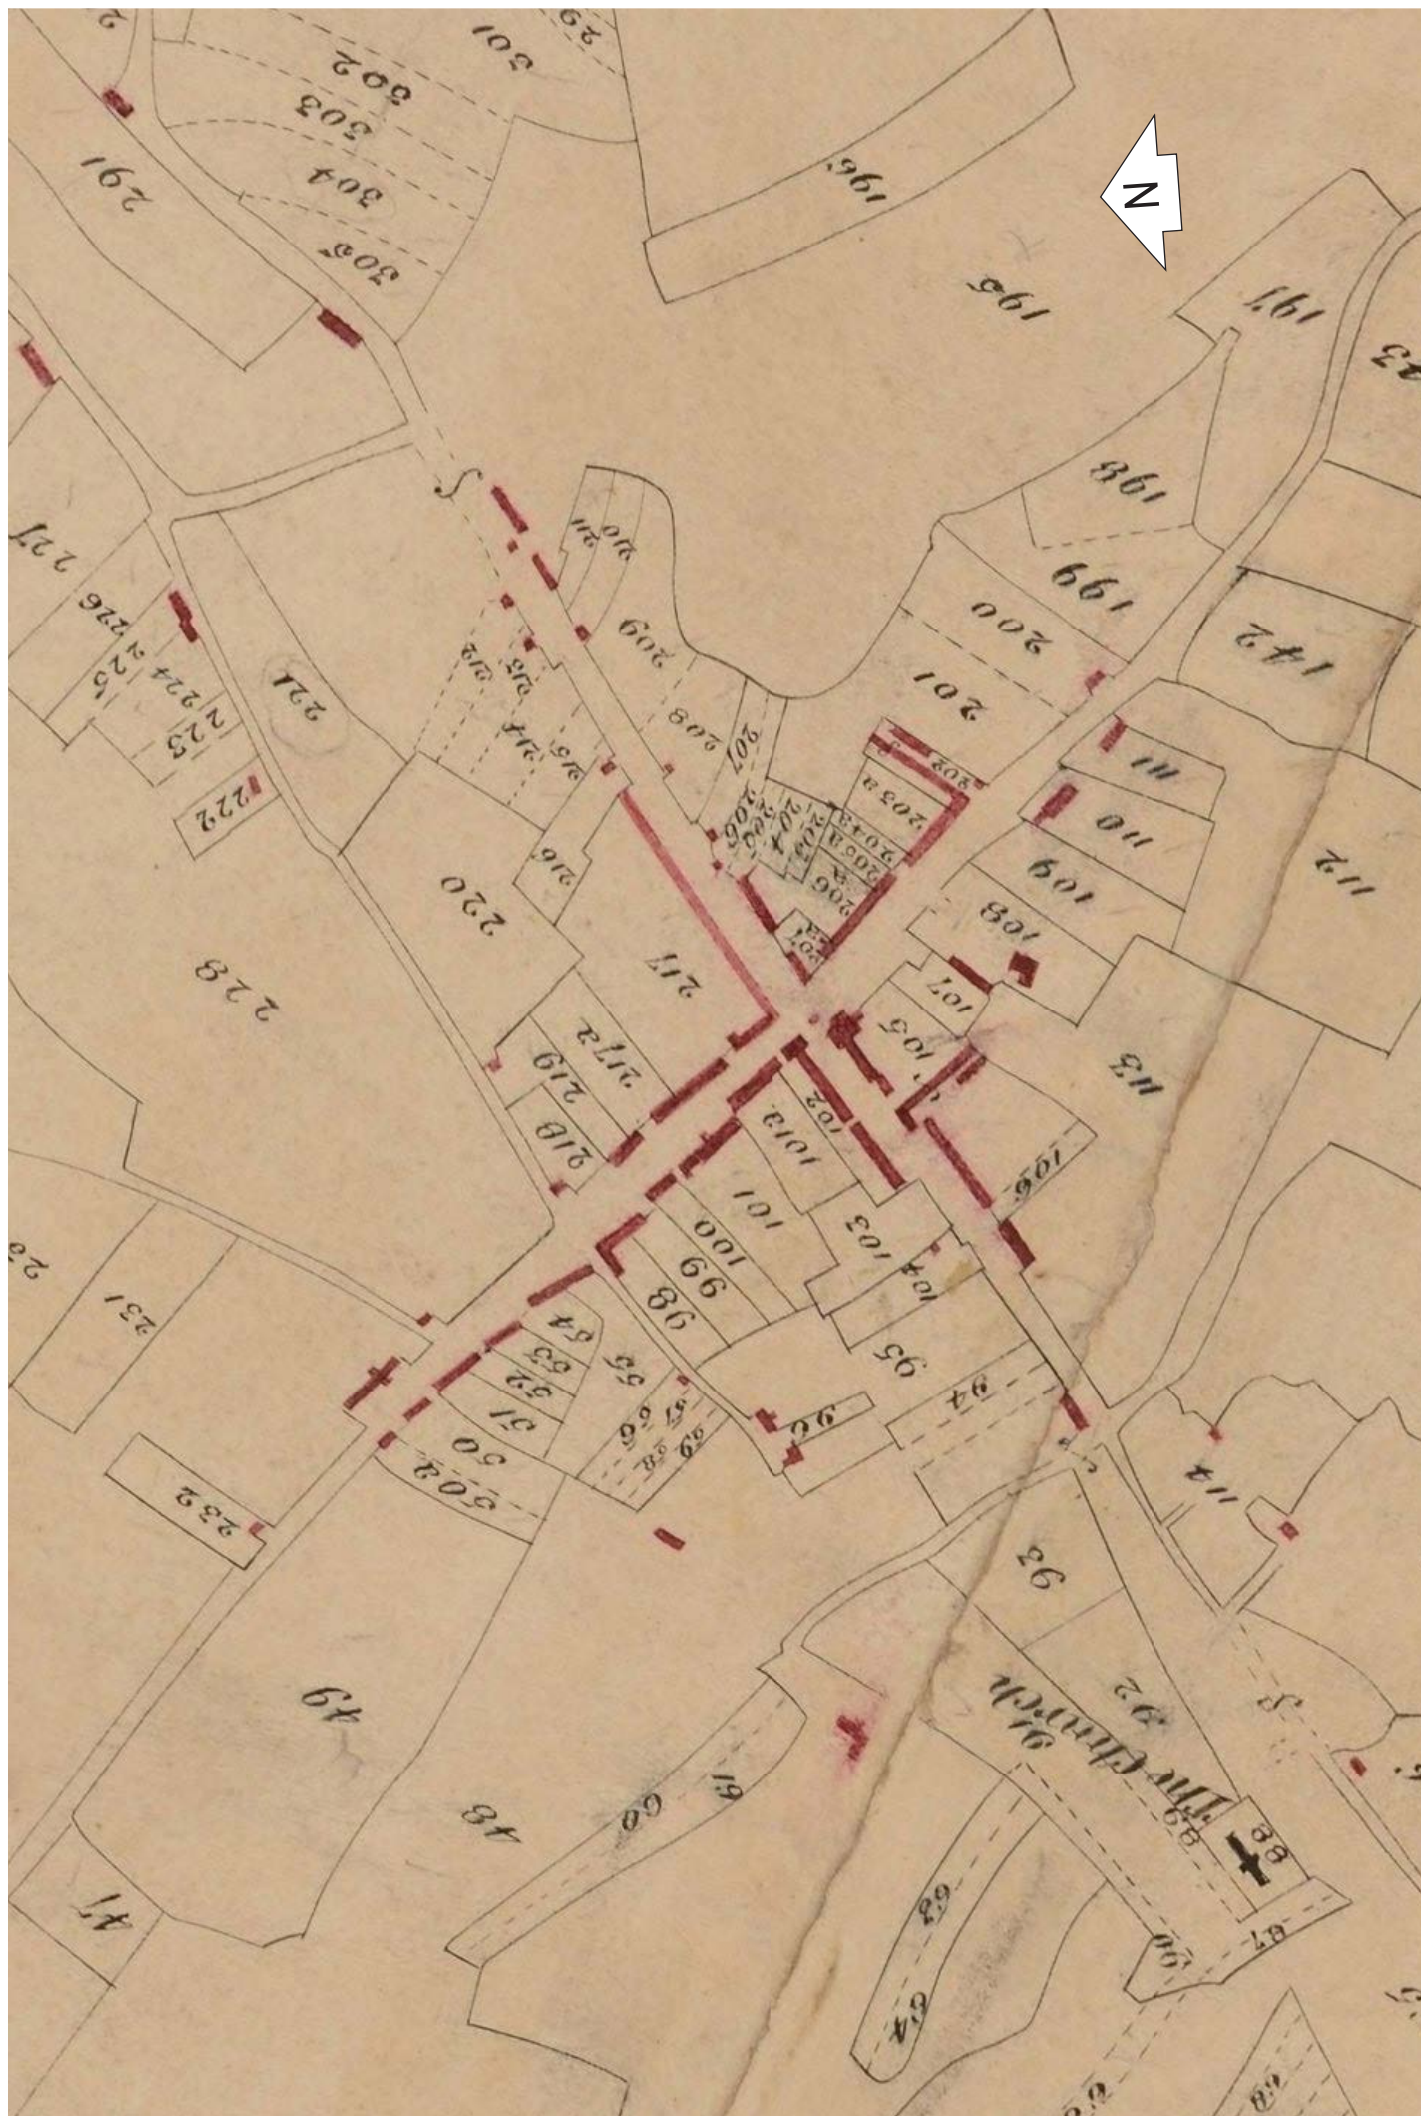
Figure 7. Part of tithe map for Llanbedr Newborough parish, date 1846, from Places of Wales website

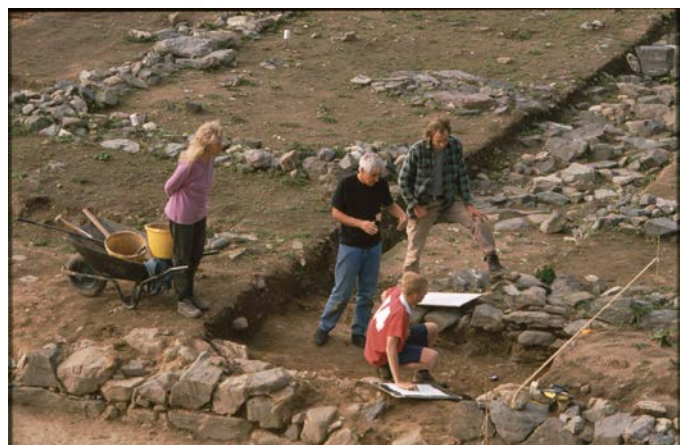
Plate 9. Excavations underway at Llys Rhosyr 1996

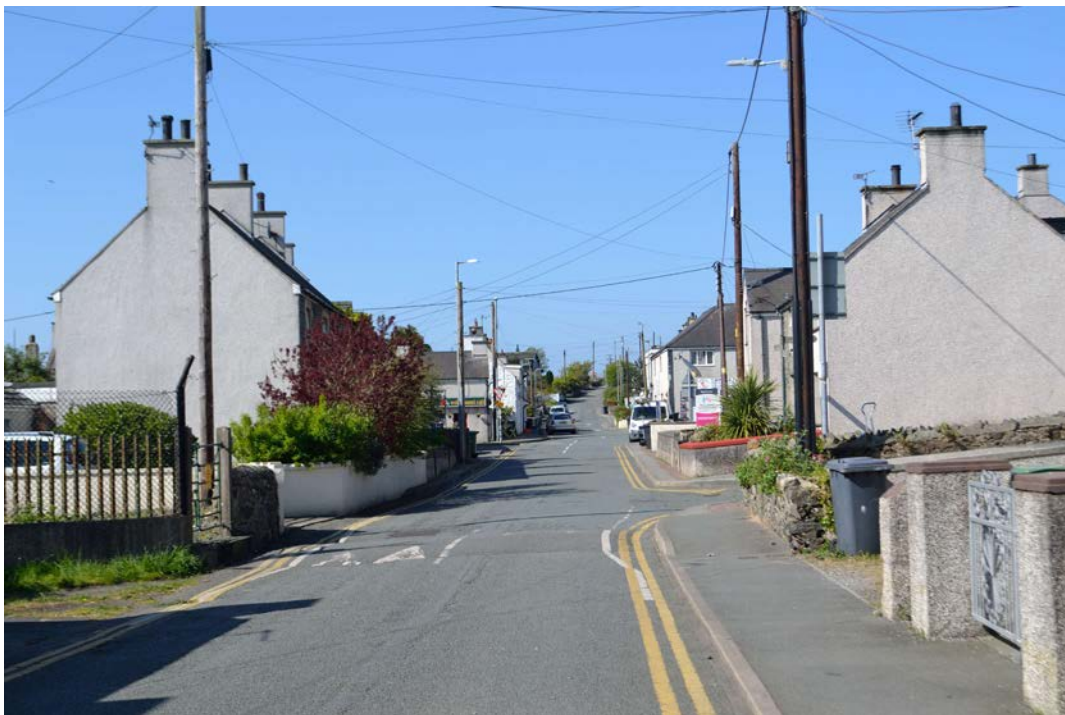
*Plate 12. View down Pendref Street and Church Street
(photograph by Jane Kenney, 11/05/2017)*

A notable feature of the village are the electricity cables criss-crossing the streets, supported on numerous poles (plate 12). The telephone lines also make use of the poles but the electricity cables are most prominent. This reflects a recent phase in the history of the village as in the 1950s, along with other Anglesey villages, Newborough still had not been supplied with electricity when much of the rest of North Wales was already connected. There was political pressure to get the area connected quickly and over-head cables were quicker to install than underground ones (David Elis-Williams pers. comm.). The character of the village is still influenced by not being on mains gas, resulting in oil storage containers and gas bottles being a feature in many gardens.

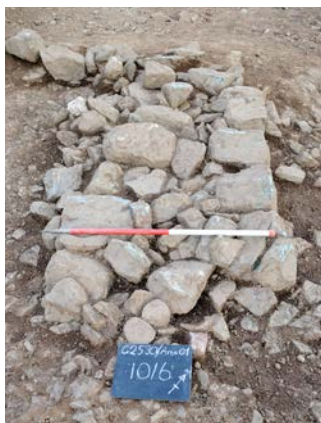
*Plate 13.
Remains of a wall
found in 2017
excavations north
of Lôn Twnti in
advance of a new
school*

been taking place in advance of the development. The work is not yet complete and results from the mitigation work is still very preliminary but the report on trial trenching has been produced (McGuinness 2016). The trial trenching showed quite even soil development across the two fields, although the soil depth is generally shallower close to the road and towards the lane running along the north-eastern side of the area (figure 16). Topsoil is between 0.15m and 0.35m deep over ploughsoil up to 0.7m deep. These deposits overlie the natural glacial clay which is generally a red-brown sandy clay with some areas of gravel usually about 0.8m to 0.9m below the modern surface. There is no sign of windblown sand recorded in this area at all.

The geophysical survey and trial trenching produced evidence of former field boundaries, some probably defining medieval strips (Evans, Hopewell and McGuinness 2016). Further excavation investigated these but also revealed more complex archaeology. In trench 01 of the mitigation trenches (Evans forthcoming) the remains of a wall were found (plate 13), probably related to a house shown in this area on an 18th century estate map (Lligwy Additional Mss 1123) (figure 2). In trench 06 pits containing burnt stone were found (plate 14), one of which produced a Bronze Age date and more dates are to be obtained. In trench 05 was a 9 post granary (plate 15) and a 4 post granary (plate 16). These are usually attributed to the Iron Age but what appears to be Bronze Age pottery was found in a feature in the 9 post granary. These features need to be studied in more detail and dates obtained but this certainly shows prehistoric activity on this side of the village, almost certainly a settlement.

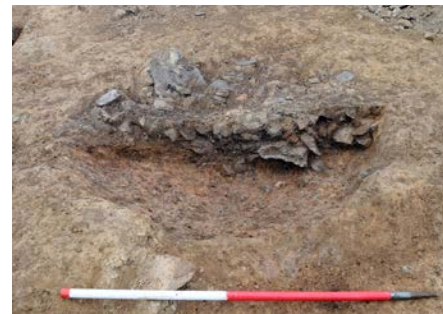
*Plate 16. Excavated postholes of a 4-post granary
found on new school site*

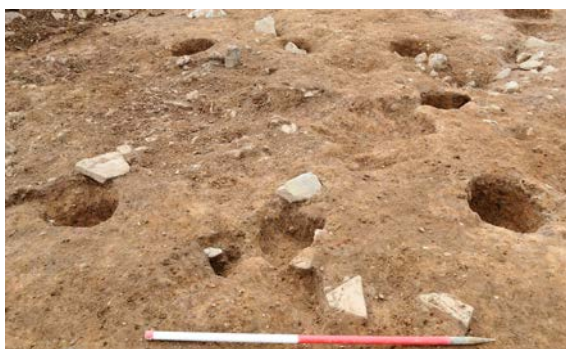
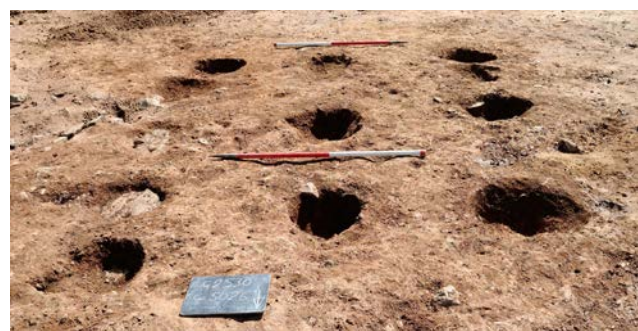
*Plate 14.
Bronze Age pit
containing burnt
stones found in
advance of a new
school*

*Plate 15. Excavated postholes of a 8-post
granary found on new school site*

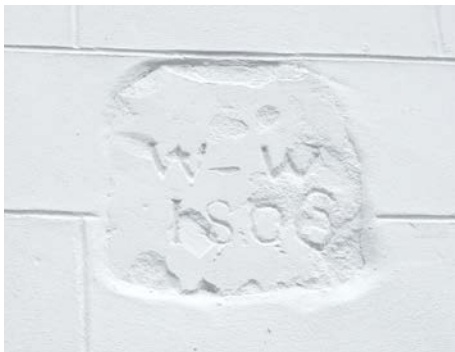
Plate 17. Date stone above the door of Cae Crwn (photograph by David Elis-Williams, 30/07/2017)

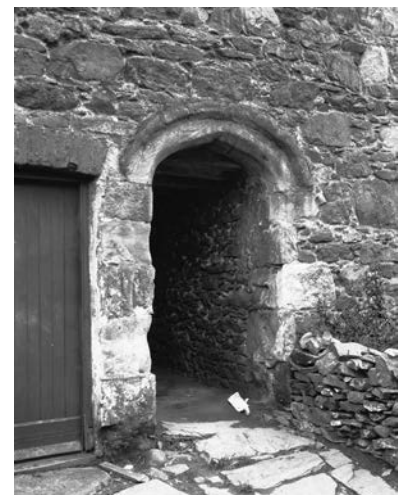
Plate 18. Early 16th century doorway photographed by RCAHMW in 1960

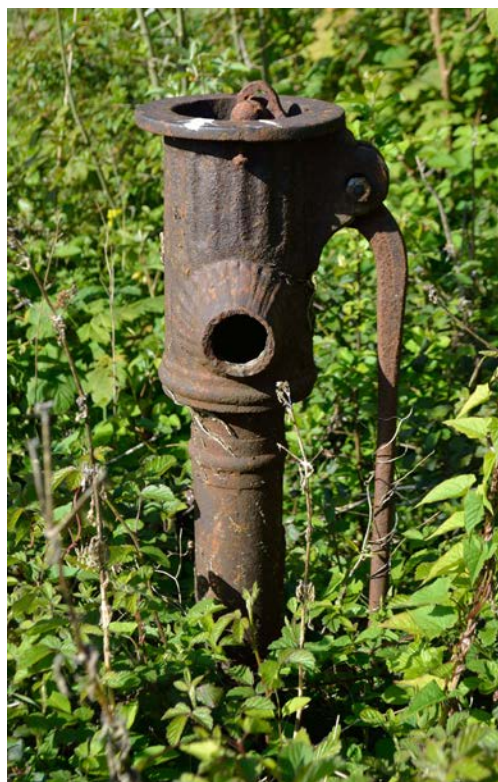
*Plate 19. Pump on Malltraeth Street
(photograph by Jane Kenney, 11/05/2017)*

North of Bodfair the burgage plots have been merged to create wider properties two or three original plots wide and, with the exception of Glan-ffynnan and Arosfa, the earlier 19th century houses have been lost. Bron Heulog was built at the very end of the 19th century as it appears on the 1900 map but not before. A terrace (PRN 67599) shown on the County Series maps from 1889 has been entirely demolished but trench 5 dug by CR Archaeology (Rees and Jones 2015b) may have revealed remains associated with the houses. The tithe map shows earlier houses on this site and these earlier houses are also shown on the 1801 estate map (figure 4). In 1801 the house was called Tŷ a Thir and it had a new stable built against the plot boundary to the south of the house. Close to where the terrace stood there is a cast iron pump (PRN 67788) by the side of the road (plate 19). This is shown on the 1900 and 1920 25 inch maps and seems to have been erected around 1902 to supply clean water to the neighbourhood, but it was locked at night, so water could only be obtained between seven in the morning and five in the evening (“Newborough and Its People” Penmon.org). The pump was in use into the 1950s (Norman Evans pers. comm.).

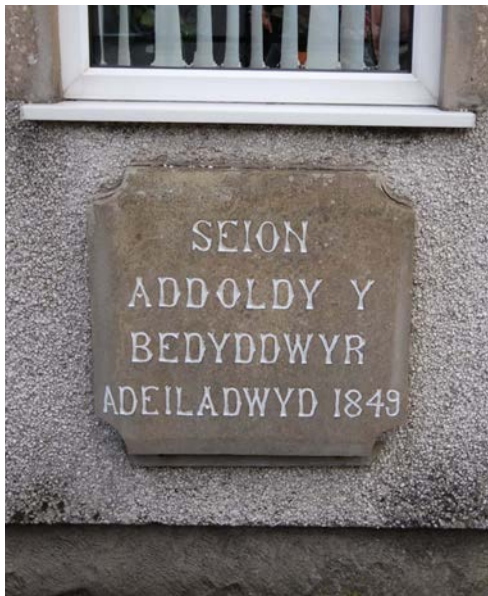
Plate 20. Plaque commemorating the building of Seion Chapel built into the wall of Cermar (photographed by David Owen, 26/07/2017)

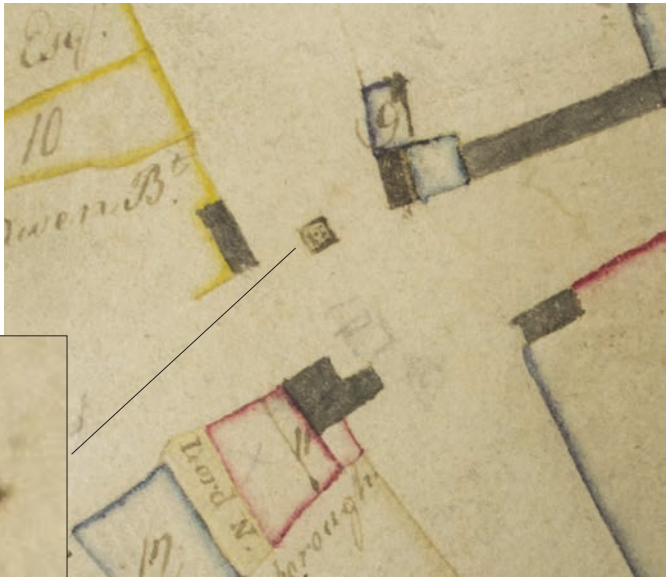
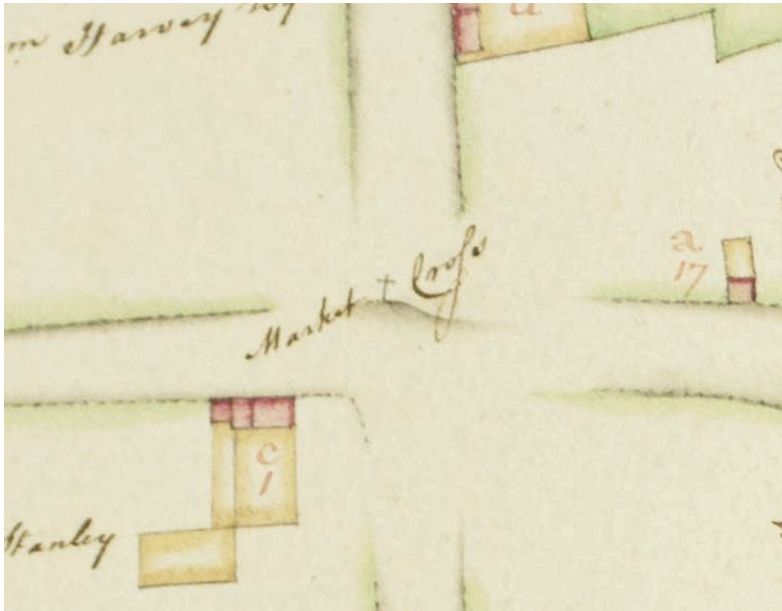
Figure 20. Comparisons of plans of the cross roads showing different representations of the market cross

Plan of the Sign 1799 with an enlarged inset of the cross on its plinth

Penrhos Estate map 1801

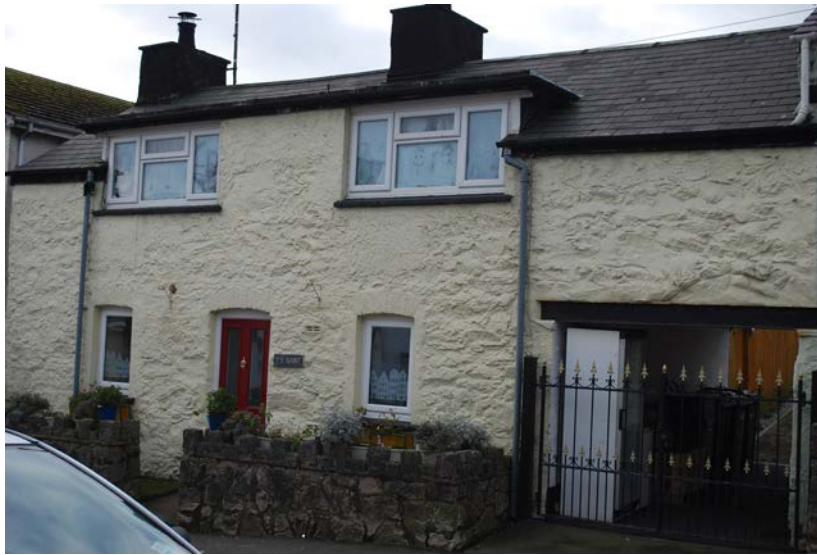
Plate 28. Ty Nant (photographed by Megan Howe, 05/02/2018)

The row of houses near the corner on the south-western side of Chapel Street is quite similar in character to the row on the other side of the street despite the houses being in origin late rather than early 19th century. Tŷ Nant still has much of its original character (plate 28), being a double-fronted cottage of the style typical of the village. As it is painted but not rendered it is possible to see that there are brick arches over the windows and door and that the roof has been raised to insert large first floor windows but the location of the original windows can still be recognised. It has a passageway through to the rear yard that is large enough for carts.

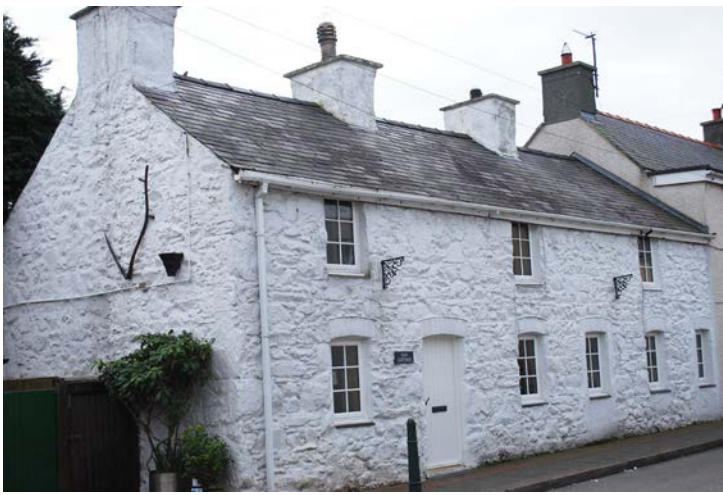
Plate 31. Sign Cottage (photographed by Megan Howe, 05/02/2018)

The north-eastern end of Church Street is dominated by pebble-dash with the exception of the white painted Sign Cottage. In the early 20th century this was three single-fronted dwellings (plate 31), but two of the doors have been converted into windows. Each cottage had its own chimney stack and the lack of render means that the field stone walls and brick arches over the windows and doors are visible.

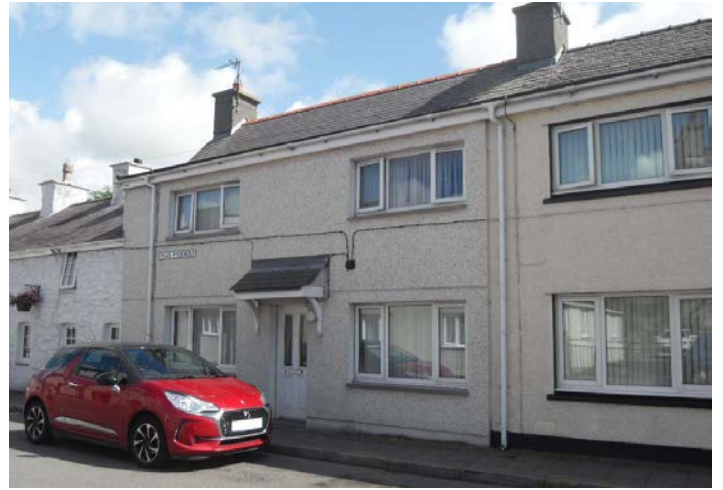
Plate 32. Plas Pydewau (photographed by Owenna Orme, 30/08/2017)

Plas Pydewau and Llain Stent have been heavily altered with large modern windows or dormer windows inserted, with pebble-dash hiding any earlier features (plate 32). Rhenc Newydd is a terrace of nine identical two storeyed, single-fronted houses with a gable over the first floor window (plate 33). Further down the street is a row of well-preserved early 19th century houses. The row was probably originally built with a mixture of single and double-fronted houses as seen today. The change in roof height between Ysgubor Ddu and College Bach is probably original (plate 34), though Spier House may have had its roof raised (Plate 35). The use of paint on render for some of the houses breaks up the pebble-dash, and College Bach has late 19th century detailing around the windows.

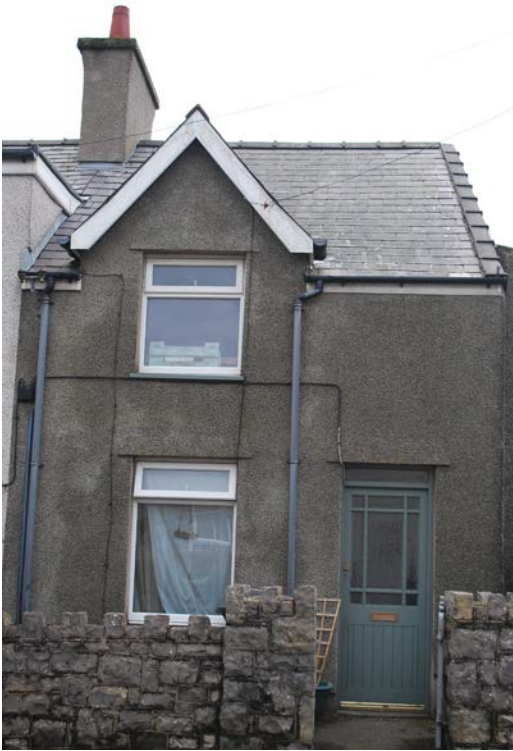
Plate 36. No. 2 Fair View (photographed by Megan Howe, 05/02/2018)

Further west along Church Street there was a late 19th century terrace, of which only Nos 1 and 2 Fair View survive, as what now appear to be semi-detached houses. No. 2 Fair View retains the original style of these houses with a small gable projecting above the roof line at the front (plate 36), while No. 1 has been altered (plate 37).

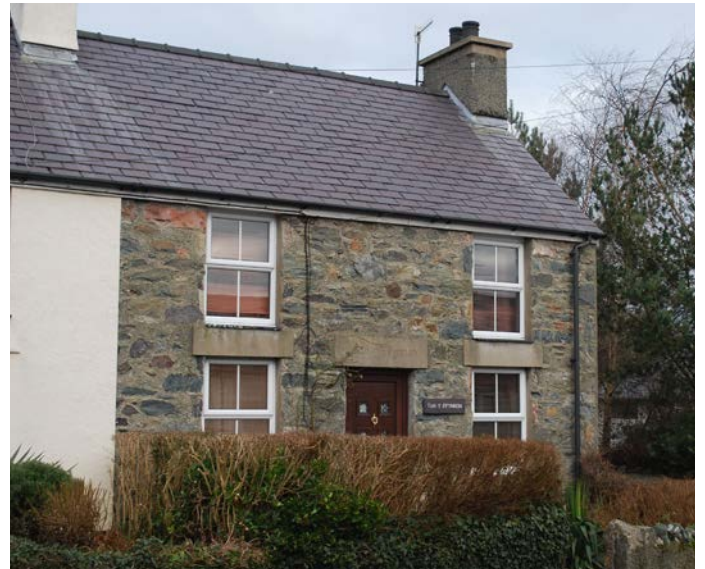
Plate 39. Tan y Ffynnon (photographed by Megan Howe, 05/02/2018)

On the other side of the street Tan y Ffynnon, Dolfor and Dwyrdd are fine late 19th century houses. All three are two-storey double-fronted houses but Dwyrdd is taller and more imposing than the others (plate 38). The render has been removed from Tan y Ffynnon and its stone walls can be seen (plate 39). It has thick sandstone lintels over the ground floor windows and door. The one over the door has the house name carved on it in gothic script.

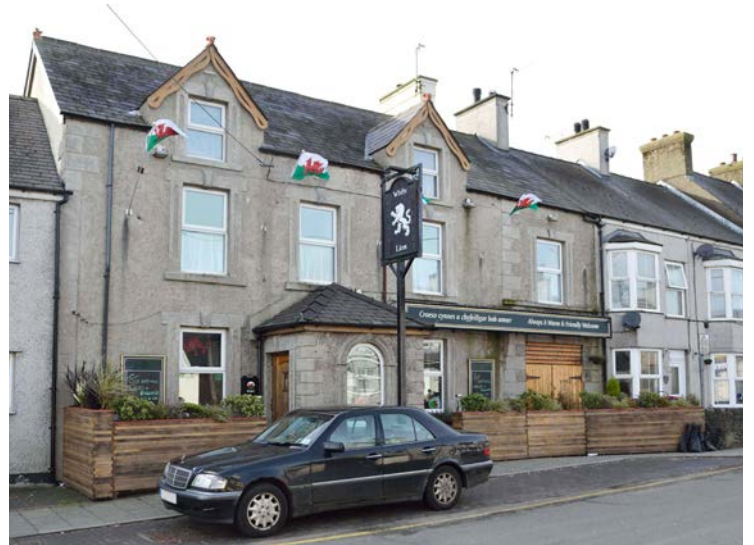
*Plate 44. The White Lion (photographed by
Jane Kenney, 16/02/2018)*

The White Lion is typical of a late 19th pub in a market town, which is what it was (plate 44). It has decorative quoins and window surrounds; a dormer window breaks the roof line and a porch projects onto the pavement. The current owners started renovating seven years ago and work is still in progress. A passage led though to the yard in the back, which is now closed off by modern double wooden doors to create a garage or storeroom. A photograph held in the Prichard Jones Institute shows how little the building has changed since the late 19th century (plate 45).

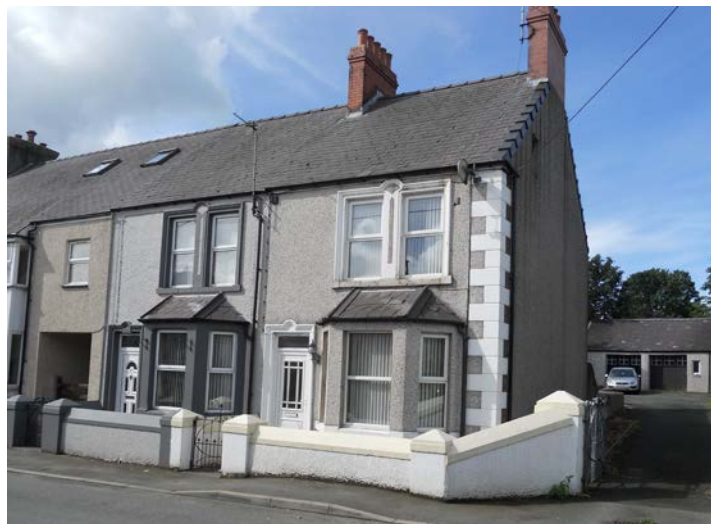
Plate 46. Treflys and Bodfair (photographed by Louise Williams, 22/07/2017)

Much of Hendre Terrace is rather featureless with no trace of the former use as a post office. The passageway through the rear yard remains with a room over the top. Trefflys and Bodfair have more features with bay windows and decorative window surrounds (plate 46). The plot with the pump (PRN 67788) on its frontage is now very over grown (plate 47). Bron Heulog stands within its mature garden (plate 48); its decorative wooden porch probably dates to the turn of the 20th century.

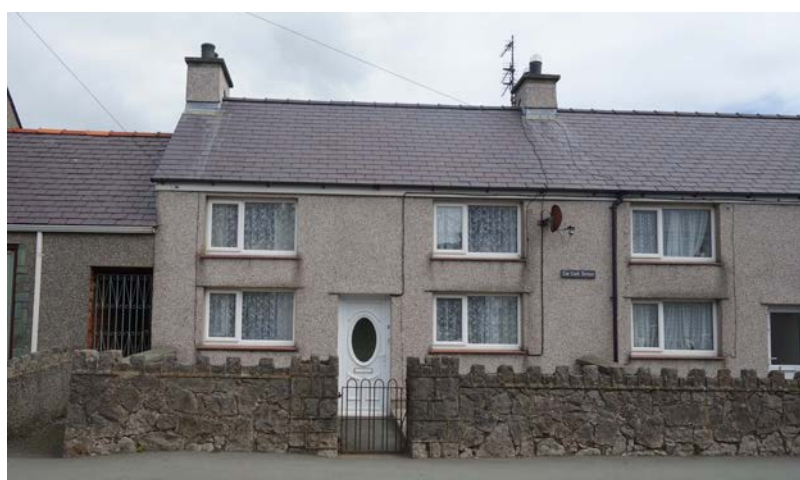
Plate 50. Cae Coch Terrace (photographed by David Elis-Williams, 27/08/2017)

Llys Alaw, Llwyn Llifon and Bodawel, although heavily modernised, retain some of their 19th century character (plate 49). Tyn Llan and Llyswen seem to be entirely modern. Cae Coch Terrace, though with new windows, doors and roof, are recognisable as 19th century double-fronted cottages (plate 50). The render has been removed from Rhose and the field stone walls and brick arches over the windows and door can be seen (plate 51). It appears to be a standard double-fronted 19th century cottage. Adjacent to the north is a small shed. This is very dilapidated and cracked render shows that much of the walls are of modern brick but the roof seems to be of rendered slate and the sag in the roof suggests that this is of some age. This seems to be the same shed as shown on the 1889 map.

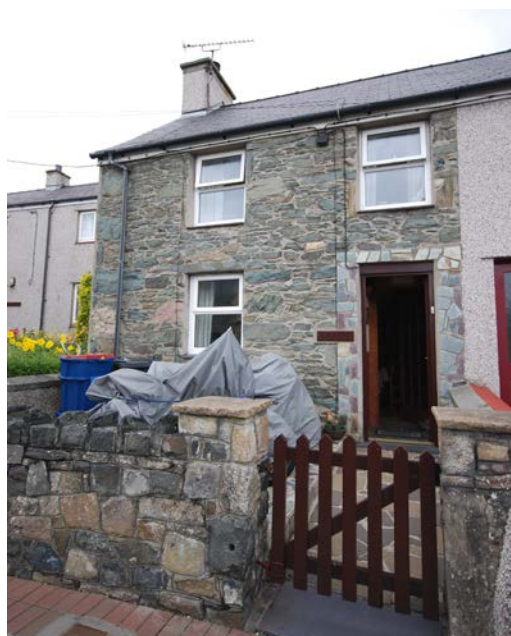
Plate 55. Elm Grove (photographed by David Owen, 26/07/2017)

Idan House was rebuilt in the 1960s so its pebble-dashed exterior is unlikely to conceal any earlier remains (plate 54). The render has been removed from Elm Grove exposing the field stone walls, large stone quoins and stone lintels of this late 19th century house (plate 55). The main row of houses along the northern side of Pendref Street has numerous alterations and additions, extensions, dormer windows, projecting roofs etc., but some houses retain their 19th century character or a few original features (plates 56 and 57). Some painted render varies the pebble-dash finish.

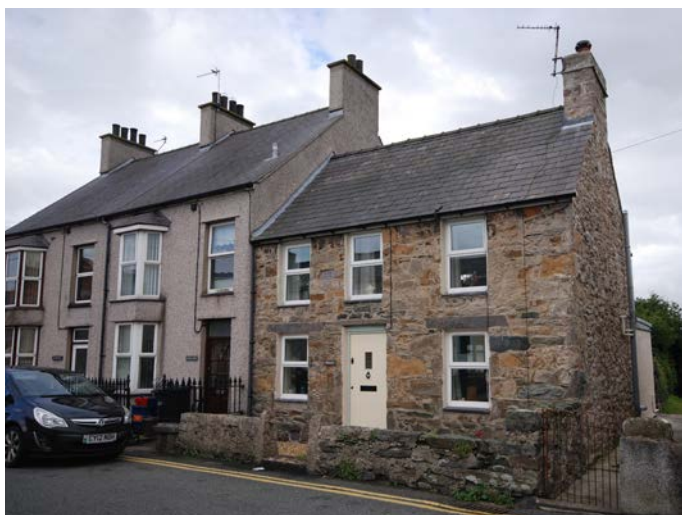
Plate 58. Rhianfa with Baron Hill next door (photographed by David Owen, 26/07/2017)

Rhianfa (plate 58) has recently been renovated, the render removed and the stone walls and slate lintels exposed. It is a double-fronted house like many in the village. It has a date stone of 1859 with initials GAG, so although it closely resembles houses such as Rhose, that claim to be early, it was built in the mid-19th century, which fits with the map evidence. The adjacent Pant is very similar in design, though smaller and was probably built at the same time. The two Baron Hill houses are essentially semi-detach houses that have been added on to the end of Rhianfa. They are single-fronted with bay windows on both ground and first floors and must have been built a little later than Rhianfa. The building is also much taller than its neighbour.

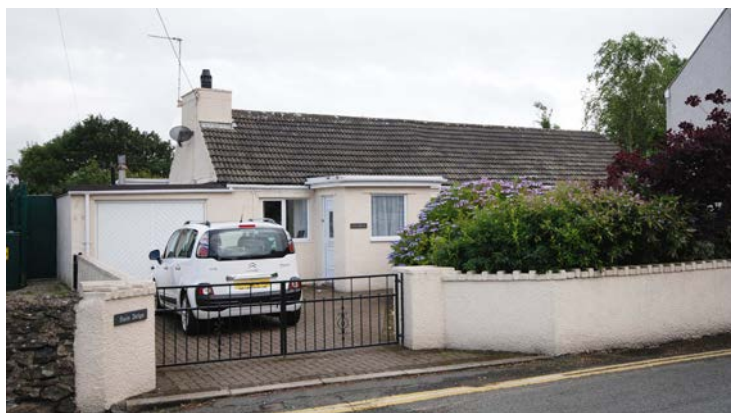
Plate 59. Sain Delyn (photographed by David Owen, 26/07/2017)

Sain Delyn appears to be a modern bungalow with only the short, wide chimney stack perhaps hinting at a longer history (plate 59). A flat roofed porch and garage have been added and the roof is now of concrete tiles but underneath are the remains of two 19th century dwellings. Plas Newydd and Llys Gwynedd are two fine mid-19th century houses. As they are not rendered the walls of quarried stone can be seen, and, although not using cut stone, the masonry is much more regular and better built than the field stone walls of older houses such as Rhouse. There are decorative pale brick surrounds to the windows and doors and alternating pale and red brick above the downstairs windows and door (plate 60). Cermar is a modern dormer bungalow with a gabled porch (plate 61). It stands on the site of Seion Chapel but seems to have been entirely rebuilt. The covered passage through to the back yard shown on the 1920 map has gone, leaving a drive which leads through to the rear garden.

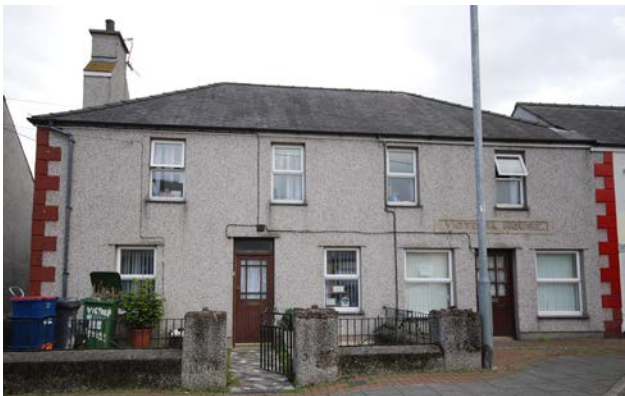
Plate 63. Victoria House (photographed by David Owen, 26/07/2017)

red window and door surrounds (plate 62). The adjacent Victoria House is distinguished by its prominent painted quoins against the usual pebble-dash. This also still has the name “Victoria House” carved in stone above the door of the flat (plate 63).

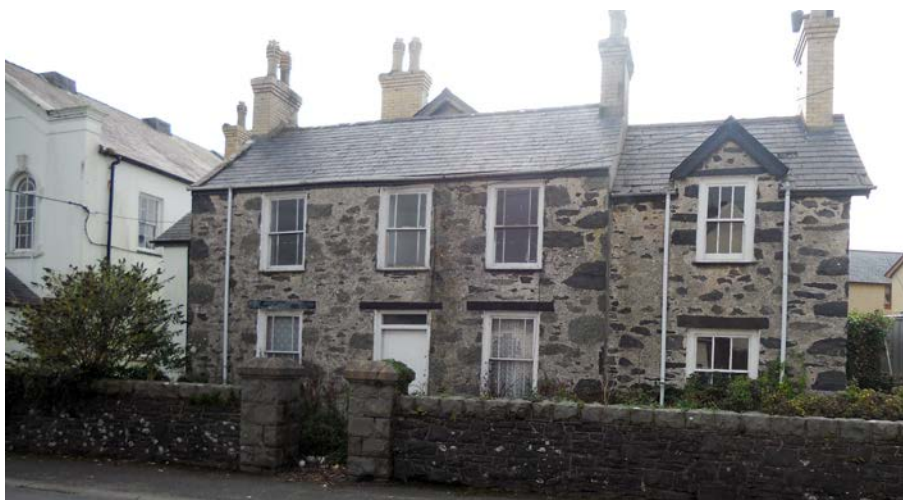
Plate 64. Tŷ Capel (photographed by Chris Jones, 26/09/2017)

Tŷ Capel (plate 64) is a two-storey, double-fronted house built of rubble masonry with large, uncut stones used as quoins, and narrow slate lintels over the downstairs windows and door. Unusually for Newborough the windows have not been replaced and they are probably the original sash windows, retaining marginally spaced glazing bars. The door may also be original. The extension on the right of the original building is built in a similar style, though its first floor window is in a gabled half dormer. The Sunday school building to the rear is L-shaped with a porch in the angle of the L (plate 65). It is rendered and painted white with tall 12-pane sash windows, again probably original. The small garden in front of Tŷ Capel is enclosed by a low wall of Penmaenmawr granite rubble with gate-pillars of roughly knapped stone.

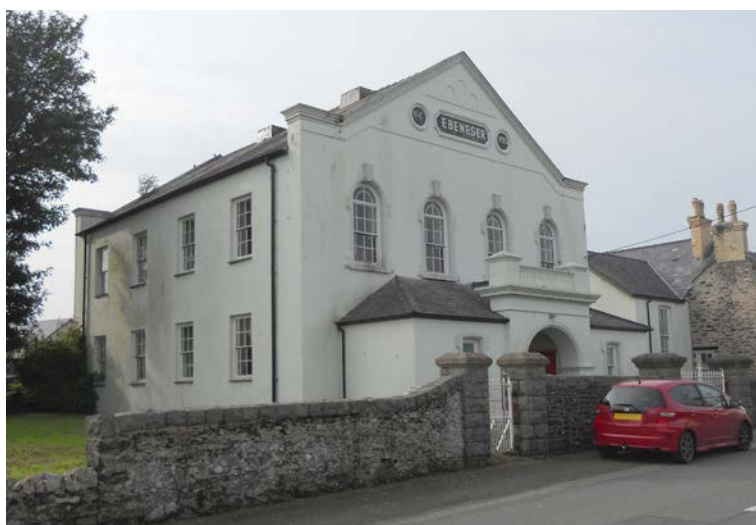
Plate 66. Capel Ebeneser (photographed by Chris Jones, 26/09/2017)

Next door is the Ebeneser Chapel (plate 66). This is a rectangular building of renaissance design with a pitched slate roof and a projecting porch with a hipped slate roof and a central bay topped with a balustraded parapet. The building is rendered and painted white, although the paint is starting to flake. The front elevation has a winged pedimented gable with projecting cornice. On the gable are three plaques: circular plaques to the left and right with "O.C." and "1785" inside them and a centre plaque reading "EBENESER". The windows on the front have round arches with cement architraves and keystones. The windows in other elevations are rectangular, tall 12 pane windows. All the windows appear to be the original sash windows. Behind the chapel is a cemetery. The wall in front of the chapel matches that of Tŷ Capel and is made of Penmaenmawr granite with knapped granite gate-pillars and coping. The chapel is a grade II listed building (reference 20552) and the chapel house and Sunday school are also grade II listed (reference 20556).

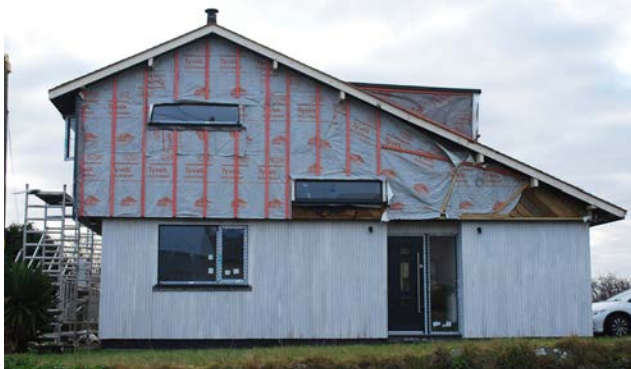
Plate 69. Forest Lodge (photographed by Megan Howe, 05/02/2018)

Tan Rofft are two modern semi-detached houses. Towards the end of the built-up street are a group of modern bungalows in large gardens. One is a dormer bungalow and one has an extension with a first floor. Forest Lodge is very modern in design (plate 69). It is a two-storey house with a dramatic asymmetrical roof and, although new, seemed to be undergoing recladding when the survey was being done.

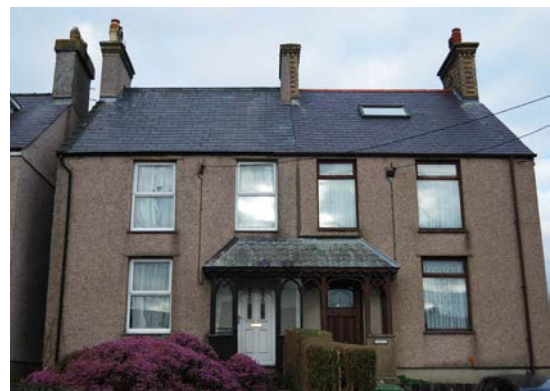
Plate 70. Bron Rallt and Awelon (photographed by Megan Howe, 05/02/2018)

Bron Rallt/Awelon and Bryn Goleu/ Sunny Cliffe are two pairs of semi-detached houses. Bron Rallt and Awelon (plate 70) are well-preserved with the original wooden porches over the doors and on Bron Rallt the two colour

brick decoration on the chimney stacks can be seen. The houses are single-fronted and a mirror image of each other. Bryn Goleu and Sunny Cliffe would have looked the same but they have lost their original porches and gained dormer windows. Tan yr Allt is a very modern house making use of stone and some brick as well as pebble-dash to create a varied finish (plate 71).

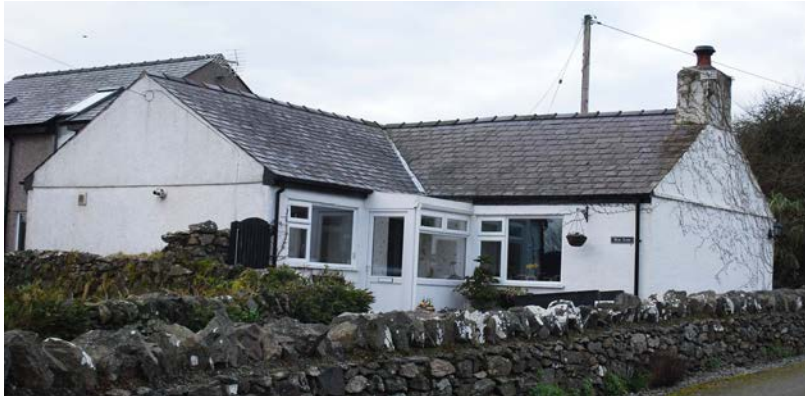
Plate 73. Tyn Lôn (photographed by Megan Howe, 05/02/2018)

Tyn y Lôn (PRN 67595) is shown on the 1846 tithe map exactly as it appears today. The current building must at least be based on buildings present in the early 19th century. The building to the east of Tyn Lôn (PRN 67596), now just a barn or shed, was shown as a house on the 1846 tithe map and County Series maps.

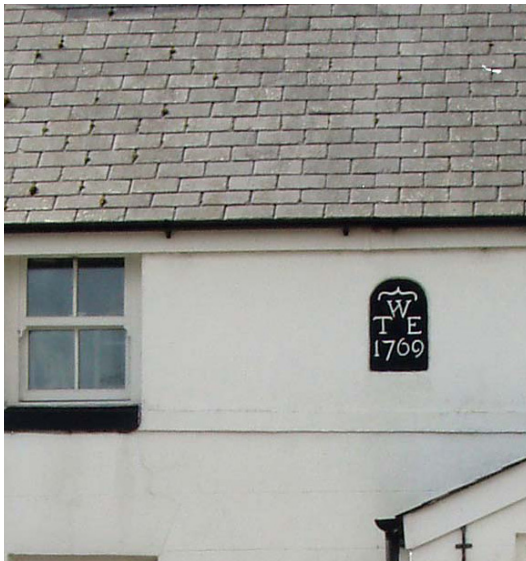
Plate 76. Date stone on Pengamfa (photographed by Marianne Jones, 01/09/2017)

been converted to windows it looks quite similar to the house today. Pengamfa (PRN 67598) has a date stone of 1769 (plate 76), so it should have been standing what the 1782 map was made. On the tithe map it is named as Pen y gamdda (plot 51) and it was first referenced in the parish registers as “Pengamfa” in 1814 or as “Ty’n gamfa” in 1817 (Owen 1952, 129, 131).

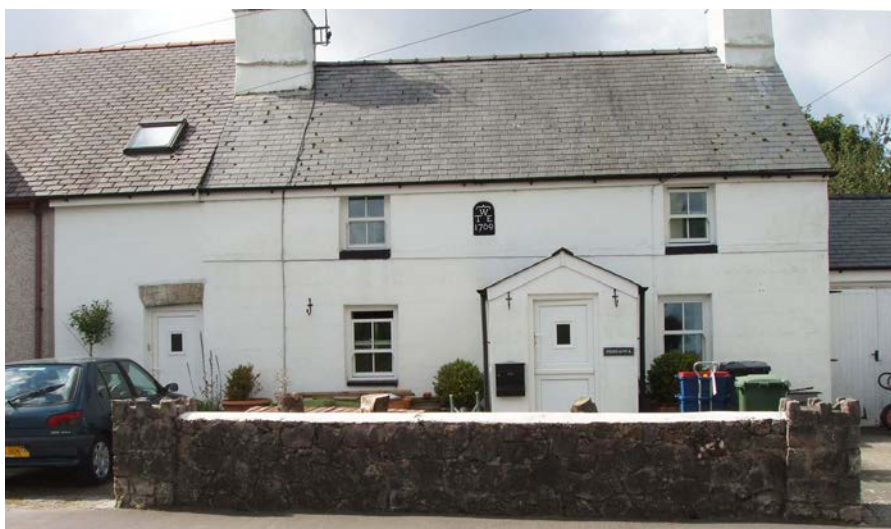
*Plate 79. Pengamfa
(photographed by
Marianne Jones,
01/09/2017)*

Pengamfa (plate 79) is a double-fronted, two-storey house with two chimneys and an extension on the left side
