Understanding Place: Characterisation and Deposit Modelling for Newborough, Anglesey

Project No. G2404

Report No. 1426

Prepared for: Cadw

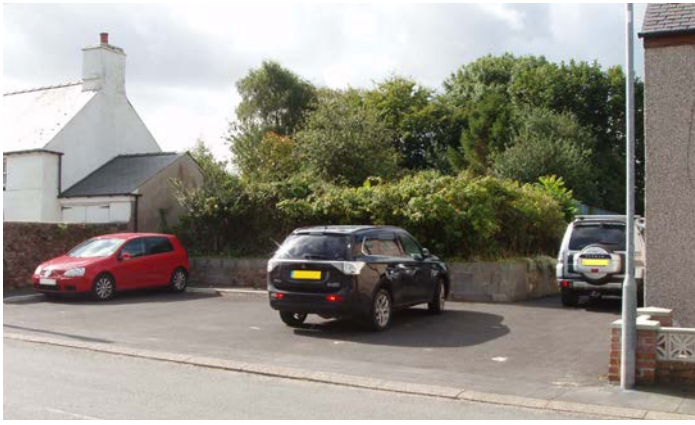
Plate 80. Vacant plot next to Boston Terrace (photographed by Marianne Jones, 01/09/2017)

The front of the vacant plot on which Llain Cleddyf cottage used to stand is currently used for parking with gardens behind (plate 80). Despite the pebble-dash Boston Terrace is still a 19th century building and apparently fairly unchanged, with decorative stone surrounds to the windows nicely exposed. Minffordd was redesigned and probably rebuilt in the early 20th century and has decorative half-timberwork on the first floor (plate 81). It has two large first floor windows with a narrow window between them. On the ground floor it has a long porch composed of two bay windows joined by the doorway.

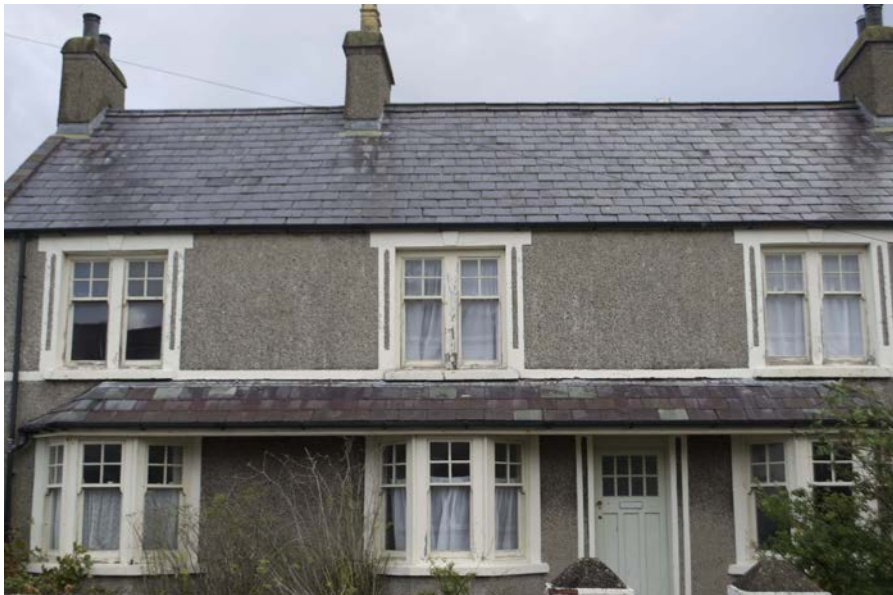
Plate 82. Pen y Bonc (photographed by Natalie Herring, 14/09/2017)

Pen y Bonc (plate 82) has three small bay windows on the ground floor joined by a single slate roof, which also provides a porch for the off-centre door. The three first-floor windows have decorative surrounds and all the windows seem to be original sash windows. Numerous stone sheds and barns survive behind the house in fairly good condition and there is a large garden behind those. The field to the south-east is improved pasture and is enclosed by a stone wall, and contains a modern gorsedd stone circle (PRN 69251) from a county eisteddfod held in 1959. The field to the north-west has been perhaps less improved. The site of Y Plas can be recognised as a low earthwork platform in the southern corner of the field (plate 83). There is a large tree growing in one corner of the Plas enclosure and shrubs over another part but most of the area is under grass.

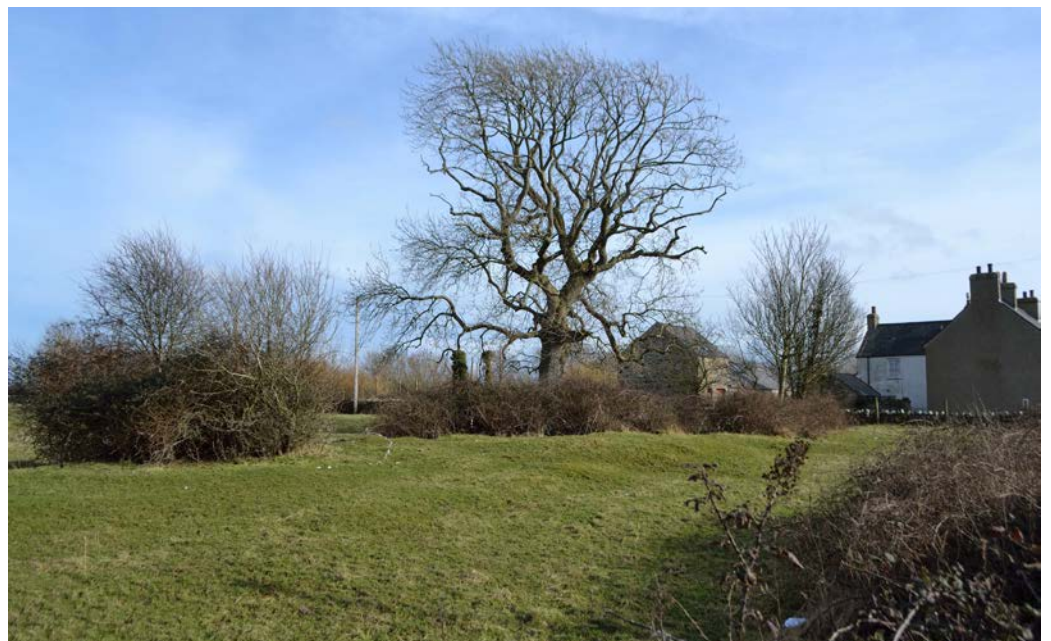
Plate 83. The site of Y Plas (photographed by Jane Kenney, 16/02/2018)

The former location of Y Plas must be considered to be of very high potential. The field would seem to be a prime spot for development and if this occurs full archaeological investigation of the history of this house, which was a prominent marker on the borough boundary, must be carried out. The lack of use of this site since Y Plas was demolished and the fact that the building was not rebuilt in 19th century, suggests a very high likelihood of survival of early post medieval and medieval remains.

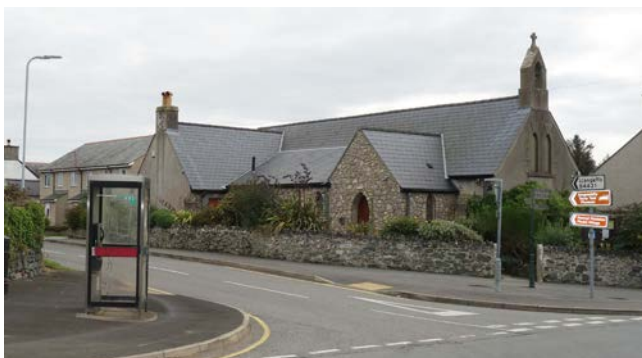
Plate 84. Eglwys Bach (photographed by David Elis-Williams, 27/08/2017)16/02/2018)

Eglwys Bach (plate 84) was originally a small church composed of a simple rectangular building with a small porch toward the south-western end. In the 20th century a larger porch was added on the north-eastern end and late in the 20th century the southern porch was rebuilt and a structure built to join the two porches and make the building wider. The original building is rendered with two arched windows, now blocked, in the south-western end. On top of the south-eastern gable is a small bell cote which still has a bell, and a simple stone cross on top. The new parts of the building are faced in fresh-looking, rather rounded stones, neatly pointed.

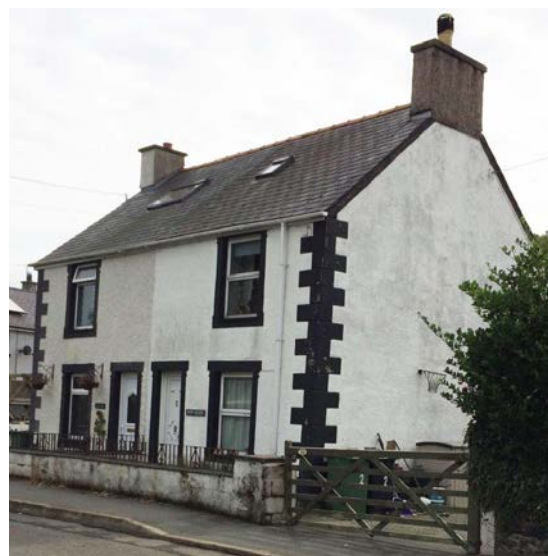
Plate 85. Nos. 1 and 2 Lôn Twnti (photographed by Anne Harris, 29/08/2017)

Nos 3 to 5 Lôn Twnti form a modern pebble-dashed terrace with porches, and a telephone exchange is housed in two small buildings just beyond. Nos 1 and 2 Lôn Twnti (plate 85) are a pair of late 19th century semi-detached houses. Each is single-fronted and they mirror each other. They have prominent ashlar quoins, made more prominent by being painted black, and stone window and door surrounds, with the rest of the building rendered and painted.

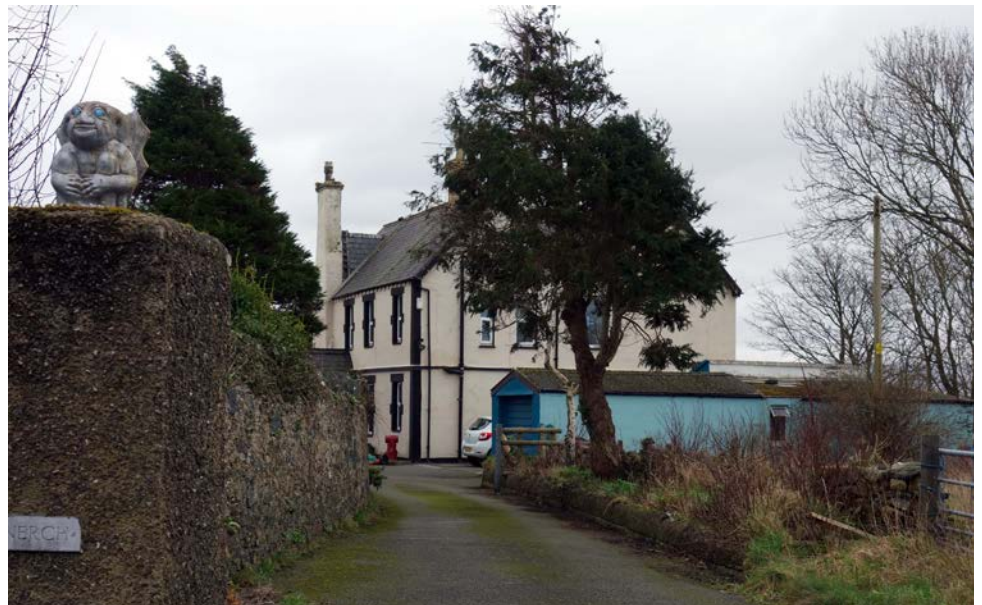
Plate 89. Llanerch (photographed by David Elis-Williams, 22/01/2018)

Llanerch, the former rectory, seems almost unchanged (plate 89). It has recently been repainted, highlighting the ashlar window surrounds, string course, and detail on the gabled porch.

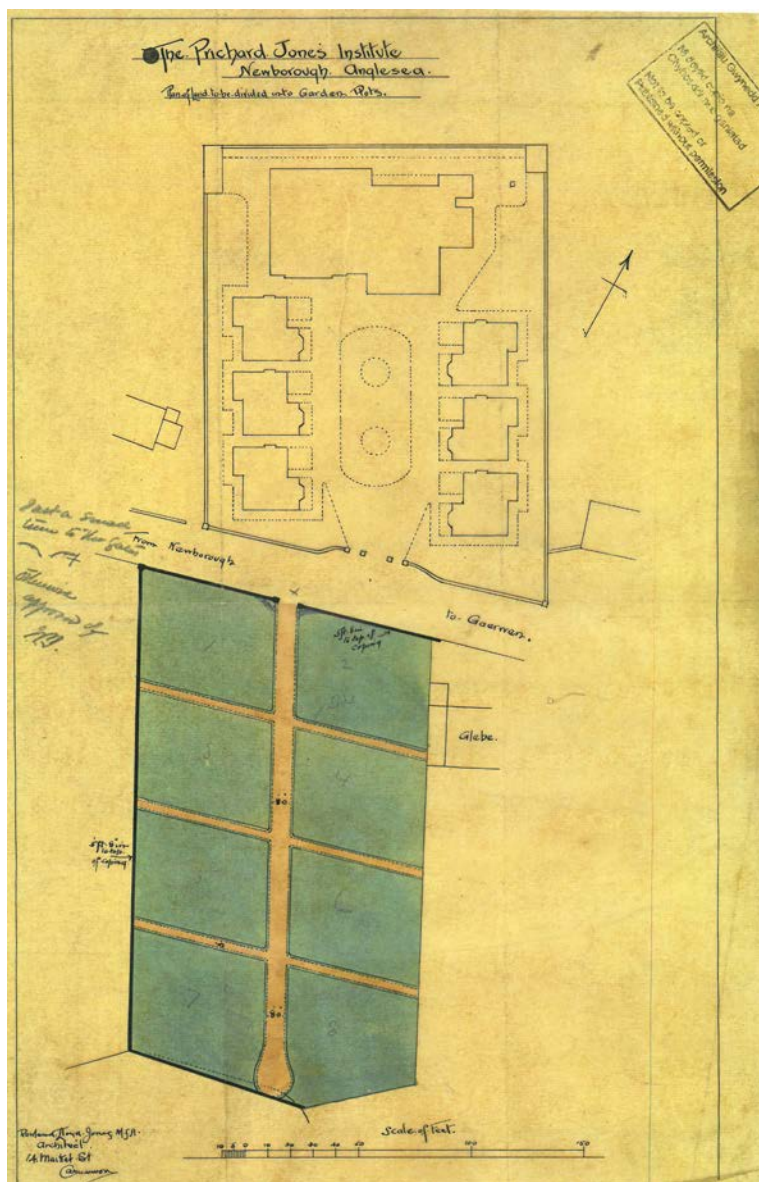
Figure 27. Outline plan of the Prichard Jones Institute and cottages showing the gardens opposite and how they were to be laid out (Caernarfon Record Office XM-MAPS-410-1)

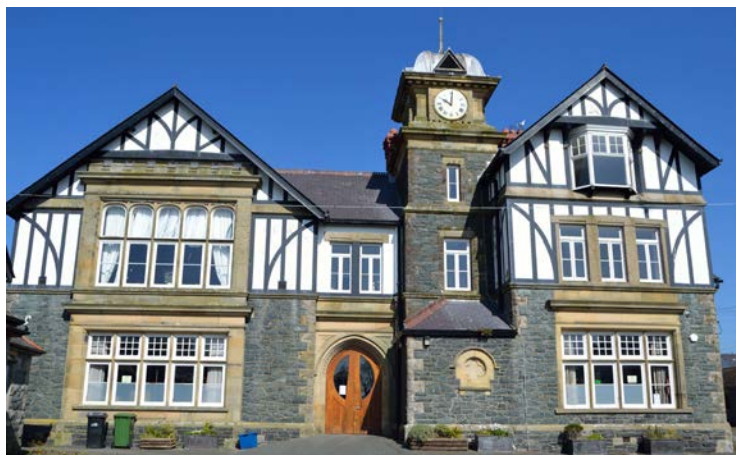
*Plate 98. The Prichard Jones Institute
(photographed by Jane Kenney, 11/05/2017)*

The Prichard Jones Institute forms the centrepiece of a planned development that includes six cottage homes and an area of garden provided for the use of the cottage residents. The Institute building is built of grey Anglesey granite with Ruabon stone detail in a Neo-Tudor architectural style, with fine half-timbered external detailing and exceptional interior fixtures, fittings and decoration (Davidson and Roberts 2008, 1). The building has an asymmetrical layout and has two storeys with attics (plate 98). Set back to right end of main building is a short

two-storey range that forms the caretaker's house. The slate roof has decorative red-brick chimney stacks and terracotta ridge tiles. The main entrance, which is central to the front of the building, is through a pointed arch. The clock tower, to the right of the entrance, has three stages with the clock stage above, which has four faces each with a clock face. The clock tower is topped by a cupola with a tall finial.

The Institute is now a grade II* listed building (reference 20554). A photographic record of the building along with written descriptions was made in 2008 before the building was renovated and improved (Davidson and Roberts 2008). The renovations have improved the appearance of the building without any loss of original detail and have ensured that it can continue its original function of serving the people of Newborough.

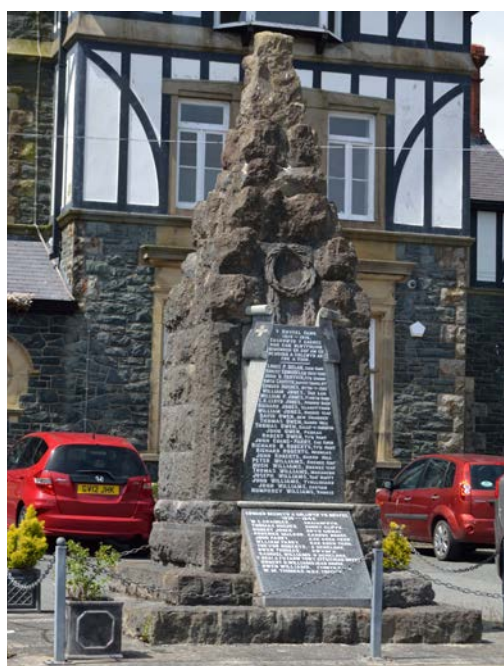
*Plate 100. The war memorial in the Prichard Jones Institute grounds
(photographed by Natalie Herring, 08/07/2017)*

The war memorial, which has been located in the centre of the yard surrounded by the cottages, has a stepped plinth supporting a heavily rusticated stone pylon which tapers in a rough, spire-like form (plate 100). It has a tapering polished granite inscription plate on the front face, which is inscribed with the names of the men of the parish who fell in the First World War. Above inscription plate is a stone wreath encircling an inscription which reads 'Ir Bewrion'. A plaque was later added to commemorate those who fell in the Second World War. This is inclined against the stepped plinth on the front face (listed building entry). The monument is a grade II listed building (ref. 20573).

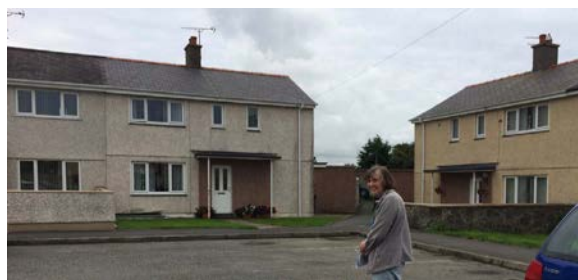
*Plate 103. Houses in Ucheldre with Marion Gash
recording (photographed by Anne Harris, 29/08/2017)*

Ucheldre is a housing estate of 39 houses (plate 103). Some are arranged around a cul-de-sac running off Lôn Twnti, and others face out onto Pendref Street. The cul-de-sac curves round sharply, with a central space used for car parking. The area consists mainly of two-storey houses, most of which are semi-detached, but there are also three rows of four terraced houses. In addition there are five bungalows arranged in a set of three and a set of two. The houses are all in a similar

style with pebble-dashed walls, of various pastel colours, and slate roofs. The houses have generous gardens both in front and to the rear, but there is little public green space.

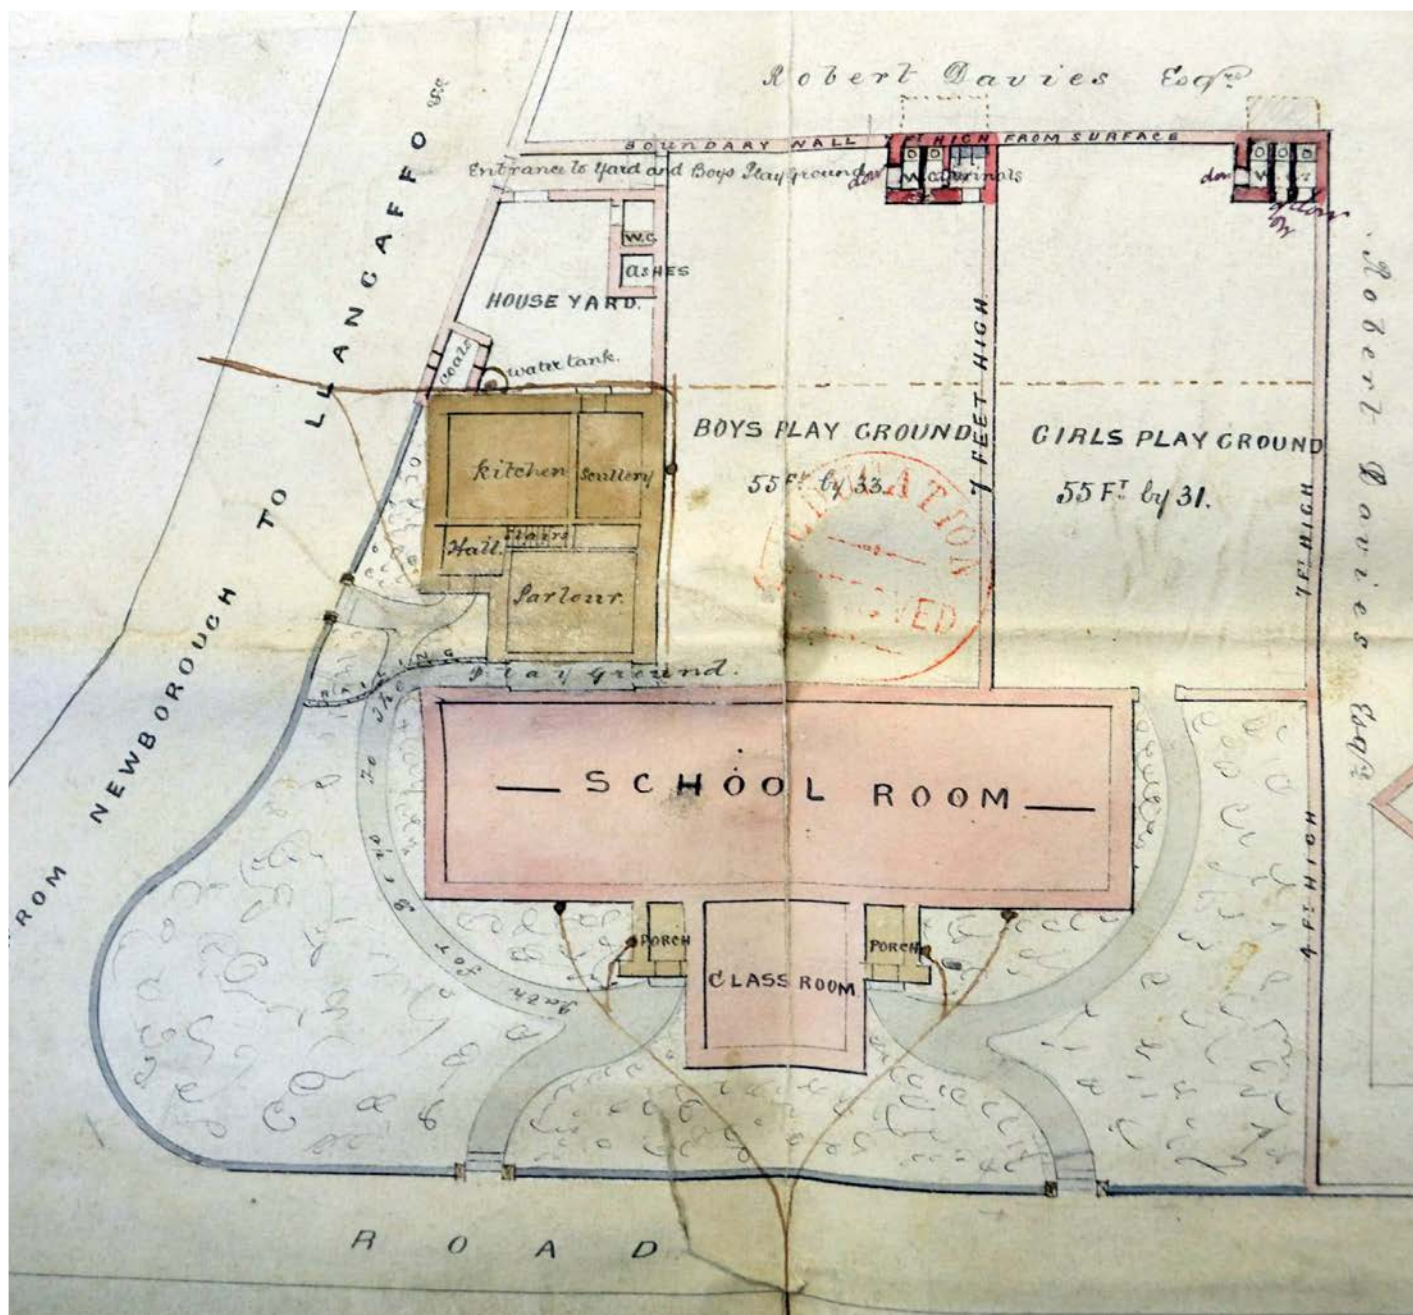
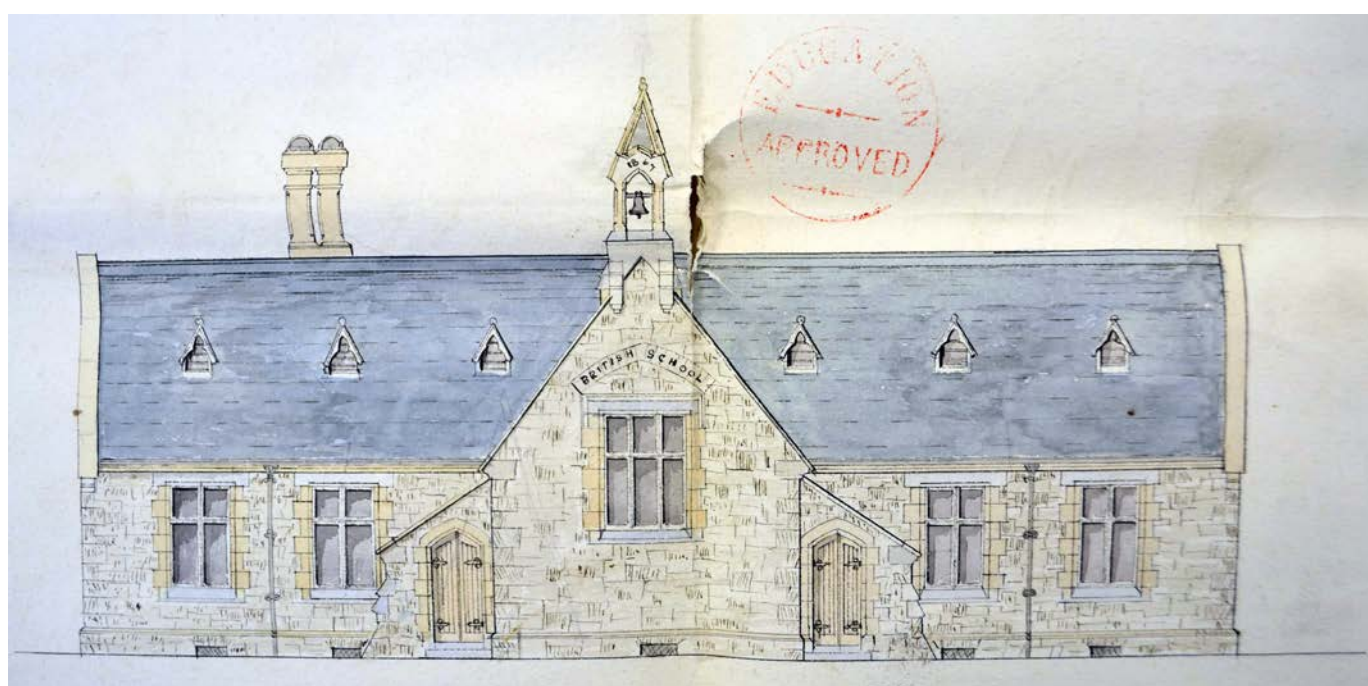
Figure 29. Original 1867 plan and drawing of the south elevation of the British School (WA/13/72, courtesy of Anglesey Archives)

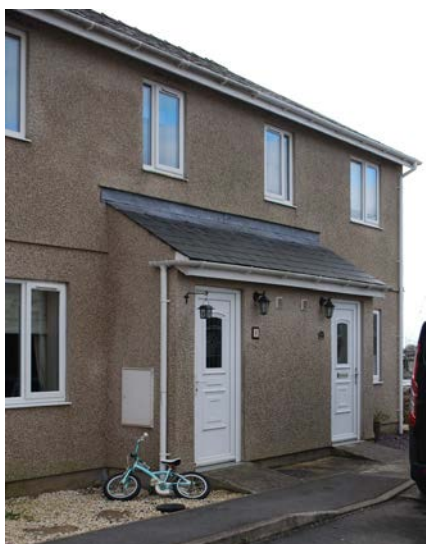
Plate 107. Stad Hen Ysgol (photographed by Megan Howe, 05/02/2018)

Stad Hen Ysgol is composed of three sets of semi-detached houses (plate 107). They are pebble-dashed with slate roofs and are fairly plain in design with a projecting slate roofed porch for the entrances. The gardens are very small but there is some off-road parking.

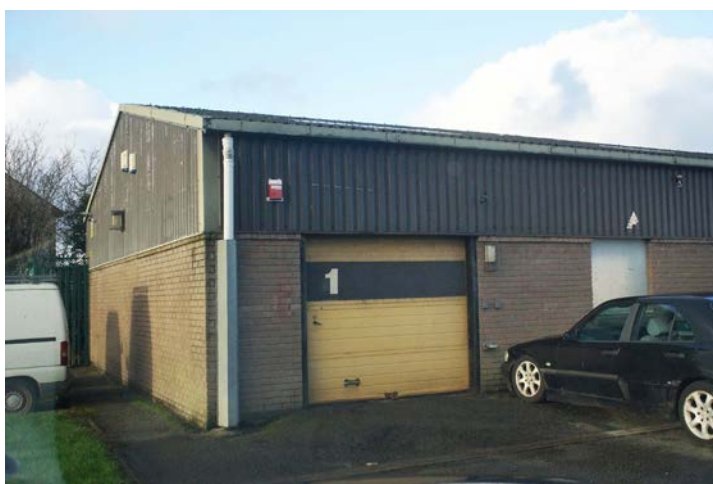
Plate 108. Gwethdai Rhosyr (photographed by Alex Kraus, 05/11/2017)

Gwethdai Rhosyr is a single storey building made of brick in the lower part with corrugated metal above (plate 108). It has considerable parking areas to the east. Ty'n Lôn Bach is a cul-de-sac with five detached, two semi-

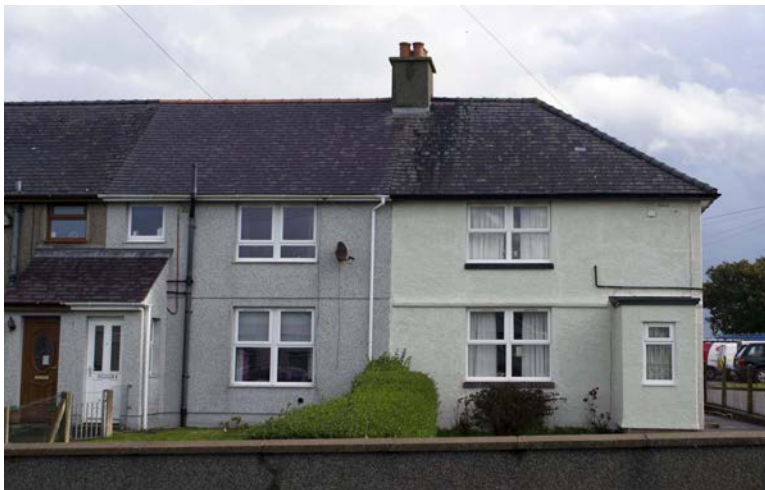
Plate 109. Nos 1 and 2 Pen Rhos, showing the probable 1940s porch on No 1 (photographed by Natalie Herring, 14/09/2017)

The 1953 6 inch map (revised in 1949) shows what is presumably Bron Meillion and a building on the site of the south-western terrace in Pen Rhos. Bron Meillion therefore seems to have been built in the 1940s. The Pen Rhos terrace initially looks too modern to have been built in the 1940s but it has probably been modernised. The small, flat roofed entrance porch on No 1 Pen Rhos does appear to be a rare remaining hint of the original 1940s style of this building (plate 109).

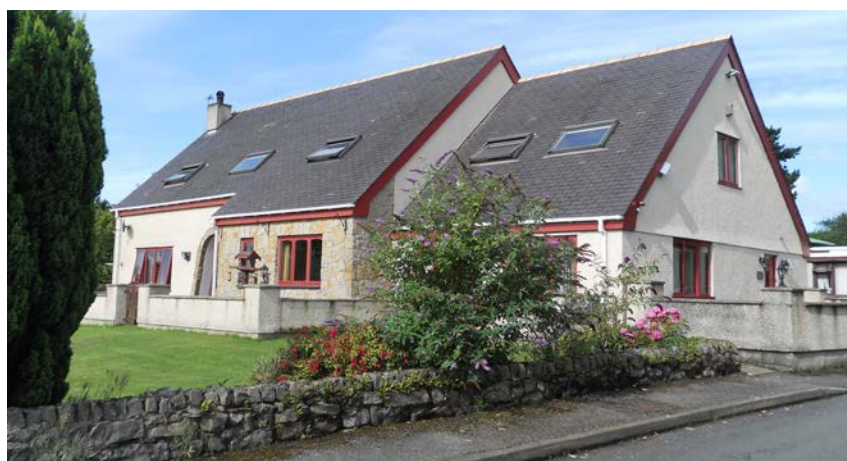
Plate 111. One of the bungalows in Tyn y Cae (photographed by Natalie Herring, 14/09/2017)

Tyn y Cae is a modern development of detached bungalows (plate 111). Their walls are generally rendered or pebble-dashed and many are painted in cream. They have slate roofs and modest gardens, some full of shrubs and some paved. Part of the area is still undeveloped. Bryn Rhedyn is a similar development of bungalows around a cul-de-sac (plate 112).

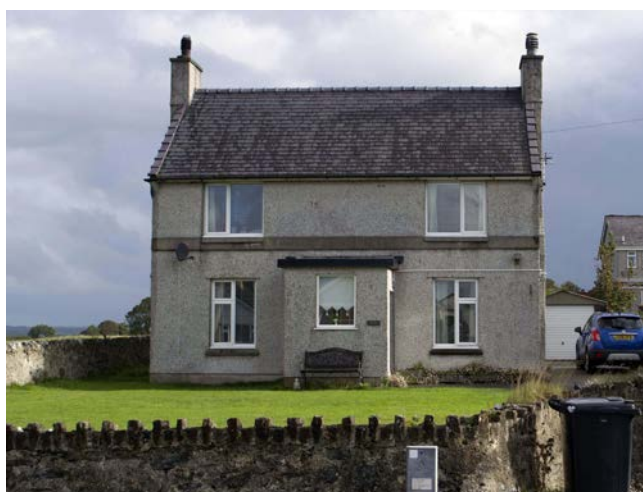
Plate 113. Bron Meillion (photographed by Natalie Herring, 14/09/2017)

Bron Meillion (plate 113) is a detached house standing in an extensive lawn with a traditional stone wall around the garden. Pen Rhos is a development of two-storey houses; a terrace of six houses, a terrace of three houses and two semi-detached houses built around a cul-de-sac. The south-west terrace faces onto Malltraeth Street and the other houses onto the cul-de-sac. They are brick built as some have the lower floor bricks exposed and the upper floor pebble-dashed; some are entirely pebble-dashed. They have fairly long, narrow gardens.

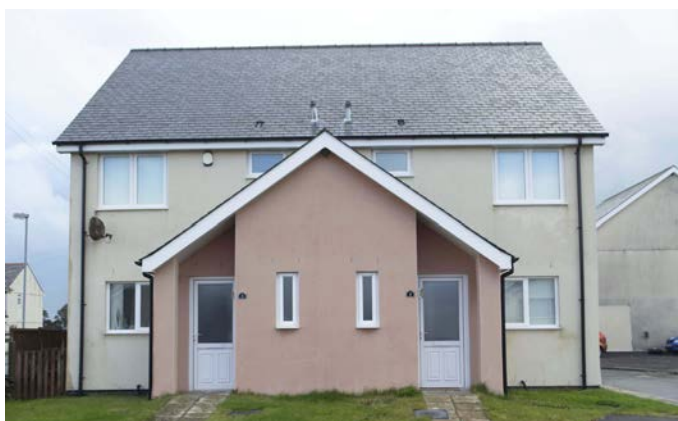
Plate 114. House in Stad Tŷ Gwyn (photographed by Natalie Herring, 14/09/2017)

Stad Tŷ Gwyn is composed of three pairs of semi-detached houses around a slightly curving cul-de-sac (plate 114). The houses are plain and simple but with a large projecting porch structure with a gable reaching to the height of the main roof. The porches are painted a strong or pale terracotta colour to contrast with the cream paint of the rest of the building. The construction is presumably of breeze-block but rendered and painted. There is room for more houses at the end of the cul-de-sac.

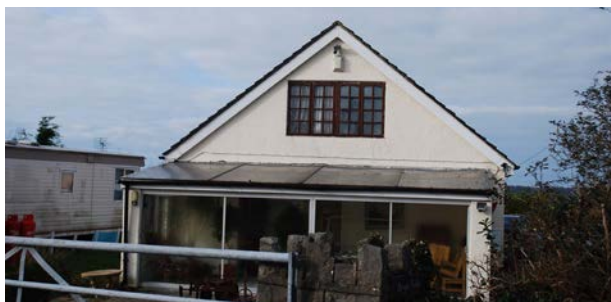
Plate 115. Bryn-felin (photographed by Megan Howe, 05/02/2018)

The current Bryn-felin (plate 115) is a modern detached house in a fairly large garden. The other houses here are also new, though Ael-y-bryn is set too far back from the road to see. It does have a substantial Leylandii hedge. Caer Glyn and Fron Dirion are bungalows, the latter with an attic room (plate 116).

The mill probably stood at the north-western end of the village on the site of the house still called Bryn-felin (PRN 36123) (Davidson 2002, 5; Carr 2011, 83). The tithe schedule calls plot 46 "Felin Wynt" and the map shows a circular blob, not the usual rectangular symbol for a house, which strongly suggests that there was still a windmill here in the early 19th century. The County Series maps from 1889 show a house aligned north-east to south-west with a long range of barns on the south-west end. This range of buildings is still shown on the 1953 6 inch map. These earlier buildings have been demolished to build the present house.

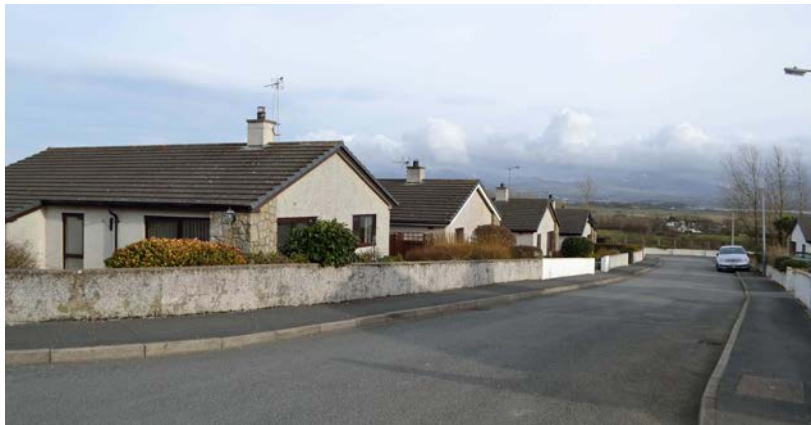
*Plate 117. Crud yr Awel
(photographed by Jane
Kenney, 16/02/2018)*

This zone is another area of modern development and is dominated by bungalows. There is a row of four terraced houses on the road into the development, with little to distinguish them apart from their porches. Most of Crud yr Awel is a development of bungalows with small but neat gardens (plate 117). Most are rendered and some have a corner clad in stone as a decorative detail.
