Bryn Cefni Infrastructure Works, Ynys Môn

Archaeological Assessment

Historic Environment Record Event Primary Reference Number 45324

Prosiect Rhif / Project No. G2577

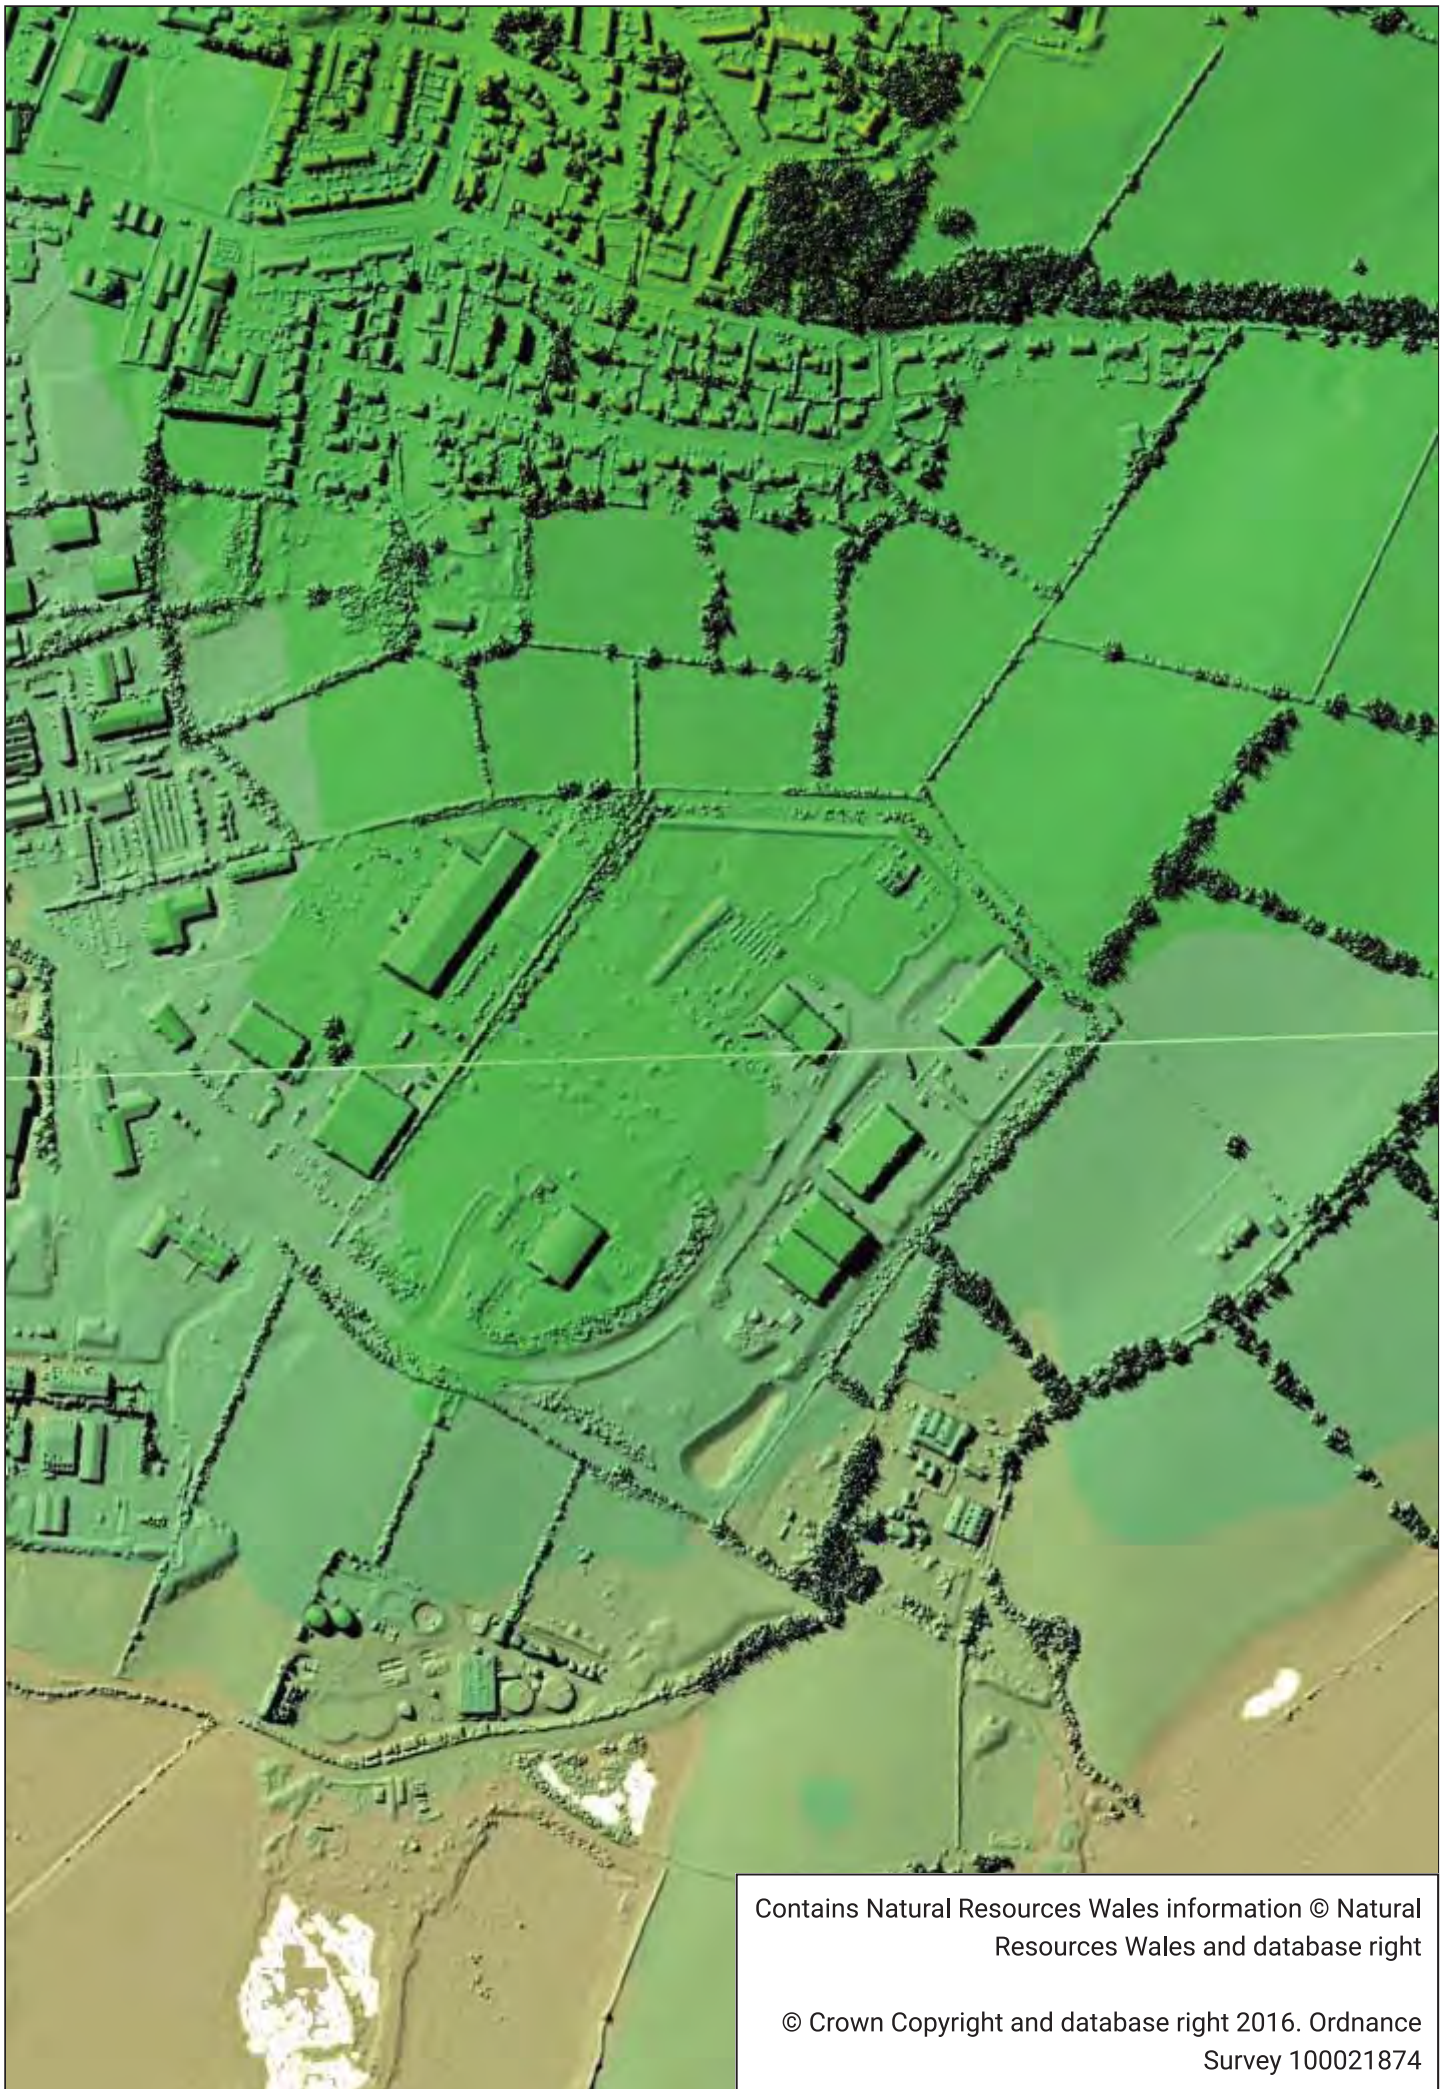
Figure 04: Reproduction of GAT Report 302 Figure 01, detailing assessment, evaluation and mitigation areas. The former fields are numbered 1 to 5.

GAT completed an archaeological assessment of the development area in 1998, followed by geophysical survey, targeted trenching and a watching brief of selected areas in advance of and during groundworks for the industrial park (GAT Report 302). The assessment included a walkover survey, which confirmed that the fields had been regularly ploughed and no earthworks were visible as upstanding features (*ibid.*: 04); parts of the area had been stripped of topsoil by the former landowner and field boundaries removed (*ibid.*: 05). The geophysical survey (magnetometer), trenching and watching brief primarily targeted the areas now developed (cf. Figure 04), including the current access road separating plot C1 from the remaining plots, as well as the area now occupied by Units 8 and 9 (cf. Figure 02). The geophysical survey included a 60m by 40m area south of plot C5, which identified three linear features of unknown origin. Evidence of post-medieval ploughing (PRN 62163) were identified in a surveyed area south of plot C7, as was an area of concentrated anomalies that was subsequently targeted by trenching to reveal a narrow drain and animal burrows (PRN 62164). Geophysical anomalies along the access road were also targeted by trial trenching but did not identify any archaeological activity. The watching brief during groundworks at the northern end of plot C2 and the area south of plot C7 did not identify any features but the watching brief along the access road to what are now Units 8 and 9 did identify two shallow clay-filled ditches at NGR SH46847494. Their function and date were undetermined, but they may continue into what is now plot C6. The archaeological works did not include plot C1 and a former quarry in plot C5 was not investigated as part of the archaeological evaluation and mitigation stages as it was outside the area to be developed at time.

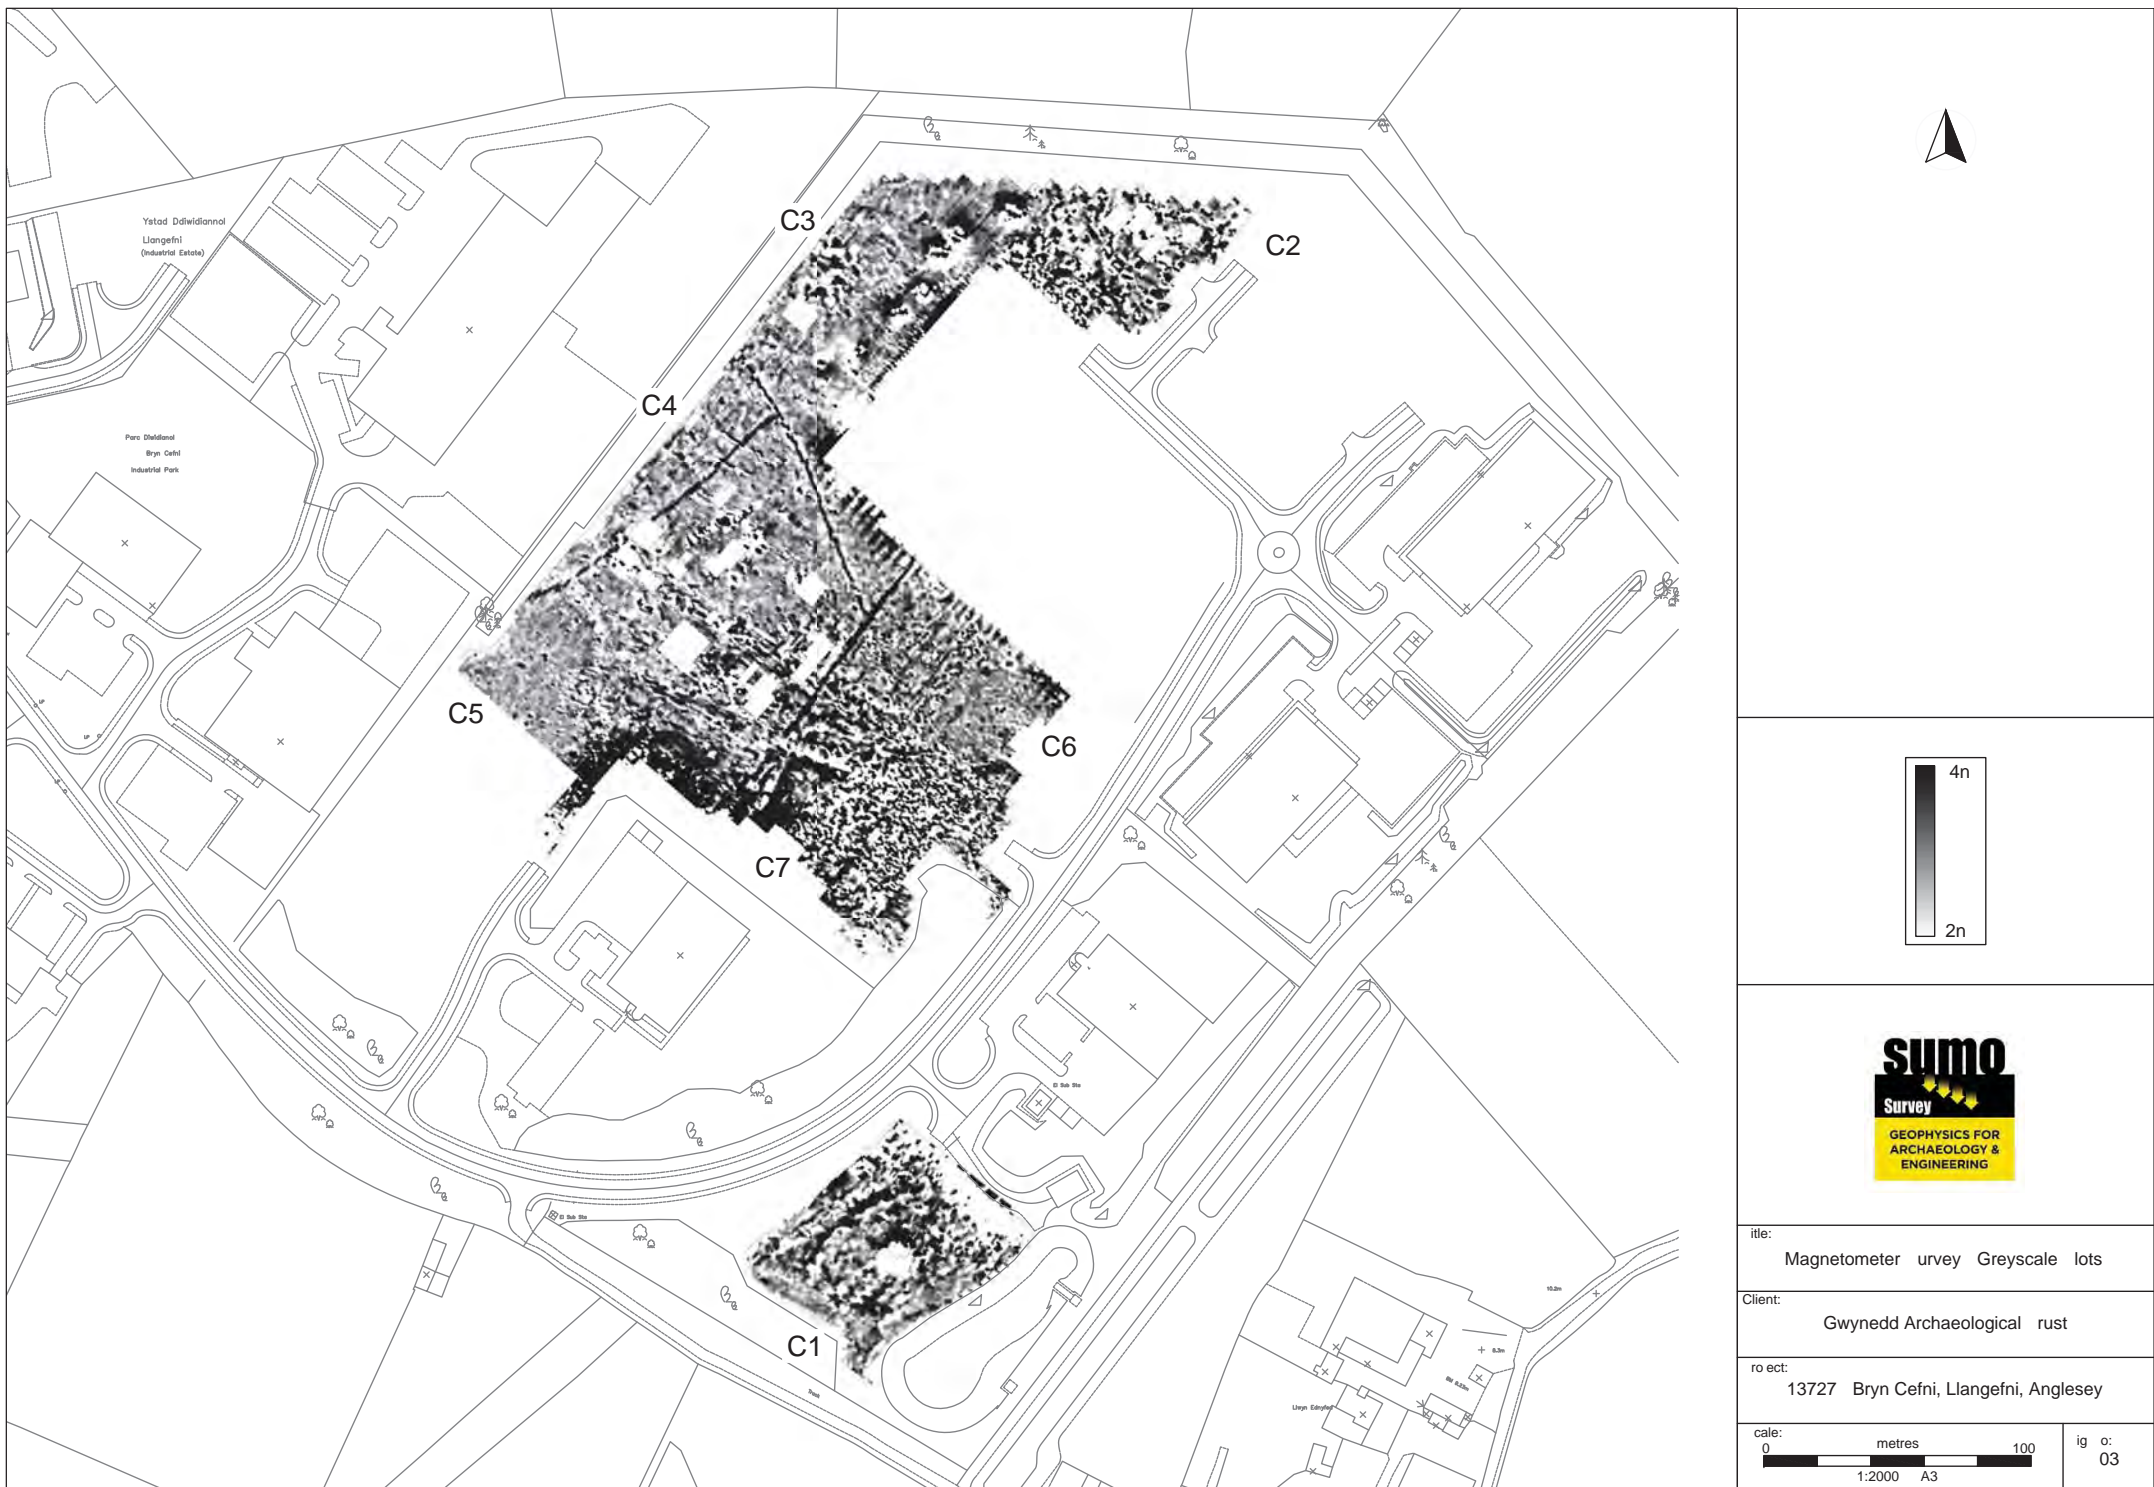
Figure 07: Reproduction of Sumo Survey Magnetometer - Greyscale Plots (Source: Sumo Survey Report 13727).

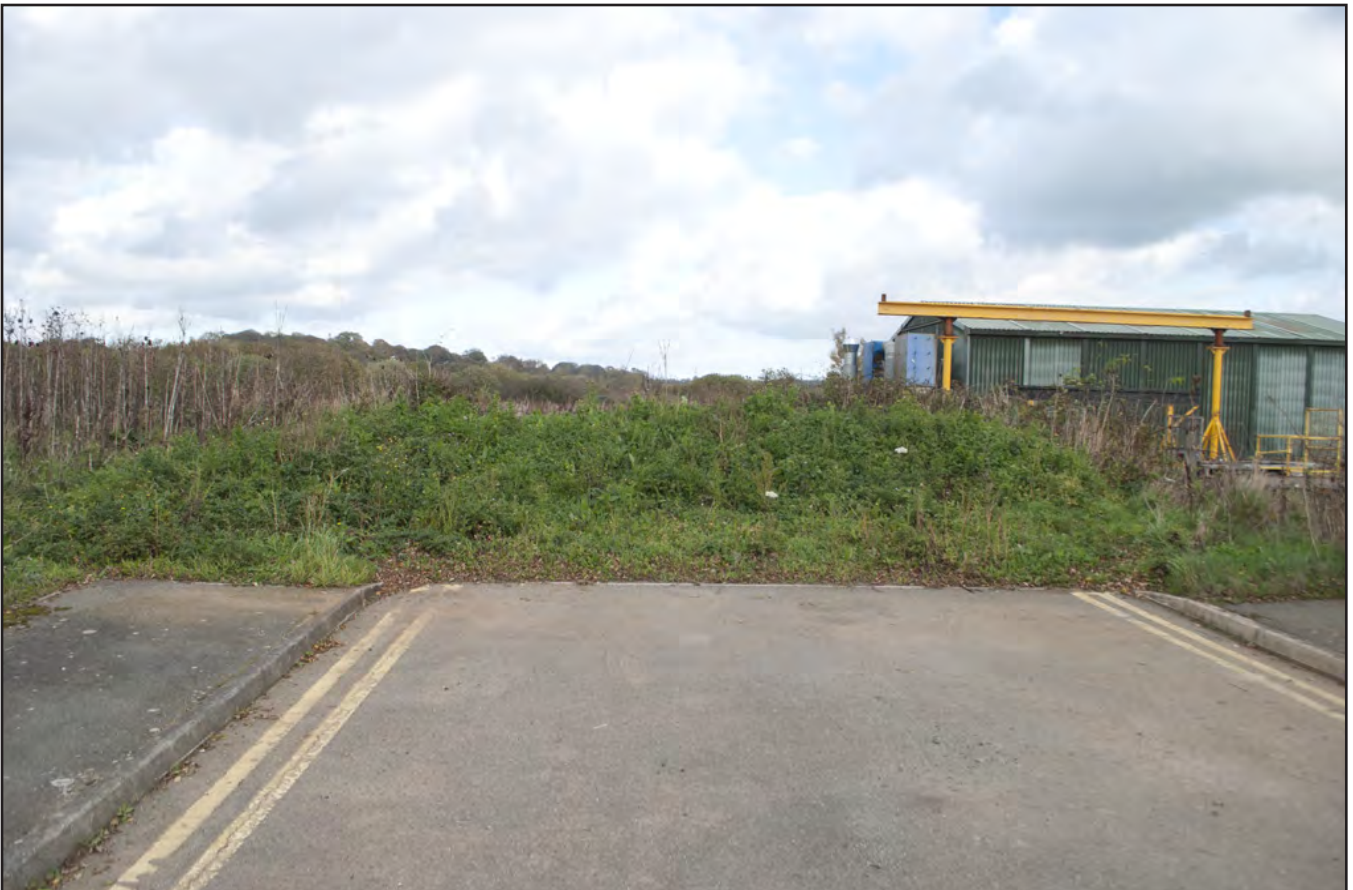
Plate 1: General view of the eastern site entrance to plots C2 to C7; scale: 1x1m (archive reference: G2577_001).

Plots C2 to C7 were not defined on the ground but were within a large open area of rough grassland, surrounded by existing business park infrastructure. Two access points were also extant at the southern and eastern end of the site respectively (Plates 1-2). The grassland stood to a height of 0.7m and was mixed with bramble, teasel, wild flowers, herb willow, nettles, patches of bracken and isolated immature trees, including ash and horse chestnut (Plates 3-15). Along the southwest boundary of the location for plots C7 and C5 (Figure 04), defunct industrial waste material, including rusting equipment, had been deposited (Plate 8). Along the northwest site boundary, an overgrown boundary line was visible that included a *clawdd* surmounted by hedgerow; the boundary line measured 0.5m high and 2.5m wide and the immature growth forming the hedgerow suggested it may not have been of any antiquity (Plate 10). A substantial soil bund, 2m high and 5m wide was also visible along the northern site boundary (Plate 12). The presence of this bund, as well as the mixed flora across the site, suggest the general area has been recently stripped and/or disturbed. No evidence for the former quarry (PRN 62162; NGR SH4658774985; Feature 5) in plot C5 was visible at ground level during the walkover survey.

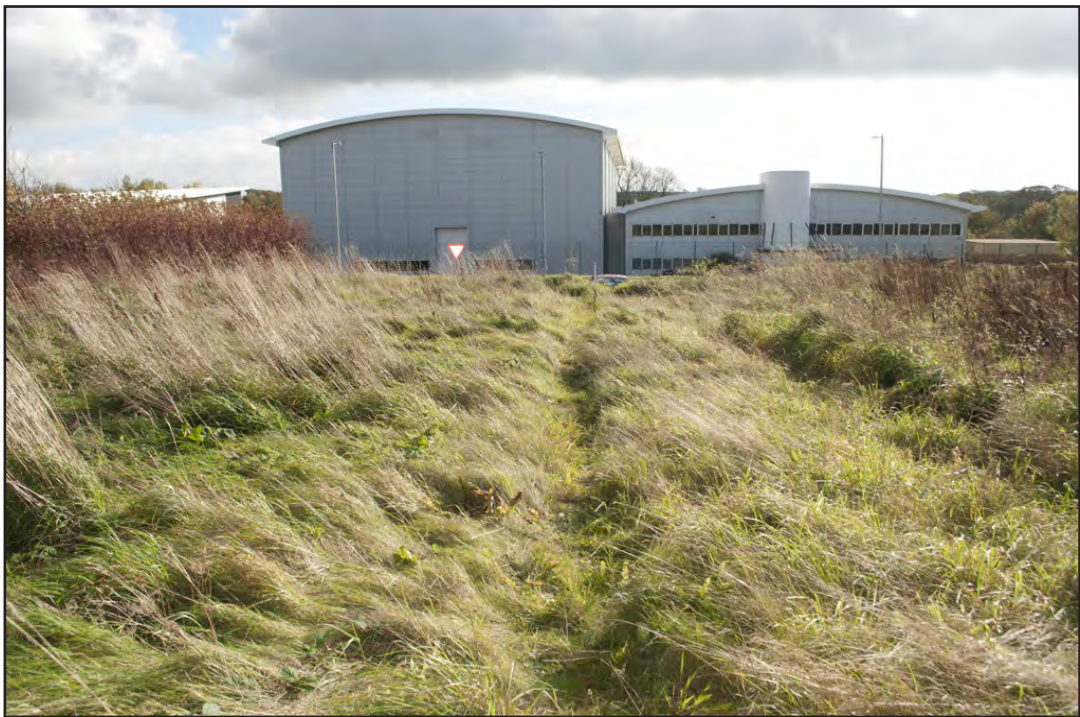
Plate 2: General view of southern site entrance; scale: not used (archive reference: G2577_030).

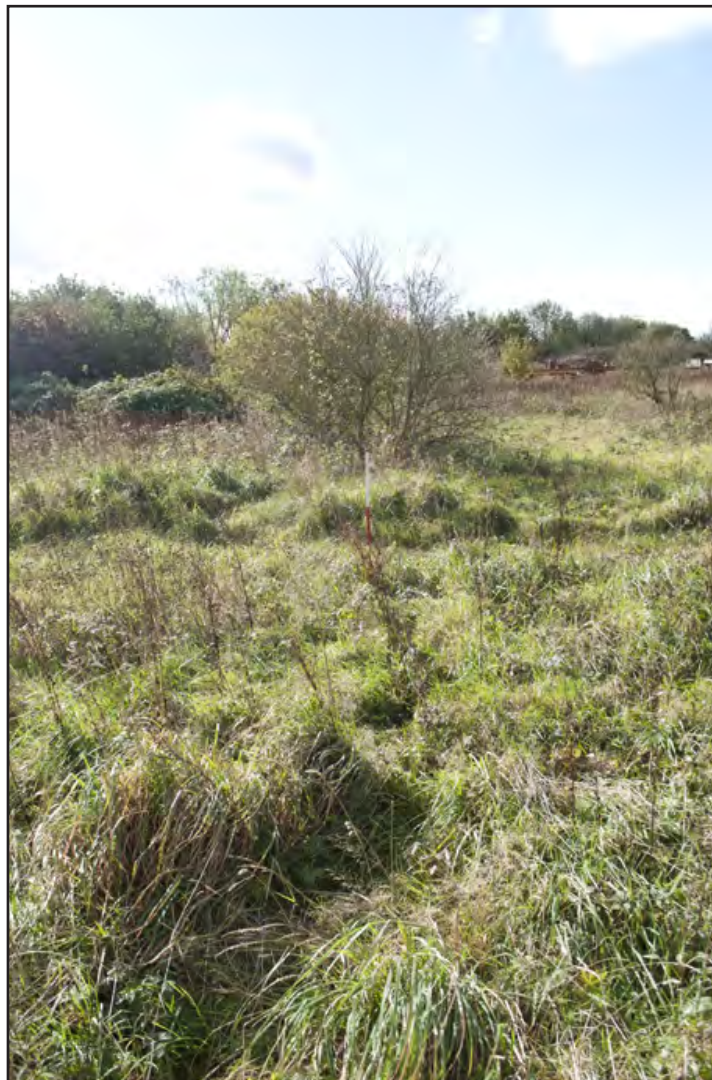
Plate 4: View along the line of the former field boundary (Feature 01) running northeast to southwest visible on the First Edition Ordnance Survey 1-inch to 25-mile County Series Map Sheet XVIII.3, 1889; scale: 1x1m (archive reference: G2577_003).

Nine features were identified within the proposed development area. Two field boundaries, [Features 1 and 2], identified within areas C2 to C7, are recommended for a basic record. Features 3 and 4 are modern infrastructure supporting the industrial park and no further recommendations are made for these. A watching brief during main groundworks is recommended for the site of a former quarry [Feature 5] in Plot C5; and watching briefs are also recommended at the locations of Features 8 and 9, which represent the geophysical anomaly 6 in Plot C3 and anomaly 7 in Plot C1, respectively. These anomalies are associated with ground disturbance activities that are either agricultural in origin or also associated with quarrying. Feature 6, represented by geophysical anomalies 1 and 2 (possible ditches/field boundaries), located across Plots C4 to C6, is recommended for either archaeological evaluation in advance of development works or mitigation with a watching brief and/or targeted excavation during groundworks. Feature 7, represented by geophysical anomaly 3 (possible rectilinear feature), located in Plot C7 is also recommended for either archaeological evaluation in advance of development works or mitigation with a watching brief and/or targeted excavation during groundworks. As well as the feature recommendations, a general watching brief is also recommended for the development as a whole to qualify and mitigate the overall results of the geophysical survey and geotechnical trial pits.

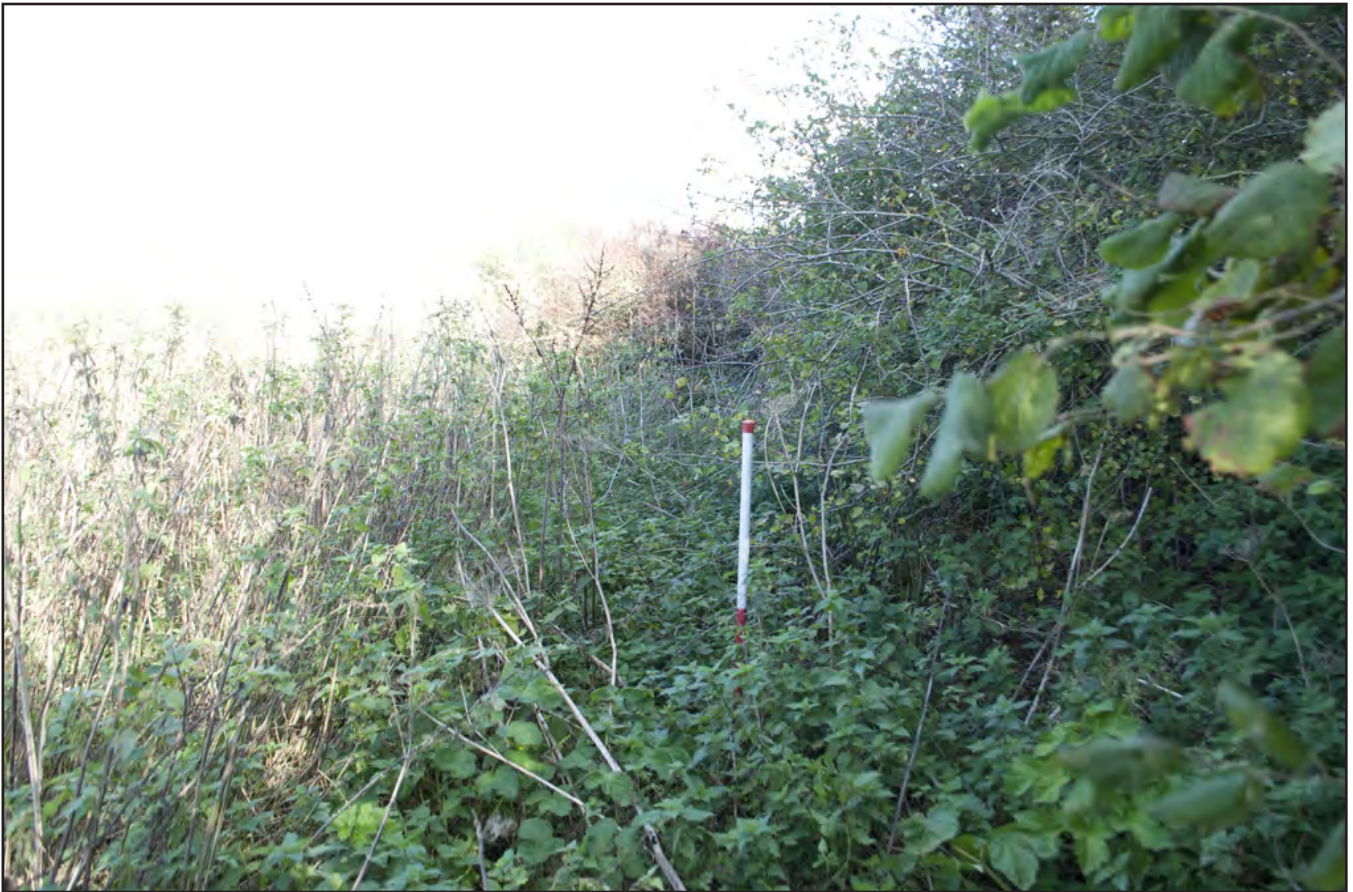
Plate 5: View along the line of the former field boundary running northeast to southwest (Feature 01) visible on the First Edition Ordnance Survey 1-inch to 25-mile County Series Map Sheet XVIII.3, 1889, showing relict field boundary extant for a length of c.30m at the southwestern end; scale: 1x1m (archive reference: G2577_004).

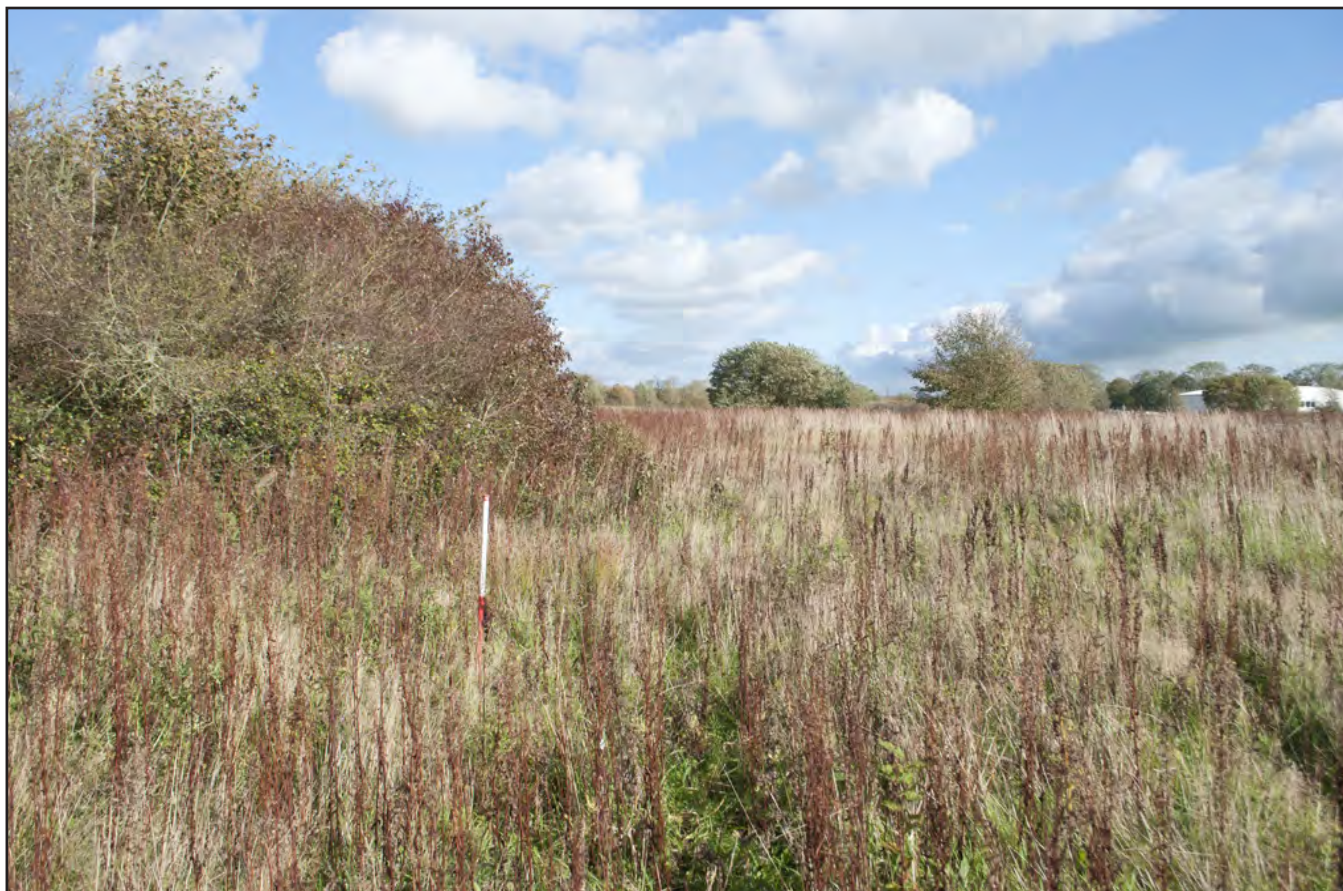
Plate 9: As above but including remnants of former field boundary (Feature 02) represented by trees; scale: 1x1m (archive reference: G2577_009).

Feature Number	2
Site name	Relict Field Boundary
PRN number	74,665
Grid reference	SH46627500 C
Period	Post-medieval
Site type	Field Boundary
Assessment category	C
Description	Relict remains of the former northwest – southeast field boundary were noted. These were located on the First to Third Edition Ordnance Survey 1-inch to 25-mile County Series Map Sheet XVIII.3 (Figure 03). This boundary line was interrupted, but a number of mature trees survived to indicate its route (Plate 9).
Impact	Considerable
Recommendation for further assessment/evaluation	None
Recommendation for mitigatory measures	Basic Recording

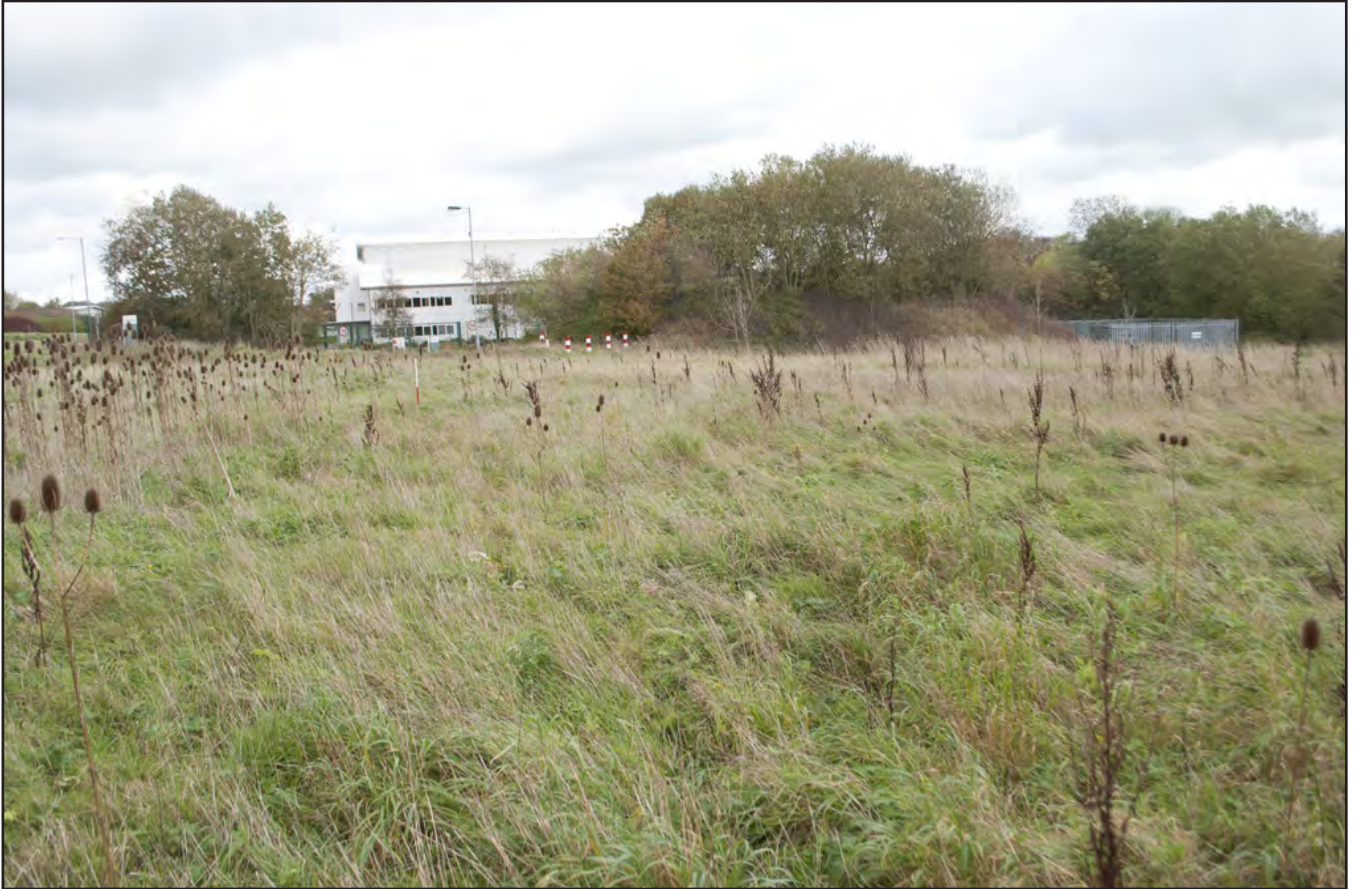
Plate 16: View of entrance to plot C1; scale: 1x1m (archive reference: G2577_021).

Plot C1 was an enclosed area located to the southeast of the business park access road and was separate from plots C2 to C7 (Plates 16-22). It was located within a former rectangular field and measured 1.45ha in size, immediately west of Scheduled Monument AN047 (Tregarnedd Fawr). A concrete track barrier ran along the northeastern edge of the plot, which led to a pumping station. The Tregarnedd Farm outbuildings that form part of the scheduled monument area were visible from the southeastern side of plot C1, on the other side of a large attenuation pond (Plates 19-20). The presence of the pumping station and track, as well as the attenuation pond confirmed that these portions of the plot have already been disturbed, with the open area limited to the central and southeastern ends of the plot. This open area was characterised by open grassland of mixed flora, including teasels, suggesting it had been recently stripped and/or disturbed (Plate 22). No archaeological features were identified and it appeared that the drain located during the 1998 assessment (PRN 62164; NGR SH46747482) at the northern end of the plot, is unlikely to still be present due to the business park infrastructure at that end. The north eastern side is also heavily affected by the new Llangefni link road infrastructure (Plate 21).

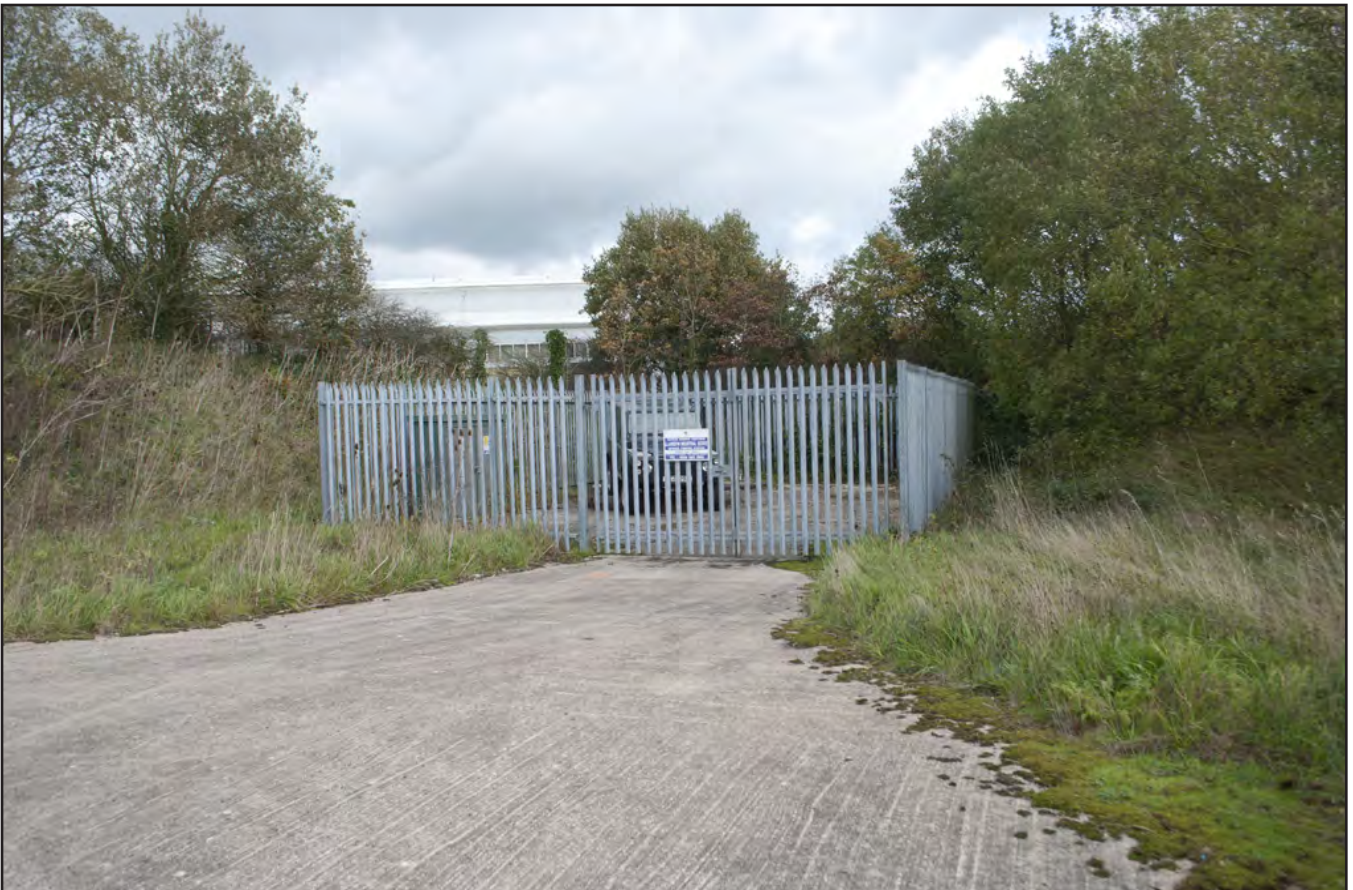
Plate 18: View of sewage pumping station within railings; scale: not used (archive reference: G2577_024).

Feature Number	3
Site name	Sewage Pumping Station
PRN number	74,666
Grid reference	SH46777478
Period	Modern
Site type	Infrastructure
Assessment category	D
Description	A 13m by 8m railed enclosure with a concrete base orientated north east – south west and approached along a concrete track accessed from the road to the north-west (Figure 02; Plate 18). It is surrounded by high galvanised railings and contains a sewage pumping station, gated on the south western side.
Impact	Unknown
Recommendation for further assessment/evaluation	None
Recommendation for mitigatory measures	None

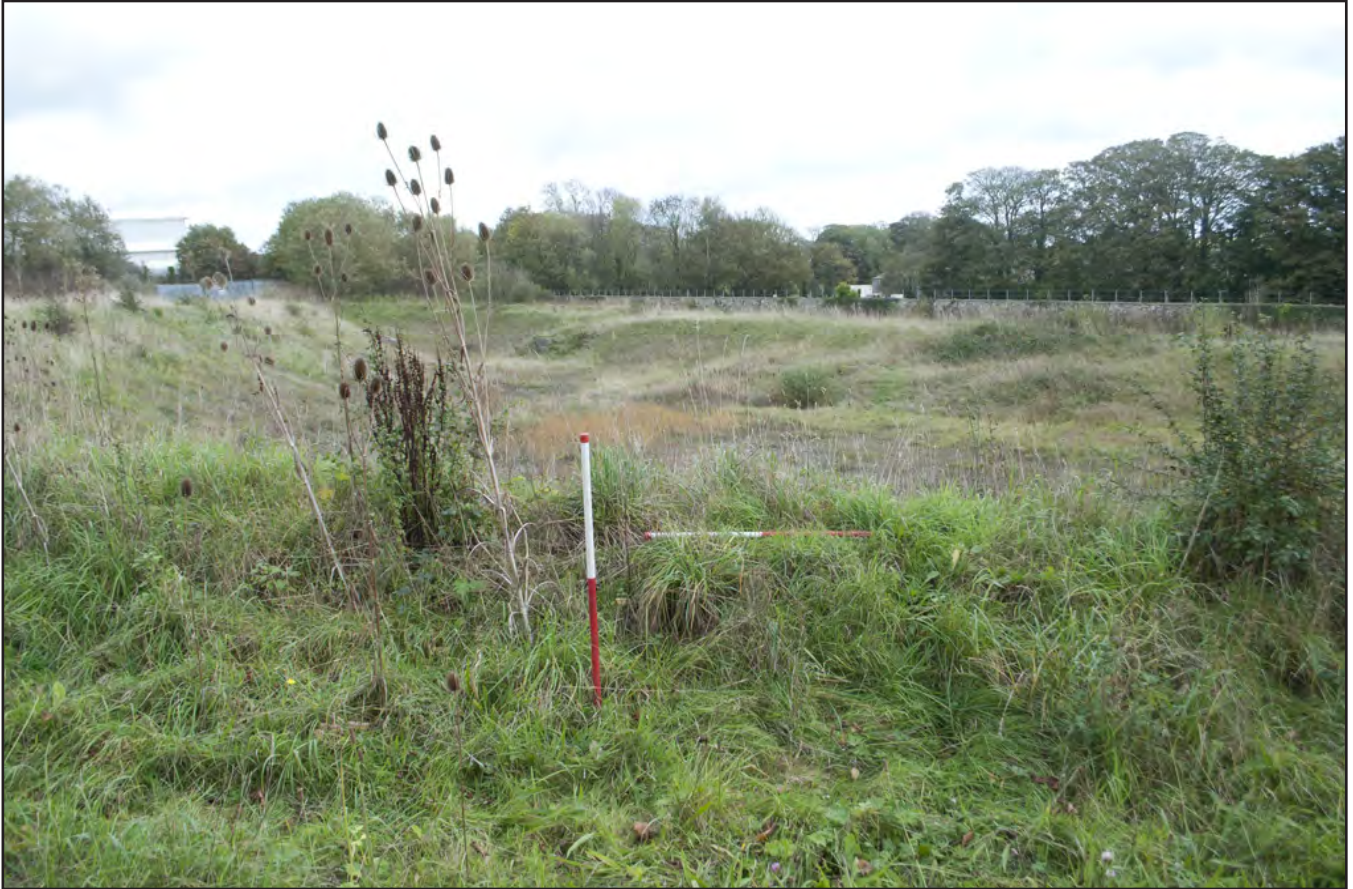
Plate 19: View of large attenuation pond, with Tregarnedd to the rear behind modern boundary wall; scale: 1x1m (archive reference: G2577_026).

Feature Number	4
Site name	Attenuation Pond
PRN number	74,667
Grid reference	SH46747473
Period	Modern
Site type	Infrastructure
Assessment category	D
Description	A large attenuation pond, 80m by 24m, with concrete steps down into it on the north east side (Figure 02; Plates 19-20). It was orientated northeast-south west and situated against the south eastern boundary of C1. It is over 5m deep, but and was empty but not accessible on the site visit. It is of entirely modern construction and no archaeology could have survived its construction.
Impact	Unknown
Recommendation for further assessment/evaluation	None
Recommendation for mitigatory measures	None

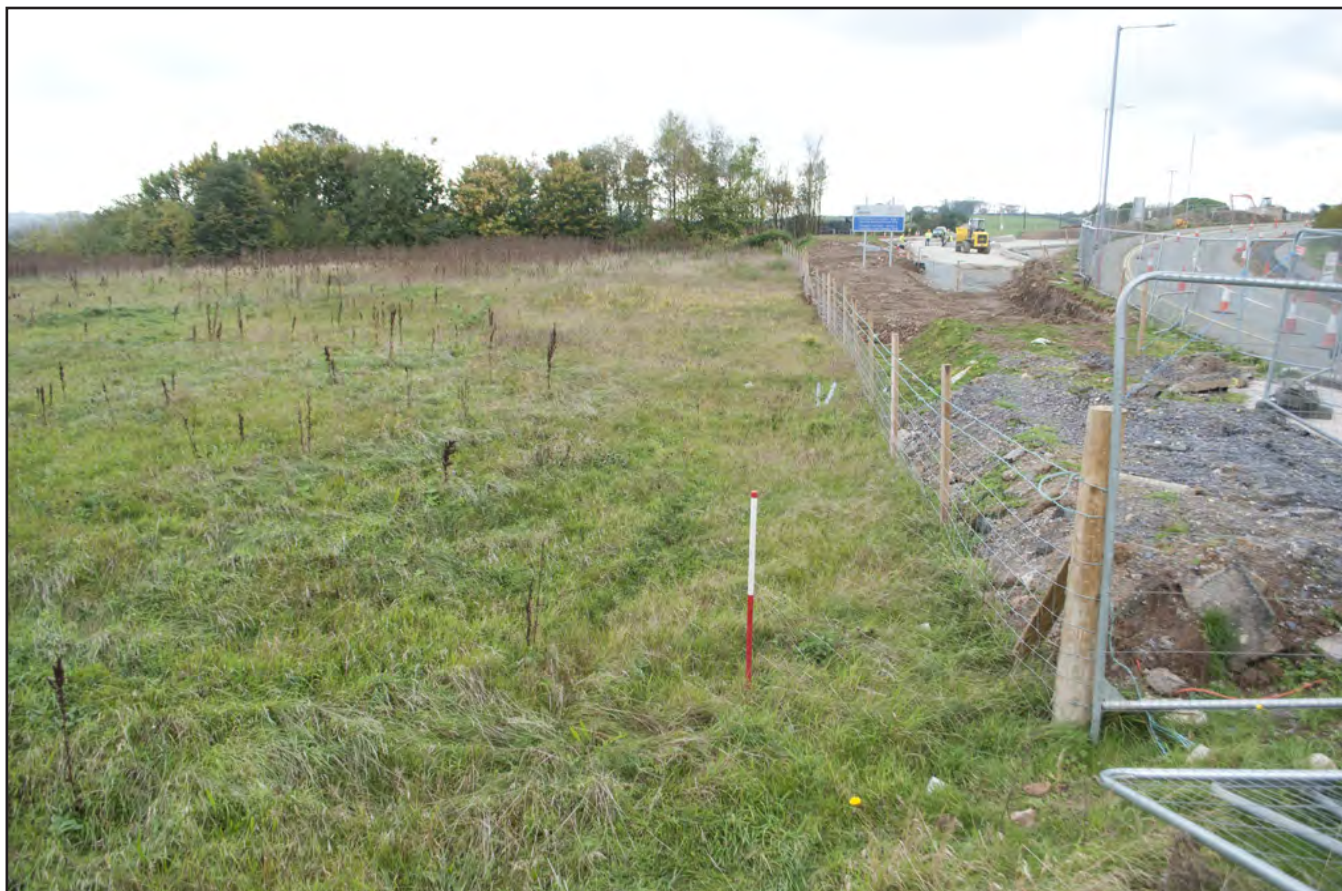
Plate 20: View of Tregarnedd Farm outbuildings from across an attenuation pond in C1; scale: 2x1m (archive reference: G2577_025).

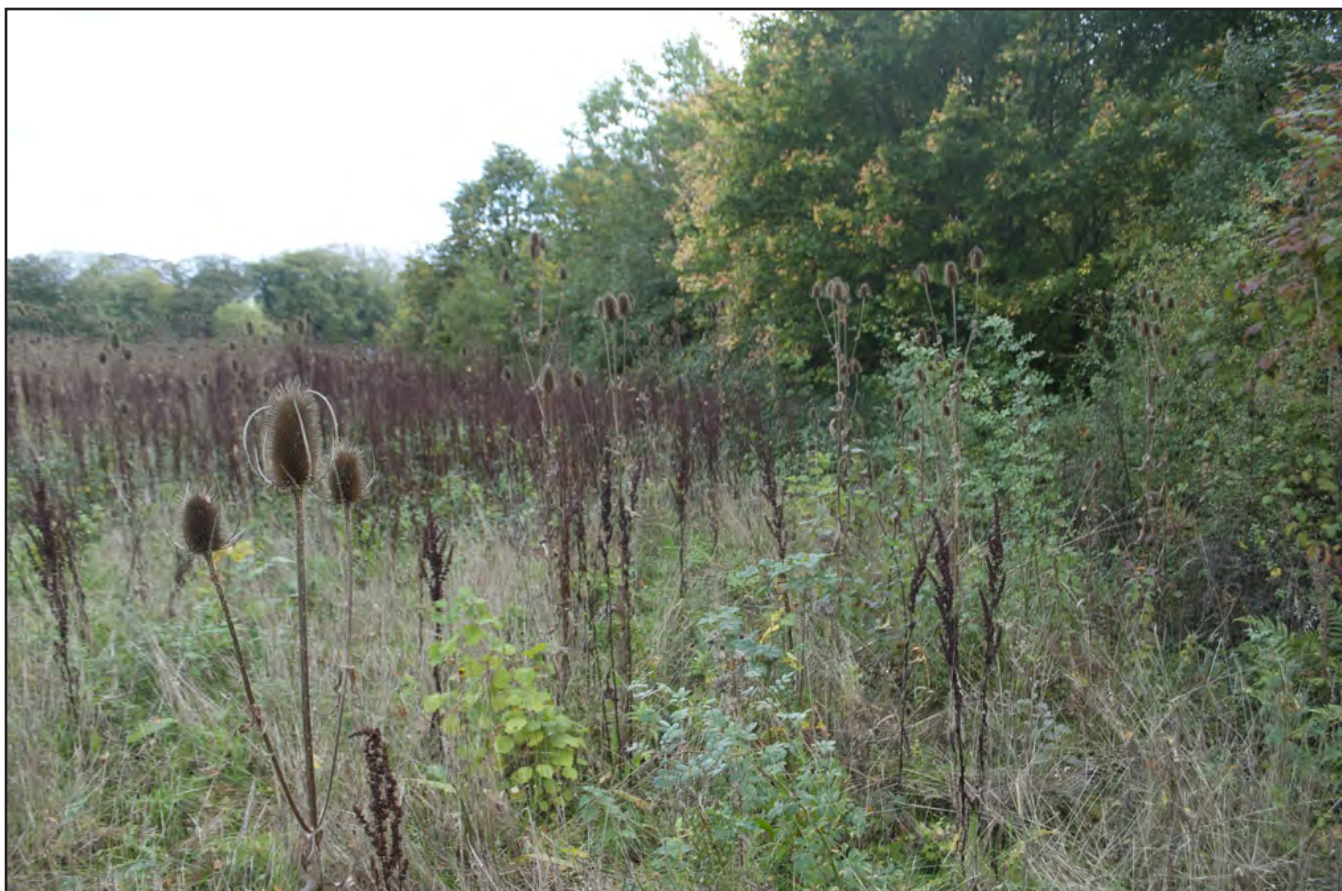
Plate 21: View of northern boundary of plot C1 with modern post and wire fence and link road infrastructure; scale: not used (archive reference: G2577_027).
