Bryn Cefni Infrastructure Works, Ynys Môn

Archaeological Assessment

Historic Environment Record Event Primary Reference Number 45324

Prosiect Rhif / Project No. G2577

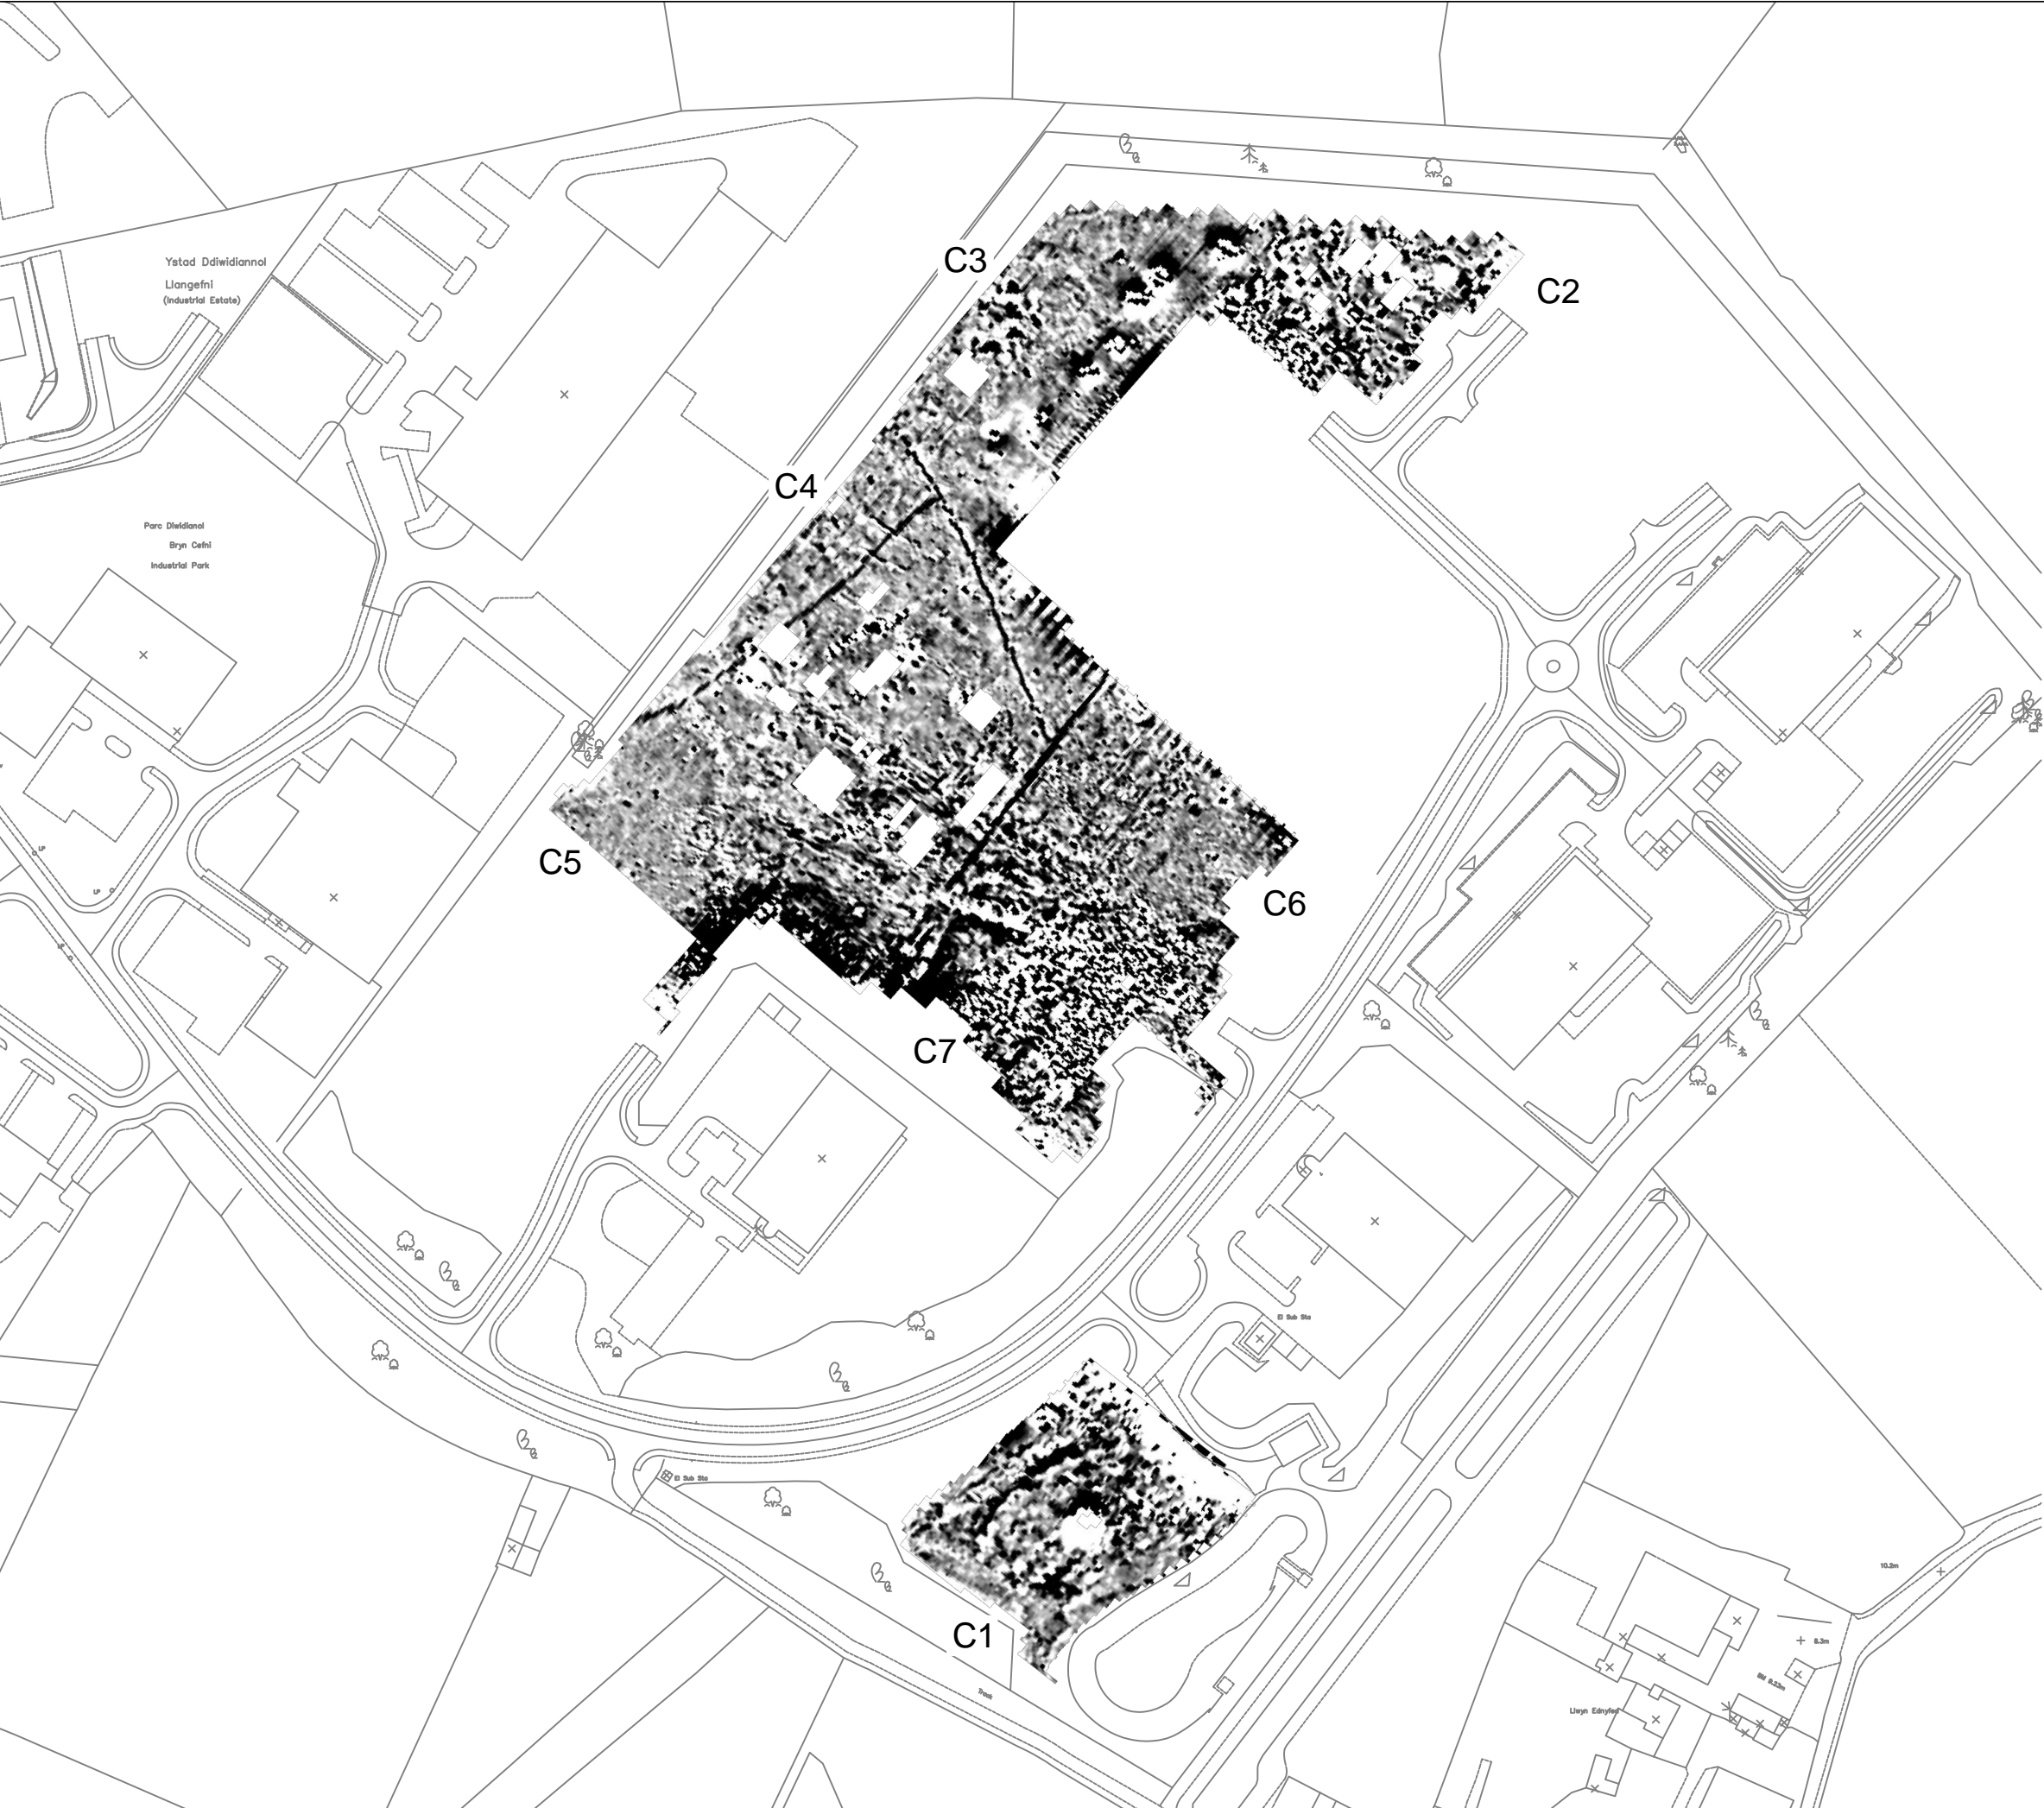
Fig No:
02

Title:
Magnetometer Survey - Greyscale Plots

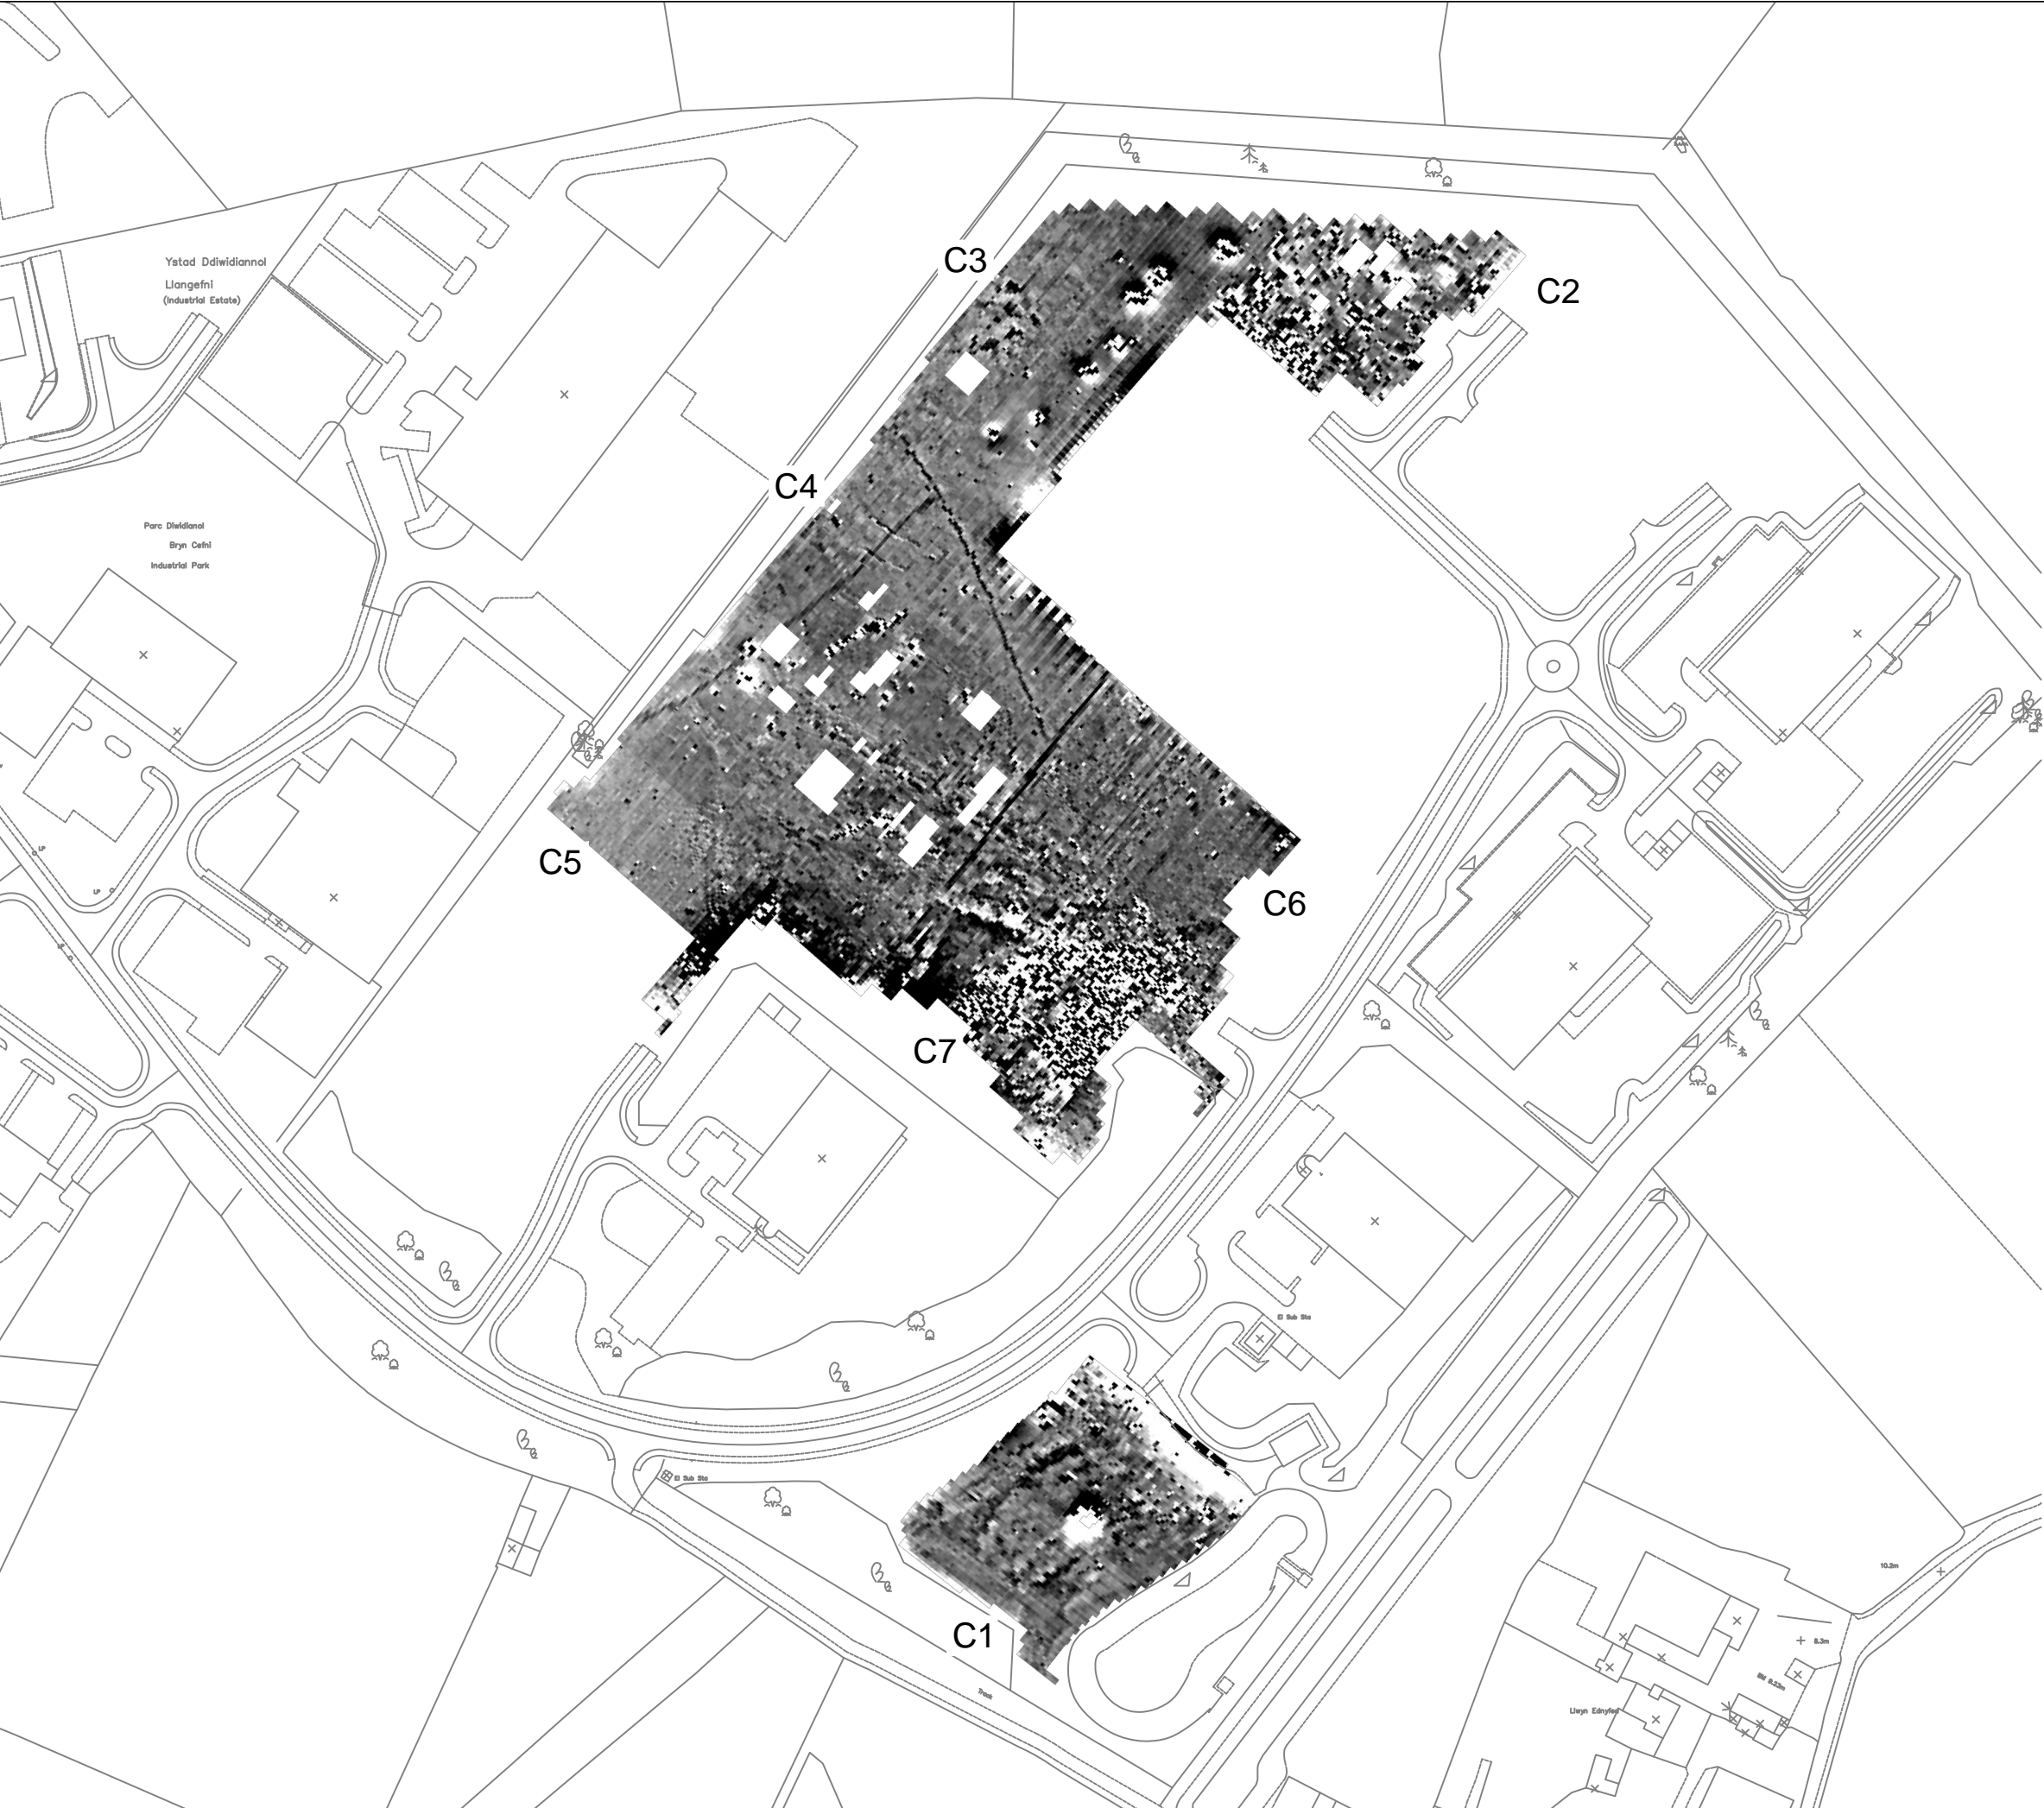
Title: Magnetometer Survey - Interpretation	
Client: Gwynedd Archaeological Trust	
Project: 13727 - Bryn Cefni, Llangefni, Anglesey	
Scale: 0 100 metres 1:2000 @ A3	Fig No: 04
