Bryn Llan, Llanrug Gwynedd

Level 2 Building Record

Historic Environment Record Event Primary Reference Number 45367

Prosiect Rhif / Project No. G2586

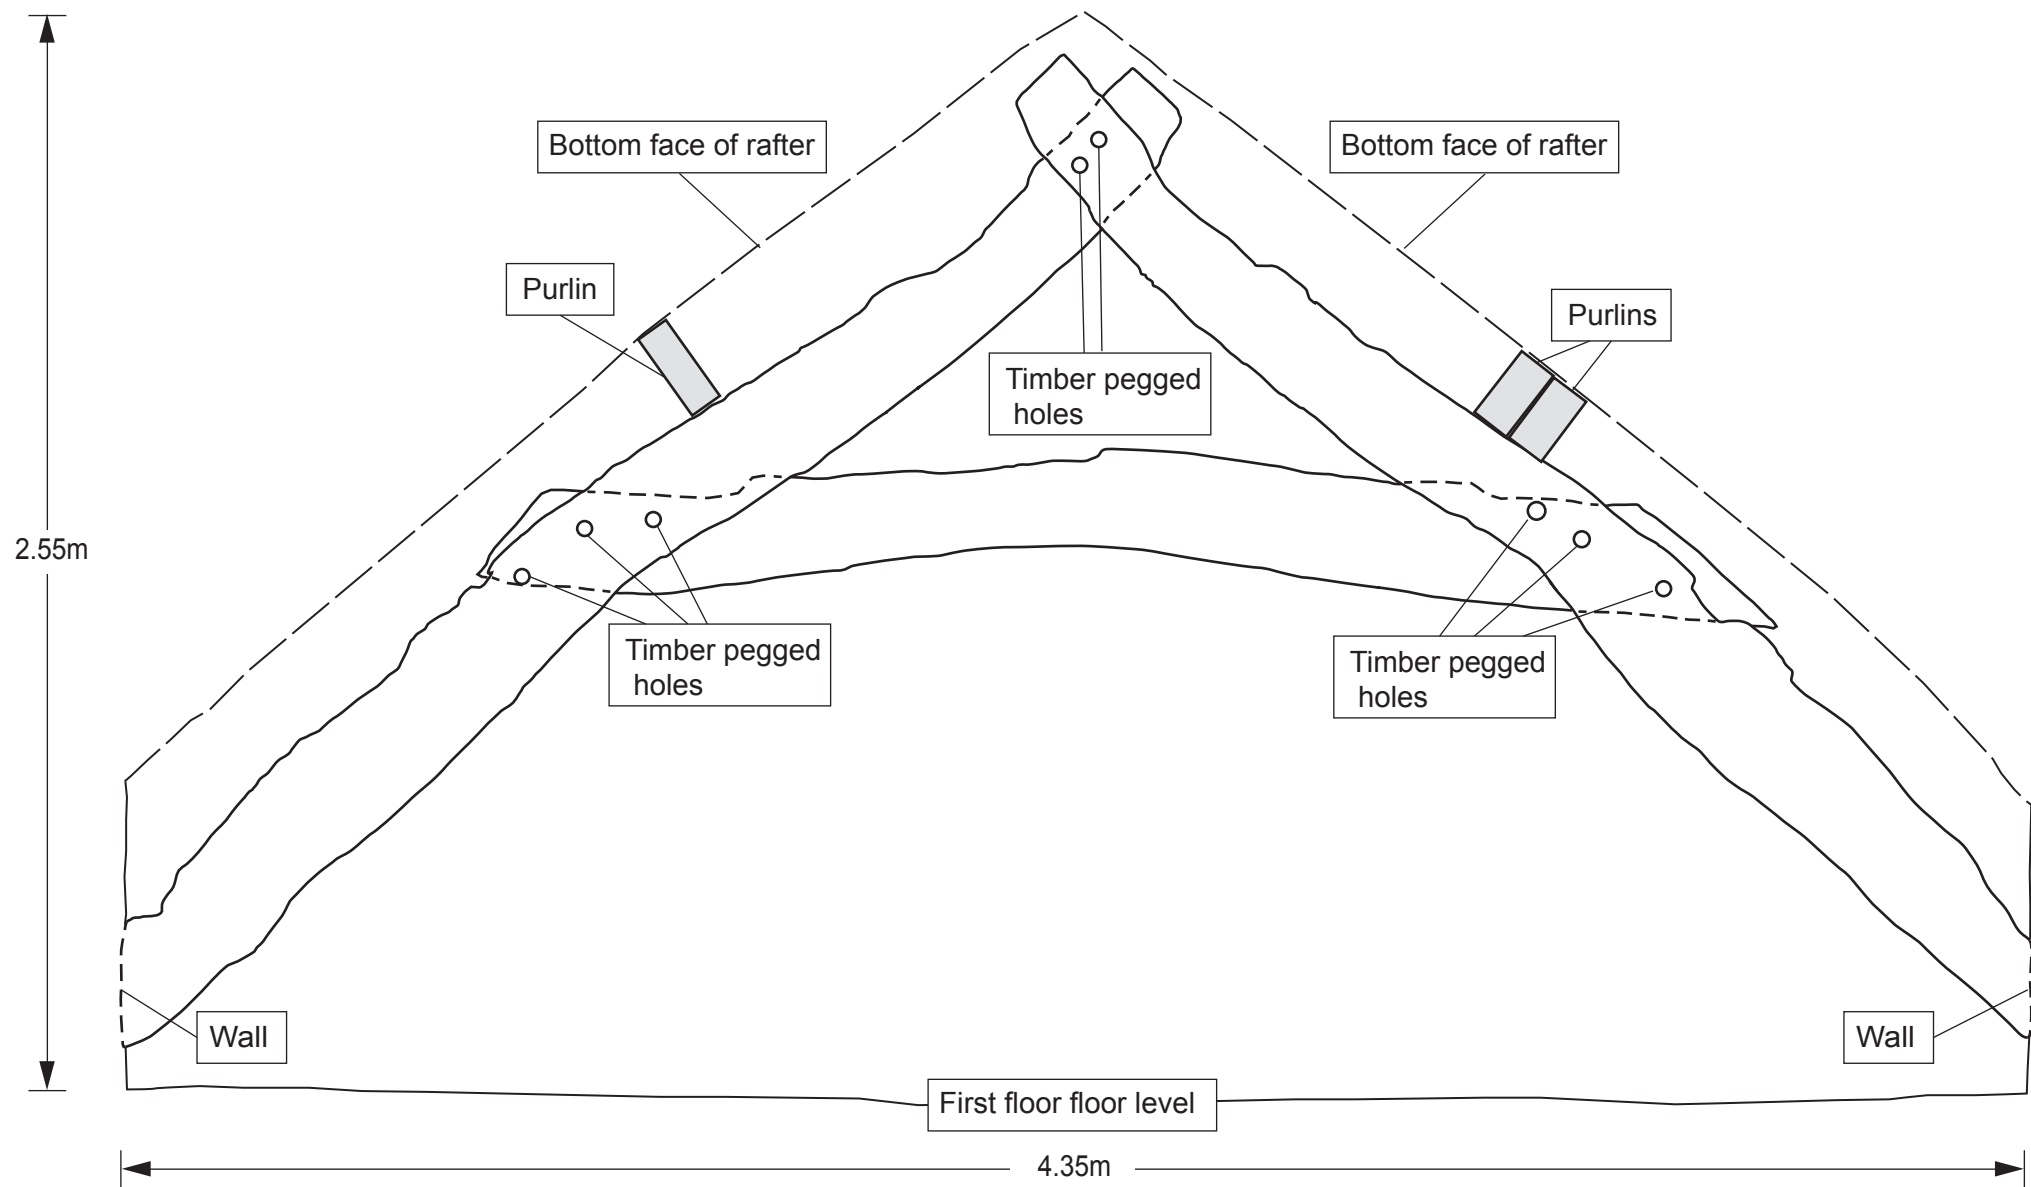
Figure 08: NE facing sketch elevation of roof truss A (nts)

Truss A is of oak construction with two pegs at the apex and two at the cross beam (Plates 34-35, 37-39). The beams in general are in good condition apart from a small section which has bad rot damage due to a hole in the roof which has led the beam to be exposed to the elements. The trusses are set into the wall, with principal rafters 0.4m below the wall plate level.

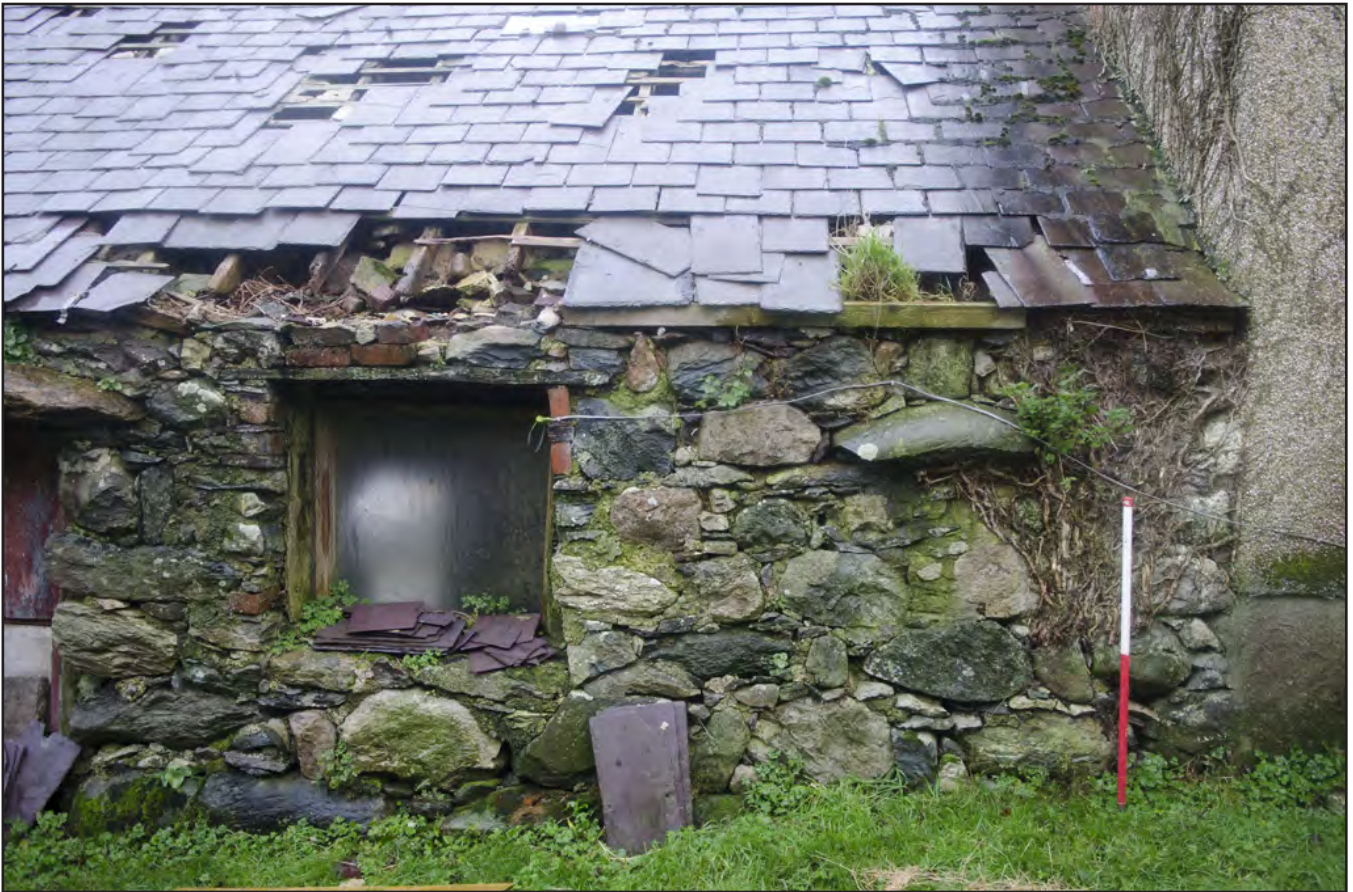
Plate 7: Southwest facing elevation: modern window and blocked up window at rear of building; scale: 1x1m (archive reference: G2586_009).

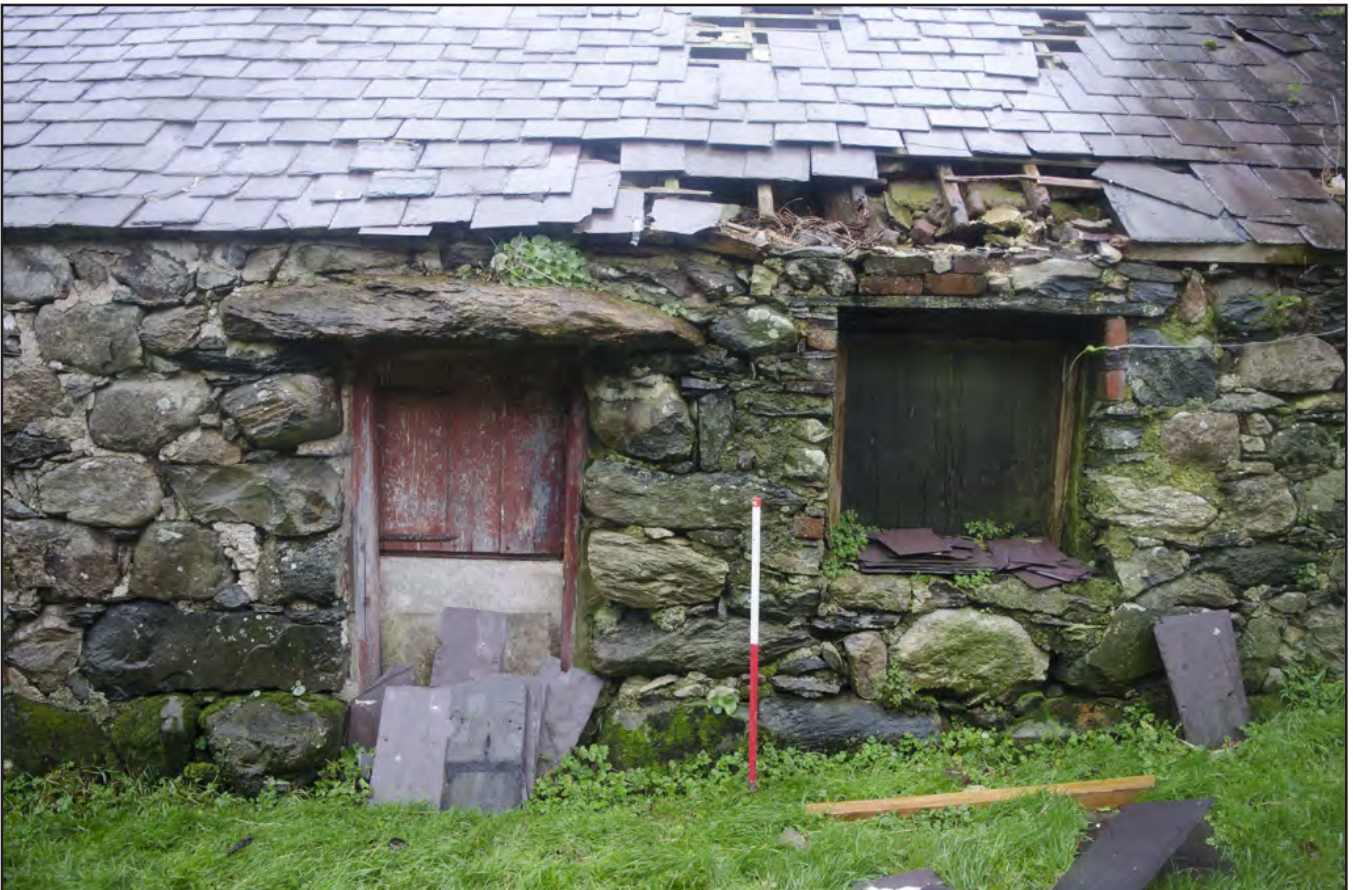
The rear access point into the store room has, similar to the front, a large schist stone lintel which measures 1.8m in length by 0.30m in height and protrudes out 0.10-0.12m making it quite a striking entrance (Plate 8). The door itself is a typical wooden split stable door, painted red and has been repaired at the bottom half at one point. The store room also has two visible windows from the rear. One is a modern wooden window with replacement red brick surrounds, and one a smaller blocked up window (Plate 7). The smaller window, which is most likely contemporary with the original structure, has been blocked up with rubble masonry at some point and is only clearly visible from the exterior of the building. The window measures 0.5m in width by 0.45m in height and is similar in character to the front and rear doors of the store, having a protruding, fairly large block lintel, measuring 0.68m in width and 0.20m in height (Plate 7). The second much larger window is a modern addition (Plate 8), with a wooden casement window with a single light, red painted frame and measuring 1.1m wide by 0.93m in height. It is set back at a depth of 0.5m.

Plate 8: Southwest facing elevation: modern window and doorway with large stone lintel at rear of building; scale: 1x1m (archive reference: G2586_010).

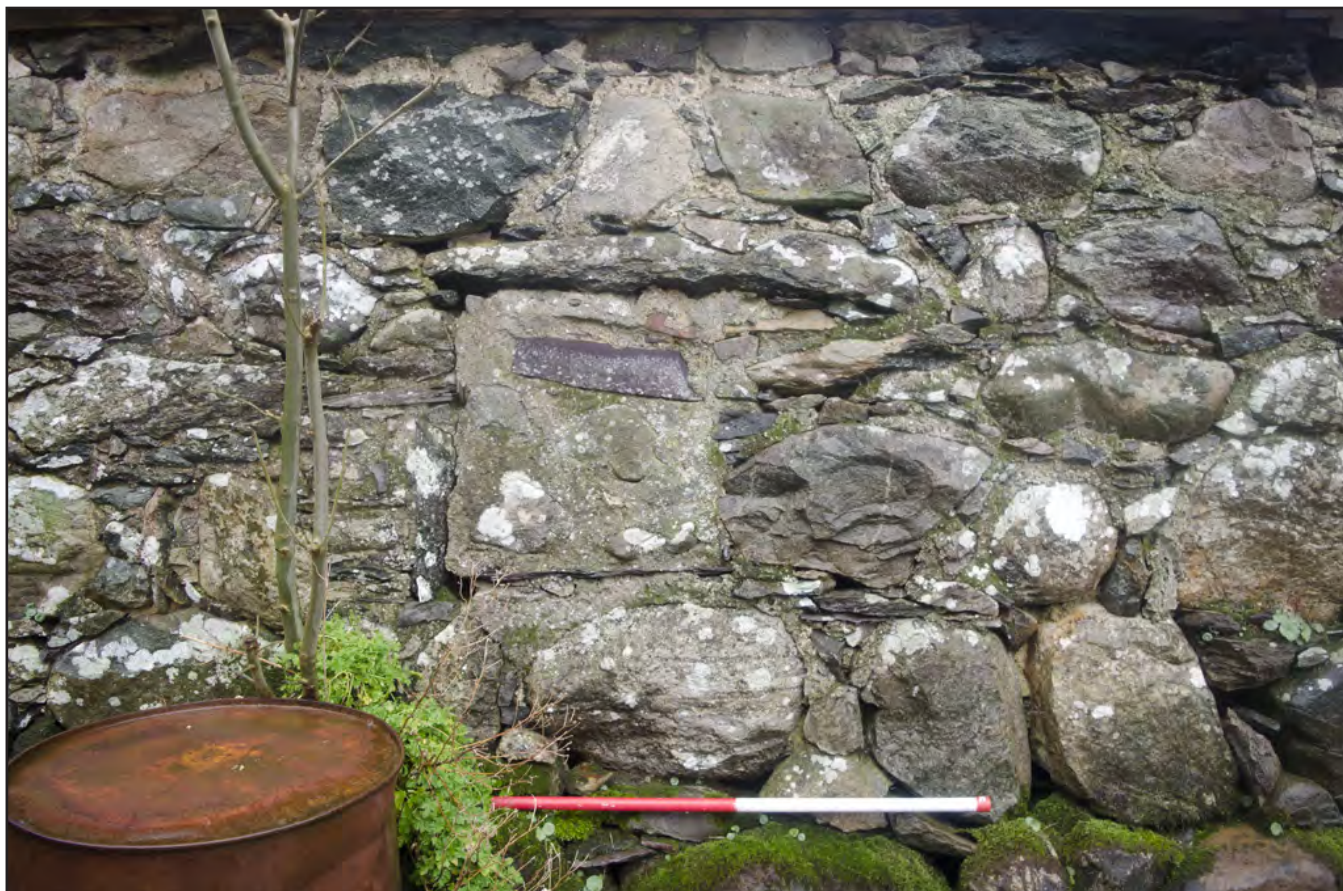
Plate 11: Southeast facing elevation: shot of blocked up window at front of building; scale: 1x1m (archive reference: G2586_013).

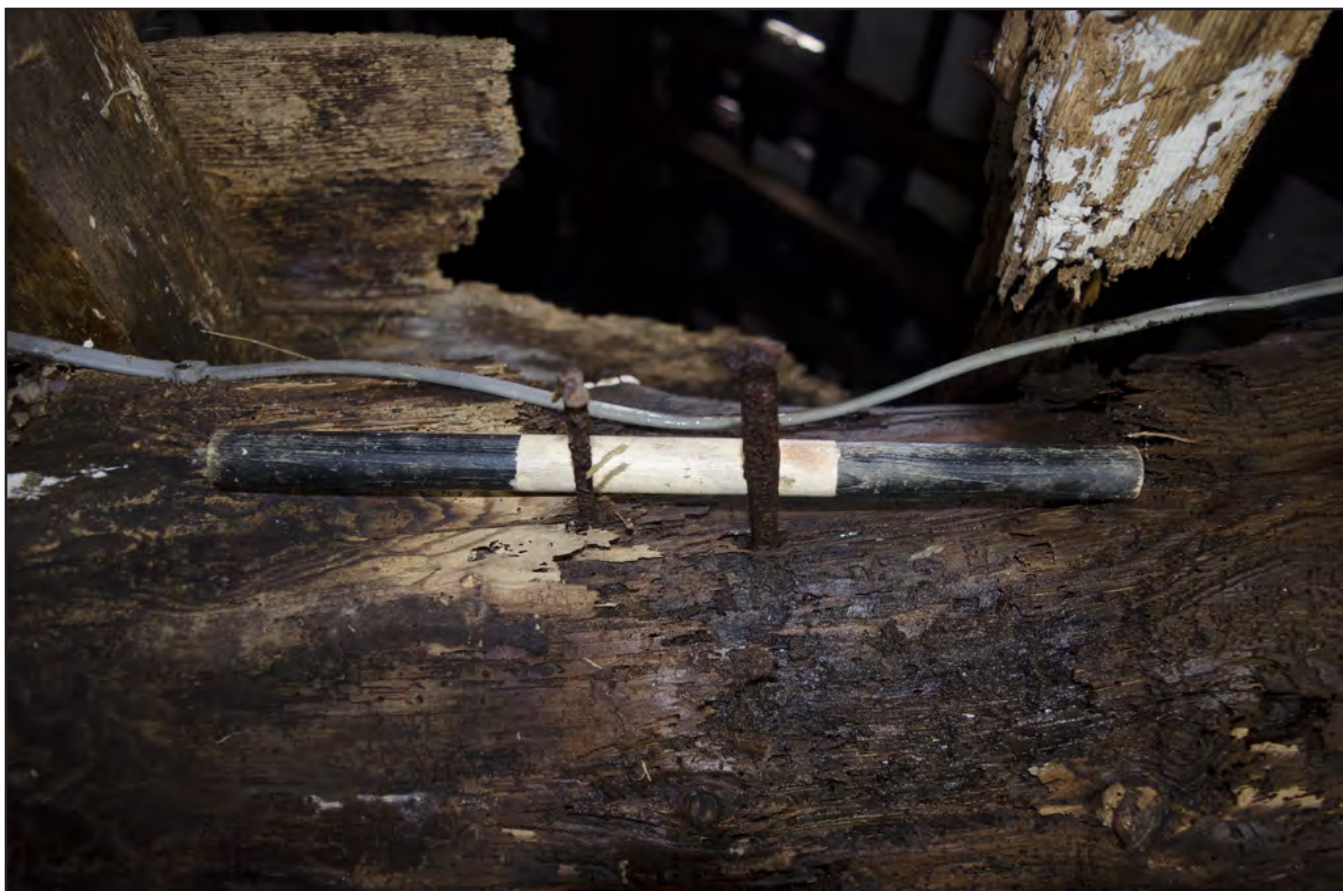
Plate 18: Store Room 1: detail of blacksmith nails within beam; scale: 1x0.3m
(archive reference: G2586_028).

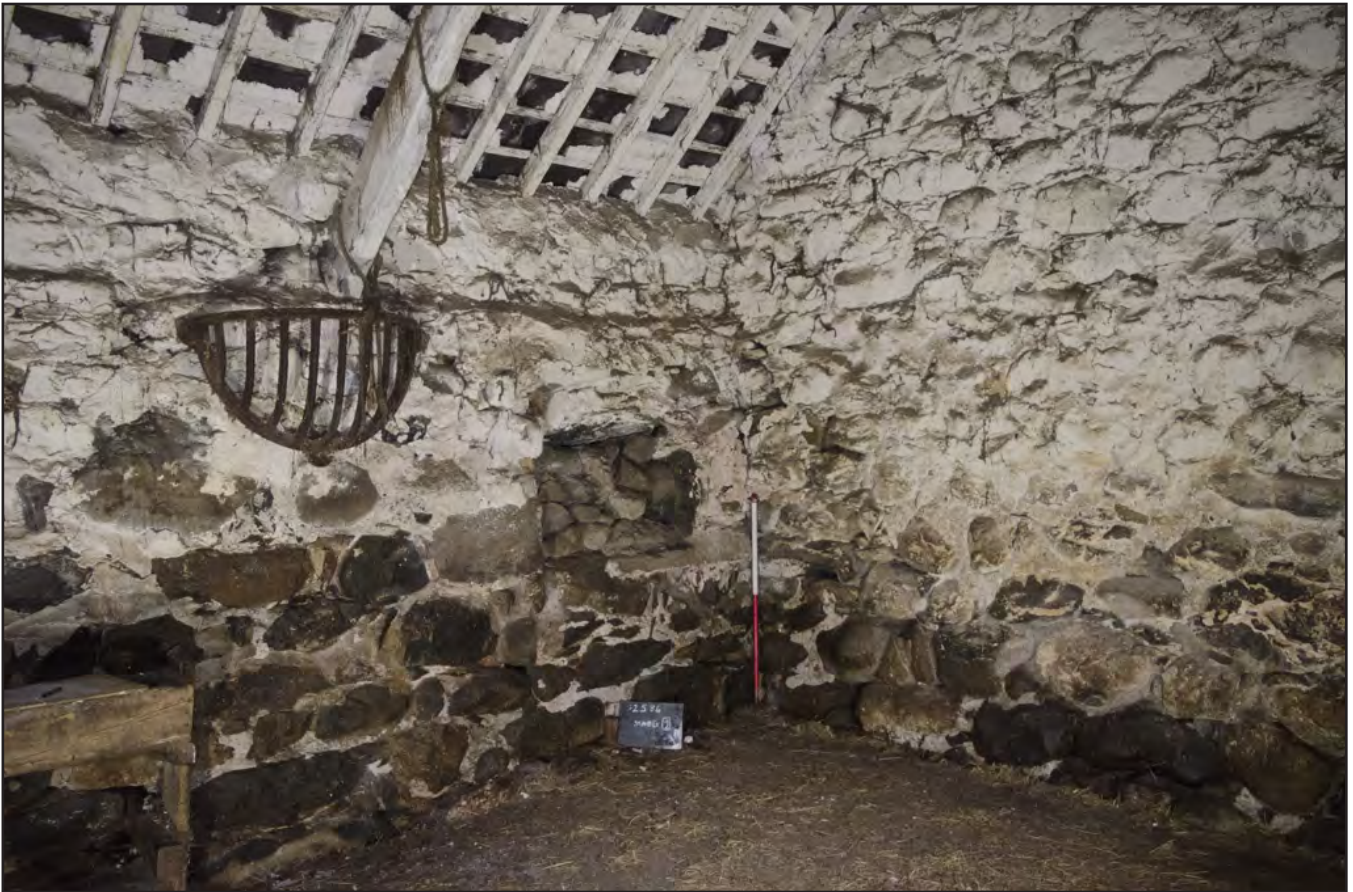
Plate 21: Stable 2: detail of southeast wall from doorway along with blocked window and manger; scale: 1x1m (archive reference: G2586_032).

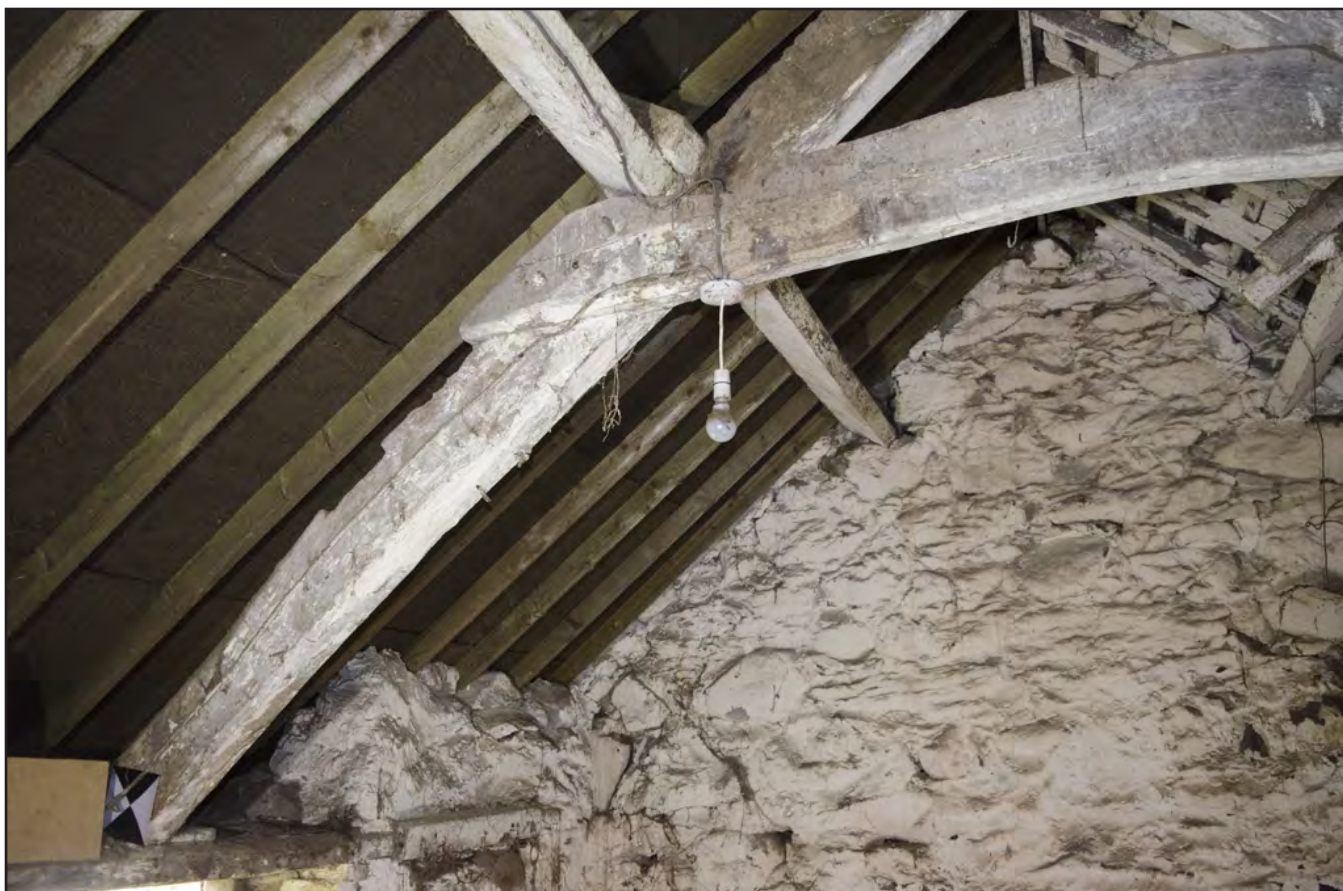
On the north western wall, signs of repair were noted to the main door into the stable using modern red brick to reinforce the oak lintel. The lintel itself has old style blacksmith nails still in situ and supports the A-frame chamfered stop end (Plate 25). The A-frame itself is in very good condition and has been white washed at one point and is of a 17th century architectural style (Plates 26-30).

Plate 26: Stable 2: detail of A-Frame Truss from southwest wall; scale: not used
(archive reference: G2586_037).

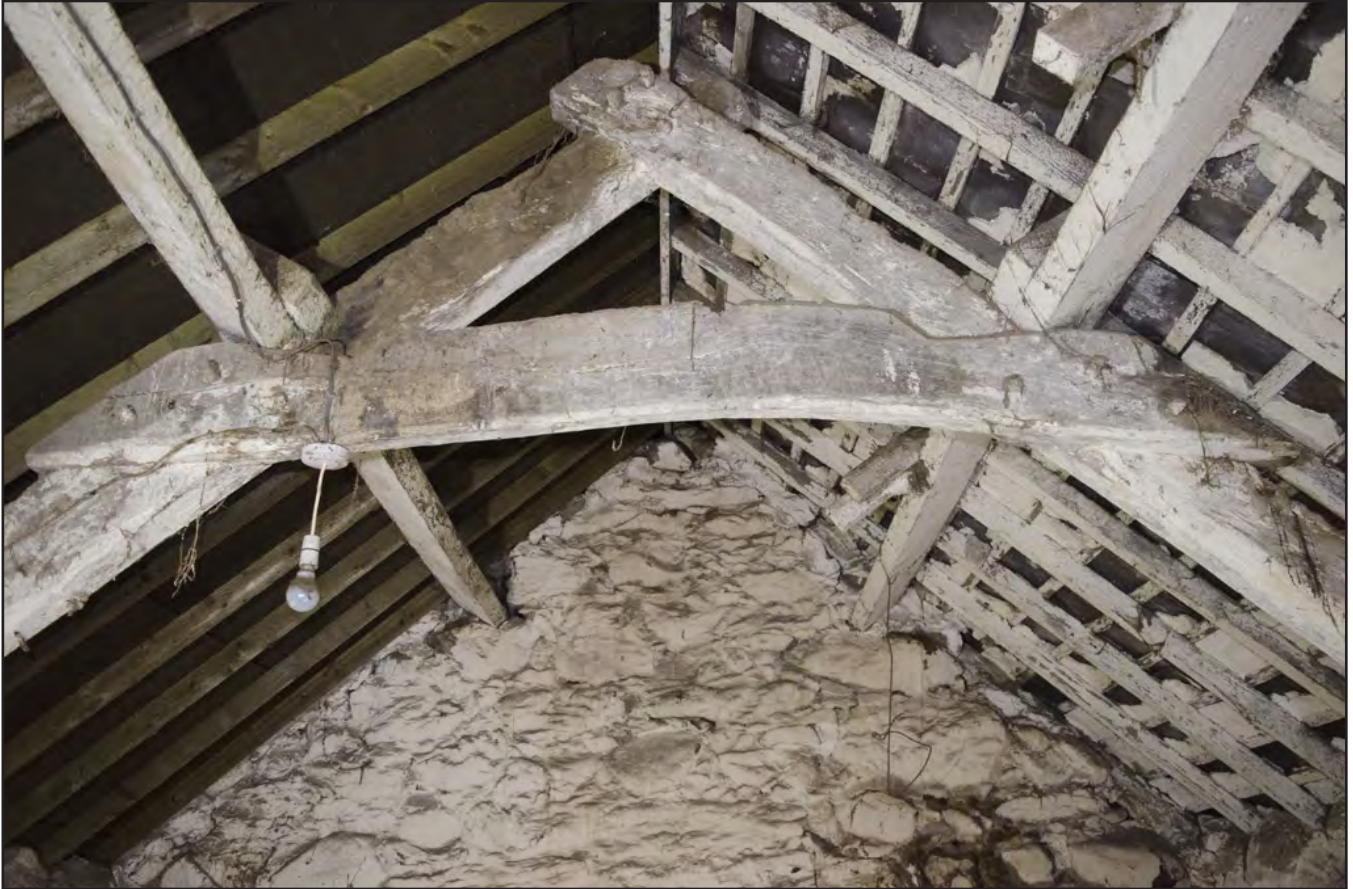
The main A-frame truss (Truss 'C') is pegged on either side to the tie beam with three pegs while also having three at the apex (Plate 27). The frame is also scarfed on the south-western side with evidence of old purlin slots still visible within the principal rafters, demonstrating original roof superstructure has been replaced. The beams have rough chamfered stops on both sides (20cm from wall) (Plates 28-29). The principal rafters also cross at the apex and do not support the modern ridge-piece, a feature also seen on the other two 'A' frame trusses. On observation of the construction techniques, the walls were built up to a certain level then the A-frame was put in place then continued to build the wall up slightly higher. The present roof and purlins consist of modern sawn timber and slates.

Plate 27: Stable 2: detail of A-Frame Truss from southwest wall; scale: not used (archive reference: G2586_038).

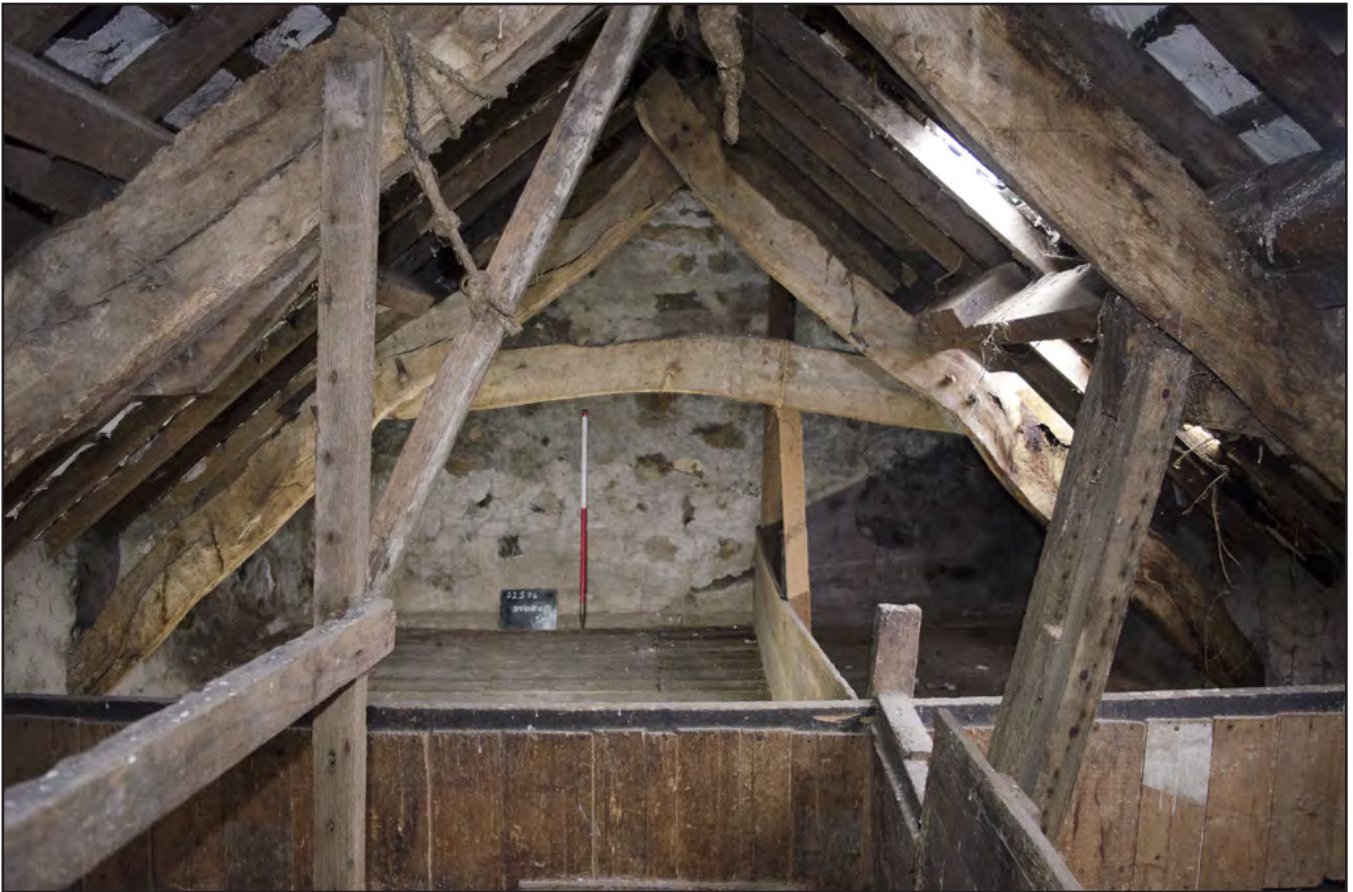
The first floor of the former potato/grain store is accessed from a wooden stairway from the ground level store room, and is located above Store Room 1. It has the form of a crog loft. The room is rectangular in shape with white washed walls and was formally used to store potatoes and grain which is seen by the surviving wooden partitioning's splitting the room into four separate spaces (E. Lynes 2018, *pers comm*). The partitioning does not reach roof level and are fairly shallow at around 1m in height. The modern roof is held up by two A-frame trusses of a similar type to the one found in the stable block, although only attached to the roof superstructure through rough sawn purlins. The south-western example, Truss A has been drawn from the north-east side to show the construction techniques (Plate 31; Figure 08).

Plate 31: Store Room 3: detail of A-Frame Truss (a); scale: 1x1m (archive reference: G2586_043).

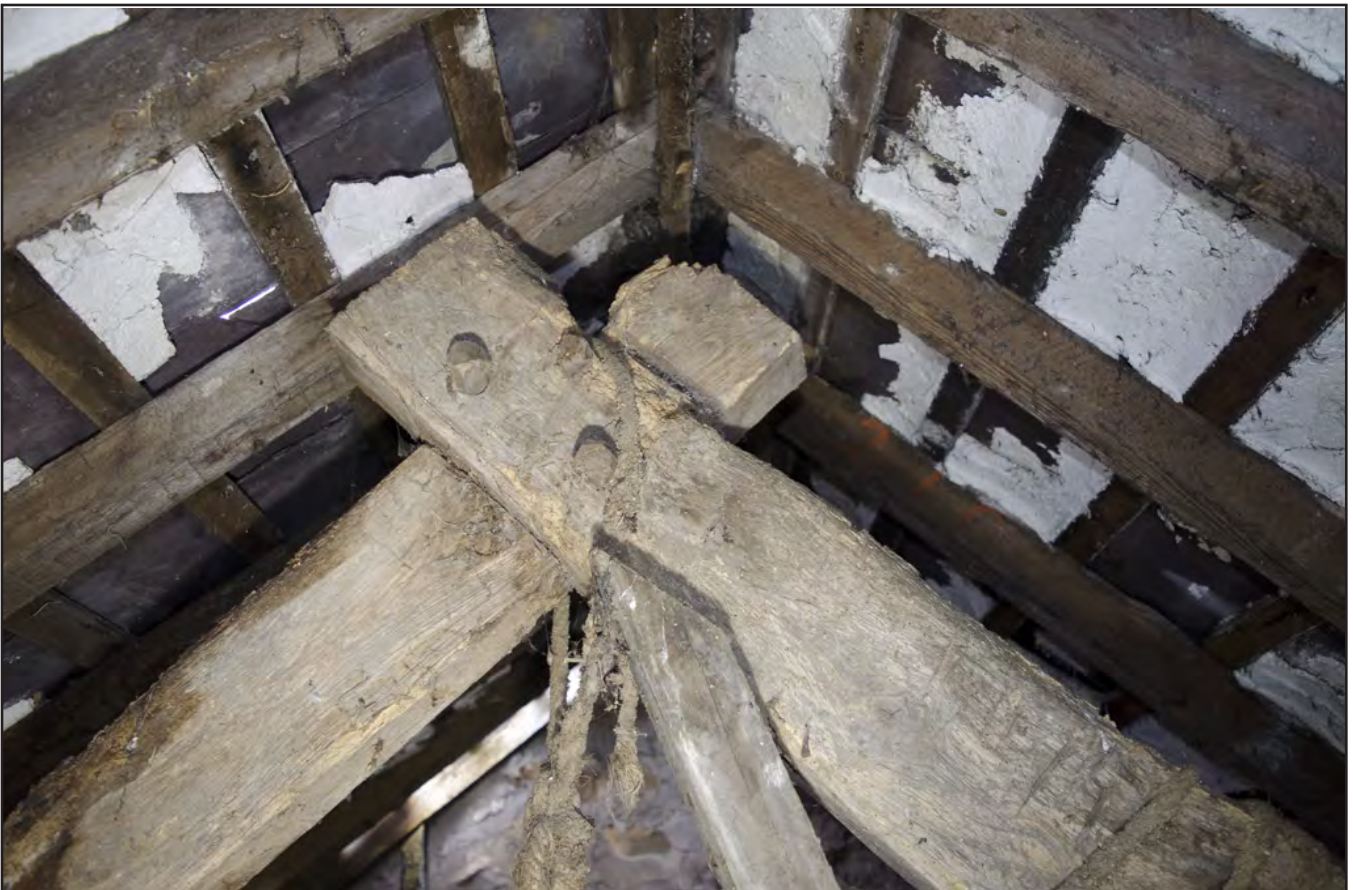
Plate 34: Store Room 3: detail of pegged apex on A-Frame Truss (b); scale: not used (archive reference: G2586_047).

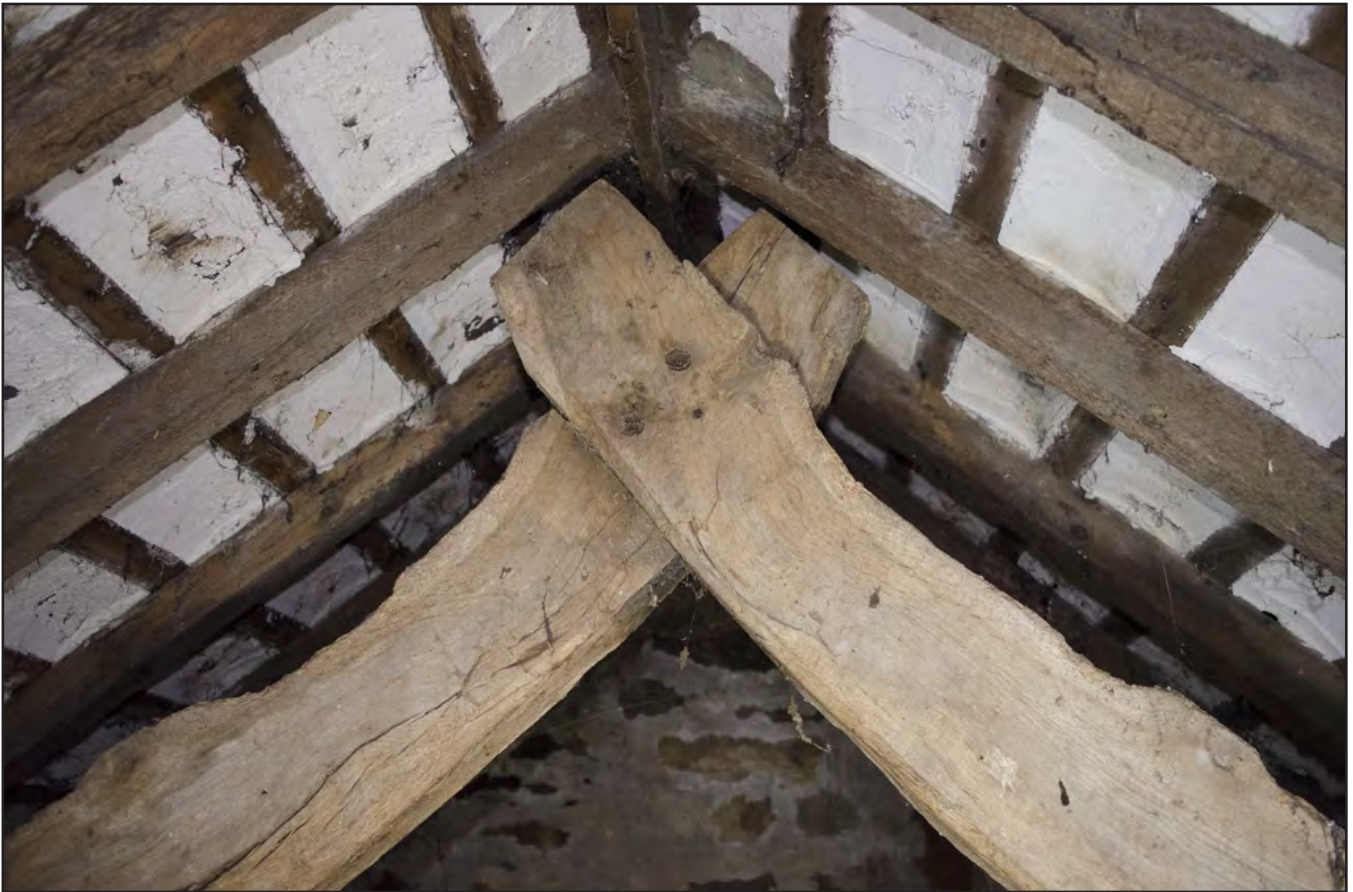
Plate 35: Store Room 3: detail of pegged apex on A-Frame Truss (a); scale: not used (archive reference: G2586_049).

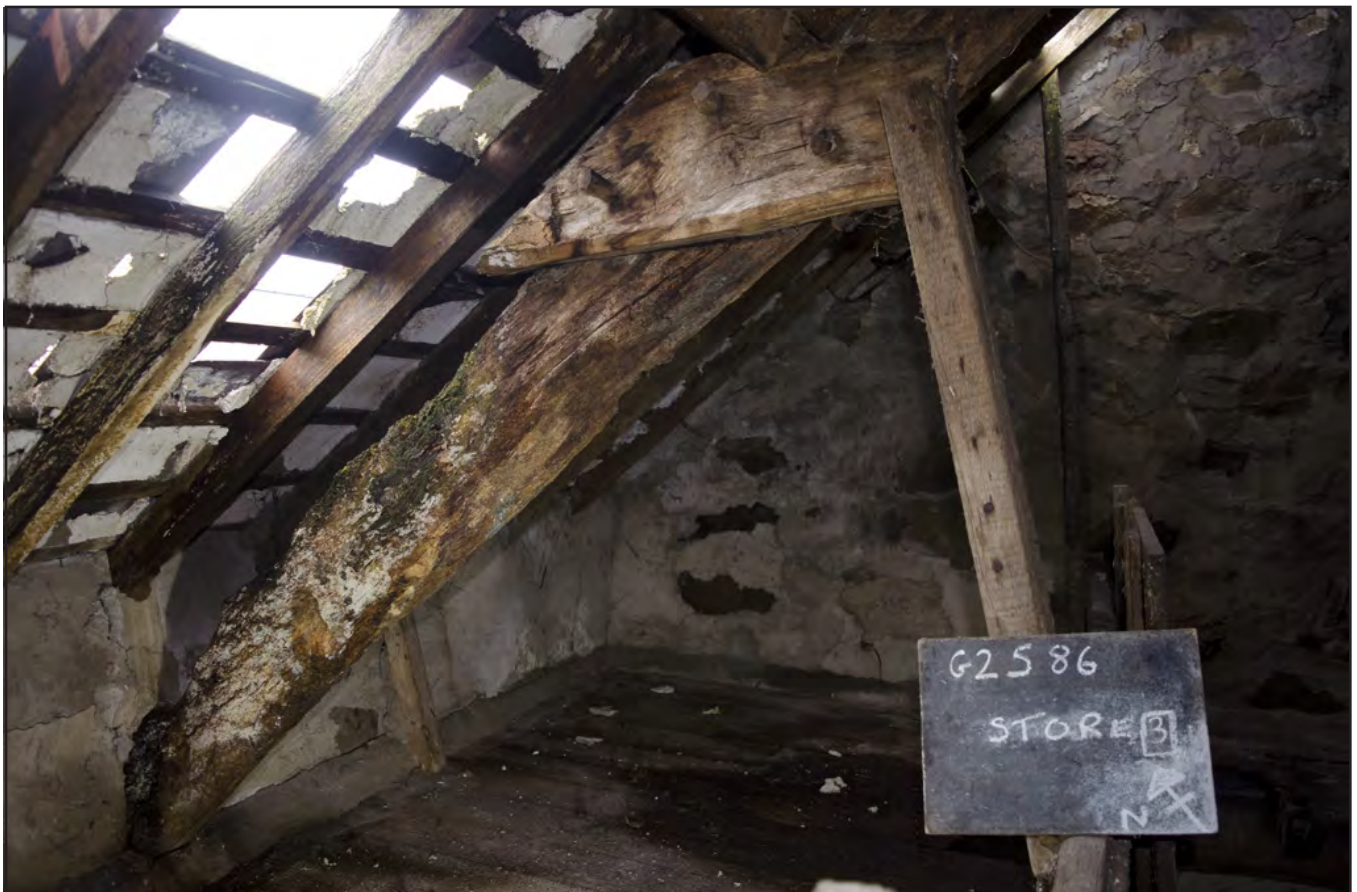
Plate 36: Store Room 3: detail of rotted end on A-Frame Truss (b); scale: not used (archive reference: G2586_048).

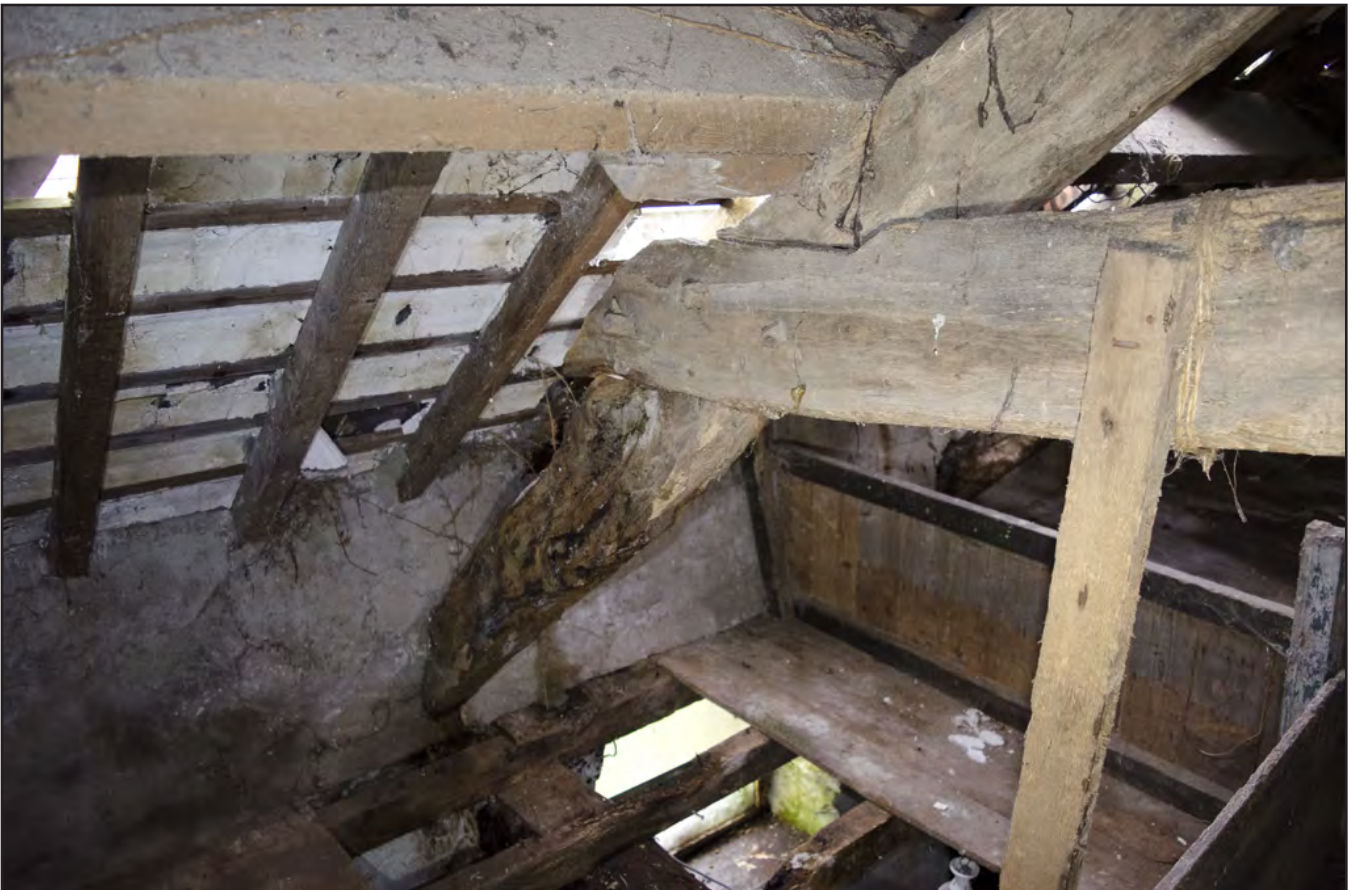
The general state of the first floor is poor in some parts with the main floor timbers rotting away and missing in patches (Sam Jones Cyf. 2018) (Plate 40).

Plate 40: Store Room 3: detail of rot on A-Frame Truss (a); scale: not used (archive reference: G2586_054).
