Rhuddlan Bâch Quarry, YNYS MÔN

Archaeological Mitigation

Prosiect Rhif / Project No. G2585

Adroddiad Rhif / Report No. 1455

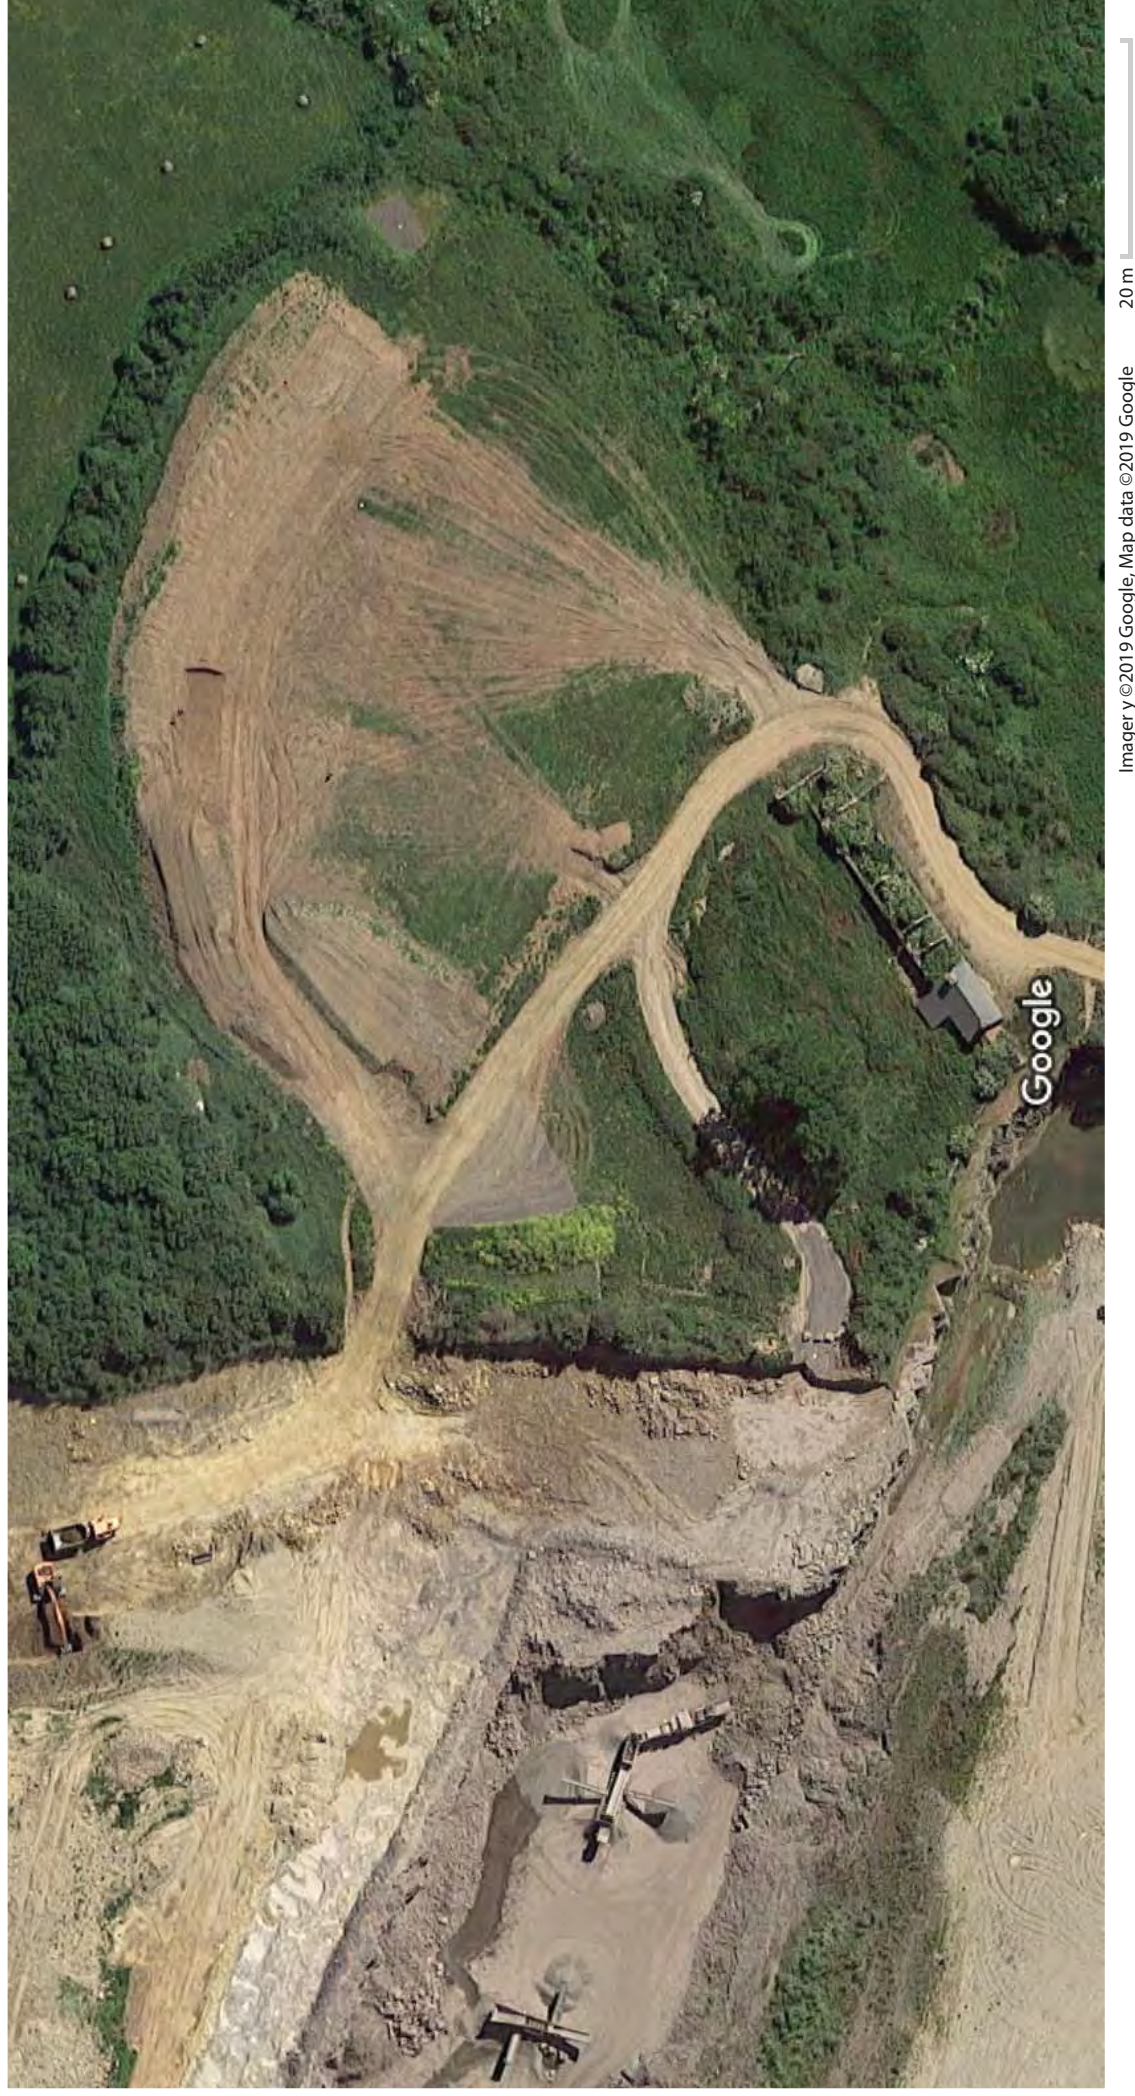
FIGURE 09: Google Earth image of Rhuddlan Bach Quarry extension area.

During the controlled strip evidence of previous movement of heavy machinery was evident from the ruts that scarred many areas, sometimes deep into the clay natural (Plate 23 & 24). These can be seen very clearly on the google earth image for the quarry area (Figure 09).

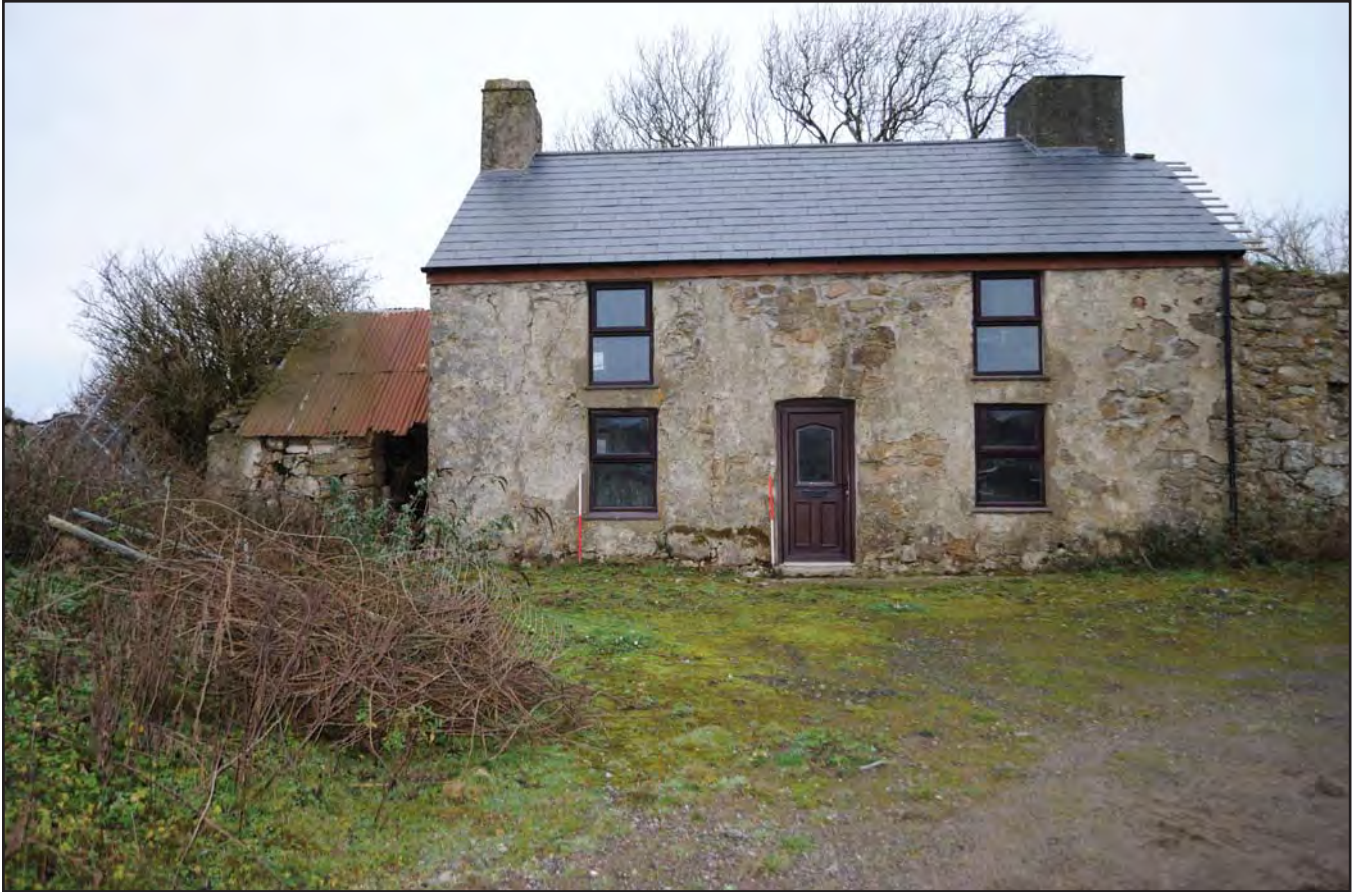
The farmhouse has dimensions of 11m x 6m with the additional 'L' shaped section to the rear measuring 5m x 3m. It is a 2 storey building built using limestone blocks and has been rendered. It has 4 windows and 1 door in the front elevation, 4 windows to the rear and 2 chimney stacks. As part of the quarry licence the Rhuddlan Bâch Farmhouse has to be kept in a habitable condition (Williams, D.W., Per Coms) and it is obvious from first glance that the building has received a new roof and windows (Plate 01). At the rear the protruding 'L' shaped section has been reconstructed using breeze blocks within the remains of the old stone walls (Plate 02).

Plate 01: Front elevation of Rhuddlan Bâch Farmhouse; scale: 2x1 m (archive reference: G2585_033).

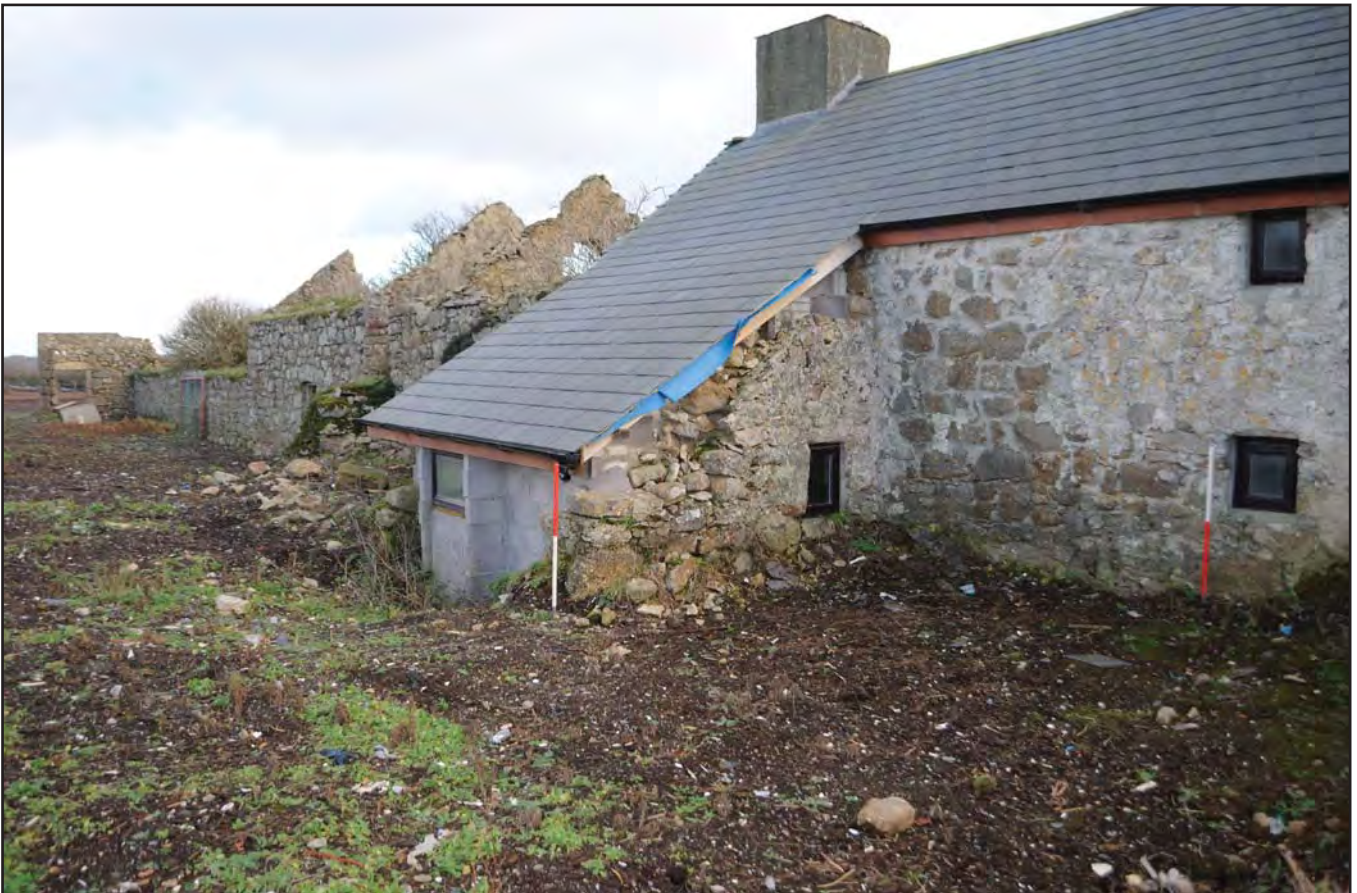
Plate 02: Oblique of rear elevation of farmhouse; scale: 2x1 m (archive reference: G2585_079).

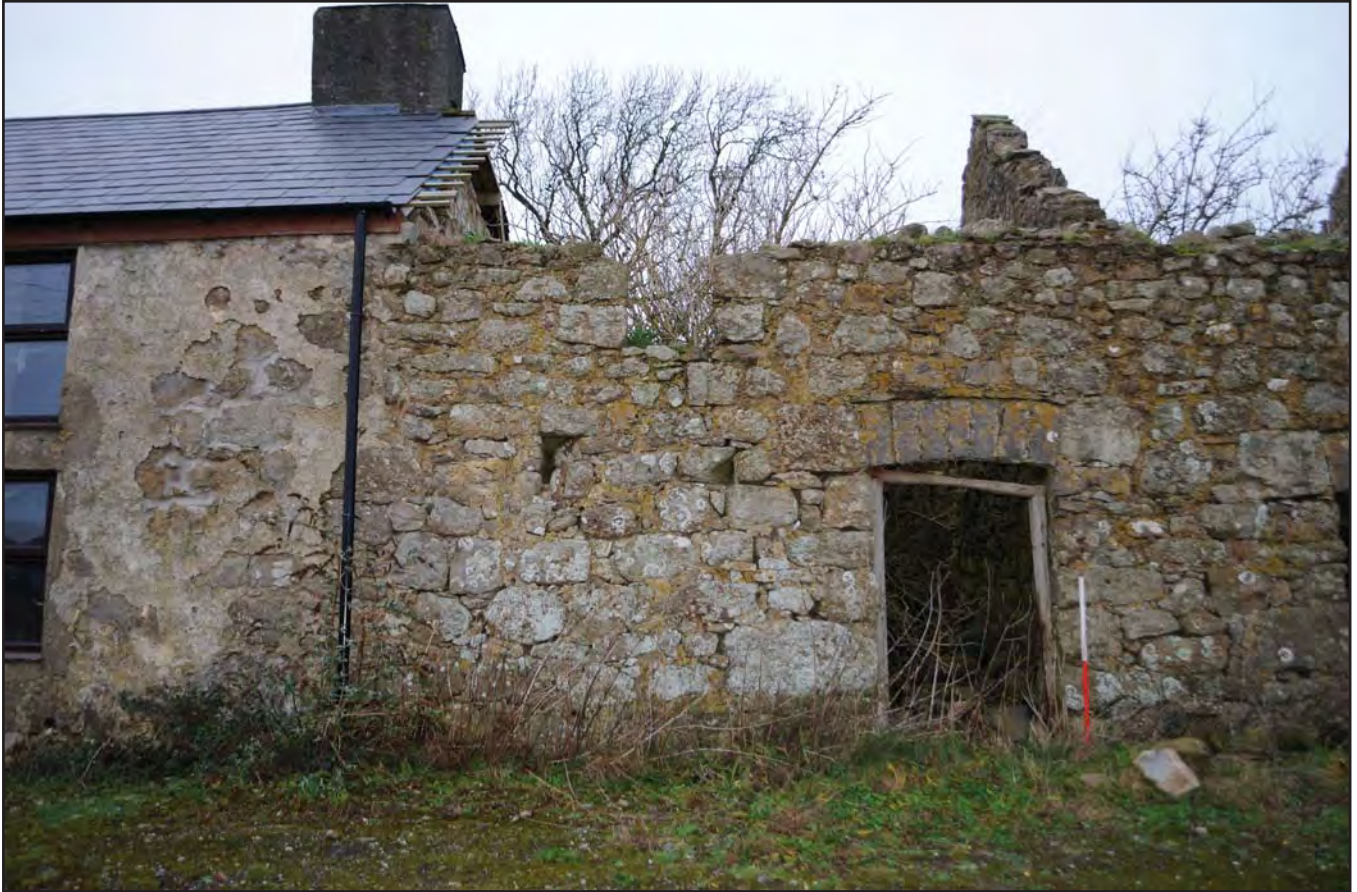
Outbuilding 1 has dimensions of 6m x 6m and is constructed from irregularly shaped limestone blocks and mortar. It appears to have had two floors and there is evidence for a small window in the front elevation at the roof line and a connecting doorway at the second floor level to outbuilding 2. The doorway, which still has some of the wooden surround in situ, is situated to the right of centre of the front elevation (Plate 03). To the rear there is evidence for definitely 1, possibly 2 blocked windows (Plate 04). There is no roof remaining.

Plate 03: Front elevation of Outbuilding 1; scale: 1x1m (archive reference: G2585_037).

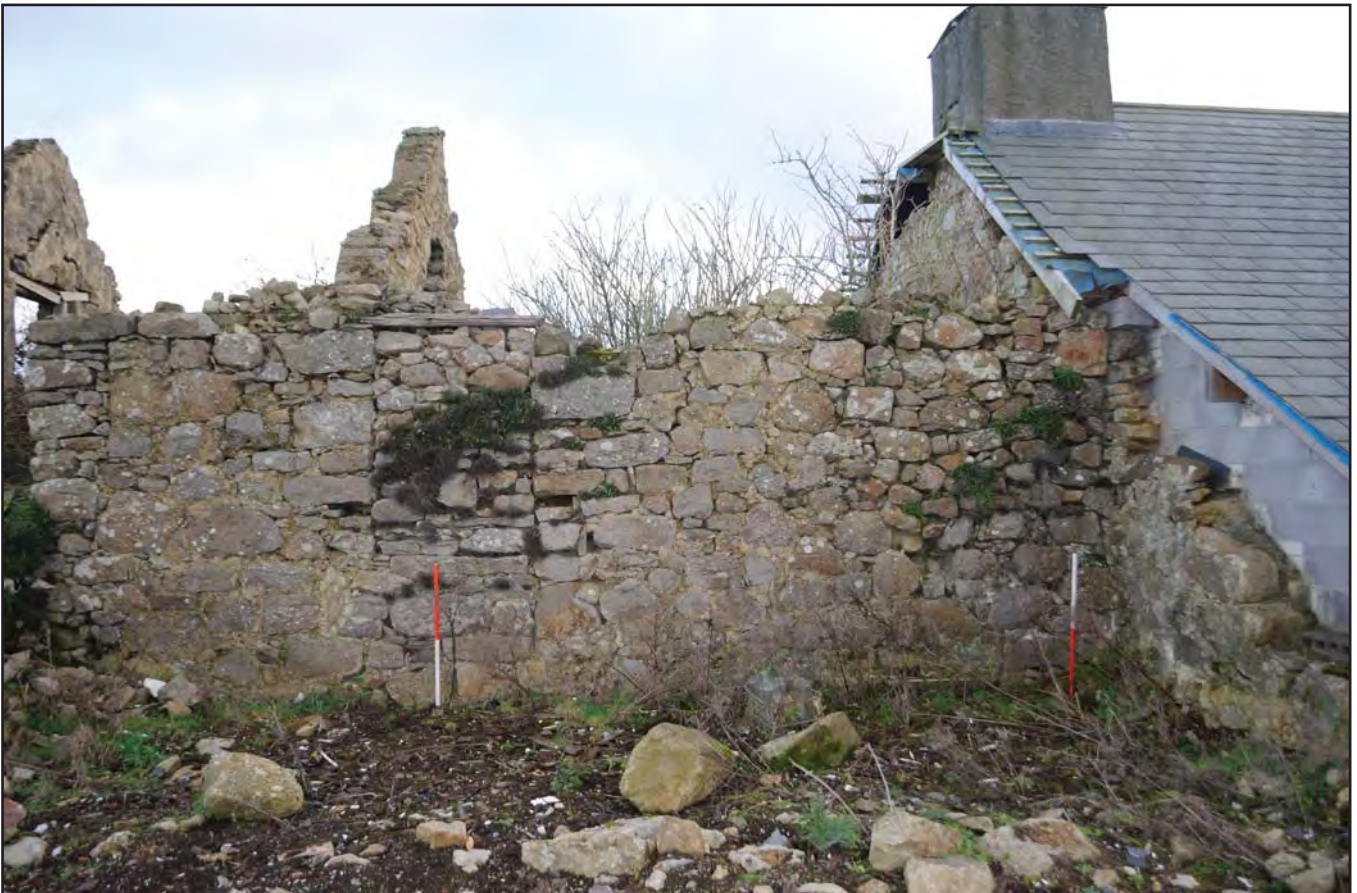
Plate 04: Rear elevation of Outbuilding 1; scale: 2x1m (archive reference: G2585_074).

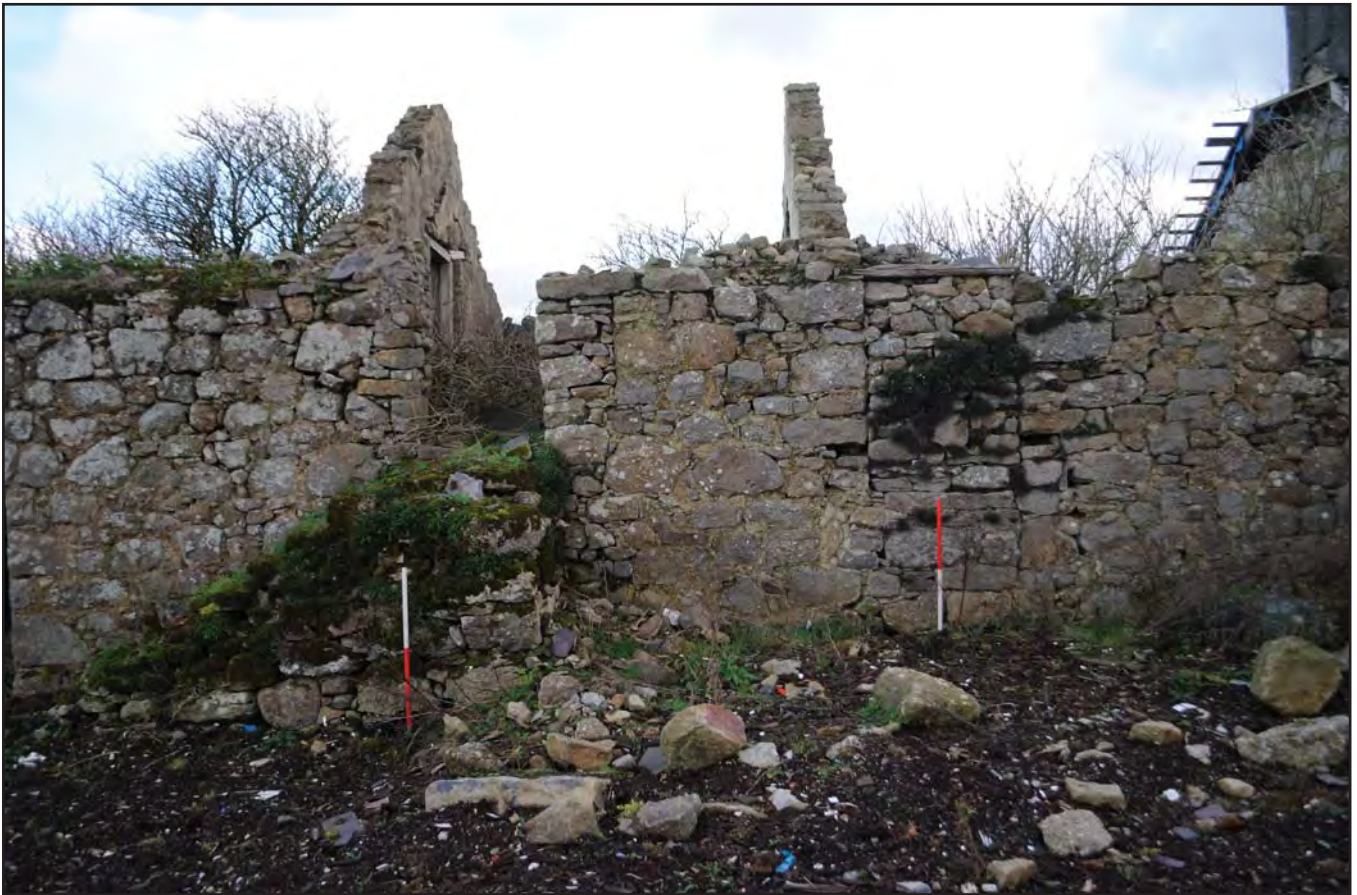
Outbuilding 2 measures 3m x 6m and is built using the same materials and construction as outbuilding 1. It appears to have had two floor levels evidenced by the connecting doors between outbuildings 1, 2 & 3 and the rear steps (Plate 05). To the front is a wide doorway

Plate 05: Rear elevation of Outbuilding 2; scale: 2x1m (archive reference: G2585_073).

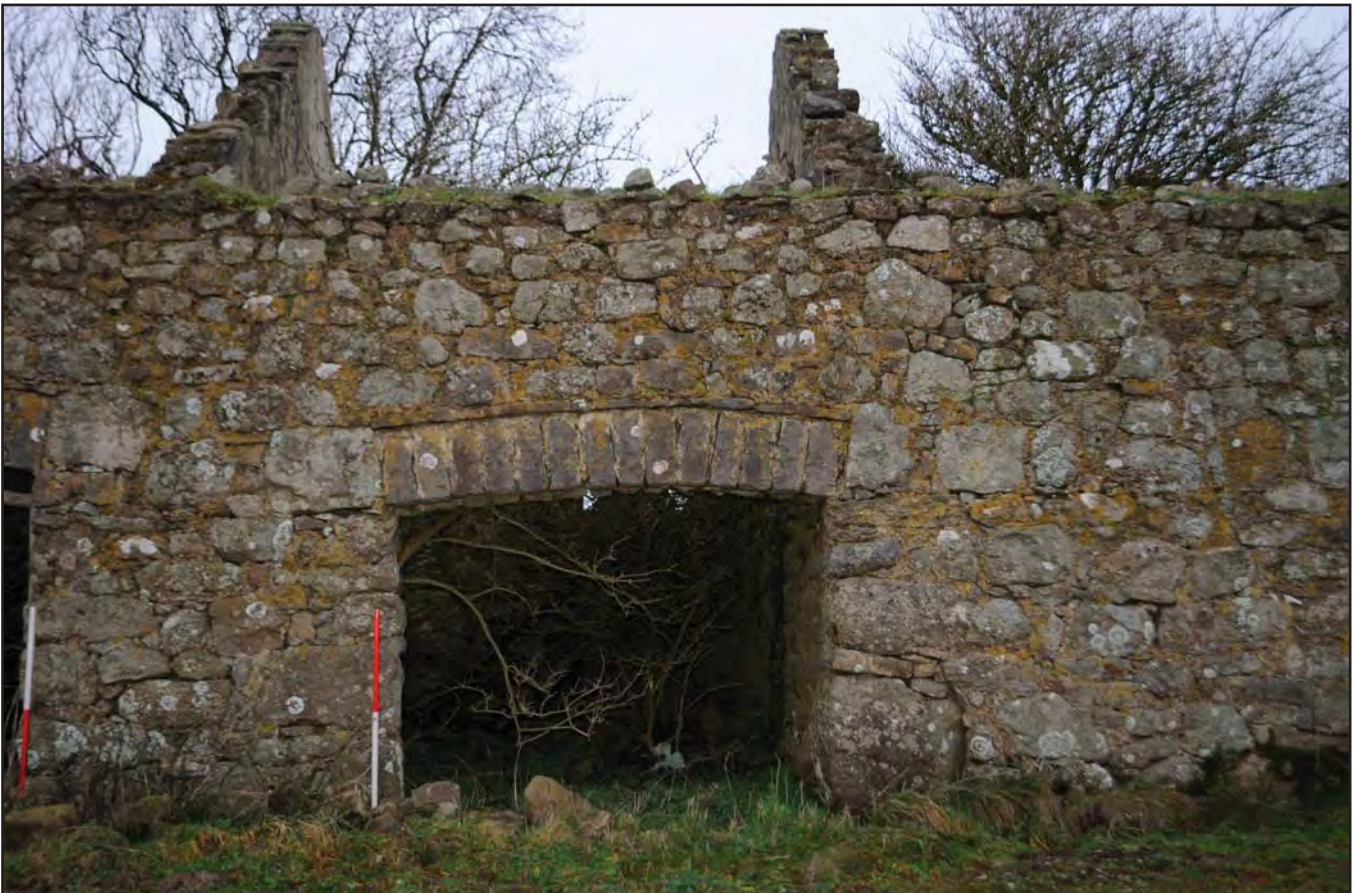
(2.25m x 1.8m) suggesting a non-domestic use for this building (Plate 06). There is no roof surviving on this building.

Plate 06: Front elevation of Outbuilding 2; scale: 2x1m (archive reference: G2585_038).

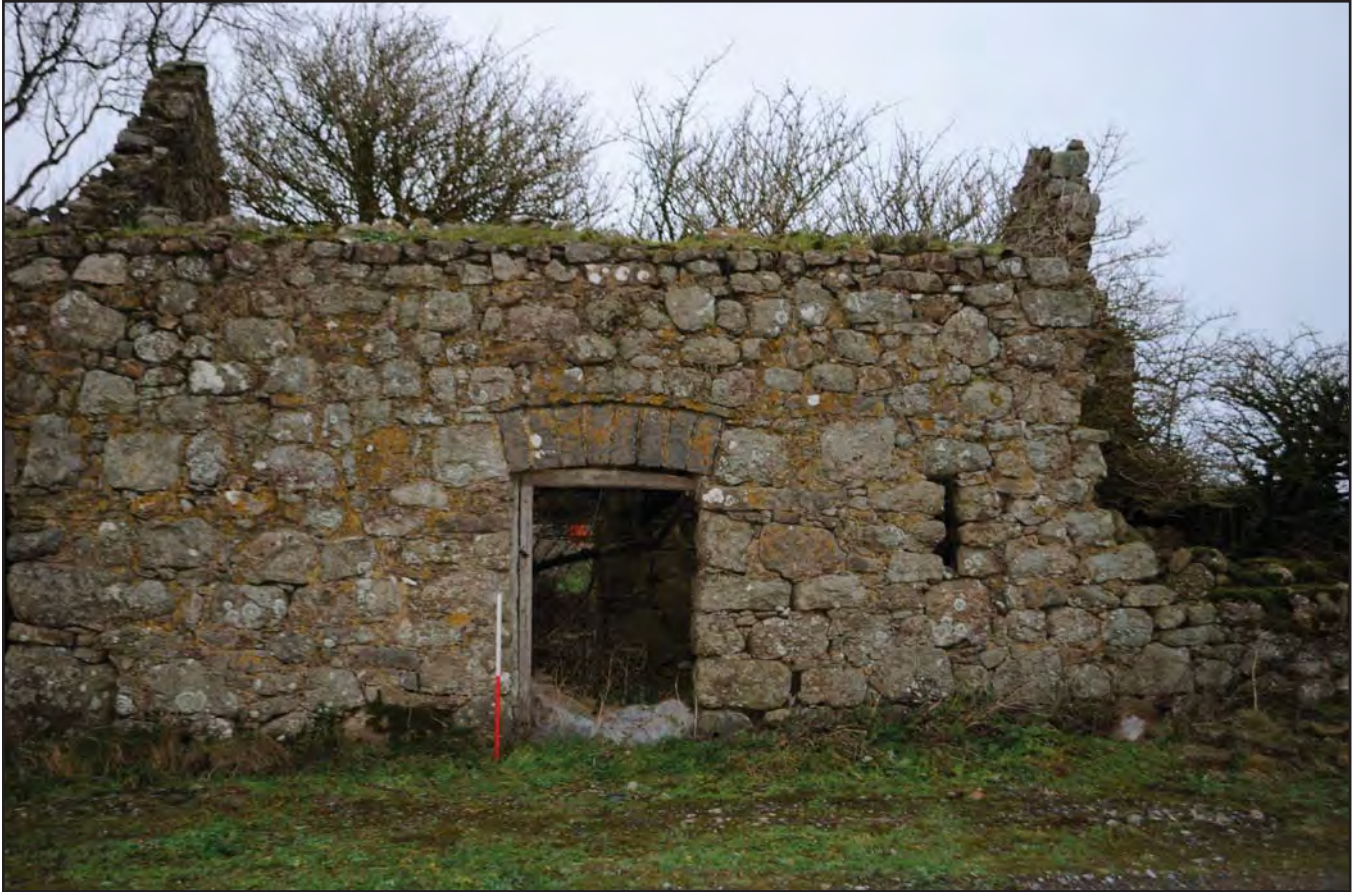
This building is of the same materials and construction as the other outbuildings and has dimensions of 10m x 6m and no roof. There is a connecting doorway (Plate 05) from outbuilding 2 at the second floor level suggesting that this building originally was 2 storeys. There are 2 centrally situated doorways, 1 in the front elevation (Plate 07) and 1 at the rear (Plate 08) which both retain parts of the wooden door surround. Both elevations have slit windows (0.15m x 0.7m) on their NE side.

Plate 07: Front elevation of Outbuilding 3; scale: 1x1m (archive reference: G2585_040).

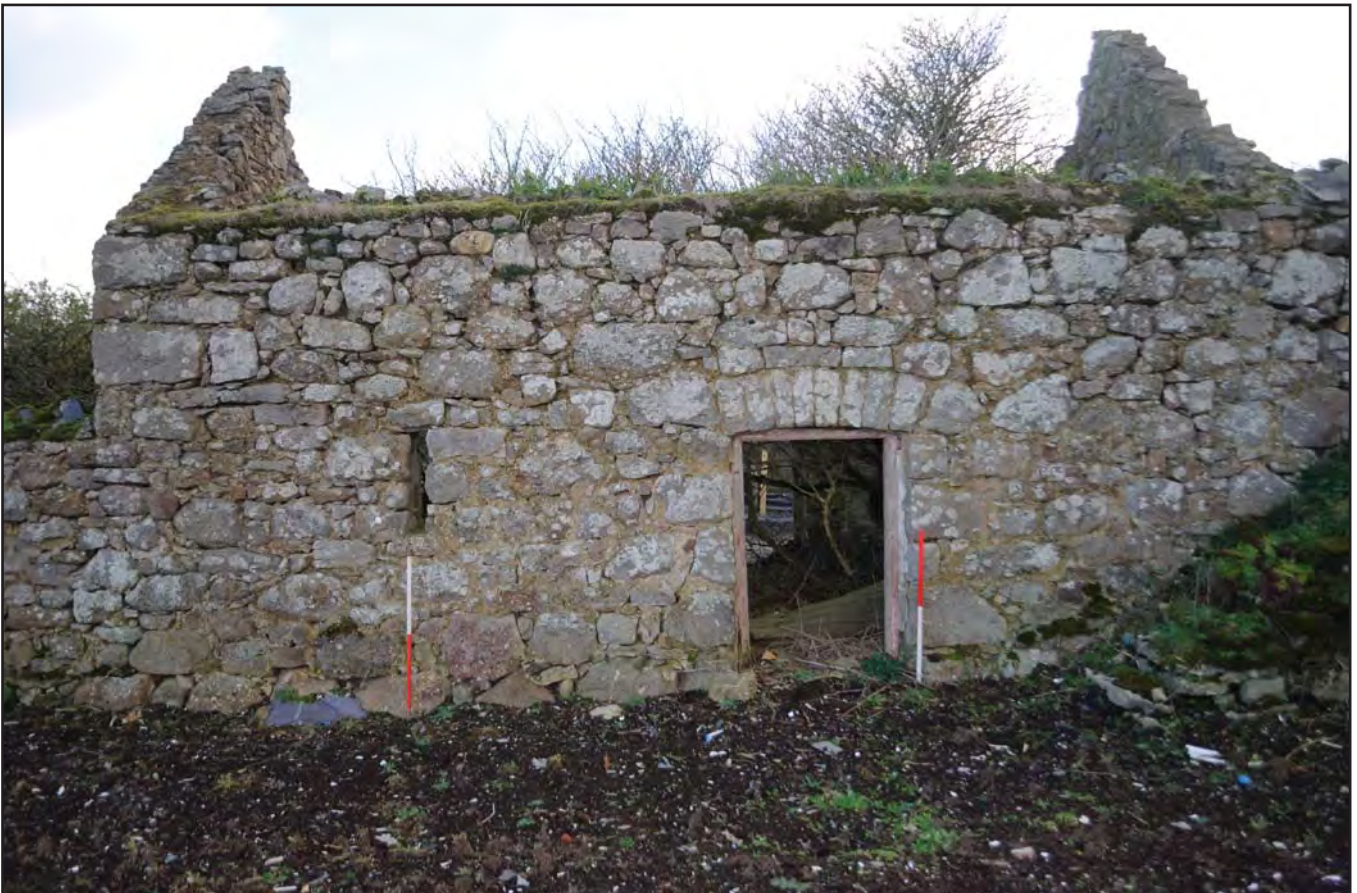
Plate 08: Rear elevation of Outbuilding 3; scale: 2x1m (archive reference: G2585_071).

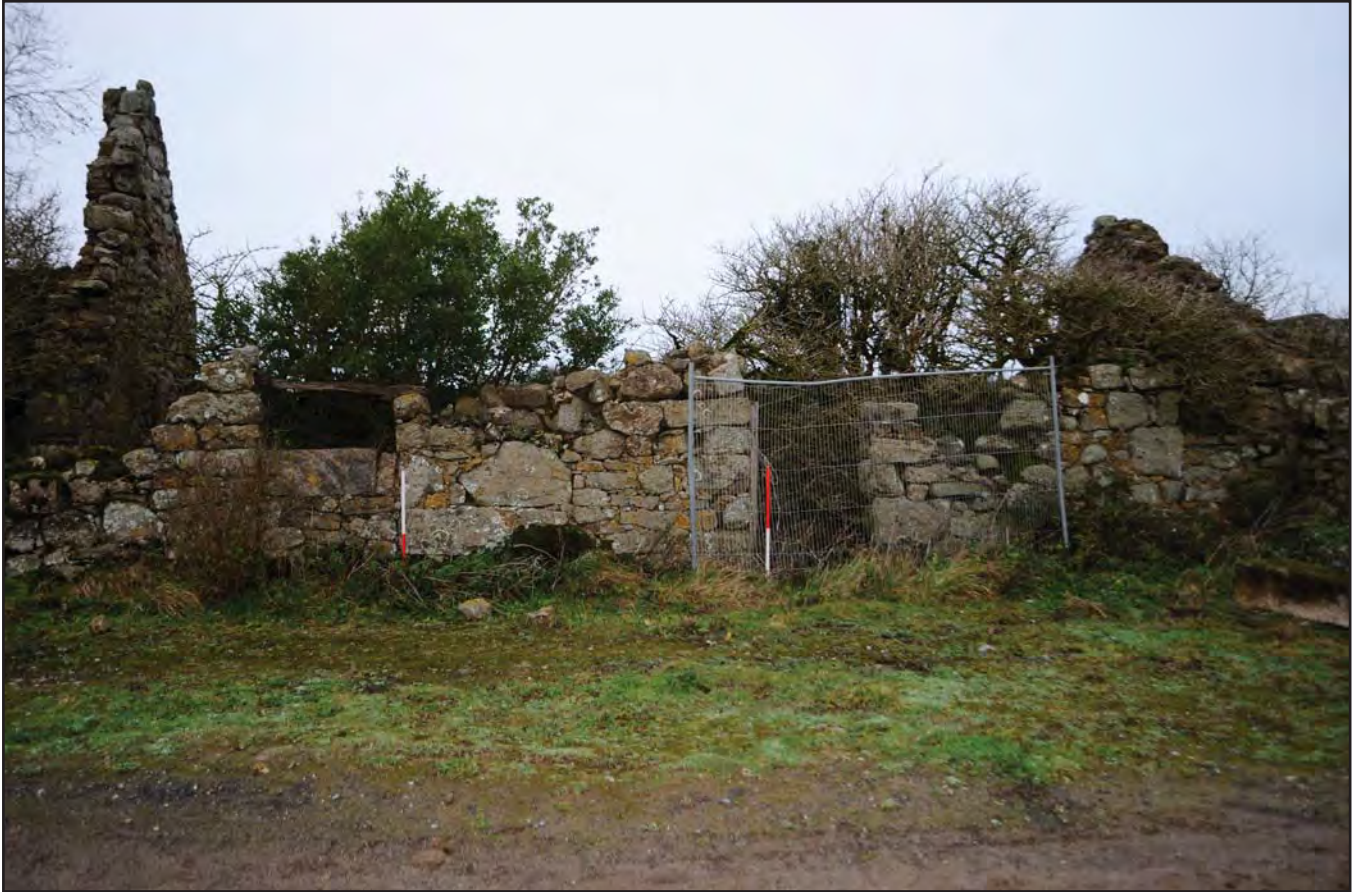
This outbuilding had suffered significant damage from the trees within and the front wall is partially collapsed. There is evidence for centrally located doorways in both the front (Plate 09) and rear (Plate 10) elevations of this building and, judging by the height of the interior dividing wall, only 1 floor level. There are 2 windows in the front elevation, 1 to the SW of the doorway and 1 to the NE.

Plate 09: Front elevation of Outbuilding 4; scale: 2x1m (archive reference: G2585_043).

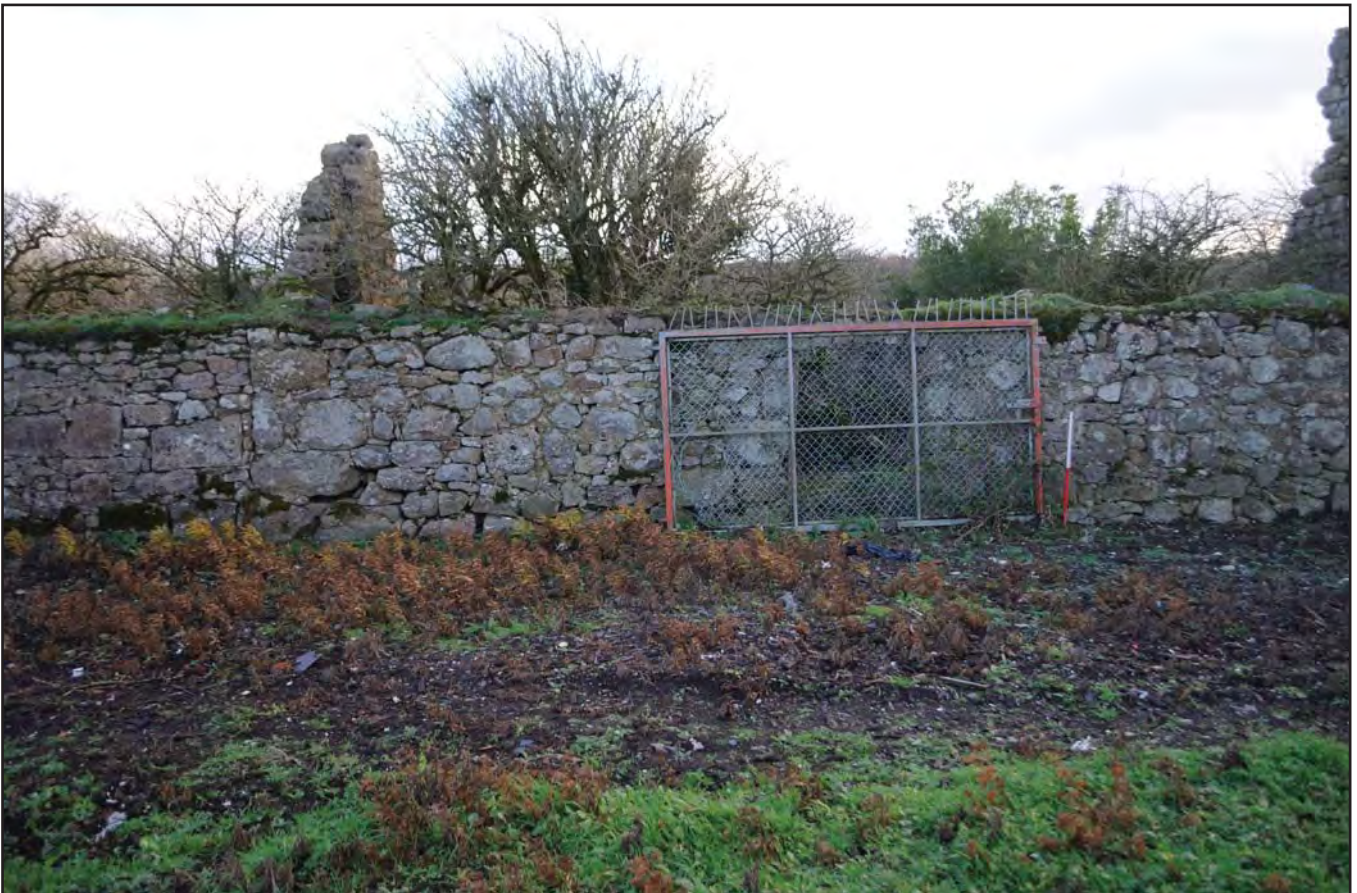
Plate 10: Rear elevation of Outbuilding 4; scale: 1x1m (archive reference: G2585_068).

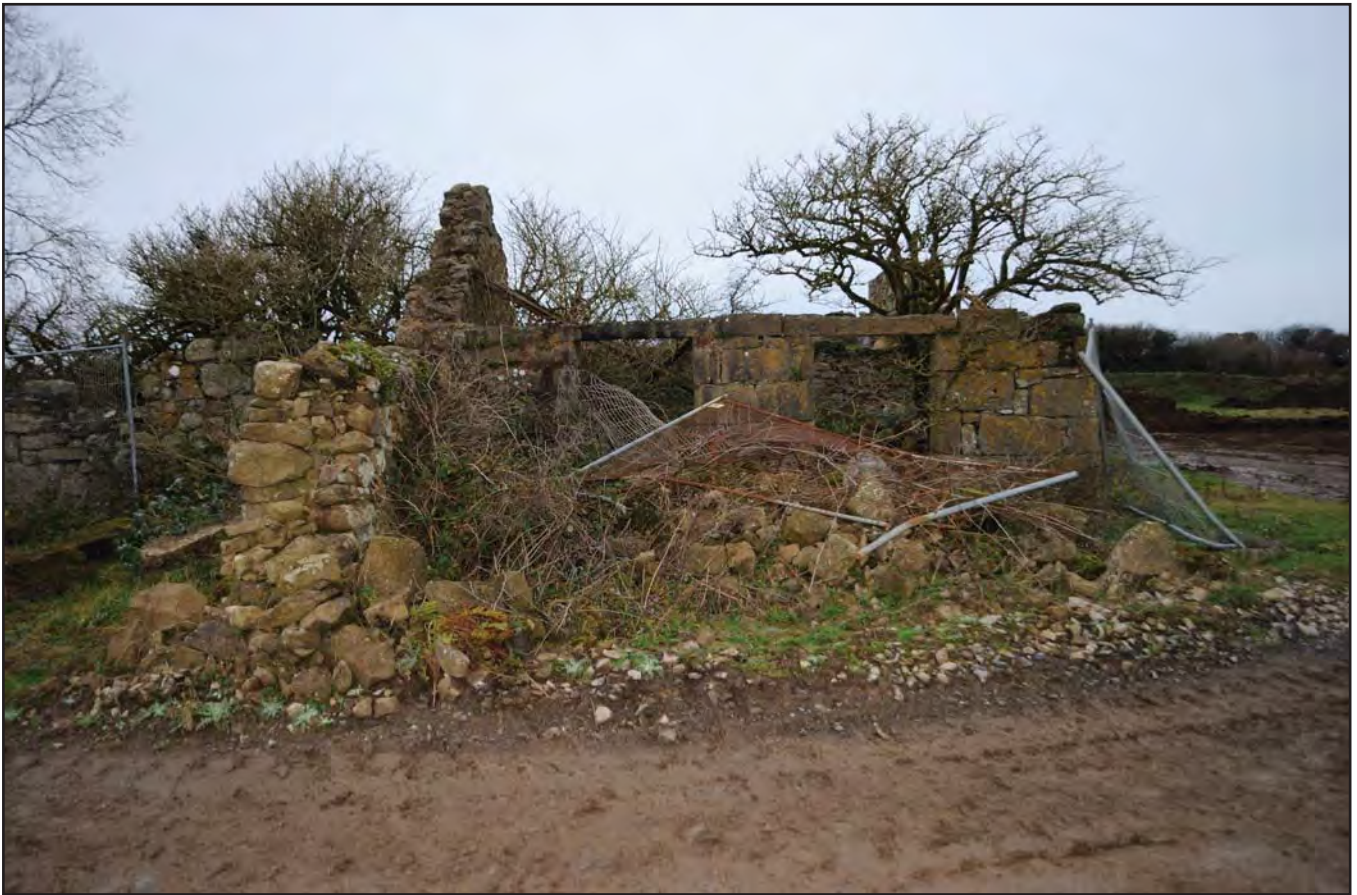
Appears to be an addition or repair to the original buildings due to the different material used in the front elevation which are regularly shaped limestone blocks rather than the irregular blocks used elsewhere (Plate 11). The dividing wall between outbuildings 4 and 5 appears to have originally continued to the SE though this is impossible to say how far due to only a small portion of this wall remaining. The rear elevation is constructed from the irregular blocks seen elsewhere but appears to be butting the rear elevation of outbuilding 4 rather than being keyed into it as elsewhere at the rear of the farmstead (Plate 12) suggesting it is a later addition. The NE wall of the farmstead is 10m long and is constructed using both the regular and irregular blocks which show alterations over time (Plate 13). This wall has one door at the NW end which leads to the rear of the farmstead (Plate 12). There is evidence that there was a return to this wall in a NE direction but this is nearly entirely gone (Plate 13). The changing arrangement of buildings at the NE end of the farmstead is evidenced on the OS 25 inch maps published in 1889, 1900, & 1920 (Figure 04, 05 & 06).

Plate 11: Front elevation Outbuilding 5; scale: none (archive reference: G2585_046).

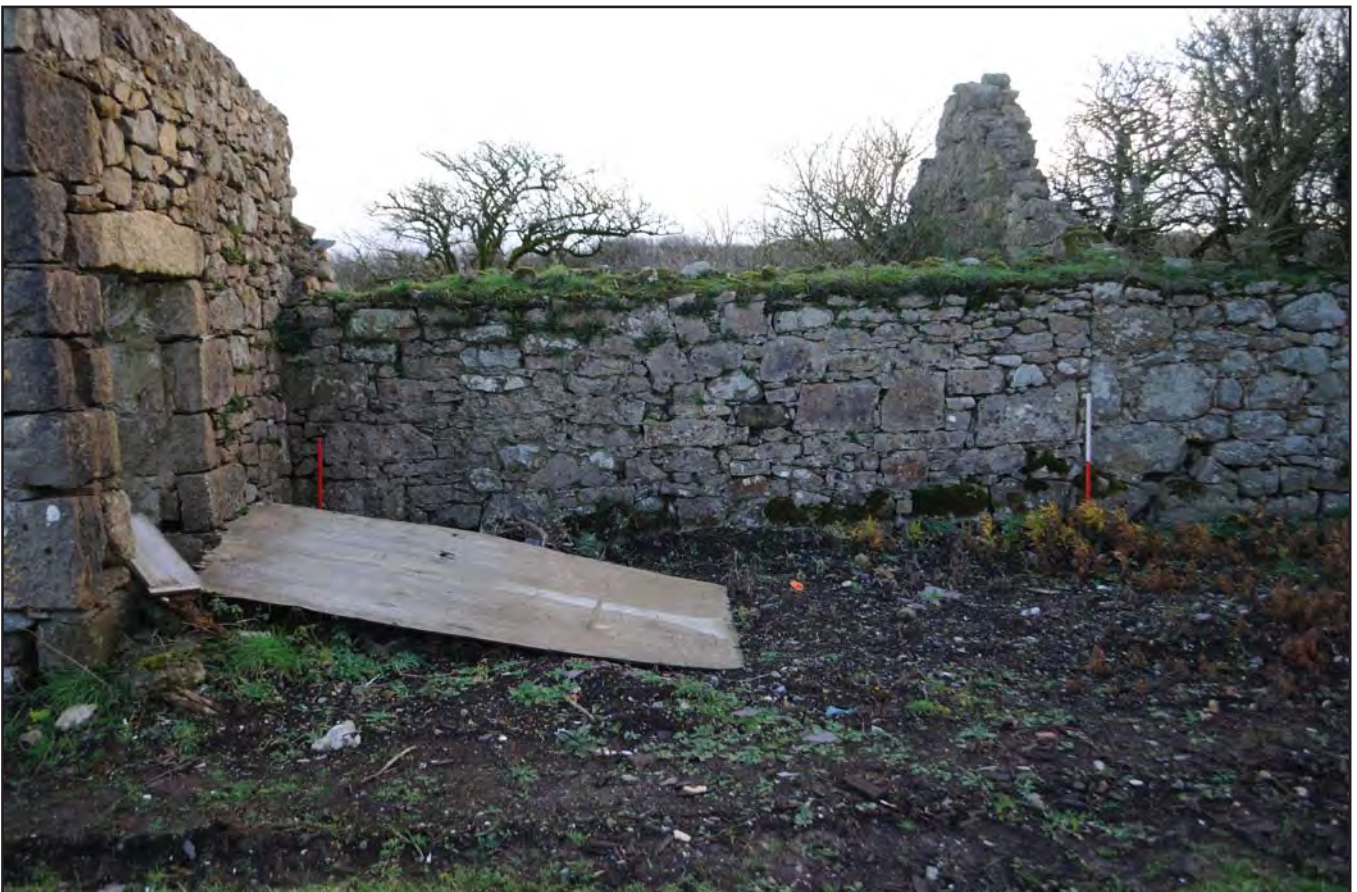
Plate 12: Rear elevation Outbuilding 5 - ; scale: 2x1m (archive reference: G2585_067).

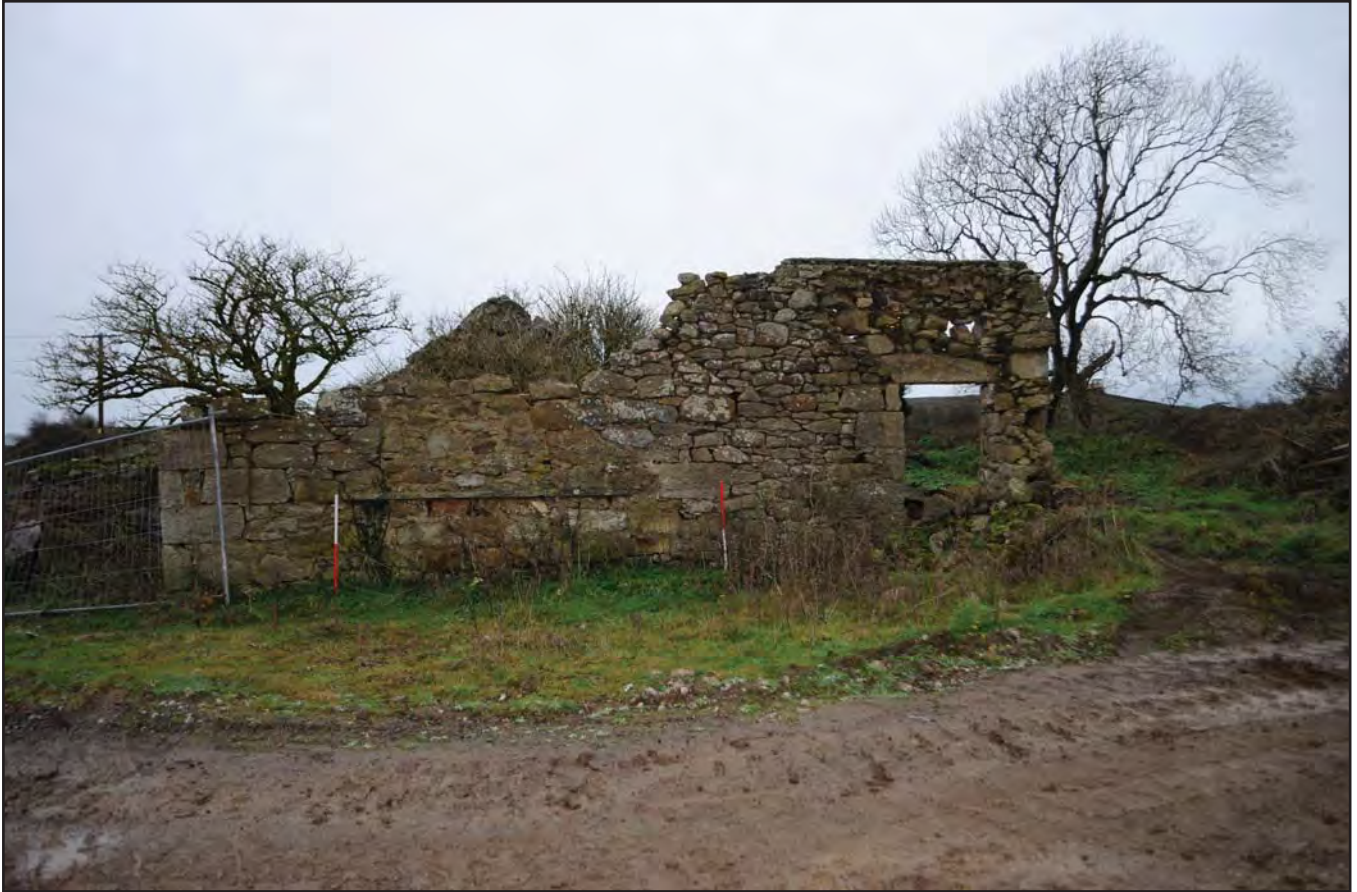
Plate 13: NE elevation of Outbuilding 5; scale: 2x1m (archive reference: G2585_047).

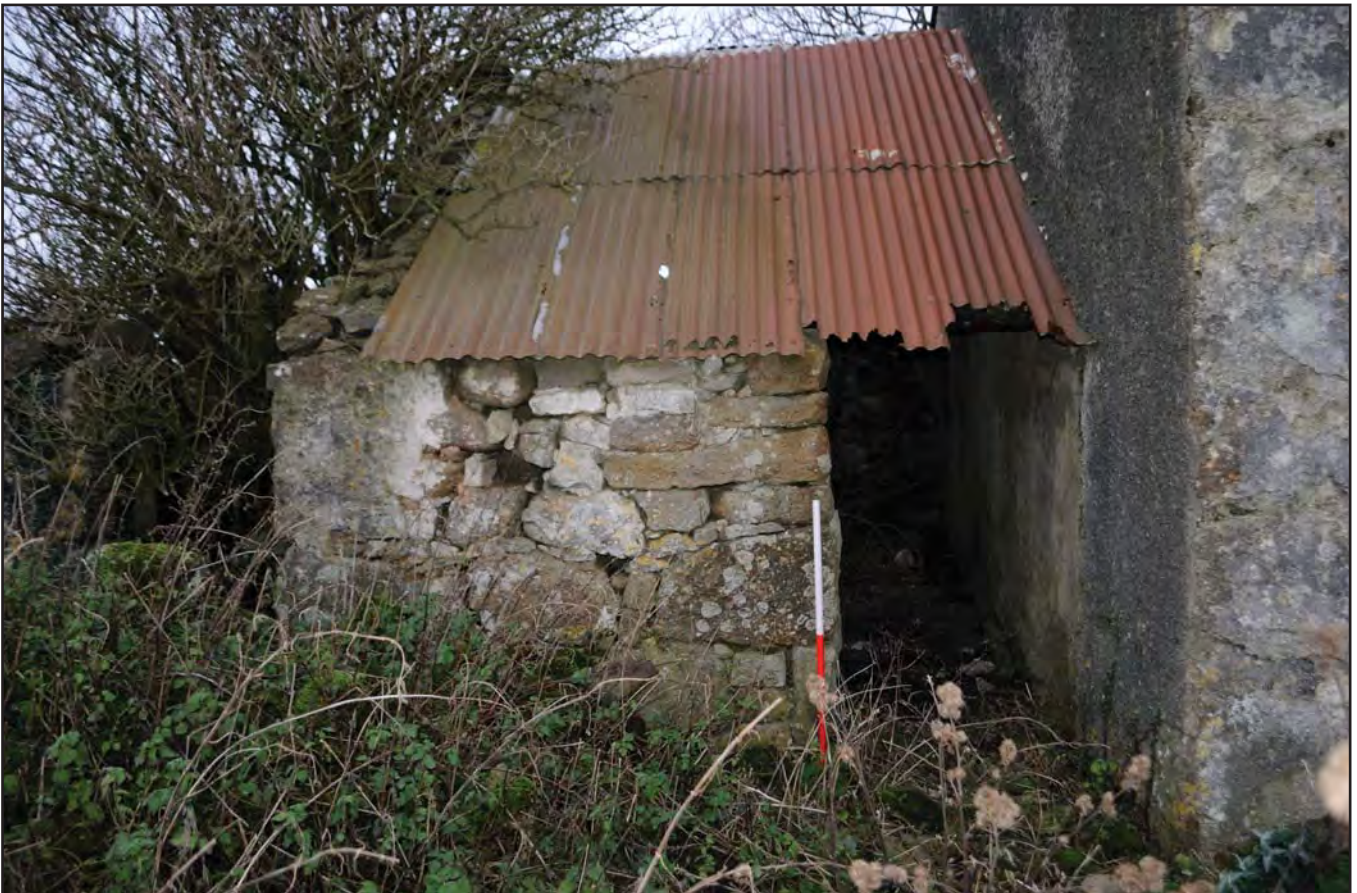
Abutting the main farmhouse is a small outbuilding with a tin roof 5m x 3m (Plate 14). It is constructed from the same irregular limestone blocks as elsewhere. The rear of this building is inaccessible due to the boundary bank at the rear (Plate 15).

Plate 14: Front elevation Outbuilding 6; scale: 1x1m (archive reference: G2585_034).

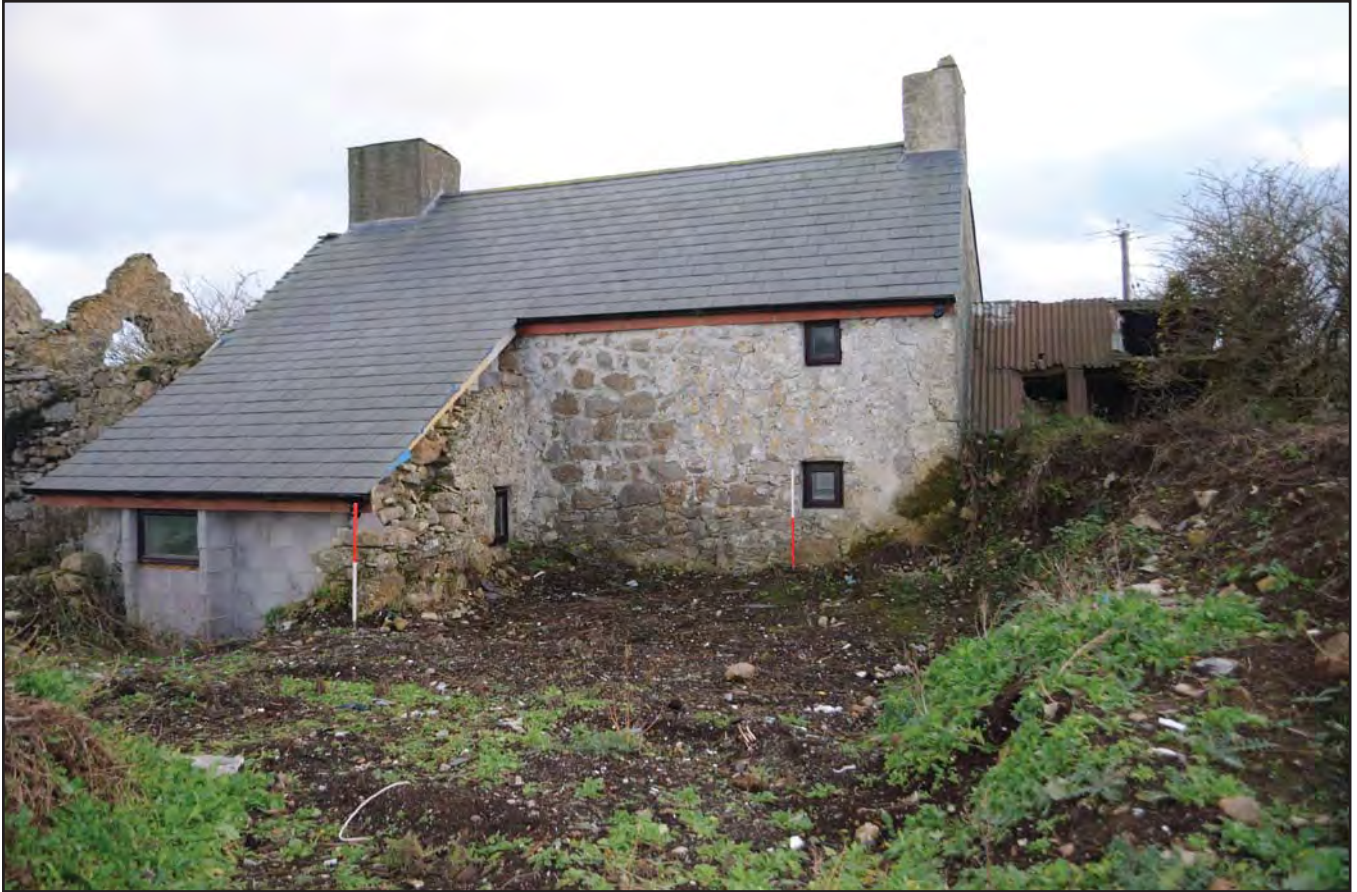
Plate 15: Rear of farmhouse and Outbuilding 6; scale: 2x1m (archive reference: G2585_077).
