Rhuddlan Bâch Quarry, YNYS MÔN

Archaeological Mitigation

Prosiect Rhif / Project No. G2585

Adroddiad Rhif / Report No. 1455

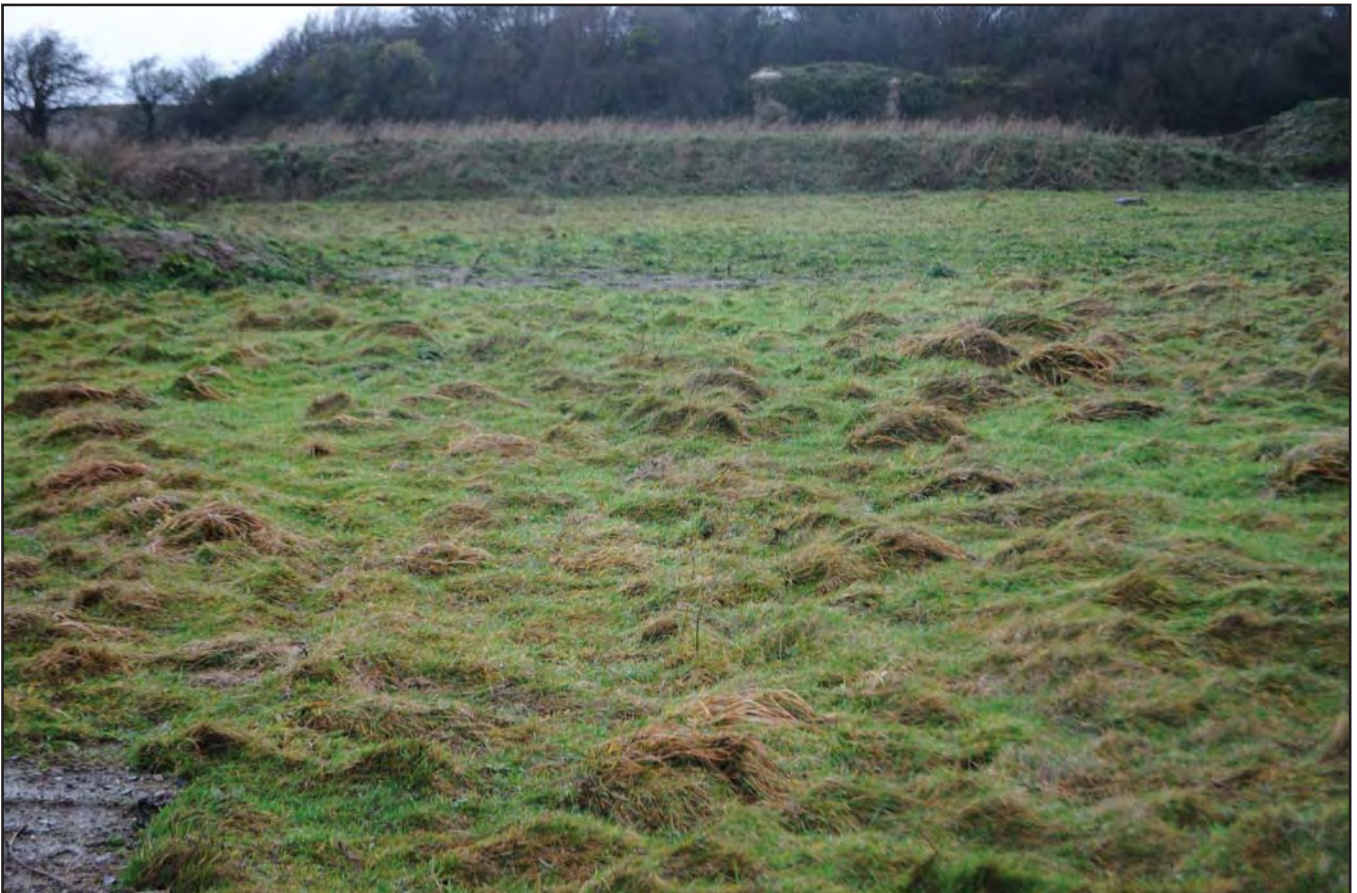
Plate 16: Topsoil storage in extension area; scale: none (archive reference: G2585_002).

The controlled strip began on the 3rd December 2018 and finished on the 18th January 2019 and consisted of 18 days on site. The field to be stripped had during the lifetime of the quarry been used for access, topsoil storage (Plate 16) and the disposal of waste water (Williams, D.W., Per Coms). Areas of the land had therefore been stripped and stoned in the past to create access for plant (Figure 07).

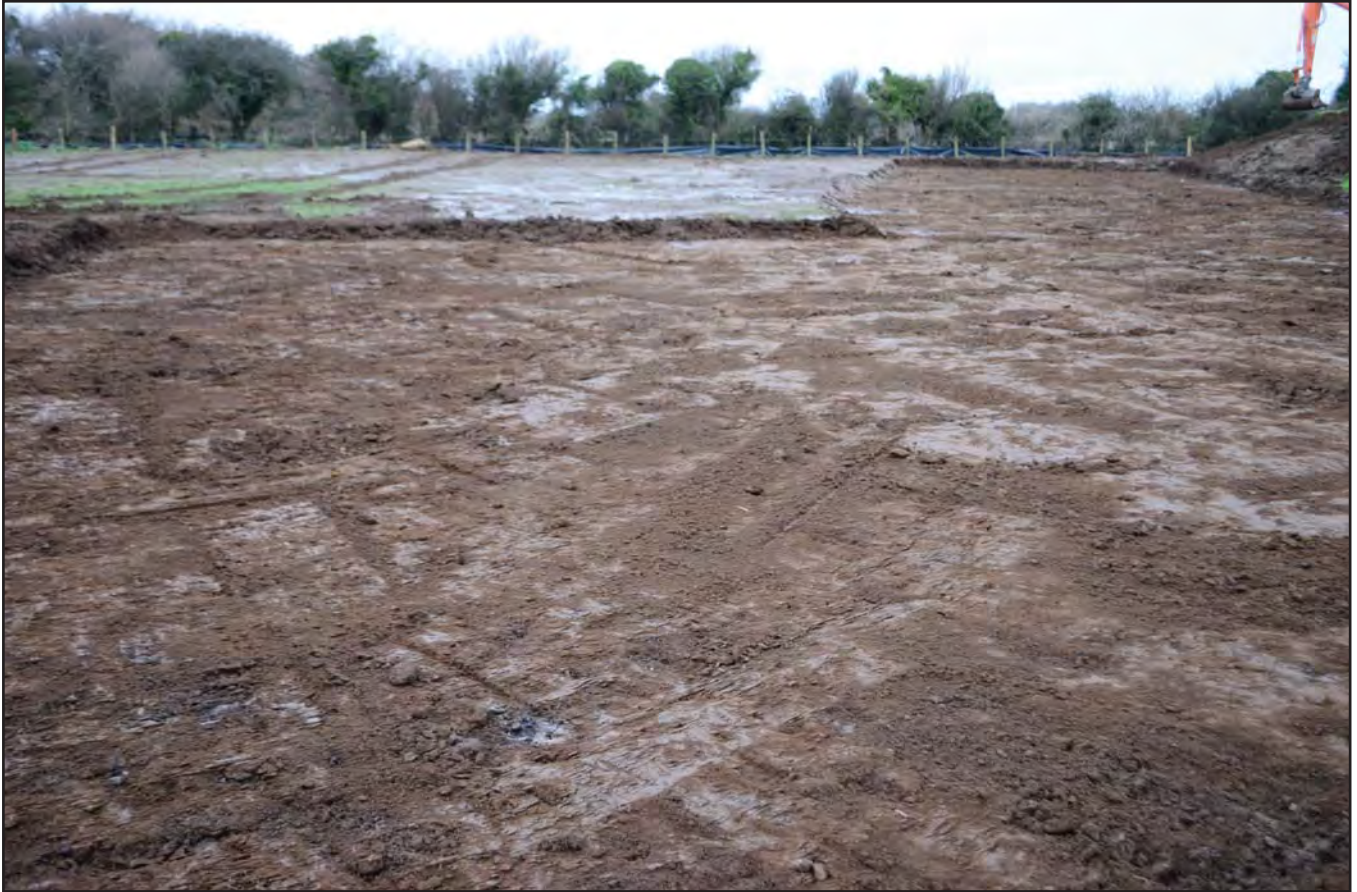
Plate 17: Area after topsoil strip; scale: none (archive reference: G2585_031).

Topsoil across the site consisted of a dark brown sandy silt that varied in depth from 0.1m closer to the edges of the field, and 0.3m in the central areas. Subsoil was a mid brown orange clayey silt and, like the topsoil, varied in depth from 0.1m to 0.35m (Plate 17). The glacial natural was orange sandy clay (orangey yellow towards the edges of the field, Figure 07) which varied in depth from 0.3m to 0.7m (Plate 18) and gave way to black limestone bedrock (Plate 019).

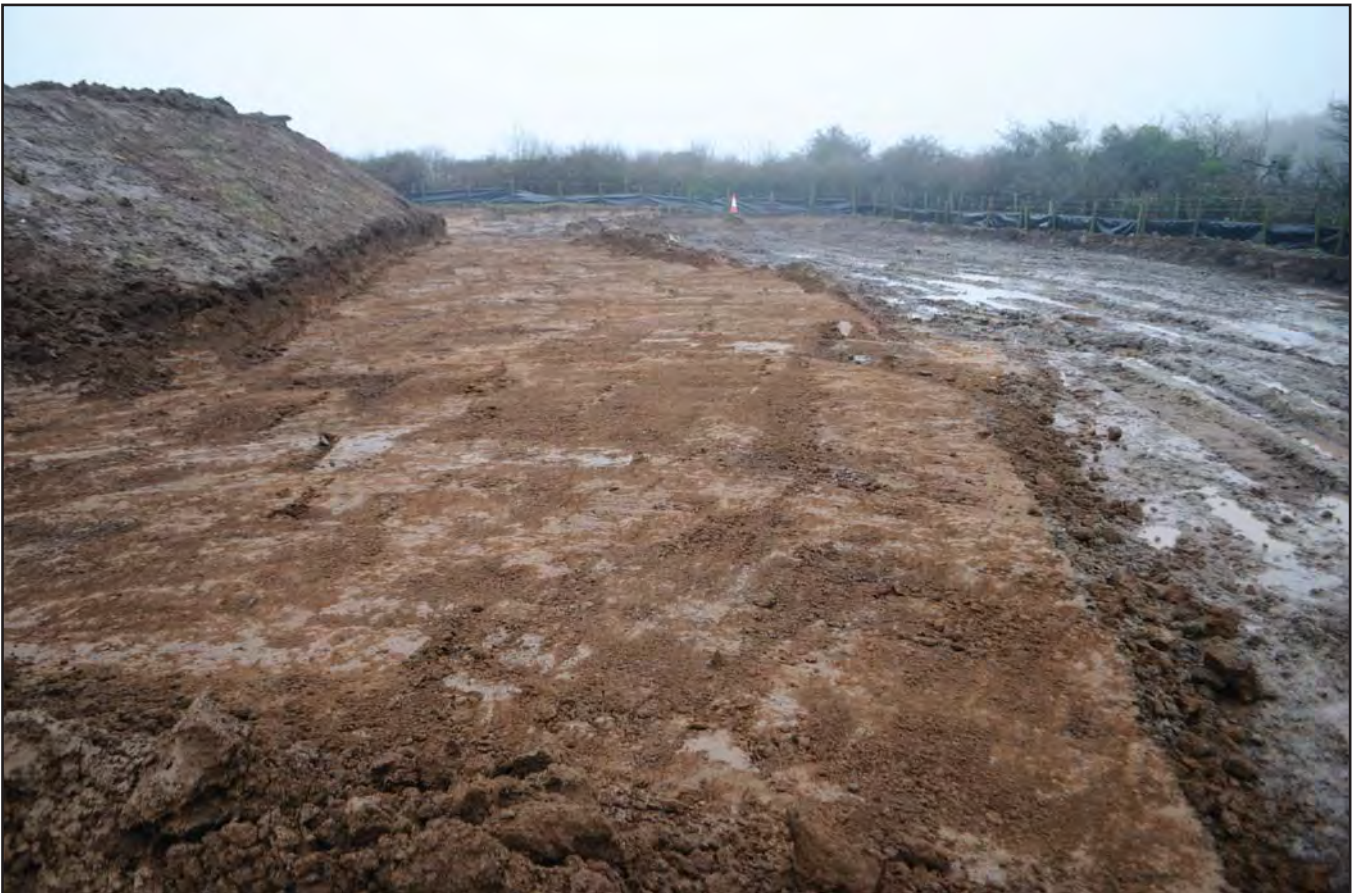
Plate 18: Orange sandy clay natural; scale: none (archive reference: G2585_061).

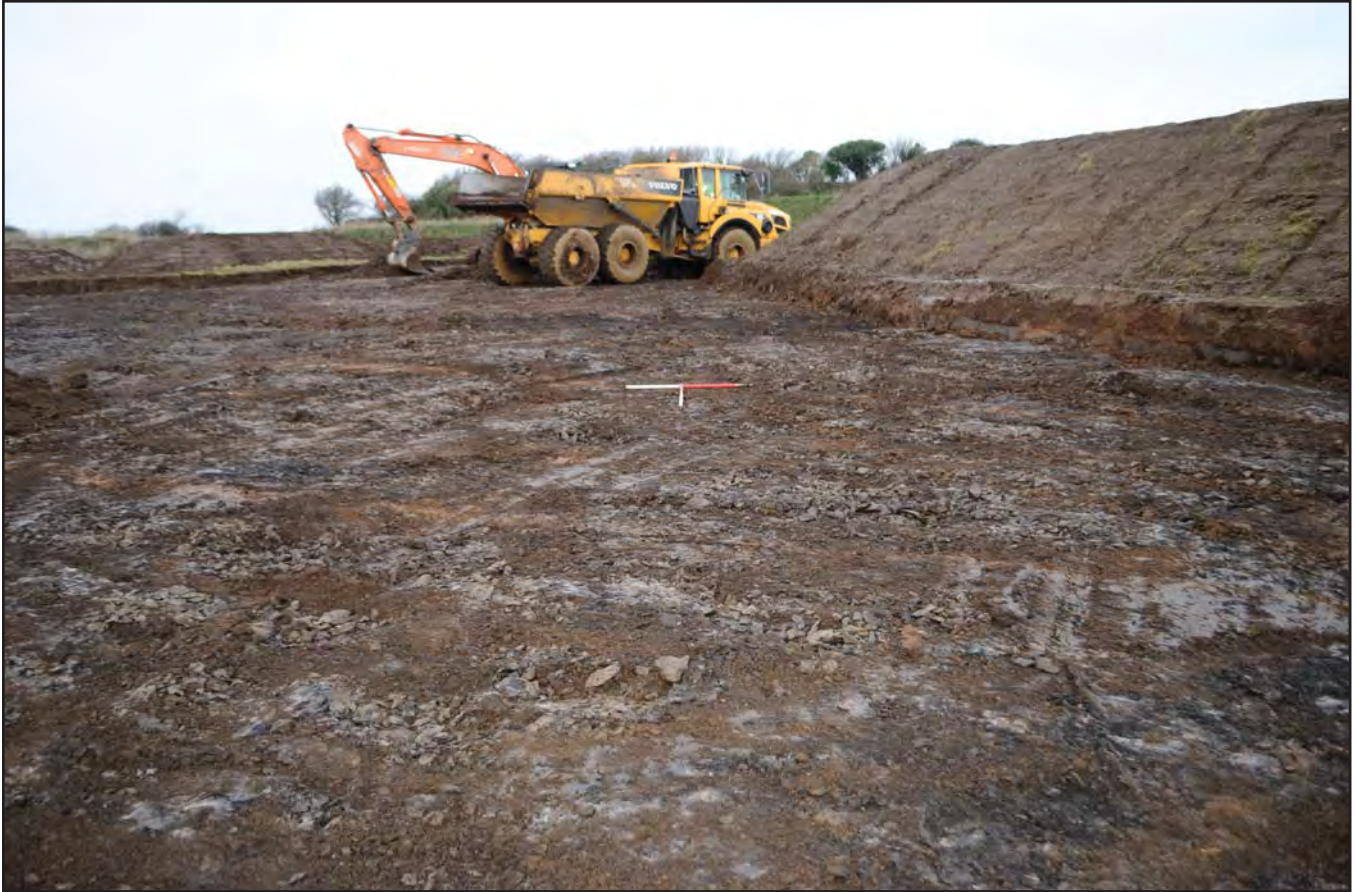
Plate 19: Black limestone bedrock; scale: 2x1m (archive reference: G2585_085).

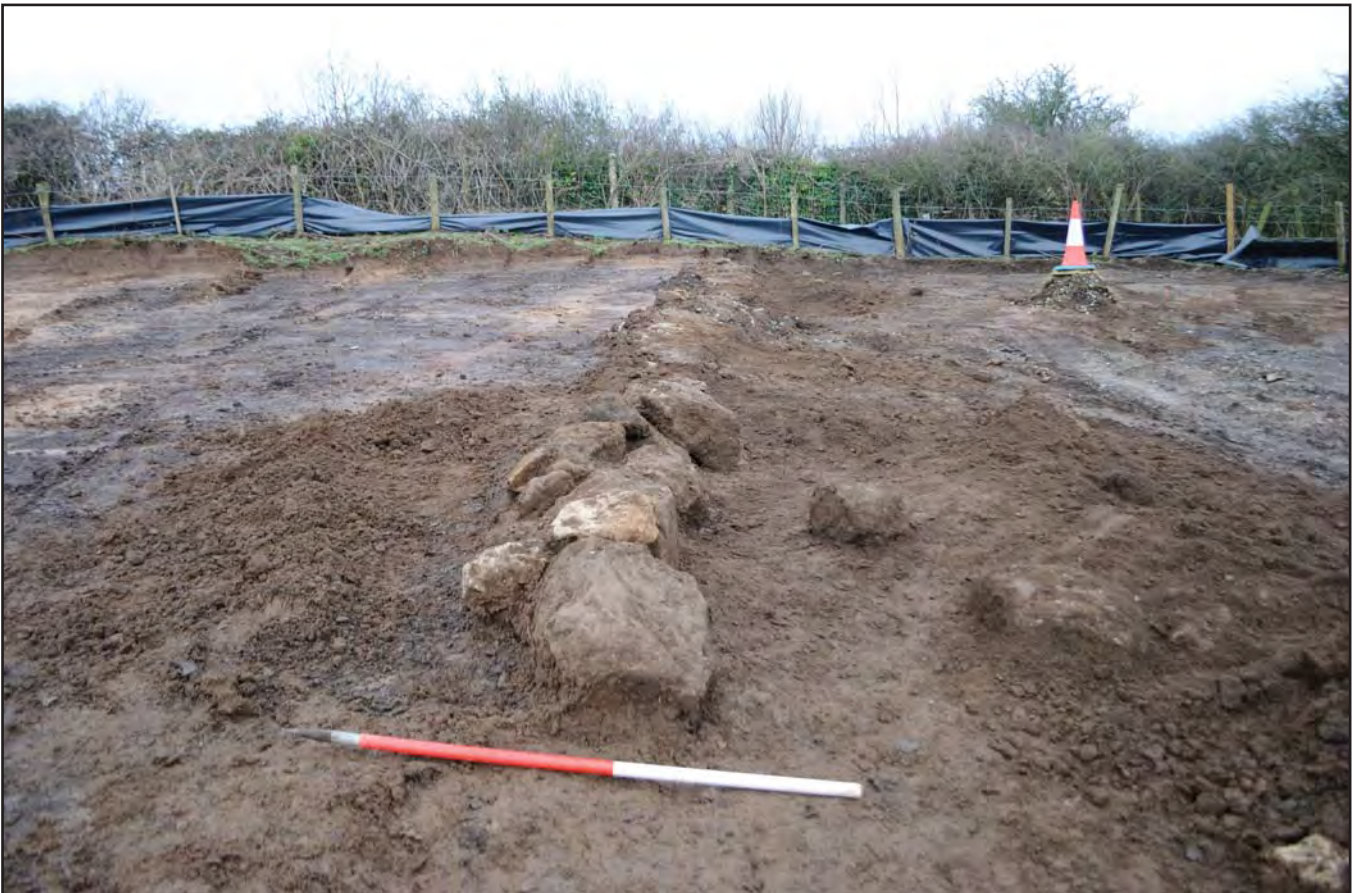
In the East corner of the field a possible rough boulder wall [004] (PRN 74974) was discovered which had probably been disturbed in the past by the stripping of material from that area of the field to create access. Thirty-seven metres of the wall survives but with some gaps that could have been caused by the previous machining in this area and it has probably been truncated by this at the WSW end (Plate 20 & 21). The wall curves slightly and it runs in a ENE-WSW direction towards the farmstead. At the ENE end the wall seems to run into and possibly joins with the existing boundary wall (Figure 08). The wall itself has been constructed using earth and stone with big stones placed as pad-stones at the bottom and built up with earth and smaller stones (Plate 22). The maximum height the wall survives to is 0.6m. Due to the proximity of previous excavation it is impossible to say if this is the true route of the wall or if it has been disturbed by plant movements. No diagnostic material was found during the excavation of this wall and it does not appear to match any of the walls on the historic mapping.

Plate 20: ENE run of wall [004]; scale: 1x1m (archive reference: G2585_091).

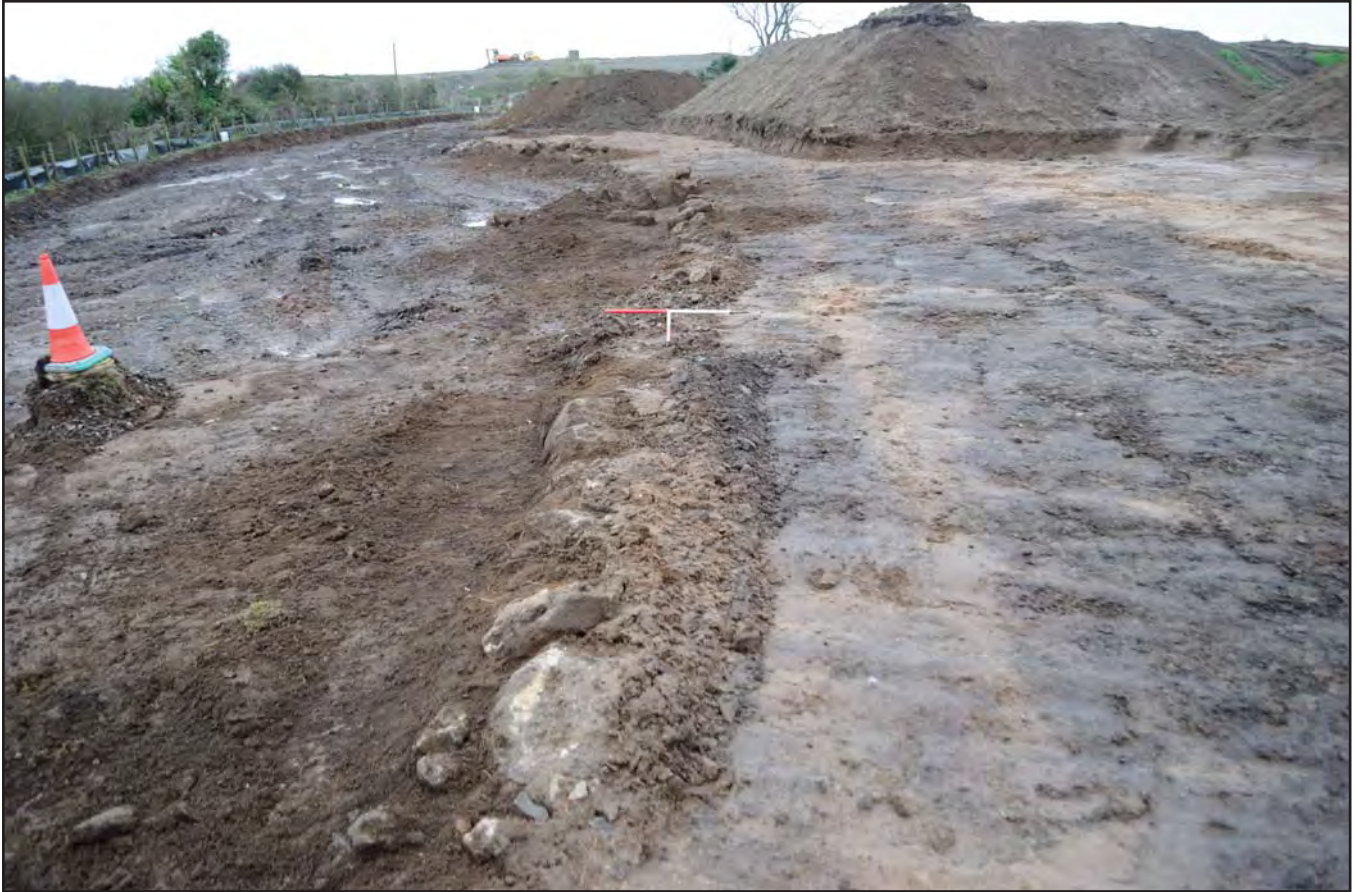
Plate 21: WSW run of wall [004]; scale: 2x1m (archive reference: G2585_093).

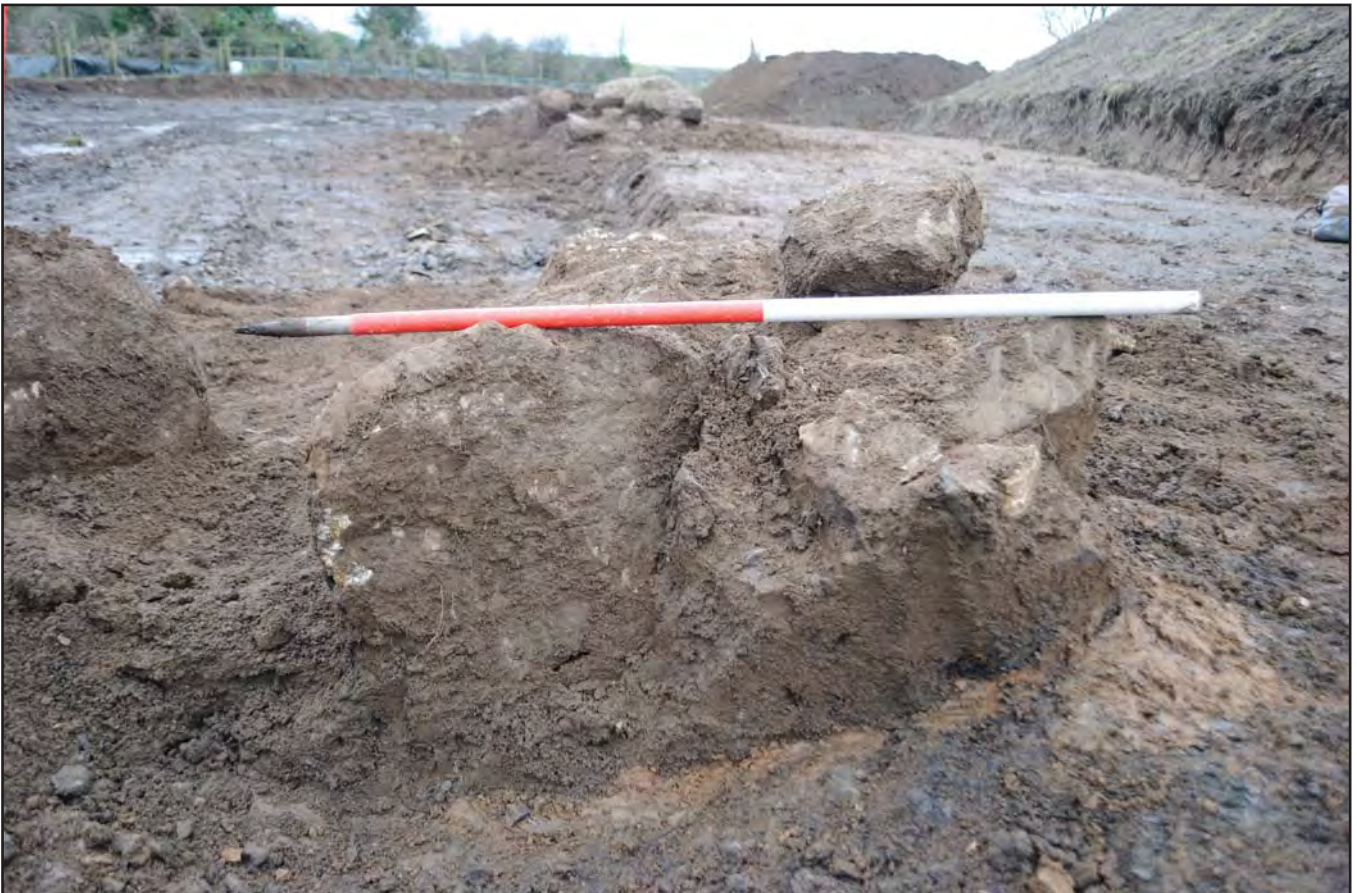
Plate 22: Section through wall [004]; scale: 1x1m (archive reference: G2585_090).

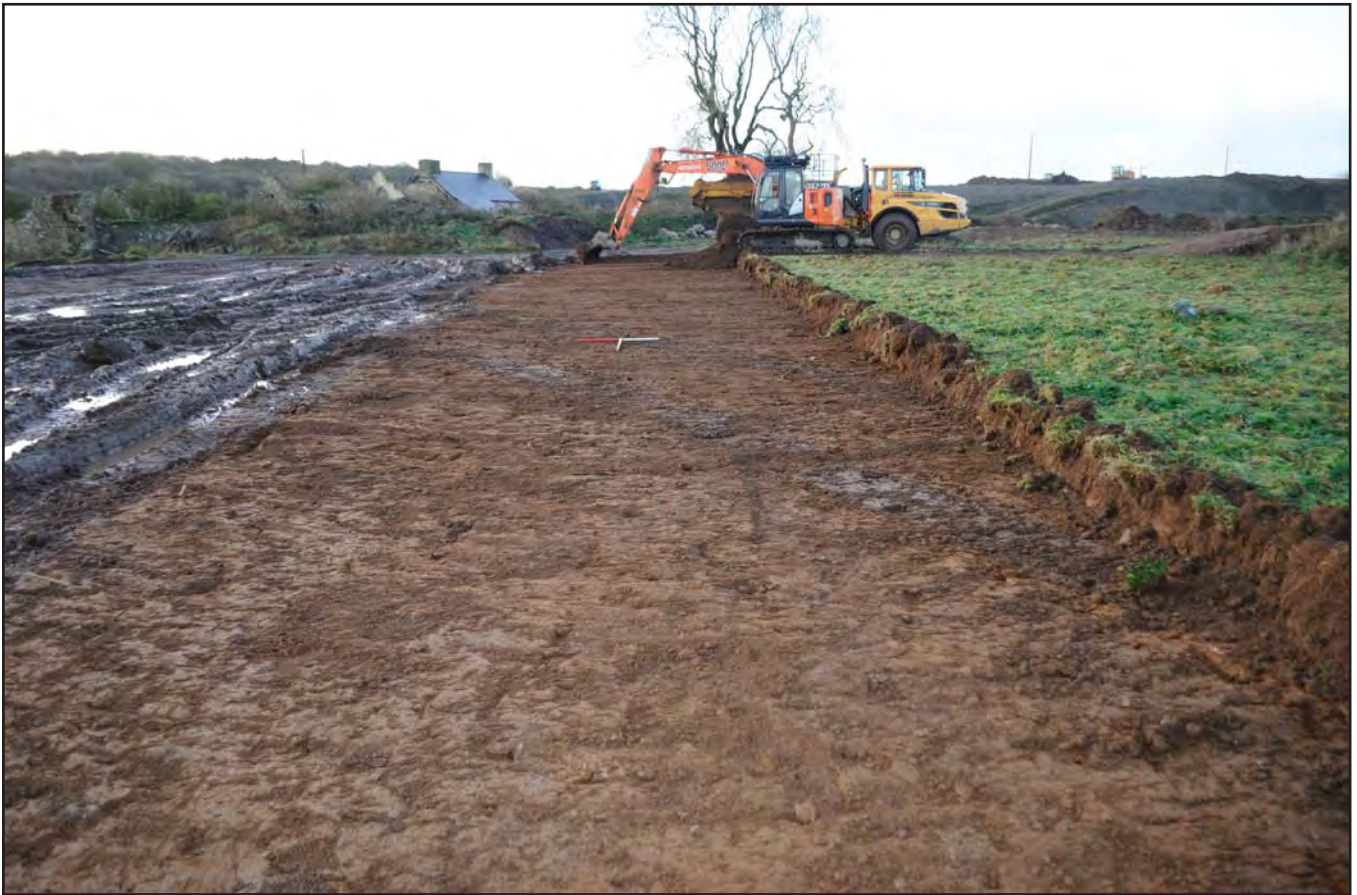
During the controlled strip evidence of previous movement of heavy machinery was evident from the ruts that scarred many areas, sometimes deep into the clay natural (Plate 23 & 24). These can be seen very clearly on the google earth image for the quarry area (Figure 09).

Plate 23: Machine ruts in subsoil; scale: 2x1m (archive reference: G2585_115).

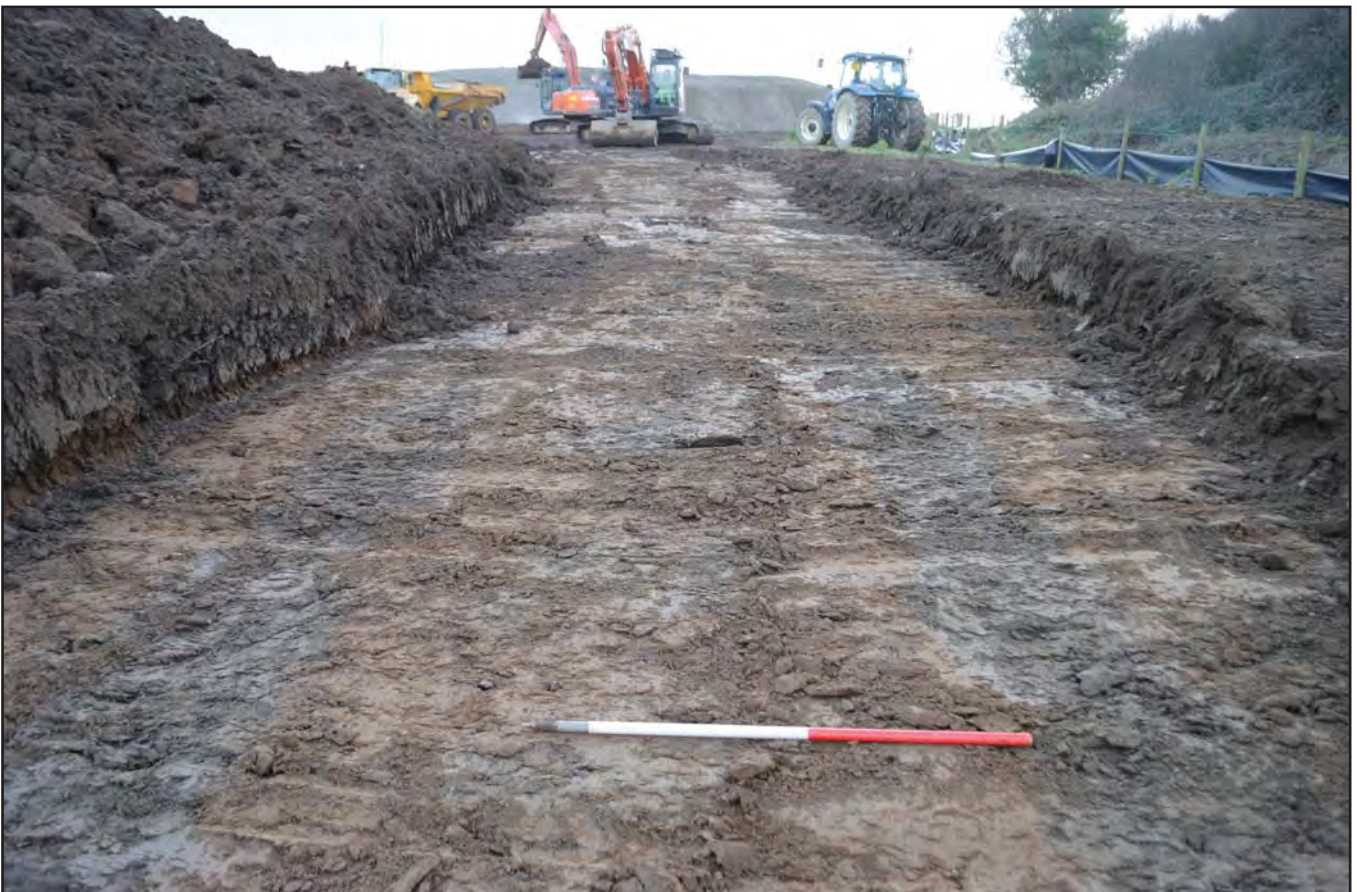
Plate 24: Machine ruts in natural; scale: 1x1m (archive reference: G2585_134).
