# Beaumaris Flood Alleviation Scheme Ynys Môn

## Archaeological Watching Brief

Prosiect Rhif / Project No. G2598

Adroddiad Rhif / Report No.1496

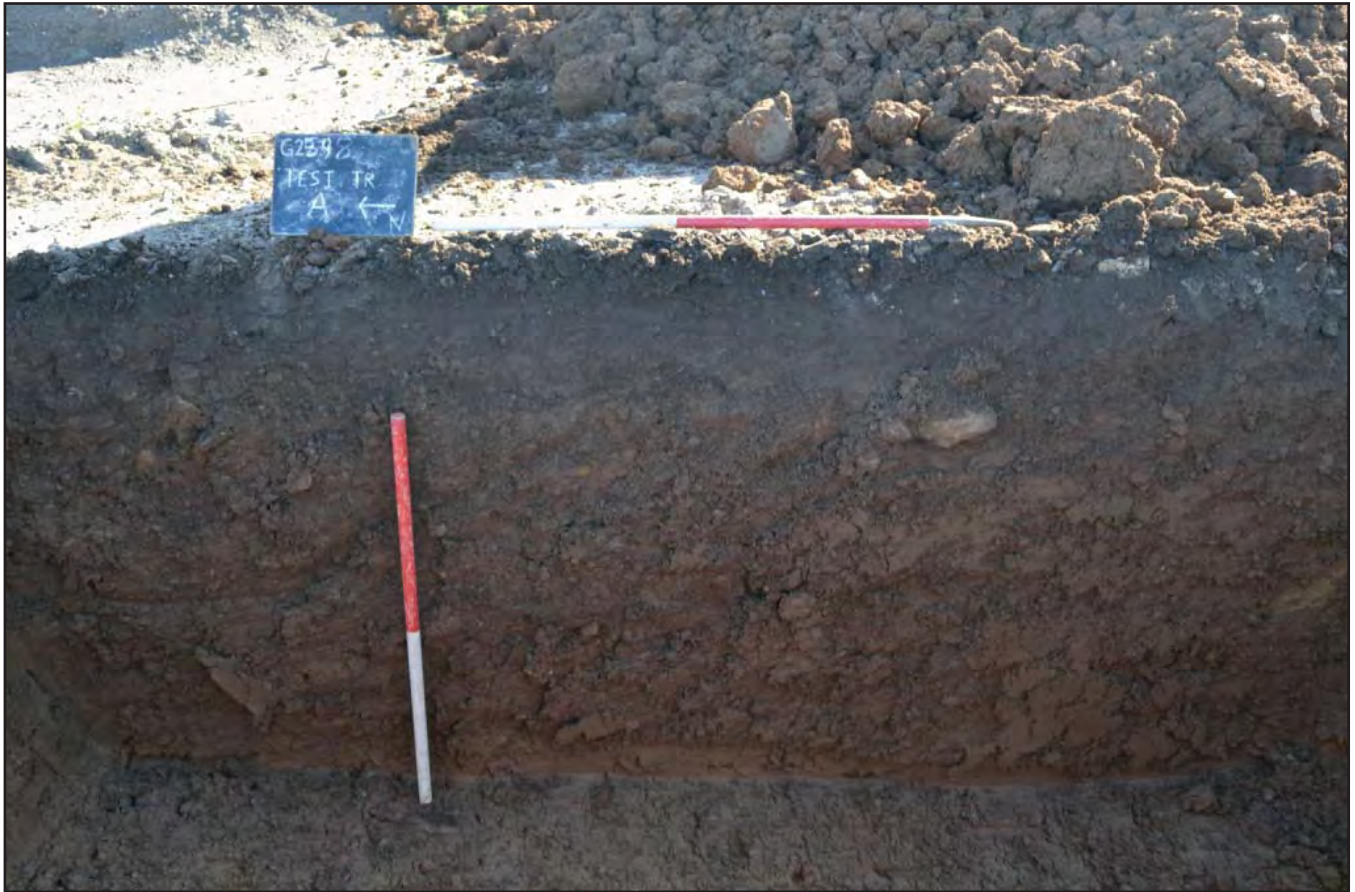
The trench measured 3.8m long x 1.5m wide x 3.0m deep and was aligned north - south (Plate 01). The topsoil (03) consisted of mid-brown slightly sandy silt with a depth of 0.25m; beneath this was the subsoil (04) which was 0.25m deep and was loose mid-brown sandy silt with charcoal flecks, gravel inclusions and some rooting. The natural (15) was fairly compact mid-brown clay with a yellow hue and infrequent sub-rounded stones. Below the level of 1.30m the ground conditions within the trench became very wet and the sides of the trench started to collapse. No archaeology was identified within the confinements of the trench.

Plate 01: Trench A - west facing section; scale: 1x1m (archive reference: G2598\_029).

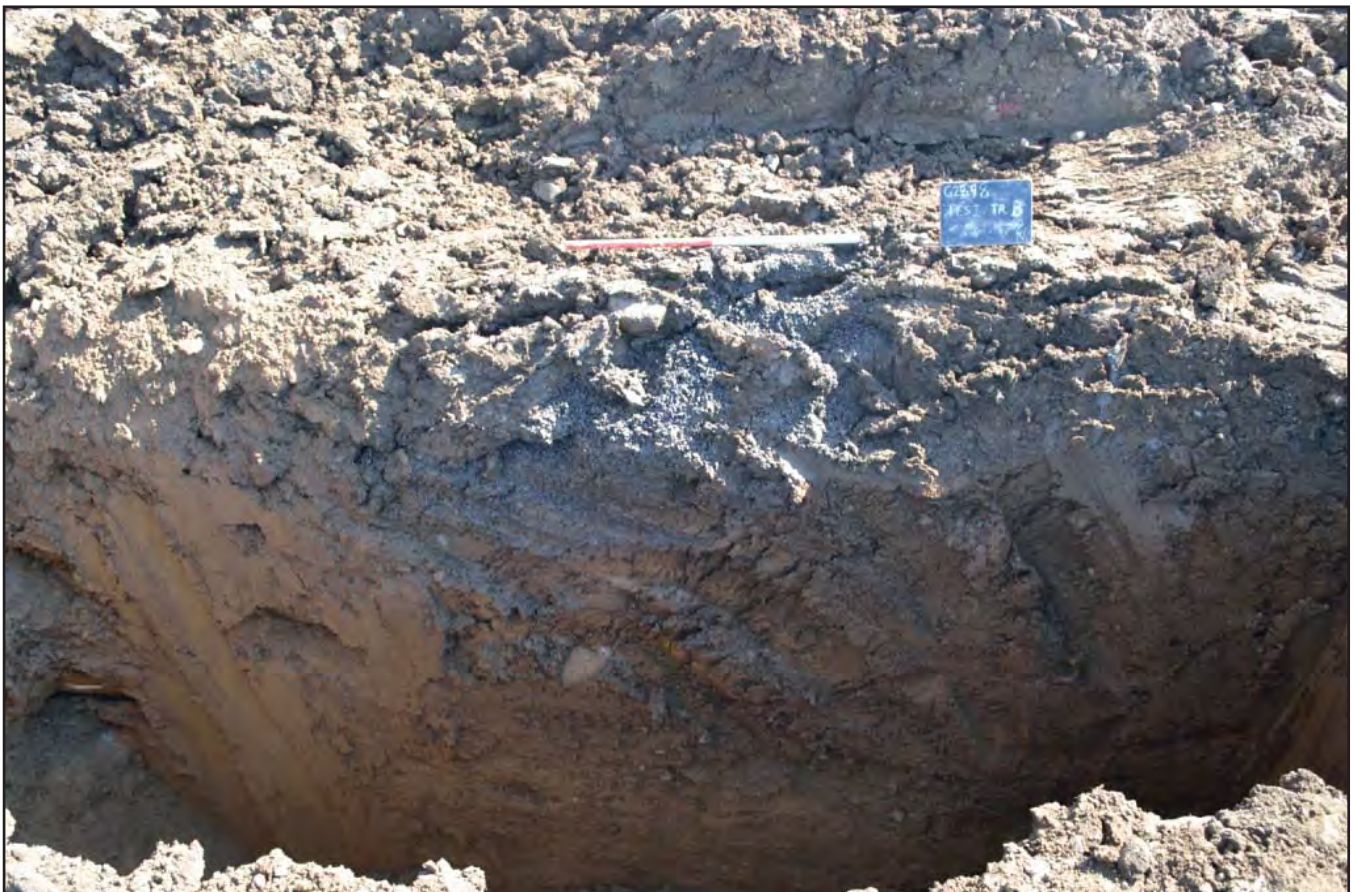
The trench measured 4.0m long x 1.5m wide x 4.5m deep and was aligned north - south (Plate 02). The topsoil (03) consisted of mid-brown slightly sandy silt with a depth of 0.20m; beneath this was the subsoil (04) which was 0.20m deep and was loose mid-brown sandy silt with charcoal flecks, gravel inclusions and some rooting. The natural (15) was moderately compact mid-brown sandy clay with a yellow hue and infrequent sub-rounded stones. Again, the sides of the trench were very unstable and the bottom was very wet. No archaeology was identified within the confines of the trench.

Plate 02: Trench B- west facing section; scale: 1x1m (archive reference: G2598\_034).

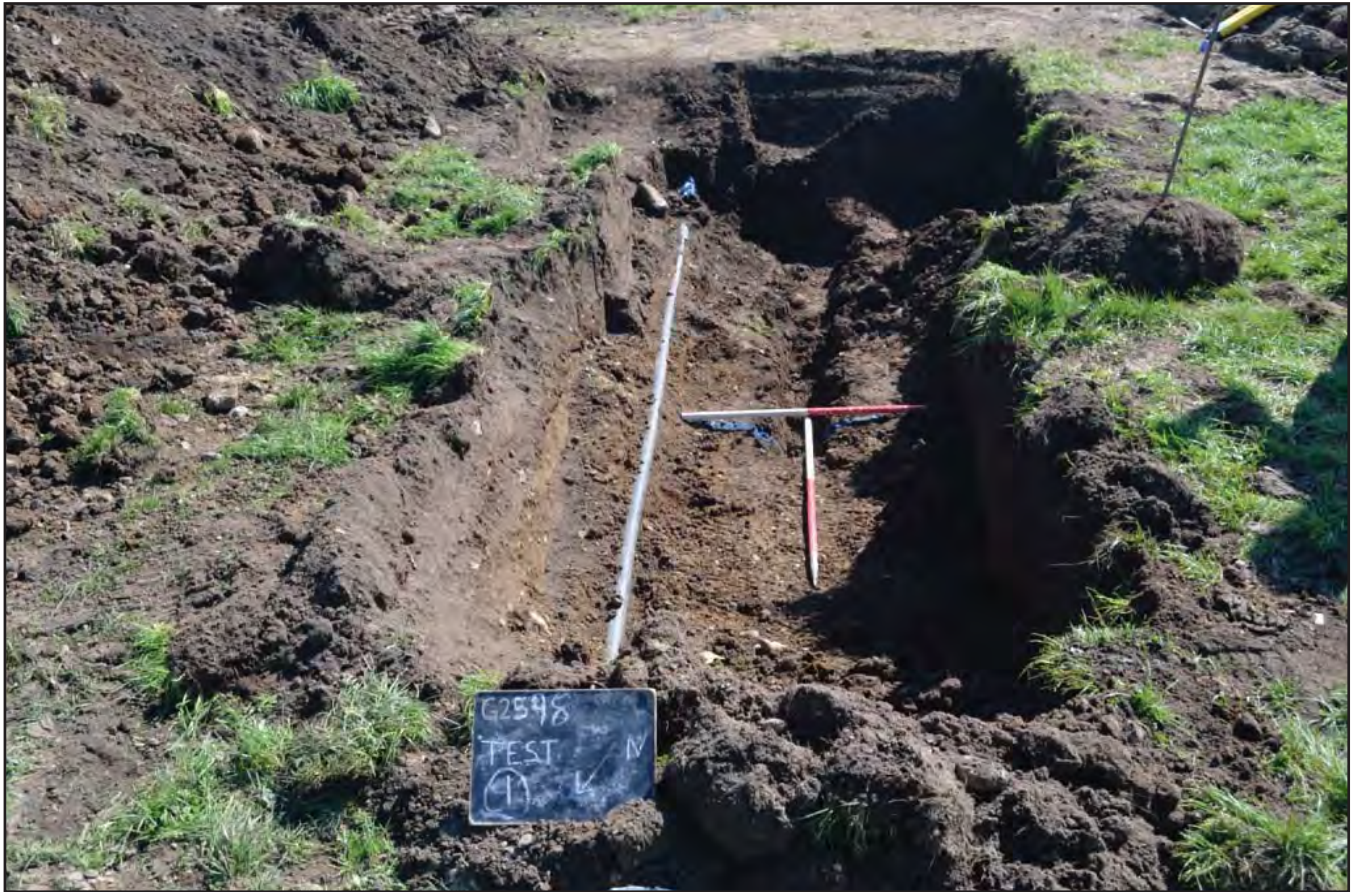
The pit measured 5.8m long x 2.7m wide x 1.5m deep and was aligned northwest - southeast (Plate 03). A live electricity cable was exposed at a depth of 0.7m. The rising main was observed at a depth of 1.1m.

The topsoil (03) consisted of mid-brown slightly sandy silt with a depth of 0.3m, below which there was a thin band (depth of 0.04m) of redeposited compact yellowy orange sandy clay (16) with gravel inclusions (15%). This sealed mid-brown silty clay (17) with some infrequent inclusions of river pebbles that had a depth of 0.13m. It in turn covered compact orange brown silty gravelly clay (18) which continued through to the depth of the trial pit. No archaeology was identified within the confines of the pit.

Plate 03: Test pit 01 with services fully exposed; scale: 2x1m (archive reference: G2598\_008).

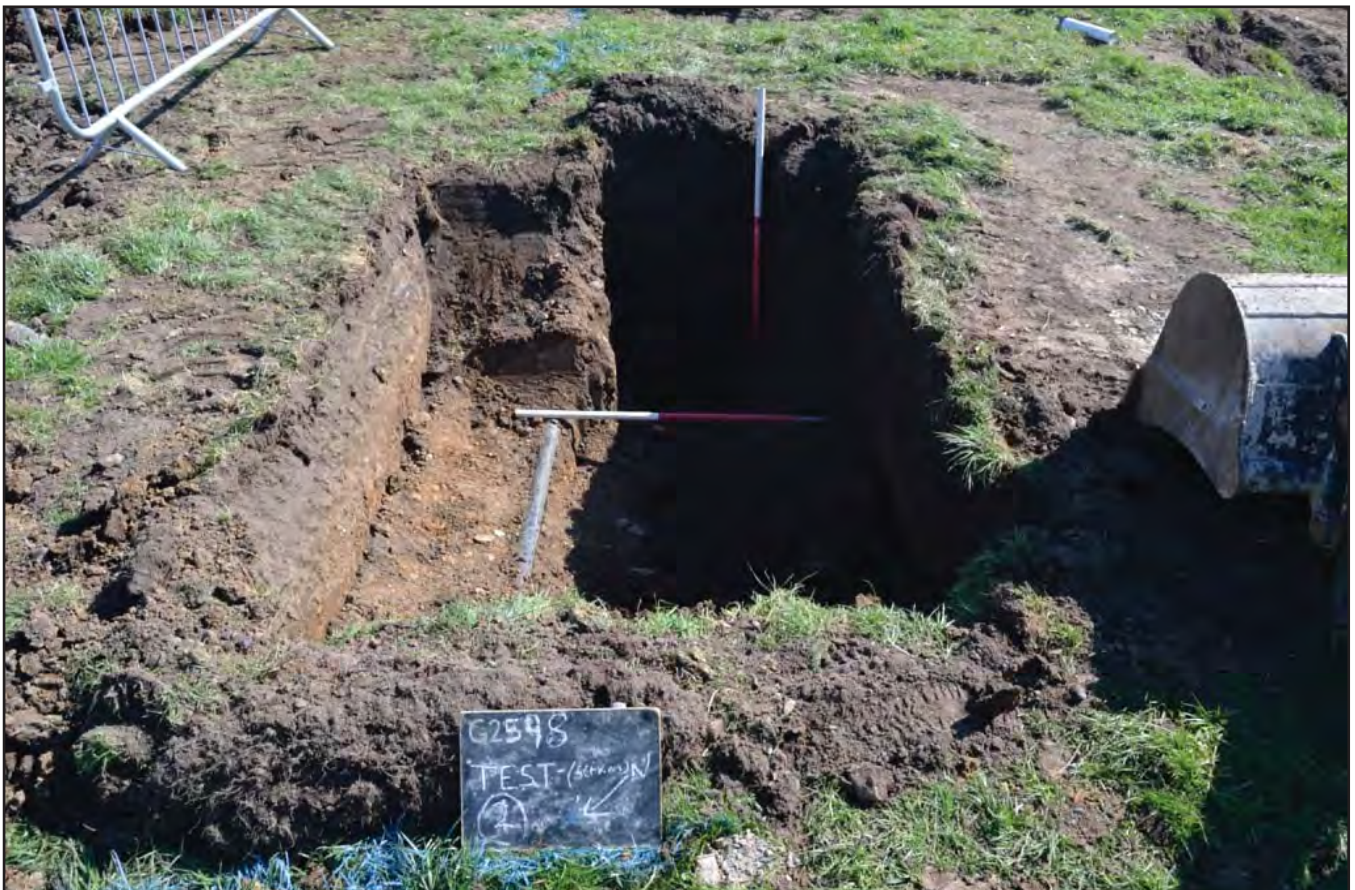
The pit measured 2.3m long x 1.6m wide x 1.1m deep and was aligned northwest – southeast (Plate 04).The live electricity cable uncovered in trial pit 01 was also exposed in the trial pit 02 at a depth of 0.7m and the water main at 1.1m.

The topsoil (03) consisted of mid-brown slightly sandy silt with a depth of 0.3m, below which there was a thin band (depth of 0.04m) of redeposited compact yellowy orange sandy clay (16) with gravel inclusions (15%). This sealed mid-brown silty clay (17) with some infrequent inclusions of river pebbles that had a depth of 0.13m. It in turn covered compact orange brown silty gravelly clay (18) which continued through to the depth of the trial pit. No archaeology was identified within the confines of the pit.

Plate 04: Test pit 02 with services fully exposed; scale: 2x1m (archive reference: G2598\_011).

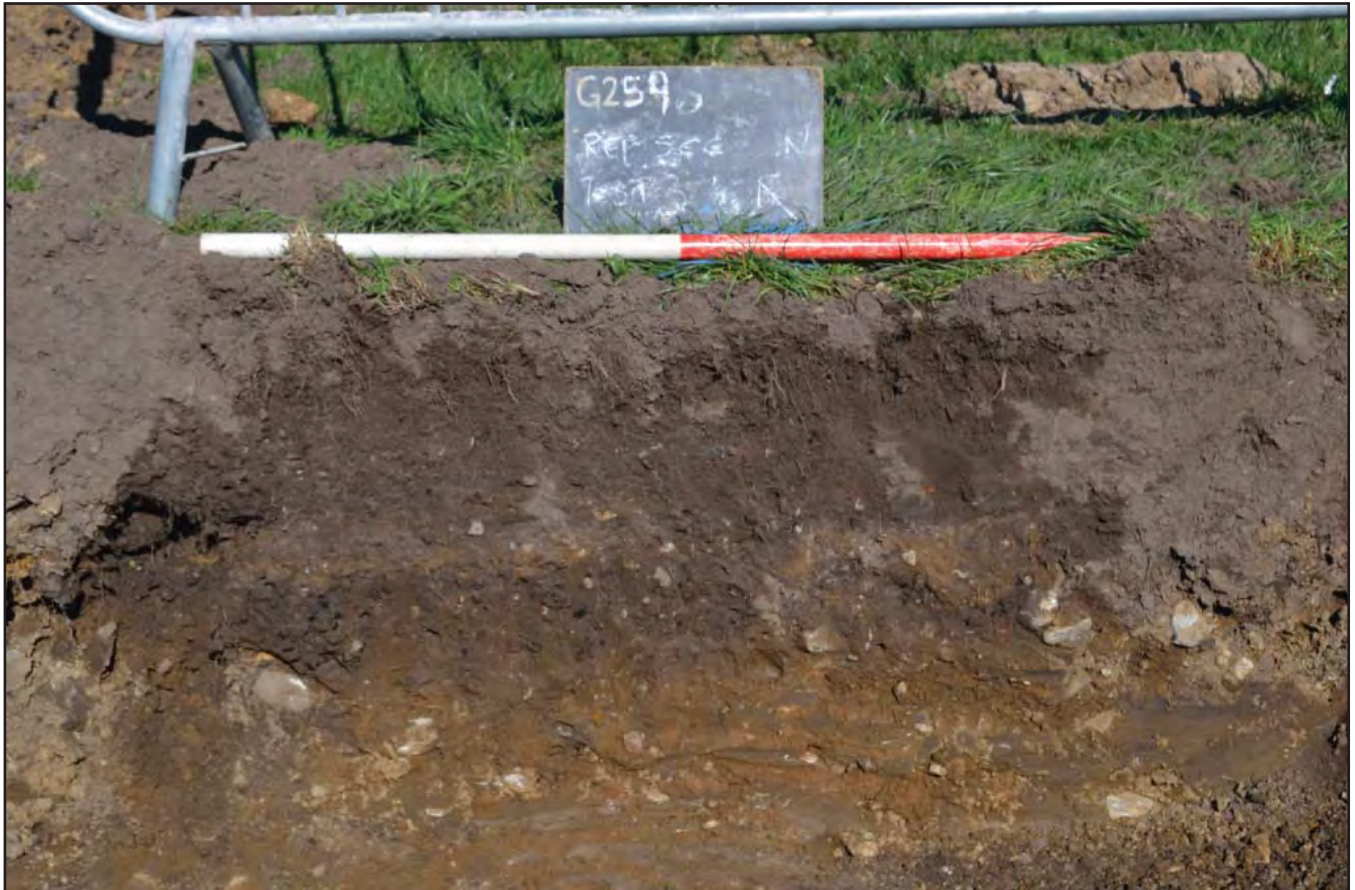
The pit measured 2.3m long x 1.6m wide x 1.1m deep and was aligned northwest – southeast (Plate 05). The live electricity cable uncovered in trial pits 01 and 02 was also exposed in the trial pit 03 at a depth of 0.7m and the water main at 1.1m.

The topsoil (03) consisted of mid-brown slightly sandy silt with a depth of 0.3m, below which there was a thin band (depth of 0.04m) of redeposited compact yellowy orange sandy clay (16) with gravel inclusions (15%). This sealed mid-brown silty clay (17) with some infrequent inclusions of river pebbles that had a depth of 0.13m. It in turn covered compact orange brown silty gravelly clay (18) which continued through to the depth of the trial pit. No archaeology was identified within the confines of the pit.

Plate 05: Test pit 03 - Southwest facing section; scale: 1x1m (archive reference: G2598\_014).

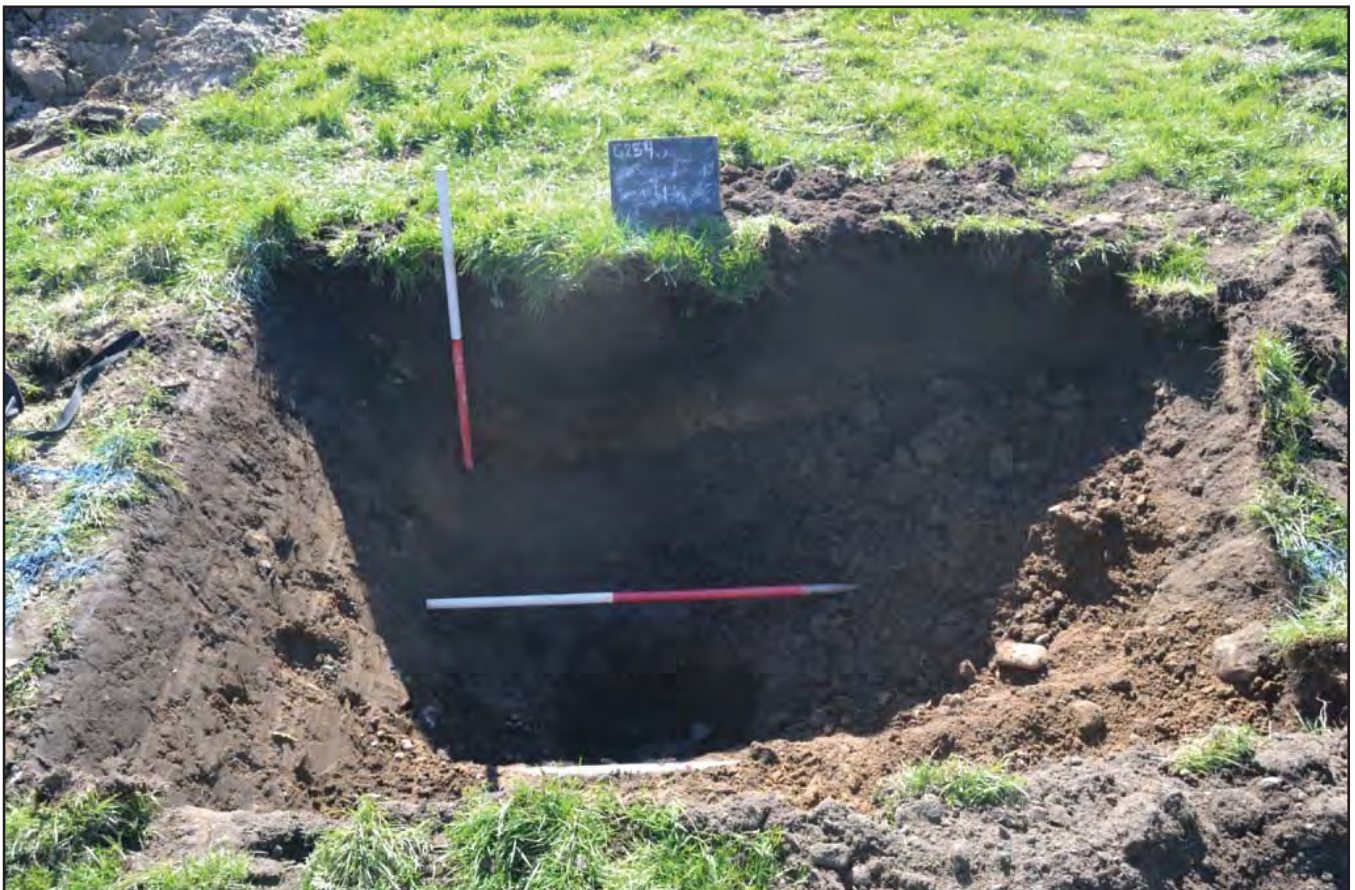
The pit measured 2.3m long x 1.6m wide x 1.1m deep and was aligned northwest – southeast (Plate 06). The live electricity cable uncovered in trial pits 01, 02 and 03 was also exposed in the trial pit 04 at a depth of 0.7m and the water main at 1.1m.

Plate 06: Test pit 04 - Southeast facing section; scale: 2x1m (archive reference G2598\_018).

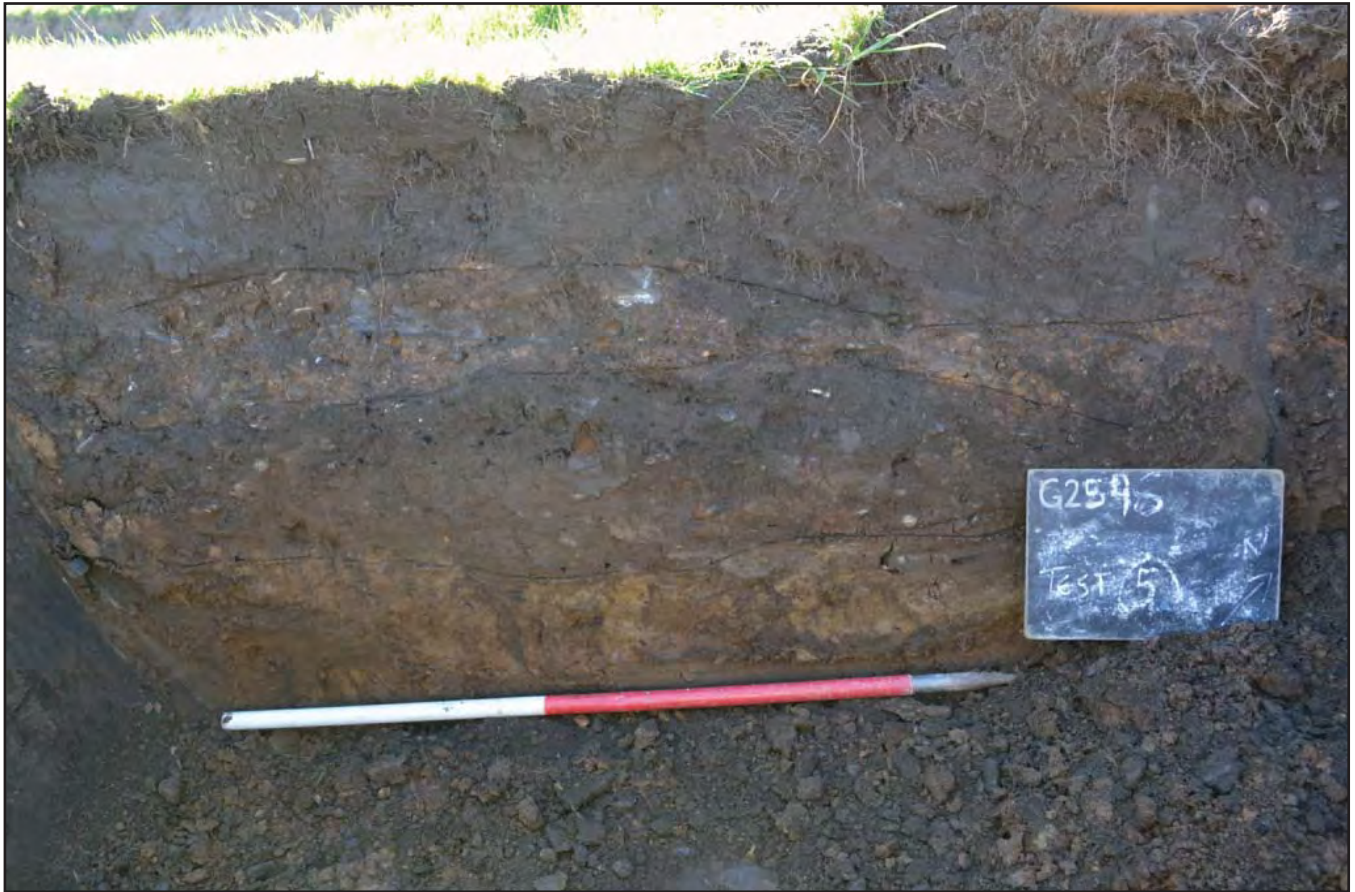
Plate 07: Test pit 05 -Southeast facing section; scale: 1x1m (archive reference: G2598\_021).

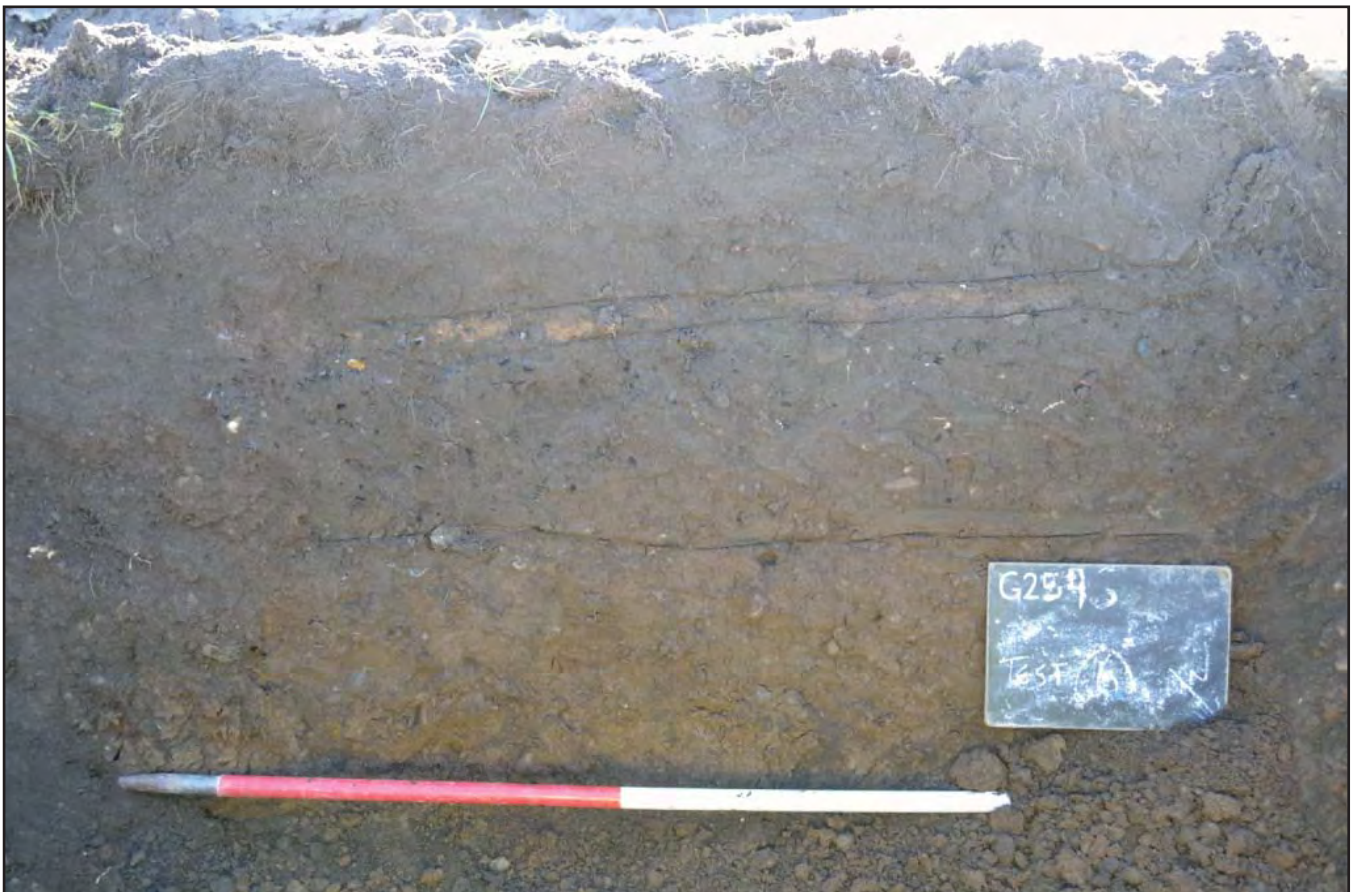
Plate 08: Test pit 06 -Southeast facing section; scale: 1x1m (archive reference: G2598\_25).

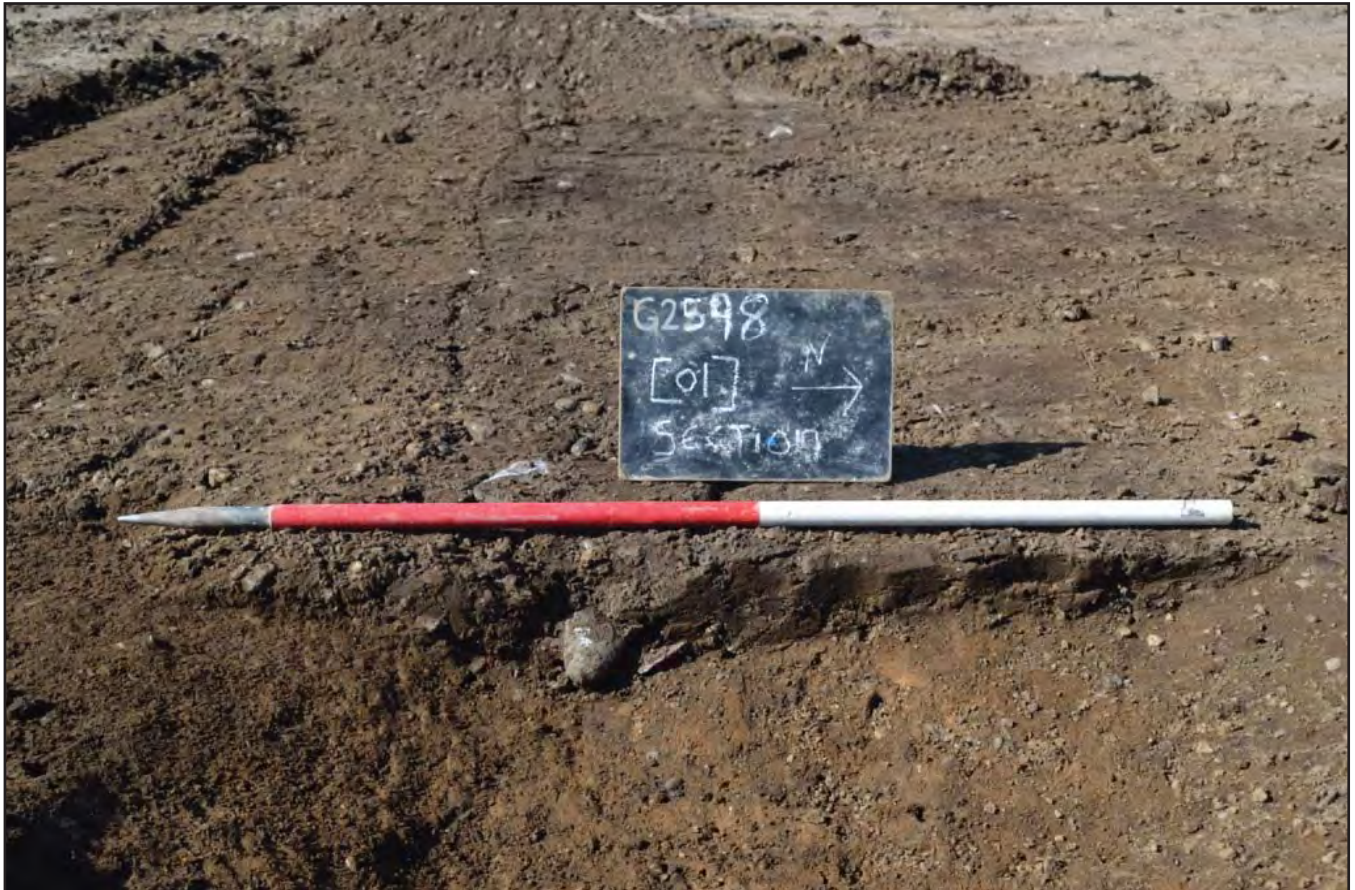
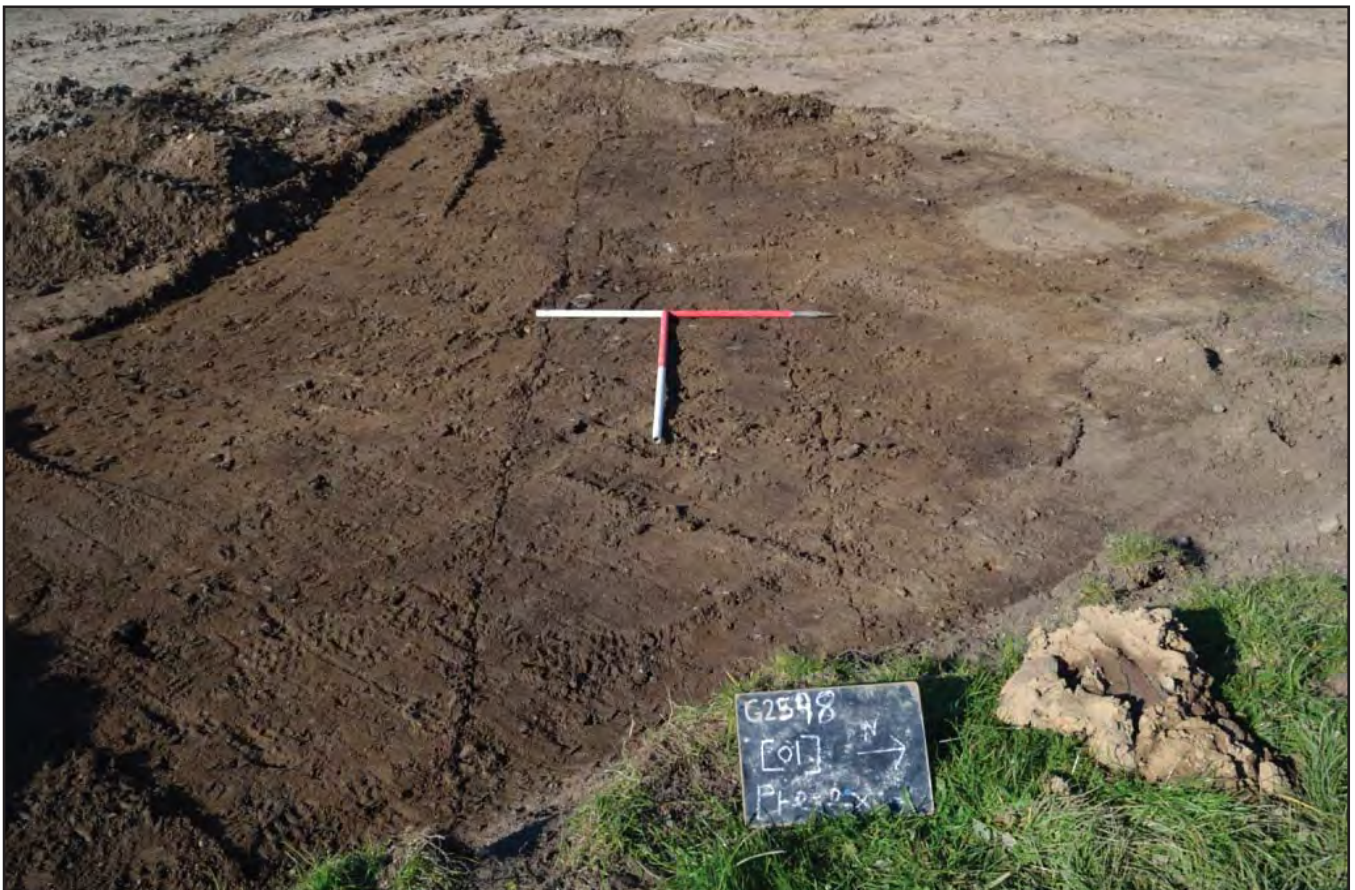
During the watching brief of the trial pits, a linear feature [01] (Plates 09 and 10) was identified within the pipe easement, extending west from the topsoil baulk which covered the DCWW rising main. The linear was aligned east – west with an exposed length of 5.0m, width of 0.97m and maximum depth of 0.11m. It had a gradual break of slope at the top with slightly concave sides, a gradual break of slope at the base which was also concave. The linear was filled by (02) loose mid-brown sandy silt with infrequent sub-angular stones which produced a sherd of Buckley ware and a clay pipe stem which suggests a post medieval date. The feature was initially interpreted as the remnants of a field boundary but such a feature does not appear on the historic Ordnance Survey maps (Figures 02 - 04). Given the 19<sup>th</sup>/20<sup>th</sup> century date of the artefacts recovered from the fill and near identical features ([05-13]) being uncovered during the topsoil strip of an additional stretch of this field (see section 4.3 below) it is more likely that [01] was a drain or plough furrow and this is why it is not denoted on 19<sup>th</sup>/20<sup>th</sup> century plans of the area.

Plate 09 : East facing section through ditch [01]; scale: 1x1m (archive reference: G2598\_005).

Plate 10: Ditch [01]; scale: 2x1m (archive reference: G2598\_004).

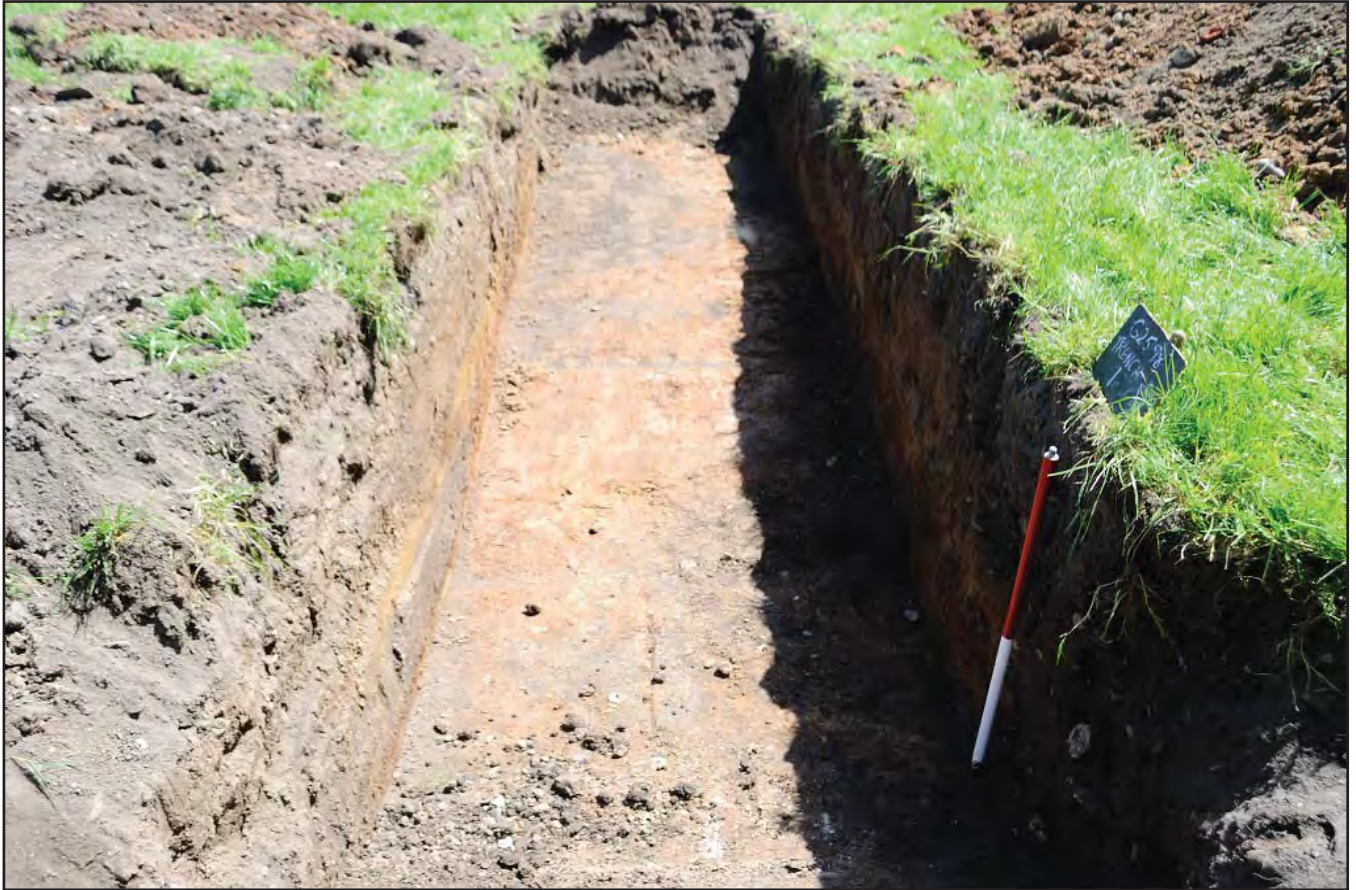
Trial pit 1 was excavated approximately 1.0m east from the estate boundary wall and 7.0m south west of the post and wire fence which delineated the compound area. The trench measured 6.0m long x 1.5m wide x 1.2m at the deepest point and was aligned northwest – southeast (Plate 11). The topsoil (03) was dark brown slightly sandy silt with occasional sub-angular cobbles and had a depth of 0.16m. Beneath this was what appeared to be a mix of topsoil and midden material (20) with inclusions of pottery sherds (Buckley), clay pipe stems, broken glass, broken bricks, a few animal bones, frequent oyster shells and some cockle shells. This deposit measured approximately 0.7m deep at the northwest end of the trench and became shallower towards the middle of the trench. The subsoil (04) was grey brown

Plate 11: Trench 01 - view from the northwest; scale: 1x1m (archive reference: G2598\_048).

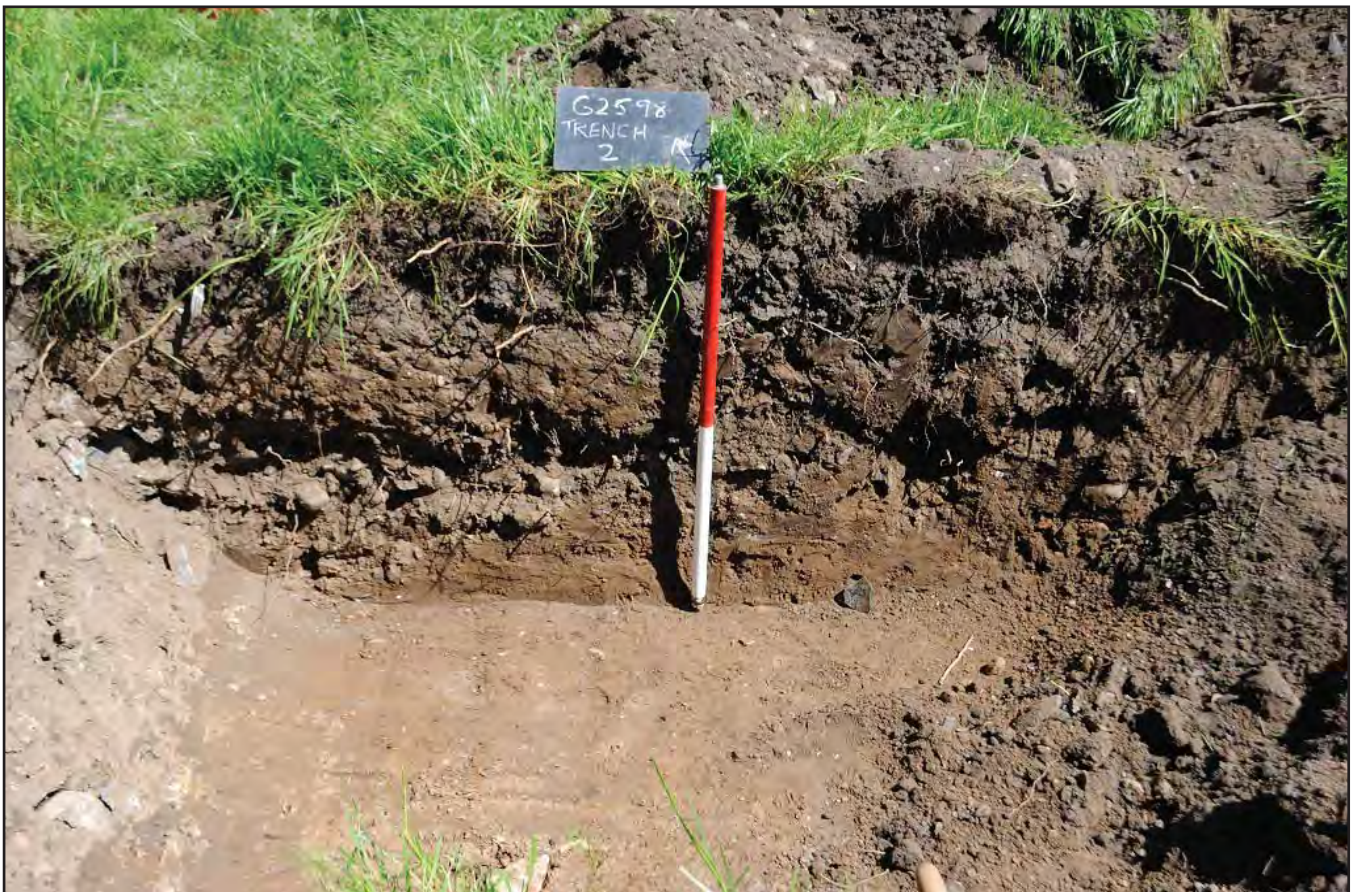
Trial pit 2 was located 6.0m to the south west of trial pit 1 and 1.0m from the estate boundary wall and measured 2.5m long x 1.5m wide x 0.9m deep. It was aligned northwest – southeast (Plate 12). The topsoil (03) was dark brown slightly sandy silt with occasional sub-angular cobbles and had a depth of 0.16m. Beneath this was what appeared to be a mix of topsoil and midden material (20) with inclusions of pottery sherds (Buckley), clay pipe stems, broken glass, broken bricks, a few animal bones, frequent oyster shells and some cockle shells; the midden material was concentrated at the north western terminal of the trial pit. The subsoil was grey brown slightly clayey sandy silt with a depth of 0.3m; the natural was compact mottled orange clay. The DCWW water main was not uncovered by the trial pit.

Plate 12: Trench 02 - Southwest facing section; scale: 1x1m (archive reference: G2598\_038).

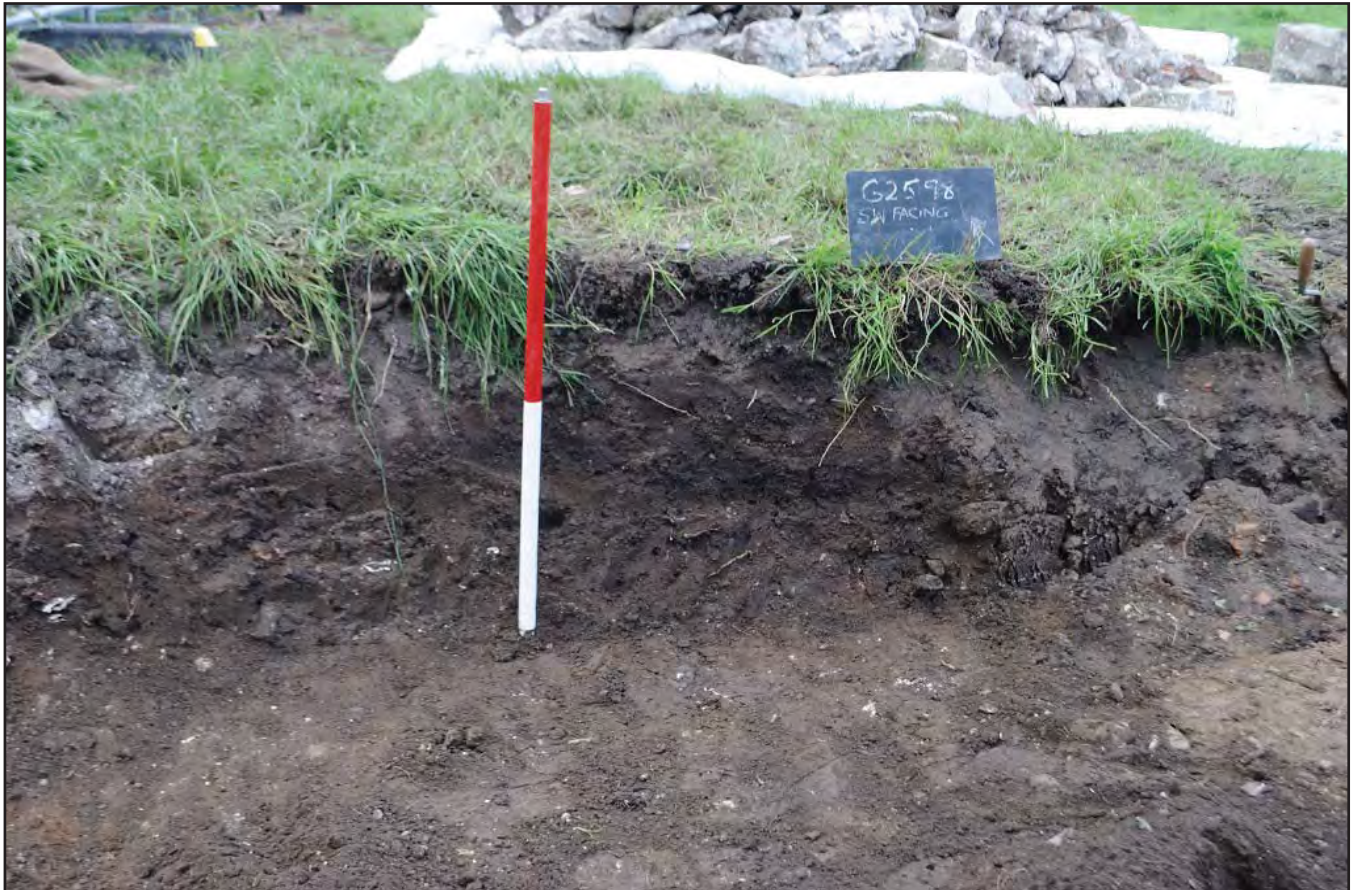
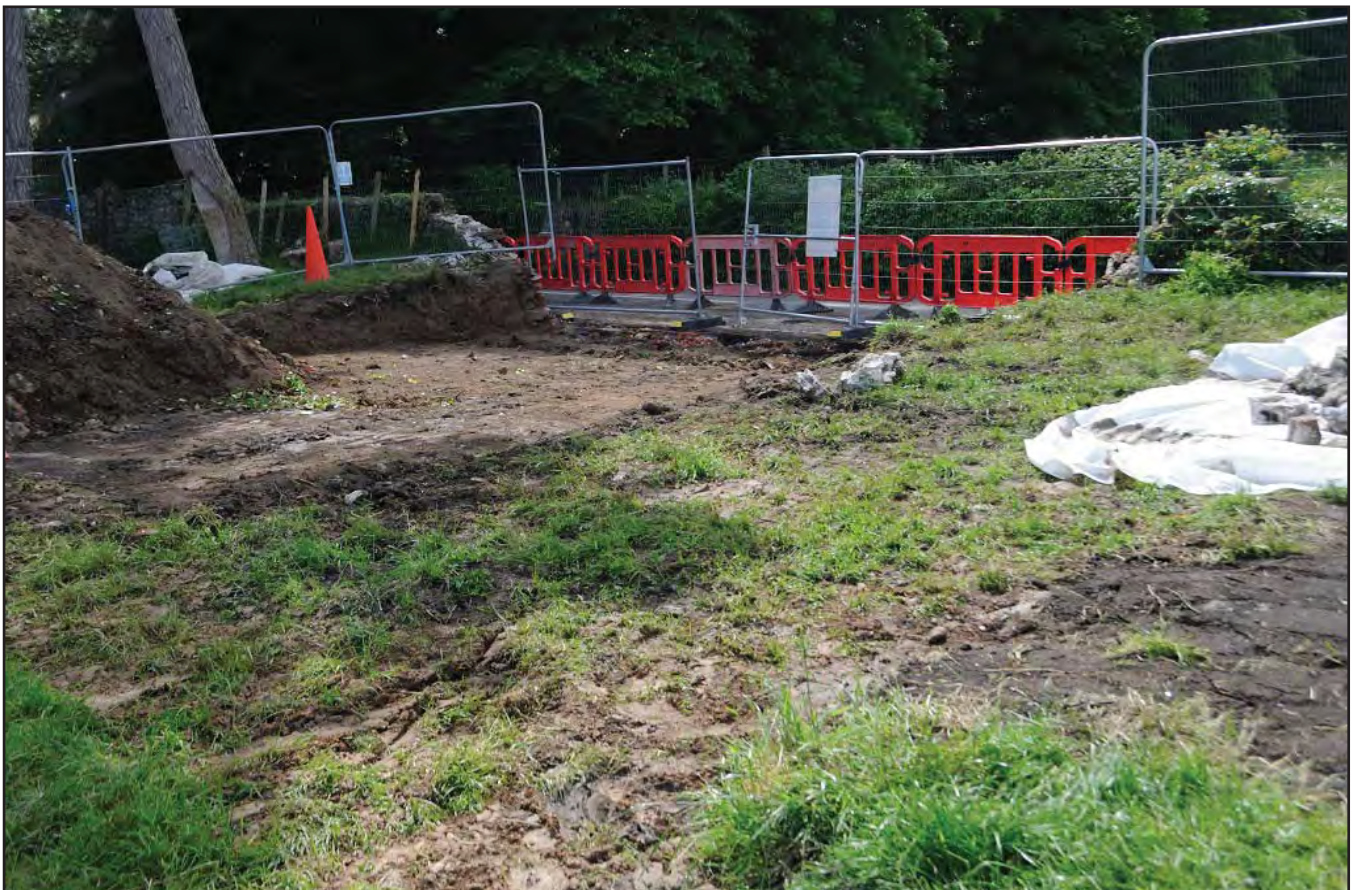
The topsoil was removed from an area measuring approximately 6.0m x 7.0m in preparation for the excavation of an access ramp into the field from Henllys Road (Plates 13 and 14). The boundary wall was removed and the ground level was reduced to approximately 0.2m below the tarmac road level. The soil descriptions are as for Trial pits 1 and 2; below the topsoil (03) was a spread of post medieval dark organic midden material (20) which contained oyster shells, some cockle shells, clay pipe stems, sherds of Buckley pottery and broken glass. Approximately 0.5m of soil mixed with midden material was removed from the area next to the wall where the soil was deepest. This reduced towards the western side of the stripped area to the point where only topsoil was removed.

Plate 13: South west facing section of reduced ground for ramp in temporary compound; scale: 1x1m (archive reference: G2598\_066).

Plate 14: General view of temporary compound area after ground reduction and wall removal; scale: 1x1m (archive reference: G2598\_072).

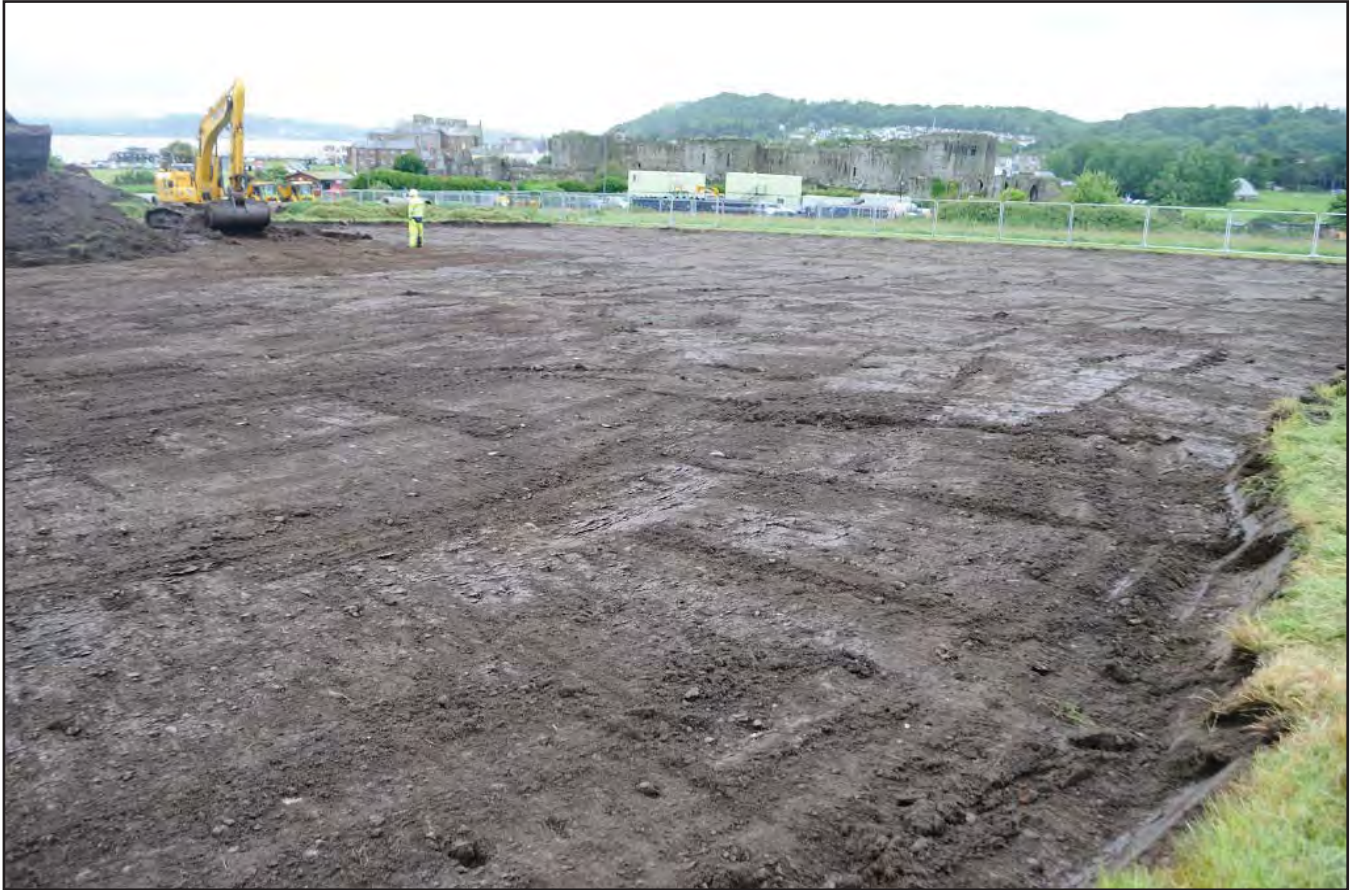
Plate 15: Mount Field - storage area topsoil stripped; no scale used (archive reference: G2598\_086).

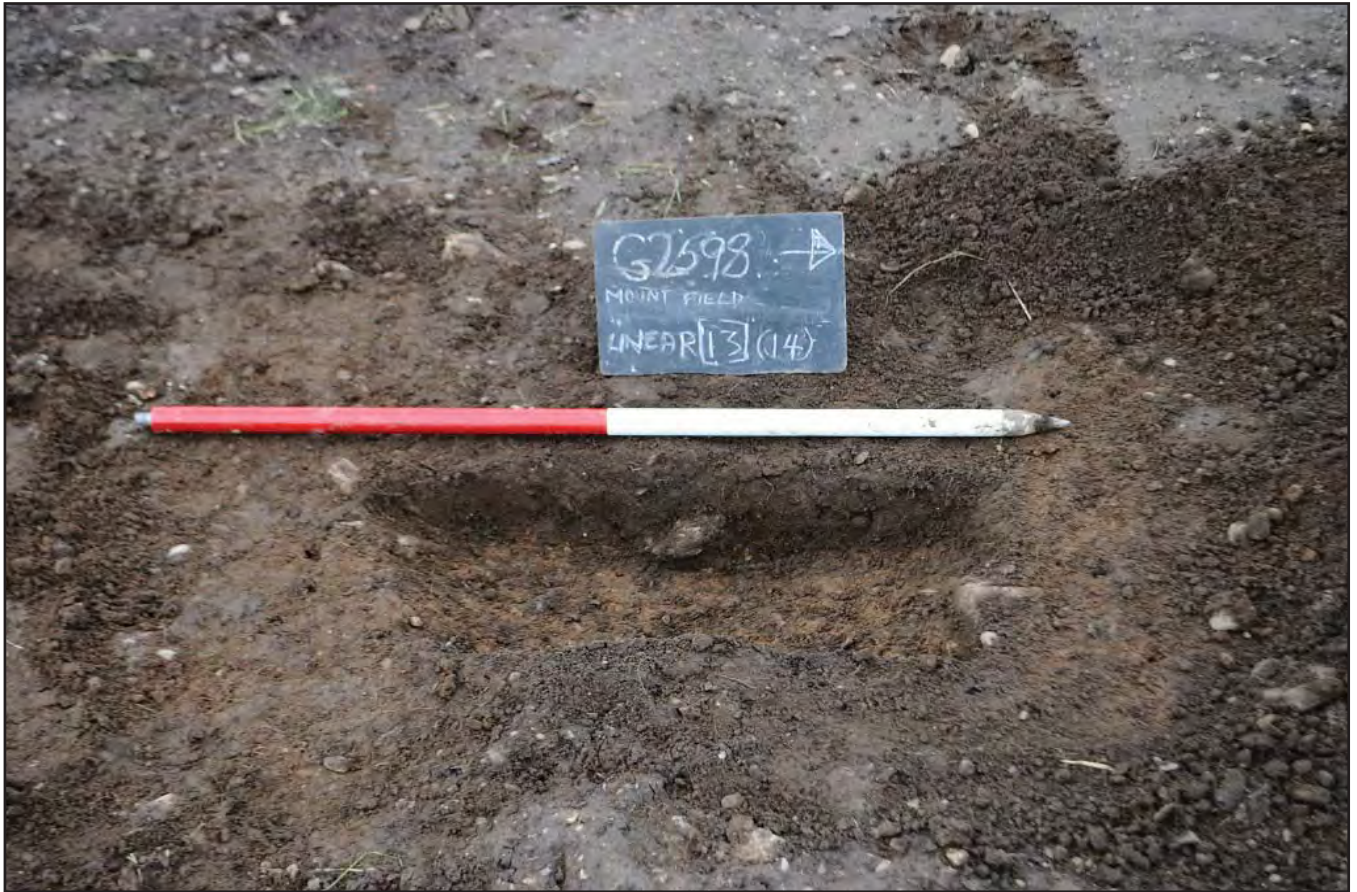
Plate 17: Mount Field - east facing section Linear 02 ; scale: 1x1m (archive reference: G2598\_103).
