FFORDD LLWYN BLEDDYN, RACHUB / LLWYN BLEDDYN ROAD, RACHUB

Asesiad Wrth Ddesg & Gwerthusiad (Arolwg Geoffisegol) / Archaeological Assessment & Evaluation (Geophysical Survey)

Prosiect Rhif / Project No. G2630

Adroddiad Rhif / Report No. 1500

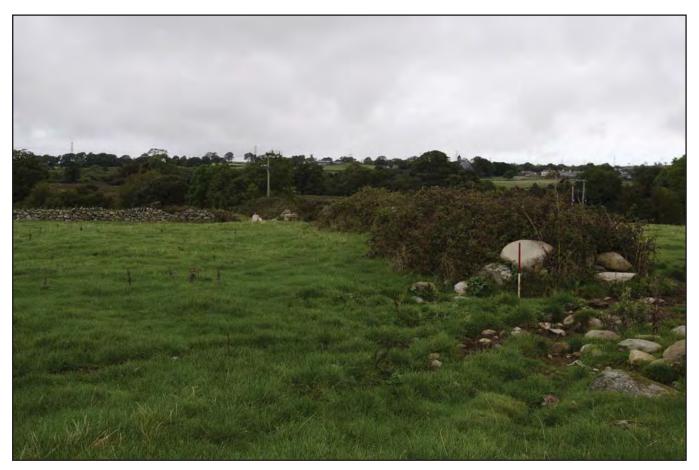
Plate 1: General view of NW edge of site showing gated entrance; scale 1x1m; view from S (archive reference: G2630_001).

The field is bounded to the south, adjacent to the road, to the east and west by drystone walling (Plates 1-2, 4). These are shown on the 1st edition 25 inch Ordnance Survey map of 1889 (Figure 03), but not on the Penrhyn Estate map of 1855 (Figure 09), so must date to between these dates. These are about 1m high and are constructed with local dry fieldstone to the south and west (Plate 2). The wall is of mortared masonry to the east; forming a boundary with Bryn Arfon that appears to have been built by Lord Newborough in the latter part of the 19th century.

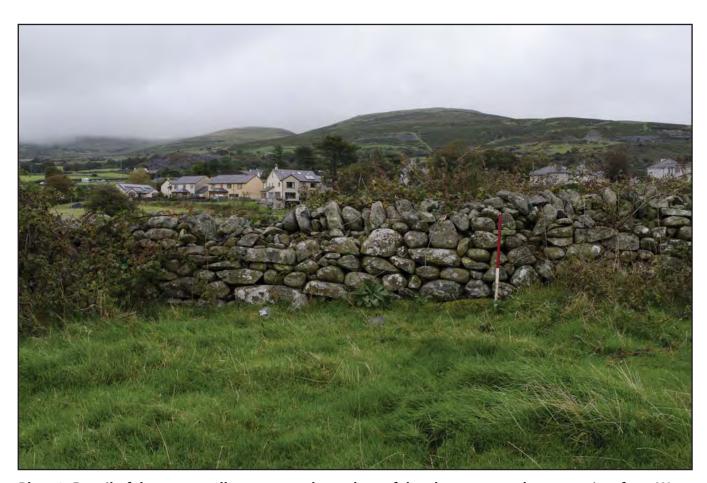
Plate 2: Detail of drystone wall on western boundary of development; scale 1x1m; view from W (archive reference: G2630_002).

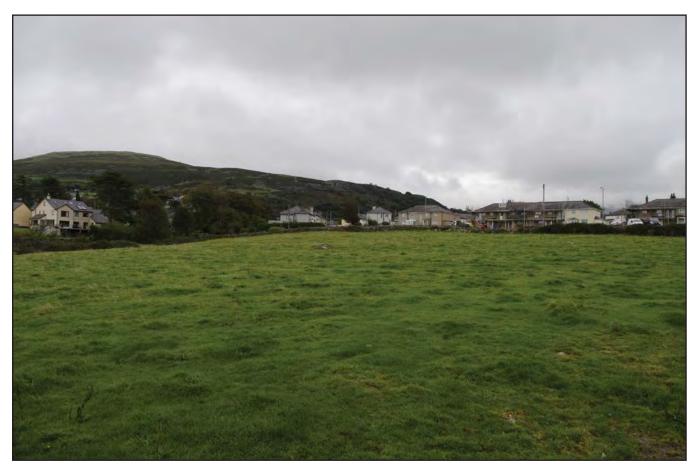
Plate 3: General view across development area; scale not used; view from NW (archive reference: G2630_003).

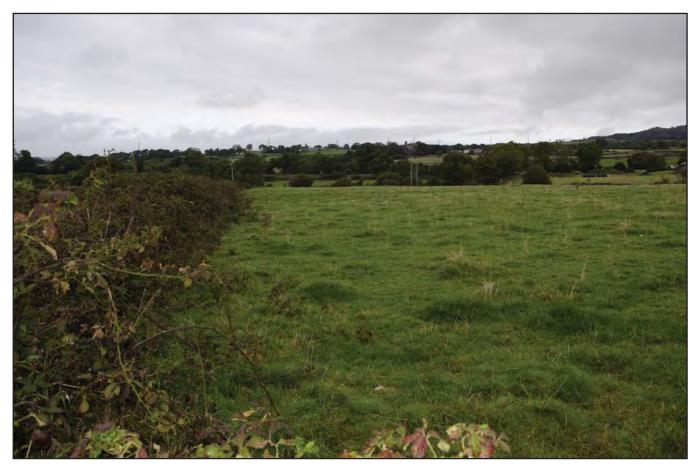
Plate 4: View along western hedge bank; scale not used; view from S (archive reference: G2630_004).

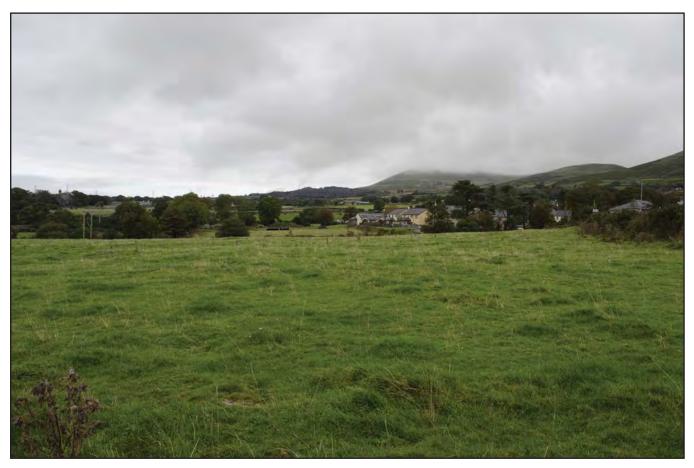
Plate 5: View across development area towards housing and beyond; scale not used; view from SW (archive reference: G2630_005).

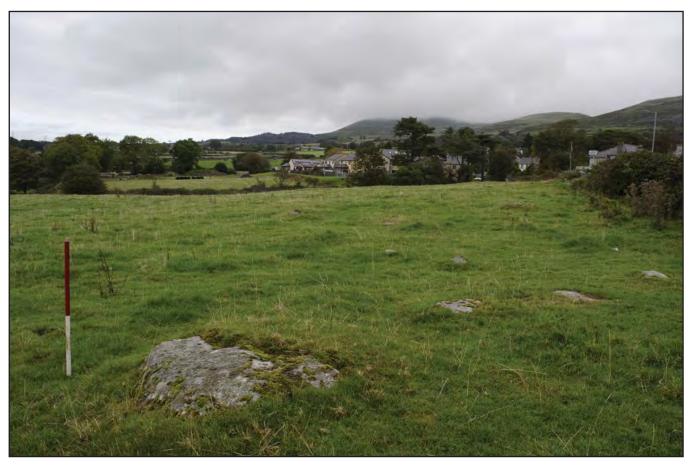
The walkover survey was carried out on 25th September 2019 in good weather conditions. The study area was noted to be generally improved pastureland (Plates 3-5), undulating with some evidence of rock outcropping (Plate 6), with a lower lying, boggy area of ground forming a small shallow valley to the north west (Plate 11), through which a public footpath passes, and a stream passes through at the lowest point. This part of the field is heavily overgrown and very soft underfoot, and has not been archaeologically improved.

Plate 6: Rocky outcropping in southern area of field; scale 1x1m; view from SW (archive reference: G2630_006).

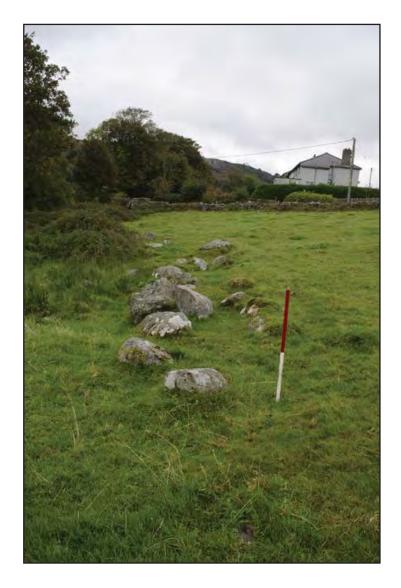
Feature Number	01 (Plates 7-8)
Site name	Terraced area with associated enclosure wall
PRN number	81382
Grid reference	SH62026806
Period	Unknown, possibly prehistoric or medieval
Site type	Settlement
Assessment category	Е
Description	A level depression in the ground, 7.8m wide is associated with a denuded stone wall 3.3m to the east, about 20m long and orientated north-south along a small scarp, which probably represents an associated enclosure boundary. Along with Features 2 and 3 it may form part of a wider settlement.
Impact	Considerable
Recommendation for	Topographic survey followed by evaluation (trial trenching).
further	
assessment/evaluation	
Recommendation for	Recommendations for full mitigation should await the results of
mitigatory measures	the evaluation

Plate 7: View of irregular stones, possibly the remains of a relicit field boundary A; scale 1x1m; view from W (archive reference: G2630_007).

As summarised in the table below, topographic survey is recommended for Features 1-3 as they include upstanding remains and it is felt that an *in situ* record of these features should be made as part of the site evaluation prior to the intrusive evaluation trenching in order that their morphology and context can be further understood prior to intrusive ground works. This would enable the remains to be placed in their wider context of similar sites known in the wider area.

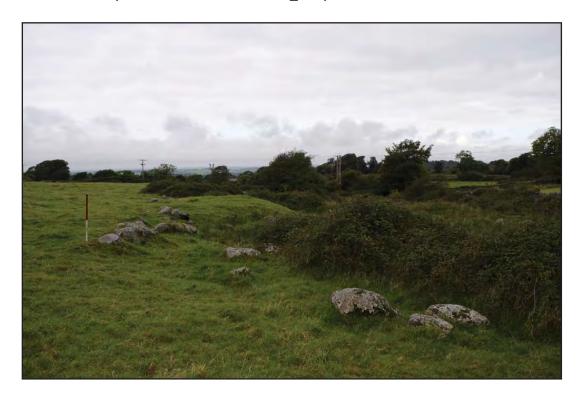
Plate 8: View of irregular stones, possibly the remains of a relicit field boundary A; scale 1x1m; view from SE (archive reference: G2630_008).

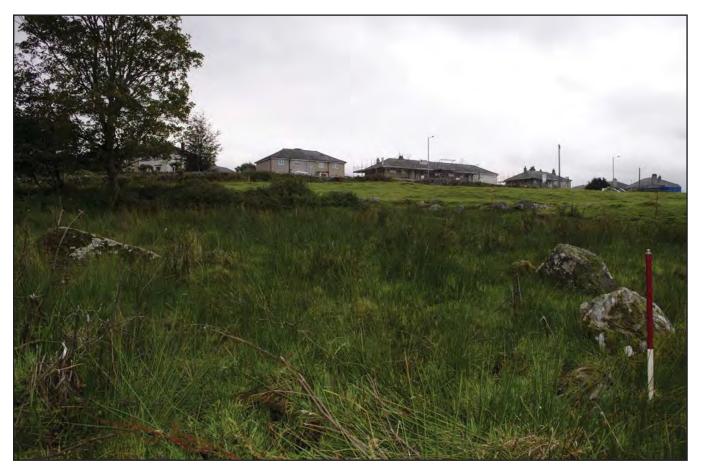
Feature Number	03 (Plate 9-11, 14)
Site name	Round house and enclosure, forming a probable settlement group
PRN number	81383
Grid reference	SH62056805 C
Period	Probably Prehistoric
Site type	Settlement
Assessment category	Е
Description	Large orthostatic stones that appear to form the shapes of two roundhouses and enclosures (stones up to 1.5m by 1m in size). Only the large stones are visible, but they appear to form part of a significant archaeological feature. Two possible roundhouse structures have been noted both on the south-west bank of the stream, the larger example to the west has a diameter of 7.2m. Evidence of enclosure walling is noted to the south-east, west and east, although the full extent of this is not fully understood. Along with Features 1 and 2 it may form part of a wider settlement.
Impact	Considerable
Recommendation for	Preservation in situ. If this is not possible then topographic

Plate 9: View of possible round house remnant with enclosure behind C; scale 1x1m; view from N (archive reference: G2630_009).

further	survey followed by evaluation (trial trenching).
assessment/evaluation	
Recommendation for	Recommendations for full mitigation should await the results of
mitigatory measures	the evaluation

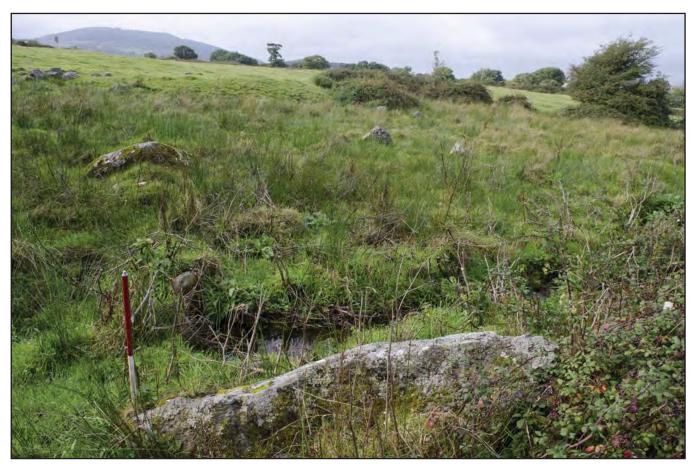
Plate 10: View of possible feature C; scale 1x1m; view from NE (archive reference: G2630_010).

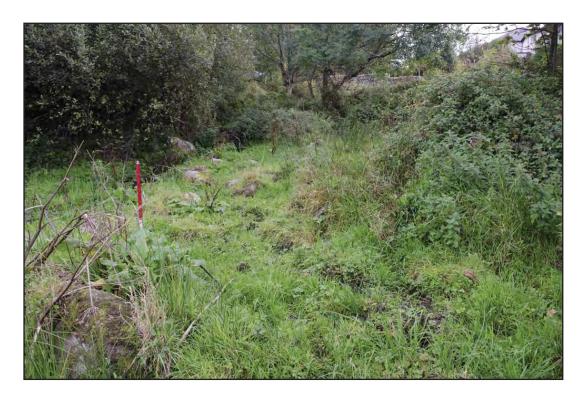
Plate 11: View of stones forming part of possible feature; scale 1x1m; view from W (archive reference: G2630_011).

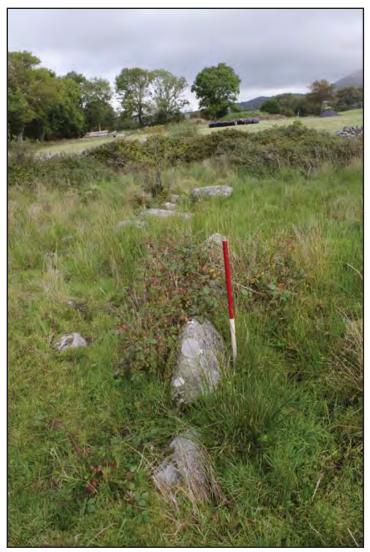
Within the proposed development area, in a boggy unimproved area at the north-eastern edge of the study area, lies a series of single lines of boulders (Feature 2, PRN 5891; Plate 12)), and possible round houses (Features 1, 3 PRN 81382-3; Plates 7-11, 13-14). These are thought to represent small enclosed settlements, which may be associated with prehistoric or Roman activity. It appears that there may be two round house foundations of upright orthostats to the south-east of the stream, with a diameter of about 7.2m (Feature 03). These are associated with enclosure boundary walls of drystone local fieldstone construction (Features 02 and 03). These may be associated with another drystone wall element associated with a possible house platform (Feature 01), situated on the dryer higher ground on a small scarp immediately to the south of the boggy area. Elements of the pre 1855 field system may be involved here too (Figure 09).

Feature Number	02 (Plate 12)
Site name	Remnant of walling
PRN number	5891
Grid reference	SH62026818
Period	Unknown, possibly prehistoric or medieval
Site type	Wall
Assessment category	Е
Description	A remnant, in the form of a row of boulders of prehistoric or medieval field systems, surviving in the unimproved boggy ground at the north-east of the study area. Along with Features 1 and 3 it may form part of a wider settlement in the area.
Impact	Considerable
Recommendation for	Preservation in situ. If this is not possible then topographic
further	survey followed by evaluation (trial trenching).
assessment/evaluation	
Recommendation for	Recommendations for full mitigation should await the results of
mitigatory measures	the evaluation

Plate 12: View of boundary wall B showing the eastern side partially obscured with brambles and possible roundhouse C to the rear; scale 1x1m; view from SW (archive reference: G2630_012).

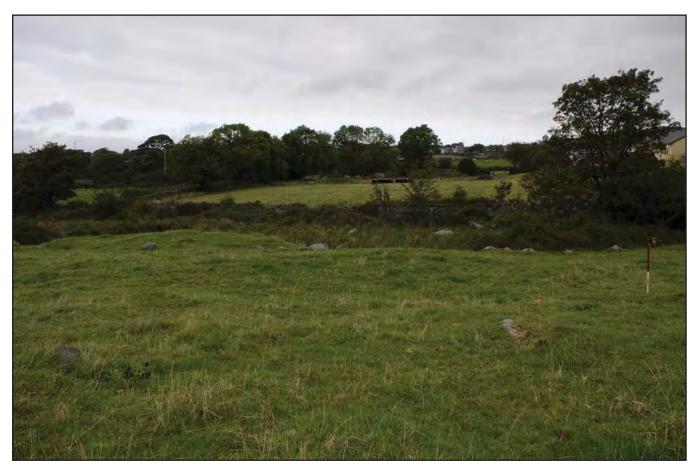
Plate 13: General view showing depression (poss. arch.) and denuded drystone wall beyond A; scale 1x1m; view from SSW (archive reference: G2630_013).

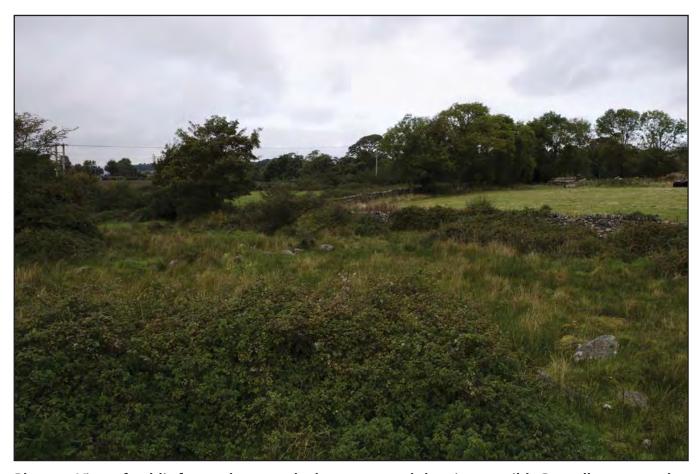
Plate 14: View of public footpath across the boggy ground showing possible Roundhouse 1 and enclosures, dry ground and platform beyond; scale not used; view from NE (archive reference: G2630_014).

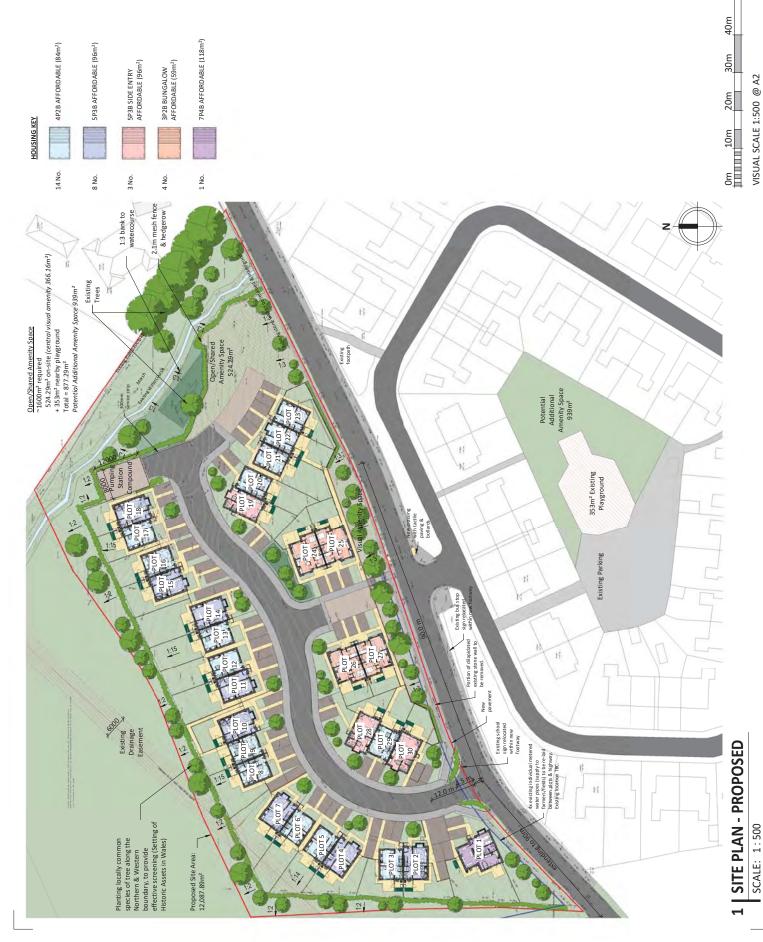
Reproduction of Ainsley Gommon Architects Drawing No. 003 Revision D, denoting development proposals.
