# ARLLWYSFA GANOL, LLANDUDNO/ GANOL OUTFALL, LLANDUDNO

Briff Gwyllo Archeolegol/  
Archaeological Watching Brief

Prosiect Rhif / Project No. G2619

Adroddiad Rhif / Report No. 1509

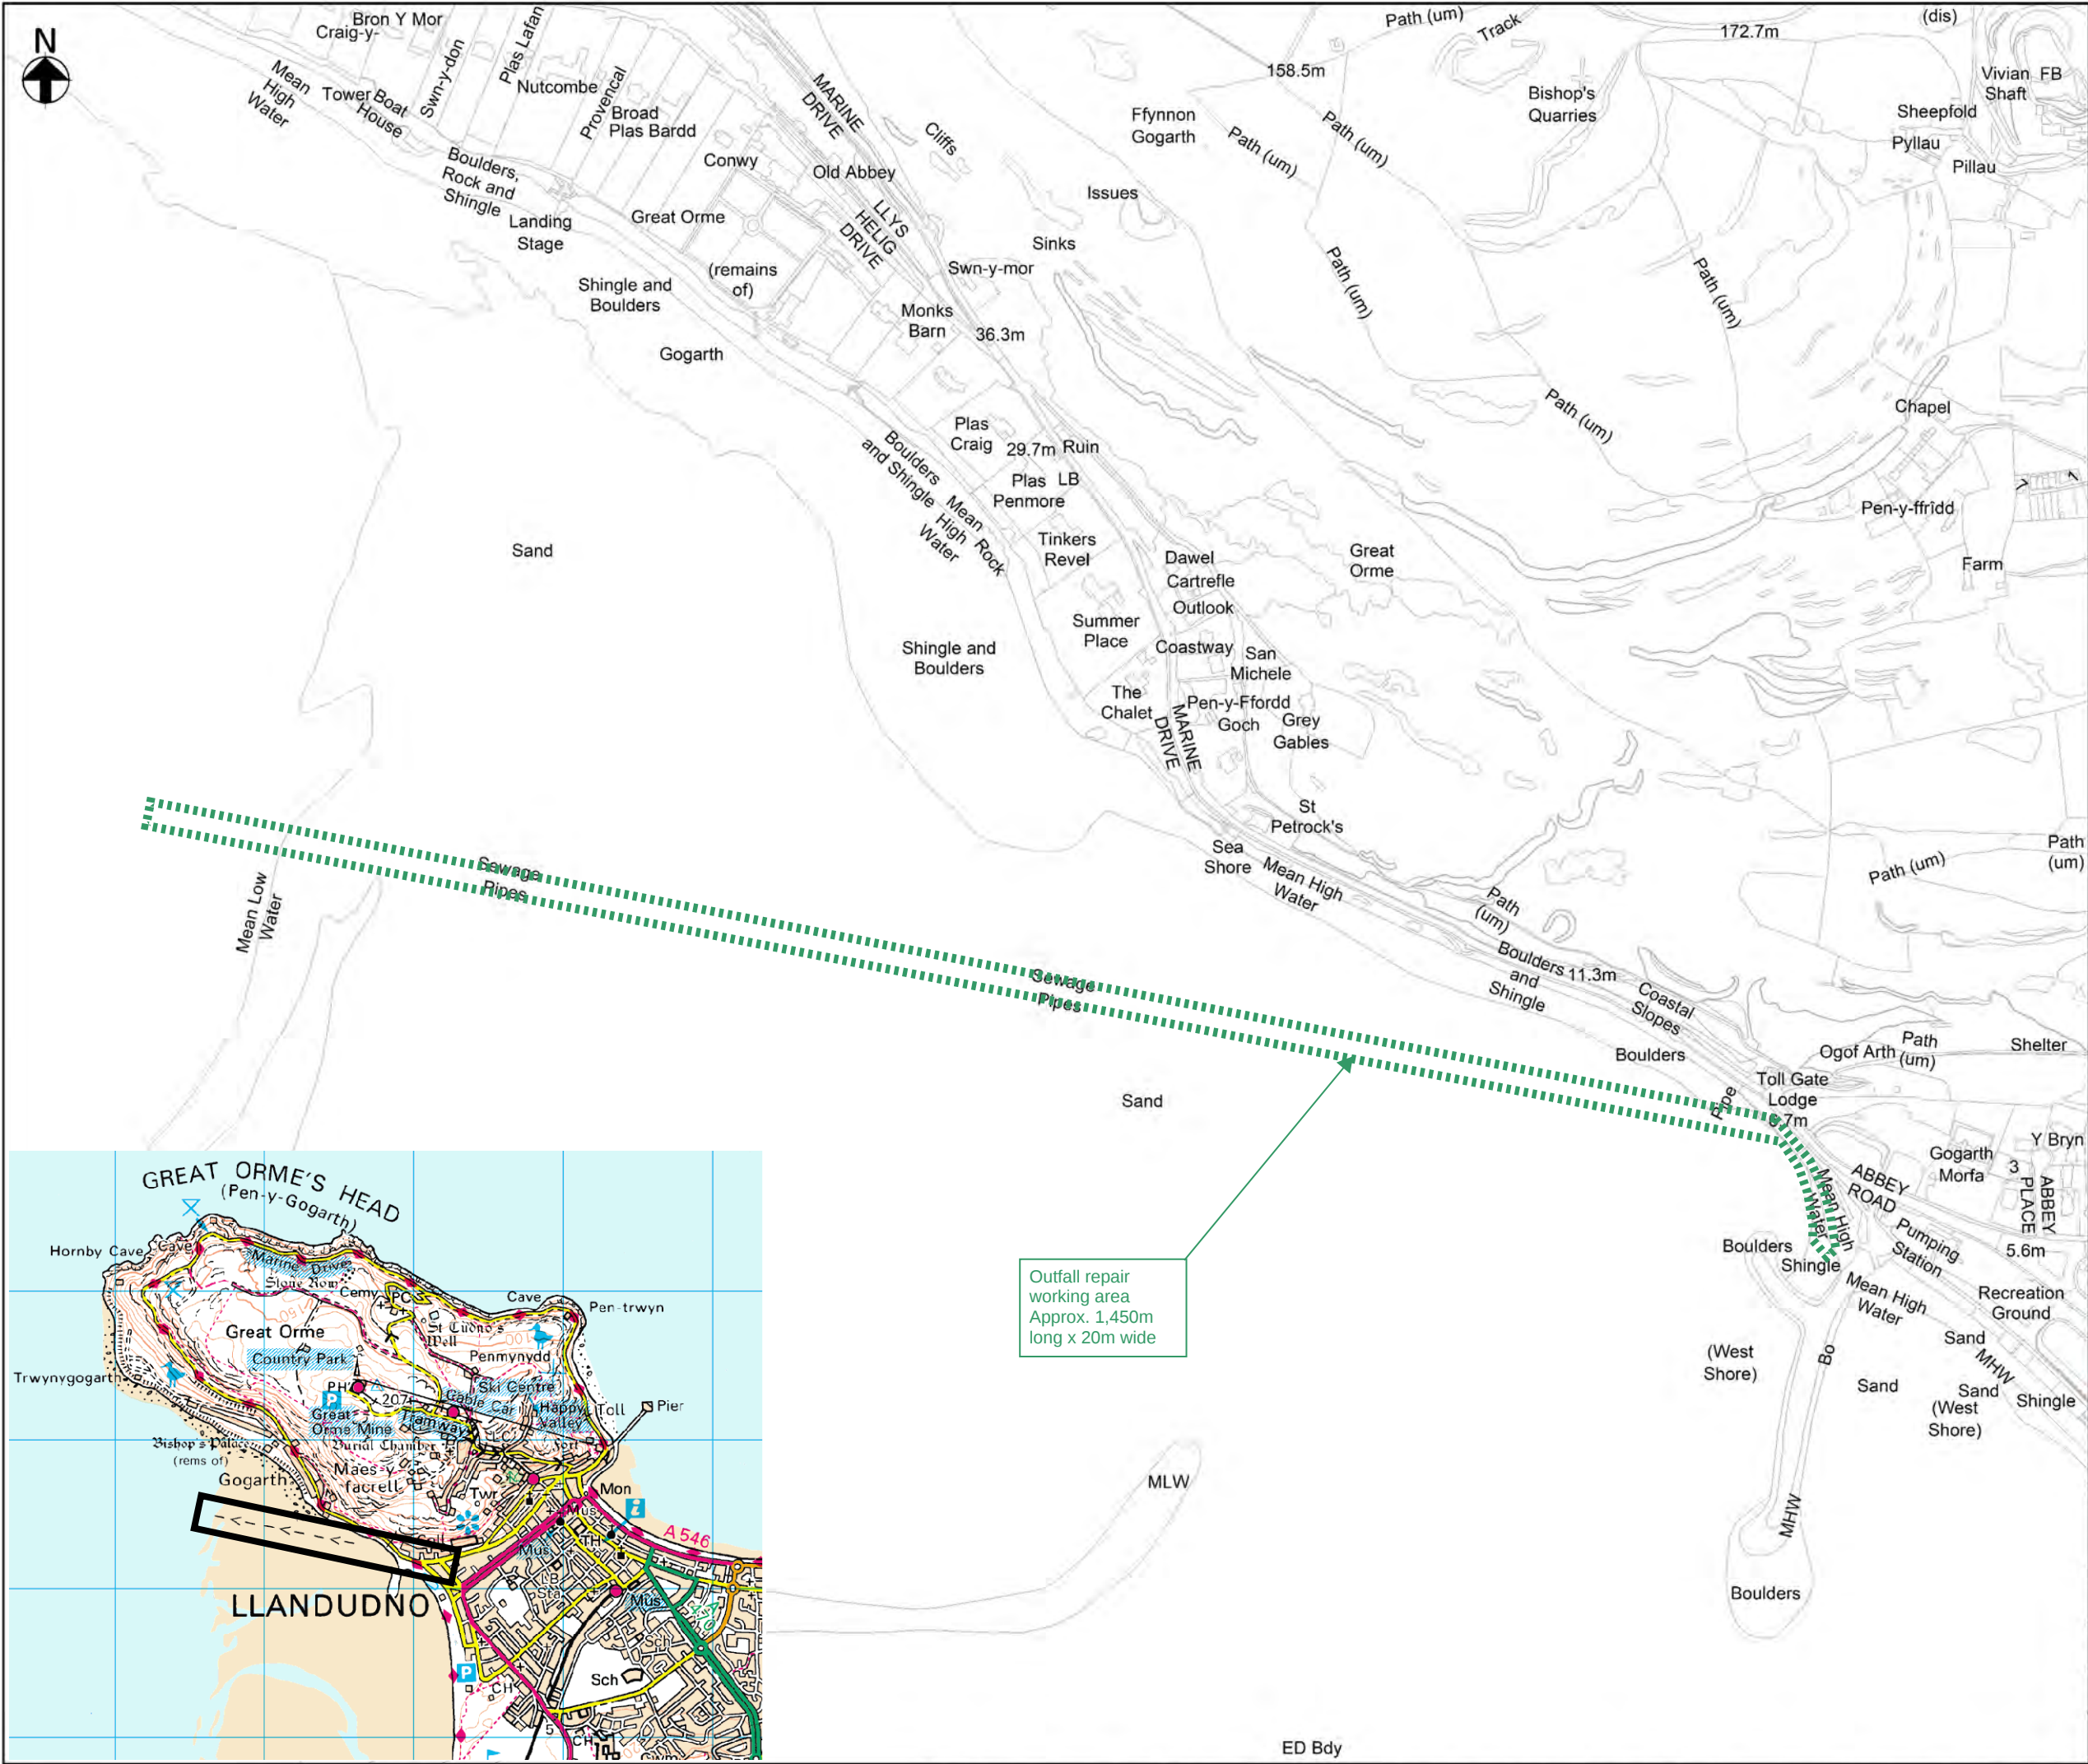
**Reproduction of DCWW Drawing No. 4591\_S\_202-ARP-XX-ZZ-DR-CX-06000**

Gwynedd Archaeological Trust (GAT) was asked by Arup to undertake an archaeological watching brief during marine works associated with the Ganol - West Shore Sewage Pumping Station in Llandudno, Conwy County Borough (NGR SH76688225; Post Code: LL30 2QZ; Figure 01). The proposed scheme was to upgrade an existing sewer outfall pipe on West Shore Beach, Llandudno. The existing 700mm diameter 1.3km long outfall pipe discharges the intermittent storm flows from West Shore and is in poor repair. The works included repairing 11 known defects in the outfall, jetting of 1.3km of the outfall, and potential repair of the pipe in the first 330m if found to be incomplete. The scheme area is located on DCWW Drawing No. 4591\_S\_202-ARP-XX-ZZ-DR-CX-06000 (Figure 01).

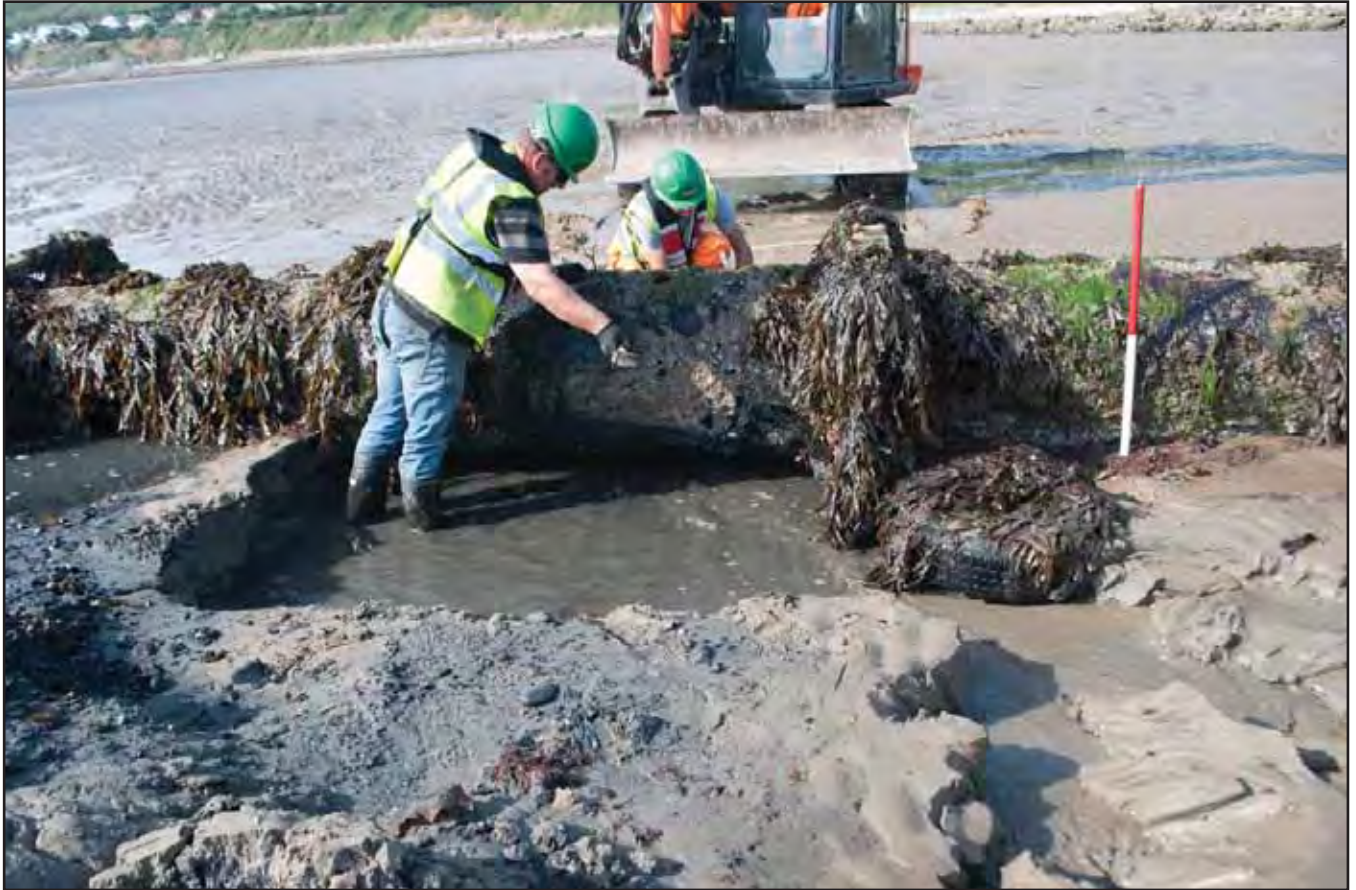
Plate 01: Cleaning a section of outfall; scale: 1x1m (archive reference: G2619\_010).

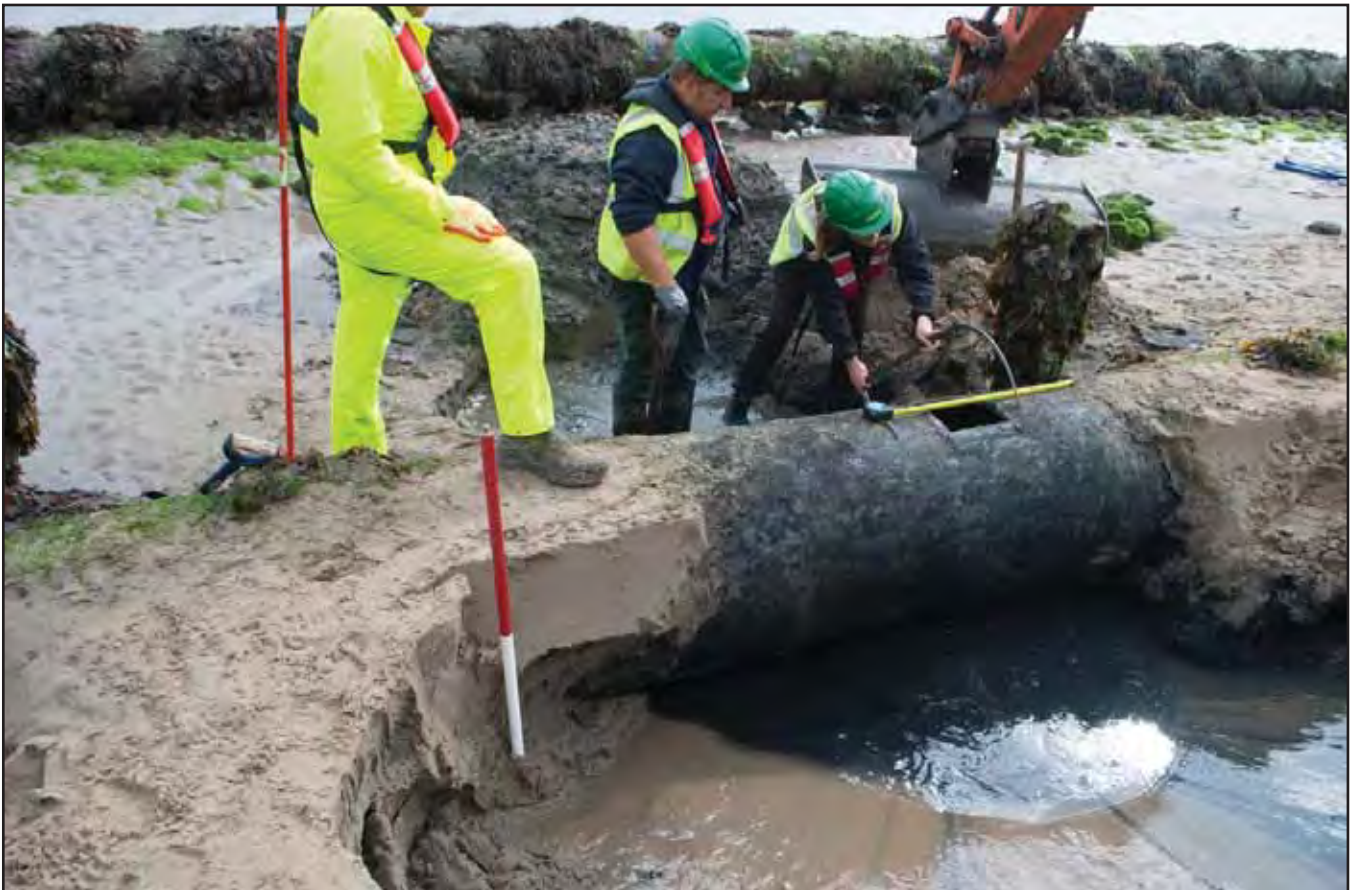
Plate 02: Measuring a section of outfall; scale: 1x1m (archive reference: G2619\_002).

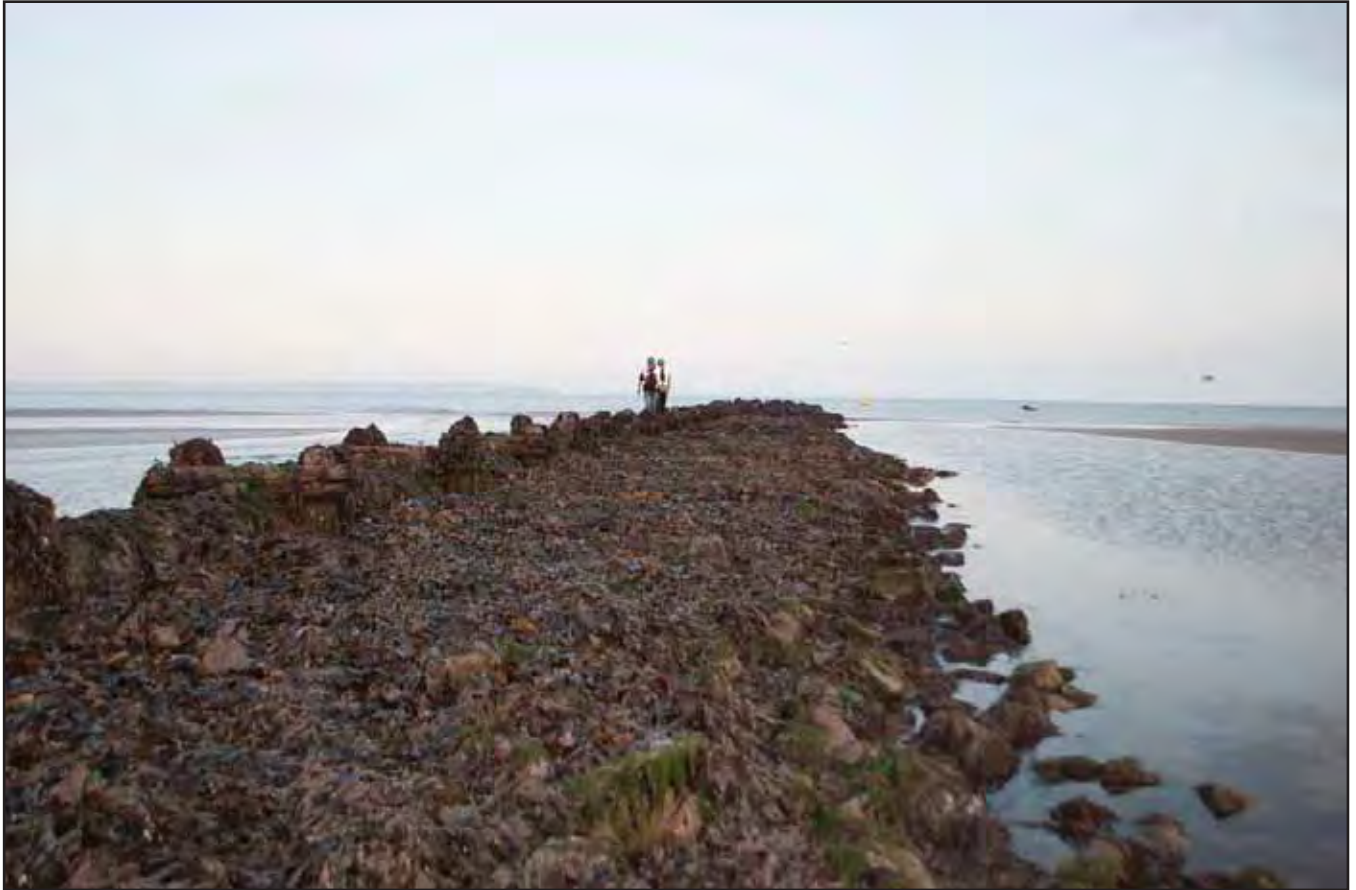
As stated previously, this repair was achieved using a plate rather than a collar and therefore required no excavation due to the amount of stone surrounding the outfall in this area (Plate 03).

Plate 03: Stones collected around the outfall; no scale (archive reference: G2619\_026).

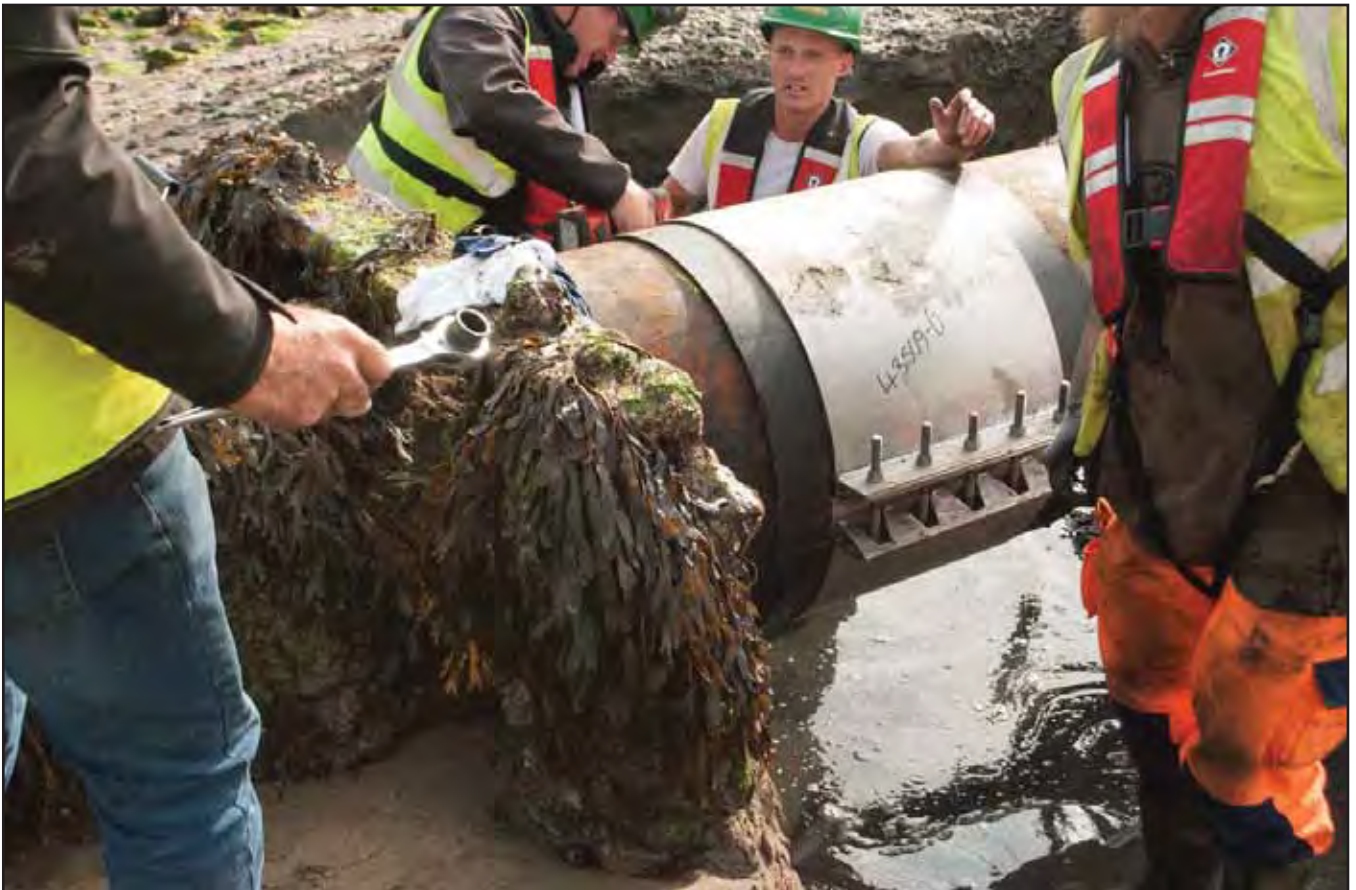
Plate 04: Fitting the repair section; no scale (archive reference: G2619\_045).

Excavations adjacent to the outfall were undertaken during the lowest tides of the month so as to maximise the time available to complete the work and to be able to access the all the repair locations. Two separate spring tides were used, the first between the 30<sup>th</sup> July and the 2<sup>nd</sup> of August, and the second between the 29<sup>th</sup> August and the 31<sup>st</sup> August 2019. During the spring tide between the 30<sup>th</sup> July and the 2<sup>nd</sup> August, 11 excavations were undertaken marked 1-11 on Figure 03. These were to enable the cleaning of the pipe at the repair locations (Plate 01) and to take an accurate measurement of the diameter of the pipe (Plate 02). Due to the amount of stones located next to the pipe along the last third of the outfall, and its location furthest out to sea, excavation 12 was abandoned in favour of a plate repair rather than a collar (Plate 03). The second spring tide between the 29<sup>th</sup> August and the 31<sup>st</sup> August was used to fit the repair sections (Plate 04).

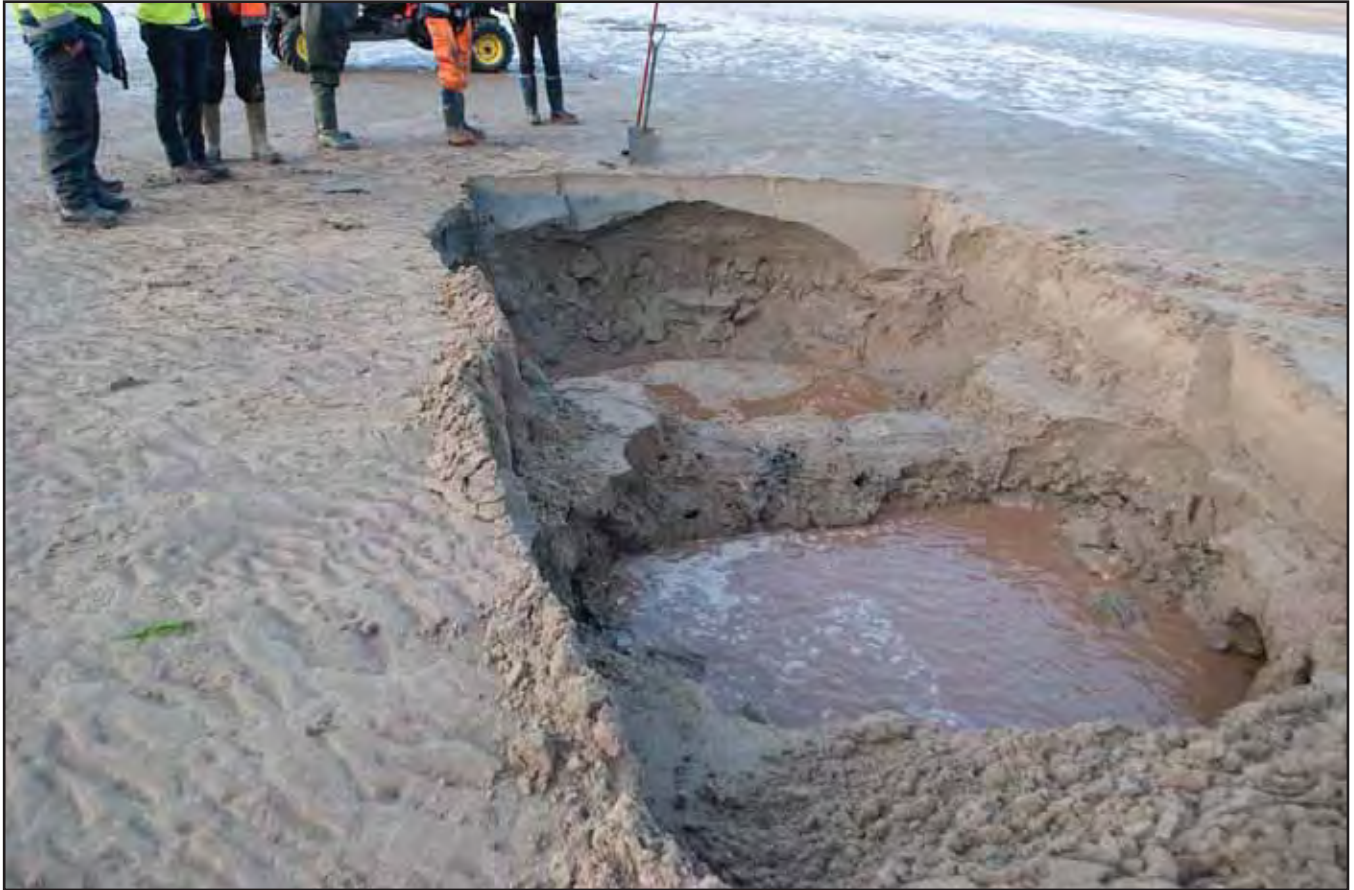
Excavation 1 was dug in order to ascertain the condition of the first 300m of pipe and to establish if it was possible to excavate a stable enough hole for a collar with jetting access to be fitted. The excavation was constantly flooding and unstable. The excavation was abandoned at approximately 1.5m depth. In this area of the beach there was a c.1m depth of clean orange sand that gave way to a gravel and grey sand layer (Plate 05). There was no archaeology encountered in this area.

Plate 05: Excavation 1; no scale (archive reference: G2619\_032).

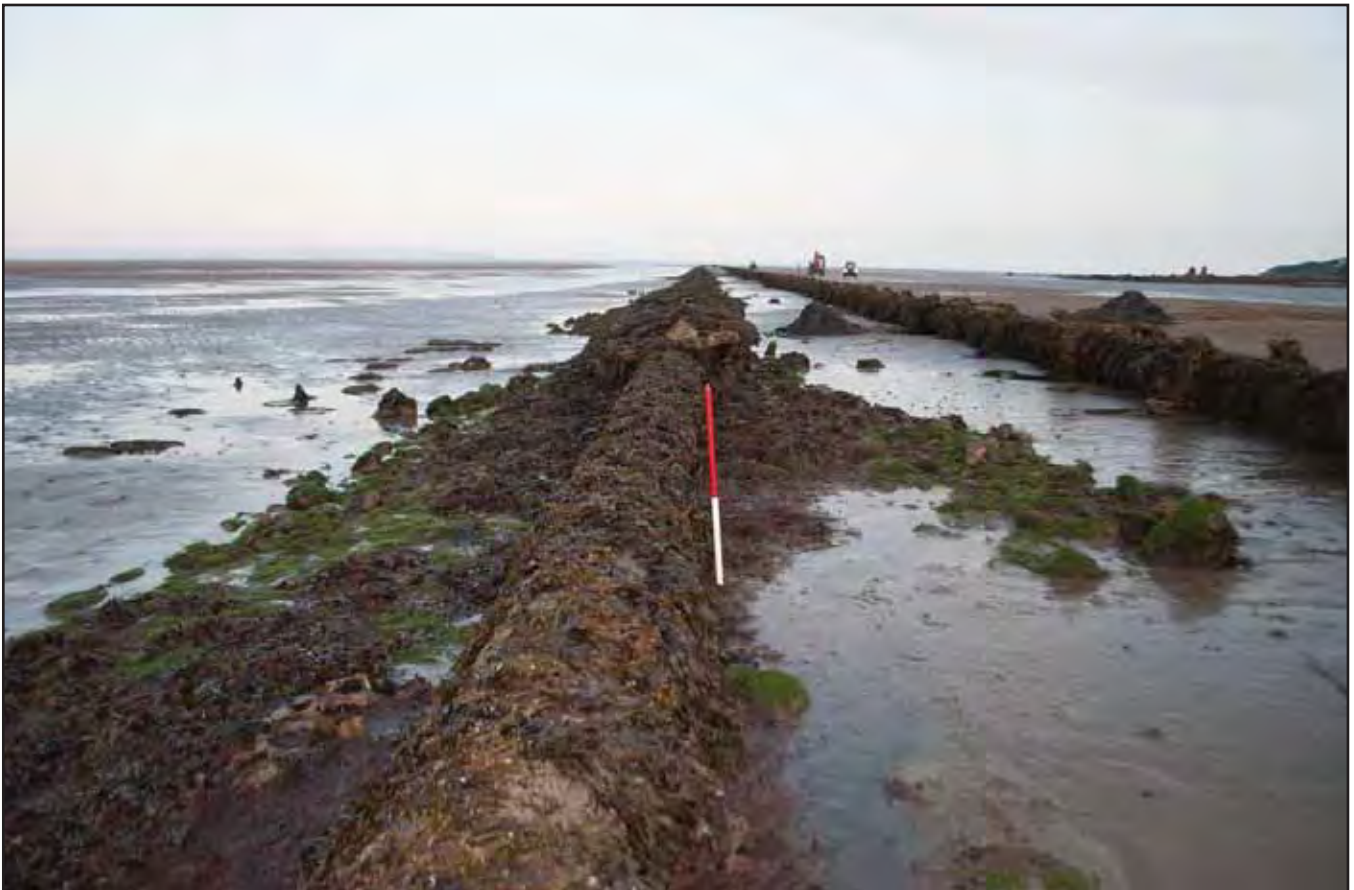
Excavation 2 was situated in an area close to the possible fish trap (PRN 77164) recorded during the archaeological assessment (Ryan Young, 2019) (Plate 06). No evidence of fish traps were seen in the excavation. The sand in this area has been stained almost black in places from the bitumen coating on the outfall pipe with only around 10cm of clean orange sand sitting on top of black/grey stained material (Plate 07). There was no archaeology encountered in this area.

Plate 06: Excavation 2 in background with possible fish trap (PRN 77164) seen leading away from the southern most outfall pipe; scale: 1x1m (archive reference: G2619\_028).

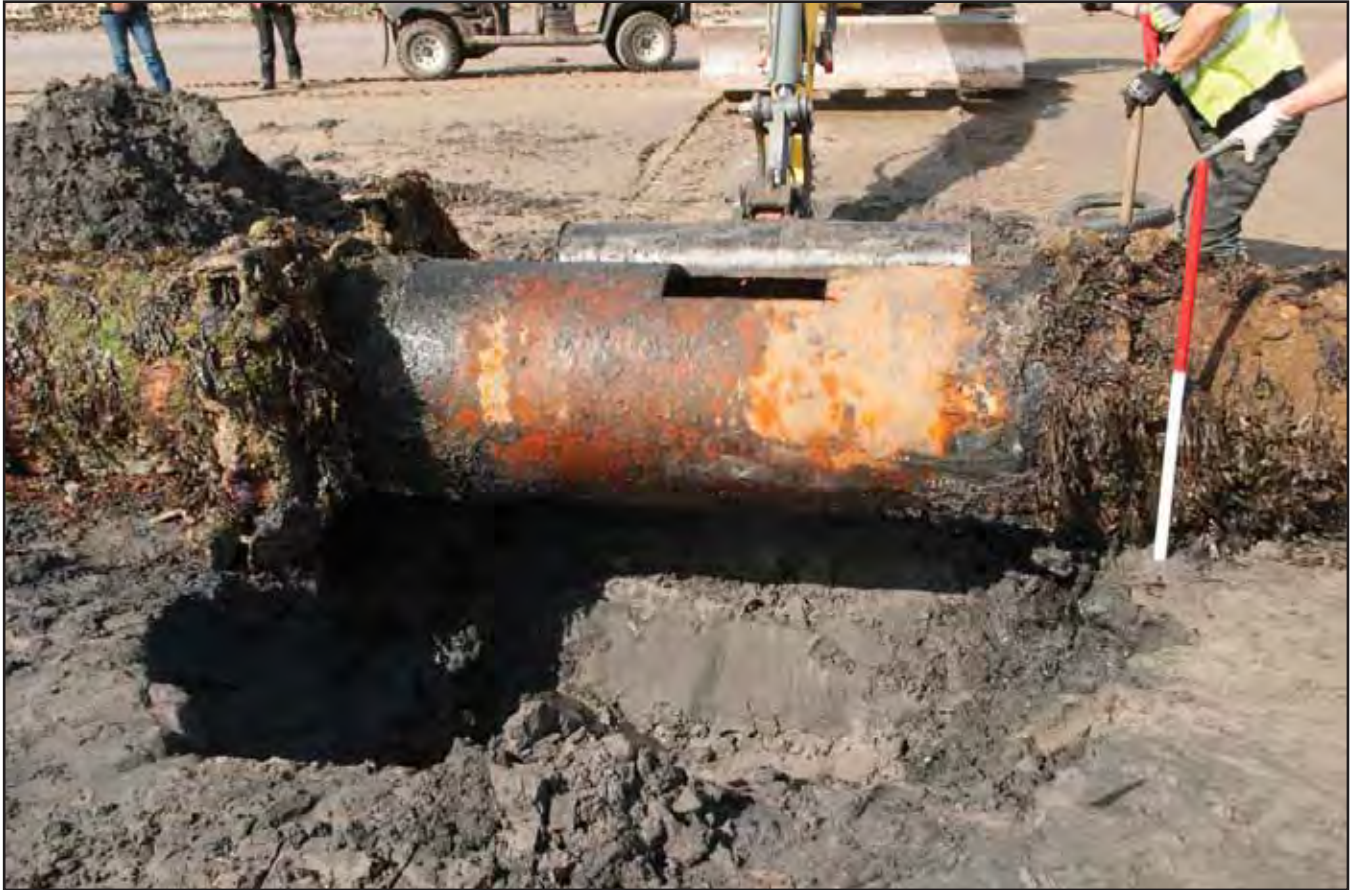
Plate 07: Excavation 2 showing bitumen stained sand; scale: 1x1 m (archive reference: G2619\_034).

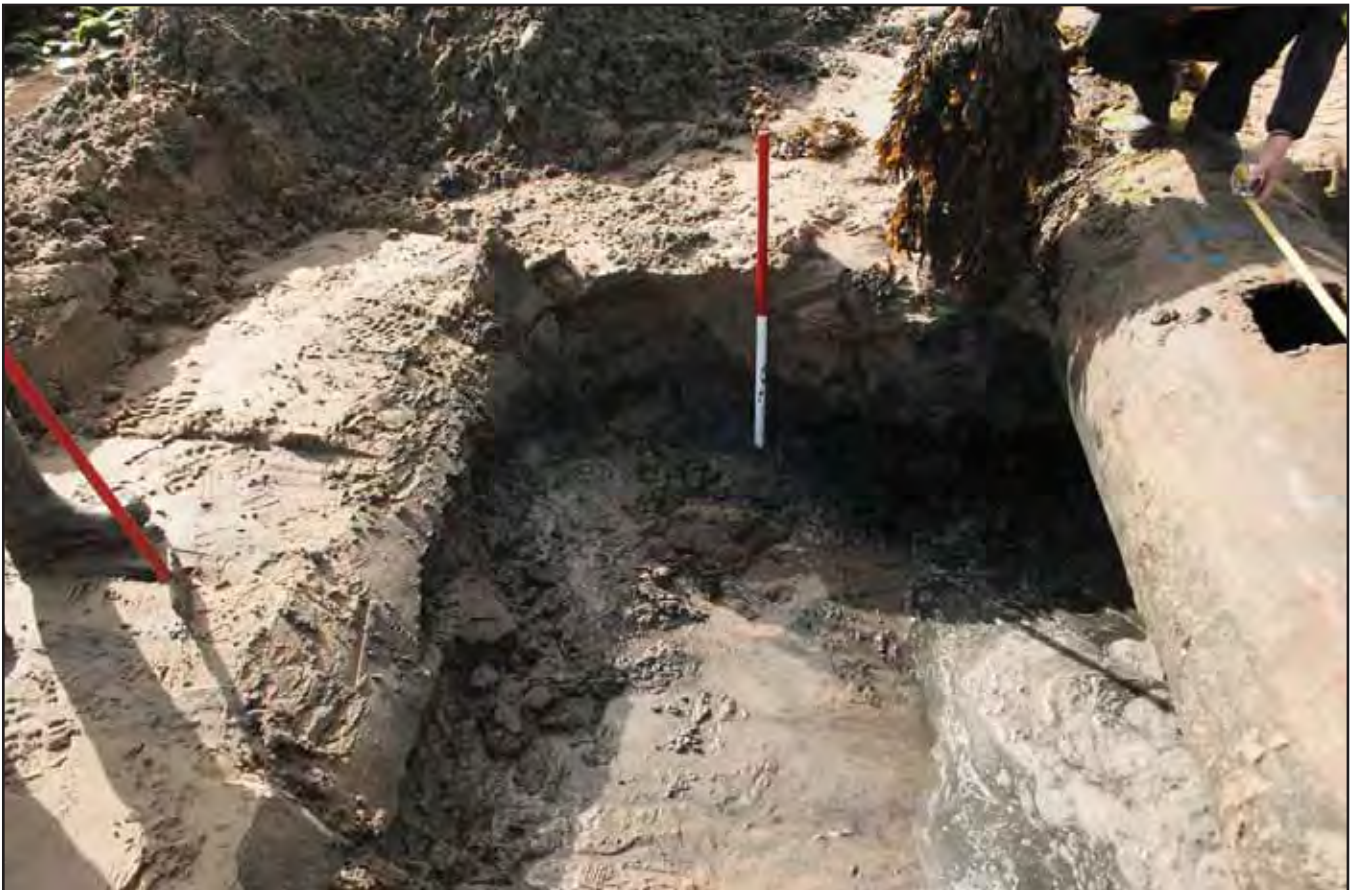
Excavation 3 revealed a layer of orange sand with a maximum depth of 0.45m which gave way to a layer of black/grey bitumen stained material (Plate 08). There was no archaeology encountered in this area.

Plate 08: Excavation 3 showing bitumen stained sand; scale: 1x1 m (archive reference: G2619\_036).

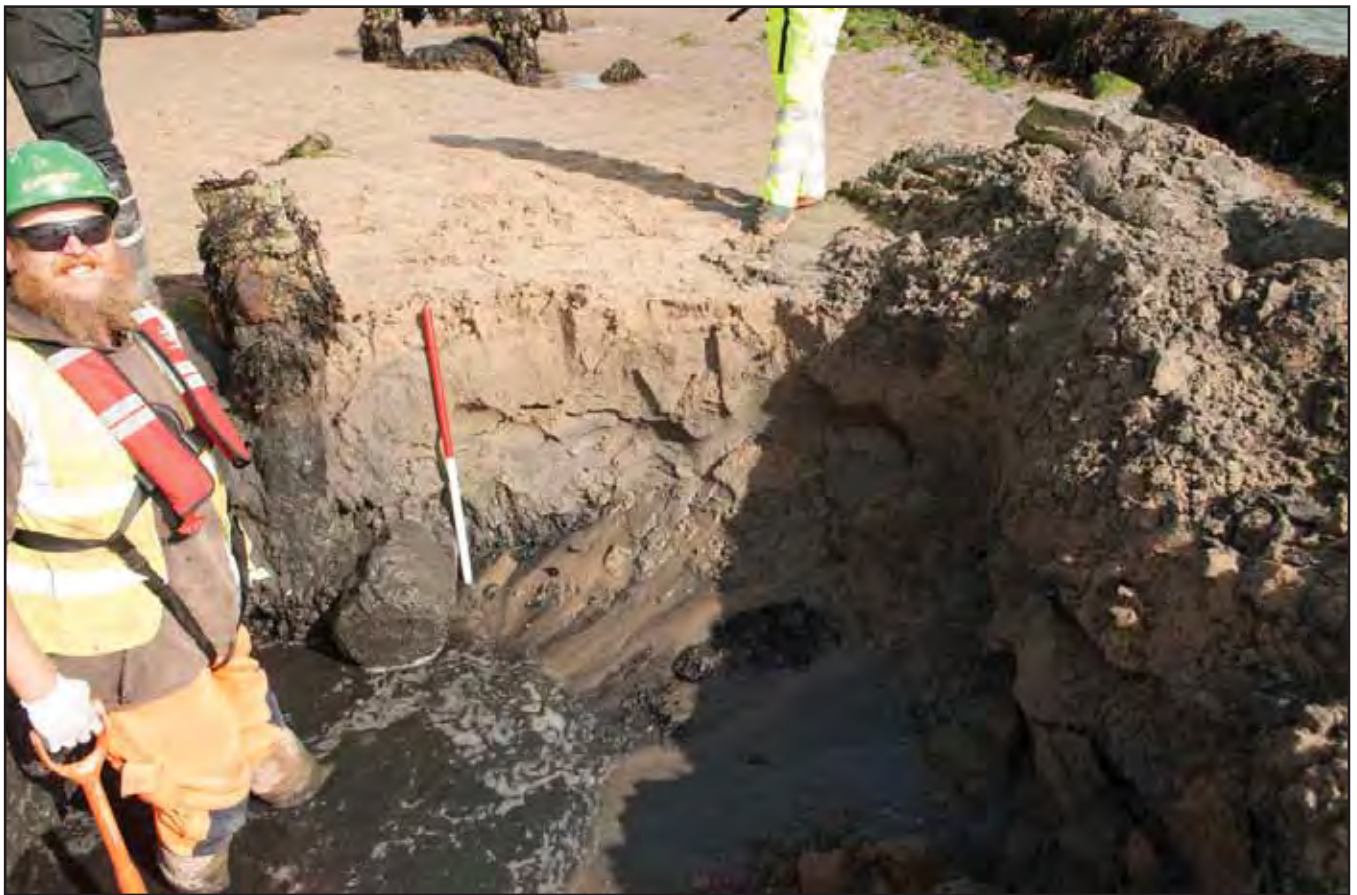
Excavation 4 revealed a layer of orange sand with a maximum depth of 0.5m which gave way to a layer of grey sand with a maximum depth of 0.3m. These layers overlaid the black/grey bitumen stained material which contained frequent gravel inclusions (Plate 09). There was no archaeology encountered in this area.

Plate 09: Excavation 4; scale: 1x1m (archive reference: G2619\_035).

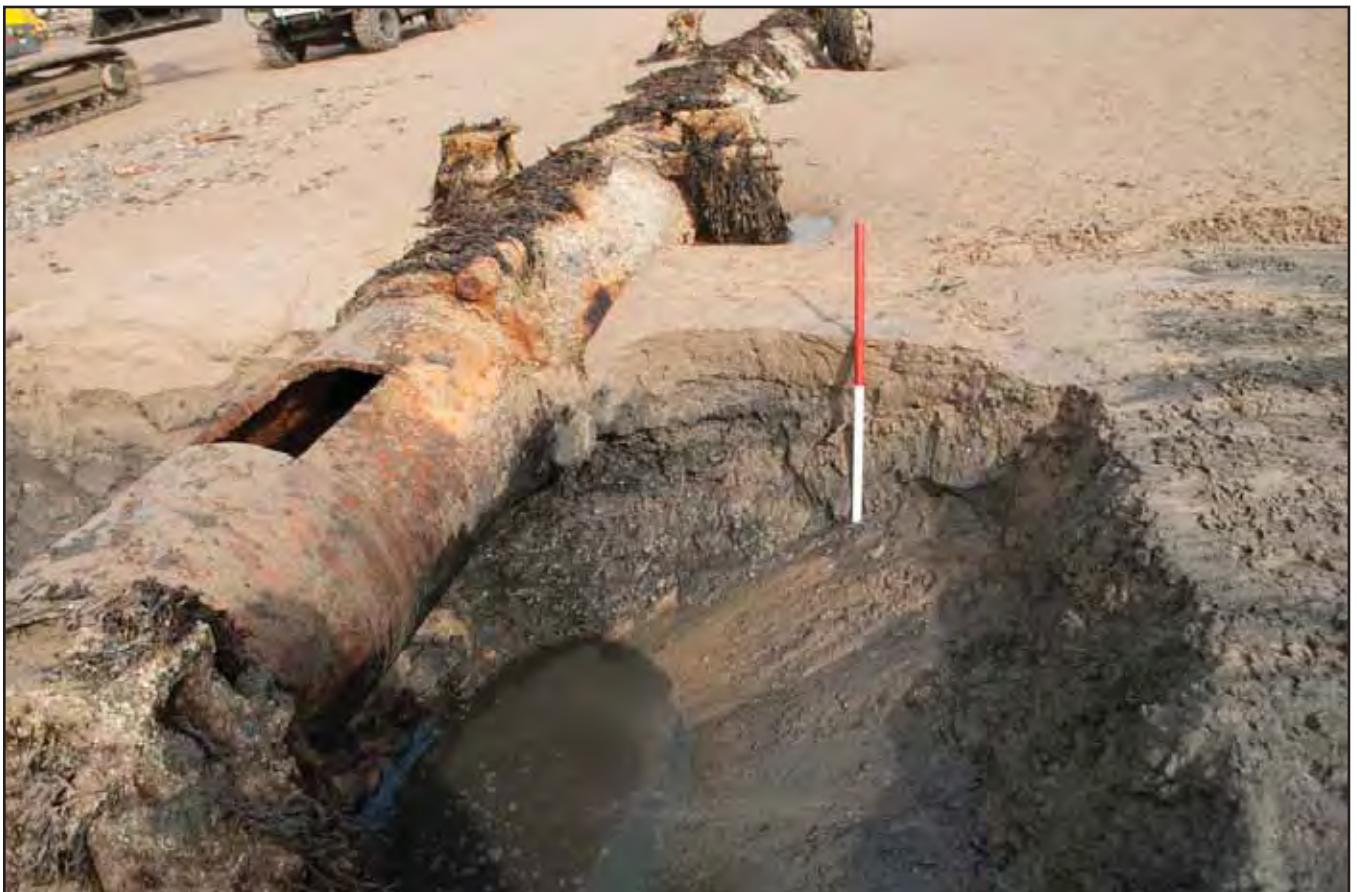
Excavation 5 revealed a layer of orange sand with a maximum depth of 0.5m which gave way to a layer of black/grey bitumen stained material which contained frequent gravel inclusions (Plate 10). There was no archaeology encountered in this area.

Plate 10: Excavation 5; scale: 1x1m (archive reference: G2619\_039).

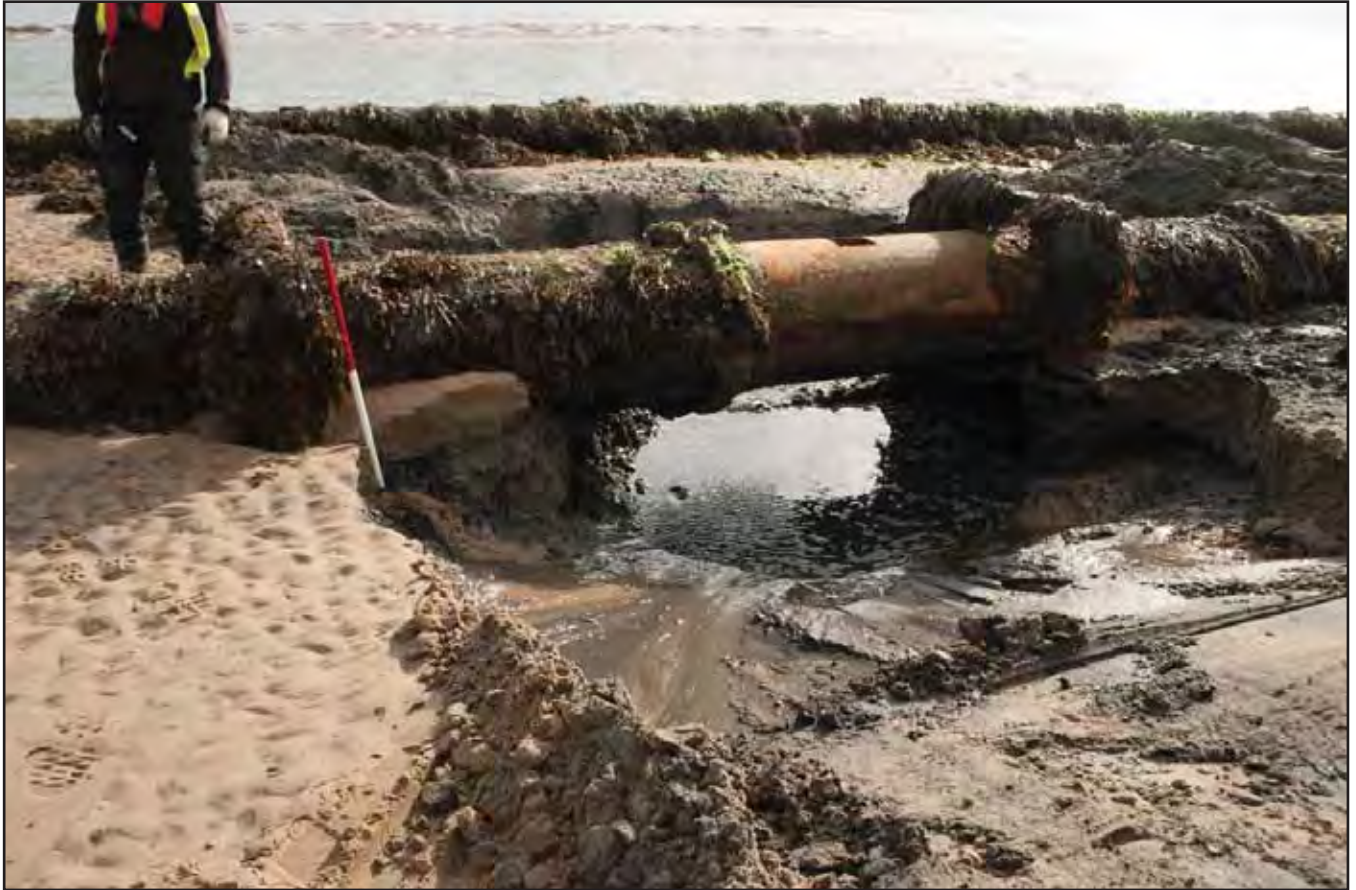
Excavation 6 revealed a layer of orange sand with a maximum depth of 0.25m which gave way to a layer of black/grey bitumen stained material which contained frequent gravel inclusions (Plate 11). There was no archaeology encountered in this area.

Plate 11: Excavation 6; scale: 1x1m (archive reference: G2619\_041).

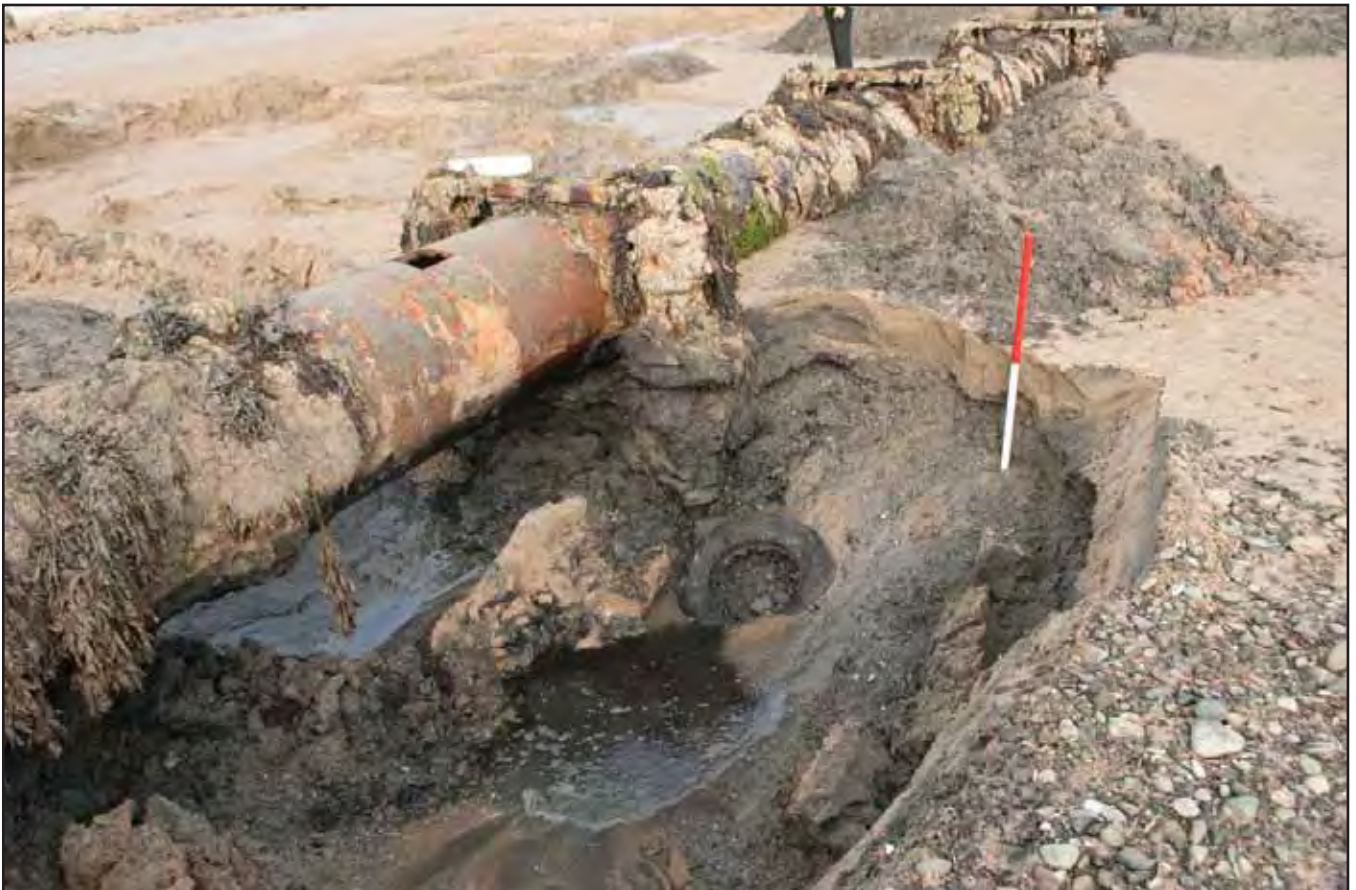
Excavation 6 revealed a layer of orange sand with a maximum depth of 0.25m which gave way to a layer of black/grey bitumen stained material which contained frequent gravel inclusions (Plate 12). There were a couple of tyres found within the upper part of the excavation. These are prevalent on the beach though it is unclear if they were dumped into the sea and have become trapped around the pipes or have been placed around the pipe for another purpose. There was no archaeology encountered in this area.

Plate 12: Excavation 7; scale: 1x1m (archive reference: G2619\_043).

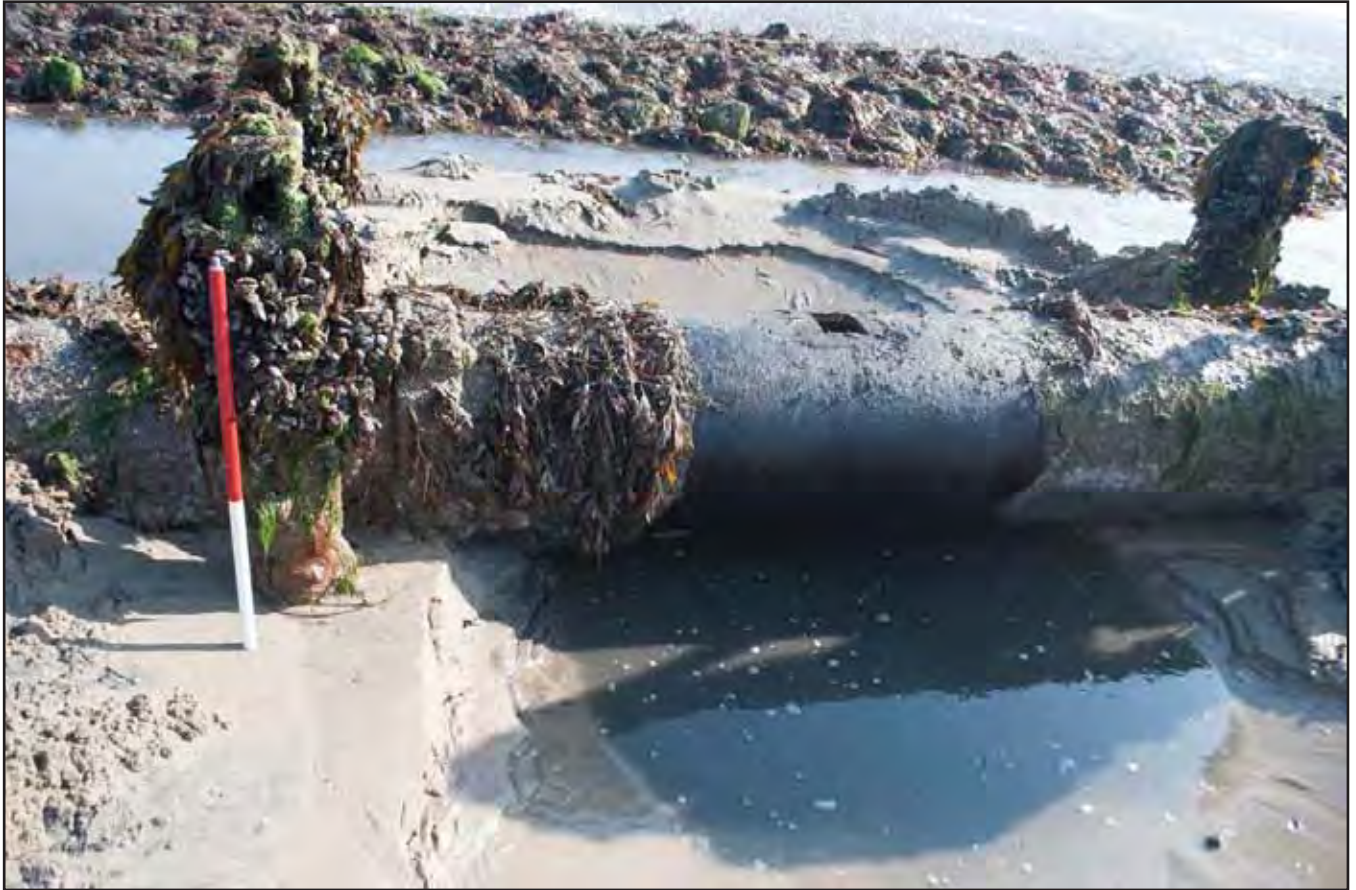
Excavation 6 revealed a layer of orange sand with a maximum depth of 0.4m which gave way to a layer of black/grey bitumen stained material which contained frequent gravel inclusions (Plate 13). There was no archaeology encountered in this area.

Plate 13: Excavation 8; scale: 1x1m (archive reference: G2619\_014).

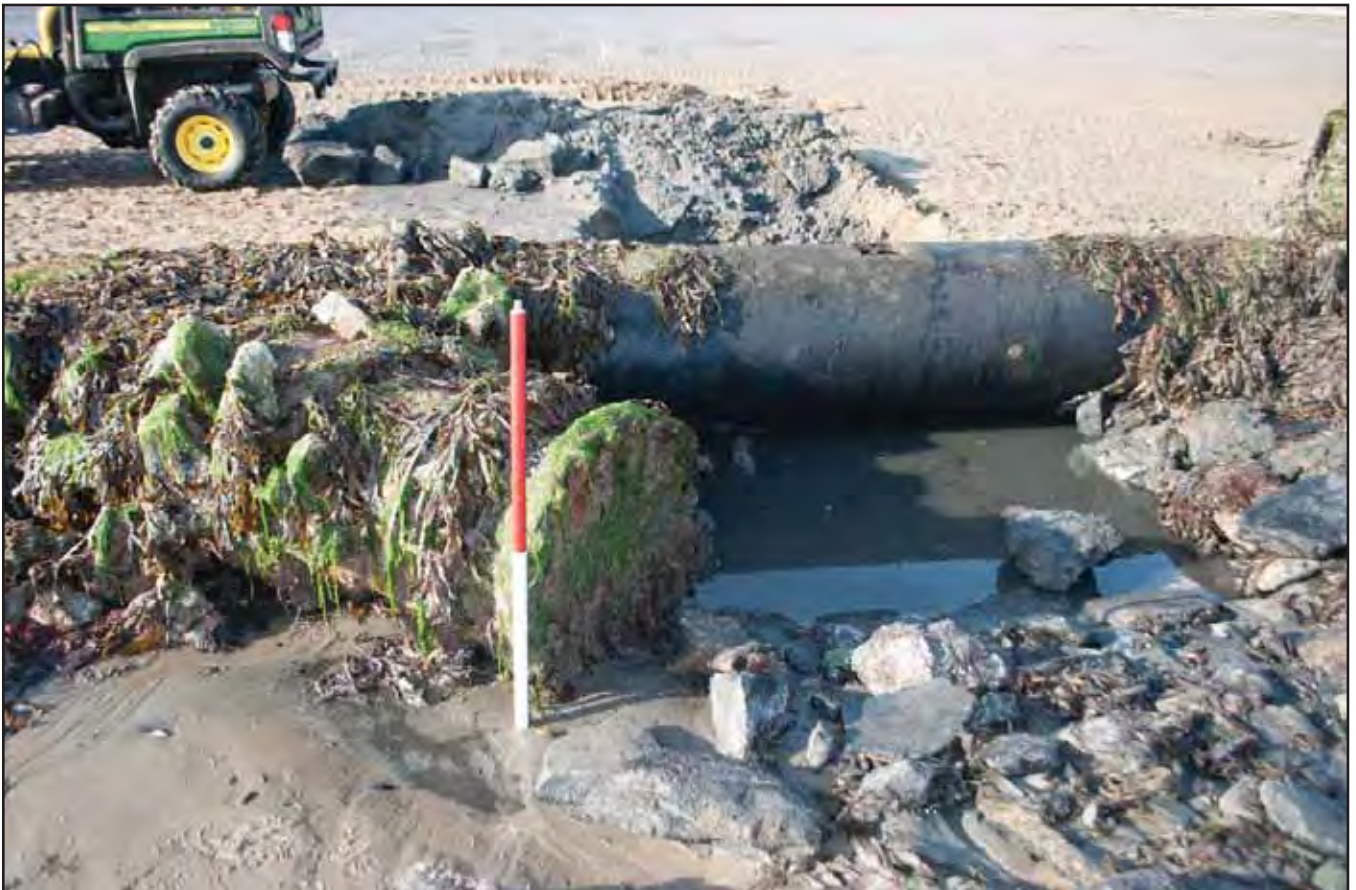
Excavation 9 was undertaken in an area where stones have collected to the south of the outfall pipe with some encrusted to the pipe itself (Plate 14). This is partly due to the metal and concrete remains associated with an obsolete connection between the 1845 and 1876 pipes (Plate 15). The orange sand in this area had a maximum depth of 0.3m and gave way to a layer of black/grey bitumen stained sand which contained frequent gravel inclusions and larger stones on the southern side of the pipe (Plate 16). During the watching brief on the 30<sup>th</sup> July 2019, a 3.5m long piece of timber was noted lying between excavations 9 and 10. It tapered along its length and was broken at both ends. There were worked holes spaced roughly 0.4m apart along its length, some square and some round (Plate 17). The wood was not noted during any of the previous visits and is not from a secure context therefore it is considered to be driftwood of unknown purpose. There was no archaeology encountered in this area.

Plate 14: Stones encrusted to outfall pipe; scale: 1x1m (archive reference: G2619\_019).
