# ARLLWYSFA GANOL, LLANDUDNO/ GANOL OUTFALL, LLANDUDNO

Briff Gwyllo Archeolegol/  
Archaeological Watching Brief

Prosiect Rhif / Project No. G2619

Adroddiad Rhif / Report No. 1509

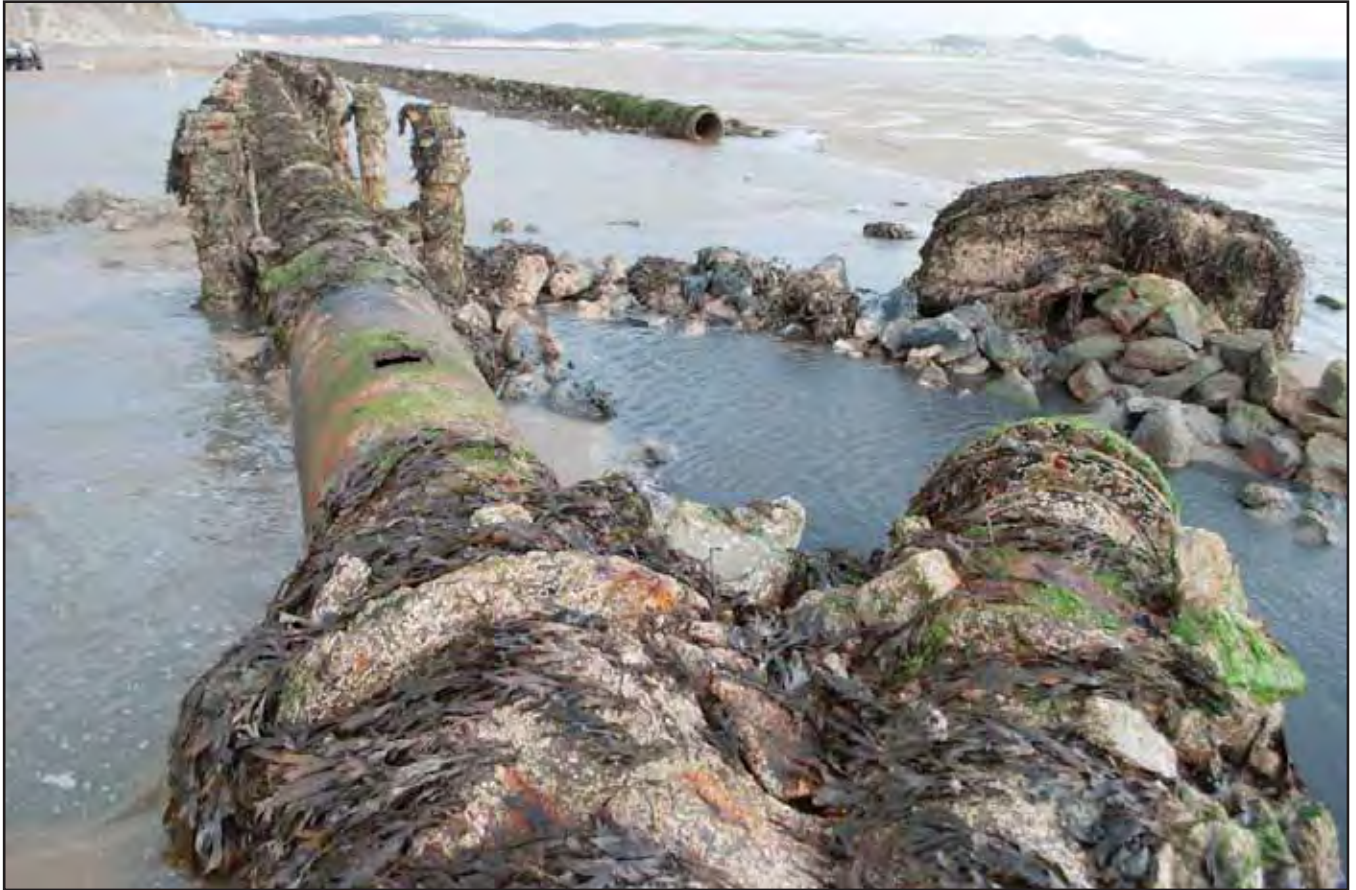
Plate 15: Stones collecting around obsolete pipe connexion; no scale (archive reference: G2619\_052).

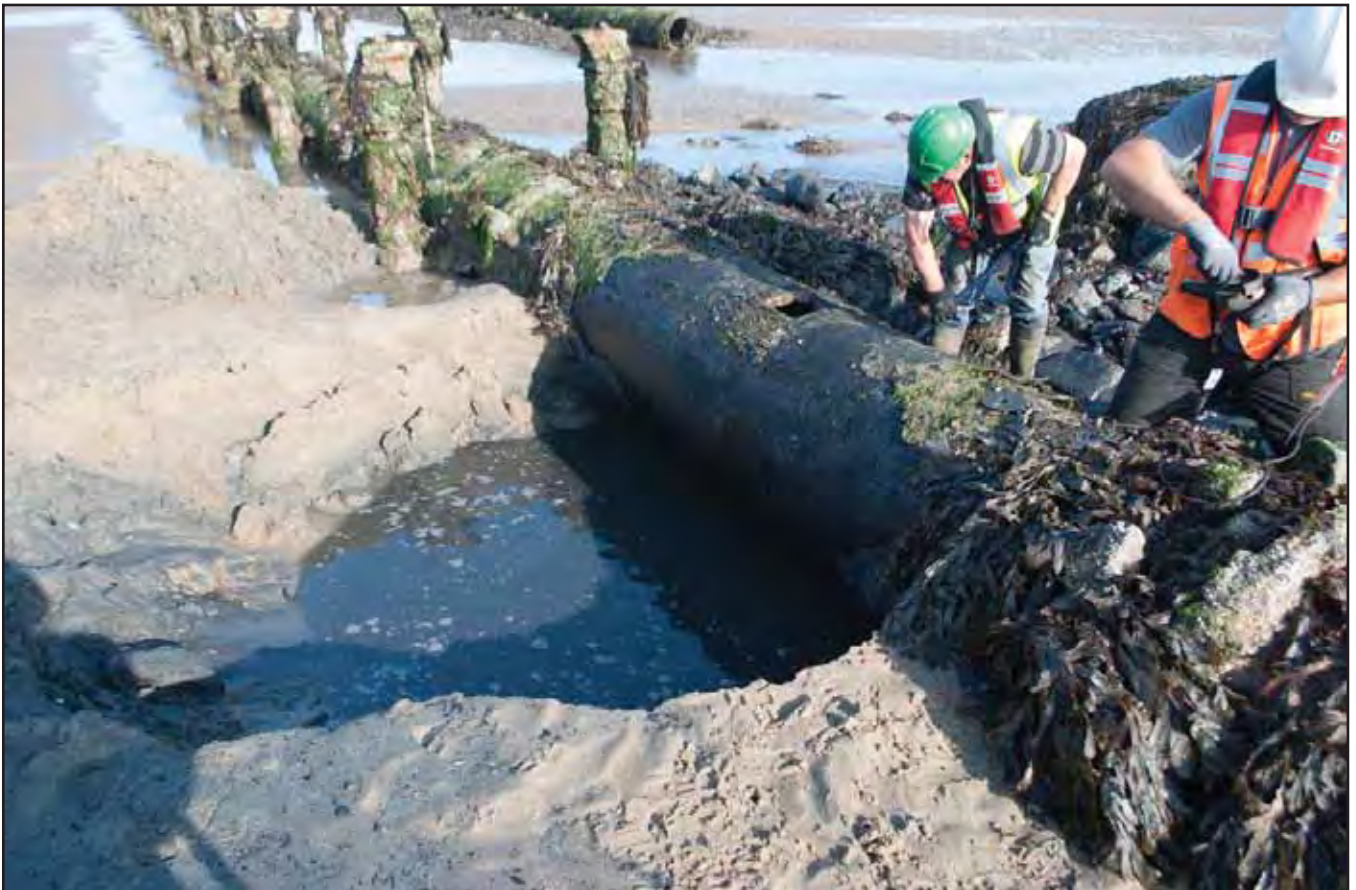
Plate 16: Excavation 9; no scale (archive reference: G2619\_015).

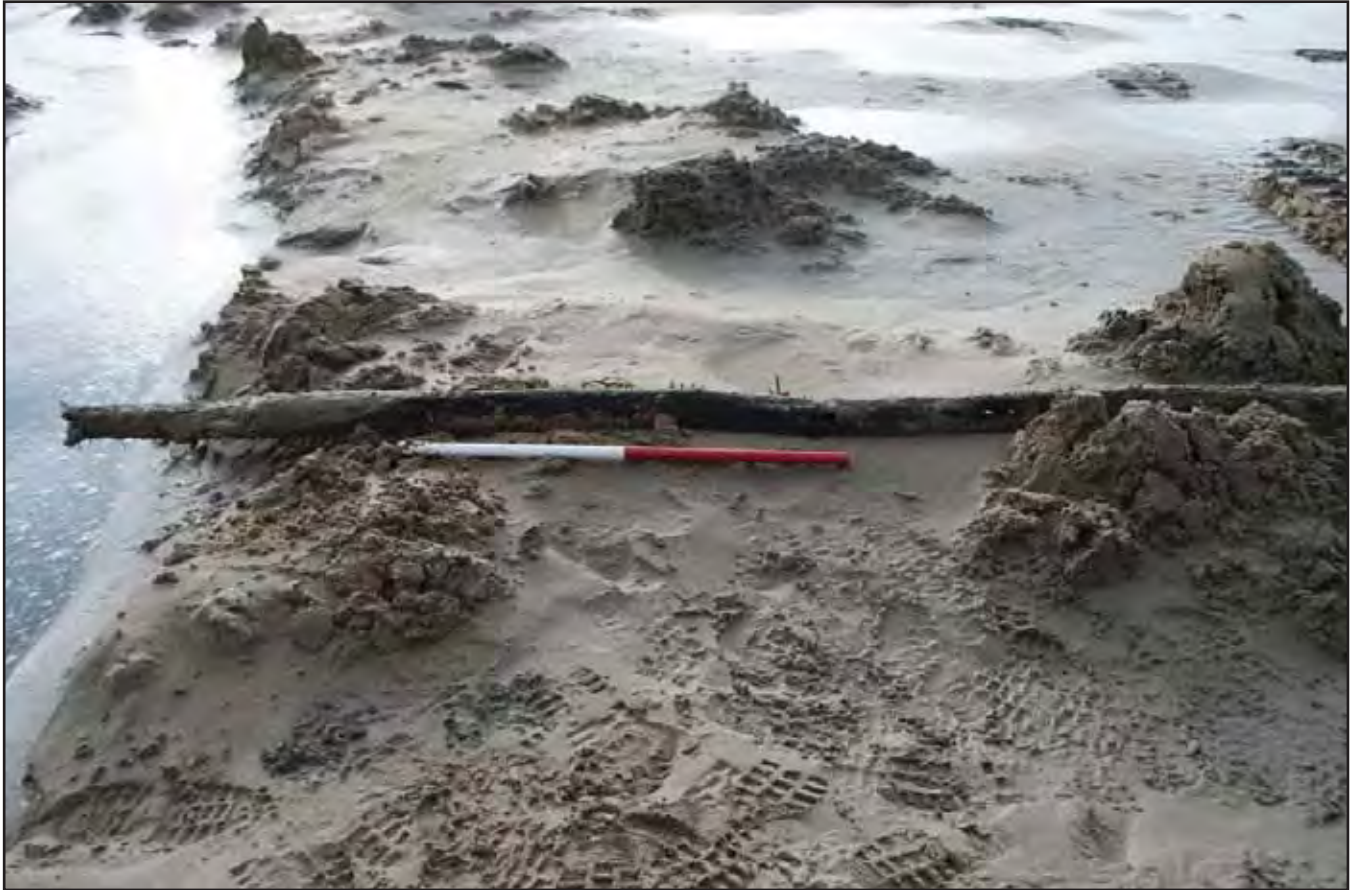
Plate 17: Timber found between excavations 9 and 10; scale: 1x1m (archive reference: G2619\_057).

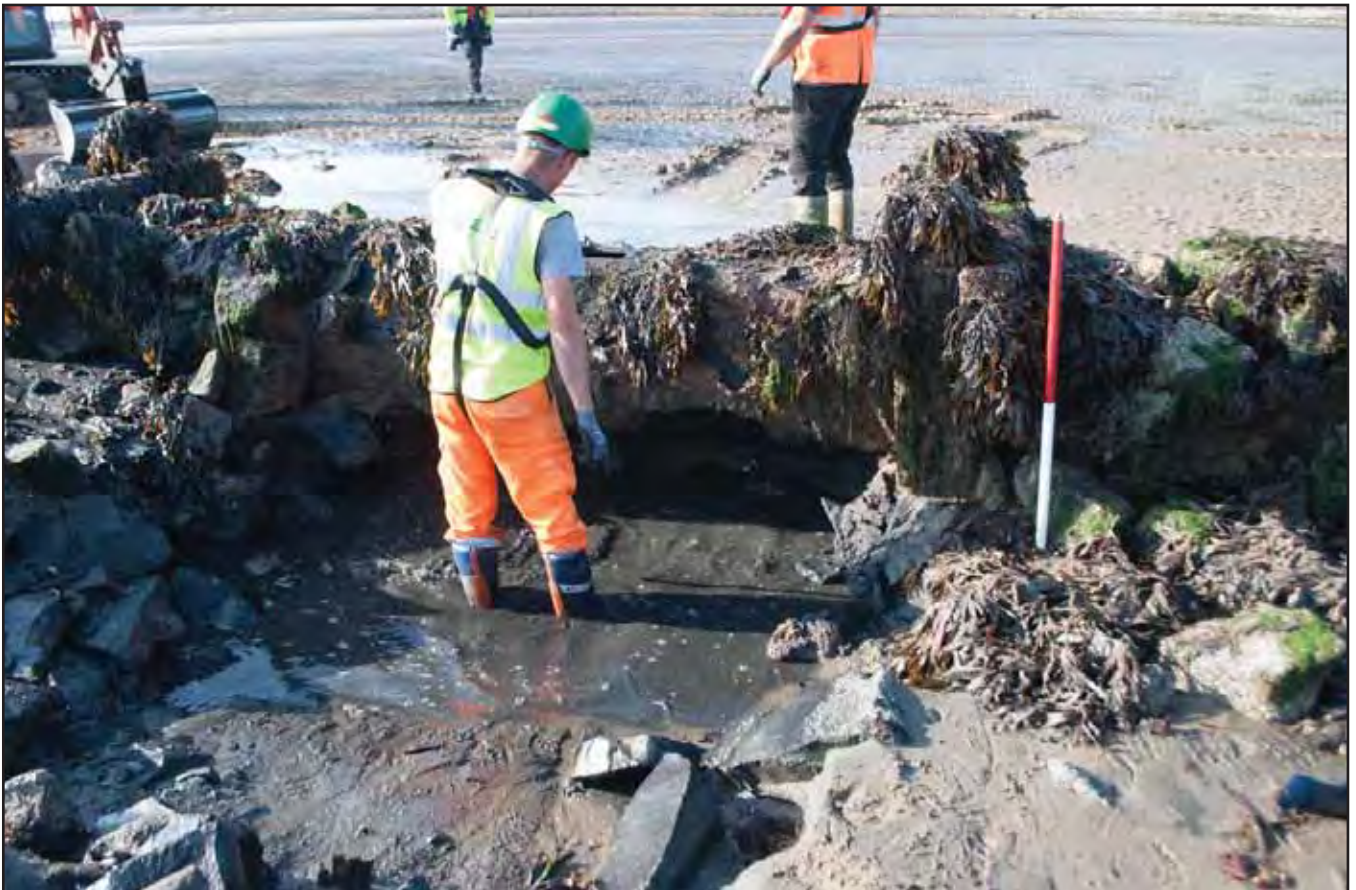
Excavation 10 was undertaken in an area where stones have collected to the south of the outfall pipe with some encrusted to the pipe itself. The orange sand in this area had a maximum depth of 0.3m and gave way to a layer of black/grey bitumen stained sand which contained frequent gravel inclusions and larger stones on the southern side of the pipe (Plate 18). There was no archaeology encountered in this area.

Plate 18: Excavation 10; scale: 1x1m (archive reference: G2619\_017).

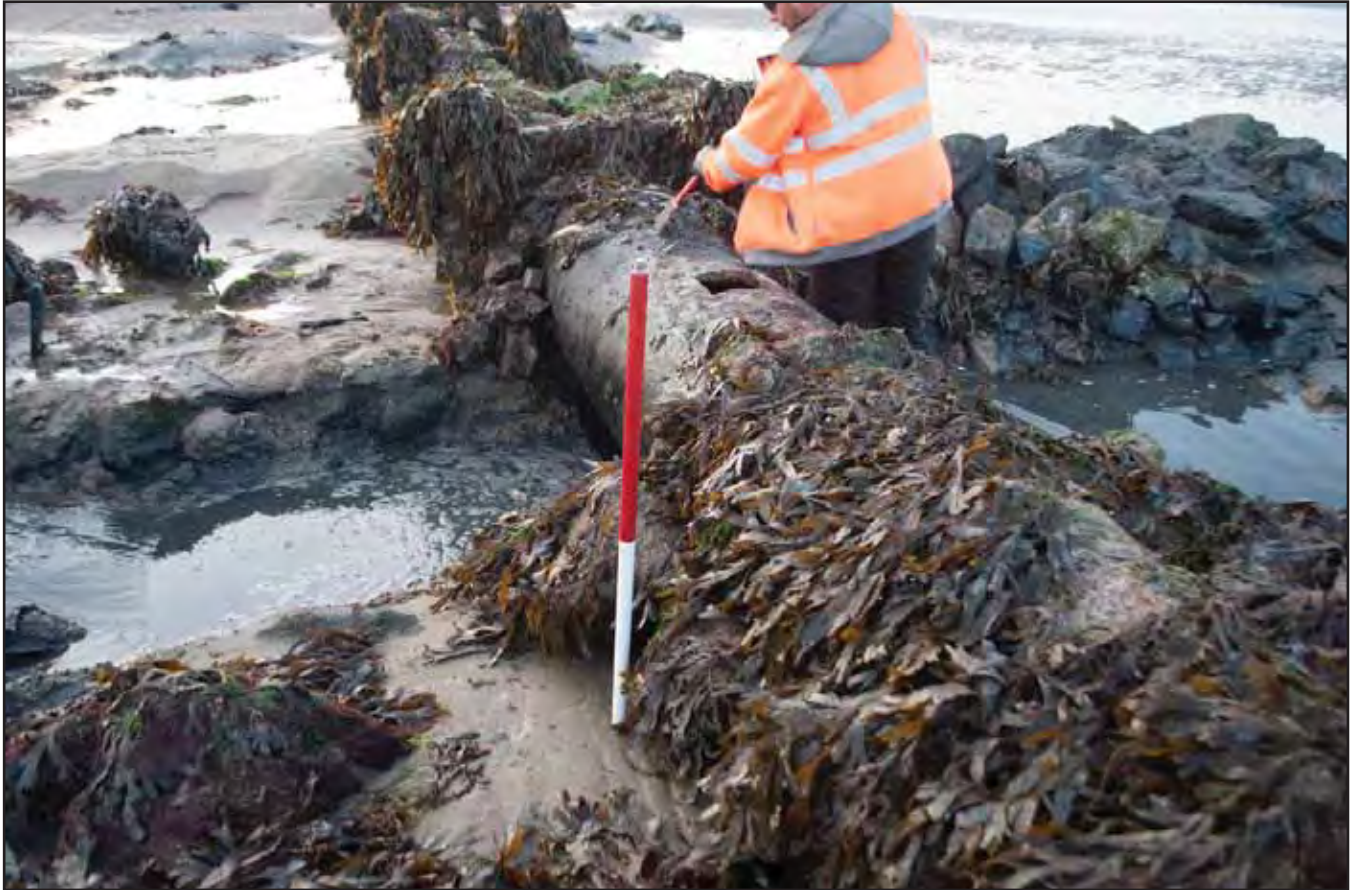
Excavation 11 was undertaken in an area where stones have collected to the south of the outfall pipe with some encrusted to the pipe itself. The orange sand in this area had a maximum depth of 0.25m and gave way to a layer of black/grey bitumen stained sand which contained frequent gravel inclusions and larger stones (Plate 19 & 20). There was no archaeology encountered in this area.

Plate 19: Excavation 11; scale: 1x1m (archive reference: G2619\_024).

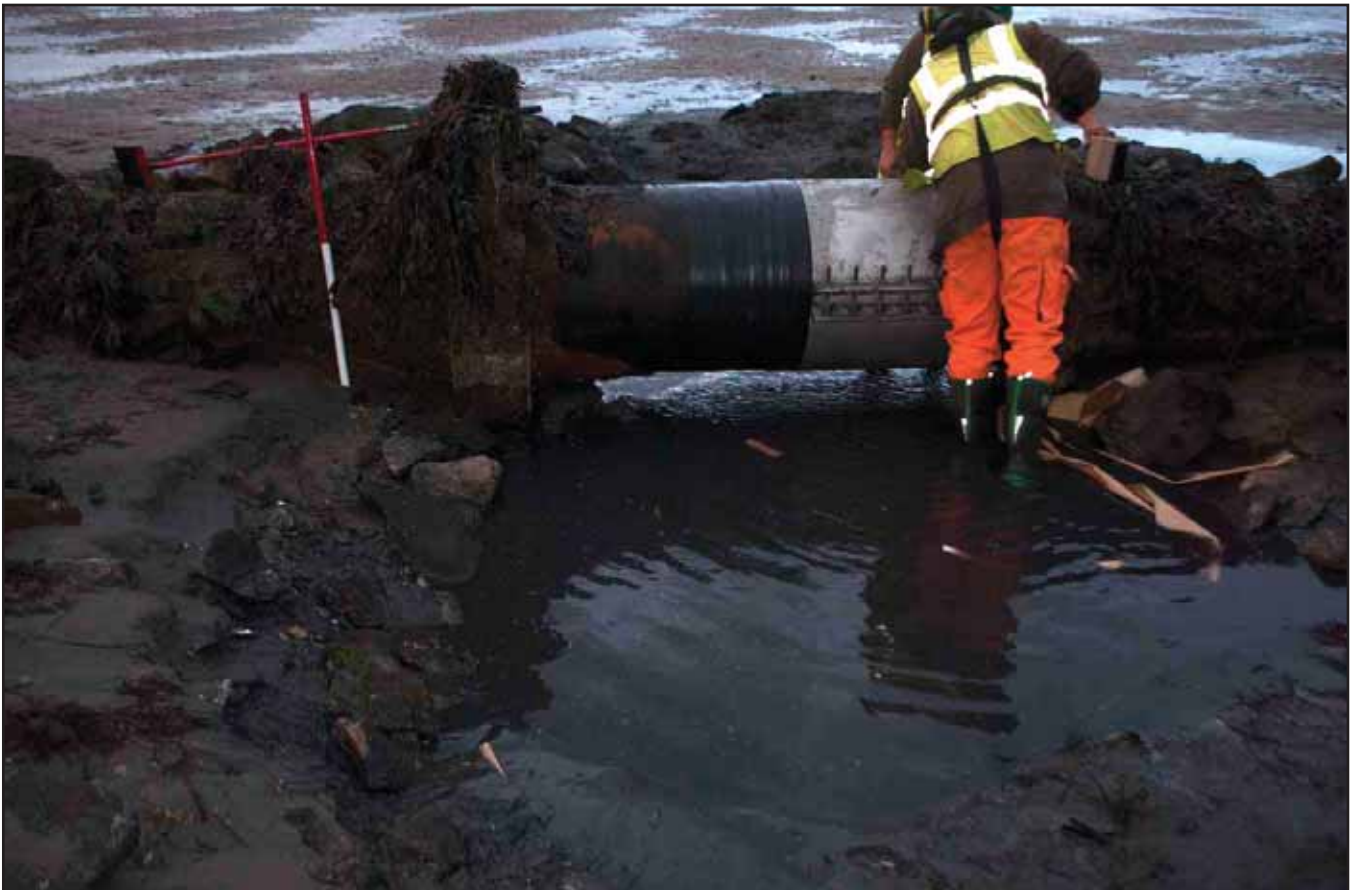
Plate 20: Excavation 11 showing repair; scale: 1x1m (archive reference: G2619\_061).

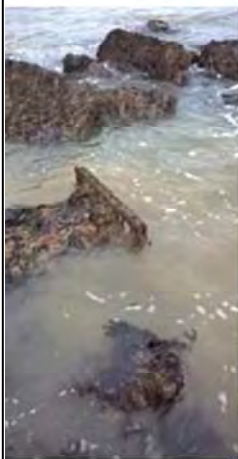
## **FIGURE 02**

**Location of archaeological features in relation to planned repairs, based on DCWW Drawing No: 4599.S.201-ARP-07-01-DR-CD-05101. Scale: 1:5500@A4.**

New inline Tideflex valve on 27" dia outfall.  
Outfall end only visible at very low tides.

Example of previous repairs to the outfall

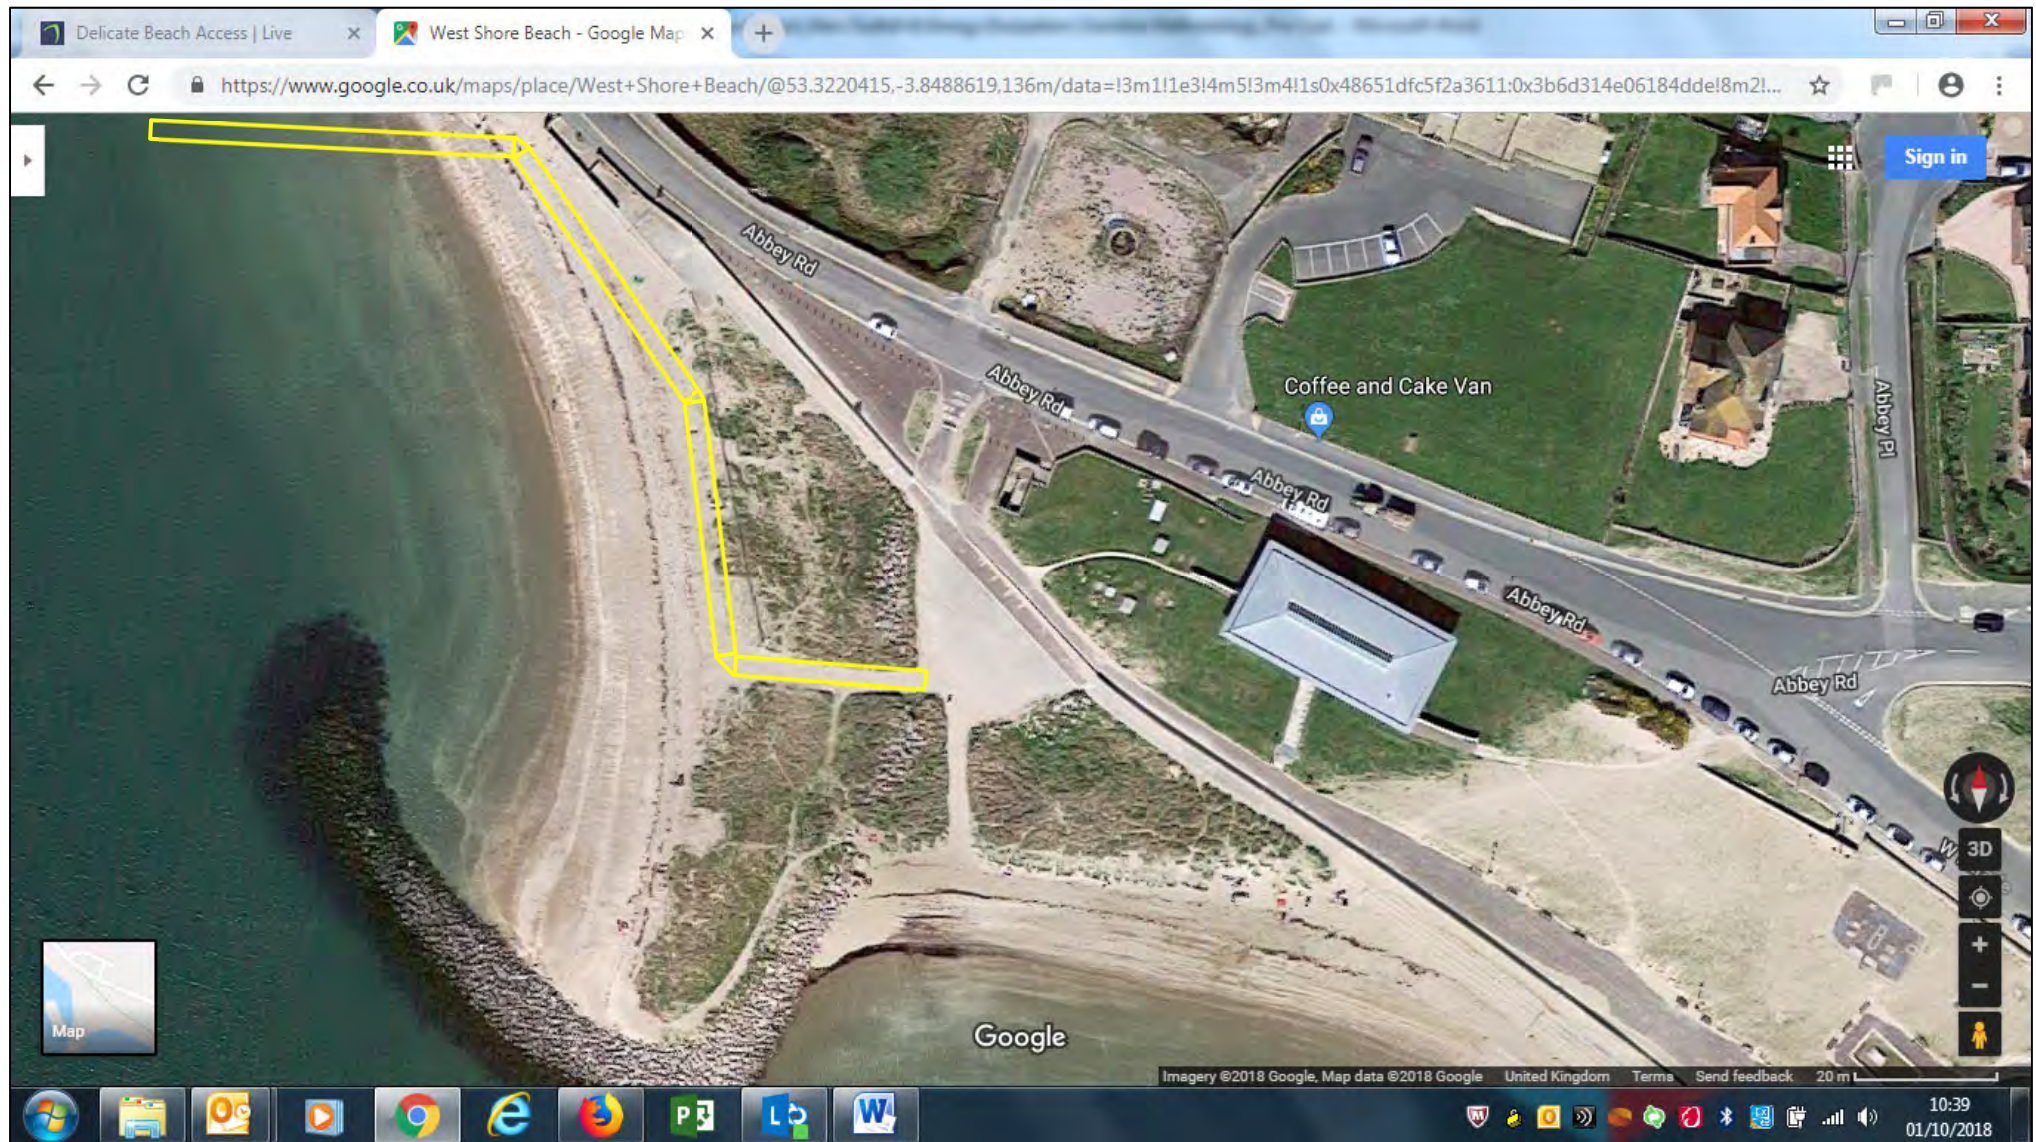
- The aluminium Trackway system is laid out ahead by a small excavator or lorry mounted crane working systematically out from already 'as-laid' panels until a roadway system has been established.

- Resistance from tidal forces will be achieved by siting heavy kentledge concrete blocks onto the Trackway surface to weigh it down between tides. Numbers and spacings of the concrete kentledge blocks will be indicated by a temporary works design carried out in advance of the works.

Trackway Installation onto the Upper Beach Level

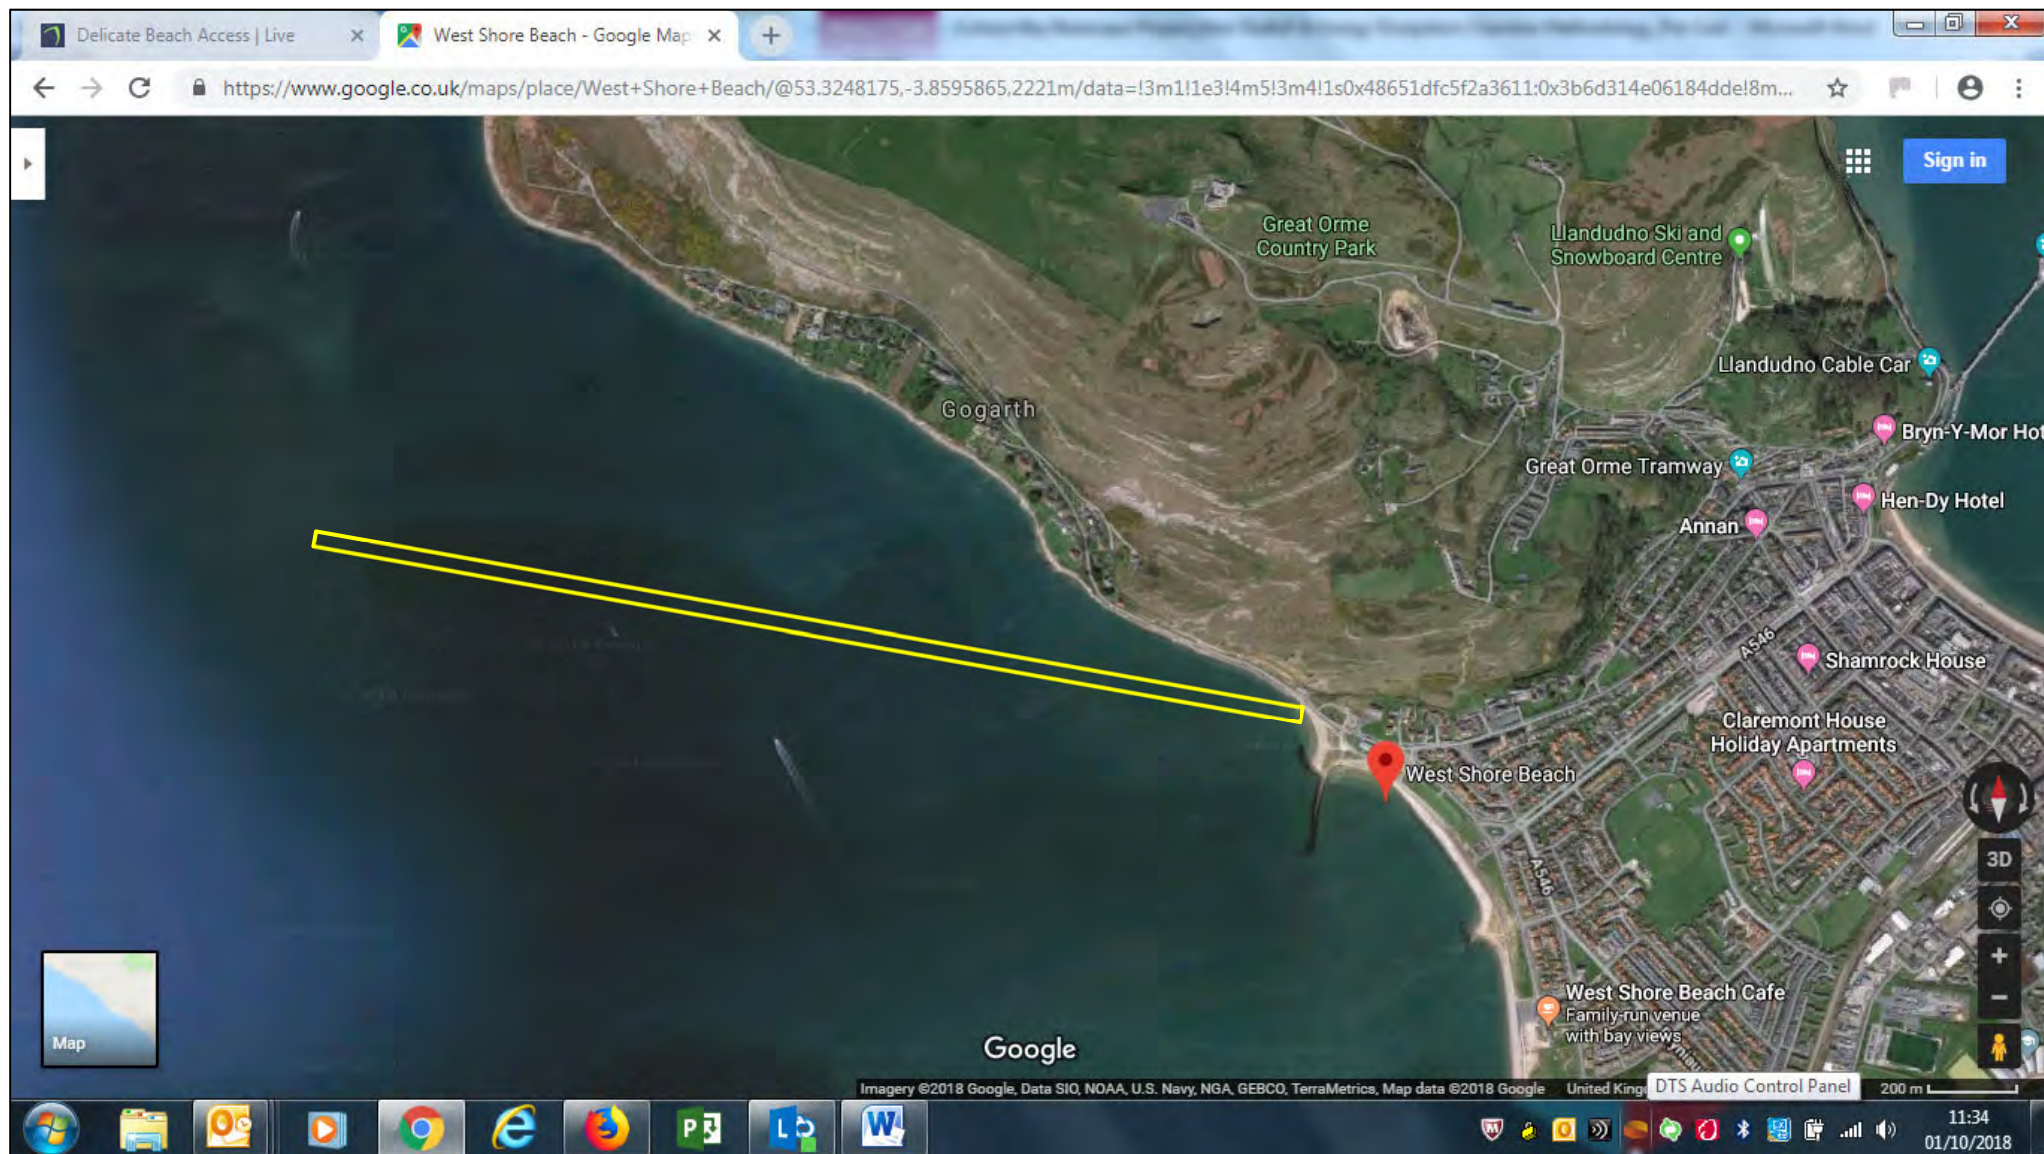
Trackway Installation from the Upper Beach Level to the end of the Short Sea Outfall

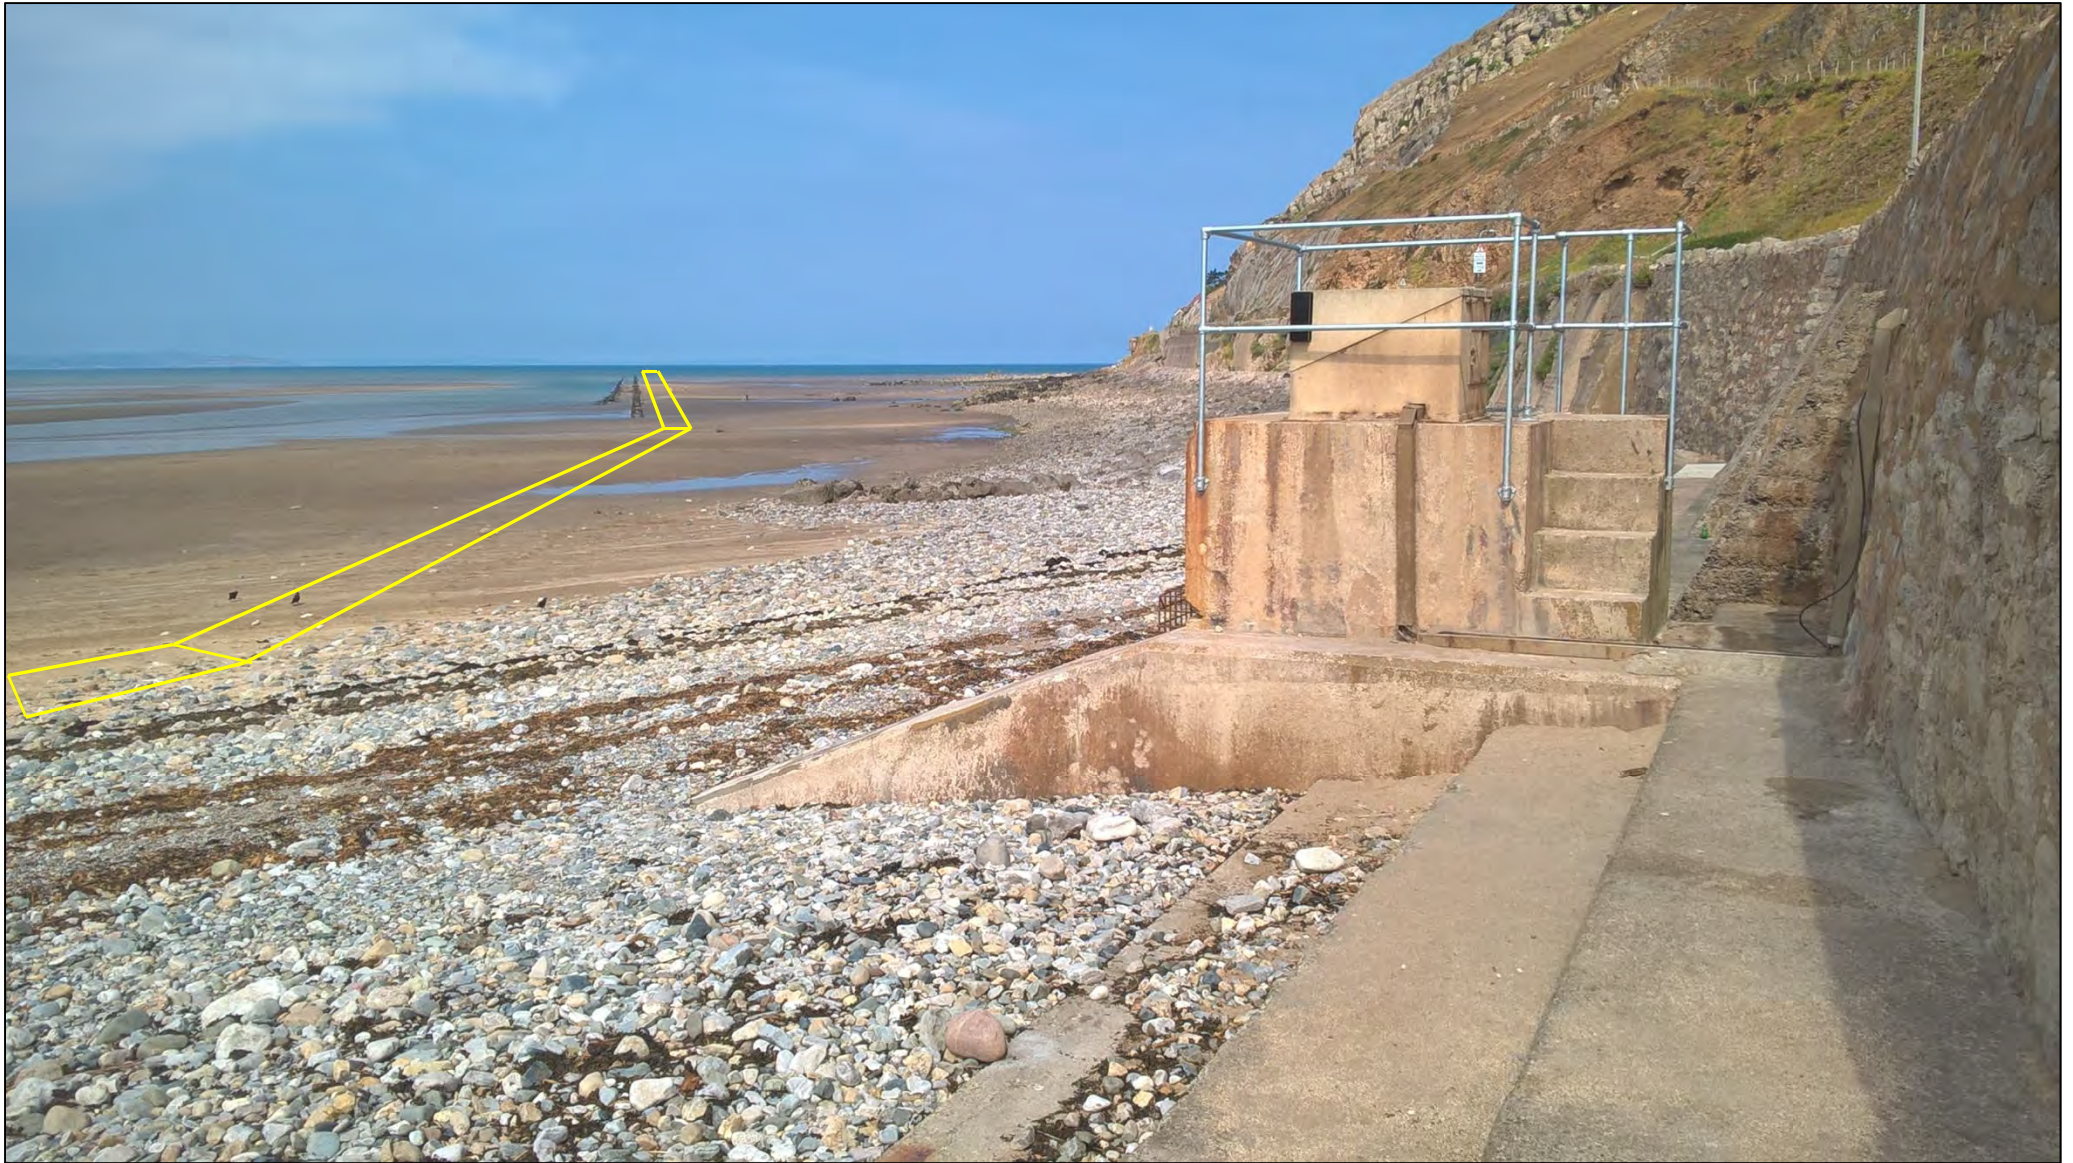
Approximate depiction of Trackway Route from the Upper Beach Level to the end of the Short Sea Outfall – Approximately 2000 metres

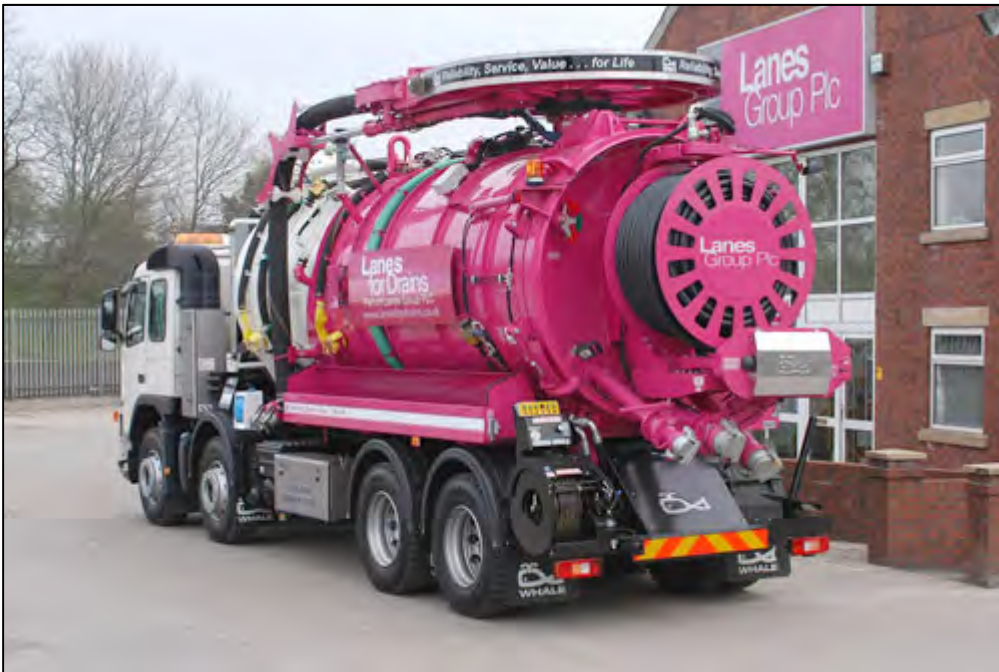
- On completion of the installation of the Trackway temporary roadway system as depicted and described above, the survey and cleansing operations can begin.
- A mobile lorry mounted jetting unit will be deployed to jet and flush the existing short sea outfall at pre-determined access points approximately 400m apart

- Utilising and re-cycling sea water, the jetting unit using high pressure heads will systematically jet clean each 400m length by flushing and vacuuming the inside of the existing short sea outfall pipe. The sands retrieved from the pipe line will be deposited next to the trackway onto the existing shore such that the incoming tide will sufficiently spread and disperse the material.
- CCTV cameras, similar to the pictures below, will then be introduced into the pipeline at the pre-determined access points to record and capture images of the inside wall of the pipeline for technical analysis and designer recommendations.

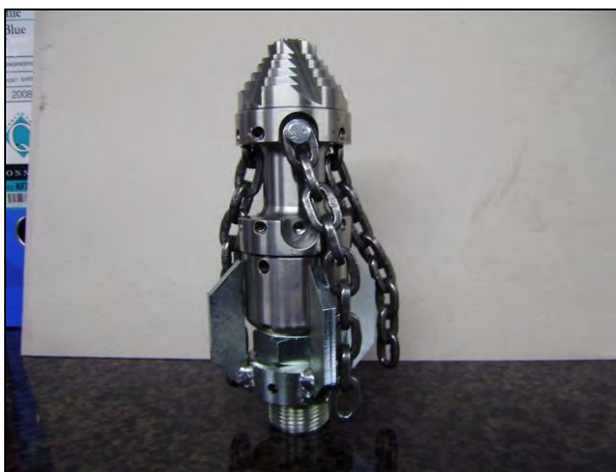
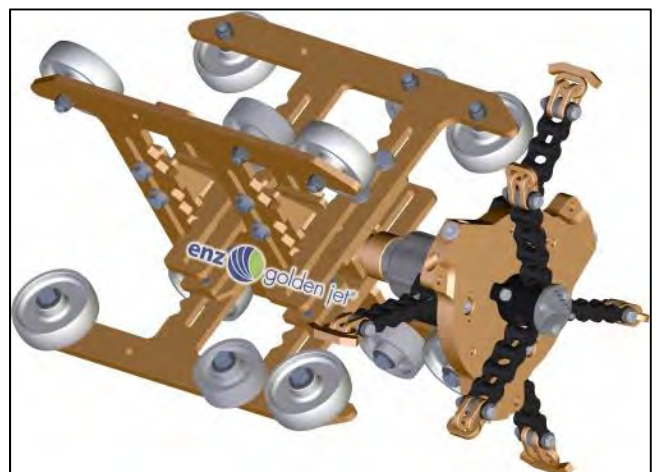
- The existing short sea outfall pipeline is known to be heavily encrusted with barnacles which in turn reducing the functionality of the pipeline and reducing the optimum flow rates able to be achieved. It is suspected that chain flailing will be required to remove and scour clean the inside diameter of the pipeline.
- Based on the images captured and the designer recommendations, all or parts of the existing short sea outfall will require chain flailing to remove the build-up on the inside wall of the pipeline to achieve a smooth hydraulically efficient bore.
- Using the same lorry mounted jetting unit pictured above, a specialist chain flail head will be attached to the jetting hose, similar to the ones depicted below, which will travel along each 400m section of pipeline scouring clean the inside wall of the pipeline.

- The debris will be jetted backwards to the insertion point where a vacuum pipe will suck up the material for disposal to a licensed tip off site.

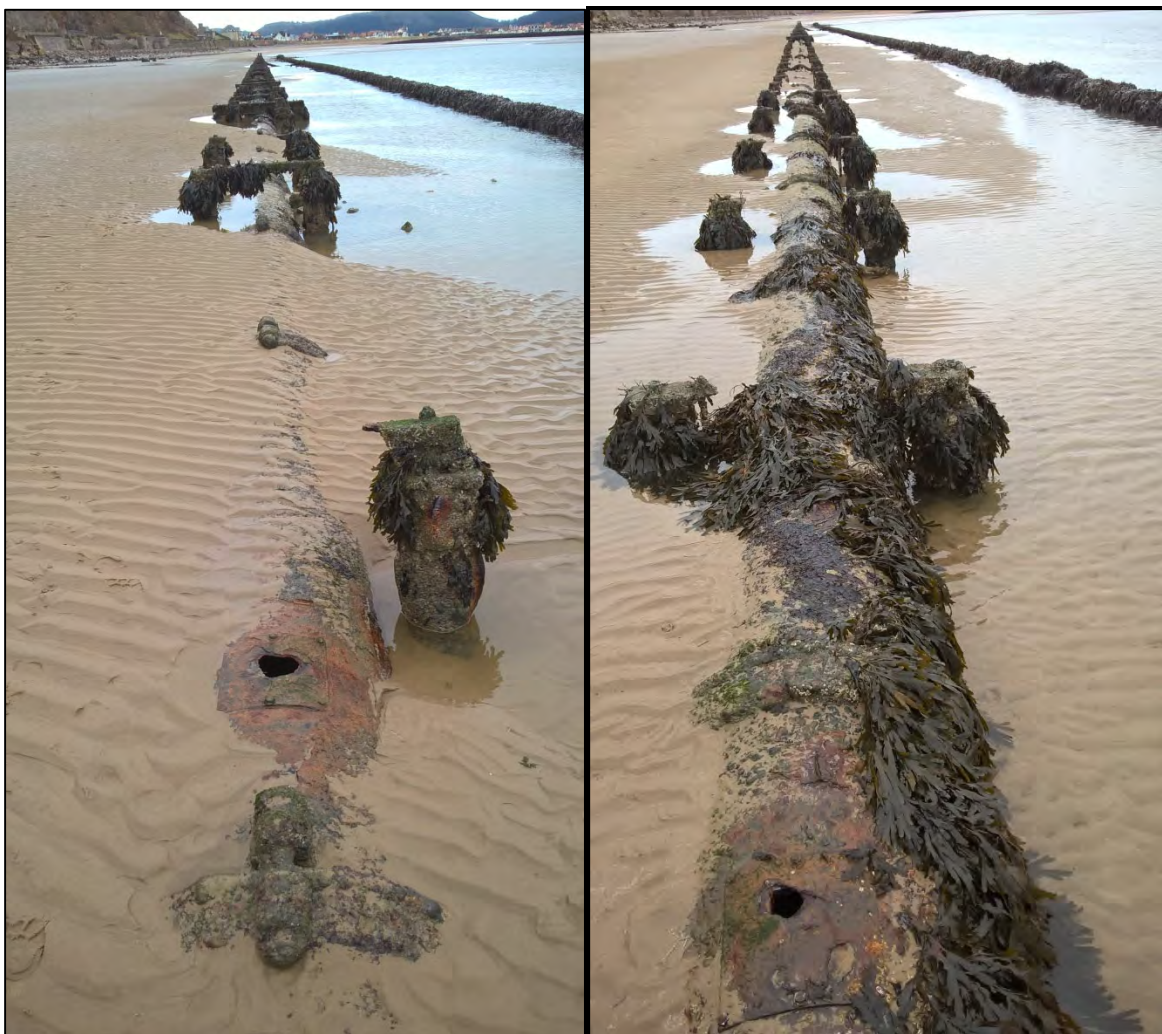
- Along the existing short sea outfall there have, in the past, been holes cut in the crown of the pipeline which will (a) possibly be enlarged for camera/jetting head insertion and/or (b) be repaired on completion whether used for camera insertion or not.
- The photos below are an example of such holes which, if fall at the desired 400m interval, will be enlarged and utilised for camera insertion – if these pre-existing holes do not fall at the desired spacing they will be ignored and repaired as part of the short sea outfall rehabilitation exercise.

- Holes will be required at 400m intervals and will be opened up as new or existing holes enlarged depending on the distances currently insitu.
- Whether enlarging the existing holes or cutting new holes, the process will be the same. A portable 'cut off' Stihl saw or similar will be used to cut a hole in the crown of the pipe approximately 600mm long and half the diameter of the pipe. The section of pipe will be transported along the Trackway for disposal to tip off site.

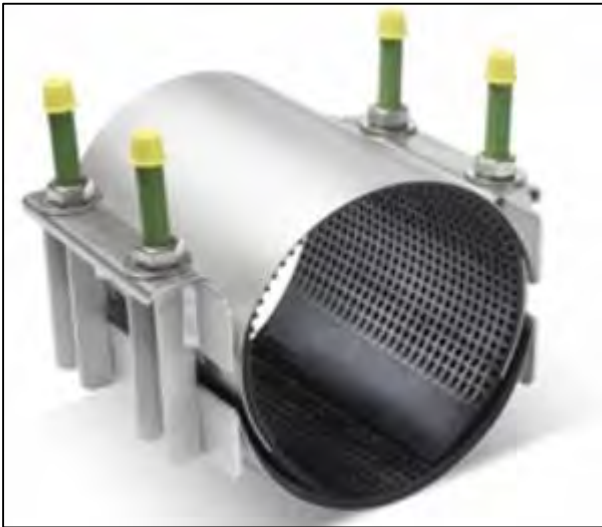
- Upon completion of the jetting and cleaning works each access hole will be required using a pre-made stainless steel clamp, similar to the one depicted below.

- The stainless steel clamps will be pre-made off site and delivered to the required location along the existing pipeline utilising the temporary Trackway roadway system.

- A small hole may need to be excavated beneath the Short Sea Outfall pipeline to facilitate all round access for the fitting of the stainless steel repair clamp. As required, excavations beneath the pipeline will be carried out by an 8t or 13t 360 degree rubber tracked or wheeled backacter and the sand arisings will be side cast and deposited onto the existing shore such that the incoming tide will sufficiently spread and disperse the material.

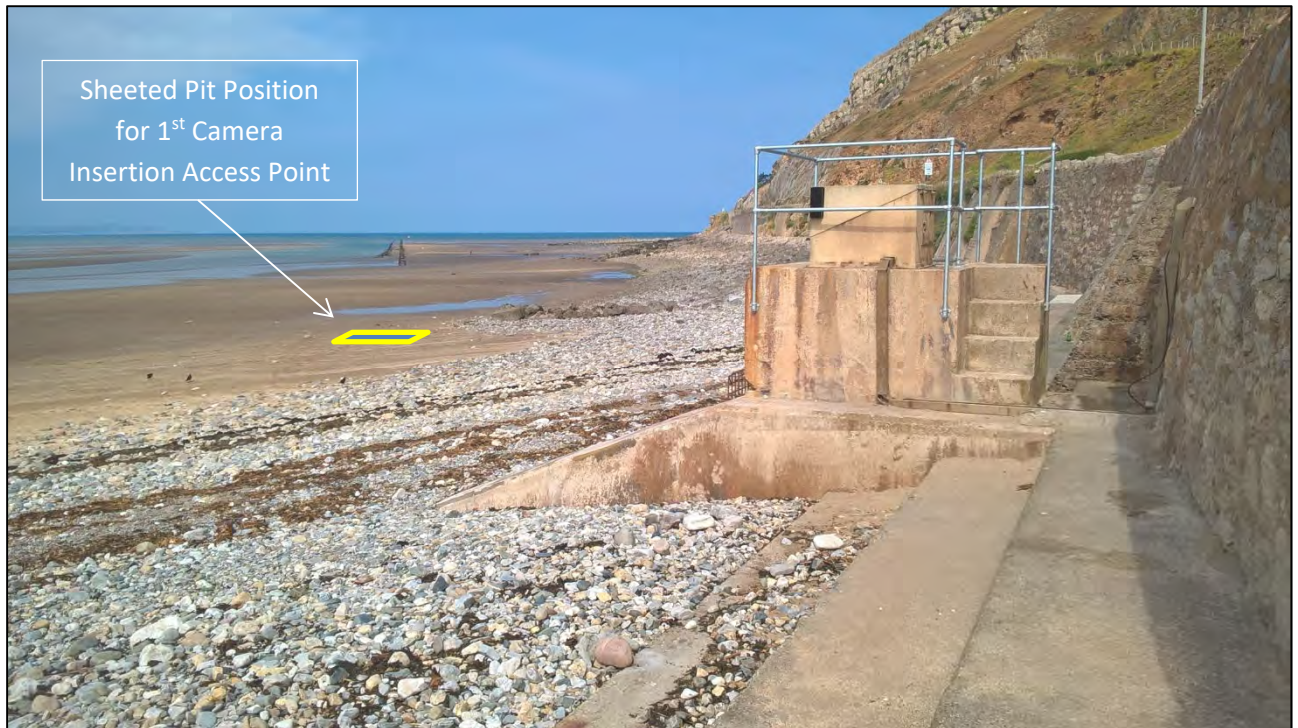
- The clamp will be positioned and fitted by two men utilising hand tools only.
- One camera insertion point, the first one, is at a position meaning that it is currently under sand in the upper beach area and will require a sheeted pit in order to safely provide access for the camera, jetting heads and the repair clamp to be fitted.

- The sheeted pit and installation method are as described and pictured below.

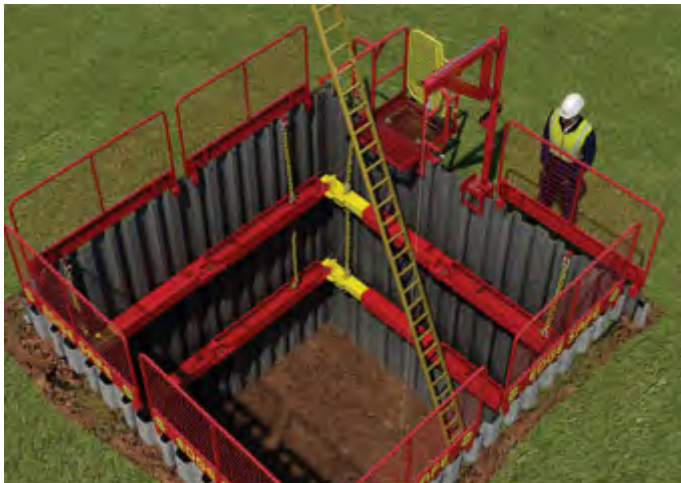
- The sheeted pit will be provided using lightweight trench sheets and hydraulic manhole braces similar to the depiction below.
- The sheeted pit will be constructed using traditional dig and push installation techniques

- The sheeted pit will be constructed using an 8t or 13t 360 degree rubber tracked or wheeled backacter working from the Trackway temporary roadway or on the shoreline of the upper beach level.
