TROS YR AFON LLANWRST

BRIFF GWYLIO ARCHAEOLOEGOL/ ARCHAEOLOGICAL WATCHING BRIEF

Prosiect Rhif / Project No. G2599

Adroddiad Rhif / Report No. 1517

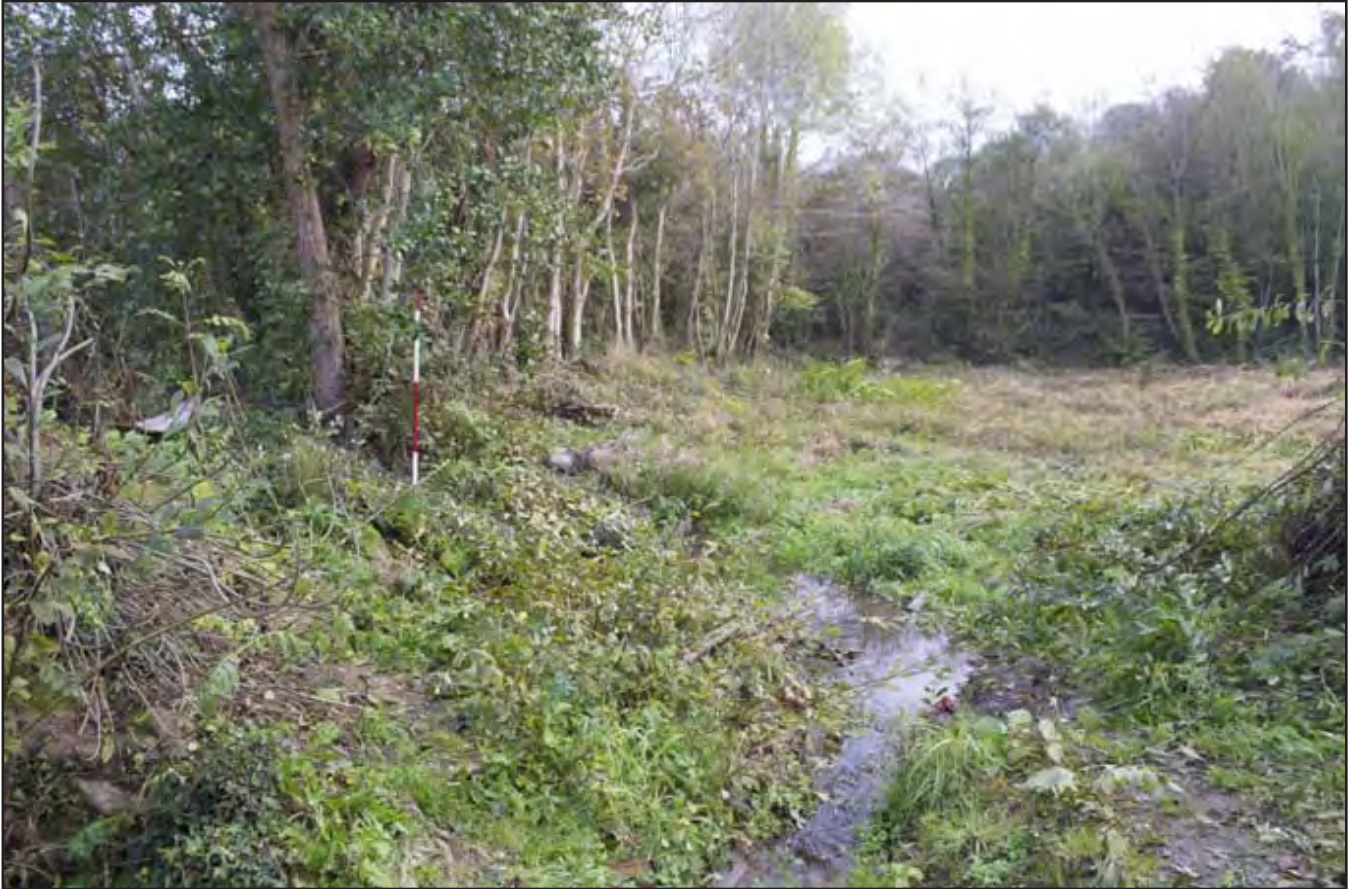
Plate 01: View of vegetation covering the northern bank; scale: 1x2m (archive reference: G2599_015).

The northern bank of the mill pond is still clearly discernible though it is completely covered by large trees, ivy and other vegetation (Plate 01). The northern bank survives to a length of c.50m. A footpath runs along the northern side of the mill pond bank. The external structure of the northern bank is completely obscured by vegetation.

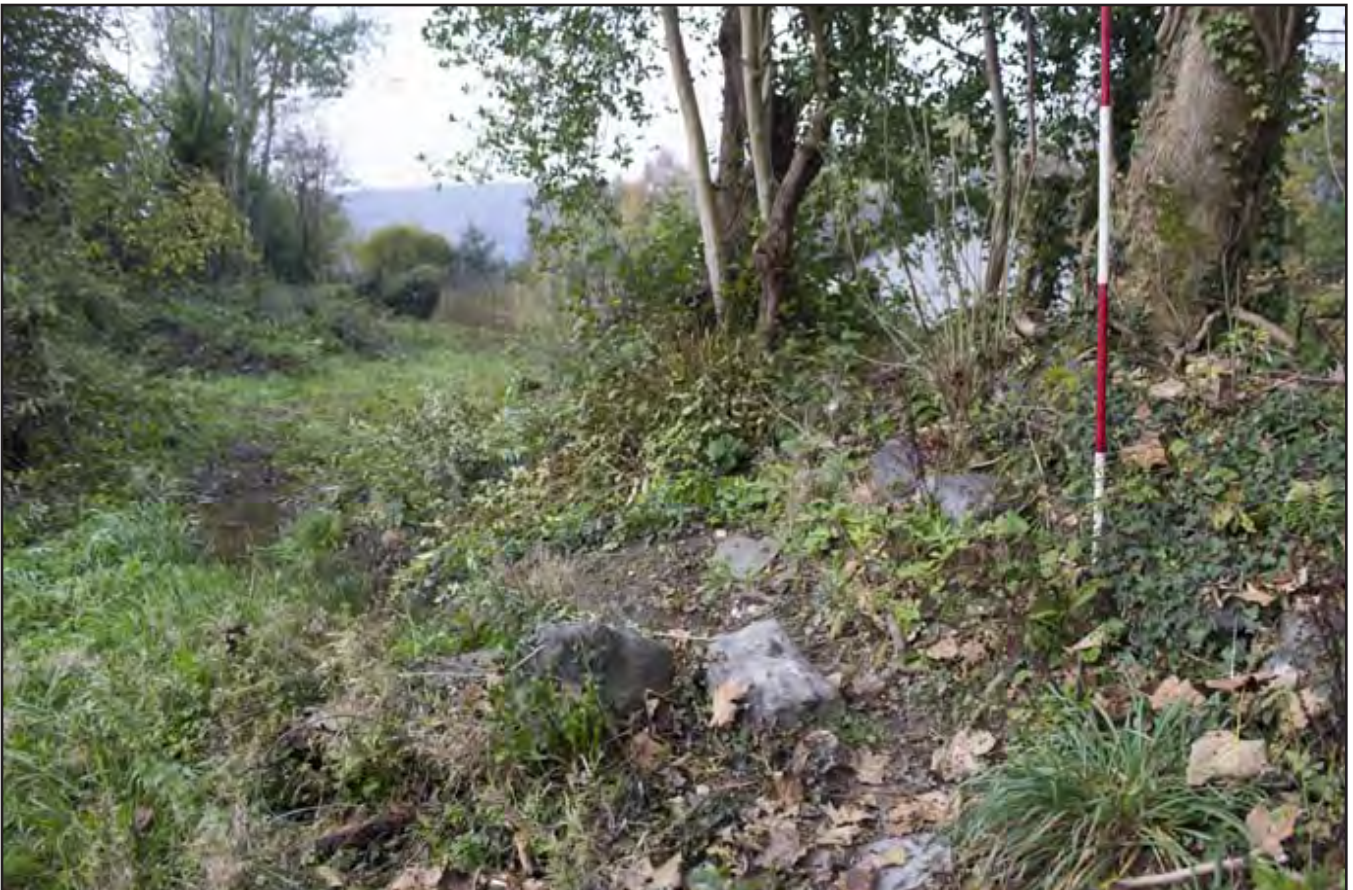
Plate 02: Revetment stones not in situ; scale: 1x2m (archive reference: G2599_018).

There are numerous large stones visible some still in situ and some in close proximity to the bank. These were revetment some of which have been displaced by the tree roots and undergrowth (Plate 02). With the stone revetment compromised, the bank appears to have 'slumped' in places. Some in situ stones are noted (Plate 03). There are 2 'informal' access routes into the main pond across the bank. These are clearly discernible due to the lower vegetation coverage and slightly eroded bank (Plate 04). These informal access routes are situated approximately 25m and 43m down the northern bank when measured from the western end. The top of the bank is only an average of 0.4m higher than the internal ground level suggesting a large amount of 'made ground' present internally.

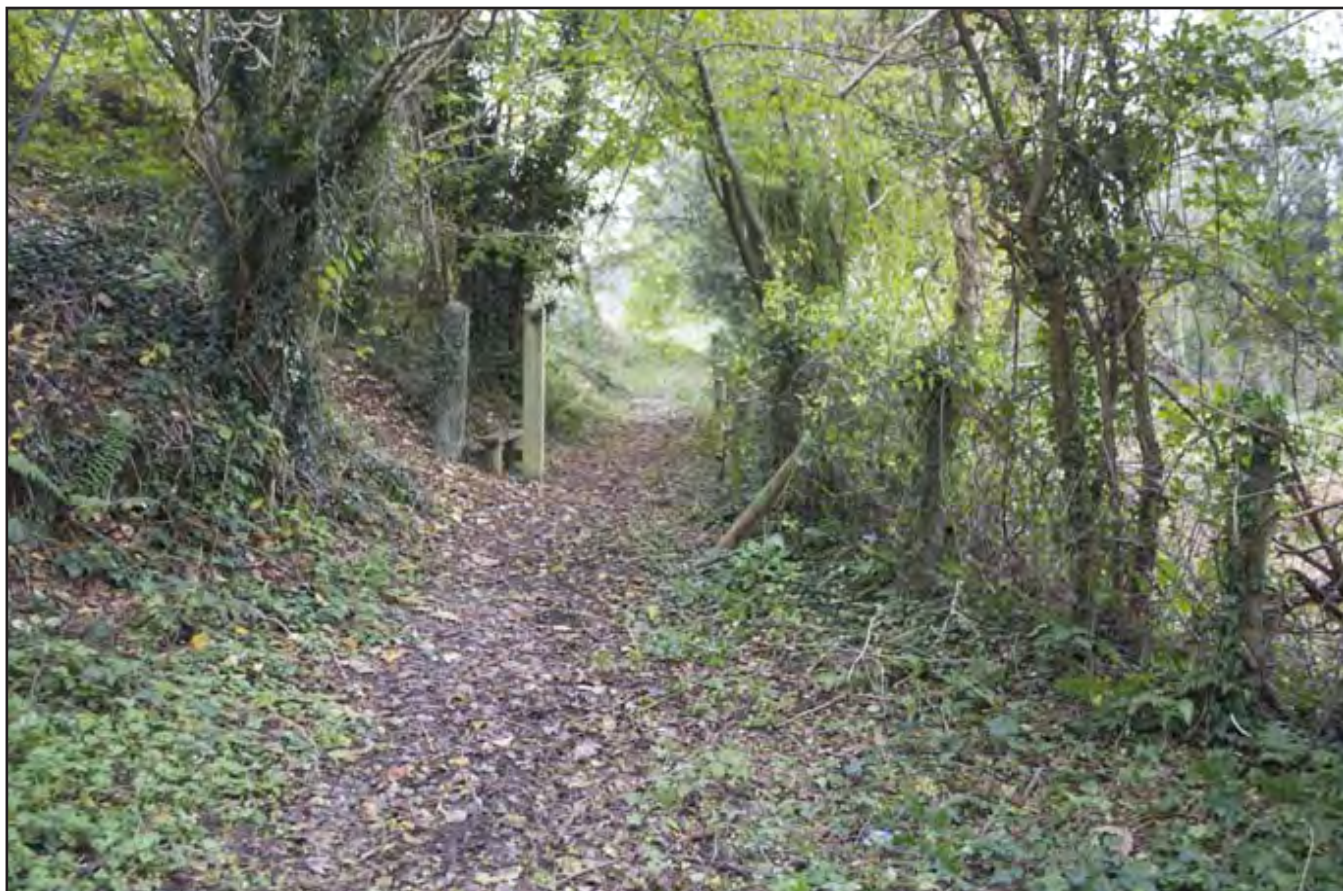
Plate 05: Footpath on eastern bank; no scale (archive reference: G2599_044).

The footpath noted along the northern bank continues along the eastern bank (Plate 05). The footpath is at the same height at the top of the bank which is approximately 2m above the internal ground level of the mill pond. No revetment is visible on top of the bank due to the trees and undergrowth.

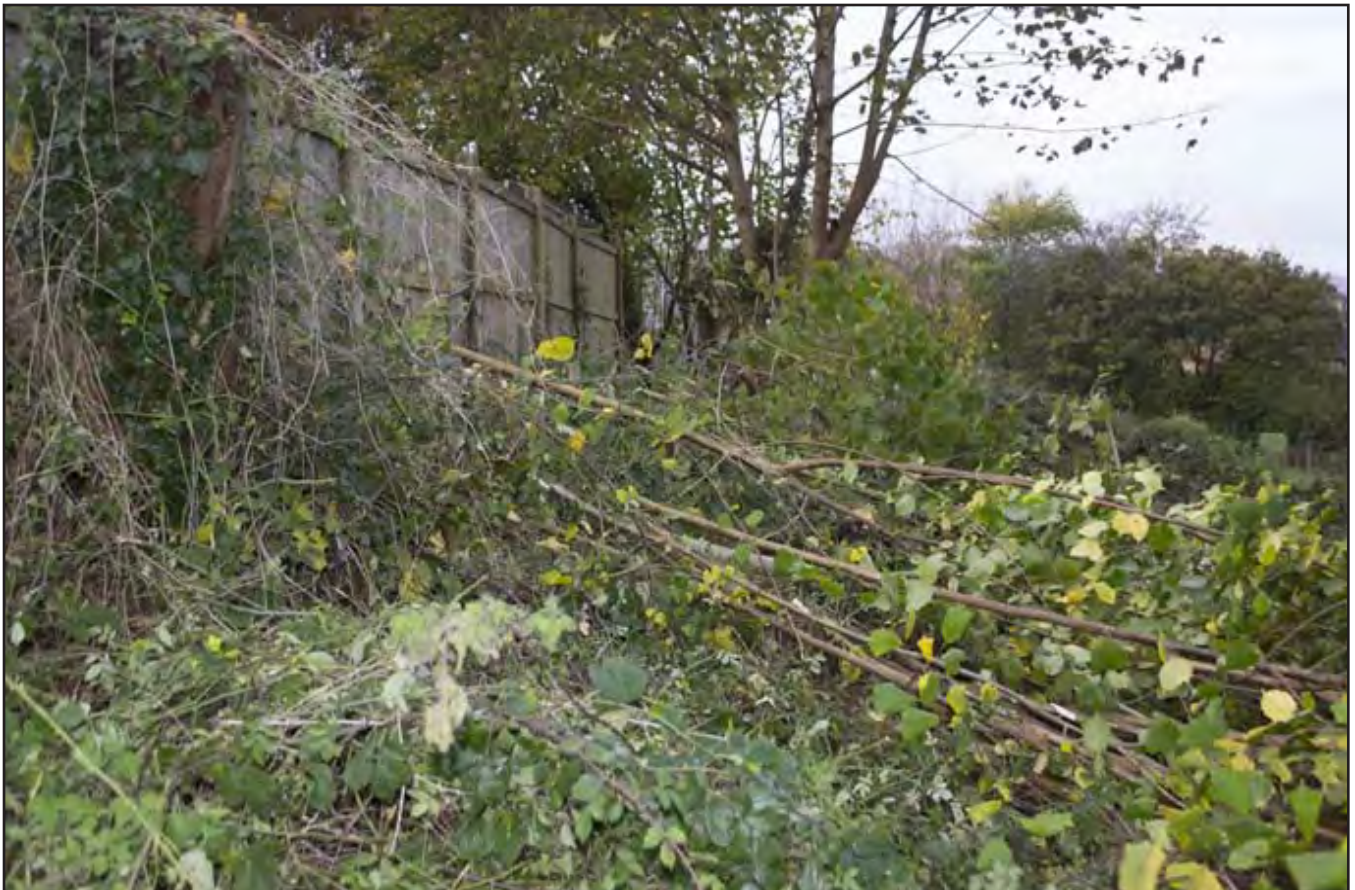
Plate 08: Western bank obscured by fencing and vegetation; no scale (archive reference: G2599_039).

The bank is far more substantial than the others, possibly due to construction debris from the development of the adjacent housing (Plate 08). Some possible revetment stones were noted through the dense vegetation coverage but do not appear to be in situ.

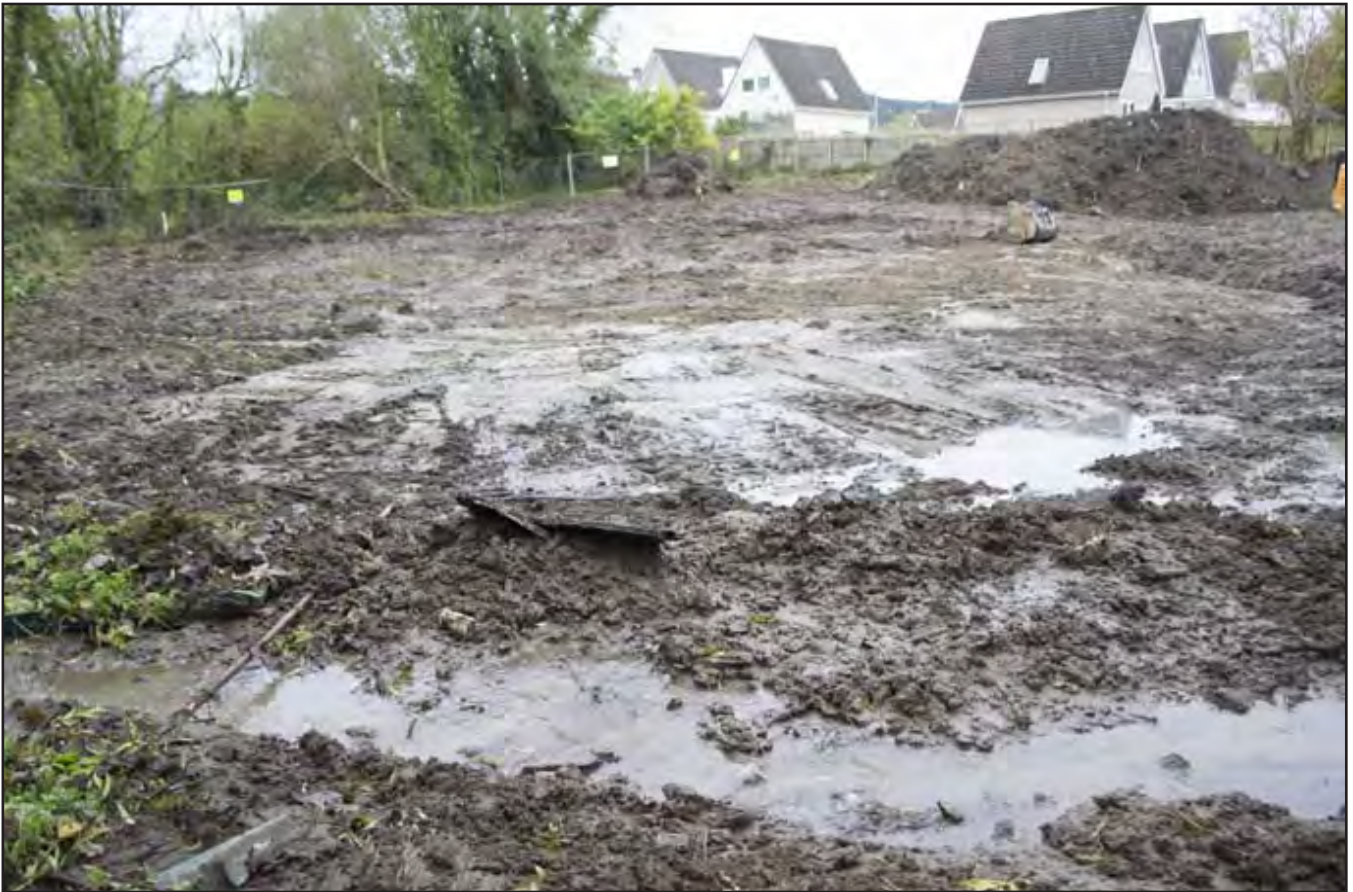
Plate 15: Mill pond after vegetation clearance; no scale (archive reference: G2599_075).

The vegetation was cleared from within the internal area of the mill pond and the ground reduced in order to remove the waterlogged material from the development area (Plate 15). The excavated material was all made ground and contained large amounts of modern material including plastic, wood, ceramic and building materials. The internal mill pond area has obviously been used as a dumping ground for a prolonged period of time.

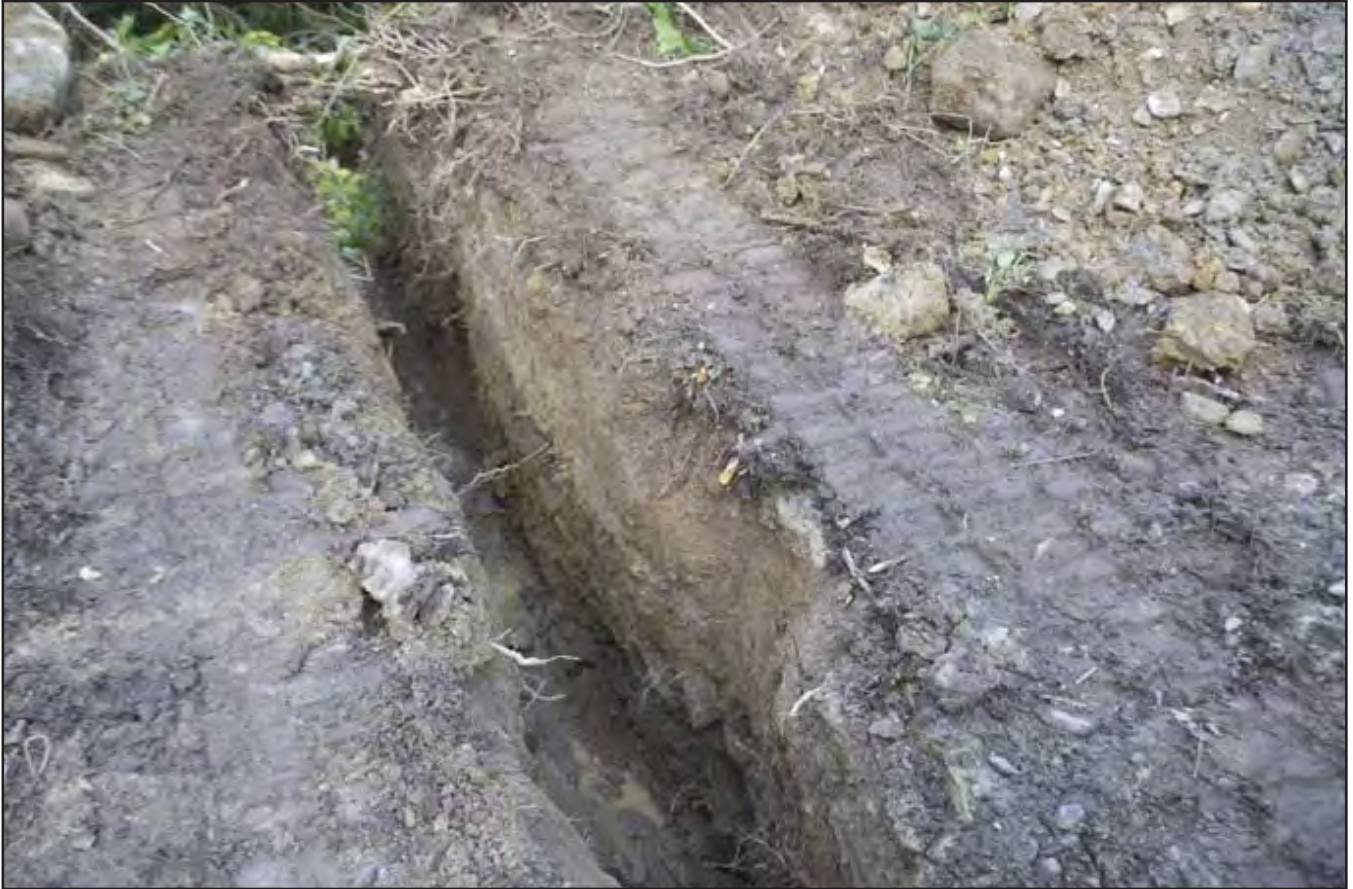
Plate 17: Pipe trench through northern bank; no scale (archive reference: G2599_144).

A trench was excavated through the NW boundary at its western end in order to install a 4" pipe for drainage. The majority of the trench was excavated through the natural and the blueish grey clay layer noted at the southern end of each of the interventions through the bank. This grey clay layer had a maximum depth within the trench of 0.4m and was only seen within the internal area of the pond (Plate 17).

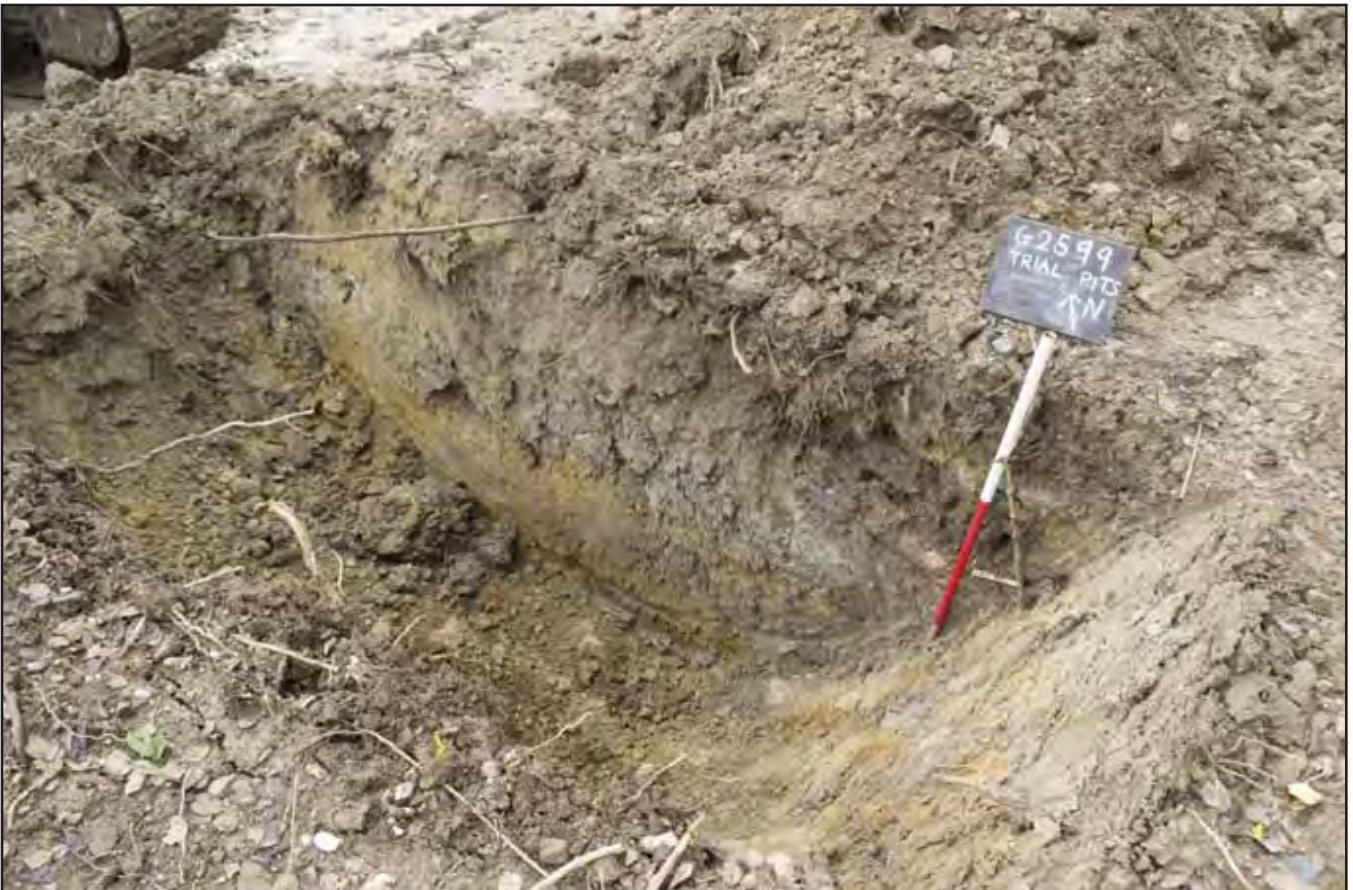
Plate 18: Test pit 2; scale: 1x1m (archive reference: G2599_168).

- Test pit 2 was located close to the southern limit of the development. It measured 3m in length and 1.2m width and was excavated to a depth of 1.4m. The initial layer of made ground (mid brown clayey silt mixed with building rubble) had a depth of 0.8m. This sealed a layer of blue grey clay with a depth of 0.3m, presumed to be the same blue grey clay seen in the bank breakthroughs. The natural in this test pit consisted of a light orange grey sandy clay mixed with frequent gravel and stone inclusions (Plate 18).
