Tŷ STANLEY, SGWÂR Y FARCHNAD, CAERGYBI /
STANLEY HOUSE, MARKET SQUARE, HOLYHEAD

BRIFF GWYLIO ARCHAEOLOEGOL/
WATCHING BRIEF

Prosiect Rhif / Project No. G2636

Adroddiad Rhif / Report No. 1522

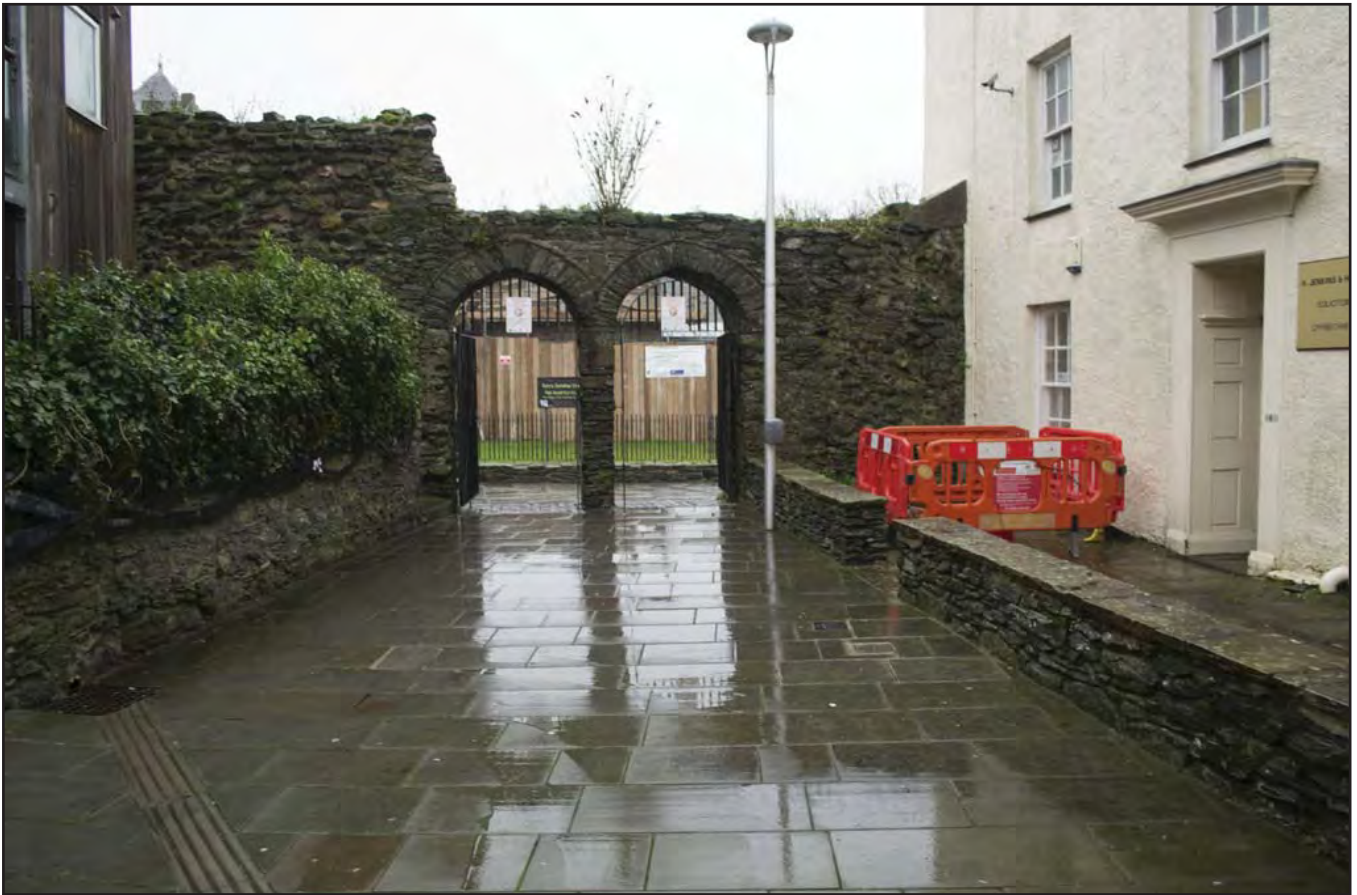
Plate 1: Location shot showing pre-excavation area, Stanley House and St Cybi's archway. - Shot from SSW; scale: Not used. (archive reference: G22636_001).

Situated directly at the front of Stanley House and Saint Cybi's church archway on Market street, Holyhead, a watching brief was conducted during excavation work associated with Scottish Power cable fault locating works (Plate 1 and 2).

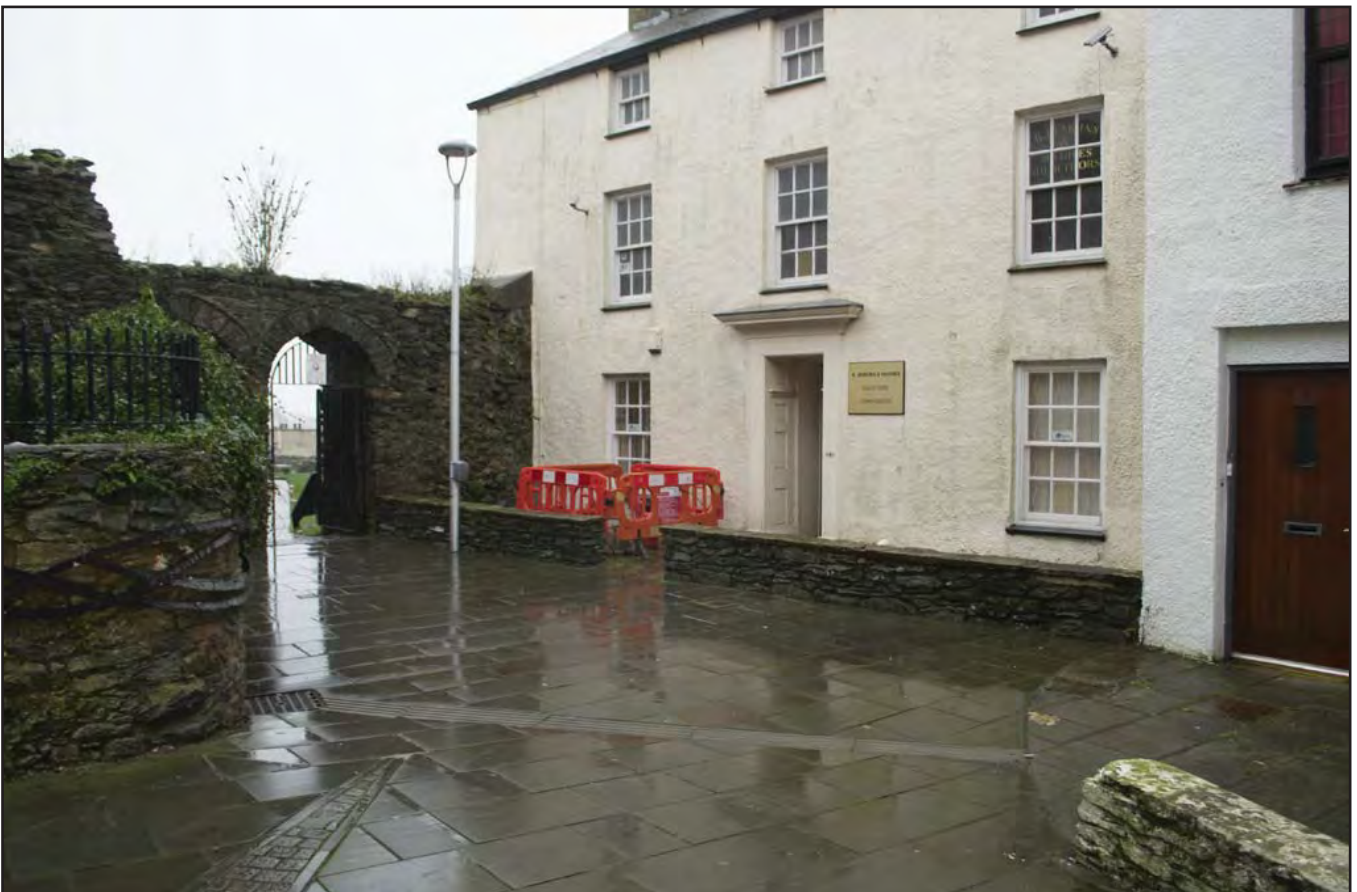
Plate 2: Location shot showing pre-excavation area from high street. - Shot from W ; scale: Not used. (archive reference: G2636_002).

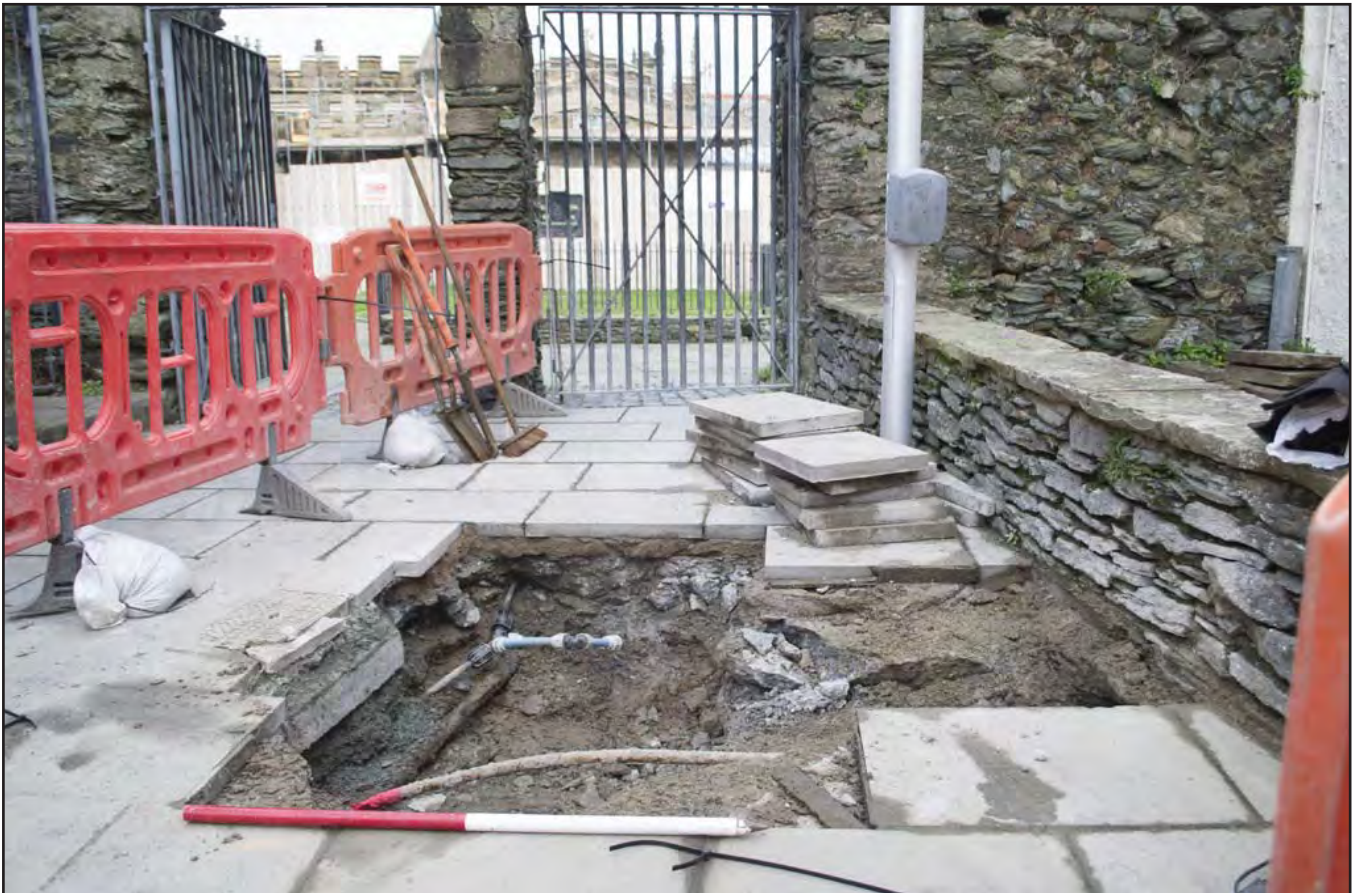
Plate 11: Location shot of trench extension post excavation showing St Cybi's archway- Shot from SSW ; scale: 1x1m (archive reference: G2636_011).

The initial trench was extended westwards following the electricity cables underneath Stanley Houses frontal boundary wall and under the paving slabs on the opposite side and adjacent to St Cybi's archway (Plate 11). Combined, the length of the trench to expose the electricity cables doubled to 4 meters while the width went up from 1.5 to 2 meters on the western side. Within the trench, the electrical services were identified at a depth of 0.5m with the addition of a mains water pipe running to Stanley house (Plate 10). The ground had a similar makeup to the adjacent side, being made up of redeposited mid-brown silty clay which was a result of modern service disturbance. In addition to the clay, inclusions of slate waste were present which had been used as a bedding compound for the water services. No archaeology was discovered within the trench extension.

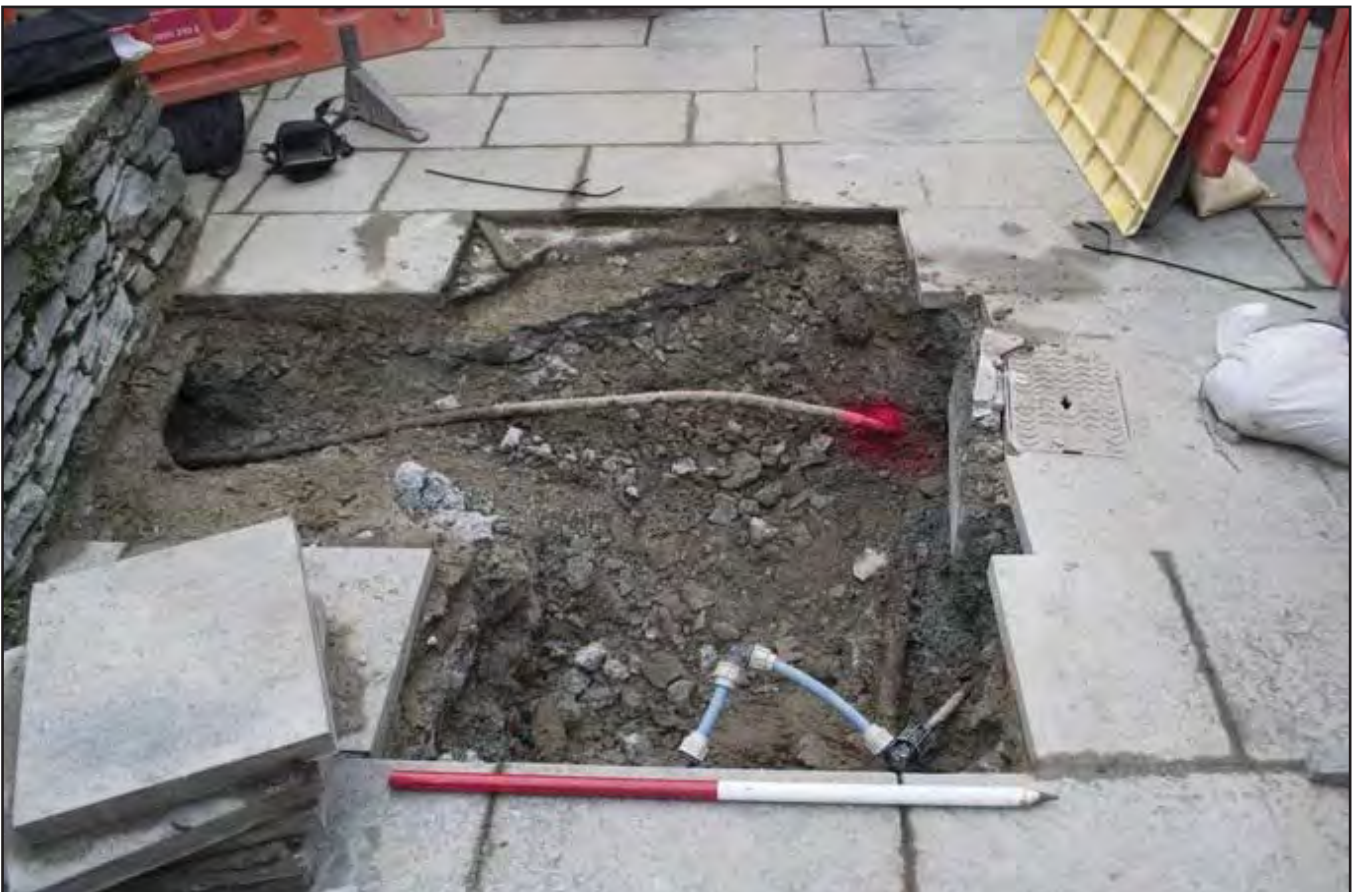
Plate 12: Post-ex shot of trench extension showing exposed services with fault (sprayed red). - Shot from SSW ; scale: 1x1m (archive reference: G2636_012).

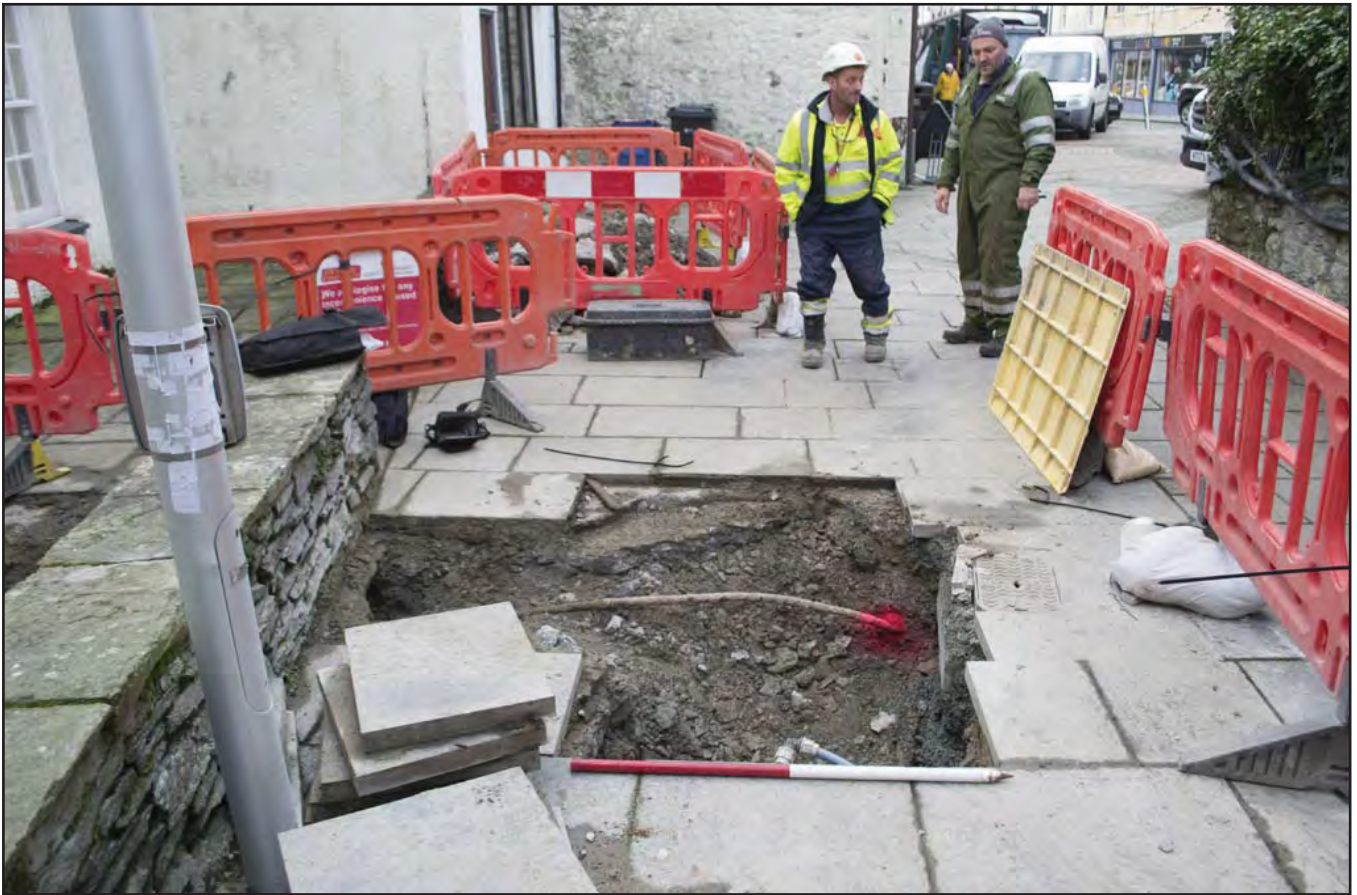
Plate 13: Location shot of trench extension post excavation towards high street - Shot from NNE ; scale: 1x1m (archive reference: G2636_014).

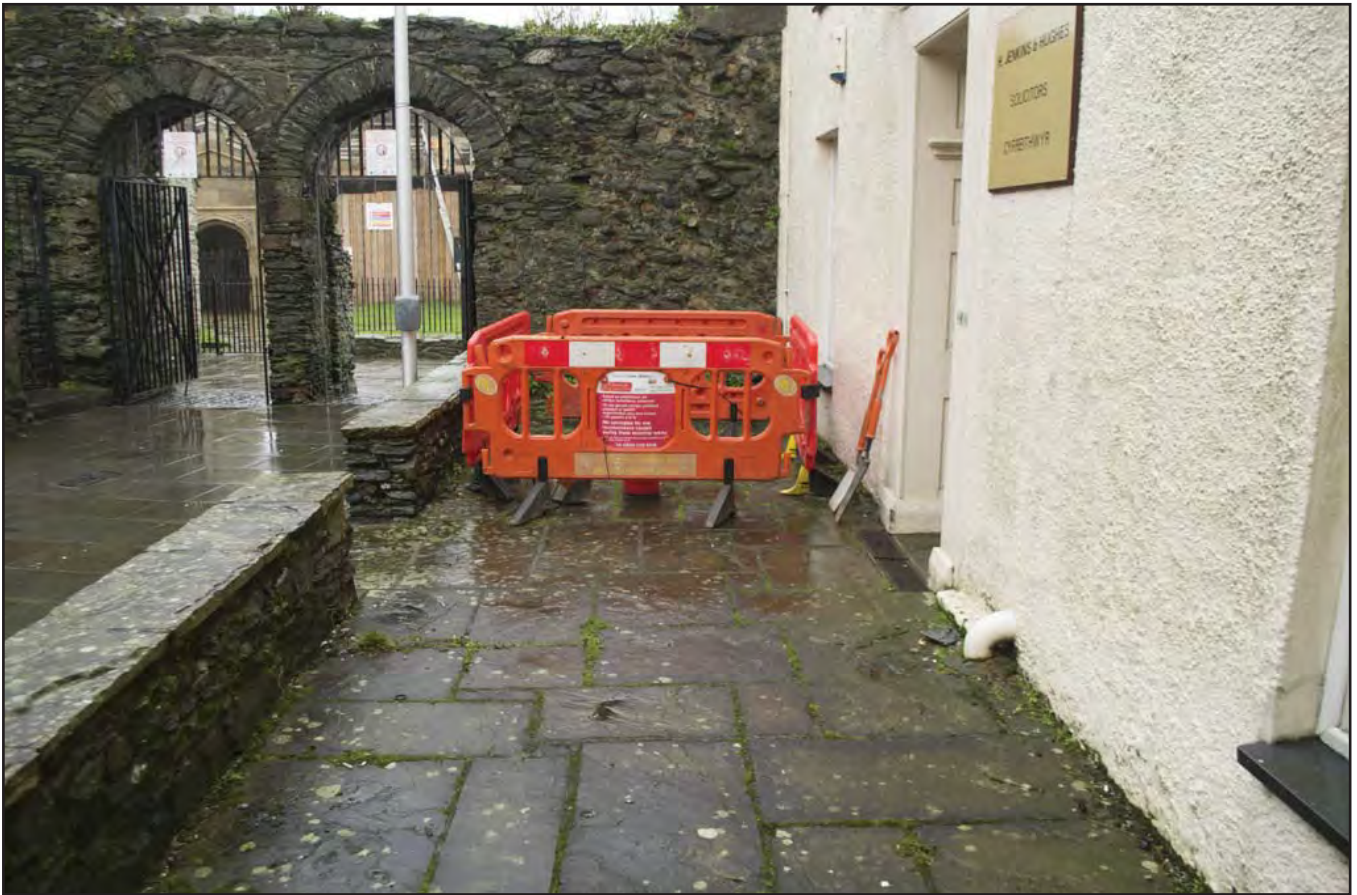
Plate 3: Pre-ex shot of 2x1m trench. - Shot from SSW ; scale: Not used. (archive reference: G2636_003).

Situated between the entrance of Stanley house and the frontal boundary wall, a 2 x 1m trench was machine and hand dug to a depth of 0.4m. The trench was excavated after hand removal of the flagstones and concrete underlay (Plate 4 and 5).

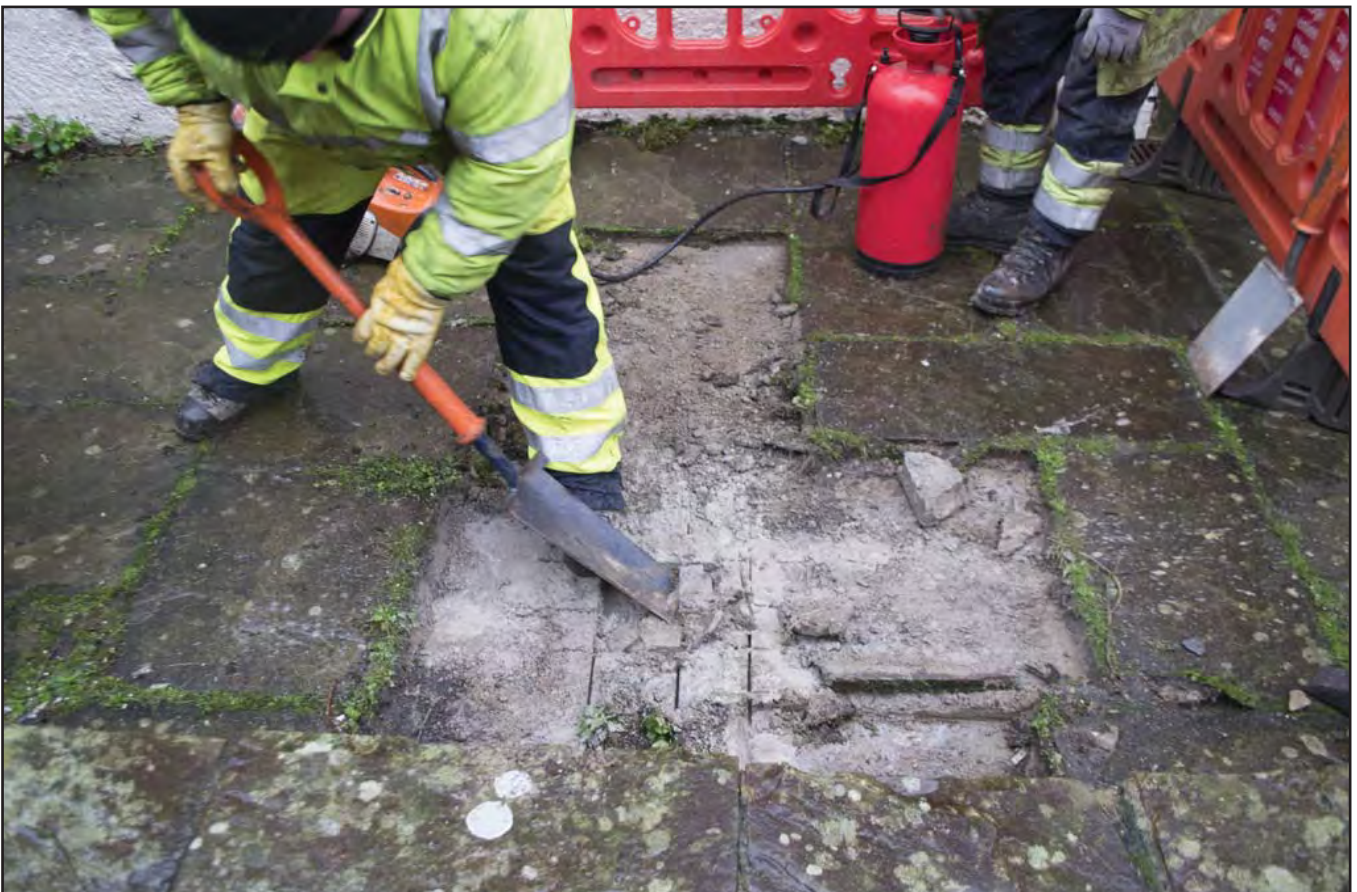
Plate 4: Working shot showing hand removal of flagstones and layer of modern concrete. - Shot from W ; scale: Not used. (archive reference: G2636_004).

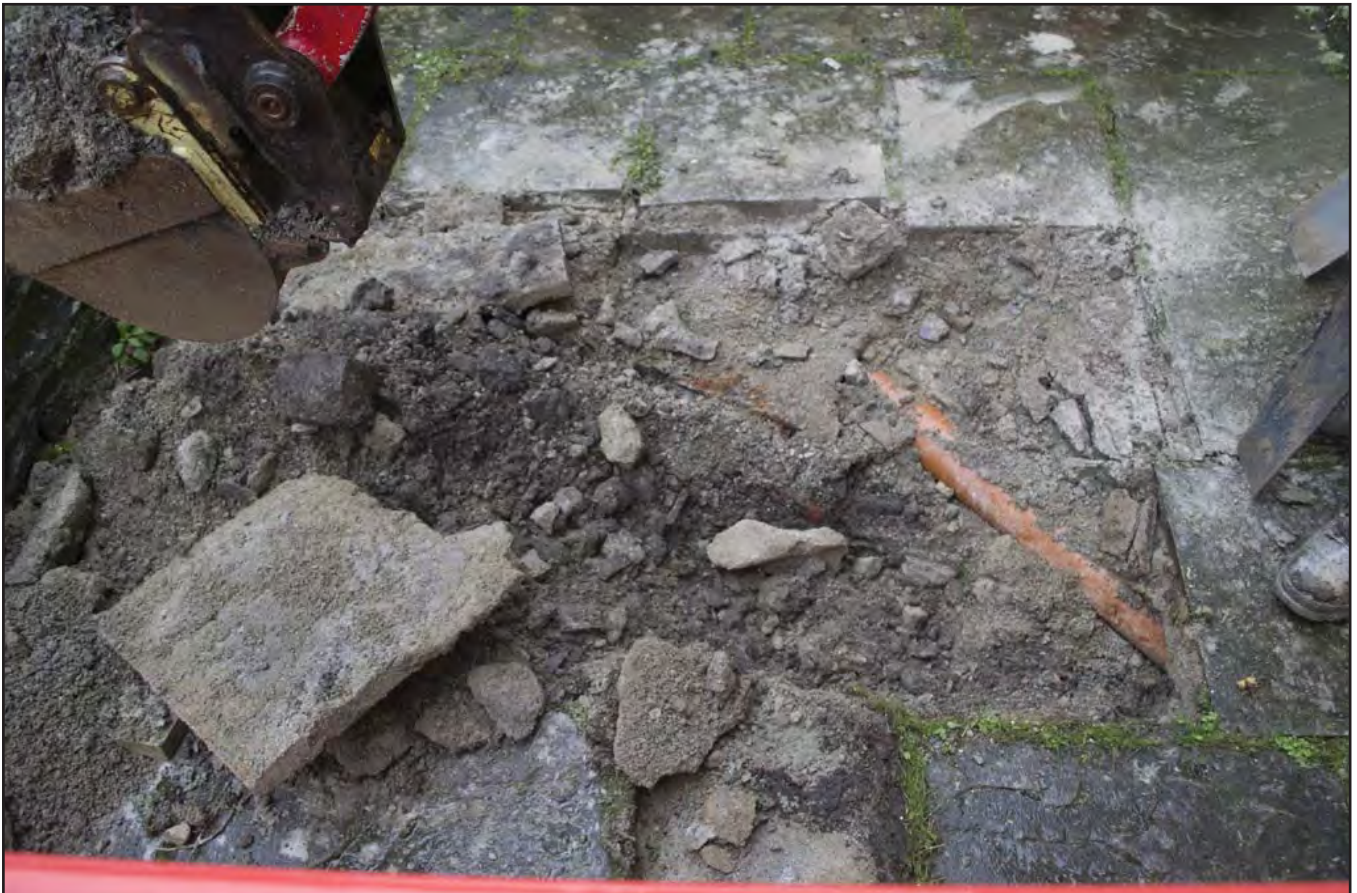
Capped by the modern concrete, an old manhole was discovered with two modern ceramic pipes running into it along with two electricity cables at a depth of 0.4m. The manhole was constructed with modern red brick with a cast iron cap. One of the ceramic drainage pipes had been recently replaced and was brand new in appearance in comparison to the other (Plate 6). The new pipe ran from the manhole pot to Stanley House. Positioned directly above the drainage pipes, the two electricity cables were discovered. Both electricity cable and drainage services were set in a redeposited silty brown clay deposit. All deposits found within the trench were a result of re-deposition during services work associated with drainage and electrical services. No archaeology was discovered within the trench.

Plate 5: Working shot showing exposed modern manhole/drain. - Shot from SSW ; scale: Not used.
(archive reference: G2636_005).

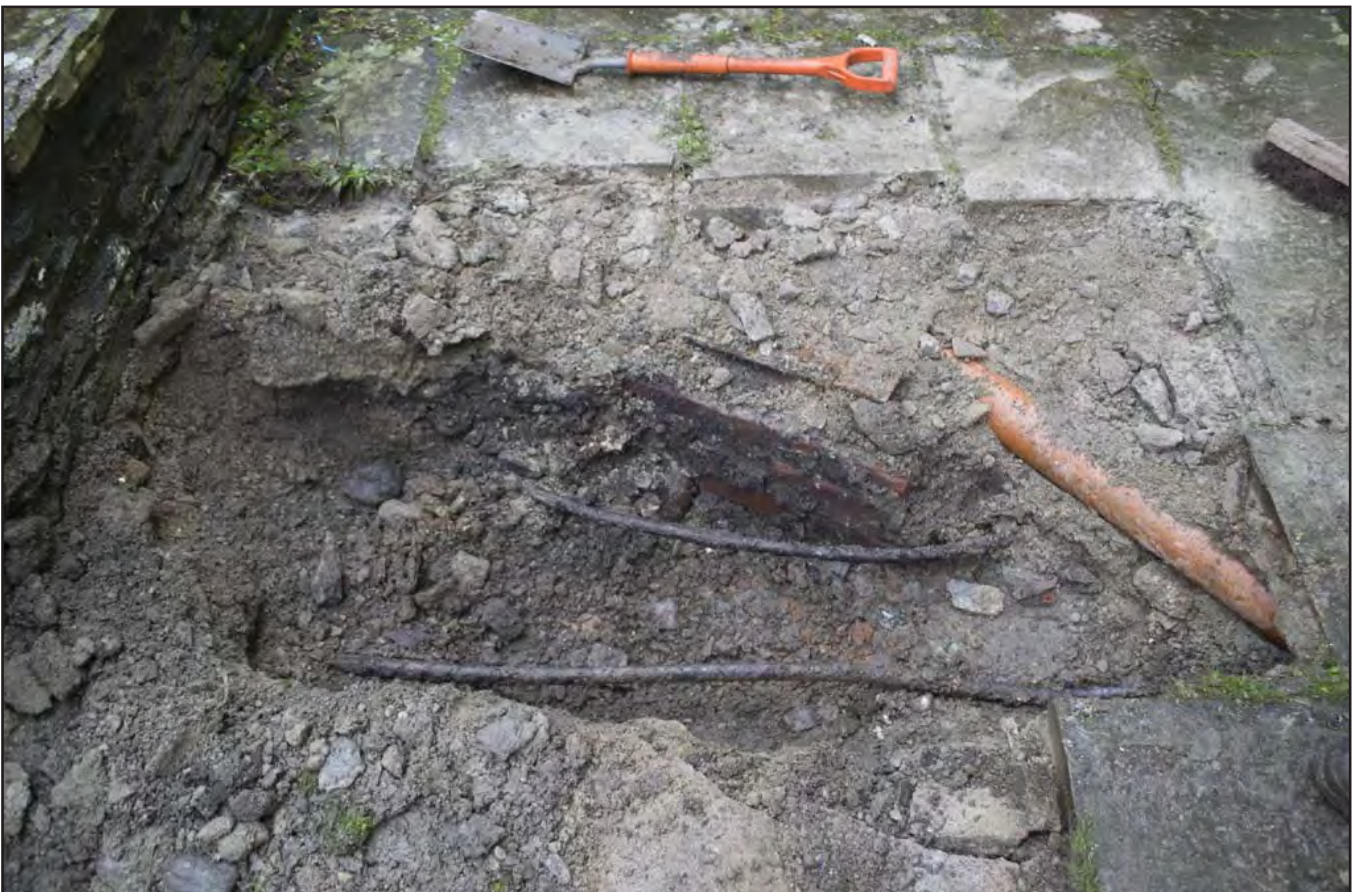
Plate 6: Shot showing x2 exposed cables, manhole and modern ceramic drainage pipes x2.- Shot from SSW
; scale: Not used. (archive reference: G2636_006).

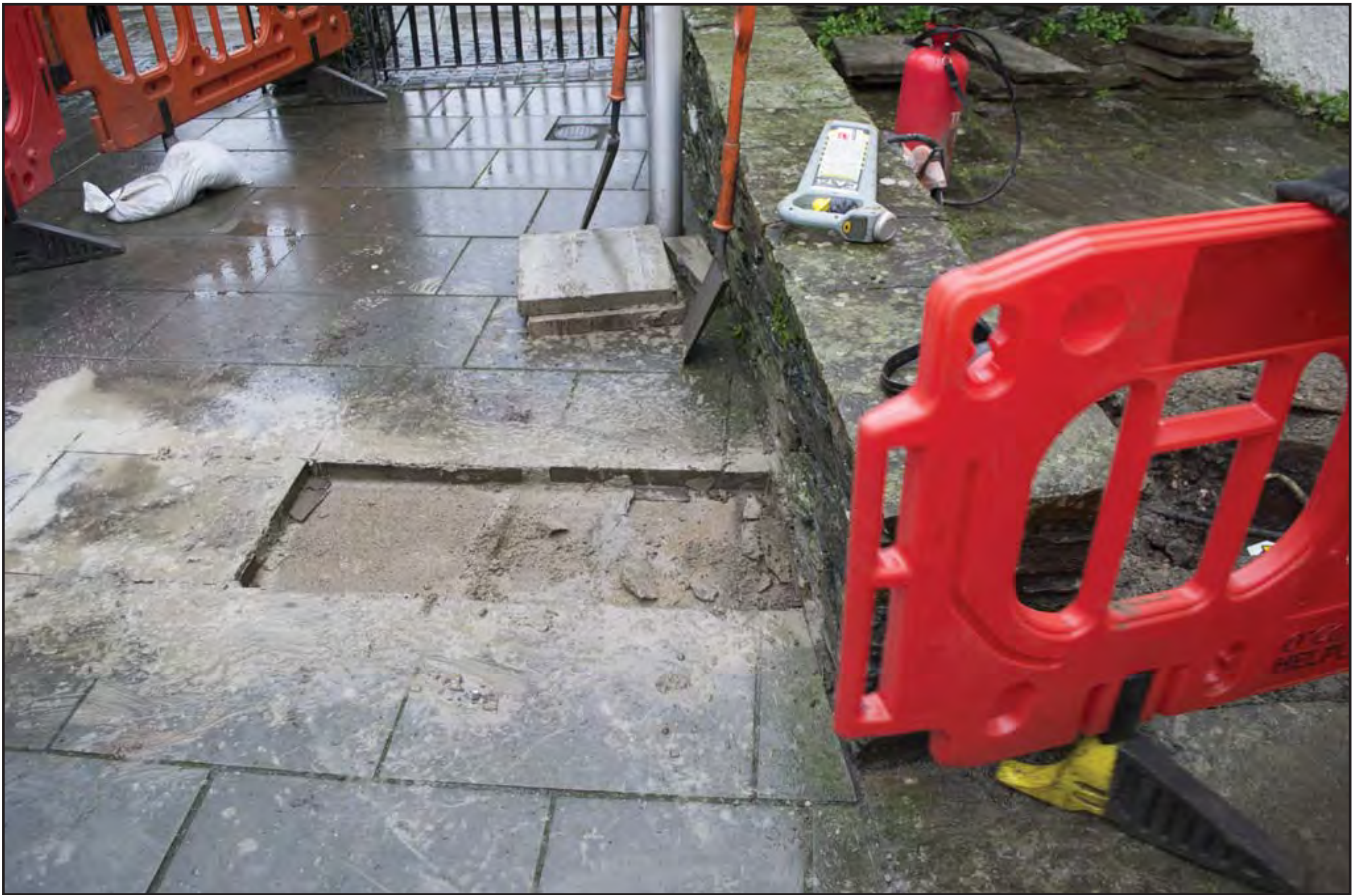
Plate 7: Working shot of trench extension western side of Stanley house boundary wall. - Shot from SSW ; scale: Not used. (archive reference: G2636_007).

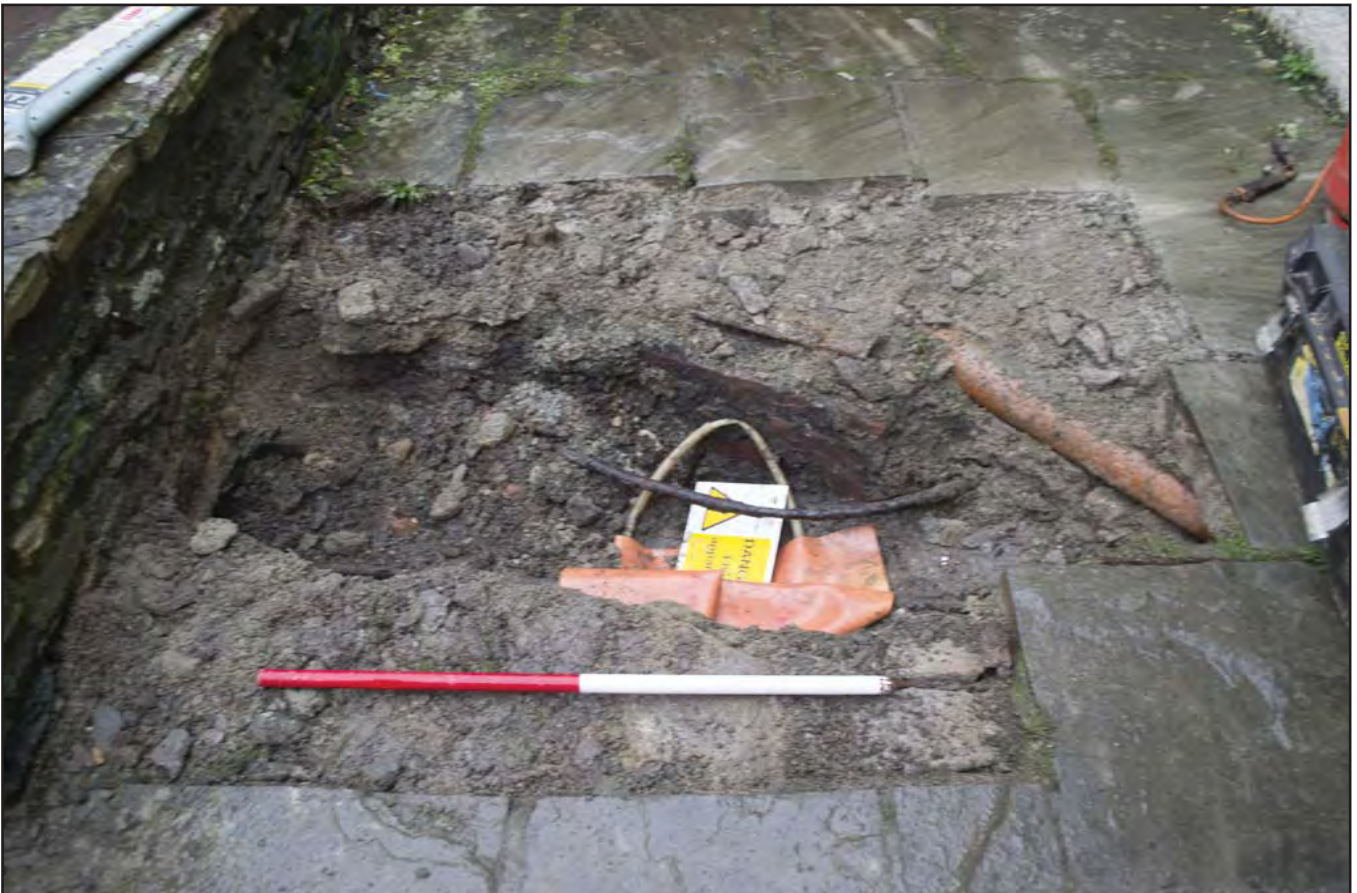
Plate 8: Post-ex shot of 2x1m trench (Stanley House) showing exposed services.- Shot from SSW ; scale: 1x1m (archive reference: G2636_008).

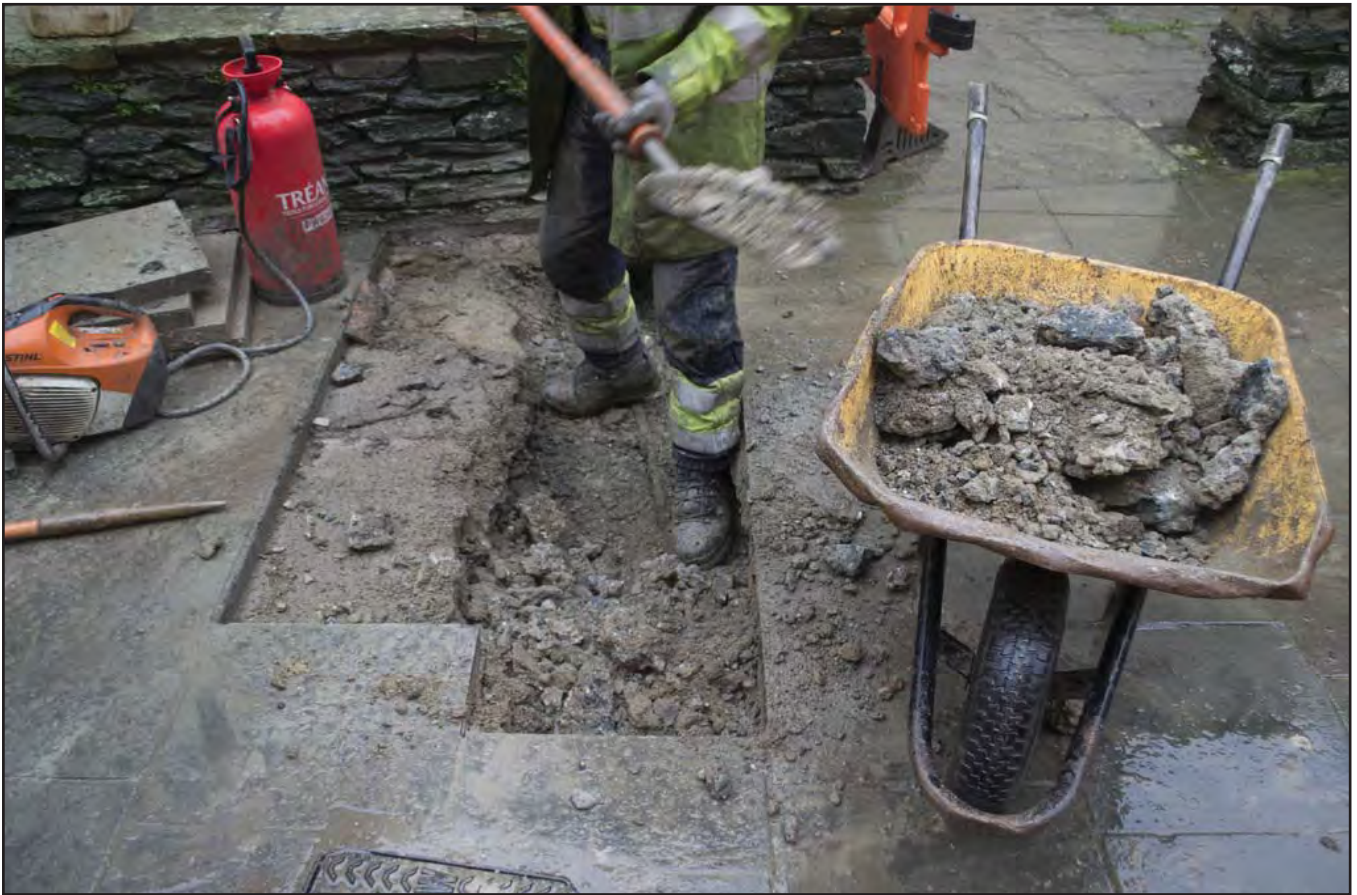
Plate 9: Working shot of trench extension western side of stanley house boundary wall. - Shot from NW; scale: Not used. (archive reference: G2636_009).

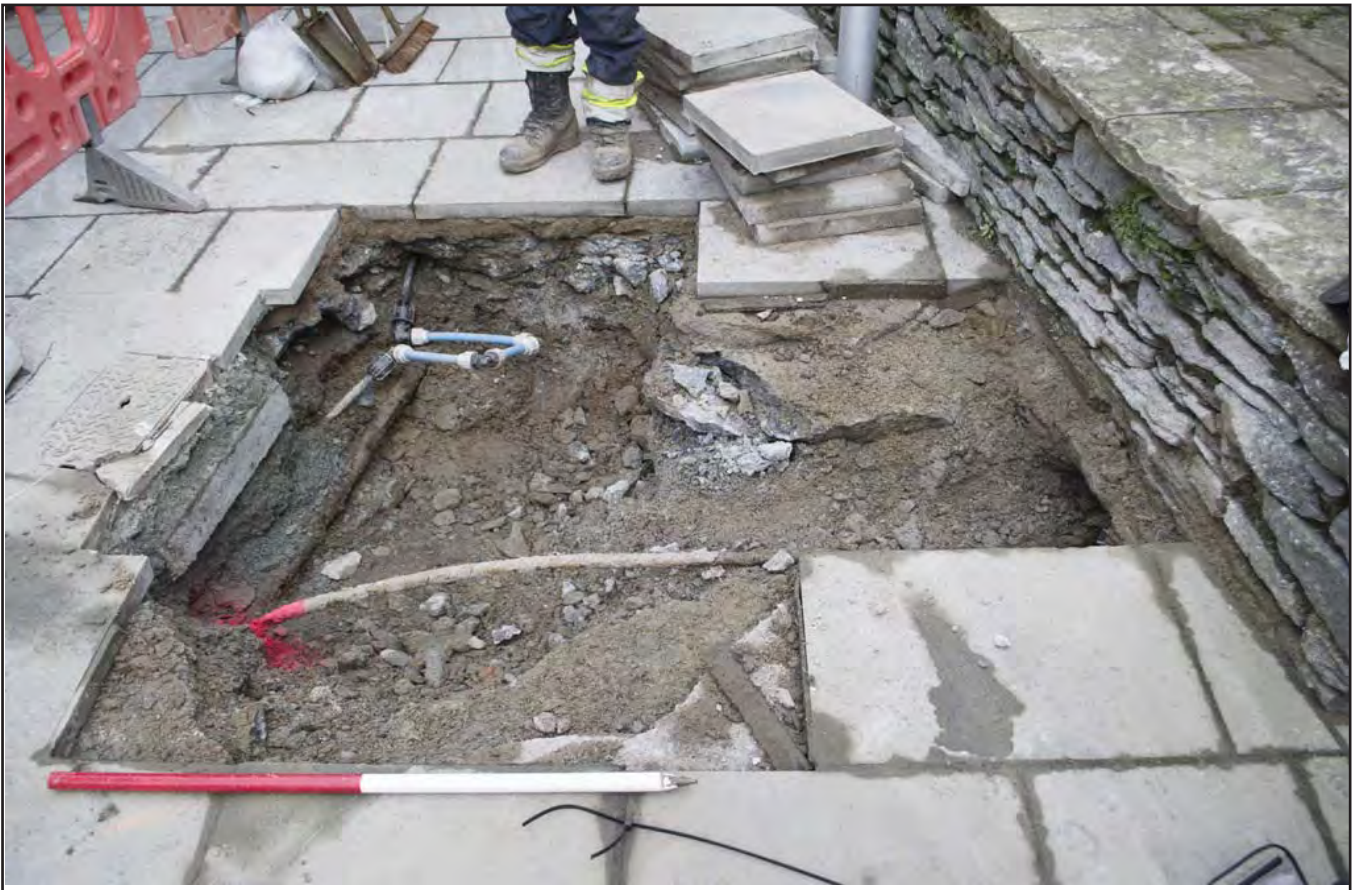
Plate 10: Shot of fully excavated trench extension western side of boundary wall showing mains water, electric and water services. - Shot from SSW; scale: 1x1m (archive reference: G2636_010).
