## LOWER HENDRE RESERVOIR, GWYNEDD

### ASESIAD ARCHEOLEGOL / ARCHAEOLOGICAL ASSESSMENT

Prosiect Rhif / Project No. G2660

Adroddiad Rhif / Report No. 1559

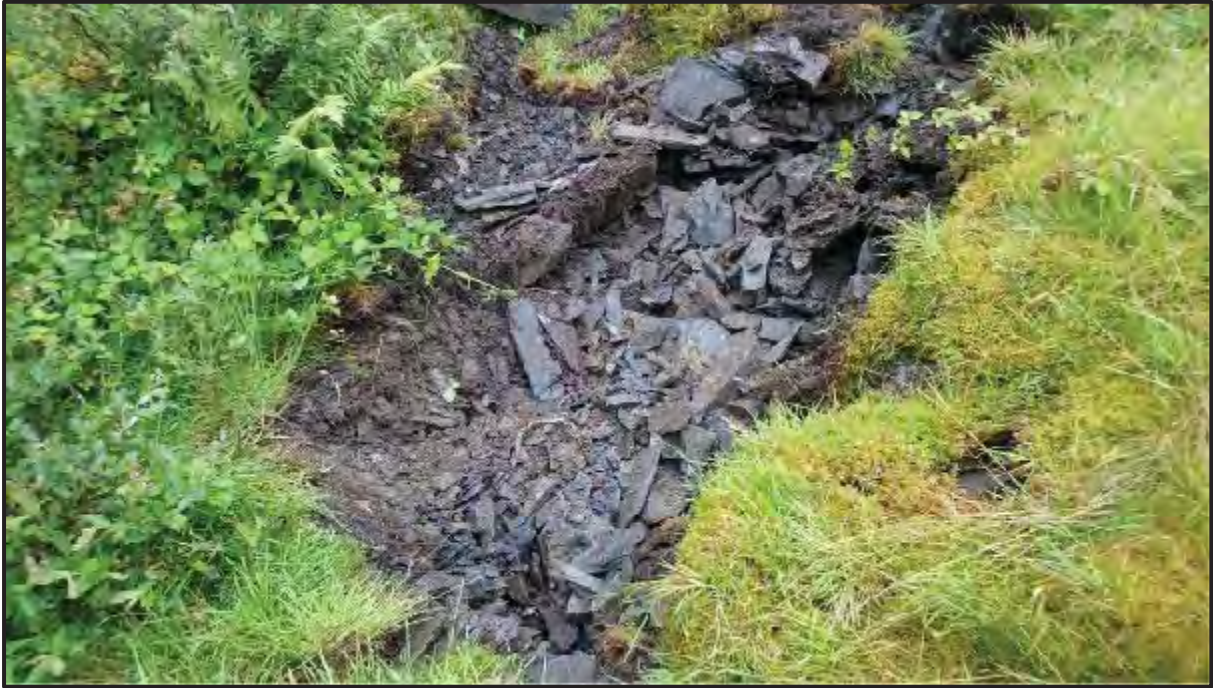
**Plate 1: Trial Pit 1 post excavation (image provided by client)**

Trial Pit 1 contained c.5cm of topsoil over loose crushed flat slate particles varying from cobble to small gravel size with a rare silt and clay matrix.

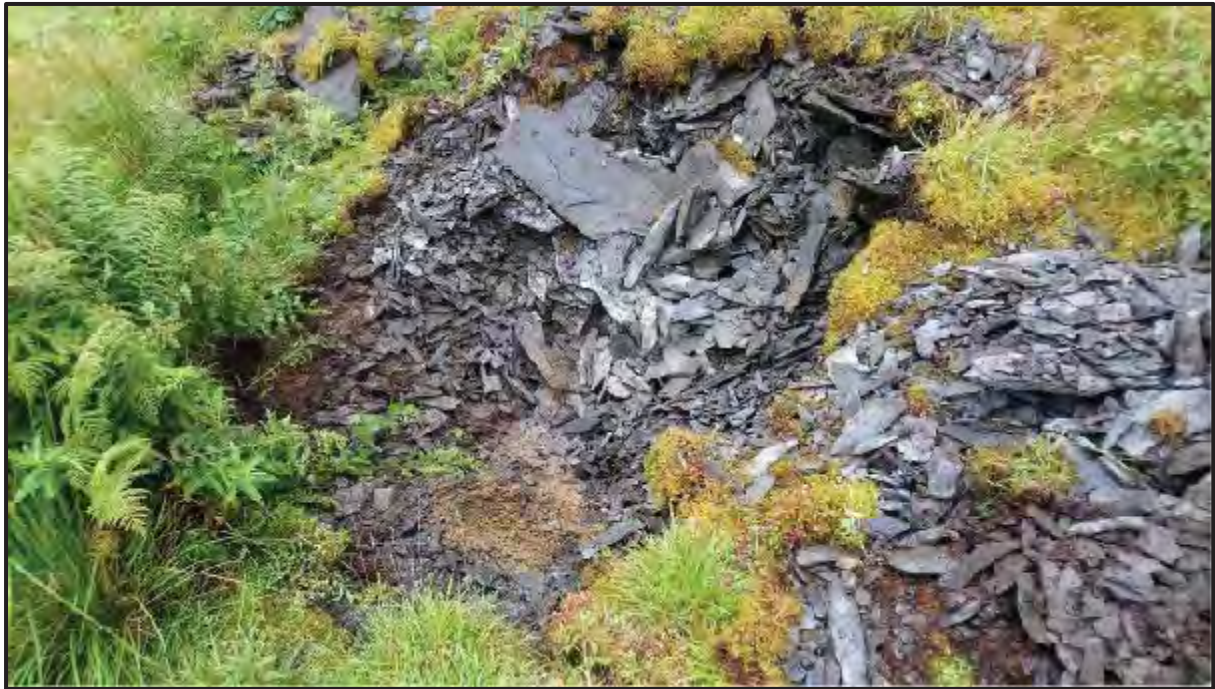
**Plate 2: Trial Pit 2 post excavation (Image provided by client)**

Trial Pit 2 contained c.5cm of topsoil over loosed crushed flat slate particles varying from cobble to small gravel size with a rare silt and clay matrix. A brown firm silty clay inclusion was found in the pit. This was localised and was not found to be continuous across the pit. The pit was excavated to a depth of 1m.

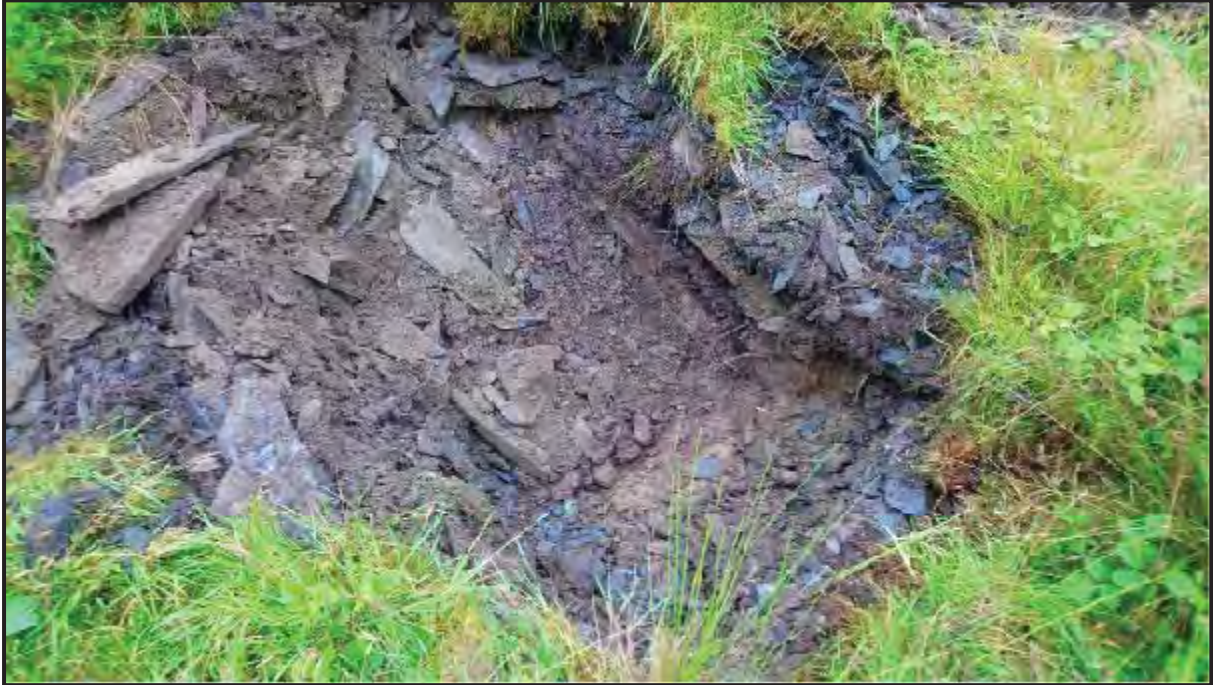
**Plate 3: Trial Pit 3 post excavation (Image provided by client)**

Trial pit 3 contained c.5cm of topsoil over loose crushed flat slate particles varying from cobble to small gravel size with a rare silt and clay matrix. The pit was excavated to a depth of 1m.

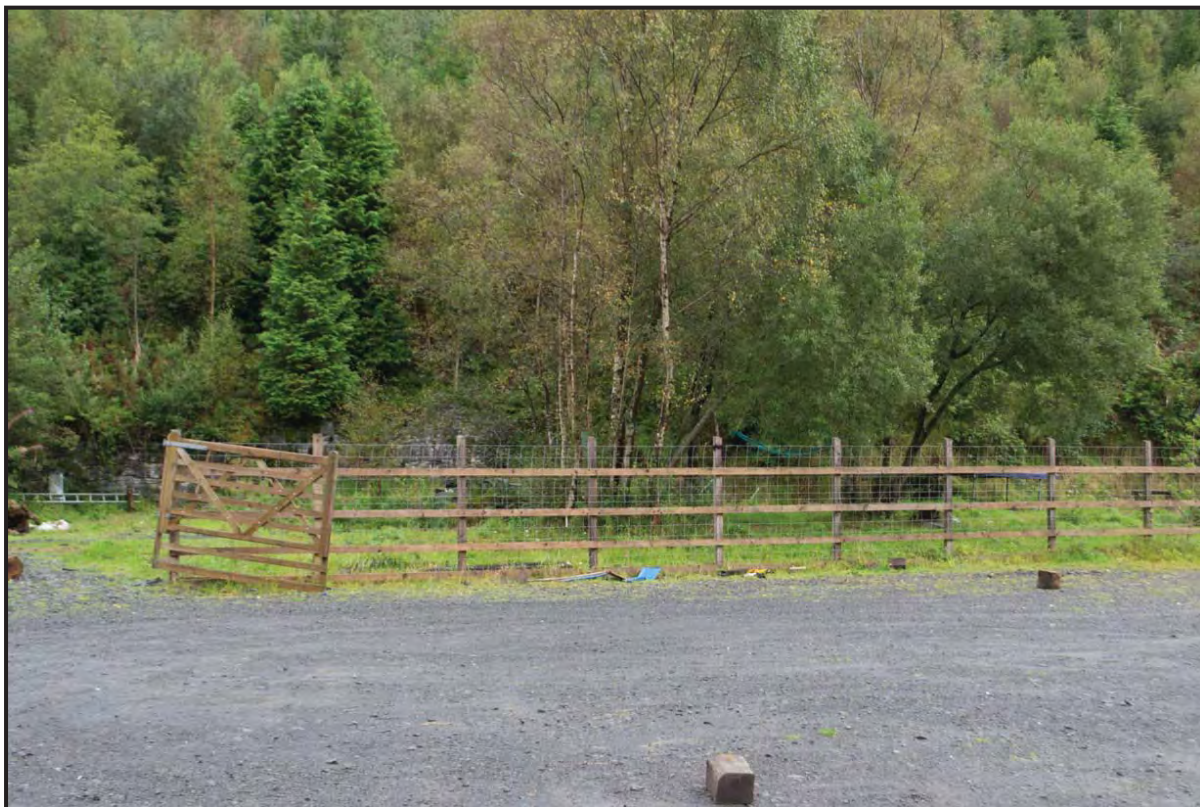
<b>Feature Number</b>	<b>02 (Plate 4)</b>
<b>Site name</b>	Hendre Ddu Quarry Building 1, Mawddwy
<b>PRN number</b>	9142
<b>Grid reference</b>	SH80131243
<b>Period</b>	Modern
<b>Site type</b>	Building
<b>Assessment category</b>	C
<b>Description</b>	Footings only survive (Brooks and Price, 1999). This now lies within the curtilage of Hendragode House (Feature 23) and was not observed. Whilst the location of the feature was generally visible, this feature was inaccessible during the 2020 field survey and assessment and the description used is from the 1998 assessment. It was listed as Category C (lesser significance) in the 1998 assessment and has been ascribed Category C (local importance) due to the limited structural survival. It is not within the route or location of the proposed works and no further recommendations are given beyond avoidance.
<b>Impact</b>	None
<b>Recommendation for further assessment/evaluation</b>	None

**Plate 4: General view of garden previous location for building 1; scale not used; view from south southwest (archive image: G2660\_008).**

<b>Recommendation for mitigatory measures</b>	Avoidance

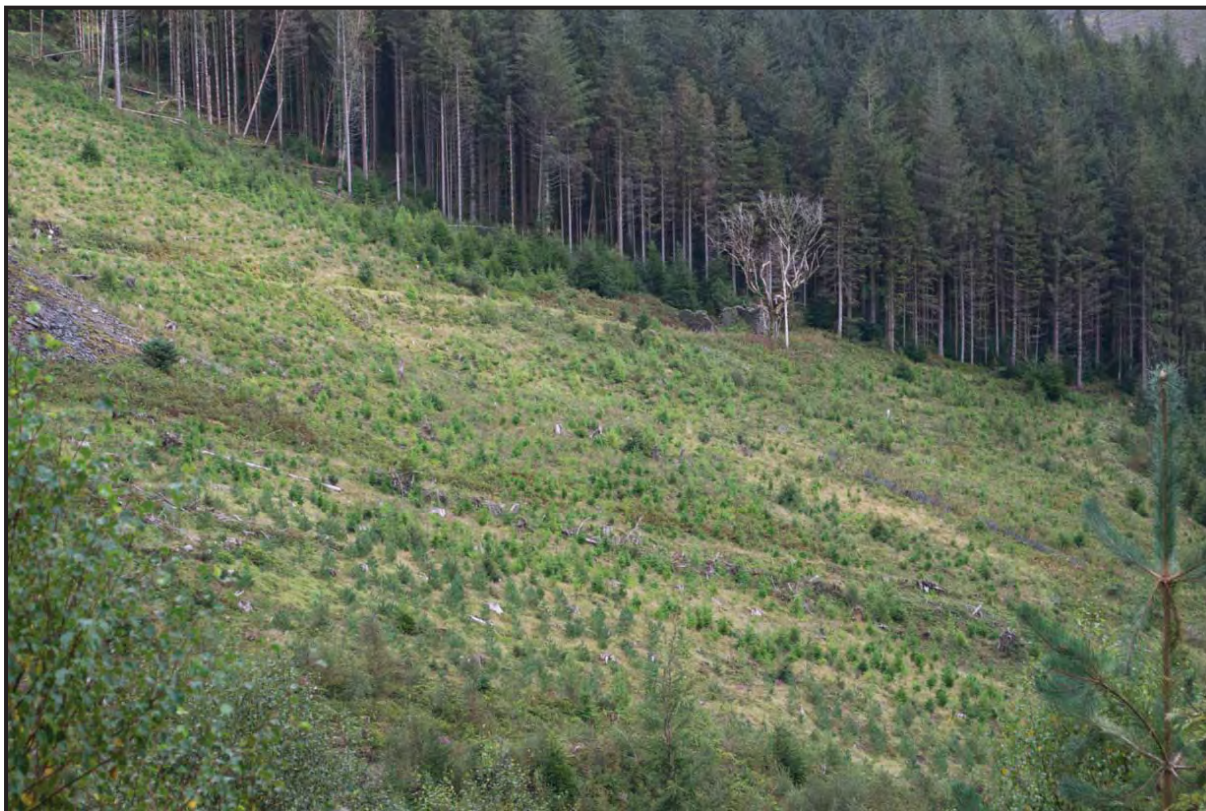
<b>Feature Number</b>	<b>03 (Plate 5)</b>
<b>Site name</b>	Hendre Ddu Quarry Building 2, Mawddwy
<b>PRN number</b>	9130
<b>Grid reference</b>	SH80111254
<b>Period</b>	Modern
<b>Site type</b>	Building
<b>Assessment category</b>	C
<b>Description</b>	Building 10 x 6m end walls survive to near roof line, side walls collapsed (Brooks and Price, 1999). The building is of drystone walling and no internal features were noted. Whilst the location of the feature was generally visible, this feature was inaccessible during the 2020 field survey and assessment and the description used is from the 1998 assessment. It was listed as Category C (lesser significance) in the 1998 assessment and has been ascribed Category C (local importance) due to the limited structural survival. It is not within the route or location of the proposed works and no further recommendations are given beyond avoidance.
<b>Impact</b>	None

**Plate 5: Feature 03: PRN 9130, general view; scale not used; view from southwest  
(archive reference: G2660\_36)**

<b>Recommendation for further assessment/evaluation</b>	None
<b>Recommendation for mitigatory measures</b>	Avoidance

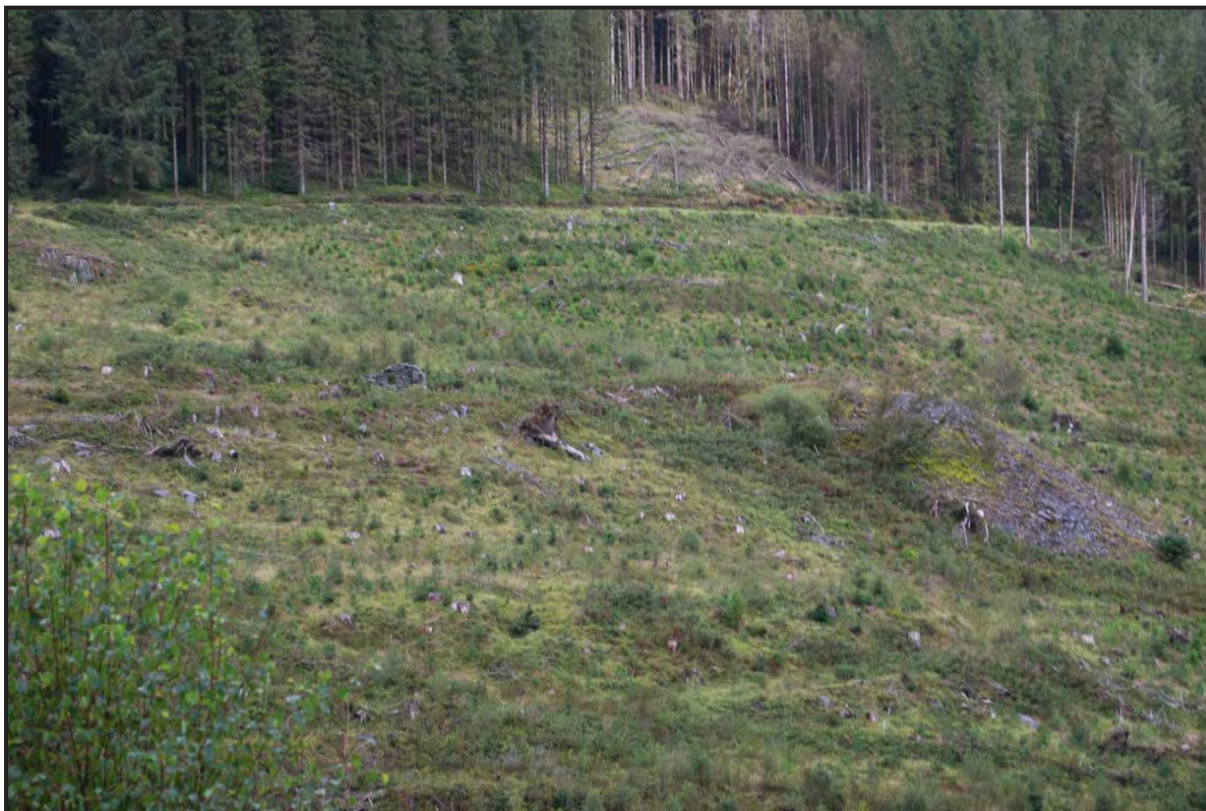
<b>Feature Number</b>	<b>04 (Plate 6)</b>
<b>Site name</b>	Hendre Ddu Quarry Building 3, Mawddwy
<b>PRN number</b>	9133
<b>Grid reference</b>	SH79921250
<b>Period</b>	Modern
<b>Site type</b>	Building
<b>Assessment category</b>	B
<b>Description</b>	Building 3m x 7m with sloping roof. Roof partly survives, slab roof. Possible external stair on western side (Brooks and Price, 1999). This appears to be the remains of a former drum house as it is at the northwest end of the probable tramway (Feature 31). No internal fittings were noted to remain. Whilst the location of the feature was generally visible, this feature was inaccessible during the 2020 field survey and assessment and the description used is from the 1998 assessment. It was listed as Category C (lesser significance) in the 1998 assessment and has been ascribed Category B (local importance) in the current assessment due to survival level. It is not within the route or location of the proposed works and no further recommendations are given beyond avoidance.

**Plate 6: Feature 04: PRN 9133, view across site to a possible drum house; scale not used; view from south (archive reference: G2660\_035)**

<b>Impact</b>	None
<b>Recommendation for further assessment/evaluation</b>	None
<b>Recommendation for mitigatory measures</b>	Avoidance

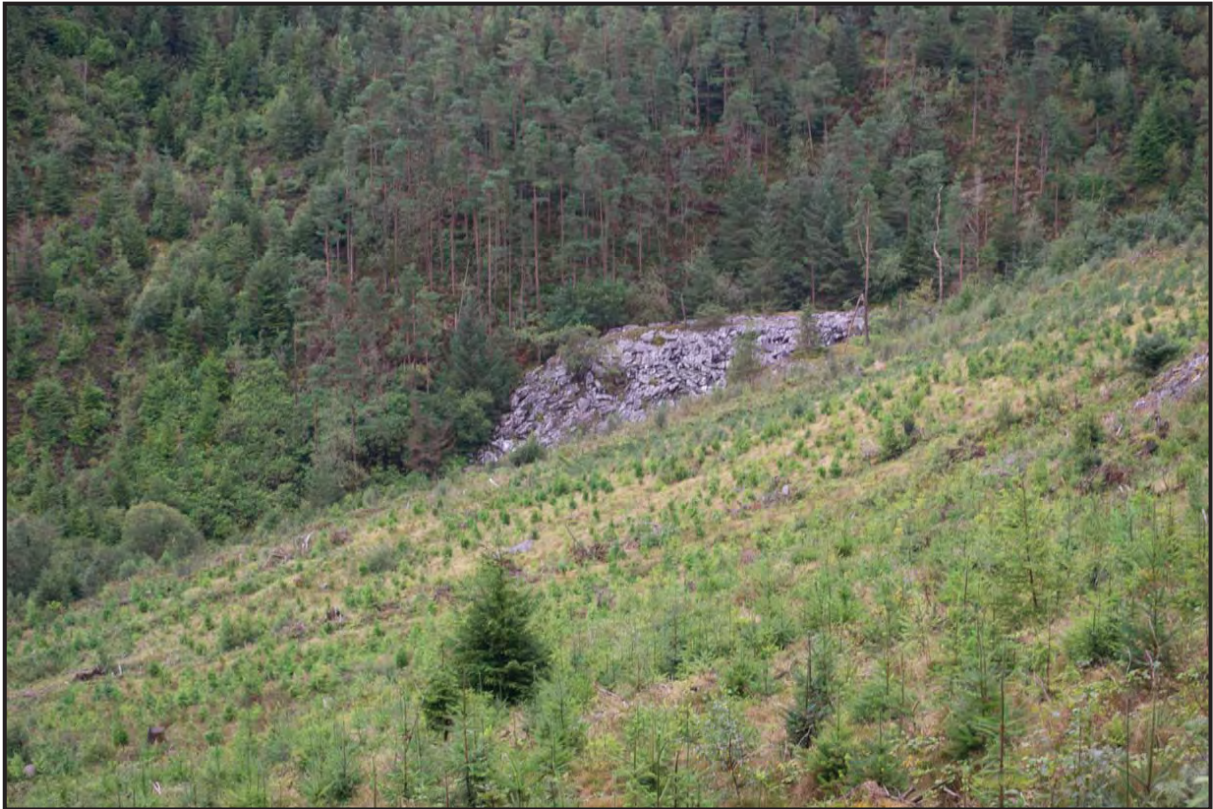
**Plate 7: Feature 09: PRN 9140, view of adit; scale not used; view from north (archive reference: G2660\_022)**

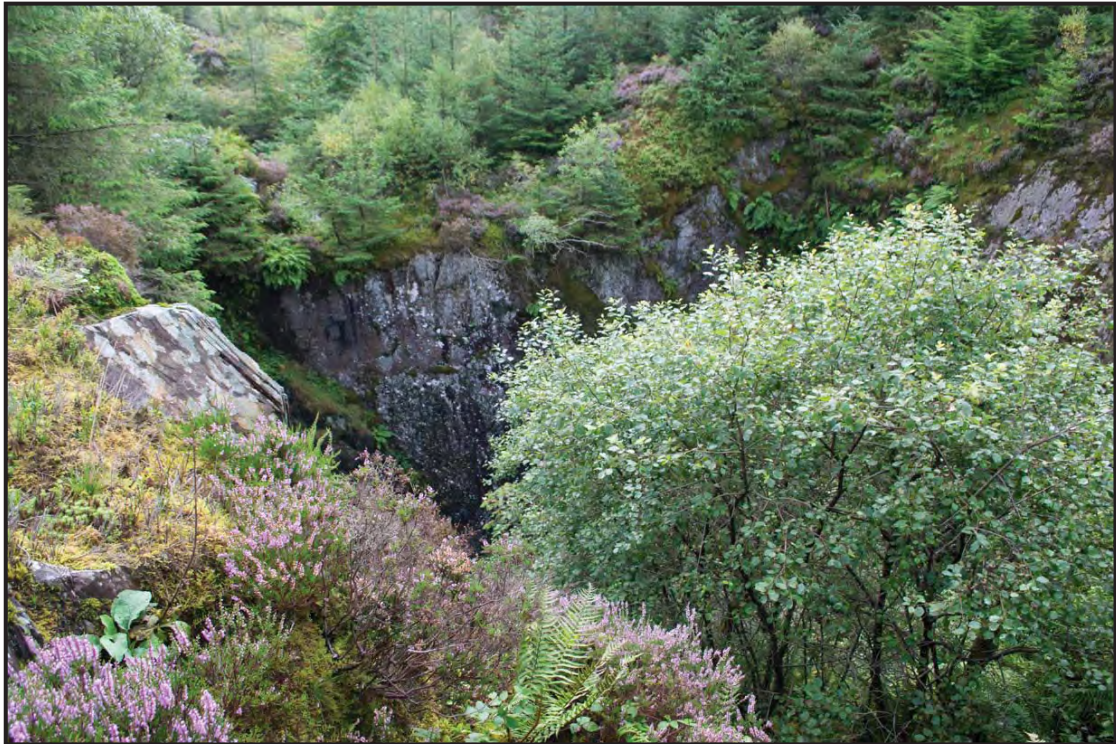
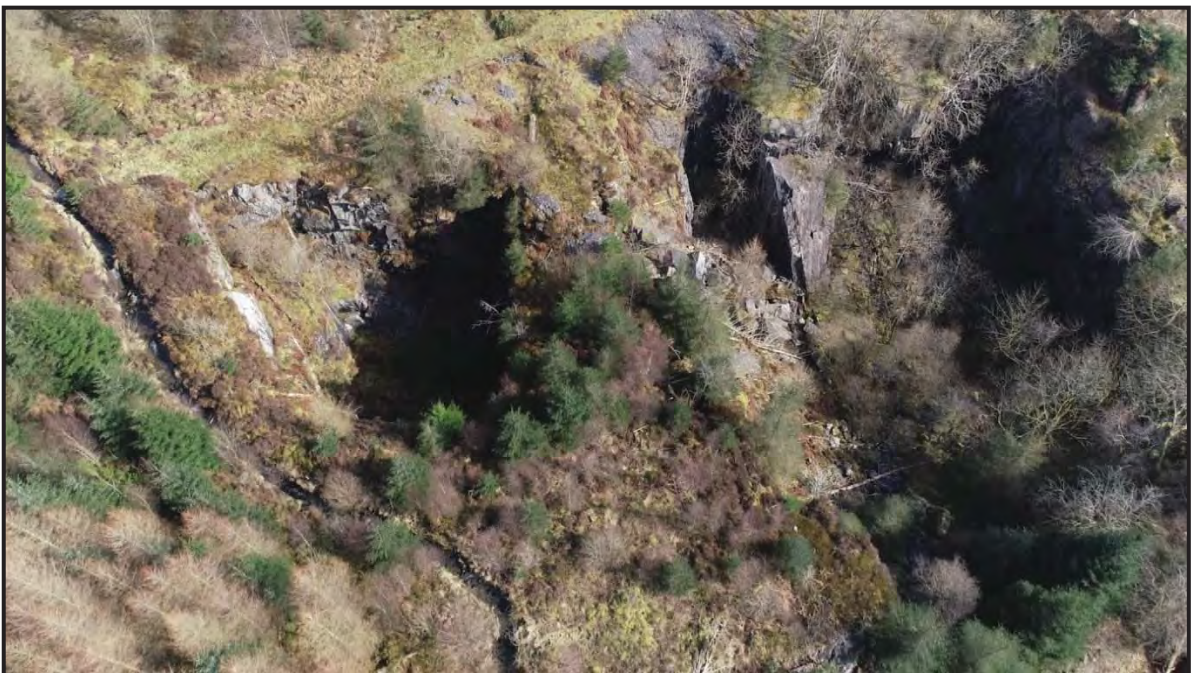
- PRN 9136 - Hendre Ddu Quarry Pit 1: large quarry pit downslope of Lower Hendre Reservoir (PRN 9147); visible during 2020 field survey but heavily overgrown with unsafe access;

<b>Feature Number</b>	<b>11 (Plate 8 &amp; 9)</b>
<b>Site name</b>	Hendre Ddu Quarry Pit 1, Mawddwy
<b>PRN number</b>	9136
<b>Grid reference</b>	SH79841258
<b>Period</b>	Modern
<b>Site type</b>	Quarry
<b>Assessment category</b>	B
<b>Description</b>	Large quarry with several levels and possible adit mines (Brooks and Price, 1999). The large quarry, located downslope of the Lower Hendre Ddu reservoir and in 2020 is heavily overgrown and dangerous of access. It was listed as Category C (lesser significance) in the 1998 assessment and has been ascribed Category B (regional importance) in the current assessment due to its function as an integral part of the quarry. It is not within the route or location of the proposed works and no further recommendations are given beyond avoidance.
<b>Impact</b>	None
<b>Recommendation for further assessment/evaluation</b>	None
<b>Recommendation for mitigatory measures</b>	Avoidance

**Plate 8: Feature 11: PRN 9136, view of Hendre Ddu Quarry, Pit 1; scale not used; view from northwest (archive reference: G2660\_024)**

**Plate 9: Feature 11: PRN 9136, view of Hendre Ddu Quarry, Pit 1; (Image taken from drone survey undertaken by client)**

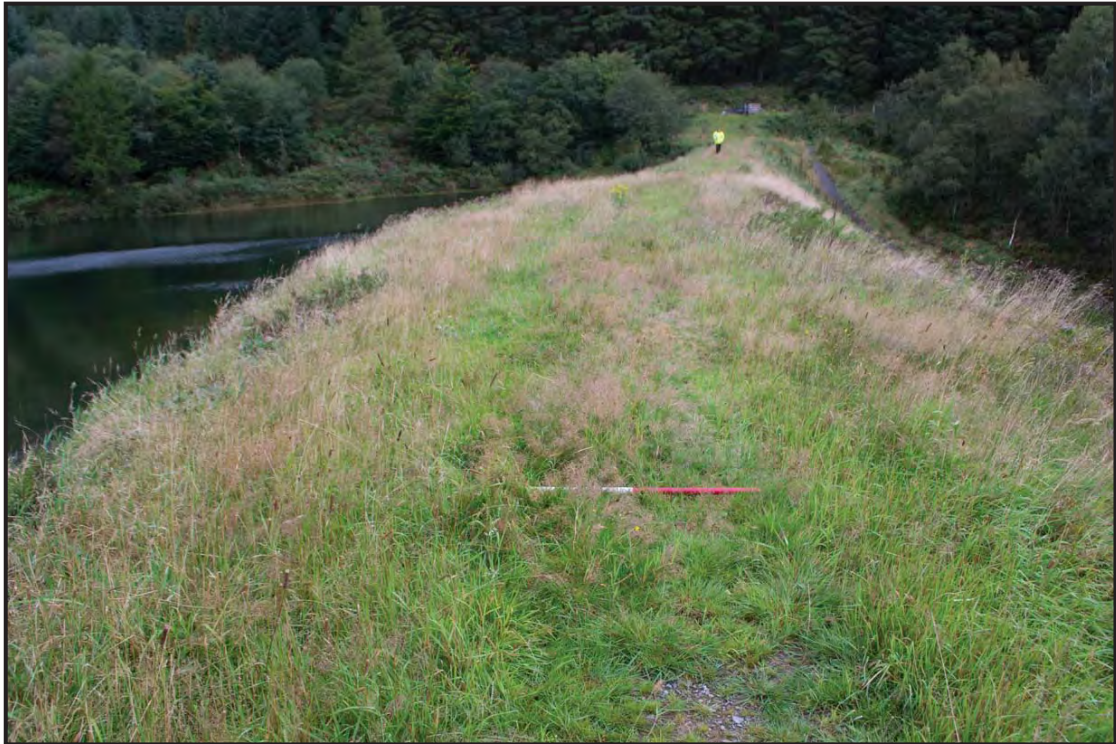
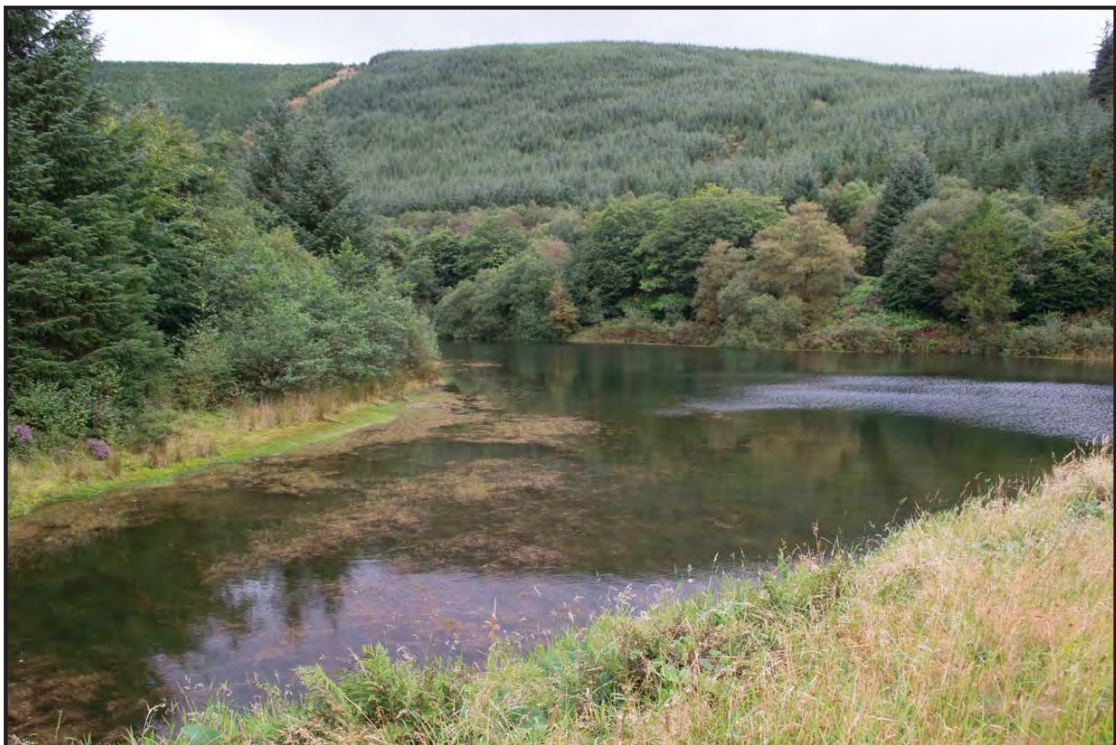
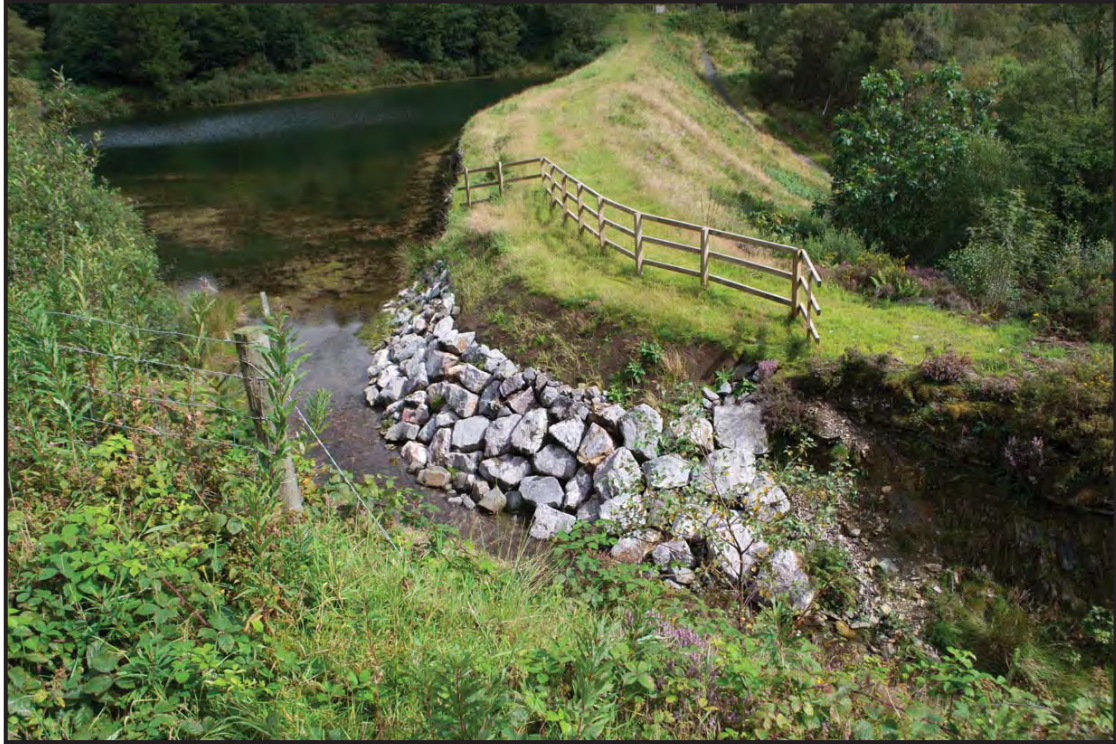
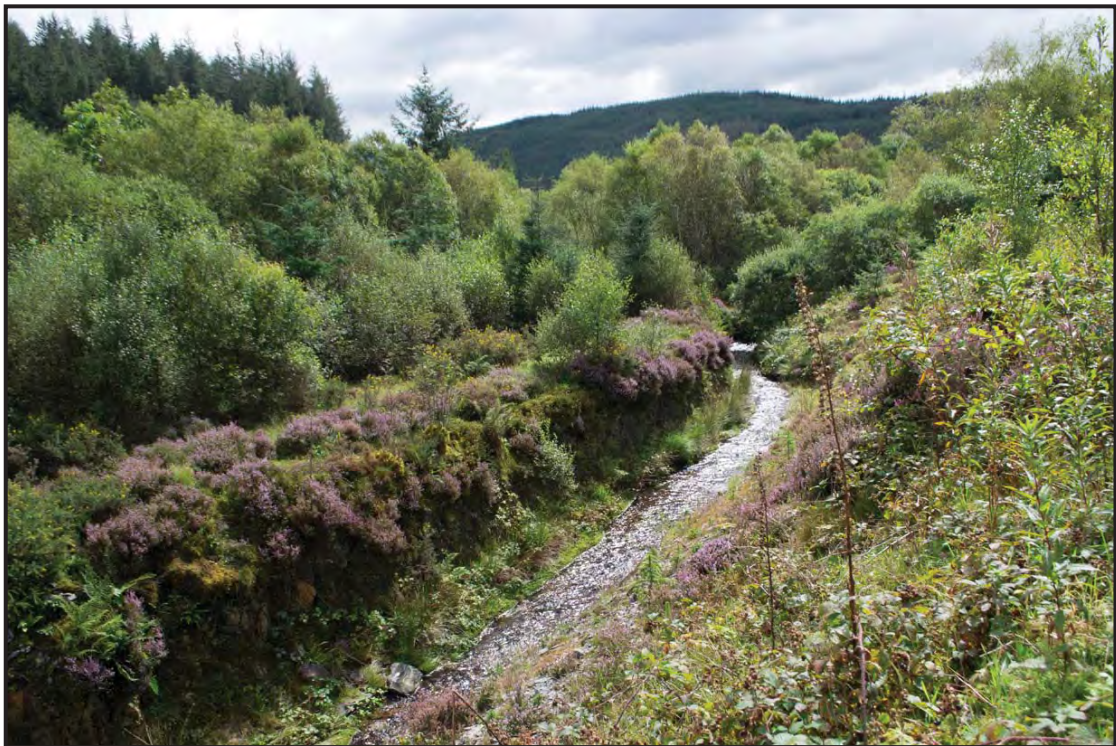
- PRN 9146 - Hendre Ddu Quarry Reservoir 1, Mawddwy; visible and accessible during 2020 field survey with evidence of clearance and recent repair;
- PRN 9147 - Hendre Ddu Quarry Reservoir 2, Mawddwy/Lower Hendre Reservoir: visible during 2020 field survey but heavily overgrown;

<b>Feature Number</b>	<b>12 (Plate 10, 11, 12 &amp; 13)</b>
<b>Site name</b>	Hendre Ddu Quarry Reservoir 1, Mawddwy
<b>PRN number</b>	9146
<b>Grid reference</b>	SH79821265 C
<b>Period</b>	Modern
<b>Site type</b>	Reservoir
<b>Assessment category</b>	B
<b>Description</b>	Triangular shaped reservoir with dam at southern end. It is still in water, and shows evidence of recent repair to ancillary walls to the dam, and site clearance around the dam. It was listed as Category B (regional importance) in the 1998 assessment and has been ascribed Category B (regional importance) in the current assessment for the same reason. It is not within the route or location of the proposed works and no further recommendations are given beyond avoidance.
<b>Impact</b>	None
<b>Recommendation for further assessment/evaluation</b>	None
<b>Recommendation for mitigatory measures</b>	Avoidance

**Plate 10: Feature 12: PRN 9146, view along Upper Hendre Reservoir dam; scale 1x1m; view from southwest (archive reference: G2660\_31)**

**Plate 11: Feature 12: PRN 9146, view along Upper Hendre Reservoir dam; scale not used; view from south (archive reference: G2660\_032).**

**Plate 12: Feature 12: PRN 9146, view of modern revetment works to the Upper Hendre Reservoir dam; scale not used; view from southwest (archive reference: G2660\_033).**

**Plate 13: Feature 12: PRN 9146, view from Upper Hendre Reservoir spillway; scale not used; view from northwest (archive reference: G2660\_034).**

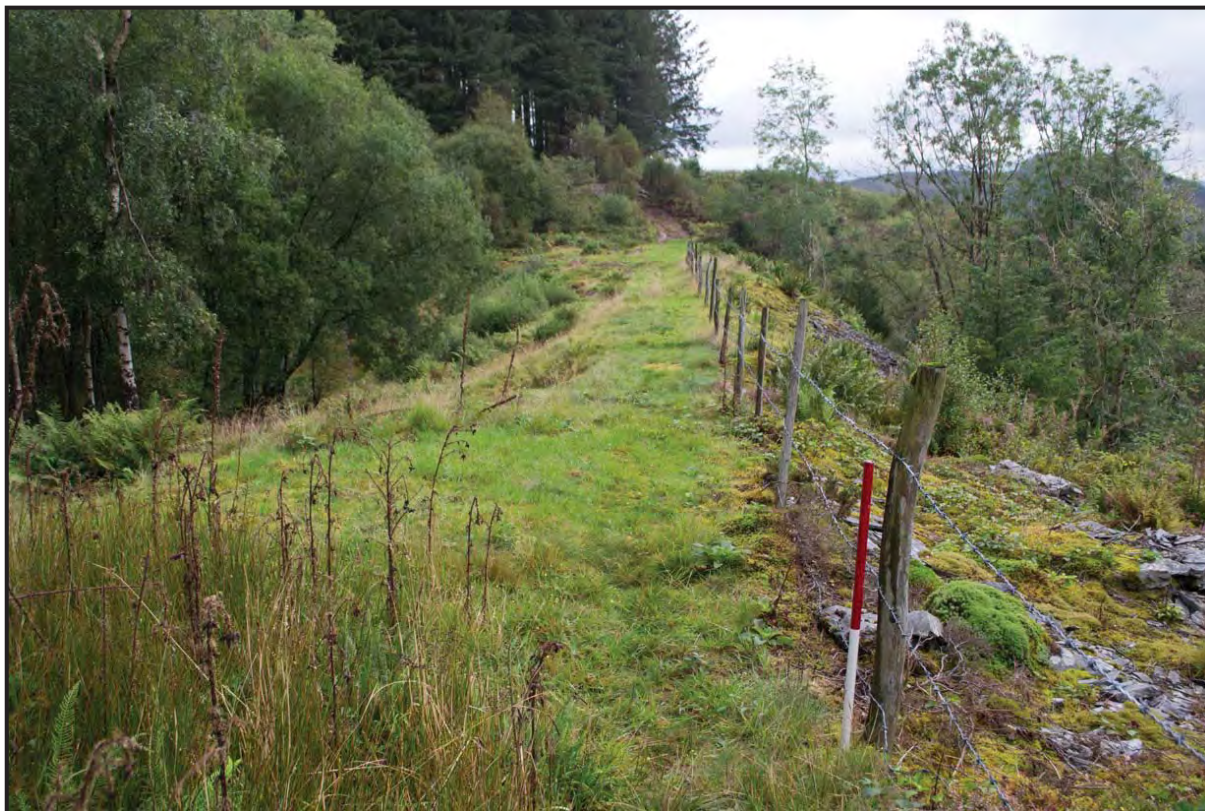
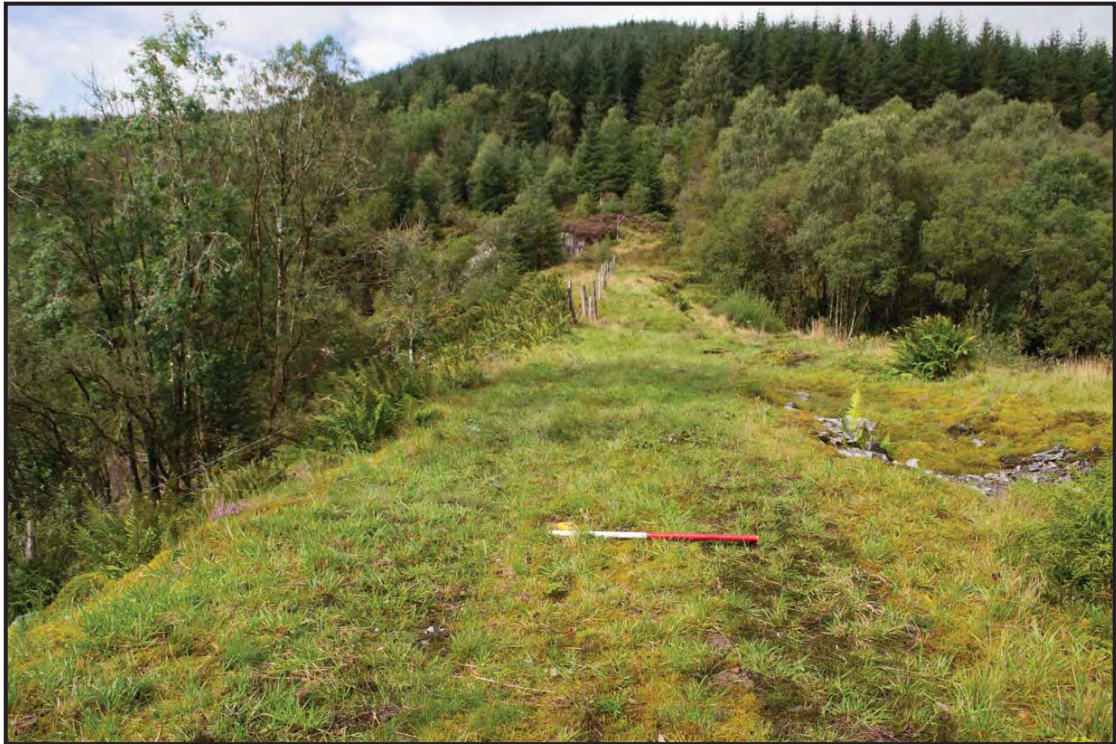
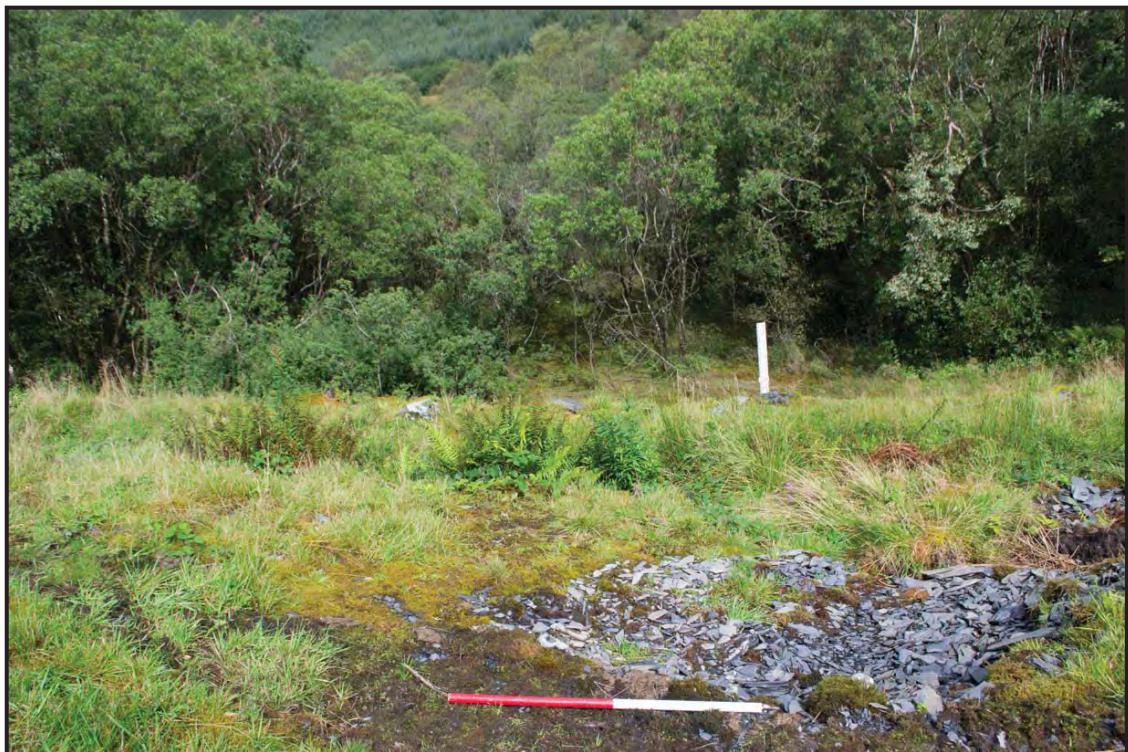
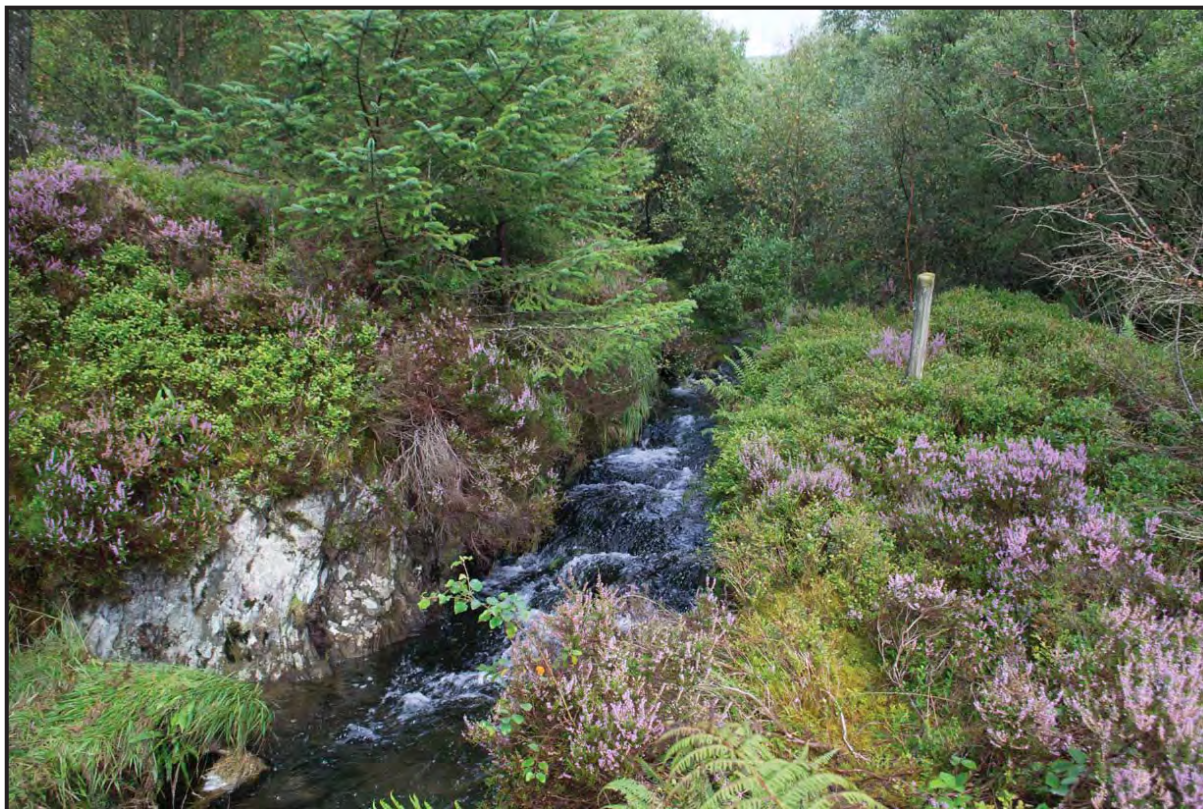
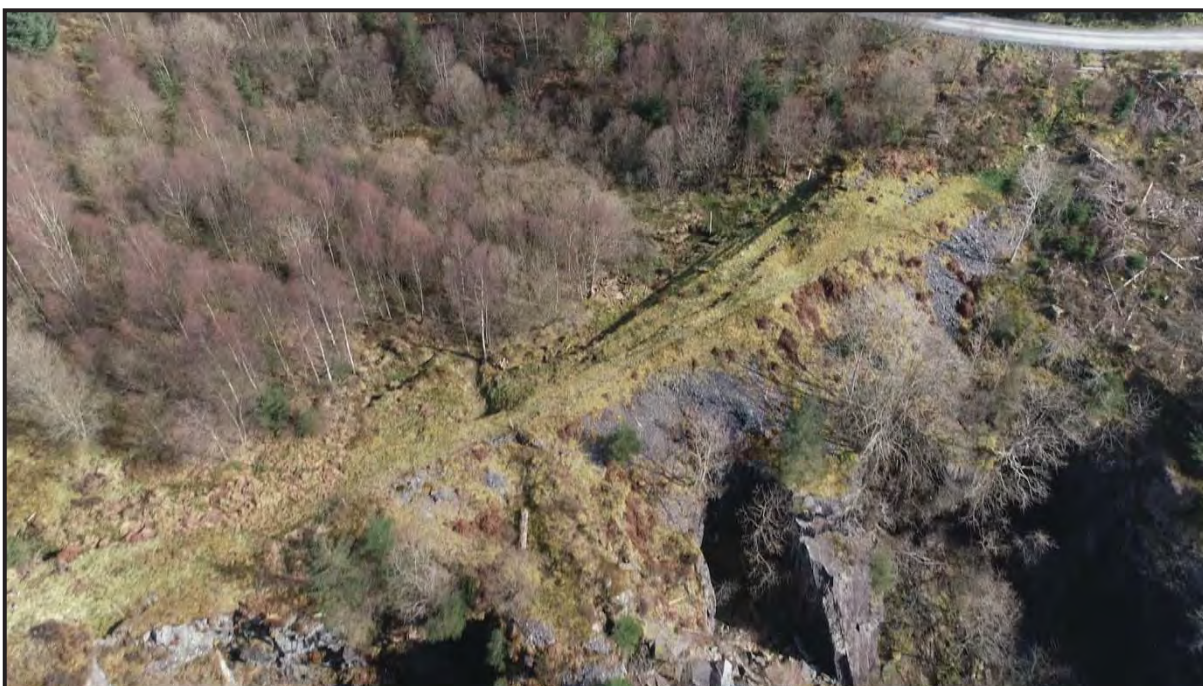
<b>Feature Number</b>	<b>13 (Plate 14, 15, 16, 17 &amp; 18)</b>
<b>Site name</b>	Hendre Ddu Quarry Reservoir 2 / Lower Hendre Ddu Reservoir
<b>PRN number</b>	9147
<b>Grid reference</b>	SH79751280 C
<b>Period</b>	Modern
<b>Site type</b>	Reservoir
<b>Assessment category</b>	B
<b>Description</b>	<p>Triangular shaped reservoir with dam at southeastern end and outfall from southern end. This is the reservoir and dam scheduled for the proposed discontinuance works. The reservoir and dam were accessible for the 2020 field survey; the reservoir was dry but heavily overgrown with trees and shrubs; the dam was in a good condition and was constructed of slate rubble, with a pronounced batter on the downslope side. The three geotechnical trial pits excavated into the top of the reservoir dam in August 2020 for contamination testing further confirmed the dam was built from slate waste. It was listed as Category B (regional importance) in the 1998 assessment and has been ascribed Category B (regional importance) in the current assessment for the same reason. The proposed discontinuance works will include the excavation of a trench through the reservoir dam, which is aimed at stopping the reservoir holding any significant volumes of water during heavy rain. As detailed in Arcadis Drawing No. 10038919-ARC-XX-XX-DR-CE-LH0200, the proposals include the excavation of a c.20m long and 2.5m wide channel; the channel side will be excavated to a 1:2 incline ratio, with a maximum width of c.28m, as indicated on Arcadis Drawing No. 0038919-ARC-XX-XX-DR-CE-LH0201. Preservation <i>in situ</i> is the preferred option for Category B sites (in the 1998 assessment this is recommended for “better examples”), but as the impact of the trench will involve the partial removal of the feature affecting its overall integrity, “damage or destruction” cannot be avoided; appropriate detailed recording is therefore proposed as an alternative.</p>

**Plate 14: Feature 13: PRN 9147, view along Lower Hendre Reservoir dam; scale 1x1m; view from west (archive reference: G2660\_023).**

**Plate 15: Feature 13: PRN 9147, view of Lower Hendre Reservoir dam wall; scale 1x1m; view from east (archive reference: G2660\_030).**

**Plate 16: Feature 13: PRN 9147, view from Lower Hendre Reservoir dam wall showing overgrowth within reservoir; scale 1x1m; view from south (archive reference: G2660\_029).**

**Plate 17: Feature 13: PRN 9147, view of channelled watercourse; scale not used; view from south (archive reference: G2660\_027).**

**Plate 18: Feature 13: PRN 9147, aerial view of dam; (Image taken from drone survey undertaken by client)**

<b>Impact</b>	Significant: will result in the partial removal of an asset (dam) affecting its overall integrity
<b>Recommendation for further assessment/evaluation</b>	None
<b>Recommendation for mitigatory measures</b>	Detailed Recording (this has subsequently been completed by GAT via a UAS Survey)

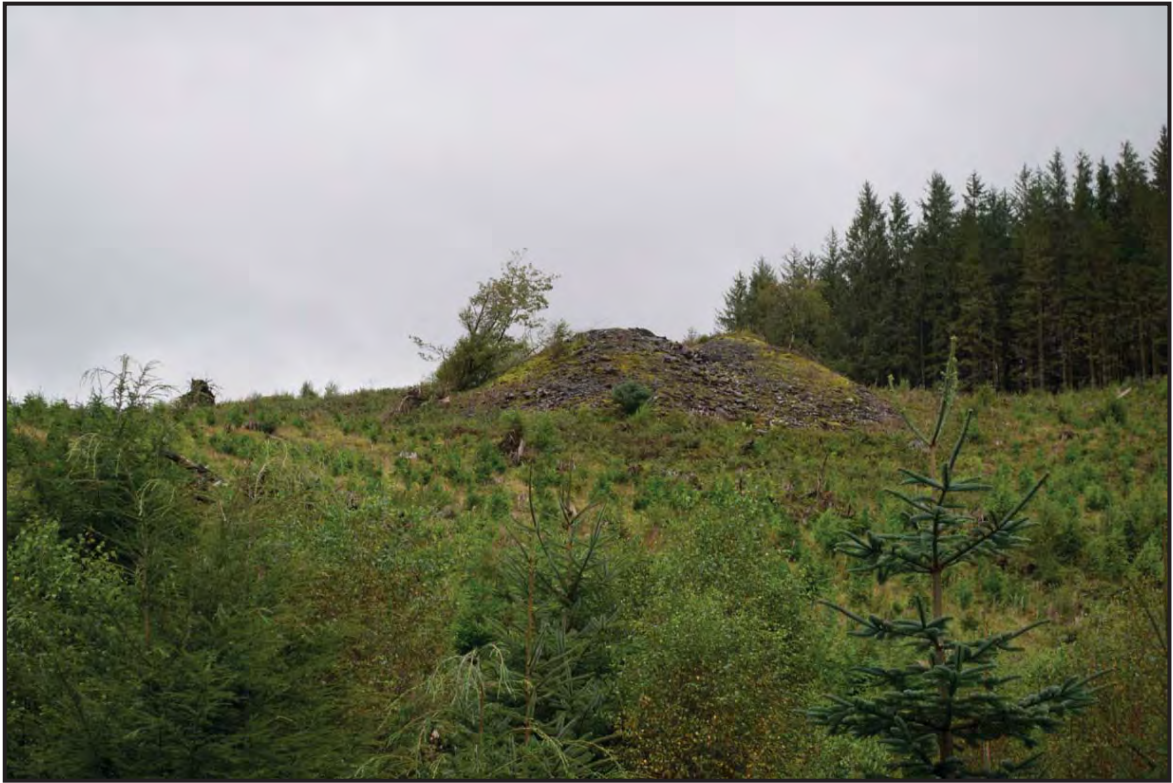
<b>Feature Number</b>	<b>14 (Plate 19)</b>
<b>Site name</b>	Hendre Ddu Quarry Spoil Tip 1, Mawddwy
<b>PRN number</b>	9132
<b>Grid reference</b>	SH79971250
<b>Period</b>	Modern
<b>Site type</b>	Spoil Tip
<b>Assessment category</b>	C
<b>Description</b>	Waste tip for 9131 (Feature 06). The tip is twin crested and is about 5m high with a base of around 20m. It is constructed of mainly medium sized fragments of slate waste with some larger blocks. The location of the feature was generally accessible and in appearance appeared similar to the “overgrown” condition identified in 1998; there was no tree planting in the immediate area, which was a recommendation in 1998. It was listed as Category C (lesser significance) in the 1998 assessment and has been ascribed Category C (local importance) in the current assessment as evidence of slate processing.
<b>Impact</b>	None
<b>Recommendation for further assessment/evaluation</b>	None

**Plate 19: Feature 14: PRN 9132, view of spoil tip; scale not used; view from south (archive reference: G2660\_015).**

<b>Recommendation for mitigatory measures</b>	Avoidance

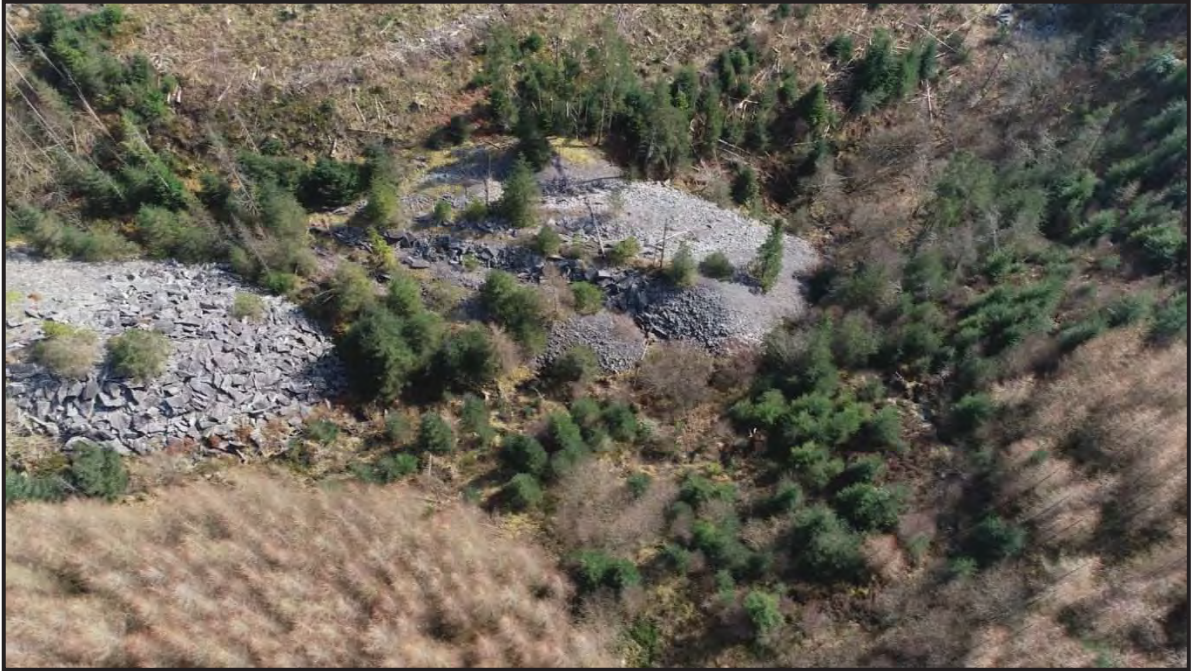
<b>Feature Number</b>	<b>15 (Plate 20)</b>
<b>Site name</b>	Hendre Ddu Quarry Spoil Tip 2, Mawddwy
<b>PRN number</b>	9139
<b>Grid reference</b>	SH79851242
<b>Period</b>	Modern
<b>Site type</b>	Spoil Tip
<b>Assessment category</b>	C
<b>Description</b>	Waste tip from 9137 (Feature 10). Five smoothed tracks are defined in the top of the tips marking the line of tramways (Brooks and Price, 1999). This feature was not accessible during the current assessment, so the current appearance and condition of the feature could not be confirmed. It was listed as Category C (lesser significance) in the 1998 assessment and has been ascribed Category C (local importance) in the current assessment as evidence of slate processing.
<b>Impact</b>	None
<b>Recommendation for further assessment/evaluation</b>	None
<b>Recommendation for mitigatory measures</b>	Avoidance

**Plate 20: Feature 15: PRN 9139, Aerial view of spoil tip 2; (Image taken from drone survey undertaken by client)**

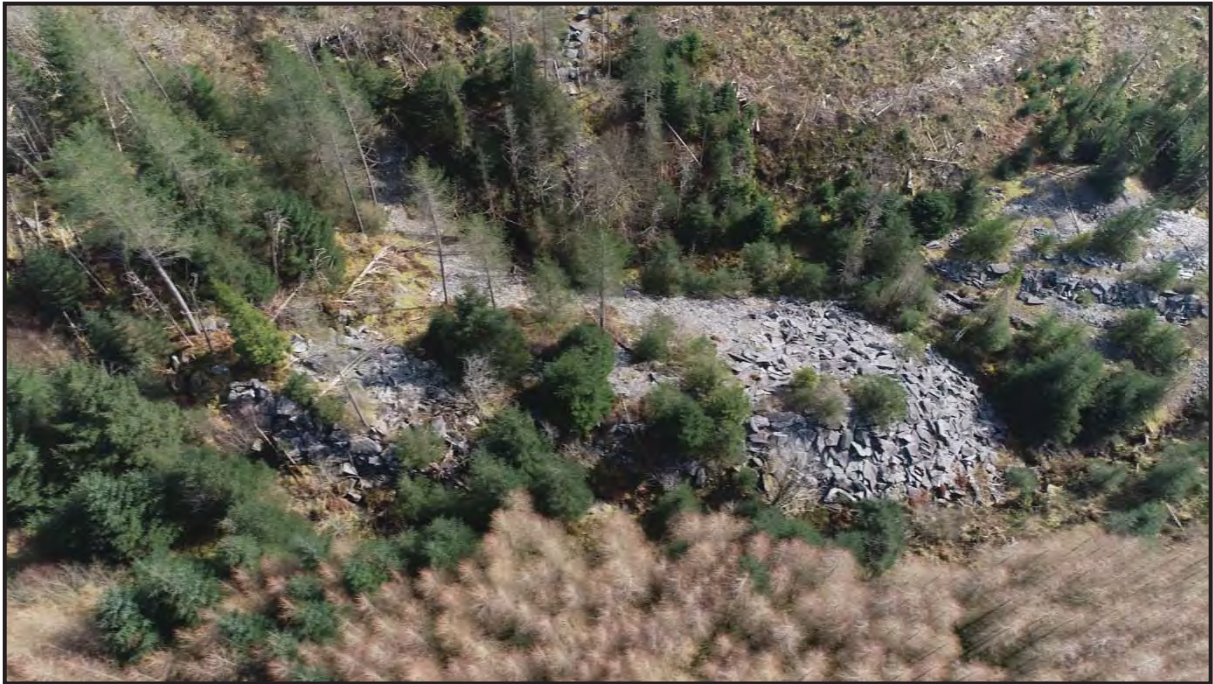
<b>Feature Number</b>	<b>16 (Plate 21)</b>
<b>Site name</b>	Hendre Ddu Quarry Spoil Tip 3, Mawddwy
<b>PRN number</b>	9135
<b>Grid reference</b>	SH79831248
<b>Period</b>	Modern
<b>Site type</b>	Spoil Tip
<b>Assessment category</b>	C
<b>Description</b>	Waste tip from 9134 (Feature 07). Top surface has six smoothed areas probably the line of trackways (Brooks and Price, 1999). This feature was not accessible during the current assessment, but an image from a drone survey completed by Arcadis suggests the appearance and condition of the feature hadn't changed. It was listed as Category C (lesser significance) in the 1998 assessment and has been ascribed Category C (local importance) in the current assessment as evidence of slate processing.
<b>Impact</b>	None
<b>Recommendation for further assessment/evaluation</b>	None
<b>Recommendation for mitigatory measures</b>	Avoidance

**Plate 21: Feature 16: PRN 9135, Aerial view of spoil tip 3; (Image taken from drone survey undertaken by client)**
