## LOWER HENDRE RESERVOIR, GWYNEDD

### ASESIAD ARCHEOLEGOL / ARCHAEOLOGICAL ASSESSMENT

Prosiect Rhif / Project No. G2660

Adroddiad Rhif / Report No. 1559

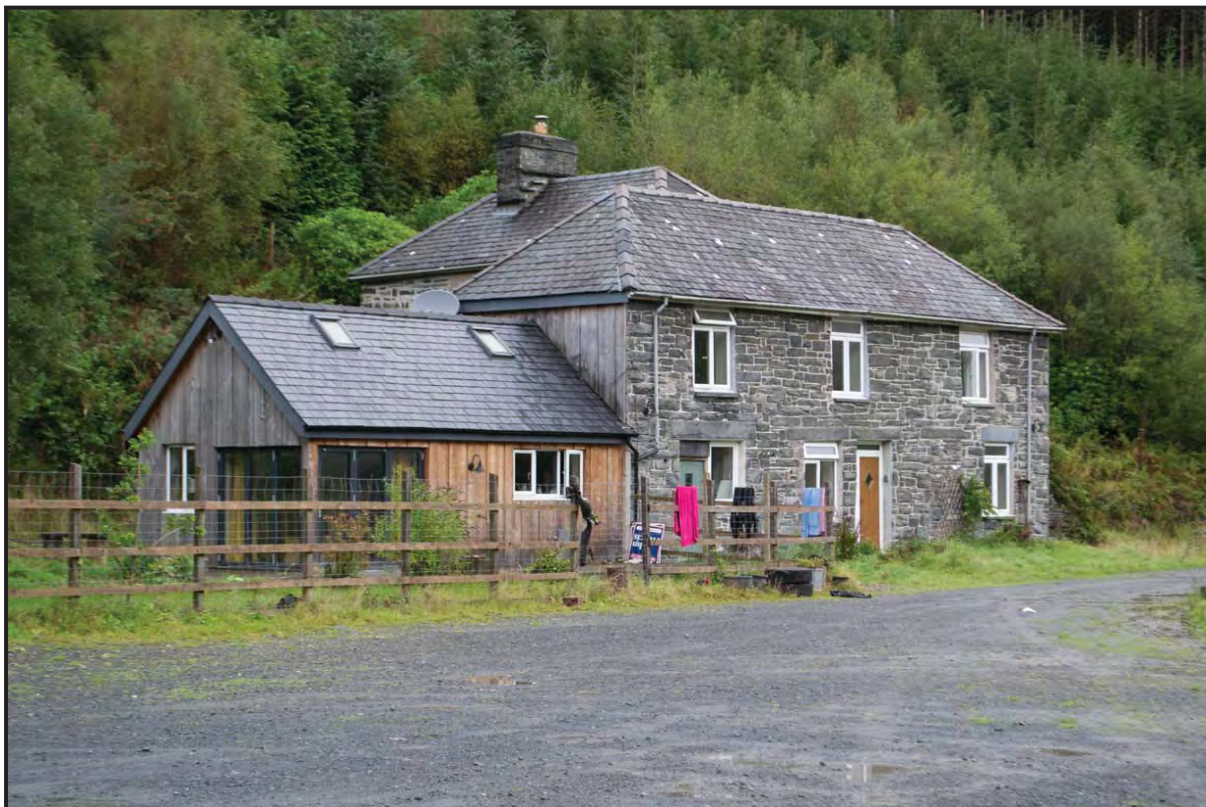
**Plate 22: Feature 23: PRN 90585, view of house Hendregoes; scale not used; view from south-southwest (archive reference: G2660\_007).**

<b>Impact</b>	None
<b>Recommendation for further assessment/evaluation</b>	None
<b>Recommendation for mitigatory measures</b>	Avoidance

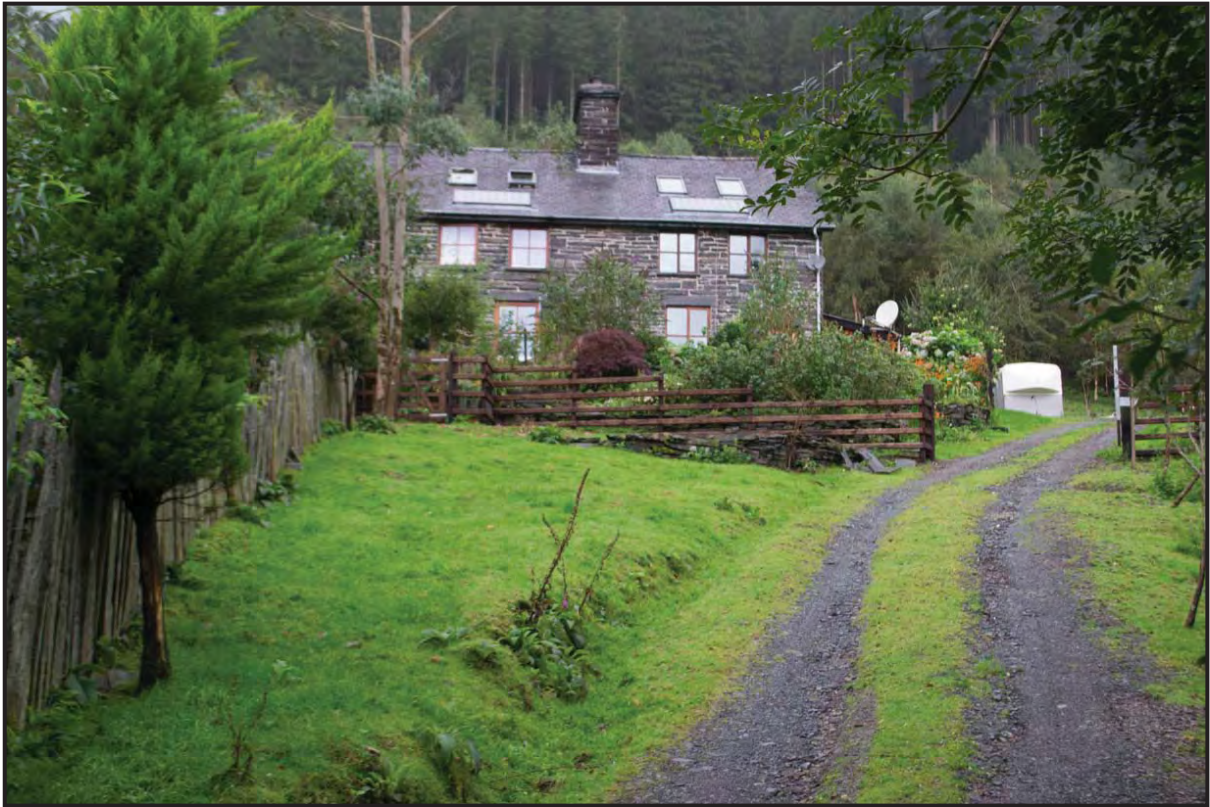
<b>Feature Number</b>	<b>24 (Plate 23)</b>
<b>Site name</b>	Hendre-Ddu Cottages
<b>PRN number</b>	90586
<b>Grid reference</b>	SH8059012529
<b>Period</b>	Modern
<b>Site type</b>	House
<b>Assessment category</b>	B
<b>Description</b>	Cottages are noted at this location on historic and modern mapping. What were formerly six cottages were noted, slate rubble built, and are now restored and inhabited. They are single pile with central gable chimneys. Cottages 5 and 6 were noted to have original features within the stonework, although doors and windows had been replaced. They are located within private gardens. These cottages were not identified or visited during the 1998 assessment; it is ascribed Category B (regional importance) in the current assessment as evidence of surviving quarry infrastructure.
<b>Impact</b>	None
<b>Recommendation for further assessment/evaluation</b>	None
<b>Recommendation for mitigatory measures</b>	Avoidance

**Plate 23: Feature 24: PRN 90856, Hendre Ddu Cottages; scale not used; view from south (archive reference: G2660\_003).**

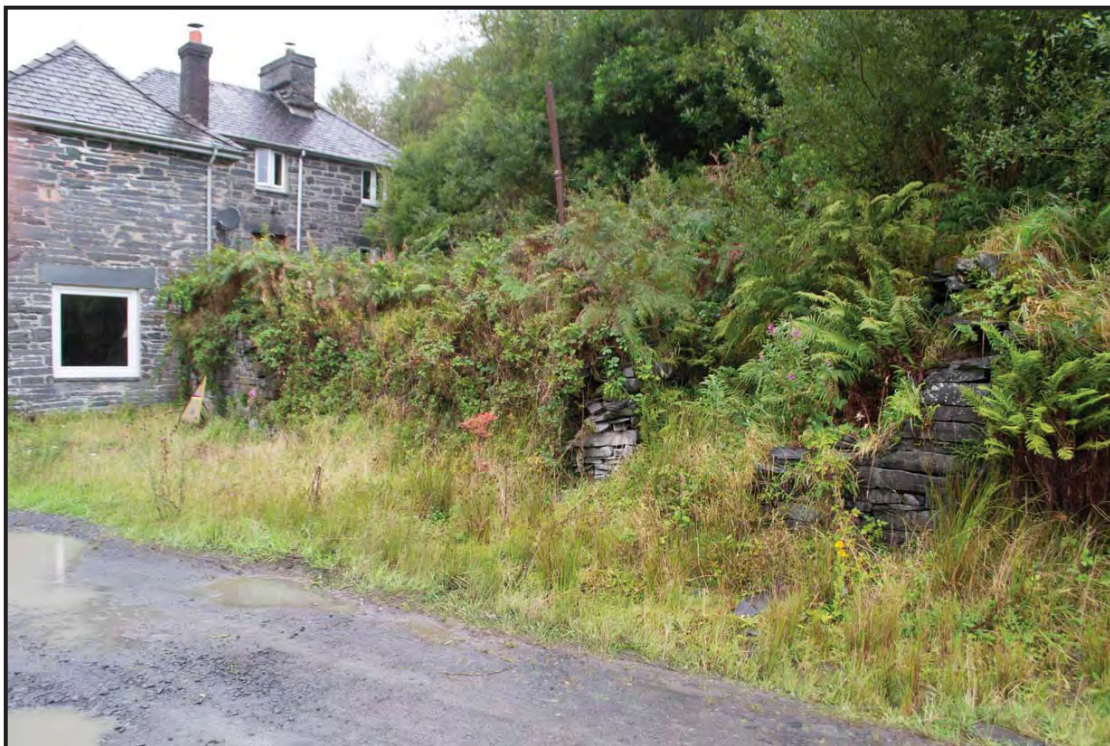
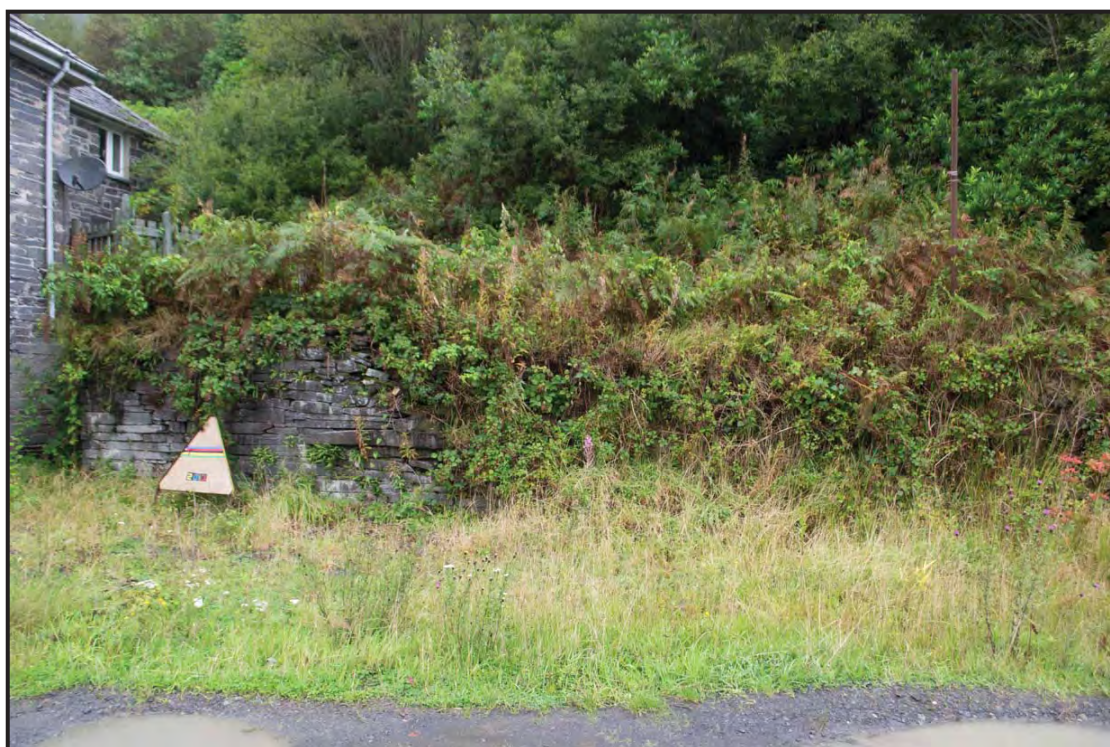
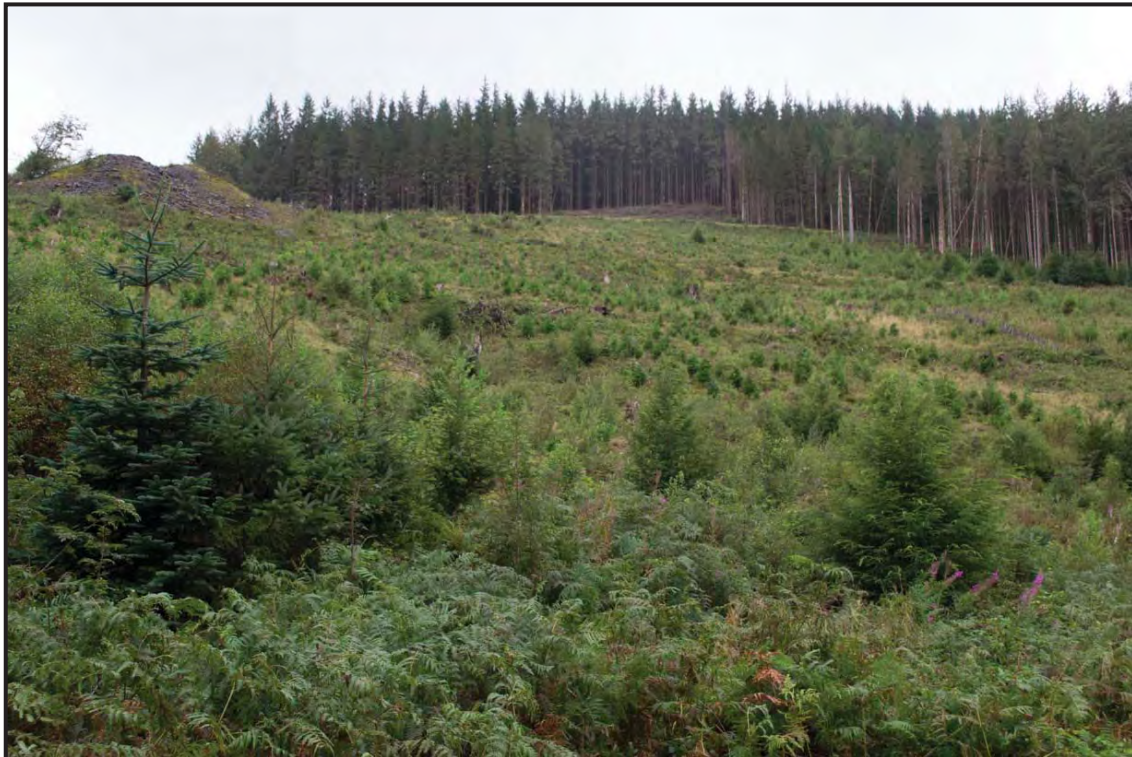
**Plate 24: Feature 29: PRN 90591 possible remains of tramway; scale not used; view from southeast (archive reference: G2660\_010).**

**Plate 25: Feature 29: PRN 90591 possible remains of tramway; scale not used; view from south (archive reference: G2660\_011).**

**Plate 26: Feature 29: Wide angle view of tramway; scale not used; view from south (archive reference: G2660\_016).**

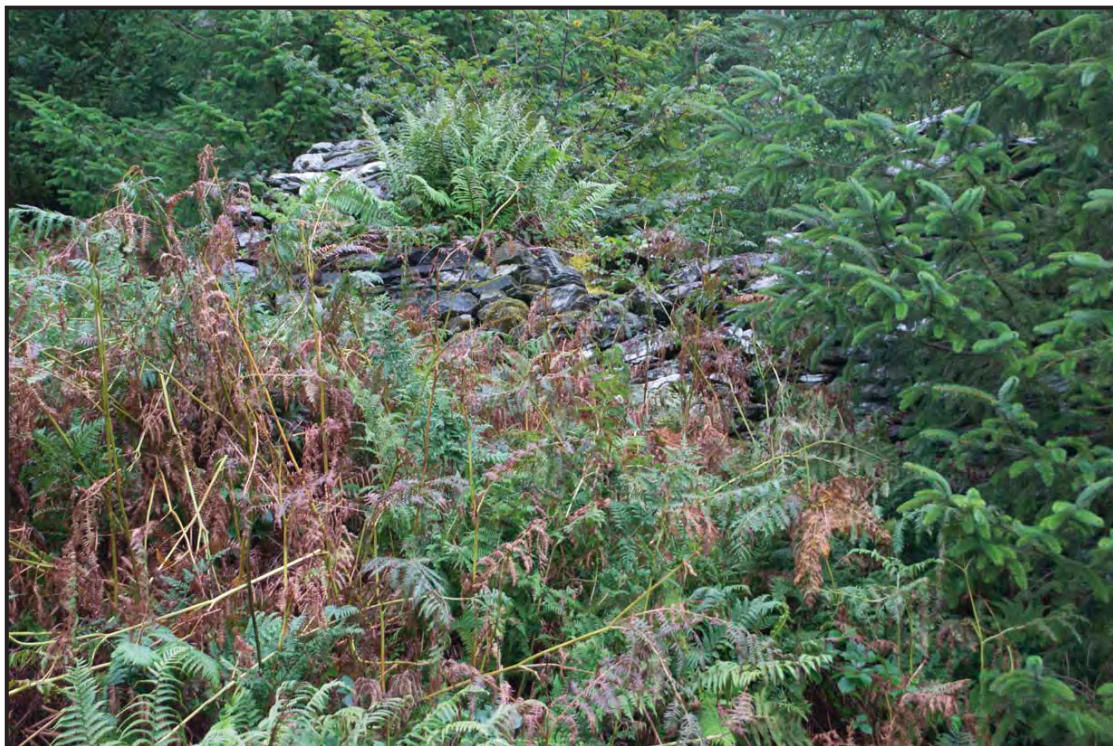
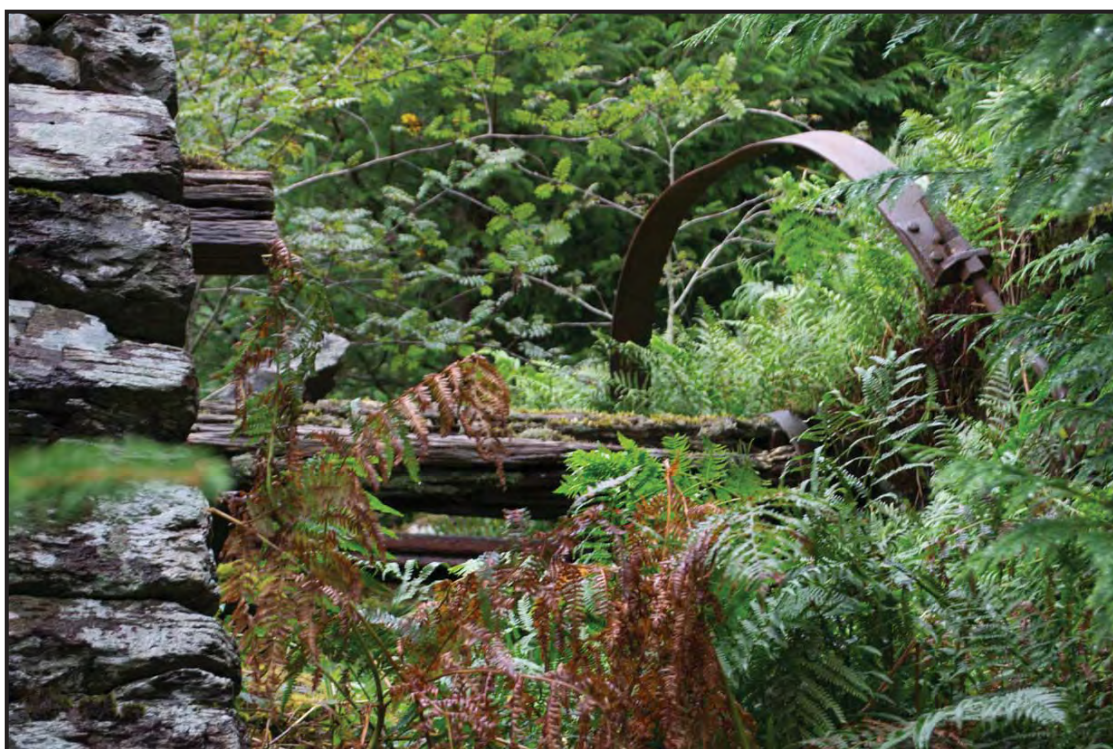
**Plate 27: Feature 30: PRN 9127: view of drum house; scale not used; view from south (archive reference: G2660\_018).**

**Plate 28: PRN 9127: view of drum house detailing metal and wood structural remains; scale 1x1m; view from southeast (archive reference: G2660\_019).**

<b>Impact</b>	None
<b>Recommendation for further assessment/evaluation</b>	None
<b>Recommendation for mitigatory measures</b>	Avoidance

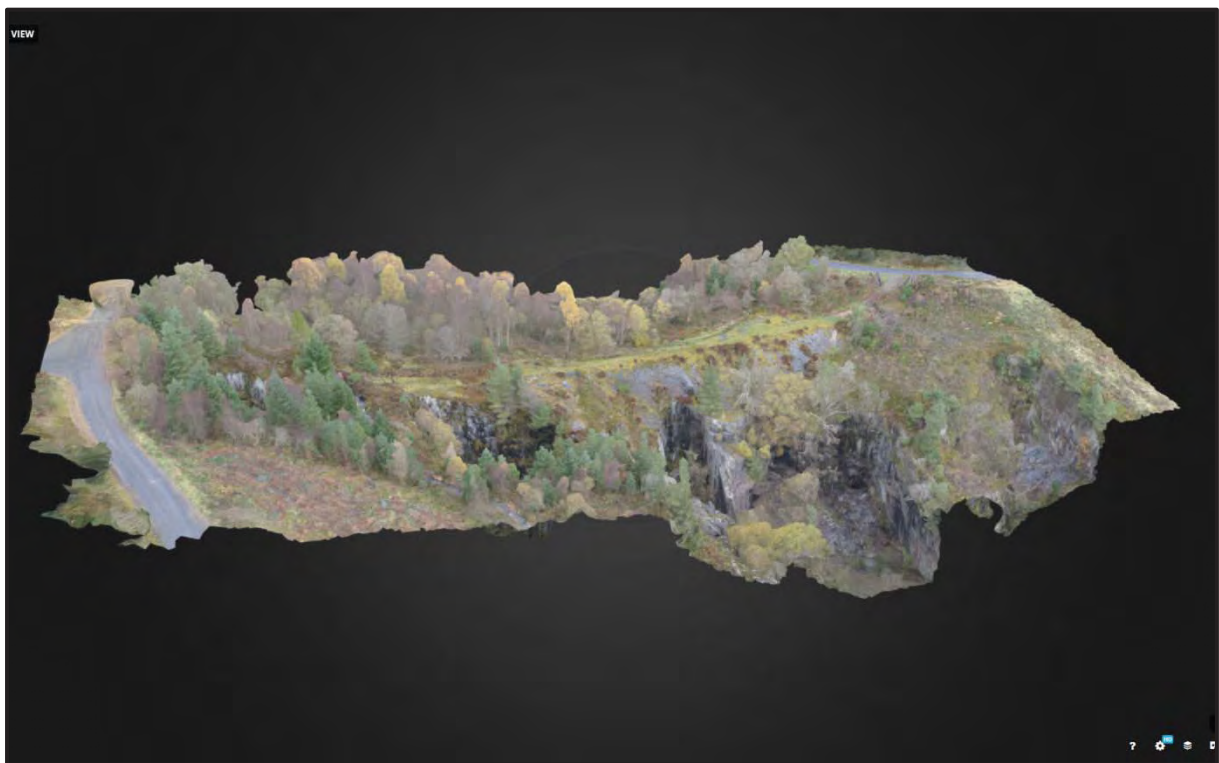
**Plate 29: Screenshot of Lower Hendre Reservoir dam 3D model**

*Detailed recording of the dam structure prior to completion has been completed by aerial photographic survey to produce a digital 3D model of the reservoir dam and record its condition.*

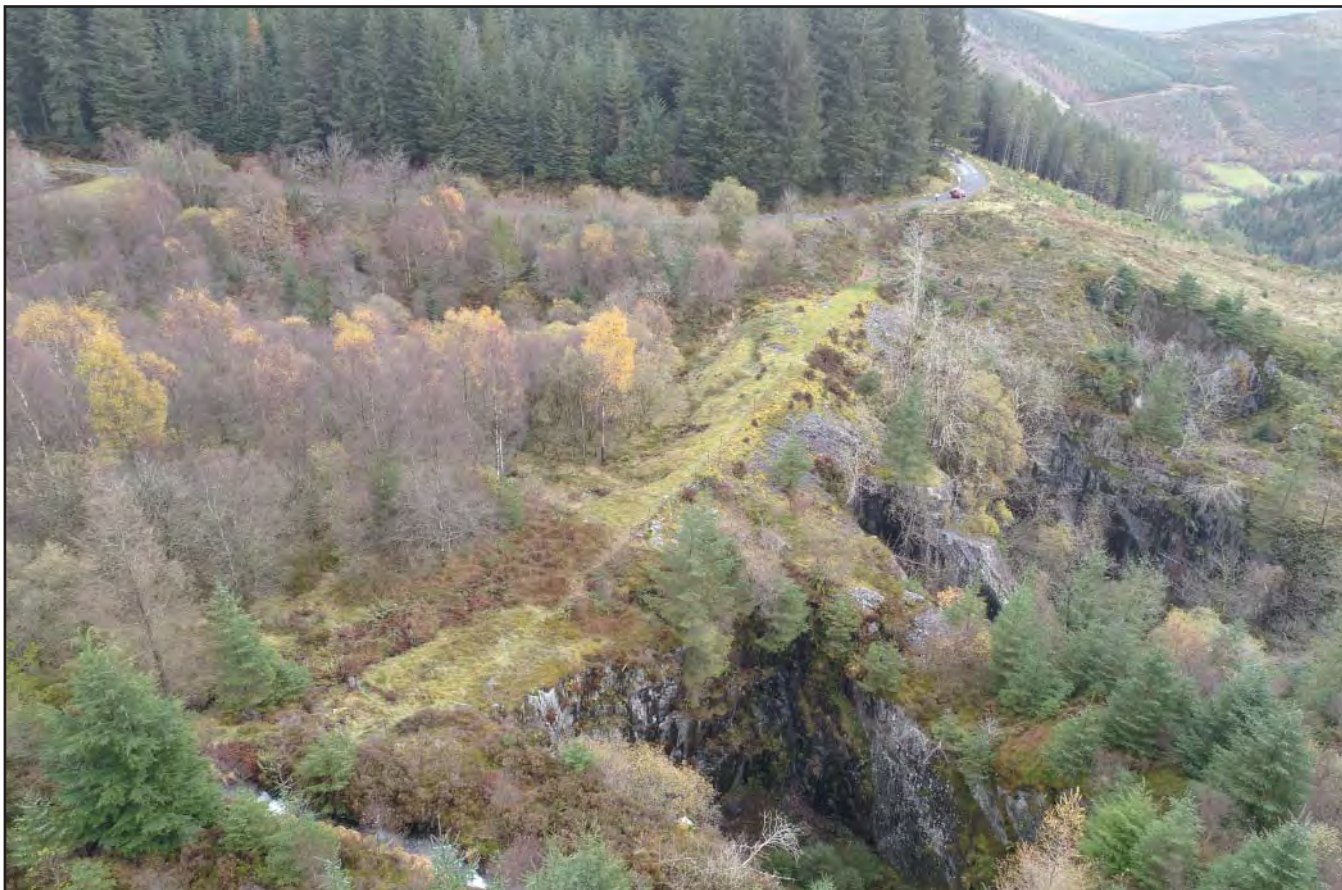
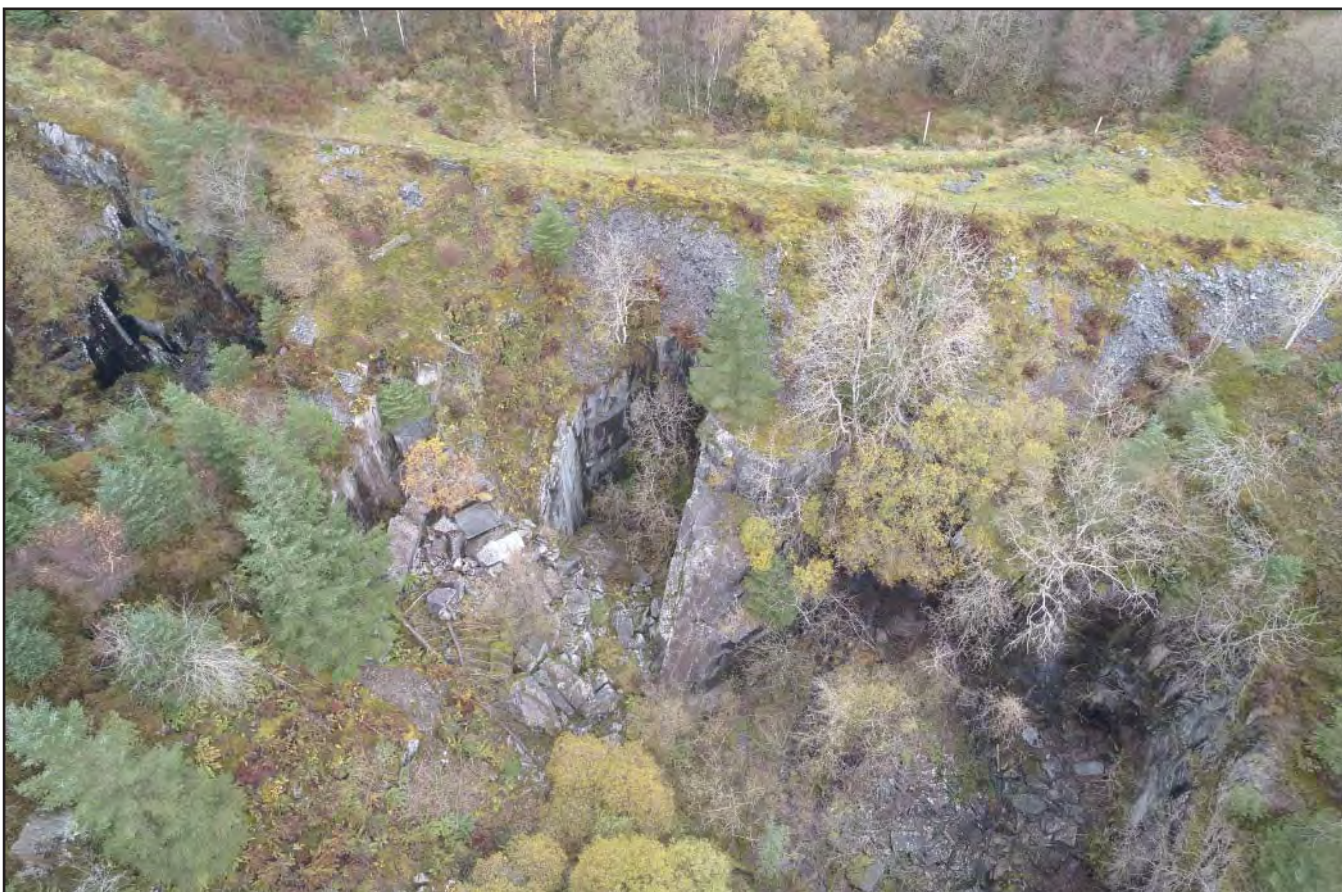
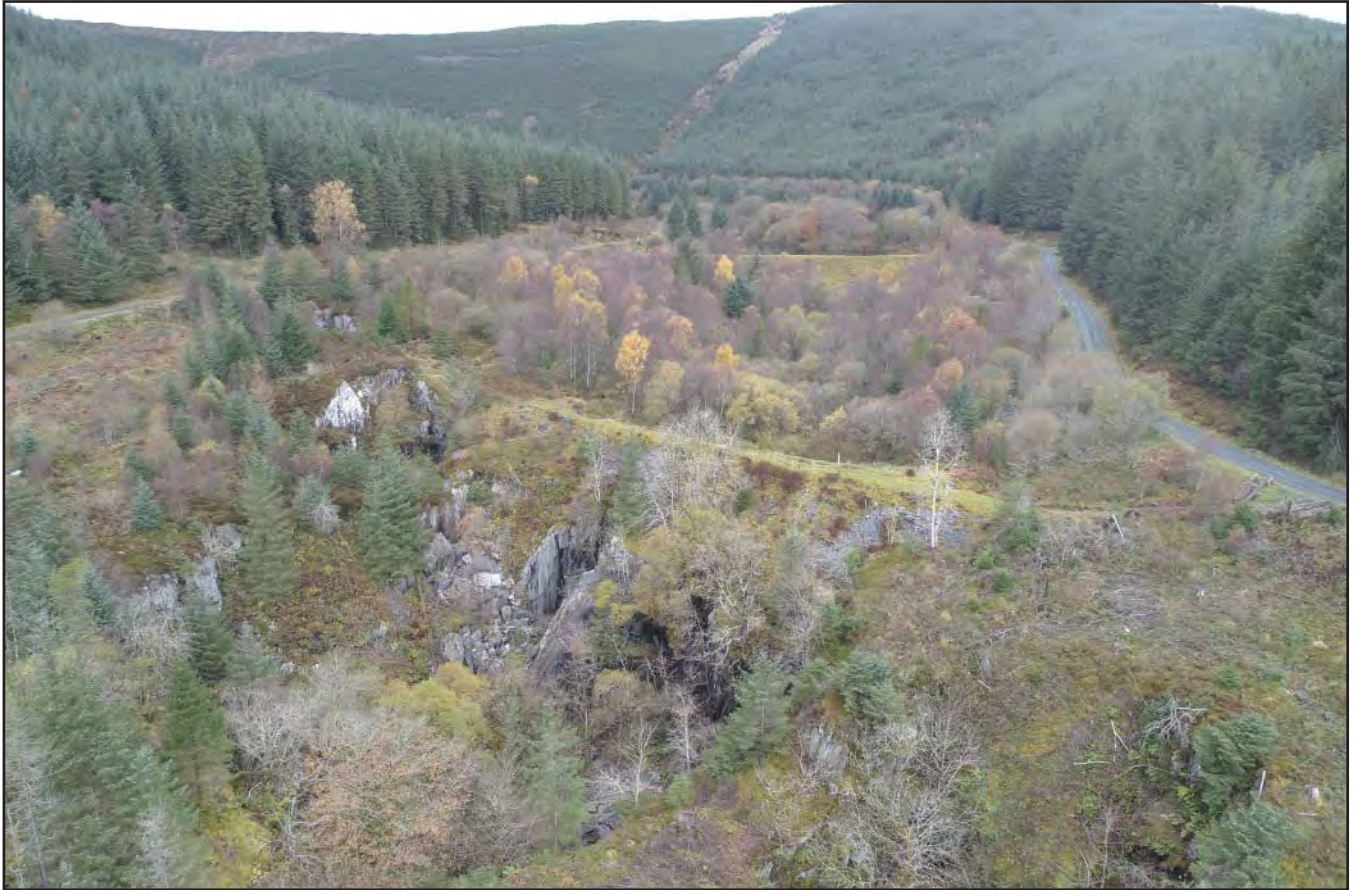
Additional oblique aerial images of the dam were also captured during the survey, a selection of which are included as Plates 30-32.

**Plate 30: Feature 13: PRN 9147, aerial view of Lower Hendre Reservoir dam; view from southwest (archive reference: G2660\_UAV\_247).**

**Plate 31: Feature 13: PRN 9147, aerial view of Lower Hendre Reservoir dam; view from south (archive reference: G2660\_UAV\_274).**

**Plate 32: Feature 13: PRN 9147, aerial view of Lower Hendre Reservoir dam; view from southeast (archive reference: G2660\_UAV\_261).**

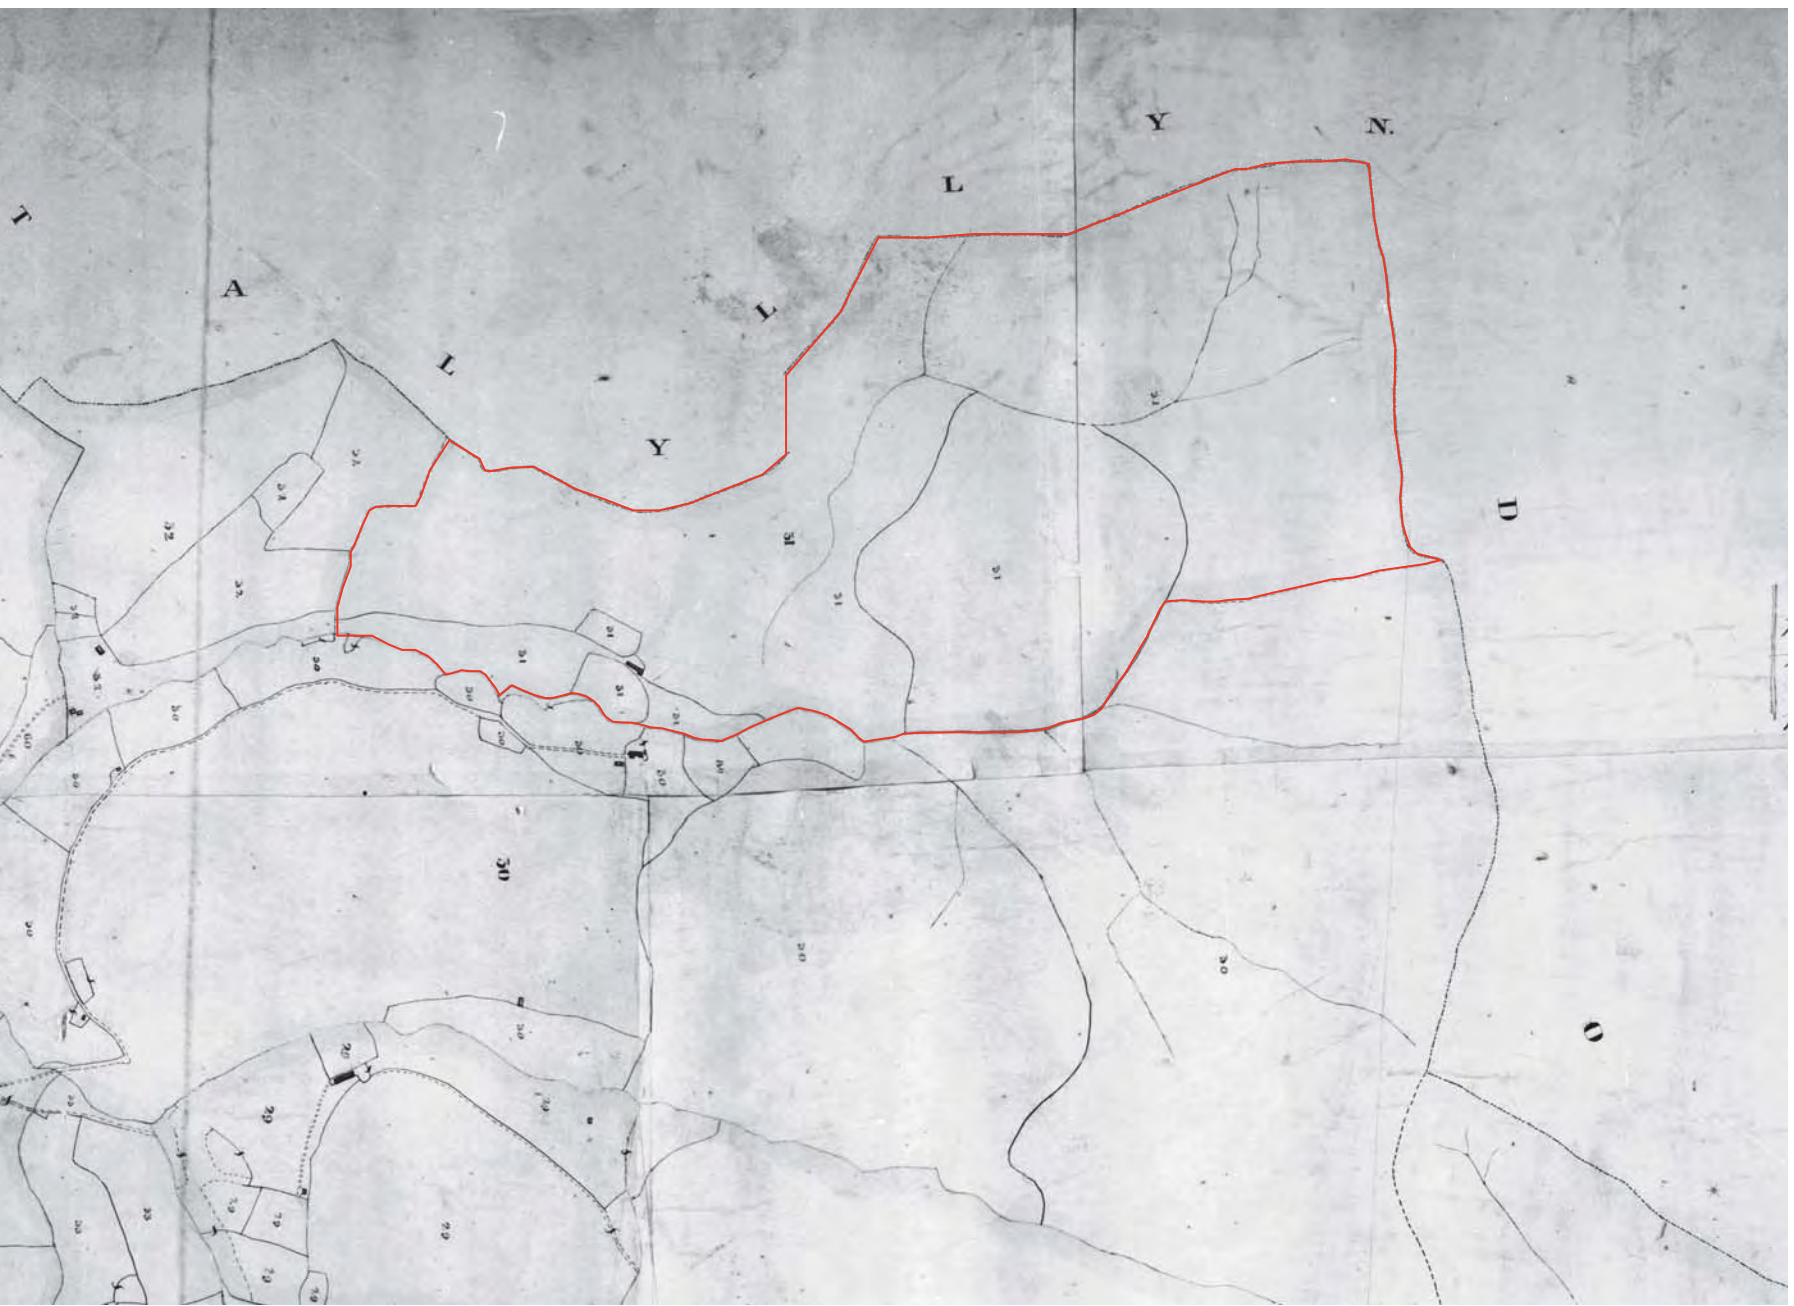
Figure 03: Extract from the Tithe Map of the Parish of Mallwyd of 1838, with Hendre Ddu (Plot 31) outlined in red. Not to Scale

Hendre Ddu quarry was located in the ancient parish of Mallwyd, which was the remotest southern parish in Meirionnydd, bordering Montgomeryshire. The tithe map of 1838 (Figure 03), dating from prior to the opening of the quarry, shows that the landowner was Sir Watkin Williams Wynn of Wynnstay, Denbighshire. The quarry area formed part of a large open area of land, with any field subdivisions within it not shown on the map. The extensive archives of that estate are available for study in the Denbighshire Archives at Ruthin and the National Library of Wales, however, these could not be accessed at the time of writing due to current Covid-19 regulations. The information from the tithe apportionment is given below:

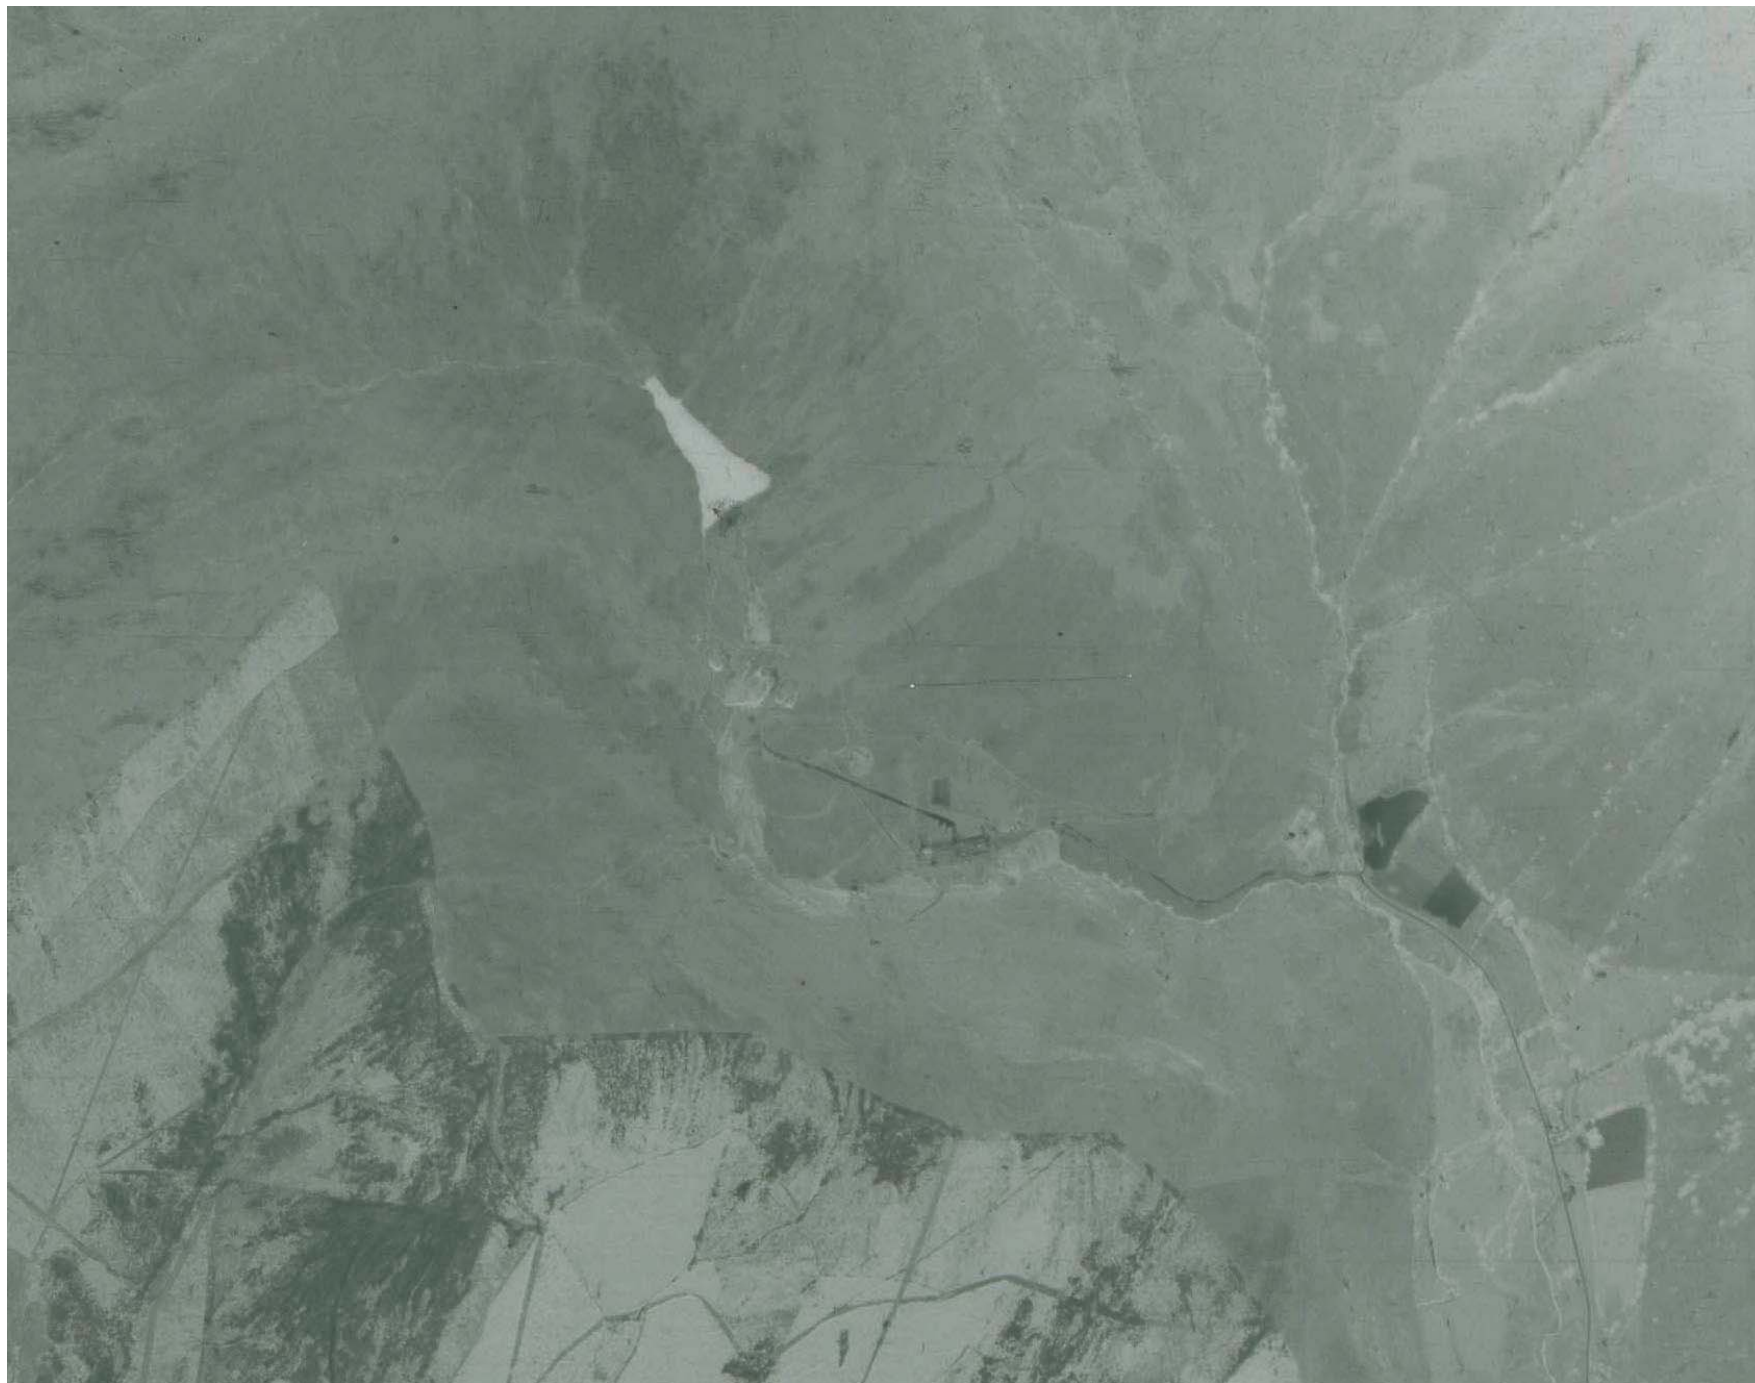
Figure 07: Detail from RAF Aerial Photograph 4801540 39 frame 5087 taken on 6th May 1948 showing Hendre Ddu Quarry. Not to Scale

- RAF 4801 540\_39 Image 5087 taken on 6<sup>th</sup> May 1948 (Figure 07).
