# Tir oddi ar Ffordd Llandygai/ Land off Llandygai Road, Bangor, Gwynedd

ASESU A GWERTHUSO ARCHEOLEGOL / ARCHAEOLOGICAL ASSESSMENT AND EVALUATION

Prosiect Rhif / Project No. G2663

Adroddiad Rhif / Report No. 1565

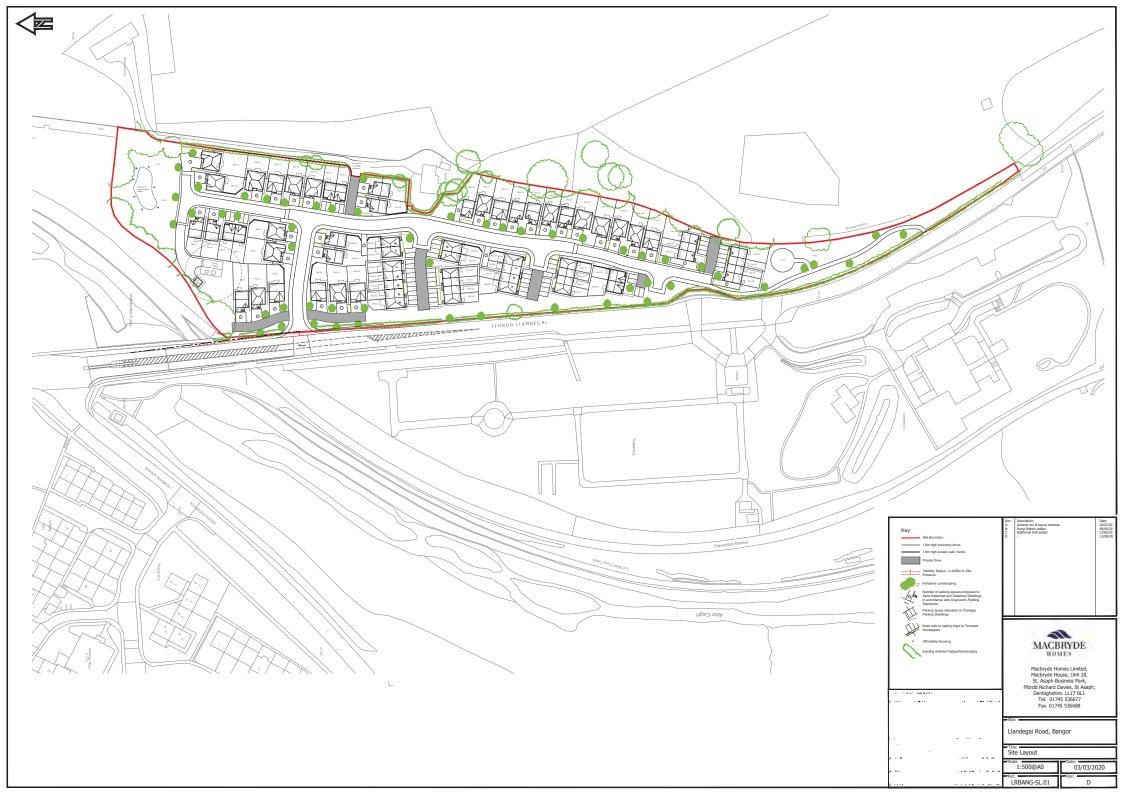
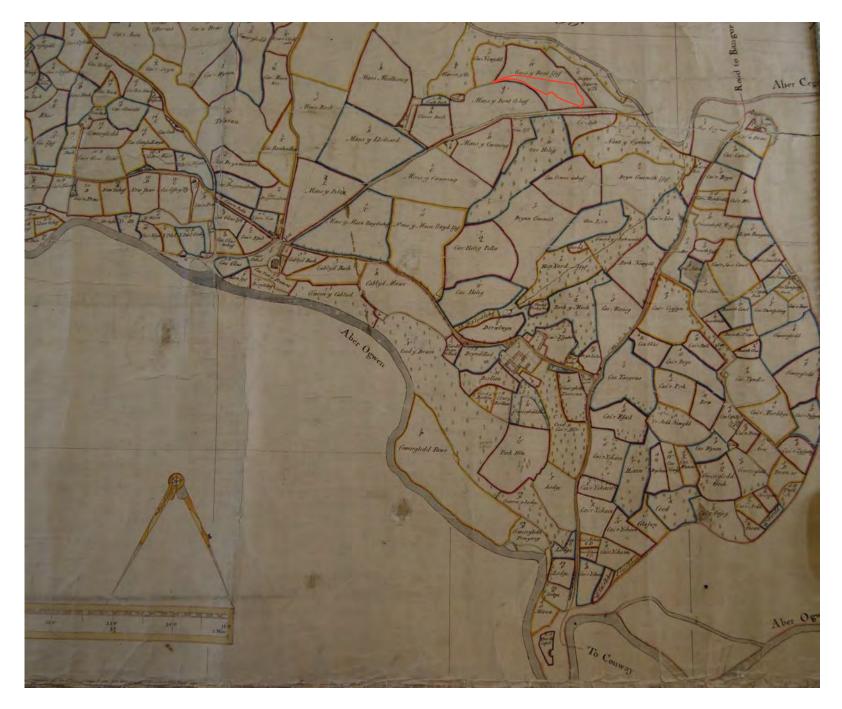
Figure 03: Detail from a 1768 Penrhyn Estate Map of the Parish of Llandegai (Bangor Archives, Penrhyn MSS S2205), showing the landscape prior to the construction of the Penrhyn quarry tramway and estate boundary wall. Approximate study area outlined in red. Not to scale.

The study area has been the property of the Penrhyn Estate and its antecedents from at least the 16<sup>th</sup> century. Numerous maps relating to the Penrhyn estate holdings cover the area, most notably an estate map of 1768 which covers the area prior to arrival of the tramway (Bangor University Archives, Penrhyn MSS S2205; Figure 03). This shows the wider pre-industrial study area as forming part of a patchwork of irregular shaped fields, with the proposed development plot in Field H *Maes y Bont Isaf.* And Field G *Higher Gwern.* A map of 1803 shows the route of the tramway and the now called Incline Cottage in detail running through plot 17 (Bangor University Archives, Penrhyn Maps 40; Figure 04). By the time of the Llandygai parish tithe map of 1840 the study area is shown within plot 93, and the tramway is shown clearly as a black line (National Archives, Figure 05). The associated apportionment for the study area and the area adjacent is given below, with the numbers corresponding to those shown on the tithe map (Figure 05):

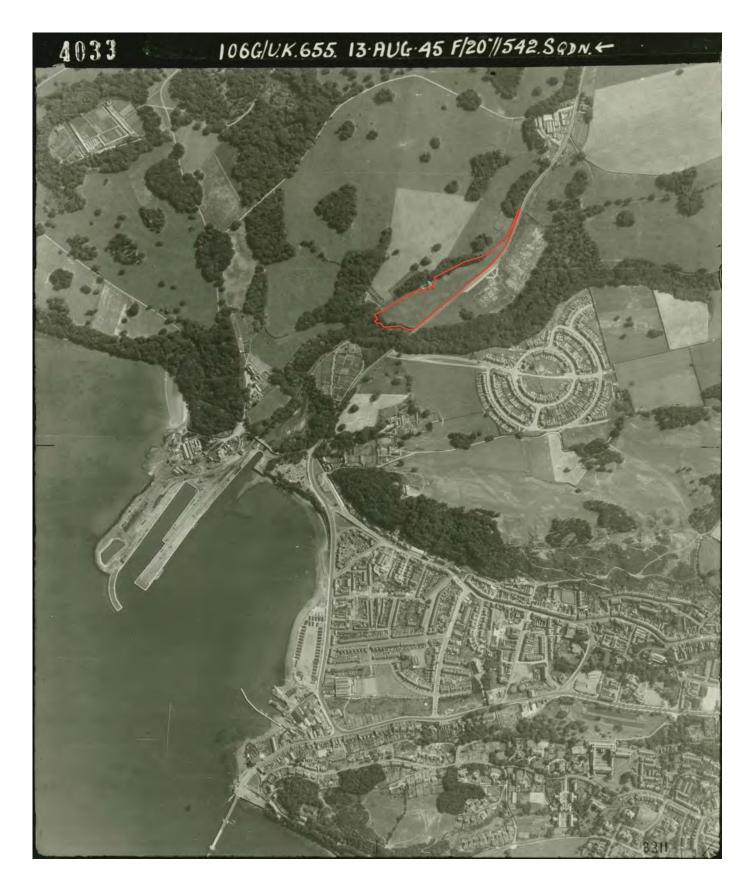
Figure 09: RAF Aerial Photograph 106G/UK 655 frame 4033 taken on 13th August 1945 showing the study area outlined in red. Not to scale

The image was clear and showed the study area in detail. Incline cottage is clearly shown, but no extra historic or archaeological detail was observed within or around the study area that had not been observed on the cartographic or other sources. In the wider area the Maesgeirchen estate is shown prior to its more recent expansion, and the image was prior to the development of the Llandygai Industrial Estate at the end of the 1960s. Surviving boundaries generally remain as those shown on the aerial photograph.

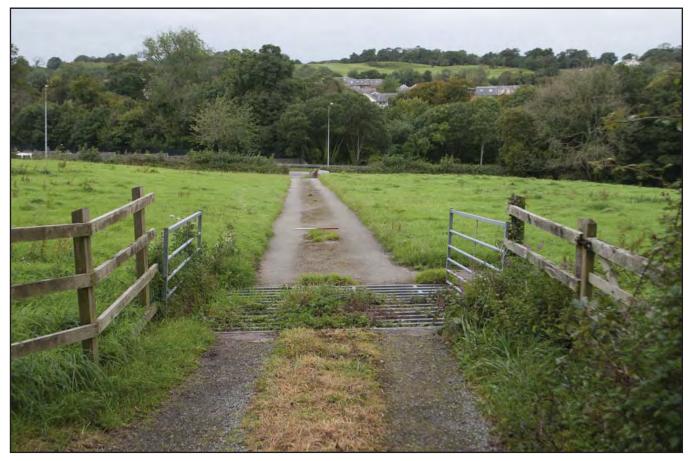
The study area was noted to consist of a field of improved grassland, and is accessed across a metalled track running east west across the northern part of the site, and leading to Incline cottage (Plate 1). It is bounded to the west by the A5, with some possible embankment and revetment walling of Telford's 1819 road surviving at the southern end (Plate 2). To the east is bounded by the Penrhyn estate demesne wall (Plates 3-4), Incline cottage and garden (Plates 5-6), and the former quarry tramway, which almost meets at a point with the A5 road at the southern point of the study area (Plate 7). Close to this point, about 10m from the southern point, an opening with an iron gate was noted in the Penrhyn estate wall [Feature 01, Plate 8], 7m west of the road embankment. A well-built slate drinking trough of Penrhyn quarry slate was noted in the middle of the field [Feature 03, Plate 9]. Its character fits well with this part of the estate being used as part of the home farm for the direct support of the estate, although it was outside the park itself.

Plate 1: General view along the access from the former tramway; scale 1x1m; view from E (archive reference: G2663\_002).

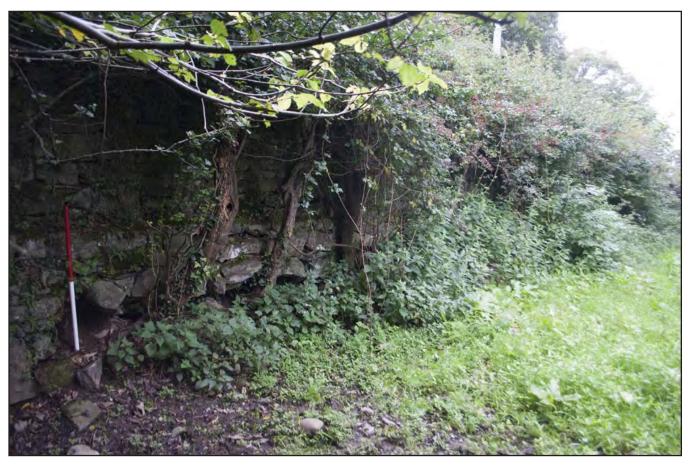
Feature Number	2 (Plate 2)
Site name	Revetted embankment for the A5
PRN number	90640
Grid reference	SH5931271608 C
Period	Post-medieval/modern
Site type	Transport
Assessment category	C
Description	3m high rubble blocks, both irregular and worked, with a 1.2m high plinth in places, for a revetment wall for the embankment of the A5, probably Telford's original pre 1819 work (Quartermaine <i>et al.</i> 2003, 52). This is much overgrown with hawthorn and bramble, and becomes much less substantial and replaced with modern walling as it bounds the A5 northwards. The western side of the road has been entirely rebuilt in modern times.
Impact	Slight
Recommendation for further assessment/evaluation	None
Recommendation for mitigatory measures	Basic Recording

Plate 2: View of rough stone revetted embankment on the west side of the site; the A5 road; scale 1x1m; view from SE (archive reference: G2663\_021).

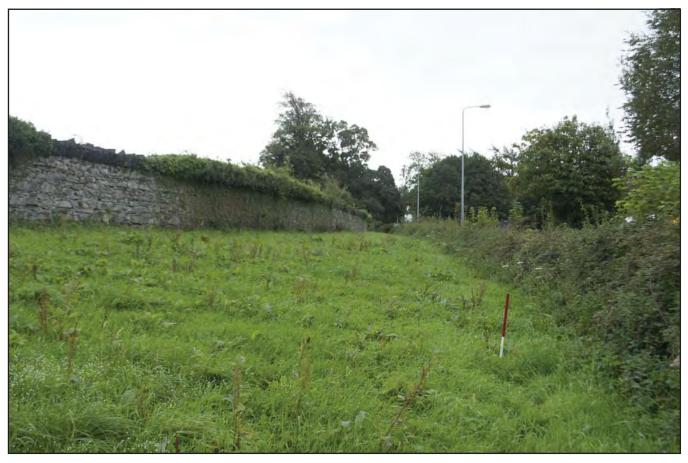
Feature Number	4 (Plates 3-4, 7-8, 17-21)
Site name	Penrhyn Estate Boundary Wall
PRN number	90642
Grid reference	SH59307183 C
Period	Post-medieval
Site type	Landscape Park
Assessment category	A
Description	A 19 <sup>th</sup> century wall, up to 3m high and capped with rough slate blocks at right angles to the wall, bounding the demesne park of Penrhyn Castle. It is built of regular and irregular slate and shale masonry, and is damaged in a minor way in places.
Impact	None
Recommendation for	None
further	
assessment/evaluation	
Recommendation for	Basic Recording
mitigatory measures

Plate 3: General view of southern narrow tip of the study area with the Penrhyn Estate wall to the west; scale 1x1m; view from N (archive reference: G2663\_016).

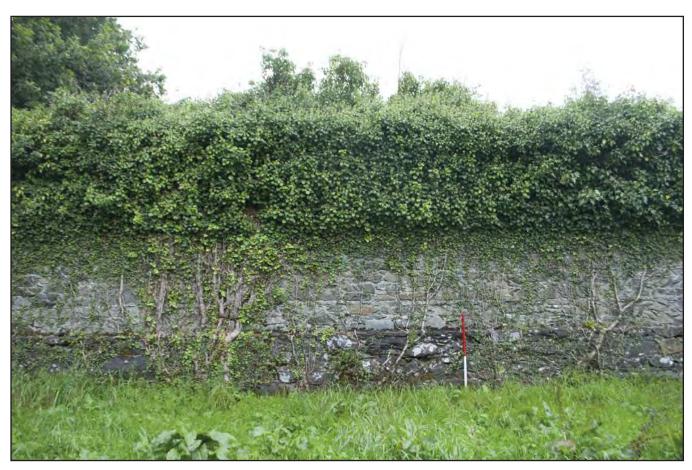
Plate 4: Elevation view of the Penrhyn Demesne boundary wall; scale 1x1m; view from E (archive reference: G2663\_017).

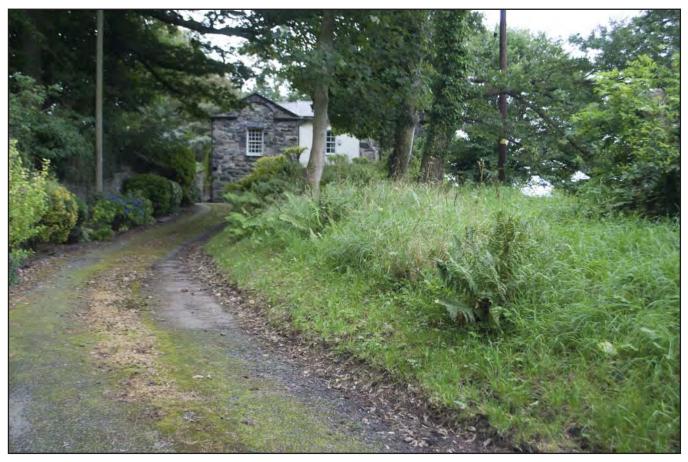
Incline cottage (Plates 5-6) is located about half way along the eastern side, with a gap in the Penrhyn boundary wall allowed the cottage to straddle the former tramway, and a garden on the western and eastern sides. Incline cottage pre-dates the wall so the latter respects the building. The quarry tramway is now partly taken up by a modern trackway leading to Nursery cottage to the northeast (Plate 13). Beyond the site boundary to the north in woodland the route of the tramway can be observed going through a cutting (Plate 15), after going out of use the tramway route was crossed by Penrhyn style estate fencing (Plate 14).

Plate 5: View of Incline cottage; scale not used; view from NE (archive reference: G2663\_012).

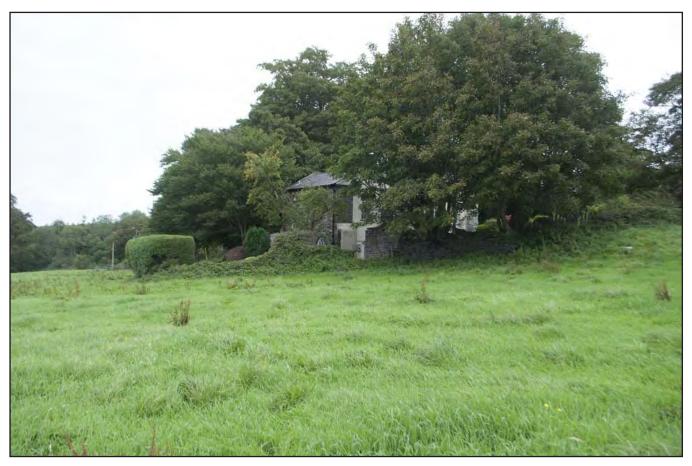
Plate 6: View of Incline Cottage showing the associated 'D' shaped garden to the west; scale not used; view from SW (archive reference: G2663\_015).

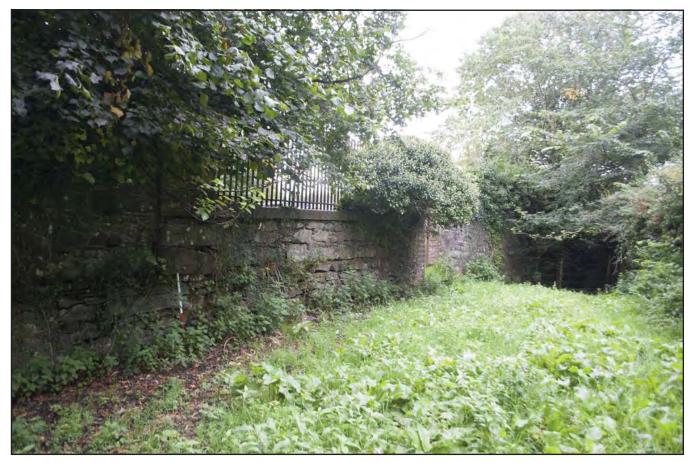
Feature Number	1 (Plates 7-8)
Site name	Iron Gate in Penrhyn Park Boundary Wall
PRN number	90639
Grid reference	SH 5931471611
Period	Post-medieval
Site type	Wall
Assessment category	С
Description	An Iron gate in a 1.7m wide opening, with a 0.35m high stone step, in the Penrhyn Estate boundary wall. To the north, and at a height of 2m, iron railings top the wall for a length of about 10m. The northern pier is of a different style; regular slate and conglomerate blocks, compared to the southern pier which is in the same style as the estate wall of slate rubble, suggesting the gate is a replacement and the northern pillar was rebuilt, perhaps in the late 19 <sup>th</sup> century
Impact	Slight
Recommendation for further assessment/evaluation	None
Recommendation for mitigatory measures	Basic Recording

Plate 7: Angled view of Iron gate opening showing railings [Feature 1]; scale 1x1m; view from NW (archive reference: G2663\_022).

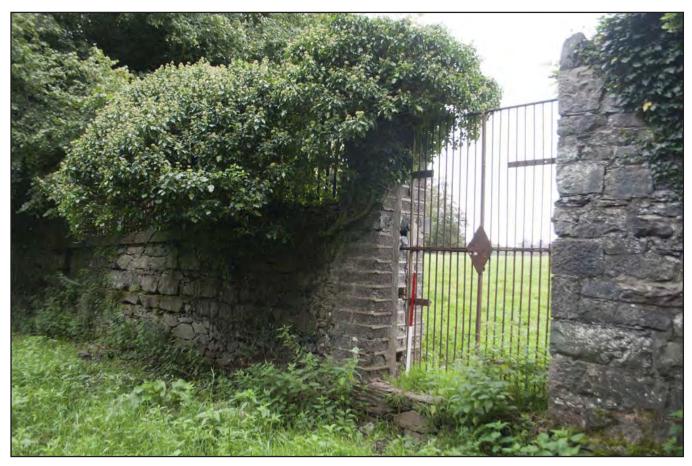
Plate 8: General view of an Iron Gate and opening into the Penrhyn demesne through the estate boundary wall; scale 1x1m; view from S (archive reference: G2663\_018).

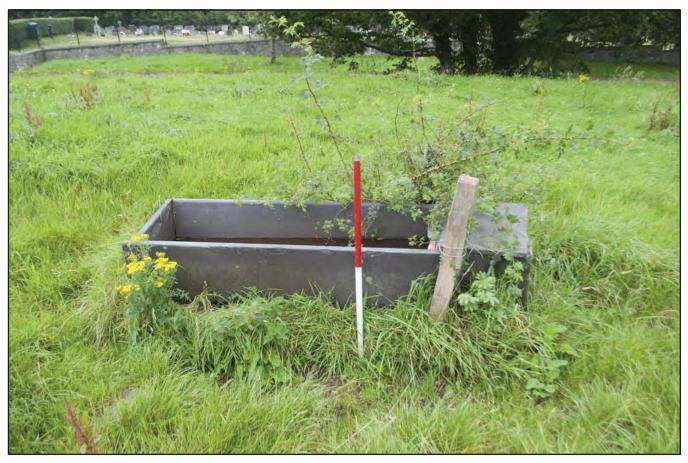
Feature Number	3 (Plate 9)
Site name	Slate livestock drinking trough
PRN number	90641
Grid reference	SH5925371871
Period	Post-medieval
Site type	Agricultural
Assessment category	C
Description	Slate animal drinking trough 2m x 0.6m x 0.5m, constructed of slate slabs 0.1m thick. Now piped in, but clearly of some age, probably late 19 <sup>th</sup> century, as the slate is of the Penrhyn quarried type. The slate slabs are bolted at both ends, with 0.6m wide end slabs to form a trough with a slate base.
Impact	Considerable
Recommendation for	None
further	
assessment/evaluation	
Recommendation for	Basic Recording
mitigatory measures

Plate 9: View of slate animal drinking trough [Feature 3]; scale 1x1m; view from E (archive reference: G2663\_027).

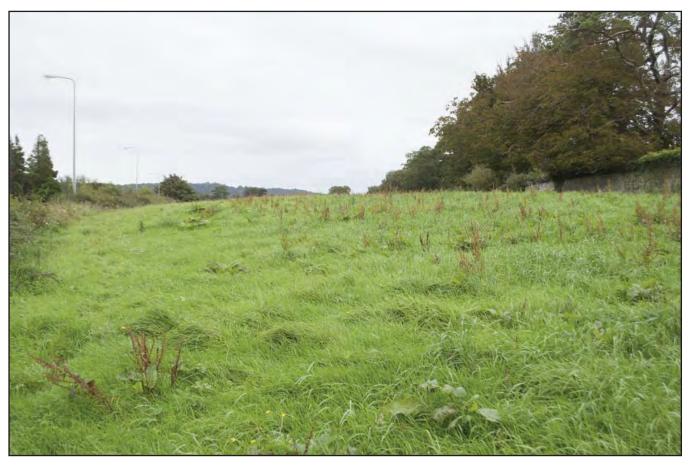
Plate 10: General view across the field showing the rising ground; scale not used; view from S (archive reference: G2663\_024).

The field itself is heavily undulating with a raised central are, at a height of about 23m OD (Plate 10). The land slopes sharply to the north, with one noticeable east-west ridge crossing it before sloping down to the northeast corner. The land south of the central raised area slopes more gently to a southern point where the A5 and the Penrhyn boundary wall almost meet, with a long narrow tail of land. The land immediately east of the A5 is for the most part more low-lying and boggy than the rest of the field (Plate 11), however in the central part of the field the land drops off to the west, suggesting a cutting for Telford's A5 road. Woodland bounds the study area to the north, and includes mature trees of oak and ash, and possible specimen park trees (Plate 12).

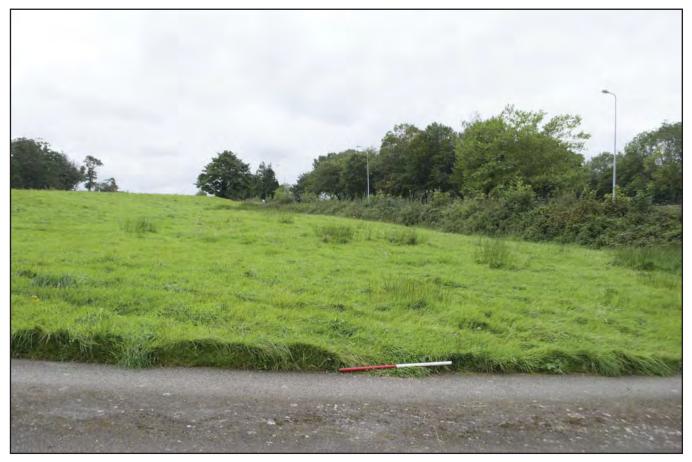
Plate 11: General view of low-lying boggy part of the field immediately south of the entrance trackway; scale 1x1m; view from N (archive reference: G2663\_030).

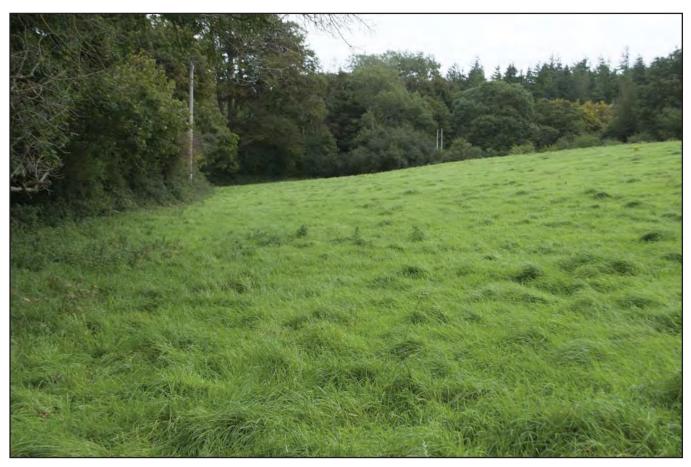
Plate 12: General view of the sloping northern end of the field; scale not used; view from ESE (archive reference: G2663\_008).

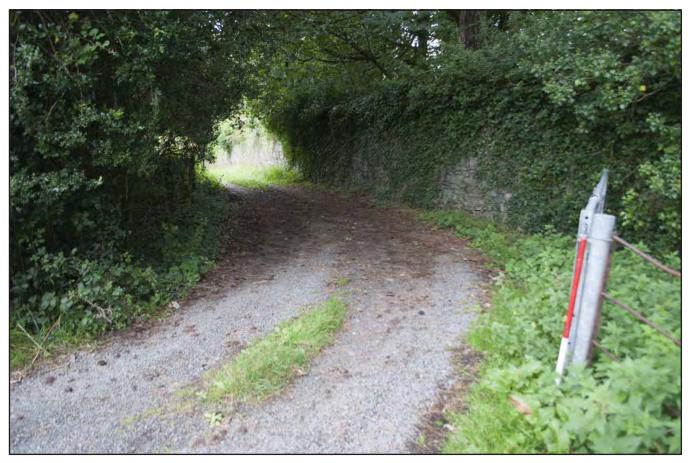
Plate 13: View along the lane that leads to Nursery Cottage, and Penrhyn Estate boundary wall; scale 1x1m; view from S (archive reference: G2663\_013).

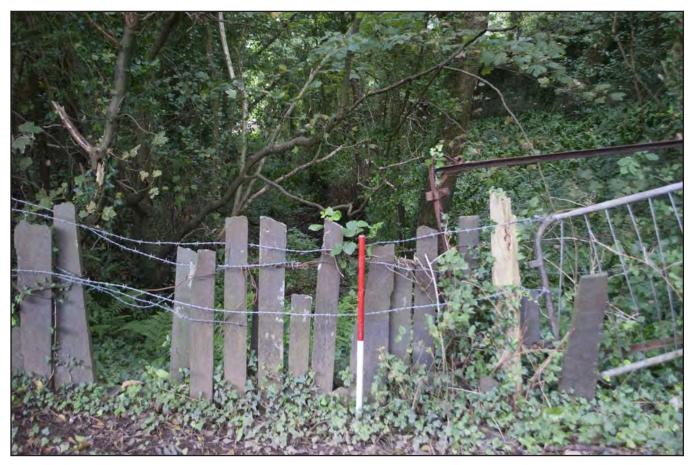
Plate 14: View of 'Penrhyn' slate fencing in the NE corner of the site and tramway route in a cutting beyond; scale 1x1m; view from S (archive reference: G2663\_005).

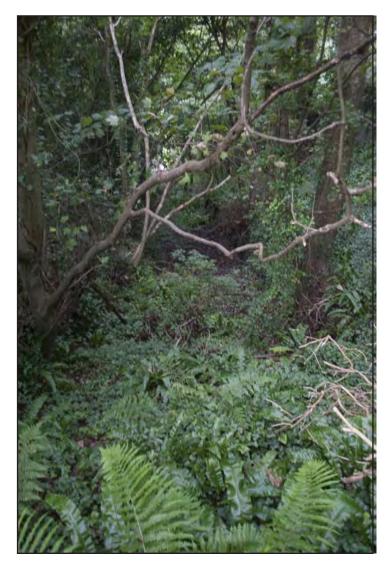
Plate 15: Close up shot nshowing the former tramway in the cutting to the north of the study area; scale not used; view from S (archive reference: G2663\_034).

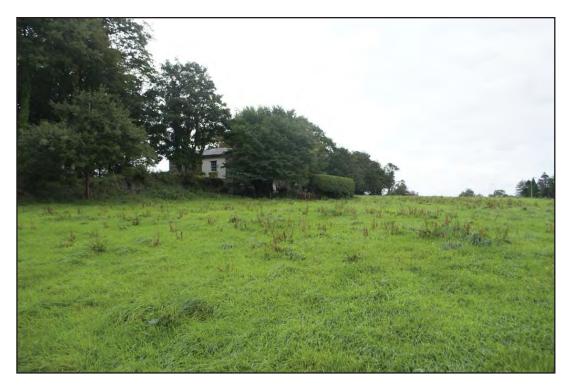
No clear evidence of buried archaeological features was noted within the field. The site is somewhat terraced to the east below Incline Cottage (Plate 16). This may be a natural feature, but would also be a suitable place for prehistoric and later settlement. Its closeness to the Afon Cegin would make it a suitable location for burnt mounds. The presence of archaeology is considered to be moderately likely given the closeness of the site to the major excavations at the Llandygai Industrial Estate and Parc Bryn Cegin where substantial prehistoric and medieval archaeology was encountered.

Plate 16: View of Incline Cottage from the access trackway; scale not used; view from NNW (archive reference: G2663\_014).

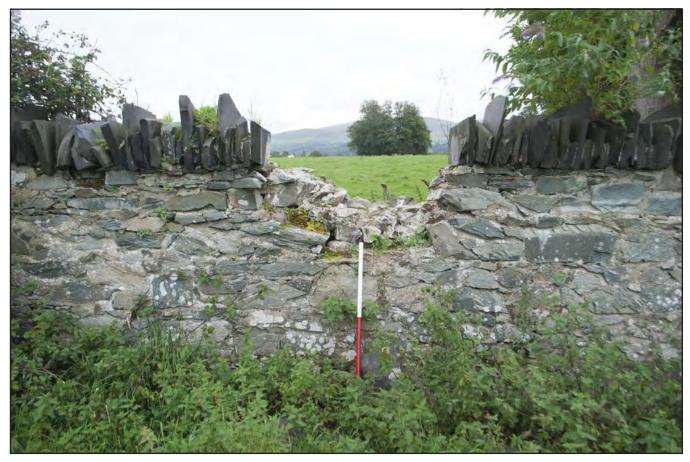
Plate 17: View of damage to Penrhyn Park boundary wall; scale 1x1m; view from W (archive reference: G2663\_025).

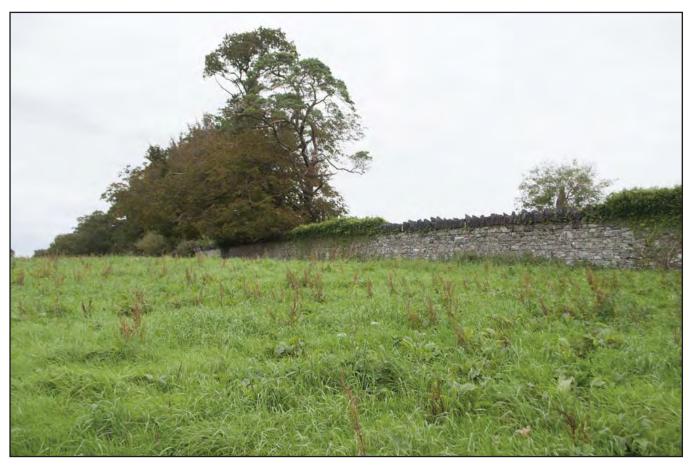
Plate 18: General view across the field showing the Penrhyn park boundary wall; scale not used; view from SW (archive reference: G2663\_023).

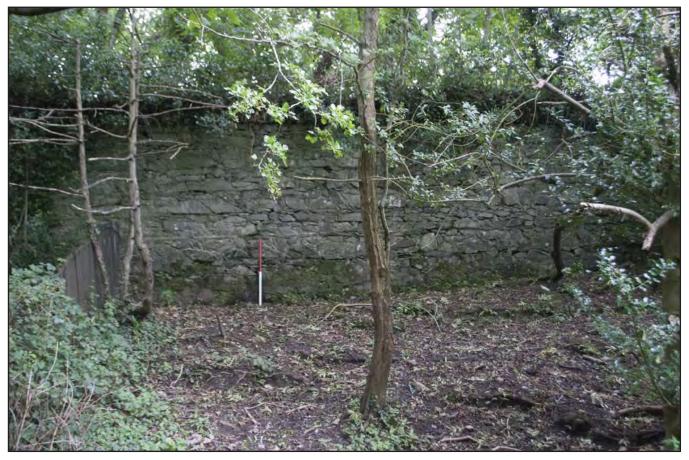
Plate 19: View of Penrhyn Park boundary wall with lane to Nursery Cottage, in the NE corner of the site beyond the lane; scale 1x1m; view from E (archive reference: G2663\_004).

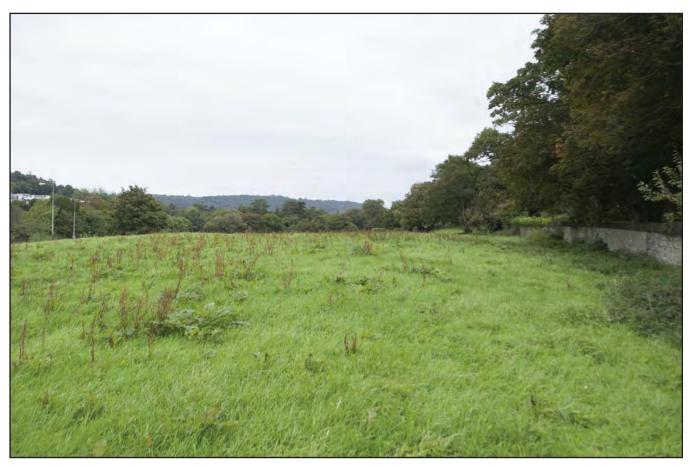
Plate 20: General view of study area showing incline cottage through the trees to the right; scale not used; view from S (archive reference: G2663\_026).

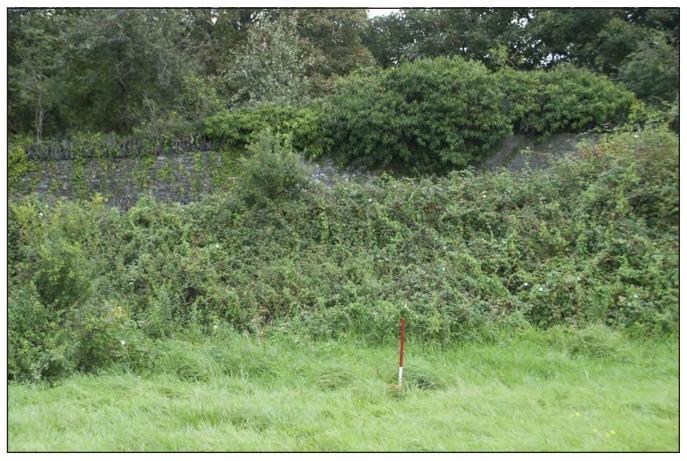
Plate 21: View of Penrhyn Park boundary wall with lane to Nursery Cottage; scale 1x1m; view from E (archive reference: G2663\_003).

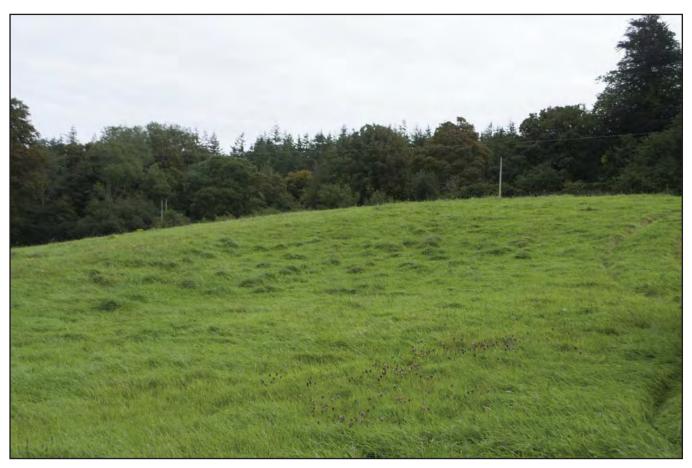
Plate 22: General view of the study area; scale not used; view from SW (archive reference: G2663\_010).

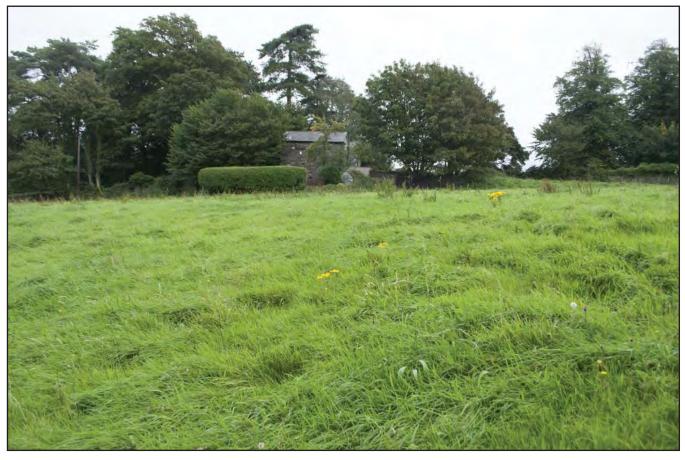
Plate 23: General view of Field showing Incline cottage; scale not used; view from W (archive reference: G2663\_029).

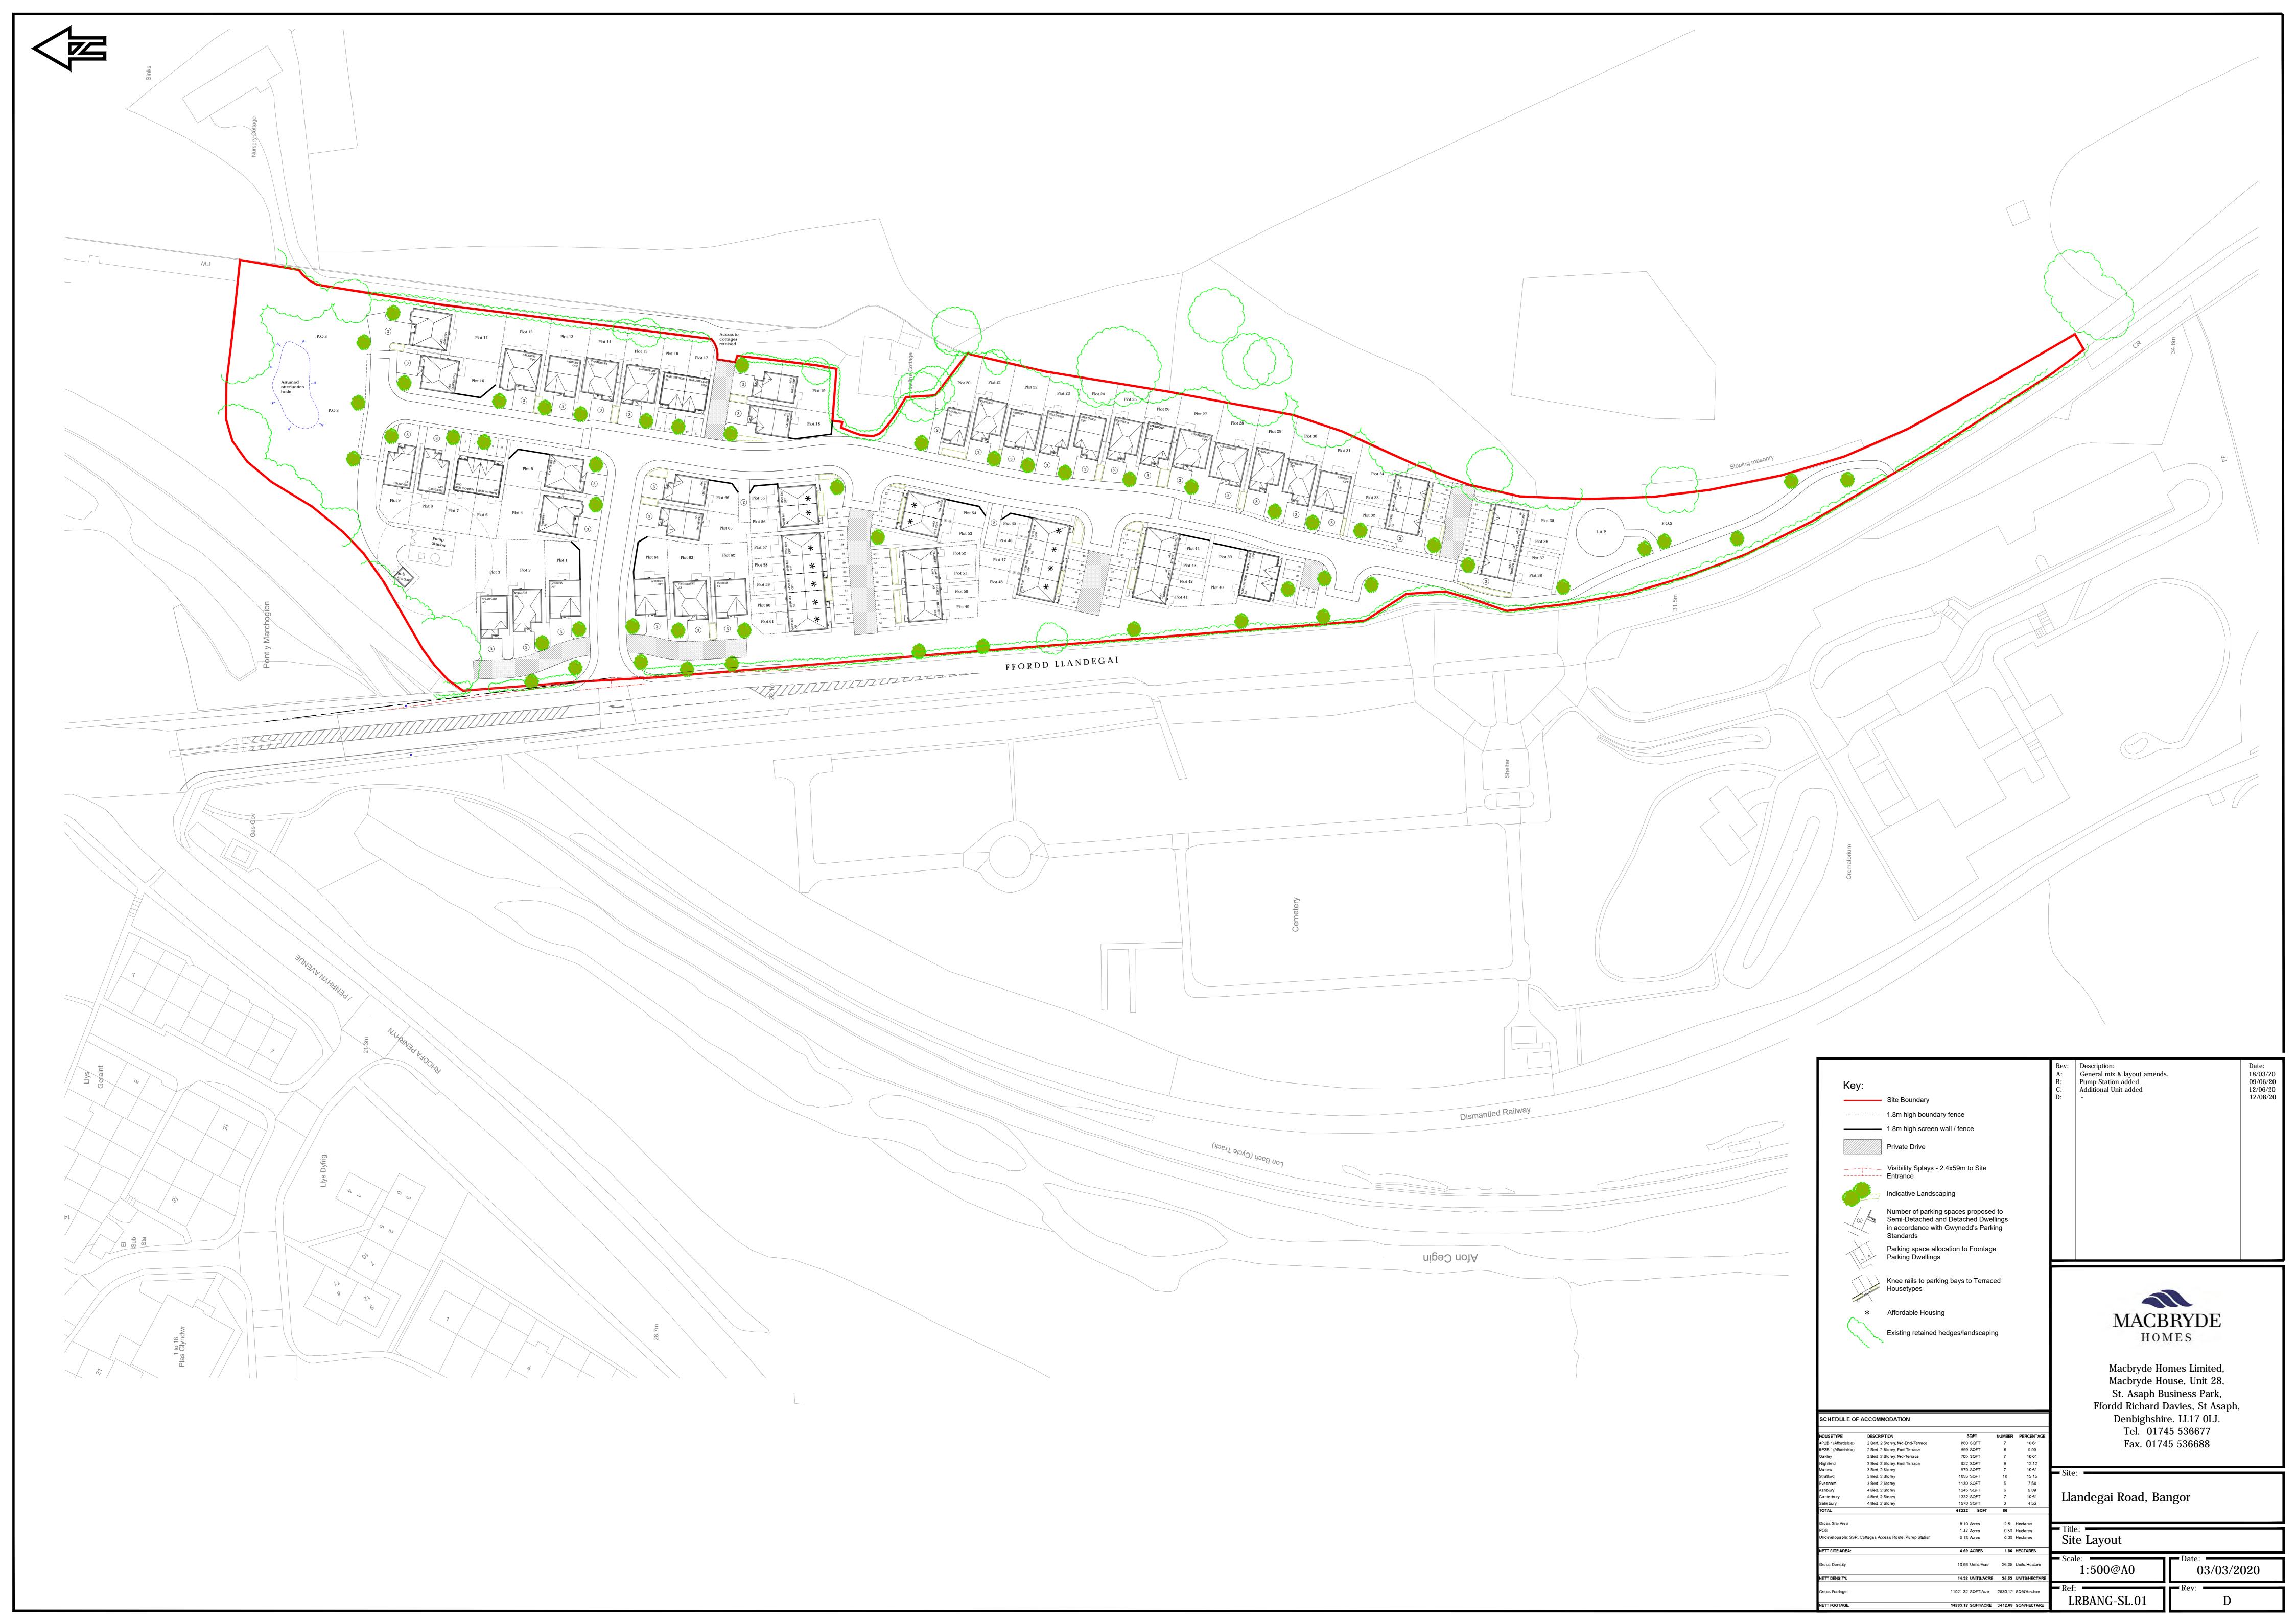
# FIGURE 02

Reproduction of Macbryde Homes Ltd. Drawing No. LRBANG-SL.01

Gwynedd Archaeological Trust (GAT) was commissioned by Macbryde Group Limited to undertake an archaeological assessment and evaluation (geophysical survey) in advance of a proposed residential development on land at Llandygai Road, Bangor, Gwynedd, LL57 4HP (NGR: SH5928171847; Figure 01; Figure 02). The proposed development area measures 2.51 ha and is located within a field of improved pasture on the eastern side of Llandygai Road. The assessment and evaluation have been undertaken as part of a planning application for 67no two-storey dwellings with associated access and car parking. The development site has been allocated for housing within the Gwynedd and Isle of Anglesey County Council Joint Local Development Plan adopted in 2017 (reference T5).
