MIN Y PORTH, FFORDD BANGOR/BANGOR ROAD, CONWY

Cofnodi Adeiladu a Briff Gwyllo Archeolegol /
Building Recording and Archaeological Watching Brief

Rhif Prosiect / Project No. G2738

Rhif Adroddiad / Report No. 1645

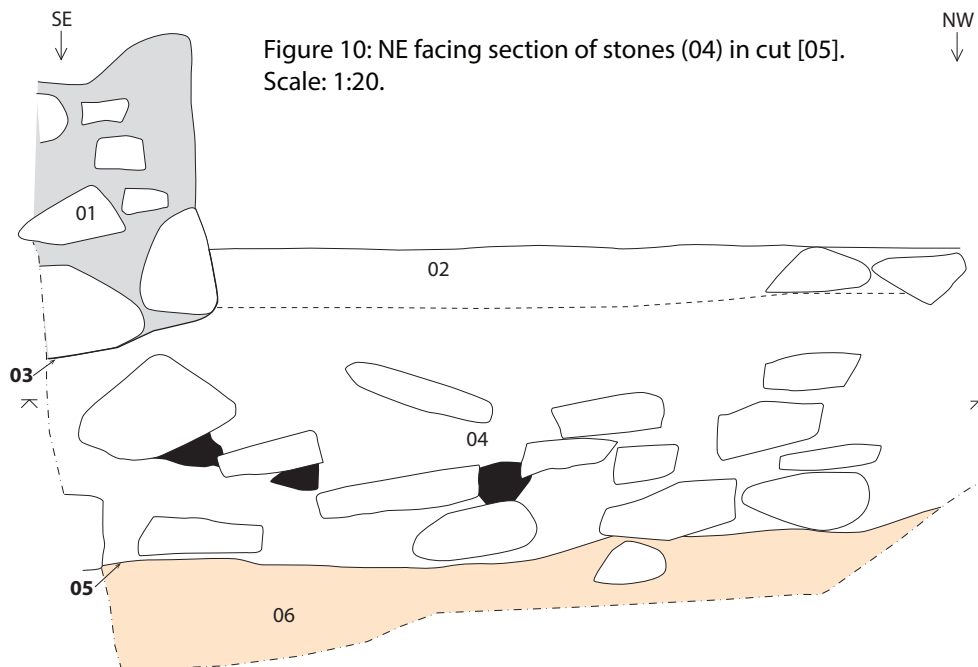
Figure 11: SE through garden soil deposits and wall (07).
Scale: 1:20.

These walls cut through the earlier garden soil ((10) and (16)) but the later garden soil and rubble ((02) and (09)) had built up against them. At the south-eastern end of the south-western foundation trench it could be seen that the trenches for walls (01) and (07) cut through an earlier feature (Figures 09 and 10). This feature had a straight, steep sided cut [05] running south-east to north-west and visible for about 4.5m within the trench. This cut was filled by large stones up to 0.5m long within a dark grey-brown clayey silt matrix (04) (Plate 21). The stones were mostly angular with some flat slabs. Some stones were laid fairly horizontally but they appeared fairly random. There were voids between some of the stones and no mortar evident. The near vertical side of cut [05] suggests that this was a foundation trench and (04) the foundations of a wall but the rather haphazard distribution of the stones and the lack of mortar may suggest that these were dumped stones. This feature was only seen in part of the width of the trench, so its character is difficult to determine. Feature [05]/(04) clearly continued under the boundary wall (01), so was earlier than the 19th century layout of this property. This feature has been allocated PRN 100,879.

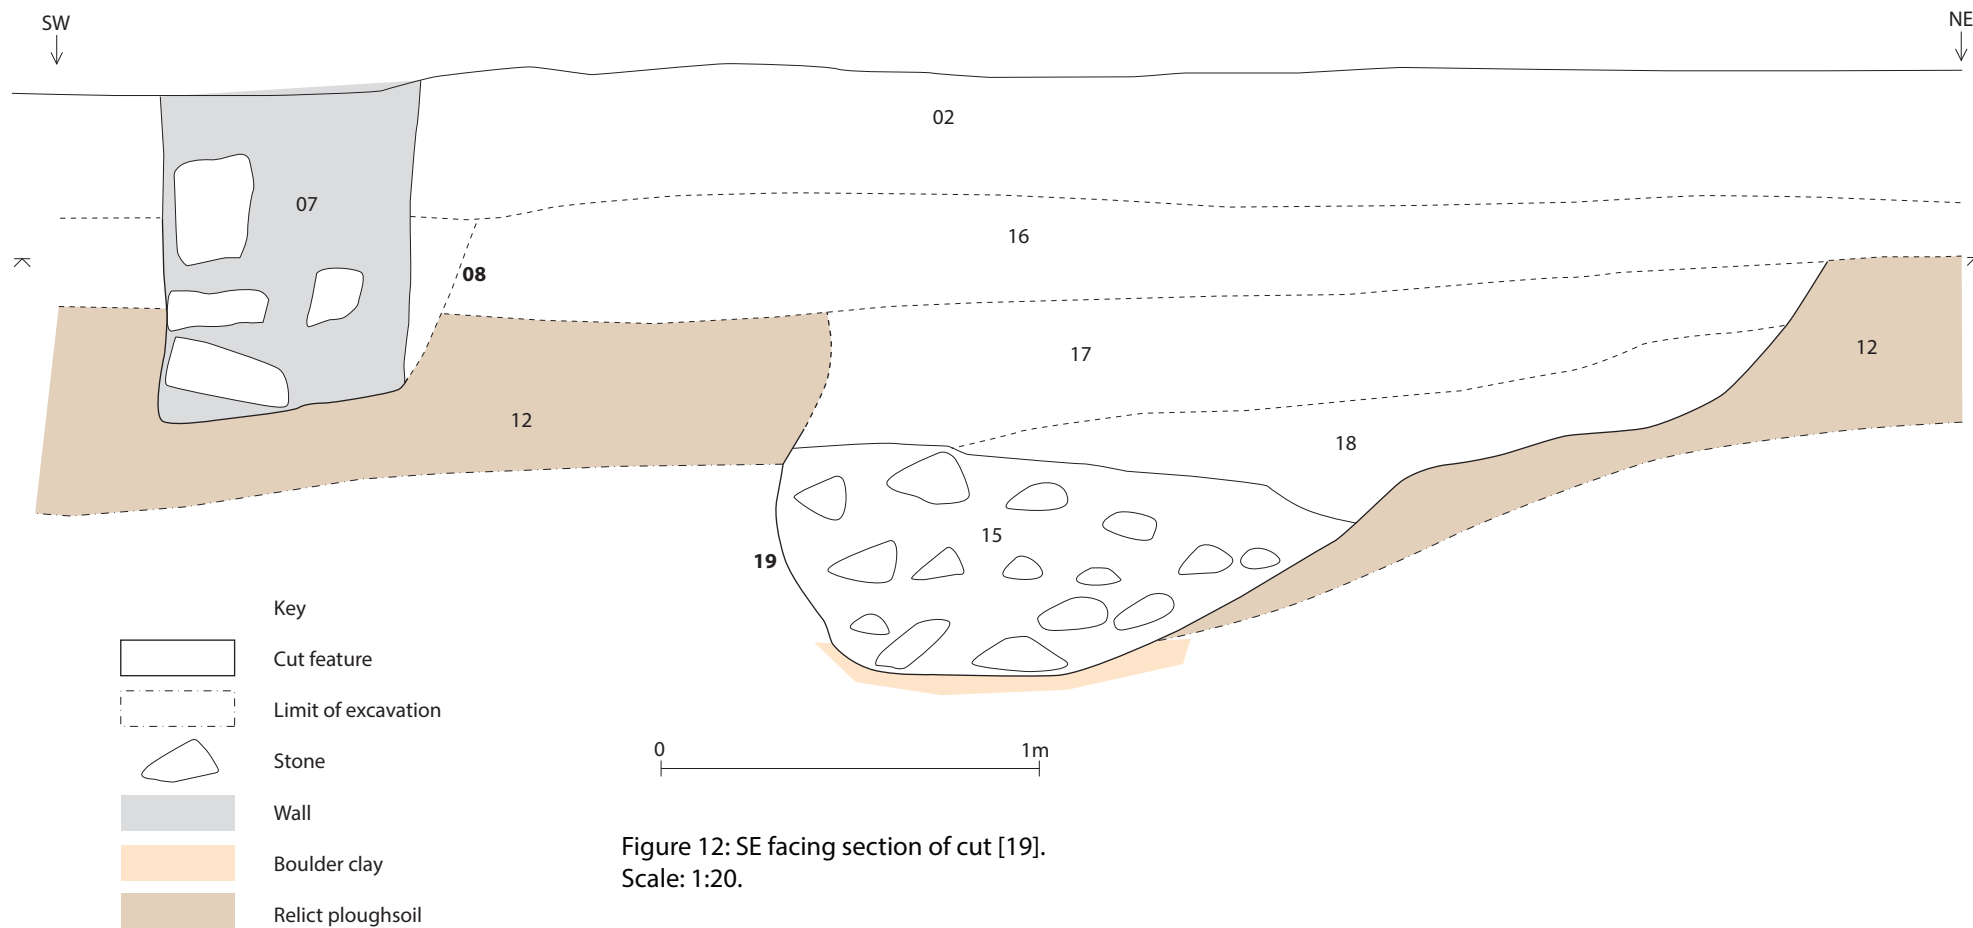
Figure 12: SE facing section of cut [19].
Scale: 1:20.

A broad cut feature was seen running across the north-western foundation trench. This feature [19] was 2.6m wide and 1.0m deep (Plate 22, Figure 12). It had a near vertical western side, which had partially collapsed before it was backfilled leaving some of the side overhanging. The eastern side was more gradually sloping, and the base of the cut rounded. The base of this cut was filled by a dump (15) of loose, voided stones with no matrix between the stones, which were rounded and sub-rounded, up to 0.2m long. Above this were two layers of mixed yellowish and greyish brown silty clay with small stones ((17) and (18)). The lowest of these (18) had numerous shaley pieces, as well as other stones. The dense, clayey nature of these deposits had sealed the stones (15), preventing silt washing in and filling the voids between the stones. This feature has been allocated PRN 100,880.

It is assumed that feature [19] is a linear feature, such as a ditch or channel, but with such a small area visible it is possible that it could be part of a large pit. Feature [19] extending underneath wall (13), with the foundation cut [14] cutting through the fill of [19]. Feature [19] is therefore earlier than the late 19th century but no finds were recovered to suggest its actual date.

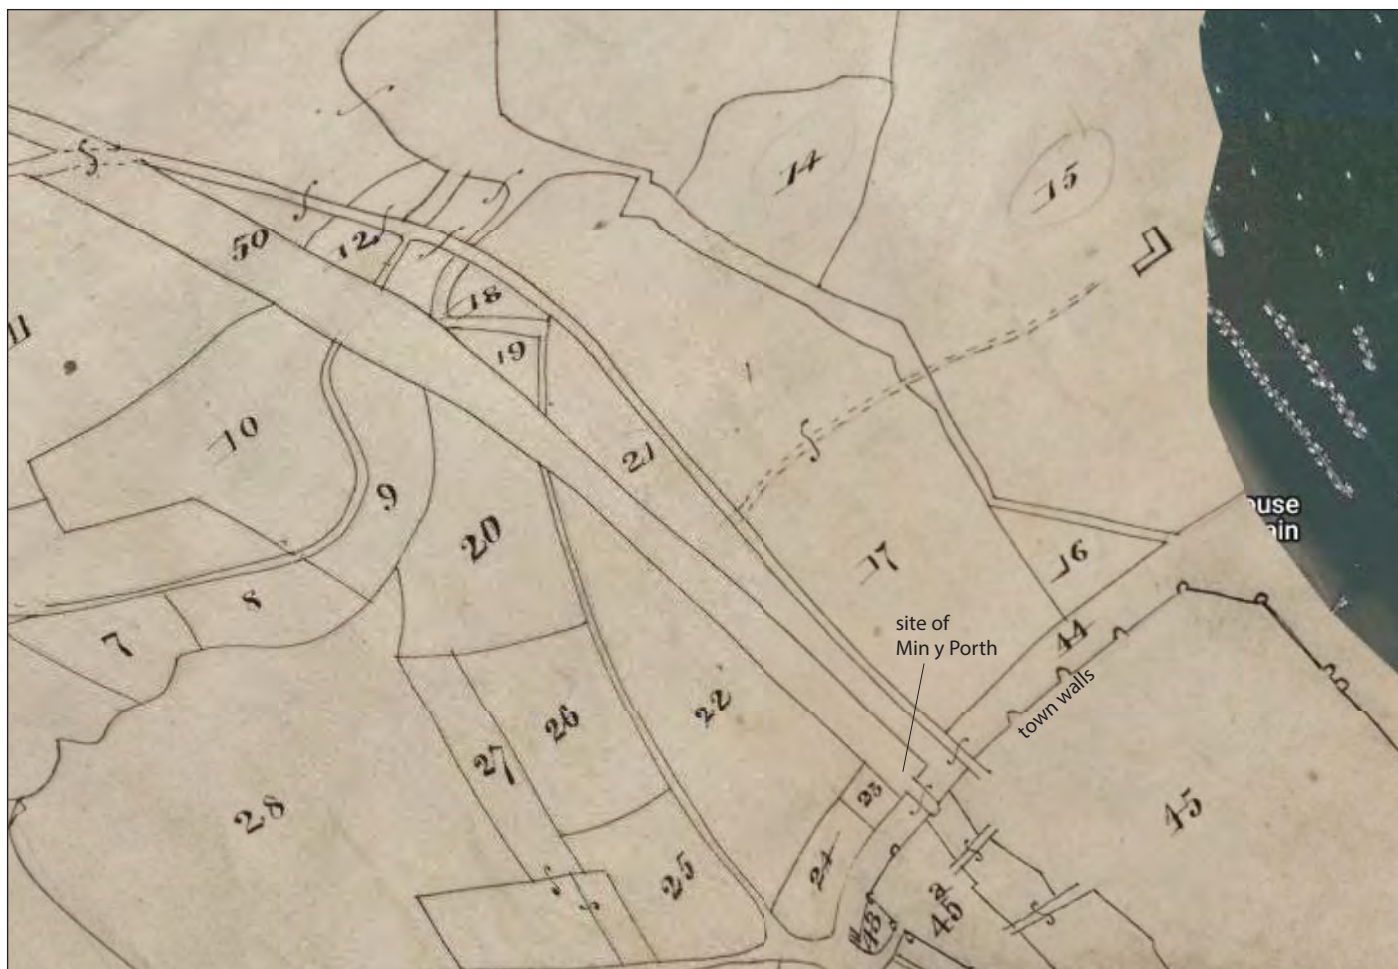
Figure 13: Part of Tithe Map of Conway parish in the County of Carnarvon (1848)
Welsh Tithe Maps, The National Library of Wales

The archaeological watching brief of the foundation trenches for the extension revealed a significant depth of relict ploughsoil over much of the plot. This probably indicates that the area was under fields prior to its development for a house in the 19th century. The 1848 tithe map confirms that this area was under fields in the early 19th century (Figure 13).

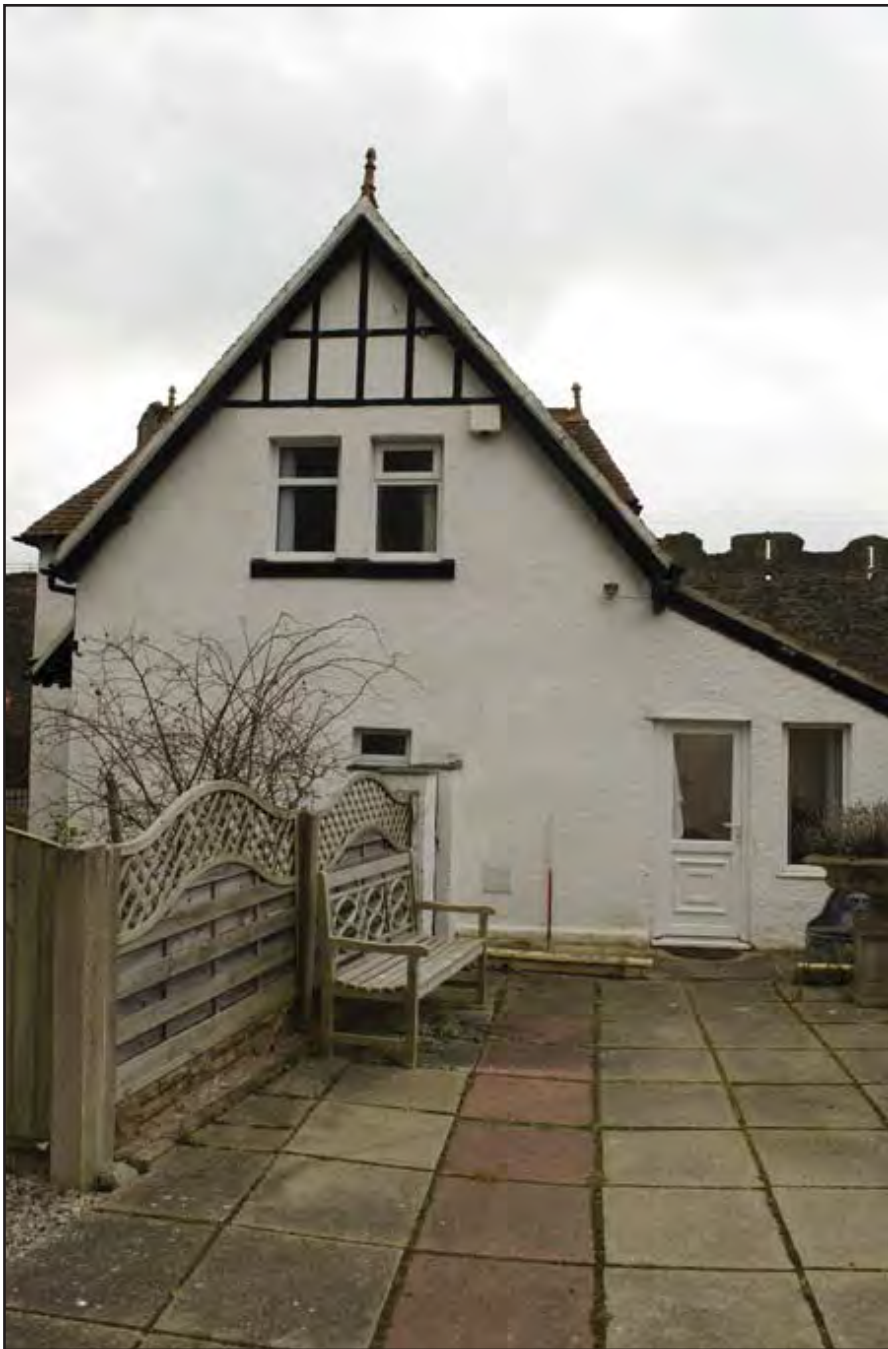
Plate 03: Northwest elevation of house with sunroom; scale 1x1m; (archive reference: G2738_004).

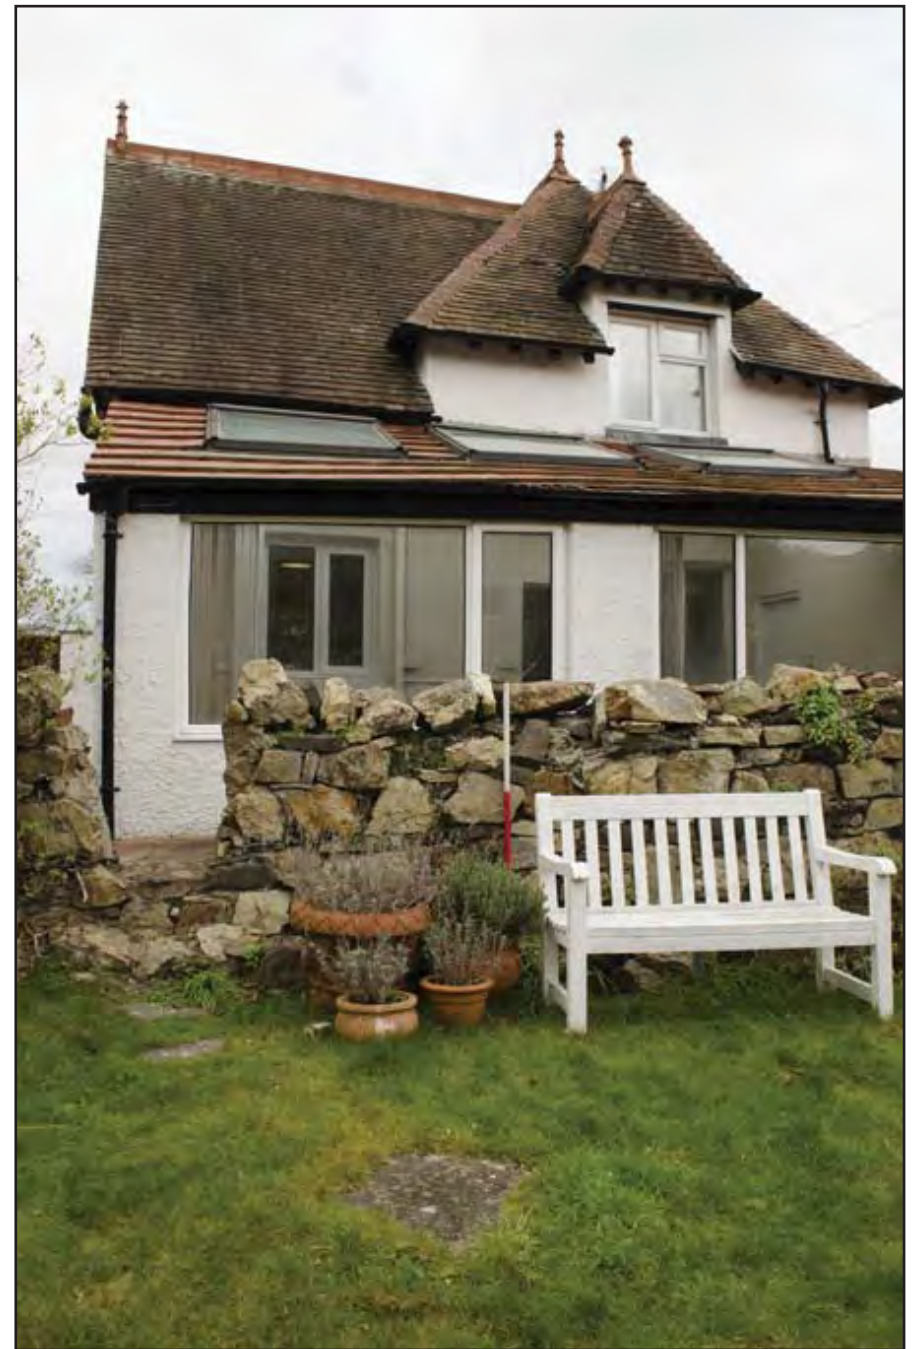
Plate 04: Southwest elevation of sunroom and rear of property from the garden; scale 1x1m; (archive reference: G2738_007).

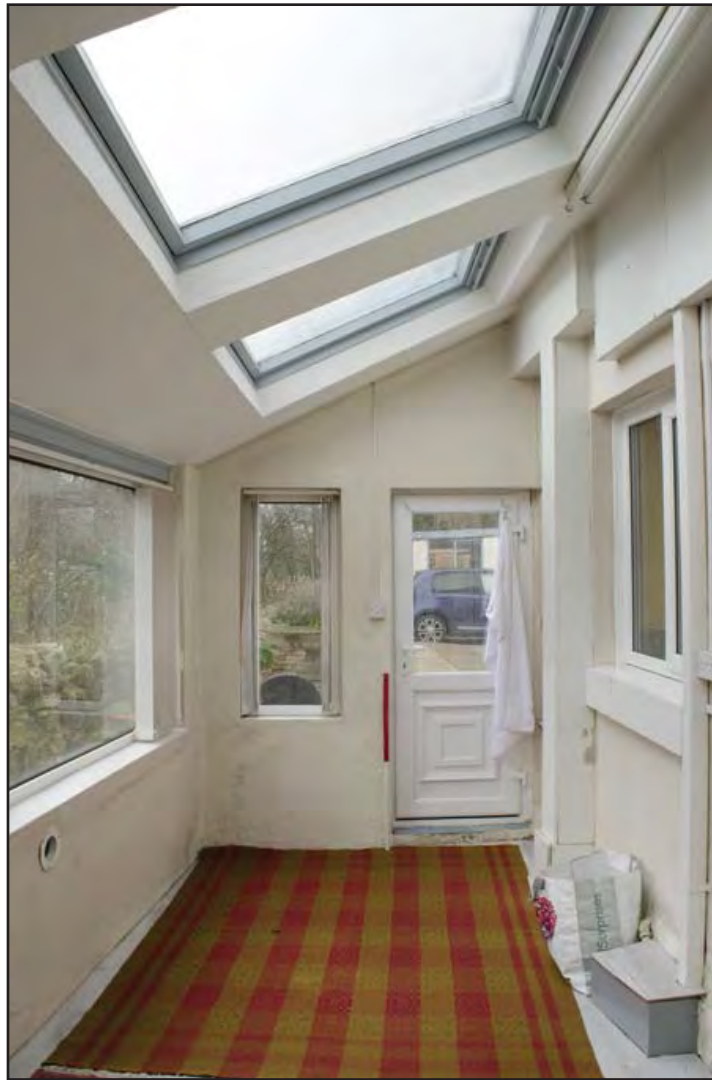
Plate 09: Interior of sunroom; scale: 1x1m; (archive reference: G2738_016).

Aside from the late 19th century house and 20th century extension, the sunroom, nothing of archaeological significance was noted associated with the property or within its grounds.

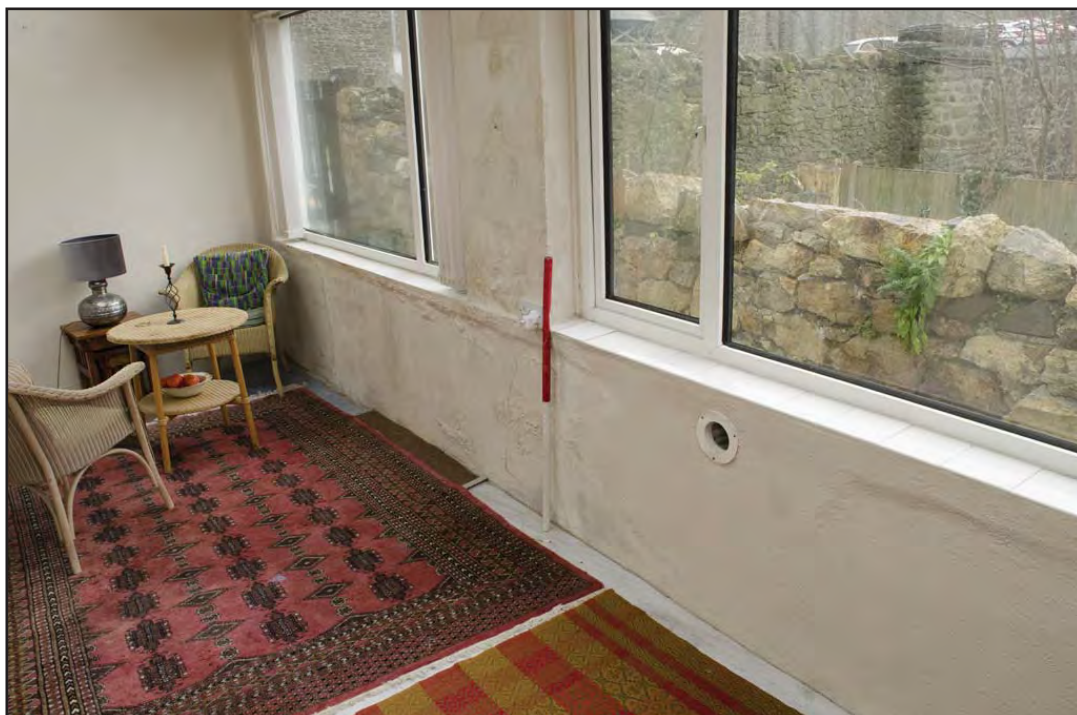
Plate 10: Oblique of southwest wall of sunroom; scale 1x1m; (archive reference: G2738_018).

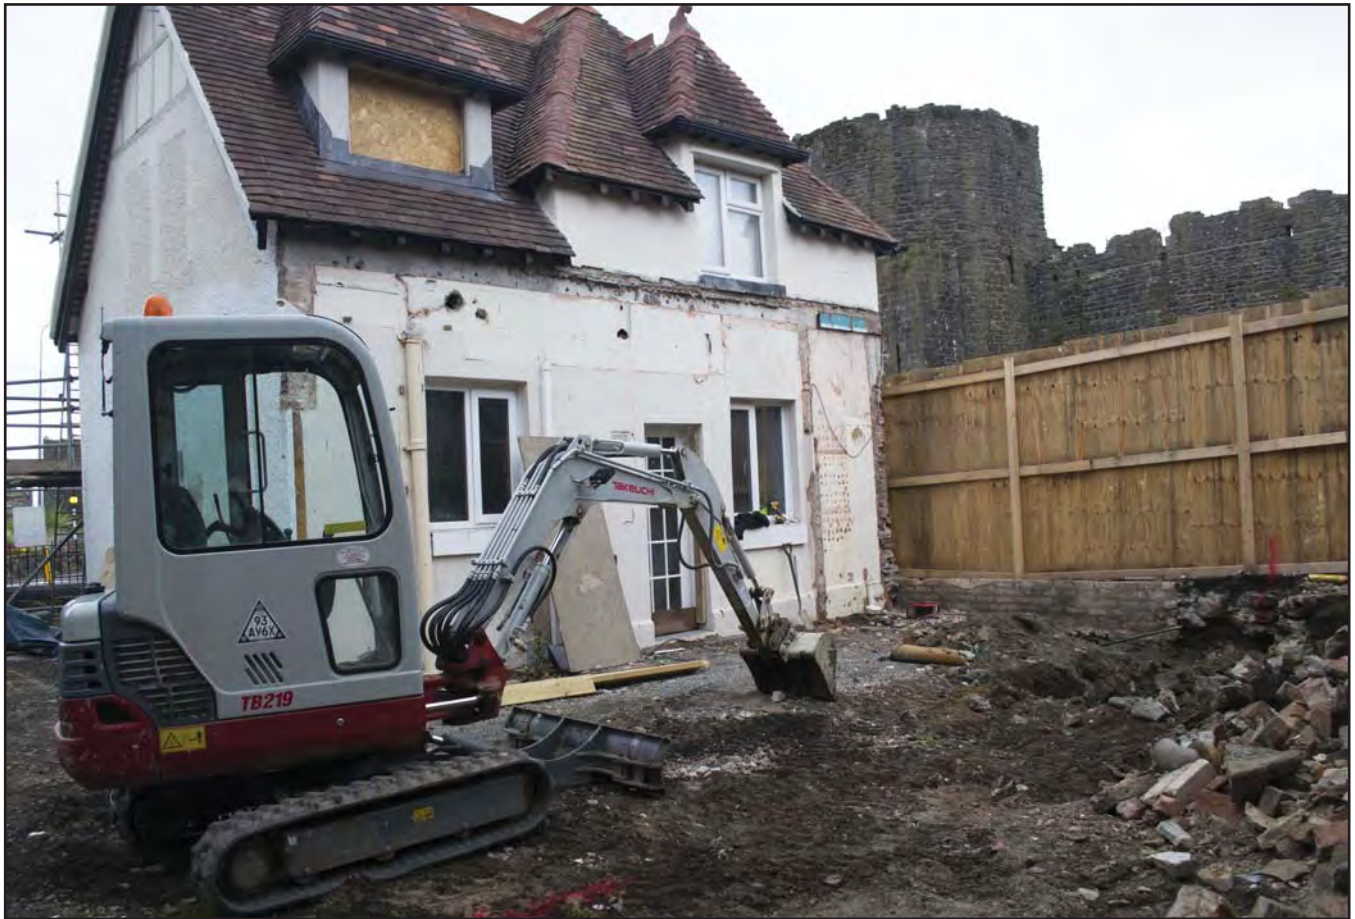
The archaeological watching brief was undertaken by Jane Kenney, Senior Archaeologist, Gwynedd Archaeological Trust on 31st July and 1st August 2023. The watching brief was on the digging of foundation trenches for the new extension and took place after the demolition of the former sunroom (Plate 13, Figure 08).

Plate 13: View of the property from the west, after the demolition of the conservatory and immediately prior to digging the foundation trenches (archive reference: G2738_032)

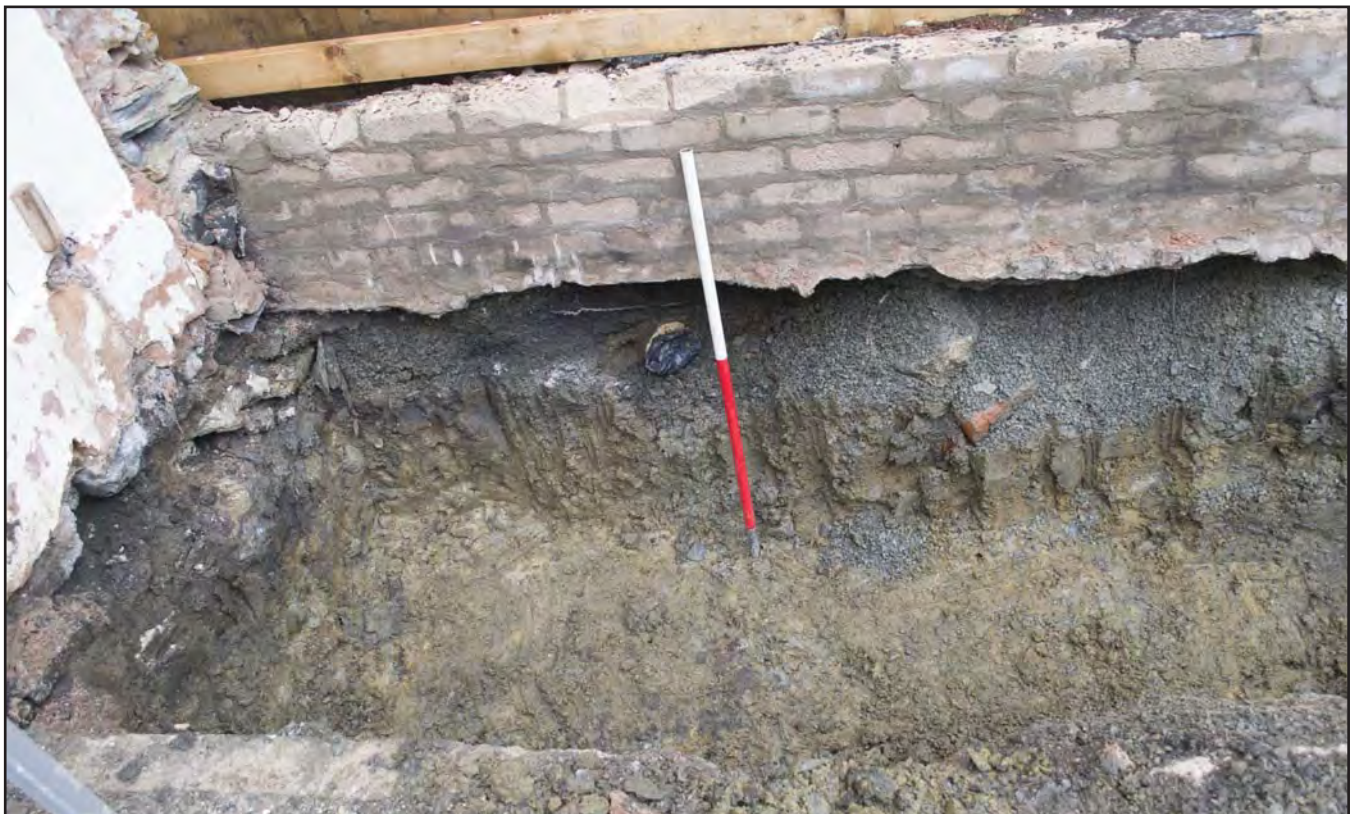
The foundation trenches were generally 0.9m wide and 1.0m deep, but the trench adjacent to the road was 1.2m wide and 0.9m deep. The trenches in the eastern part of the site cut into natural boulder clay (Plate 14) but those in the western side of the site did not reach this or only just reached its surface and were mainly cut through relict garden or plough soil (Plate 15). Remains of boundary walls and other features were recorded.

In the eastern part of the site the natural boulder clay was just below the modern construction layers, but sloped down to the west, where it was just below the depth of the 1.0m deep foundation trenches. The boulder clay (06) was a yellow-brown silty clay with numerous large sub-rounded boulders. It was mottled with lenses of crushed shale.

Plate 14: Natural boulder clay visible in foundation trench in south-eastern part of the site; scale: 1m (archive reference: G2738_038)

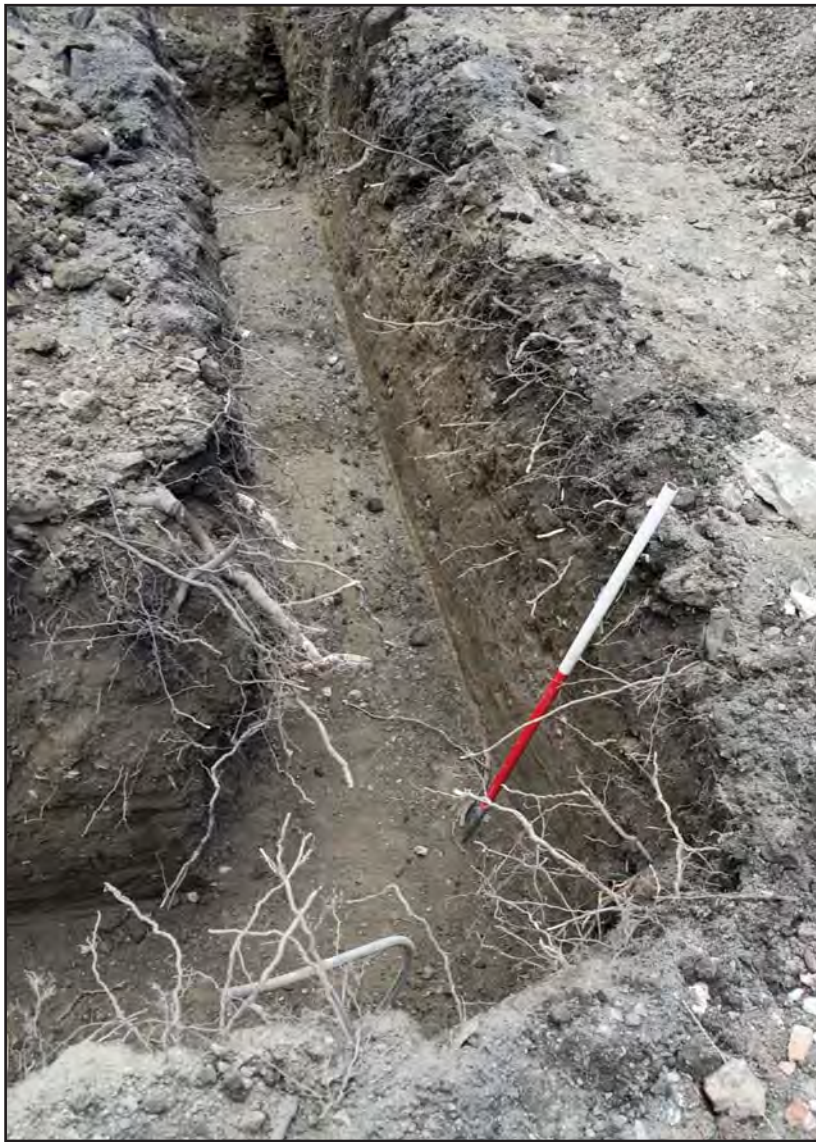
Plate 15: Foundation trench in north-western part of the site cutting through relict ploughsoil (12); scale: 1m (archive reference: G2738_059)

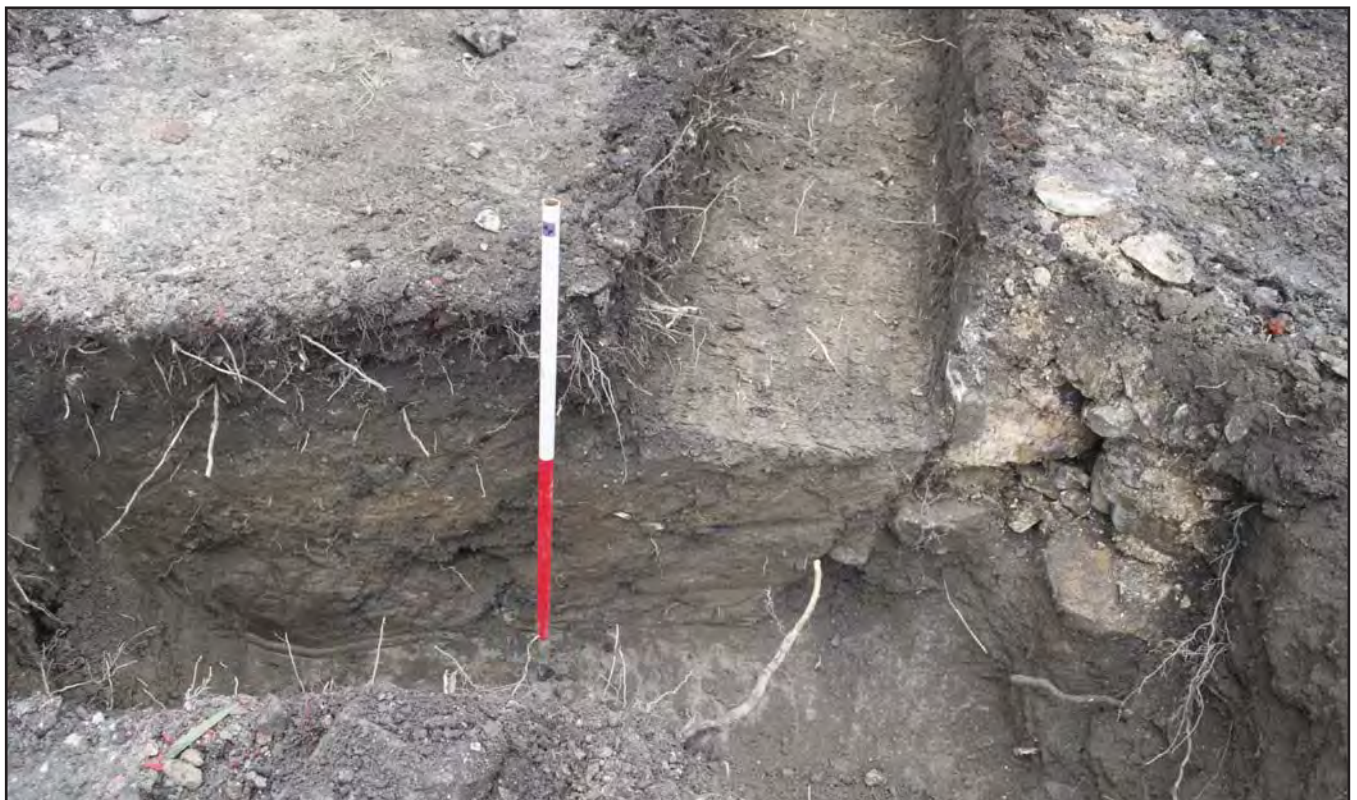
Plate 16: Section through garden soils with wall (07), see Figure 11; scale: 1m (archive reference: G2738_044).

The foundations of boundary walls for the 19th century house were recorded (cf. Figure 04). Wall (07), which defined the edge of the land taken for the railway, had become a low garden wall before it was demolished for this project. Wall (13) was the original north-western boundary of the property. This has since been moved further north-west, including some of the narrow strip of land that is now wooded to be included in the property. This current north-western boundary is poorly built of a mix of stone and brick and is clearly a fairly recent addition.

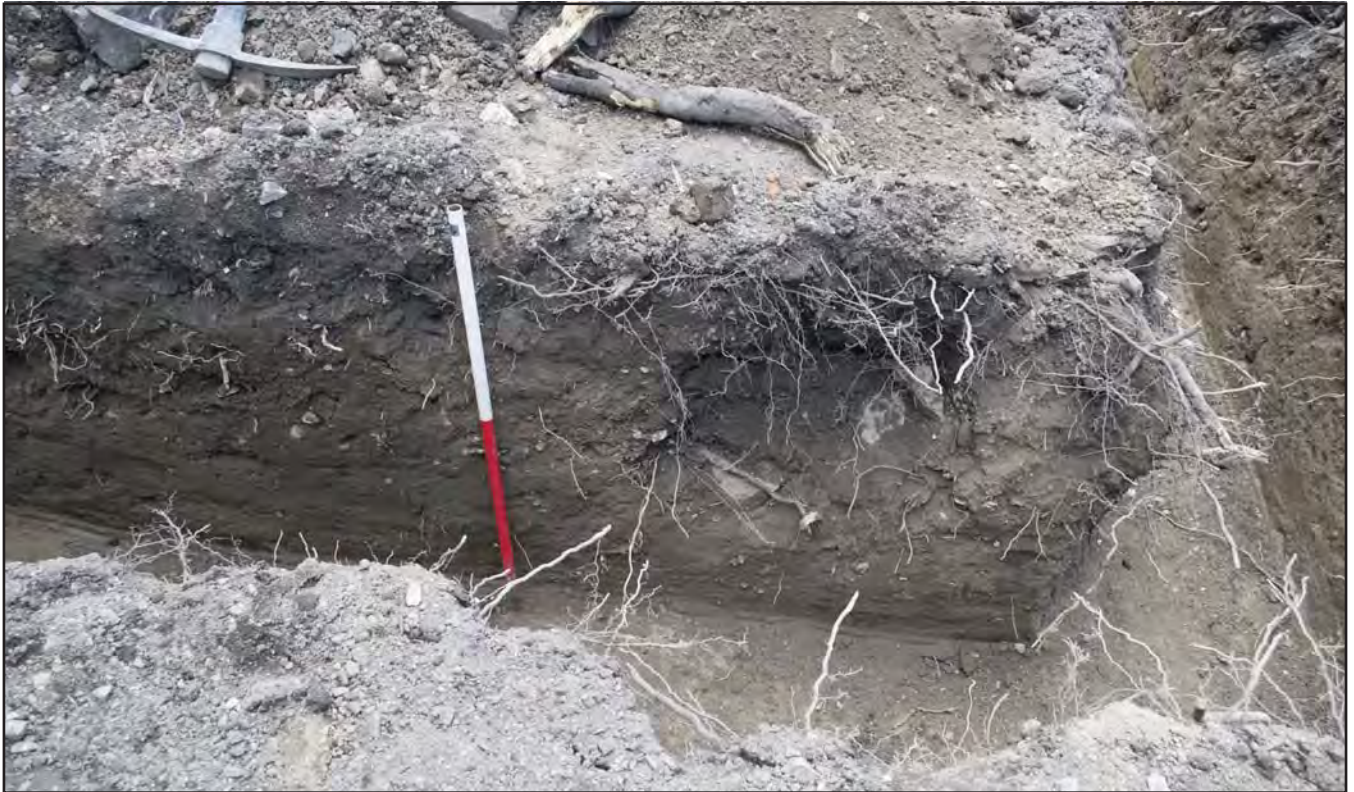
Plate 17: Depth of relict ploughsoil in north-western part of the site. Also shows a section through wall (13); scale: 1m (archive reference: G2738_055).

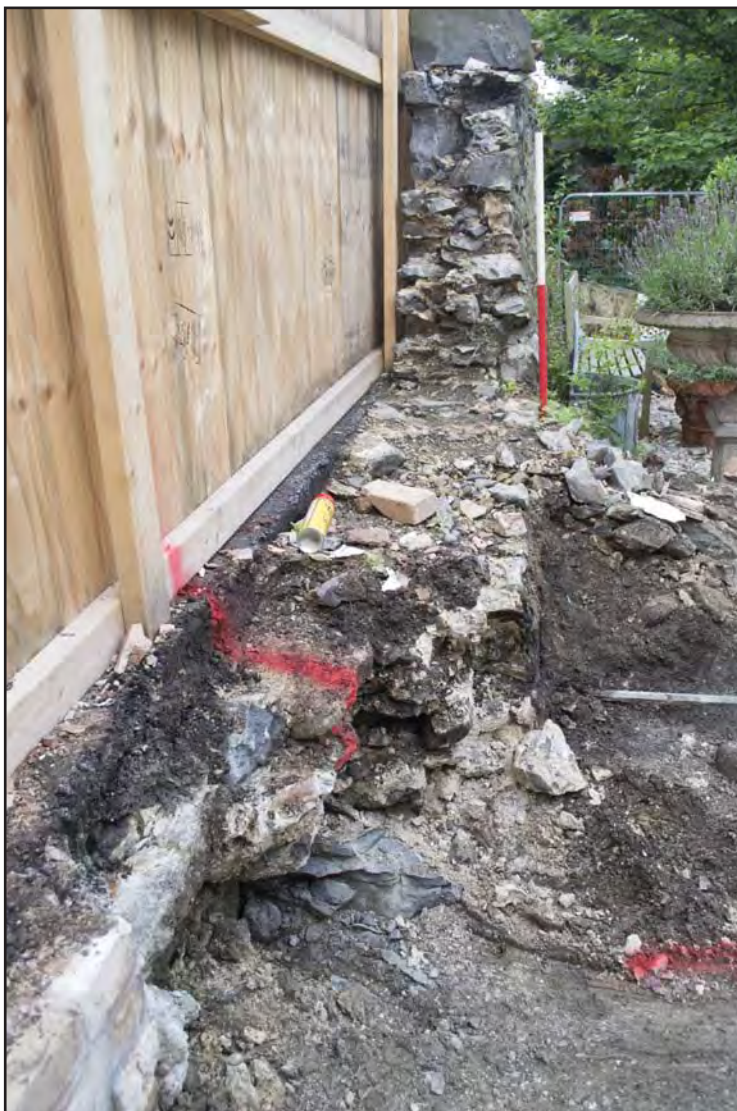
Several features were cut through layer (12) and the boulder clay (06). The wall forming the south-west boundary of the property (01) was built within a steep-sided foundation cut [03]. Wall (01) was 0.66m wide at its base and built of unworked angular stone, very roughly coursed, with a hard very pale grey-brown mortar. Large sub-rounded boulders (up to 0.6m long) were used in the foundations. Part of this wall had been demolished for this project, but most remains upstanding (Plate 18). Wall (01) was joined by wall (07). This wall was recorded in the photographic survey but within the area of the extension had been demolished to ground level. Wall (07) was constructed in the steep-sided foundation trench [08], and was 0.5m wide (Plate 19, Figure 11). It was made of angular stones with a hard cream coloured mortar. Very large stones, some up to 1.0m long, were used in the foundations. Where the foundation trenches for the extension cut along the line of this wall the wall foundations were removed. This wall defined the land associated with the adjacent Chester and Holyhead Railway and the wall continues north-west, well beyond the current property, defining one side of what is now an area of woodland.

Plate 18: Boundary wall (01) partially demolished; scale: 1m (archive reference: G2738_025)

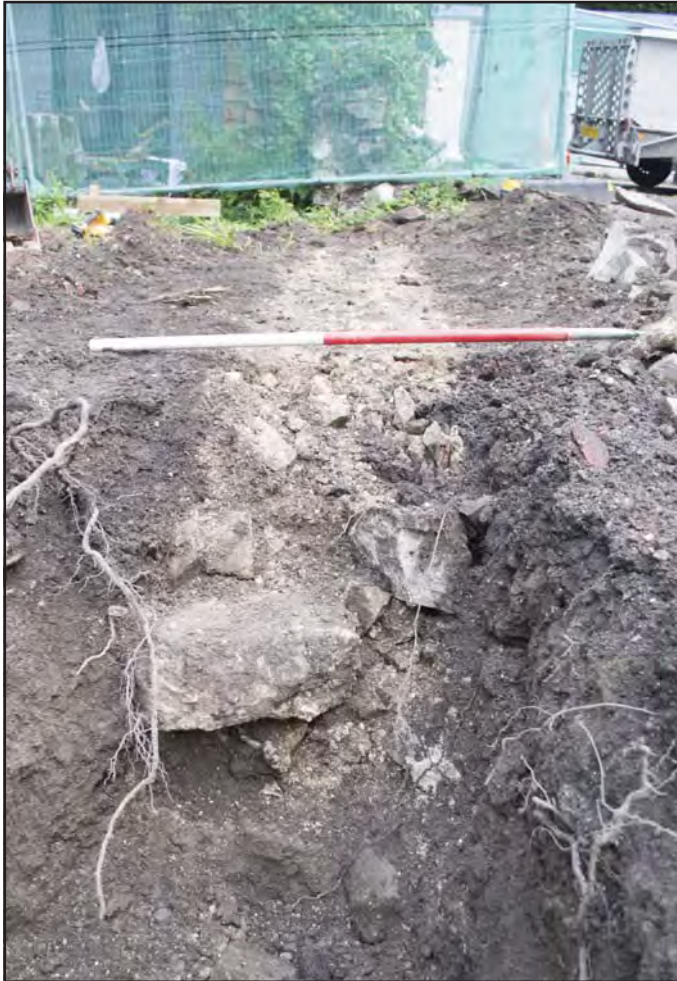
Plate 19: Foundations of wall (07); scale: 1m (archive reference: G2738_042)

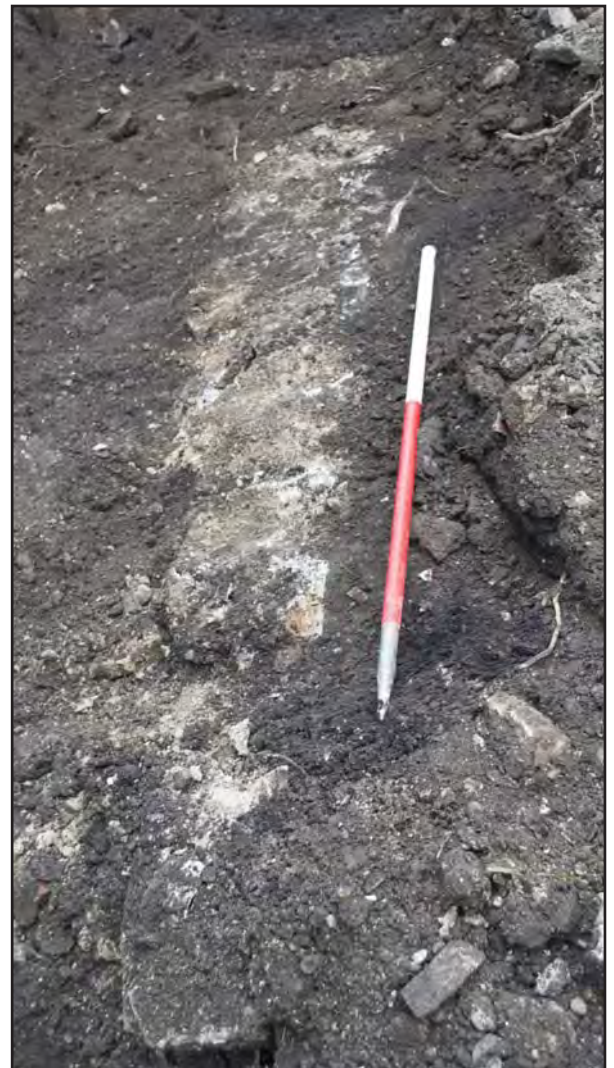
Running north-east from wall (07) was another wall of very similar character. This wall (13) was 0.5m wide and built in a foundation trench [14] (Plate 20). It was mortared with very large angular stones in the foundations. Many of these large stones appeared fresh and uneroded as if quarried stone and may have come from the digging of the railway cutting. Wall (13) had been demolished to ground level before the current owners bought the property and had been sealed under flags that formed the parking area. However, this wall is visible County Series maps as the north-western boundary to the property and was present by 1889.

Plate 20: Foundations of wall (13); scale: 1m (archive reference: G2738_047)

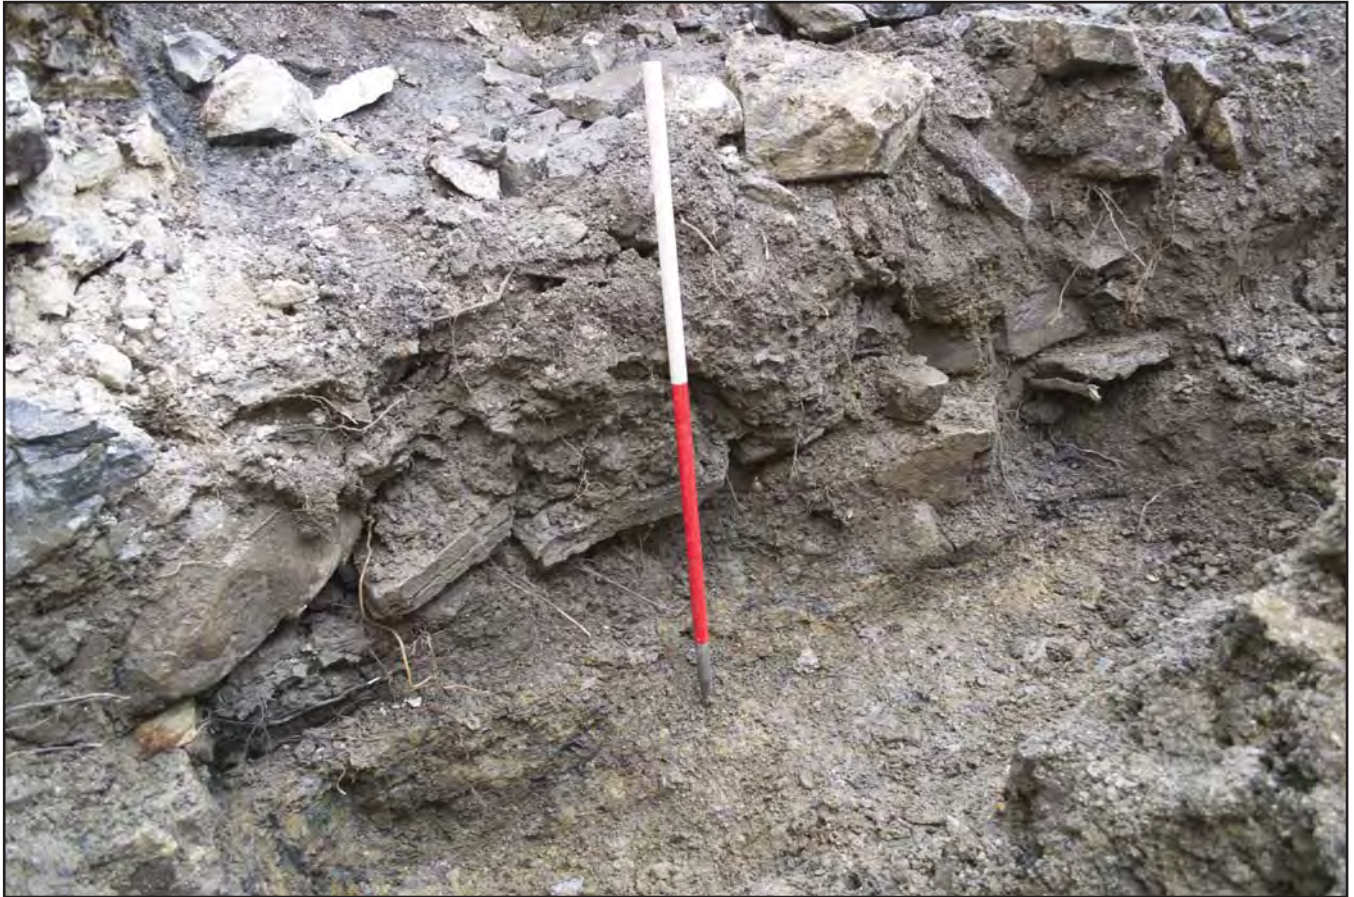
Plate 21: Section through stone deposit (04) in cut [05], see Figure 10; scale: 1m (archive reference: G2738_037).

There was also a similarly undated feature [05] cut by the boundary walls on the south-west side of the plot. This may have been a foundation for a wall but the poorly laid stone within it and the lack of mortar suggest that this might not be the case. The cut was continuing beyond the trench to the west, and so it is unlikely to be related to the outbuilding shown on the County Series maps (Figures 04 and 05). It is possible that it was related to the construction of the adjacent railway tunnel, with the stones providing a rough revetment or even backfilling an open terrace. The boundary walls are likely to have been built after work on the tunnel was completed, explaining why they were built over this feature.

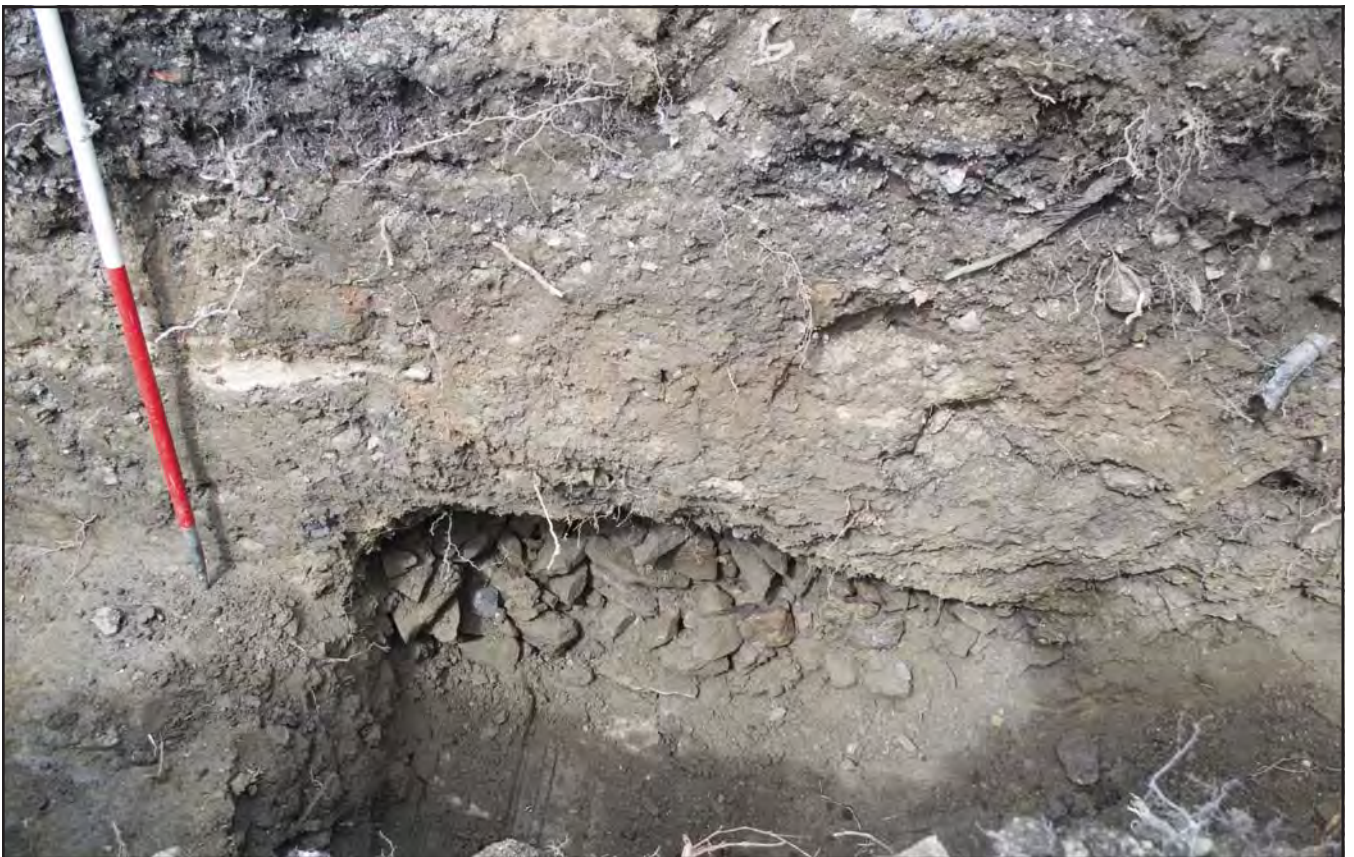
Plate 22: SE facing section through cut [19] showing loose rubble (15) in base, see Figure 12; scale: 1m (archive reference: G2738_051).
