Investigation of a wall found at Penparc, Penmon, Anglesey

PRN 97003

Project No. G40

Report No. 1650

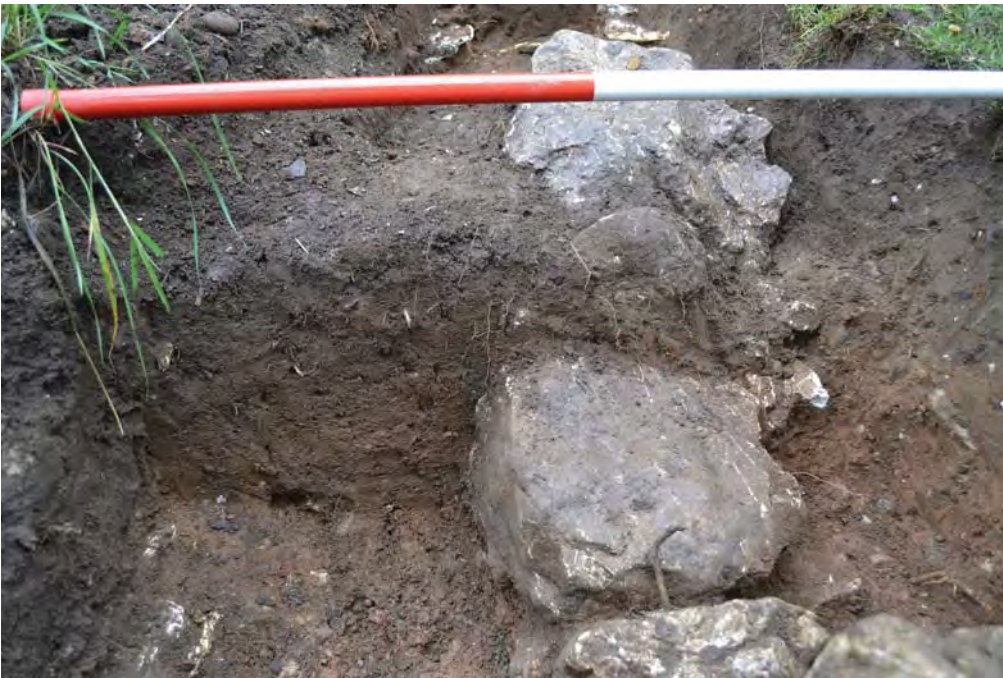
Plate 5. South facing section across wall (04)

Built up against the wall was a dark red-brown silty sand (03) about 0.15m deep (Figure 3, plate 5). This had occasional stones and a cattle bone was recovered from this deposit on the south side of the wall. This deposit is probably hillwash and formed the basis of the garden soil above. The garden soil had a lower layer (02), 0.18m

Structure (04) does appear to have been a wall of some form. The lack of a double-faced structure suggests that it was not a free-standing wall. The surviving remains could not have supported further courses on top if free-standing. It may have been a revetment wall to support deposits to the south. On this side it was slightly terraced into the slope and the face of the structure seems to have been on the north side. However, deposit (03) was seen on both sides of the structure and no evidence of other deposits built up against this revetment were found.

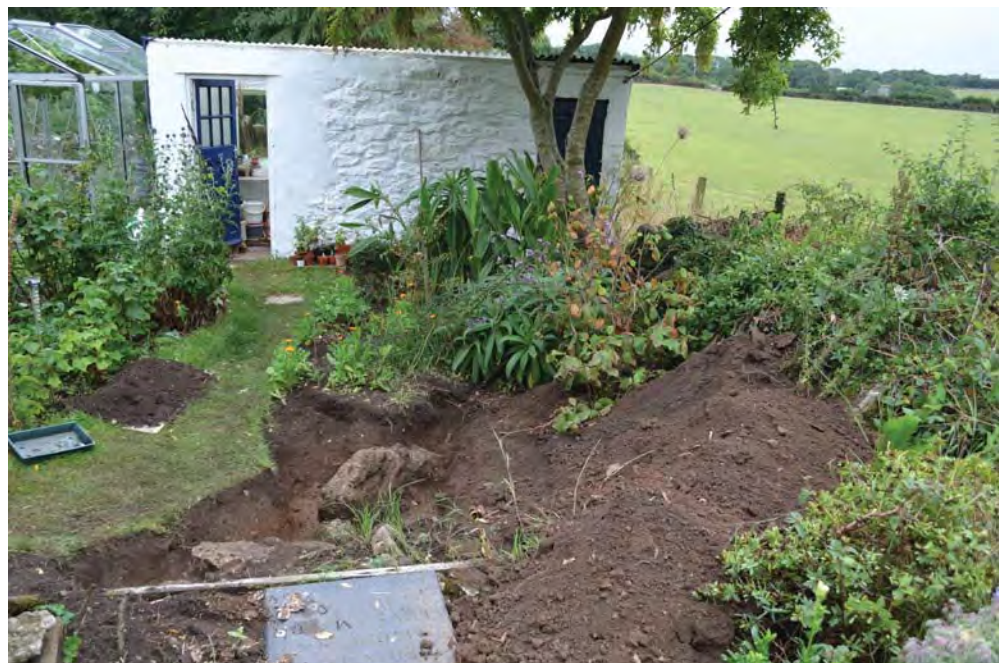
Plate 6. Trench with garden shed beyond, from the south-south-east

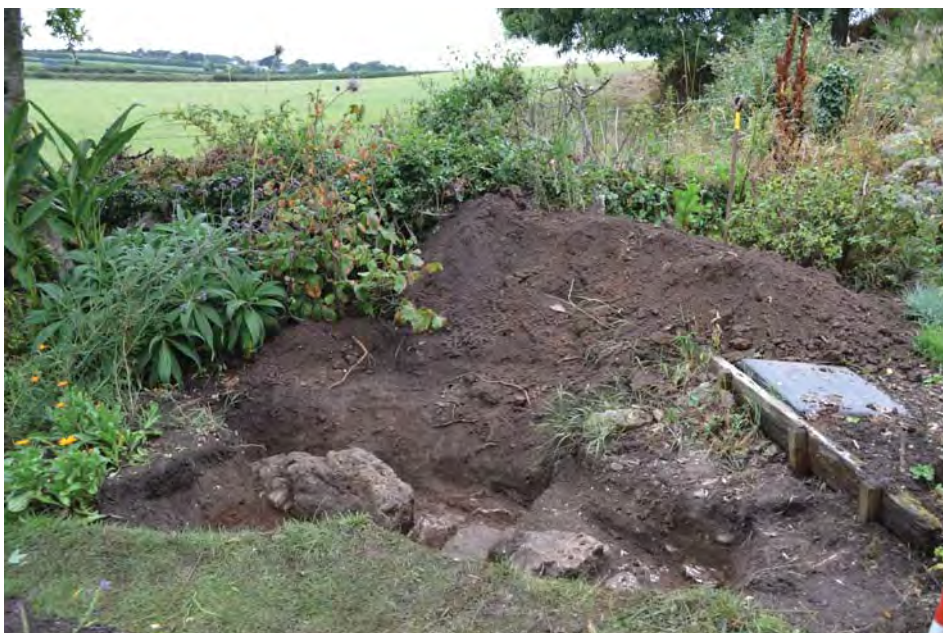
Plate 7. Trench within the garden, from the north-east

Garden soil and hillwash was removed by hand digging. The length of wall exposed was increased by removing a small area of the lawn and some stones, with permission. The excavation was limited by the small area where soil could be stored, and by minimising the damage to the garden (plate 7).
