FFERM COLEG GLYNLLIFON / GLYNLLIFON COLLEGE FARM

ASESIAD ARCHEOLEGOL - HWB ECONOMI WLEDIG /
ARCHAEOLOGICAL ASSESSMENT - RURAL ECONOMY HUB

Prosiect Rhif / Project No. G2743

Adroddiad Rhif / Report No.: 1684

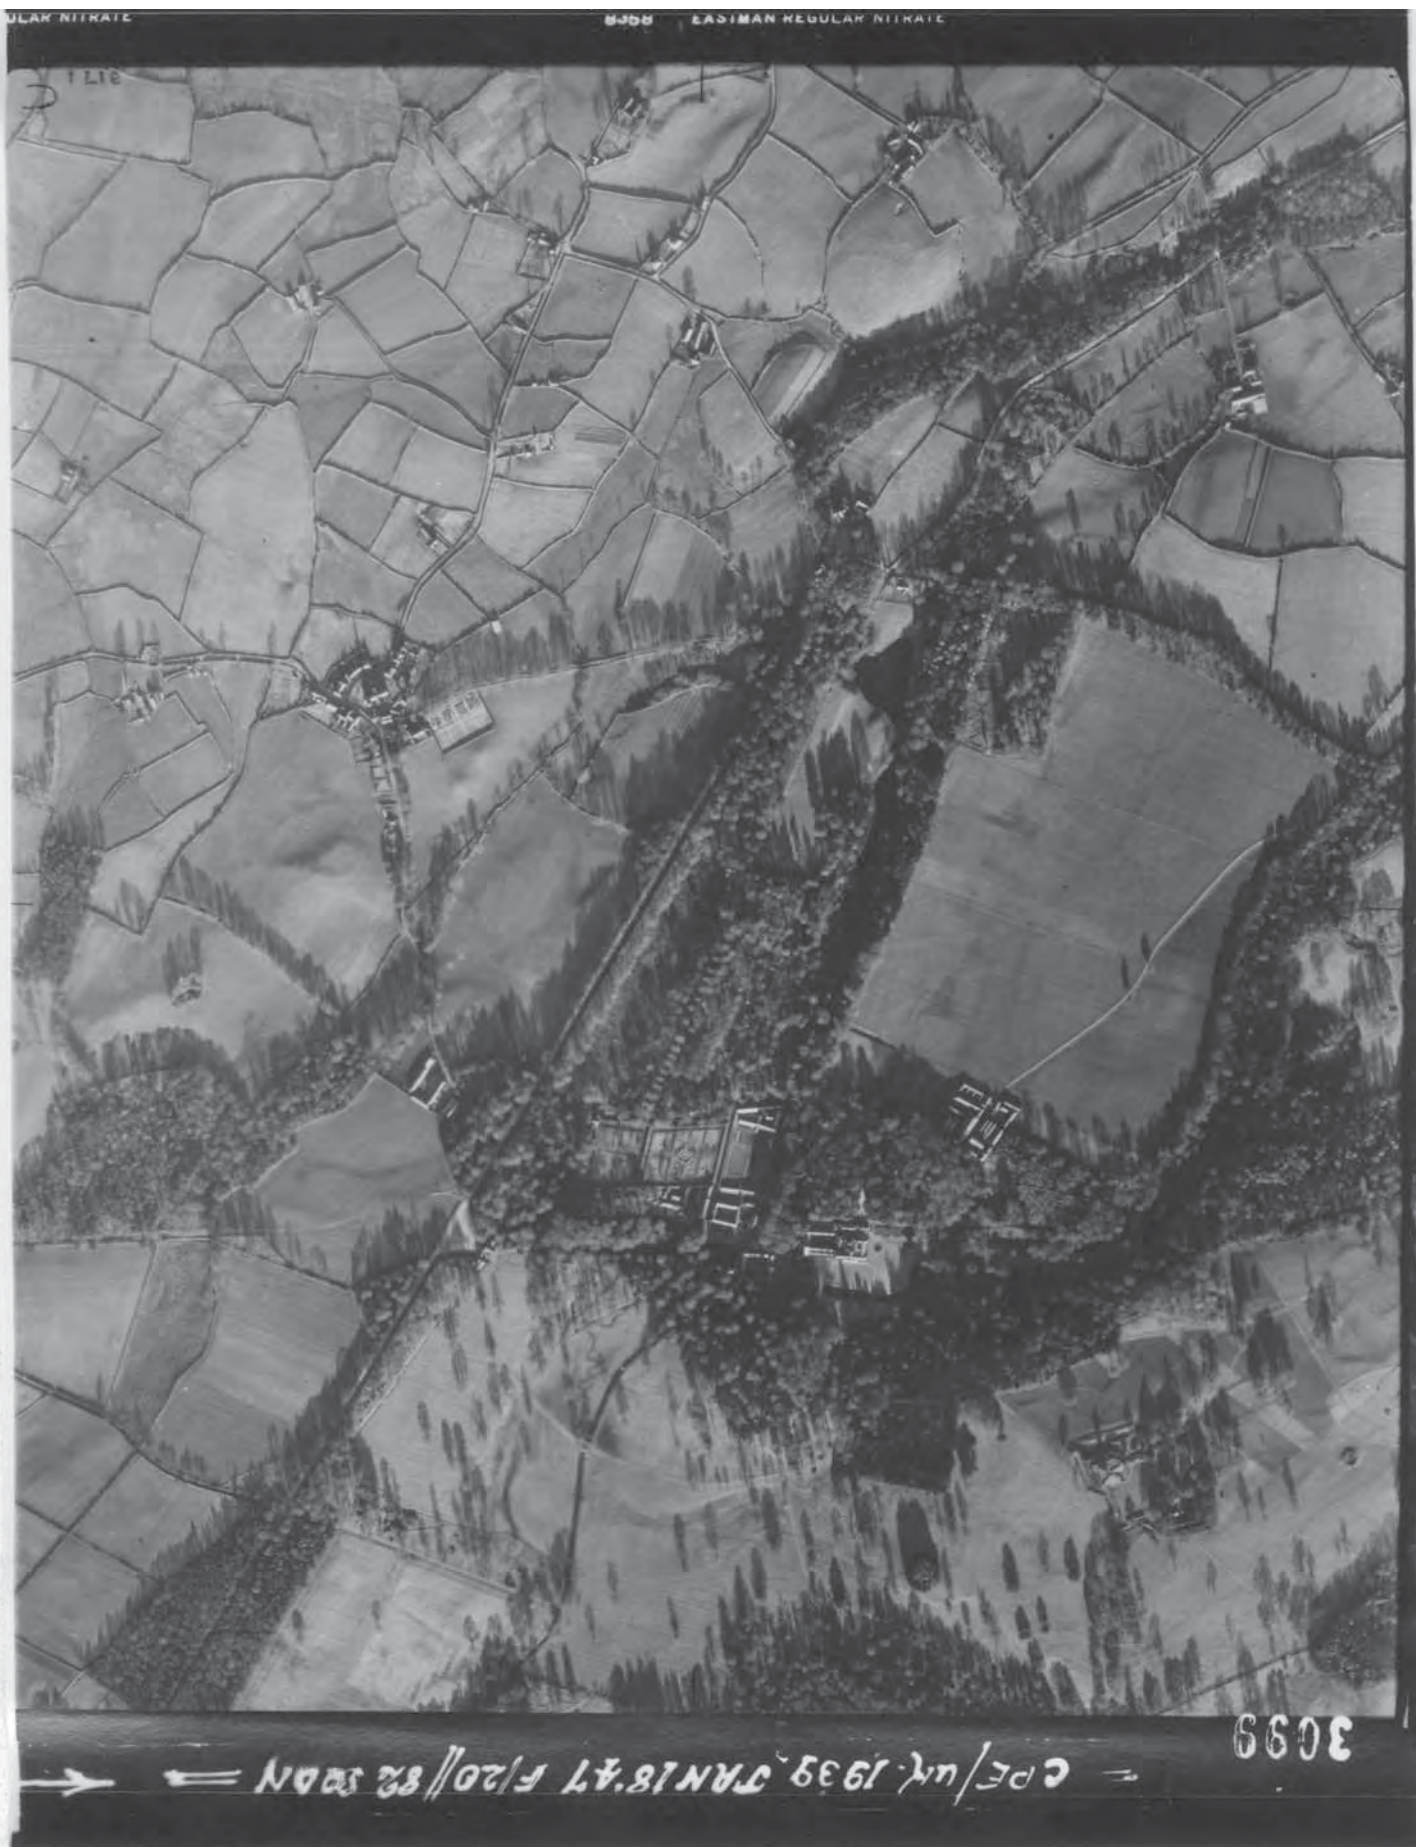
Figure 11: Reproduction of 1947 aerial photograph 4707 RAF CPE UK 1939 Frame 3099. Not to scale.
Source: Welsh Government.

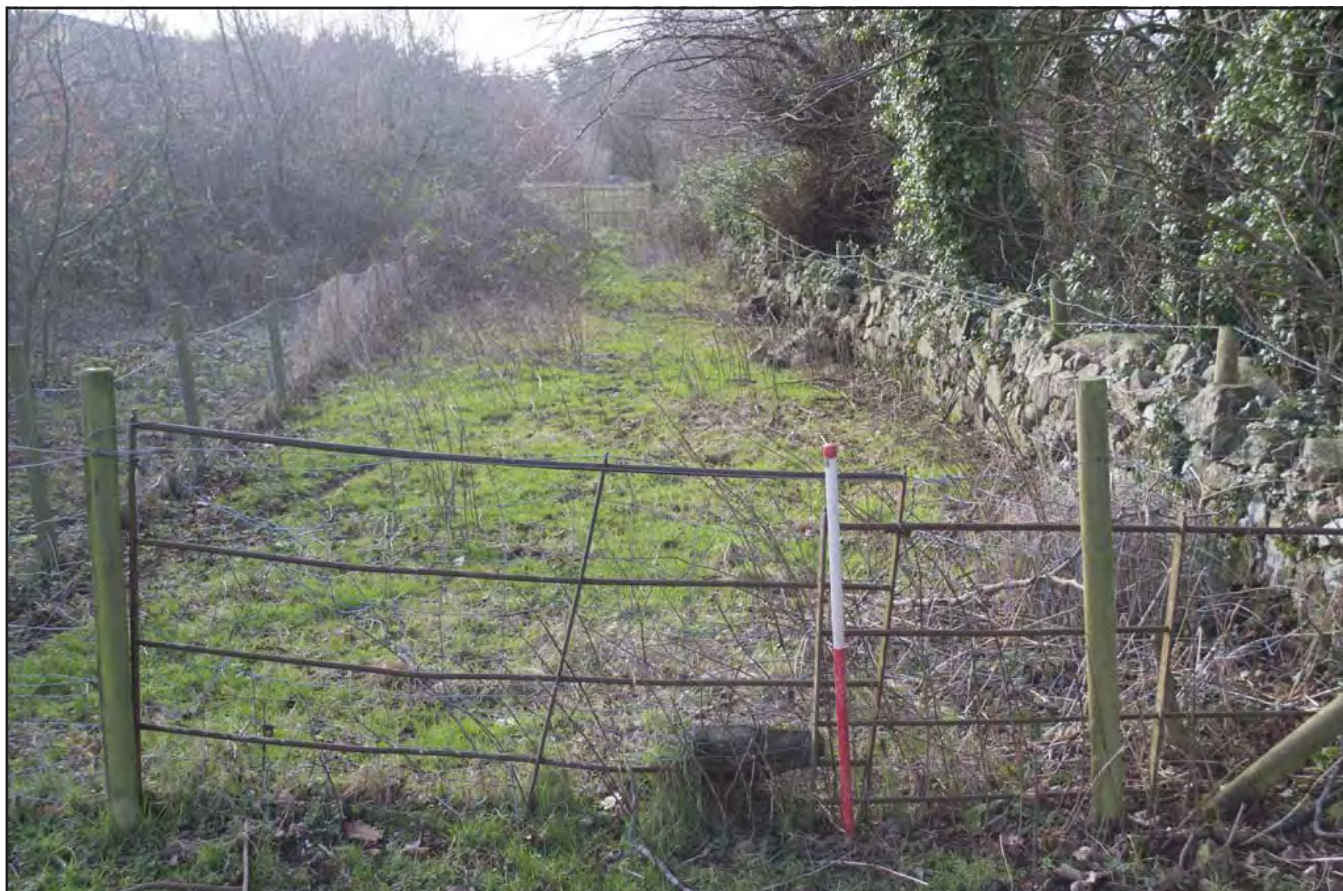
Asset Number	35
Site name	Drainage Ditch, Glynllifon
PRN number	97057
Grid reference	SH4576255771
Period	Unknown
Site type	A drainage ditch
Designation	N/A
Assessment category	C
Description	Drainage ditch located 0.36m beneath the topsoil
Impact	Unlikely
Recommendation	None

Plate 1: Rough scrub land located south of development area where asset35 is located; scale 1x1m; view from N (archive reference: G2743_55).

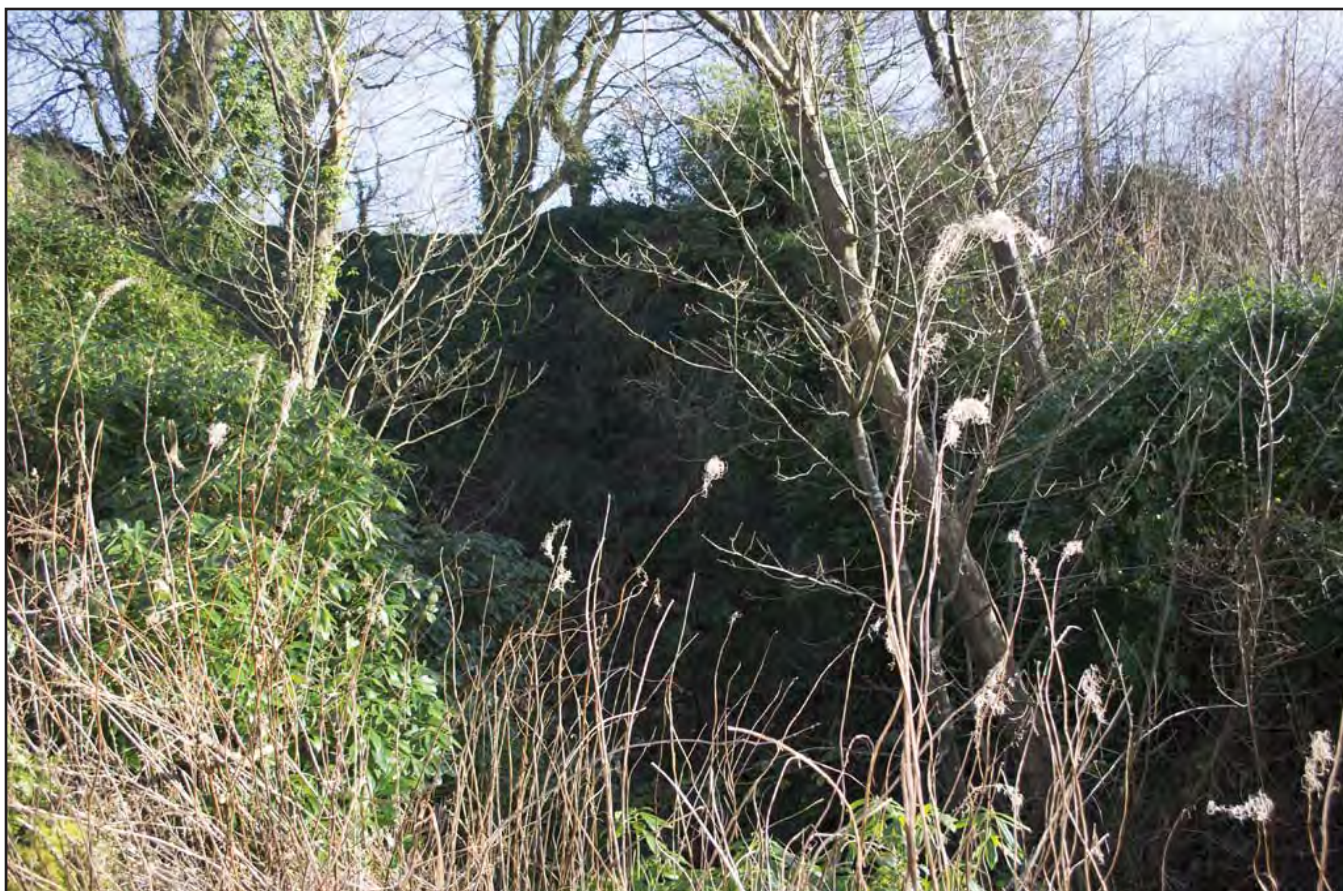
Asset Number	73
Site name	Small Quarry, Glynllifon
PRN number	31013
Grid reference	SH4574855836
Period	Post-medieval
Site type	Quarry
Designation	N/A
Assessment category	C
Description	A quarry is excavated into the natural escarpment to the west of the study area, and is approximately 20m in height. The quarry is depicted on the first (1889), second (1900) and third (1918) edition county series OS maps, and is labelled as old quarry on all three (Cooke & Kenney 2009).
Impact	Likely
Recommendation	Watching brief during development groundworks to record the extent and appearance of the asset

Plate 2: Quarry (asset 73); scale not used; view from N (archive reference: G2743_79).

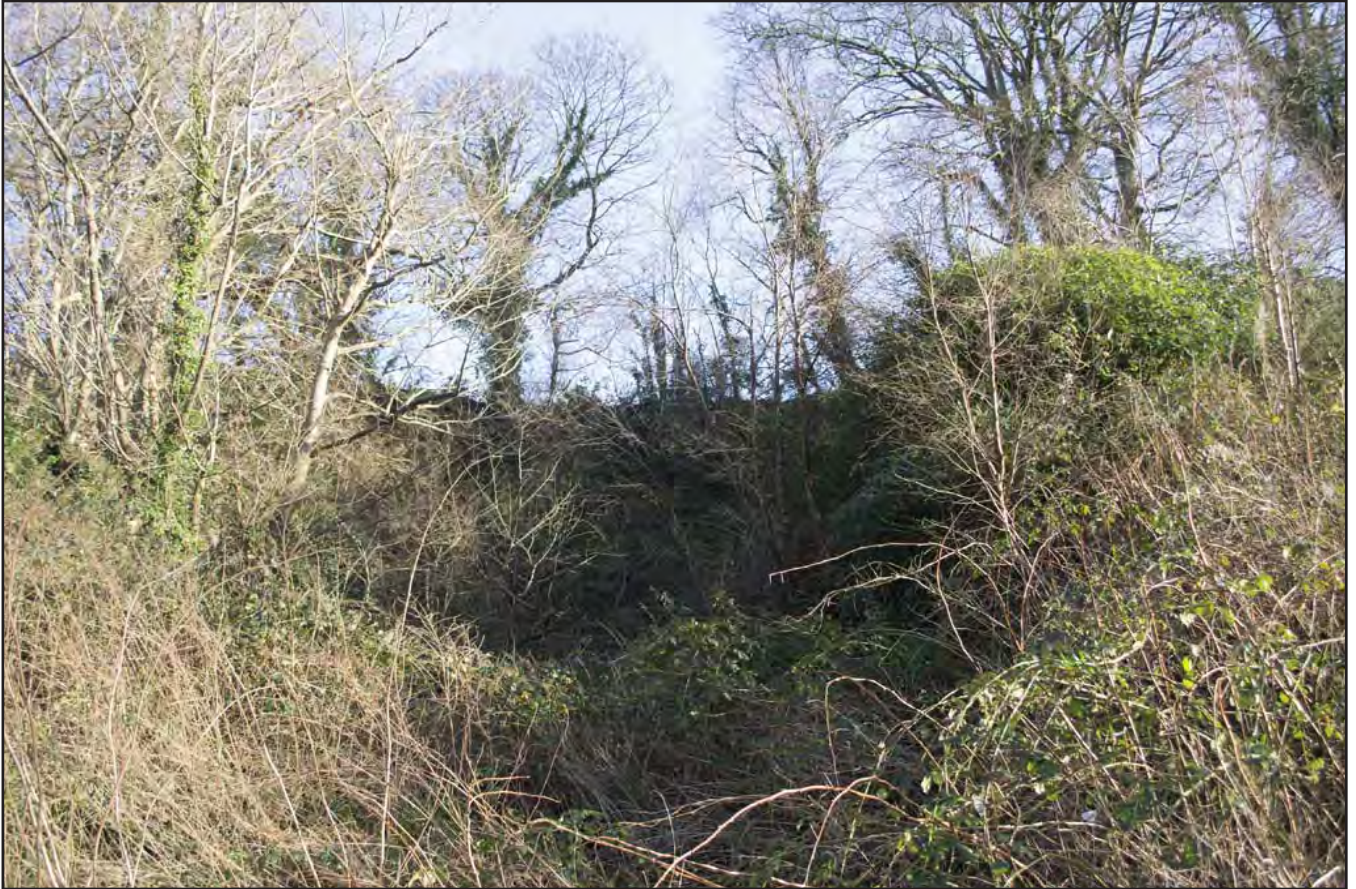
Asset Number	74
Site name	Quarry, Glynllifon
PRN number	25834
Grid reference	SH4576955880
Period	Post-medieval
Site type	Quarry
Designation	N/A
Assessment category	C
Description	Quarry marked on the OS 1st edition map of 1889. (Flook 2007)
Impact	Likely
Recommendation	Watching brief during development groundworks to record the extent and appearance of the asset

Plate 3: Big Quarry (asset 74); scale not used; view from W (archive reference: G2743_80).

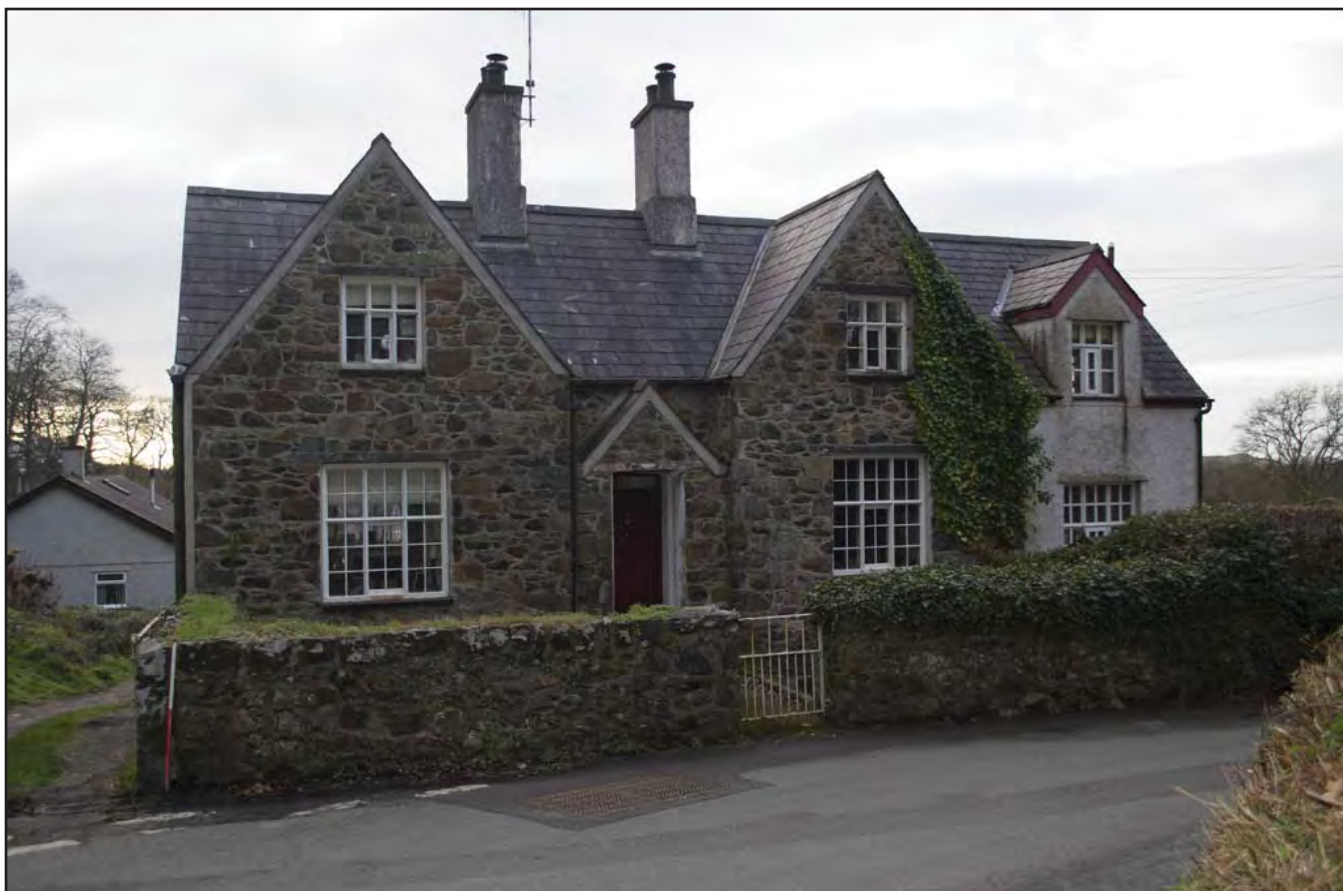
Asset Number	84
Site name	Cottage/outbuilding at Tan-y-groeslon
PRN number	64123
Grid reference	SH4566356209
Period	Post Medieval
Site type	Cottage
Designation	Grade II listed building
Assessment category	B
Description	A cottage shown on the 1840 Tithe Map.
Impact	Unlikely
Recommendation	None

Plate 14: View of cottage (asset 84); scale 1x1m; view from NW (archive reference: G2743_96).

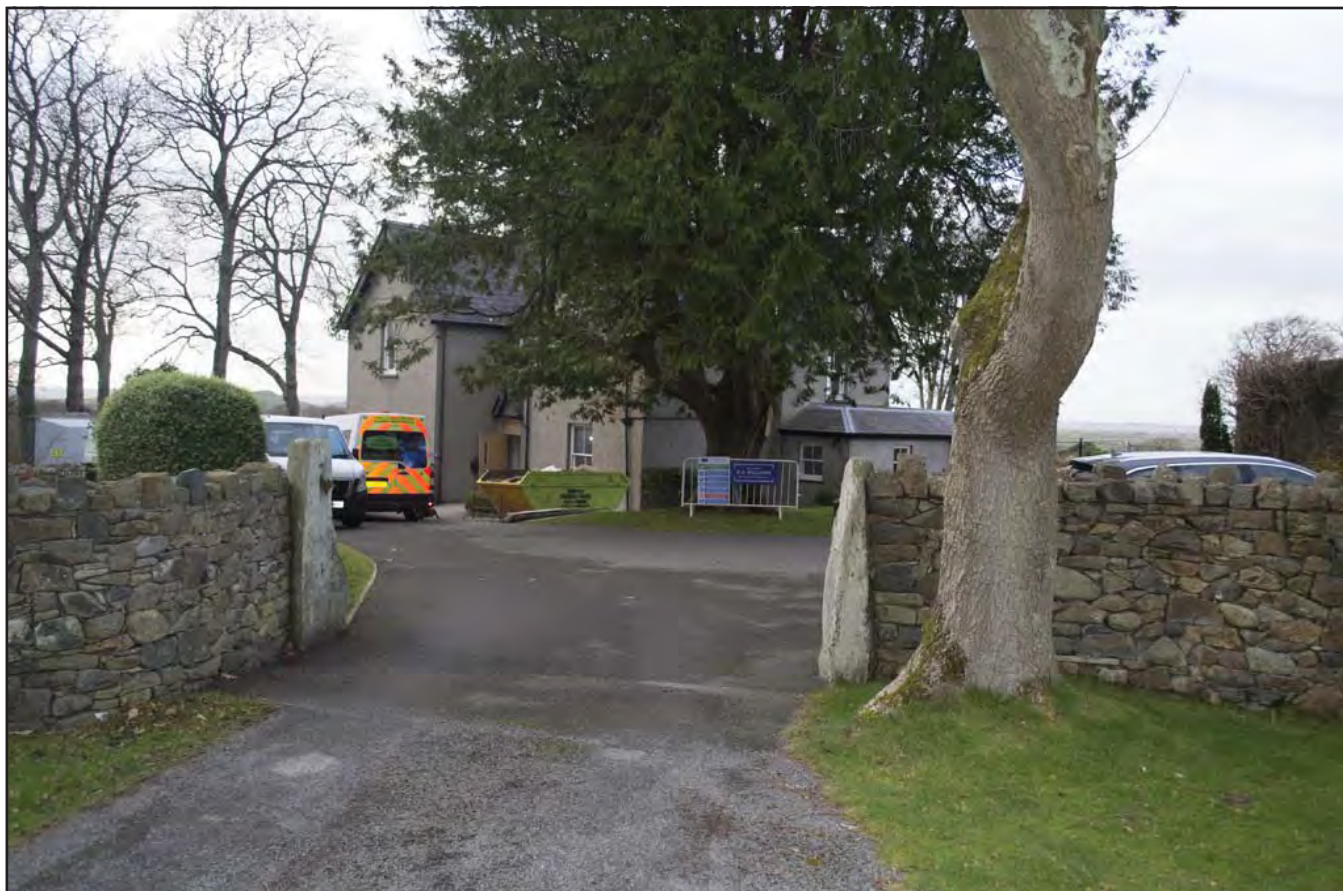
Asset Number	85
Site name	Tan-y-groeslon
PRN number	64097
Grid reference	SH4566956223
Period	Post Medieval
Site type	House
Designation	Grade II listed building
Assessment category	B
Description	A farmhouse built between 1860 and 1870.
Impact	Unlikely
Recommendation	None

Plate 15: View of Tan Y Groeslan (asset 85); scale 1x1m; view from SE (archive reference: G2743_97).

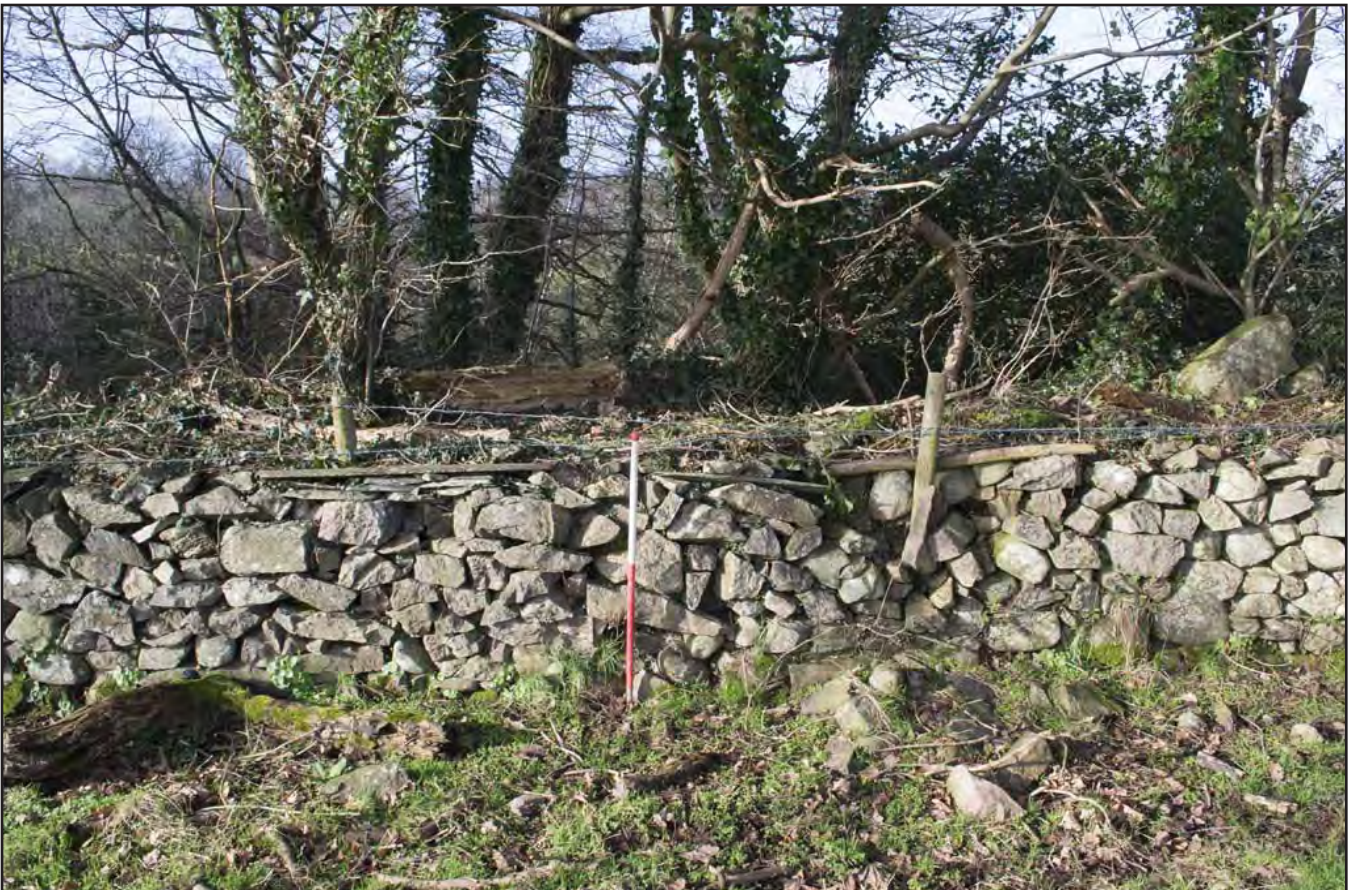
Plate 22: View of drystone wall which is part of western boundary; scale 1x1m; view from E
(archive reference: G2743_59).

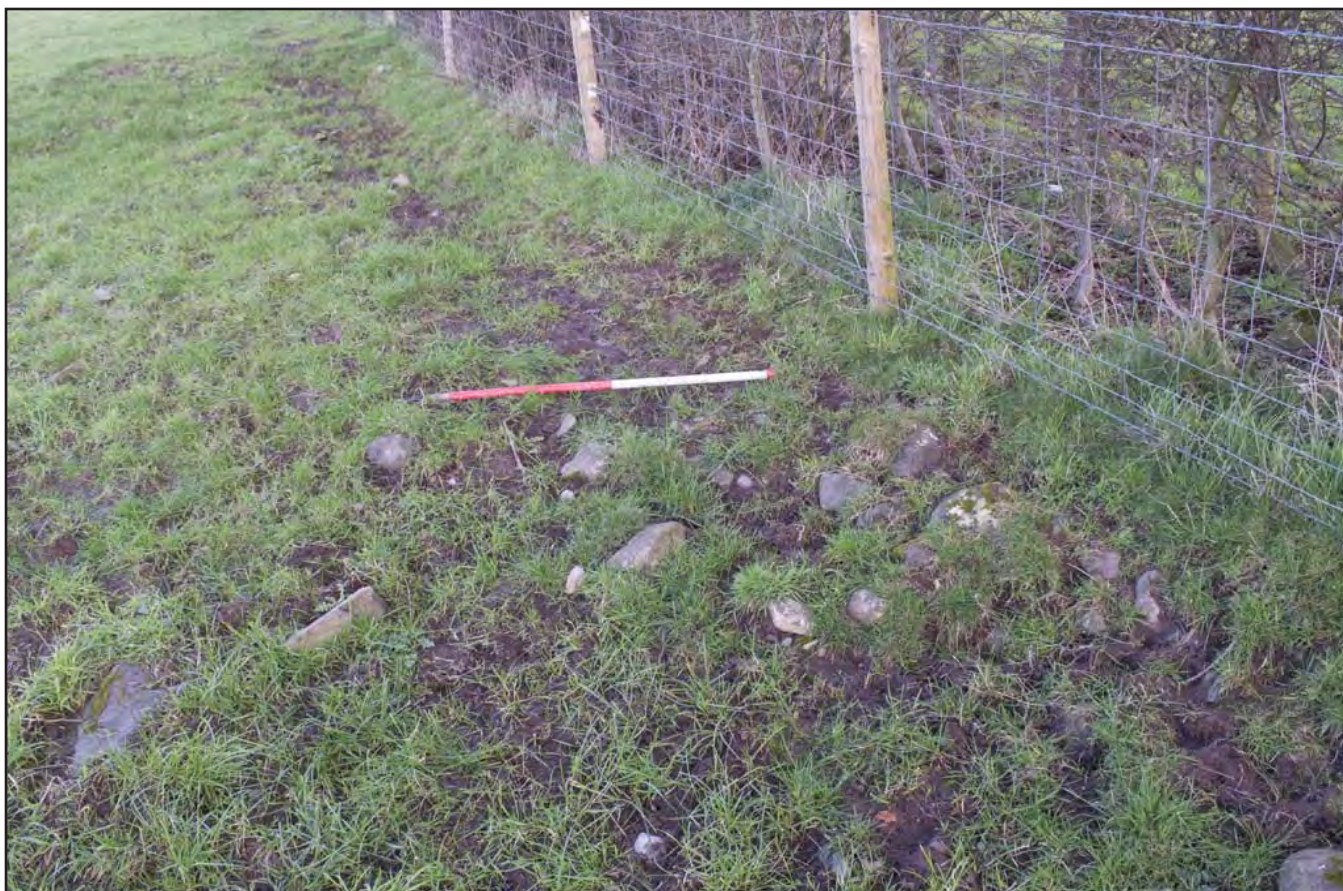
Plate 26: Stones by eastern boundary, probably part of old boundary wall; scale 1x1 m;
view from S (archive reference: G2743_63).

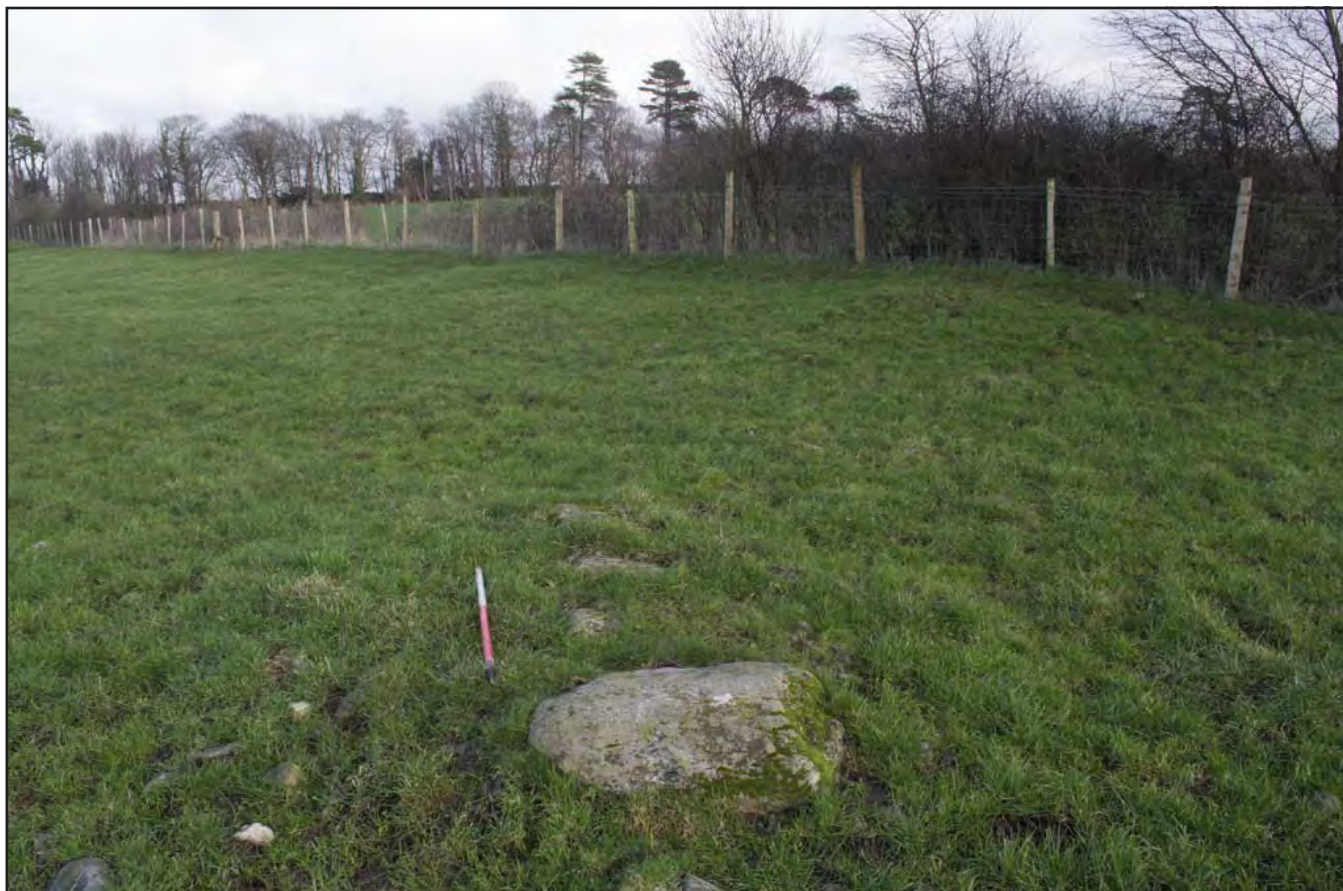
Plate 27: Stones in field, possible remains of clawdd; scale 1x1m; view from SE (archive reference: G2743_64).

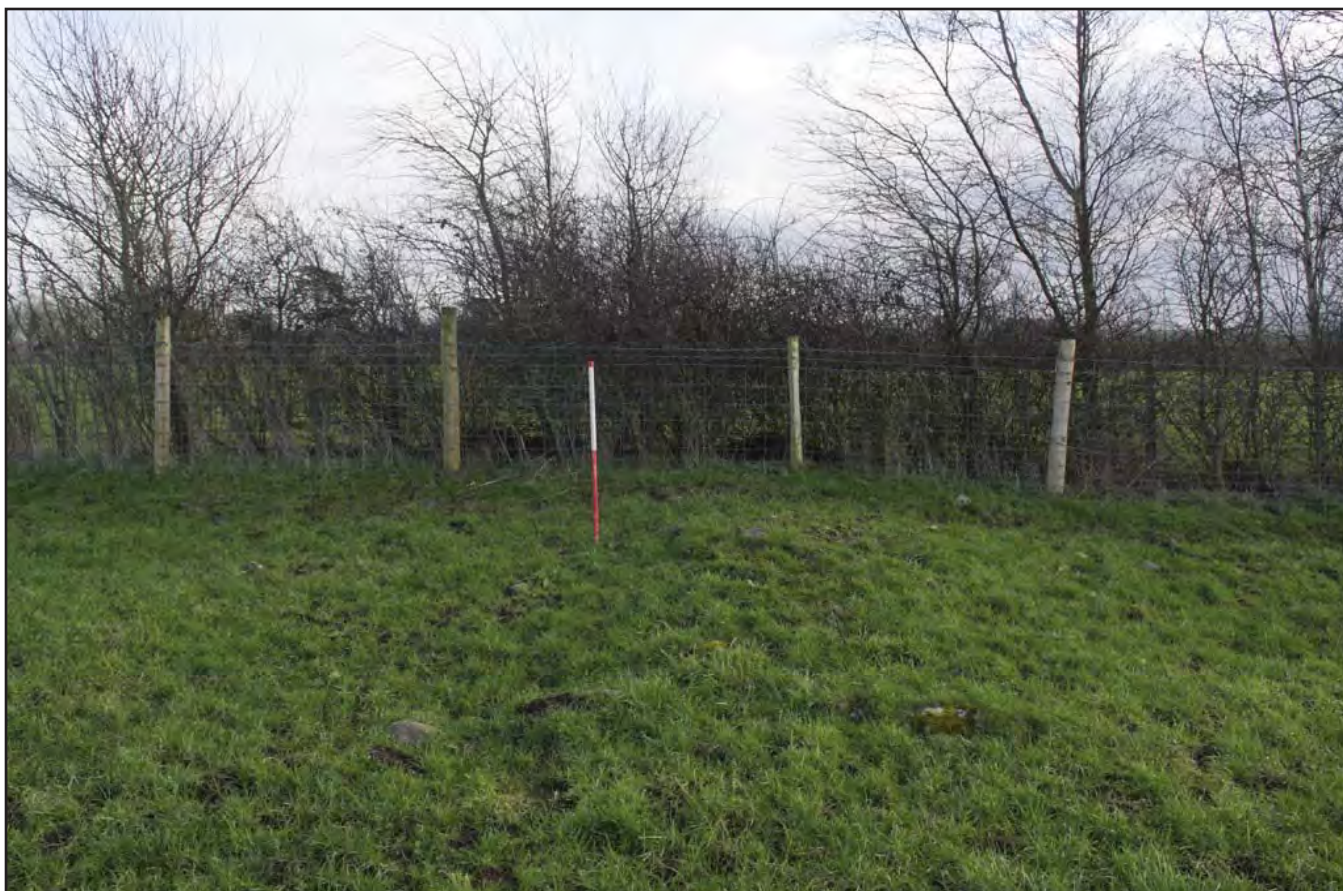
Plate 28: View of raised mound in eastern boundary, possible remains of clawdd; scale 1x1m; view from E (archive reference: G2743_65).

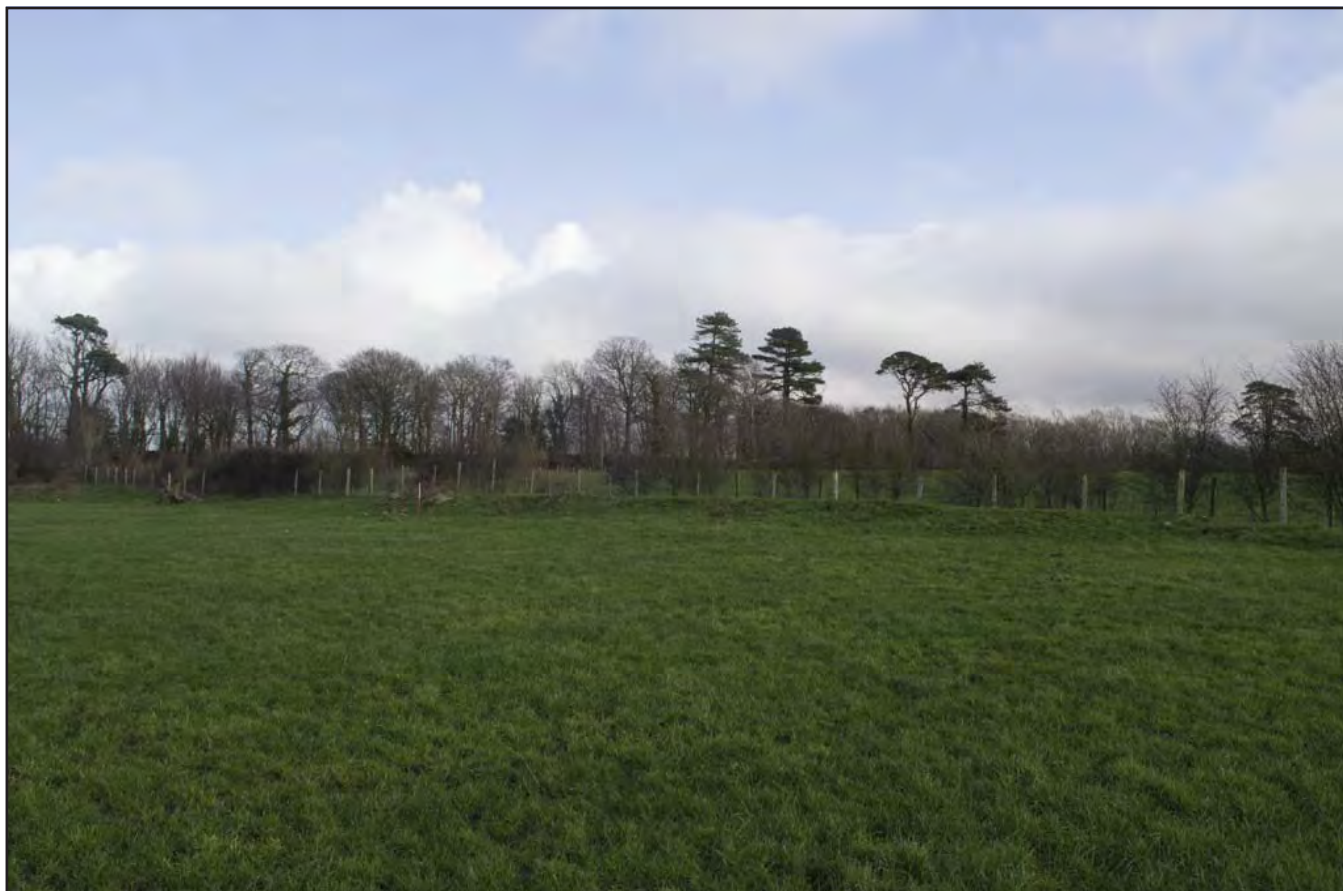
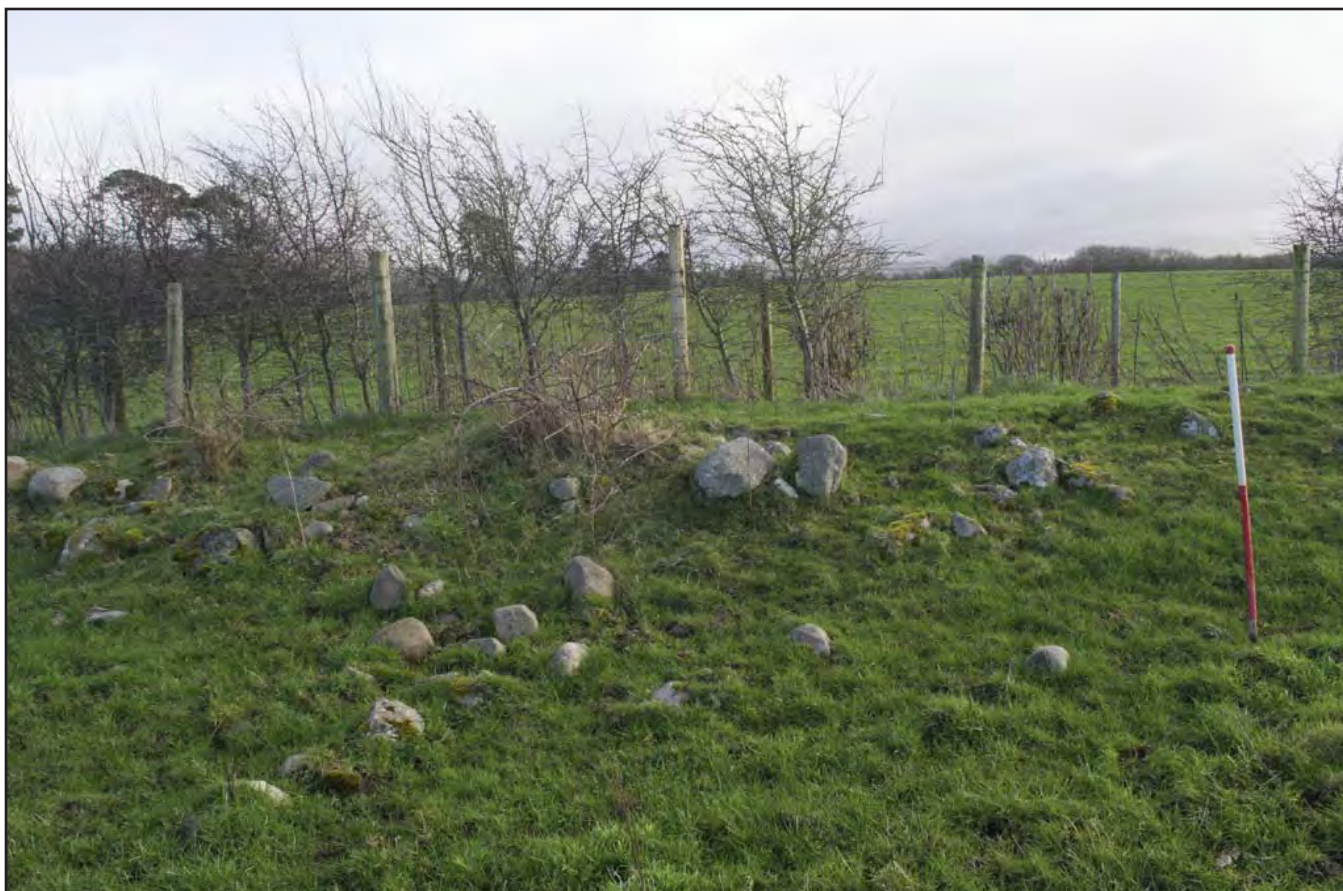
Plate 29: Curvi-linear earthwork, heads southeast into eastern boundary; scale 1x1m; view from E (archive reference: G2743_66).

Plate 30: Curvi-linear earthwork, heads southeast into eastern boundary; scale 1x1m; view from E (archive reference: G2743_67).

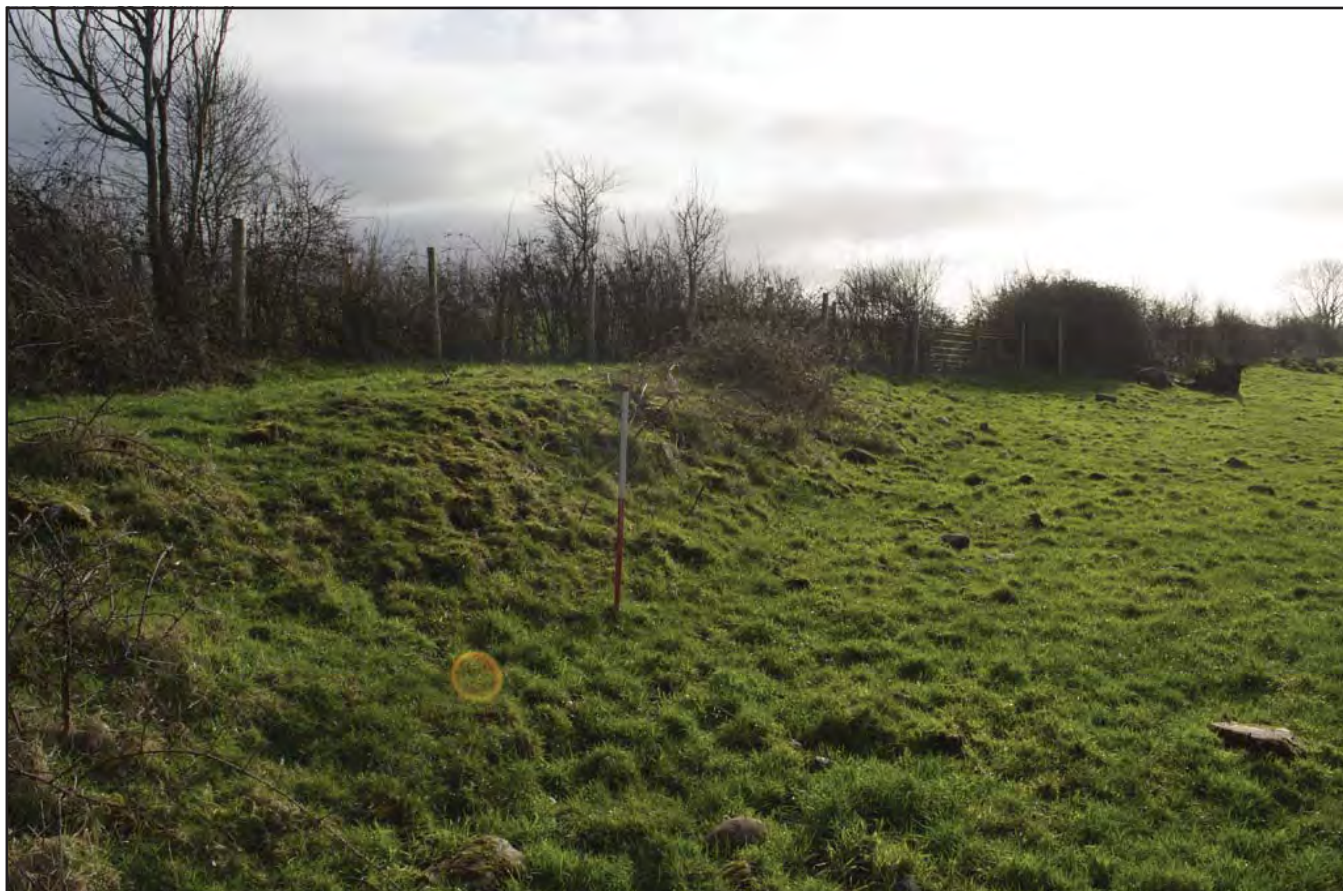
Plate 31: Oblique view of earthwork on eastern boundary; scale 1x1 m; view from SE (archive reference: G2743_68).

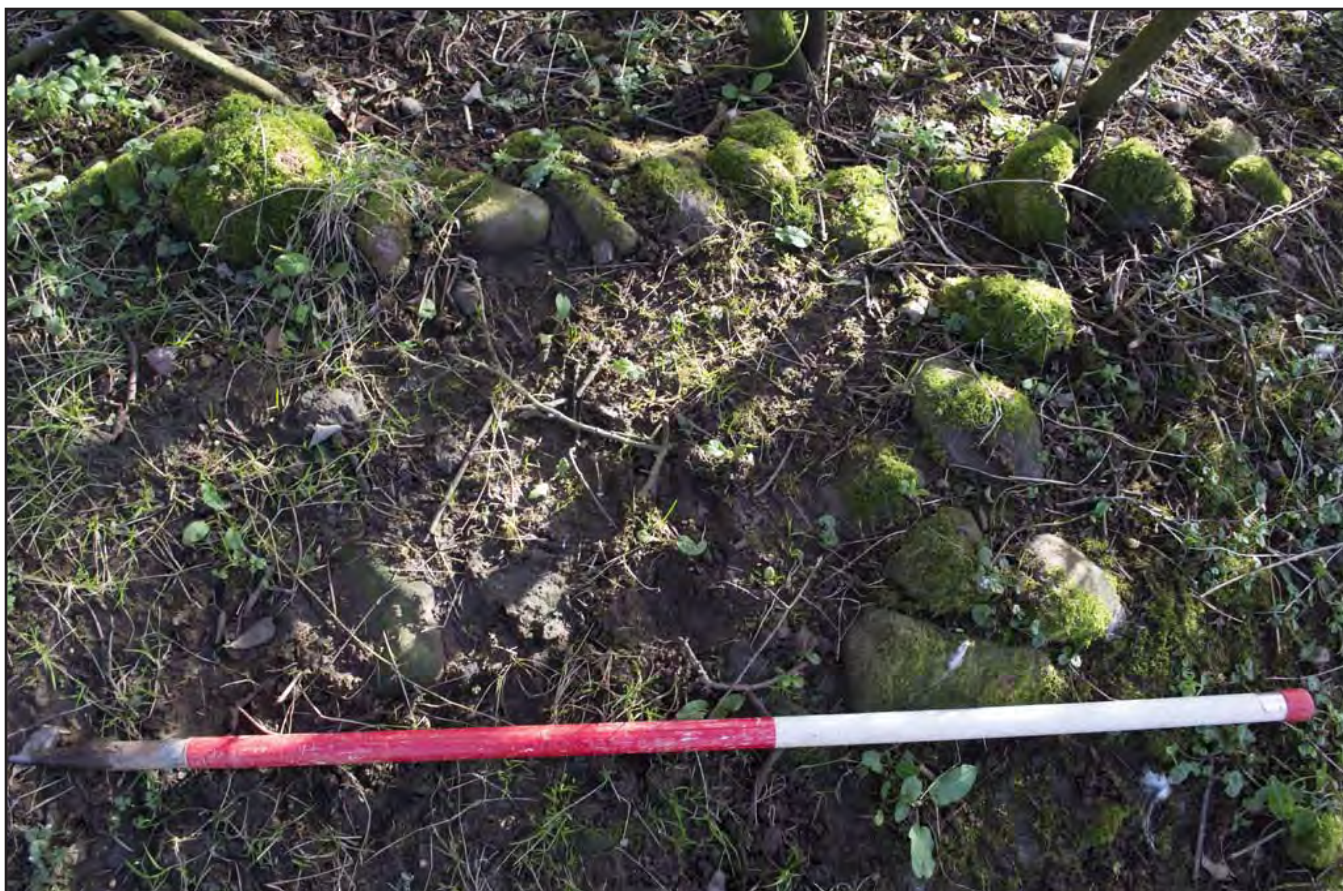
Plate 32: Remnants of cobble facing, possible relict clawdd; scale 1x1 m; view from E (archive reference: G2743_69).

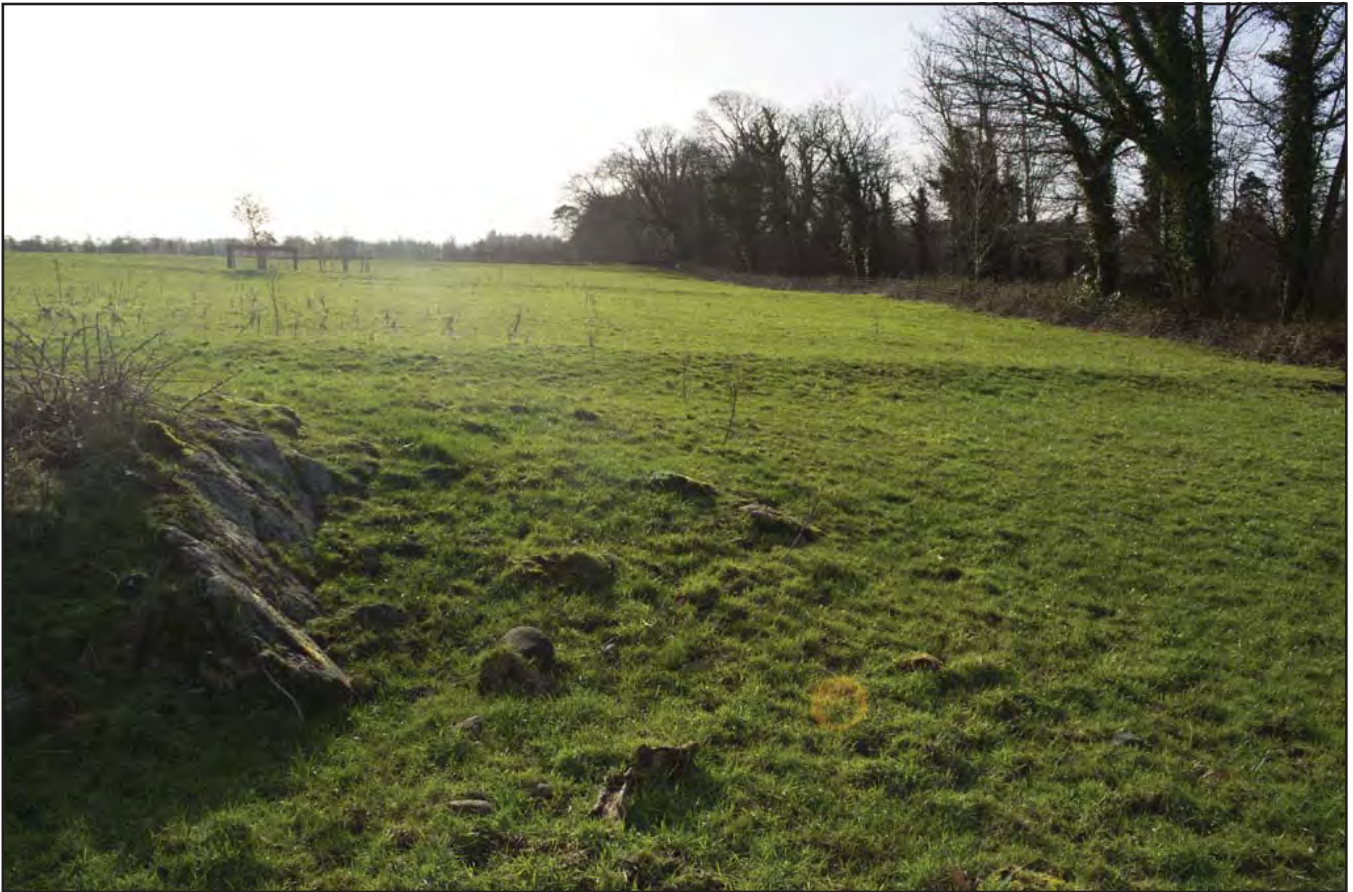
Plate 35: Earthworks in Field 2; scale 1x1m; view from N (archive reference: G2743_72).

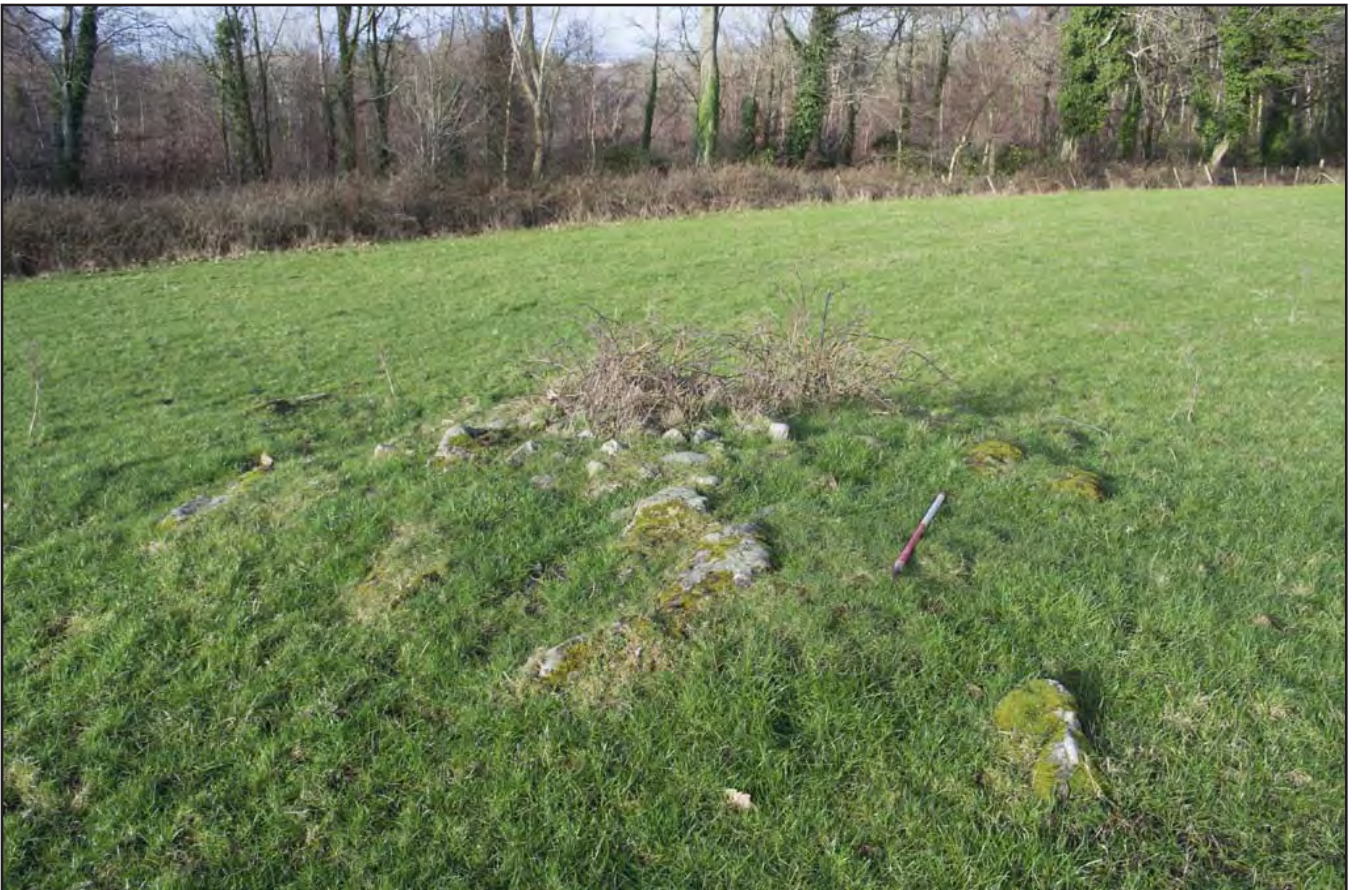
Plate 36: Clearance cairn on outcrop; scale not used; view from NW (archive reference: G2743_73).

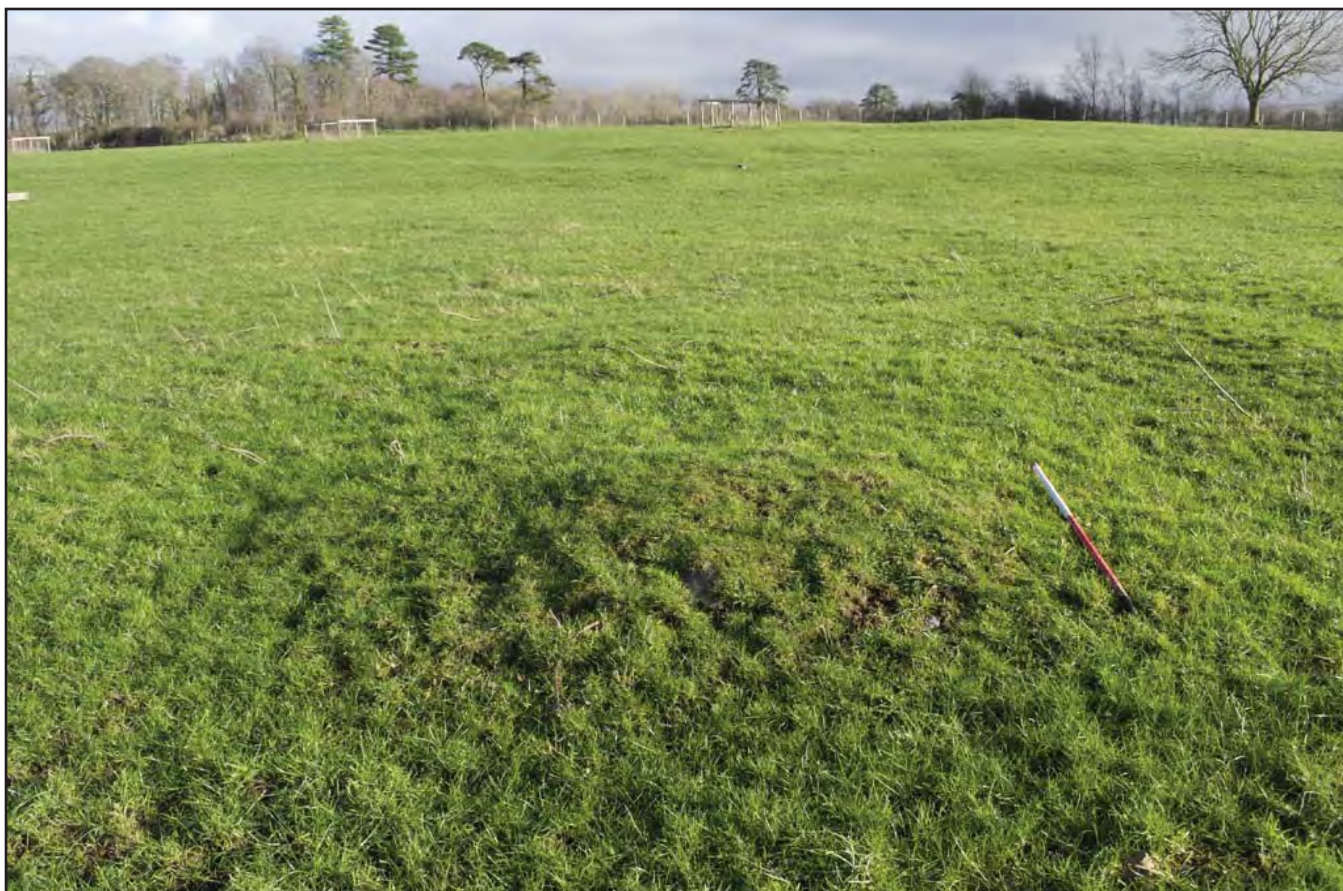
Plate 38: Raised mound in Field 2; scale not used; view from E (archive reference: G2743_75).
