FFERM COLEG GLYNLLIFON / GLYNLLIFON COLLEGE FARM

ASESIAD ARCHEOLEGOL - HWB ECONOMI WLEDIG /
ARCHAEOLOGICAL ASSESSMENT - RURAL ECONOMY HUB

Prosiect Rhif / Project No. G2743

Adroddiad Rhif / Report No.: 1684

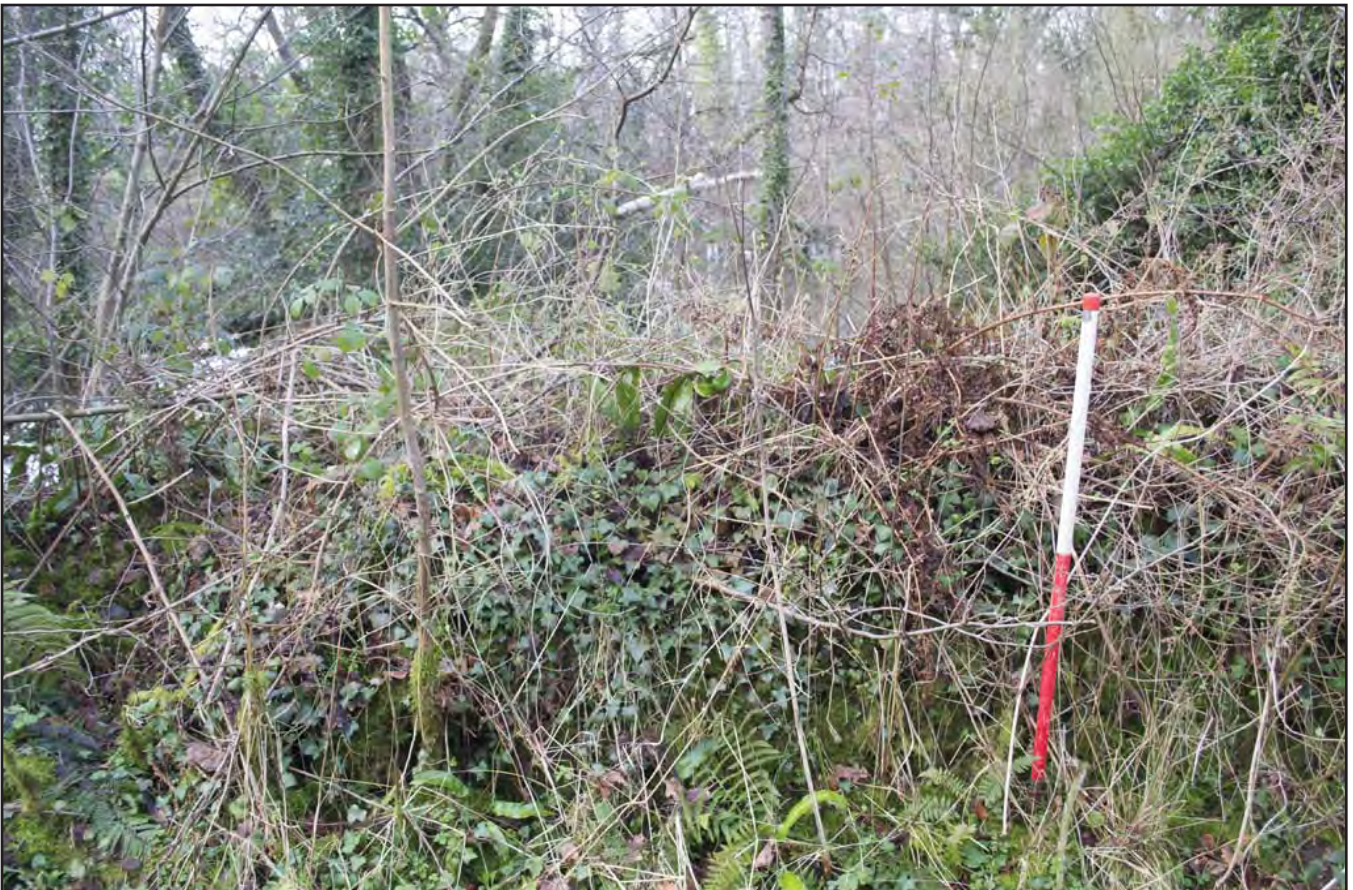
Plate 42: Old boundary for trackway; scale 1x1m; view from E (archive reference: G2743_87).

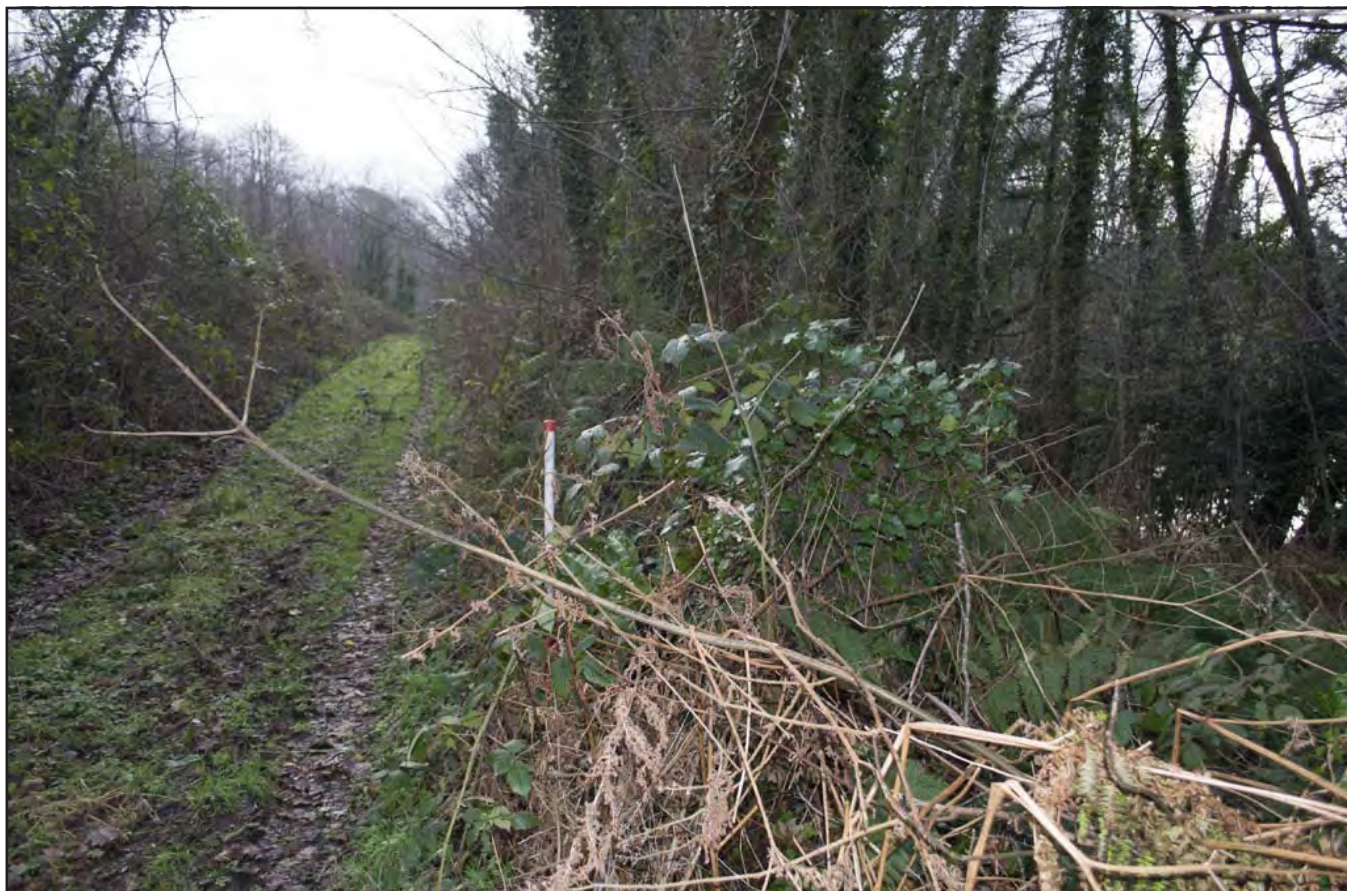
Plate 43: End of old wall with slate gate post; scale 1x1m; view from N (archive reference: G2743_88).
