MOEL DDINAS, RHOSYGWALIA, Y BALA,

Cofnod Adeiladau Hanesyddol/
Historic Building Recording

Rhif Prosiect / Project No. G2778

Rhif Adroddiad / Report No. 1705

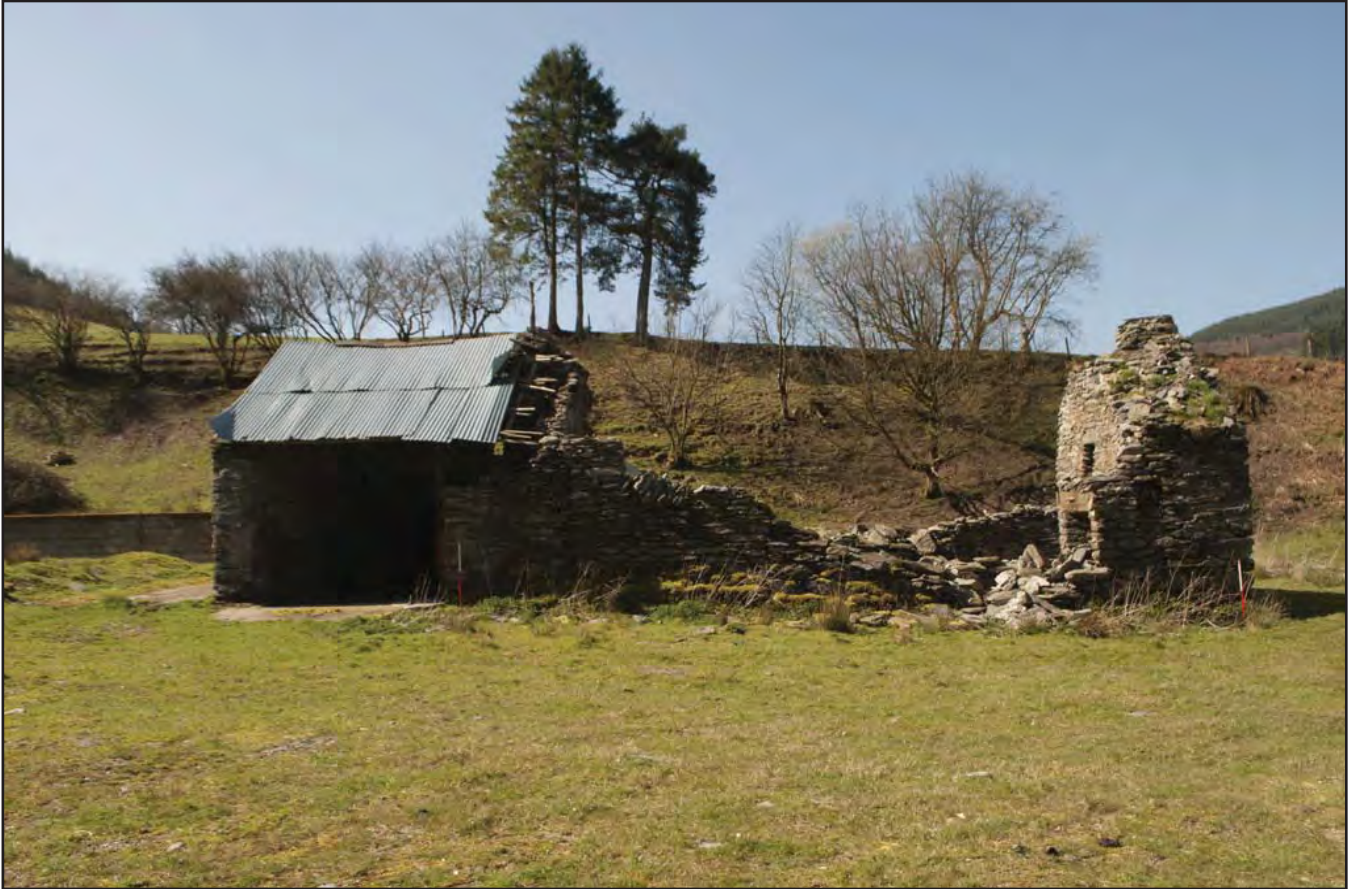
Plate 1: Exterior - View of exterior NE wall of cottage and large entrance to barn; scale 2x1m; view from NE (archive reference: G2778_001).

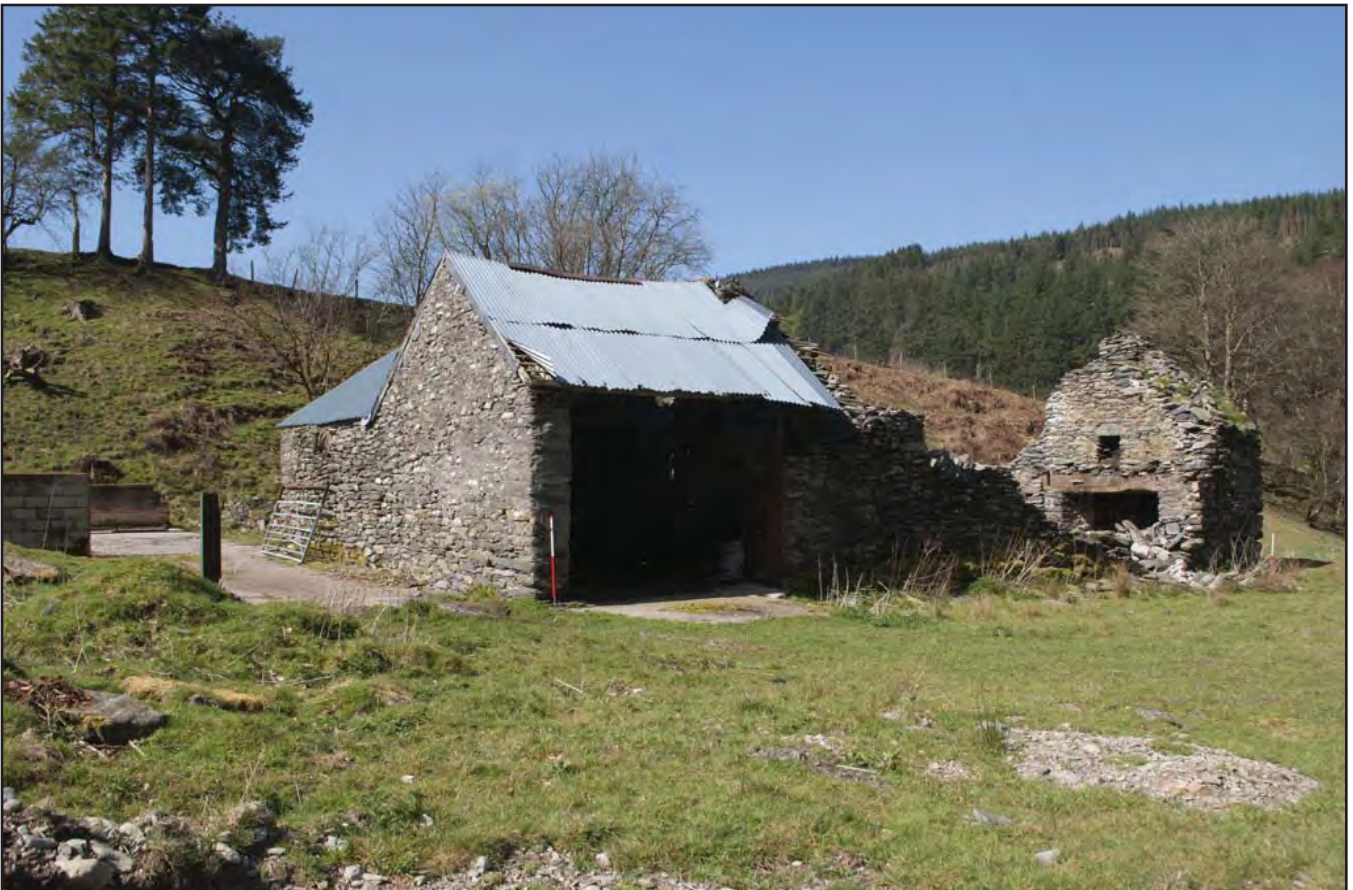
Plate 2: Exterior - Oblique view of barn and cottage from the E corner, exterior; scale 2x1m; view from E (archive reference: G2778_002).

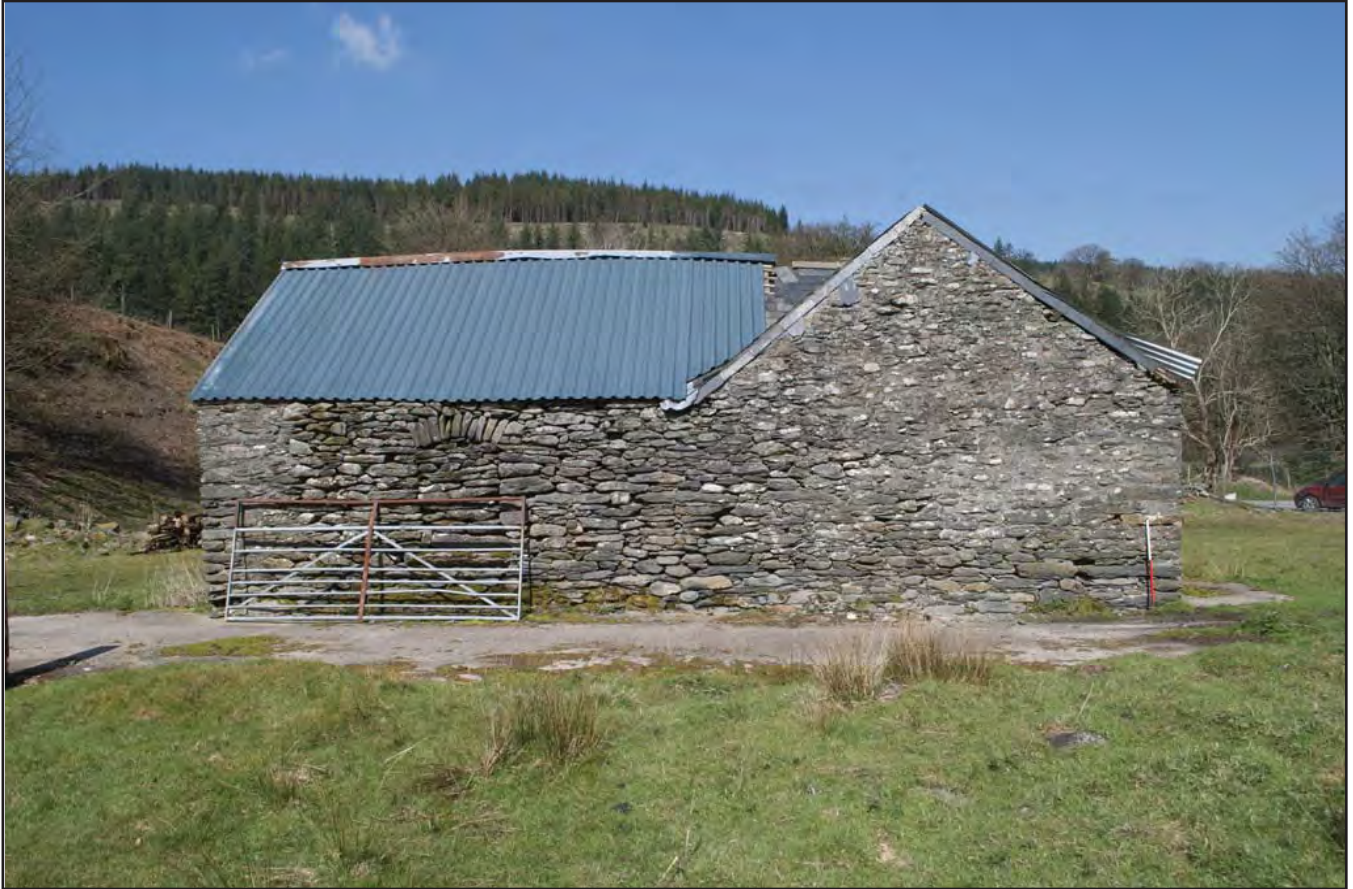
Plate 3: Exterior - View of exterior SE wall of barn, showing window infilled with stone; scale 1x1m; view from SE (archive reference: G2778_003).

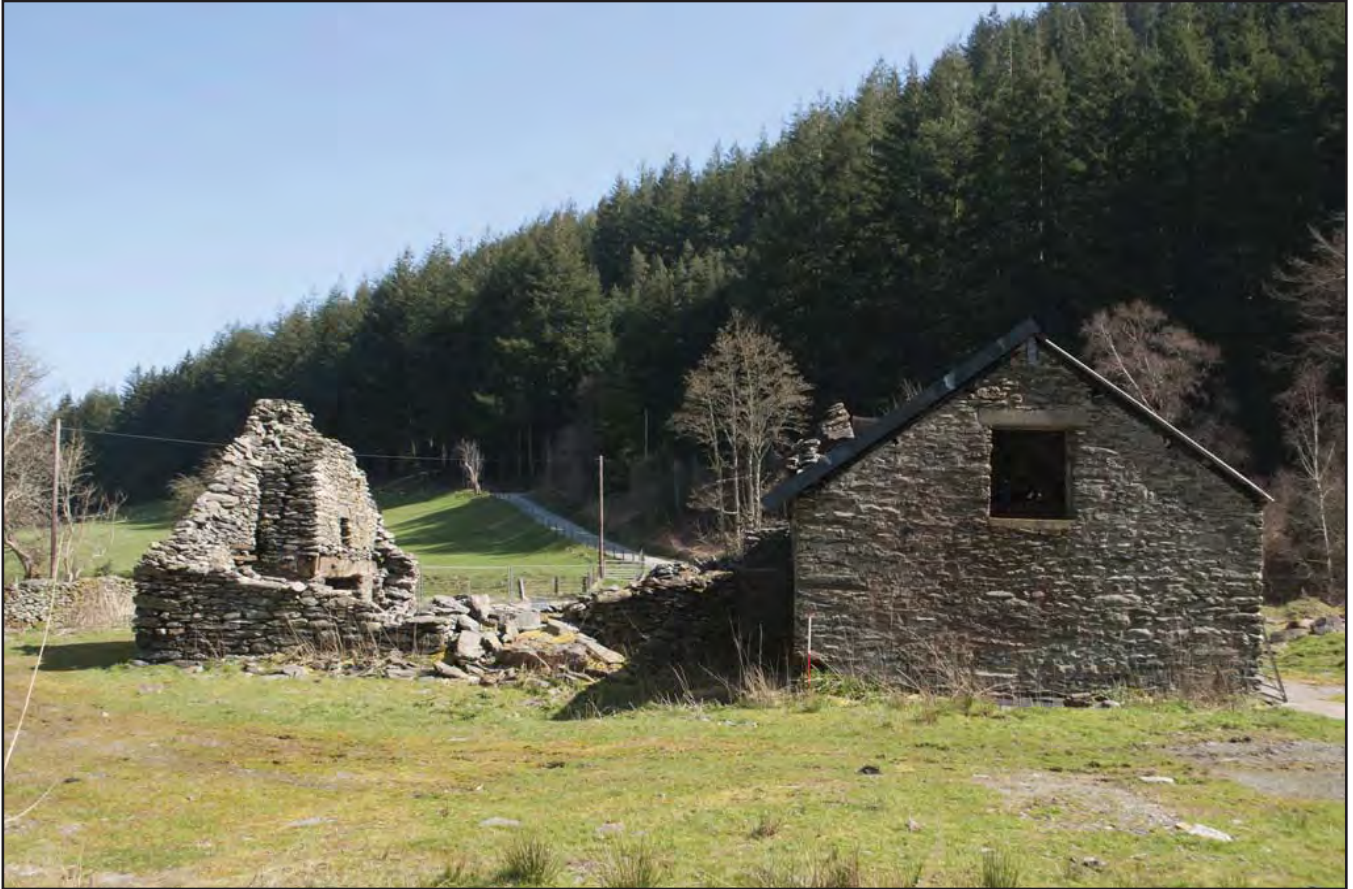
Plate 5: Exterior - View of exterior SW wall of cottage and barn, showing window of barn; scale 1x1m; view from SW (archive reference: G2778_005).

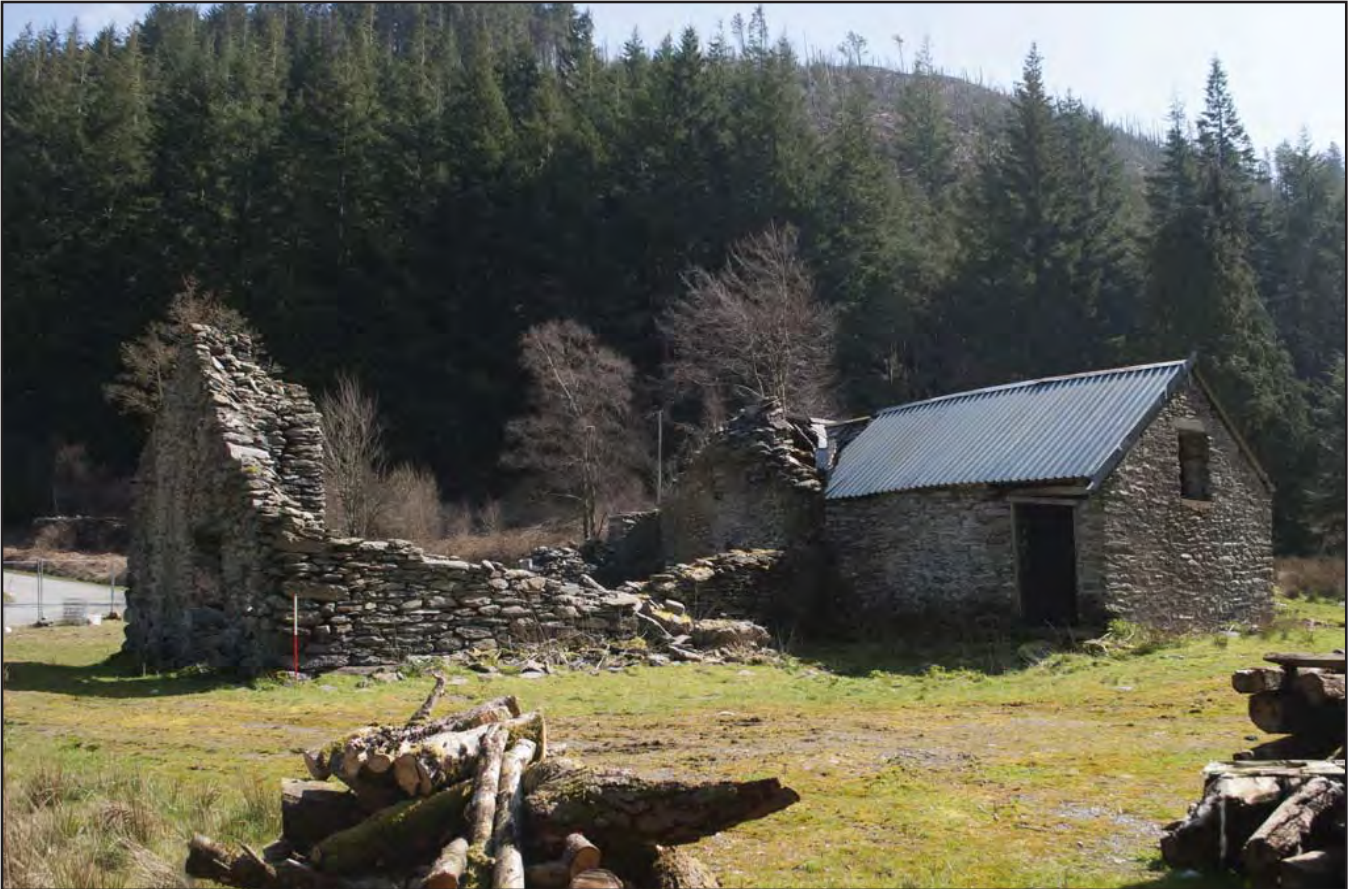
Plate 6: Exterior - Oblique view of NW corner of cottage and barn, showing door into barn; scale 1x1m; view from NW (archive reference: G2778_006).

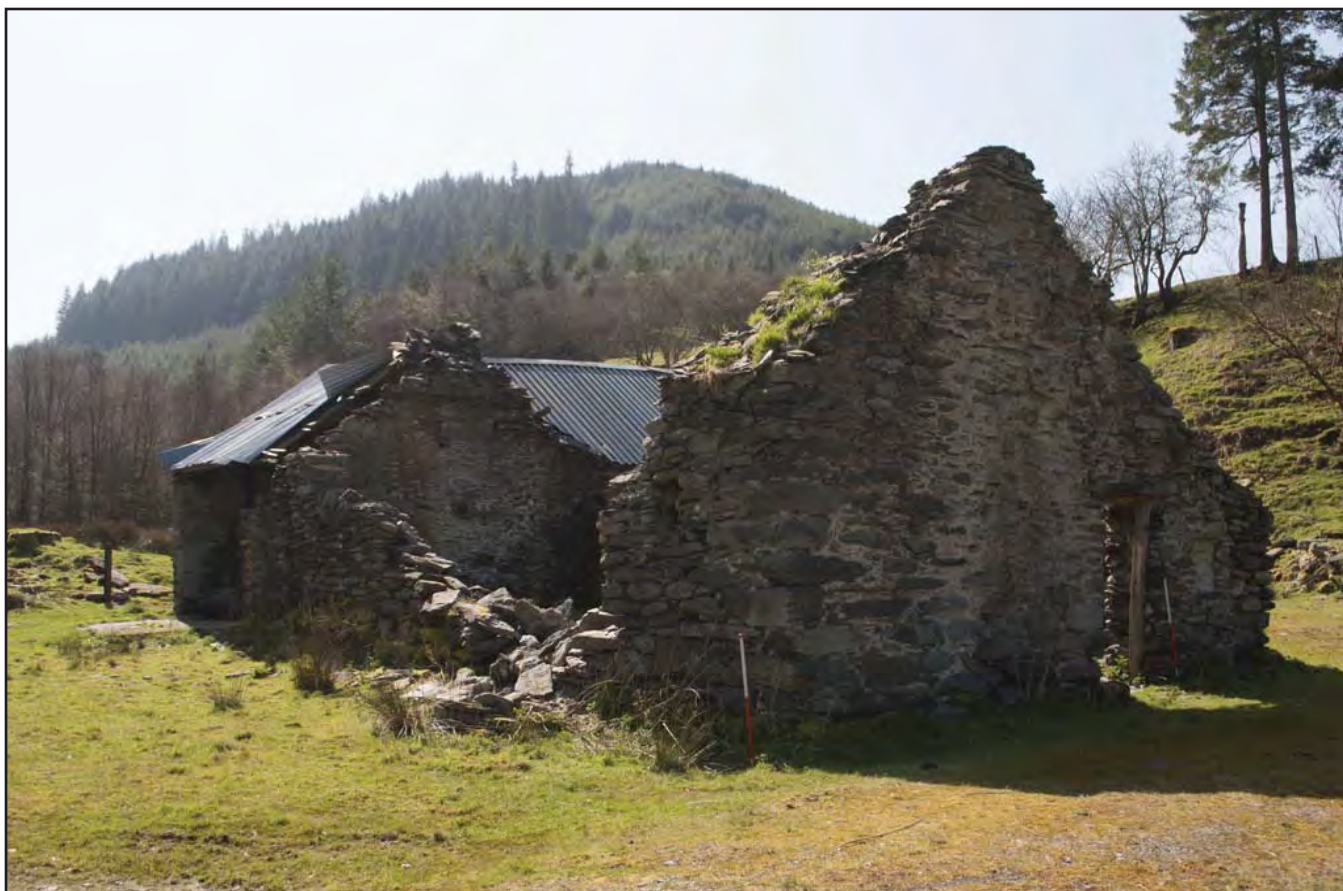
Plate 8: Exterior - Oblique view of N corner of cottage showing collapsed wall; scale 2x1m; view from N (archive reference: G2778_008).

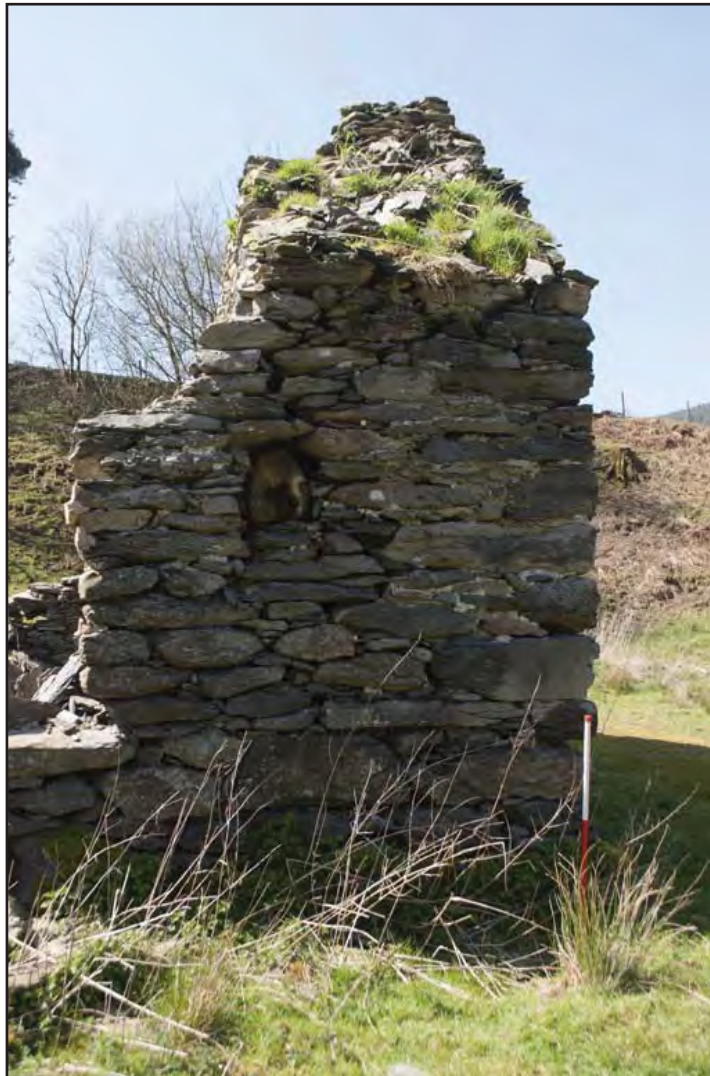
Plate 9: Exterior - View of NE corner of cottage showing fireplace beam; scale 1x1m; view from NE (archive reference: G2778_009).

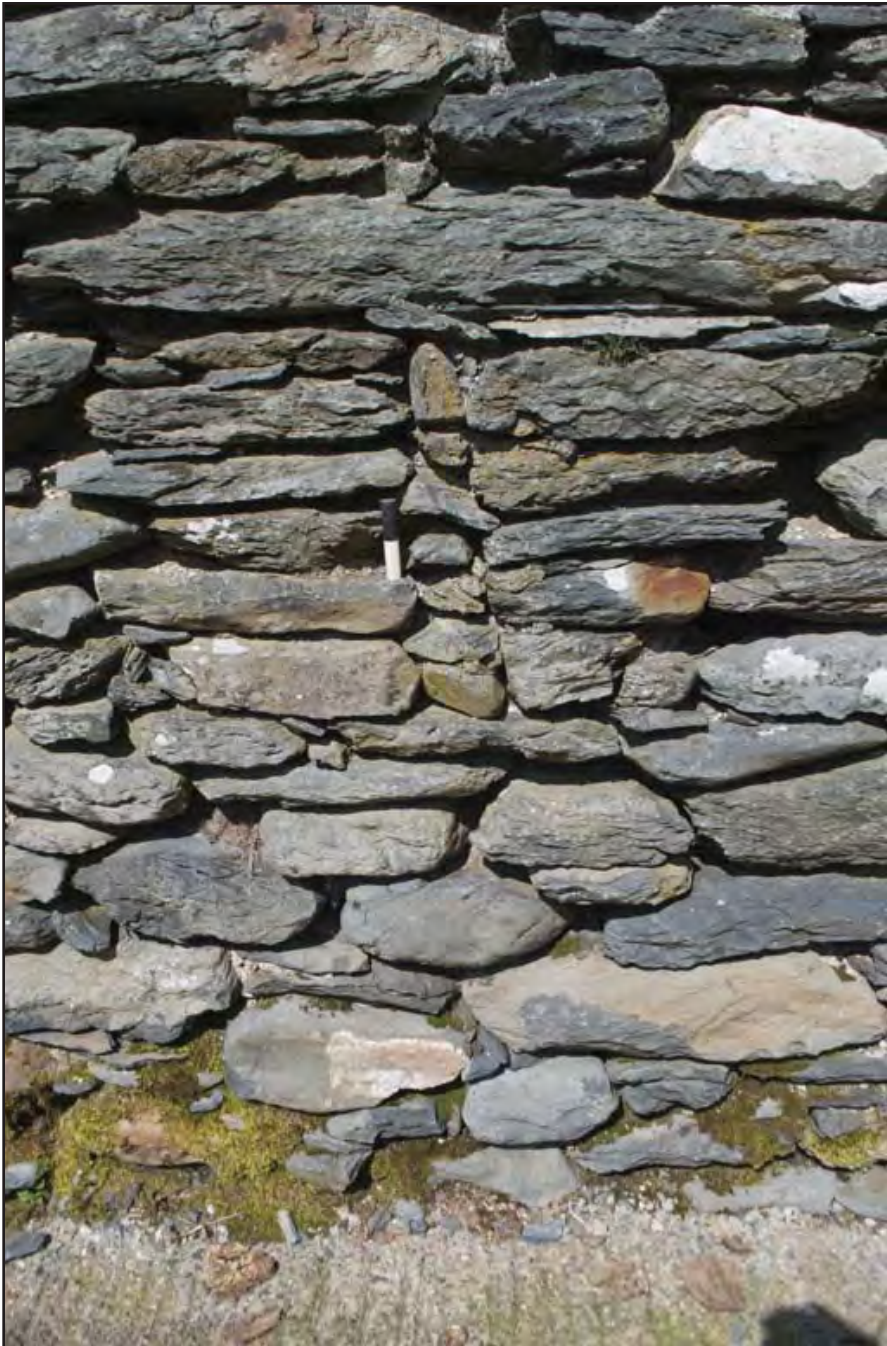
Plate 11: Exterior - Infilled ventilation slit in SE wall of barn; scale 0.10 m; view from SE (archive reference: G2778_011).

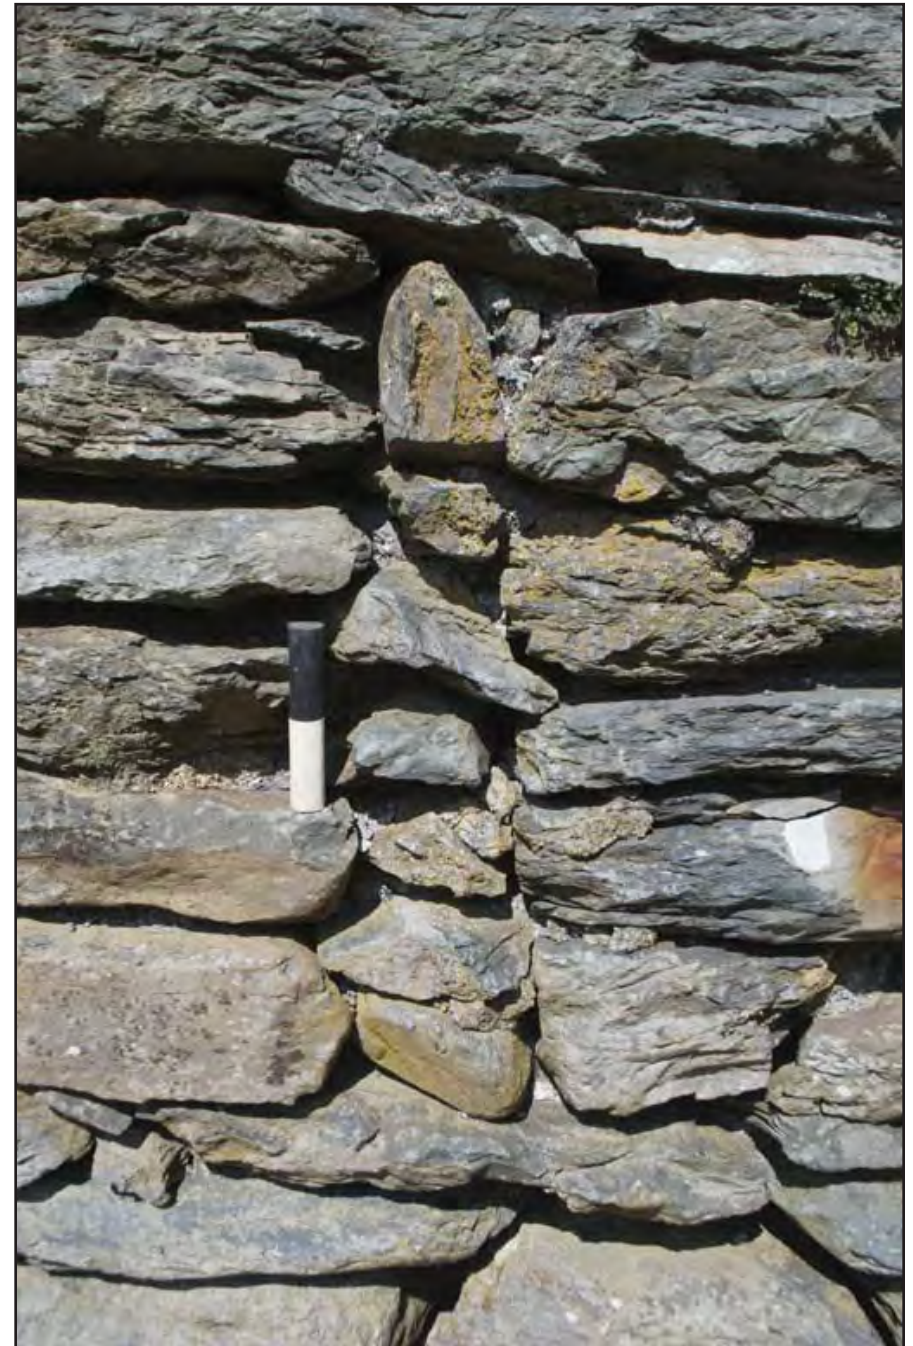
Plate 12: Exterior - Close-up of infilled ventilation slit in SE wall of barn; scale 0.10 m; view from SE (archive reference: G2778_012).

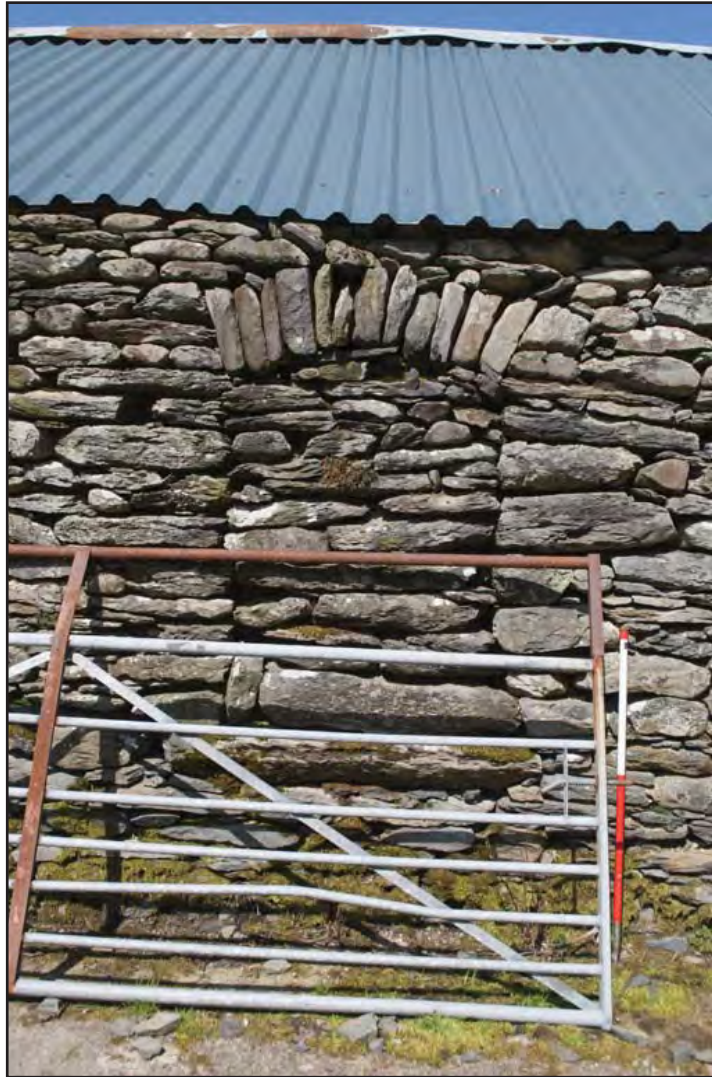
Plate 13: Exterior - Close-up of window infilled with stone in SE wall of barn; scale 1x1m; view from SE (archive reference: G2778_013).

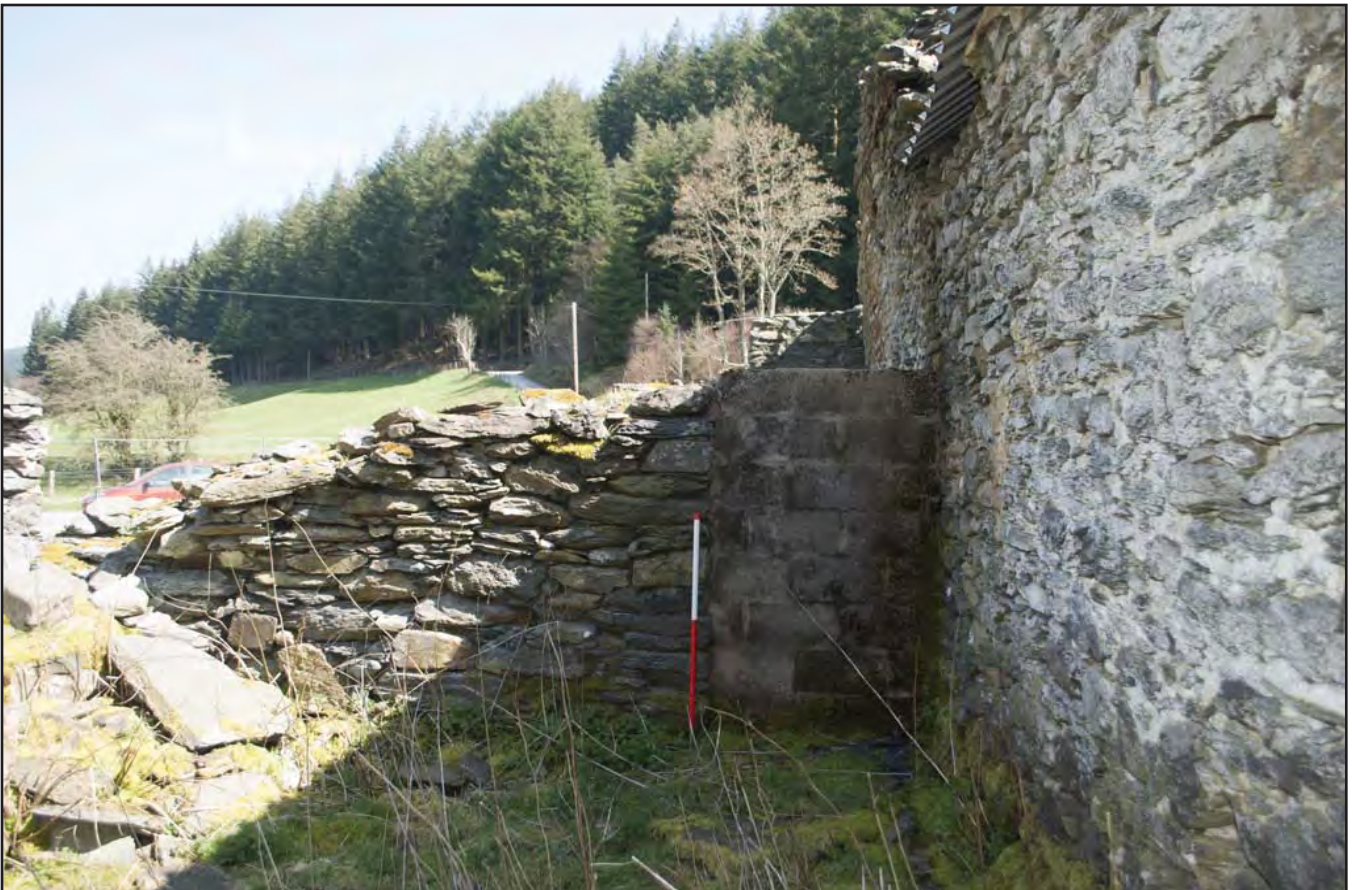
Plate 16: Exterior - View of blocked up doorway into cottage; scale 1x1m; view from SW
(archive reference: G2778_016).

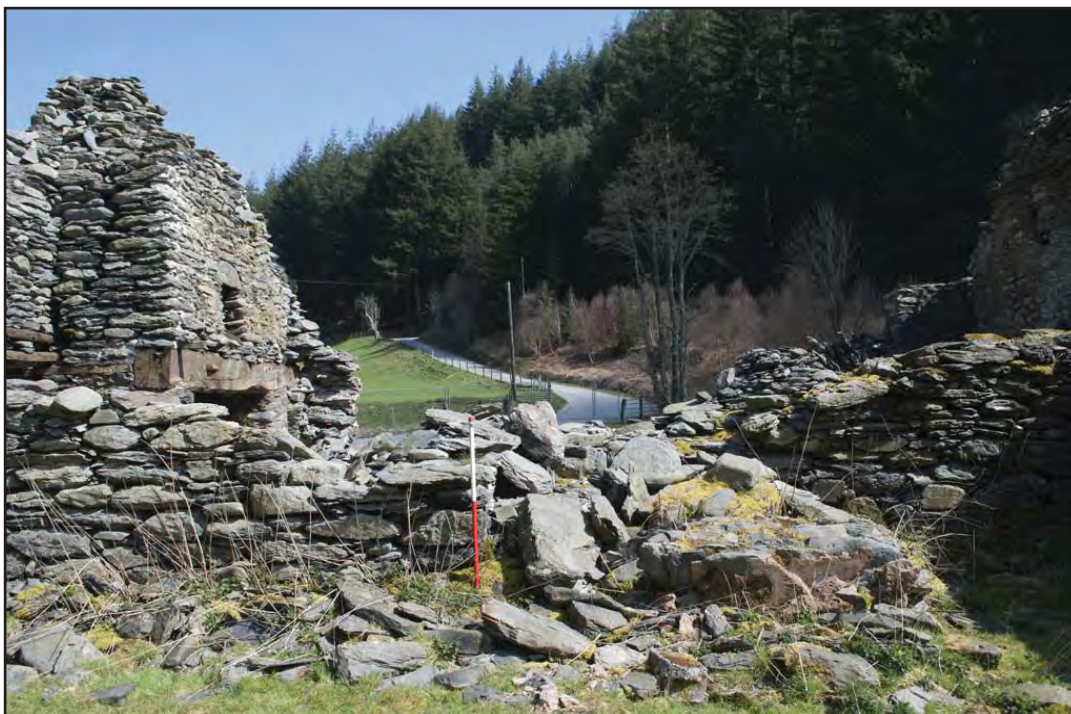
Plate 17: Exterior - View of collapsed SW wall of cottage and fireplace within; scale 1x1m; view from SW (archive reference: G2778_017).

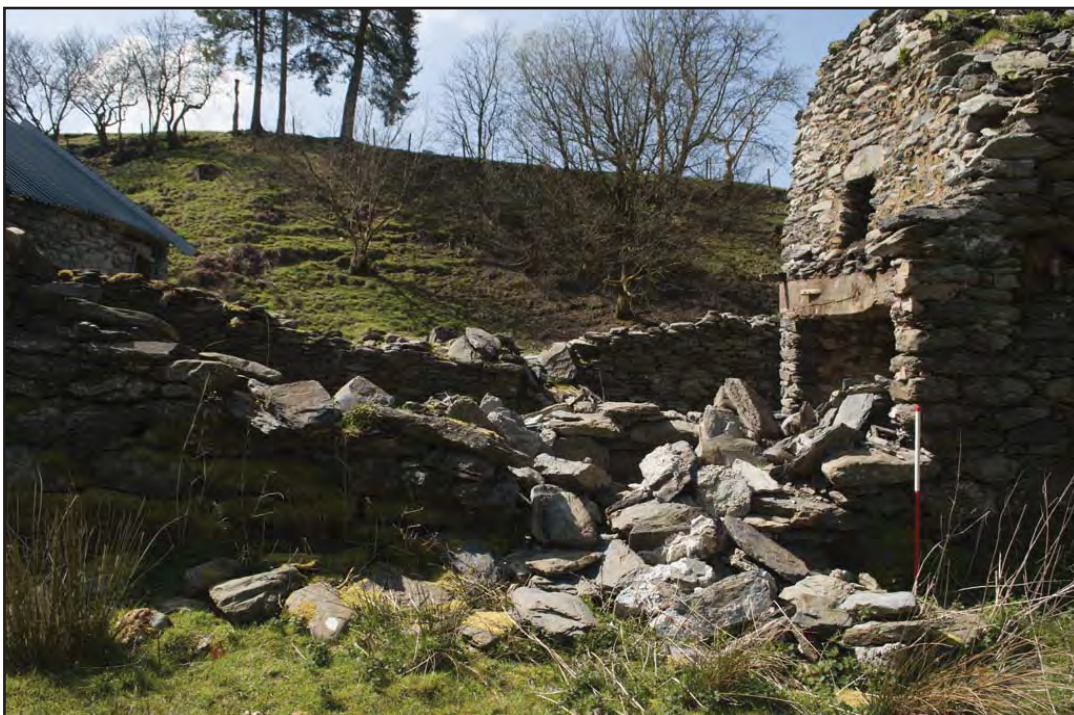
Plate 20: Exterior - View of collapsed NE wall of cottage and fireplace within; scale 1x1m; view from NE (archive reference: G2778_020).

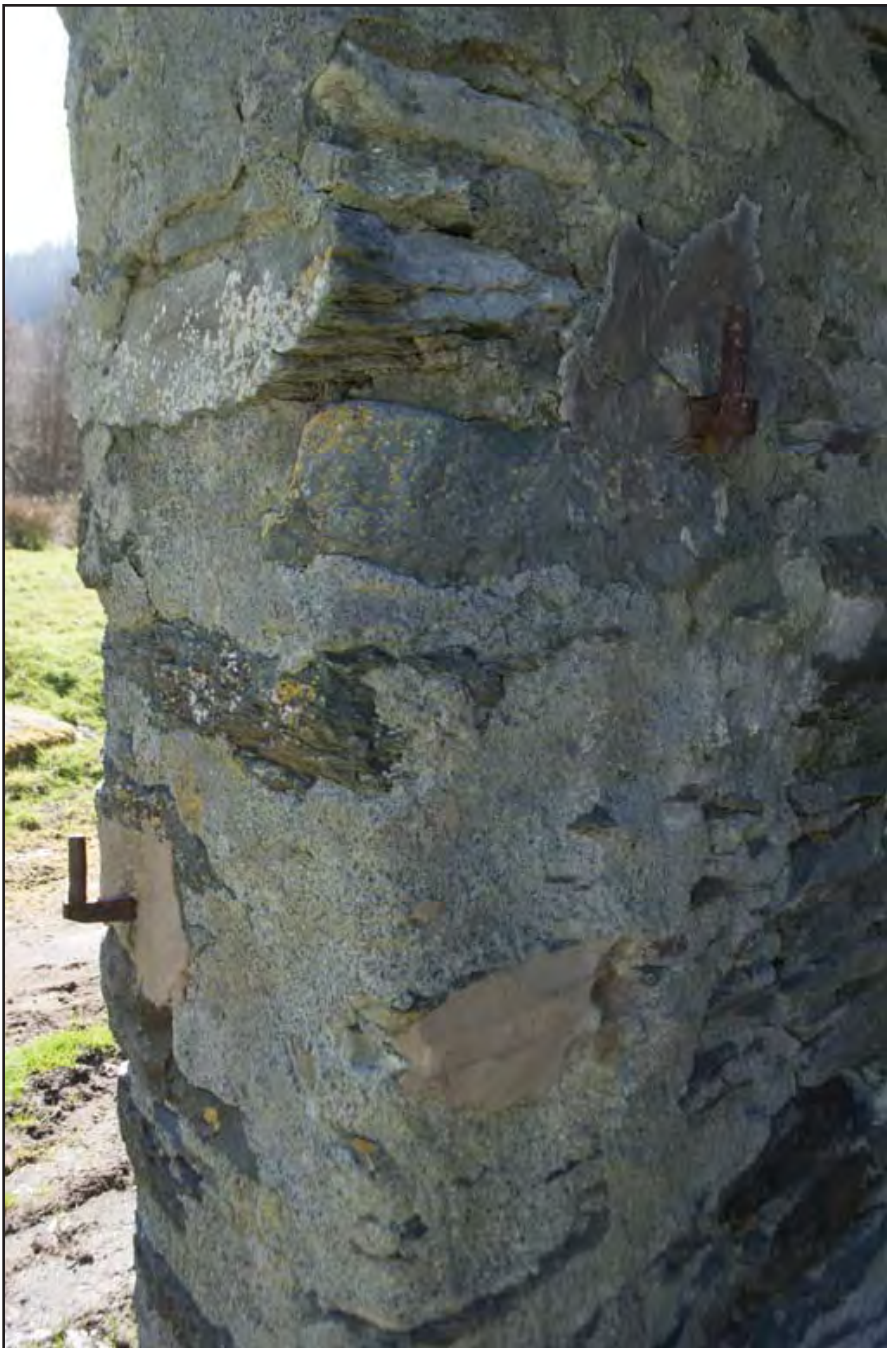
Plate 21: Exterior - Close-up of metal pins for gate in large entrance to barn; scale not used; view from N (archive reference: G2778_021).

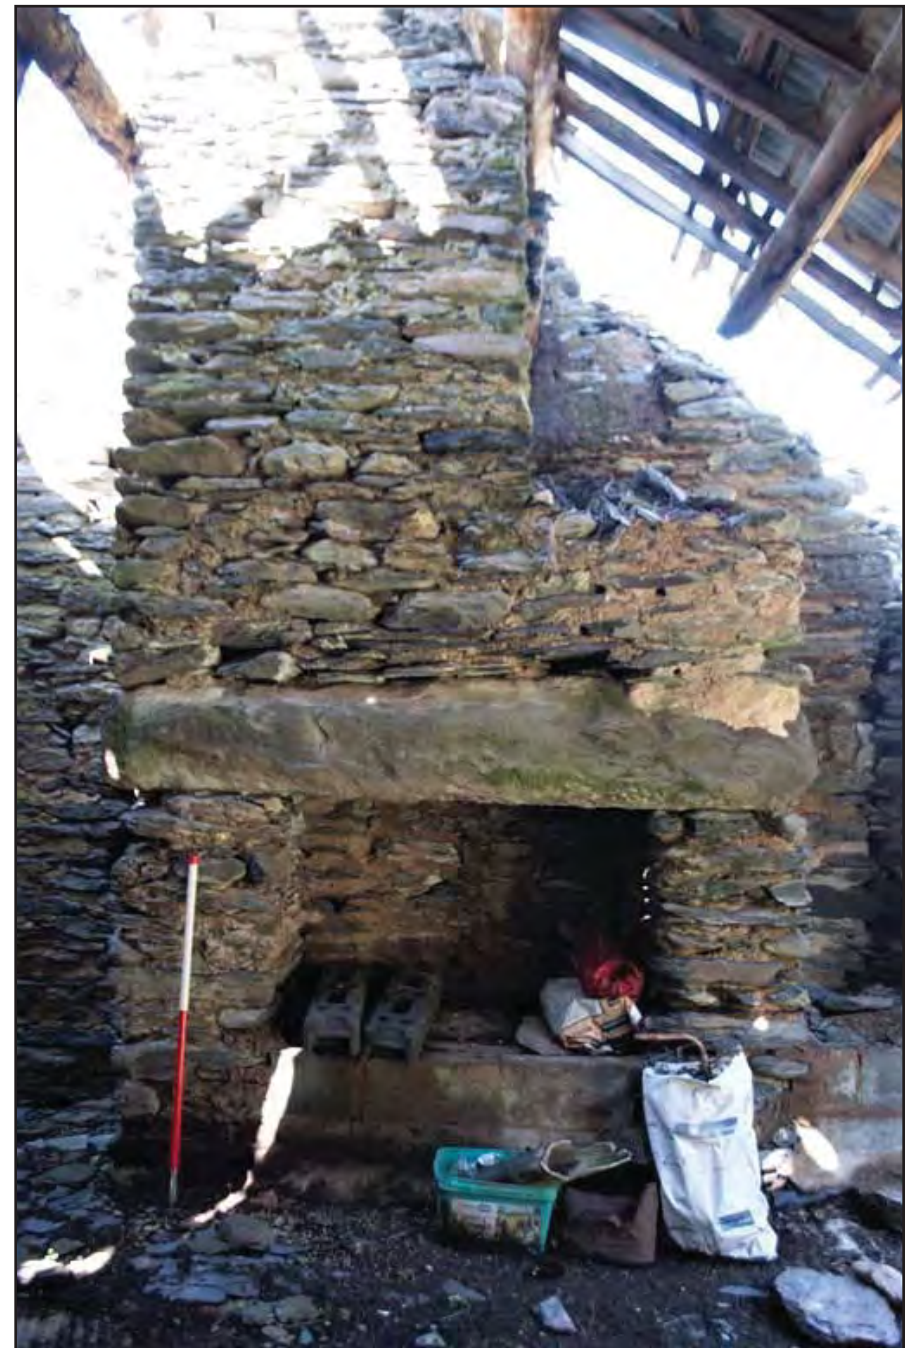
Plate 22: Interior Barn - View of large fireplace inside barn; scale 1x1m; view from S (archive reference: G2778_022).

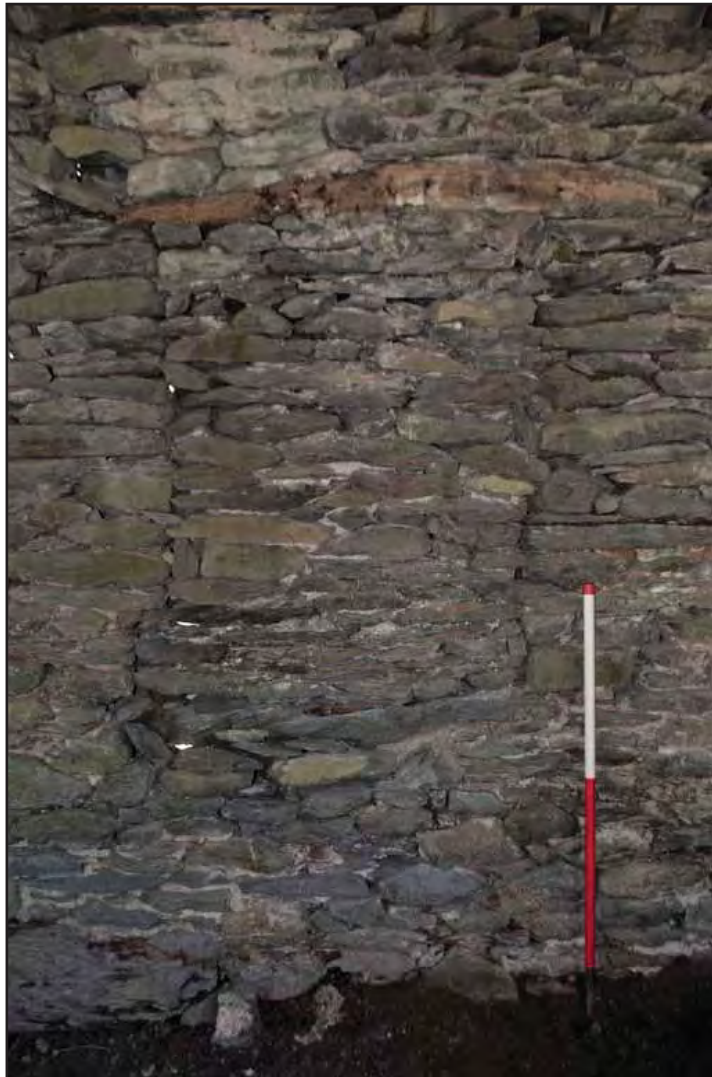
Plate 27: Interior Barn - View of window infilled with stone; scale 1x1m; view from N (archive reference: G2778_027).

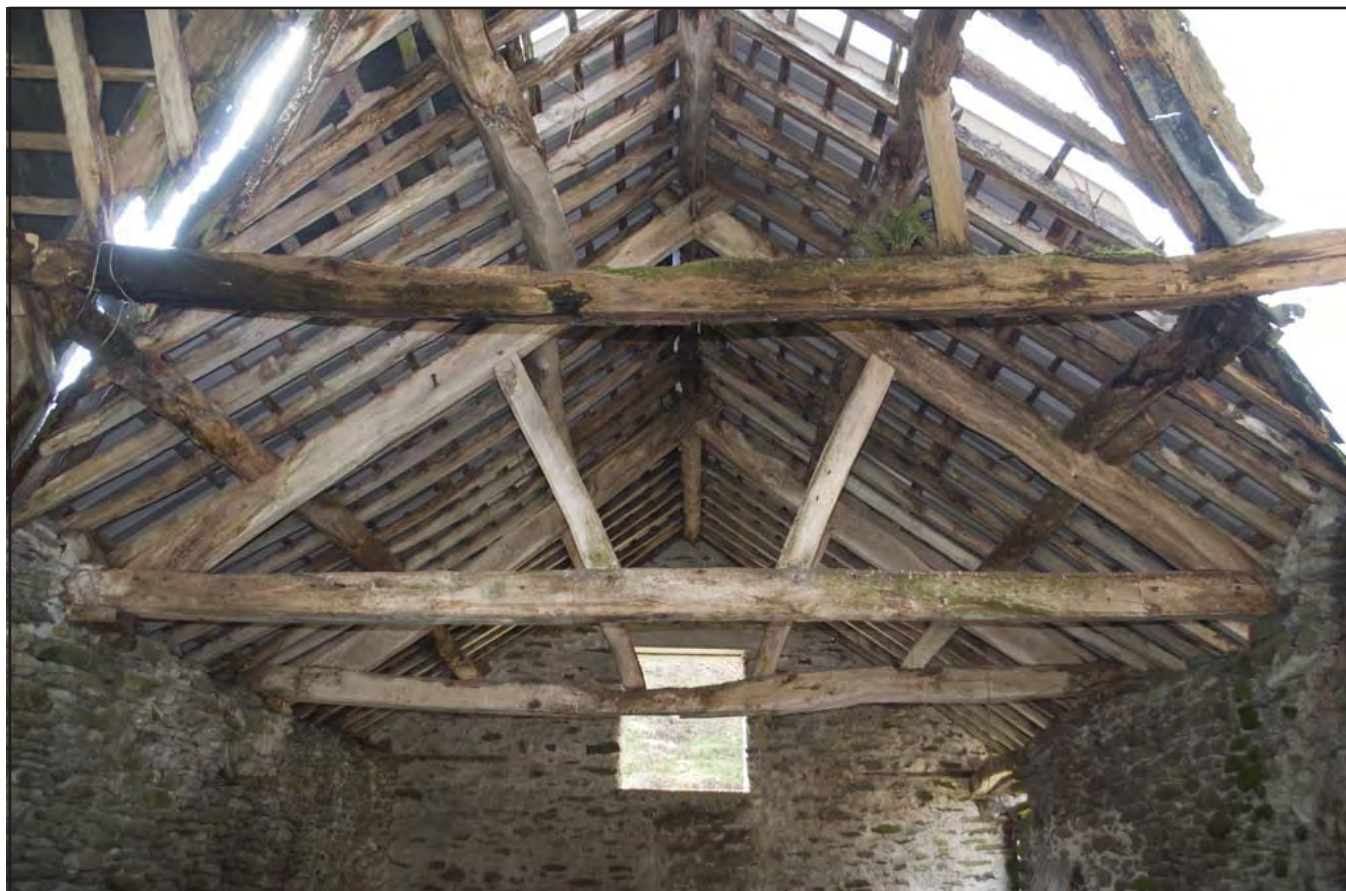
Plate 29: Interior Barn - View of trussed roof inside barn; scale not used; view from E (archive reference: G2778_029).

fields. The cottage (room 1) appears to be of an earlier 18th or 17th century date. The large fireplace lintel in room 1 and the roof trusses in the barn (room 2) seem suitable for dendrochronology in order to better estimate the date of the building, if this was considered appropriate. (cf. Figure 03). The river runs alongside the cottage to the north and east and would have provided essential supplies. To the rear of the building, evidence of a modern yard was noted. In the southwest corner of the western lateral wall was a doorway, 1.28 m wide and 1.8 m high. A large slate threshold slab was noted against the southern gable end wall. The southern gable end wall has a high window opening (unable to measure) that had a concrete sill and lintel, suggestive of modern work being carried out. Damage was noted to the bottom of the southwest corner of the gable.

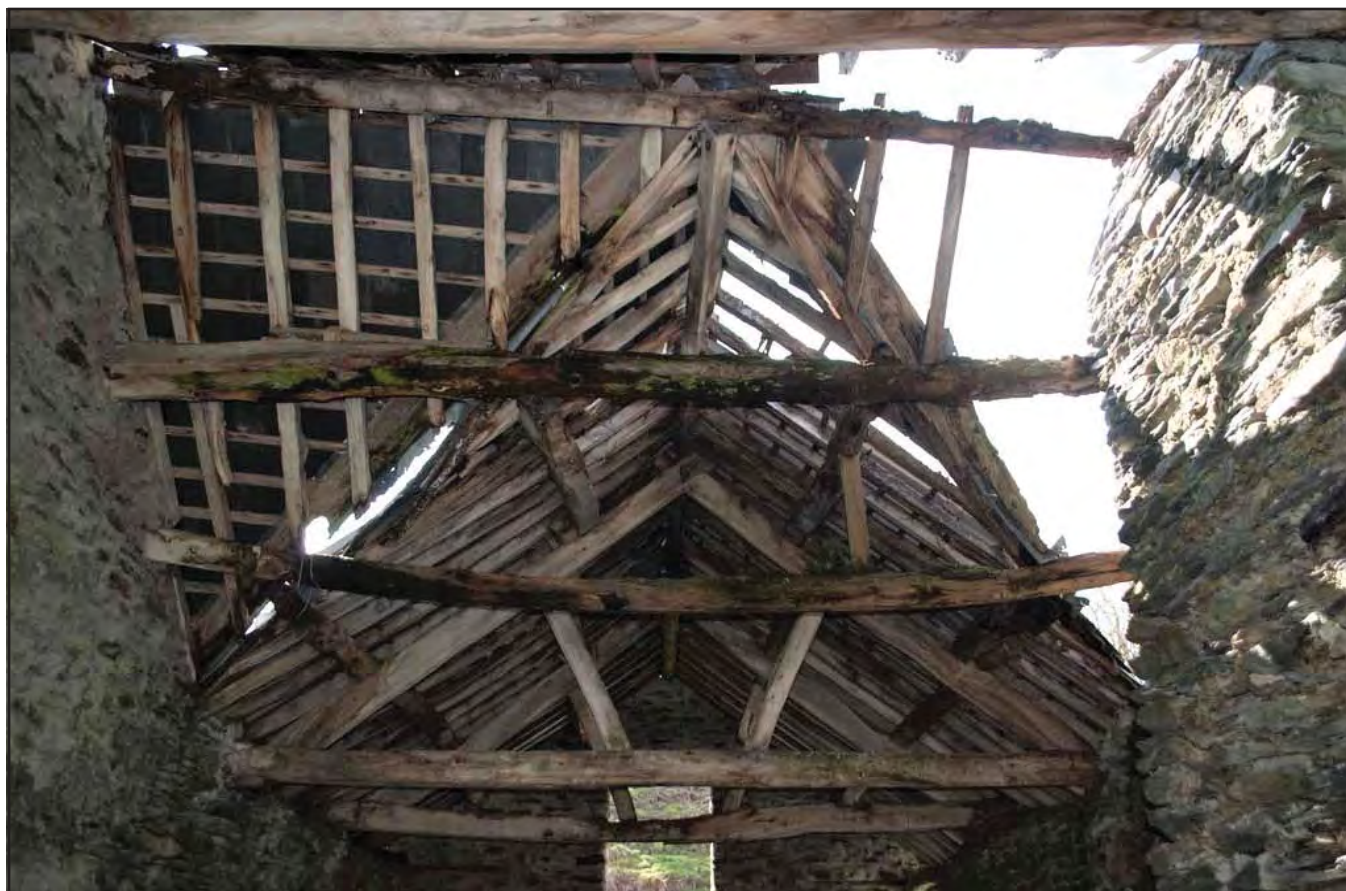
Plate 30: Interior Barn - View of trussed roof inside barn showing collapse; scale not used; view from E (archive reference: G2778_030).

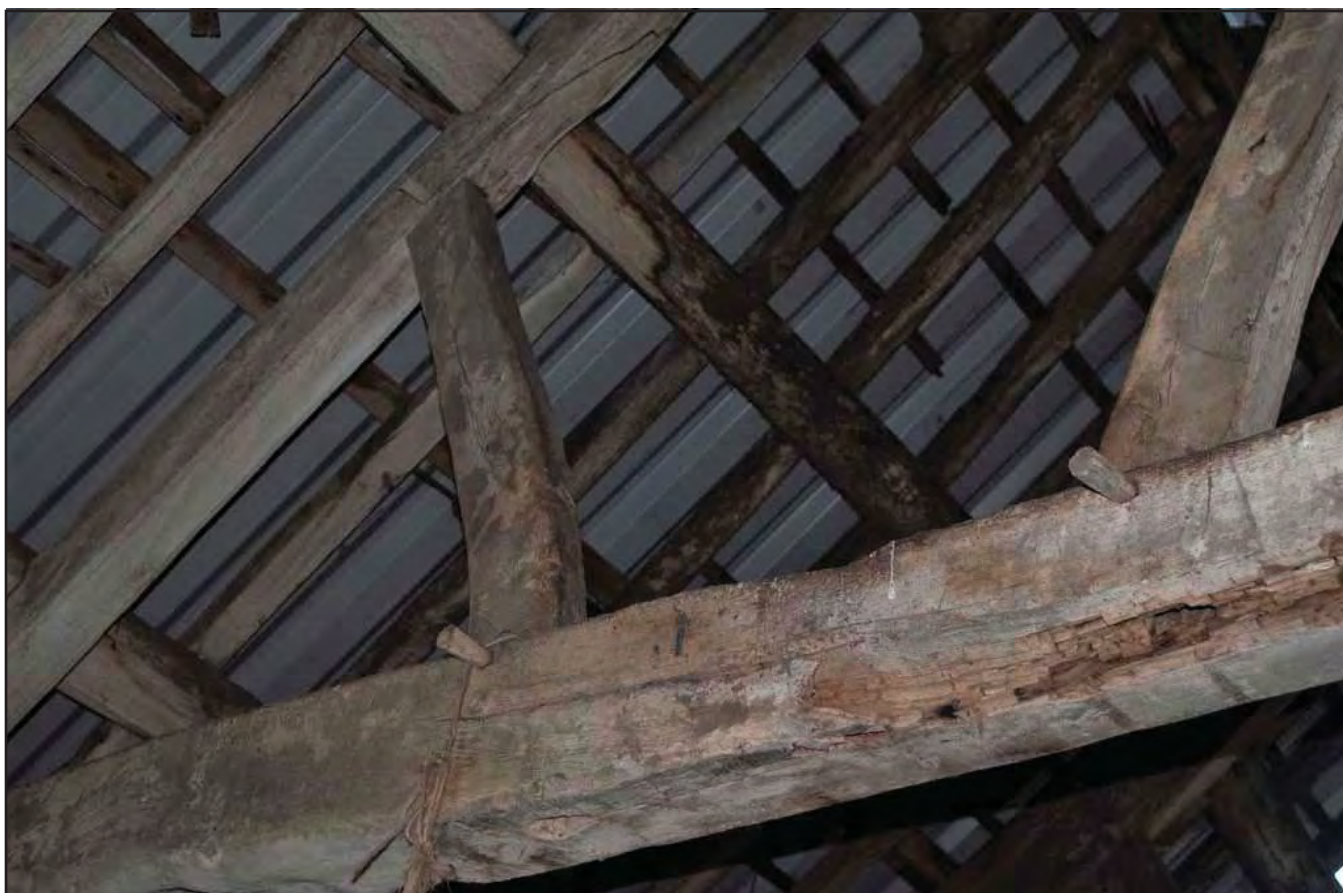
Plate 32: Interior Barn - Close-up of wooden pegs in trussed roof; scale not used; view from SW (archive reference: G2778_032).

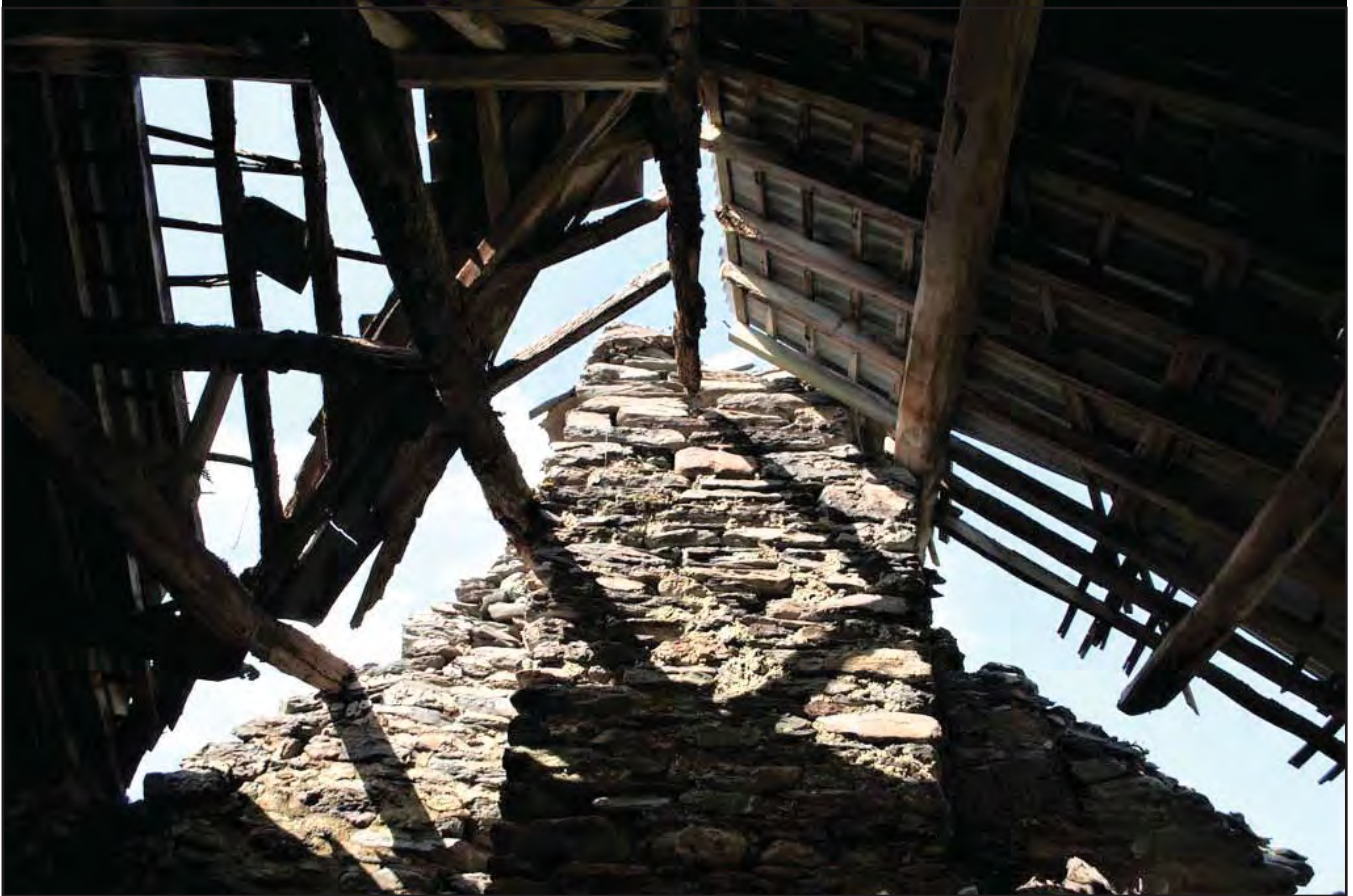
Plate 33: Interior Barn - View of collapsed roof above fireplace in barn; scale not used; view from S (archive reference: G2778_033).
