MOEL DDINAS, RHOSYGWALIA, Y BALA,

Cofnod Adeiladau Hanesyddol/
Historic Building Recording

Rhif Prosiect / Project No. G2778

Rhif Adroddiad / Report No. 1705

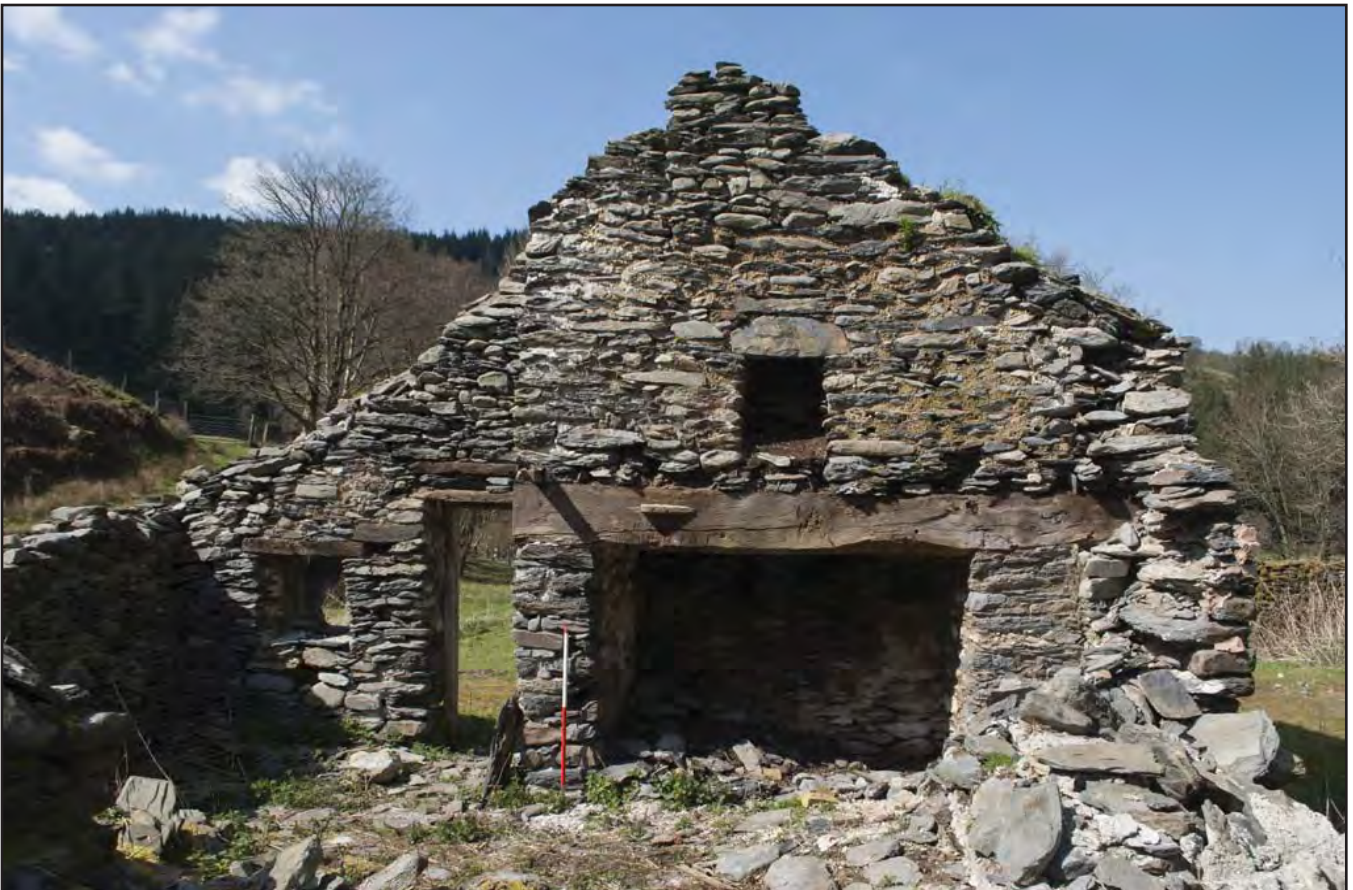
Plate 36: Interior Cottage - View of large fireplace in N wall of cottage; scale 1x1m; view from SE
(archive reference: G2778_036).

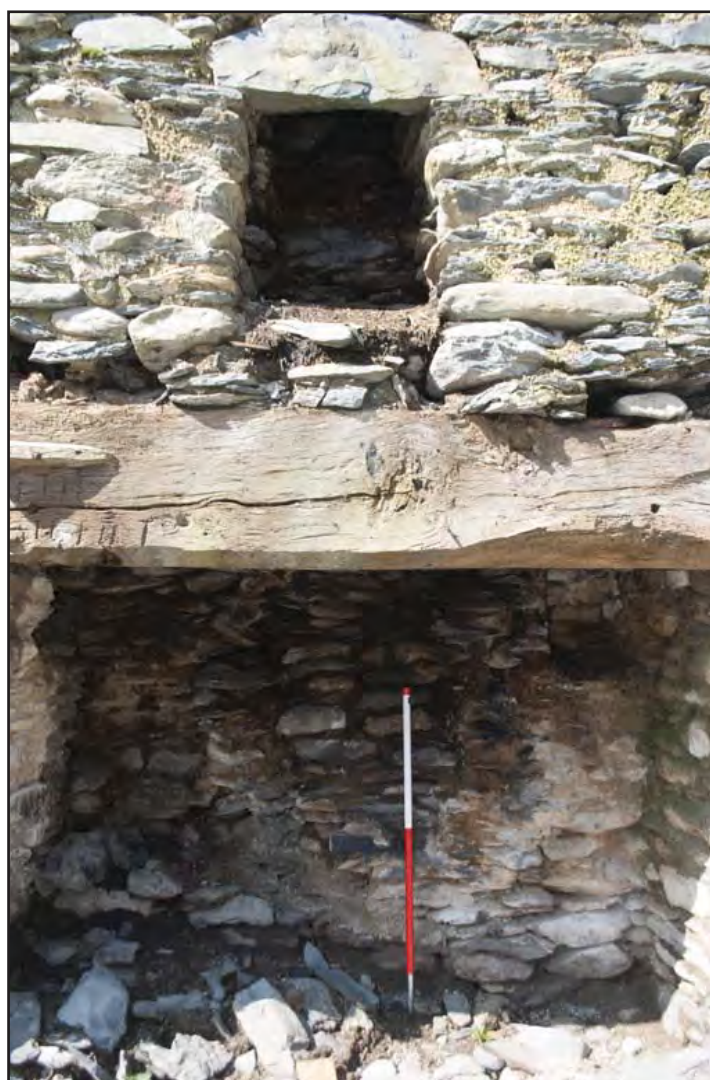
Plate 40: Interior Cottage - Close-up view of fireplace showing first floor fireplace above and small alcove in the right hand corner; scale 1x1m; view from SE (archive reference: G2778_040).

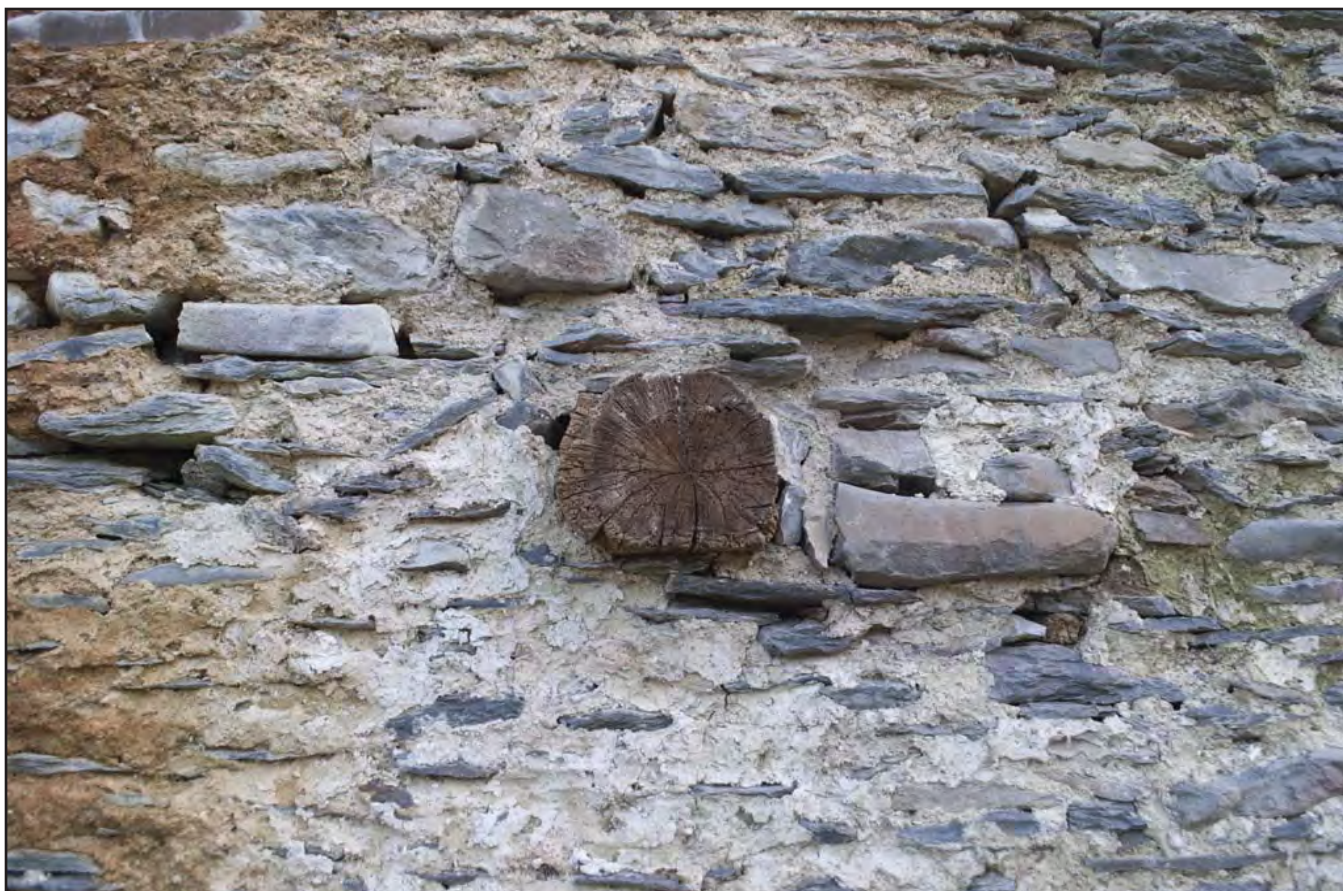
Plate 44: Interior Cottage - Close-up view of wooden beam protruding from SE gable end of the cottage; scale not used; view from N (archive reference: G2778_044).

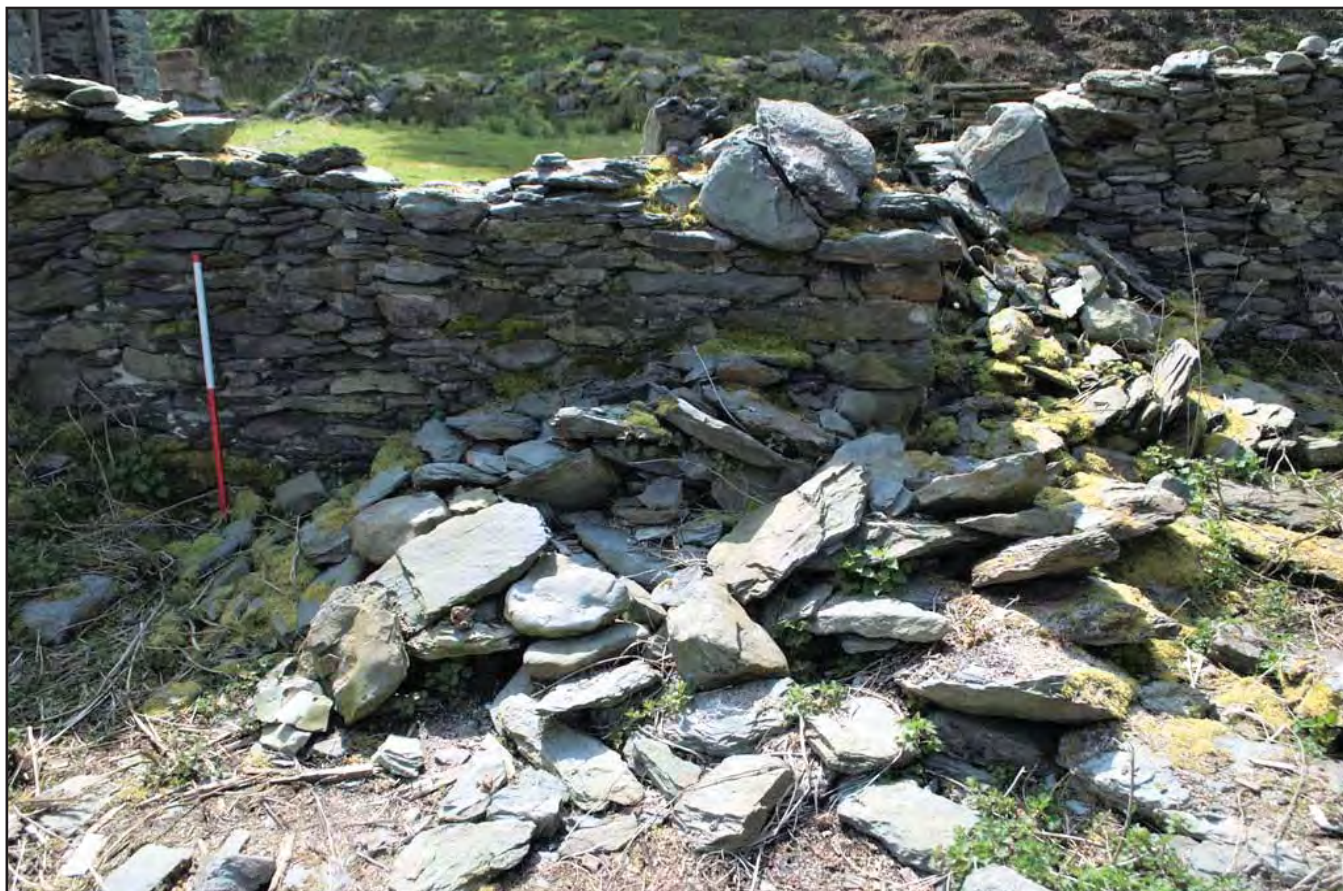
Plate 47: Interior Cottage - View of SW wall of the cottage showing collapse; scale 1x1m; view from NE (archive reference: G2778_047).

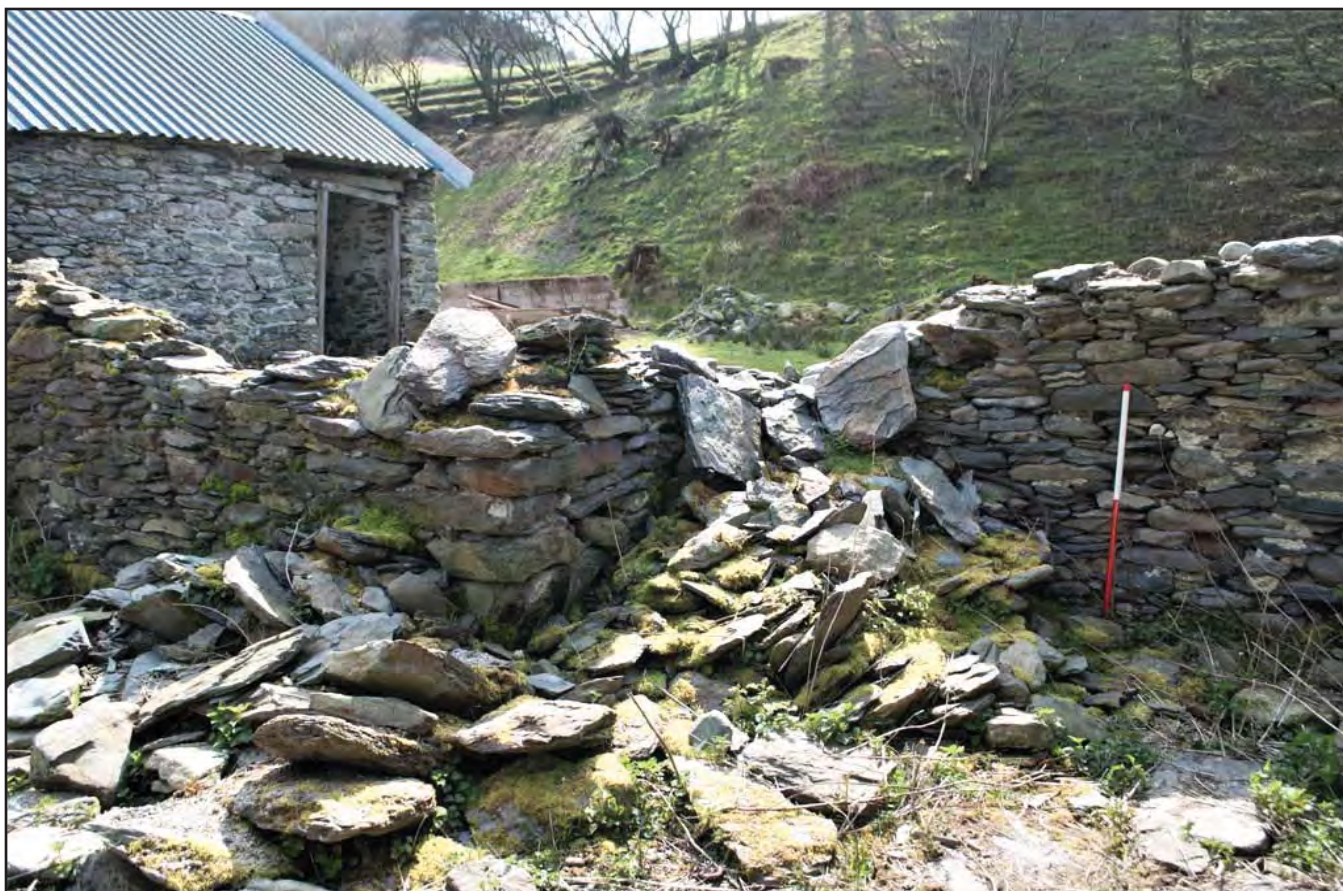
Plate 48: Interior Cottage - View of SW wall of the cottage showing collapse; scale 1x1m; view from N (archive reference: G2778_048).

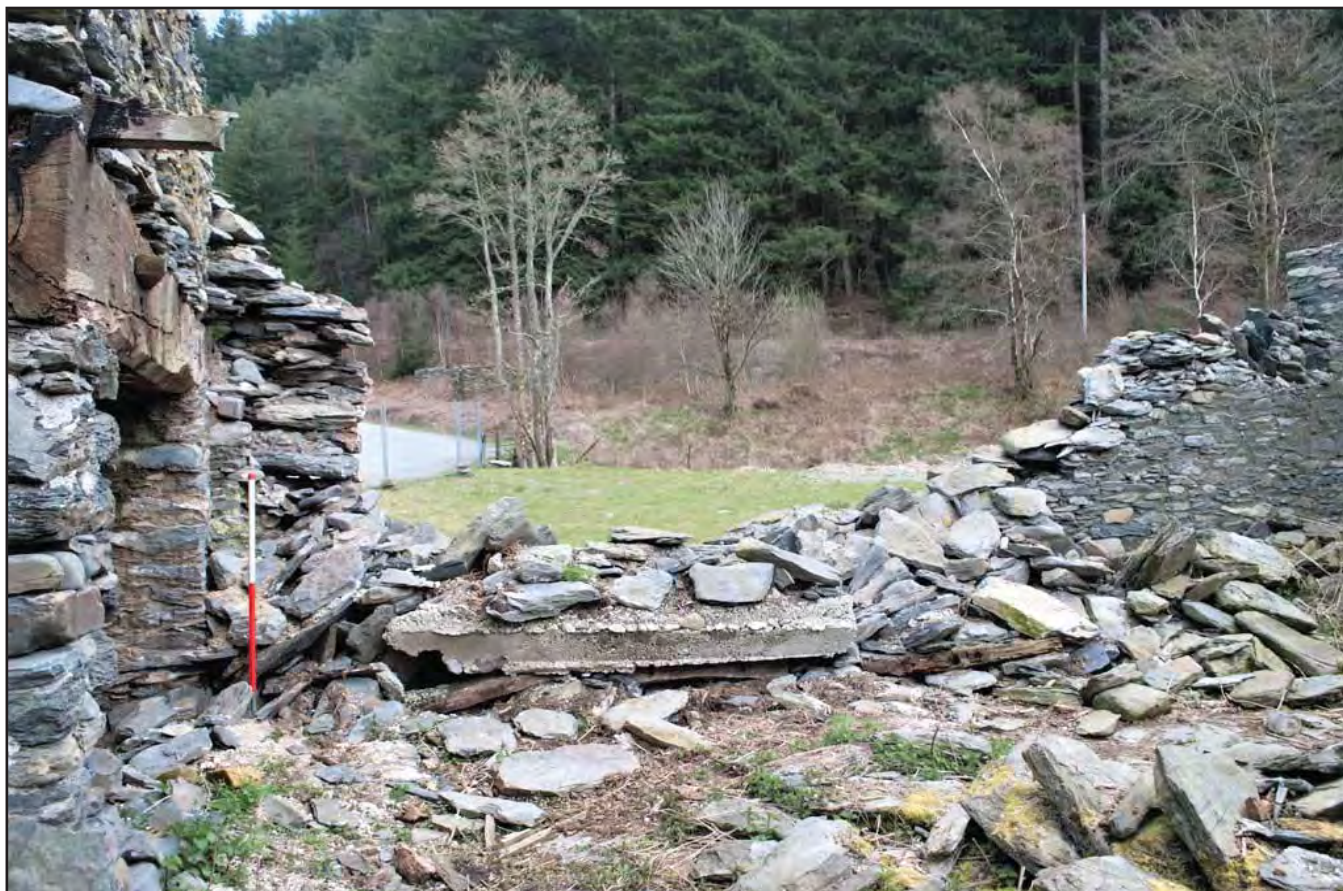
Plate 49: Interior Cottage - View of the NE wall of the cottage showing collapse, large concrete block; scale 1x1m; view from W (archive reference: G2778_049).

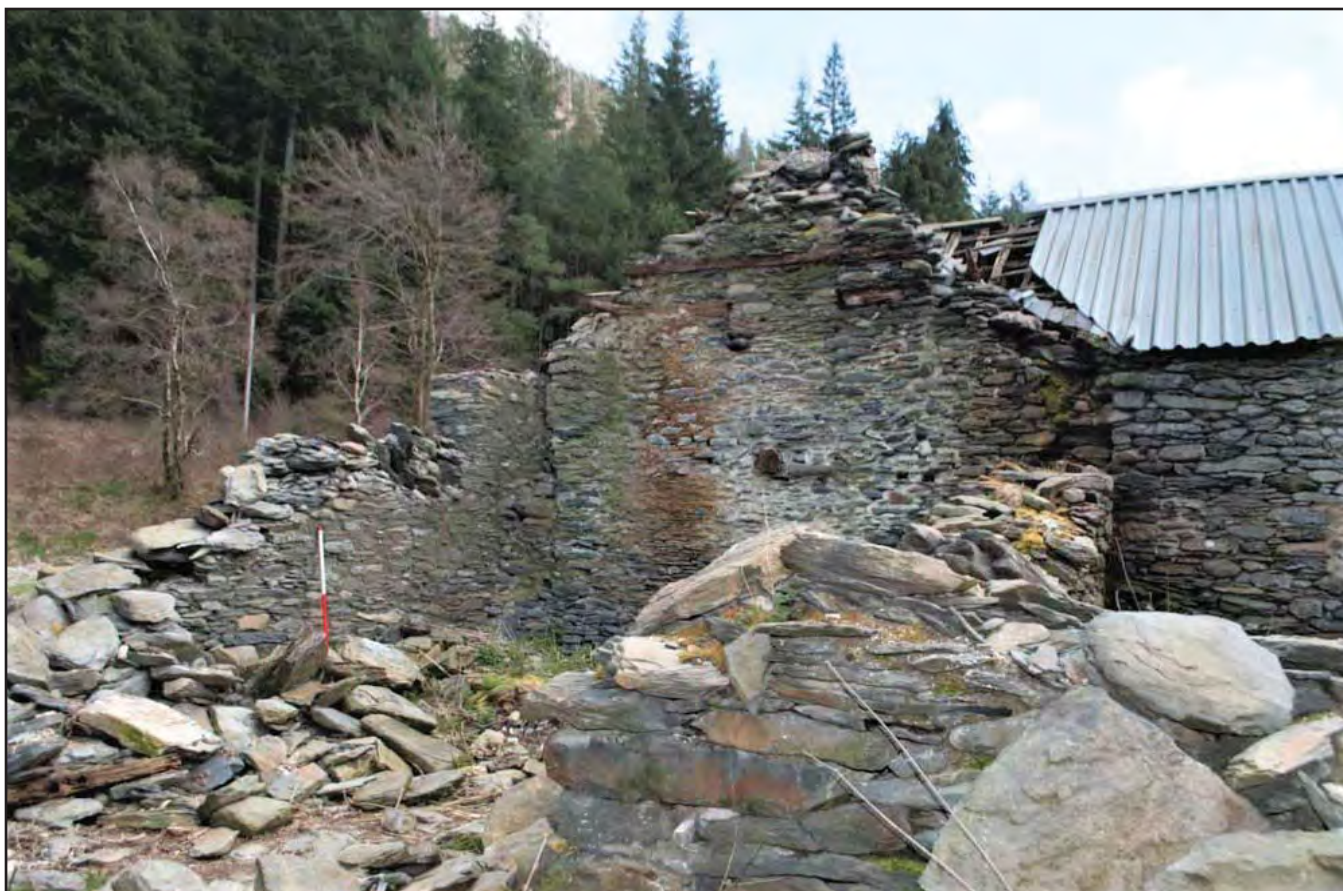
Plate 50: Interior Cottage - View of the NE wall of the cottage showing collapse, large concrete block; scale 1x1m; view from W (archive reference: G2778_050).

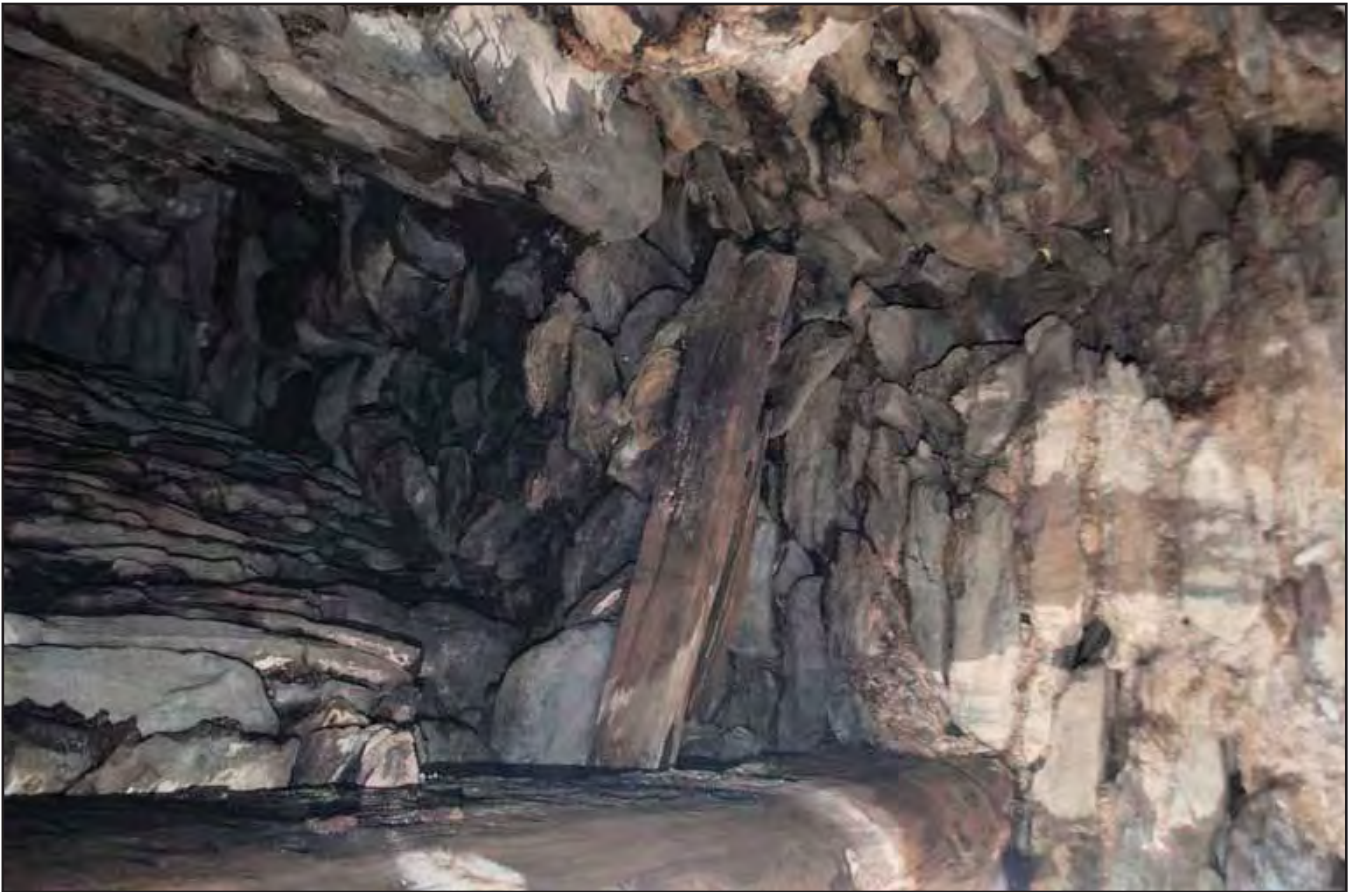
Plate 53: Interior Cottage - View up into fireplace chimney in cottage, showing collapsing beam; scale not used; view from E (archive reference: G2778_053).

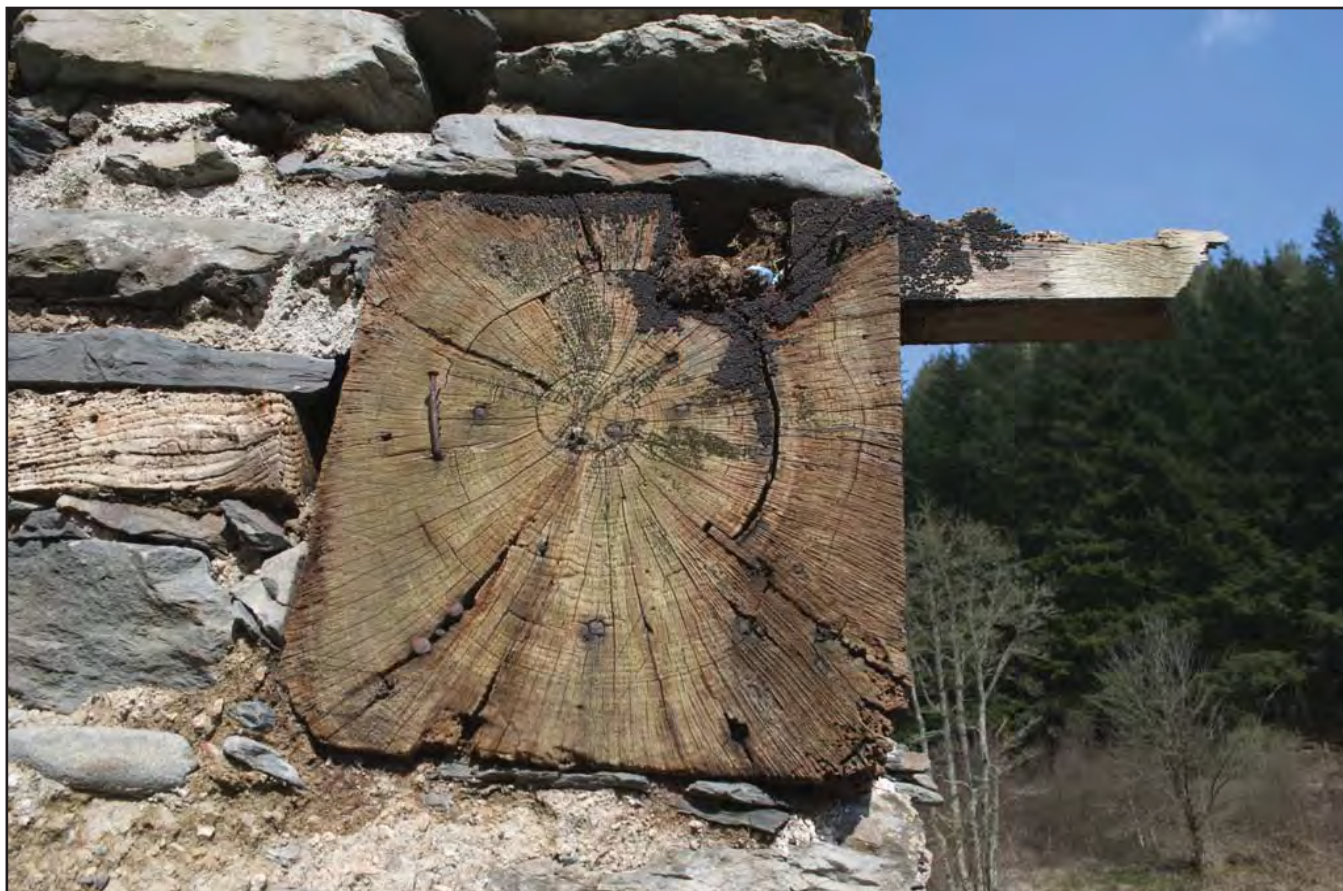
Plate 55: Interior Cottage - Close-up of wooden fireplace lintel; scale not used; view from SW (archive reference: G2778_055).

fields. The cottage (room 1) appears to be of an earlier 18th or 17th century date. The large fireplace lintel in room 1 and the roof trusses in the barn (room 2) seem suitable for dendrochronology in order to better estimate the date of the building, if this was considered appropriate. (cf. Figure 03). The river runs alongside the cottage to the north and east and would have provided essential supplies. To the rear of the building, evidence of a modern yard was noted. In the southwest corner of the western lateral wall was a doorway, 1.28 m wide and 1.8 m high. A large slate threshold slab was noted against the southern gable end wall. The southern gable end wall has a high window opening (unable to measure) that had a concrete sill and lintel, suggestive of modern work being carried out. Damage was noted to the bottom of the southwest corner of the gable.

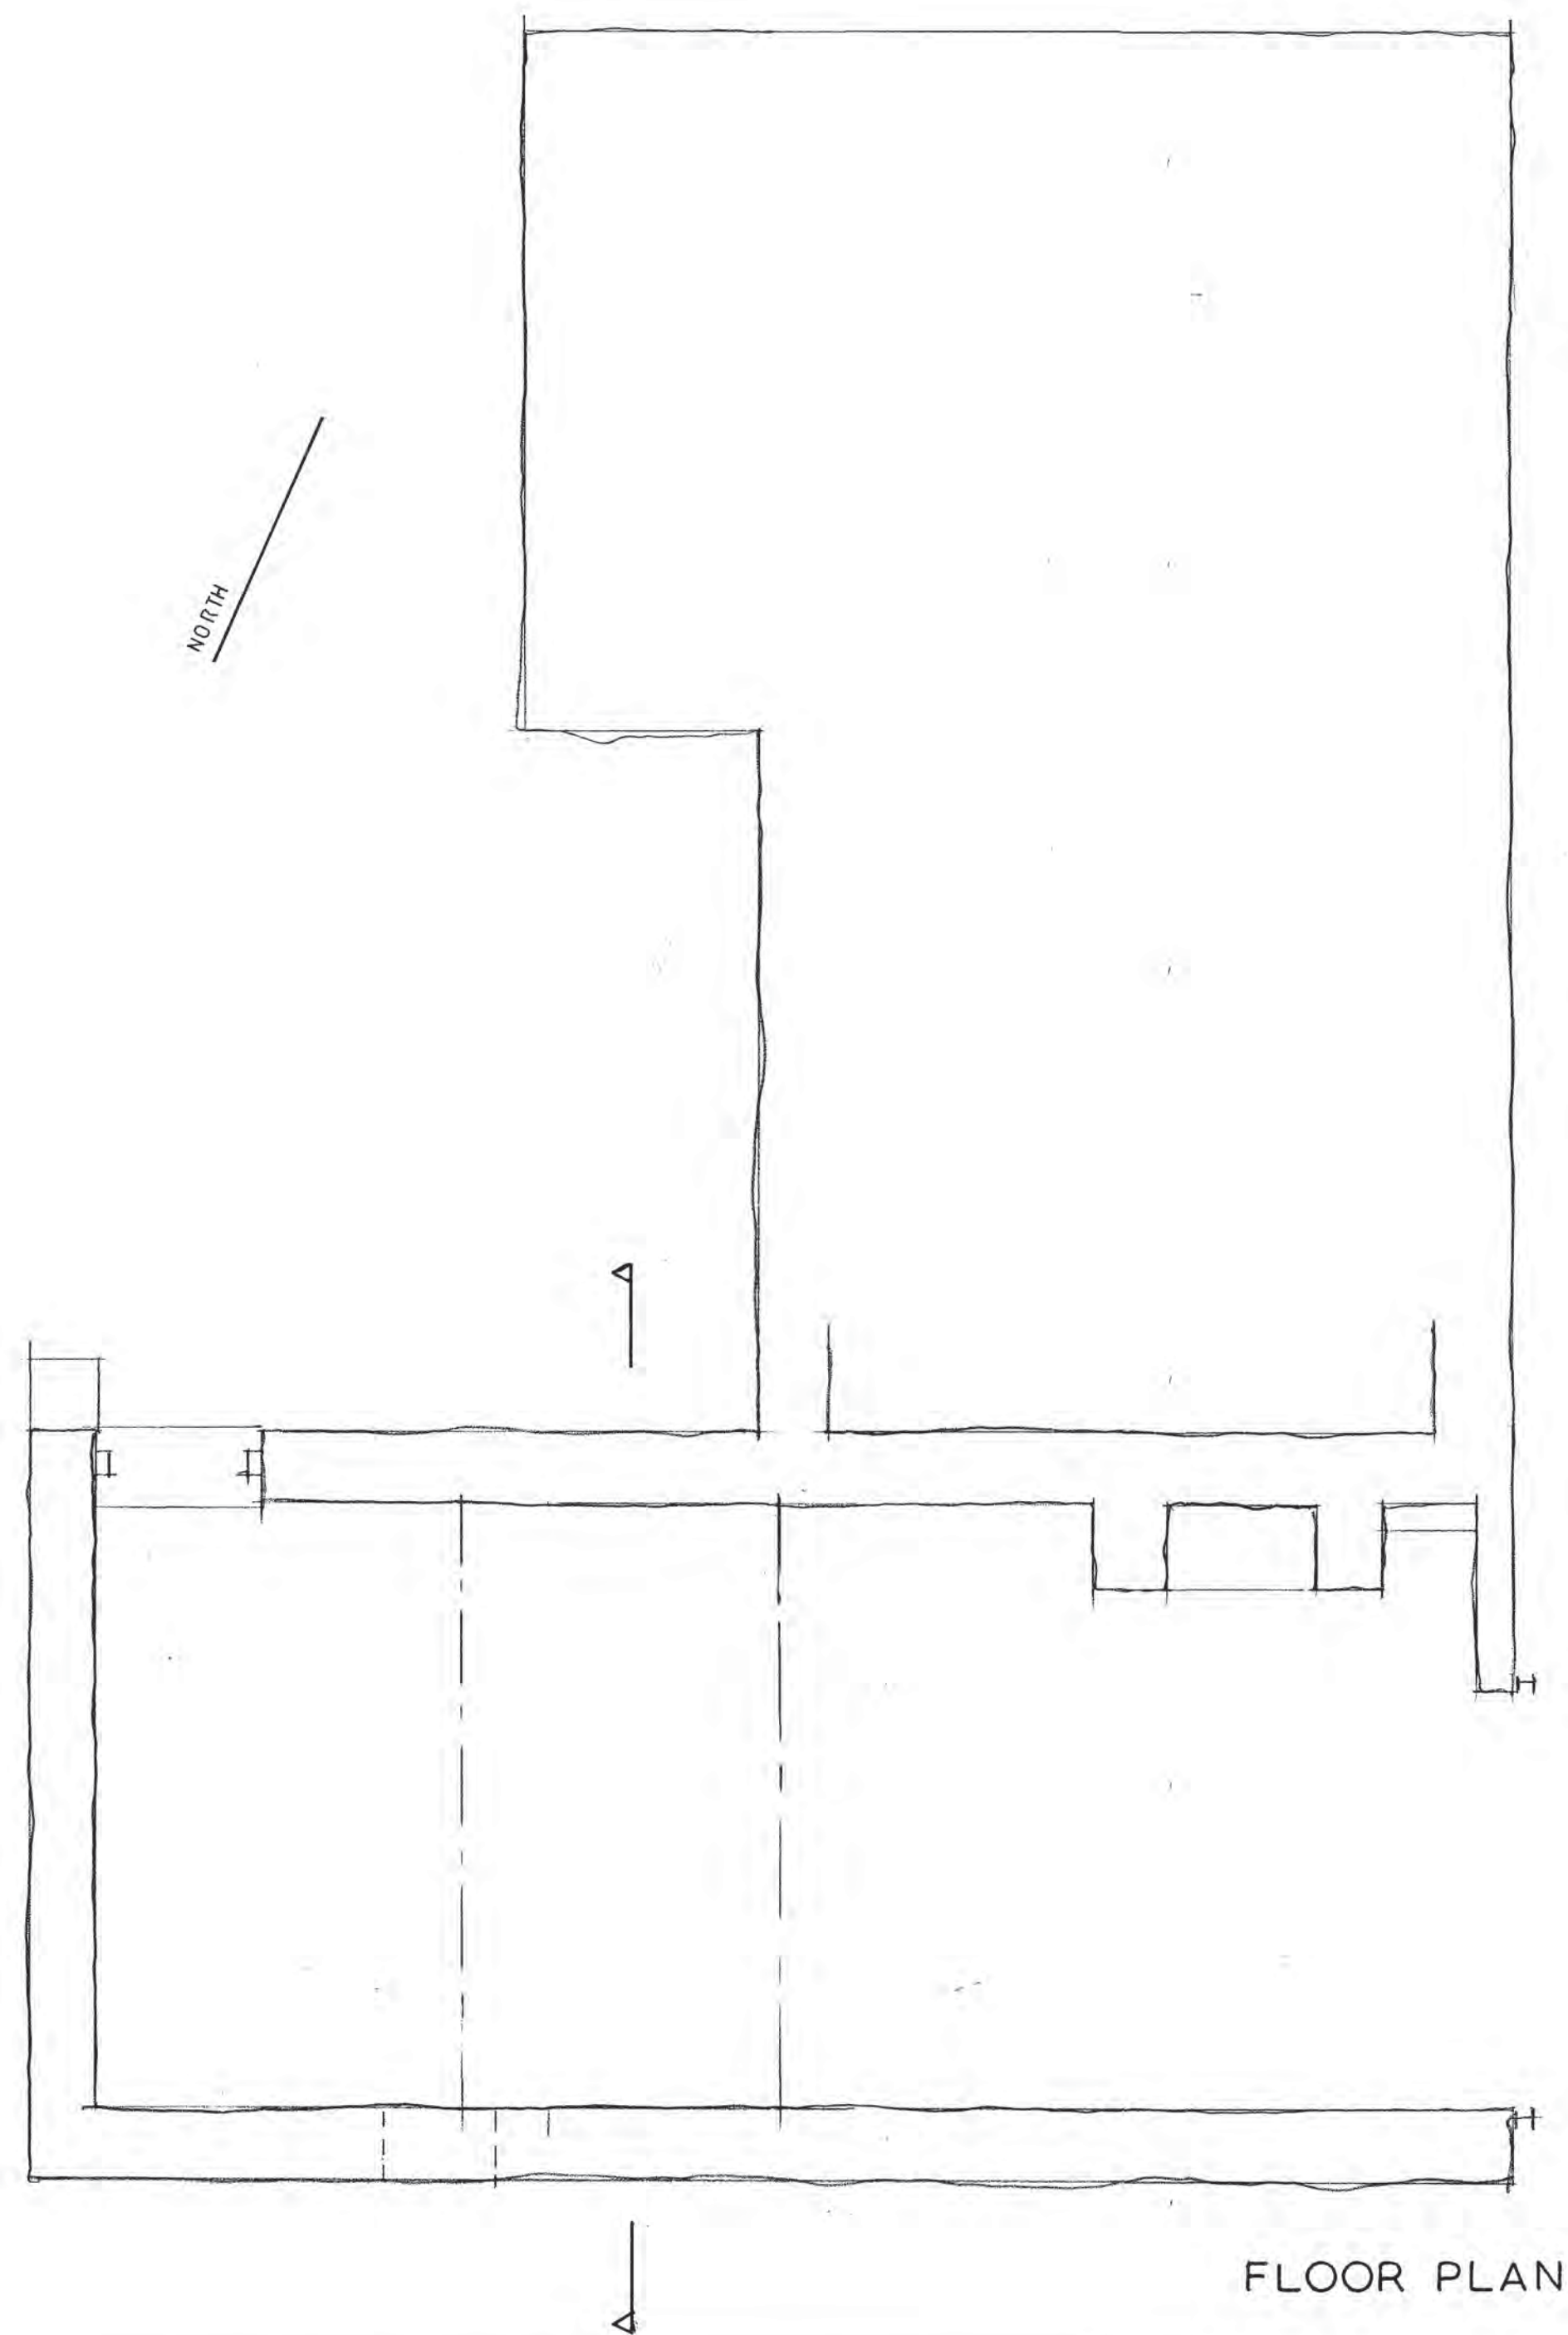
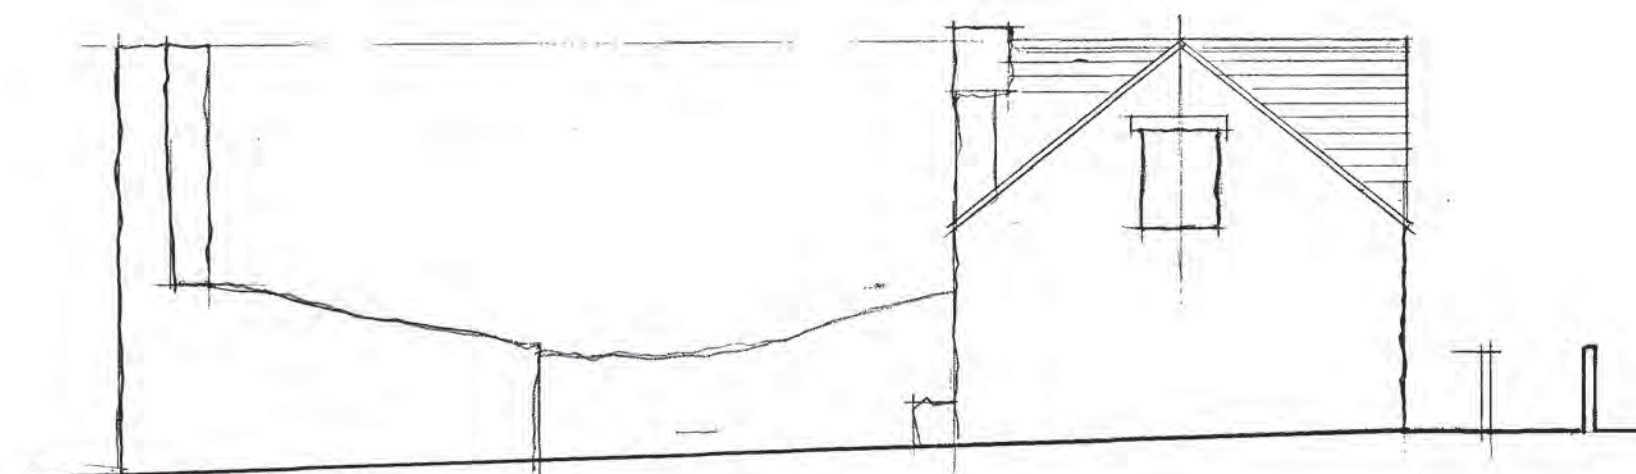
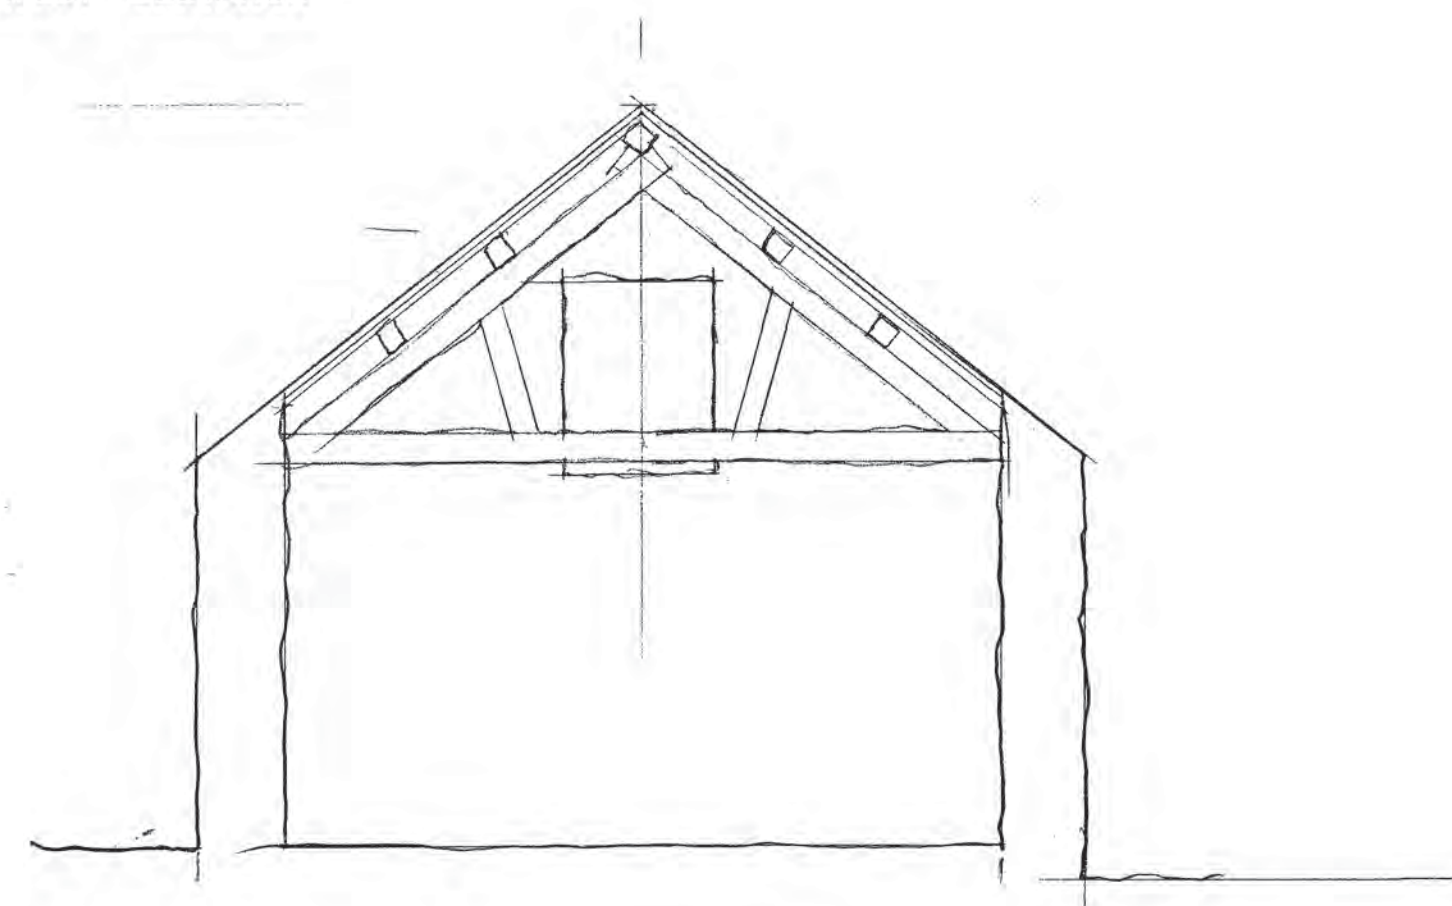
FIGURE 02

Reproduction of Gruffydd Price drawing 01 job 1824. Scale: 1:50 and 1:100@A2
