BANGOR STREET, CAERNARFON

Brîff Gwyllo Archaeolegol / Archaeological Watching brief

Rhif y Prosiect / Project Number: G2766

Rhif yr adroddiad / Report Number: 1720

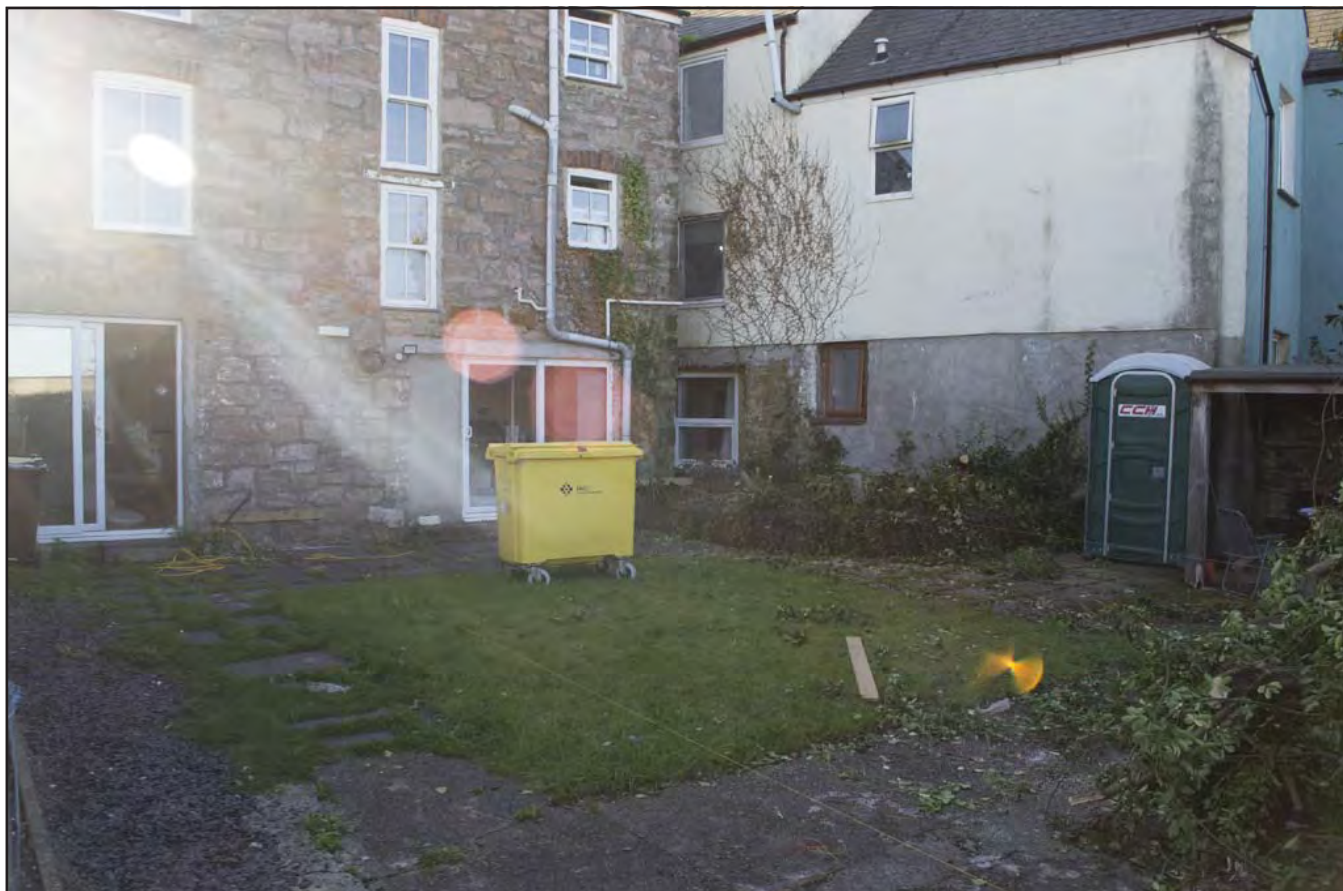
Plate 1: Southeast facing pre-excitation shot showing the extension area; scale not used; view from NW (archive reference: G2766_001).

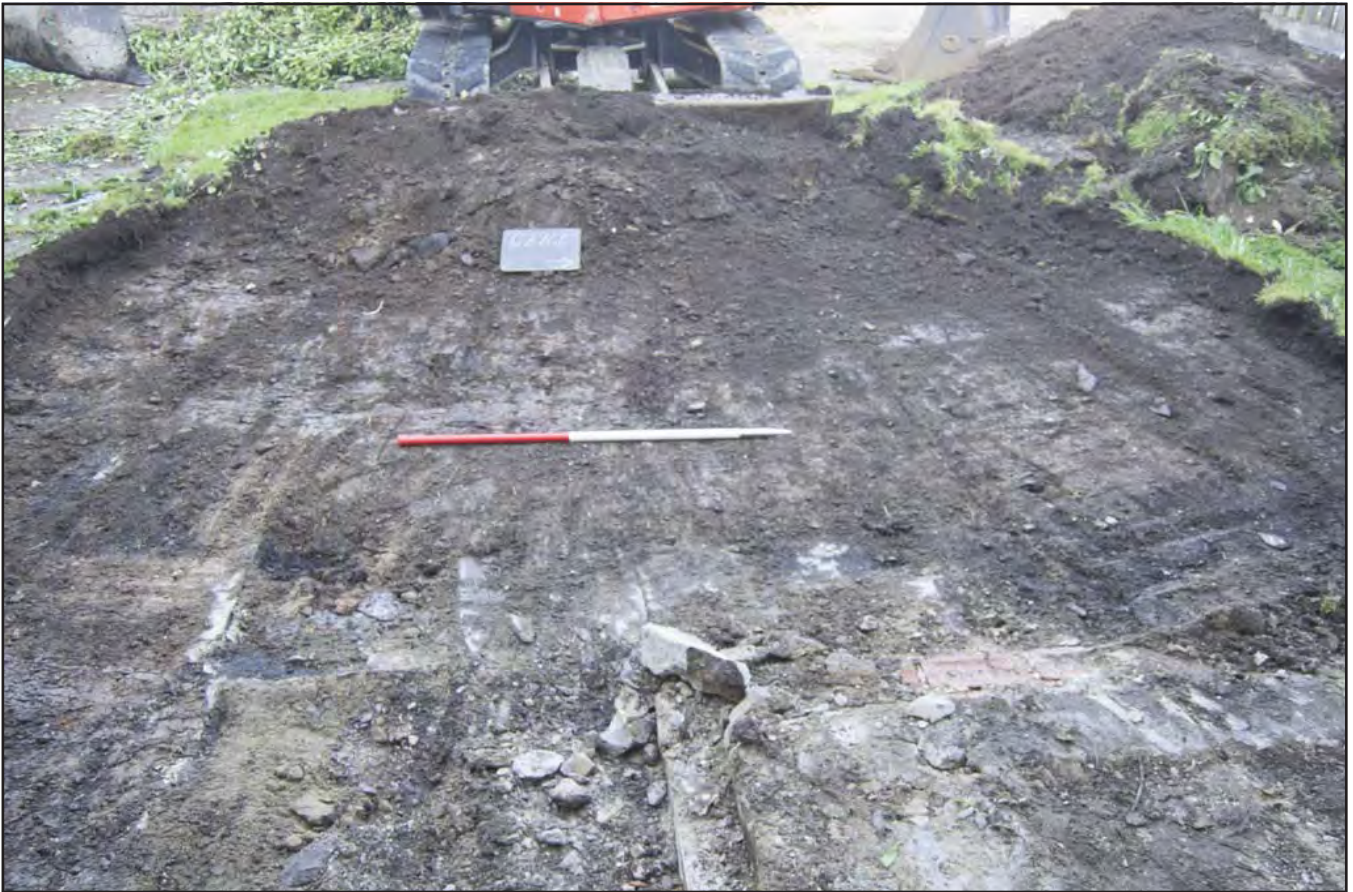
Plate 3: View of extension area after topsoil removed; scale 1x1m; view from E (archive reference: G2766_003).

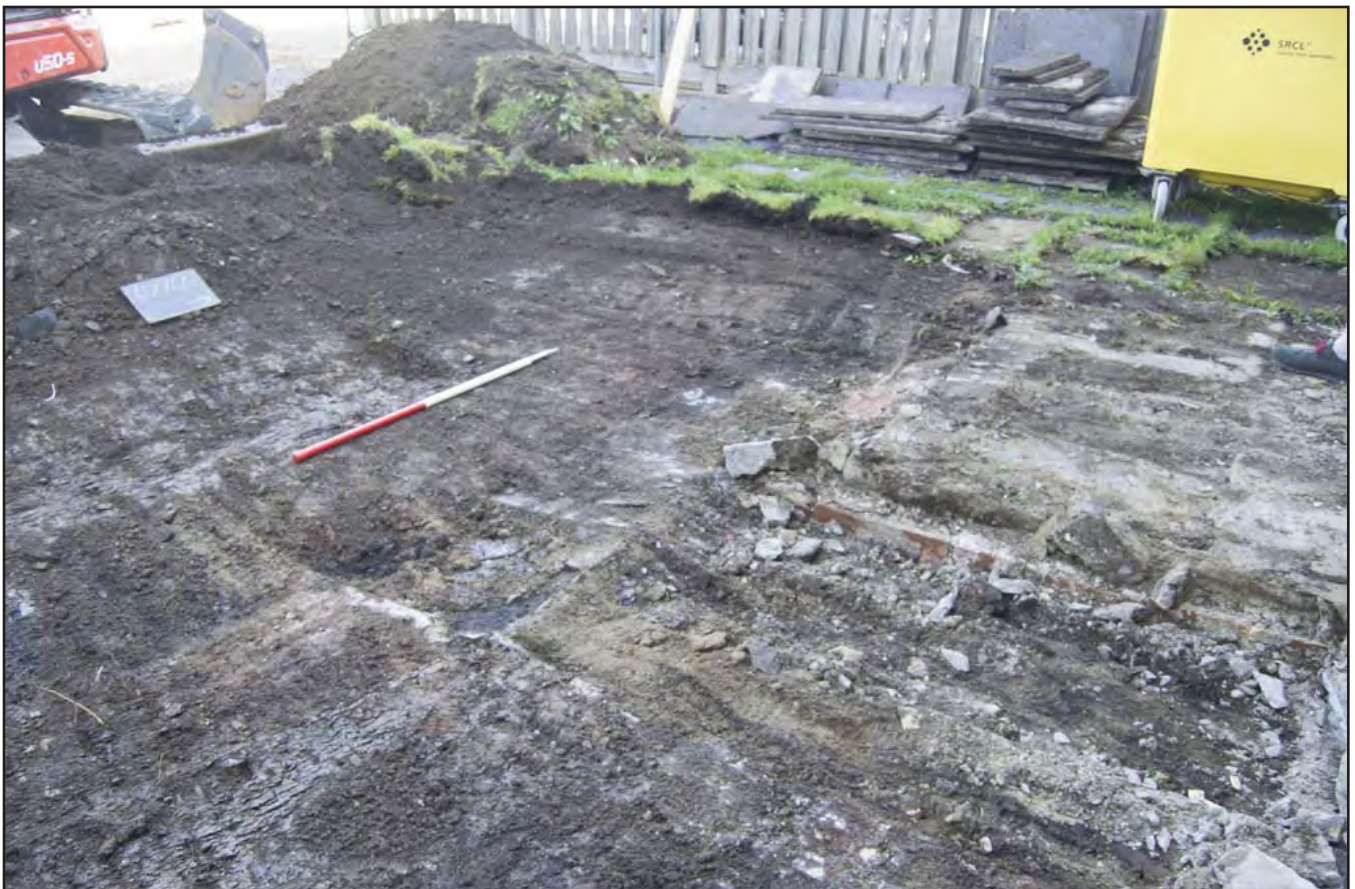
Plate 4: Stripped area with concrete pad and bricks in the NE of extension area (mid-excavation); scale 1x1m; view from SE (archive reference: G2766_004).

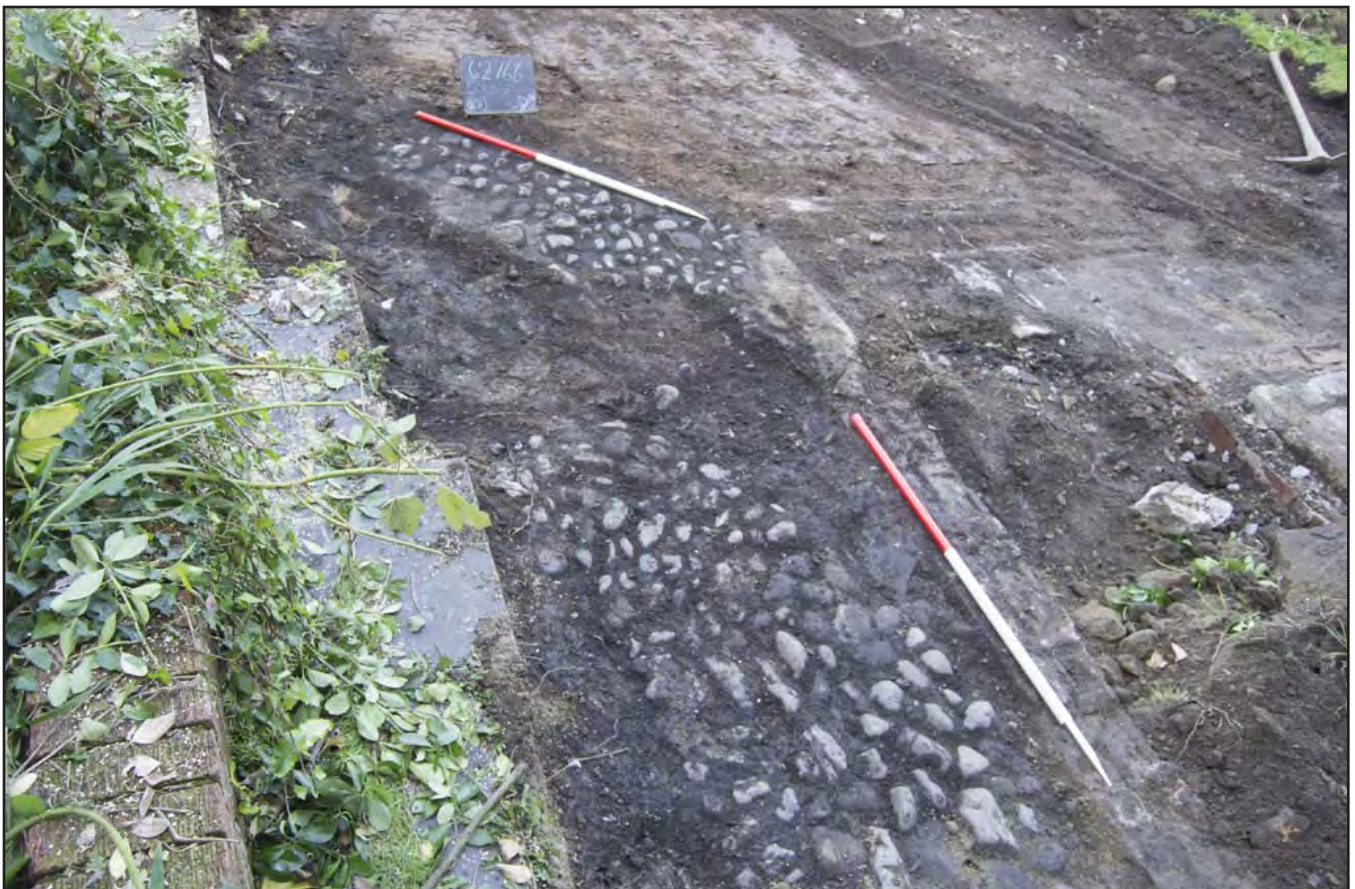
Plate 6: View of cobbled path in the SE of the extension area; scale 2x1m; view from E
(archive reference: G2766_006).

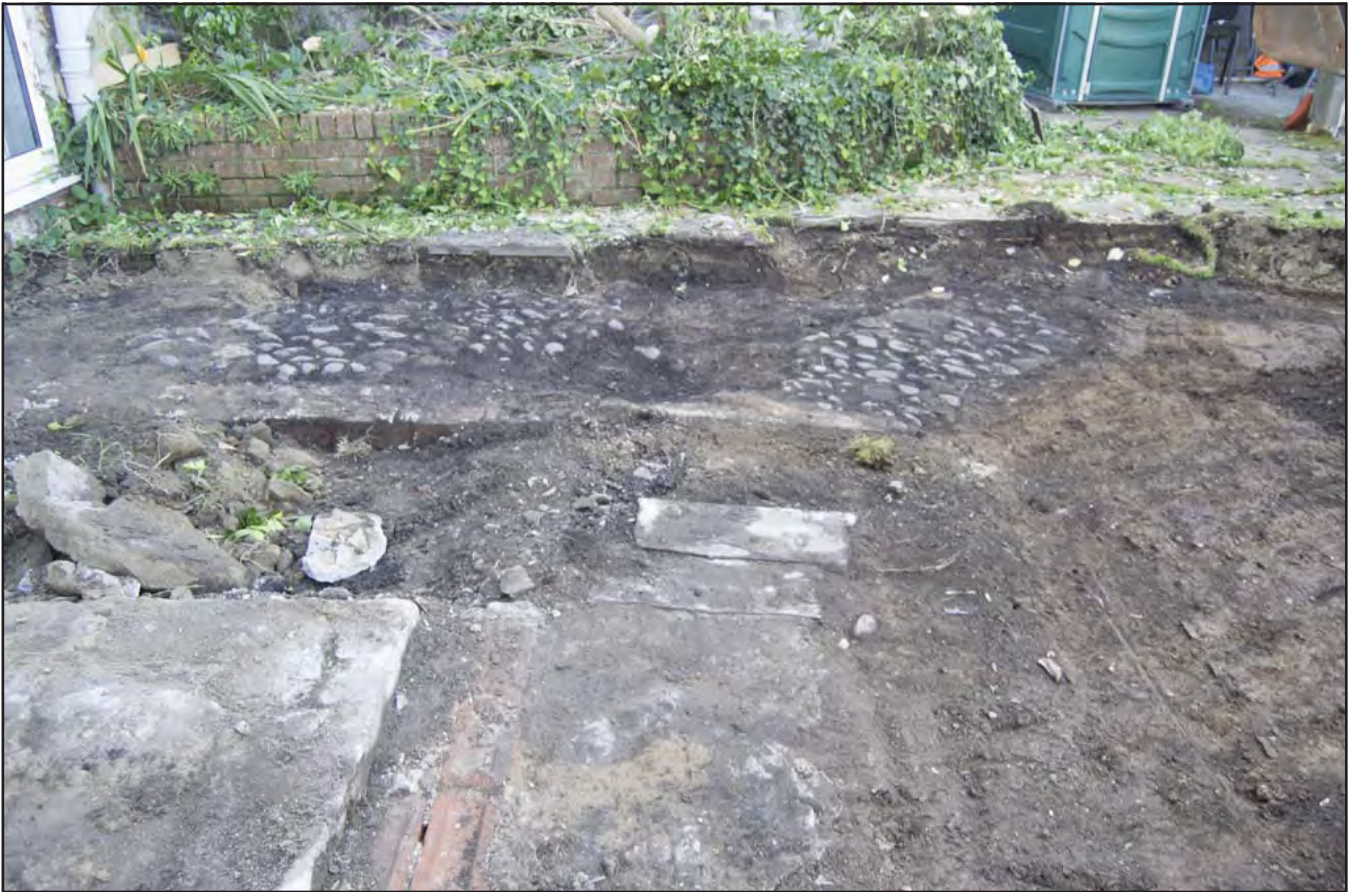
The removal of the cobbled surface and modern raised garden bed (cf. Plate 7) exposed a compacted soil surface ((104); cf. Plates 29 and 30). A 0.50m wide and 0.40m deep drainage trench for the extension was cut through this deposit (cf. Plates 31 and 32); this exposed an east-west aligned 0.45m wide cut for a former wall or drainage feature, which was heavily truncated, with the only the base of the cut visible. The cut was filled by the compacted soil surface ((104); cf. Plates 33 to 36). This feature was also identified when a foundation cut was inserted across the northern end of the extension area (cf. Plate 37).

Plate 7: View of cobbled path; scale not used (archive reference: G2766_010).

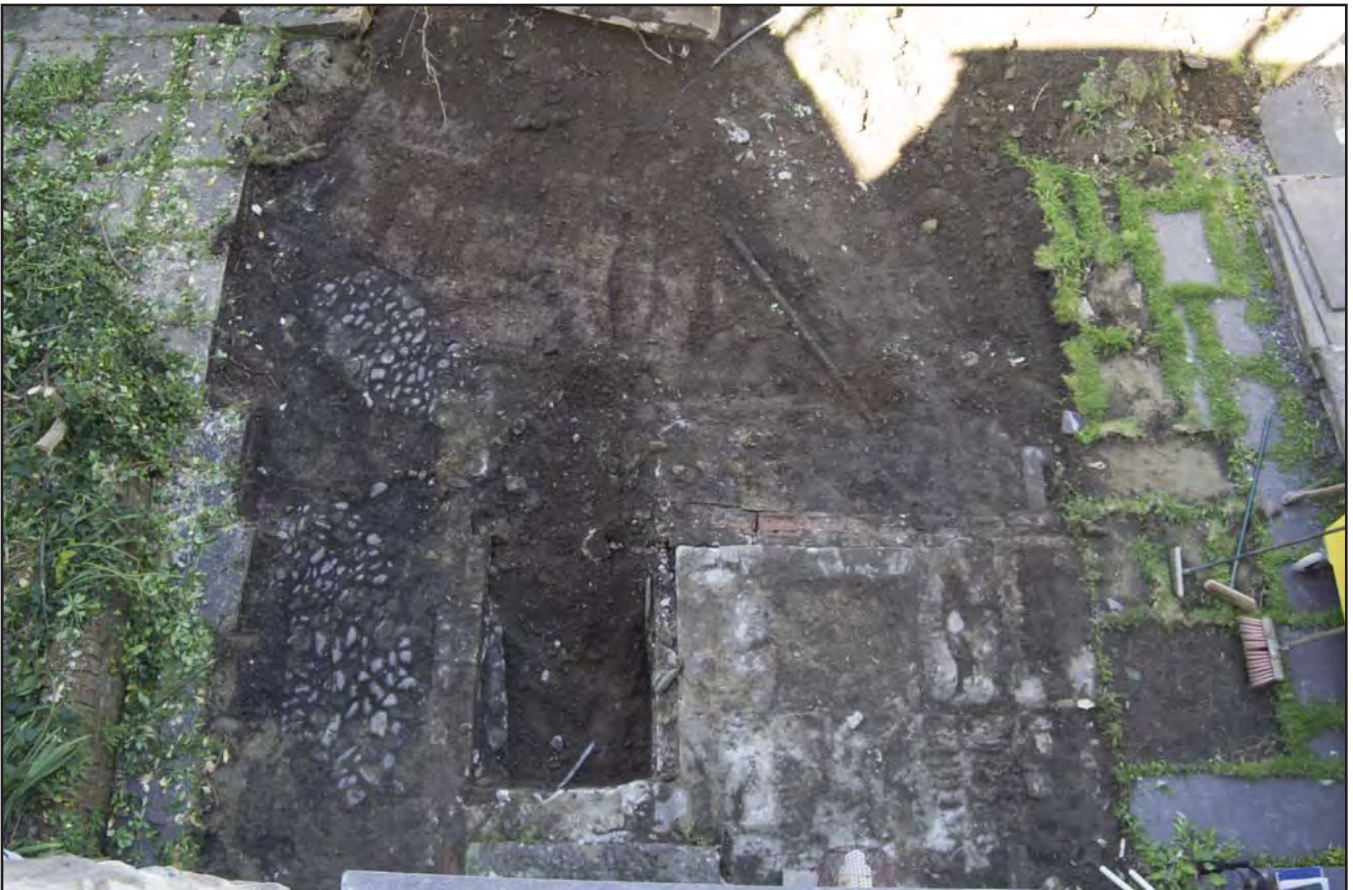
Plate 8: Overhead view of stripped area and cobbled paths; scale not used (archive reference: G2766_011).

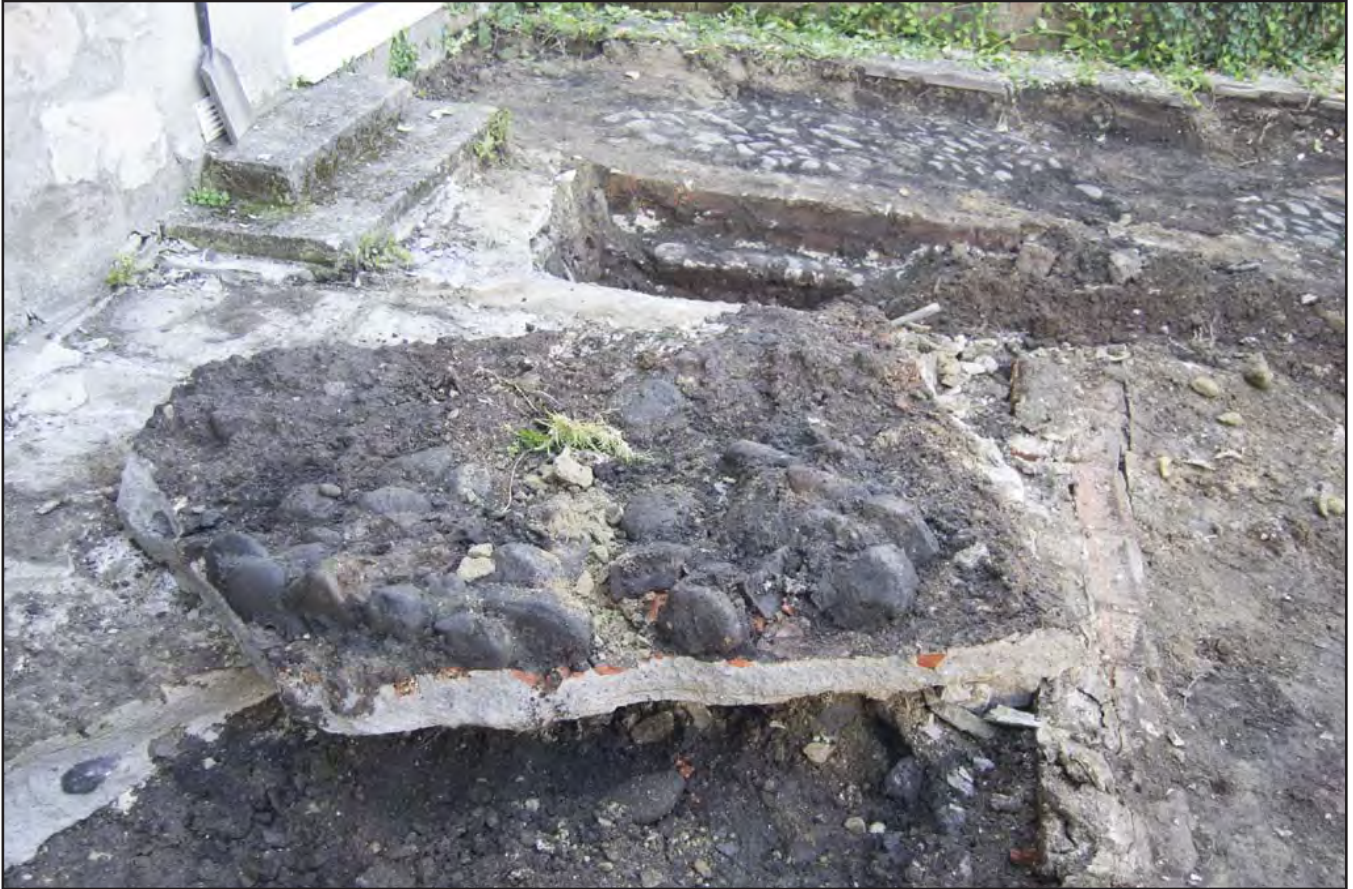
Plate 9: Shot of yard cobbles attached to the underside of removed concrete pad; scale not used; view from N/A (archive reference: G2766_012).

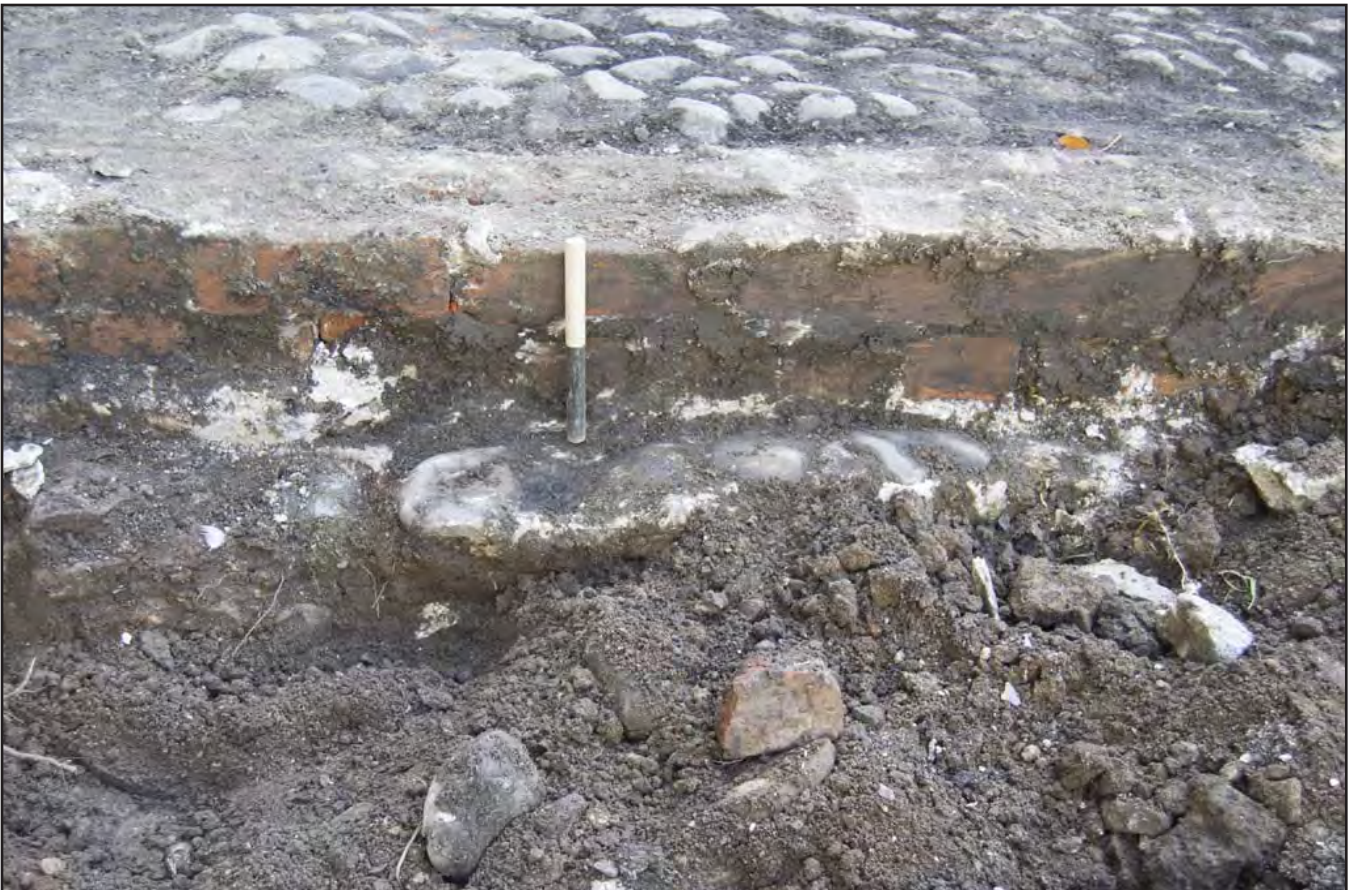
Plate 10: Cobbles below brick edge around concrete pad; scale 1x0.3m; view from N (archive reference: G2766_014).

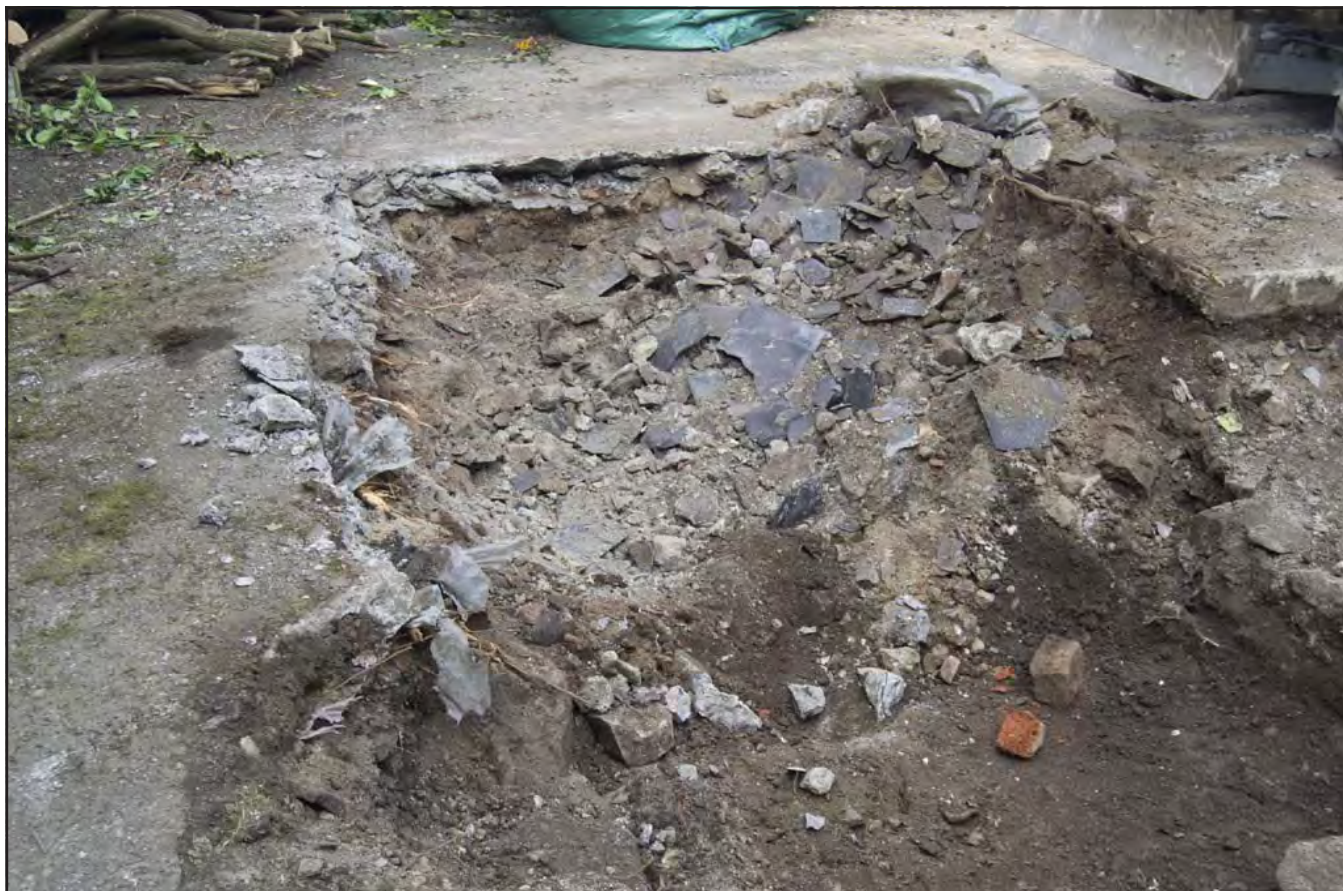
Beneath the concrete area at the western end of the site was a deposit of stone, brick and mortar fragments ((123); cf. Plates 11, 12 and 16), interpreted as demolition material associated with the former outbuildings. This deposit partly sealed foundation level structural remains that included internal divisions and exterior walls for the outbuildings. The exterior wall {106} was orientated north to south and ran across the extension footprint for a length of 5.0m; it was in a degraded condition, measured 0.40m in width x 0.20m in depth, and was constructed from irregular sized and shaped stone with lime mortar (cf. Plates 17 to 20). The truncated patch of brick flooring (105), butted the west facing edge of the wall, suggesting they were associated, whilst a patch of degraded floor surface (111) was attached to the interior of the wall at southern end (cf. Plates 16 and 17). Possible internal partitions were also visible, including an east-west aligned wall {107} that butted {106}; this wall measured 0.80 in length, 0.40m in width and 0.20m in depth and was built from irregular sized and shaped stone with limestone mortar. Further subdivisions and phases were also visible, including a brick and stone wall ({121}; cf. Plate 22) aligned northeast-southwest that butted {107} and a north-south aligned wall {108=112} to the west of {106} (Plates 20, 22, 24 and 26), with an associated foundation cut [117]. Located between walls {106} and {108} was a truncated cobbled area

Plate 11: Working shot - view of demolition debris at west end of extension area; scale not used; view from E (archive reference: G2766_017).

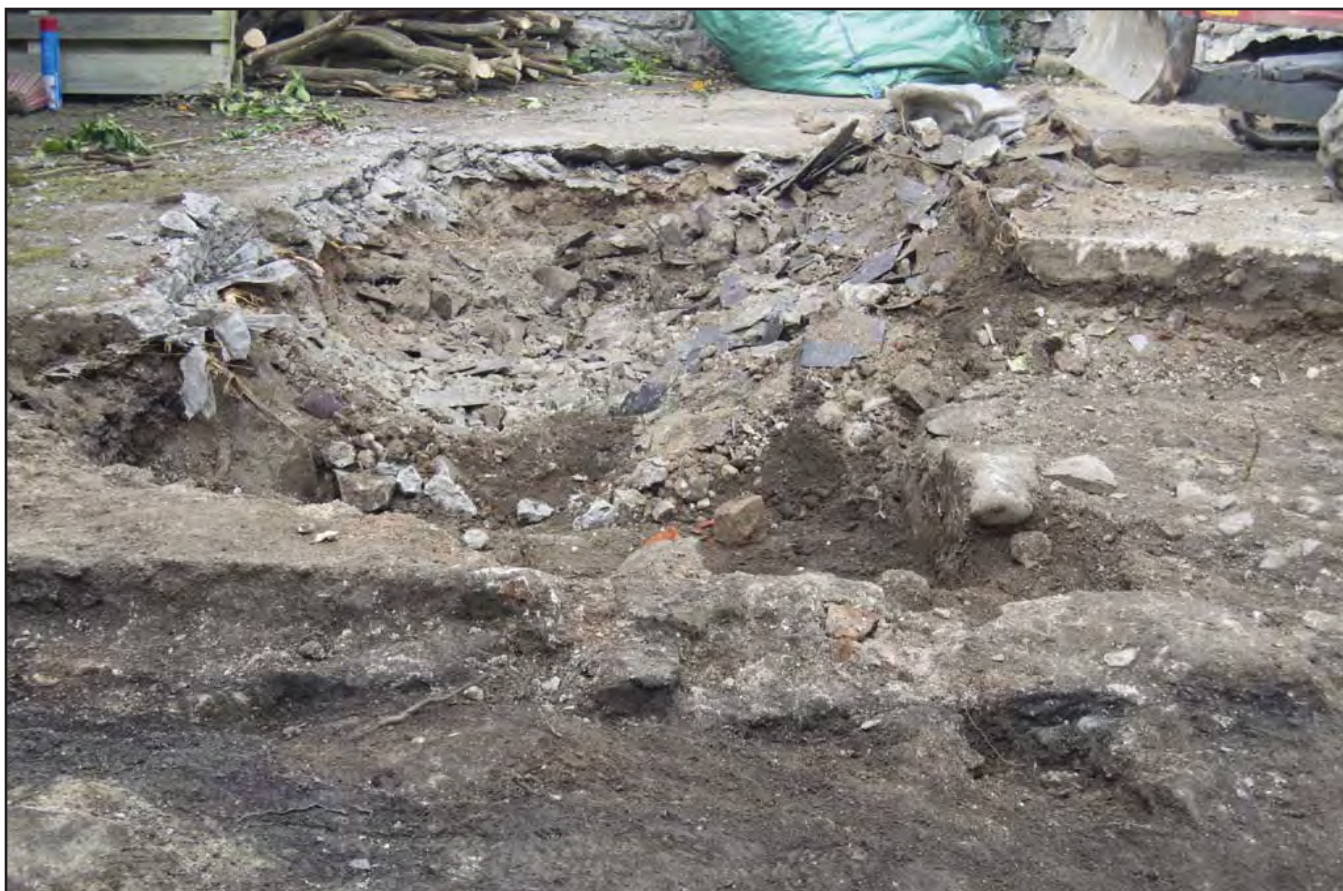
Plate 12: Working shot of removal of demolition debris to west end of extension area; scale not used; view from NE (archive reference: G2766_018).

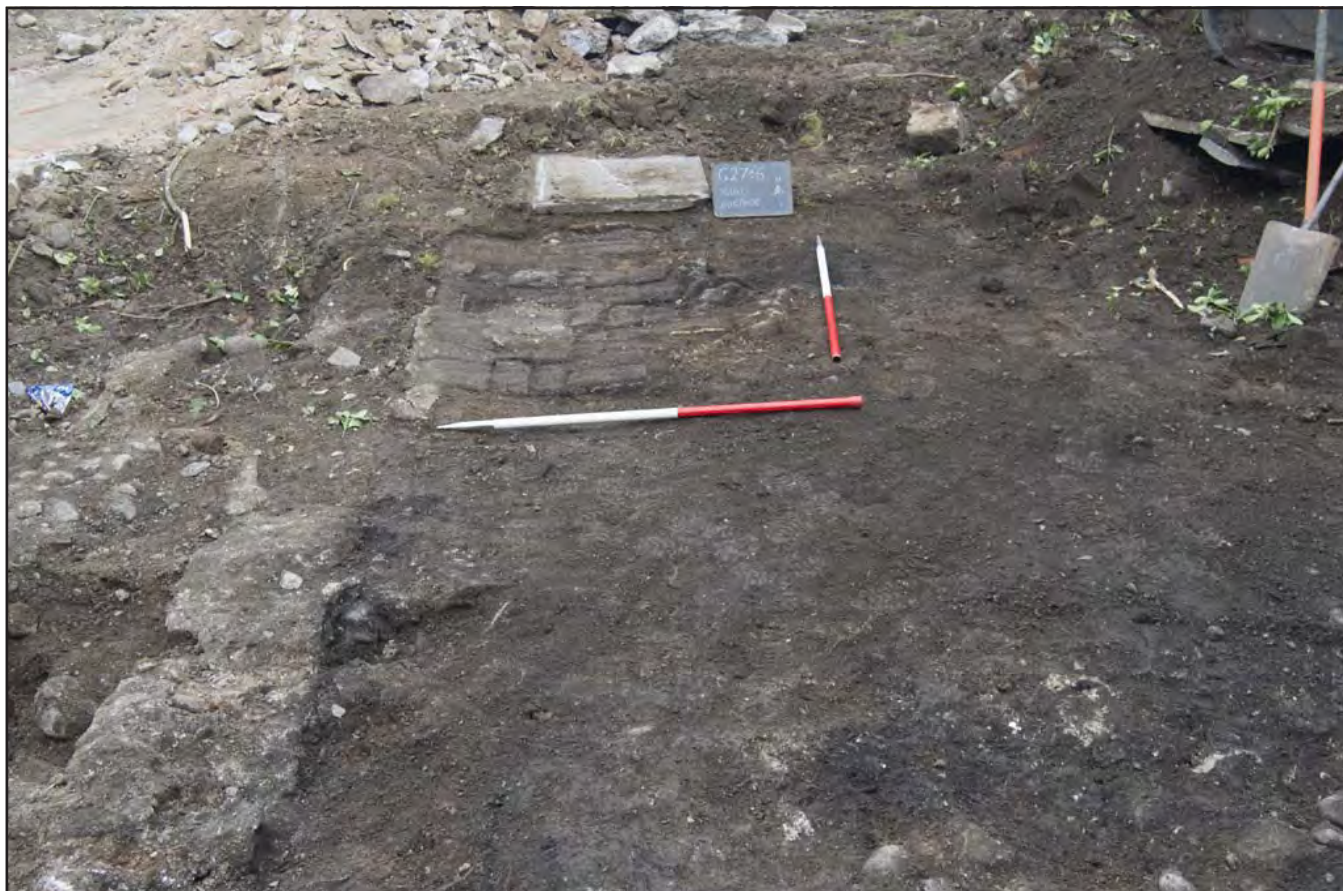
Plate 13: View of slate manhole cover and brick yard surface and wall aligned N/S; scale 2x1 m; view from S (archive reference: G2766_019).

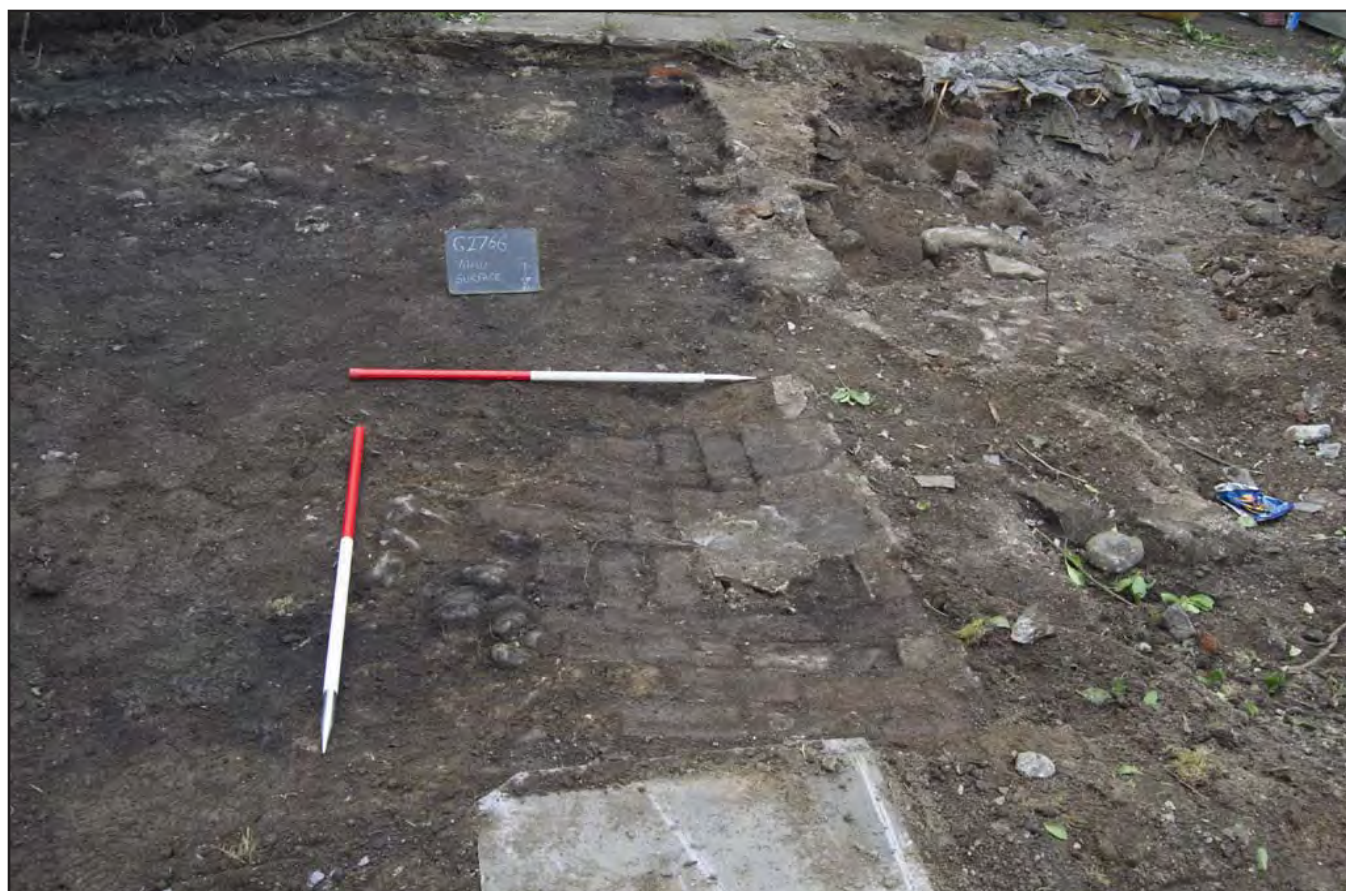
Plate 14: View of slate manhole cover and brick yard surface and wall aligned N/S; scale 2x1 m; view from N (archive reference: G2766_020).

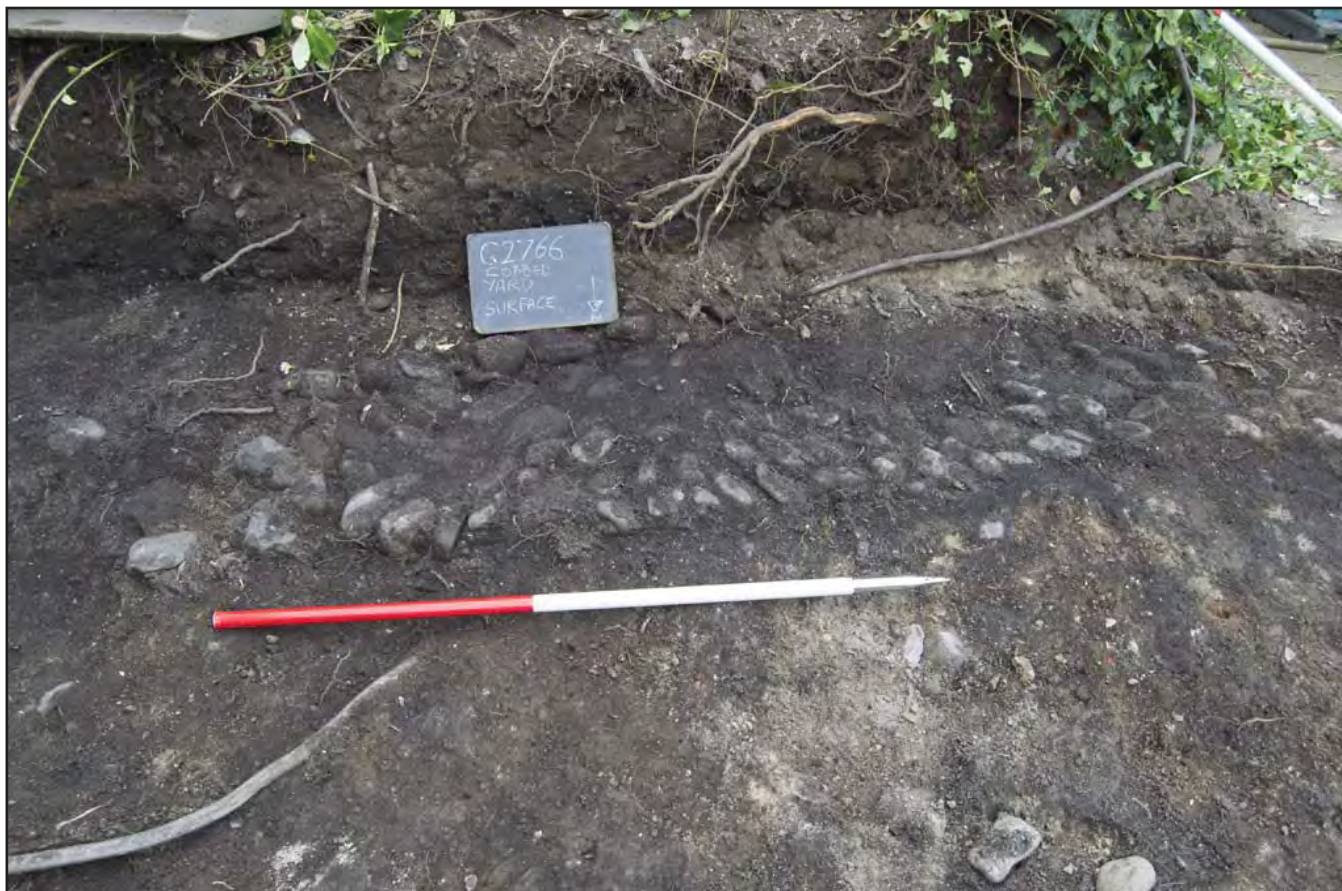
Plate 15: View of cobbled path at southern end of extension area after brick wall of raised flower bed was removed; scale 1x1m; view from N (archive reference: G2766_021).

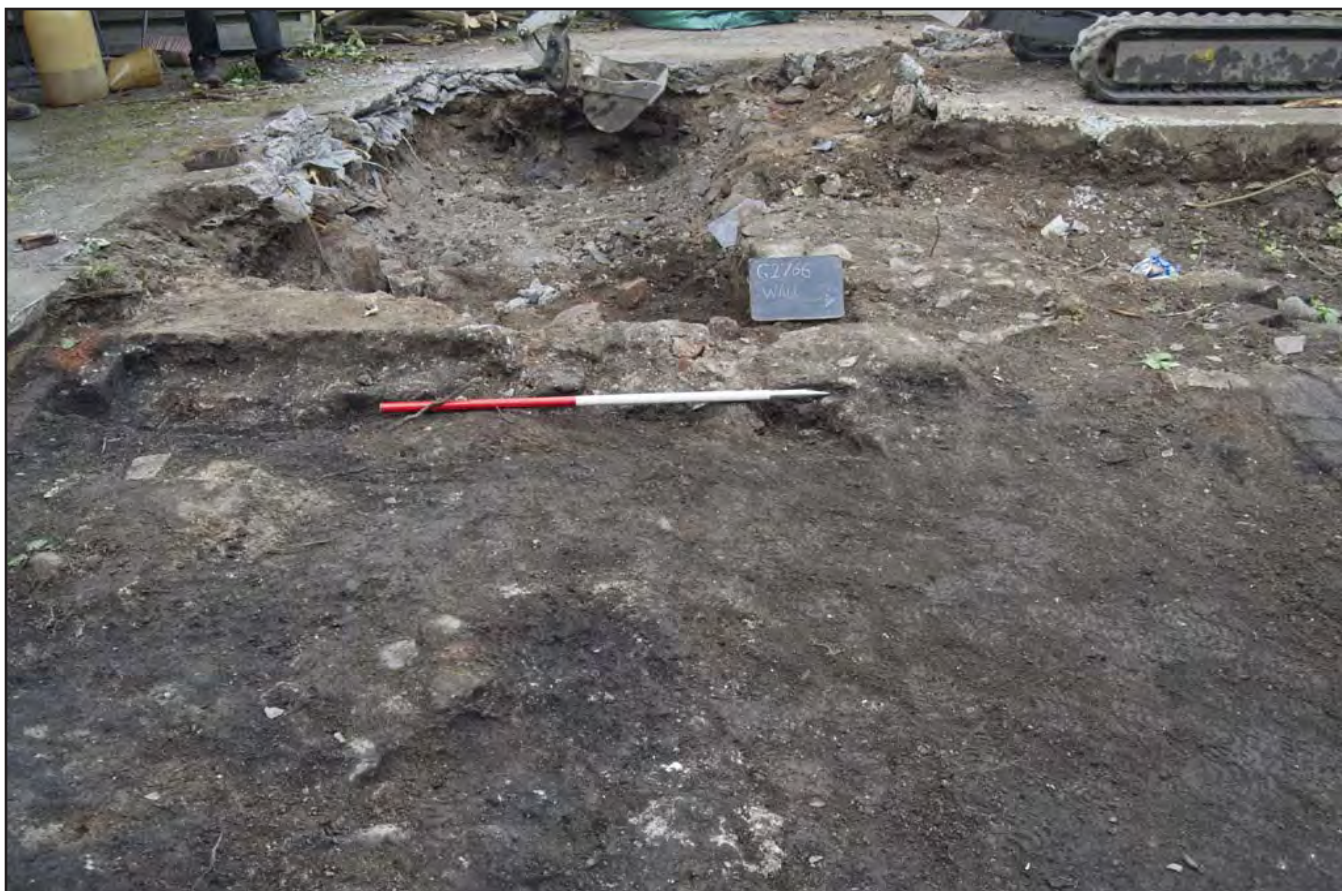
Plate 16: View of yard and 19th century wall; scale 1x1m; view from S (archive reference: G2766_022).

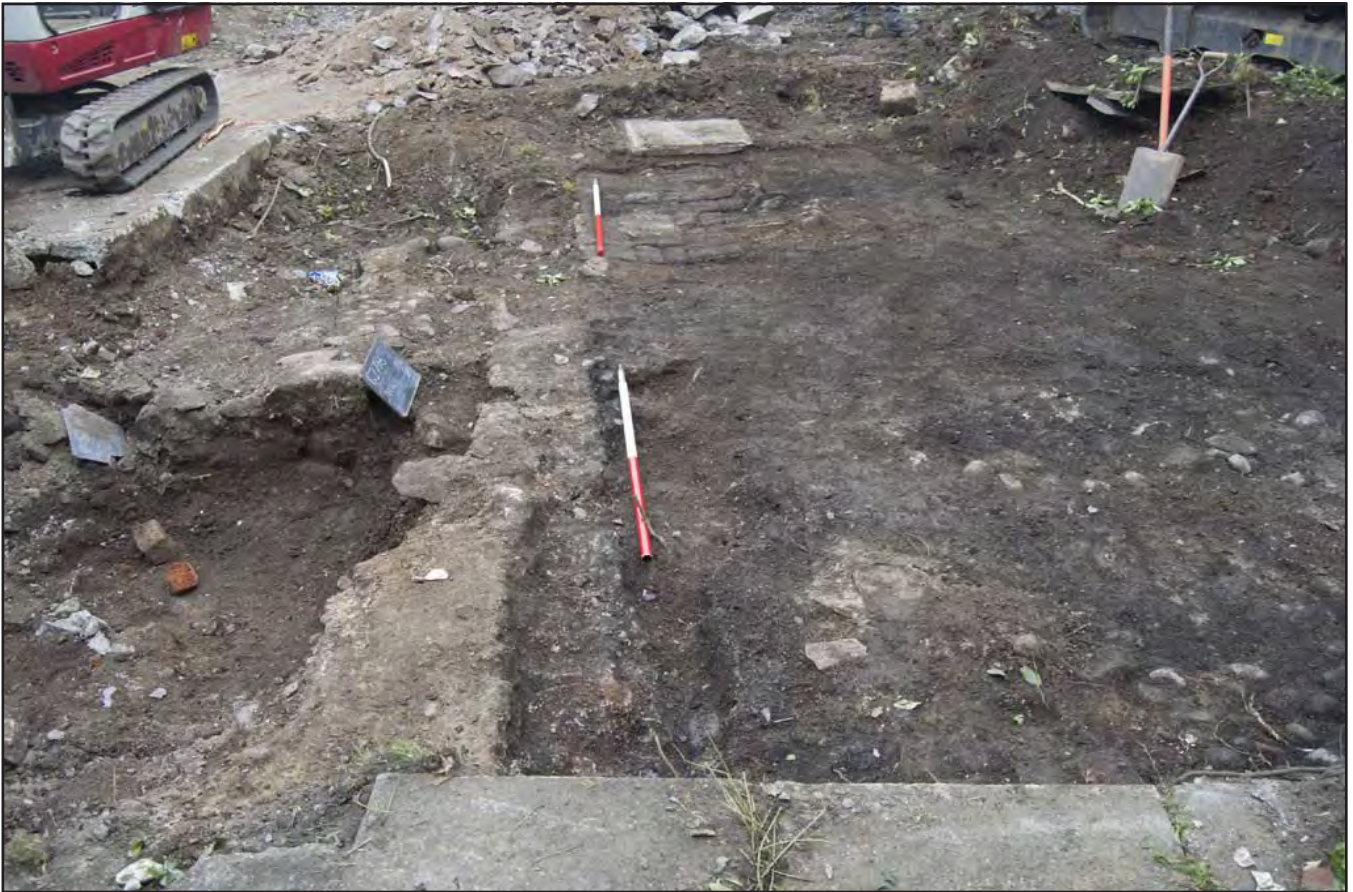
Plate 17: Mid-ex shot of western end of extension area showing wall and yard area; scale 2x1m; view from S (archive reference: G2766_024).

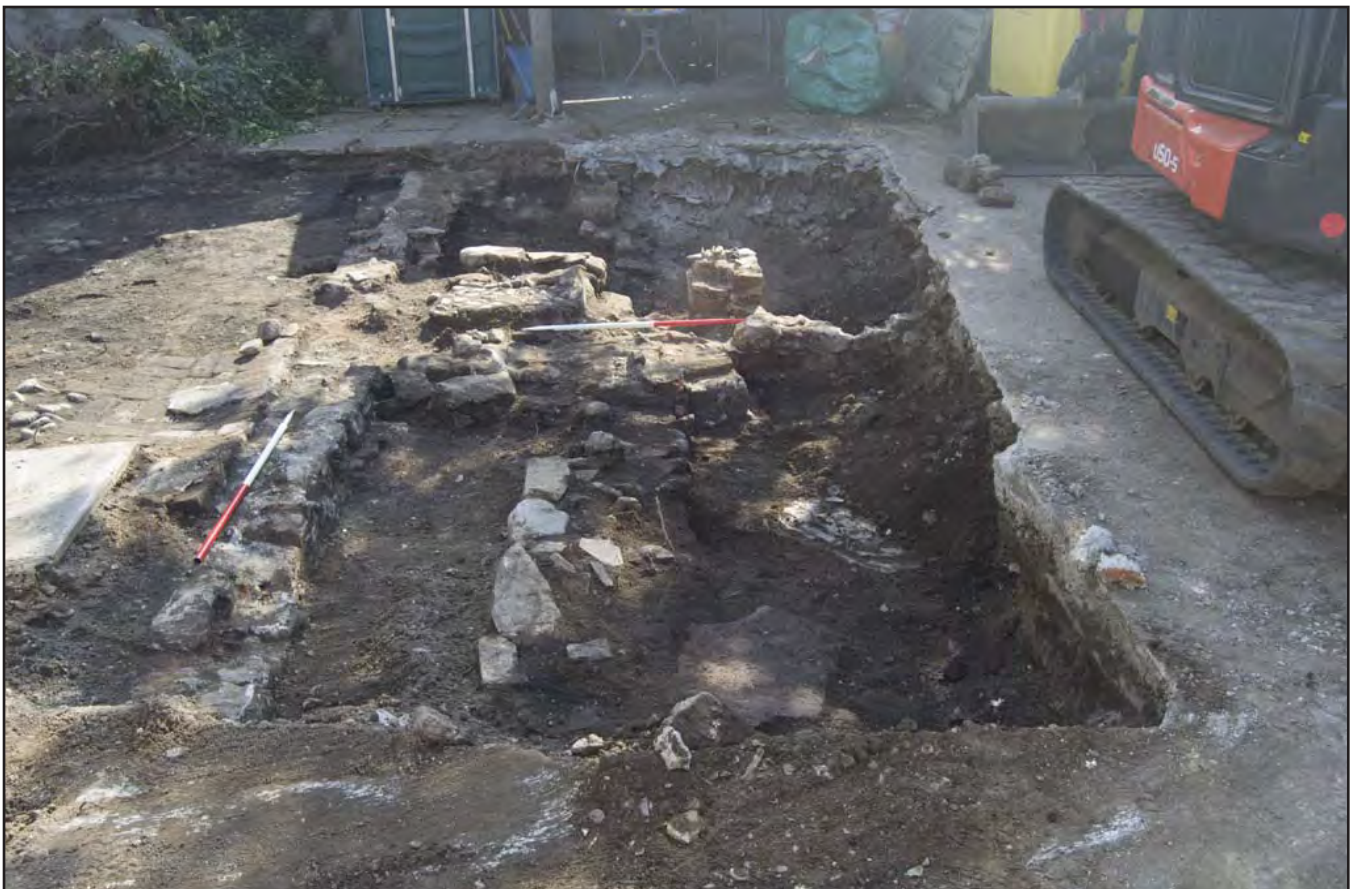
Plate 18: Post-ex shot of base of buildings and yard area; scale 2x1m; view from N (archive reference: G2766_028).

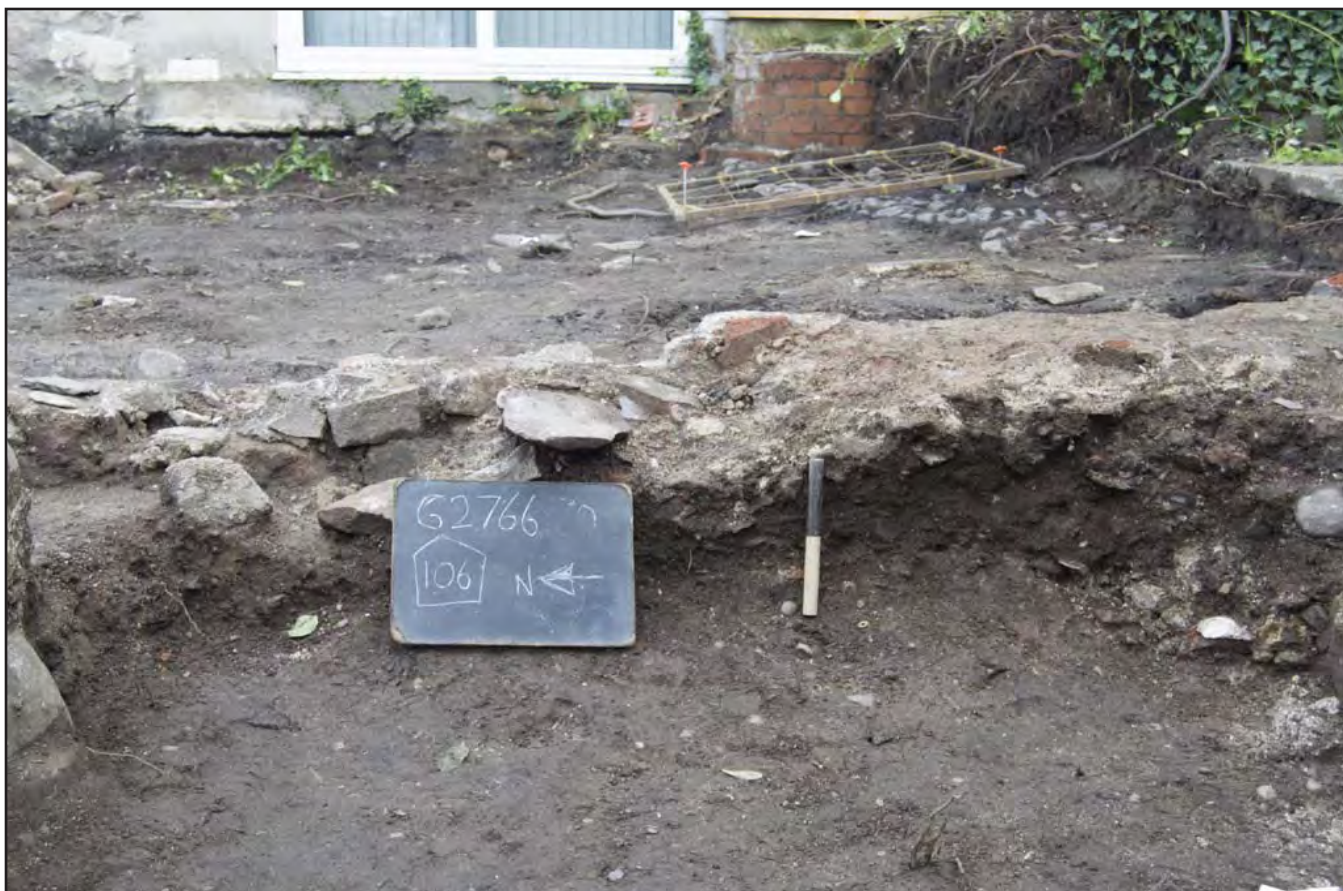
Plate 20: West facing elevation of 108 at the northern end; scale 1x0.3m; view from W
(archive reference: G2766_038).

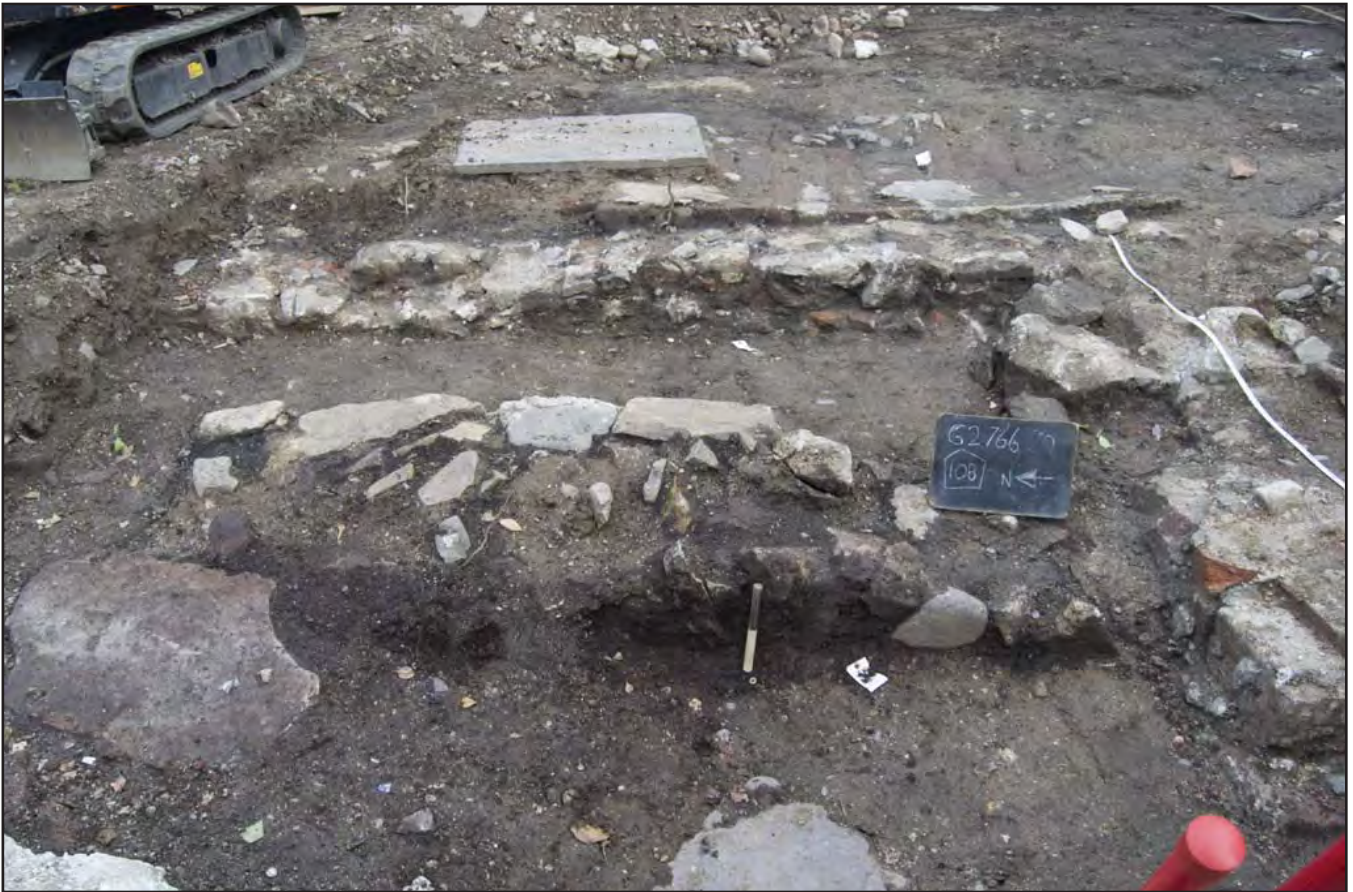
Plate 21: West facing elevation of wall 108; scale 1x0.3m; view from W (archive reference: G2766_040).
