BANGOR STREET, CAERNARFON

Brîff Gwyllo Archaeolegol / Archaeological Watching brief

Rhif y Prosiect / Project Number: G2766

Rhif yr adroddiad / Report Number: 1720

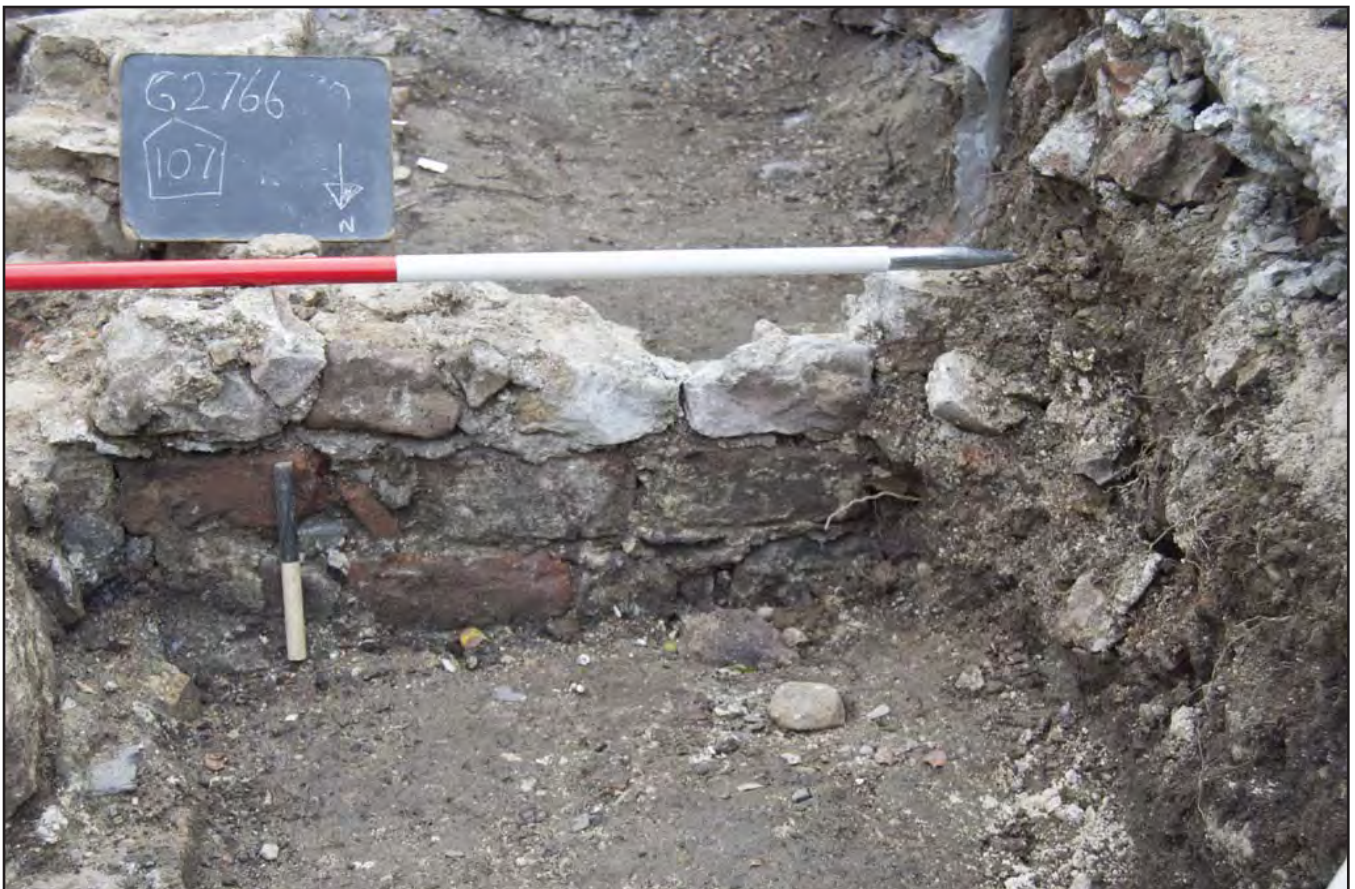
Plate 22: South facing elevation of wall 121 with 107 in the background; scale 1x0.3 & 1x1m; view from N (archive reference: G2766_041).

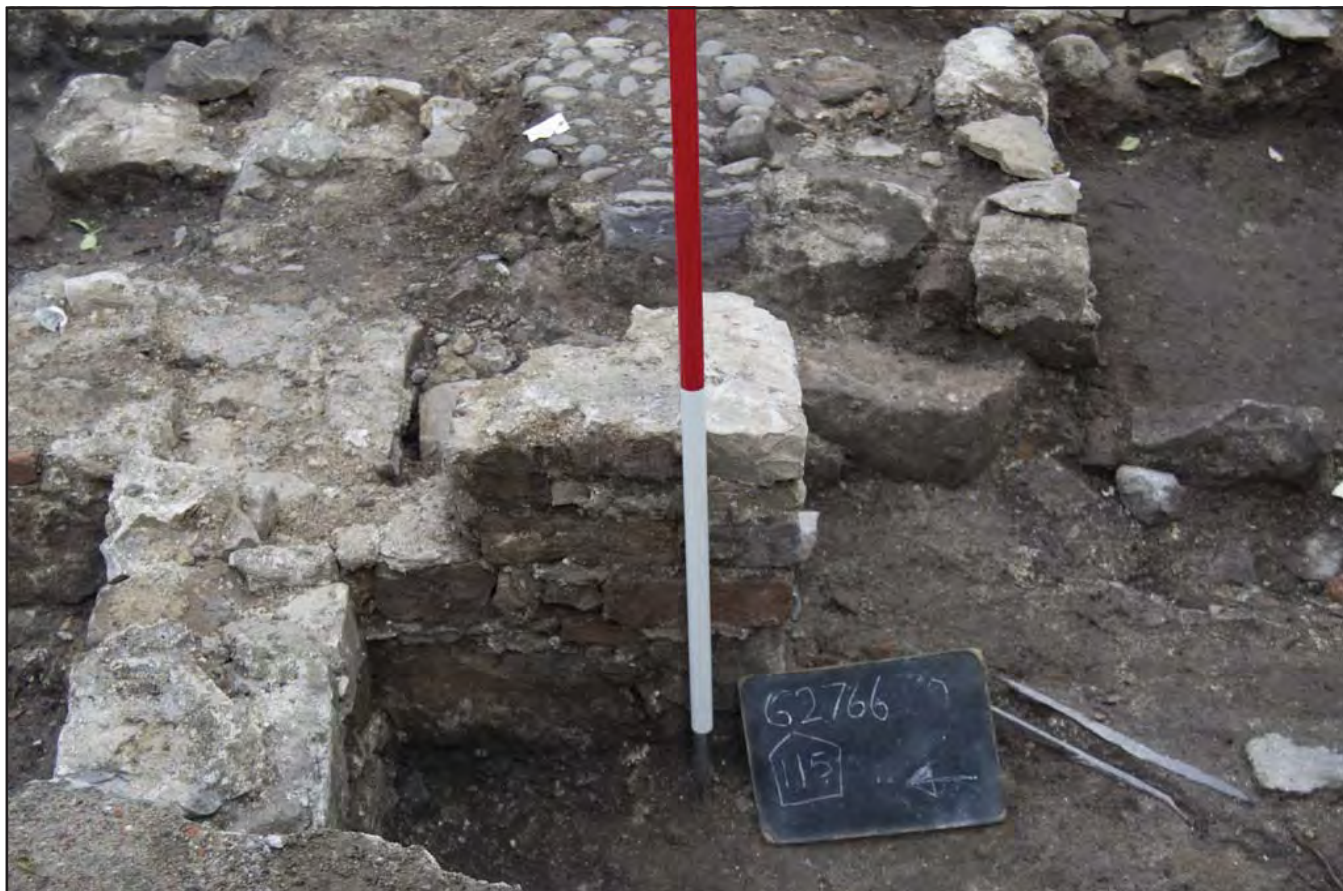
Plate 23: South facing elevation of wall 114/115; scale 1x0.3 1x1m; view from W (archive reference: G2766_042).

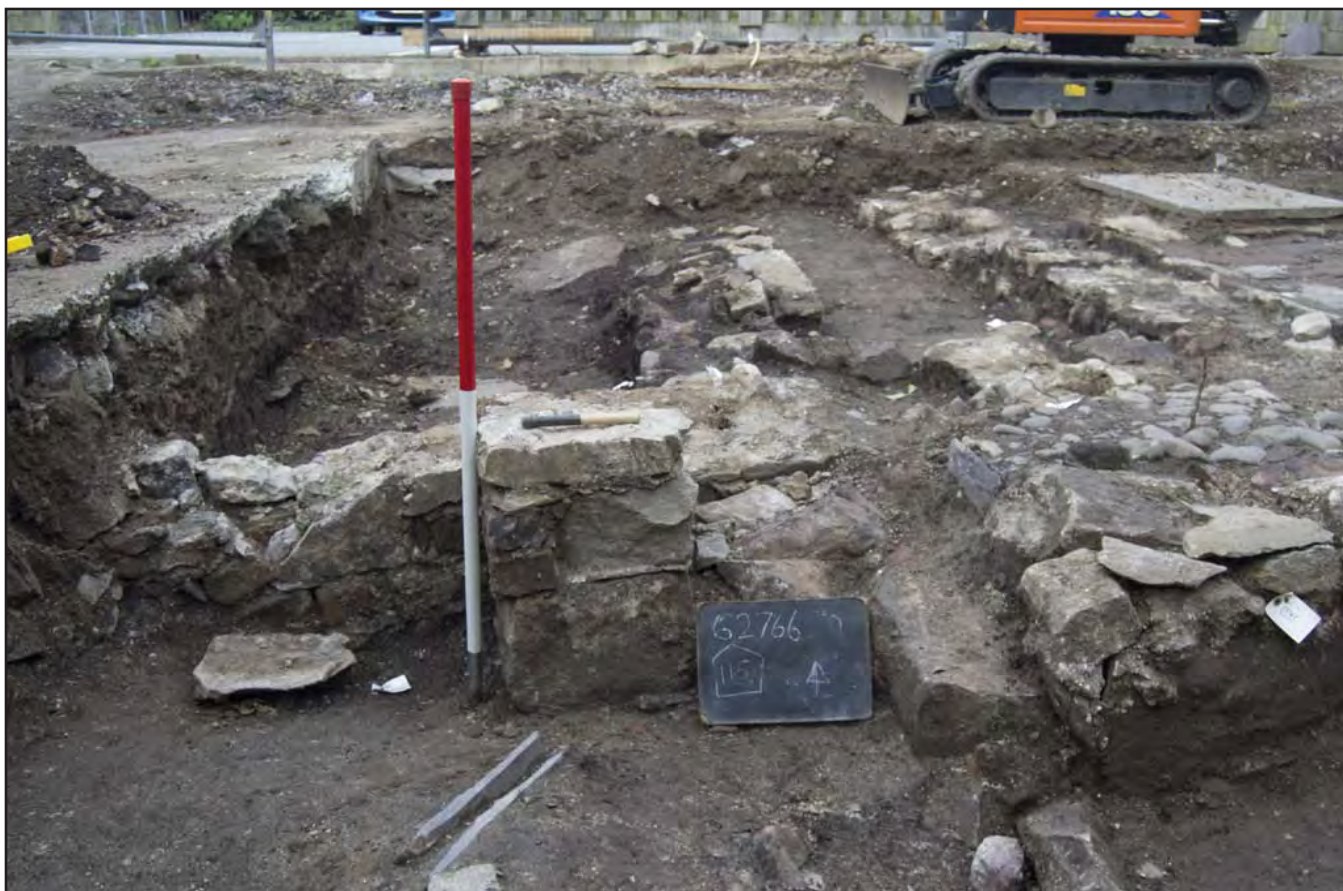
Plate 24: East facing elevation of wall 114/115 with 121 in the background; scale 1x0.3 & 1x1m; view from S (archive reference: G2766_043).

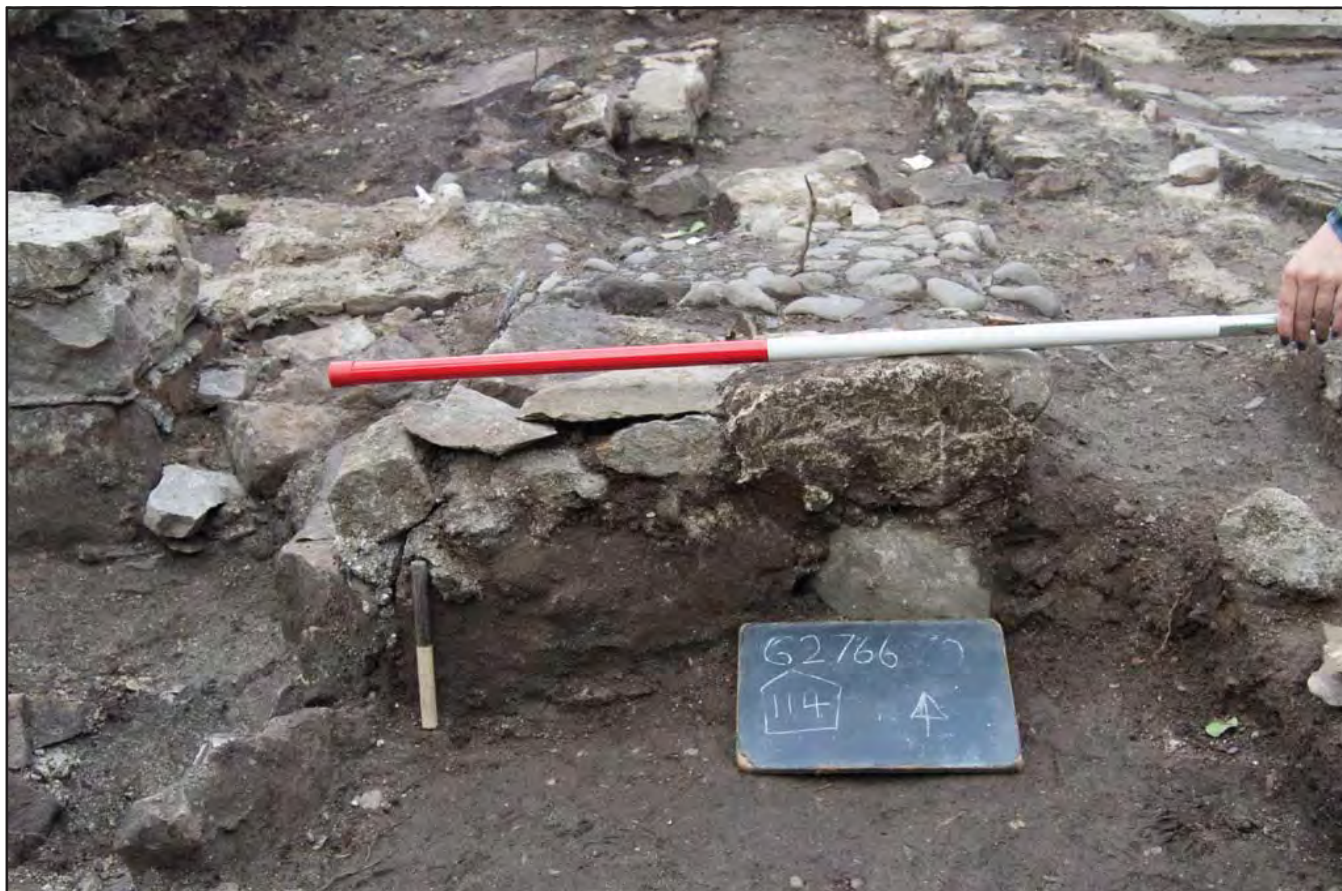
Plate 25: South facing elevation of wall 114/115; scale 1x0.3 1x1m; view from S (archive reference: G2766_044).

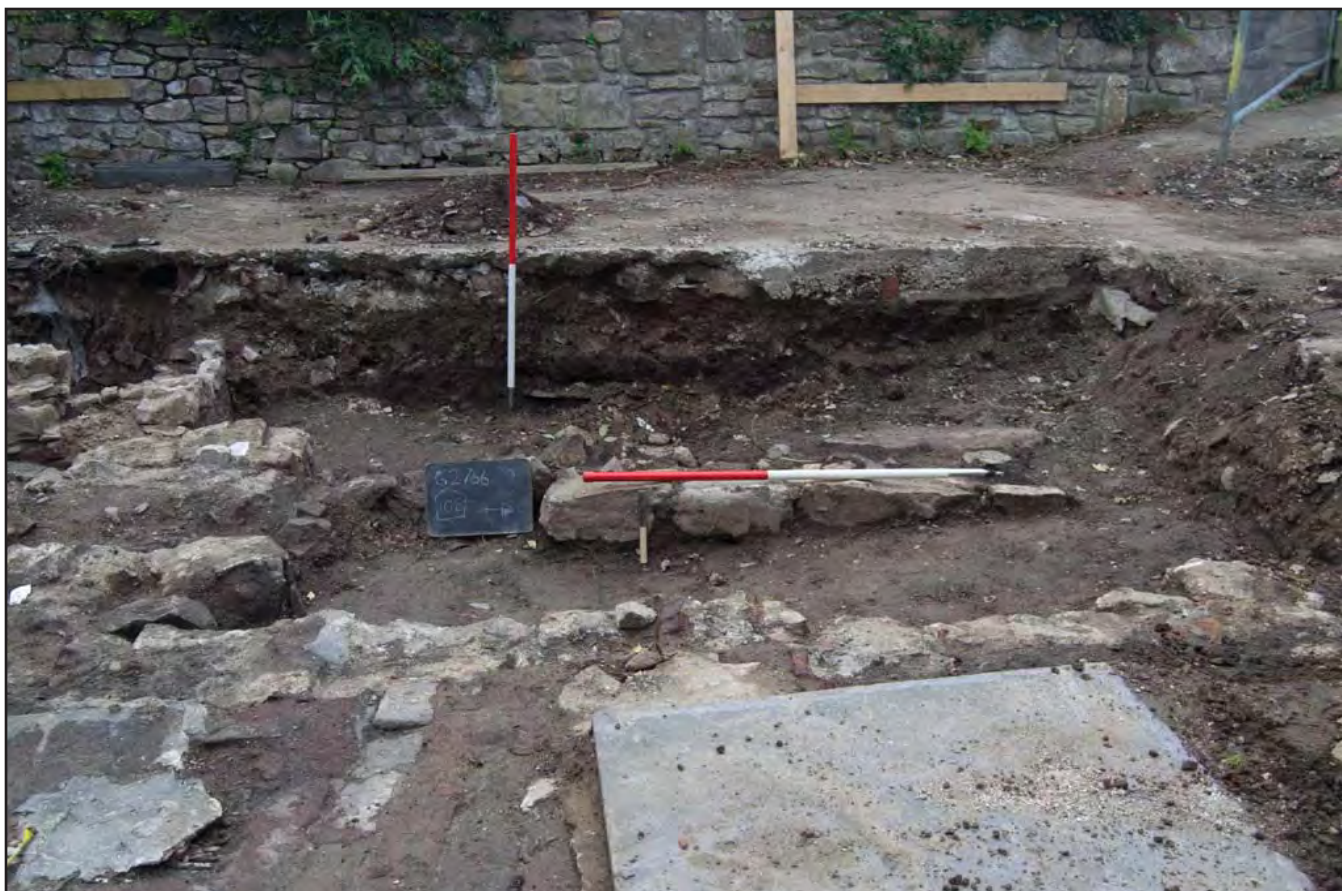
Plate 26: East facing elevation of wall 108 - northern end of wall with 106 in the background; scale 1x0.3m 2x1m; view from E (archive reference: G2766_045).

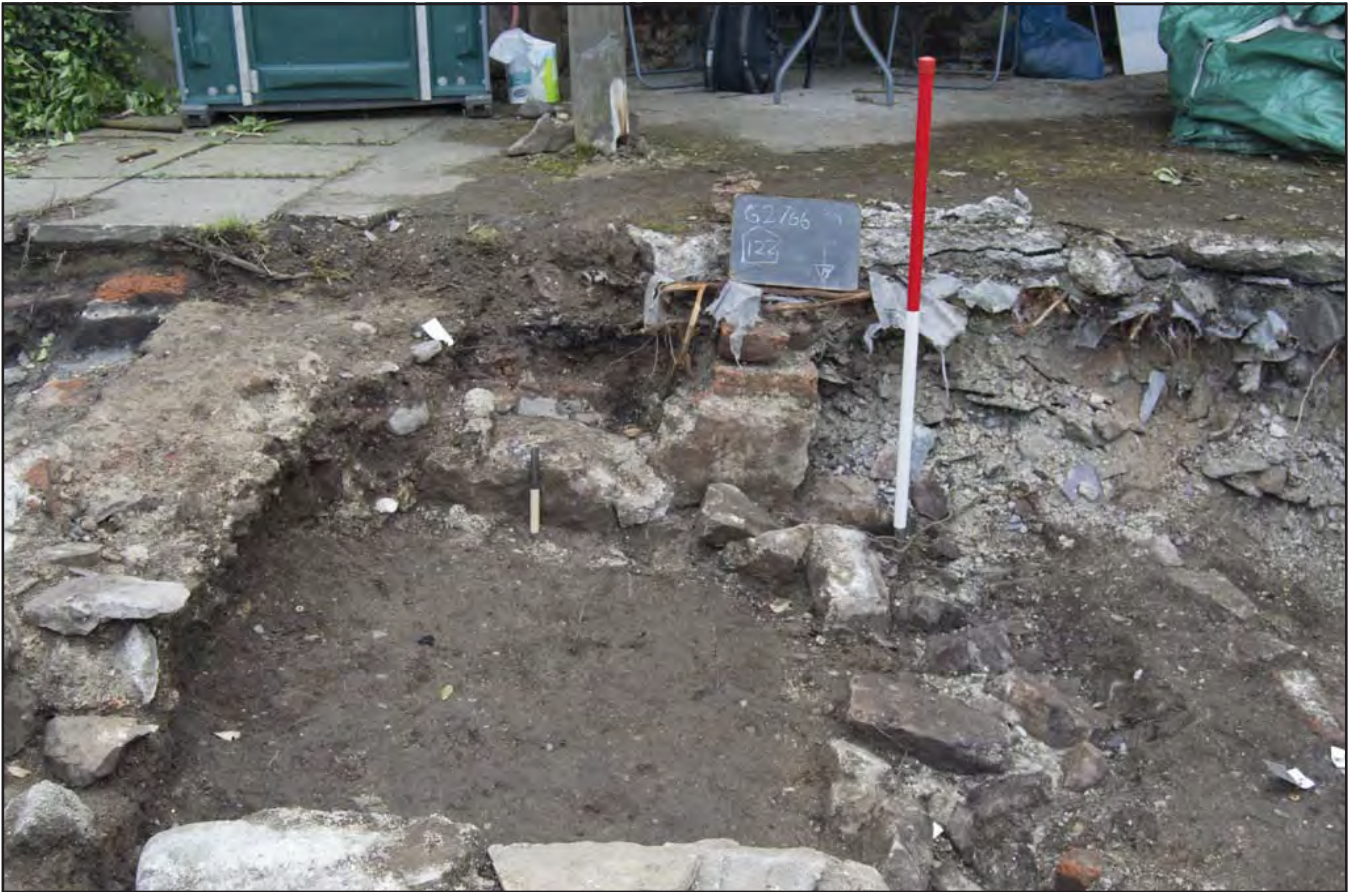
Plate 27: North facing view of wall 122; scale 1x0.3 1x1m; view from N (archive reference: G2766_047).

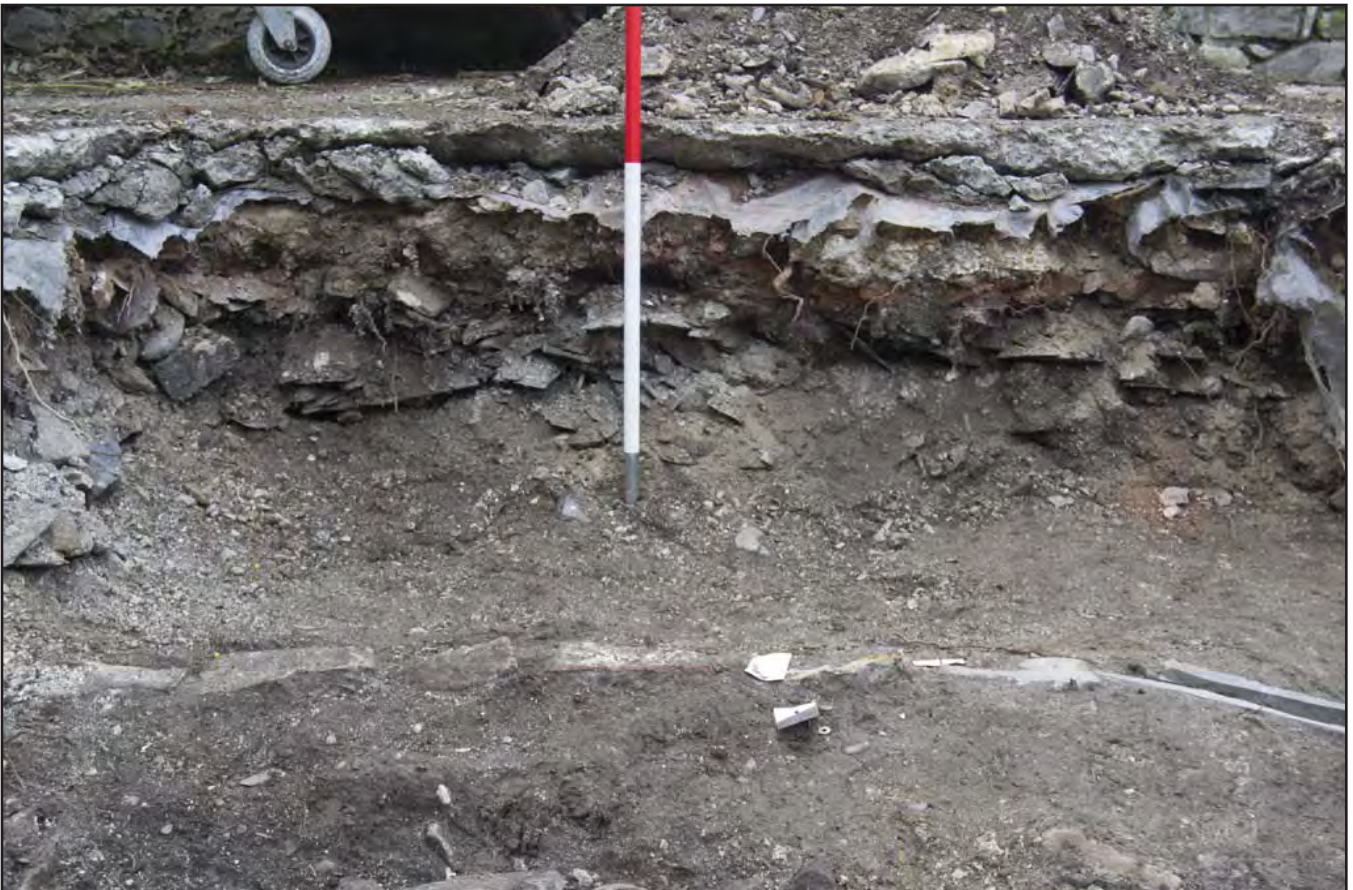
Plate 28: East facing section at the limit of the excavation showing concrete, plastic and demolition material; scale 1x1m; view from E (archive reference: G2766_048).

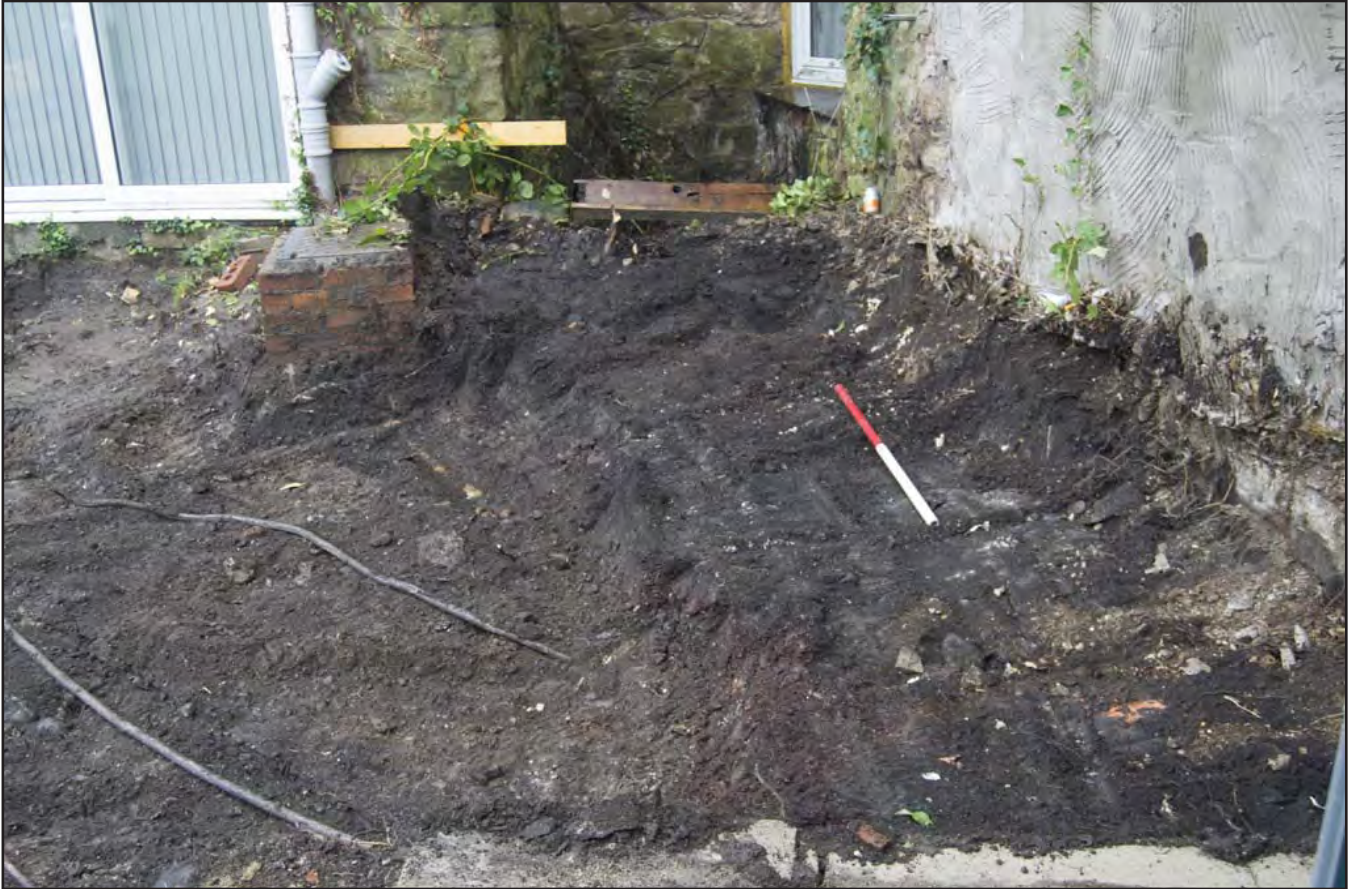
The removal of the cobbled surface and modern raised garden bed (cf. Plate 7) exposed a compacted soil surface ((104); cf. Plates 29 and 30). A 0.50m wide and 0.40m deep drainage trench for the extension was cut through this deposit (cf. Plates 31 and 32); this exposed an east-west aligned 0.45m wide cut for a former wall or drainage feature, which was heavily truncated, with the only the base of the cut visible. The cut was filled by the compacted soil surface ((104); cf. Plates 33 to 36). This feature was also identified when a foundation cut was inserted across the northern end of the extension area (cf. Plate 37).

Plate 29: Southern boundary wall after raised flower bed was removed; scale 1x1m; view from W (archive reference: G2766_050).

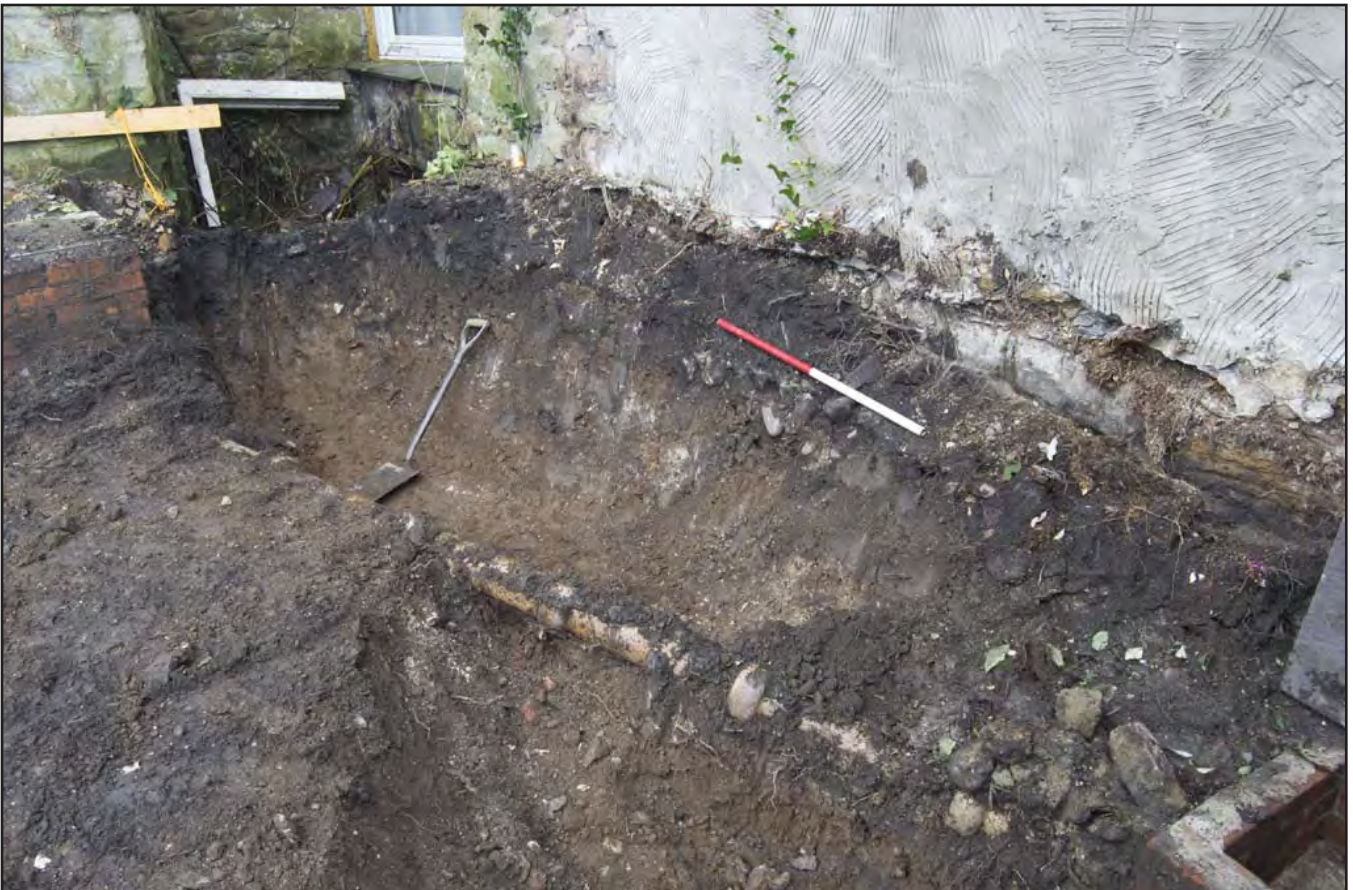
Plate 30: View of southern drainage ditch showing remnant cobbles of yard surface; scale 1x1m; view from NW (archive reference: G2766_056).

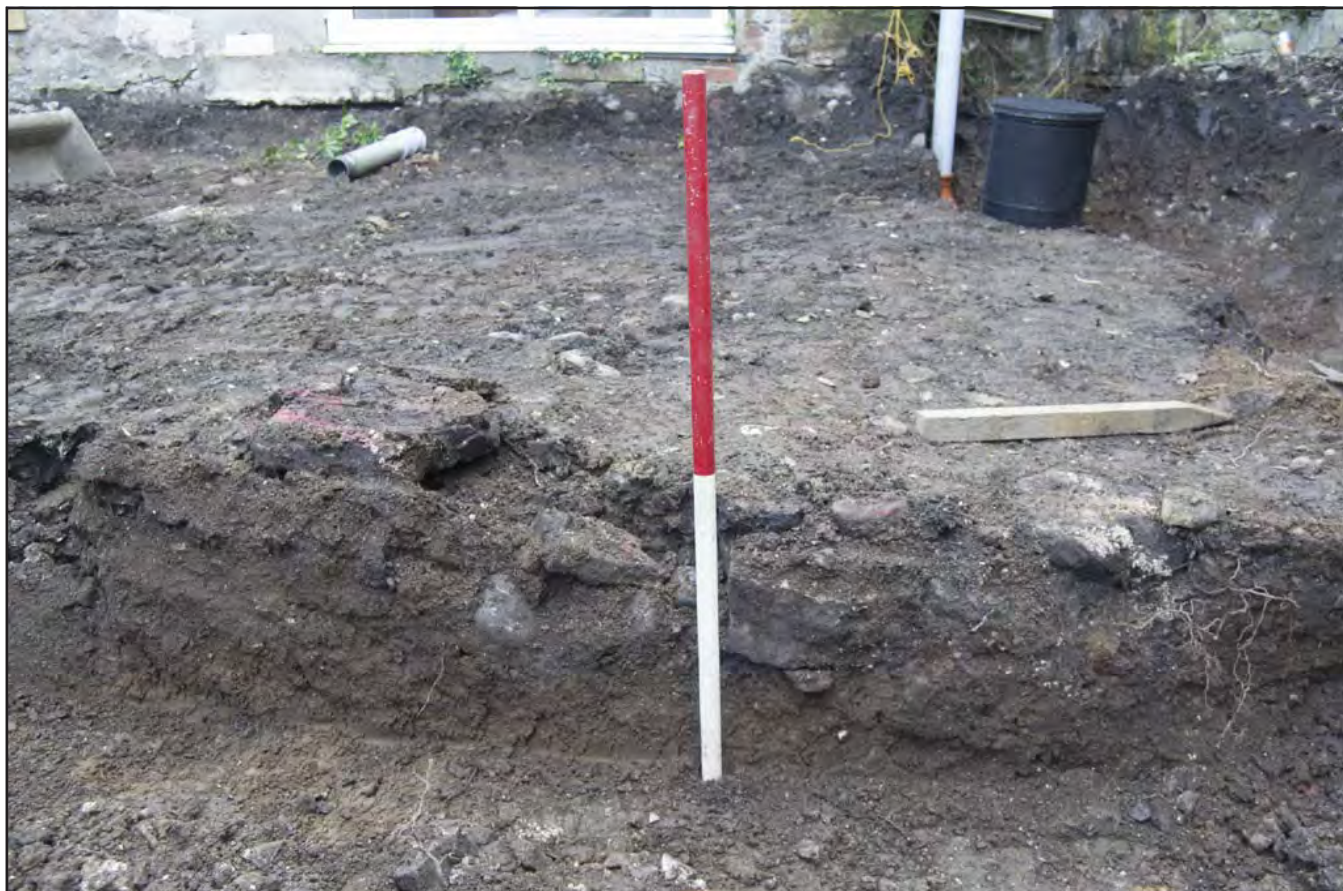
Plate 31: West facing section of drainage trench showing stones and cobbles of yard surface; scale 1x1m; view from W (archive reference: G2766_061).

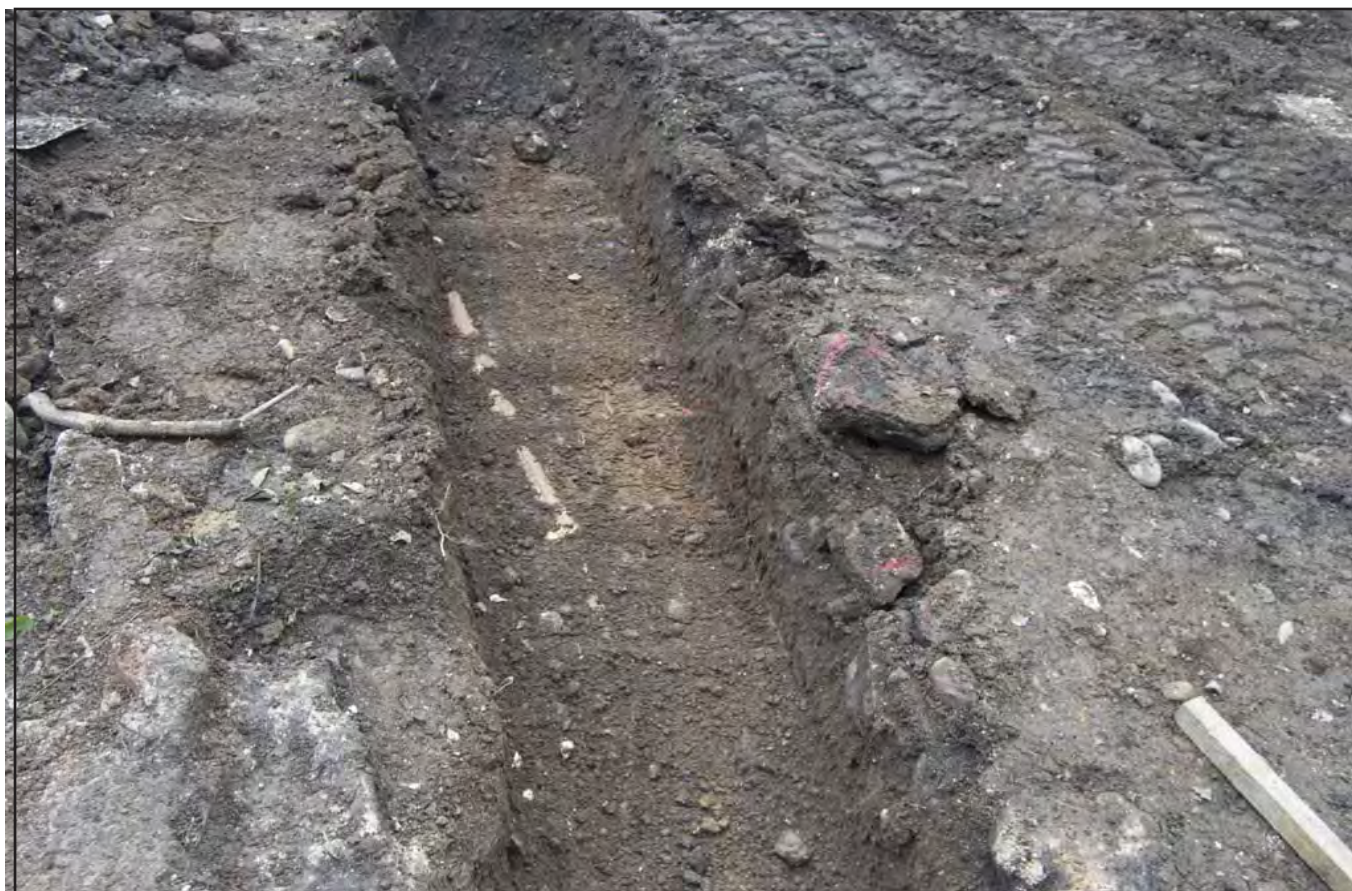
Plate 32: Length of central drainage trench showing modern waste pipe; scale not used; view from S (archive reference: G2766_063).

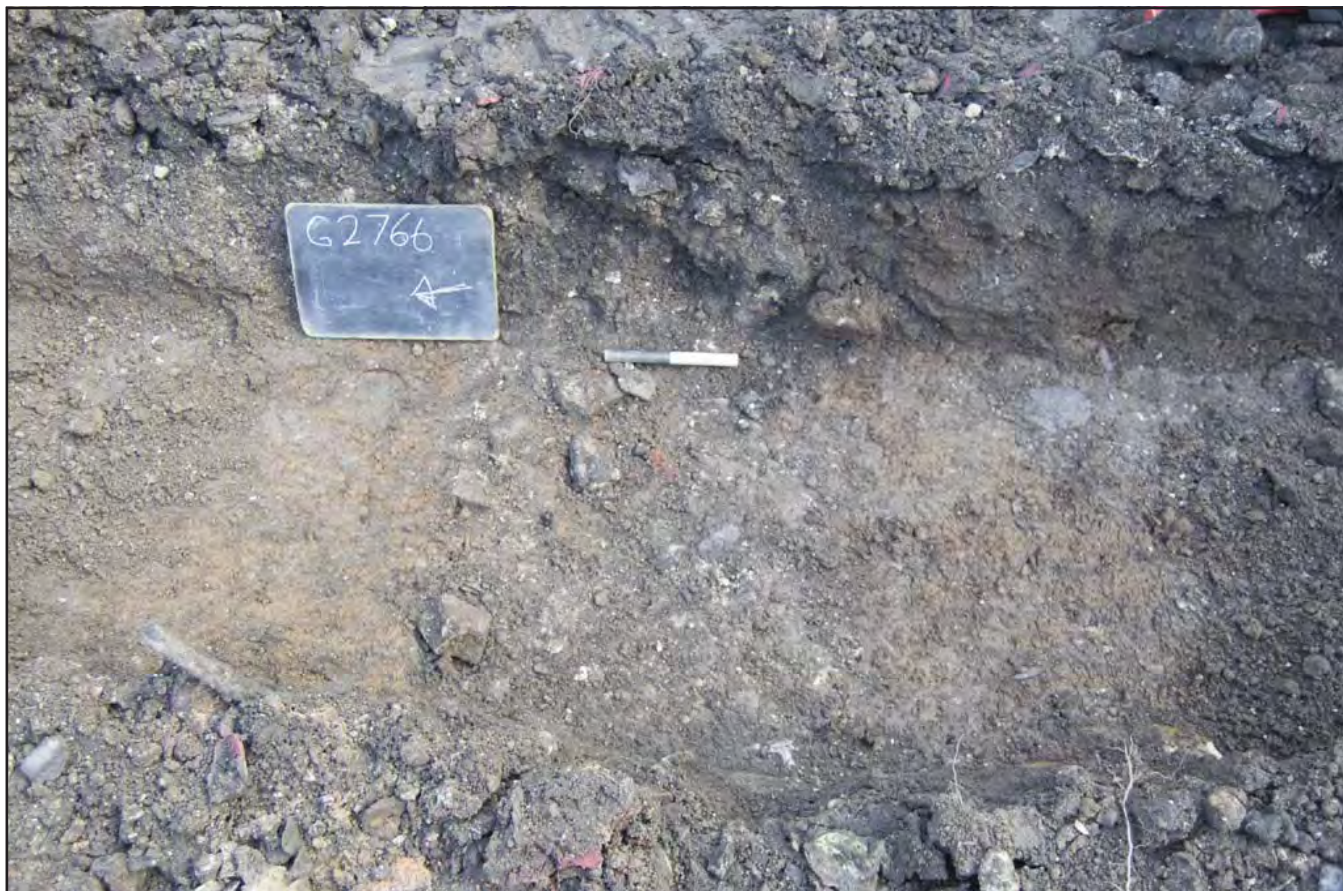
Plate 33: Remains of wall 125 in the base of central drainage trench; scale 1x 0.3m; view from W (archive reference: G2766_064).

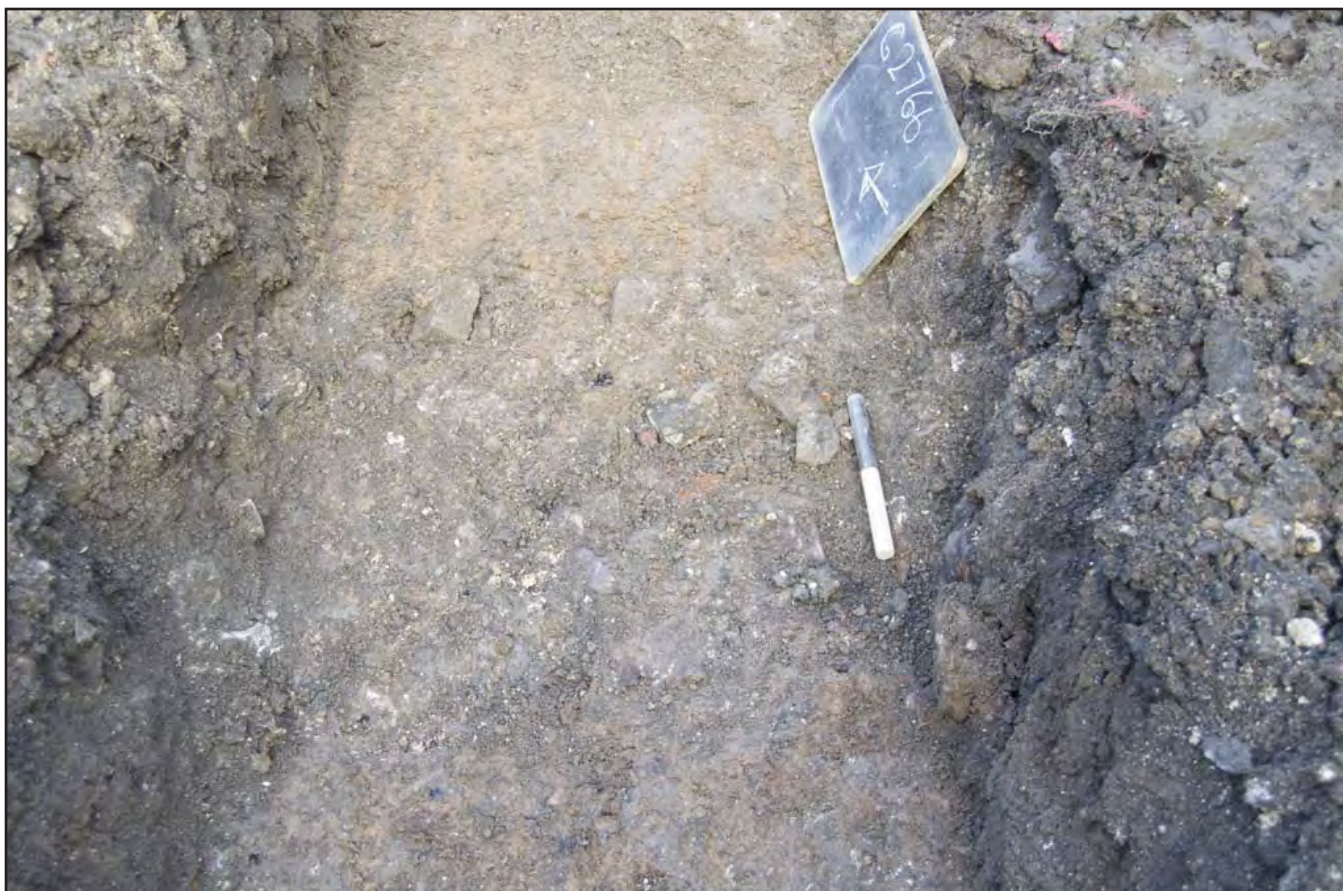
Plate 34: Remains of wall 125 in the base of central drainage trench; scale 1x 0.3m; view from S (archive reference: G2766_065).

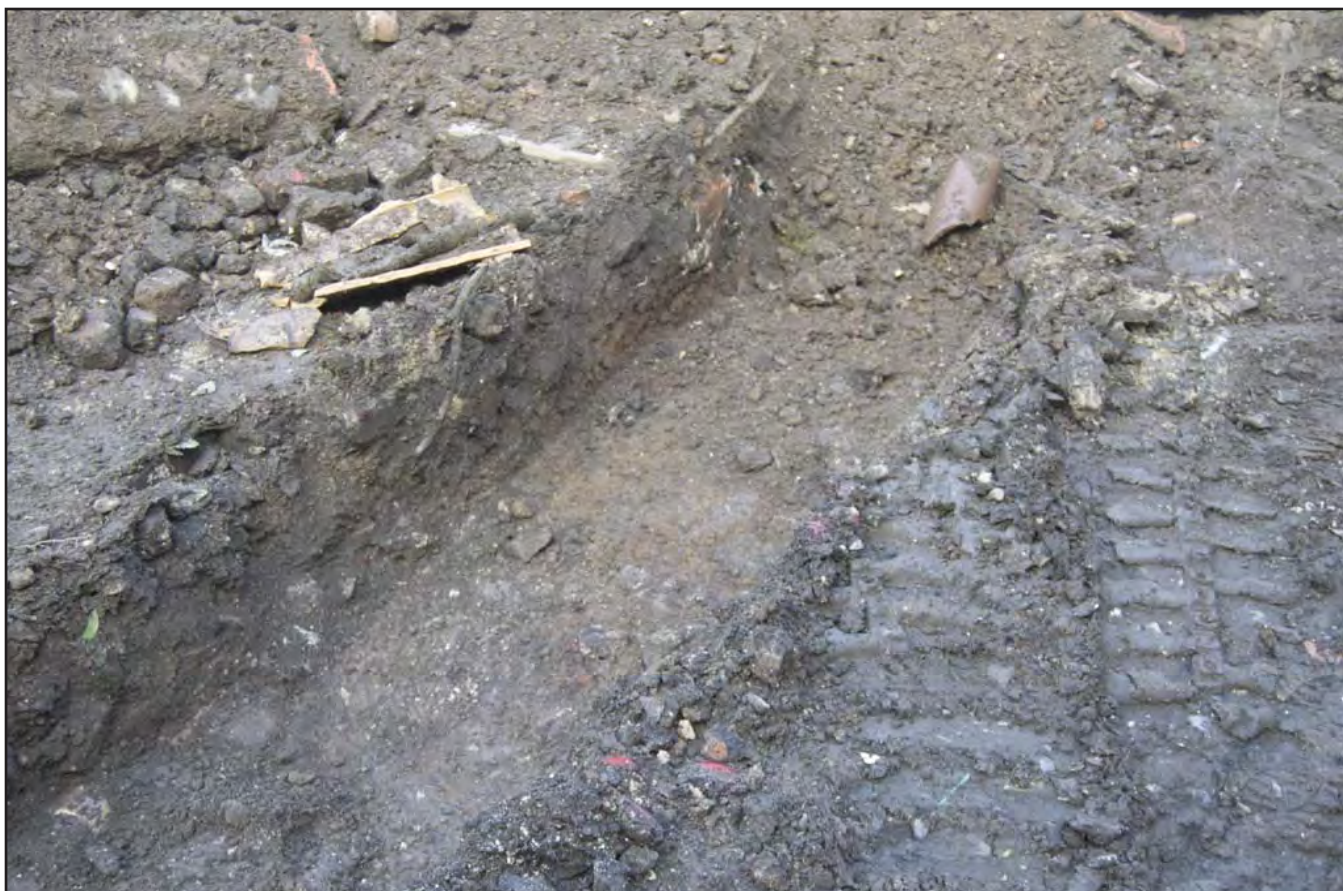
Plate 36: Remains of wall 125 in central drainage trench; scale not used; view from SE (archive reference: G2766_070).

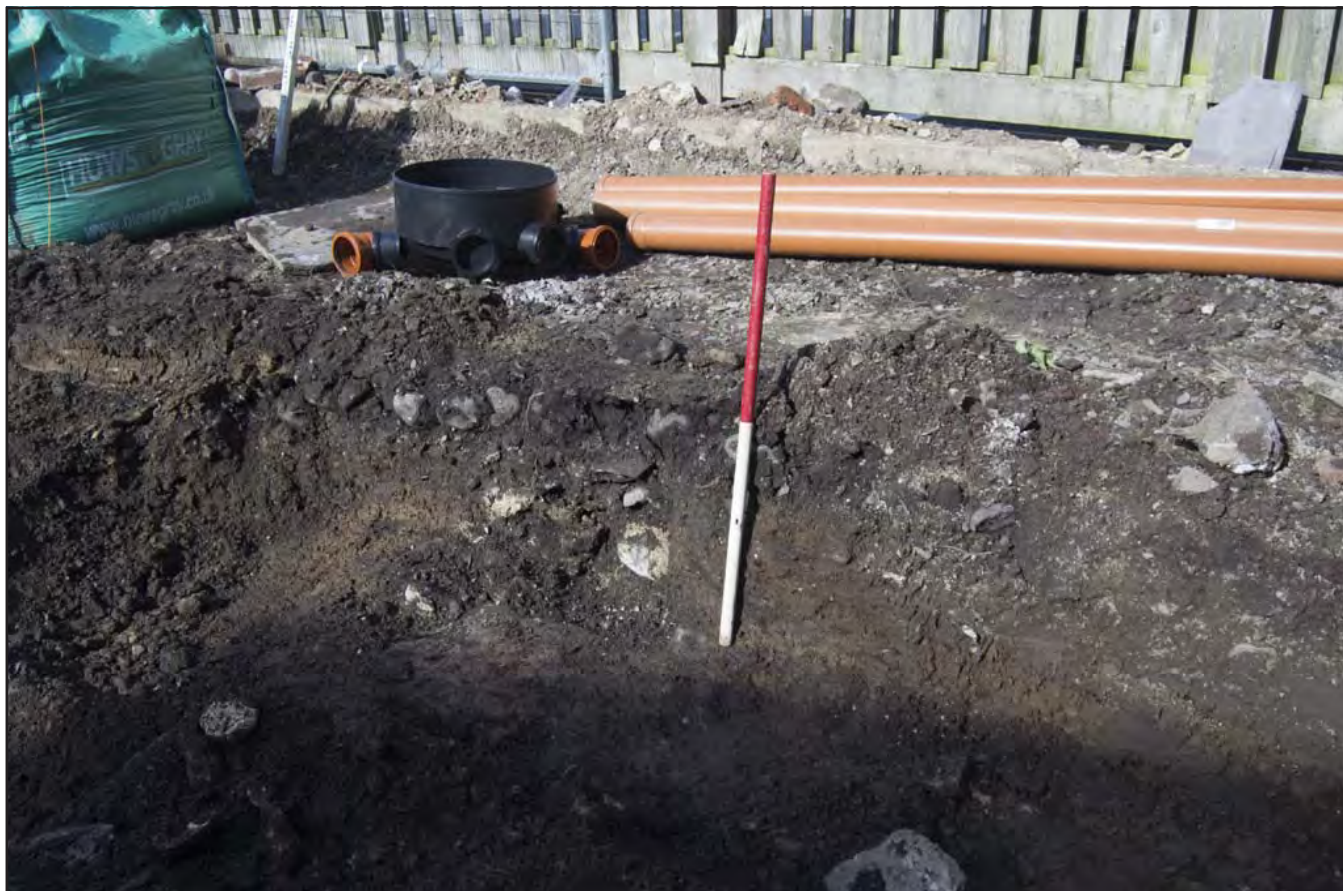
Plate 37: Remains of wall 125 in central drainage trench; scale 1x1m; view from SSE
(archive reference: G2766_074).

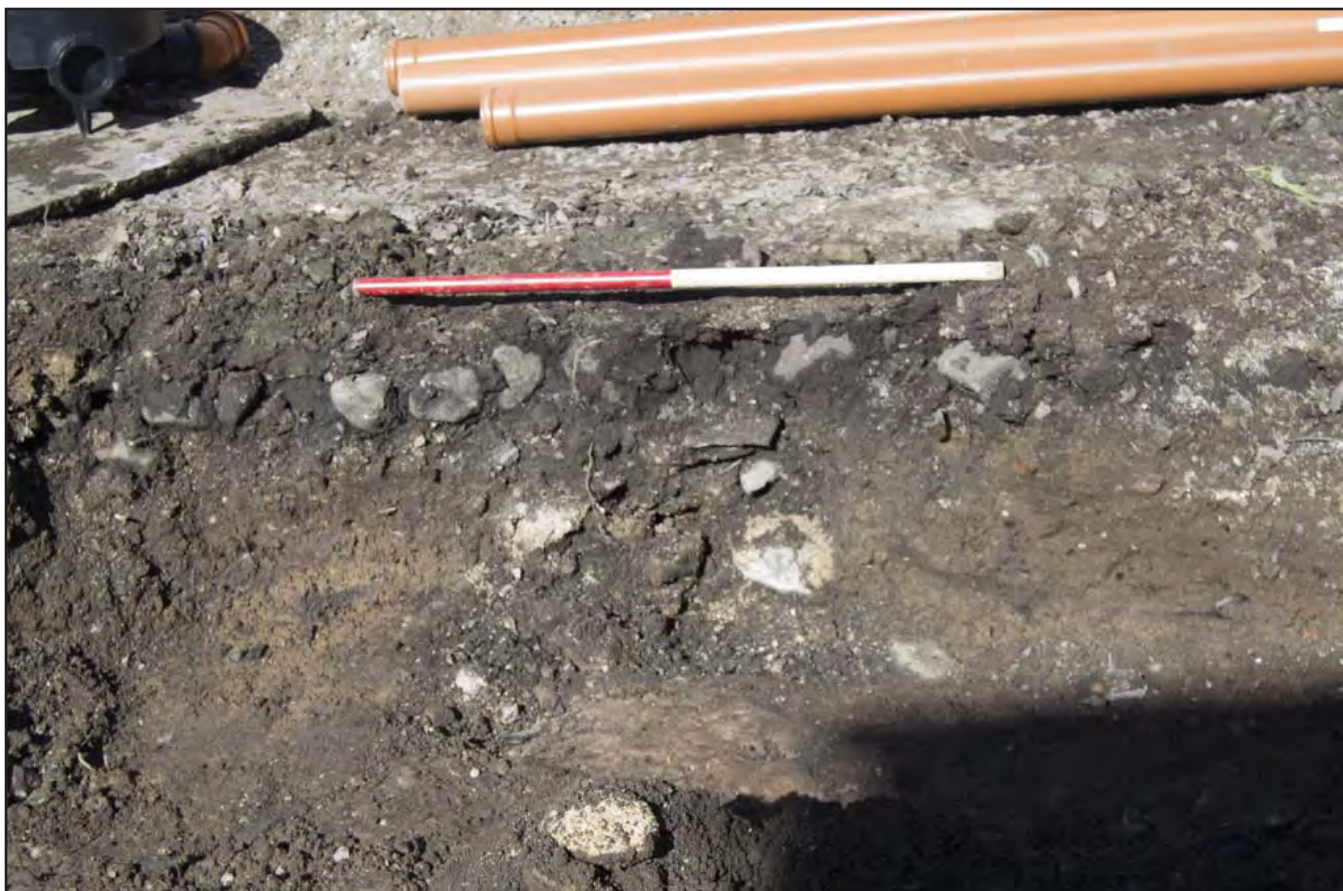
Plate 38: Remains of wall 125 in central drainage trench; scale 1x1m; view from S
(archive reference: G2766_075).

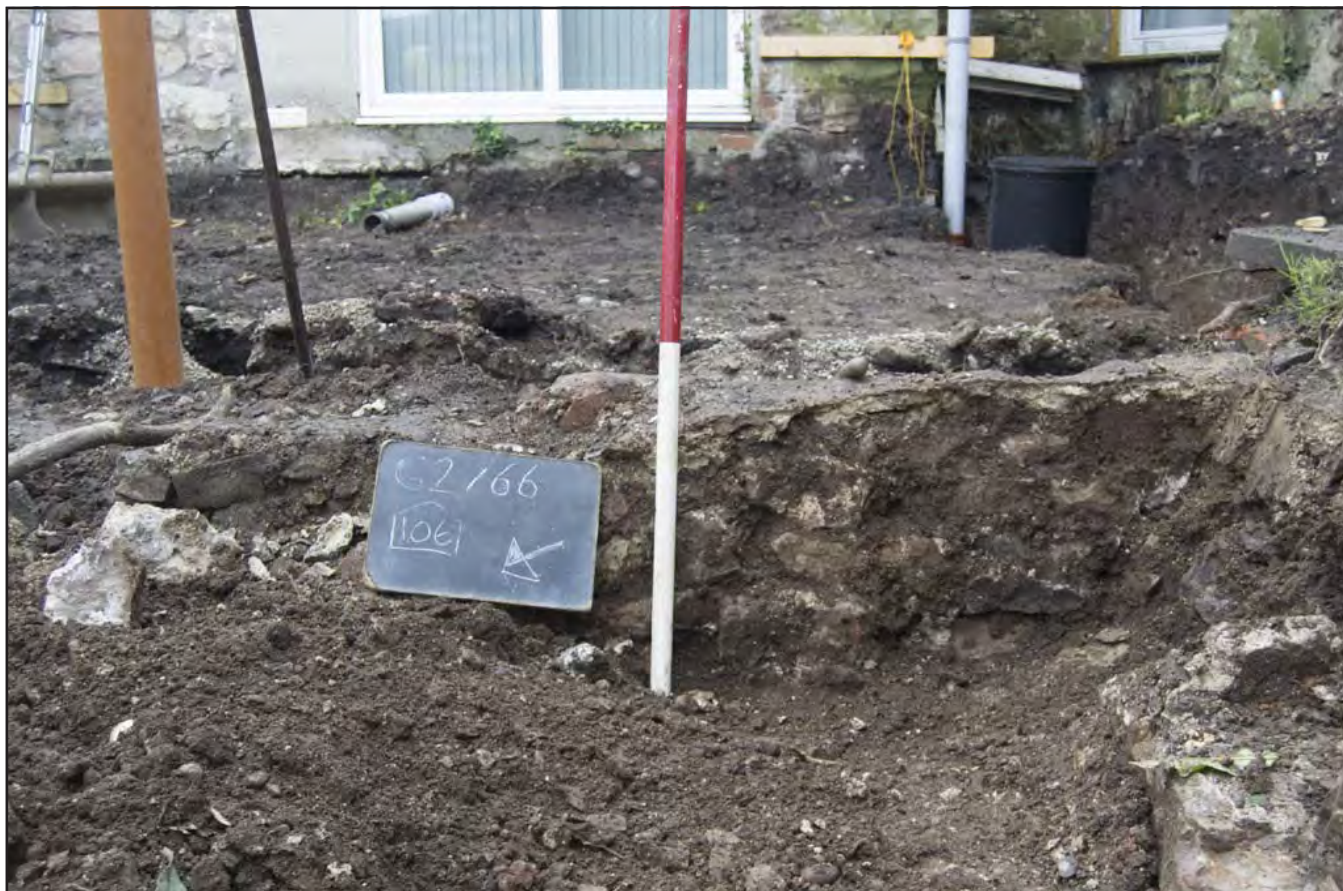
Wall {106} was partly removed to accommodate the southern foundation cut for the extension area; this exposed a depth of 0.48m and further characterised the wall, showing the use of stone and brick fragments in its construction (cf. Plates 39 to 41). The remainder of the southern foundation cut exposed garden soil (cf. Plates 42 and 43), whilst the remainder of the northern foundation cut exposed a more compacted soil and a modern drainage cut.

Plate 39: NW elevation of wall 106 in southern footings; scale 1x1m; view from NW (archive reference: G2766_077).

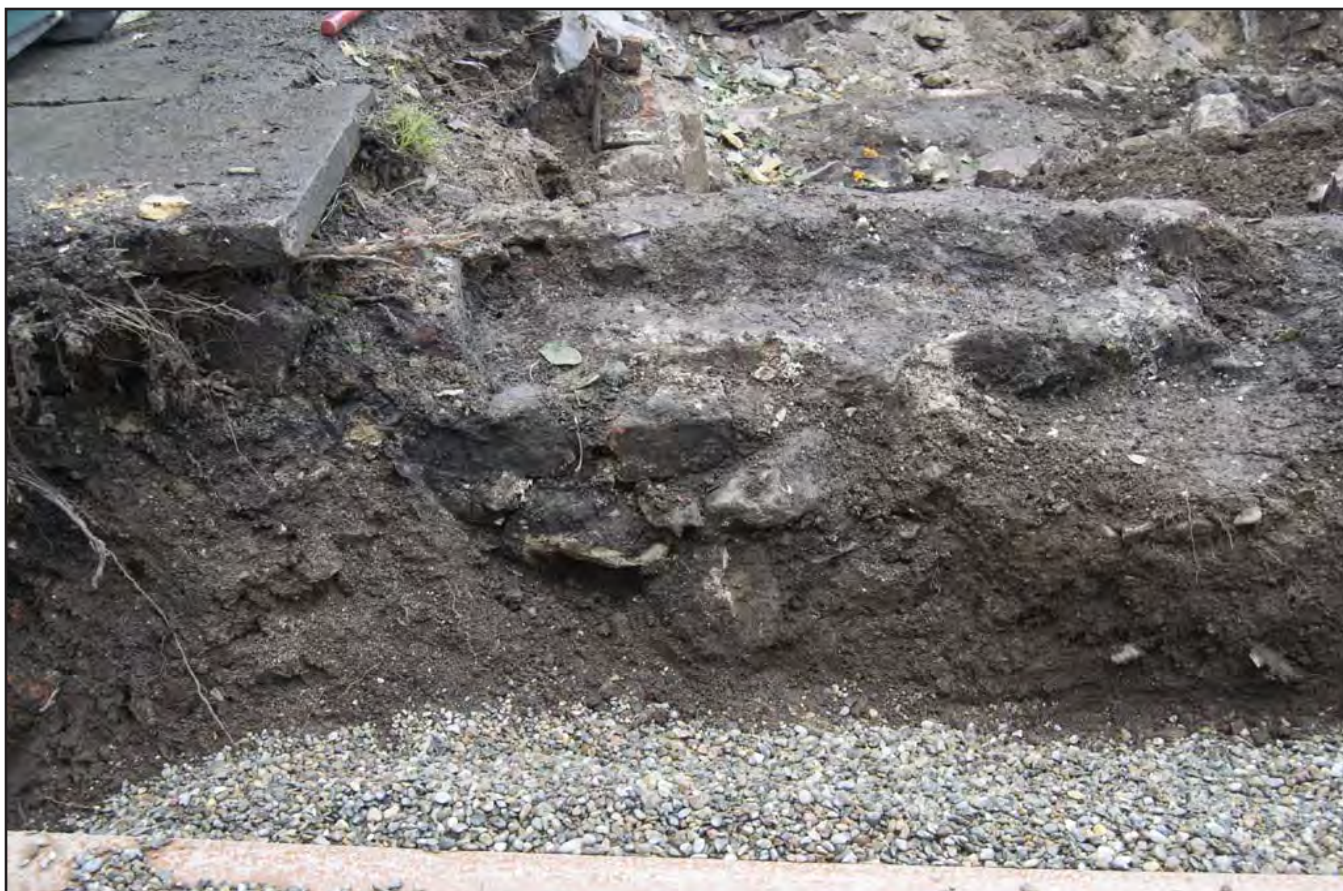
Plate 40: East facing elevation of 106; scale not used; view from E (archive reference: G2766_079).
