BANGOR STREET, CAERNARFON

Brîff Gwyllo Archaeolegol / Archaeological Watching brief

Rhif y Prosiect / Project Number: G2766

Rhif yr adroddiad / Report Number: 1720

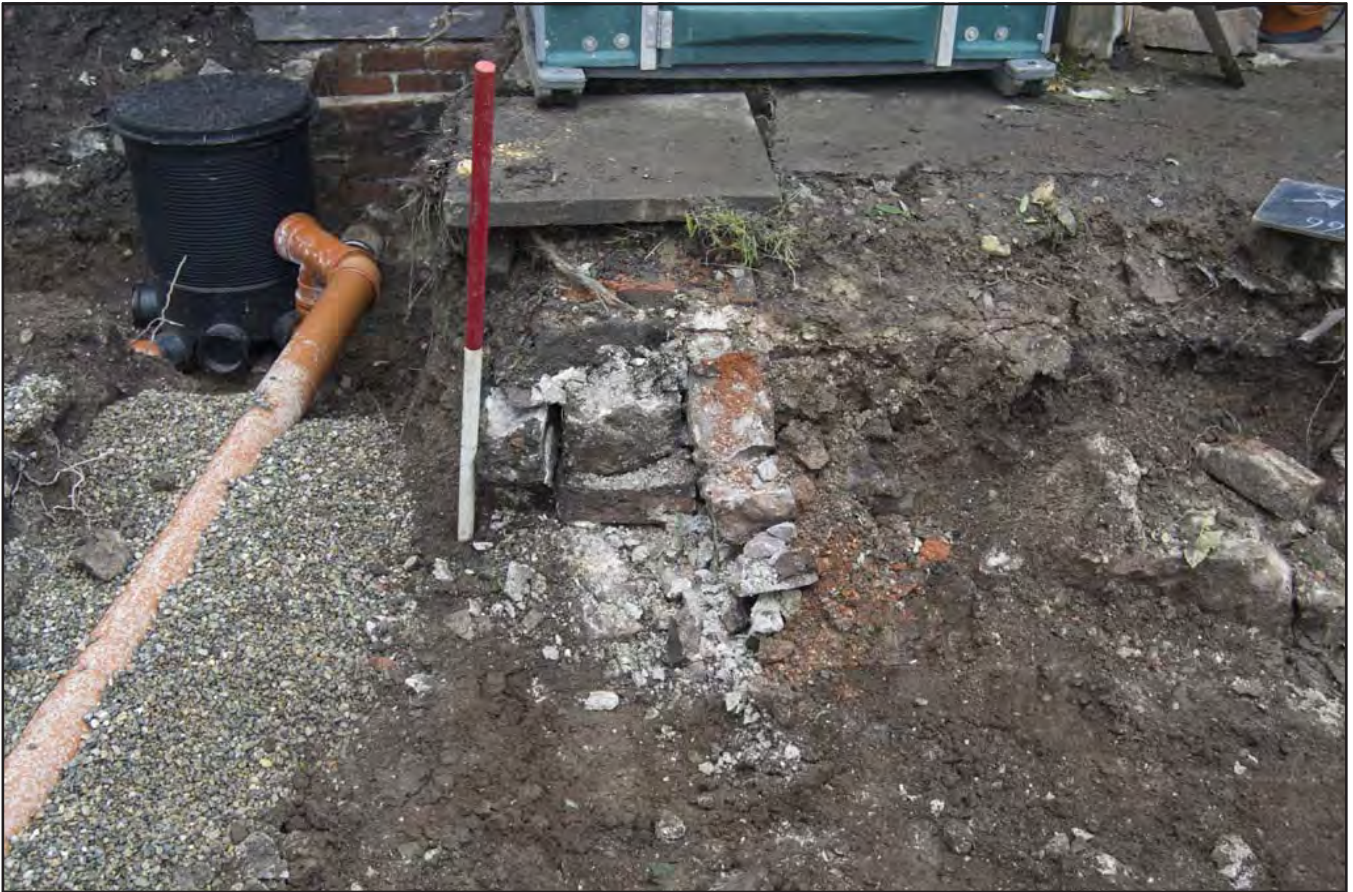
Wall {106} was partly removed to accommodate the southern foundation cut for the extension area; this exposed a depth of 0.48m and further characterised the wall, showing the use of stone and brick fragments in its construction (cf. Plates 39 to 41). The remainder of the southern foundation cut exposed garden soil (cf. Plates 42 and 43), whilst the remainder of the northern foundation cut exposed a more compacted soil and a modern drainage cut.

Plate 41: North facing elevation of 106 partially removed; scale 1x1m; view from N (archive reference: G2766_084).

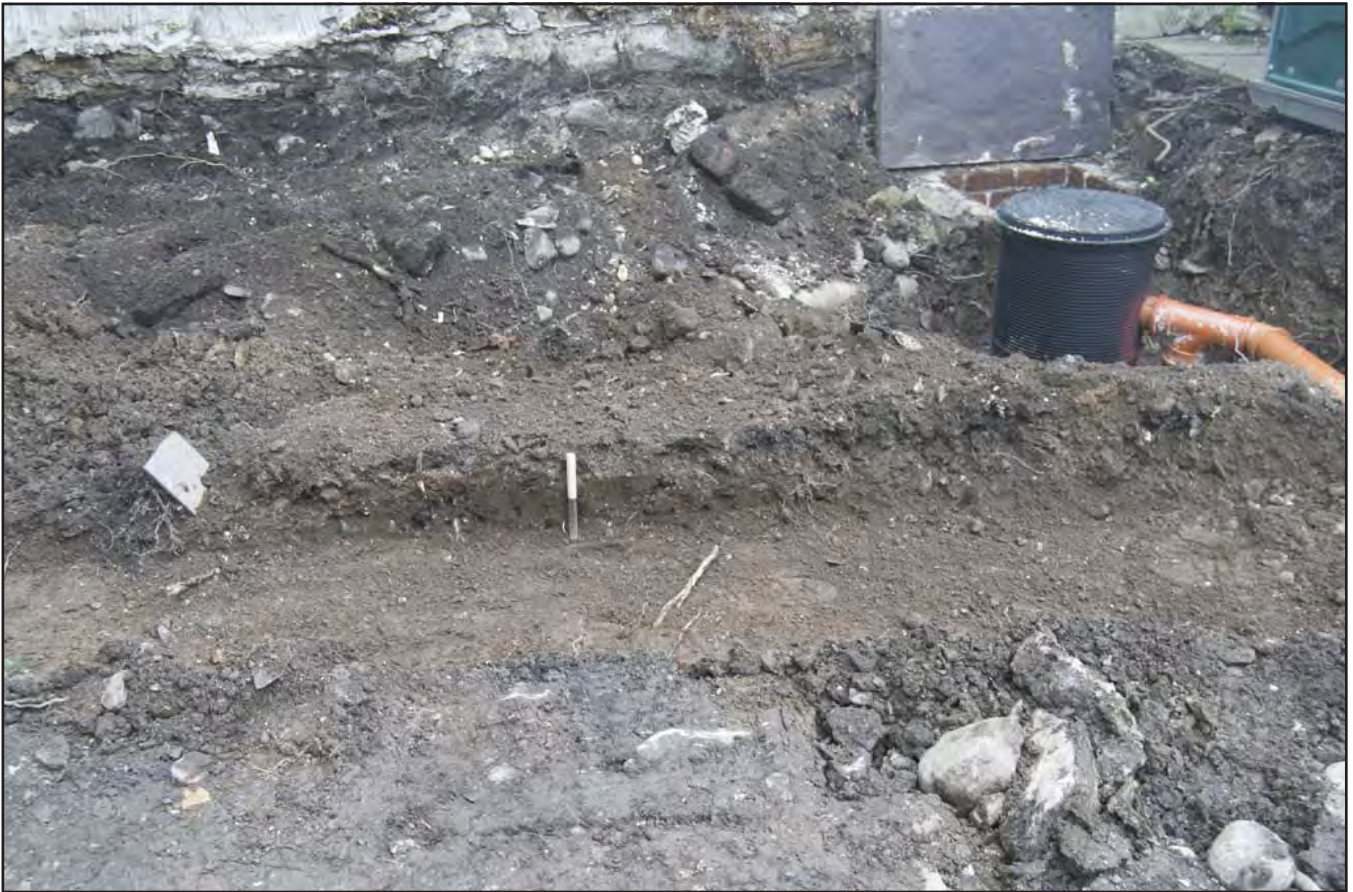
Plate 43: Layers of former yard surface in southern foundation trench; scale 1x 0.3m; view from N (archive reference: G2766_088).

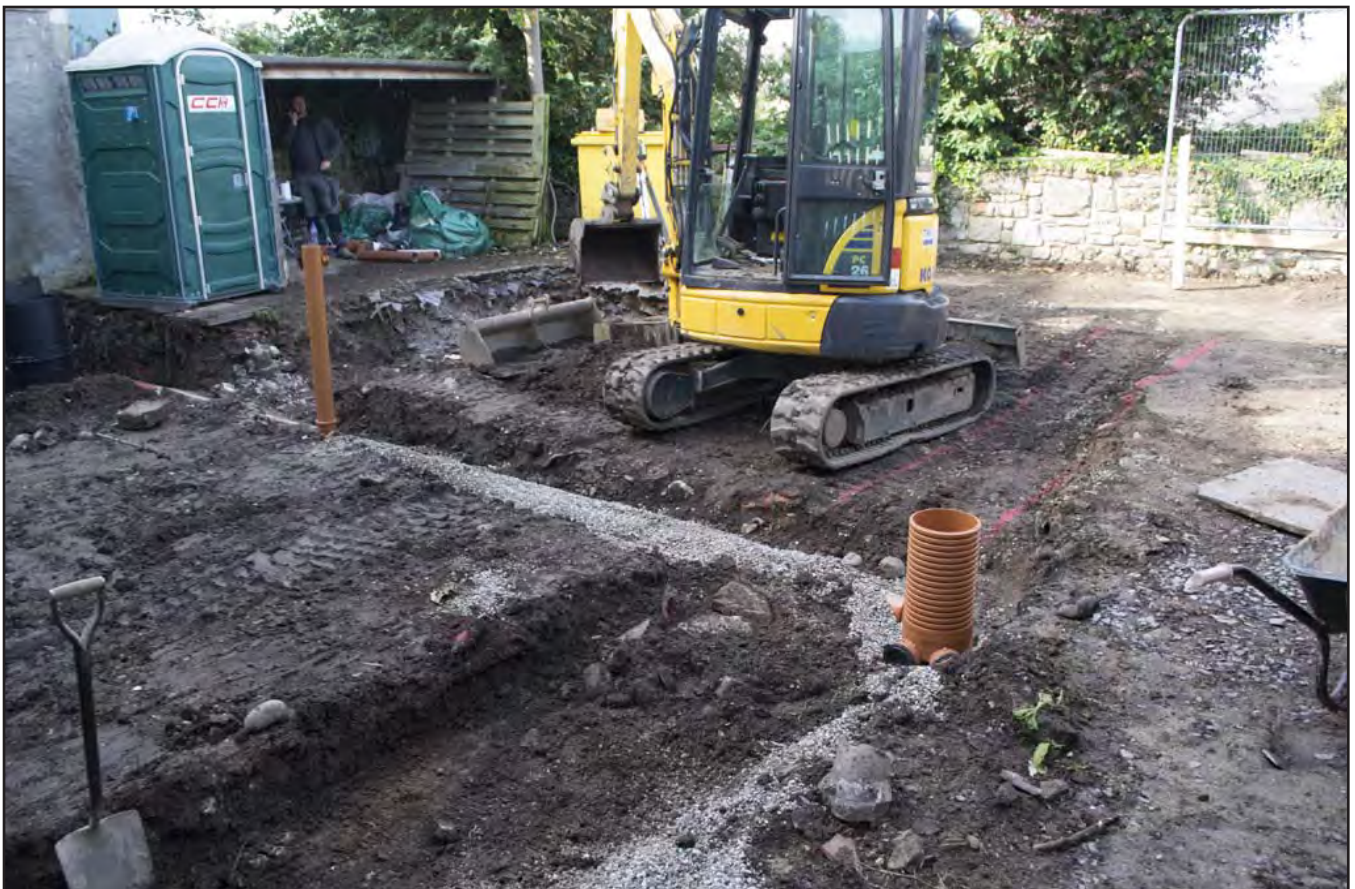
Plate 44: View from northeast of foundation trench (northern end) showing in-situ irregular shaped stones; not structural; scale not used; view from NE (archive reference: G2766_093).

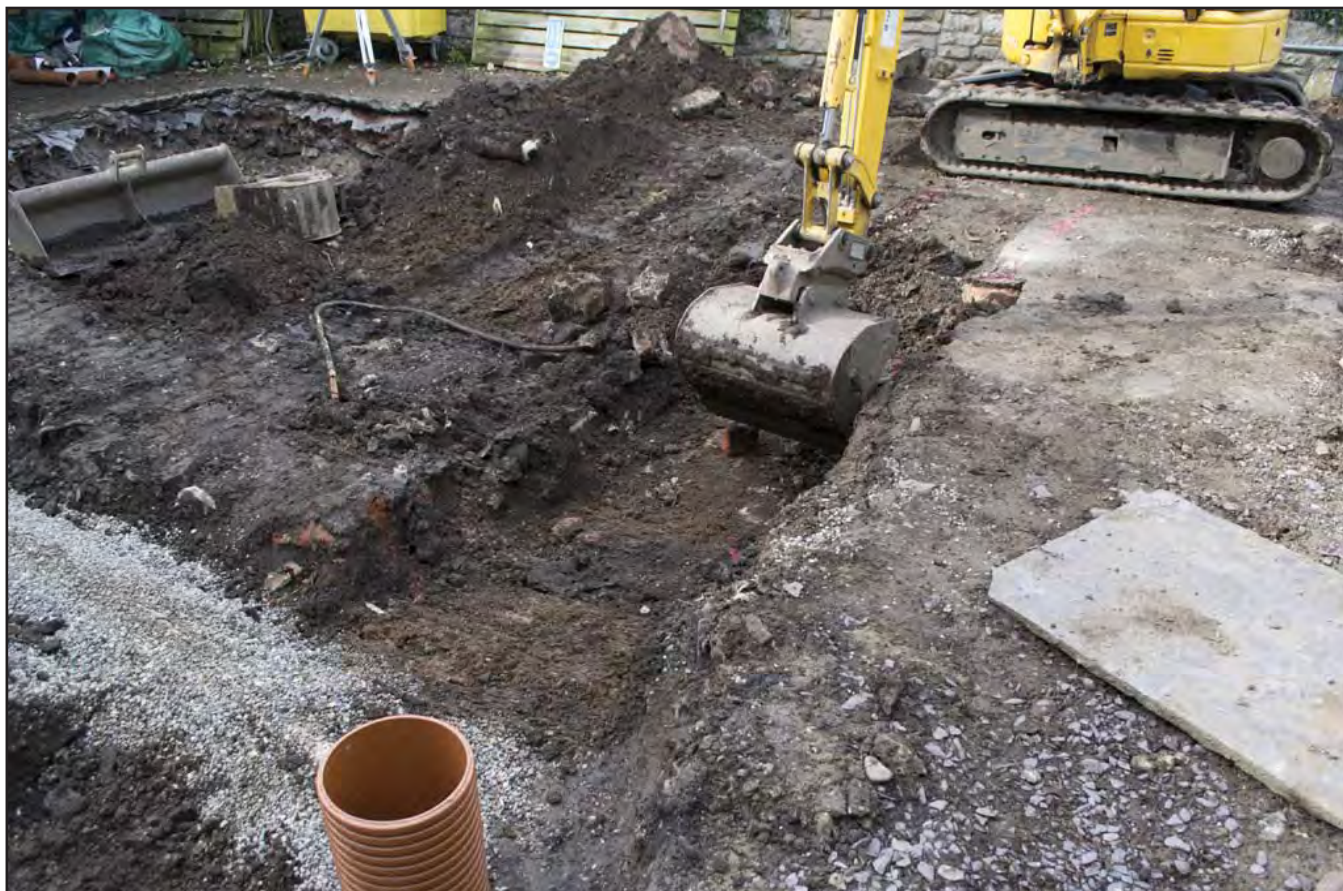
Plate 45: View from northeast of foundation trench (northern end) detailing modern drainage cut; scale not used; view from SE (archive reference: G2766_096).
