A470(T) CANCOED TO MINFFORDD
IMPROVEMENT
ARCHAEOLOGICAL RECORDING (G1336)

REPORT NO. 172

Ymddiriedolaeth Archaeolegol Gwynedd
Gwynedd Archaeological Trust

prepared for Welsh Office Highways Directorate

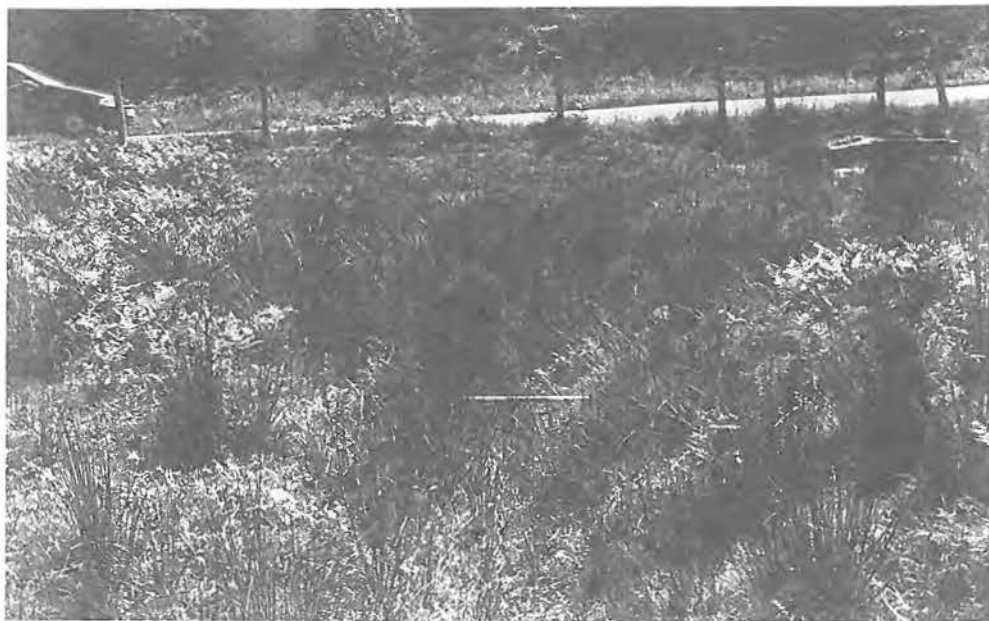
Plate 2 - Site 48: Depression, view from W (G1336/1/21)

This site is visible as an amorphous shaped depression, nearly rectangular, measuring, at the top, 6.9 m long and 3.9 m wide and between 0.5 and 0.7 m deep. A curving channel enters the depression from the west. The details of the site are shown in fig. 2b. The area is extremely boggy and it is likely that the rectangular feature forms part of a relatively recent drainage system. A number of inter-connecting drainage ditches are located in the area. Adjacent to the south and west are the remains of a raised causeway with evidence of stone metalling, also visible are a number of scoops (the largest c. 17 m across) probably associated with the construction of the causeway. This appears to be a redundant length of road connecting the main road with the trackway which leads north-west to the early 19th century route between Blaenau Ffestiniog and Pont Sarn-ddu, via the farm of Hen Gorddian.

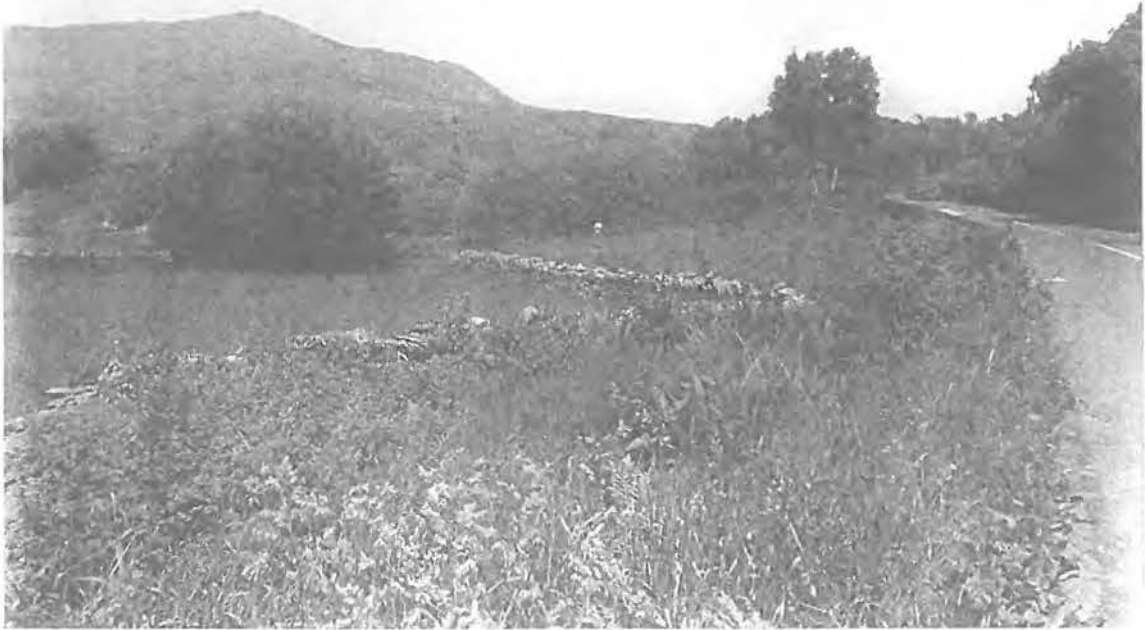
Plate 5 - Site 51: Location, view from S (G1336/2/3)

A roughly "L" shaped length of walling running north from the A470(T) south-west of the railway bridge and west of Bertheos. The wall is constructed of a mixture of quarried local stone and field clearance material. It stands to a height of c. 1.5m and retains an upright capping along most of its length. This drystone field boundary is typical of local work of the 18th and early 19th century.

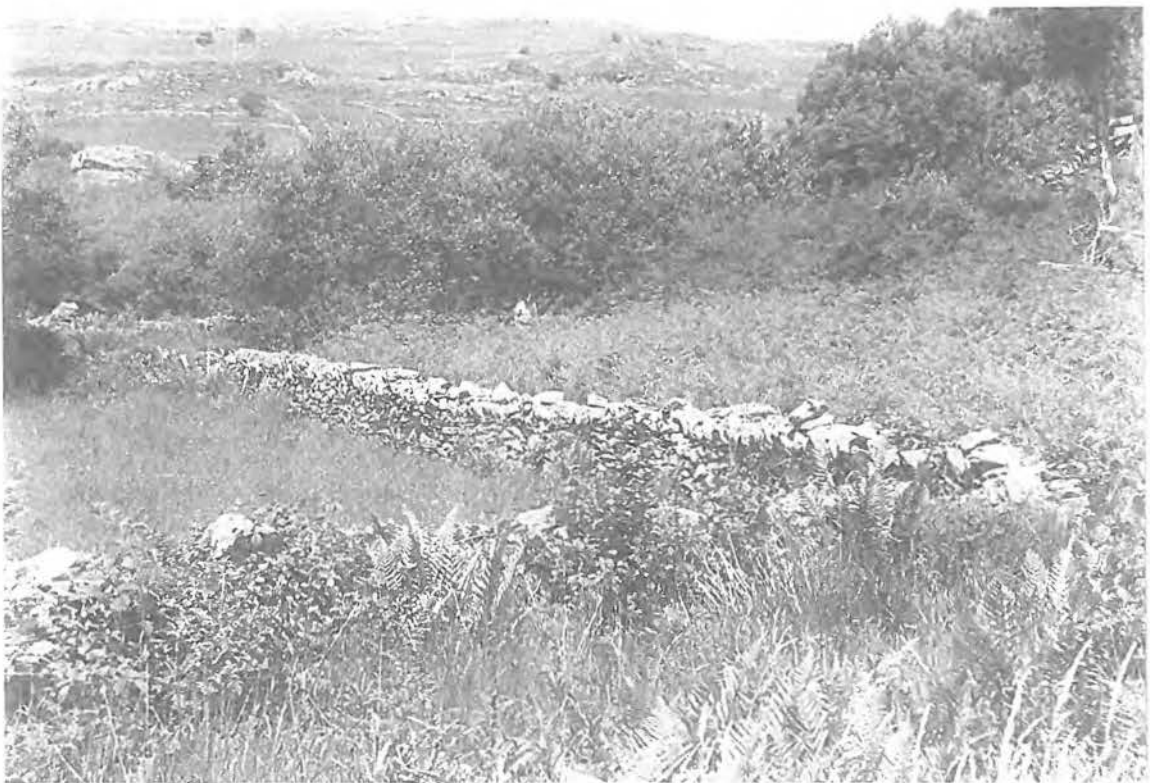
Plate 6 - Site 51: Drystone field wall, from S (G1336/2/4)

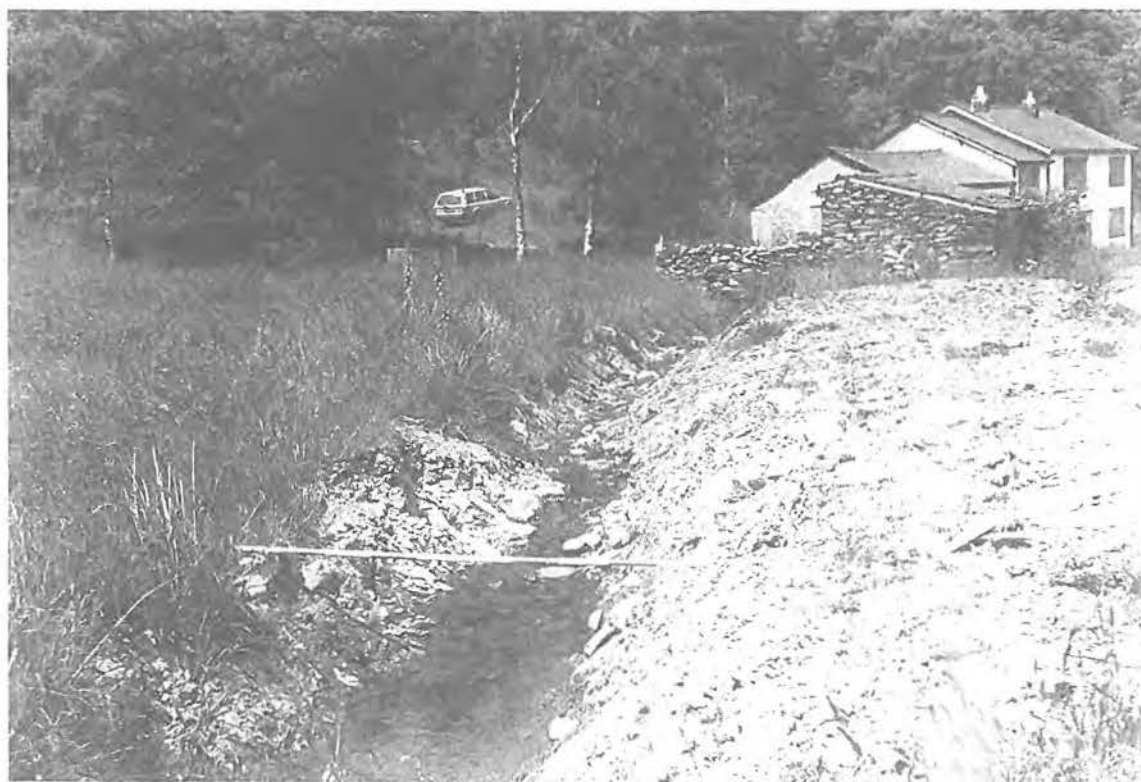
Plate 7 - Site 55: Mill race, view towards Bod unig (G1336/2/7)

The mill race runs north from the Afon Lledr, where water originally entered via a sluice gate, passing just west of the small stone structure and the house of Bod unig, then curving round to the north-east, where it would have driven a wheel situated against the south elevation of the woollen factory. The original race has been partially destroyed towards its south end, by infilling and re-cutting, but sufficient remains to allow its construction to be examined. The feature varies in width, but is between 2.0 and 2.0m wide and up to 1.0m in depth.

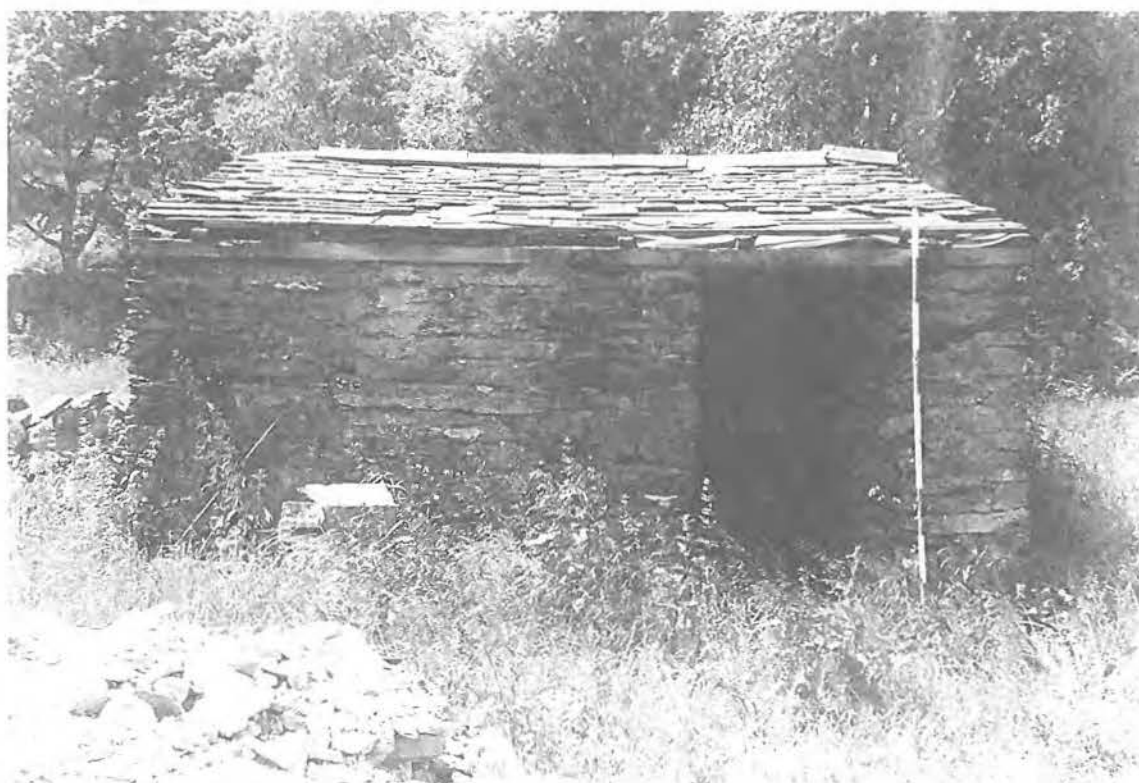
Plate 8 - Site 55: Small structure, SE elevation (G1336/2/11)

South of Bod unig and just to the east of the mill race lies a small structure 4.3 long by 3.97m wide, walls 0.5m thick. It is roughly rectangular in plan with a curved south-east corner. Its main axis runs northeast - southwest. A small compound is situated adjacent to the west of the structure; open along its north side, its west and south sides are delineated by a drystone wall which abuts the curved south east-corner of the building. The mill race continues diagonally through the compound, passing under the southern enclosure wall. The wall is carried over the mill race, supported by a lintel set on rough boulder piers.

The small structure is constructed largely of drystone masonry. Evidence of 2 phases of construction was noted: the height and length of the original structure had been increased, while the positions of the gable walls were left un-altered. In its final phase, the originally single pitched roofed building gained a concrete floor, and a slate roof with red ceramic ridge tiles, mainly pitched as before towards the east, though now, in addition, a slight pitch towards the west. There are window openings in the north-west and north-east walls, the entrance lies at the east end of the south-east elevation and measures 0.95 X 1.84 (to the base of its softwood lintel). A wall stub remains against the north end of the north-east elevation, the remains of an enclosure which once lay to the north-east of the building. The exact use of the building is unknown, but it may originally have been a duck house, and more latterly a storeshed.
