A55 BRYNGWRAN TO HOLYHEAD
(EAST SECTION)

ARCHAEOLOGICAL EVALUATION (G1367)

REPORT NO. 204

Ymddiriedolaeth Archaeolegol Gwynedd
Gwynedd Archaeological Trust

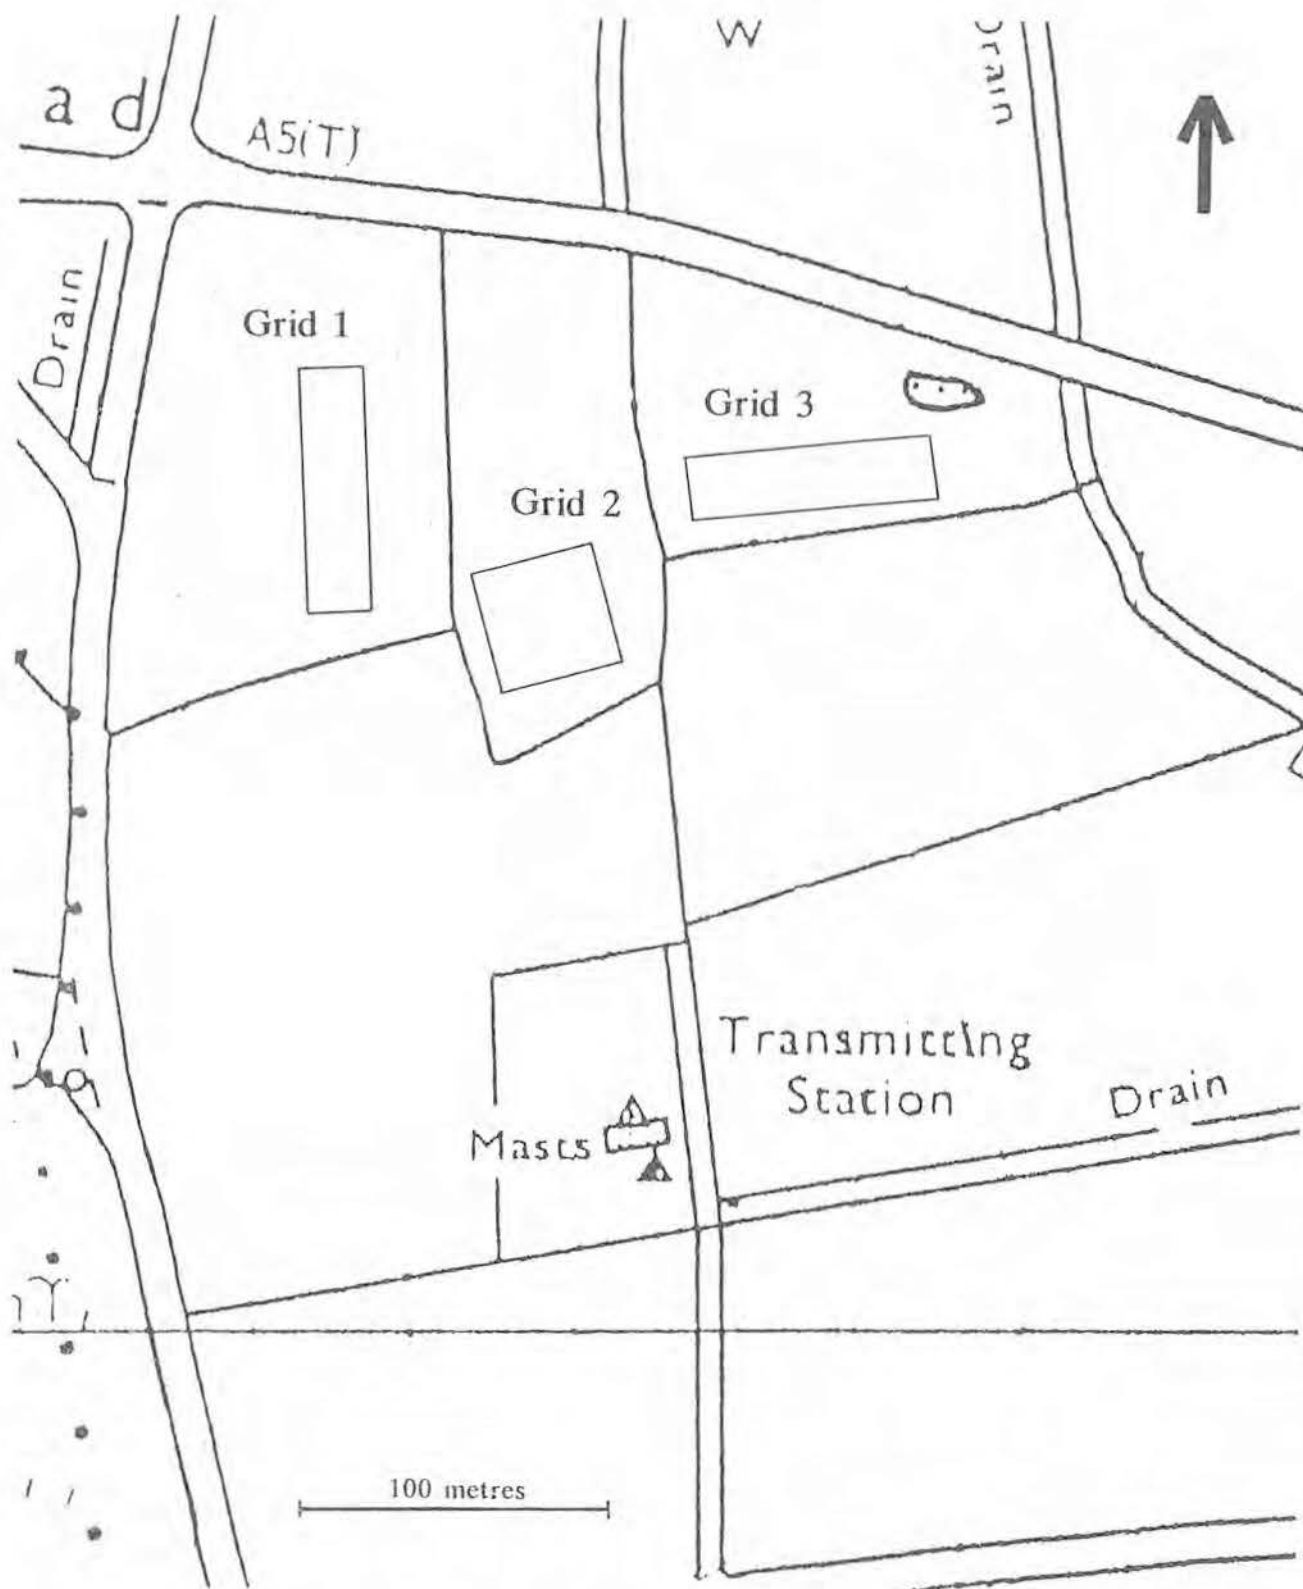
fig 6

A55 GRADIOMETER SURVEY Area 3

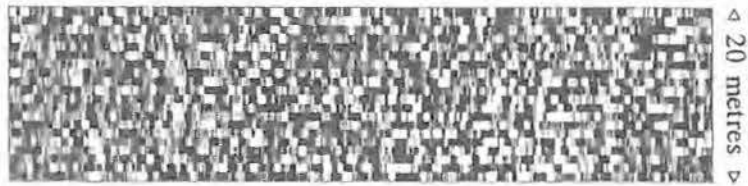
A55 GRADIOMETER SURVEY Area 3 / Grid 1

SHADE PLOT

Data clipped to -1 + 1 nT

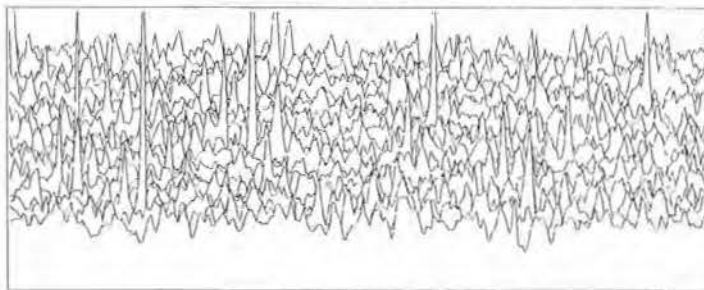
TRACE PLOT

Resolution 5.0 nT/cm
Hidden Line On

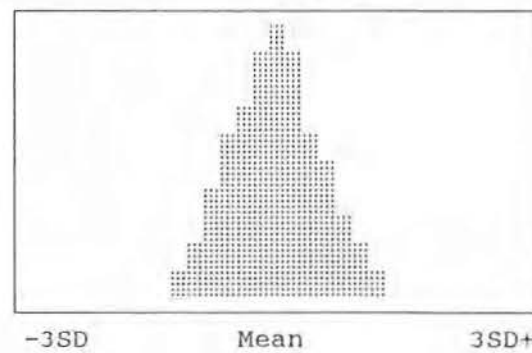
HISTOGRAM

Statistics			
Mean	0.00967	Dummies	0
SD	1.13811		
3 SD	3.41433		
Min.	-24.87867		
Max.	25.17534	Dum.Val.	2047.5

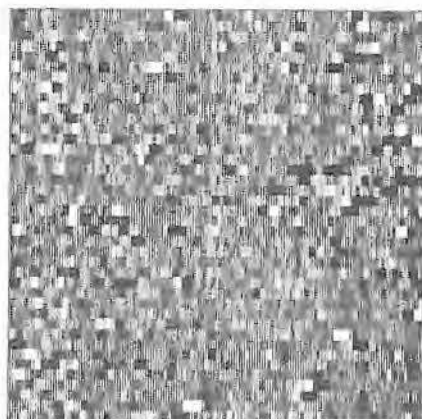
A55 GRADIOMETER SURVEY Area 3 / Grid 2

SHADE PLOT

Data clipped to -1 + 1 nT

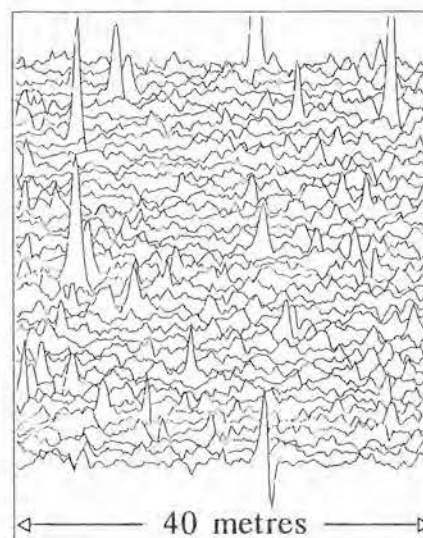
TRACE PLOT

Resolution 10.0 nt/cm
Hidden Line On

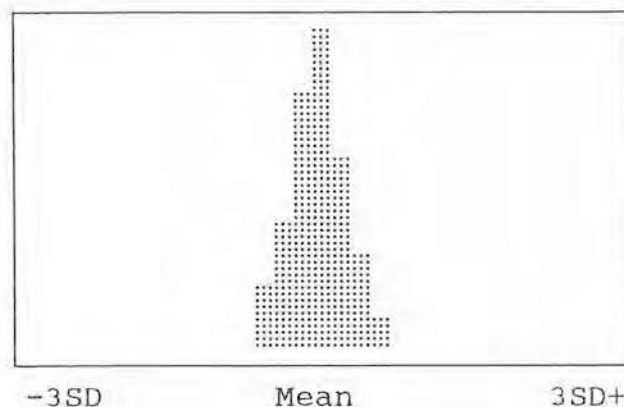
HISTOGRAM

Statistics			
Mean	0.07583	Dummies	0
SD	1.68962		
3 SD	5.06885		
Min.	-49.86183		
Max.	55.81515	Dum.Val.	2047.5

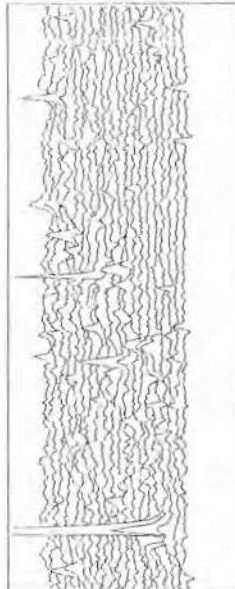
TRACE PLOT

Resolution 18.8 nt/cm
Hidden Line On

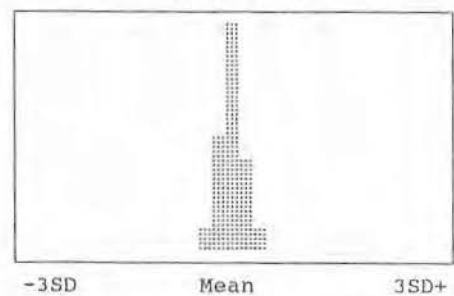
HISTOGRAM

Statistics			
Mean	0.02714	Dummies	0
SD	4.23456		
3 SD	12.70368		
Min.	-177.57101		
Max.	103.52898	Dum.Val.	2047.5

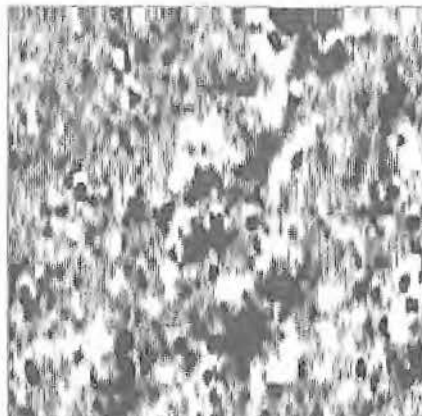
A55 GRADIOMETER SURVEY Area 1 / Grid 2

SHADE PLOT

Data clipped to -1 + 1 nT

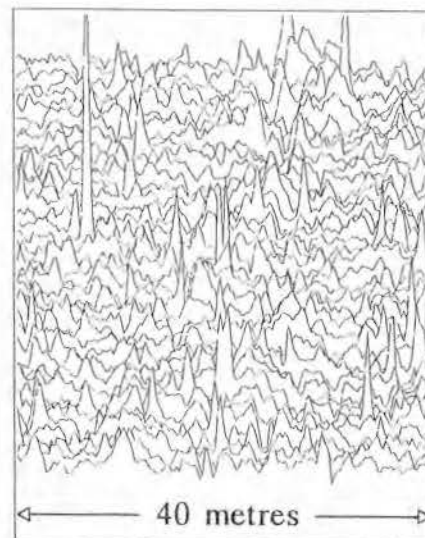
TRACE PLOT

Resolution 12.1 nt/cm
Hidden Line On

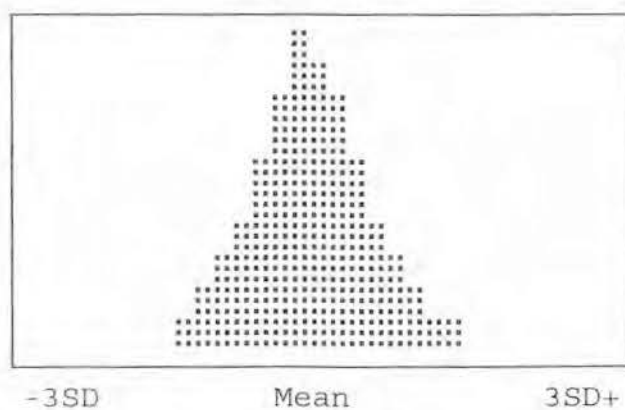
HISTOGRAM

Statistics			
Mean	0.07967	Dummies	0
SD	2.04883		
3 SD	6.14649		
Min.	-26.88539		
Max.	41.83533	Dum.Val.	2047.5

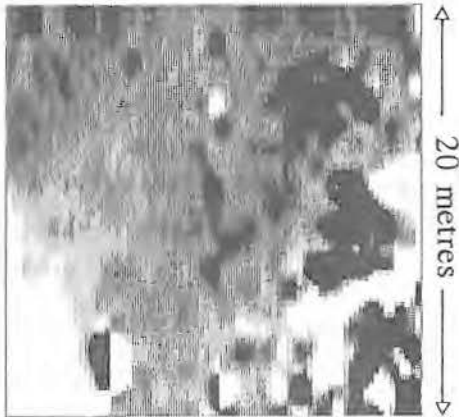
A55 GRADIOMETER SURVEY Area 2 / Grid 2

SHADE PLOT

Data clipped to -1 + 1 nT

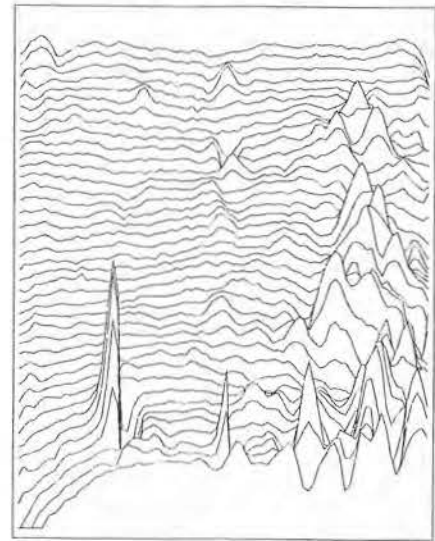
TRACE PLOT

Resolution 18.3 nT/cm
Hidden Line On

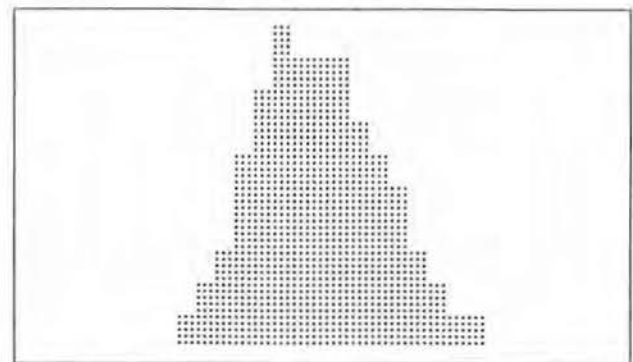
HISTOGRAM

Statistics			
Mean	0.00950	Dummies	0
SD	5.30761		
3 SD	15.92282		
Min.	-41.06925		
Max.	66.83075	Dum.Val.	2047.5
