LLANLLECHID STW - RISING MAIN
ARCHAEOLOGICAL RECORDING
AND MONITORING (G1363)

REPORT NO. 212

prepared for Dwr Cymru/Welsh Water

July 1996

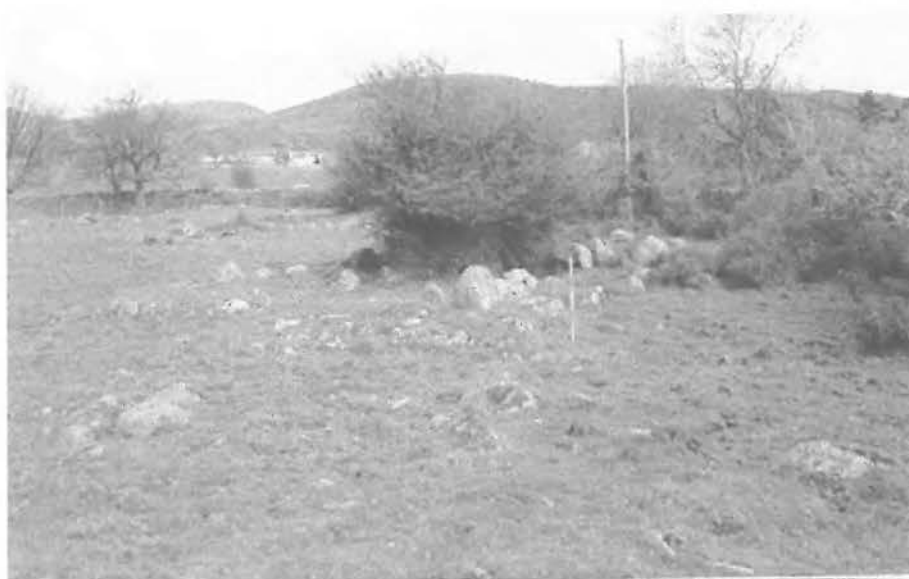
The structure measures approximately 16m by 8m externally, with walls 1m - 1.2m wide and up to 0.5m high. It is well built with orthostats facing the interior and exterior of the walls. The external corners are slightly rounded, and a slight boulder plinth is visible along the base of the south-west side. An entrance 1.90m wide lies in the centre of the north-east end. Another possible entrance (1.2m in width) lies in the north-west wall towards its north-east extent. The south-west angle of the structure appears to have been damaged, and is now partly breached.

The interior of the structure consists a single rectangular compartment measuring 13.5m by 5.2m, and orientated NW-SE. There are hints of internal features at the south-west end.

View of long hut (site 2) from west

This structure is most likely a dwelling house, of Medieval or immediately Post-medieval date (that is, occupied sometime between the 13th century and the 17th century). It is not marked on any of the available early maps, and the field name on the 1768 map is *Rhosydd* (i.e. moor land).

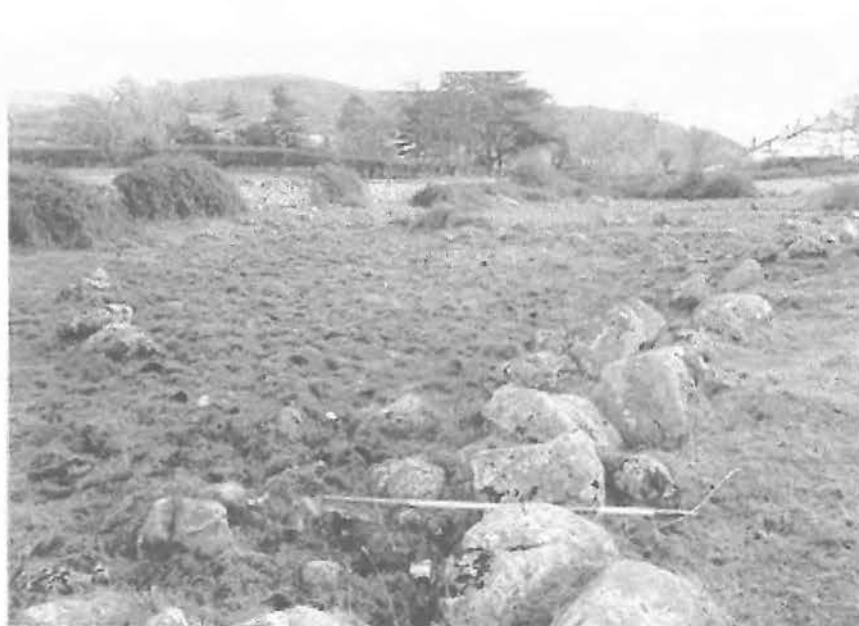
This site consists of lines of boulders, assumed to be the remains of wall foundations, located alongside a small stream. The walls are confined to an area of low-lying land some 190m by 40m forming the south-west side of the stream terrace. The area is bounded to the south-west by a moderately steep but low hill, the base of which has been revetted and enclosed by a length of meandering dry-stone boulder walling of one, though occasionally two courses in height (c. 0.18 - 0.6m in height). The exact form of the revetment wall has been obscured by collapse and dumping, however it ranges from between 2.0m - 3.0m in width.

A series of low dry-stone walls extend from the revetment wall to the north-east into the low-lying area towards the stream. The walls are mostly visible as single lines of boulders, although some have evidence of inner and outer facing and there is at least one stretch of walling formed by boulders set upright. The walls are fragmentary, but they remain up to 2m in width and 0.5m in height.

Although difficult to understand, the walls appear to have originally extended across the stream, and the extant boundary north-east of the stream which is in part of orthostatic construction may have originally been linked to them. They appear to have formed a series of small enclosures, and occasional platforms suggest the sites of buildings.

Site 1: looking north-east

It is very difficult to date the remains: the estate maps of the 18th and 19th centuries (see GAT Report No. 177) indicate very rapid changes during those centuries. The 1768 map suggests the area was part moor land, whereas the 1855 map shows the farm of Cefn Bedw south-west of the site, but this, along with its associated fields had completely disappeared by 1917, by which time the fields had been completely re-designed and laid out as rectangular enclosures. The revetment wall at the base of the slope is shown on the 1855 map, but the fragmentary walling alongside the stream is not indicated. Neither are shown on the 1768 map. The majority of the walling occupying the low lying area adjacent to the stream are not marked on any of the maps. Typological comparisons would suggest the walls may once have formed part of a late Prehistoric or Roman settlement, but this would need to be confirmed by excavation.
