LLANWENDA TO PENYGROES GAS PIPELINE

ARCHAEOLOGICAL RECORDING & WATCHING BRIEF (1506)

REPORT NO. 278

**Prepared for
BRITISH GAS - TRANSCO
December 1997**

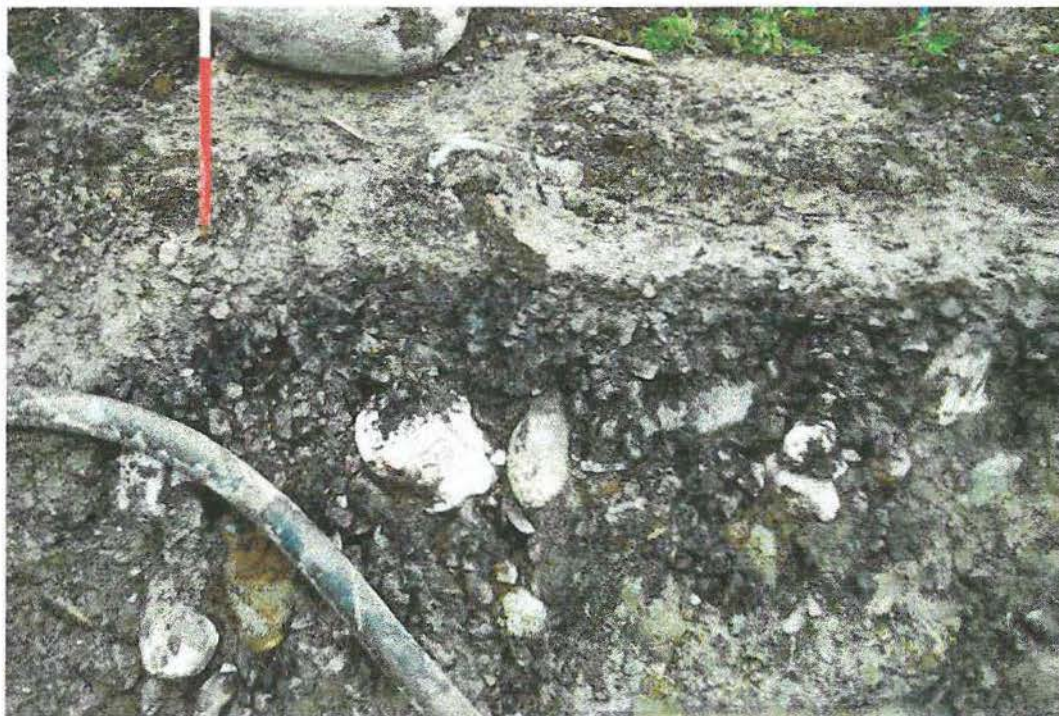
Plate 4 - Burnt mound during trenching

was recorded by photograph, written description and scaled drawings and was further examined and recorded during trenching. This showed the mound in section with a pit in the centre which would have contained the trough used for the cooking process (plate 4). A sample of charcoal obtained from the body of the mound was submitted to Beta Analytic Radiocarbon Dating Laboratory for analysis and resulted in a Radiocarbon Age Before Present of 3220 +/- 100. This date calibrated to 1 sigma was 1605-1400 BC and calibrated to 2 sigma was 1705-1265 BC. This gives a Mid Bronze Age date for the Cefn Hendre burnt mound.
