# **POOL SIDE DEVELOPMENT CAERNARFON**

**ARCHAEOLOGICAL EVALUATION (G1500)**

**Report No. 280**

**Prepared for  
WATKIN JONES & SON LTD  
January 1998**

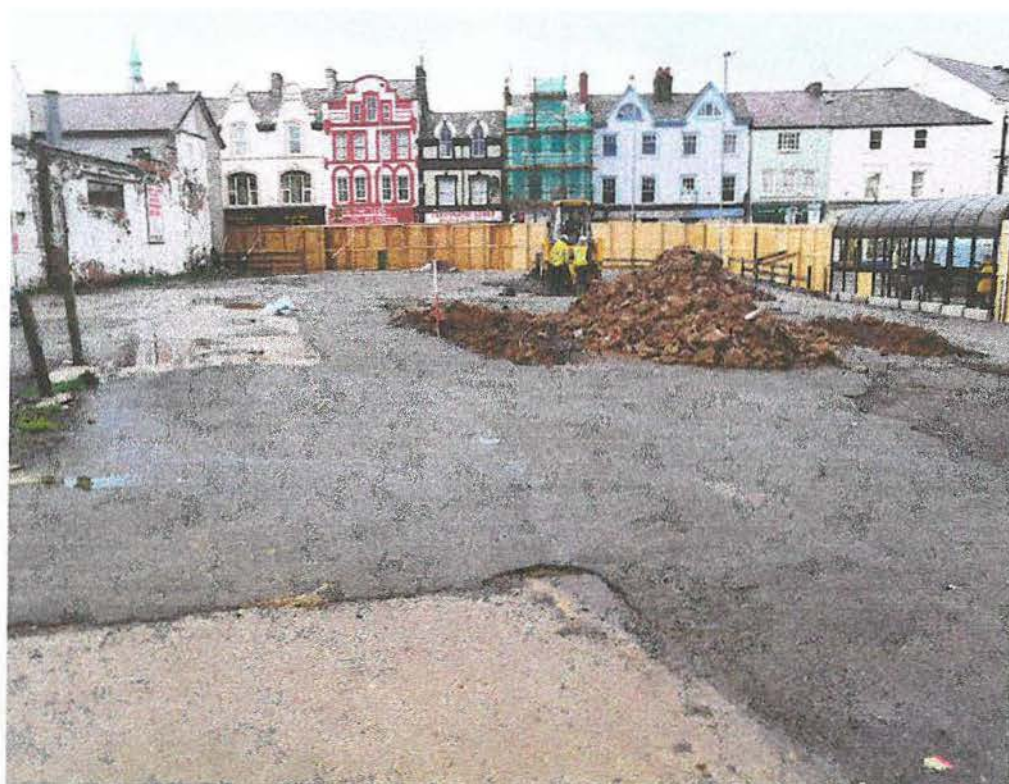
Caernarfon is situated on a peninsula projecting from the south shore of the Menai Strait between the estuaries of Afon Cadnant and Afon Seiont. The site is located to the north east of Caernarfon Castle centred at SH 48016274 between Pool Side to the north, Bridge Street to the west, Penllyn to the west and the properties on the north side of Pool Hill to the south. The site covers an area c. 50m by 25m oriented east-west with a surface of compacted rubble, partly tarmaced with areas of concrete.

Pool Side Caernarfon - Site prior to development - December 1997
