MOELFRE TO BENLLECH
SEWAGE PUMPING MAIN

REPORT NO. 281

MOELFRE - BENLLECH SEWAGE PUMPING MAIN (G1474)

Archaeological watching brief for Dwr Cymru

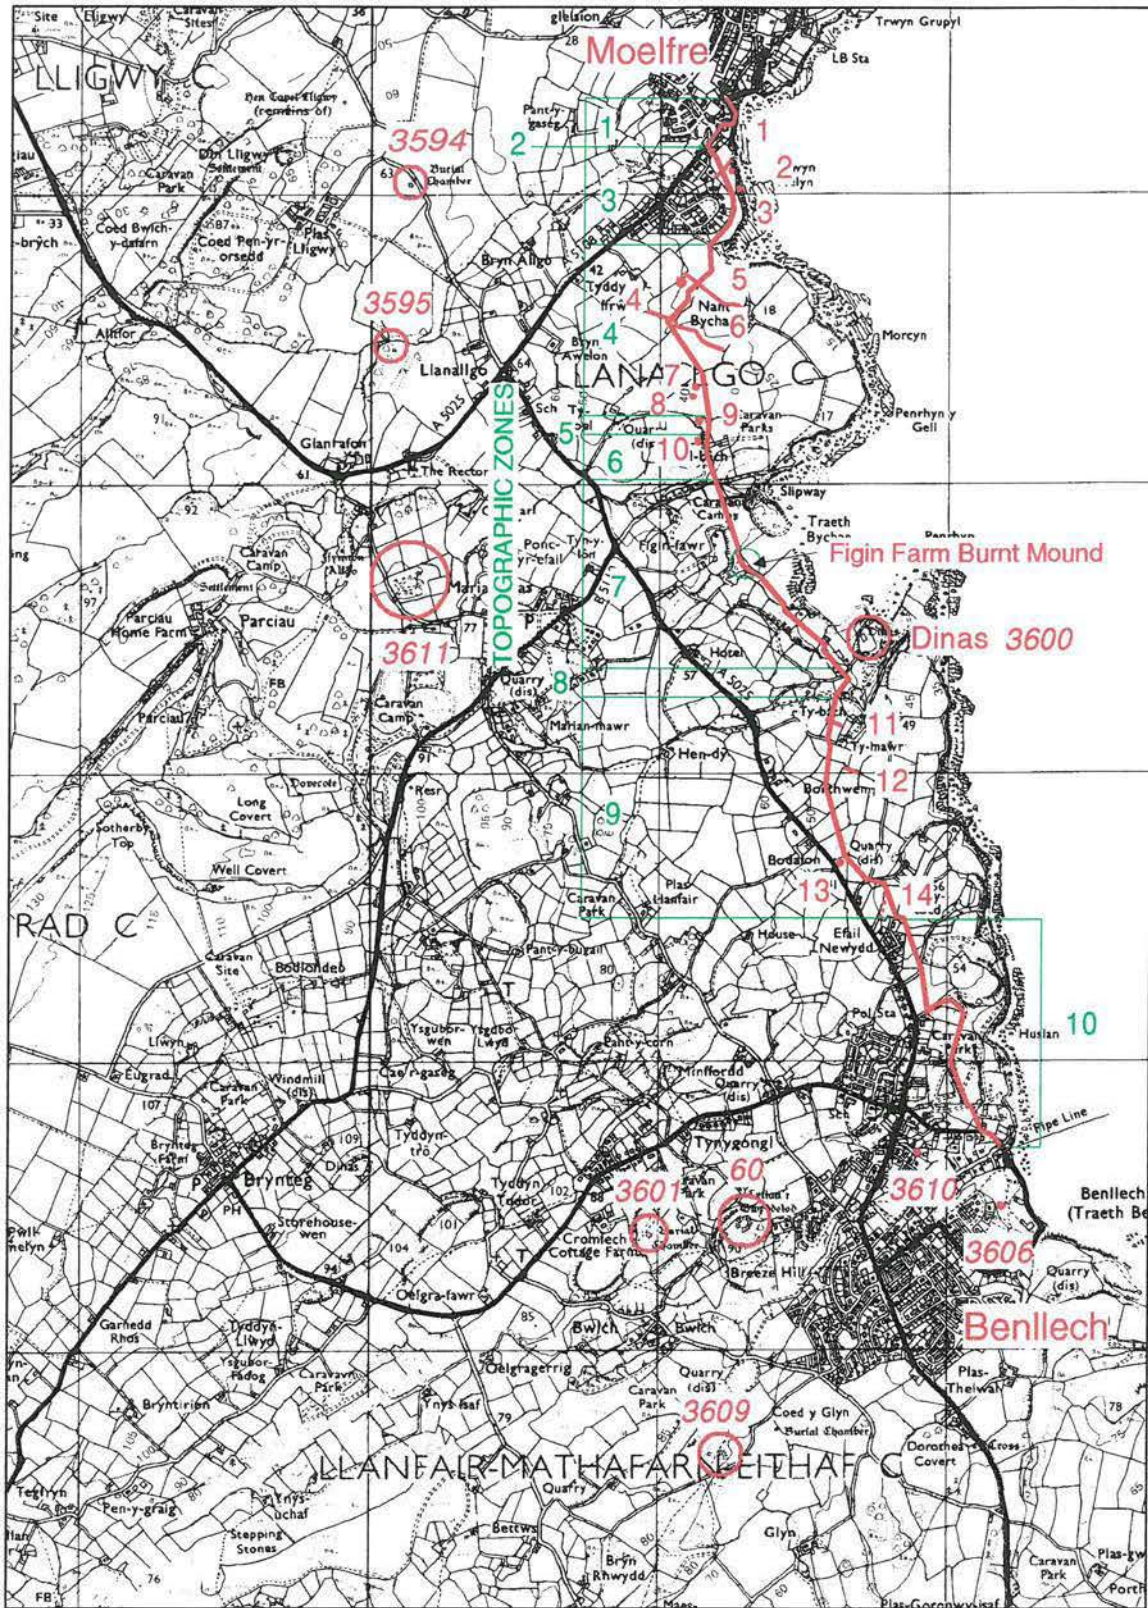
Dwg. no: 1474 /01

Title: Location of Archaeological Features

The construction work took place using a single work gang from north to south except the portion from Moelfre harbour along the public road. The work took place in short stages defined by the topography or the land ownership. Each stage was topsoil stripped overall followed by continuous trenching and immediate backfilling. The archaeological observation followed the same stages and will be described in the same manner with the stages numbered 1 to 10 from north to south (Fig. 1).

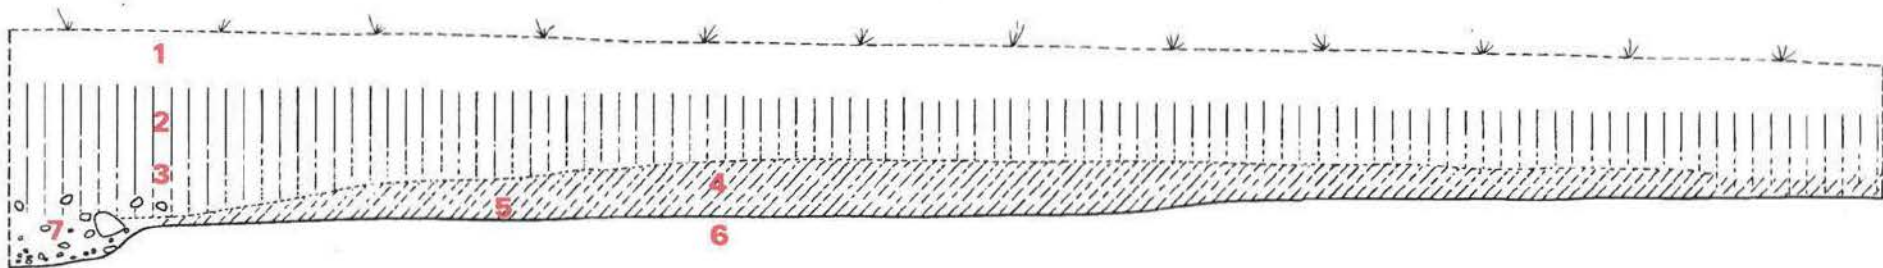
Dwg. no: 1474 /02 Drawn by: GHS

Title: Site 16 - Figin Farm Burnt Mound : Section through mound

3.4 Description (note the numbers in brackets refer to the context layers as identified on the section drawing Fig. 2)

The burnt mound was not visible before the cutting of the pipe trench either in ground contours or in soil colour. It was completely buried by a deep layer of homogenous ploughsoil colluvium (2) to a minimum depth of 0.35m even after removal of c. 0.3m of turf and topsoil (1). The pipe trench was cut to a depth of c. 1.0m below the ground surface revealing the burnt mound in the sides of the trench (Plate 6). Thanks to the co-operation of the contractors it was possible to leave the trench open temporarily so that the archaeological features could be recorded and sampled.

The mound, as revealed in the trench section (Fig. 3) consisted of an extensive lens of dark material (4) extending over a maximum distance of c. 9.0m and with a maximum depth of 0.30m. The lens was approximately symmetrical and appeared equal in both sides of the trench. There is no indication of the overall shape or extent of the mound. The dark material (4) consisted of c. 50% burnt and fractured stone mixed with black, charcoal-rich silty loam. The overlying colluvium was a single, homogenous layer although becoming slightly paler in colour in its lower half (3). The burnt mound material appeared to lie directly on the brown silty clay subsoil (6) with no indication of any buried land surface at the interface between the two (5).

Excavated examples of burnt mounds are often found in association with pits which form part of their use. Just beyond the north-west end of the Figin Fawr mound was a shallow pit or gulley (7) c. 0.25m deep filled with reddish-brown silty clay containing c. 50% sub-rounded pebbles, mostly c. 0.05 - 0.10m in length. Only part of this feature was available for study since the rest of the pipe trench had already been backfilled when the find was notified. It cannot be certain from the limited exposure whether the feature is man-made or a natural water-worn gulley. Its fill had no obviously water-laid lenses but on the other hand the stone content consists of water-worn pebbles quite different to the angular, fractured limestone in the burnt mound.

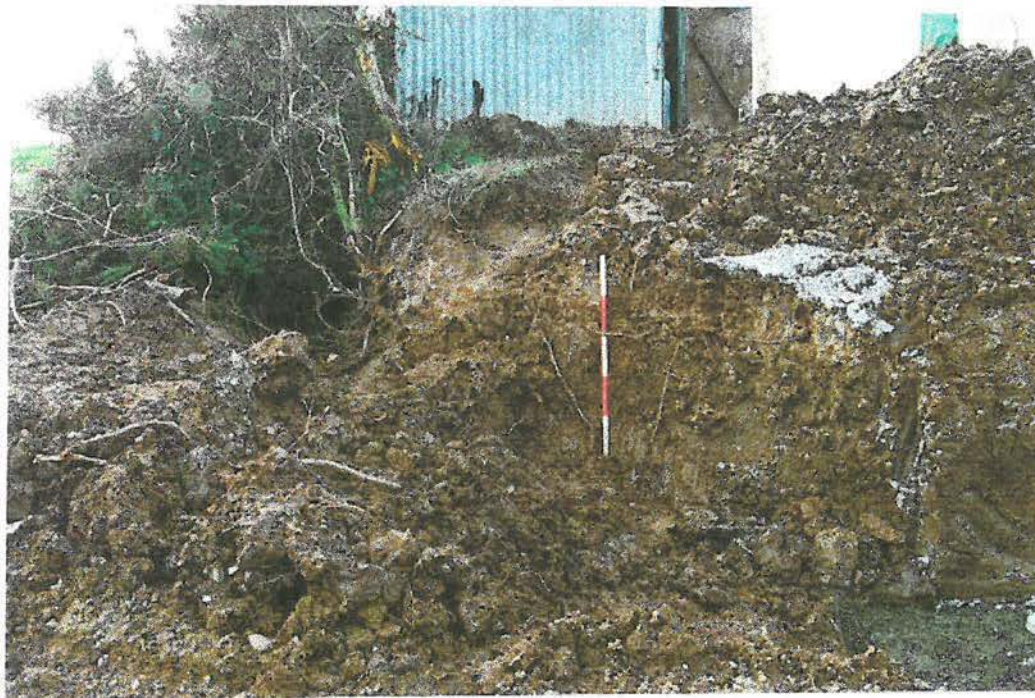
Plat 1: Section through field boundary AF6, Nant Bychan

Two of the existing field boundaries crossed by the easement in this part of the route were identified in the assessment report as being of possibly early origin and therefore of local importance, deserving a watching brief and possibly detailed recording (AF 5 and 6). Only one (AF 6) was cut through in clear enough manner to allow observation of its structure. It consisted of a bank and ditch, the bank constructed entirely of clay subsoil cast up from the ditch (Plate 1). Its make-up appeared to be simple, i.e. with no evidence of multiple phases of construction or of buried soils. The bank appeared to lie on a raised ridge of subsoil defined on one side by its ditch and on the other by a drop in ground level. This suggests that the bank was isolated by plough erosion of the surrounding subsoil surface as it lies on a slope. The apparent lack of complexity of the bank itself suggests that it is not of great antiquity.

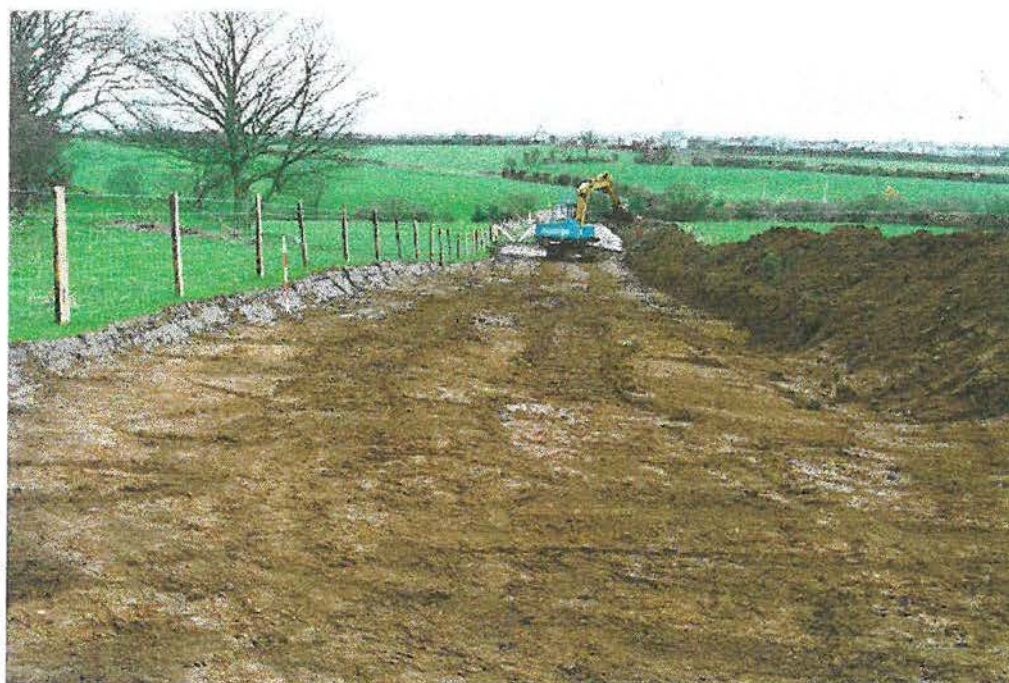
Plat 2: General view of stripped easement, Nant Bychan

The second part of this length of the route was stripped in ideal dry conditions and the subsoil surface was clean and well defined with good visibility (Plate 2). Two shallow patches of charcoal were revealed, one close to the stream, the other higher up the slope, but they were not associated with any other features.

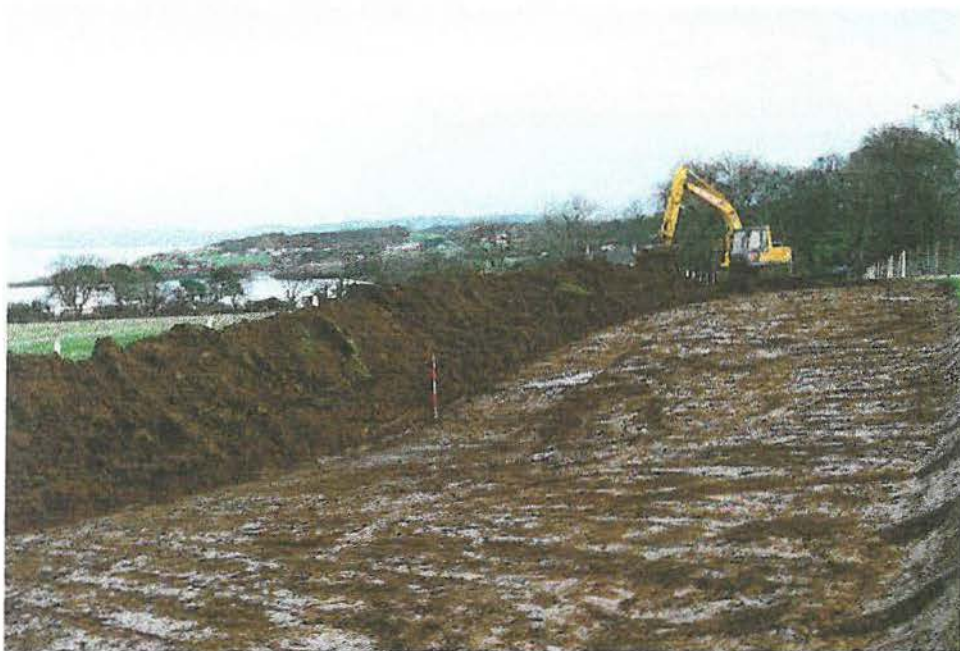
Plate 3: Section through hollow/platform AF 7, Gell Fawr

The final part of this length comprised the summit of a low ridge close to a pond (AF 8) and crossing a hollow or platform (AF 7). The latter was recorded as a site of potential value, a possible house or building platform of medieval or post-medieval date. The topsoil stripping across this area was therefore observed closely. Excavation showed it to be a hollow with gently sloping sides filled with ploughsoil, c. 0.80m deep (Plate 3). A stone-lined drain ran into the hollow taking overflow from the nearby pond (AF 8). If the hollow had been a building platform it would have shown a regular shape, particularly where cut into the slope, and might have preserved some trace of building stone footings or trenches. The lack of any such shape, or features and its shallow scoop profile, with no buried soil horizon suggests it is the remnant of a natural hollow or possibly part of a drainage system subsequently graded over and obscured by many ploughing episodes.

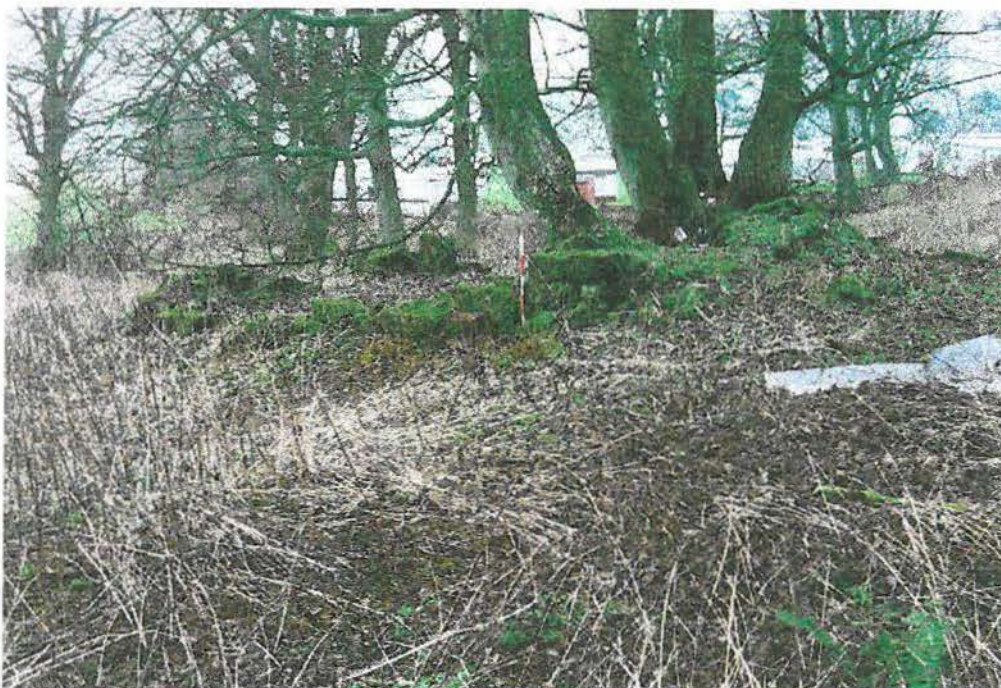
Plate 4: Ruined building AF 9, Gell Bach

This site consists of a stone walled enclosure containing the foundations of a rectangular building, and various terraces with slight traces of walls, suggesting it was once a farmyard complex, now largely obscured by trampling and dumping of rubble (see Report No. 241). The building was assigned to the category of regional importance and it was hoped that observation of trenching through the enclosure might provide some artefactual evidence which would help to assign a date to the building. However, conditions were poor when trenching cut through the yard area as a spring rises there. The revealed soil was dark and humic and there was no evidence for any former yard surface e.g. cobbling, suggesting that this part of the enclosure may have been a garden plot rather than a yard. The excavated soil was carefully searched but no artefacts of earlier than 19th - 20th century date were found.

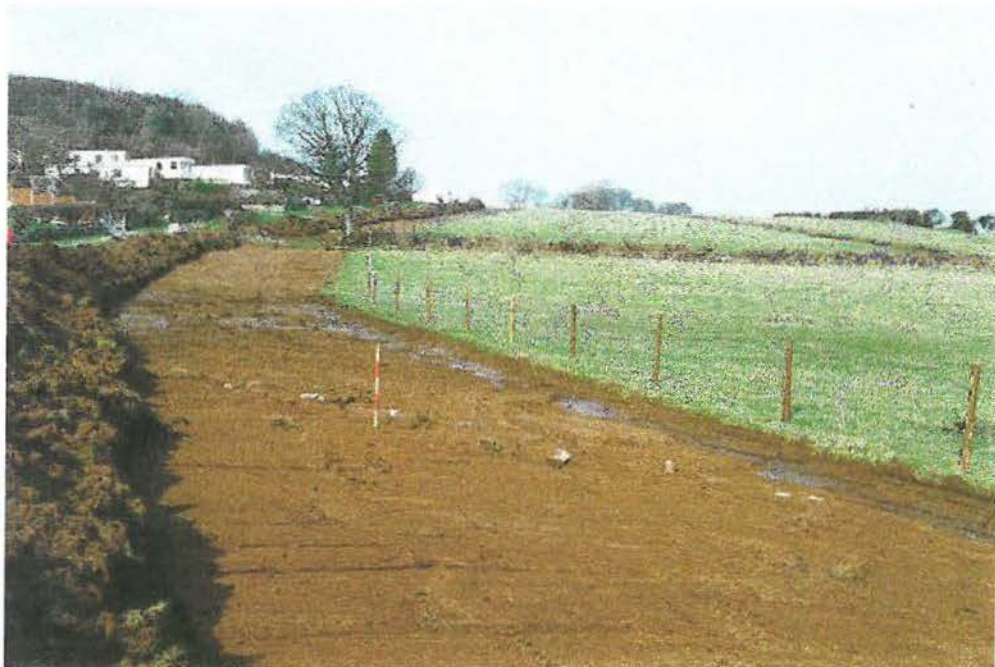
Plate 5: Footings of former field boundary and area of burnt mound before discovery, Figin Fawr

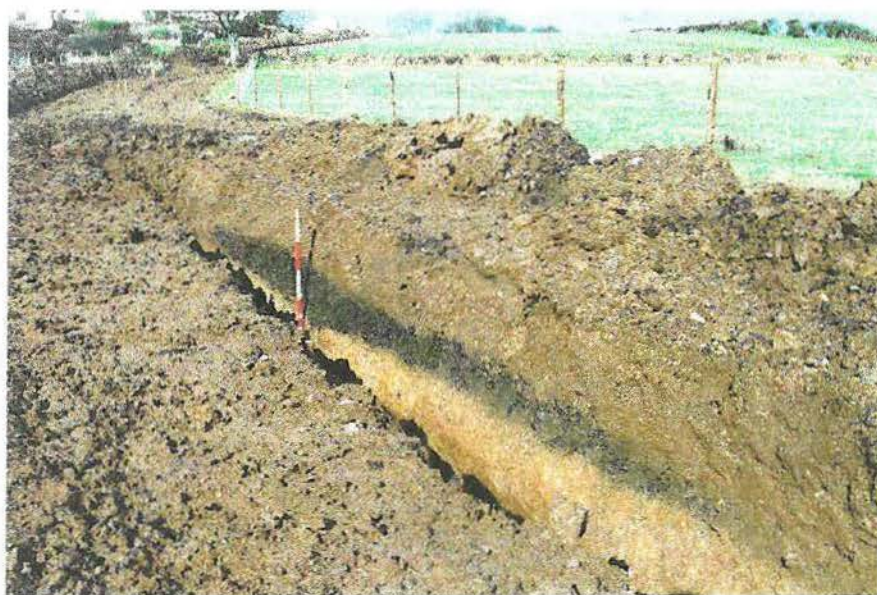
Plate 6: Section through burnt mound, Figin Fawr
