Ogwen Hydro-Power Scheme

Archaeological Assessment

Report No. 346

ARCHAEOLOGICAL ASSESSMENT (G1570)

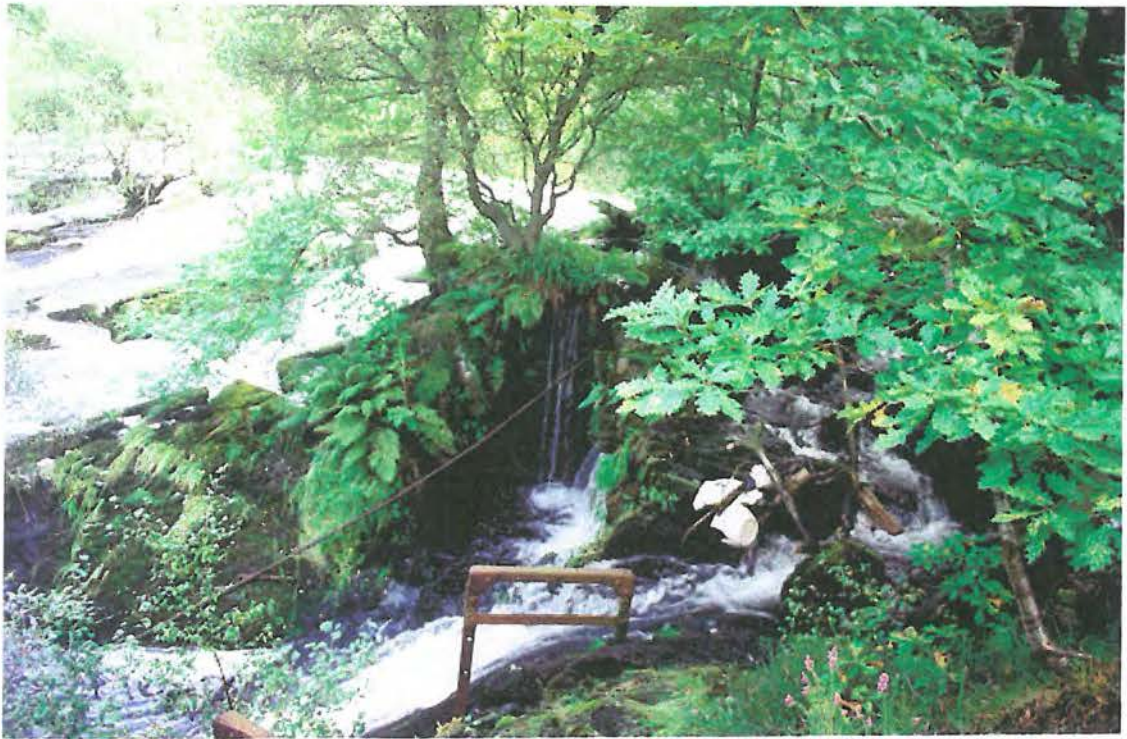
4 Leat and sluice gate SH 6267 6536

Category B Impact: Likely

A rock cut leat joins the iron girder supported leat from site 3 and runs along the river bank in a north-west direction into a tank (site 5). This is believed to be a water course for a underground pressure engine.

Figure 1: Site 4, sluice gate on the weir (site 3 in background) and an iron support for leat (foreground).

Recommendations for further assessment: None
Recommendations for mitigatory measures: Detailed recording and watching brief

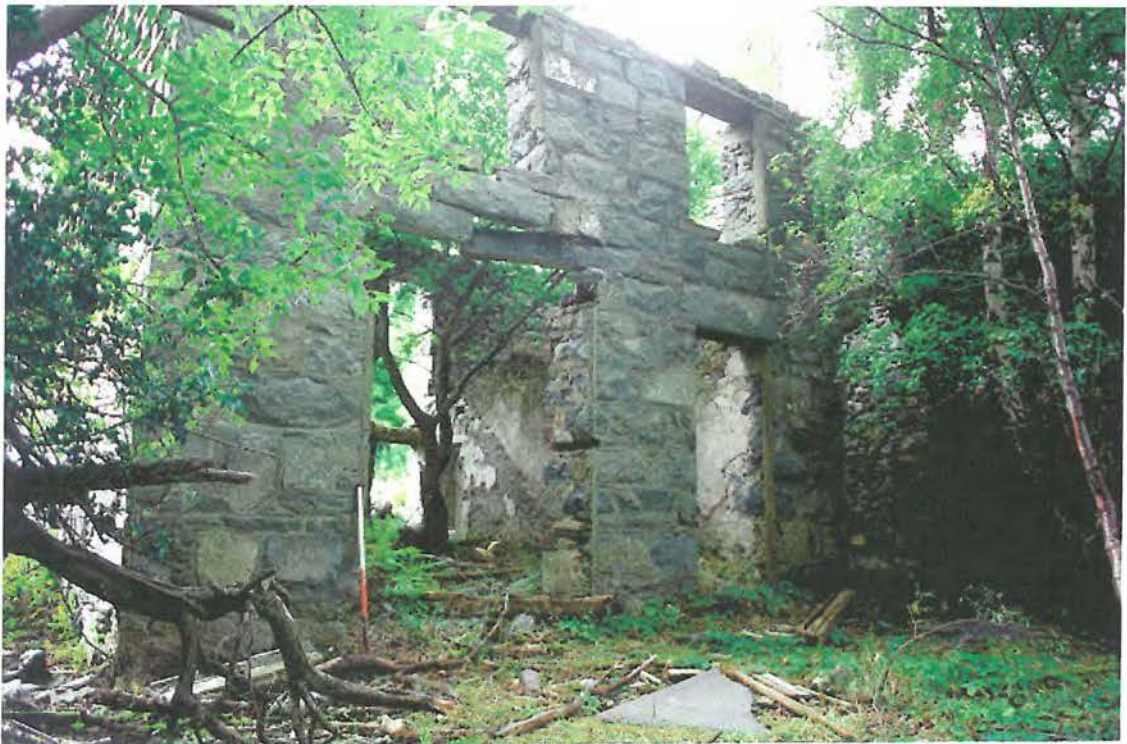
9 Buildings, Bryn-Llwyd (PRN 5699) SH 6240 6560

Category C Impact: None

A small complex of buildings, the date and origins of which are not clear at present but they may represent farm buildings. It consists of a one storey, stone structure, now internally gutted and in a unstable condition with associated outbuildings. The immediate area has been much disturbed by recent quarrying activity *i.e.* vehicle tracks.

Figure 2: Site 9, main building at Bryn-Llwyd

Recommendations for further assessment: None
Recommendations for mitigatory measures: None
