A470 Cardiff to Glan Conwy Trunk
Road

Ty Nant to North of Maentwrog Road
Station Improvement

Archaeological Evaluation

Report No. 369

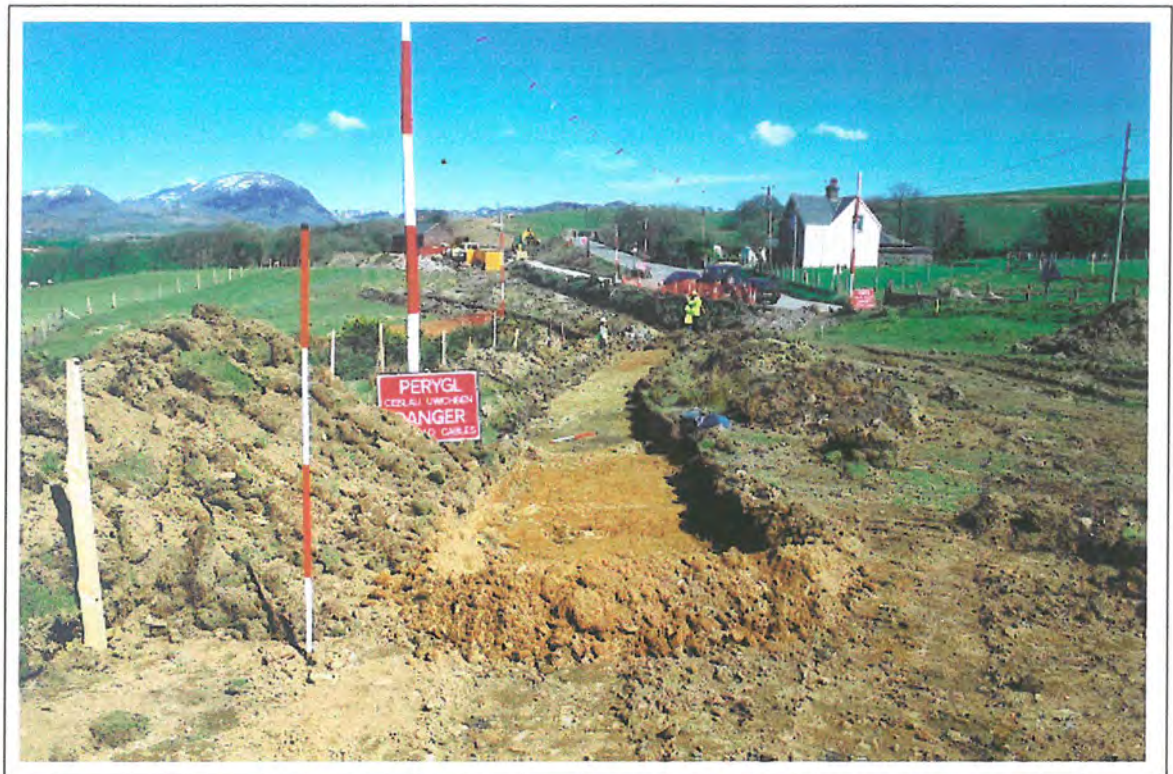
Figure 1: Trench A, near Ty'r Orsaf.

The first trench (A) was approximately 30m long and 2.5m wide. At the north-eastern end, where it was thought that the Roman road was located, the trench was excavated directly up to the stone and earth bank (site 3). Approximately 0.2m of topsoil was removed before a hard yellow stony clay was encountered. This was interpreted as the natural subsoil. It appeared that the footpath had been terraced into the yellow subsoil and that there had been some slumping from the slope above. Several fragments of modern bottle glass were recovered from the surface of the path amongst the slumped material. The footpath was not built up in any way and nothing was encountered to suggest that it was anything other than a post medieval footpath.

One other feature was identified in Trench A. This was a linear cut, running diagonally across the trench at the south-west end. It was 2.6m long and 0.5m wide, but terminated at the north side before it reached the side of the trench. The cut had an almost vertical southern side and a more sloping northern side. The base of the cut was flat and it was filled with a loose fill of dark brown silty clay, 50% of which consisted of angular to rounded small stones. This feature was interpreted as a field drain.

Recommendations: No further mitigation is required at this location.

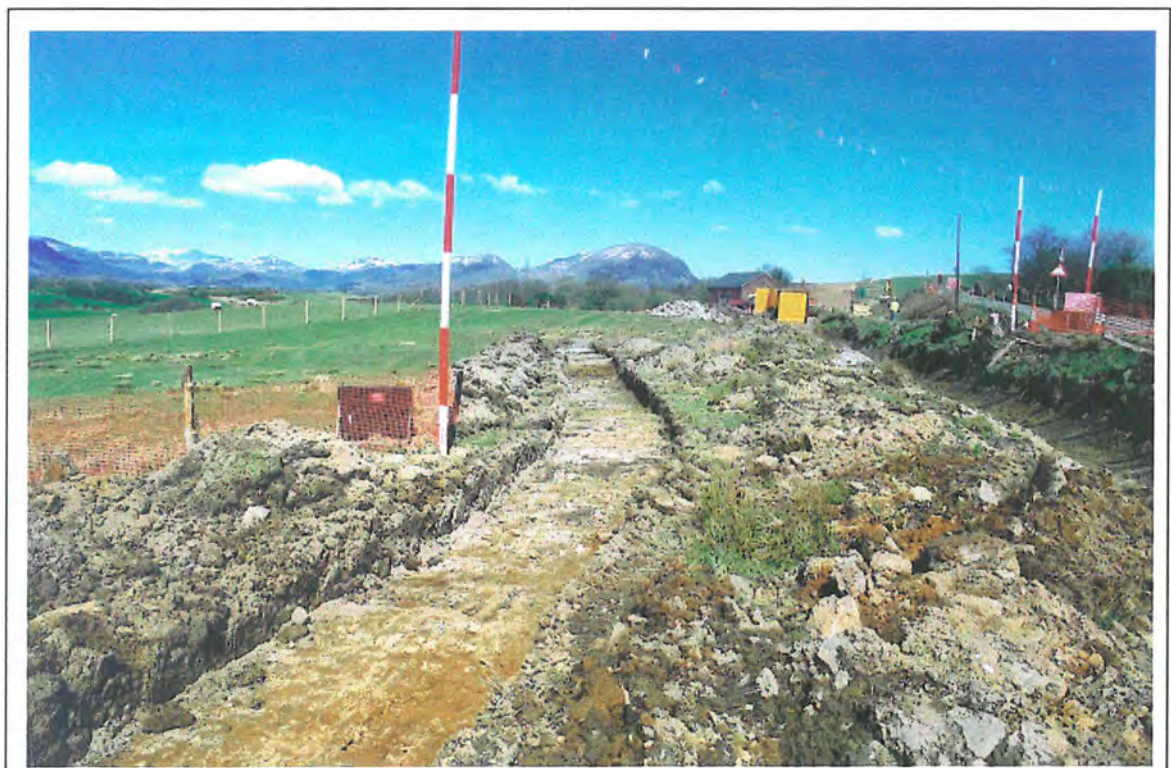
Figure 2: Trench B, near Ty'r Orsaf.

Trench B, on the northern side of the small stream, was also excavated by machine and was approximately 47m long and 2.5m wide. It was decided to open this trench to investigate a linear hollow (see plan and feature 02) visible in the field running in a east – west direction which it was thought may have been the Roman road. On excavation this was revealed to be a field drain consisting of a 1.4m wide ditch that was filled with stones.

Two other features were identified in this trench, both of which were field drains, reflecting the damp conditions in this part of the field.

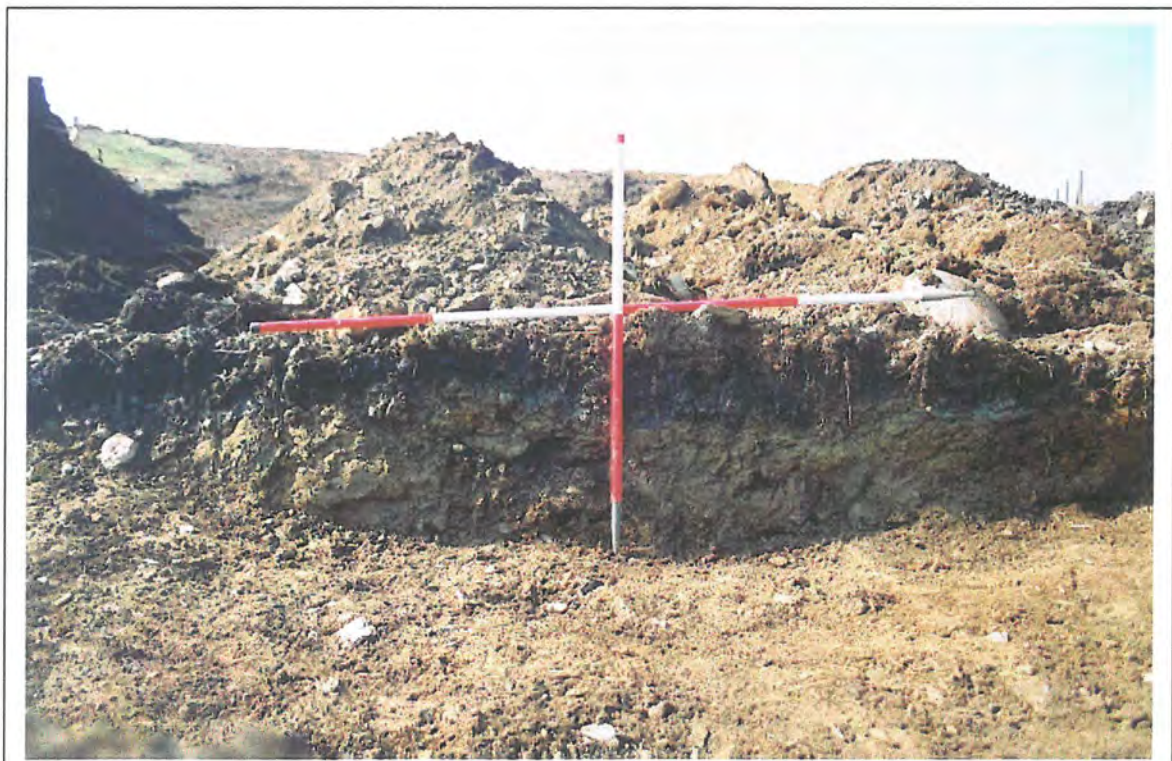
Figure 4: Section through site 6 (tarmac road).

A trench (D) was excavated by machine, it was 14m long by 2m wide. The deepest layer encountered (0.15m) was a compact, yellowish brown clayey silt, which became more orange in colour to the top of the layer. This was interpreted as the subsoil. Overlying this in the centre of the trench was a layer of hardcore (100mm) and on top of this a layer of tarmac.

This tarmac layer was 4.8m wide and 60mm deep and was covered in a layer of topsoil and vegetation. At the north-western end of the trench the subsoil was overlain by an old ground surface (100mm deep). This was overlain by the artificial slope that leads up to the modern road (A470) and which consisted of a dark brown clayey silt. Both the artificial slope material and the old ground surface were overlain by a bank consisting of a mixture of topsoil and subsoil. At the south-eastern end of the trench the subsoil was overlain by humic, root material.

A watching brief was also carried out in the area immediately to the north-east of the exposed section of road (site 6). In the assessment it was suggested that this road or trackway continued parallel to the present A470 in this direction. However, topsoil stripping revealed that the tarmac road rejoined the present course of the A470 almost immediately and did not run parallel with it. Indeed, the 1901 OS map of the area (Merionethshire Sheet XII.9, 1:2500) clearly shows that the A470 curved sharply at this location and at some time since this date the road has been straightened at this point leaving this short section of tarmac road (the original A470) abandoned and overgrown.

A topographical survey of the area around site 6 was carried out using an EDM. This recorded two stone and earth banks located either side of the tarmac road and probably contemporary with the tarmac road during its use. A photographic record of stone revetting associated with a drainage channel that ran under the tarmac road was also made.

Recommendations: No further mitigation is required at this location.

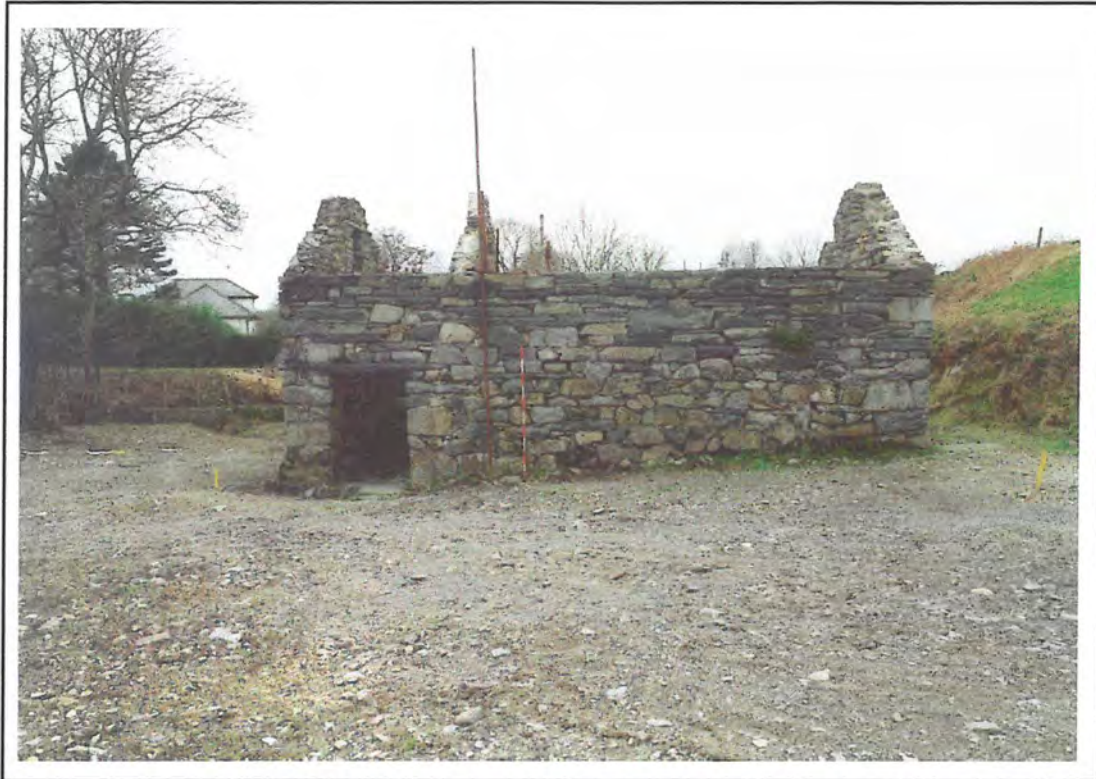
Figure 5: Elavation of corn-drying at Melin Tyn-y-nant.

At the western end of the route is a 17th-century mill, Melin Tyn y Nant, altered in the 19th century, and alongside it a corn-drying kiln dated 1799. The Bala to Ffestiniog railway line runs alongside the route and include the former station building at Maentwrog Road Station, which dates to the first half of the 19th century. Thus a historical sequence from prehistory to the present day can be demonstrated for the area, making it of considerable interest.

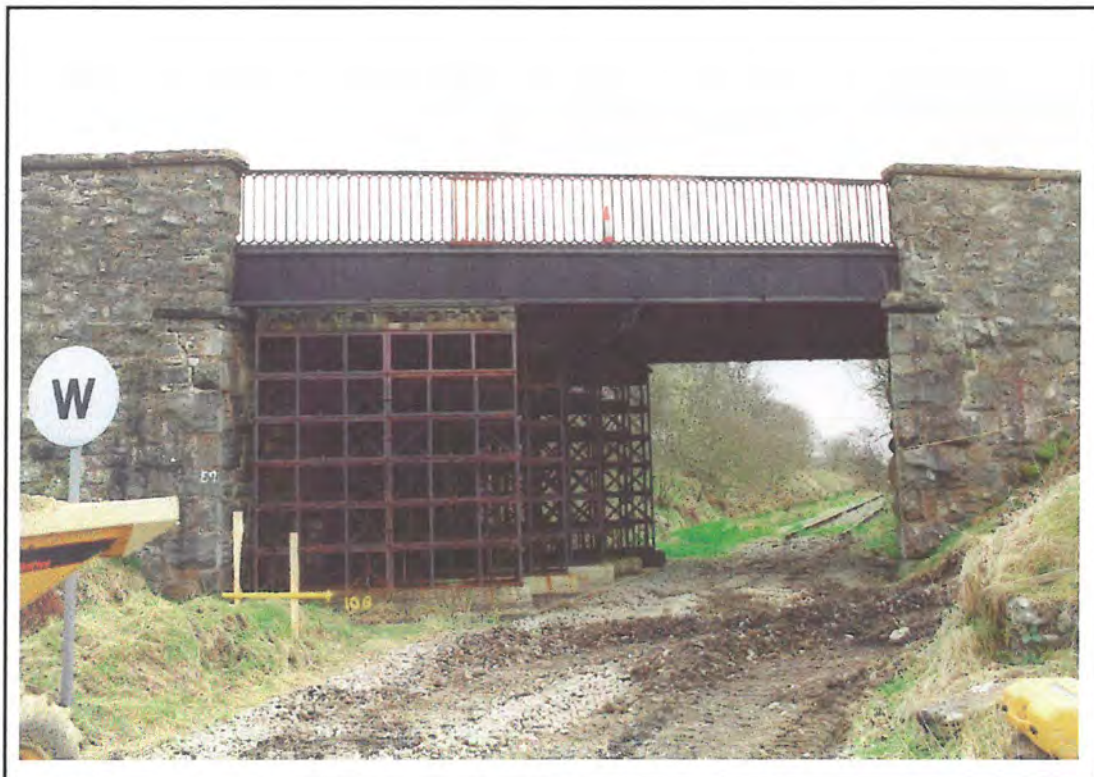
Figure 6: Railway bridge (constructed in 1879), north of Maentwrog Road Station.

This site is to be partly dismantled and a photographic record is required prior to this. This involved recording all elevations and features of particular interest. A number of general photographs showing the site in its setting should also be taken.

A photographic record of the structure and details (railings) of the bridge was made. Both colour and black and white films were used.
