# EXCAVATIONS AT THE BISHOP'S PALACE, BANGOR 1996

REPORT 370

prepared for  
Cyngor Gwynedd Council

Project G1376

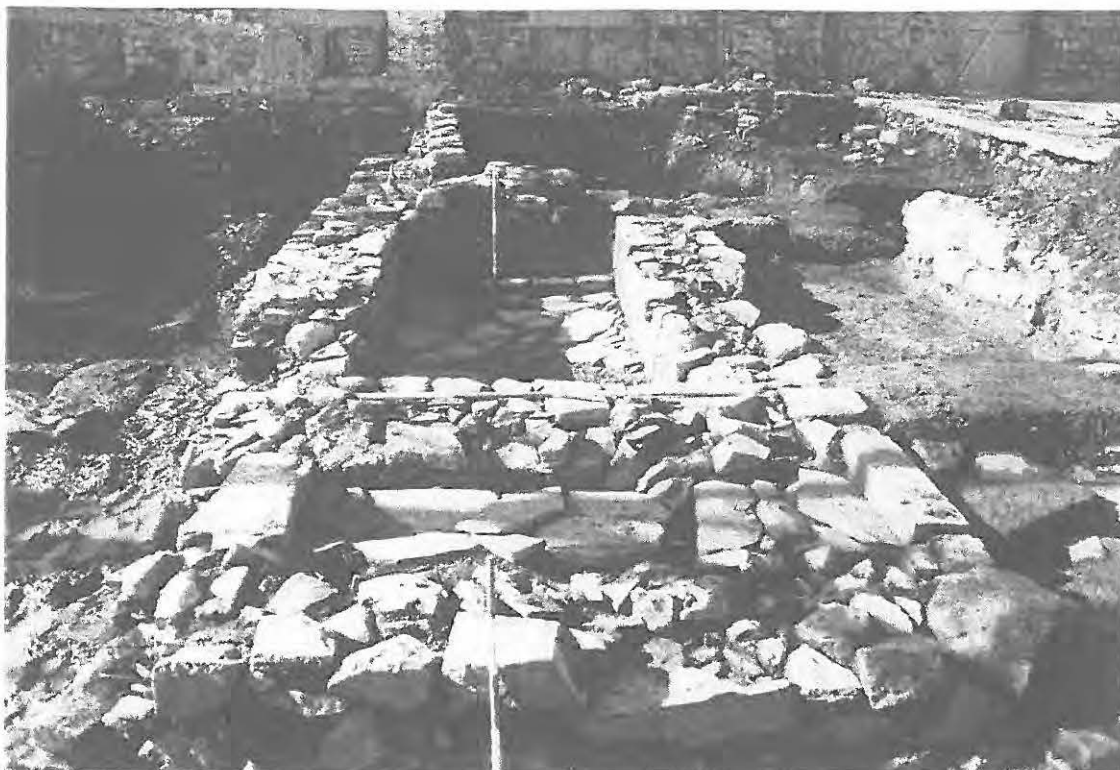
Bishop's Palace, Bangor . Plate 3 - west facing view along structure 'B', with 'C' and 'A' to the rear, respectively.

On the east side of structure C a stone lined drain discharged into the river (Fig 3). The southern terminal of the drain had been provided with an elaborate stone structure built forward of the riverbank. The north and south ends of the structure had stone lintels and the roof of the drain passage was lined with slate slabs, which continued beyond the elaborate stone structure to the north. The south and north walls of structure C were keyed into the west side of structure B which forms one end of the tank. The two structures are therefore contemporary. The drain was probably designed as part of a drainage or sewage disposal system for the Bishop's palace. The silted fill of the drain consisted of an organic silty sediment.
