**LLYS RHOSYR, NEWBOROUGH, ANGLESEY,  
HERITAGE PROJECT**

***SCHEDULED ANCIENT MONUMENT A129***

**ARCHAEOLOGICAL RECORDING, MONITORING  
AND CONSOLIDATION: CONSERVATION REPORT**

**Report No. 377**

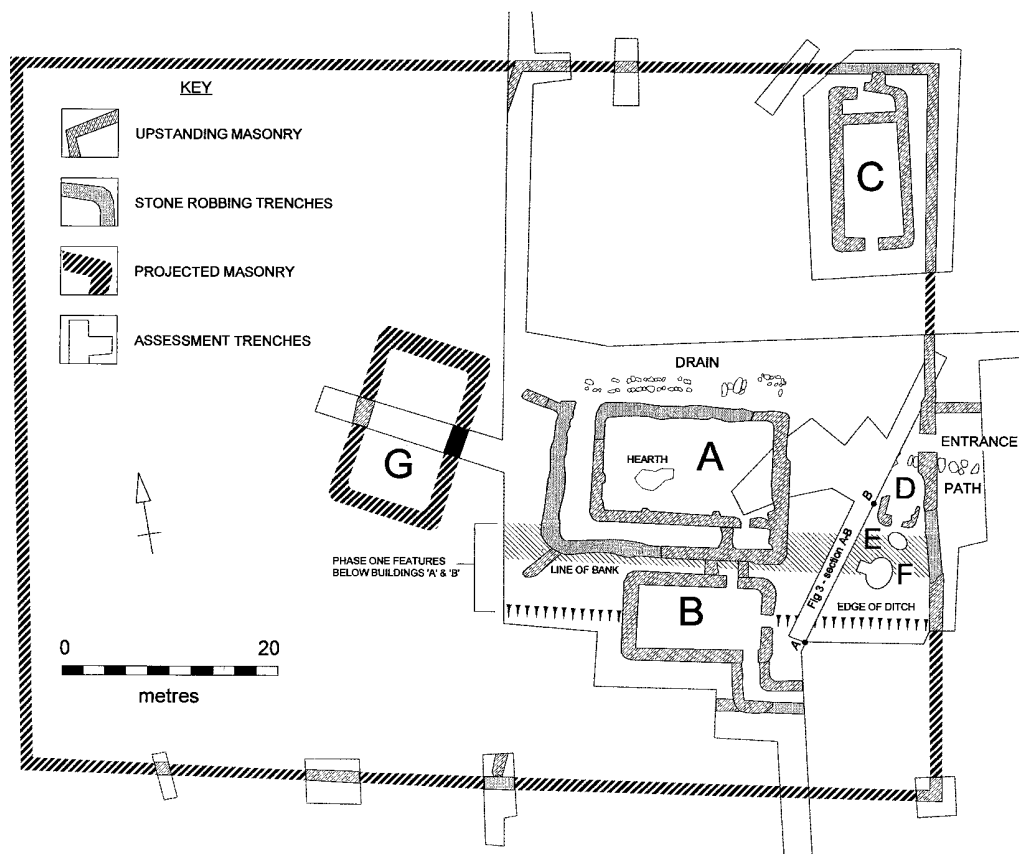
**Fig. 1a Llys Rhosyr, Newborough: Extent of excavation area and projected outline of the *llys* enclosure.**

2.1 Llys Rhosyr consists of the remains of a Royal court of the Welsh kingdom of Gwynedd. It was the *maerdref* or manorial court of the administrative area of the *Commote of Menai*, a large area comprising of the whole south-west portion of Anglesey. The existence of the site was known from documentary evidence, for example a reference to Llywelyn ap Iorwerth signing a charter there in 1237. The actual location of the site, however, was known only from vague antiquarian references and physical remains that were probably part of the site were only positively identified by GAT during small scale trial excavation in 1992. Extensive excavations then followed in 1994, 1995 and 1996 and an area of about 60m by 60m with a complex of buildings was uncovered (Fig. 1a). The whole extent of the known remains was scheduled as an ancient monument in 1997 (Fig. 1b).

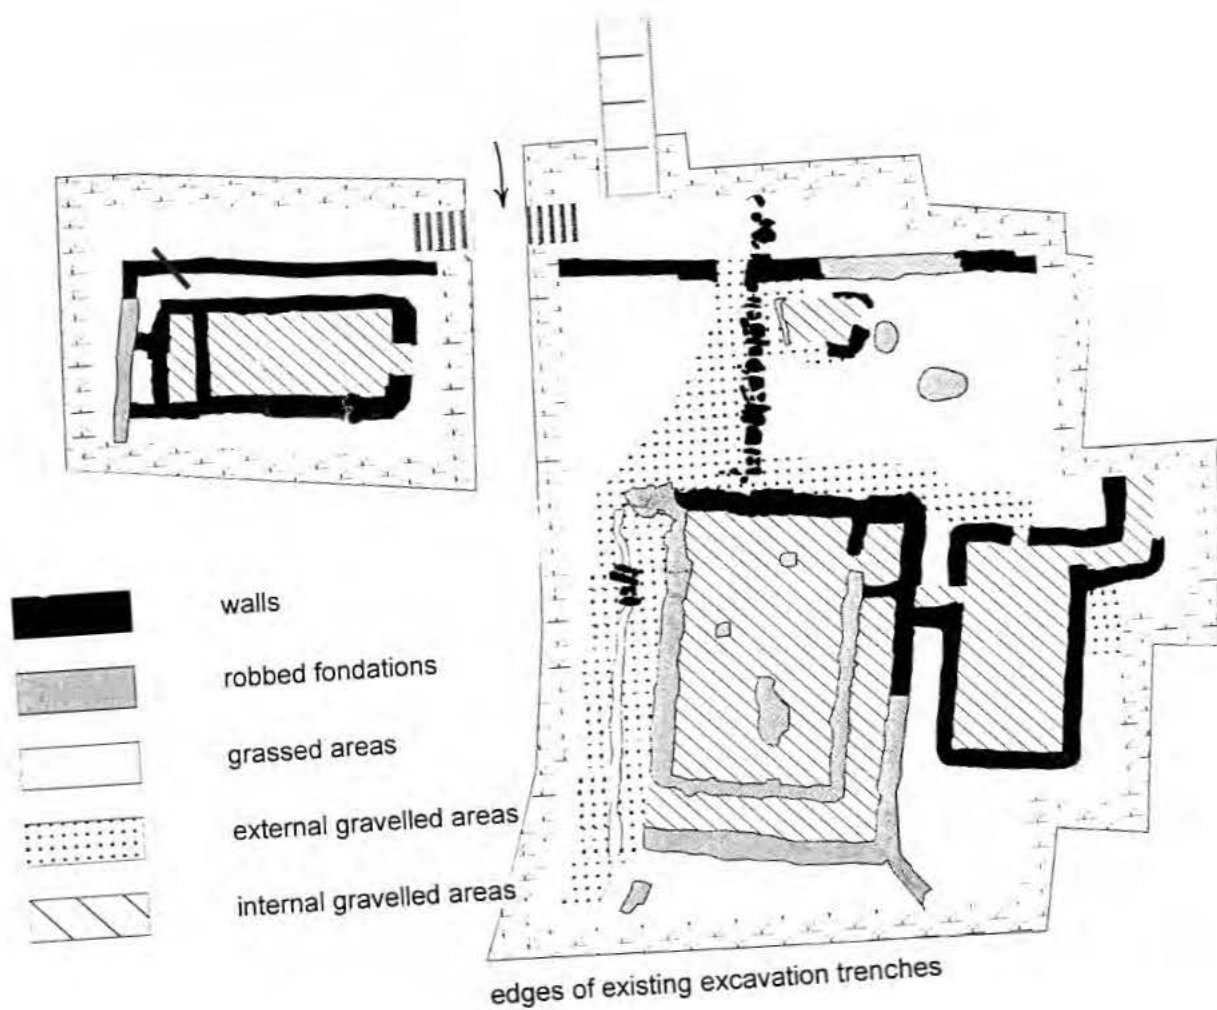
Fig. 2 Llys Rhosyr, Newborough, Anglesey: Location of laid surface areas

5.3 Internal areas (Fig. 2, 'A') were laid with 'Bryncir' gravel screened at half an inch.

5.4 External floors (Fig. 2, 'B') were laid with crushed slate chippings.

5.5 Robbed out walls and other features (Fig. 2, 'C') were marked out with laid stone edgings and filled with 'Gwyndy' dark granite chippings to provide a contrast with the other surfaces. This was a change to the first specifications.

5.6 The remaining areas within the former excavation trenches, to be grassed (Fig. 2, 'D') were laid with sandy soil from the excavation spoil heaps.

5.11 One short length of perimeter wall had been robbed to such a depth that it was impossible to create a stable internal surface. This area of wall (Fig. 2, 'E') was rebuilt in a similar style to the rest.

4.3 Areas of external flooring, to be laid as slate chippings (Fig. 2, 'A'), were marked out with roadline spray paint.

4.4 The positions of robbed out wall lines and other features, to be defined by edgings of laid stones filled with dark granite chippings (Fig. 2, 'C') were marked out with surveyors pegs and roadline spray paint.

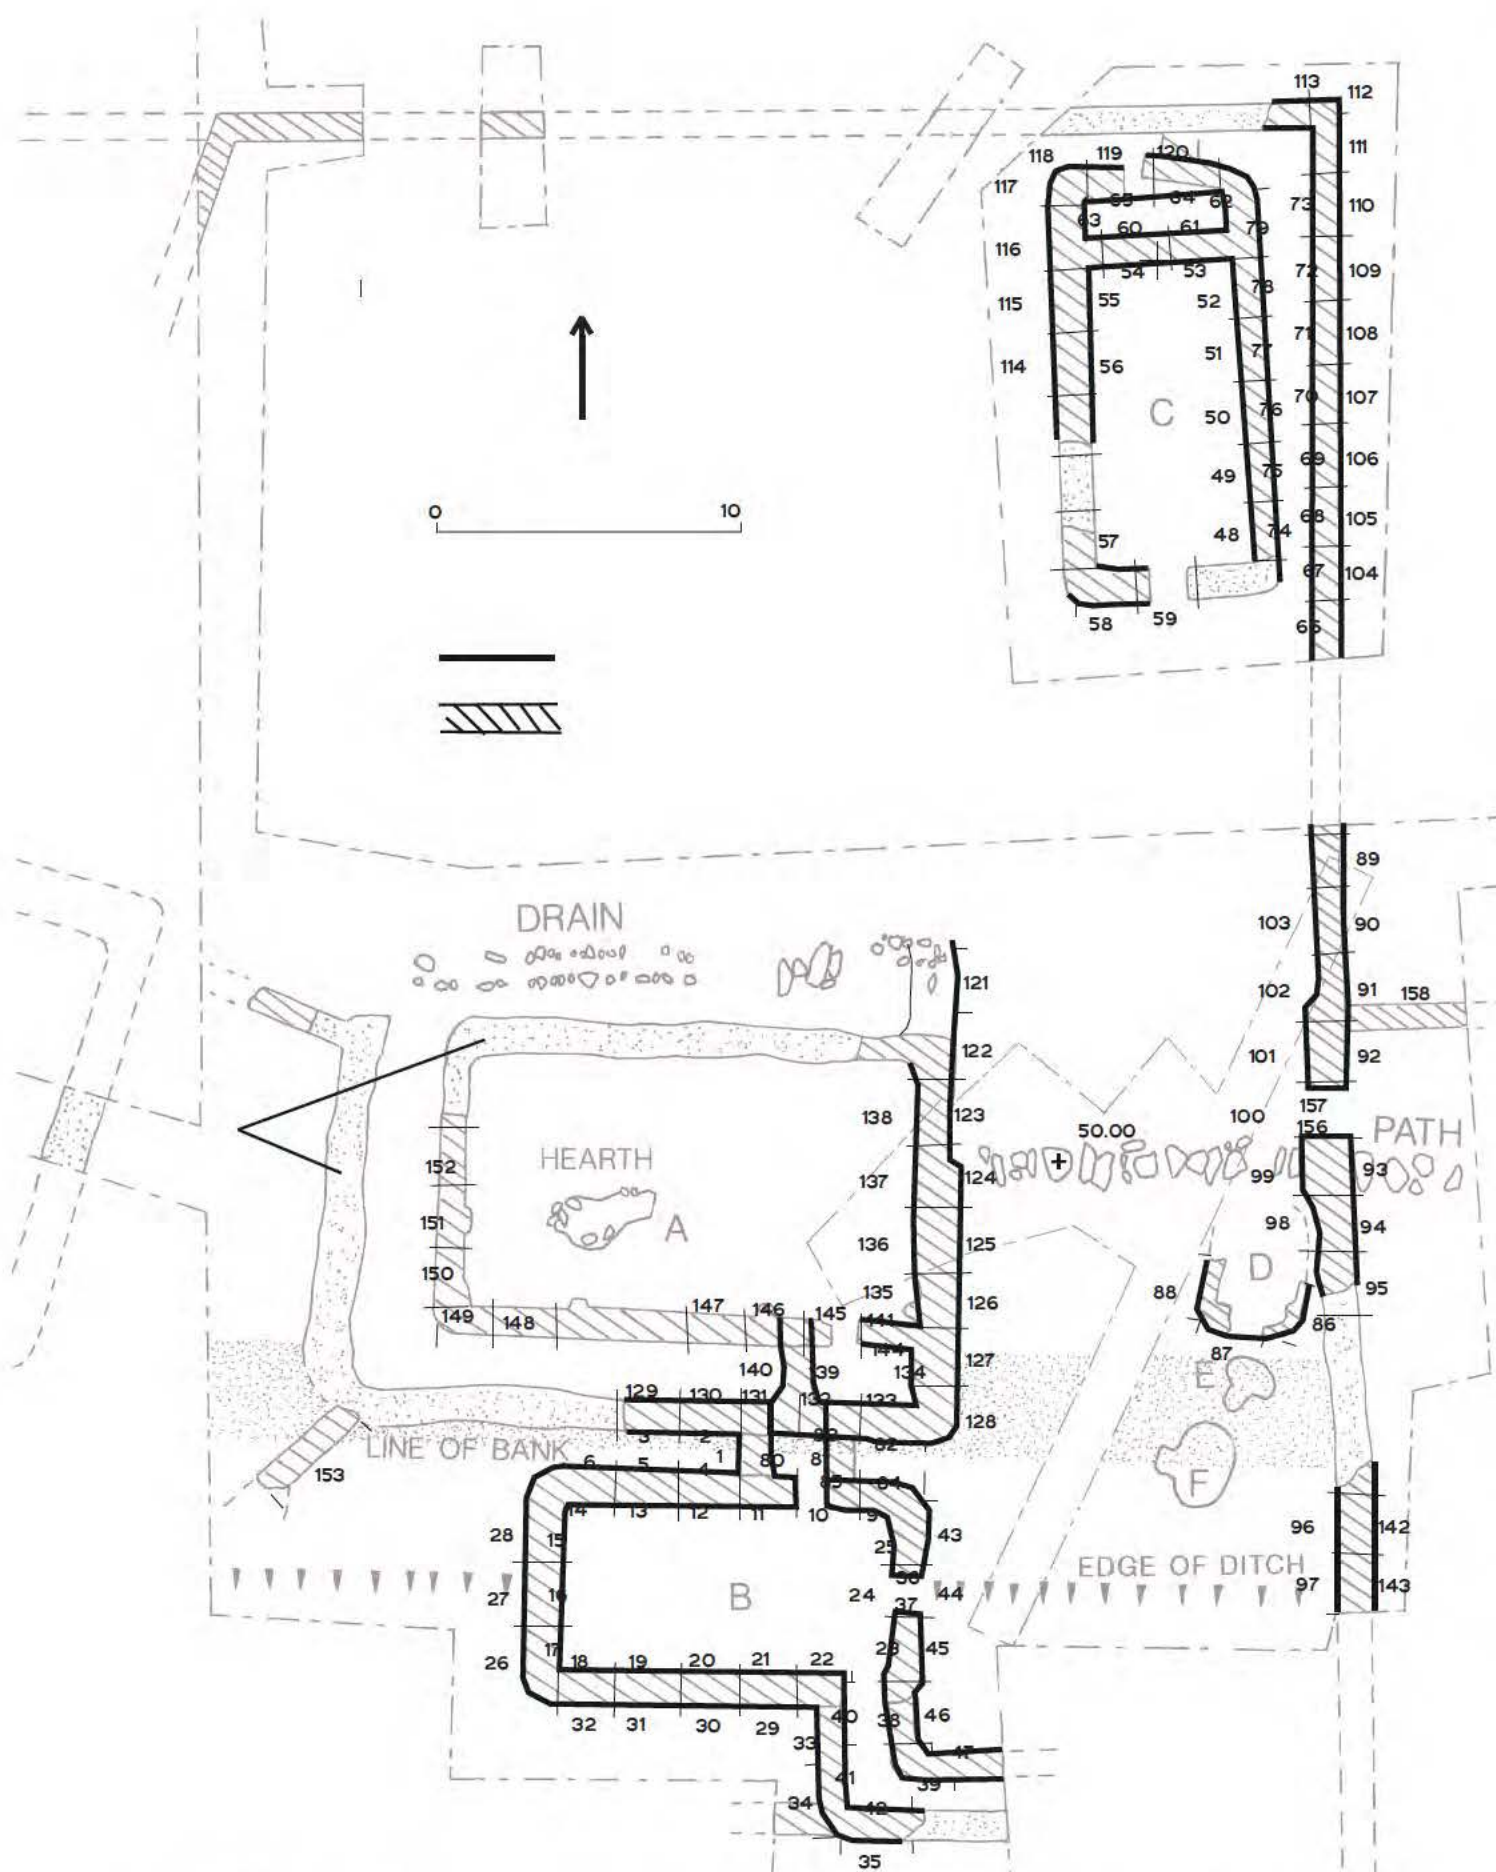
Fig. 3 Llys Rhosyr, Newborough, Anglesey: Location of wall recording context segments 1-158 and of drawn wall elevations (bold line). Illustrated context examples in bold italic.

All walls were first marked out in 2m segments, each of which was given a context number and these 158 contexts (Fig. 3) provided the units of the record according to the project design (Appendix 2) Each segment of standing wall face, front and back, was photographed in horizontal view, from a set distance (4m), with 1m ranging rods at 2m intervals, where possible. Oblique views were taken of wall segments that were robbed and survived only in plan. Each segment was photographed in duplicate and in both colour negative and colour transparency.

A stone by stone drawn record was then made of the face of each standing portion of wall at 1:20 scale, where it had not been recorded as part of the original excavation. This produced 17 A3 sheets of drawings: approximately 176m length of newly drawn wall face. The areas of drawn elevations are shown in Fig. 3. A TBM was established, marked by a cross on the centre of the largest horizontal slab of the pathway between Building A and the east perimeter wall (Fig. 3). The TBM was given the nominal height of 50m, approximating to the actual OS datum.

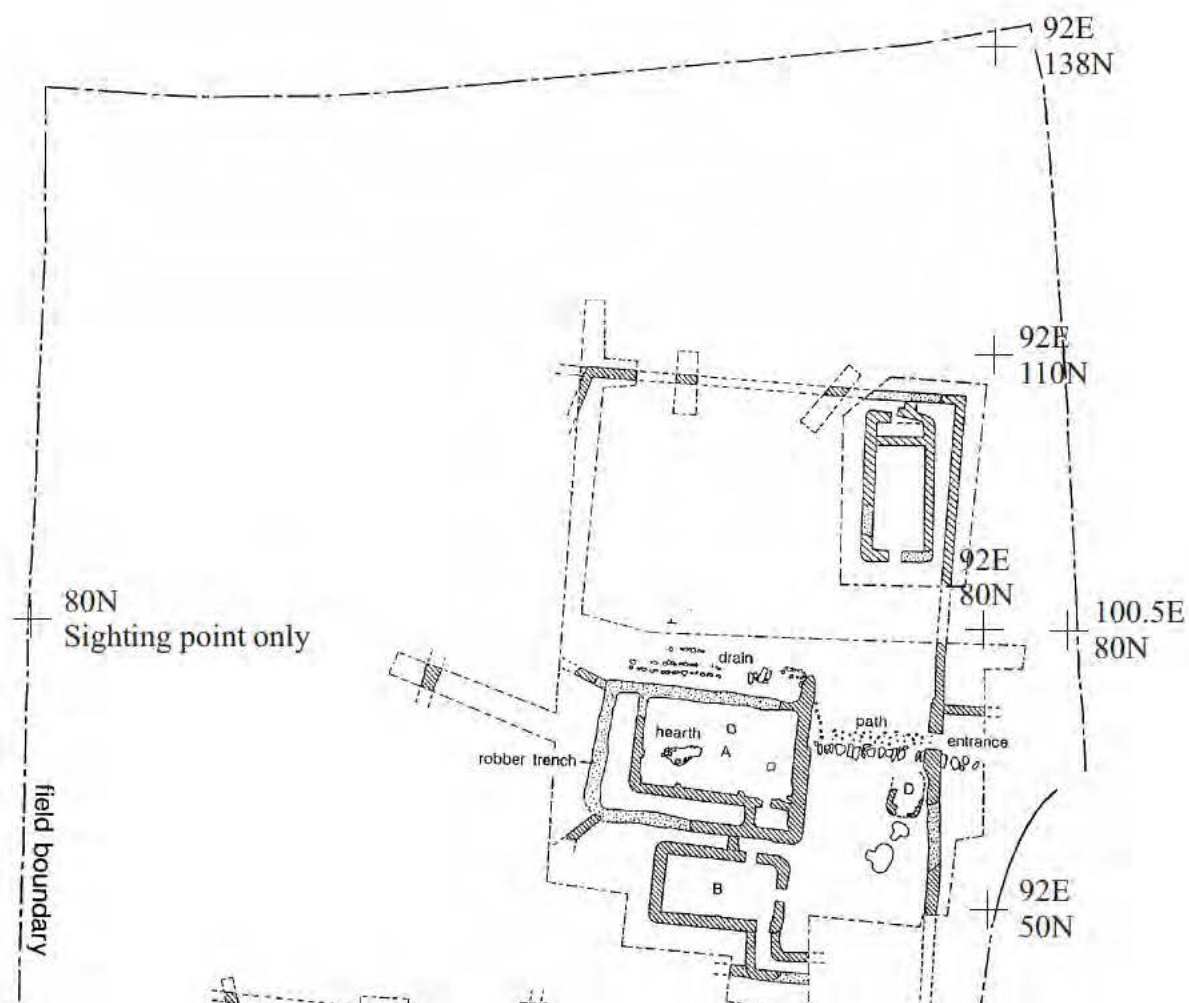
**Fig. 4 Llys Rhosyr, Newborough, Anglesey: Location of permanent surveying stations**

4.2 The site grid, defined by base lines of surveying pegs, was first extended and tied in to more permanent markers along the boundaries of the field because the site grid would be removed during landscaping and it was possible that further excavation might take place in future. The position of these 'permanent' surveying stations - iron pegs, well driven in - is marked on Fig. 4.

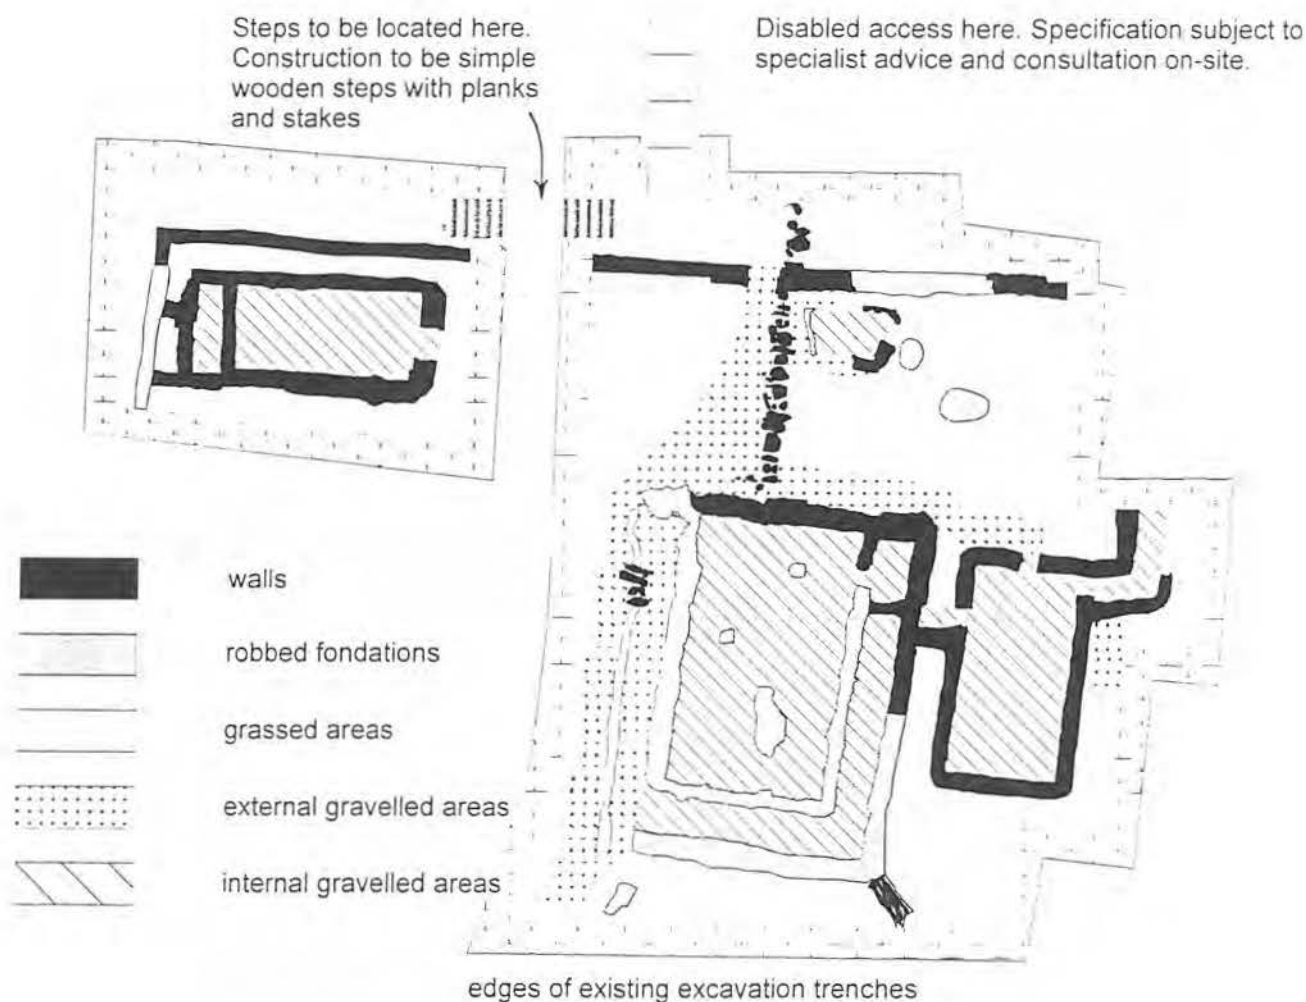
Masonry features to be consolidated are shown solid on the accompanying plan.

Features which have been robbed of stone will be marked out on the consolidated surfaces with edge set stones and slabs utilising local stone from the excavation spoilheaps wherever possible.

These are shown with a grey tone on the plan.

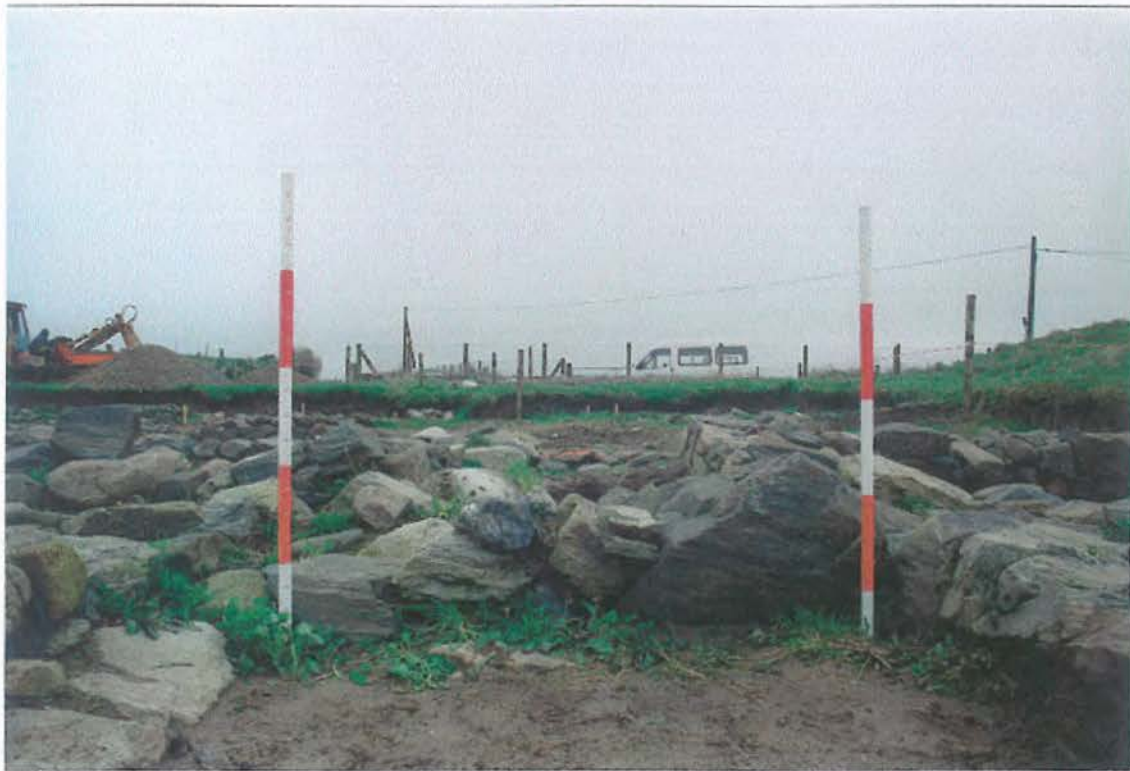
1-1 (From 2m)

PHOTOGRAPHS - Film No./ Frame No.  
BEFORE CONSERVATION

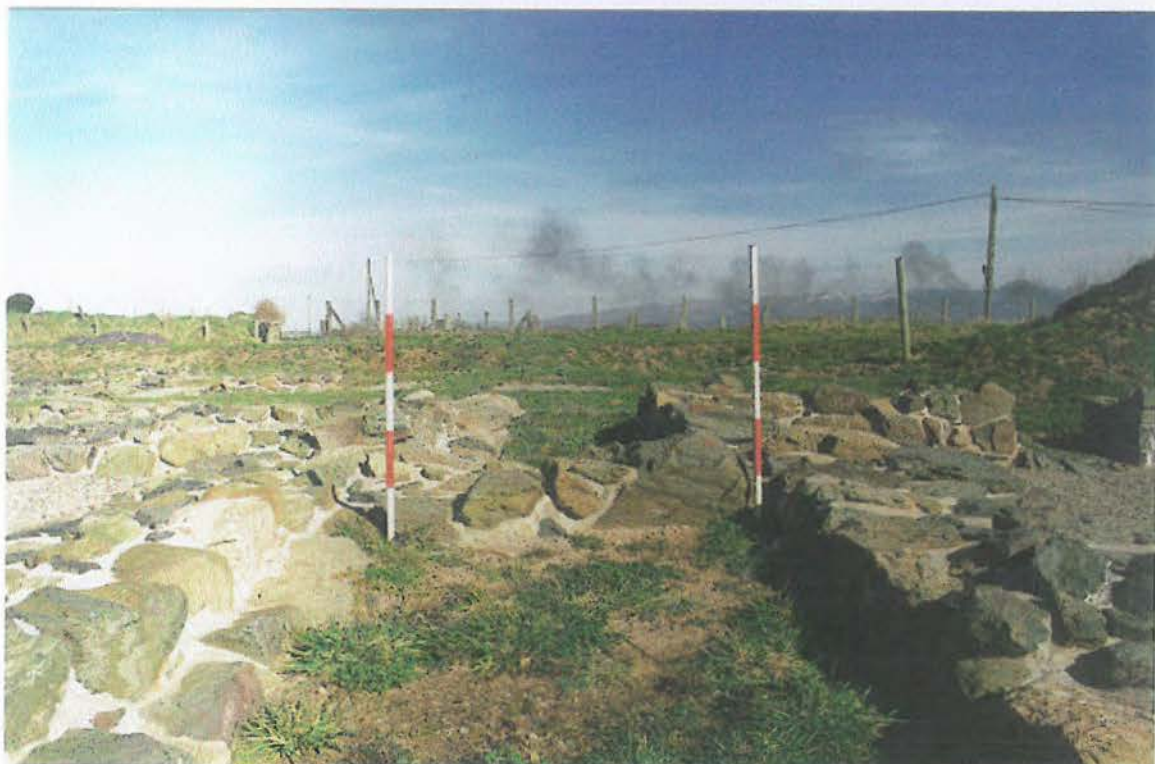
19-00 (From 4m)

PHOTOGRAPHS - Film No./ Frame No.  
AFTER CONSERVATION

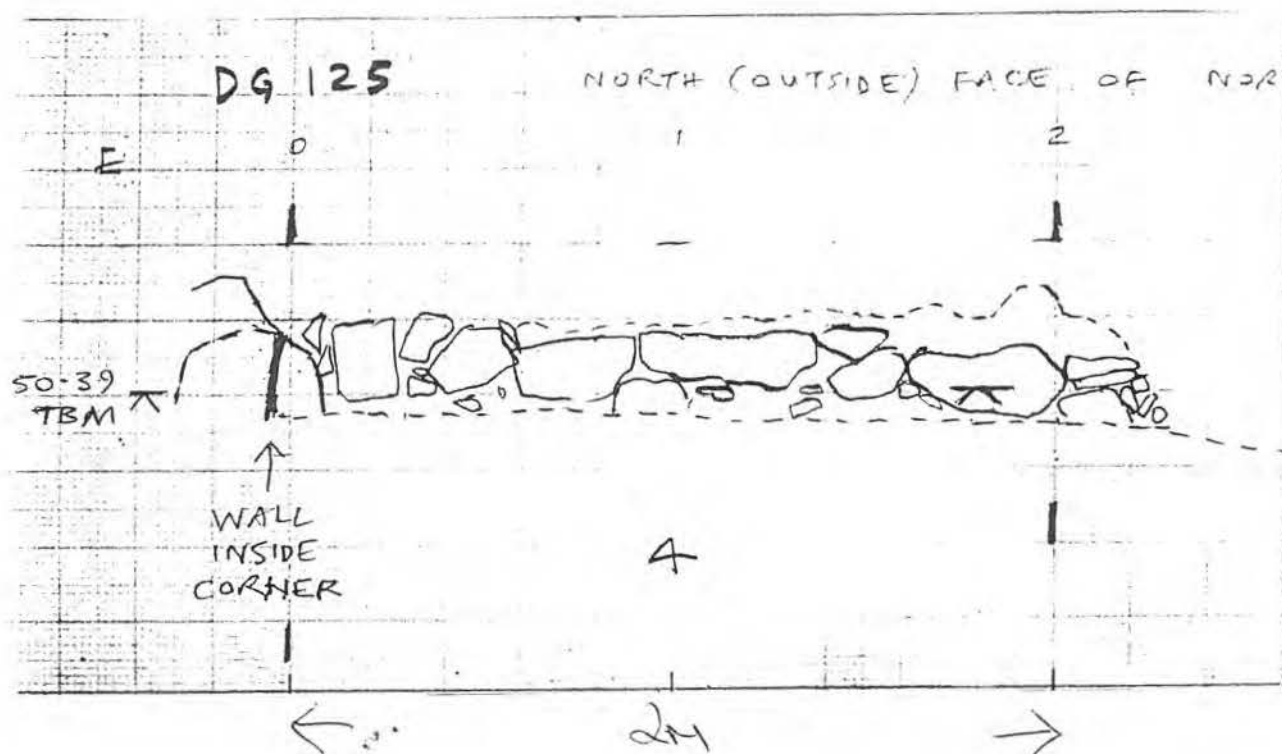
NORTH (OUTSIDE) FACE OF NORTH WALL OF BLDG B

ANS		SECTIONS/ELEVATIONS	
Sheet No.		Sheet No.	159
Drawing No.		Drawing No.	125
PHOTOGRAPHS - Film No./ Frame No.			
General			
Before	1-7		
After	19-5		
INTERPRETATION/DISCUSSION		PART OF	CONSISTS OF
		ON D/BASE <input type="checkbox"/>	INITIALS/DATE EW / 13794
