# HOLYHEAD WASTE WATER TREATMENT WORKS

## ARCHAEOLOGICAL ASSESSMENT

Report No. 383

# **HOLYHEAD WASTE WATER TREATMENT WORKS (G1660)**

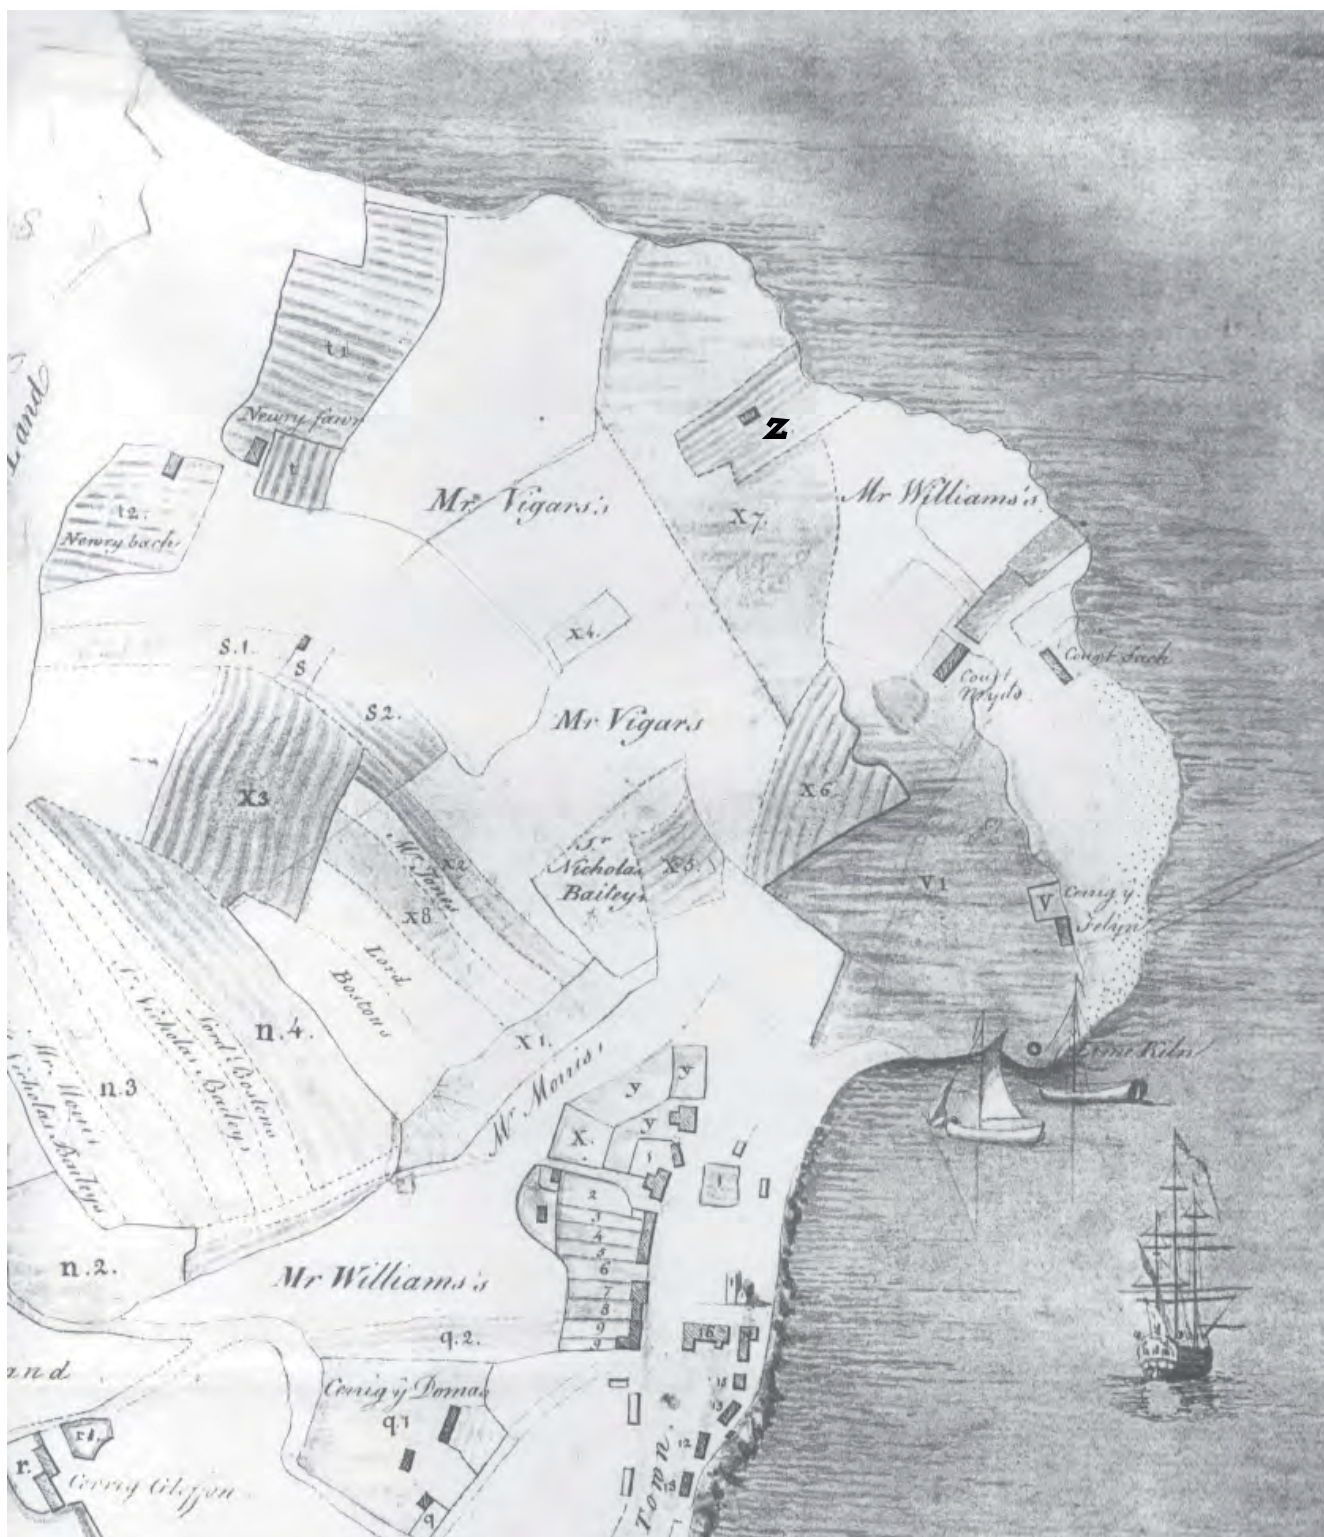
Figure 2. Penrhos estate map 1769. Study area probably located near "z".

The changing field boundaries can be followed through the cartographic sources. The Penrhos estate map dating from 1769 (**figure 2**) shows field layouts around Holyhead to have been very different from that of today. Much of the land still seems to have been farmed under the medieval open field system. However, the study area may have been an exception. It is difficult to locate precisely on this map, but it seems to be related to a field marked "z". Unfortunately "z" has been overlooked in the schedule associated with this map, so there is no further information on field names or ownership. This field is shown as having no field walls, and having ridge and furrow strips resulting from ploughing. There is also a building marked near the centre of the field, probably a farmhouse.

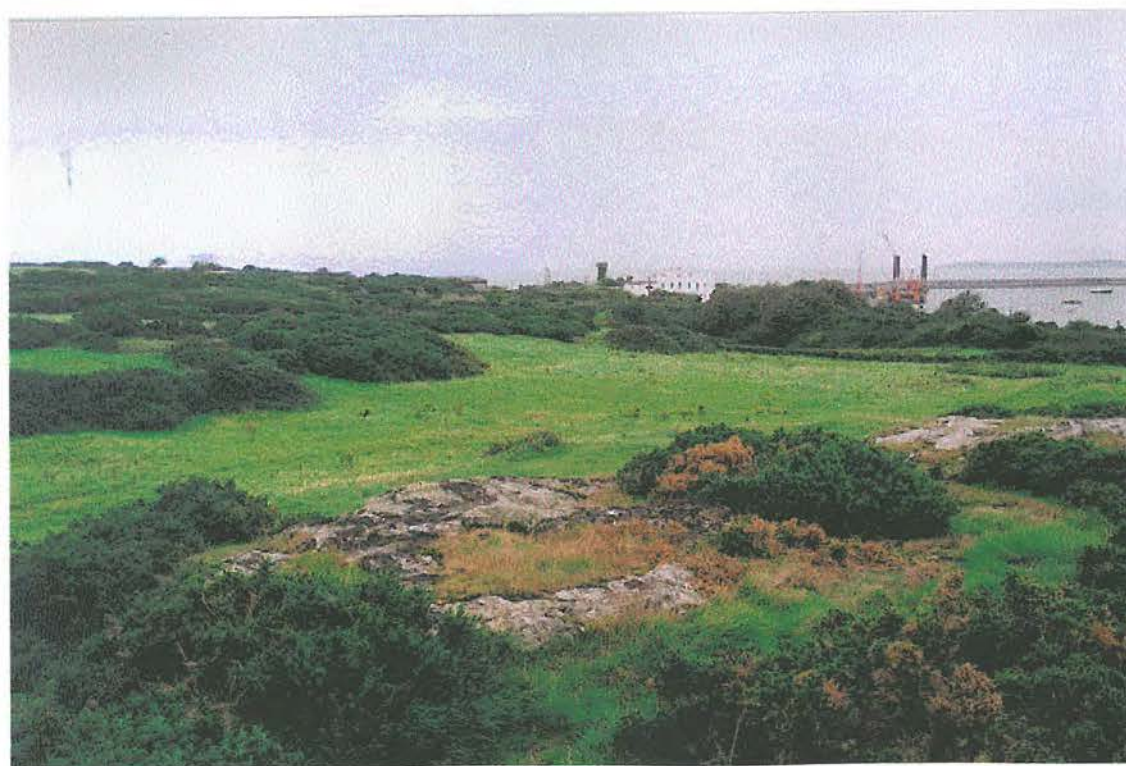
Plate 2. A view of Soldier's Point House from within the study area.

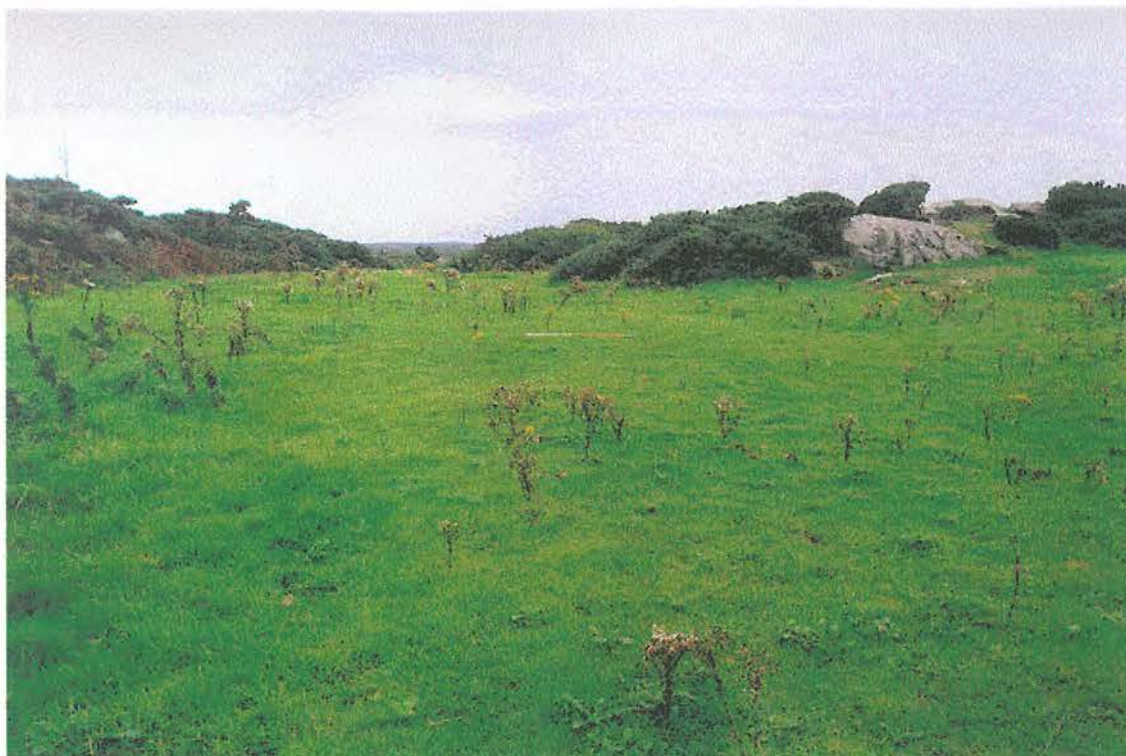
At the south-eastern side of the site a very gentle, straight, linear scarp **(g)** runs between the two rocky ridges, aligned approximately south-east to north-west. The scarp is visible for a length of c.15m, and is 1.7m wide and a maximum of 0.2m high. To the north-west, on the other side of the ridge, is a similar scarp **(h)**, aligned in roughly the same direction. This has a slope c.2m wide, and is poorly defined; being more disturbed than the eastern scarp. The alignment of these scarps is similar to that of the existing north-west to south-east aligned field walls, and both may be remains of the same former field boundary. This assumed boundary was not indicated on most of the maps consulted, but it may be the south-western end of the field marked "z" on the 1769 map. If this is the case traces of ridge and furrow cultivation may be preserved in the north-eastern part of the study area, although these must be very slight as nothing was visible on the surface or on the aerial photographs consulted.

Plate 3. Site 2, linear scarp, looking south-west. The ranging rod lies on the top of the scarp and is aligned along it.

**Recommendations for mitigatory measures:** Basic recording

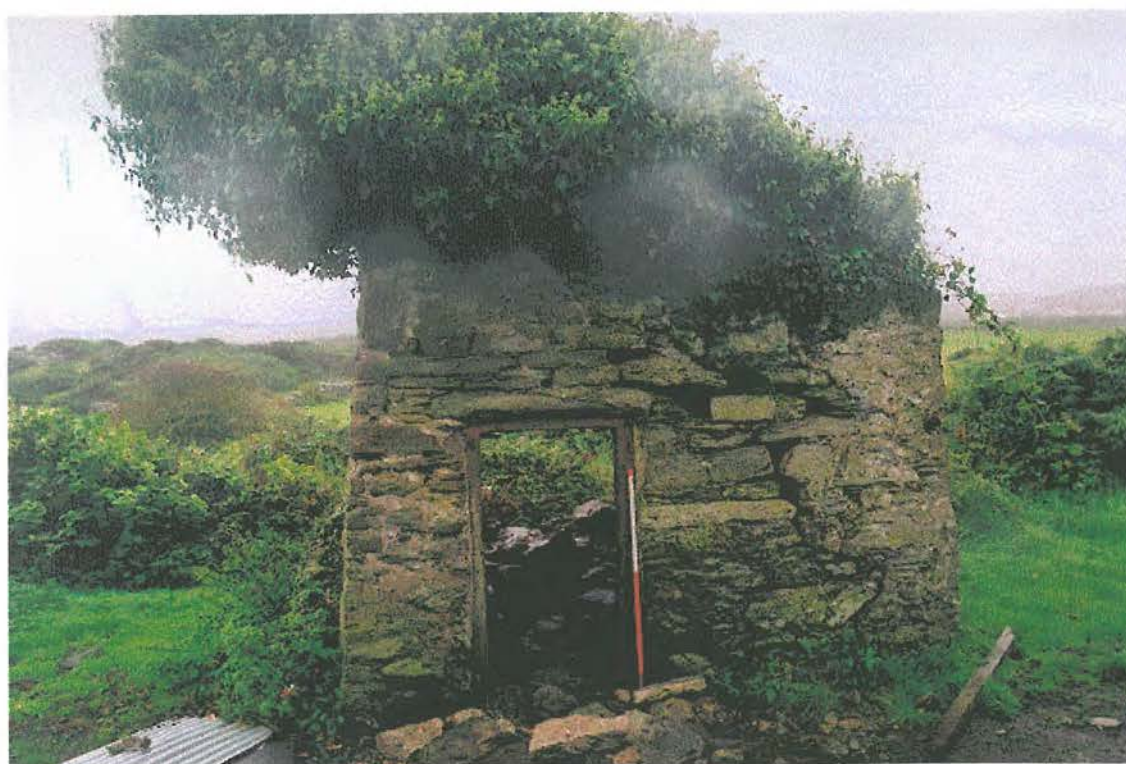
Just outside the study area a group of buildings is shown on the County Series map and the modern OS 1:10,000 map. They survive as heavily overgrown, derelict structures. The main building was too overgrown, and too far from the development area, to be recorded in detail, but a small square structure **(m)**, is located about 10m from the boundary, and was recorded. It is built of local stone, measures 3.1 x 3.1m externally, and lacks a roof, but survives to a height of 2.2m. There is a tiny fireplace and chimney in the southern corner, and a door with a schist lintel in the north-western wall. The structure is well built, with the remains of external plastering. The foundations of a former, broader wall are visible in the base of the north-eastern wall. This building is clearly too small to have been a house, and must have been some sort of outbuilding requiring the heating from the small fireplace.

Plate 4. Small square building at Tref-engan-bach, viewed from the north-west.

**Recommendations for further assessment:** None  
**Recommendations for mitigatory measures:** Avoid

Tref-engan-bach is of potential interest, and would justify further recording if it were under threat. In the present case care should be taken to ensure that it is not damaged accidentally during construction work, or used for the dumping of rubble, etc, which might obscure the remains.
