A470 CARDIFF TO GLAN CONWY TRUNK ROAD: GELLIGEMLYN IMPROVEMENT

INITIAL ARCHAEOLOGICAL ASSESSMENT (G1644)

Report number : 400

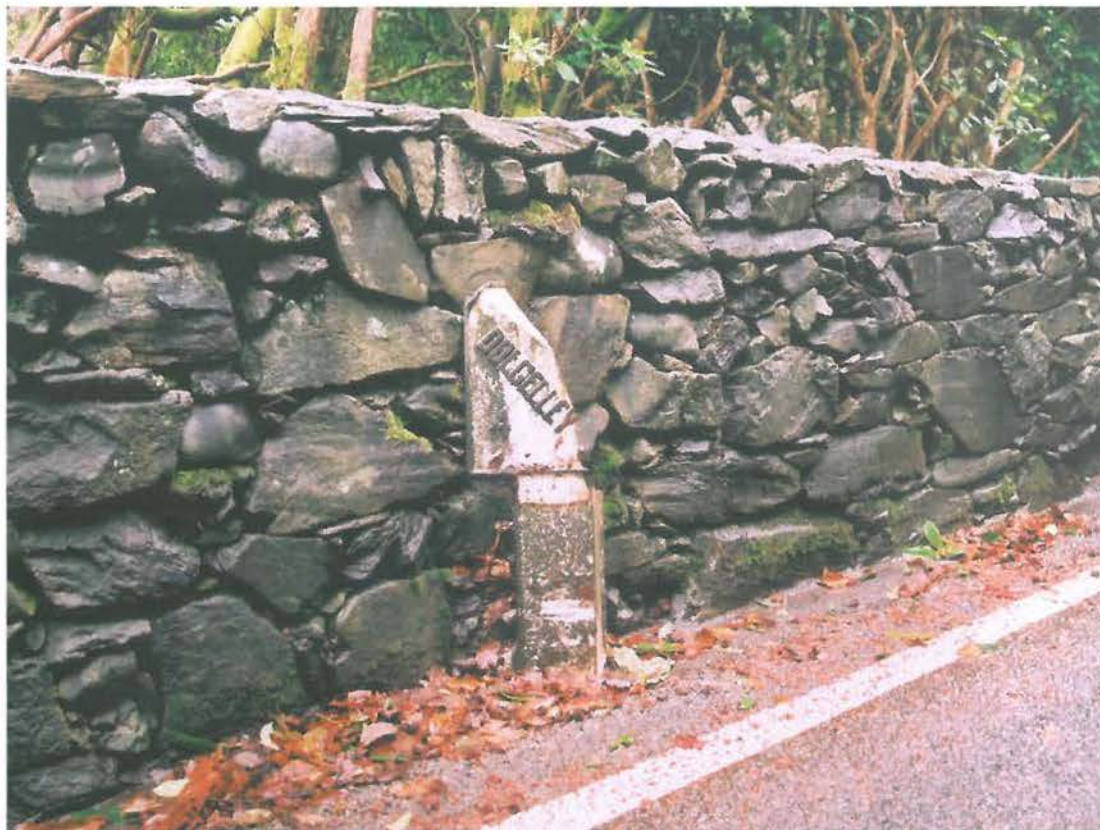
Plate 1. Cast iron milepost (site 11)

A grade II listed structure described as 'A late 19th century cast iron milepost with a triangular profile stands on the east side of the A470. The north face reads 'Dolgelley 4' and the south 'Trawsfynydd 8''. The milepost has been severely damaged in recent years, presumably as a result of a road traffic accident. The upper part has been smashed, one side reading 'Dolgelley 4' is detached but still present. The other side is missing.

Only one of the category A sites, site 11 the grade II listed cast iron milepost, appears to be in the area that will be directly affected by the road improvements within the road corridor. This site is currently in a poor condition. It may be necessary to sympathetically restore and relocate the feature. The other category A sites are occupied dwellings and do not appear to be directly affected.

Recommendation for mitigatory measures: Avoidance and restoration if possible. It may also be possible to remove, restore and sympathetically reinstate this feature. Listed building consent must be obtained before any works commence that are likely to affect this feature.
